Taieri Flood Protection Scheme

Floodbank Risk Assessment

Prepared for
Otago Regional Council

Prepared by
Tonkin & Taylor Ltd

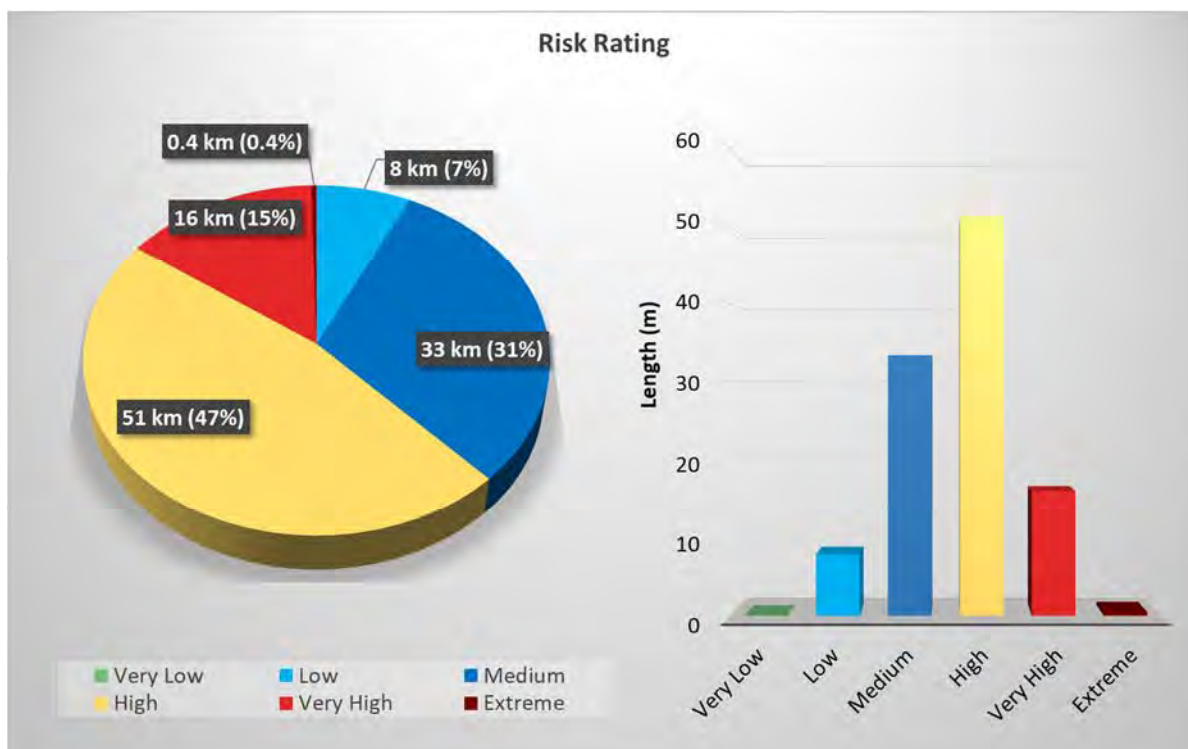
Figure 2: Risk rating summary

Taieri River right floodbank between Outram and Otokia	Catastrophic consequence rating due to PAR >100. Medium or high likelihood rating caused by field condition and capacity/overtopping.
	Taieri River right floodbank downstream of Otokia to Waipori confluence	Moderate consequence rating due to PAR between 2 and 10. Very high likelihood rating caused by field condition and capacity/overtopping.
	Contour Channel downstream Dow Road	Major consequence rating due to PAR between 11 and 100. Low, medium, high or very high likelihood rating.
	Several sections of Taieri River left floodbank upstream of Silver Stream confluence, Silver Stream downstream of Gladfield Road	Moderate consequence rating due to inundation of McKays Triangle Wetland. High or very high likelihood rating due to overtopping.
Medium Low Very low	Contour Channel upstream of Dow Road	Reasons vary along sections. Consequence rating either insignificant, minor or moderate. Likelihood rating vary from very low to very high.

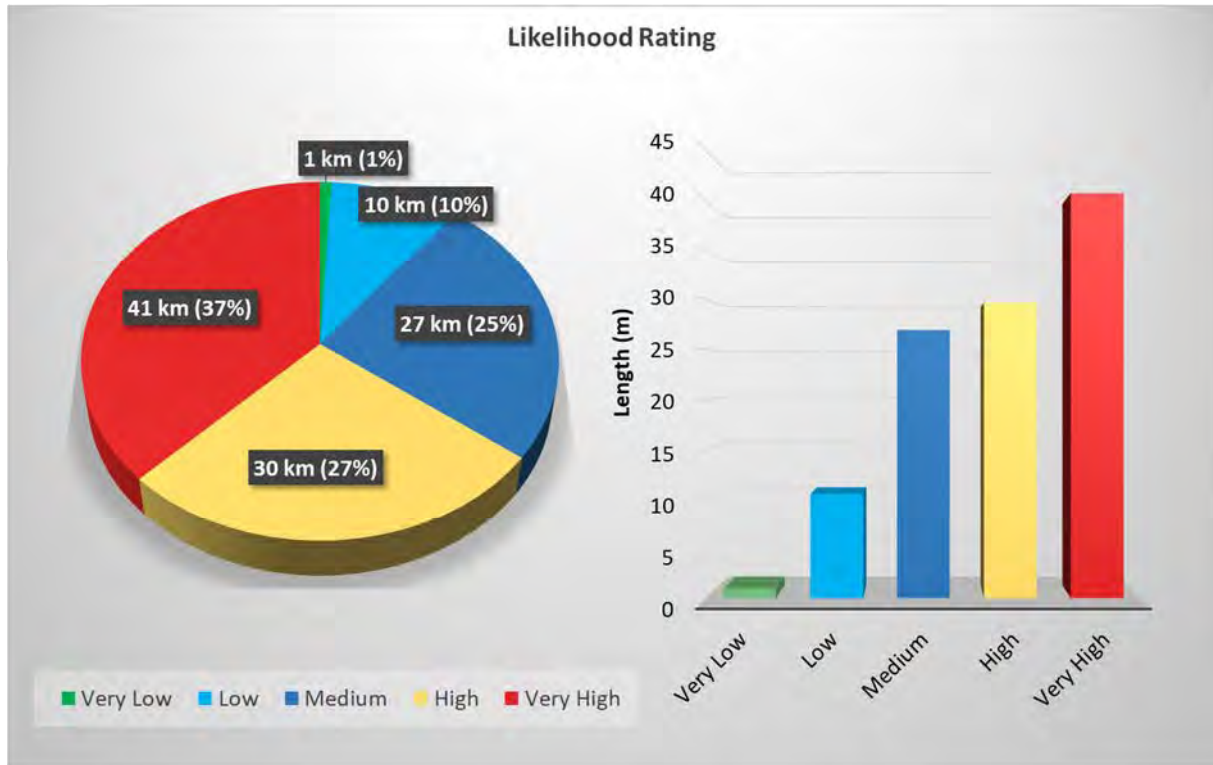
Figure 9: Likelihood rating summary

Figure 9 shows that 71 km (64%) has a high or very high likelihood rating. This means that based on the three failure modes (field condition, intrinsic strength, and capacity), the likelihood of failure is high or very high during the specified design flood event. The remaining floodbank sections have a medium or lower likelihood rating.

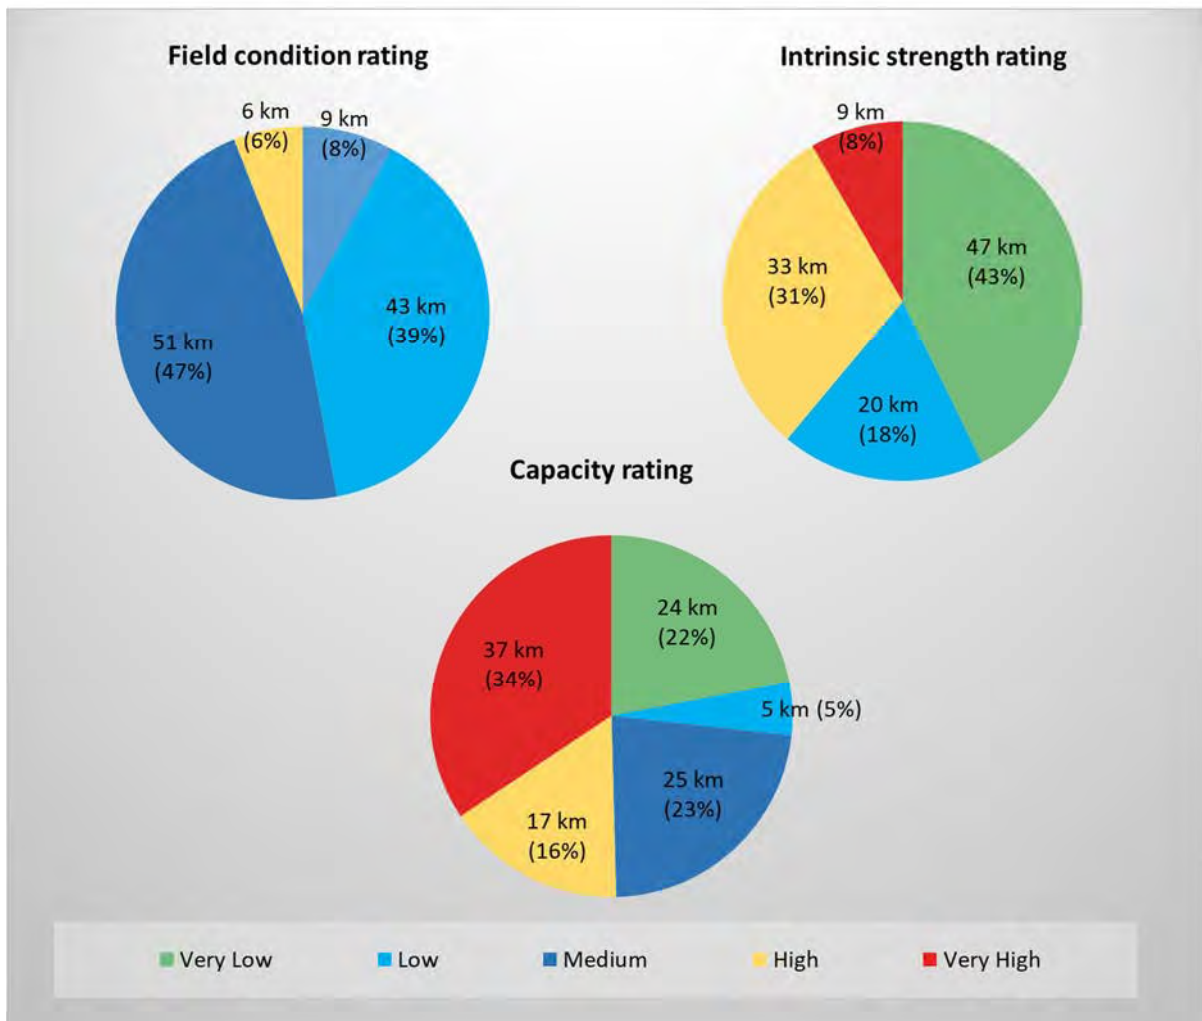
Figure 10: Likelihood rating summary breakdown

The reasons for the different likelihood ratings along the floodbank vary. Figure 10 shows the likelihood rating for the three failure modes.
