MEMORANDUM

To: Tom De Pelsemaeker – Team Leader, Freshwater and Land
From: Brodie O’loughlin – Senior Environmental Officer
Date: 13/03/2024
Re: NESCF Compliance and sedimentation issues in Otago

This memo presents information and examples of National Environmental Standard – Commercial Forestry (NES-CF) compliance matters within Otago that have contributed to sedimentation issues.

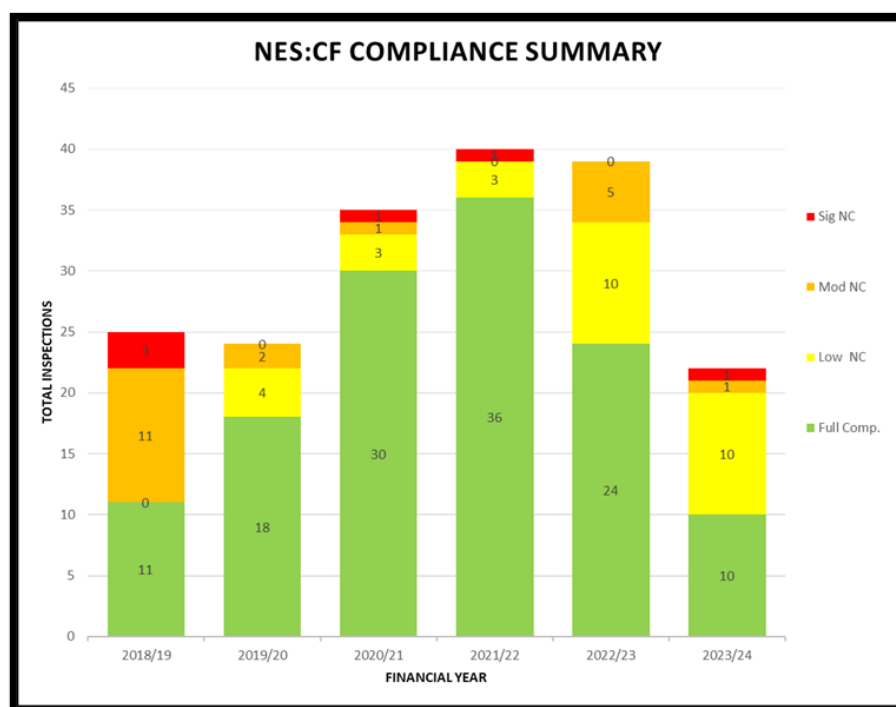
Figure 1: Summary of NES:CF compliance within Otago – (data as of November 2023)

Figure 1 shows the number of NES-CF audits undertaken within Otago since its implementation in 2018, providing a range of compliance gradings over each financial year as of November 2023. A total of 199 audits have been completed during this timeframe, 56 of these resulting in non-compliances. Nearly half of non-compliances relate to stabilisation and/or stormwater control issues – almost a third were identified as having noticeable sedimentation issues.

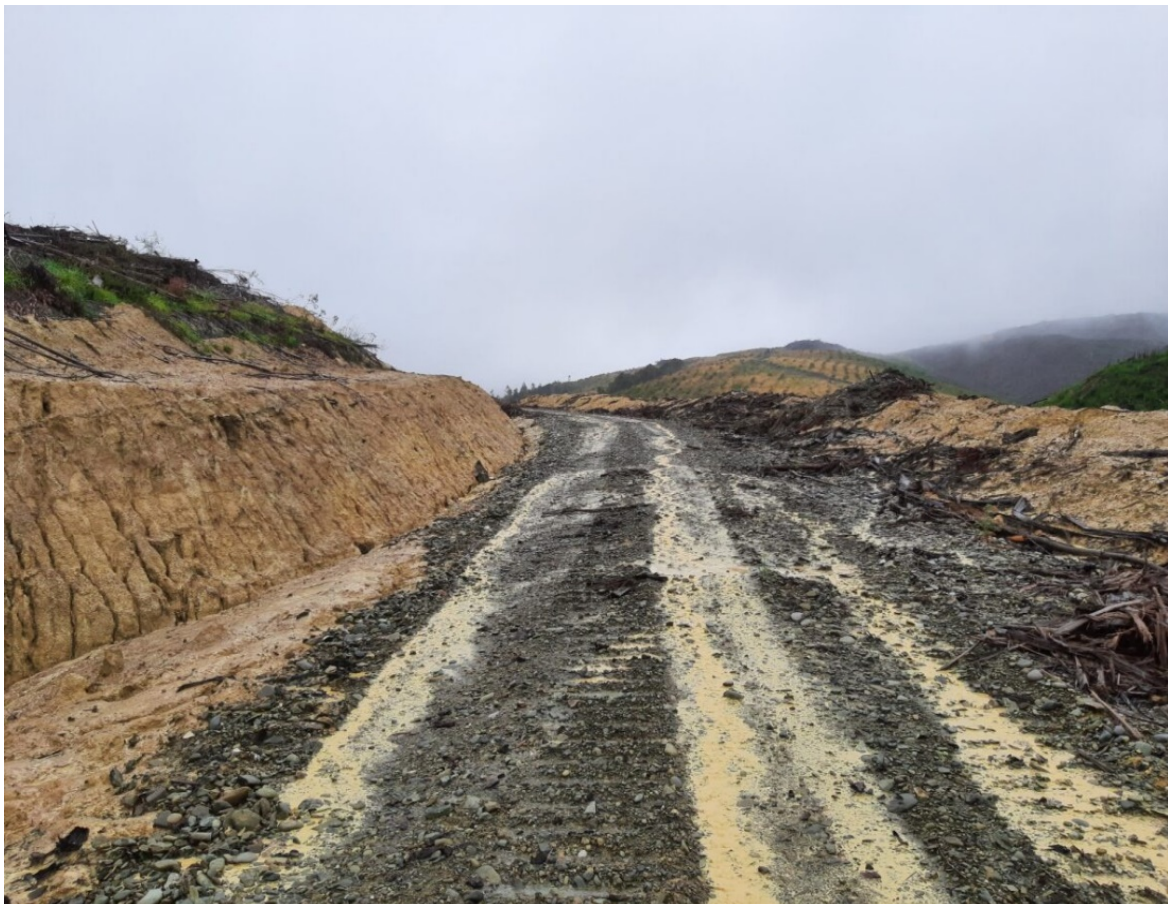
The spoil material placed on the side of the road was non-compliant with NESCF Regulation 30 (2(d)) – being deposited onto land in circumstances that may enter water, NESCF Regulation 31(2) – Sediment control measures not maintained and NESCF Regulation 32 – exposed areas of soil not being stabilised. However, the banks that had been compacted and stormwater controls in place would likely have been compliant with NESCF Regulation 31 and 32 at the time of installation, despite not being fit for purpose.

Image 1: Haul road within the forestry block: (Left side) material from road construction has been compacted but has not achieved adequate stability due to erosion. (Right side) Spoil material is sitting on side of road un-stabilised; slash appears to have been used as mulch in some areas but ineffective.

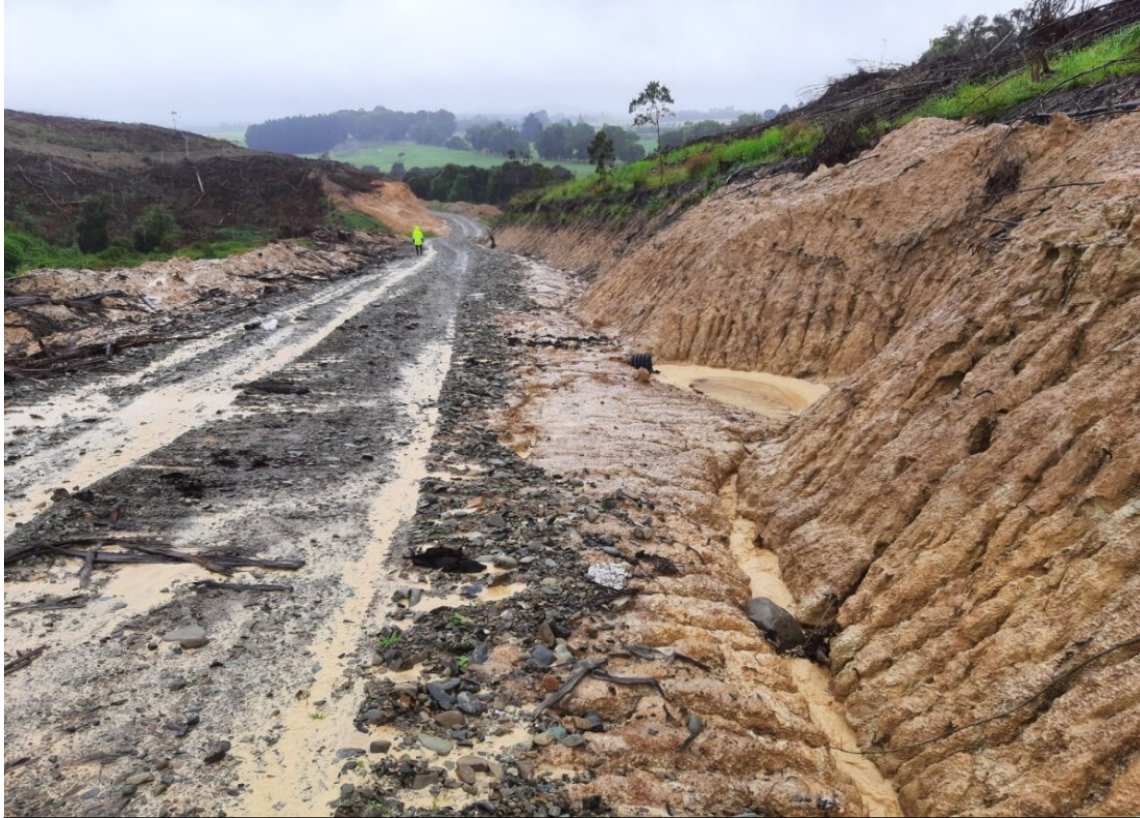
Image 2: Downhill of haul road: (Right side) Water table with stormwater containing substantial amounts of sediment within it. A sediment trap is located before a culvert pipe before discharging to the receiving environment – sediment exposed above the waterline would suggest this trap required maintenance

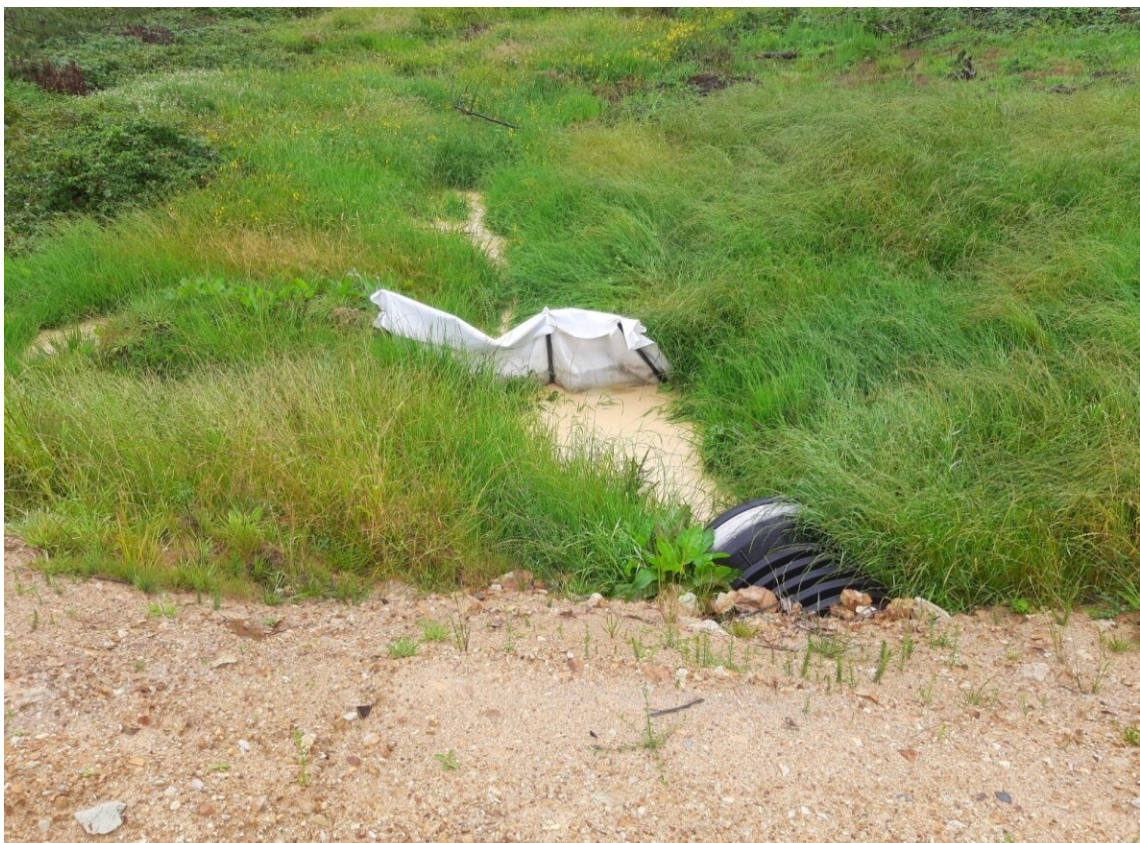
Image 3: Discharge point from culvert: Silt fence is placed at the outlet as further stormwater control – clarity of water is still poor beyond the silt fence.

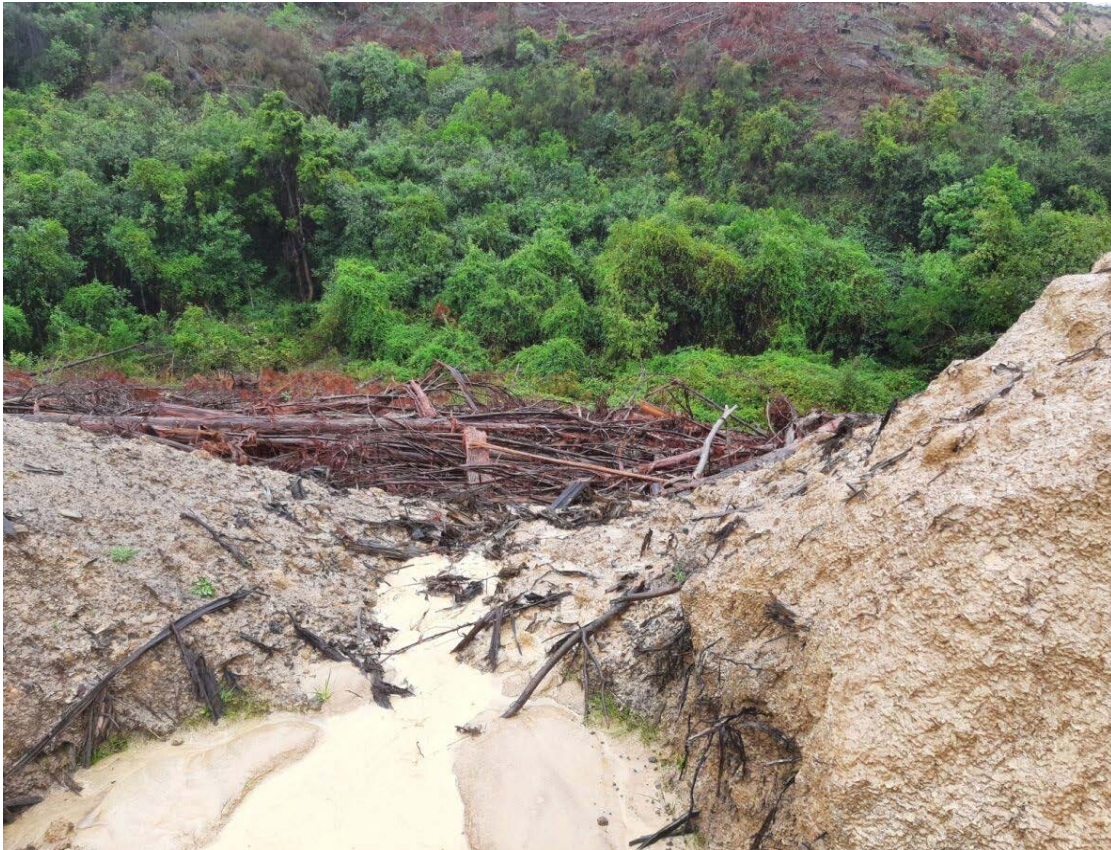
Image 4: Discharge point from Haul road's water table: Flow is being dispersed into slash as a filtration method and into native forest

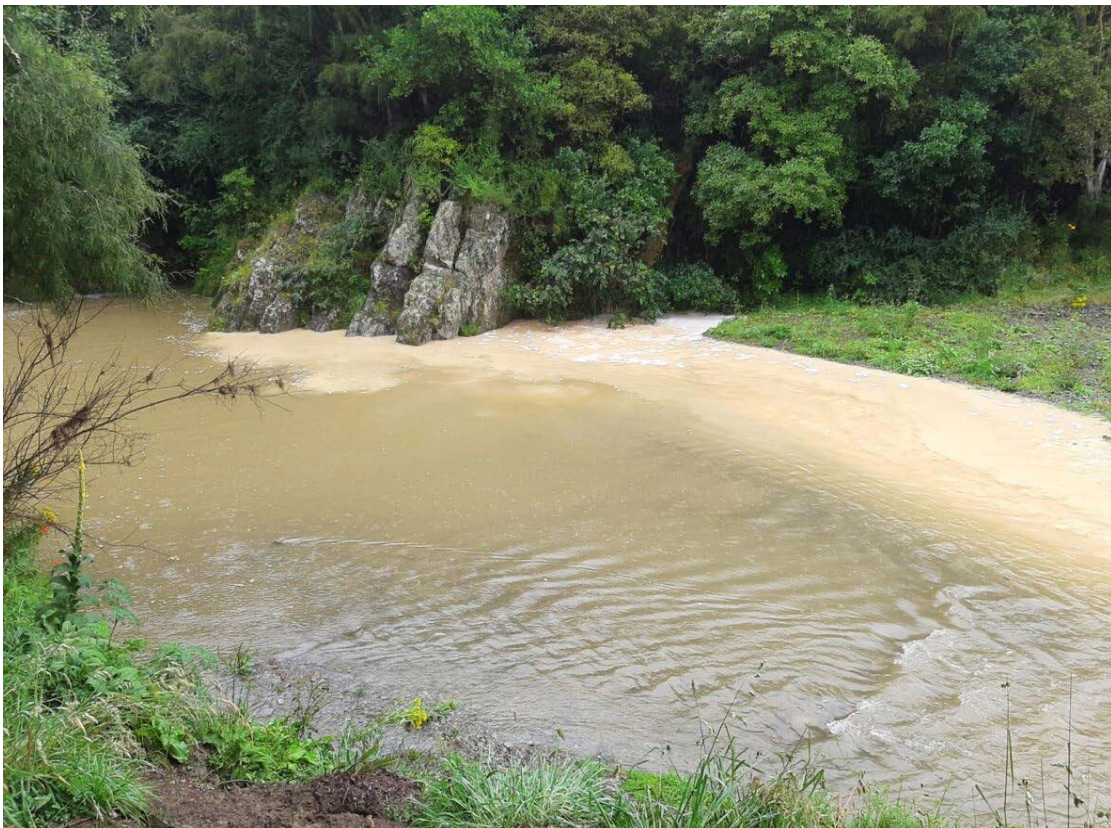
Image 5: Discharge point to Wainakarua river: Discharge coming from the forestry block

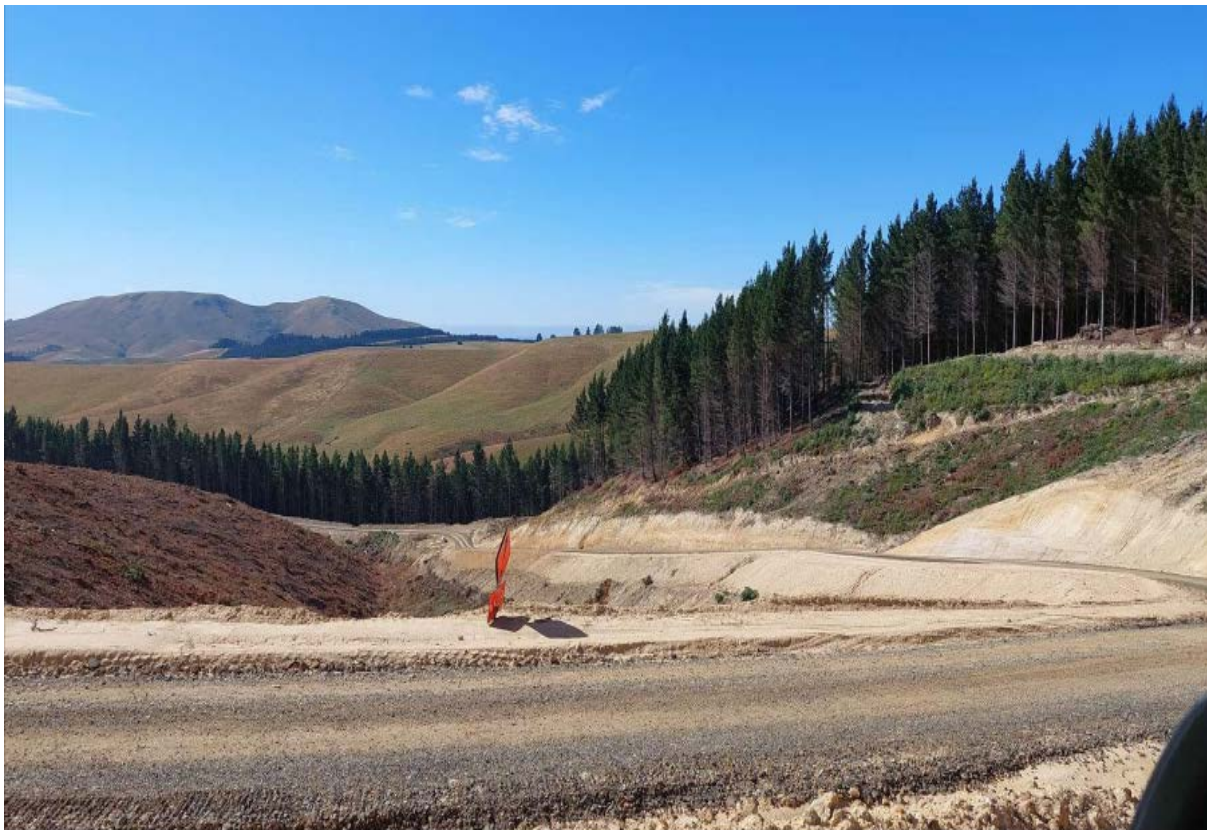
Image 6: Haul road up-hill from sediment discharge: Cut faces from road construction are battered and compacted, side-cast/fill material has been compacted and appears to be placed on

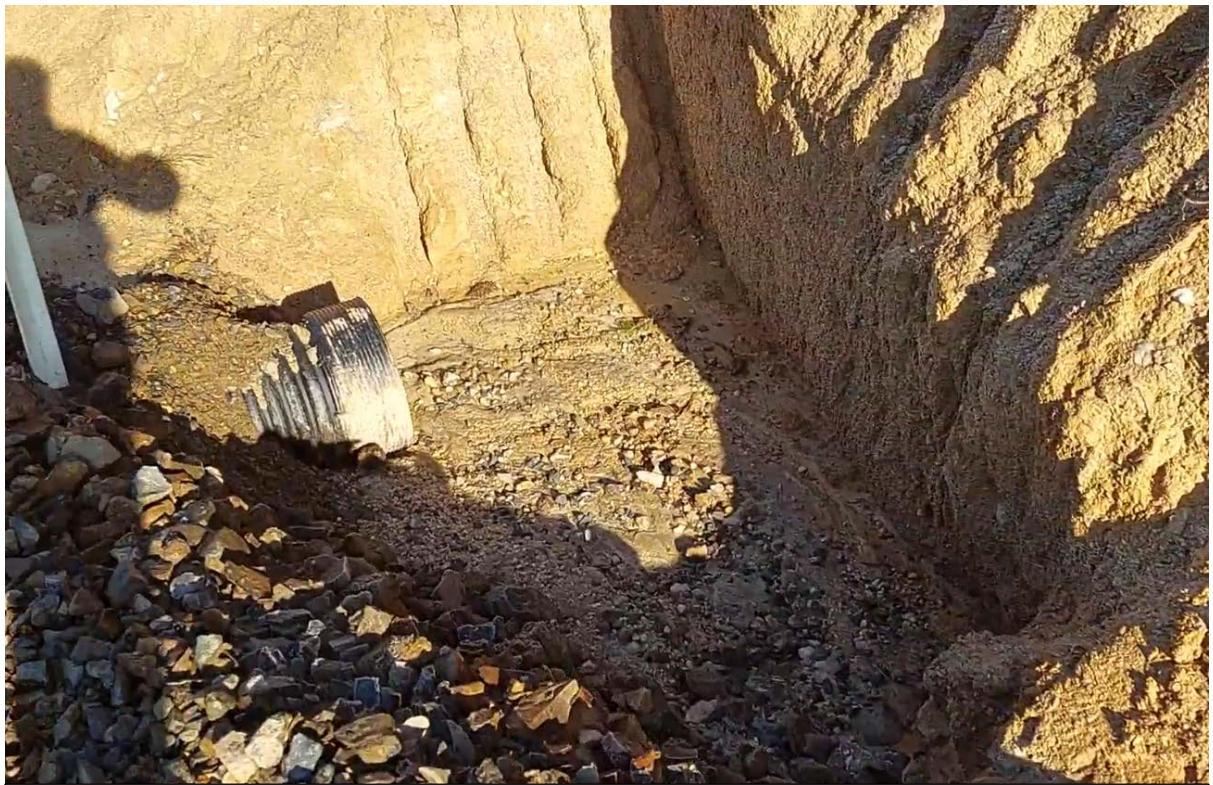
Image 7: Large sediment trap – inundated with sediment from weather event.

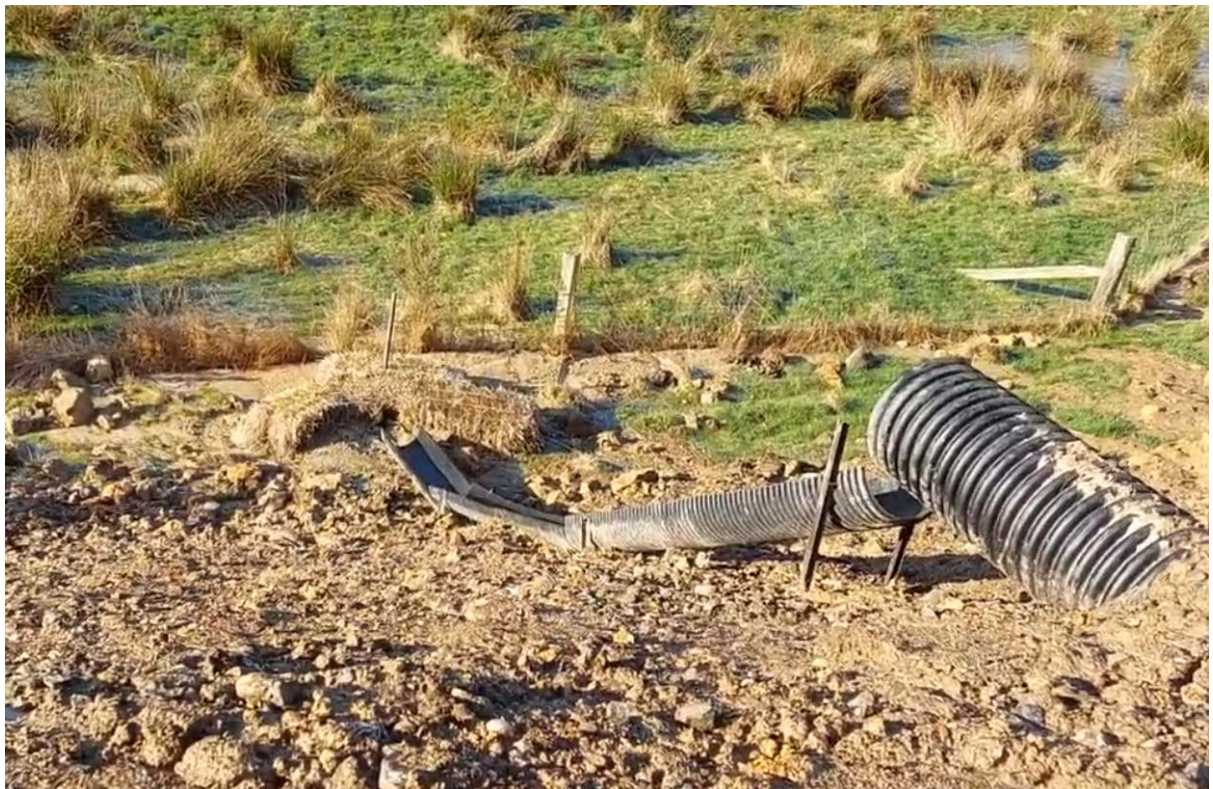
Image 8: Stormwater flume discharging to a sediment trap with hay bales – sediment controls have been inundated with sediment and is overflowing.

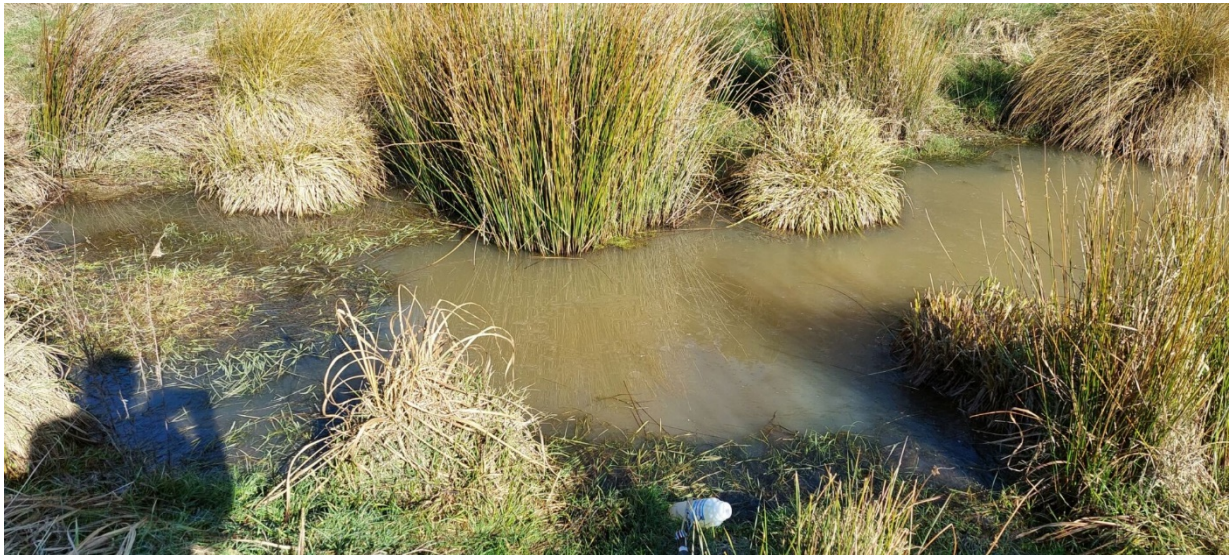
Image 9: Downstream from the overland flow of sediment – river has become discoloured from sedimentation.

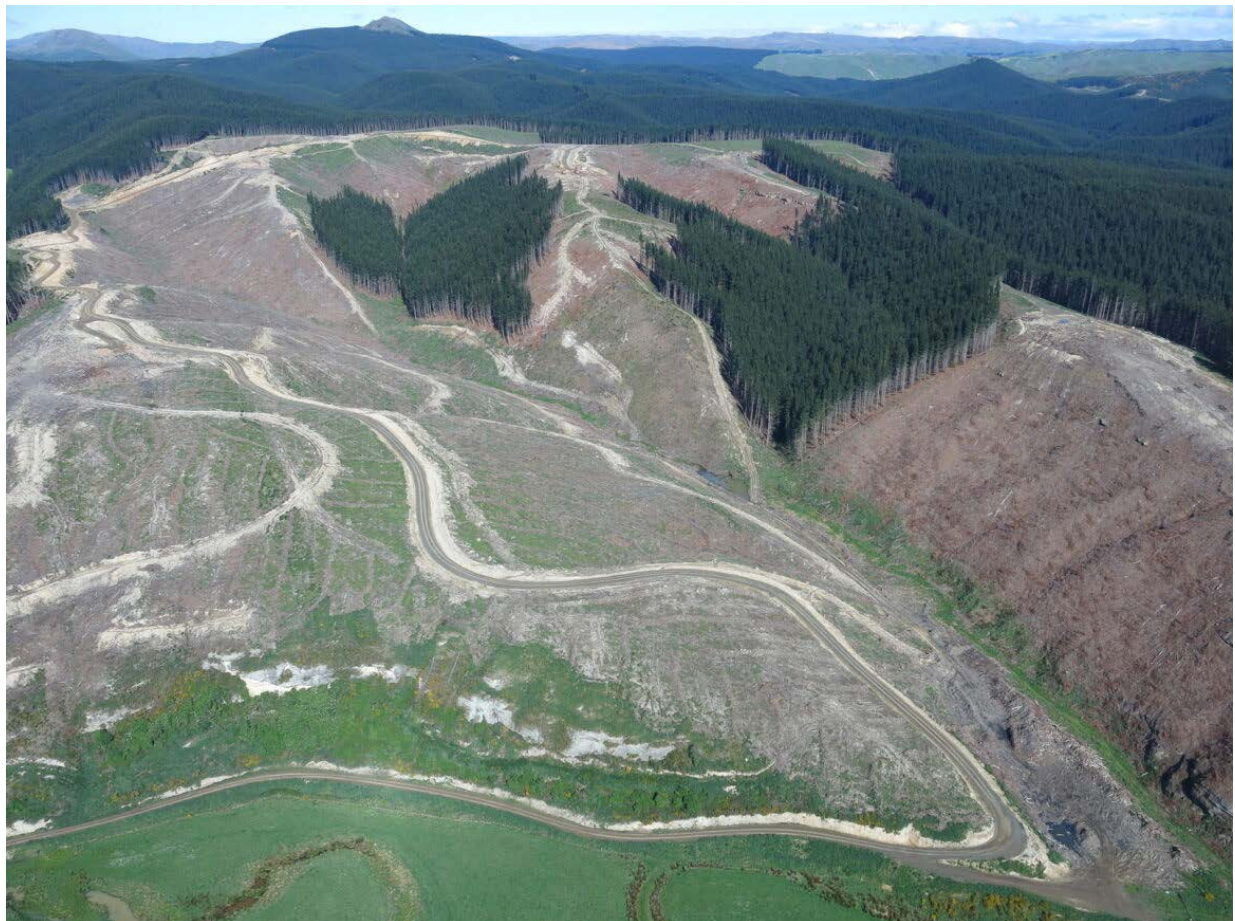
Image 10: Post discharge event (approx. 18 months) – Gradient of road from aerial footage. Point of discharge was located at the bottom right road bend of image

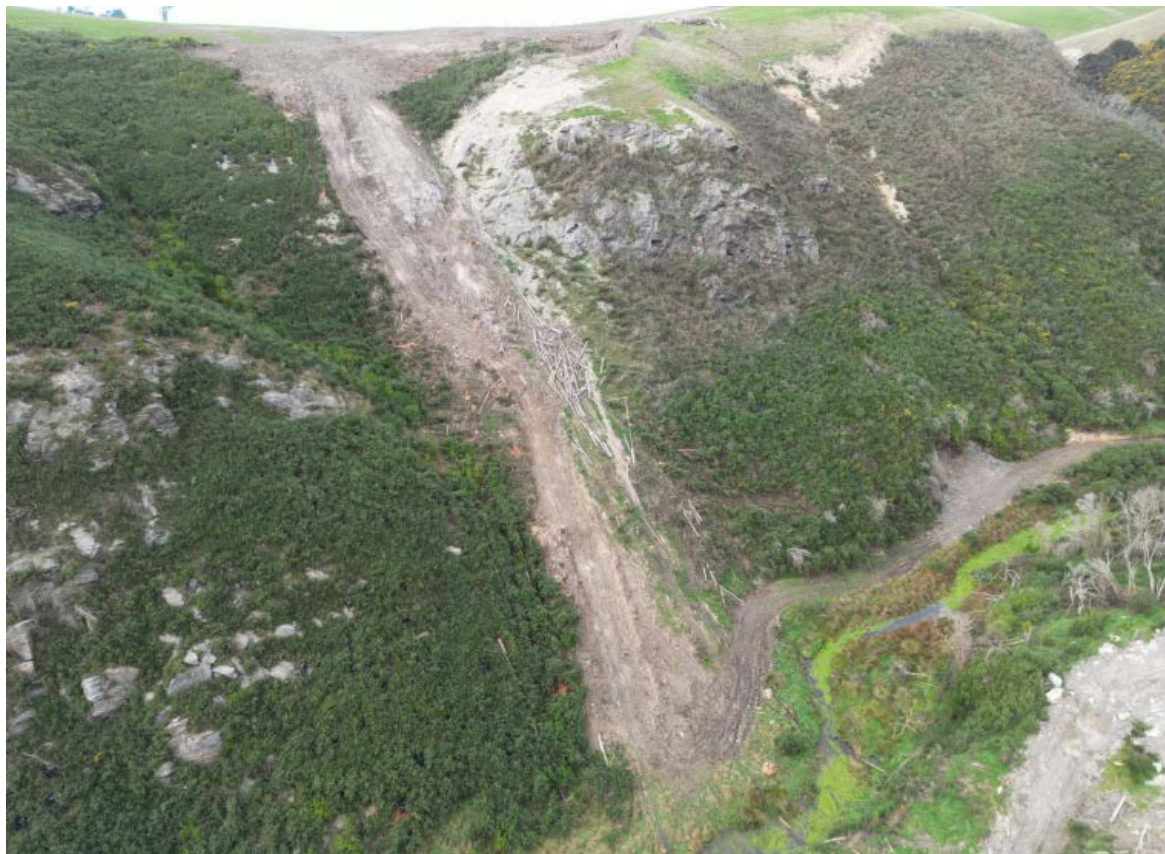
Image 11: Scoured bank from cable hauling activities: Trees have been dragged up the hillside face

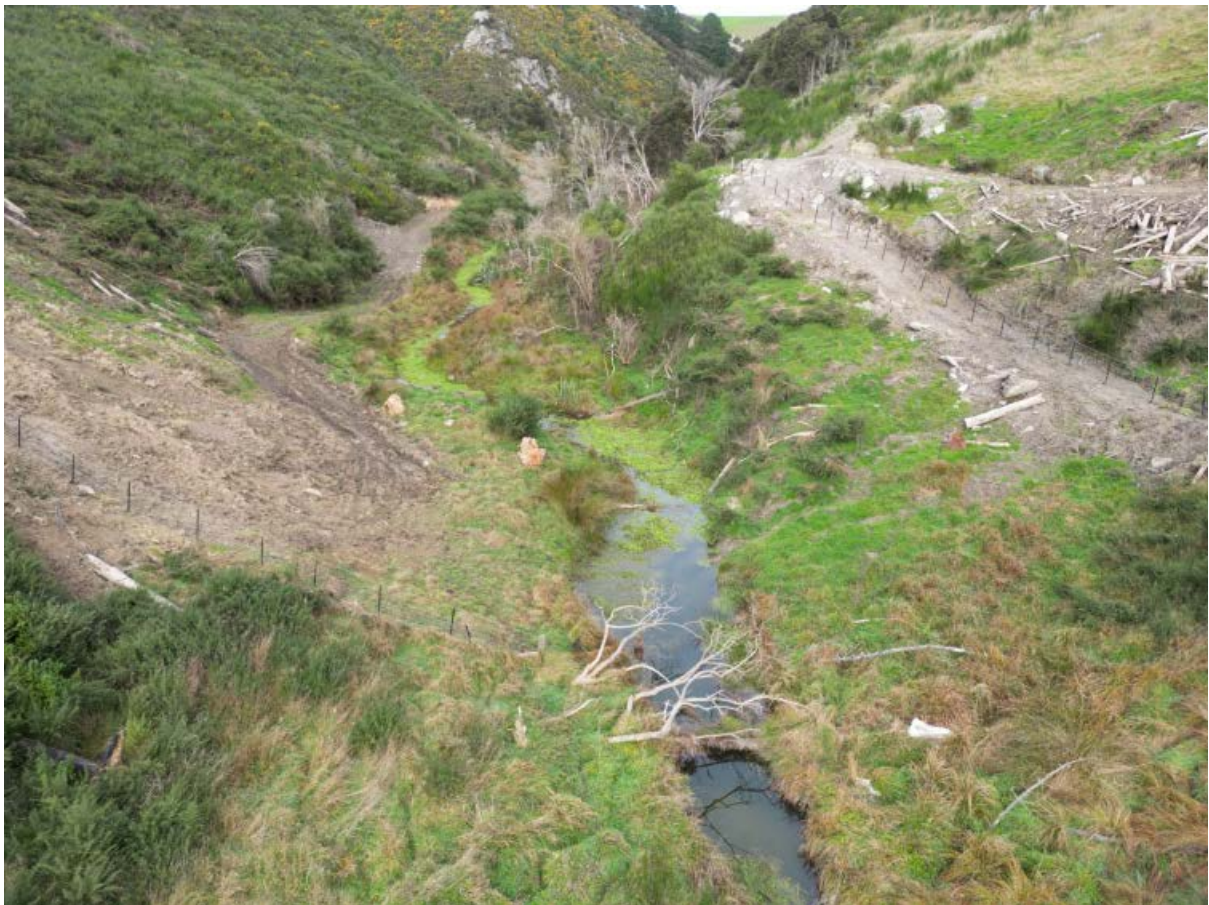
Sediment was identified to be discharging into the waterway, primarily sourced from the roading that was in close proximity to the river (refer to images 13 and 14). The roading/tracking was concluded to be compliant with NESCF Earthworks setbacks due to the works being an upgrade of existing tracks – as permitted by NESCF Regulation 29(3(c)). The roading and scoured hillside however was non-compliant with NESCF Regulation 31 – Sediment and stormwater control measures and NESCF Regulation 32 – Stabilisation.

Image 13: Watercourse between cable hauling points - Tracking from activities has not been stabilised or controls put in place

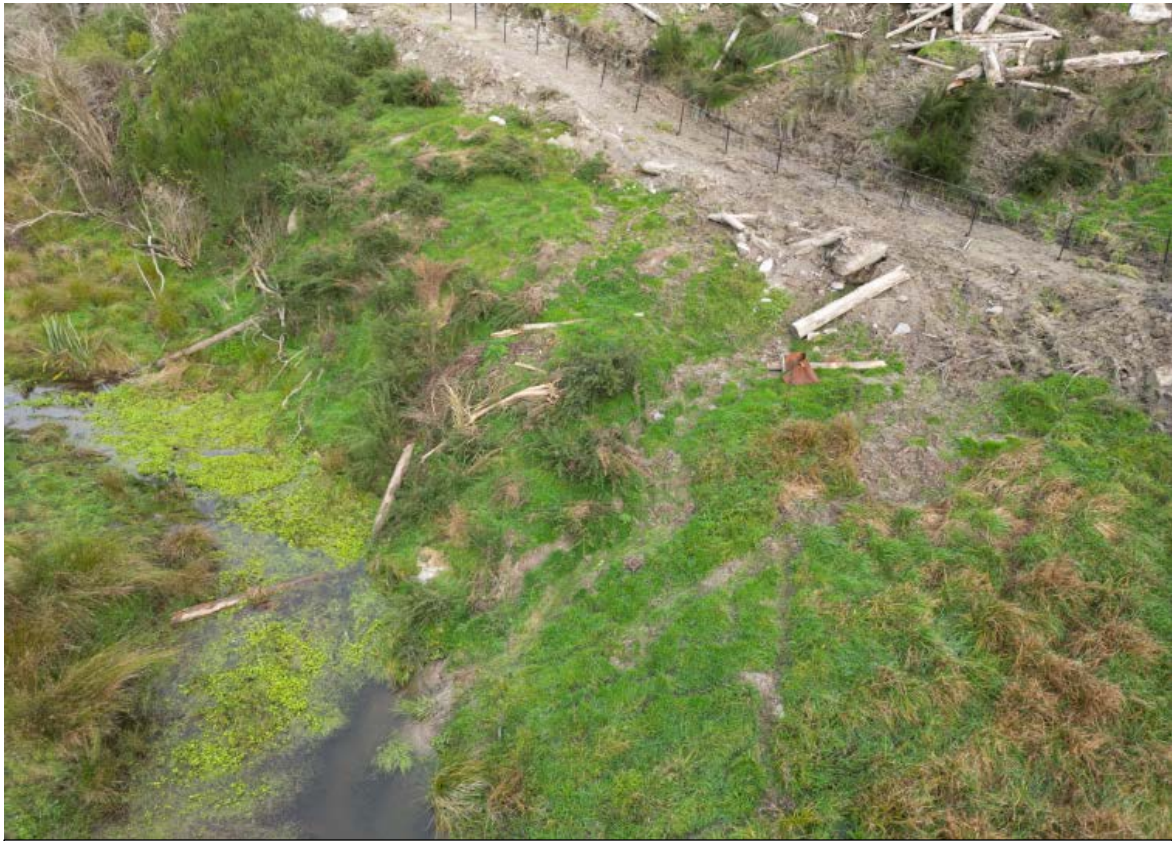
Image 14: Sediment running into river due to no stabilisation and controls

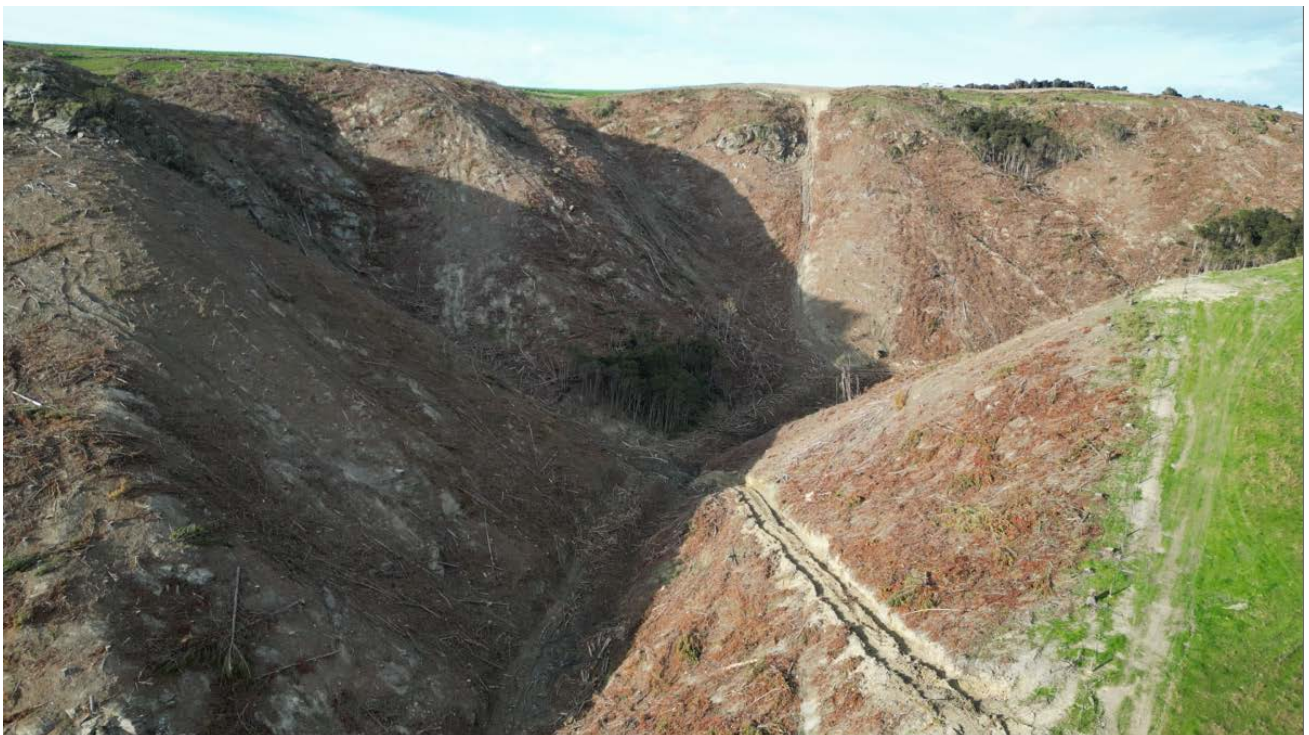
Image 15: Section of harvested block where trees were felled and cable hauled to the top of the gully. Trees are then transported as shown in Images 11 and 12.
