Document Id: A801392

Report Number: 2015/1008
Prepared For: Technical Committee
Prepared By: Michael Goldsmith, Manager Natural Hazards
Jean-Luc Payan, Senior Investigations Engineer
Rebecca Morris, Groundwater Scientist
Chris Valentine, Manager Engineering
Scott MacLean, Manager Operations
Lu Xiaofeng, Resource Scientist Hydrology
Nineva Vaitupu, Senior Environmental Data Officer
Ben Mackey, Natural Hazards Analyst

Date: 8 July 2015

Subject: **Coastal Otago Flood event 3 June 2015**

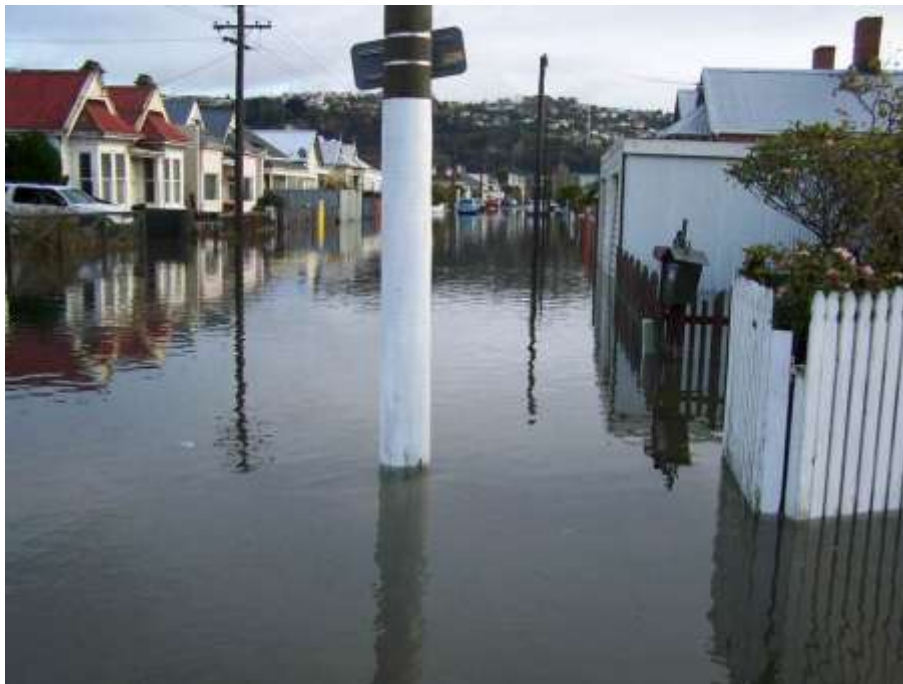
Figure 10. Ponding of surface water on Loyalty Street, South Dunedin, 4 June 2015

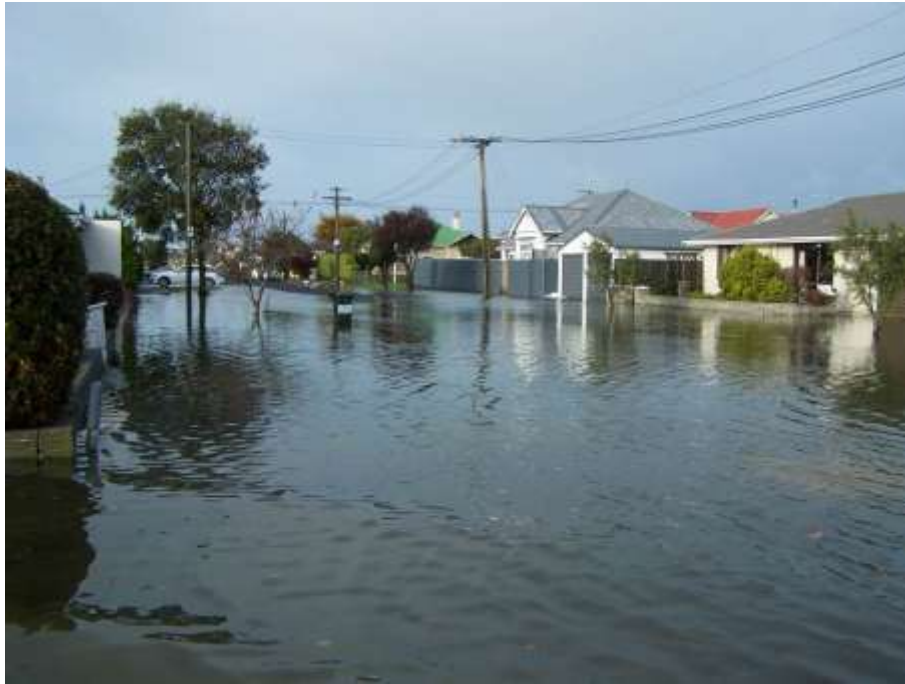
The South Dunedin area was affected by widespread and prolonged flooding as a result of the rainfall which fell on 3 June. ORC staff undertook a reconnaissance trip on the morning of 4 June and observed water was still ponding across much of this area, as illustrated in Figure 10 to Figure 12. This inspection indicated that the area bounded by King Edward Street, and Hillside, Prince Albert, Victoria and Forbury roads had been most affected, with little sign of inundation further east.¹³ It is noted that the lowest part of South Dunedin at Tainui is known to have been affected by floodwater previously, as shown in Figure 13. Considerable localised variability in water depths was observed on 4 June, depending on slightly undulating local topography (e.g. Figure 11).

Figure 11. Ponding of surface water on Dalgety Street, South Dunedin, 4 June 2015

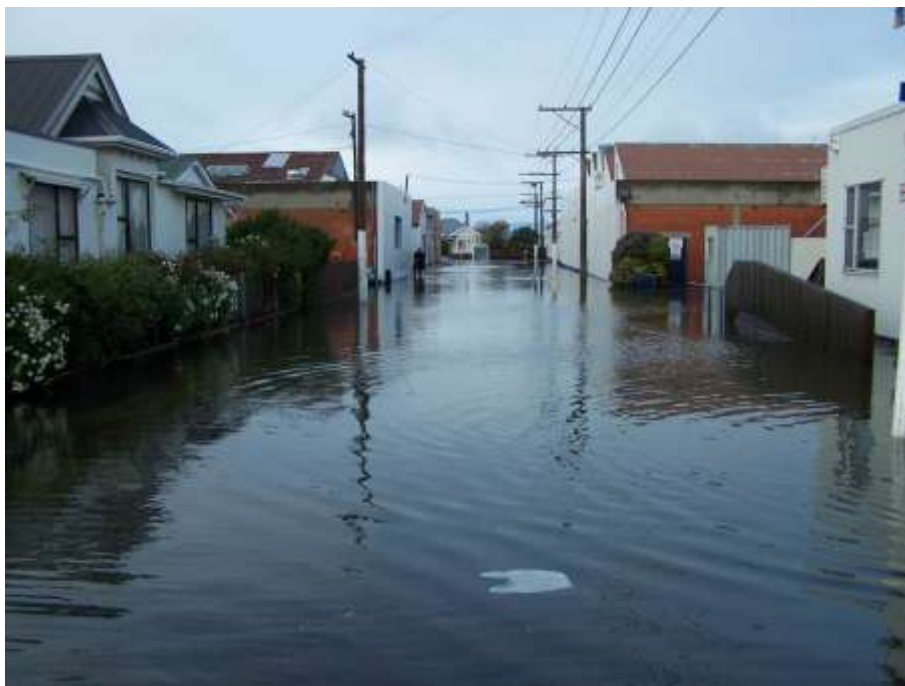
Figure 12. Ponding of surface water on Bradshaw Street, South Dunedin, 4 June 2015

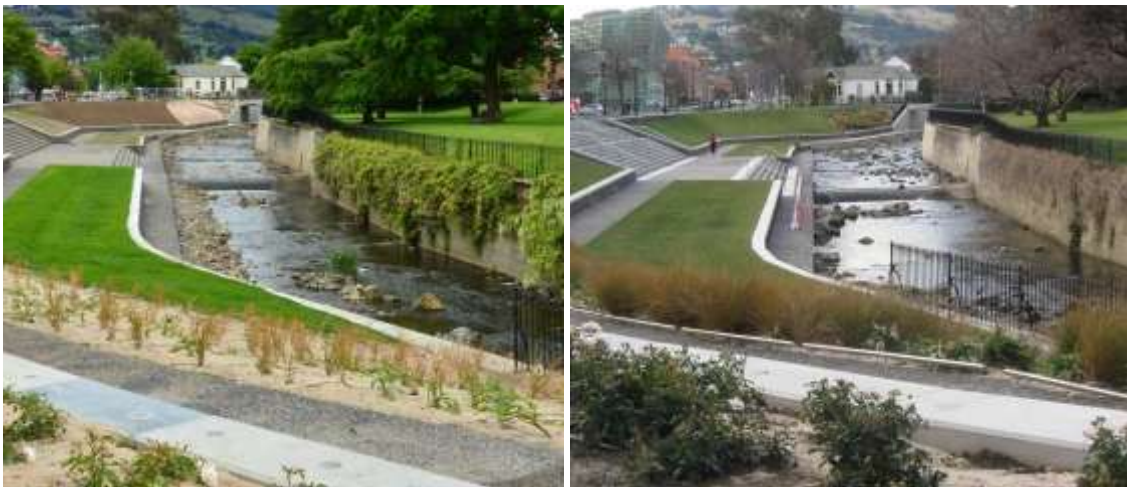
The recent flood protection upgrade between St David St to Union St performed satisfactorily. There was no damage to the left bank. On the right bank riprap has been scoured away over a 100m length of the recently completed lower right bank pathway (Figure 25). The riprap lost over the lower 38 metres has resulted in a fall height greater than 1m from the walkway to the river bed. Options are being evaluated to remediate the fall height, for the interim access has been restricted by a barrier to eliminate the fall risk. Hydraulic loadings to the balustrades, compounded by significant build-up of debris, resulted in failure of the fixings to the concrete foundation. This failure has been attributed to a construction defect rather than design deficiencies, these defects have been remedied by the contractor. The turf and botanical plantings withstood the event with minor remediation and clean-up requirements.

Figure 25. Water of Leith before and after – looking upstream from near the Staff Club. Note the loss of some riprap on the true right bank.

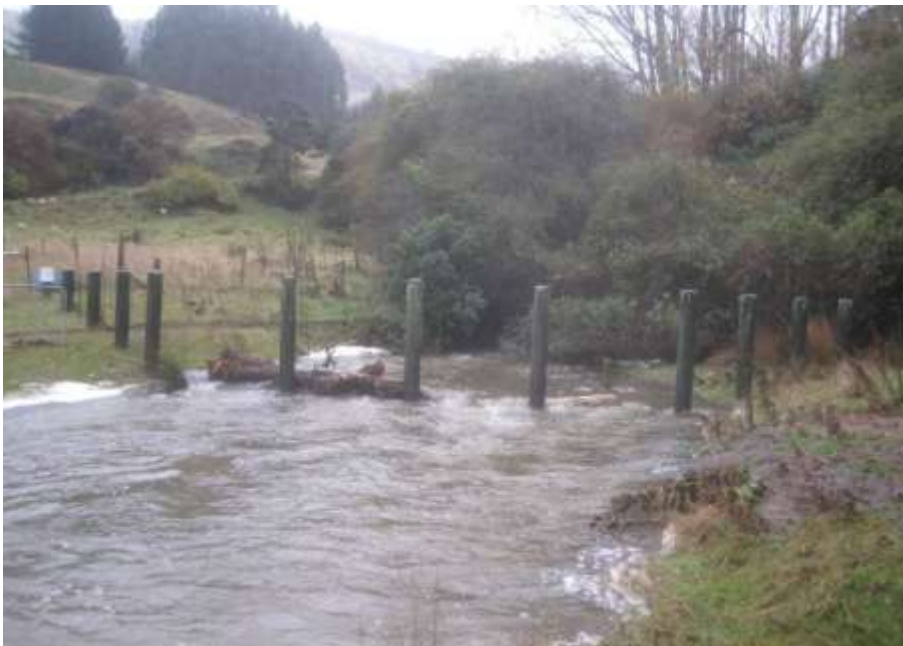
The Lindsay Creek debris trap caught what little material came down to that point (Figure 27). Numerous sections of Lindsay Creek experienced significant bank erosion, as shown in Figure 28 to Figure 30.

Figure 27. Lindsay Creek debris trap at Bethunes Gully during the event, 3 June 2015

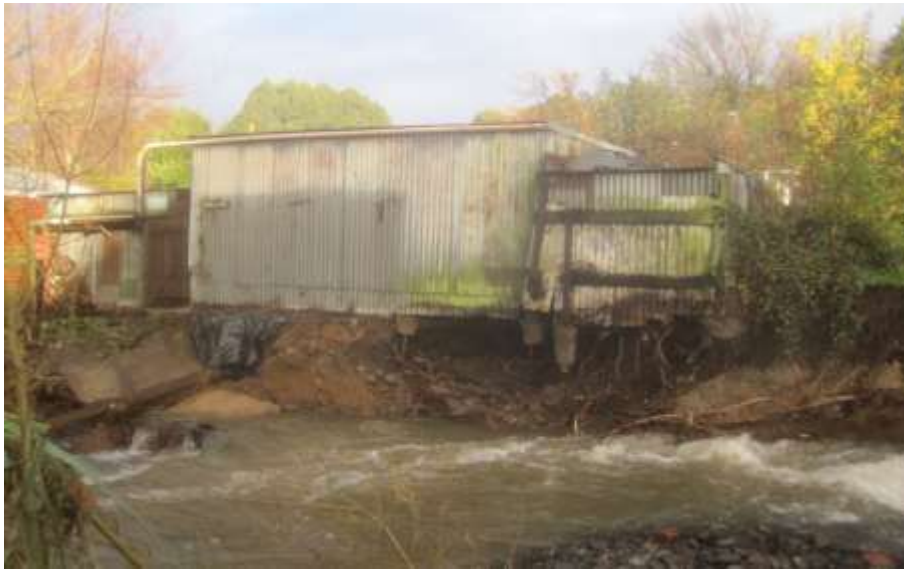
Figure 28. Bank erosion undermining a shed alongside Lindsay Creek at Kelvin Road, 4 June 2015

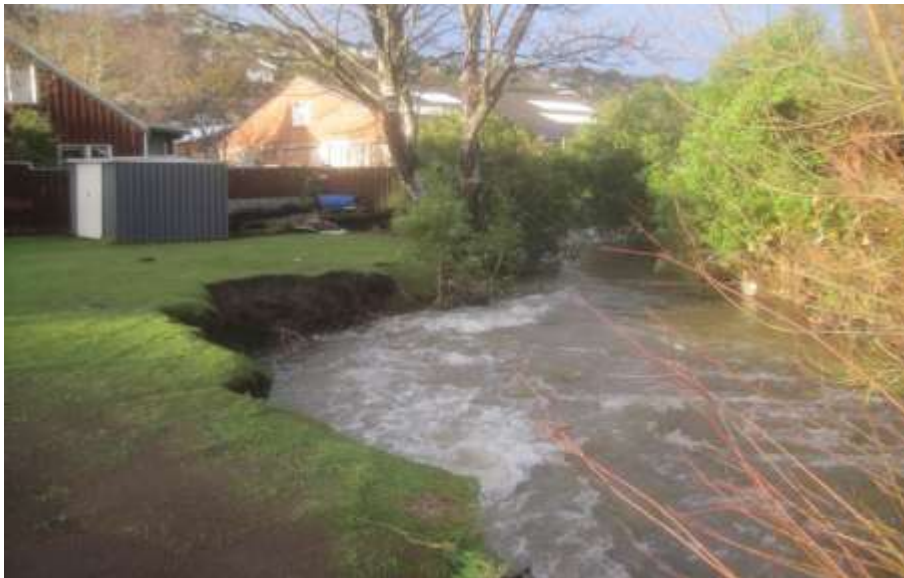
Figure 29. Bank erosion alongside Lindsay Creek at Kelvin Road, 4 June 2015

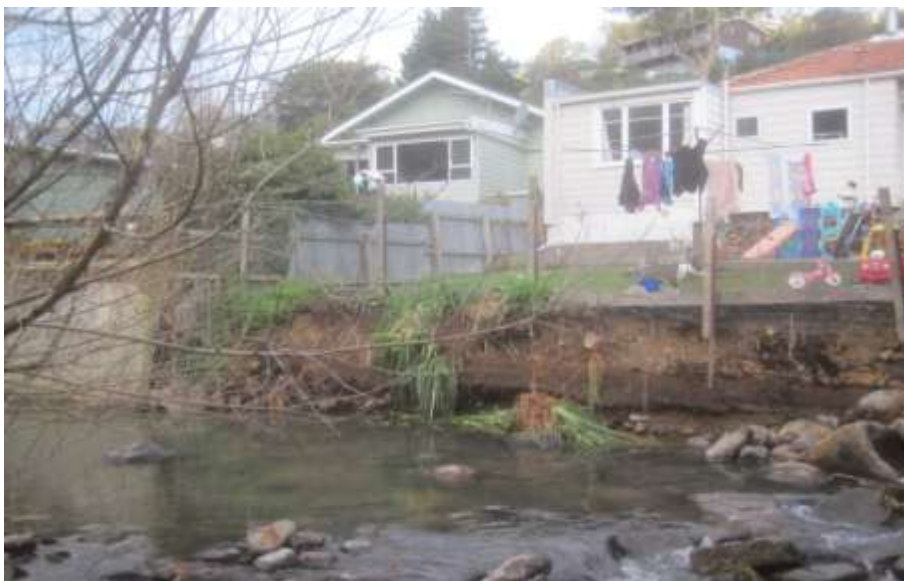
Figure 30. Bank erosion alongside Lindsay Creek at Norwood Street, 4 June 2015

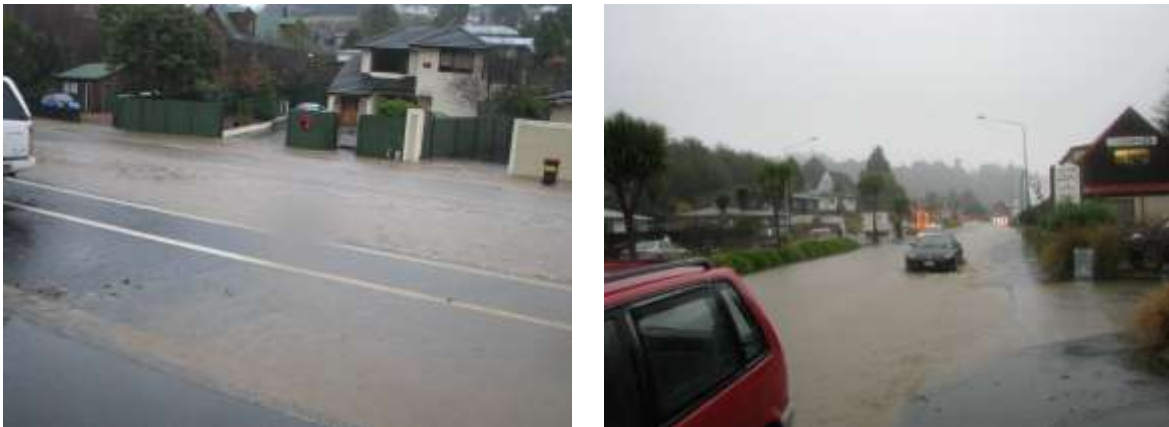
Figure 31. Examples of surface flooding on Kaikorai Valley Road, midday on 3 June 2015

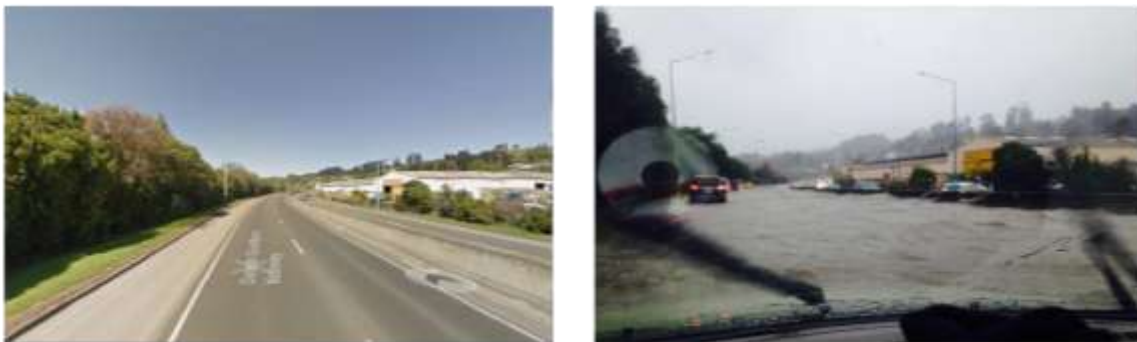
Figure 32. The northbound lane of the Dunedin Southern Motorway, east of the Carnforth Street underpass. Left: normal conditions (Google StreetView), Right: During the peak of flooding at approximately midday on 3 June.

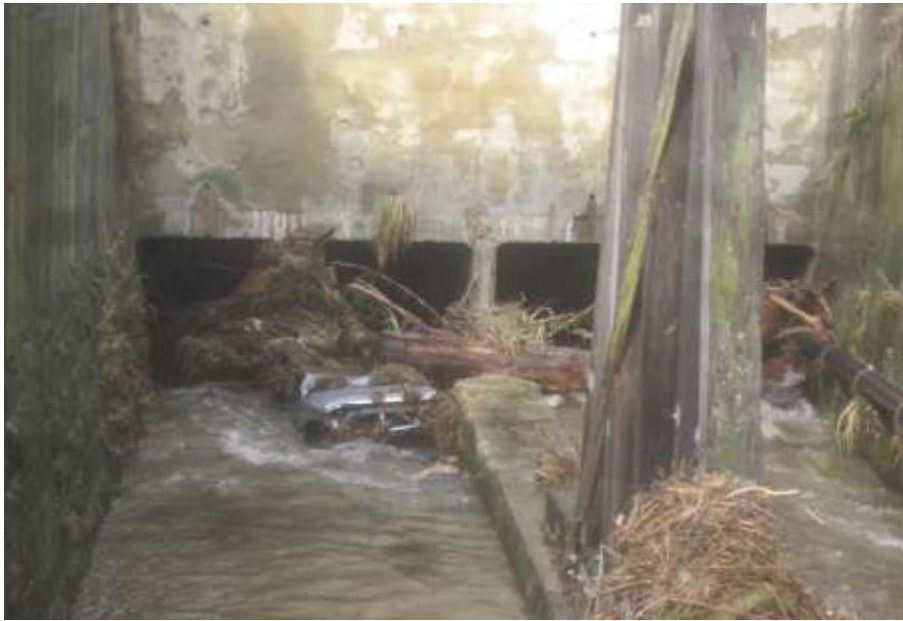
At 12:30pm, a car and tree were reported in Kaikorai Stream, wedged in an NZTA box culvert under SH1 at Burnside (Figure 33), with a tree and other debris further upstream, caught up under a bridge (Figure 34). NZTA's contractor was contacted by ORC operations staff but was unable to remove the blockage in a timely manner because of other priorities. All blockages were removed by ORC staff by 4:35pm.

Figure 33. Car and tree lodged in culvert beneath SH1 at Burnside, 3 June 2015

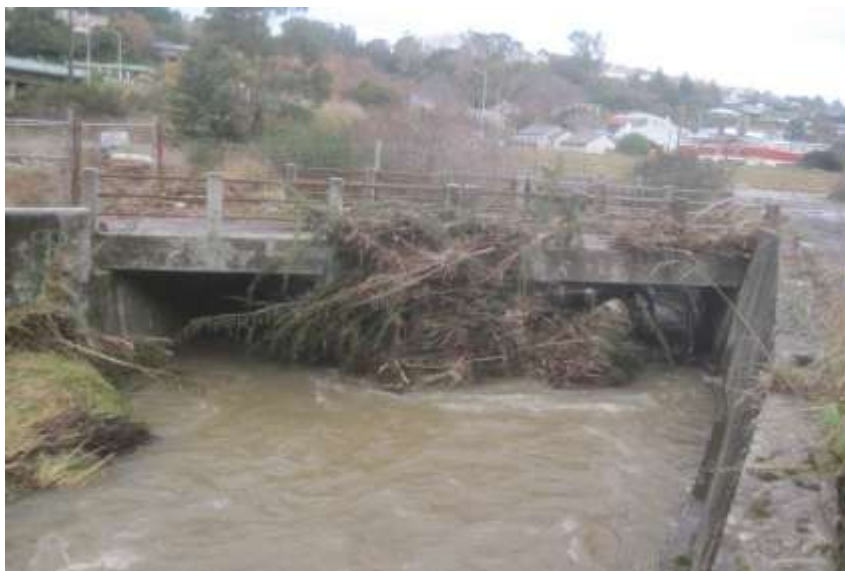
Figure 34. Tree and debris trapped under bridge at Burnside, 3 June 2015

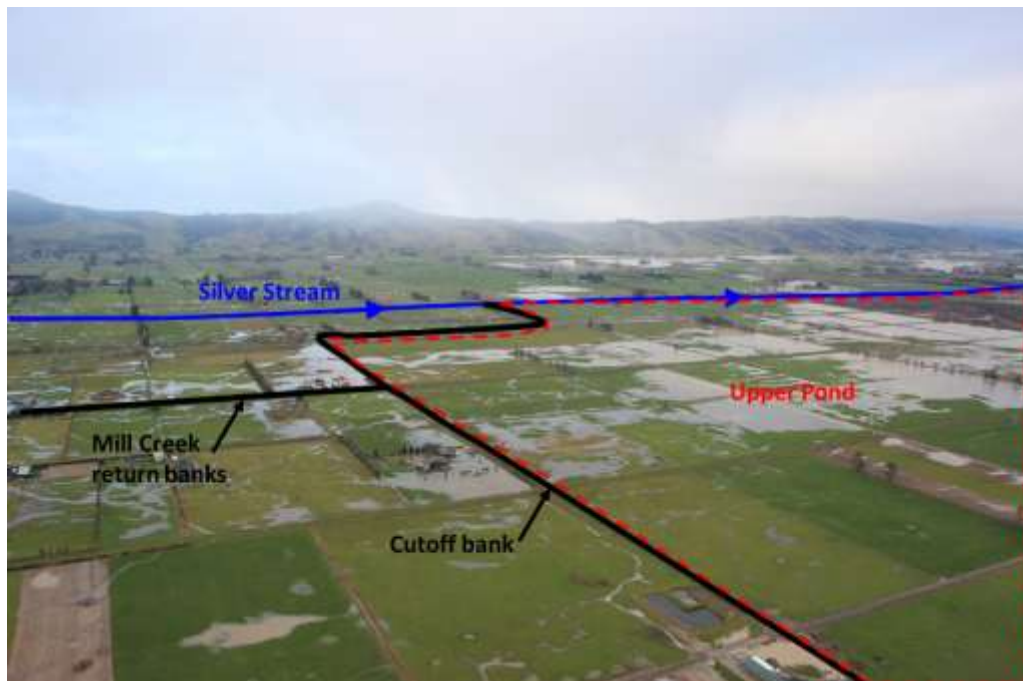
Extensive flooding was observed upslope (to the northeast) of the Lower Taieri Flood Protection Scheme Cutoff Bank (Figure 40). This ponding was due to runoff from the northern hill catchments, rainfall accumulation and from the Silver Stream overtopping after the brief operation of the Gordon Road Spillway.²² The extent of ponding behind the Cutoff Bank was less than during the April 2006 flood event due to less overtopping at the spillway and an improved connection between the area behind the Cutoff Bank and the Upper Pond (improvements made by the ORC after the 2006 flood event).

Figure 40. Ponding behind the Cutoff Bank, view is towards the south – 4 June 2015

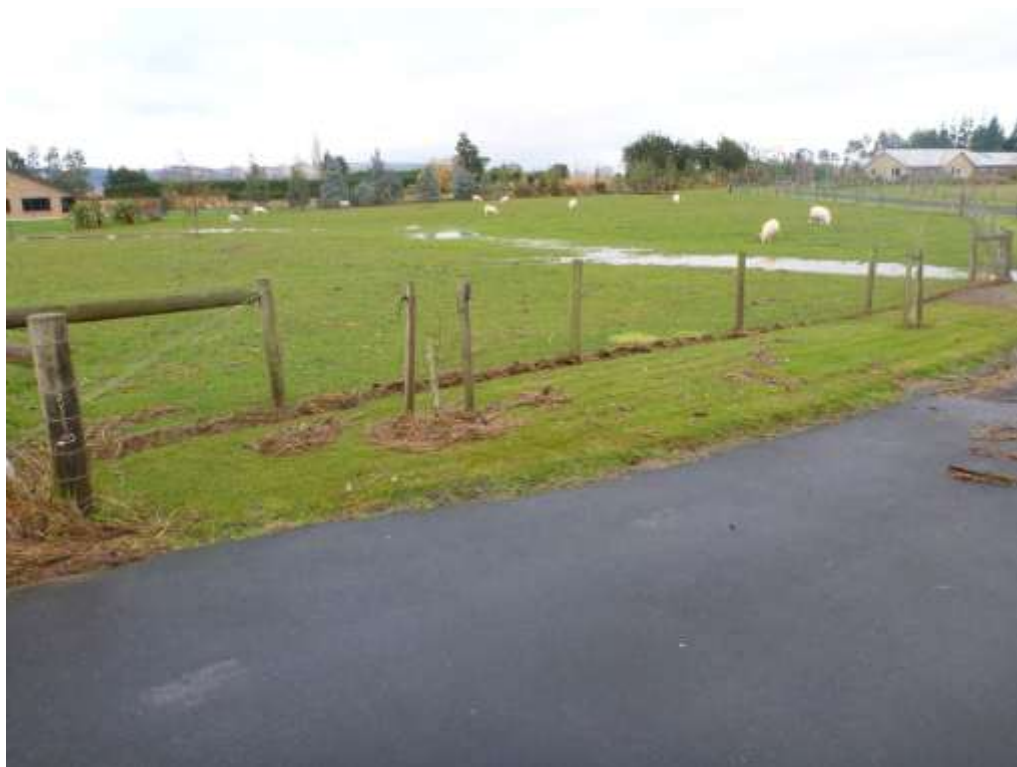
Figure 41. Debris marks indicative of overland flow and ponding in the vicinity of Wyllies Crossing – 4 June 2015

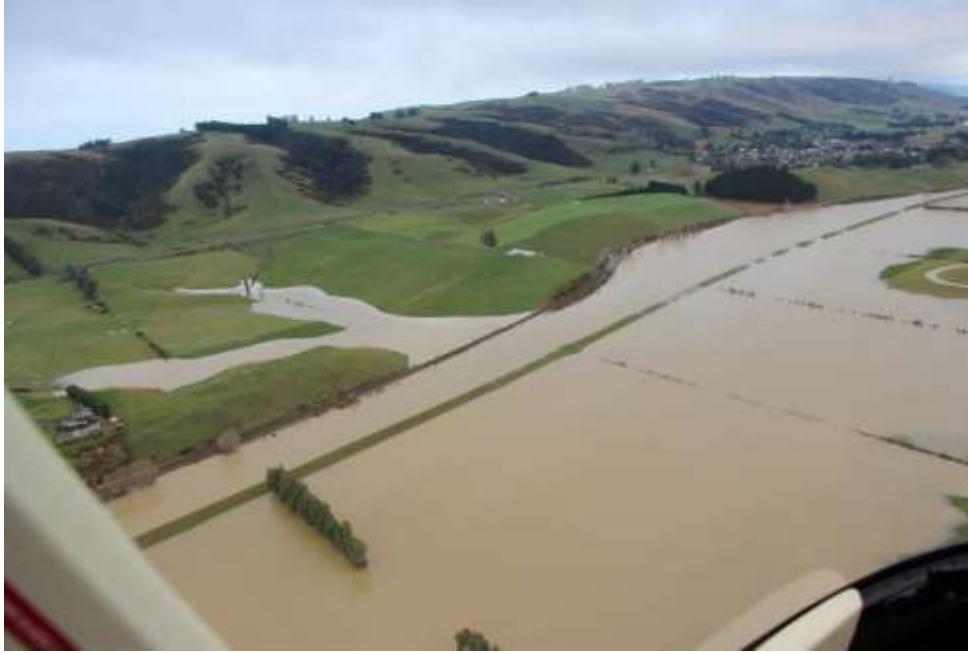
Figure 44. Ponding in the Lower Pond (note the overtopping of the Owhiro Stream true right bank) and at the flanks of the coastal hills – 4 June 2015

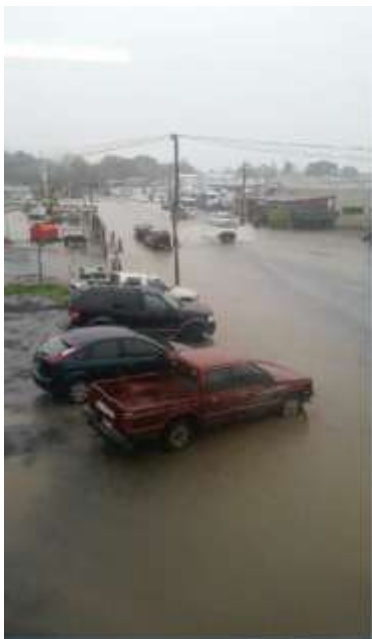
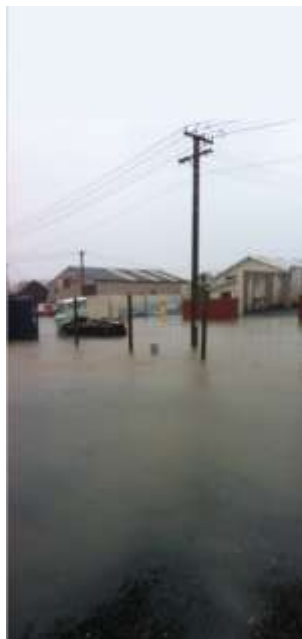
Figure 45. Flooding in Gow (left) and McGlashan (right) Streets, Mosgiel – 3 June 2015 (photos courtesy of PW Engineering and Payne Aluminium)

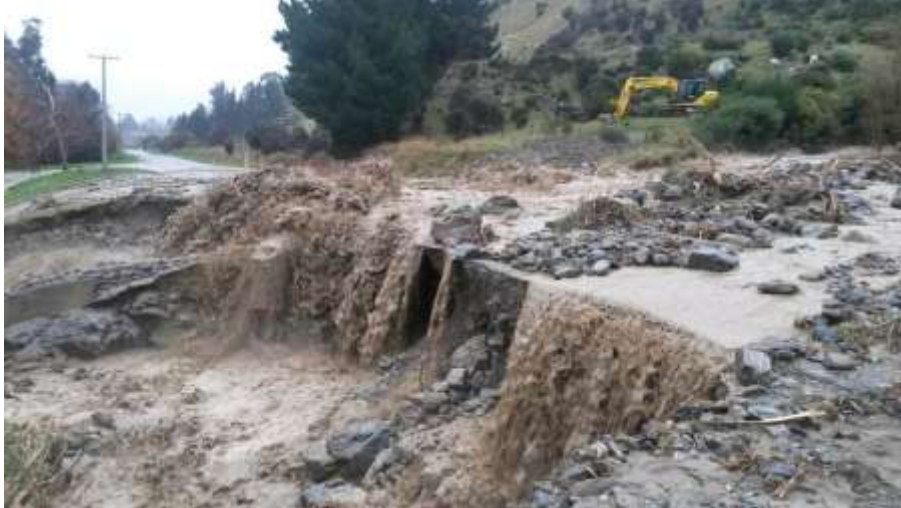
Figure 51. Flooding at Blackjacks Creek at SH8, 3 June 2015

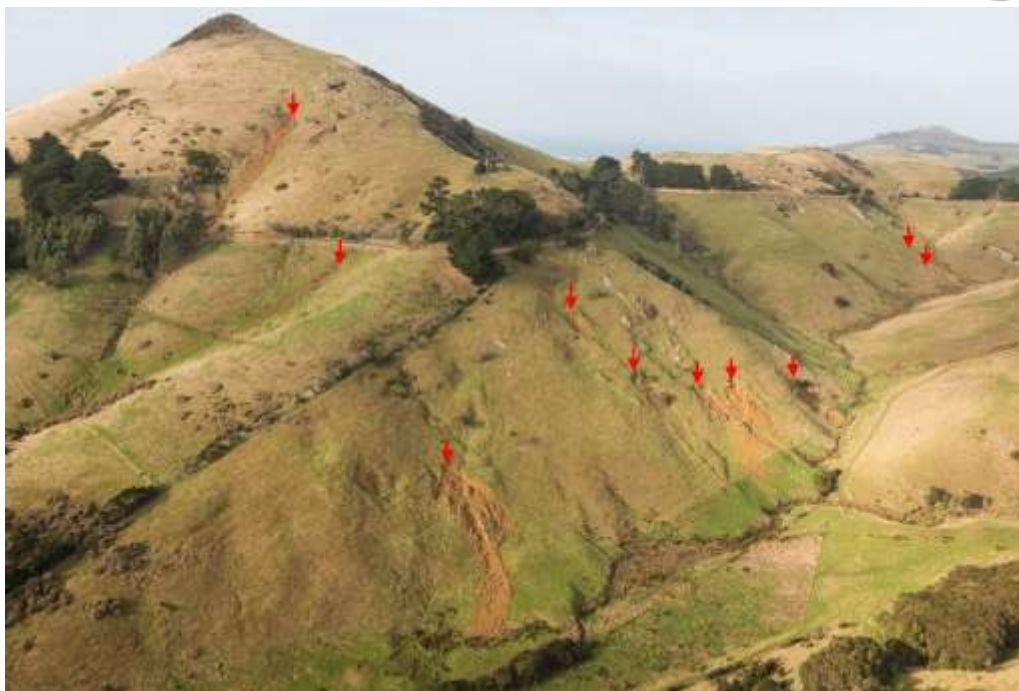
Figure 52. Aerial view of Harbour Cone, with landslide locations marked with red arrows, 16 June 2015
