Cardrona River Channel Morphology

May 2016

Otago Regional Council

Technical summary

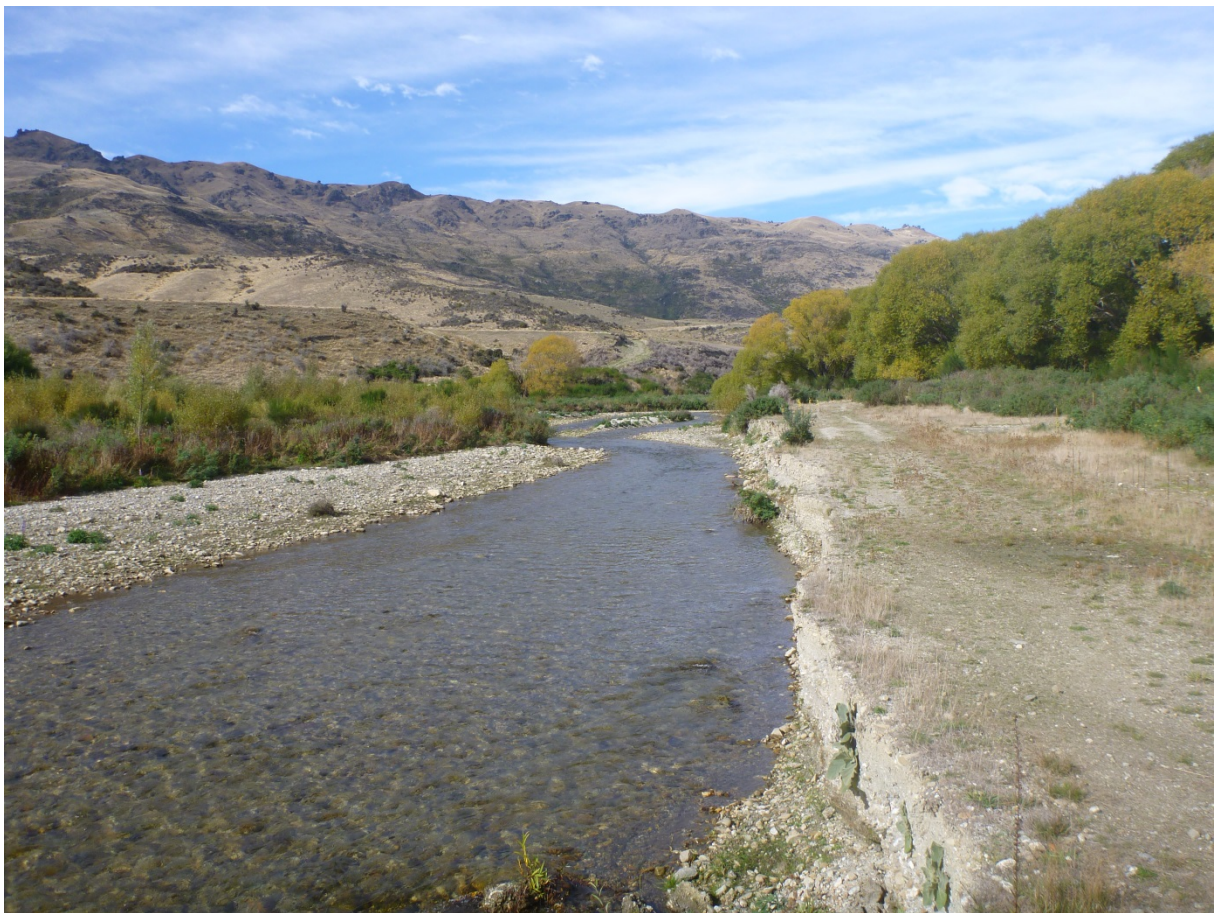
Bank erosion is considered to be the erosion of the margins of the active channel fairway and not the erosion of the low flow channel or channel braid migration. Bank erosion was observed at five of the forty two surveyed cross-sections. Other areas of bank erosion outside of the surveyed cross-sections were identified using aerial photography and site visits (Figure 4 to Figure 8). An example of bank erosion is shown in Figure 13.

Figure 13. Bank erosion of the true left bank downstream of cross-section CR11-1 (Figure 6)

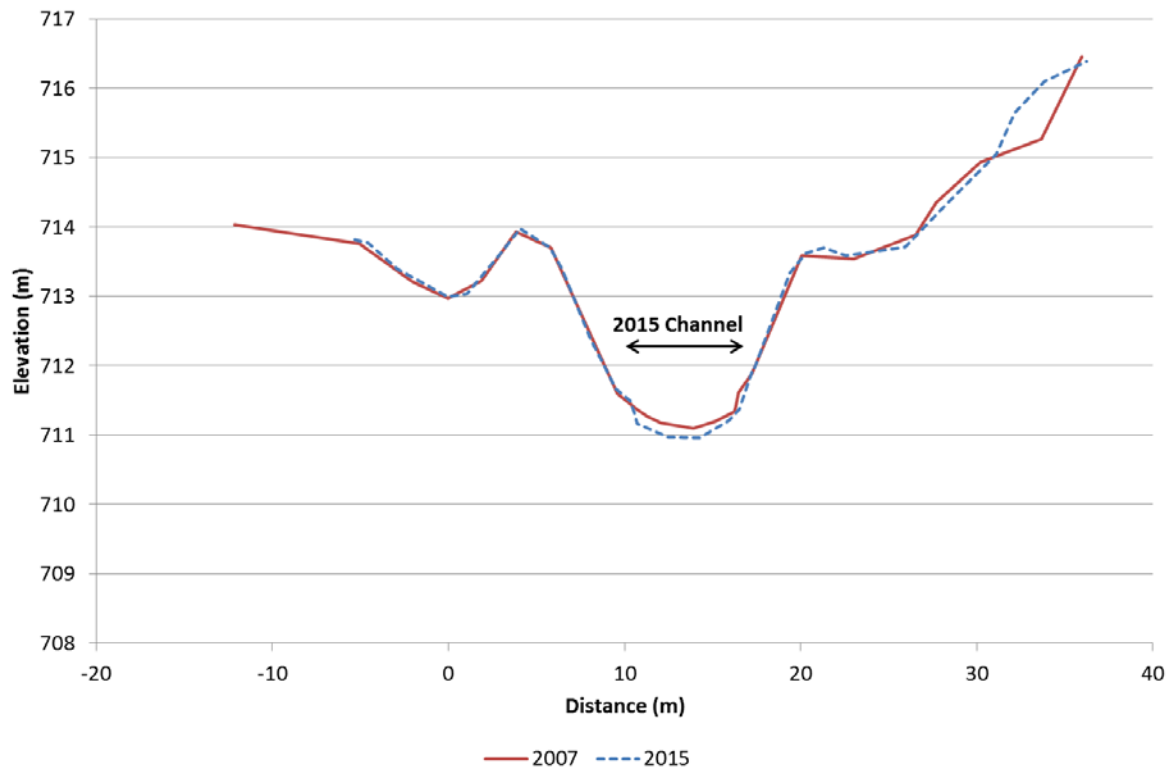
Cardrona River cross-section CR25-7

Figure 46. Cardrona River cross-section CR25-7, looking downstream refer to Figure 8 for location

Cross-section CR25-7 is located 31 km upstream of the confluence with the Clutha River/Mata-Au. The main channel has degraded at this location between 2007 and 2015 with minimal change across the wider of the floodplain.

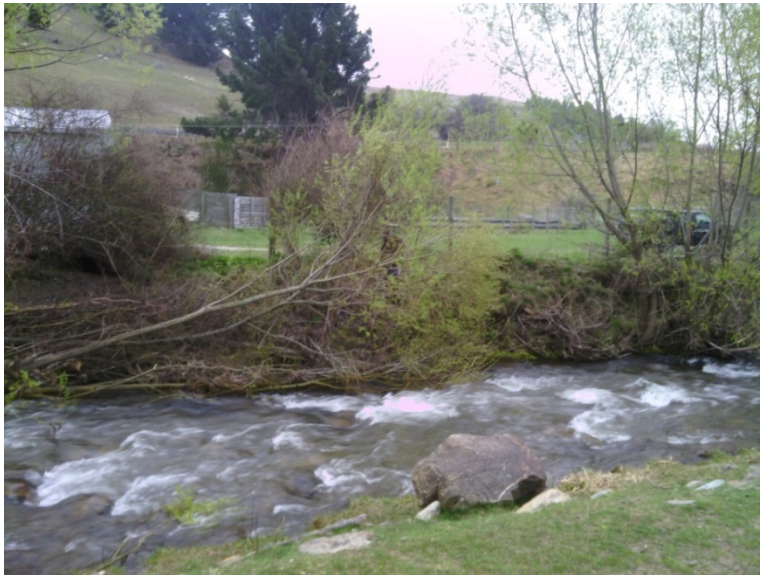
Figure 50. Cardrona River cross-section CR25-5, looking from true right to true left bank, November 2015

Cross-section CR25-5 is located 29.5 km upstream of the confluence with the Clutha River/Mata-Au. The channel has degraded between 2007 and 2015 with aggradation occurring on the true right bank.

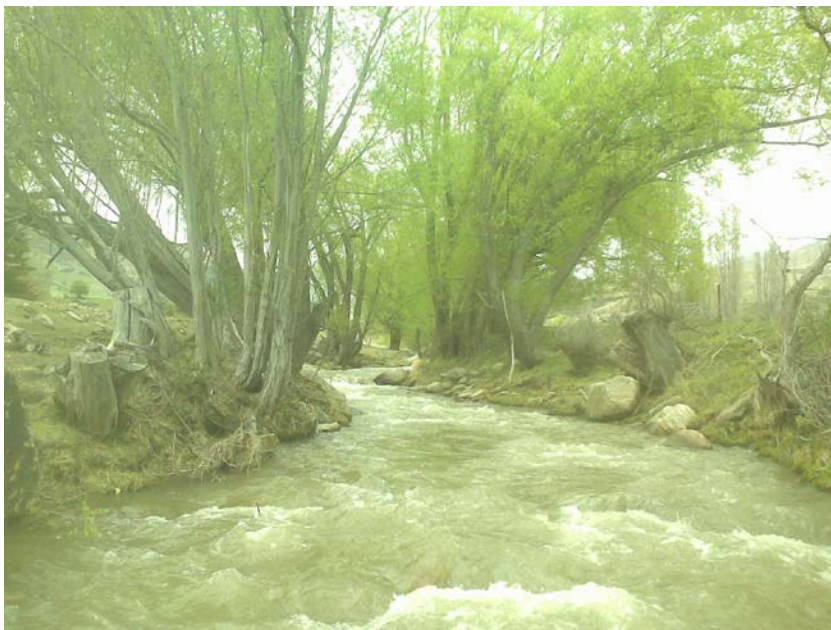
Figure 56. Cardrona River cross-section CR25-2, looking upstream, November 2015

Cross-section CR25-2 is located 27.1 km upstream of the confluence with the Clutha River/Mata-Au. The main channel has remained in a similar position between 2007 and 2015. The true left floodplain has both aggraded and degraded between 2007 and 2015.

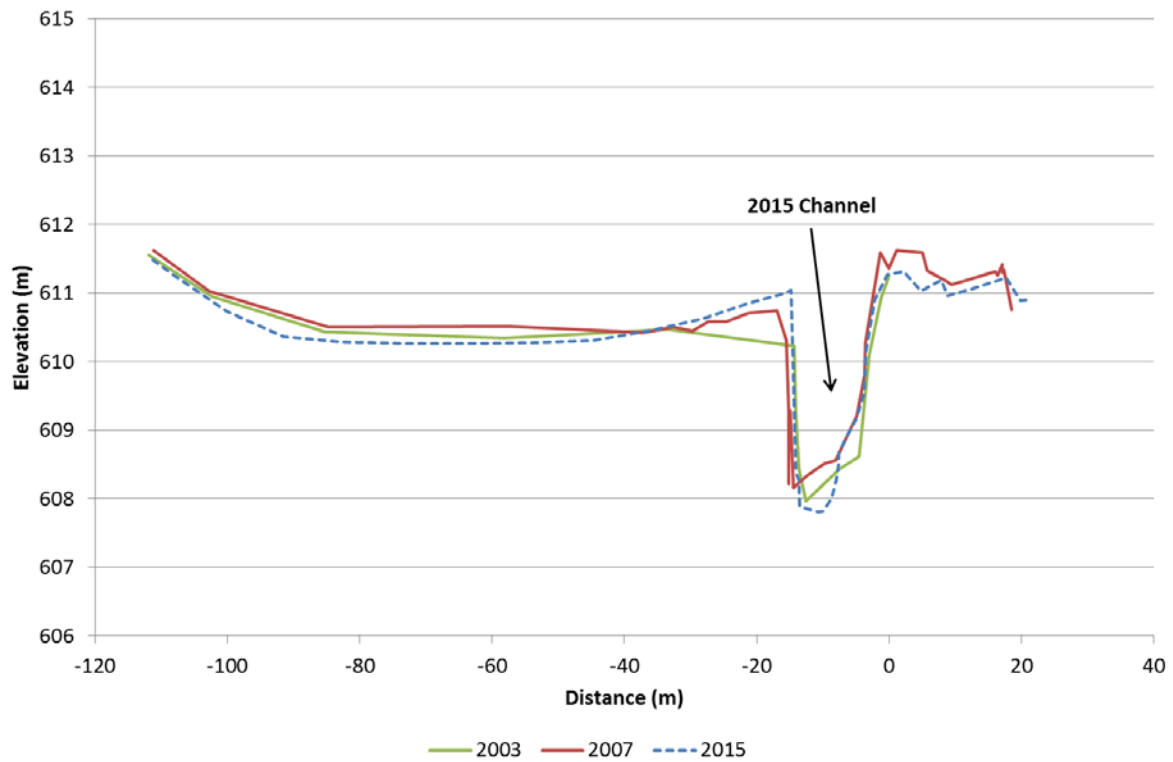
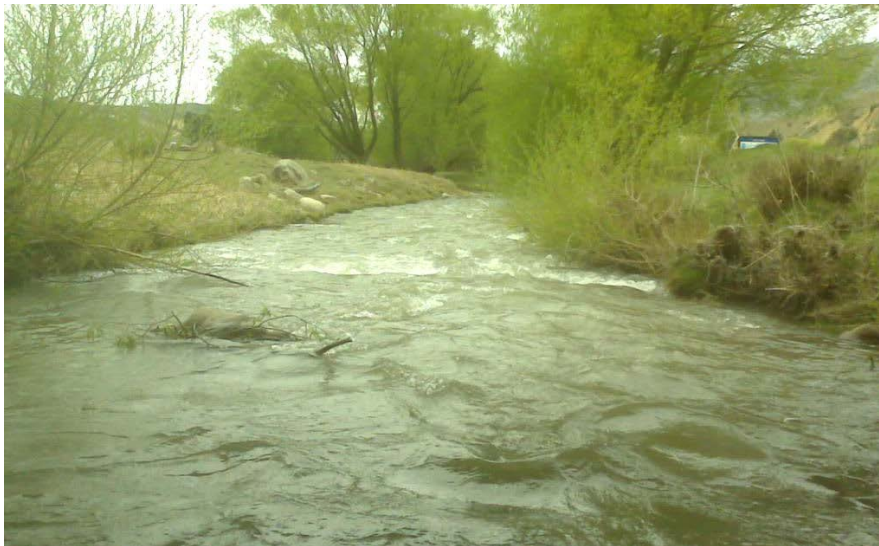
Cardrona River cross-section CR25-1

Figure 58. Cardrona River cross-section CR25-1, looking downstream, November 2015

Cross-section CR25-1 is located 26.5 km upstream of the confluence with the Clutha River/Mata-Au. Between 2003 and 2015 the main channel has experienced degradation. Aggradation has occurred on the true left channel bank between 2003 and 2015 with degradation occurring on the wider true left and right bank floodplain between 2007 and 2015.

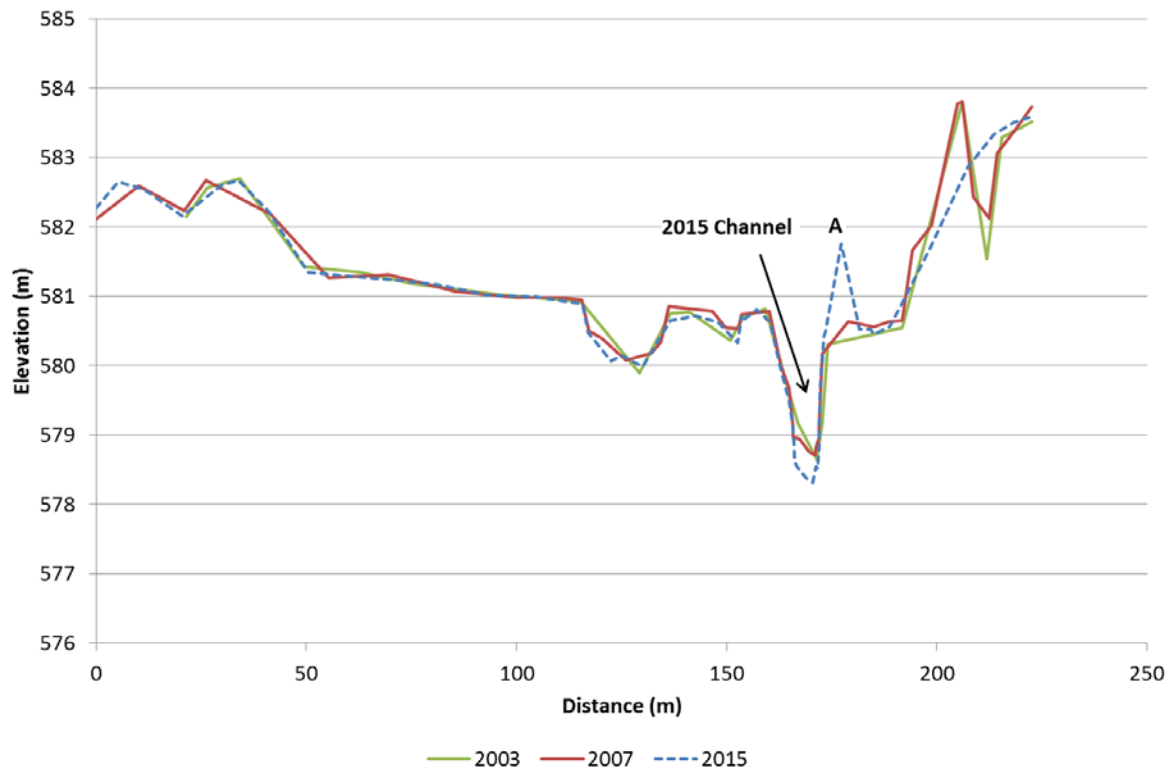
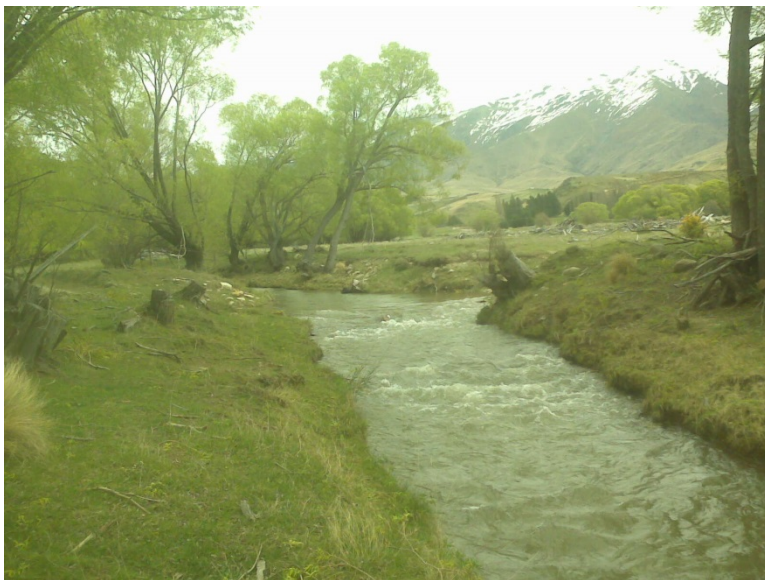
Cardrona River cross-section CR22

Figure 60. Cardrona River cross-section CR22, looking upstream, November 2015

Cross-section CR22 is located 24.1 km upstream of the confluence with the Clutha River/Mata-Au. The main channel has degraded between 2003 and 2015 with the creation of a feature at the point labelled A. Bank erosion occurred on the true right bank between 2003 and 2015.

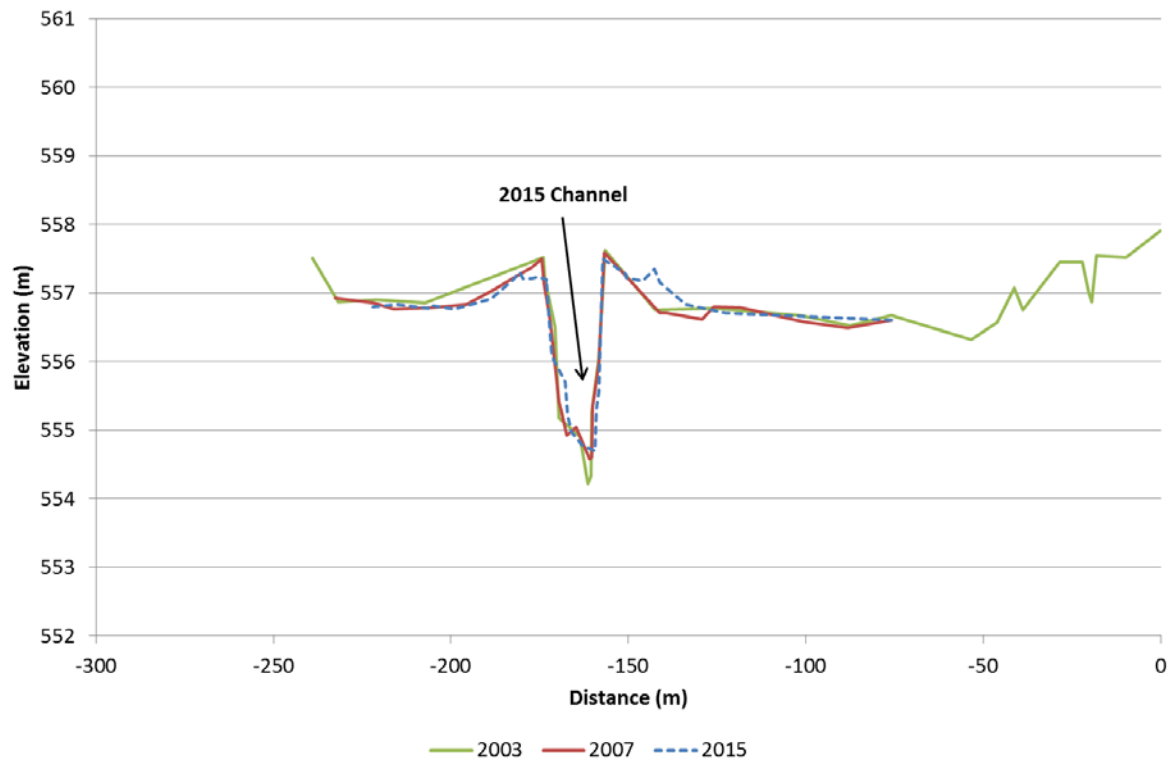
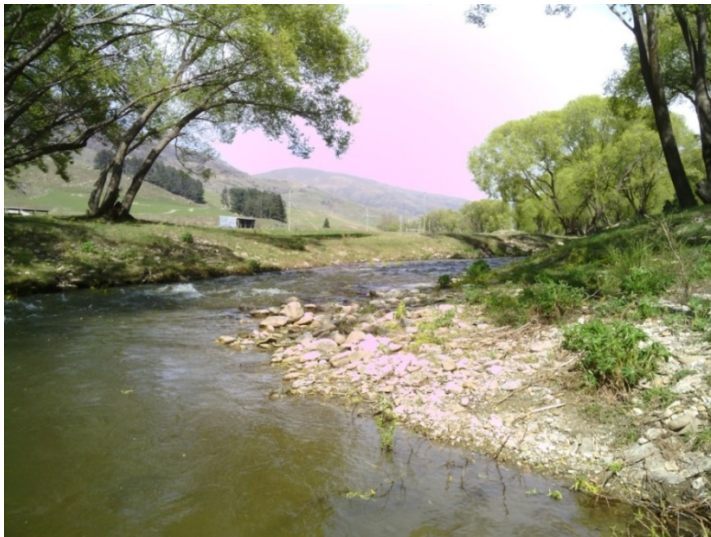
Cardrona River cross-section CR18-1

Figure 62. Cardrona River cross-section CR18-1, looking upstream, November 2015

Cross-section CR18-1 is located 21.74 km upstream of the confluence with the Clutha River/Mata-Au. The channel has aggraded between 2003 and 2015 but has remained in a similar position between 2007 and 2015. The true right floodplain has aggraded between 2003 and 2015. The true left floodplain has degraded between 2003 and 2015 but has remained in a similar position between 2007 and 2015.

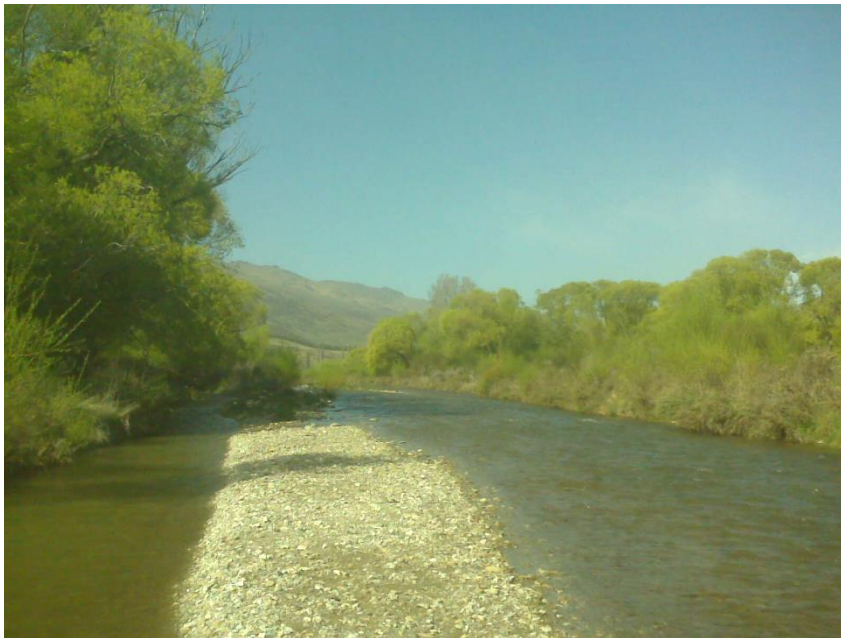
Figure 66. Cardrona River cross-section CR11-1, looking upstream, November 2015

Cross-section CR11-1 is located 17.5 km upstream of the confluence with the Clutha River/Mata-Au. Between 2003 and 2015 the main channel has degraded and become more confined. The true left floodplain has aggraded between 2007 and 2015.

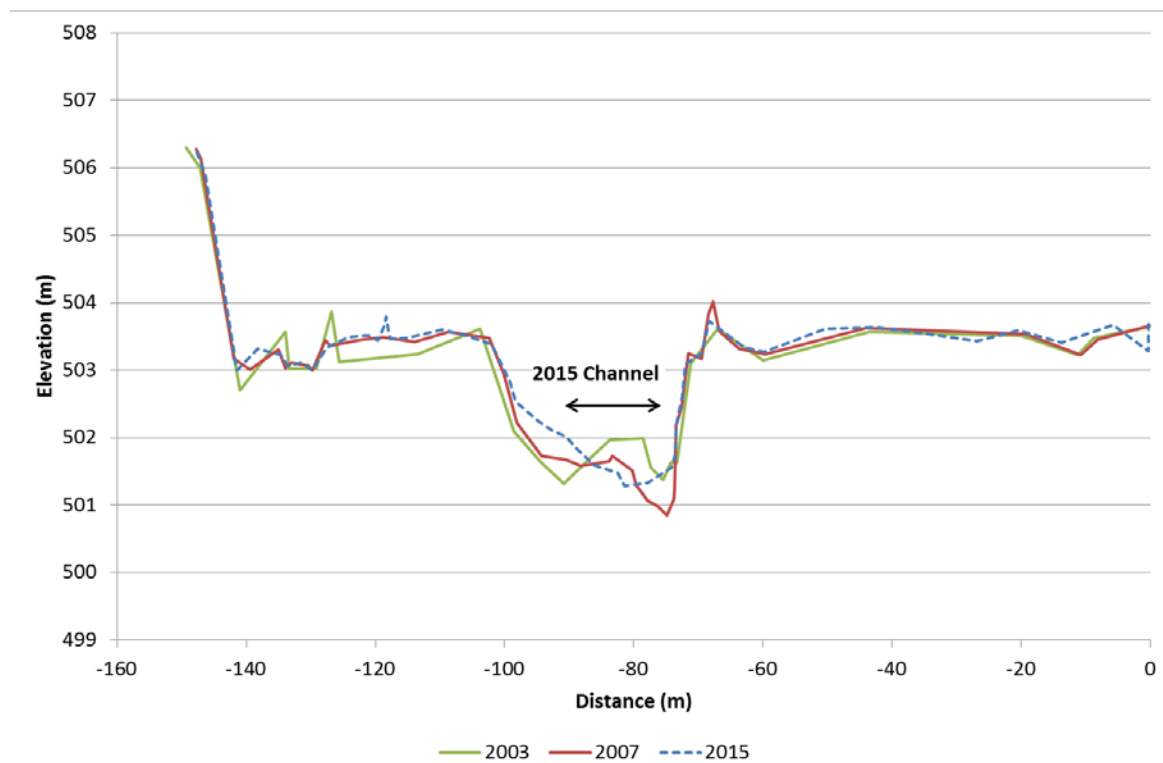
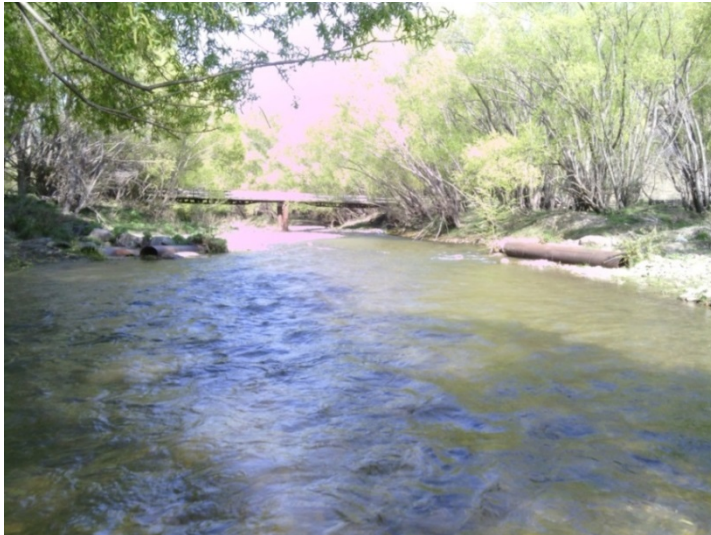
Cardrona River cross-section CR9

Figure 68. Cardrona River cross-section CR9, looking upstream, November 2015

Cross-section CR9 is located 15.7 km upstream of the confluence with the Clutha River/Mata-Au. The main channel has aggraded on the true left and true right, but has degraded in the centre between 2007 and 2015 creating a more confined channel. The wider floodplain has remained similar between 2007 and 2015 but has experienced aggradation between 2003 and 2015.

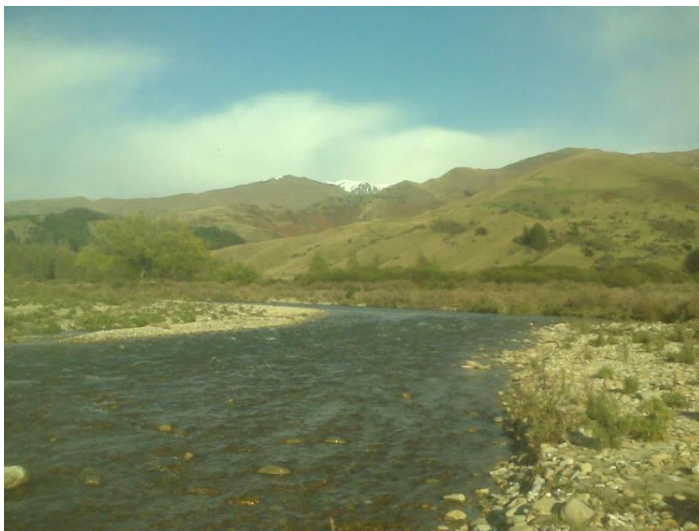
Figure 74. Cardrona River cross-section CR3, looking upstream, November 2015

Cross-section CR3 is located 11.7 km upstream of the confluence with the Clutha River/Mata-Au. The channel at this location is braided with one main channel in the centre of the active fairway and several low flow channels. These channels have both aggraded and degraded between 2003 and 2007. Aggradation of the true left bank terrace has occurred between 2007 and 2015.

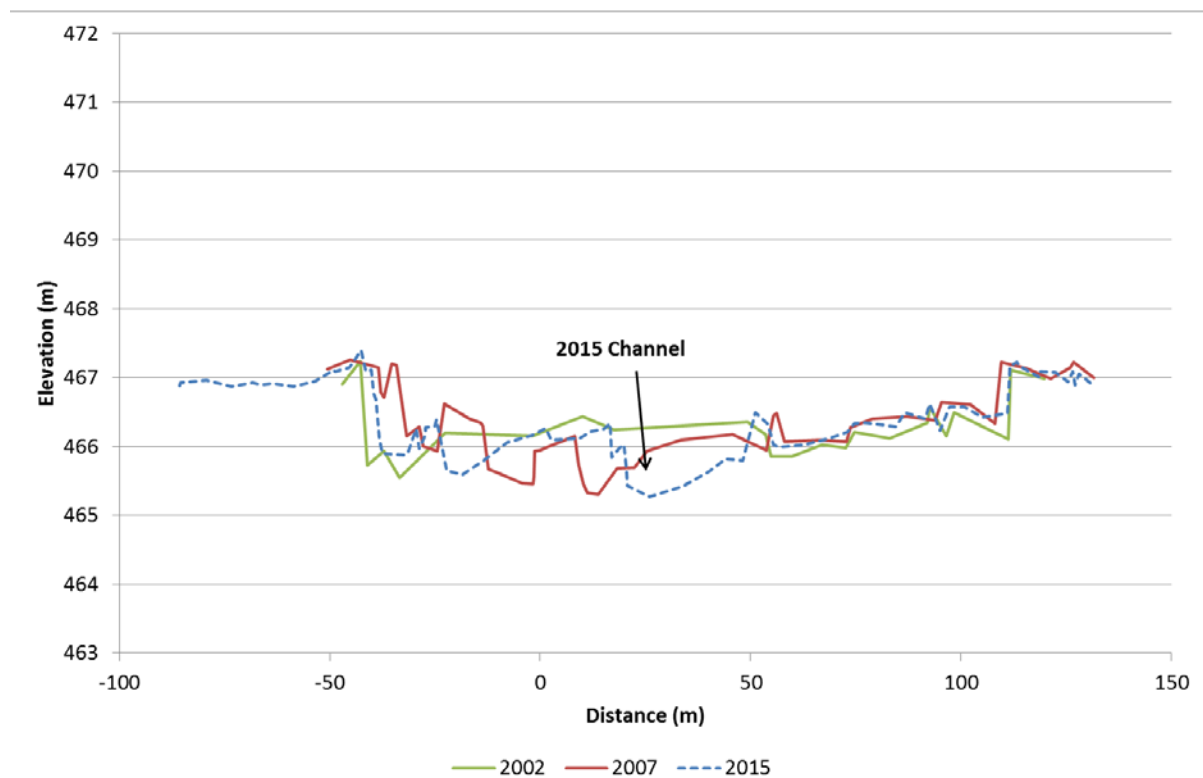
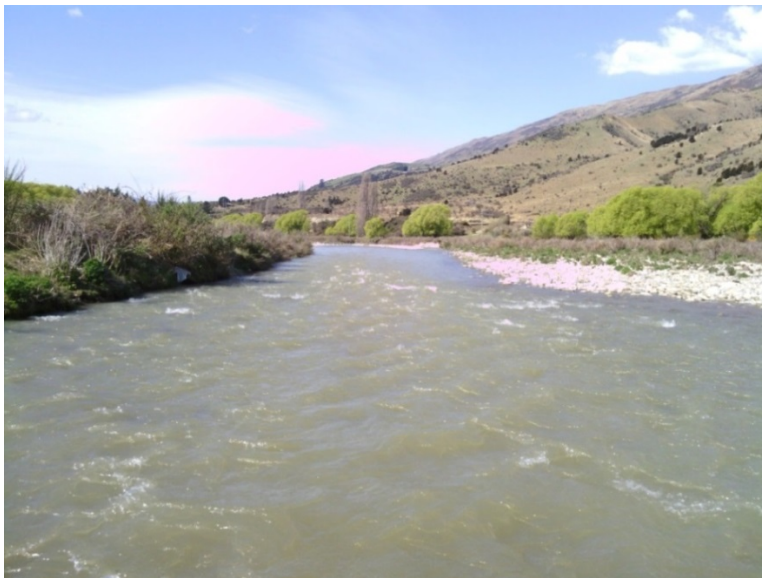
Cardrona River cross-section CR2B

Figure 76. Cardrona River cross-section CR2B, looking downstream, November 2015

Cross-section CR2B is located 11.4 km upstream of the confluence with the Clutha River/Mata-Au. The main channel has been migrating towards the true right bank between 2003 and 2015 with both aggradation and degradation occurring as previous channel became infilled. The true left bank floodplain has eroded between 2007 and 2015.

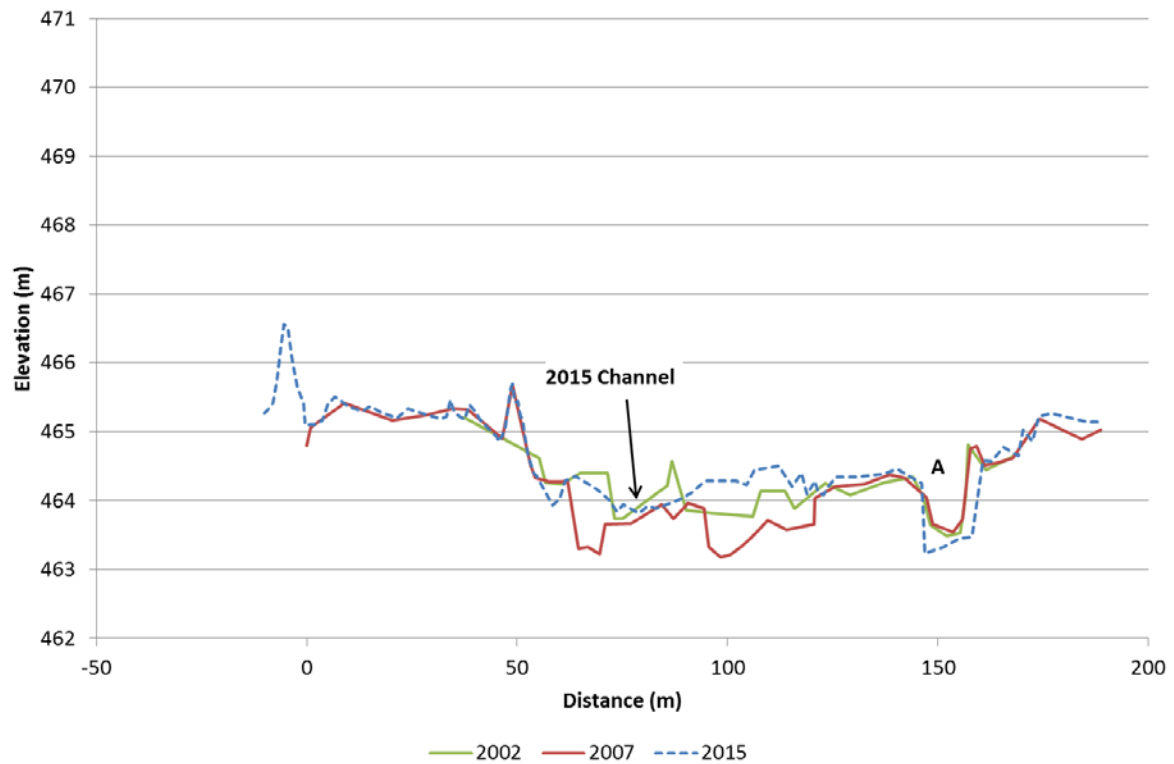
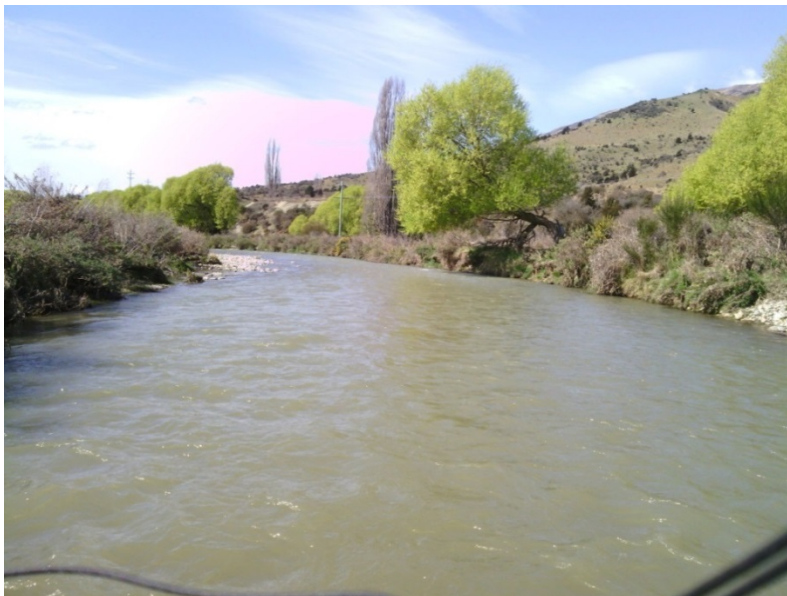
Cardrona River cross-section CR2

Figure 78. Cardrona River cross-section CR2, looking downstream, November 2015

Cross-section CR2 is located 11.2 km upstream of the confluence with the Clutha River/Mata-Au. The wider braid network has experienced aggradation between 2007 and 2015 with the exception of a secondary channel at the point labelled A, which has degraded between 2007 and 2015 as well as eroding the true right bank.

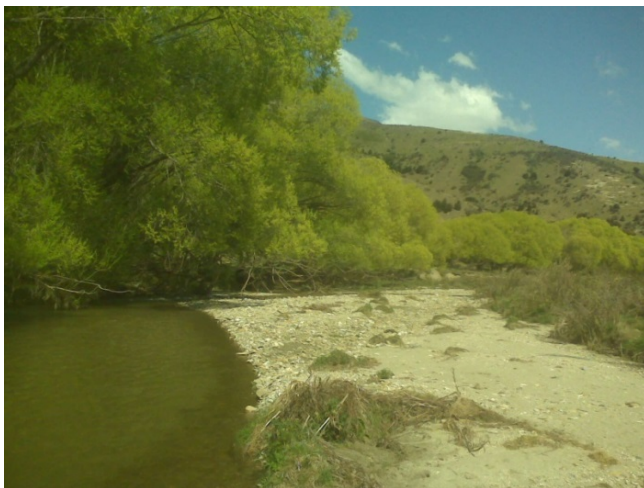
Figure 82. Cardrona River cross-section CR1B, looking upstream, November 2015

Cross-section CR1B is located 10.7 km upstream of the confluence with the Clutha River/Mata-Au. Aggradation has occurred on the true left of the fairway with degradation occurring on the true right between 2007 and 2015. The main channel has switched from the true left of the fairway in 2007 to the true right side of the fairway in 2015. Aggradation has occurred on the true right bank between 2007 and 2015.

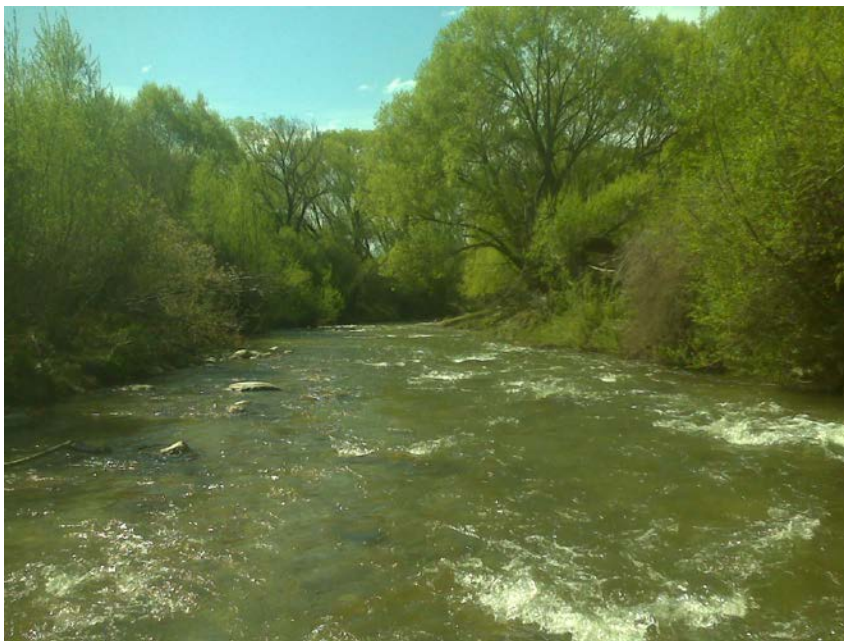
Figure 86. Cardrona River cross-section CR28-2, looking downstream, November 2015

Cross-section CR28-2 is located 10.18 km upstream of the confluence with the Clutha River/Mata-Au. The main channel has degraded between 2007 and 2015 with degradation occurring on the true left and right bank floodplain.

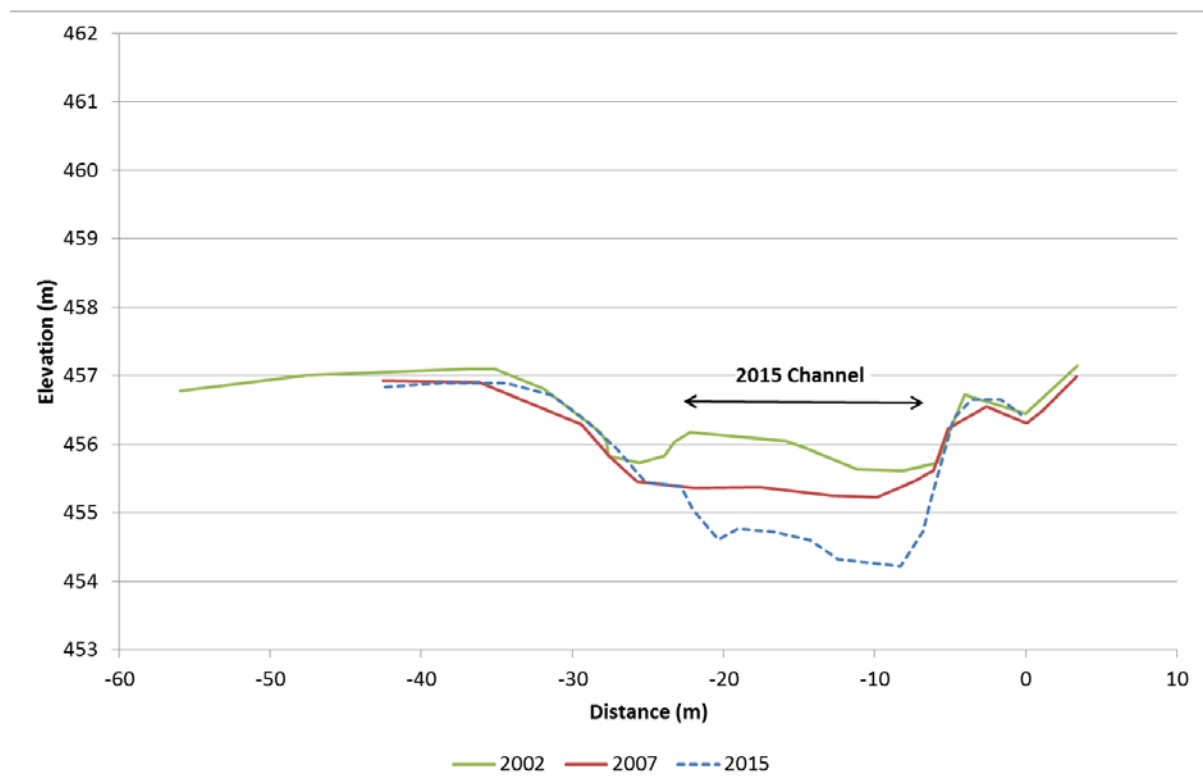
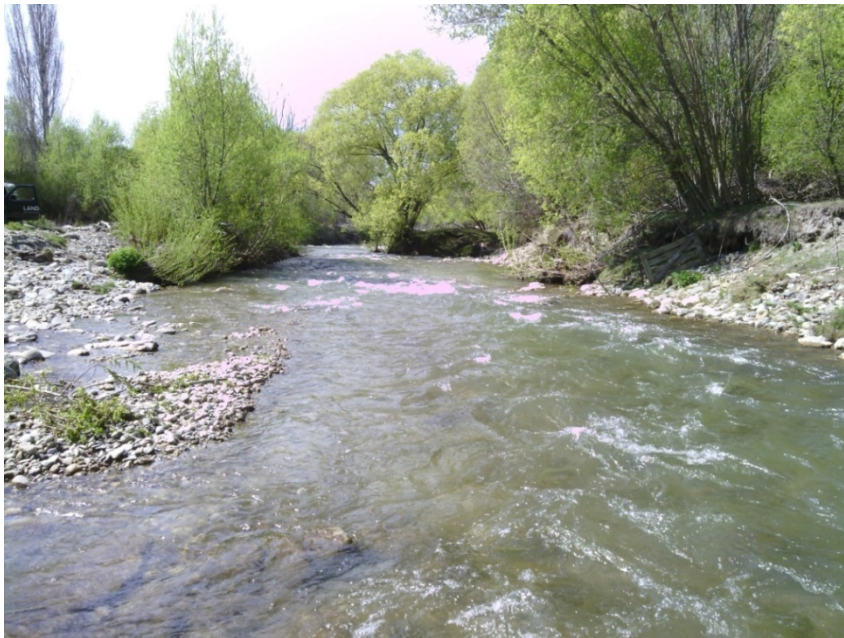
Cardrona River cross-section CR28-1

Figure 88. Cardrona River cross-section CR28-1, looking downstream, November 2015

Cross-section CR28-1 is located 10 km upstream of the confluence with the Clutha River/Mata-Au. The main channel has degraded between 2002 and 2015 with minimal change occurring across the wider floodplain.

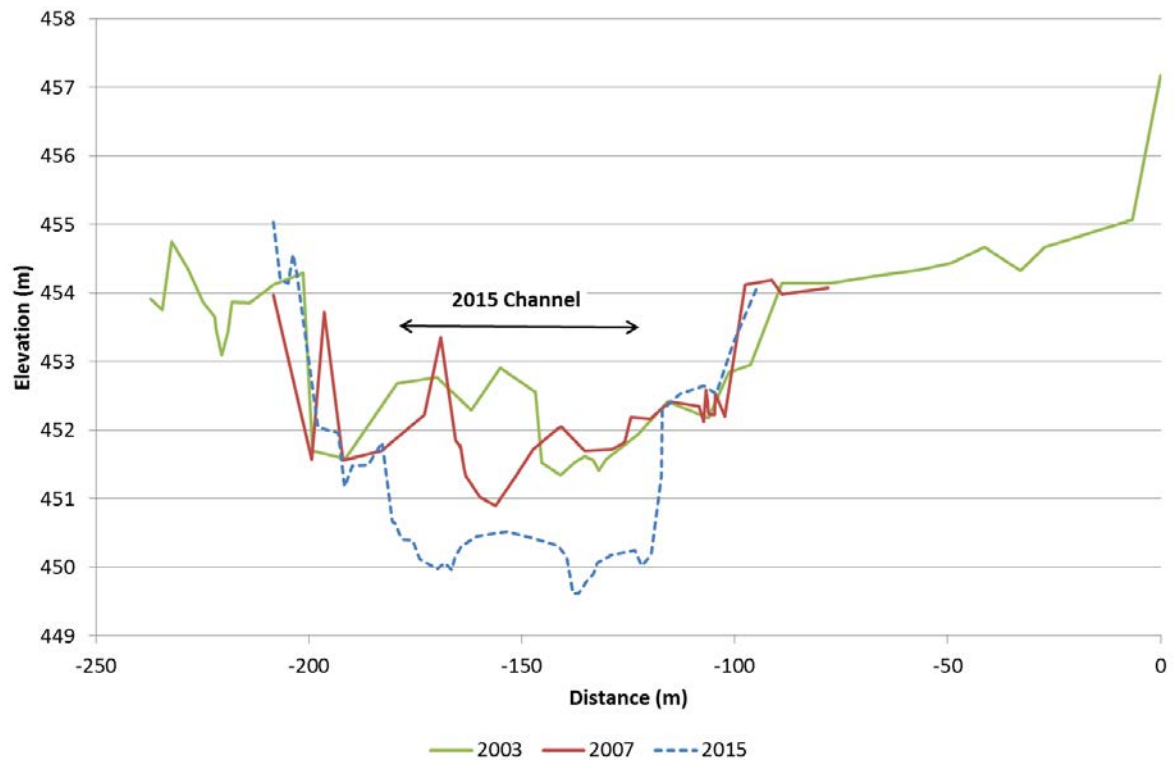
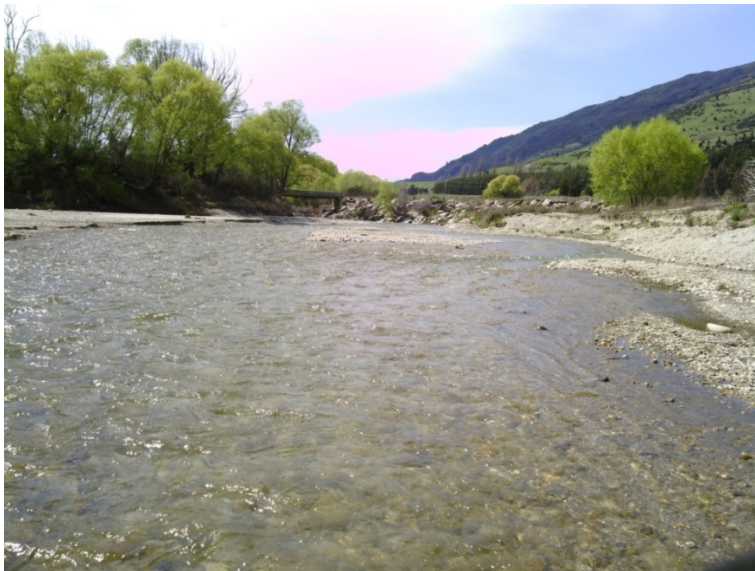
Cardrona River cross-section CR54-2

Figure 90. Cardrona River cross-section CR54-2, looking downstream, November 2015

Cross-section CR54-2 is located 9.5 km upstream of the confluence with the Clutha River/Mata-Au. The main channel has degraded between 2007 and 2015 which has created a more confined channel.⁸

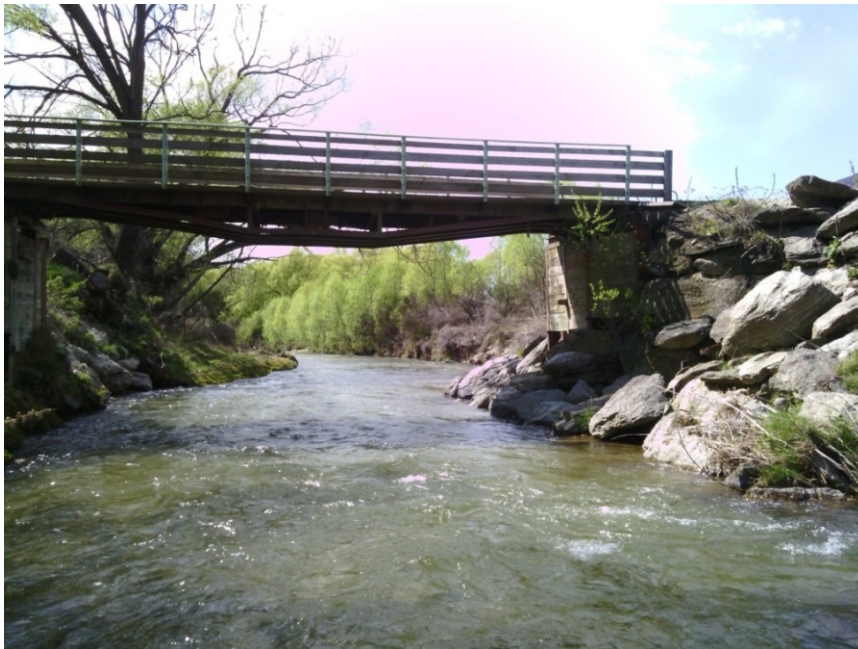
Figure 92. Cardrona River cross-section CR54-1, looking downstream, November 2015

Cross-section CR54-1 is located 9.4 km upstream of the confluence with the Clutha River/Mata-Au. The main channel has degraded between 2007 and 2015 with some degradation occurring on the true right bank floodplain.

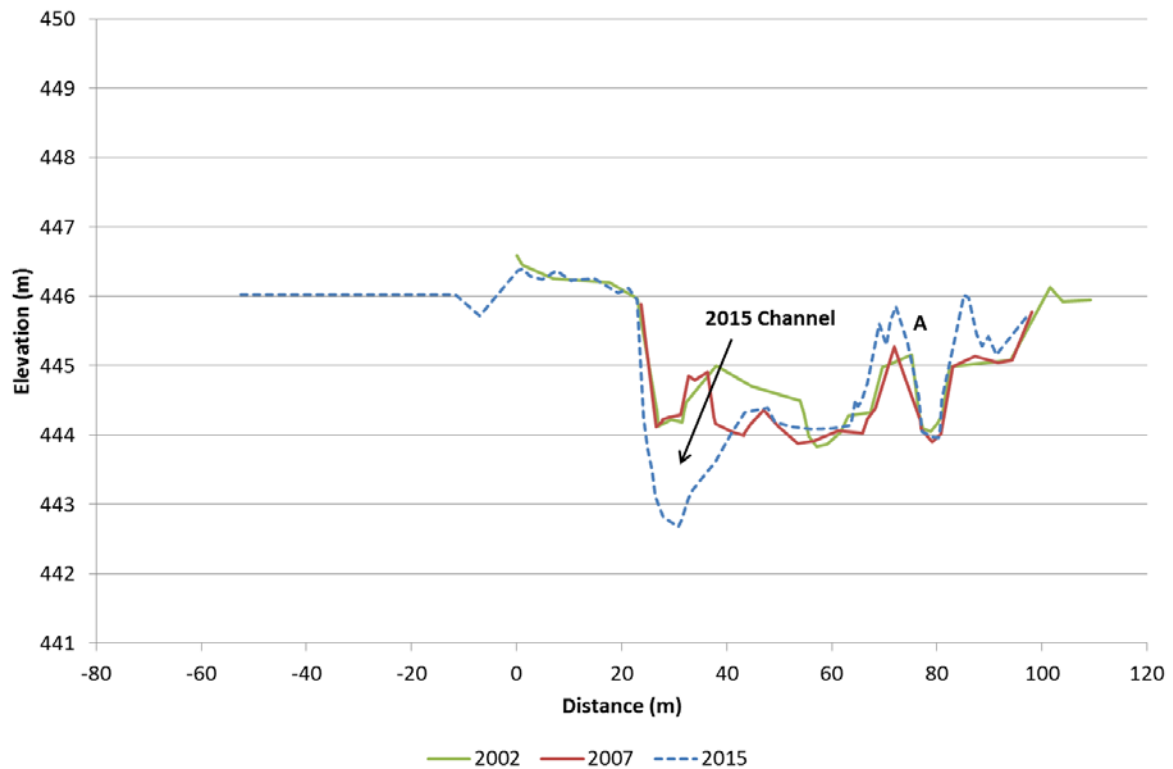
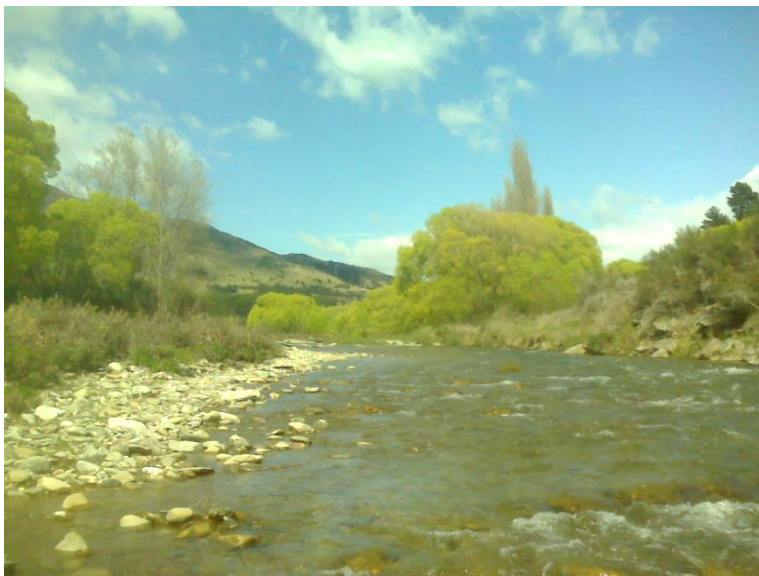
Cardrona River cross-section CR30-1

Figure 94. Cardrona River cross-section CR30-1, looking upstream, November 2015

Cross-section CR30-1 is located 8.6 km upstream of the confluence with the Clutha River/Mata-Au. The main channel has shifted to the true left of the active fairway and degraded between 2007 and 2015 creating a more confined channel. The secondary channel at the point labelled A has become more confined between 2007 and 2015.

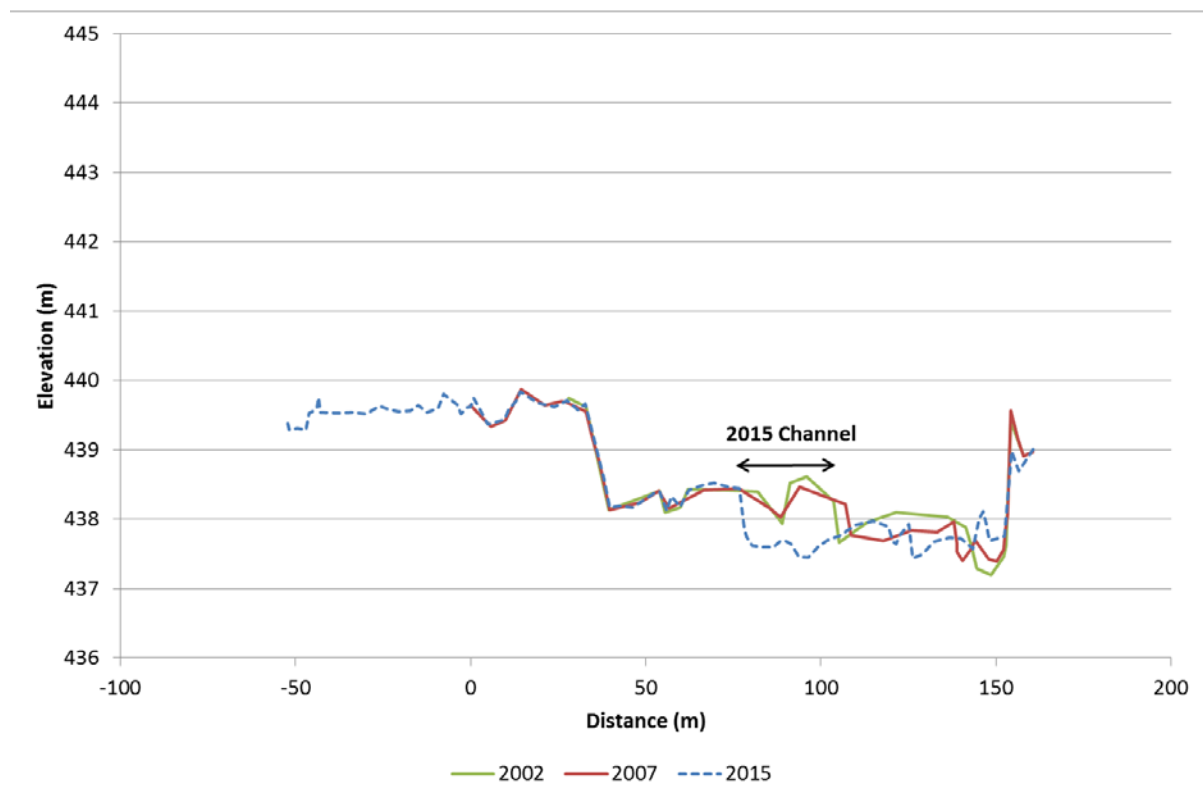
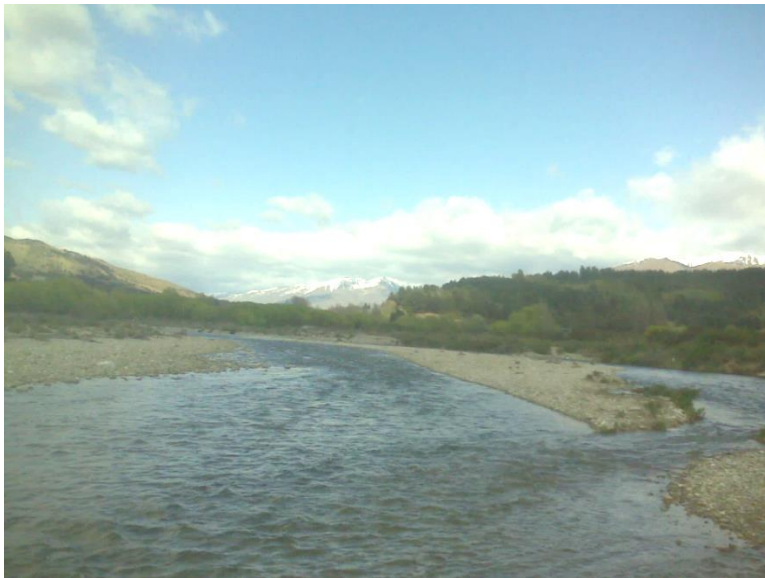
Cardrona River cross-section CR31-1

Figure 96. Cardrona River cross-section CR31-1, looking upstream, November 2015

Cross-section CR31-1 is located 7.9 km upstream of the confluence with the Clutha River/Mata-Au. The main channel shifted to the true left of the active fairway between 2007 and 2015, the true right of the active fairway both aggraded and degraded between 2003 and 2015.

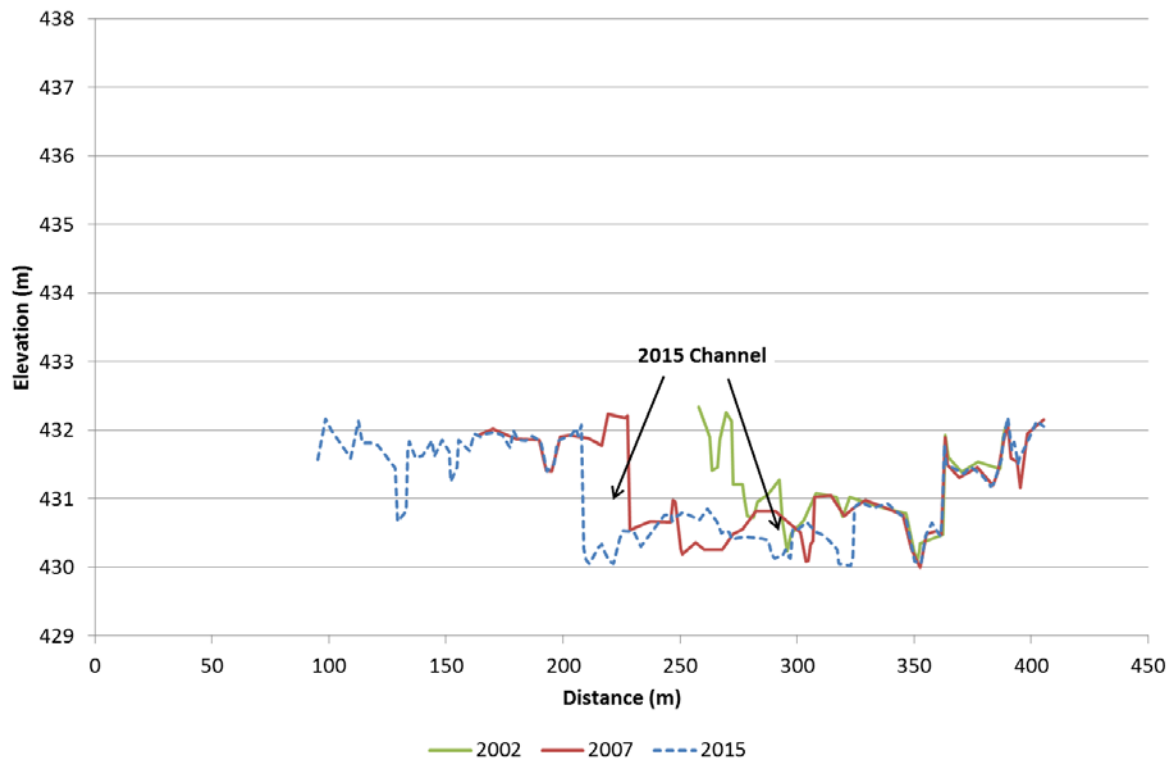
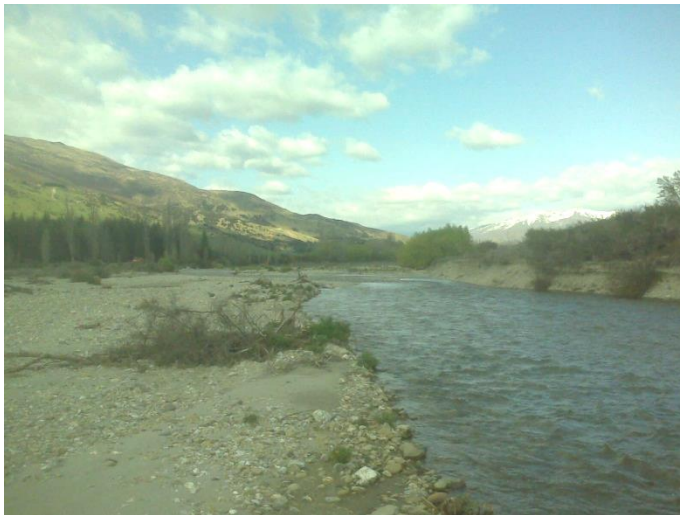
Cardrona River cross-section CR36-1

Figure 98. Cardrona River cross-section CR36-1, looking downstream, November 2015

Cross-section CR36-1 is located 7.1 km upstream of the confluence with the Clutha River/Mata-Au. The true left and right banks of the active fairway have continued to erode between 2002 and 2015 creating a wider active fairway. Both aggradation and degradation has occurred between 2007 and 2015 in the active river fairway as the river braids migrate.⁹

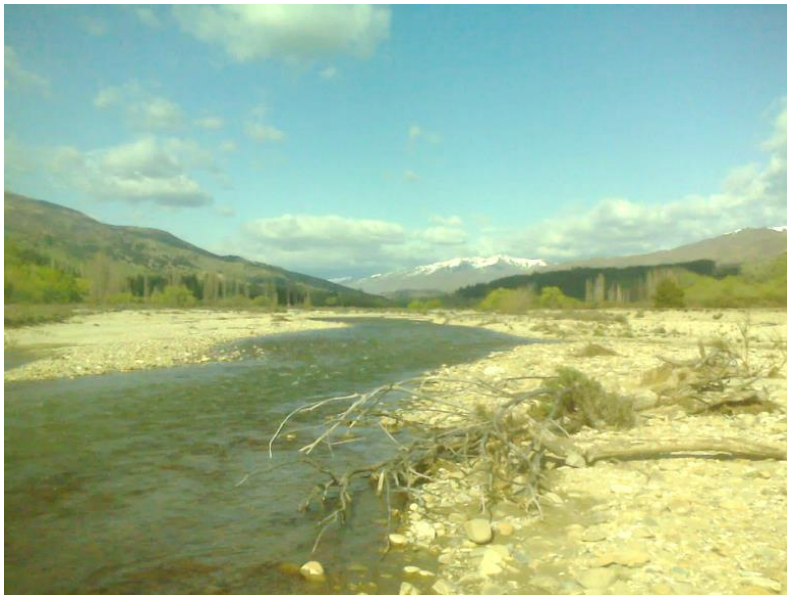
Figure 100. Cardrona River cross-section CR39, looking upstream, November 2015

Cross-section CR39 is located 6.6 km upstream of the confluence with the Clutha River/Mata-Au. The true left bank of the active fairway has eroded between 2007 and 2015. The active fairway has both aggraded and degraded between 2007 and 2015 as the river braids migrate across the river fairway.
