Cardrona River Channel Morphology

May 2016

Otago Regional Council

Technical summary

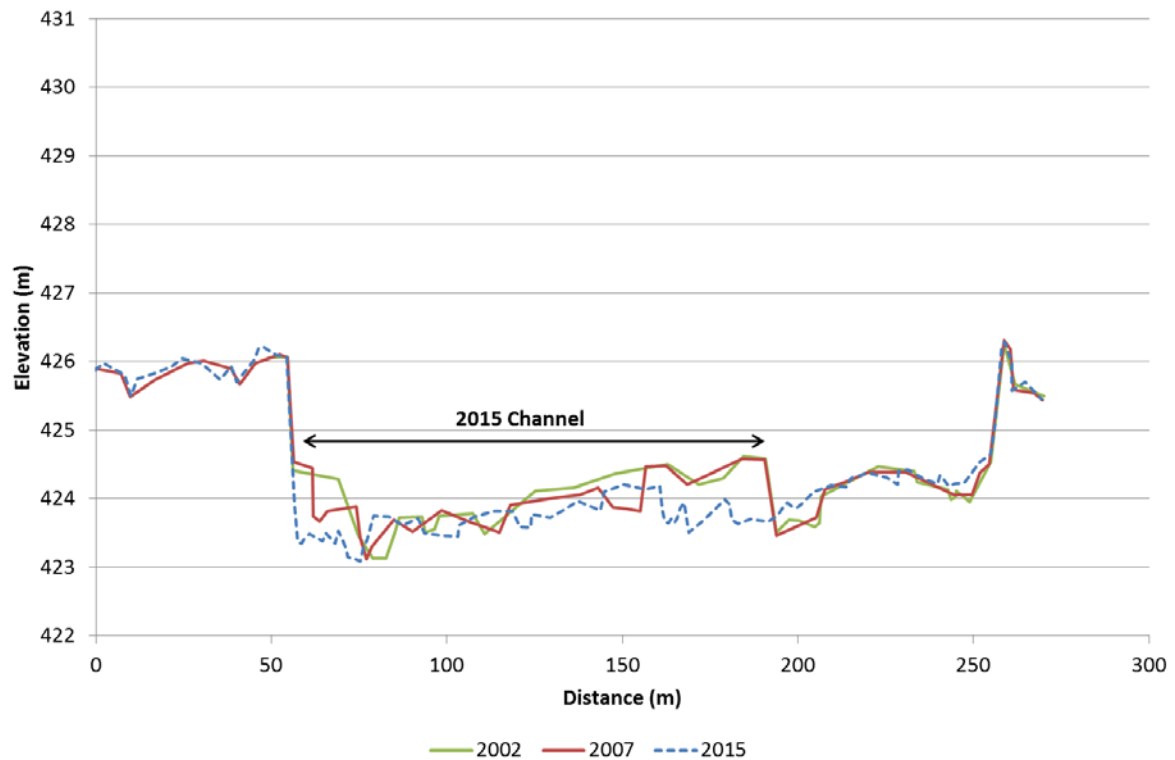
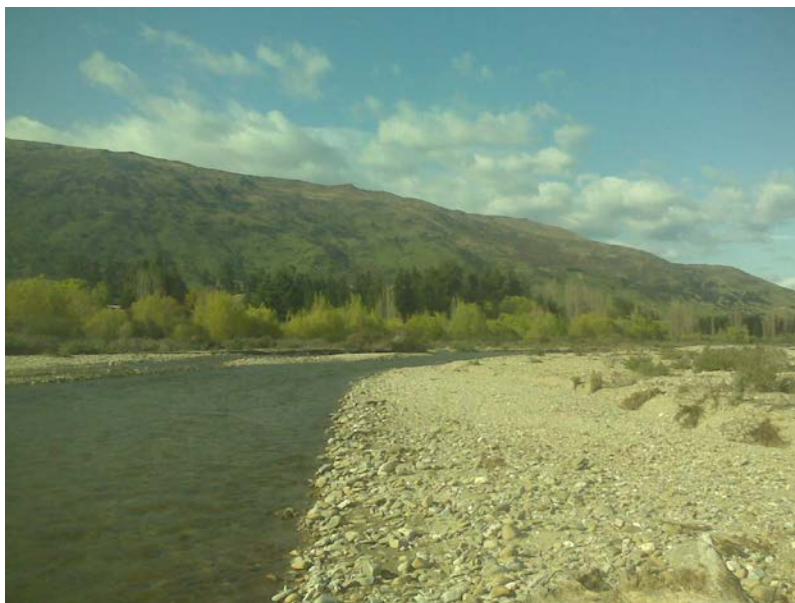
Cardrona River cross-section CR39-1

Figure 102. Cardrona River cross-section CR39-1, looking upstream, November 2015

Cross-section CR39-1 is located 6.5 km upstream of the confluence with the Clutha River/Mata-Au. The active fairway has experienced mostly degradation between 2007 and 2015. Erosion of the true left bank of the active fairway has occurred between 2002 and 2015. The wider floodplain has remained similar between 2007 and 2015.

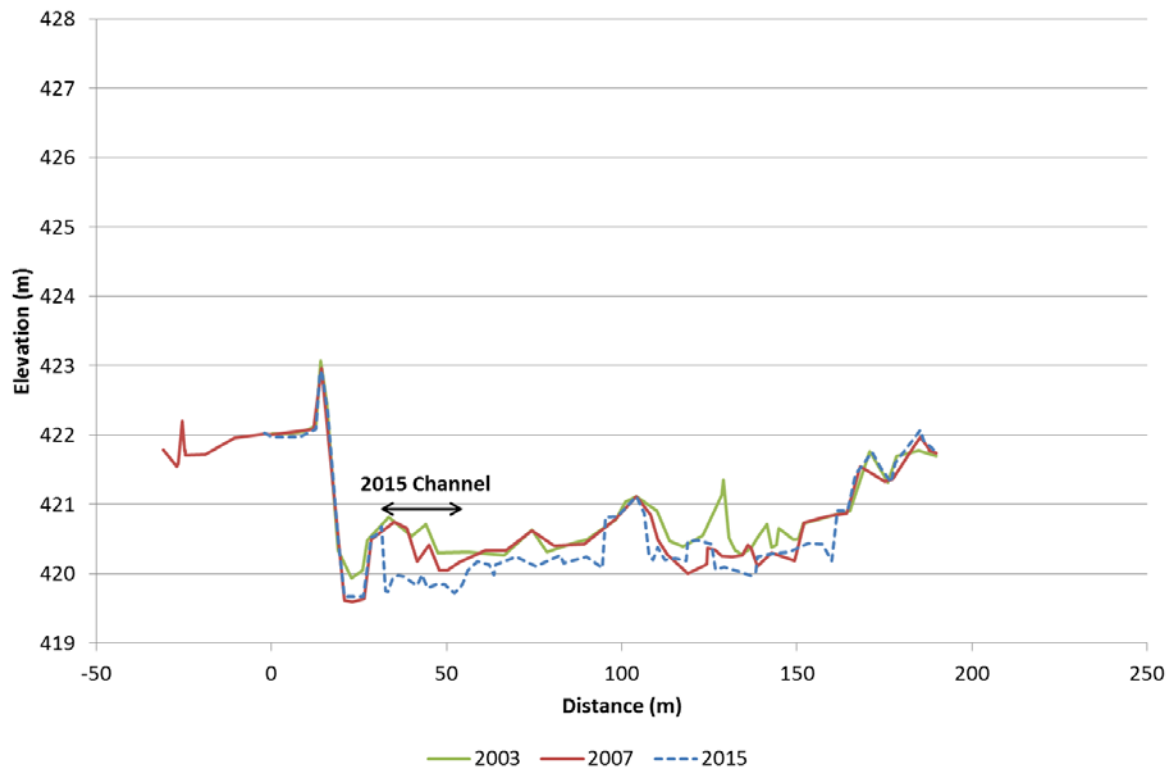
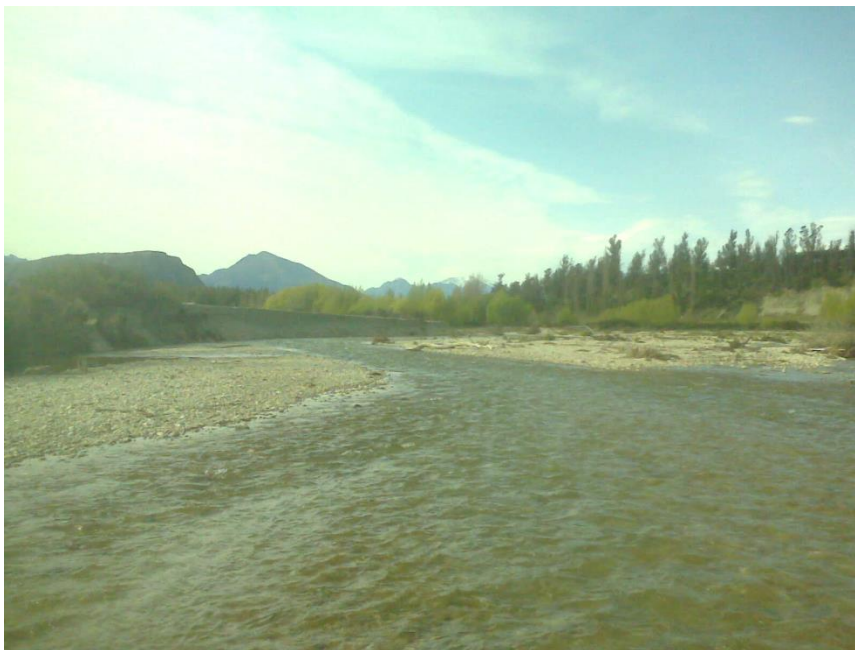
Cardrona River cross-section CR40-1

Figure 104. Cardrona River cross-section CR40-1, looking downstream, November 2015

Cross-section CR40-1 is located 6 km upstream of the confluence with the Clutha River/Mata-Au. The active fairway has experienced mostly degradation between 2007 and 2015. There has been minimal change of the wider floodplain between 2007 and 2015.

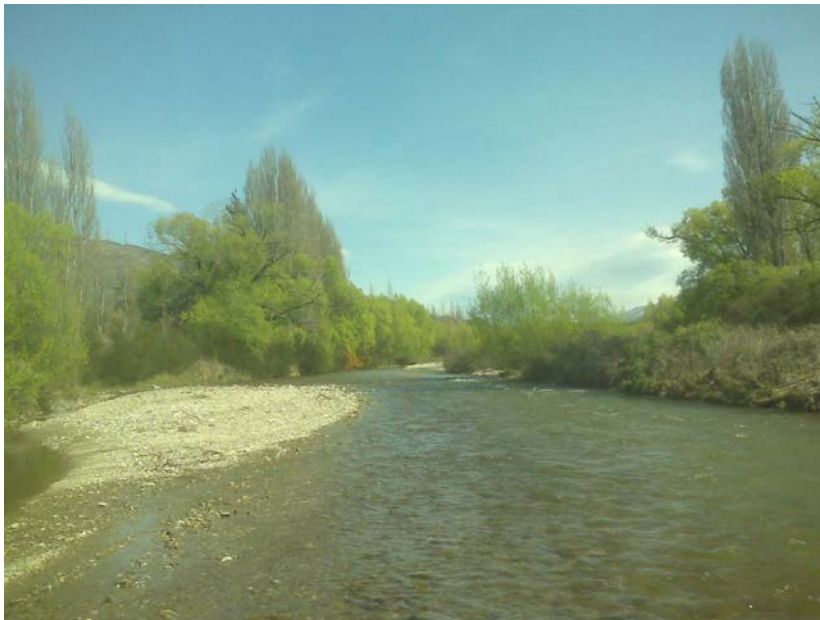
Figure 108. Cardrona River cross-section, looking upstream, November 2015

Cross-section CR42 is located 5.1 km upstream of the confluence with the Clutha River/Mata-Au at the Ballantyne Road bridge. The active channel at this location is confined by the presence of the bridge and has continued to degrade between 2002 and 2015.
