Coastal Otago flood event
3 June 2015

Published October 2015

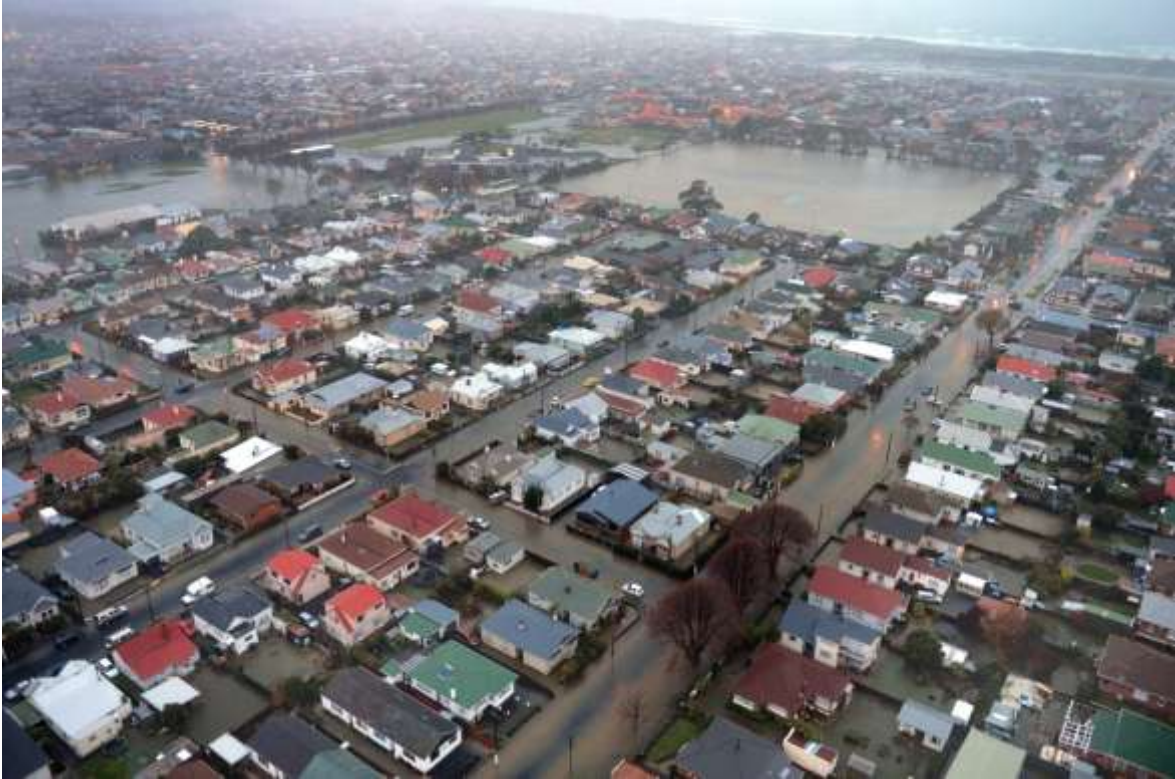
The South Dunedin area was affected by widespread and prolonged flooding as a result of the rainfall that fell on 3 June, as illustrated in Figure 10 and Figure 11.

Figure 10. View of the South Dunedin area, looking southeast from near Forbury Corner, towards Tonga Park and St Kilda. Photo taken late afternoon on 3 June 2015 (courtesy Otago Daily Times).

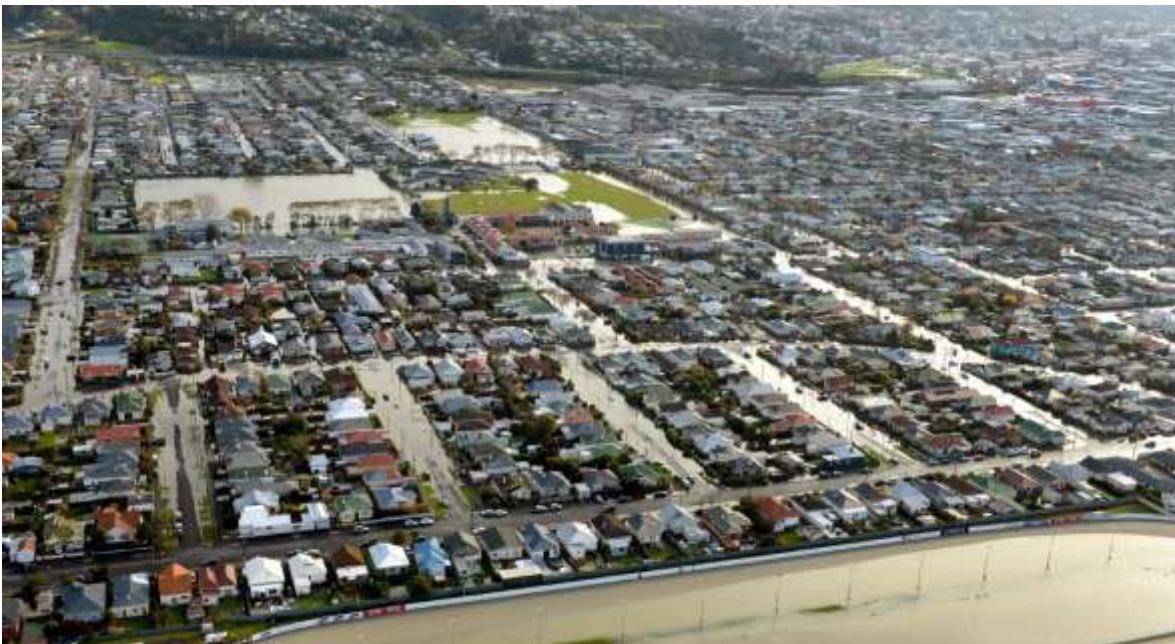
Figure 11. View of the South Dunedin area, looking northeast from Forbury Park Raceway towards Forbury. Photo taken 4 June 2015 (courtesy Otago Daily Times).

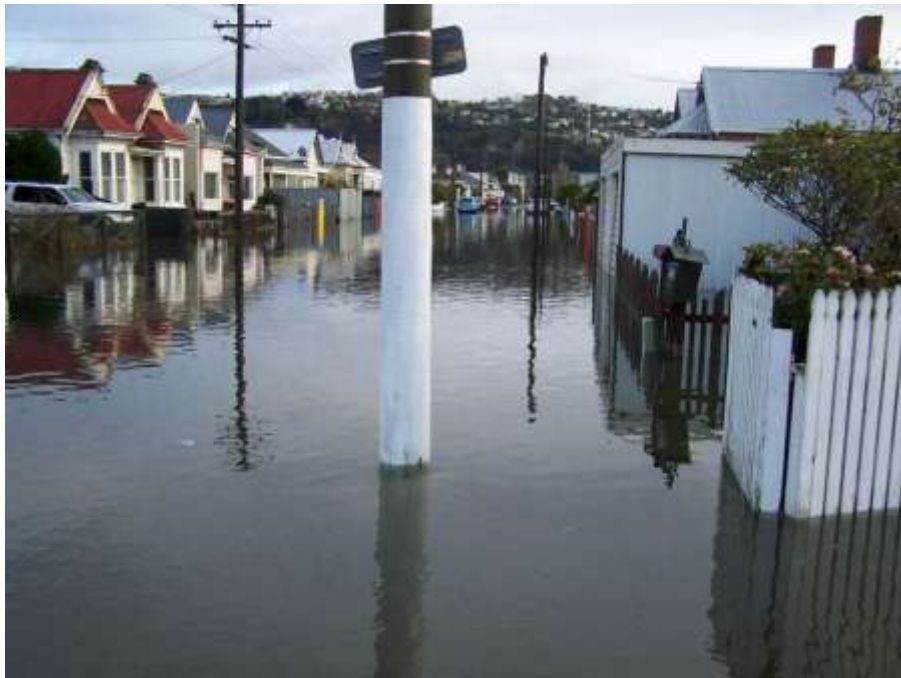
ORC staff undertook a reconnaissance trip on the morning of 4 June and observed water was still ponding across much of this area, as illustrated in Figure 12 to Figure 14. This inspection indicated that the area bounded by King Edward Street and Hillside, Prince Albert, Victoria and Forbury roads had been most affected, with little sign of inundation further east.¹⁵ It is noted that the lowest part of South Dunedin at Tainui is known to have been affected by floodwater before, as shown in Figure 15. Considerable localised variability in water depths was observed on 4 June, depending on slightly undulating local topography (e.g. Figure 13).

Figure 12. Ponding of surface water on Loyalty Street, South Dunedin, 4 June 2015

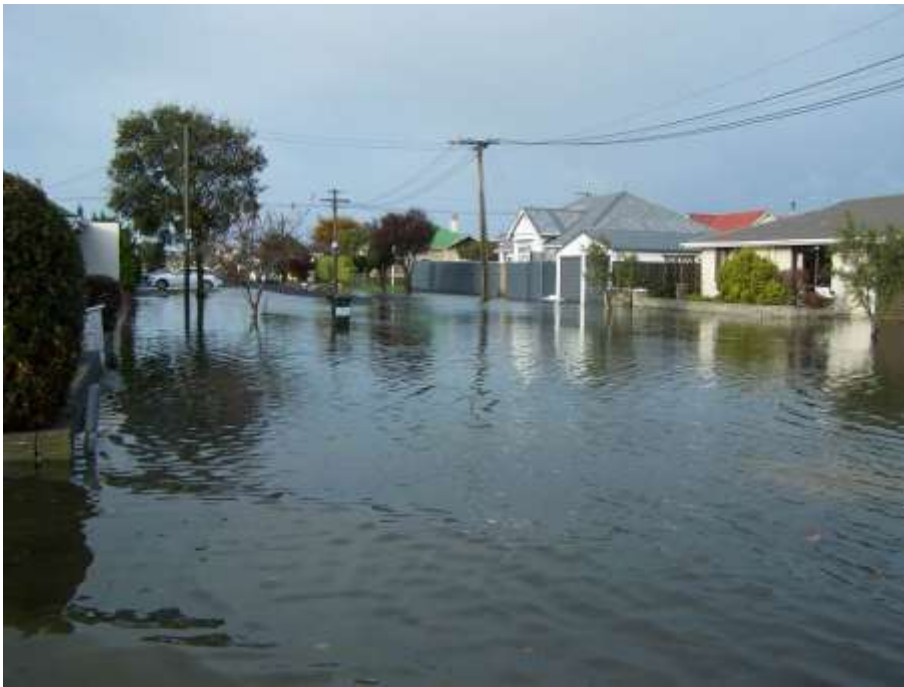
Figure 13. Ponding of surface water on Dalgety Street, South Dunedin, 4 June 2015

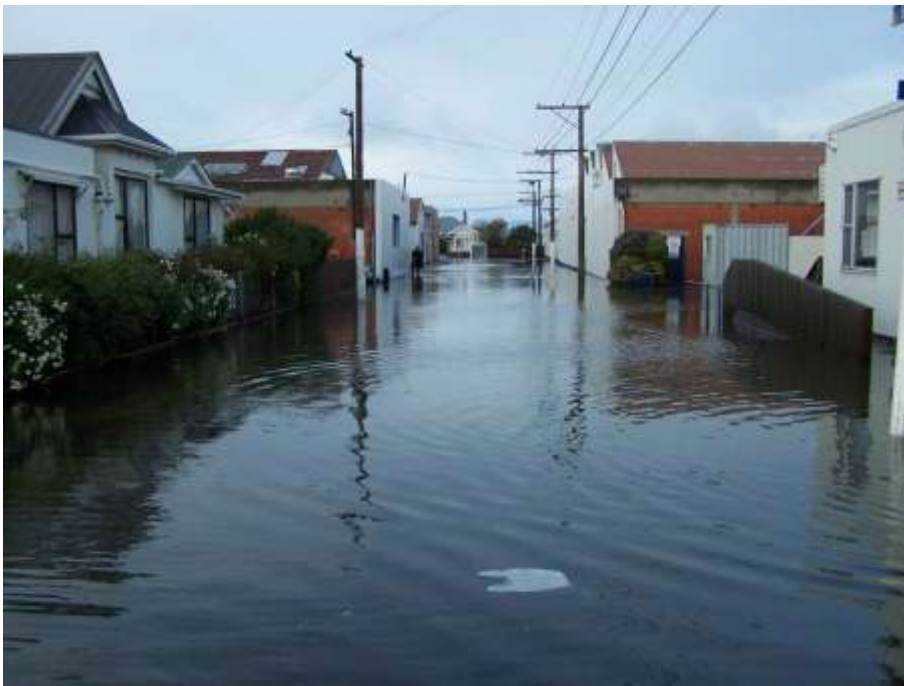
Figure 14. Ponding of surface water on Bradshaw Street, South Dunedin, 4 June 2015

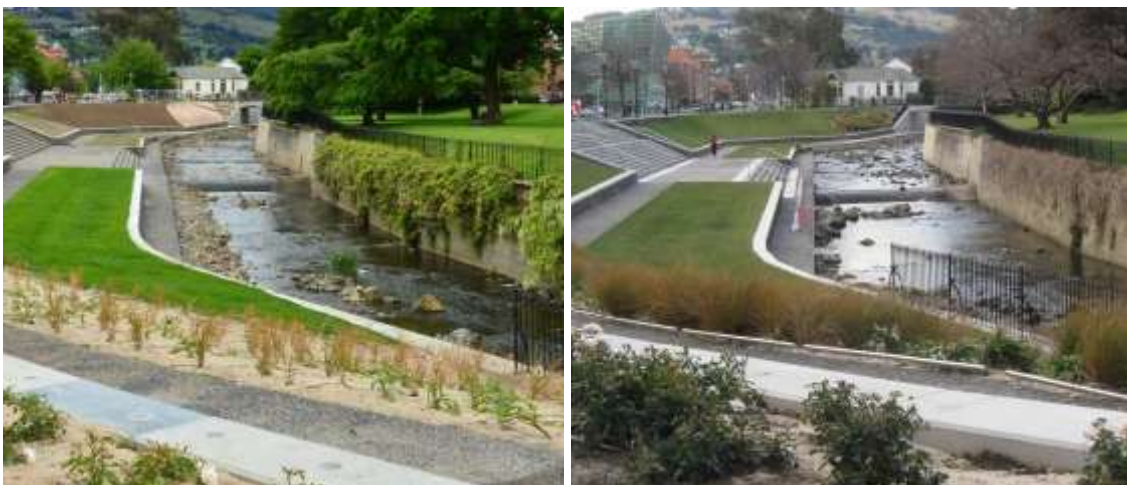
The recent flood-protection upgrade between St David Street to Union Street performed satisfactorily. There was no damage to the left bank. On the right bank, riprap has been scoured away over a 100 m length of the recently completed lower-right bank pathway (Figure 27). The riprap lost over the lower 38 m has resulted in a fall height greater than 1 m from the walkway to the riverbed. Options are being evaluated to remediate the fall height, for the interim access has been restricted by a barrier to eliminate the fall risk. Hydraulic loadings to the balustrades, compounded by significant build-up of debris, resulted in failure of the fixings to the concrete foundation. This failure has been attributed to a construction defect rather than design deficiencies. These defects have been remedied by the contractor. The turf and botanical plantings withstood the event with minor remediation and clean-up requirements.

Figure 27. Water of Leith before and after: Looking upstream from the University of Otago Staff Club. Note the loss of some riprap on the true-right bank.

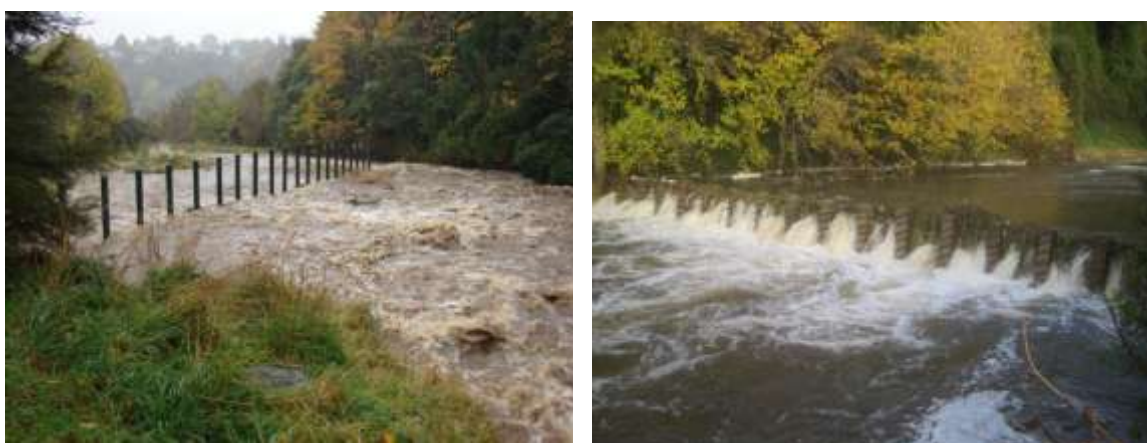
Figure 28. Water of Leith debris trap at Malvern Street (left) and Woodhaugh Street boulder trap (right) during the event, 3 June 2015

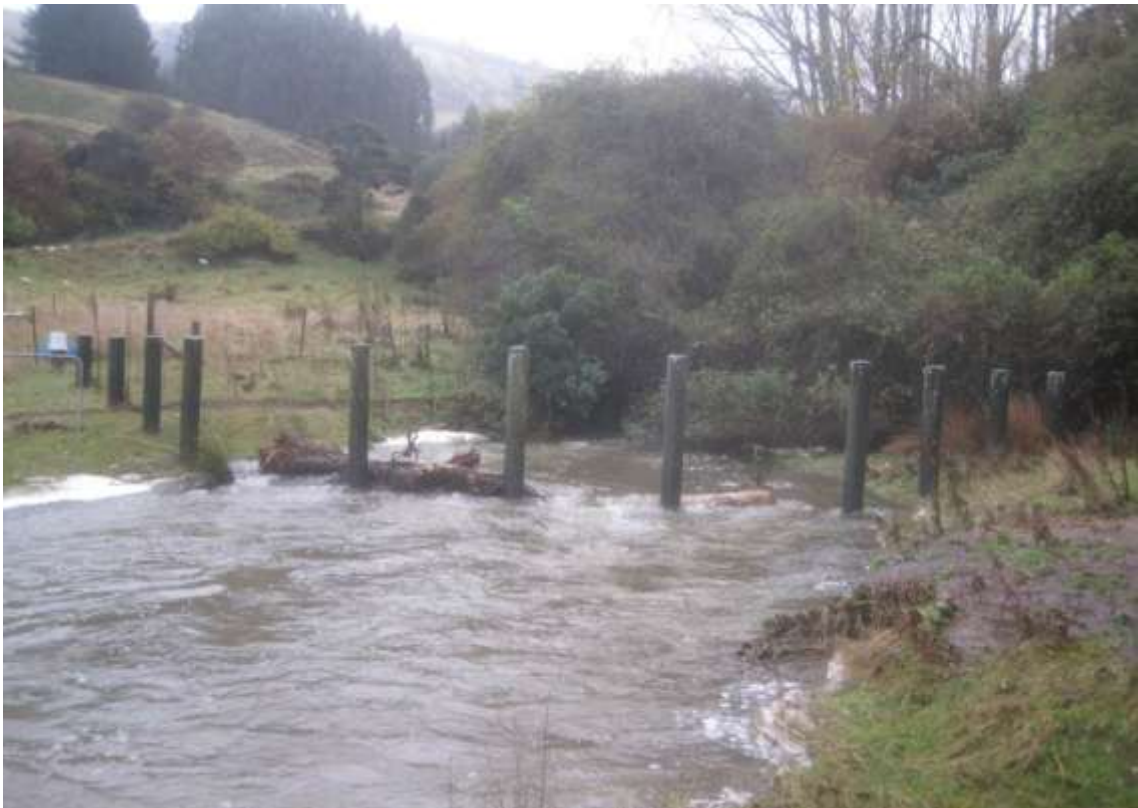
Figure 29. Lindsay Creek debris trap at Bethunes Gully during the event, 3 June 2015

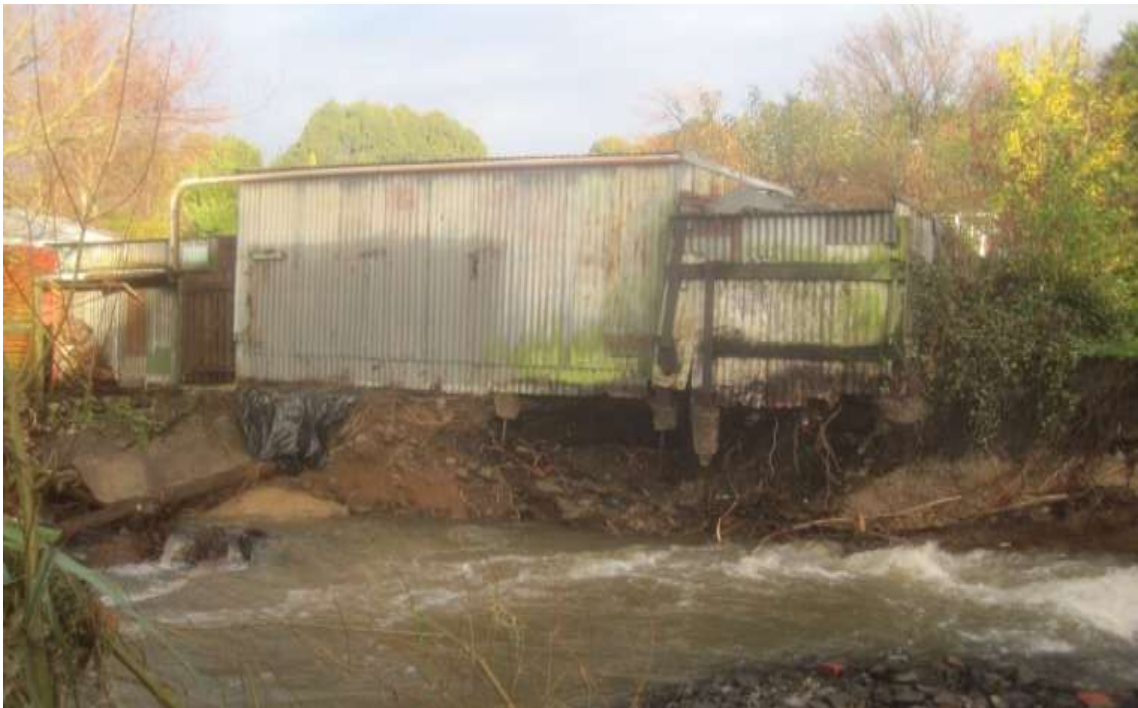
Figure 30. Bank erosion undermining a shed alongside Lindsay Creek at Kelvin Road, 4 June 2015

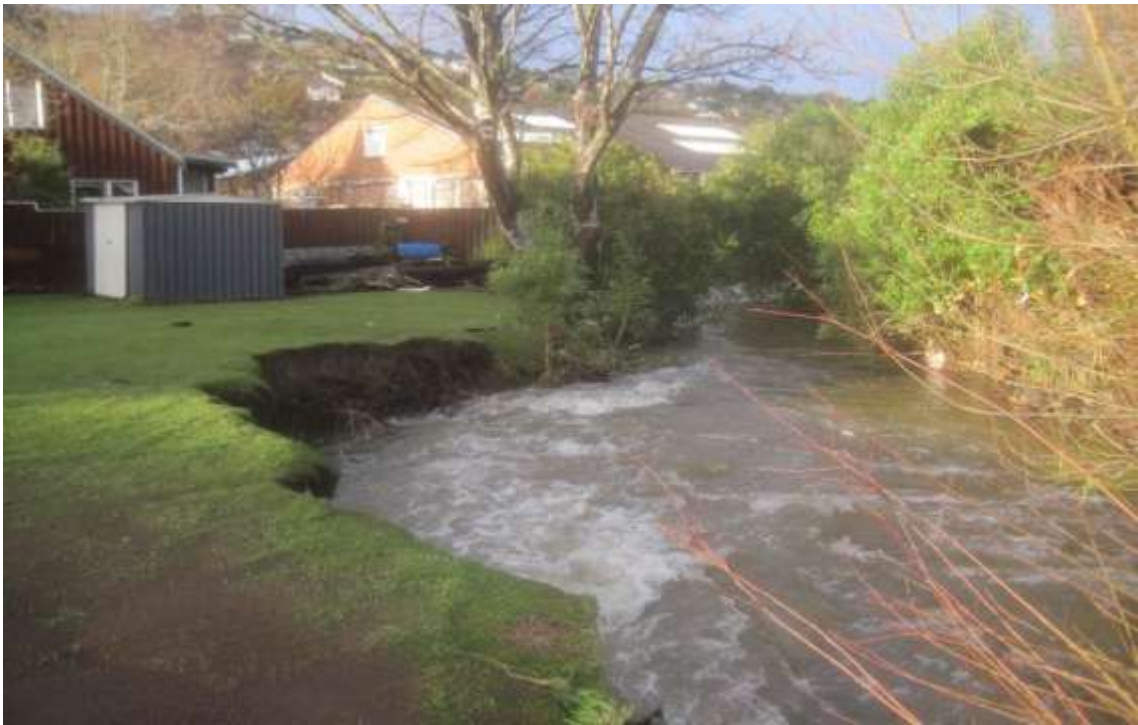
Figure 31. Bank erosion alongside Lindsay Creek at Kelvin Road, 4 June 2015

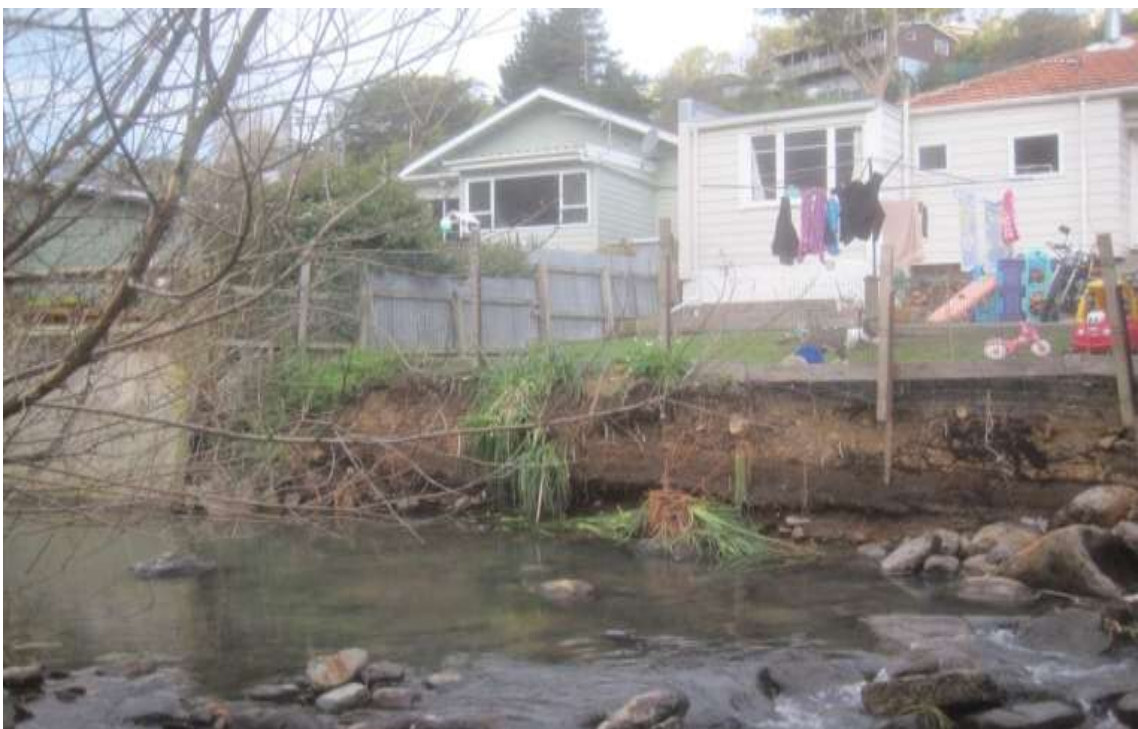
Figure 32. Bank erosion alongside Lindsay Creek at Norwood Street, 4 June 2015

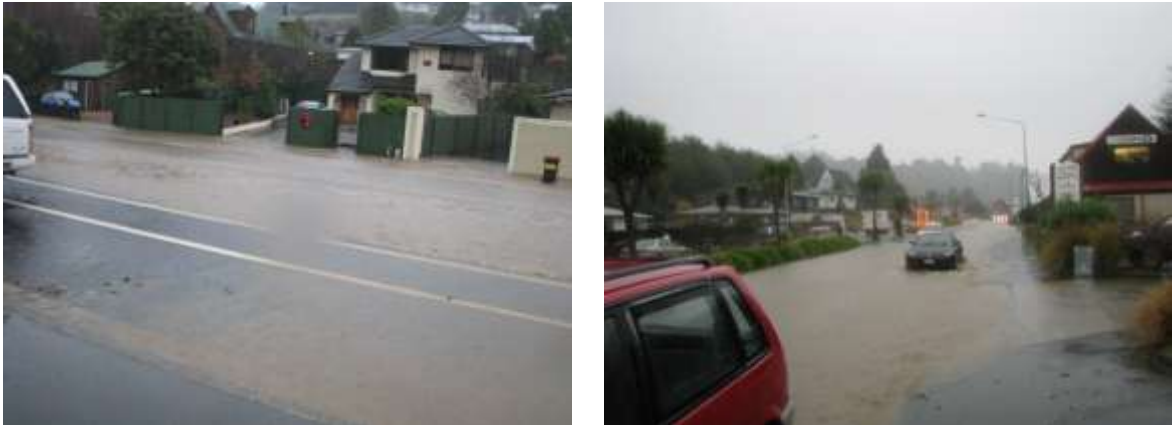
Figure 33. Examples of surface flooding on Kaikorai Valley Road, midday on 3 June 2015

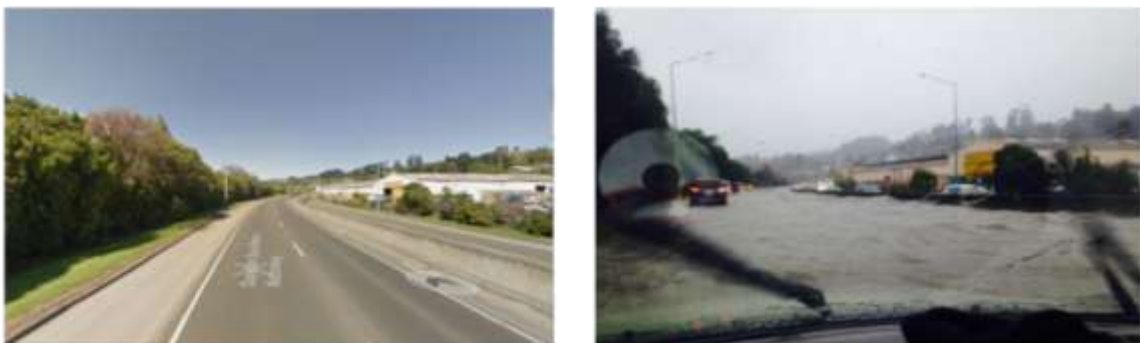
Figure 34. The northbound lane of the Dunedin Southern Motorway, east of the Carnforth Street underpass. Left: Normal conditions (Google StreetView); Right: During the peak of flooding at approximately midday on 3 June.

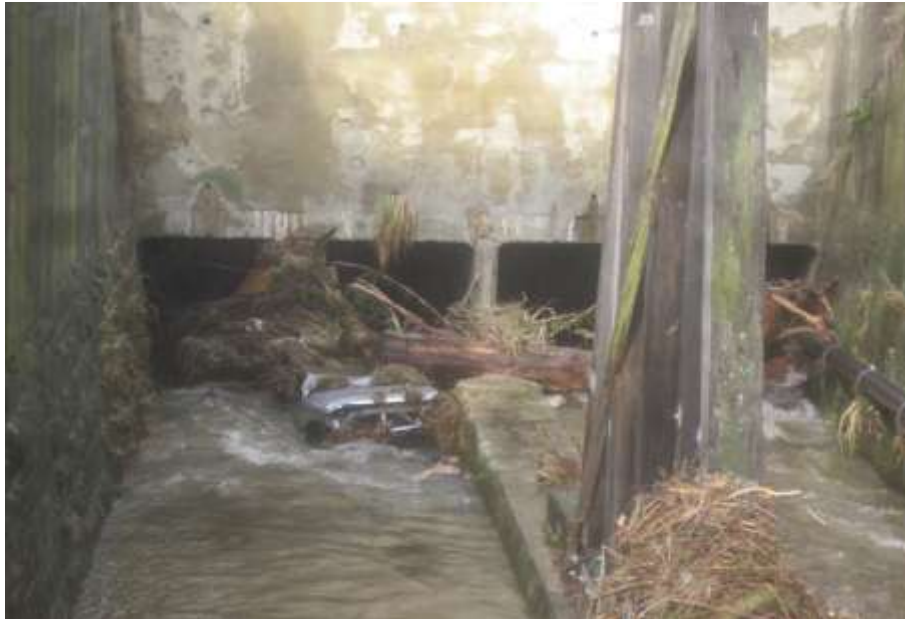
Figure 35. Car and tree lodged in culvert beneath SH1 at Burnside, 3 June 2015

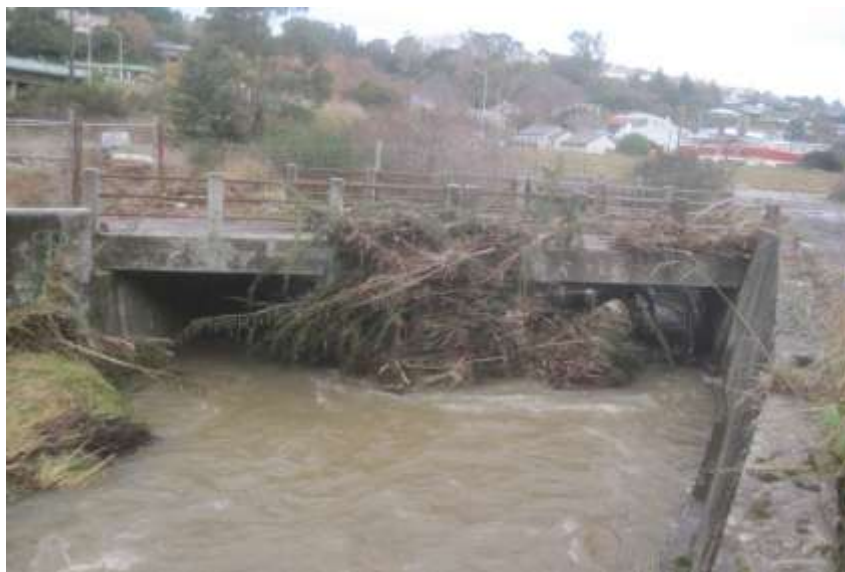
Figure 36. Tree and debris trapped under bridge at Burnside, 3 June 2015

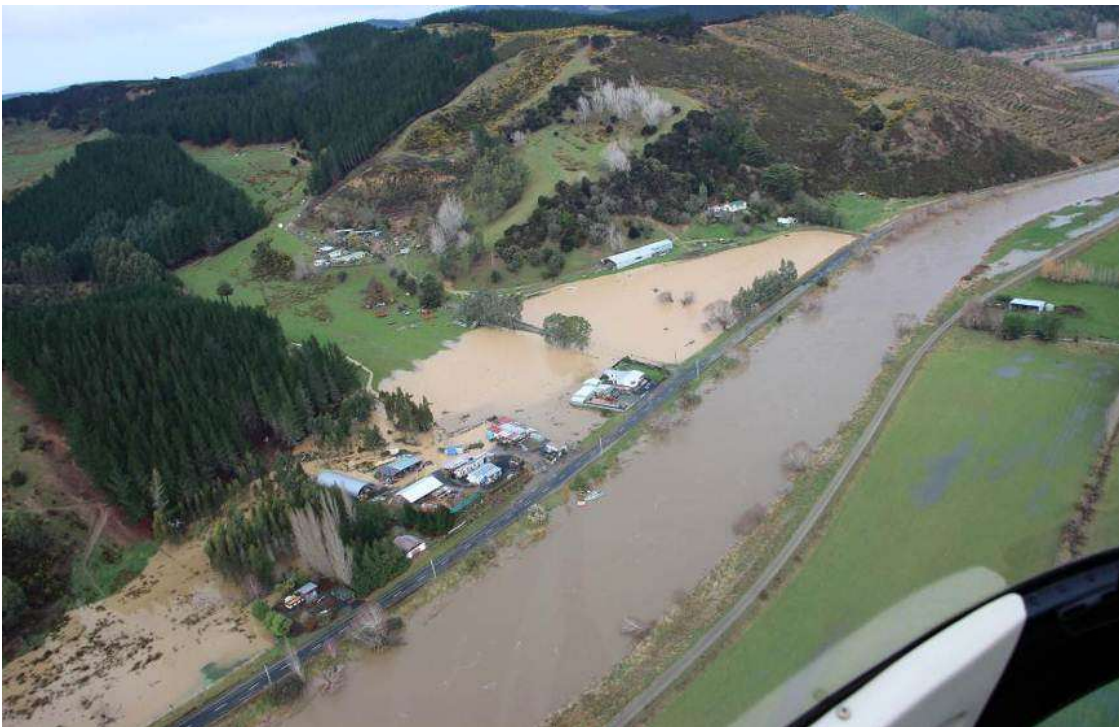
Figure 39. Aerial view towards the south of floodwater at Henley – 4 June 2015

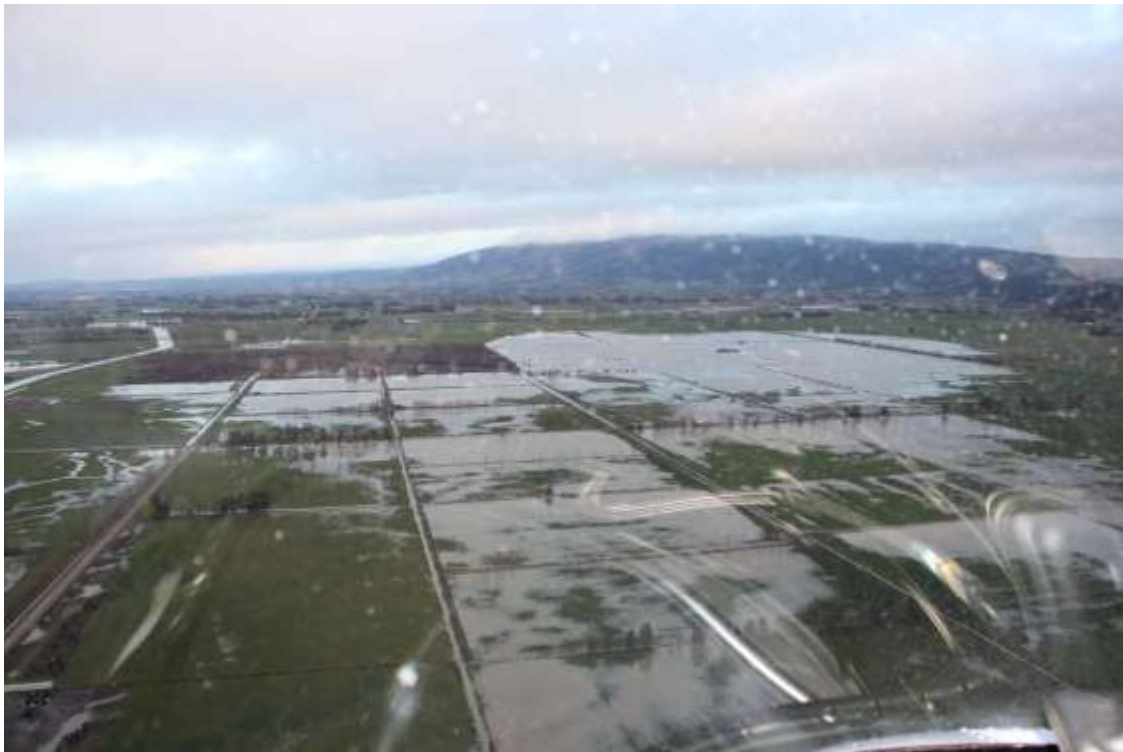
Figure 40. Ponding in the Upper Pond, view is towards the southwest – 4 June 2015

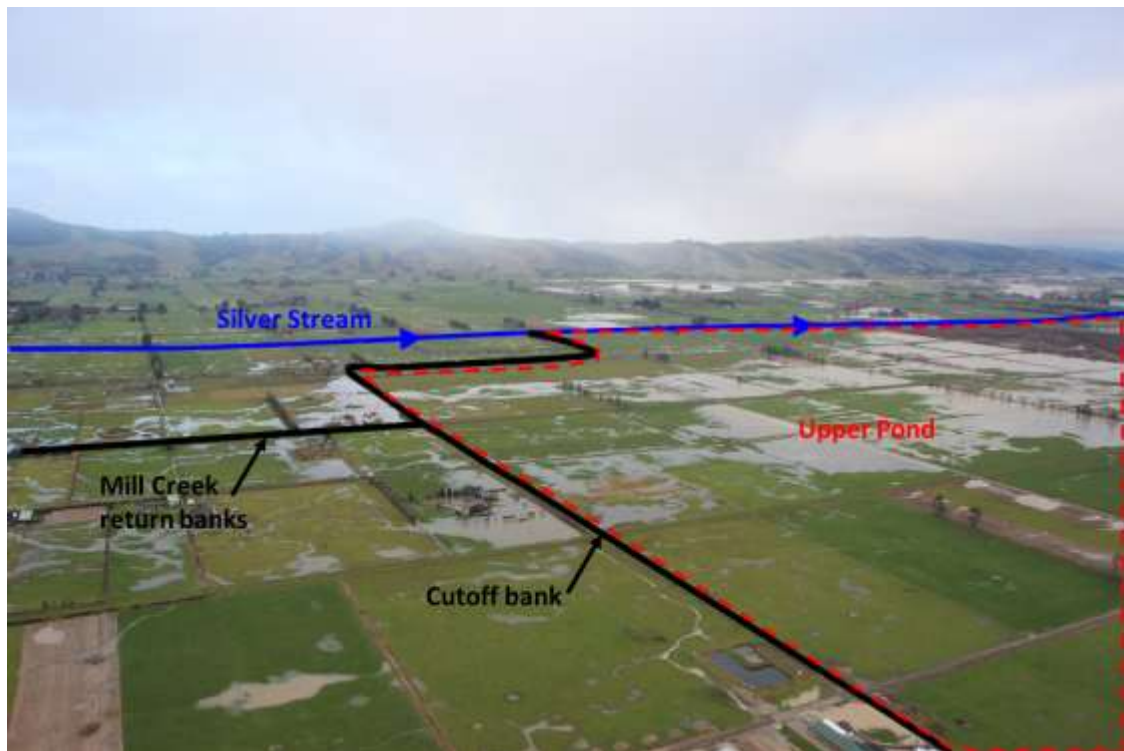
Figure 42. Ponding behind the Cutoff Bank; view is towards the south – 4 June 2015

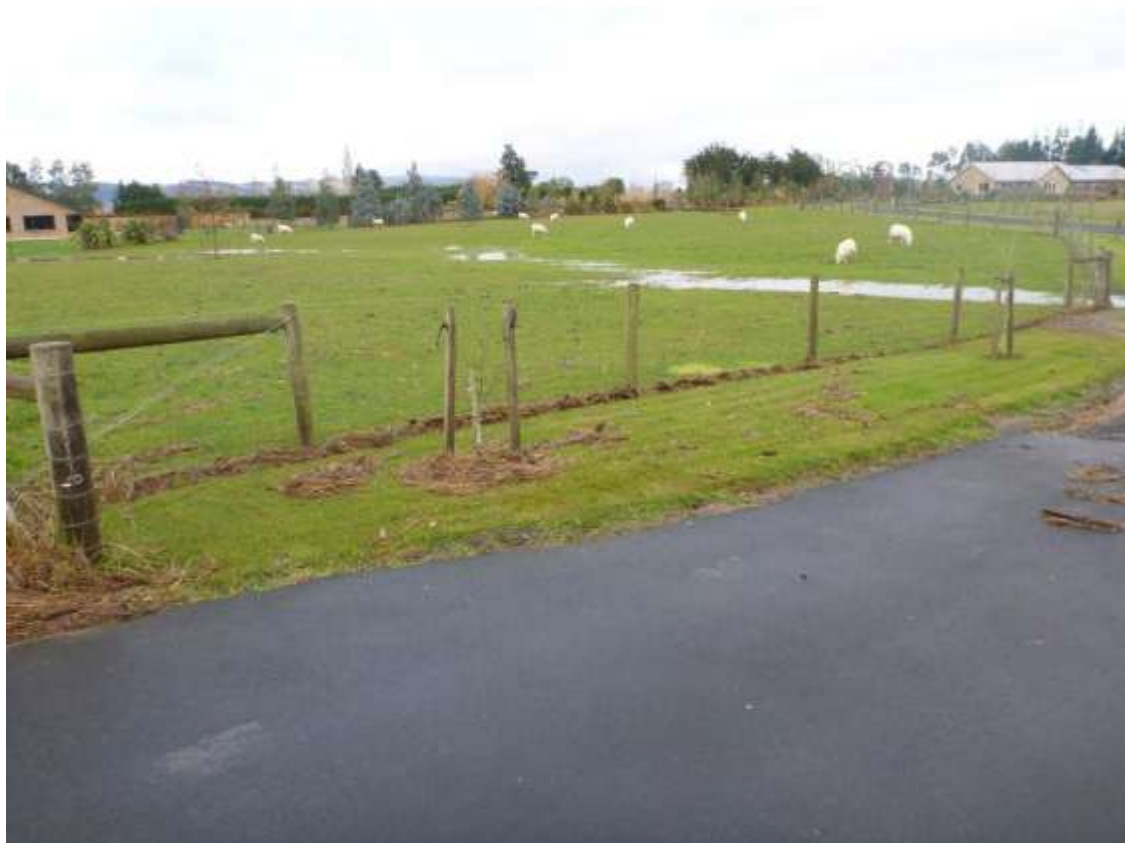
Figure 43. Debris marks indicative of overland flow and ponding in the vicinity of Wyllies Crossing – 4 June 2015

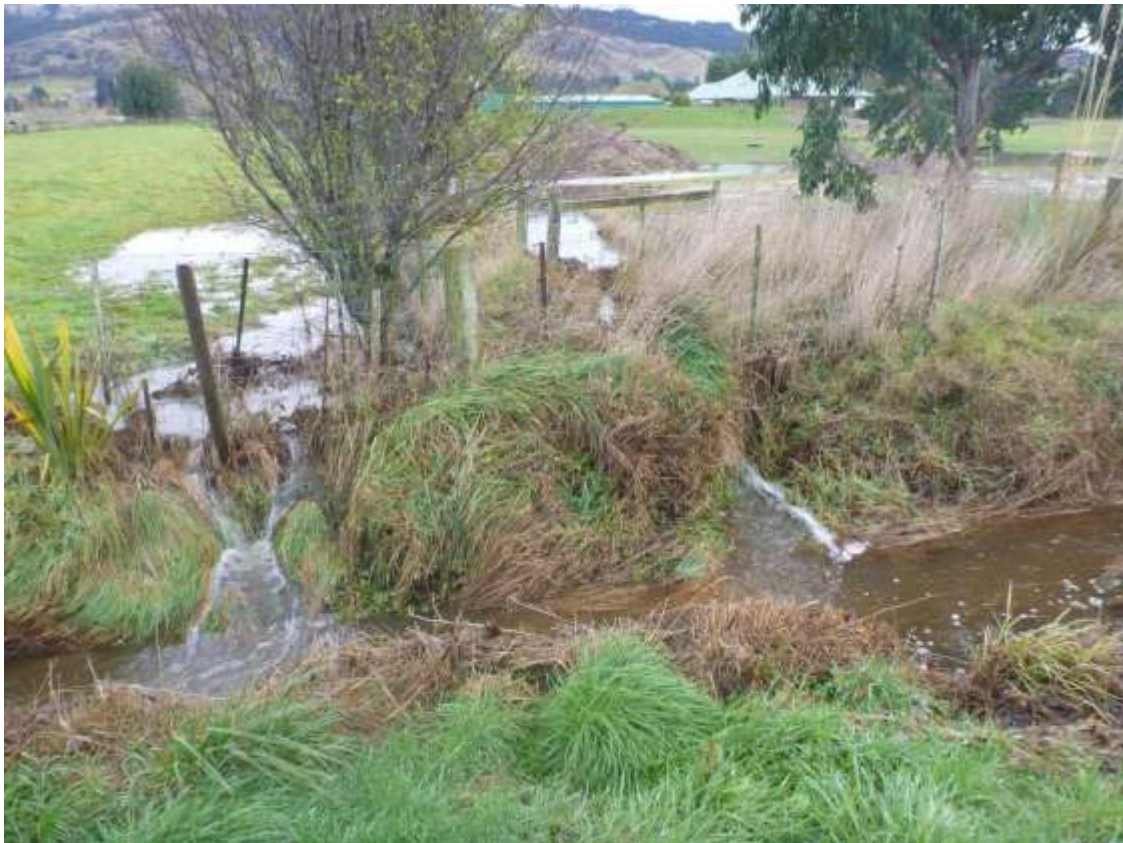
Figure 44. Example of overland-flow path conveying runoff from the hill catchments to an ORC drain between Riccarton Road and Gordon Road – 4 June 2015

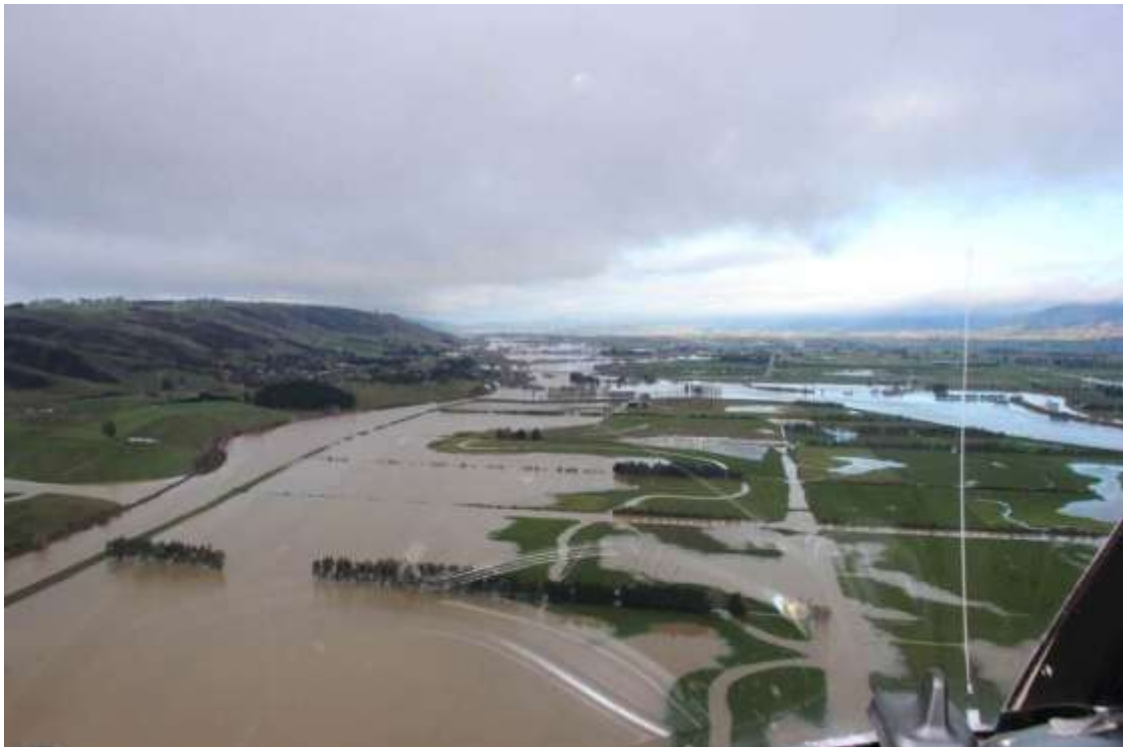
Figure 45. Ponding in the Lower Pond; view is towards the southwest – 4 June 2015

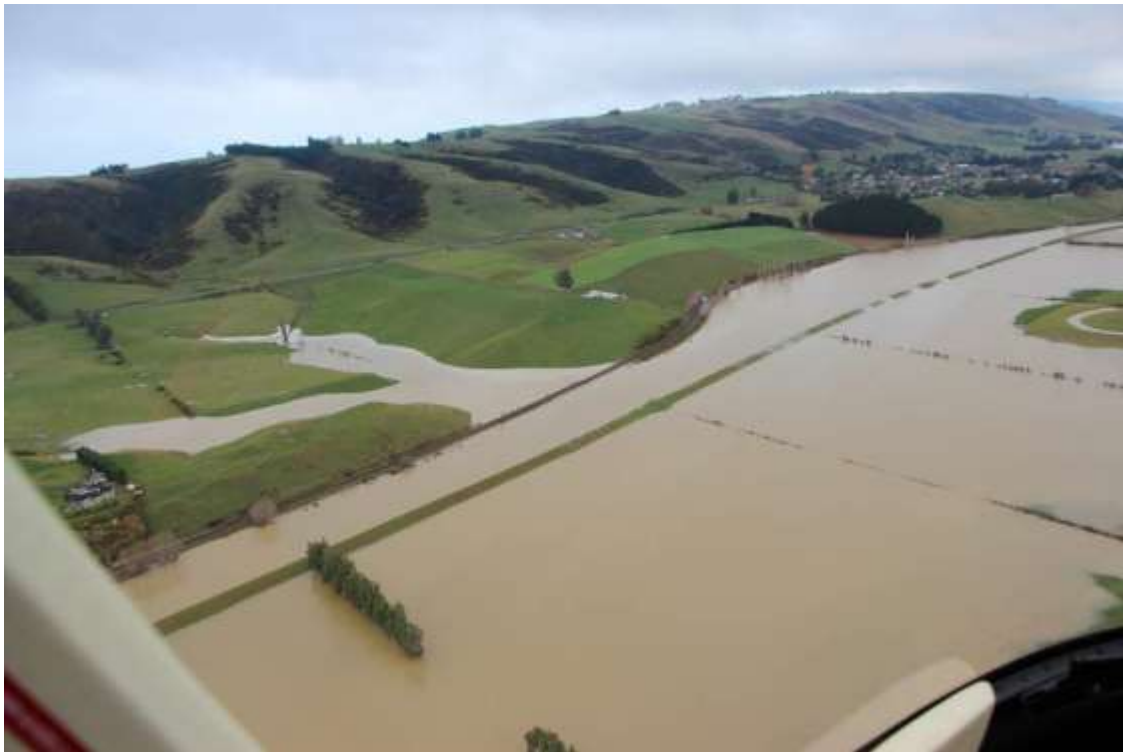
Figure 46. Ponding in the Lower Pond (note the overtopping of the Owhiro Stream true- right bank) and at the flanks of the coastal hills – 4 June 2015

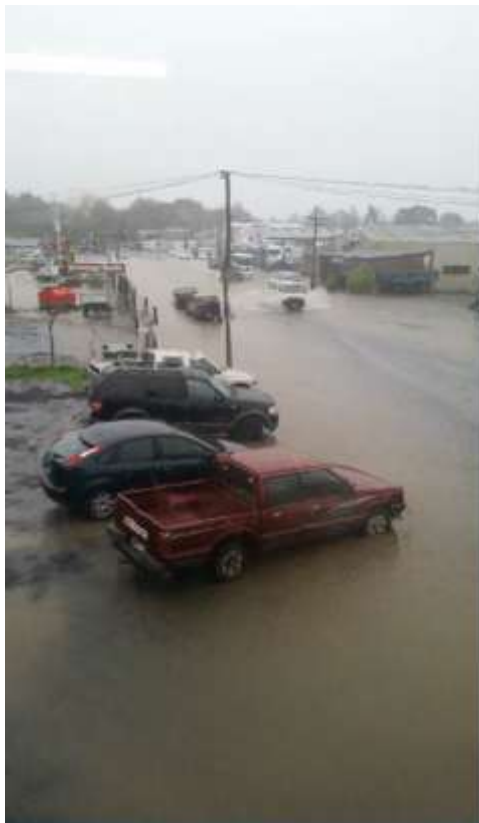
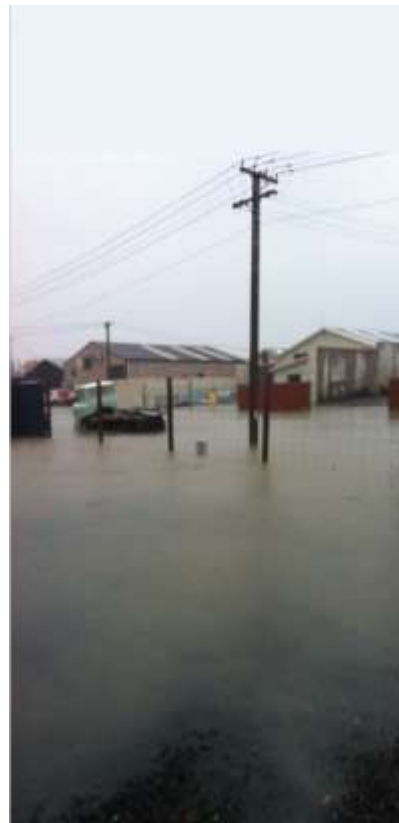
Figure 47. Flooding in Gow (left) and McGlashan (right) streets, Mosgiel – 3 June 2015 (photos courtesy of PW Engineering and Payne Aluminium)

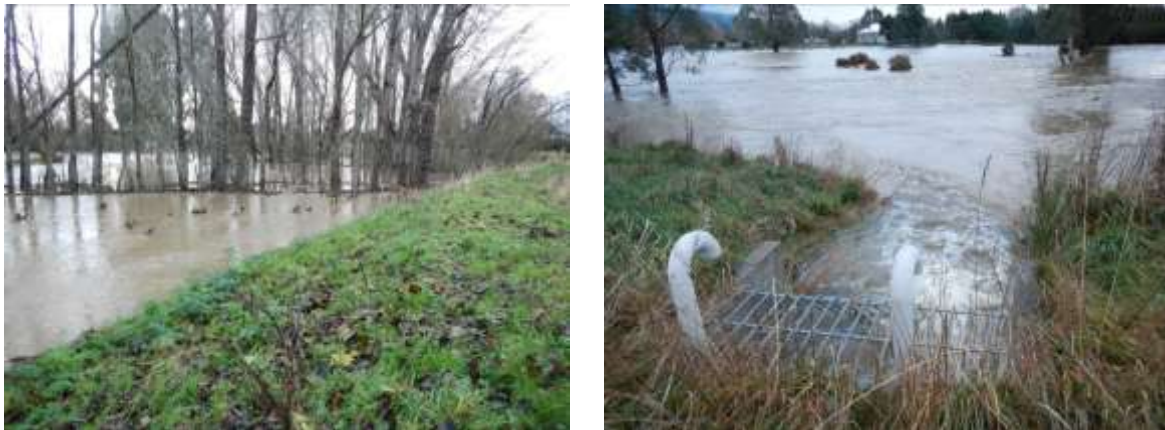
Figure 49. The floodbank (left) and pump station outlet (right) at Milton, downstream of SH1, 3 June 2015

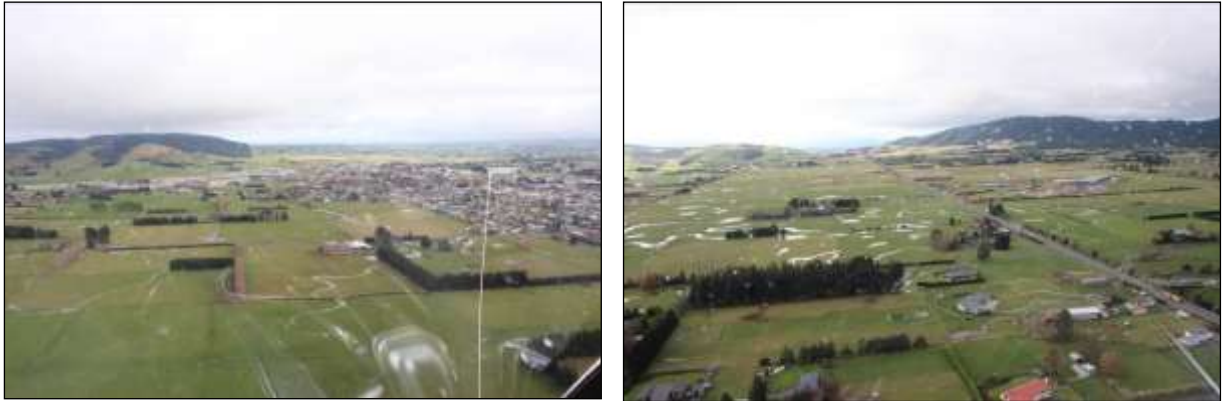
Figure 50. Residual floodwater in swale features, 4 June 2015. The left image shows the area to the east of Milton (looking southwest), and the right image shows the area to the north of Milton (looking northeast), with SH1 visible.

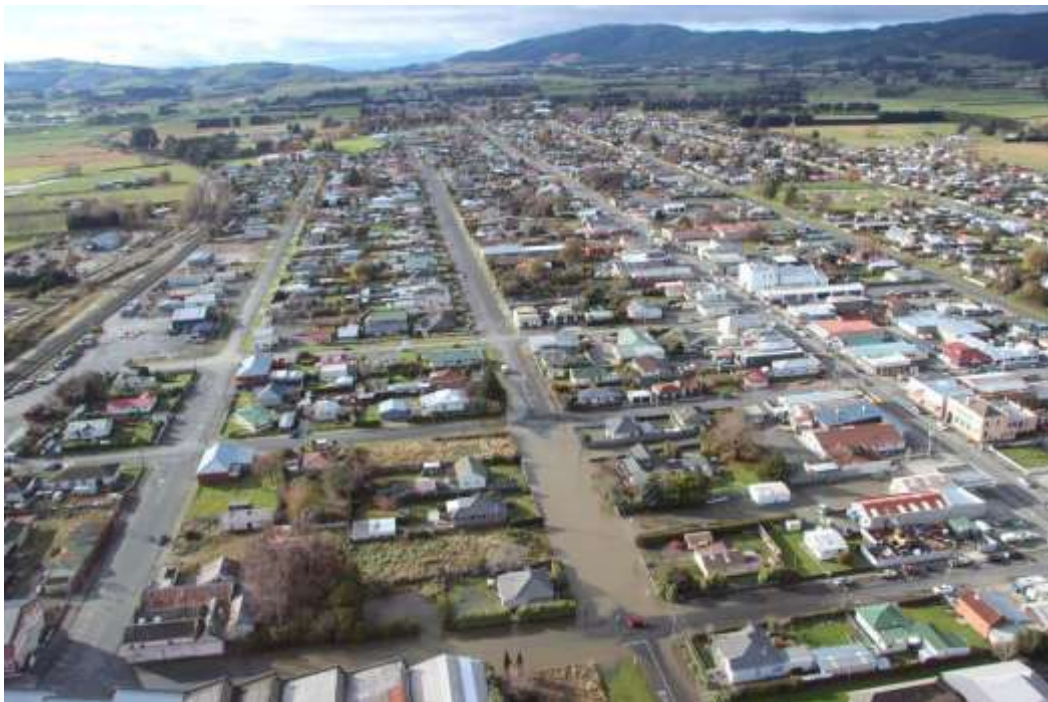
Figure 51. Aerial view of floodwater on Ajax Street (centre) Milton, with Union Street (SH1) to the right, 4 June 2015

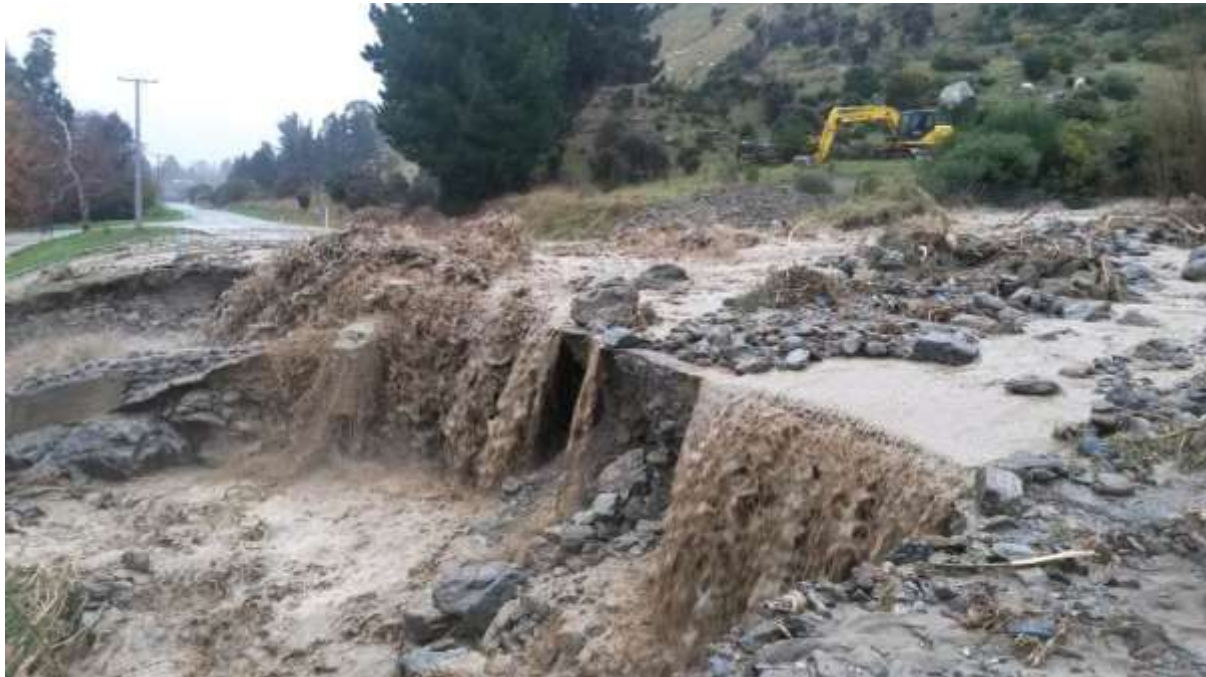
Figure 53. Flooding at Black Jacks Creek at SH8, 3 June 2015

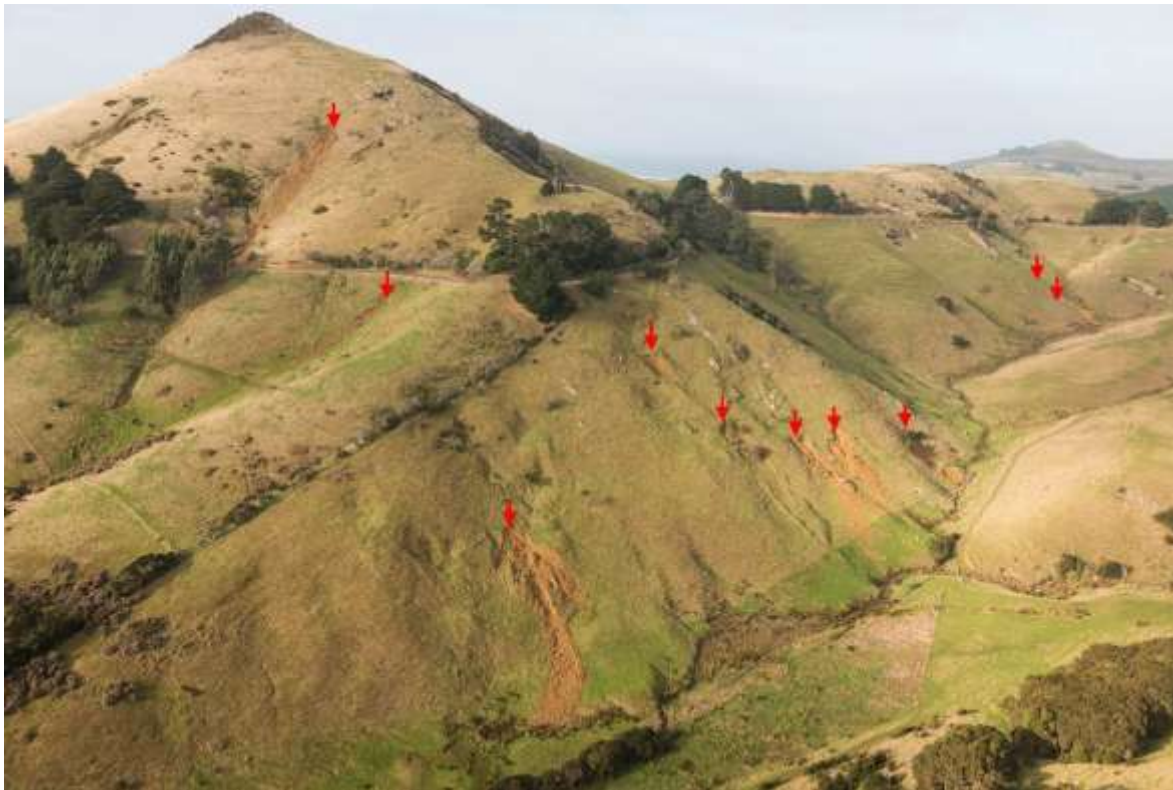
Figure 54. Aerial view of Harbour Cone, with landslide locations marked with red arrows, 16 June 2015
