# Kevin Rosengren & Associates Pty. Ltd.

February 28, 2011  
30028

Oceana Gold (NZ) Limited  
Golden Point Road  
**MACRAES FLAT 9483**  
**NEW ZEALAND**

### **MACRAES GOLD MINE - FOOTWALL FAULT PEER REVIEW OF PSM REPORT**

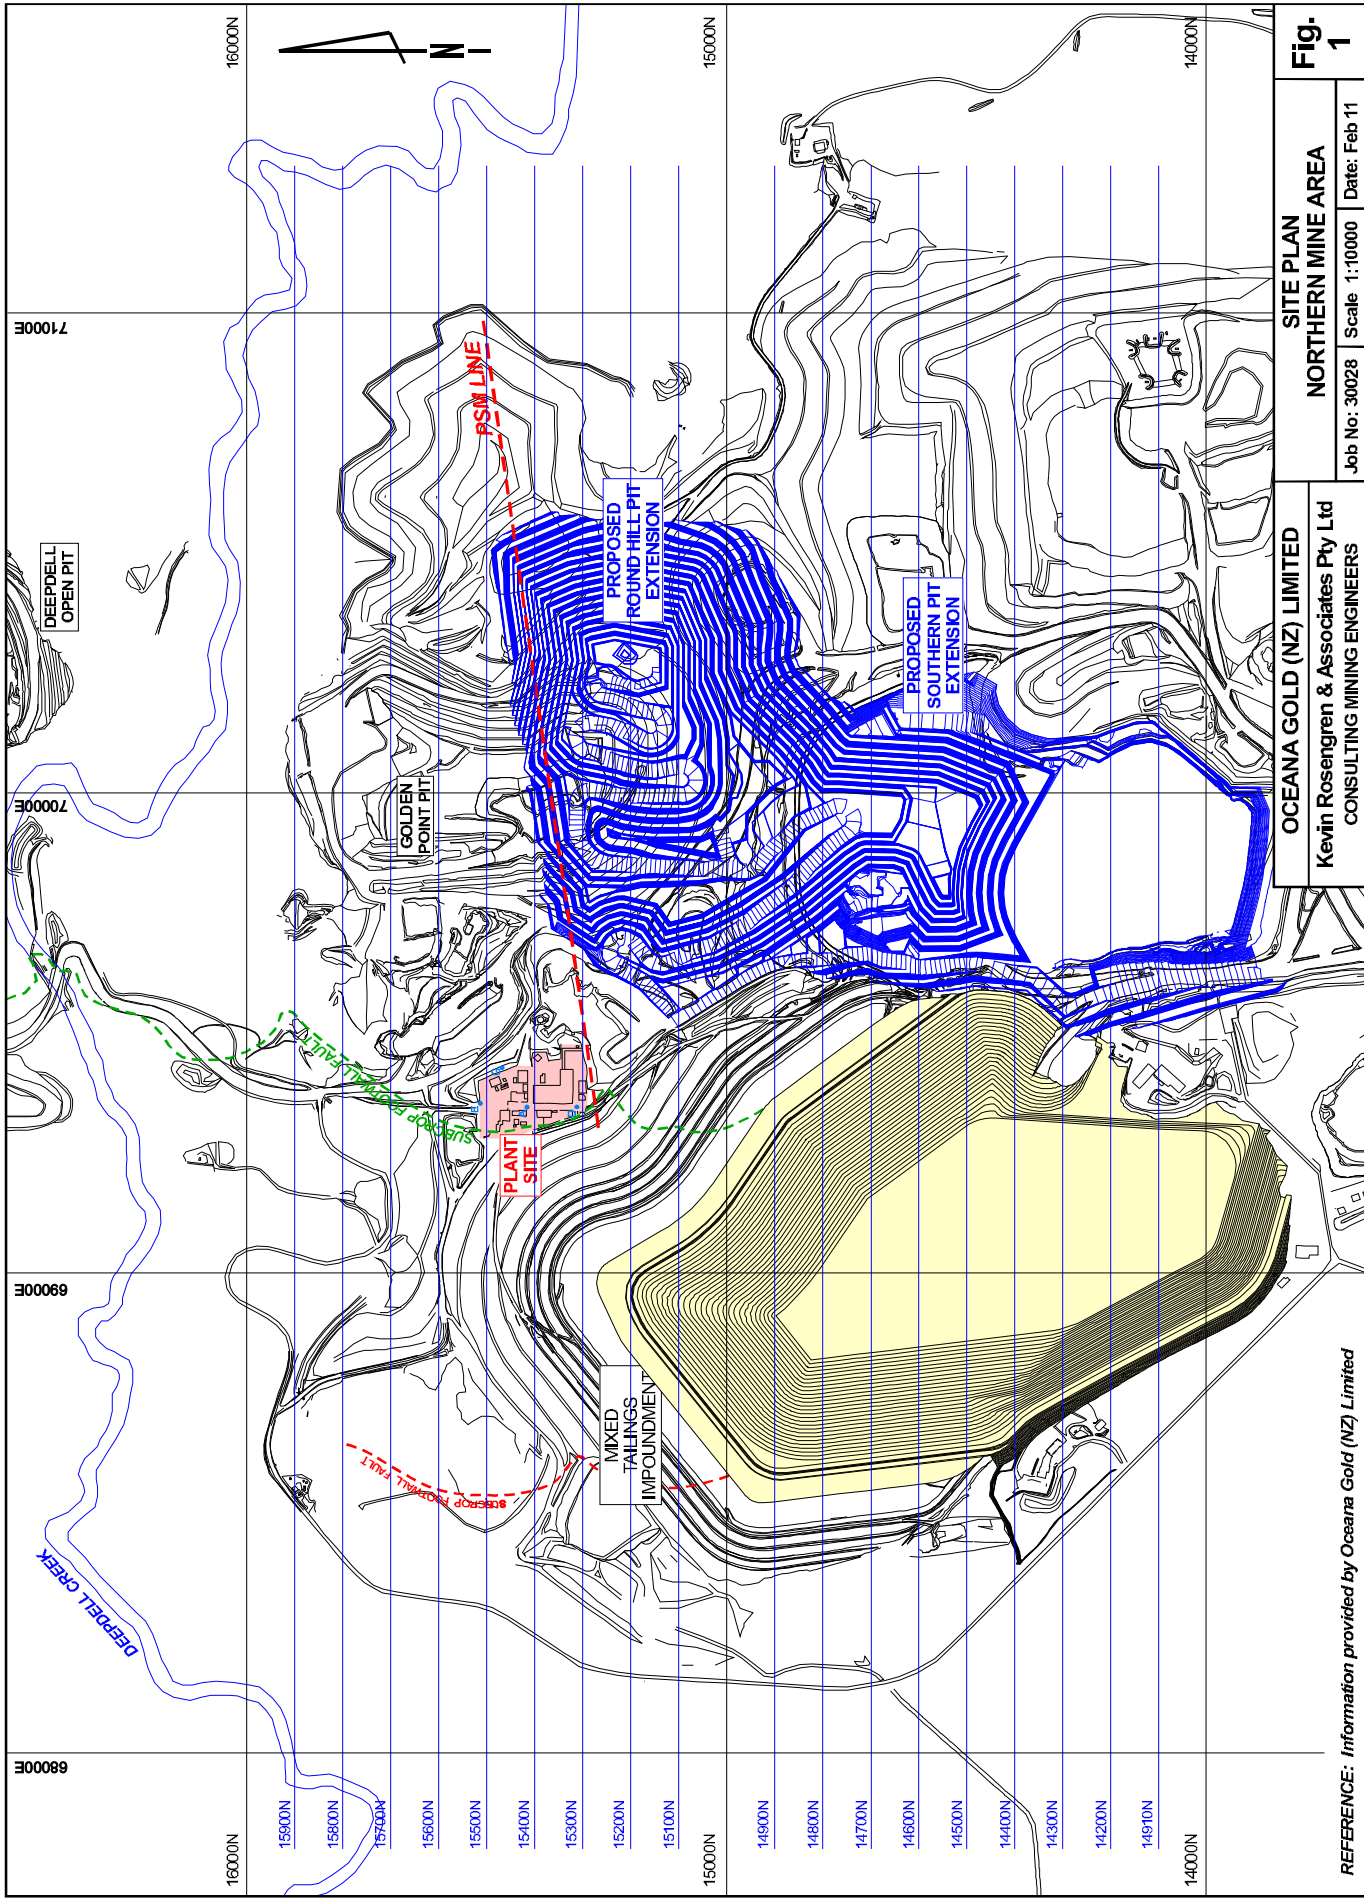
**Fig. 1**

The extent of the proposed northern area cut-back is shown on plan in Fig. 1. It is proposed that the existing Mixed Tailings Impoundment (MTI) will be decommissioned and partially dewatered reclaimed tailings from the Southern Pit cut-back will be drystacked on top of the MTI. A set of cross-sections through the northern mine area is shown on Figs. 3 to 9.

If there were no restraints, the pit cut-back would extend further to the north, to include the Golden Point open pit. However, because of concerns about the influence of such mining on the stability of the processing plant, the northern limit of mining has been specified by a "PSM Line" at approximately 15250N (Ref. 1), (Figs. 1 and 2).

- reducing depth of mining to RL350, or
- restricting mining south of the PSM line (Figs. 1 and 2).

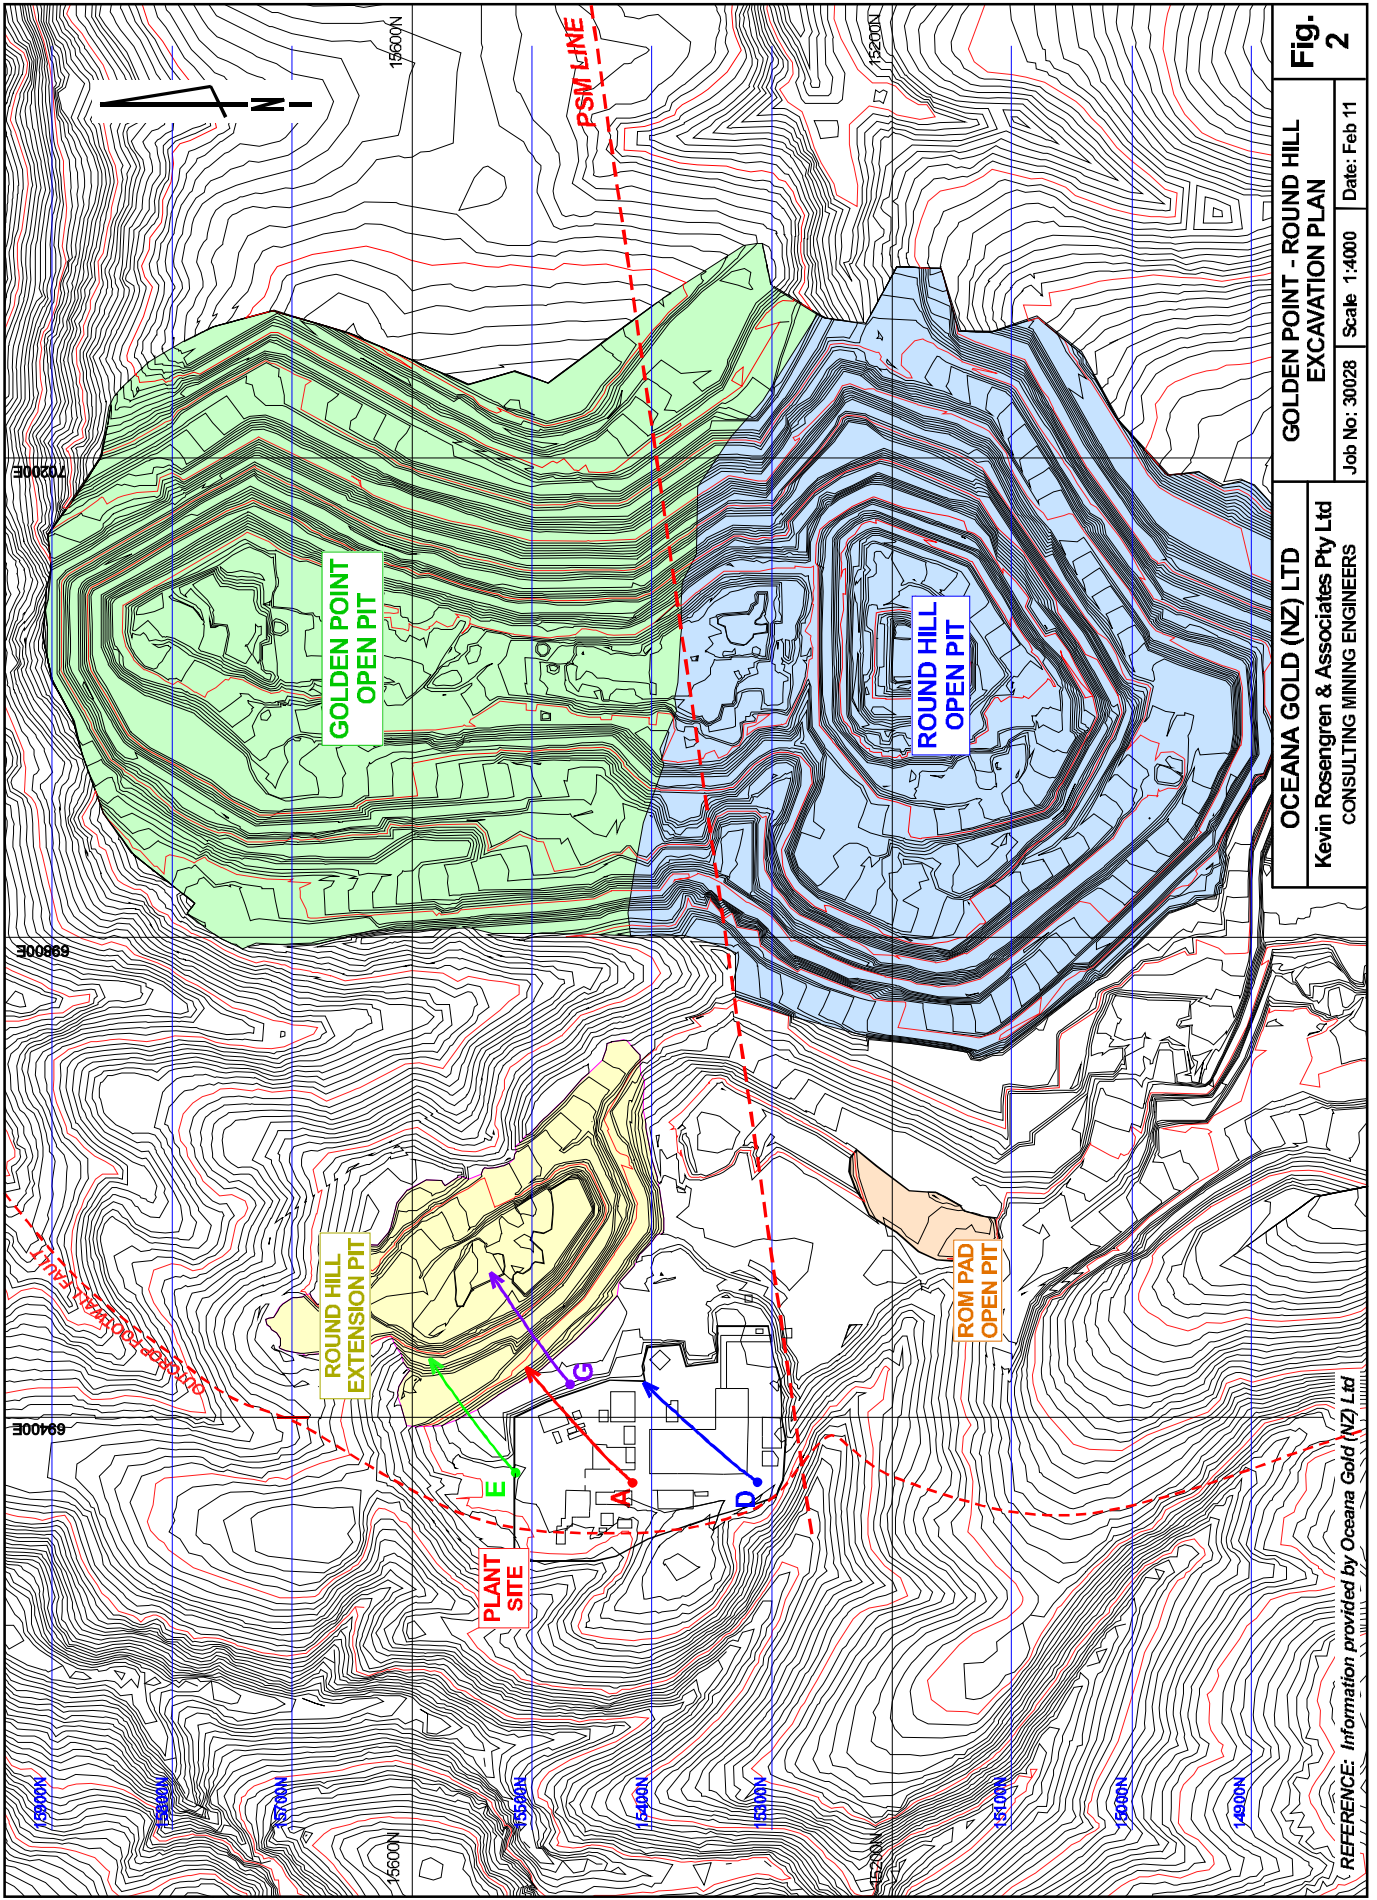
**Fig. 2**

Two small open pits were mined during 2003 and 2004, as follows (Fig. 2):

- Round Hill Extension (= North-West) pit, immediately north-east of the plant site, between April 2003 and October, 2004
- ROM Pad pit, a very small open pit, located 150m south-east of the plant site, between March and May, 2003.

Four survey pillars were established in the plant site area in 2000 (Fig. 2). Monitoring of pillars A and D commenced on July 7, 2000 and of pillars E and G on November 2, 2000. Results of this monitoring are summarised on Fig. 10. All four pillars showed similar movements with a total horizontal movement of around 4m to the north-east, and a settlement of around 1m. A fault scarp with a vertical displacement of 1.1m, developed along the rear of the plant site (Fig. 2, Plate 1).

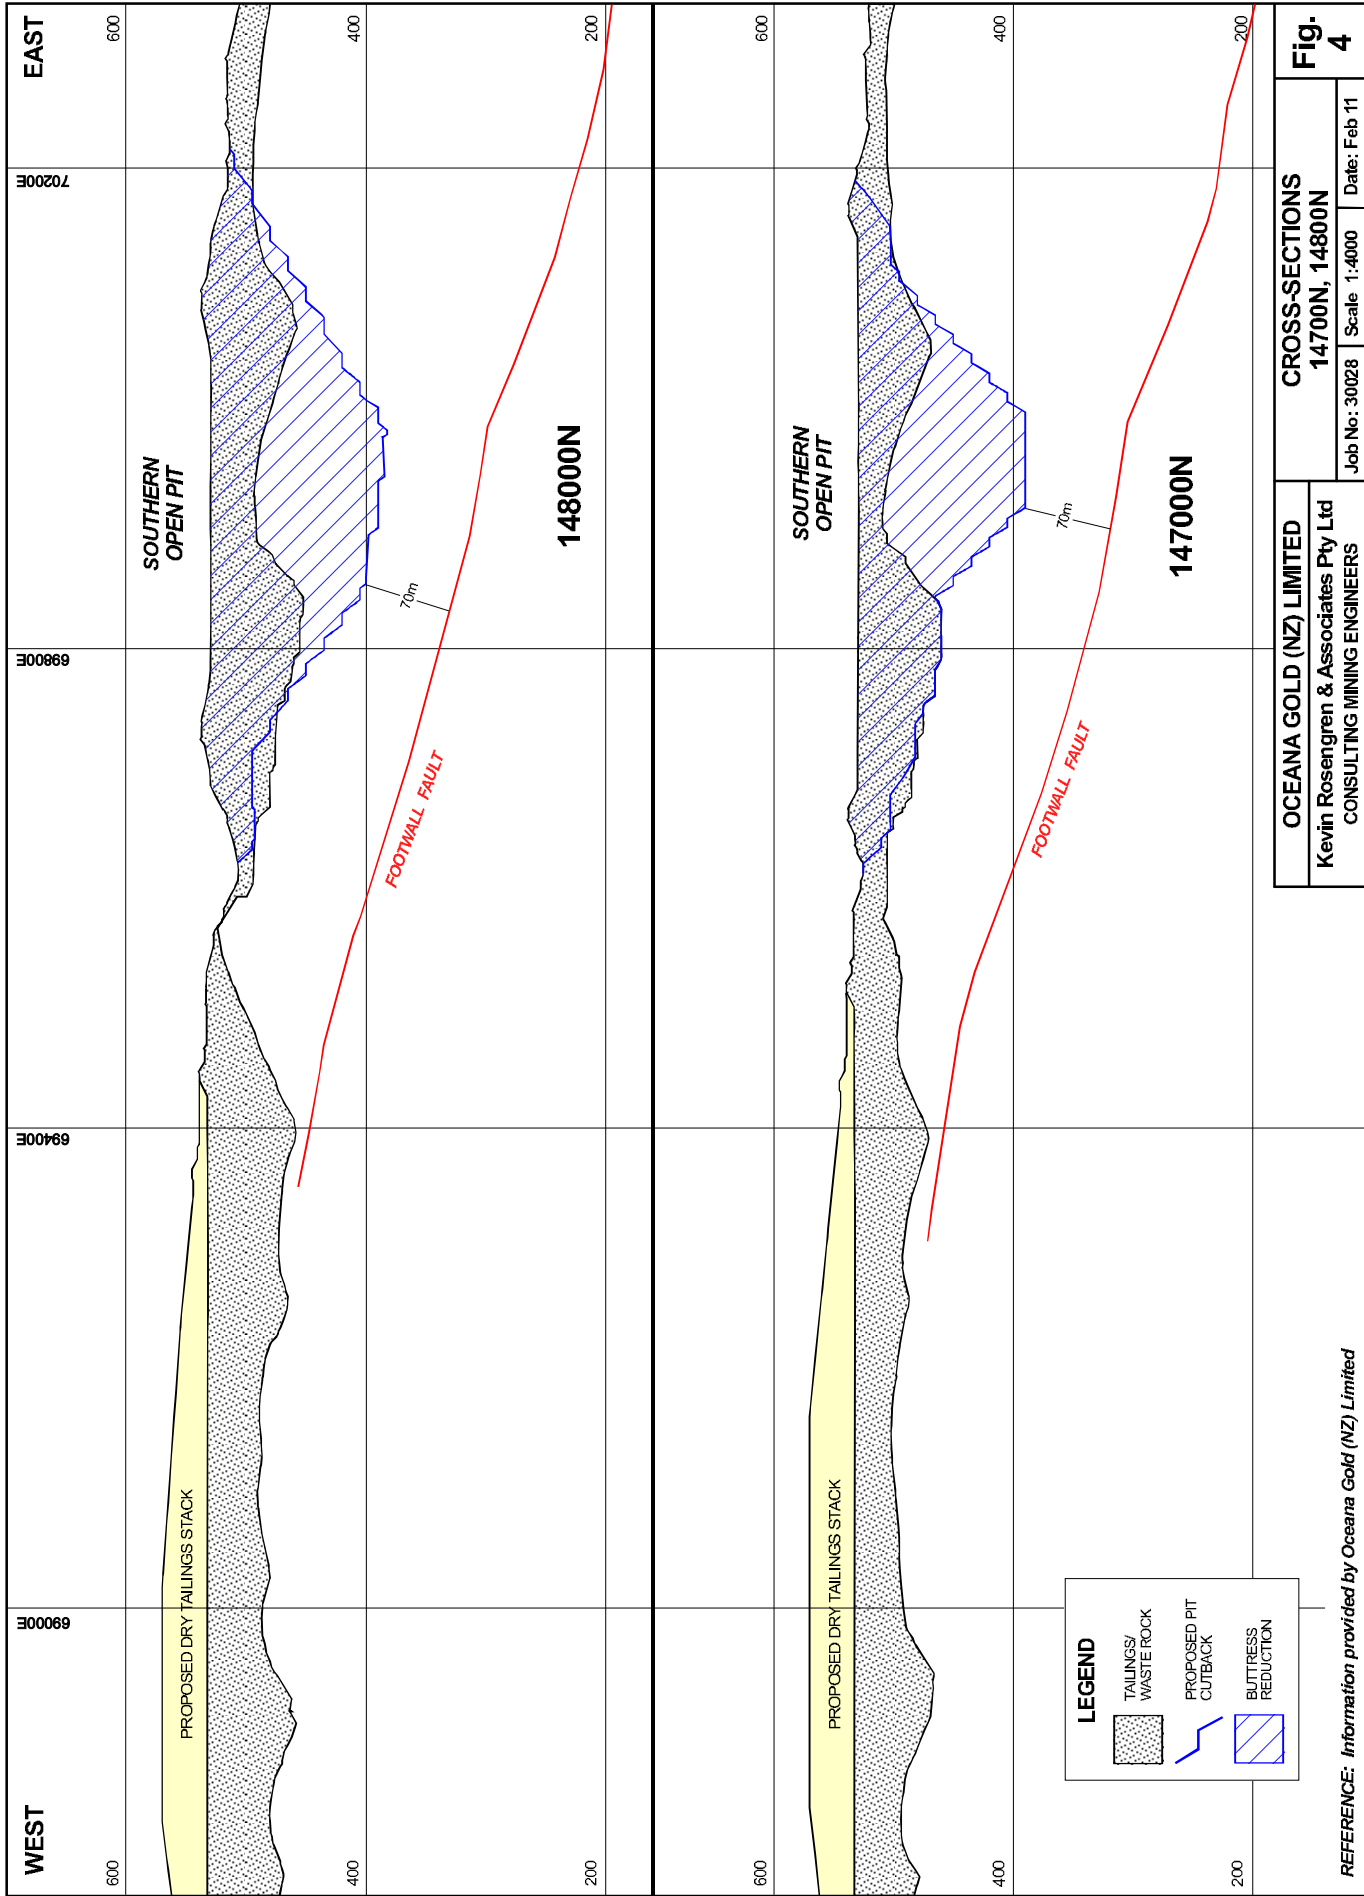
Fig-  
**4**

The cross-sections (Figs. 4 to 6) show that the Footwall Fault continues beneath the MTI, south of 15200N. With movements of several metres predicted in this area, there will be substantial cracking of the base of the MTI, with direct connection to the Footwall Fault. It is planned that the MTI will be decommissioned but, if it is not completely dewatered, it will provide a source of constant recharge to the fault, which will potentially generate even larger movements.

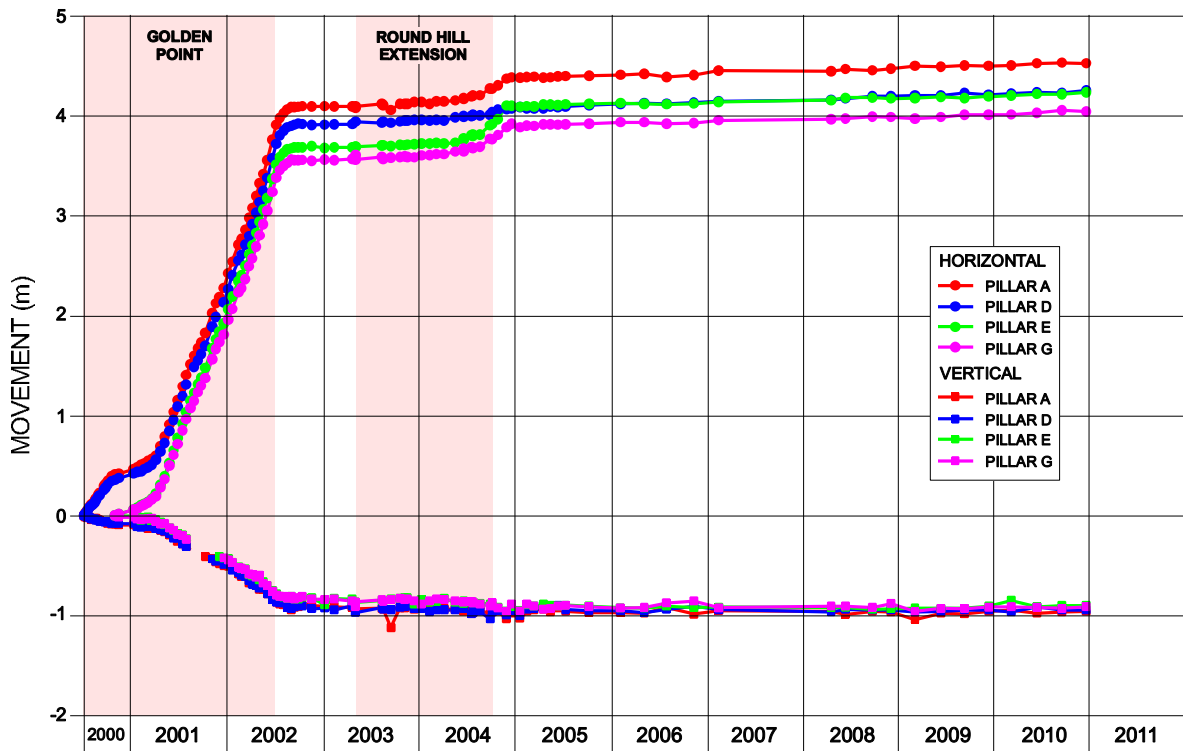
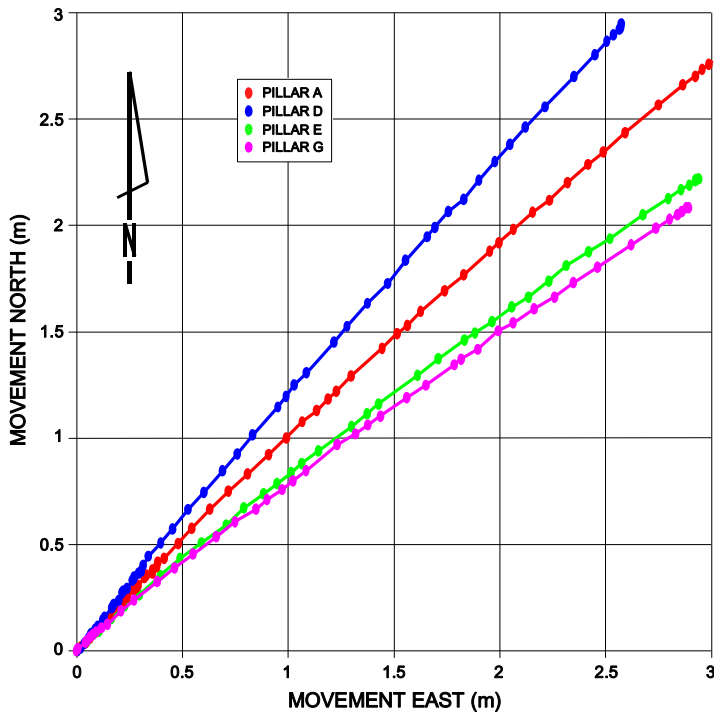
**(a) MOVEMENT MAGNITUDE  
(JULY, 2000 - SEPTEMBER, 2002)**

The bulk of the movement occurred between March 2001 and June 2002, during the mining of Stage 3 of the Golden Point open pit, at a remarkably constant rate of 8mm/day, determined by the stop/start mining sequence. Movements effectively ceased as soon as mining was completed. There was additional small movement in the second half of 2004, corresponding to the mining of the Round Hill Extension pit. There have been steady small movements since that time.

The directions of movement of the three pillars are shown on Fig. 10. The directions are consistently to the north-east, on bearings between 037° and 050°. Some northerly component of movement would be expected because the Golden Point pit is located north of the plant site. In addition, the dip direction (075°) of the Footwall Fault in this area is slightly north of east.

However, the much larger northerly components actually recorded are unexpected and, in our opinion, are not readily explainable. It has been suggested that they have been caused by the fact that the Footwall Fault outcrops in Deepdell Creek, 900m to the north (Fig. 1). In view of this large separation, we find this explanation difficult to accept.

The movements caused by the mining of the Round Hill Extension open pit are shown on the monitoring record on Fig. 10. Although only relatively small, this pit was mined close to the subcrop of the Footwall Fault and to within 20m of the fault. The movements occurred towards the end of the mining period because this represents the closest proximity to the Footwall Fault.

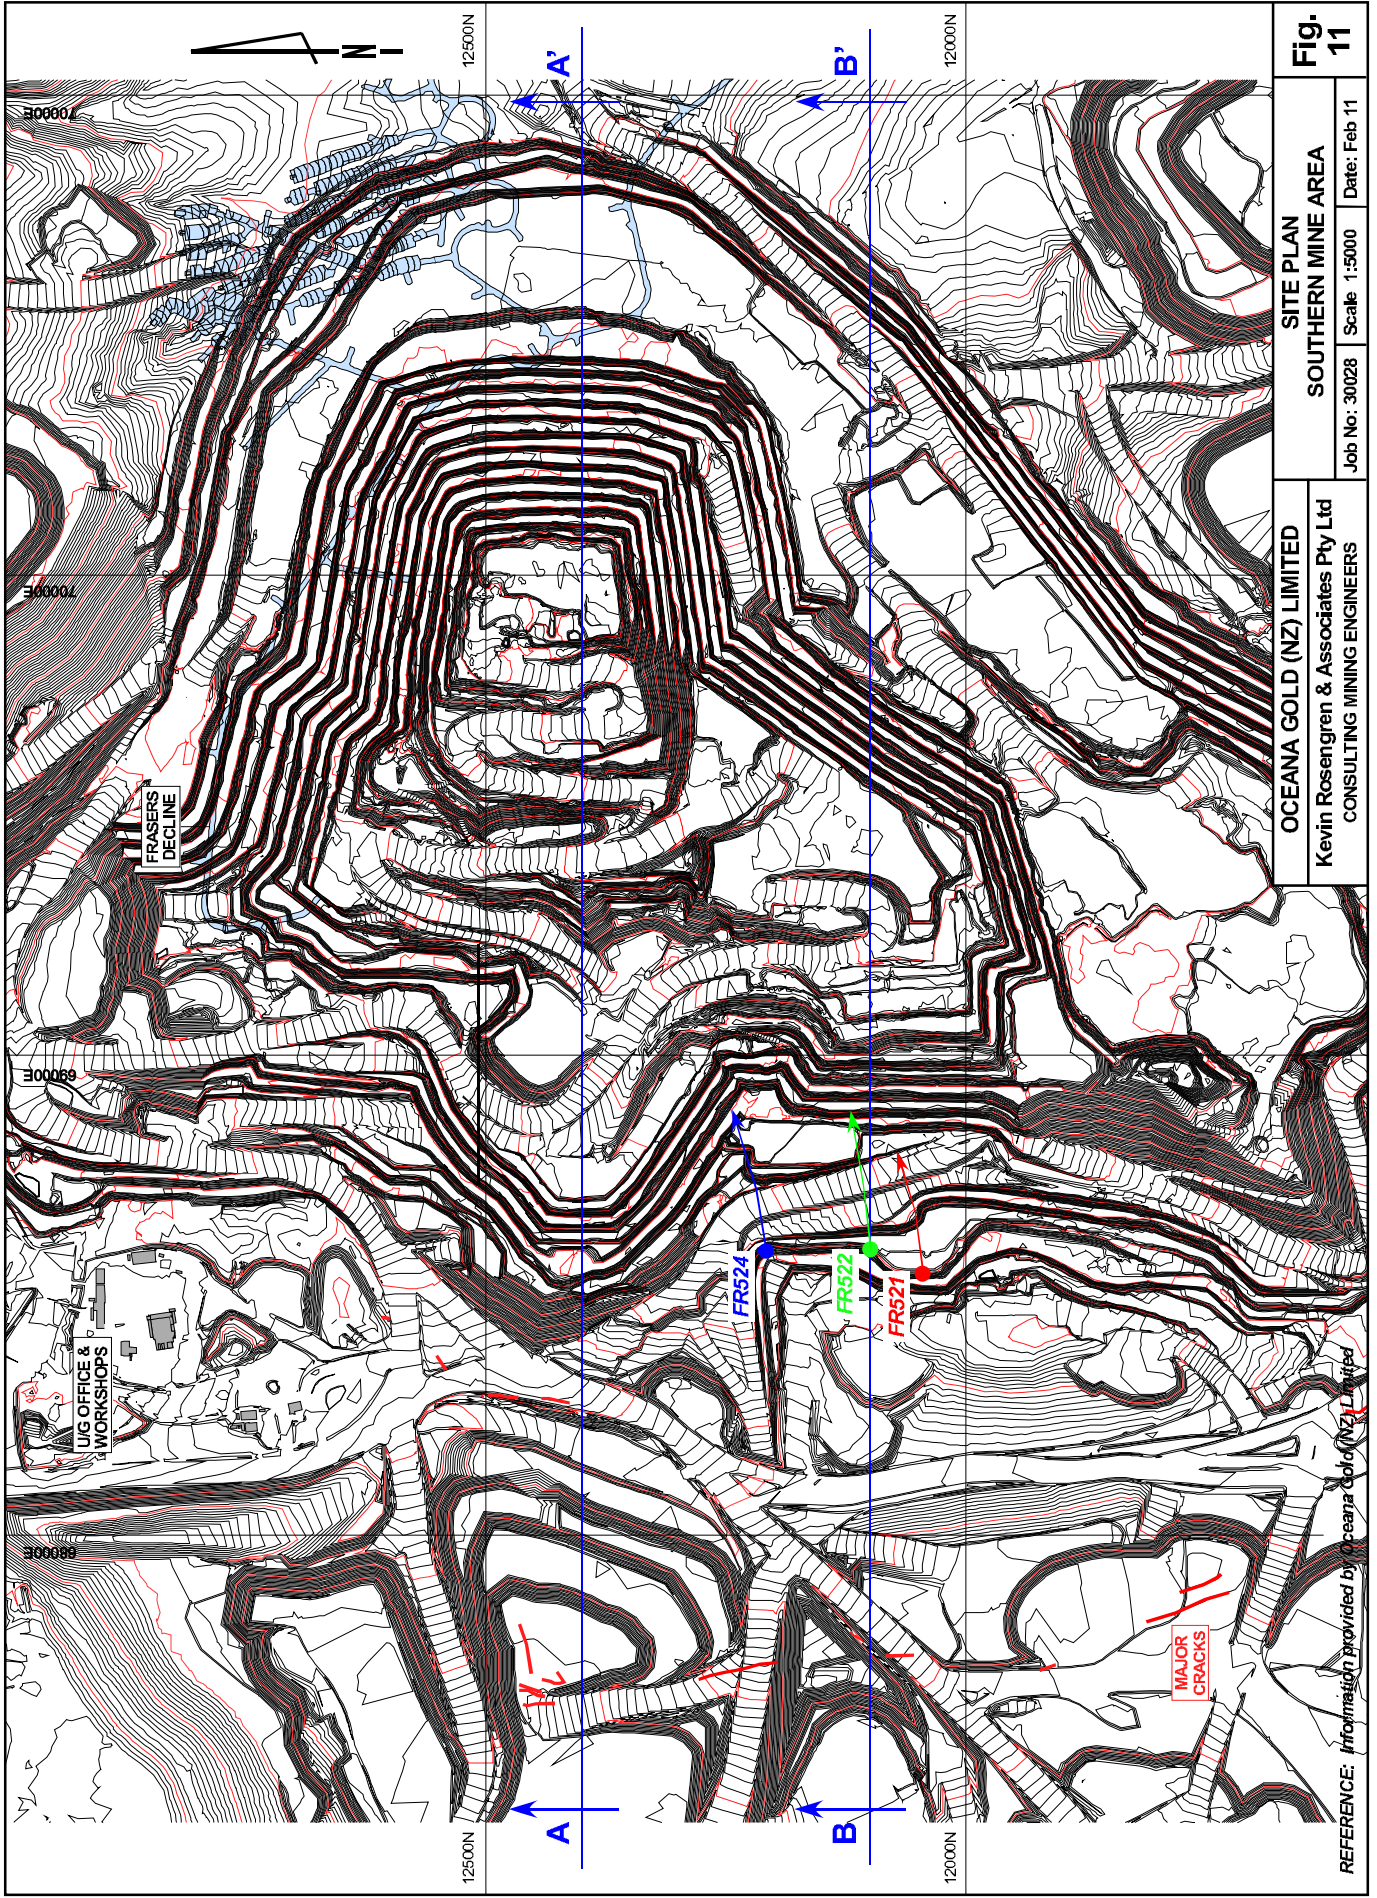
**Fig. 11**  
**SITE PLAN**  
**SOUTHERN MINE AREA**

Mining of Frasers pit has generated movement on the Footwall Fault, causing deterioration of the west wall of the pit. It has also caused dislocation of the Macraes-Dunback Road, north of the open pit, which requires regular repairs to maintain operation. However, there is no major infrastructure in the footwall area, except the underground mine office and workshops, located immediately north of the pit (Fig. 11).

An extensive movement monitoring program is being carried out. The movement history of three stations located on the crest of the west wall (Fig. 11) is shown on Fig. 13. Over a 14 month period, ending December, 1010, these stations show horizontal movements of 15m to 18m, and subsidence of 6m to 8.8m. Note that there is a small progressive increase in the movements, from

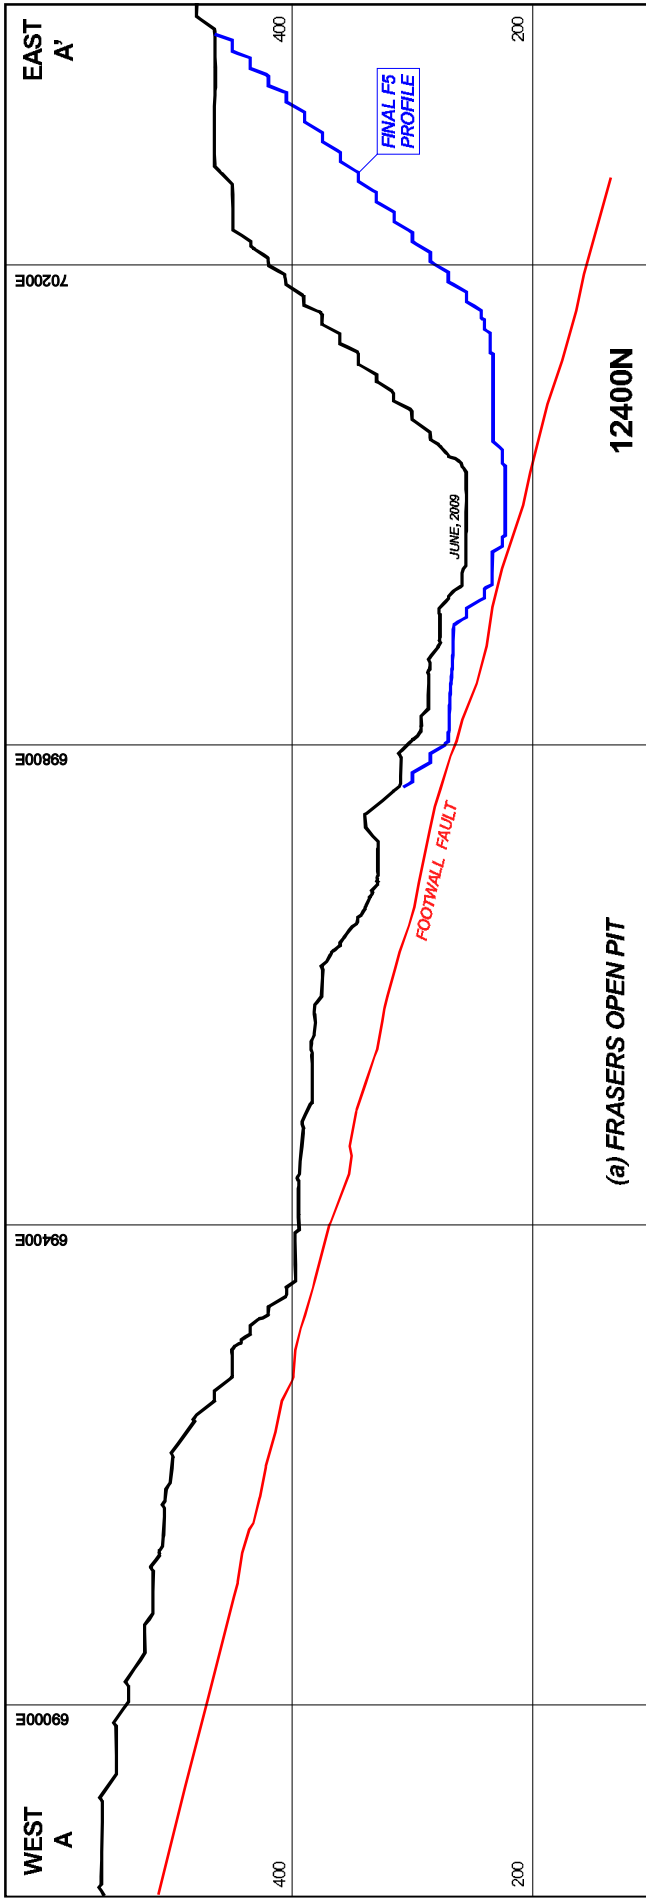
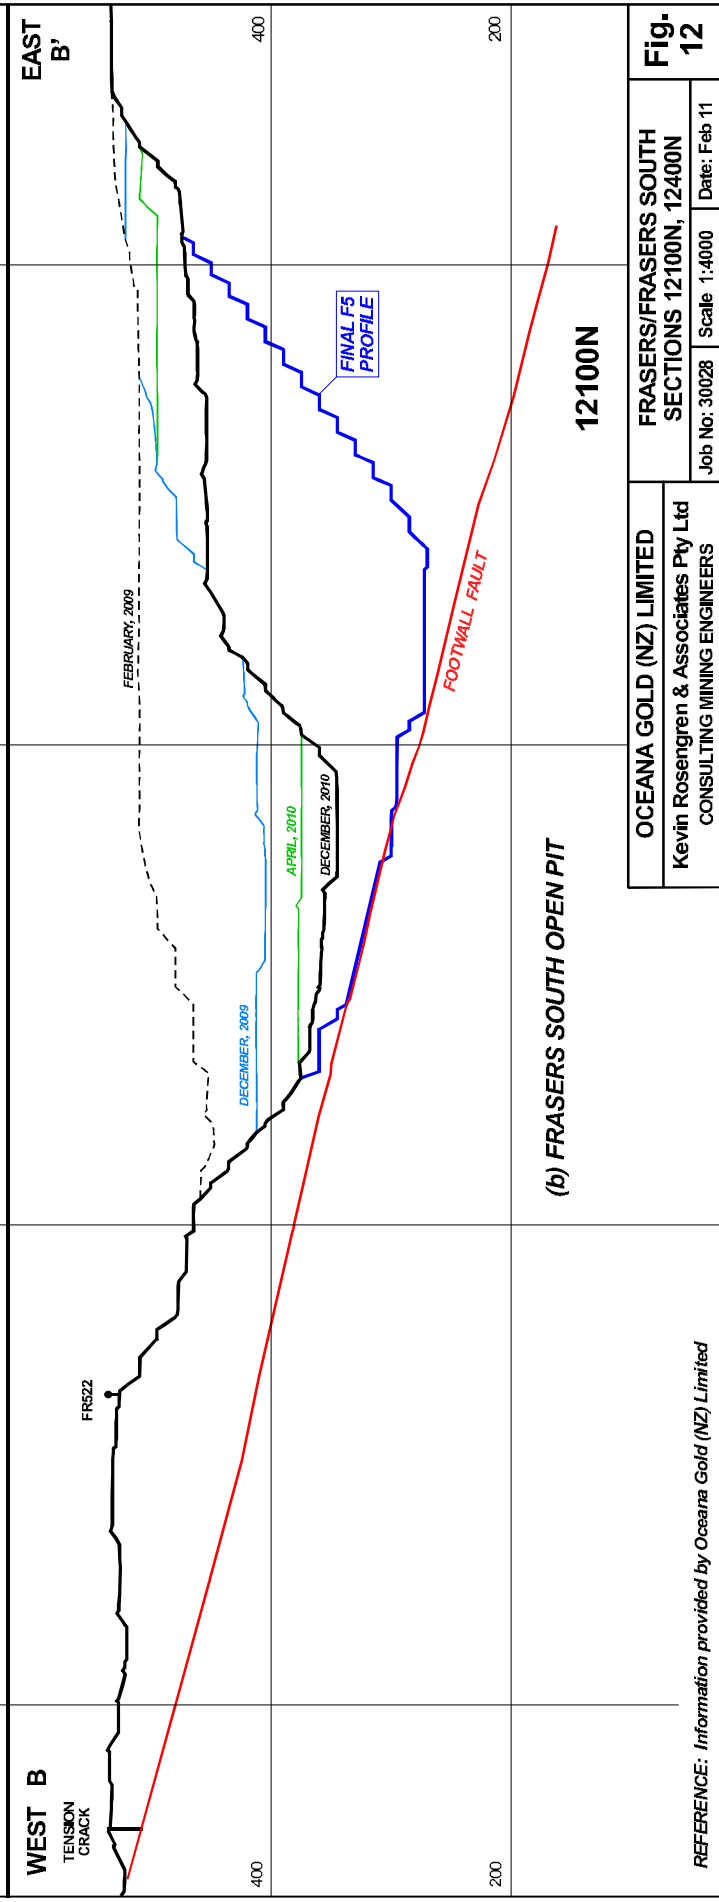
<b>OCEANA GOLD (NZ) LIMITED</b> Kevin Rosengren & Associates Pty Ltd CONSULTING MINING ENGINEERS	<b>FRASERS/FRASERS SOUTH</b> <b>SECTIONS 12100N, 12400N</b>	<b>Fig-12</b> Job No: 30028    Scale 1:4000    Date: Feb 11
	<b>FRASERS SOUTH OPEN PIT</b>

The locations of the pits, which are contiguous, are shown on Fig. 11. A typical cross-section through each pit is shown on Fig 12. The Frasers open pit has a depth of 230m and is currently inactive. However a major cutback of the east wall is planned (Fig. 12). The Frasers South pit is currently active and is the major production centre for the mine.

It should also be noted that it is planned that both Frasers and Frasers South open pits will be mined down to the Footwall Fault (Fig. 12). This will be equivalent to Stage 4 of Fig. 14 and will generate large scale movements in the footwall area. This may be quite acceptable provided that there is no essential infrastructure located in this area.

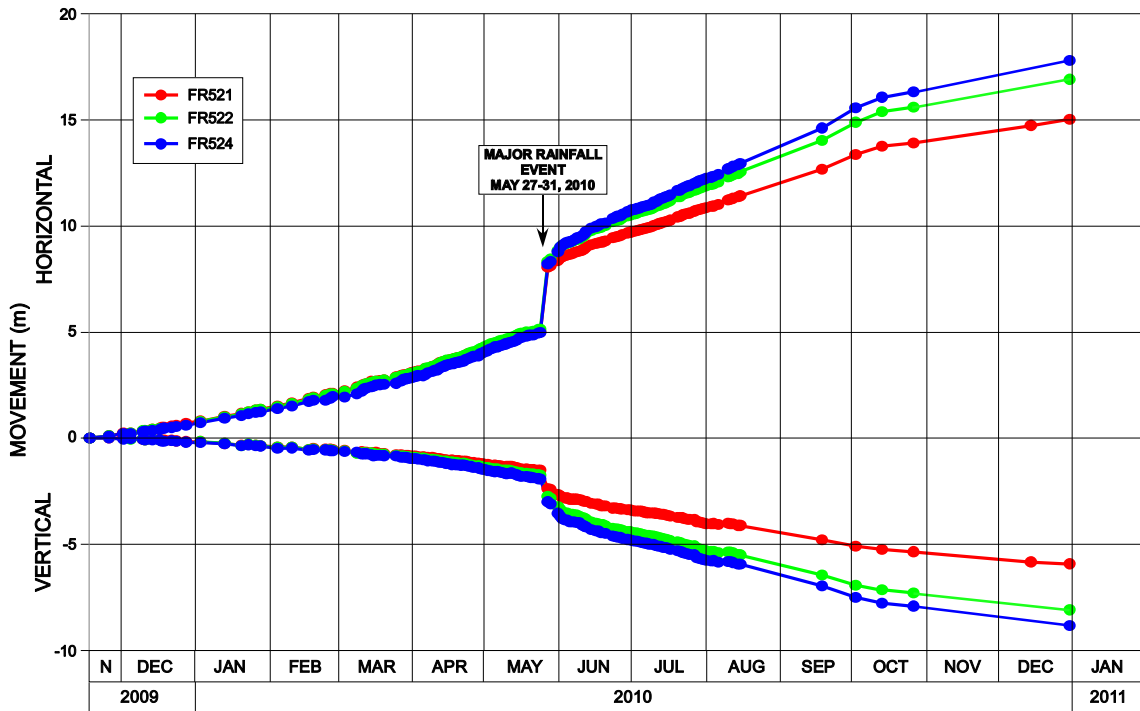
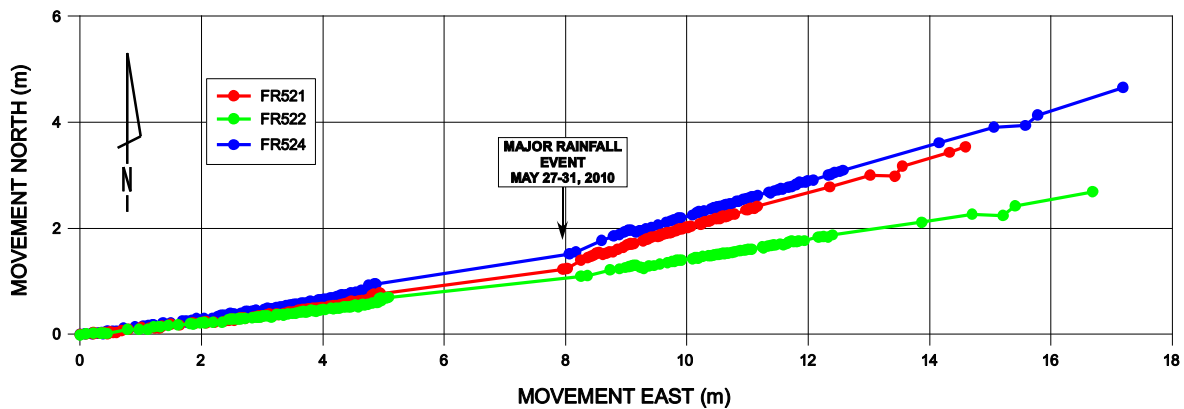
(a) MOVEMENT MAGNITUDE  
(FROM NOVEMBER 17, 2009)

south to north. Station FR521 shows the smallest movement because it is closest to the south wall (abutment) of the pit. Station FR524 shows the largest movement because it is closest to the existing large void of Frasers pit.

There was a sudden increase in movements, of 4m horizontal and 1.5m vertical, in late May, 2010 (Fig. 13). This followed heavy rainfall of 250mm, over a five day period from May 27, which was rated as a 1 in 30 year event.

The directions of movement are shown on Fig. 13b. Prior to the heavy rainfall event, the bearing of the movement direction was 080° to 083°. Following the heavy rainfall event, movements of stations FR522 and FR524 deviated to a bearing of 073°. These movement directions are consistent with the dip direction of the Footwall Fault, taking into account the existing large void of the Frasers open pit. The northerly component of movement is significantly less than that for the plant site pillars during the mining of the Golden Point open pit (refer above).

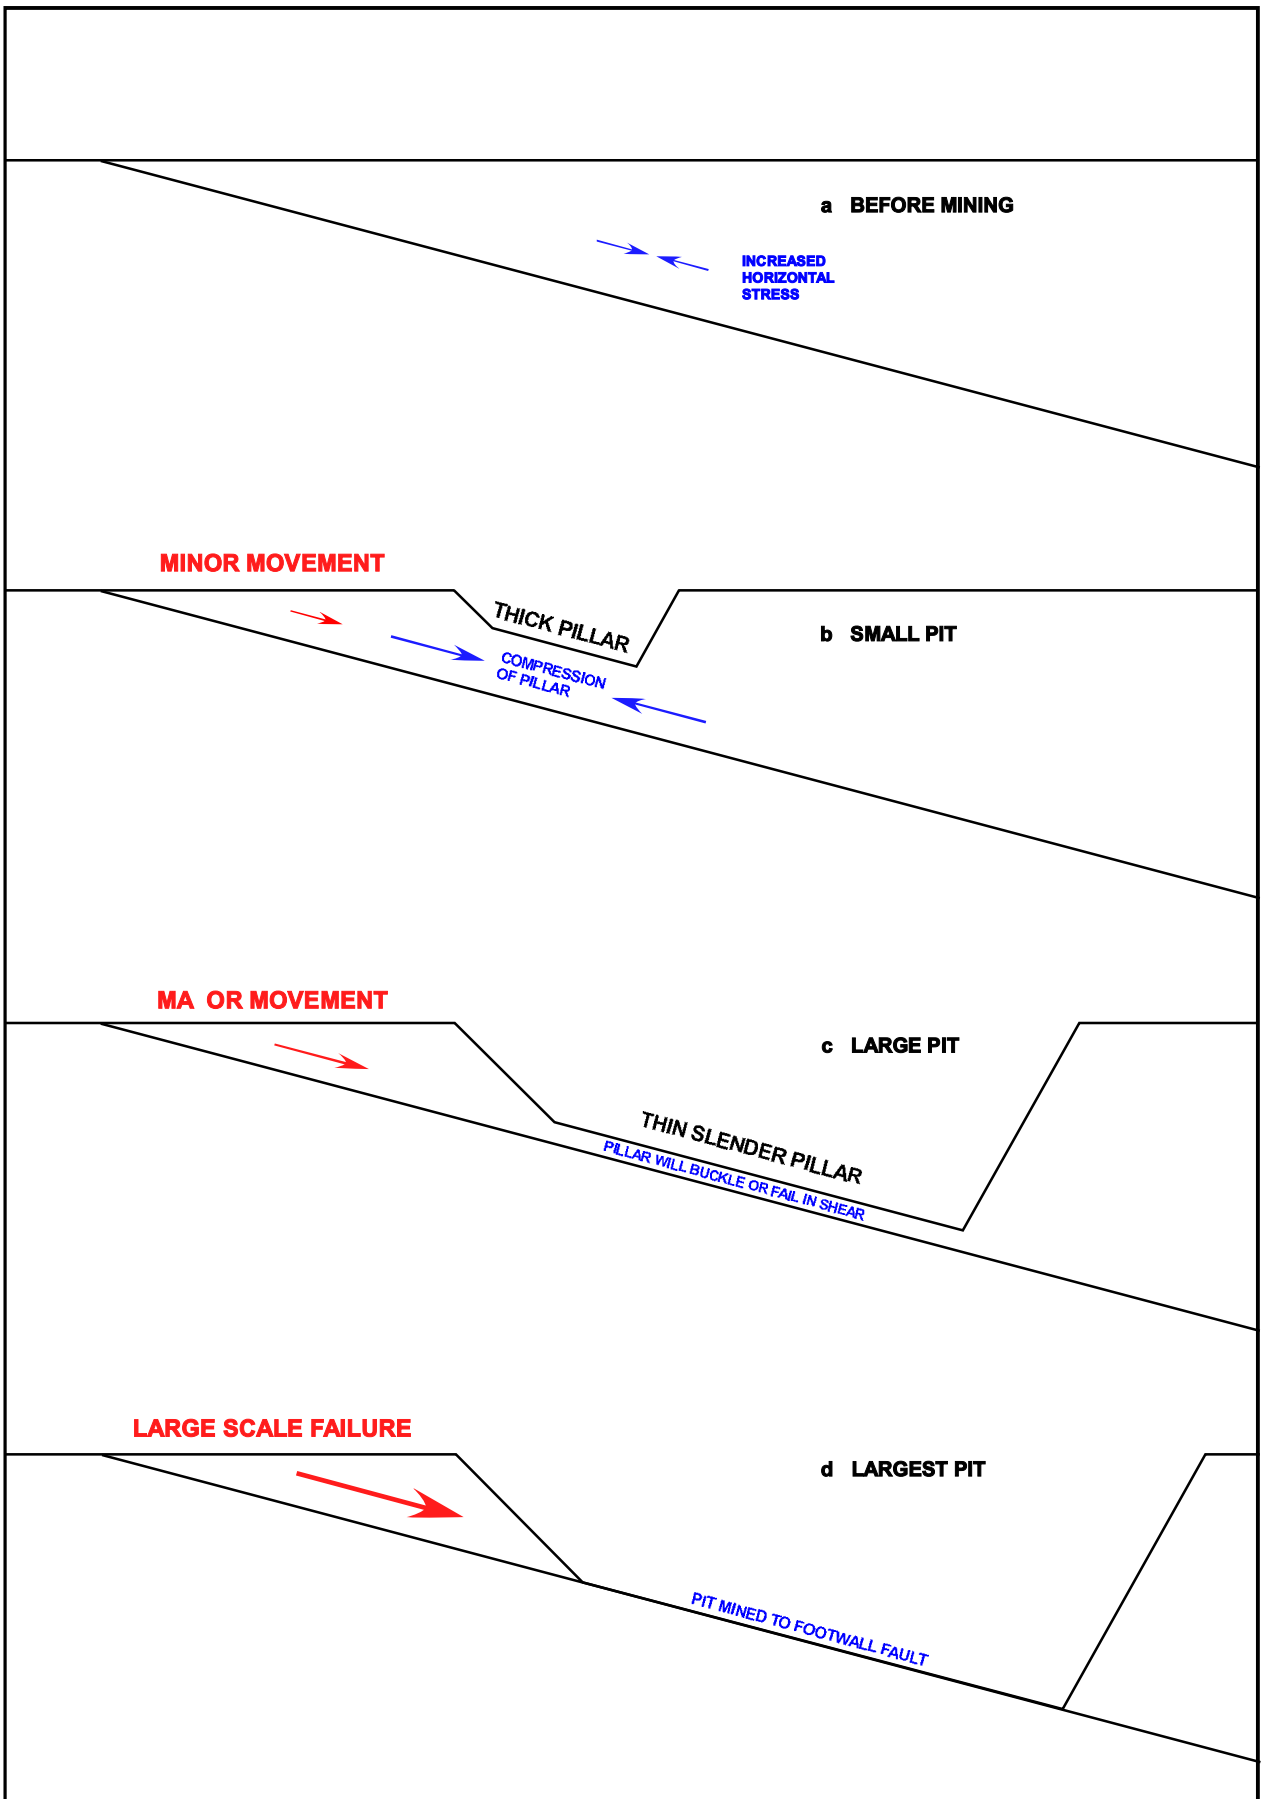
<b>OCEANA GOLD NZ LIMITED</b>	<b>MOVEMENT MECHANISM</b>		<b>Fig. 14</b>
Kevin Rosengren & Associates Pty Ltd CONSULTING MINING ENGINEERS	ob No 30028	Scale 1 2500

Our concept of the mechanism of failure is shown diagrammatically on Fig. 14, in four stages as follows:

- (i) Stage 1 - no mining - block above fault is compressed by incipient slip down the fault but equilibrium is maintained. This situation has existed for at least recent geological time.
- (ii) Stage 2 - shallow pit mined - pillar between pit floor and fault is compressed and deforms and the western block will show small movement down the fault.
- (iii) Stage 3 - deep pit mined - pillar between pit floor and fault becomes slender, more highly

compressed, may buckle or suffer shear failure (Plate 4) - western block experiences large movement (Plates 2 and 3).

- (iv) Stage 4 - pit mined through to fault - no resistance to sliding - western block suffers complete failure.

Note that Fig. 14 shows a two dimensional slice without side restraint and applies strictly to a pit with significant strike length. The lateral restraint is the reason why the Round Hill pit caused such minor movement, even though it was mined relatively close to the Footwall Fault (Figs. 6, 7). As discussed above, in our opinion, the increase in strike length of mining is also the reason why such large movements are being experienced at Frasers South.

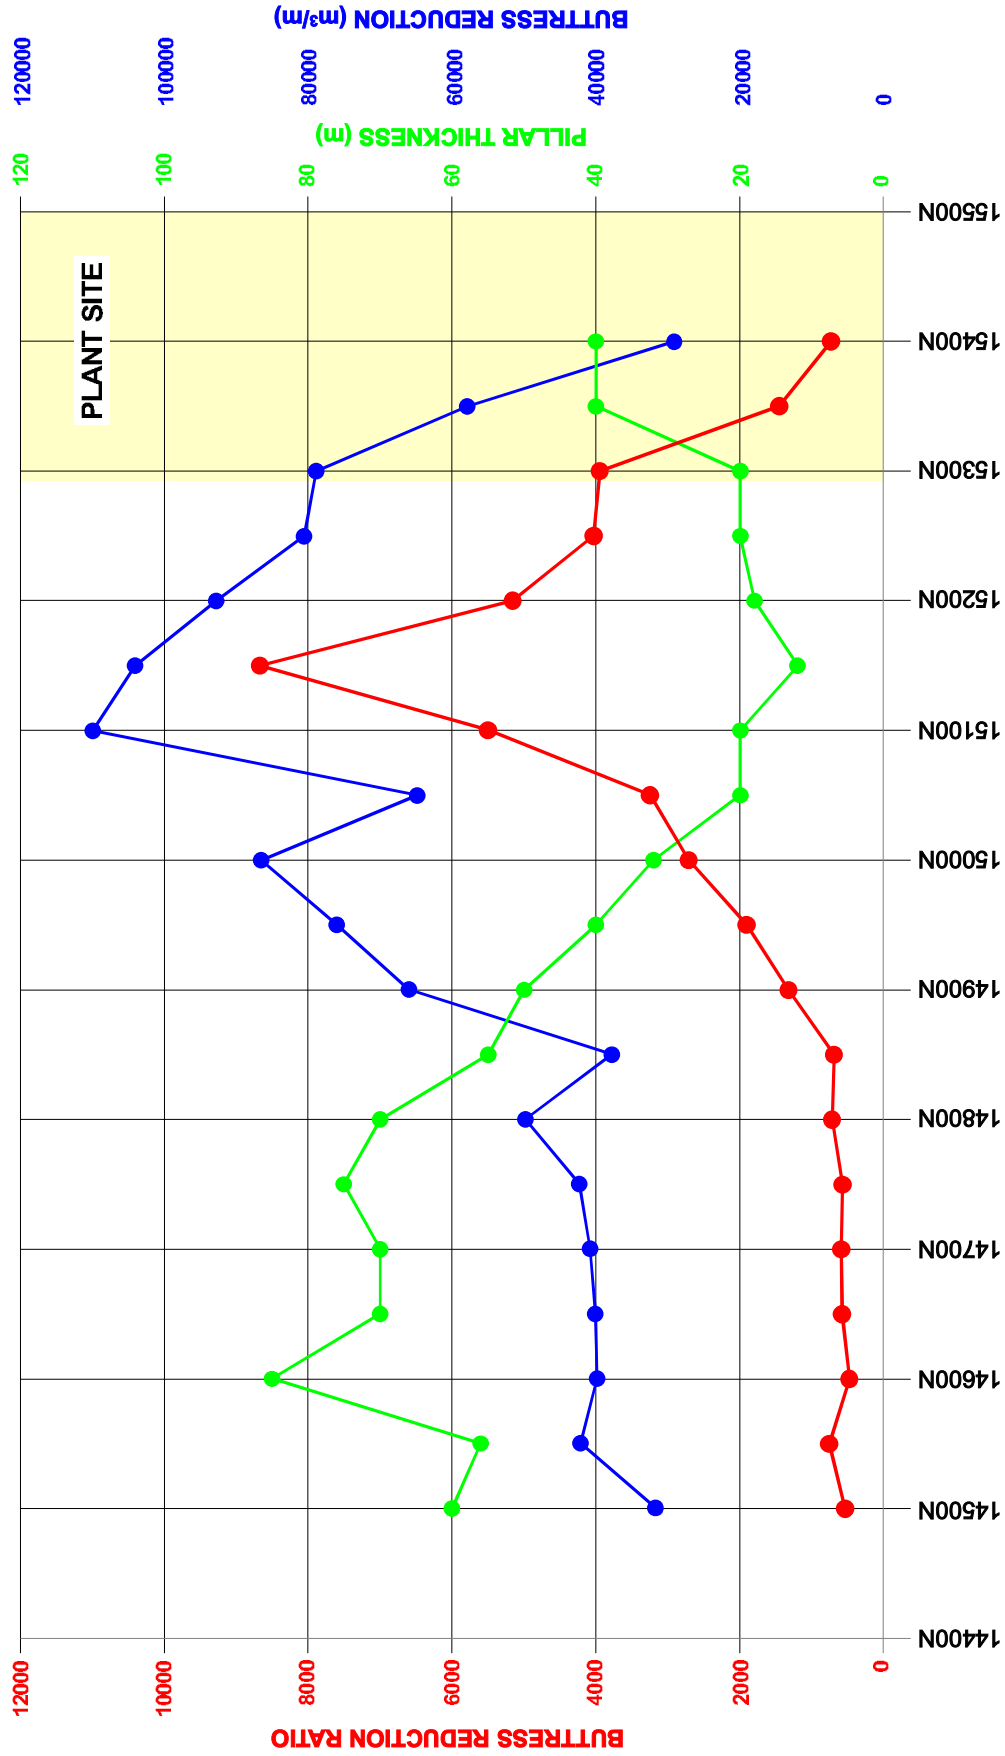
Fig. 15  
 BUTTRESS/PILLAR STATISTICS

For the proposed cutback operation, the situation is summarised diagrammatically on Fig. 15 which shows, for 50m spaced cross-sections:

- buttress reduction ( $B = \text{m}^3$  removed per metre strike length)
- minimum pillar thickness (T)
- buttress reduction ratio ( $BR = B/T$ ), which is an index of the likely magnitude of the ground movements.

Fig. 15 shows that BR value is low south of 14850N, indicating that footwall ground movements in this area will be relatively small. However, the value is high between 15000N and 15300N, indicating that ground movements in this area will be large. In this area, the Footwall Fault

outcrops beneath the MTI (refer above).
