Lower Taieri Floodbank System

Structural Integrity Assessment

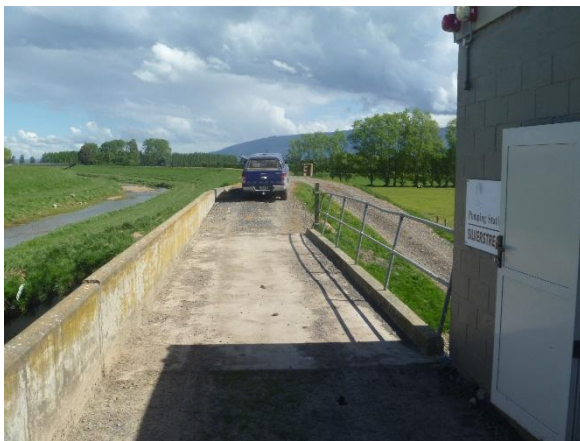
Photo 1: Looking downstream along Silver Stream towards River road (10 October 2017). Note cracking in parapet wall on left coincident with inferred extent of sheet pile support to underside of gravity gate and bridge structure.

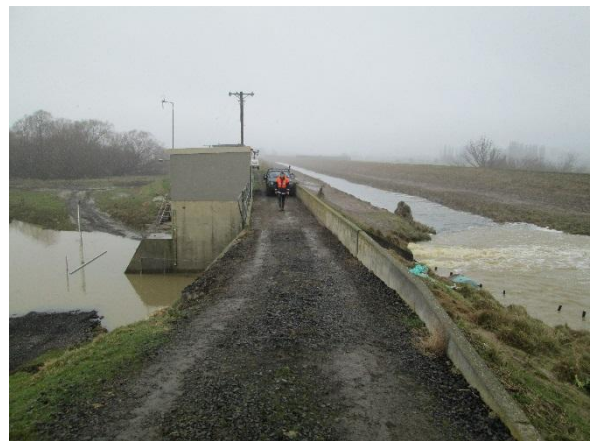
Photo 2: Looking upstream towards Silver Stream pumping station on 1 August 2017 following the July flood event whilst water levels still elevated albeit dropping.

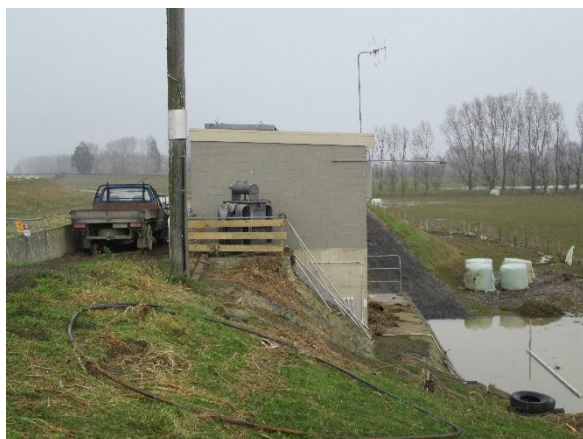
Photo 3: Grouted rock fill below the station transformer and location of historical seepage and seepage reported during July 2017 flood event.

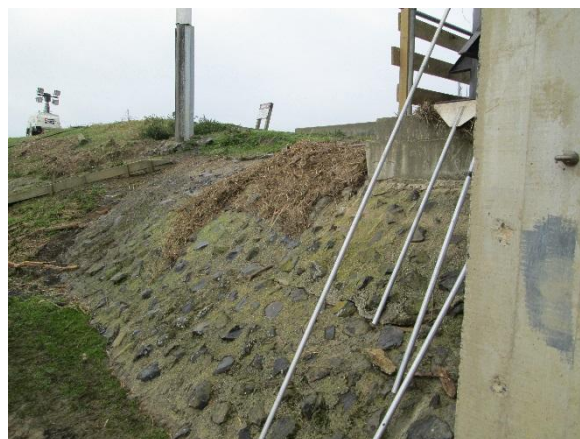
Photo 4: Cracking in grouted rock fill below the station transformer and location of historical seepage. Understanding is that seepage reported during July 2017 flood event emerged from top crack immediately below formed face of transformer foundation.

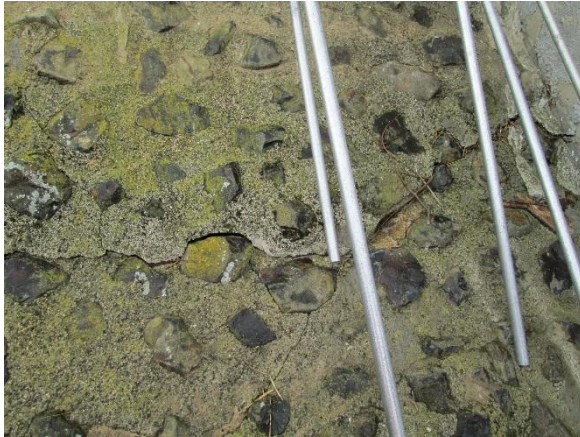
Photo 5: Cracking in grouted rock fill below the station transformer. Location of historical seepage and seepage reported during July 2017 flood event emerged from above crack shown.

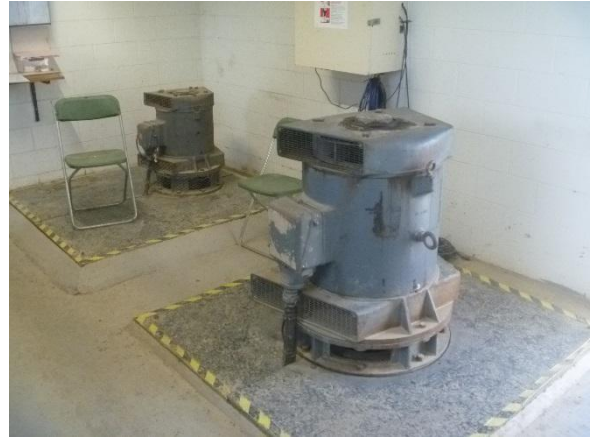
Photo 6: Pump motor – ORC report that the water level exceeded the floor level by about 0.2 – 0.3 m during the July 2017 flood event.

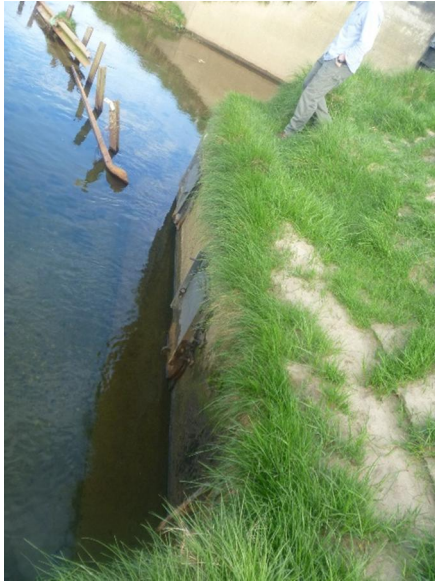
Photo 7: Outlet head wall, two flap gates located at the rising main outlets are visible. The wall footing below water level has suffered significant undermining, attributed to turbulent flow at the rising main outlets.

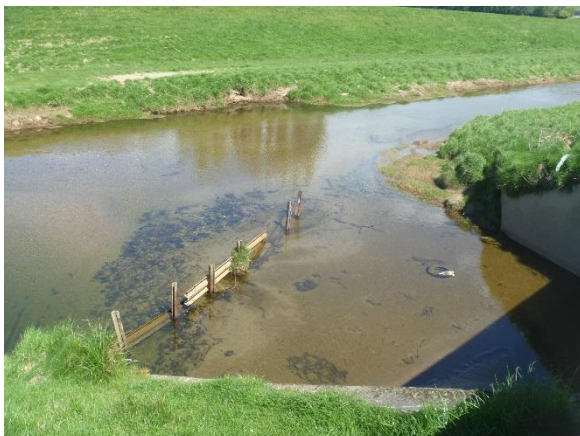
Photo 9: Debris barrier in vicinity of gravity gate outlet channel confluence with Silver Stream.

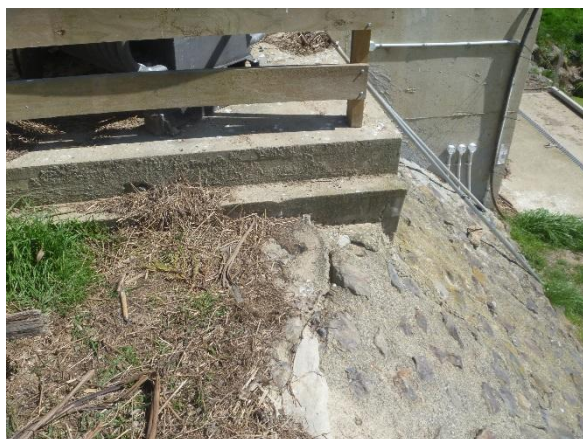
Photo 10: Displaced ground below the transformer slab previously repaired by concrete below the original slab in the vicinity of the recent seepage.

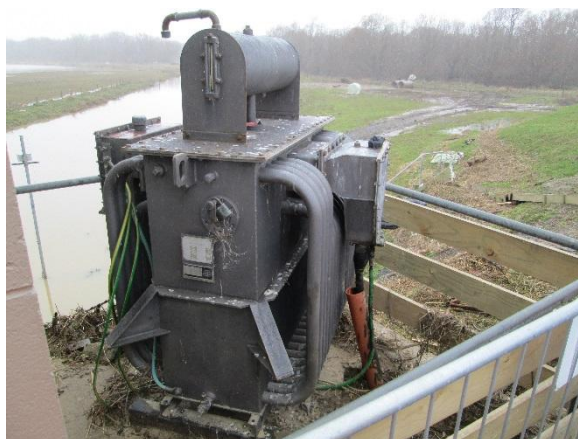
Photo 11: Silver Stream pumping station transformer.

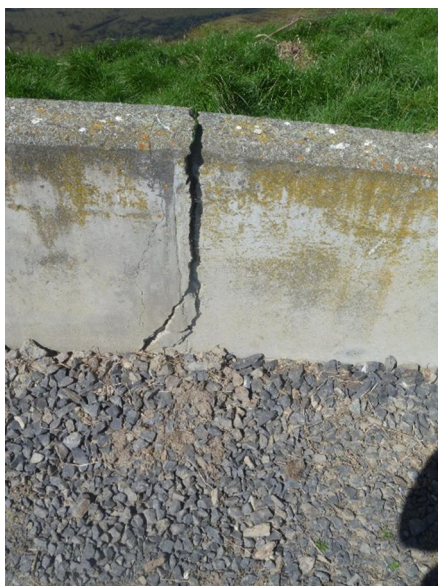
Photo 12: Parapet wall cracking from vehicle access. Installation and monitoring of tell-tale device recommended.

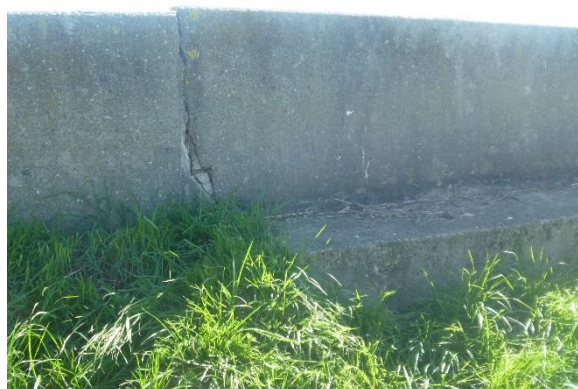
Photo 13: Parapet wall cracking coincident with stiffness discontinuity at extent of sheet pile cut off and capping beam. Installation and monitoring of tell-tale device recommended.

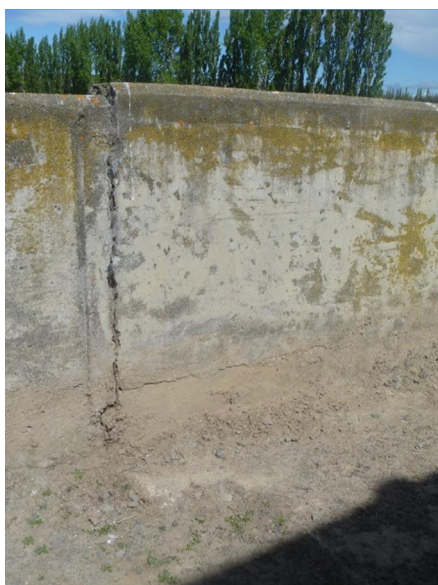
Photo 14: Cracking in parapet wall. Note inferred extent of original extent of concrete wheel stop at underside of parapet wall visible to the right of the right of the vertical crack.

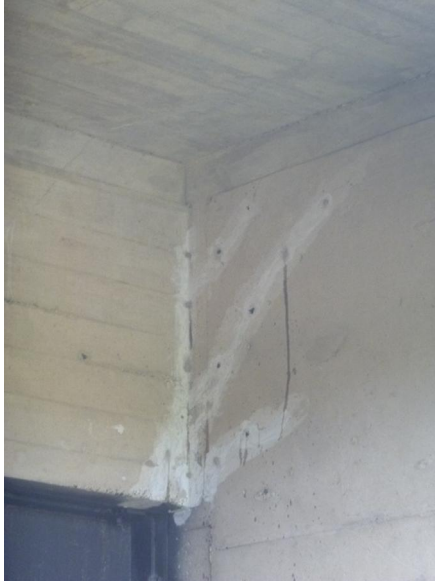
Photo 15: Flood gate bridge cracking – previously repaired.

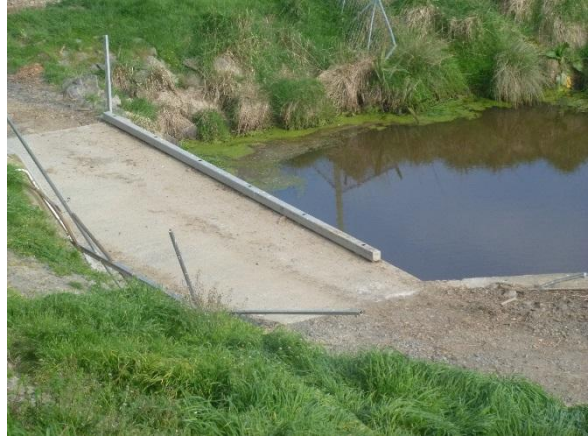
Photo 16: Lower bridge crossing in the vicinity of pump intake.

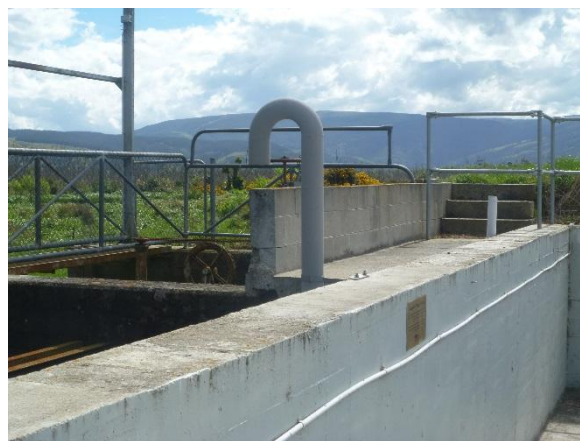
Photo 18: Low spot in crest wall approximately 600 mm high associated with pumping station reconfiguration work.

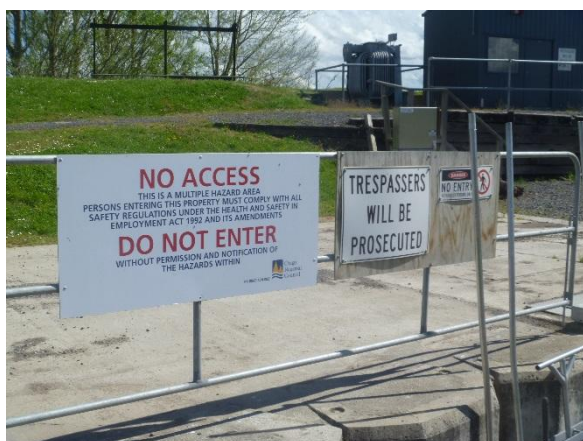
Photo 19: Waipori Pumping Station signage.

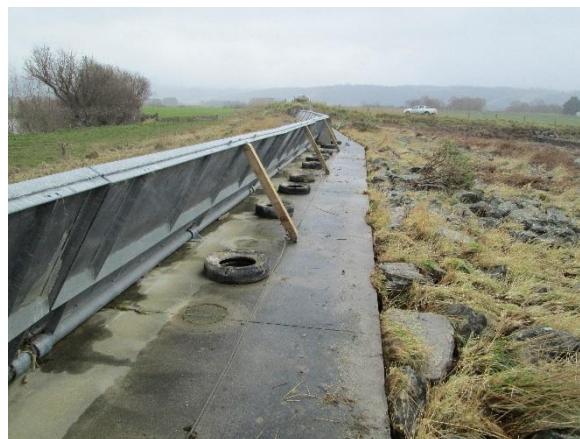
Photo 24: Riverside Road Spillway, short gated section looking downstream.

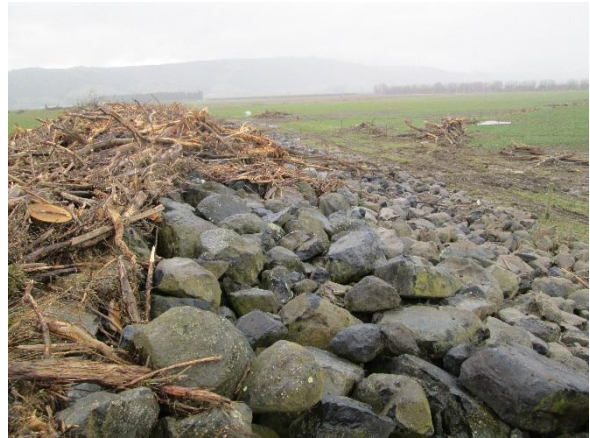
Photo 26: Crest debris from July 2017 flood event.

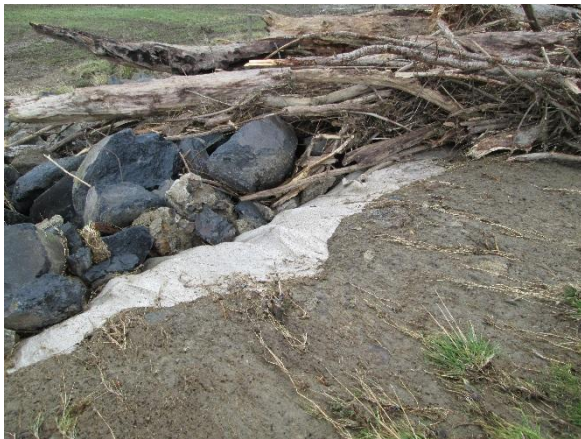
Photo 27: Crest damage.

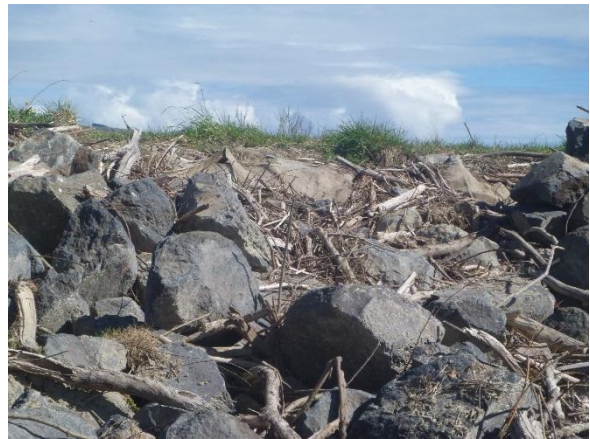
Photo 28: Crest damage.

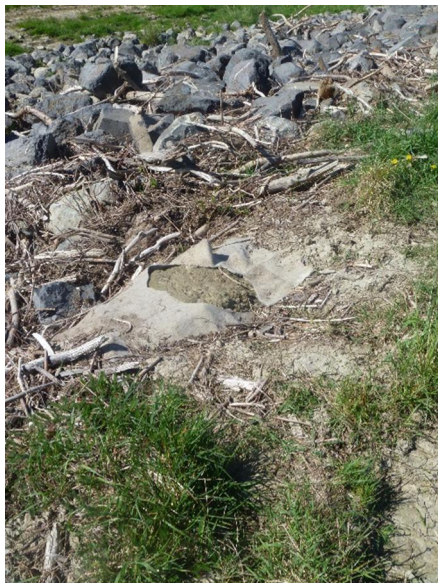
Photo 29: Crest damage.

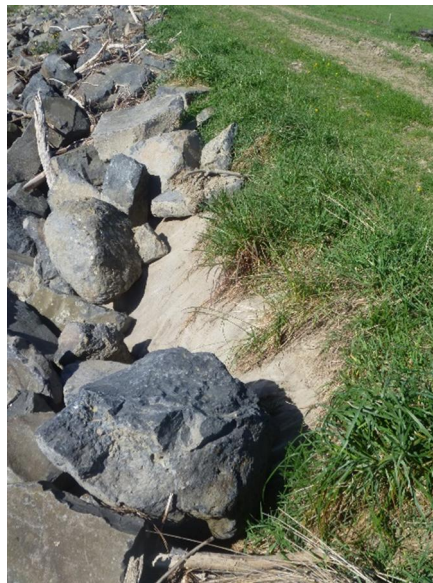
Photo 30: Crest damage.

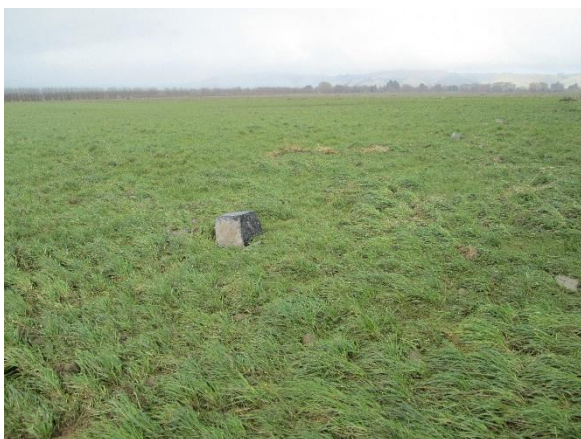
Photo 31: Rip rap rock deposited in paddocks downstream of the spillway following the July 2017 flood.

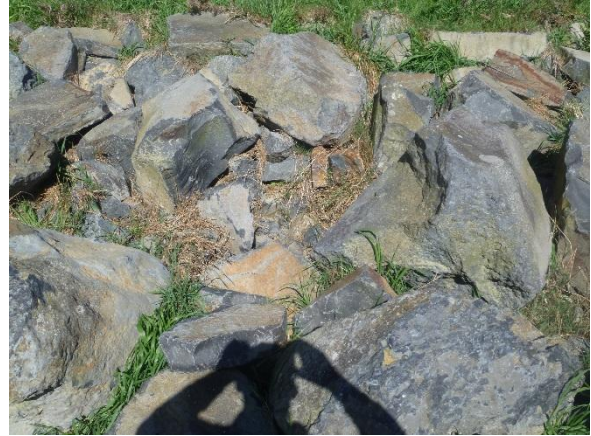
Photo 34: Damaged rip rap near the crest– note loss of rock.

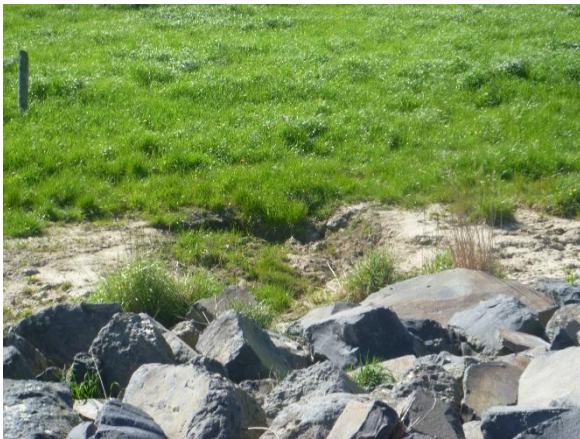
Photo 35: Scour damage.

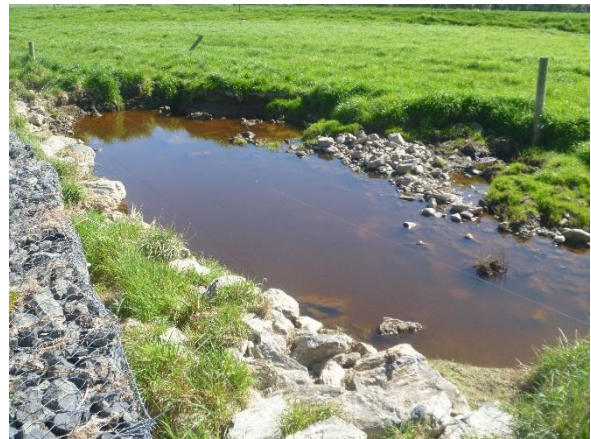
Photo 36: Scour damage downstream of spillway gated section.

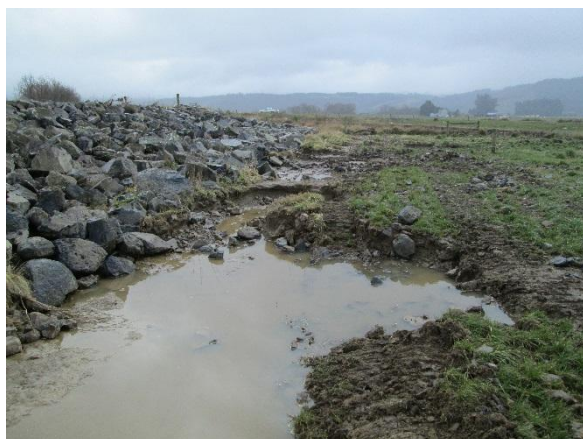
Photo 37: Scour damage.

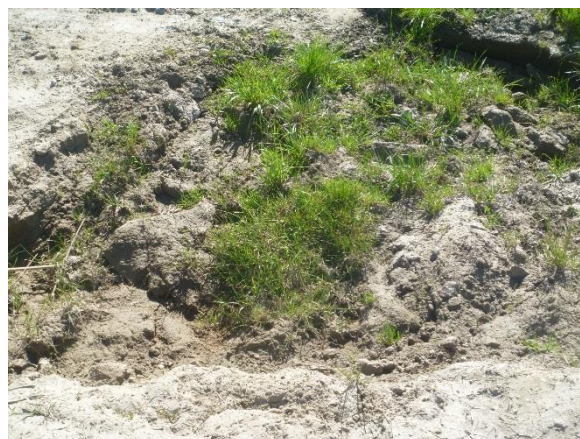
Photo 38: Scour damage.

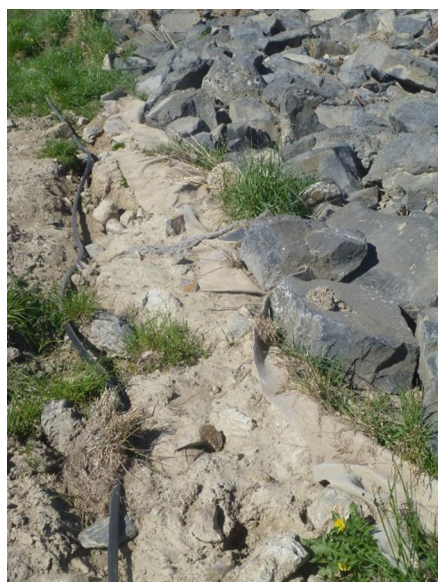
Photo 39: Scour damage.

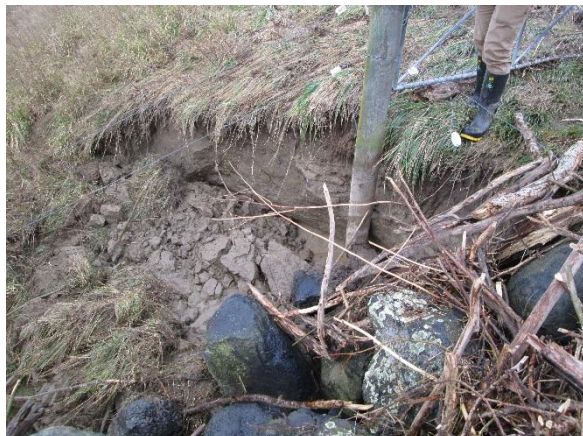
Photo 40: Right abutment damage from the July 2017 flood event. Location at significant risk of further damage.

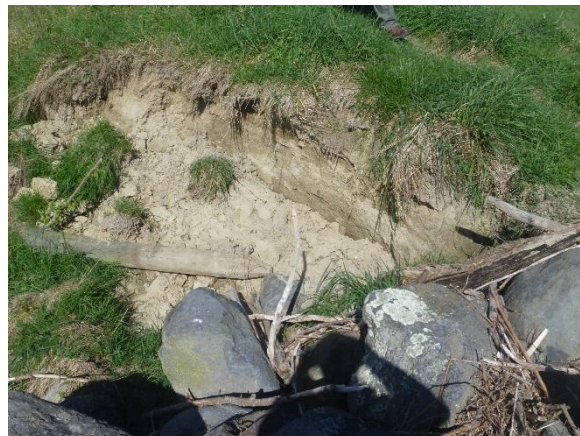
Photo 41: Right abutment damage from the July 2017 flood event. Location at significant risk of further damage.

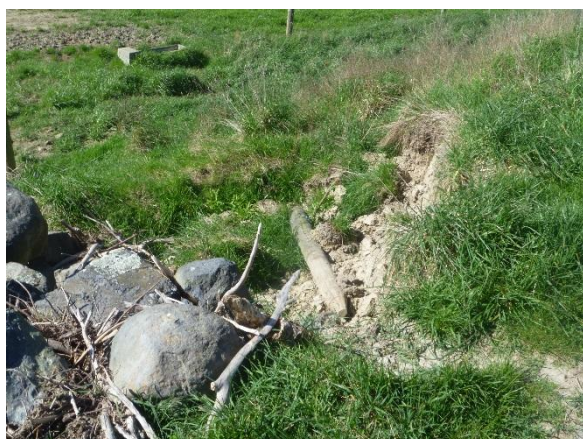
Photo 42: Right abutment damage from the July 2017 flood event. Location at significant risk of further damage.

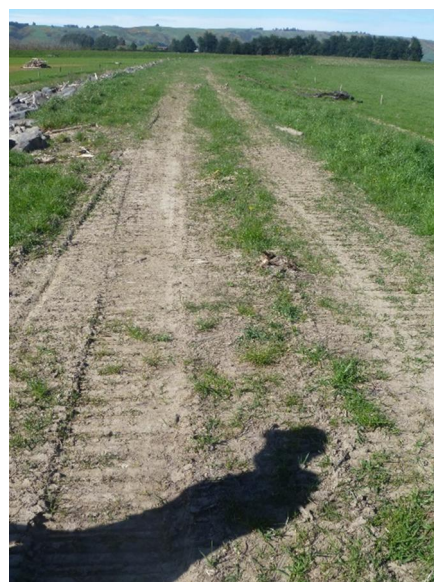
Photo 43: Crest damage arising from repair works. Appropriate grass cover is necessary to minimise the potential for scour erosion.

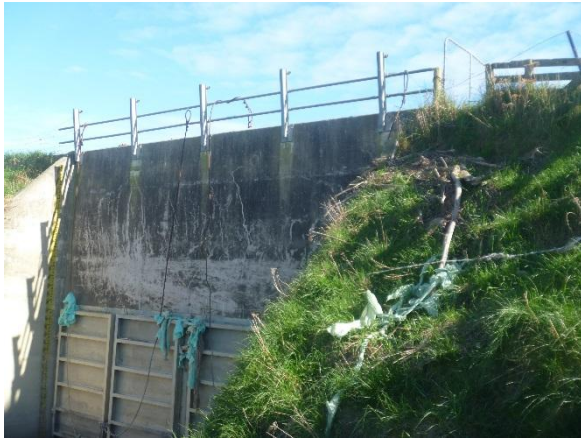
Photo 44: View of structure from the downstream. Missing hand rail and flood debris on gate visible.

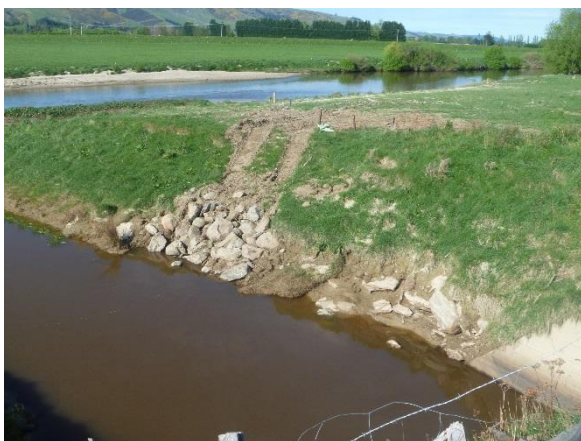
Photo 45: View towards Taieri River from A1 Outfall. Note recent scour and recent placement of rip rap rock.

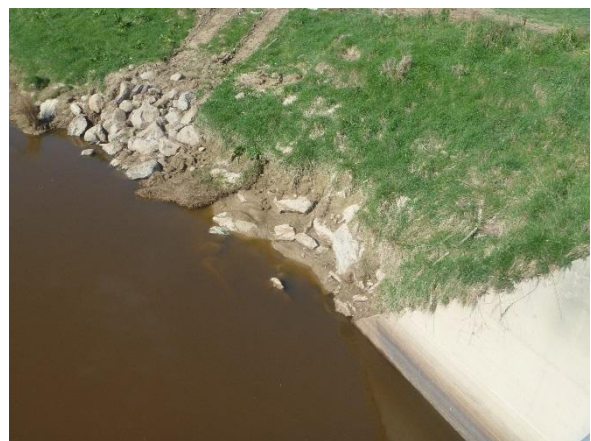
Photo 46: Recent scour and recent placement of rip rap rock.

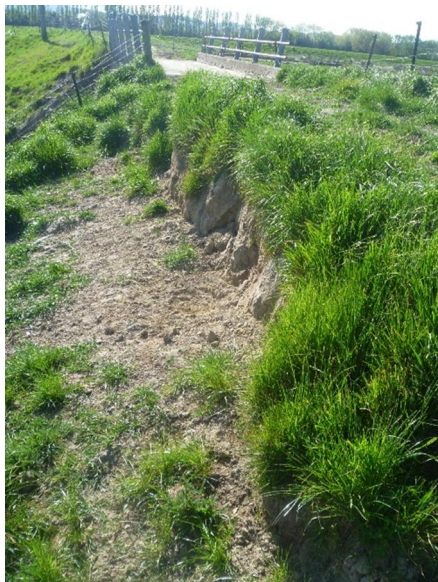
Photo 47: Damage to floodbank earth fill adjacent to the structure right hand side abutment.

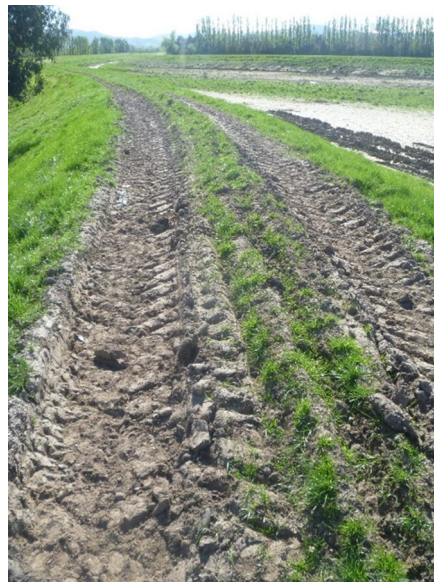
Photo 48: Floodbank crest damage in the vicinity of the A1 Outfall structure.

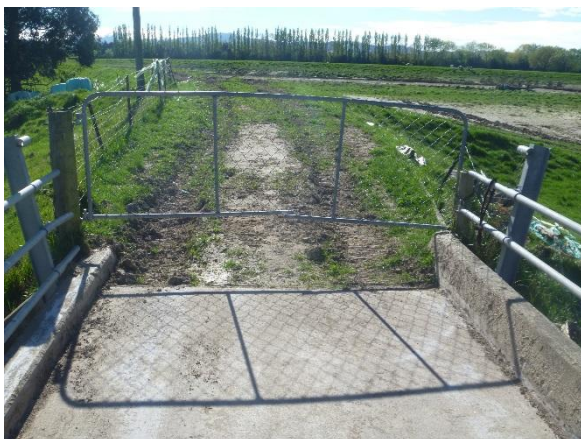
Photo 49: True left abutment gate. Review requirement for stock (sheep) proof gate at this location.

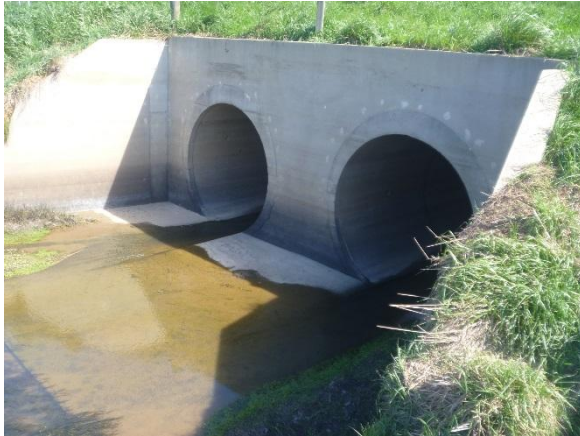
Photo 50: Owhiro Outfall.

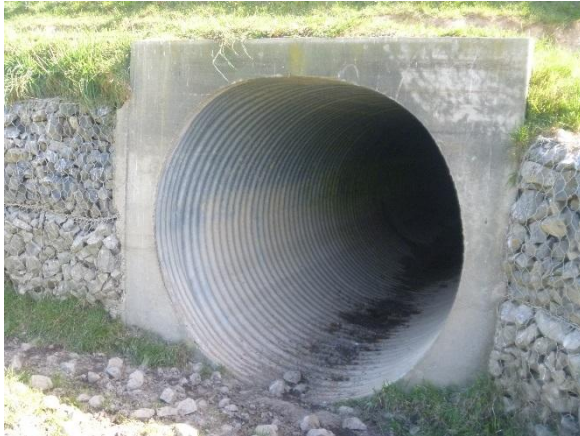
Photo 53: Inlet to the Lower Pond Outlet culvert.

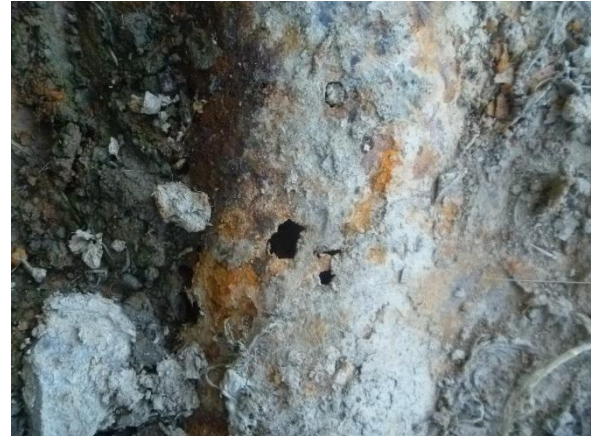
Photo 54: Corrosion at the invert of the Lower Pond Outlet invert near the inlet headwall. Indications are that a void is present behind the rust hole in the steel culvert and repair is warranted.

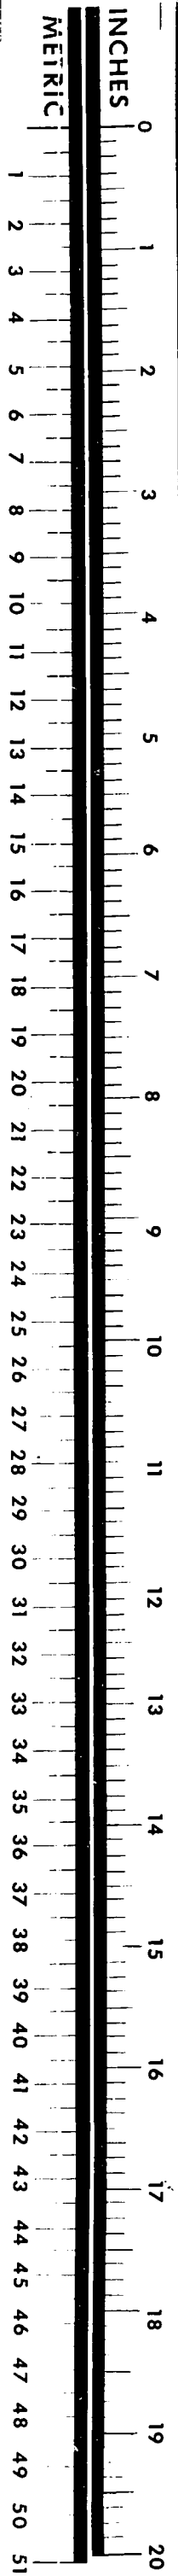
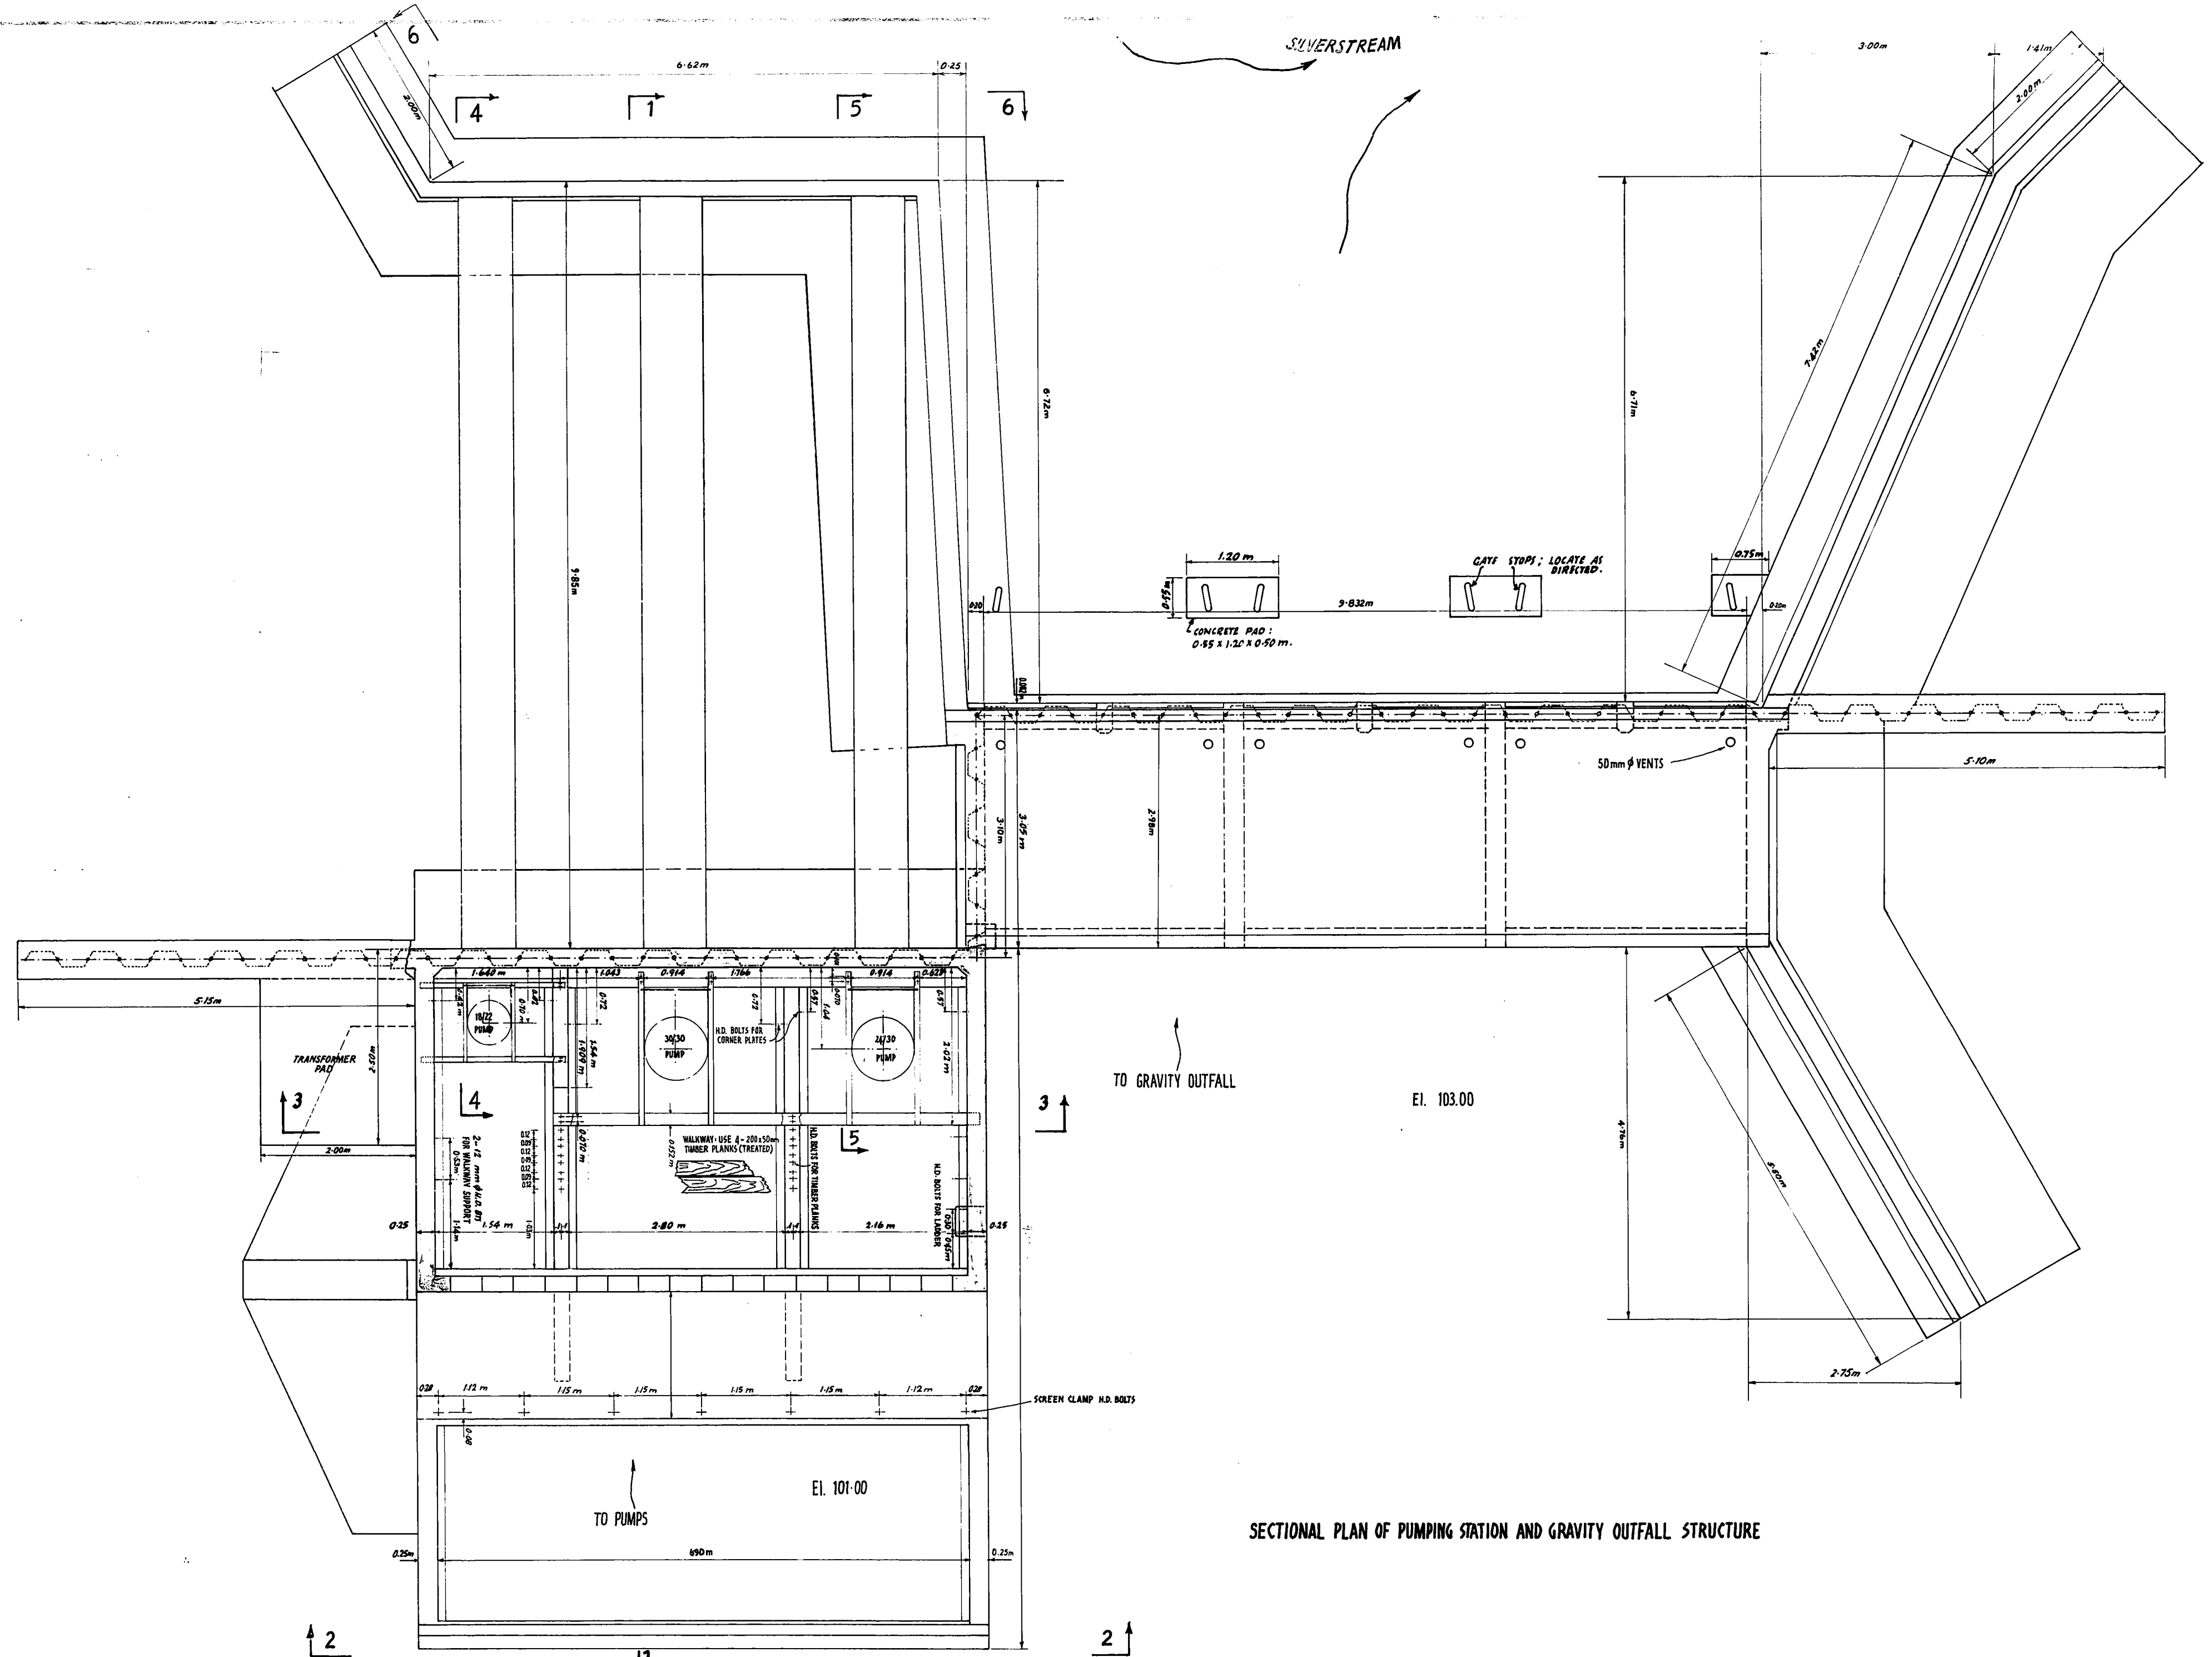
SECTIONAL PLAN OF PUMPING STATION AND GRAVITY OUTFALL STRUCTURE
