Lower Taieri Floodbank System

Structural Integrity Assessment

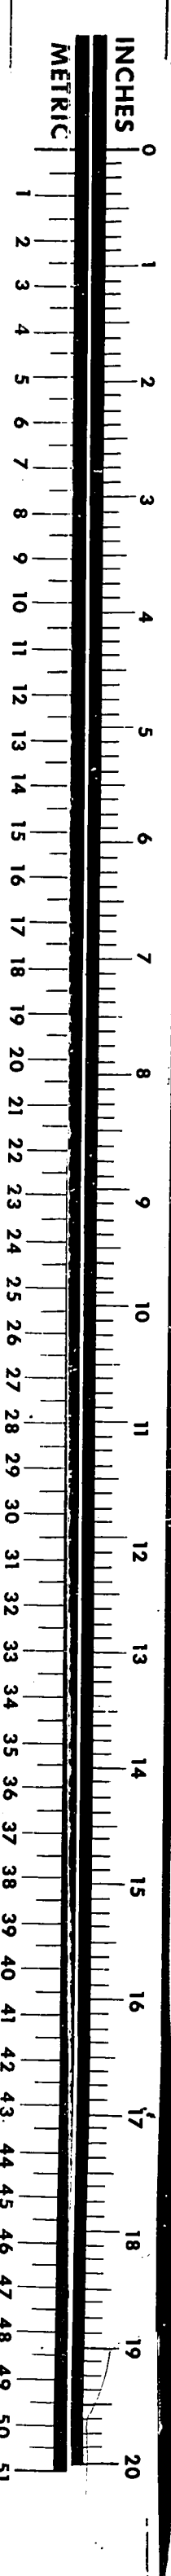
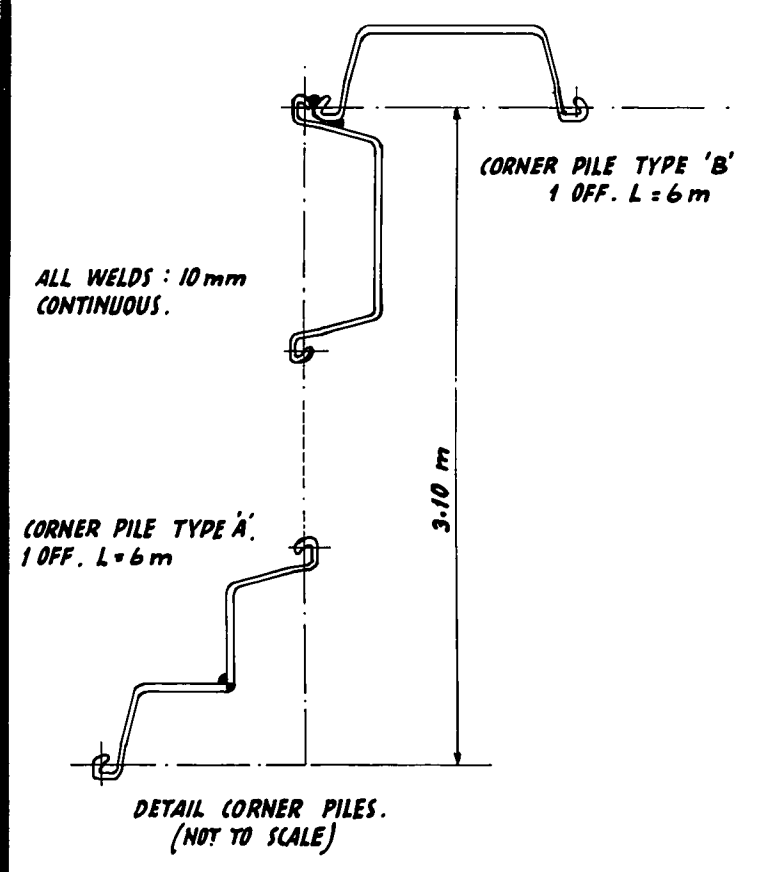
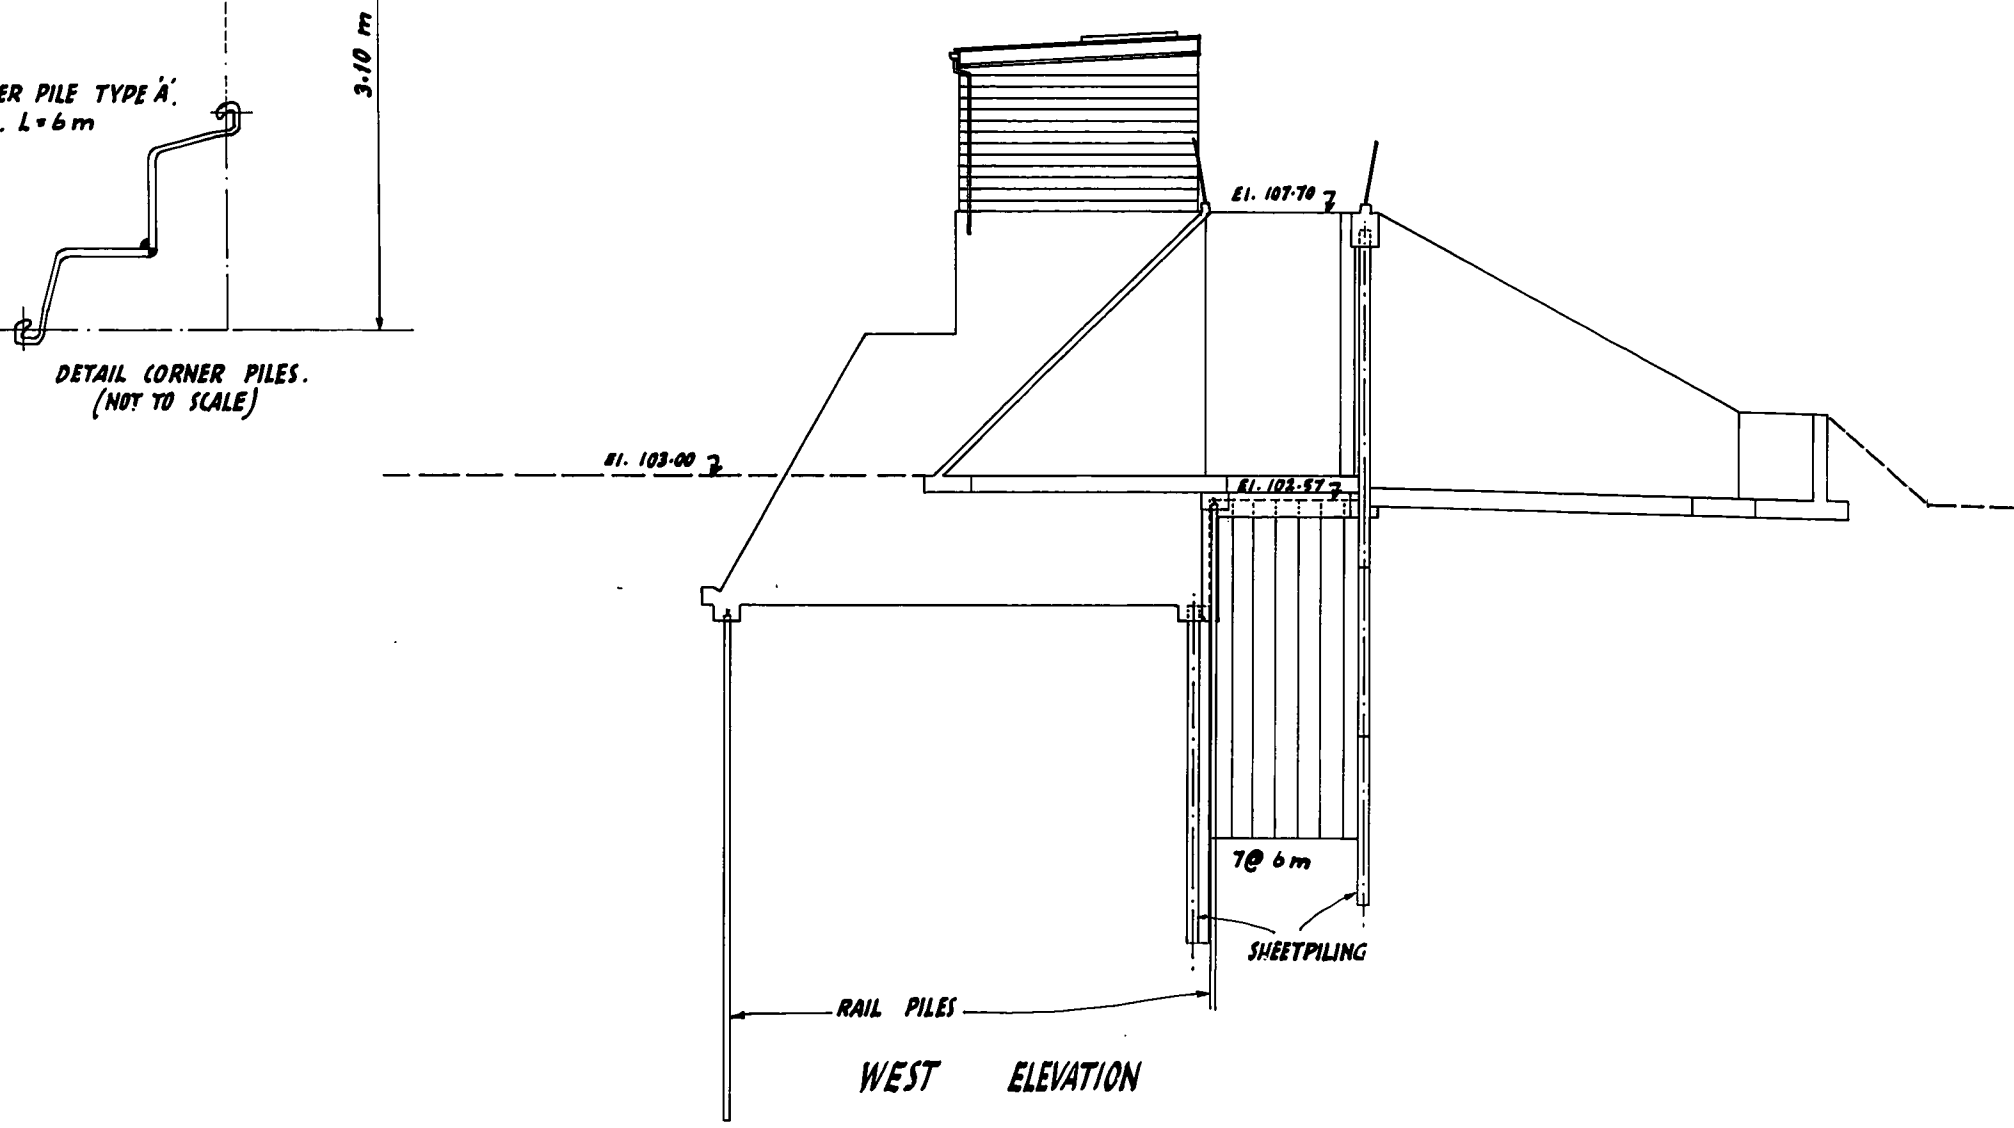
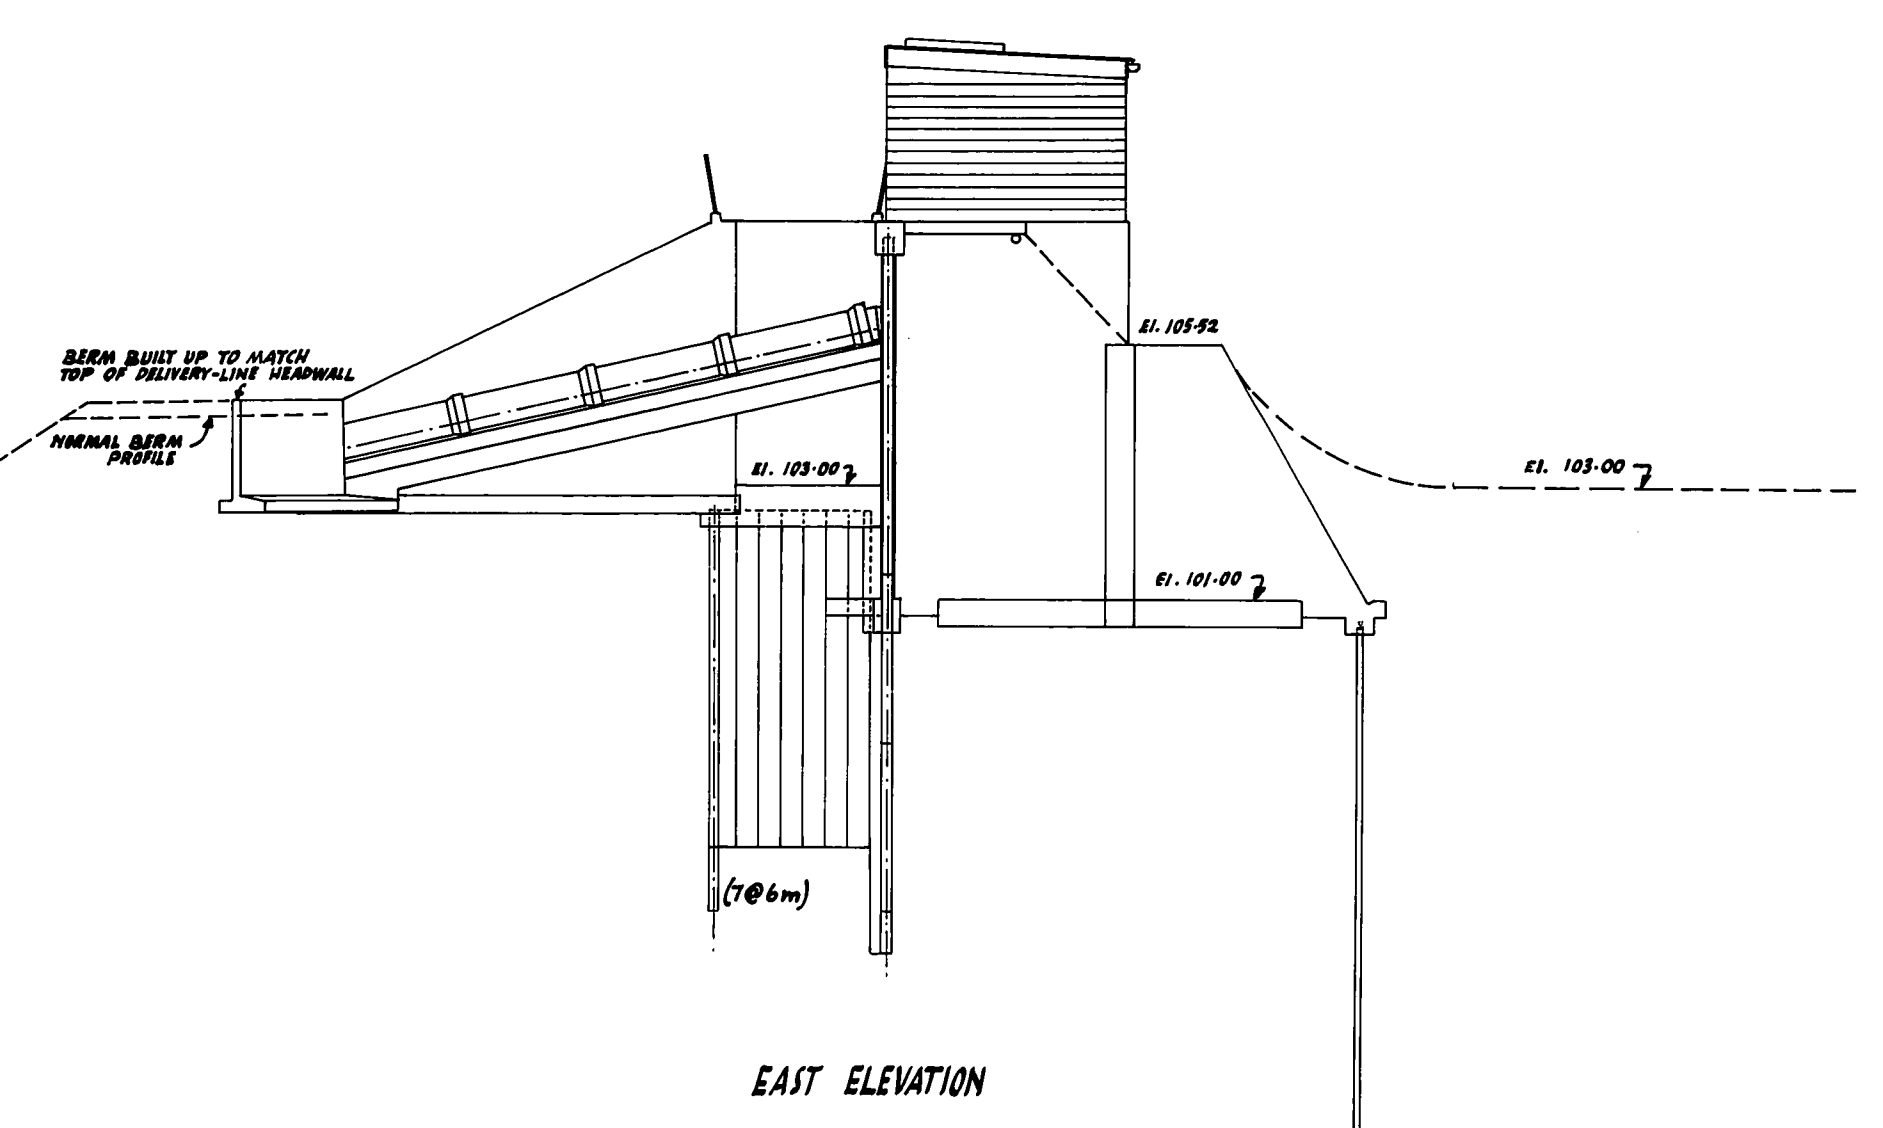
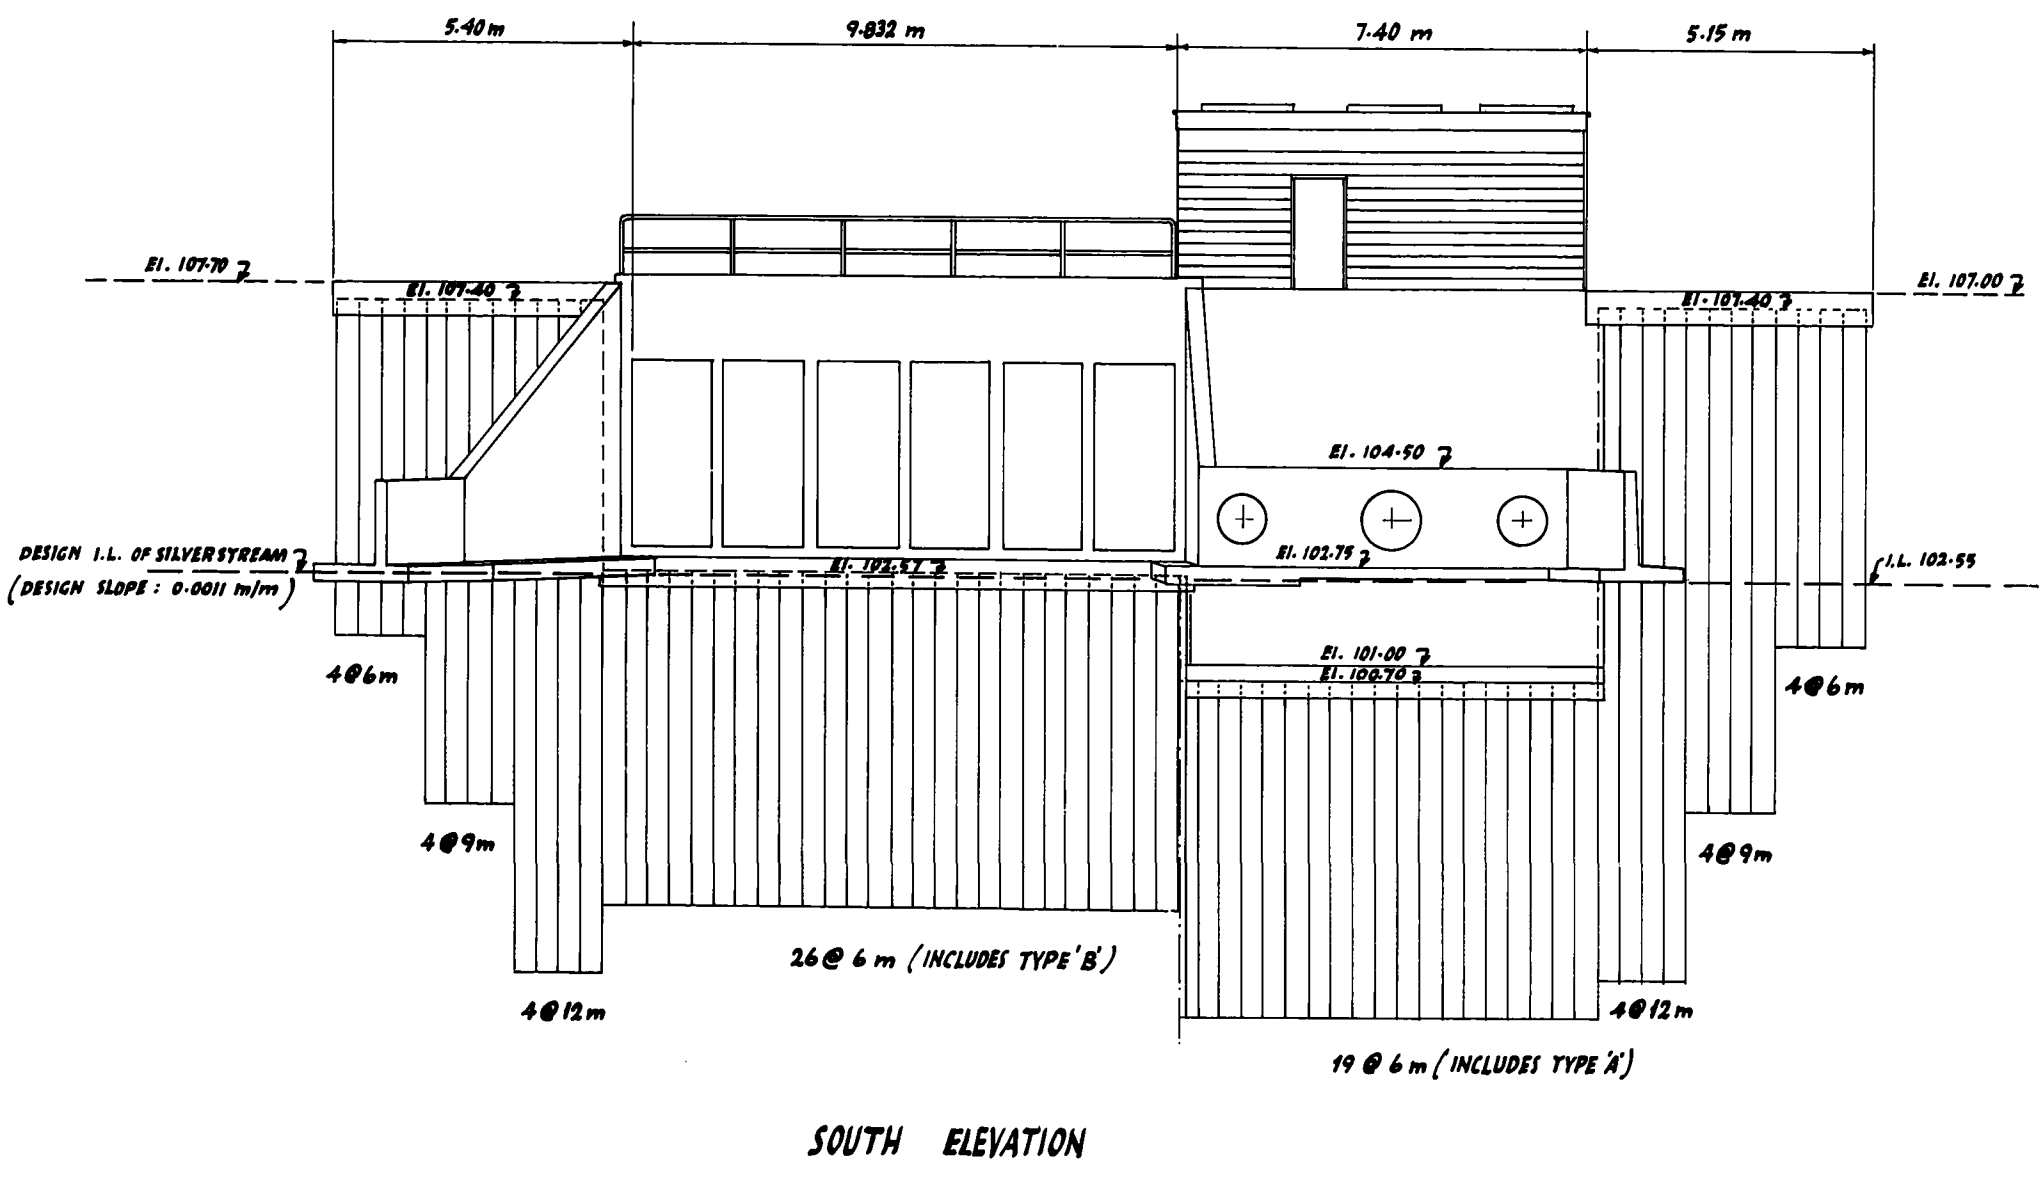
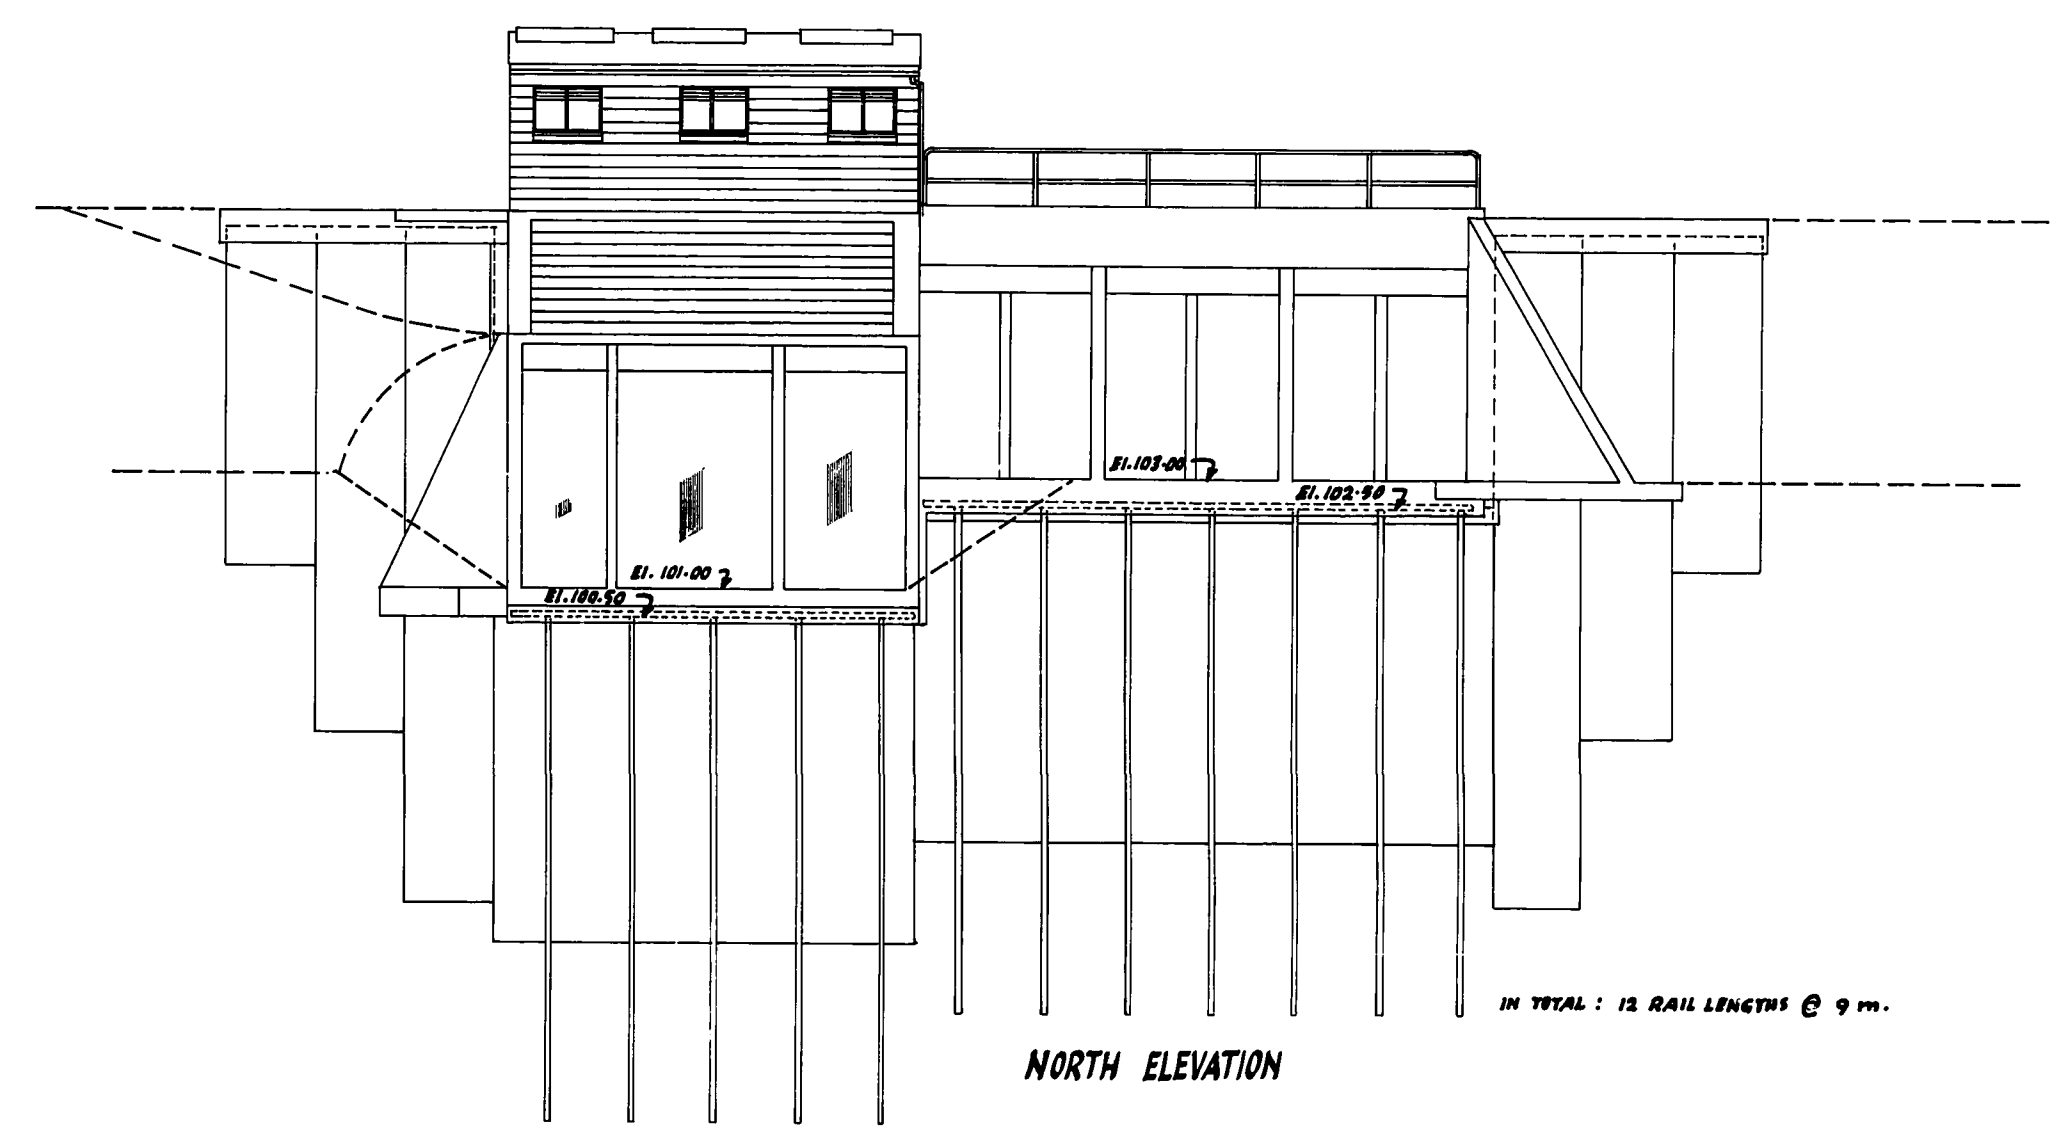
ENGINEERING REF. No.	AMENDMENTS	APPD	DATE	NAME	DATE	APPROVED	OTAGO CATCHMENT BOARD	JOB No 5/822/14/1	C No 743090
				SURVEYED		 A.J. GILLIES B.E., B.Sc., F.N.Z.I.E., M.I.C.E. CHIEF ENGINEER	<h1>SILVERSTREAM PUMPING STN</h1>	<h1>L 8022/2</h1>	
				AERIAL PHOTO REF					
				DRAWN	1-10-1975				
				TRACED	1-10-1975				
				DESIGNED	11. I.M. SCARP				
				CHECKED	I.G.S. THARPM, I.M. SCARP				
SOIL AND WATER CONSERVATION FORM PLAN No.				RECOMMENDED	5-10		SCALE: 1:100

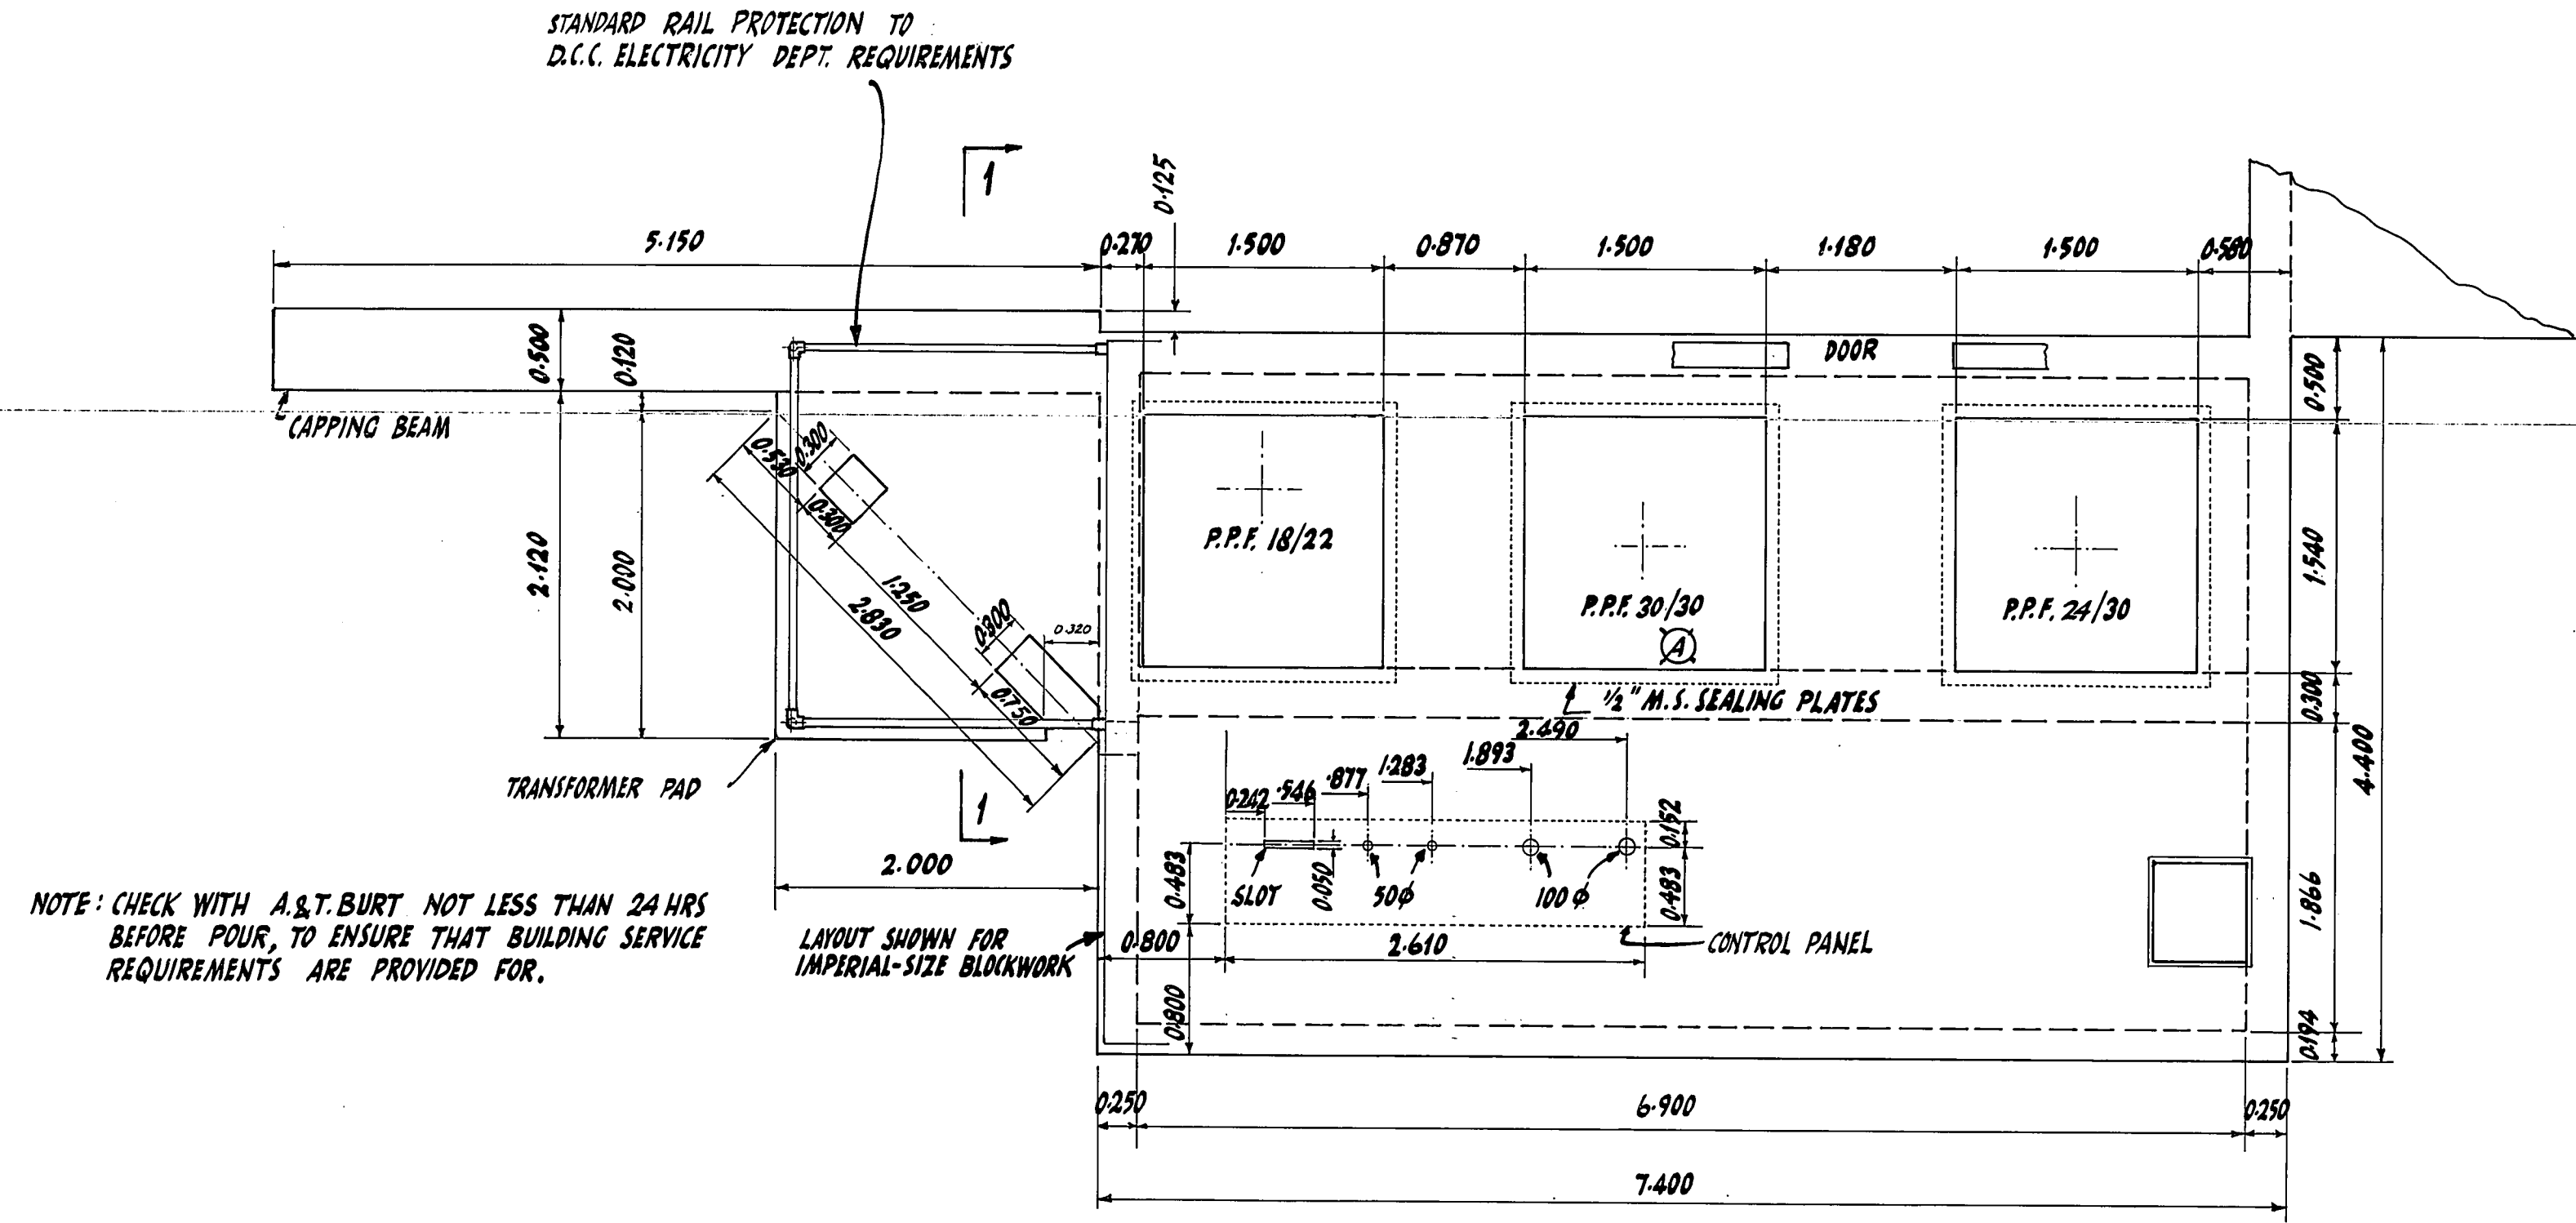
PLAN MOTOR FLOOR
SCALE=1:40

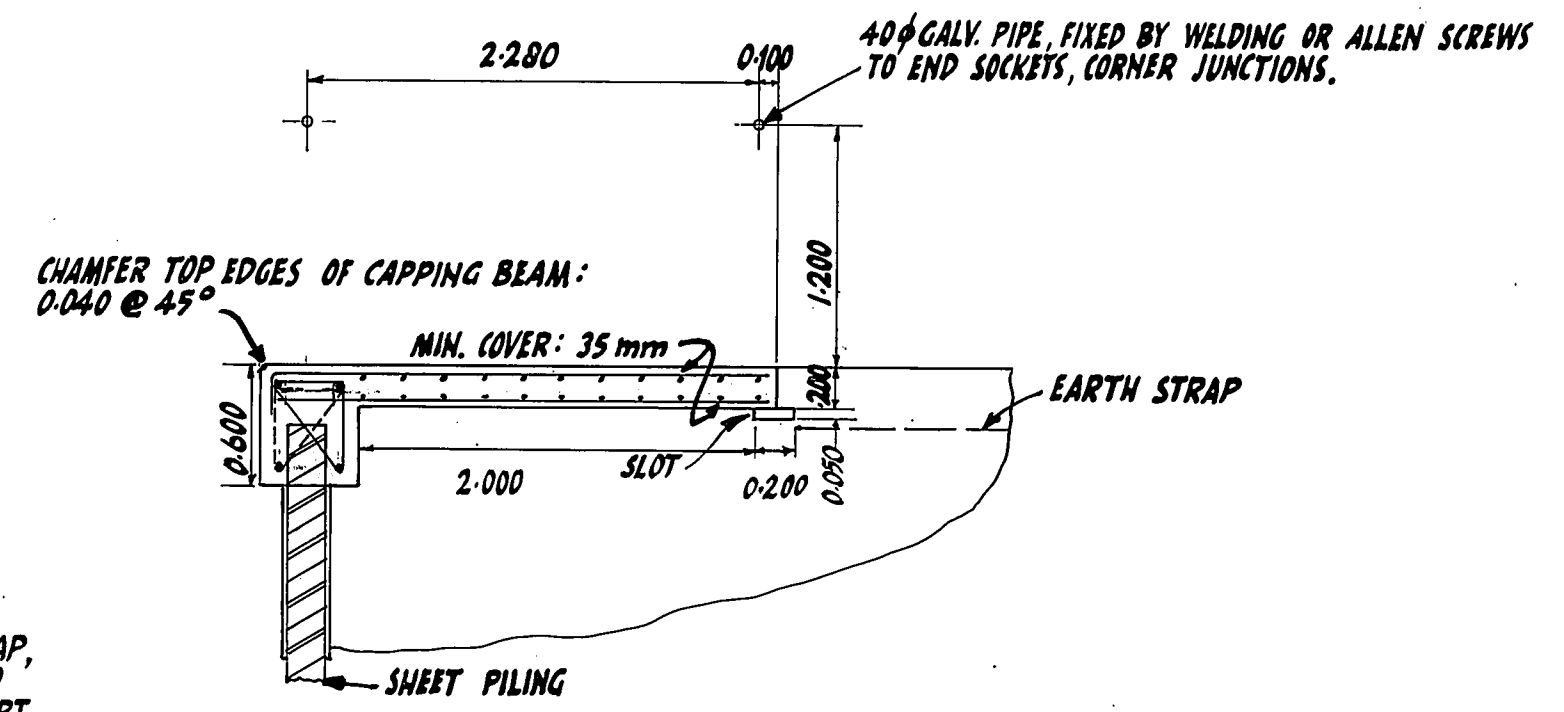
REINFORCEMENT DETAIL
