Lower Taieri Floodbank System

Structural Integrity Assessment

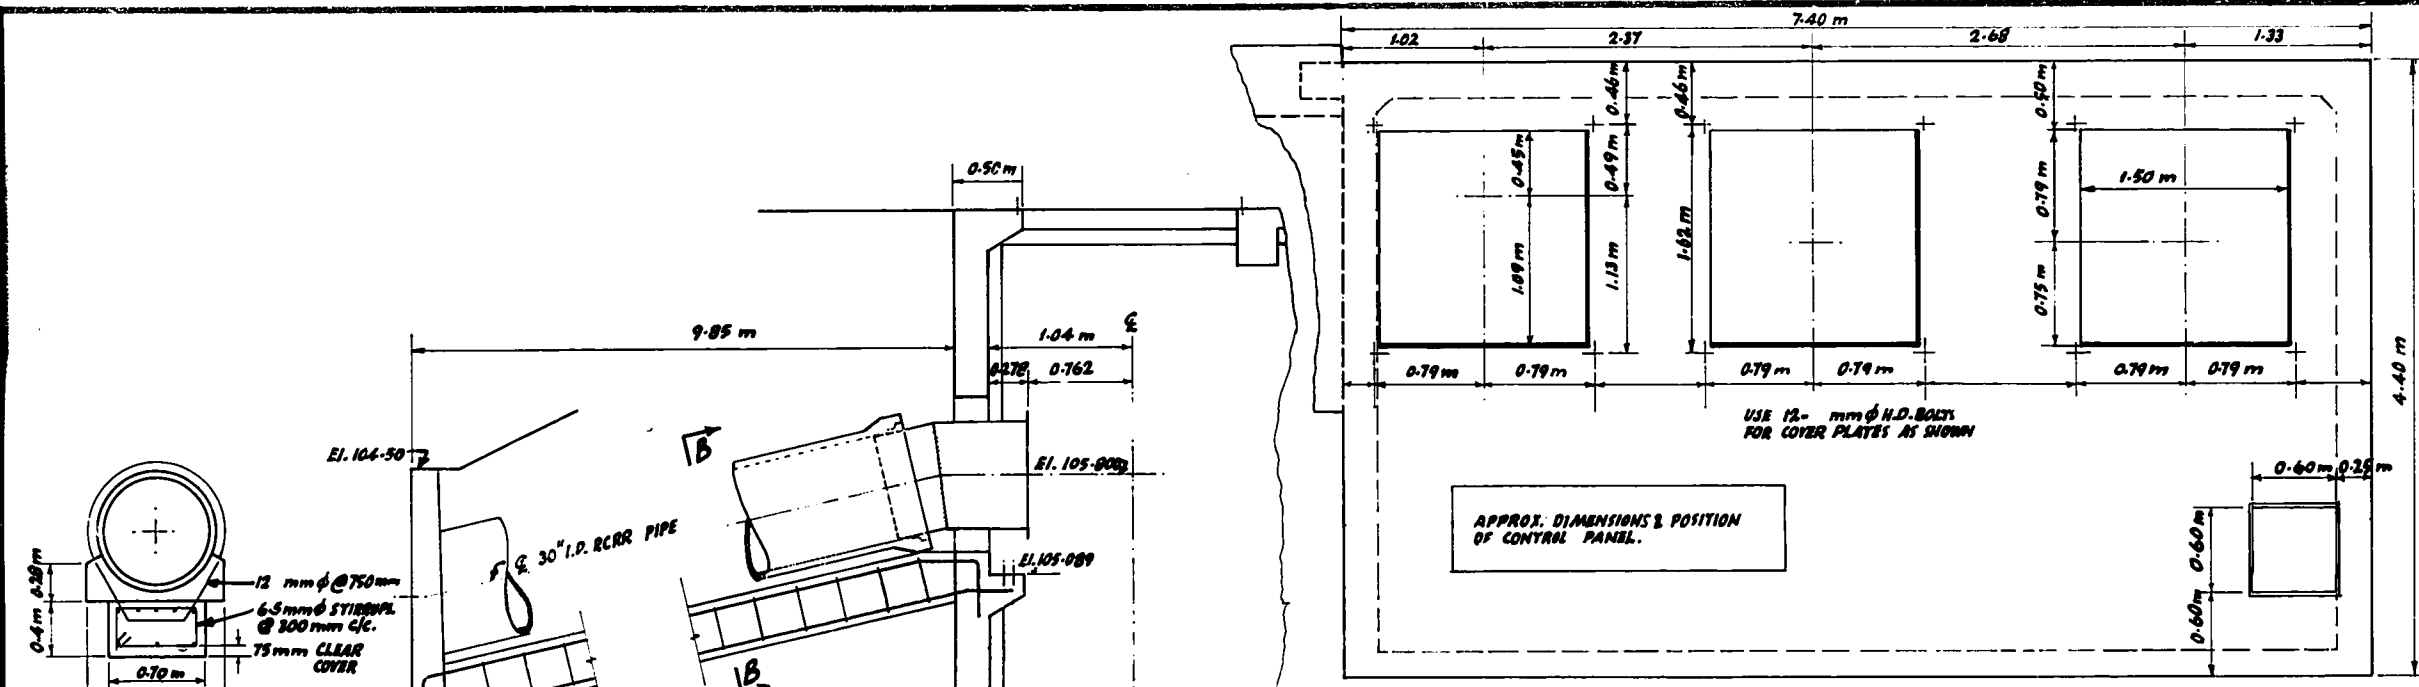
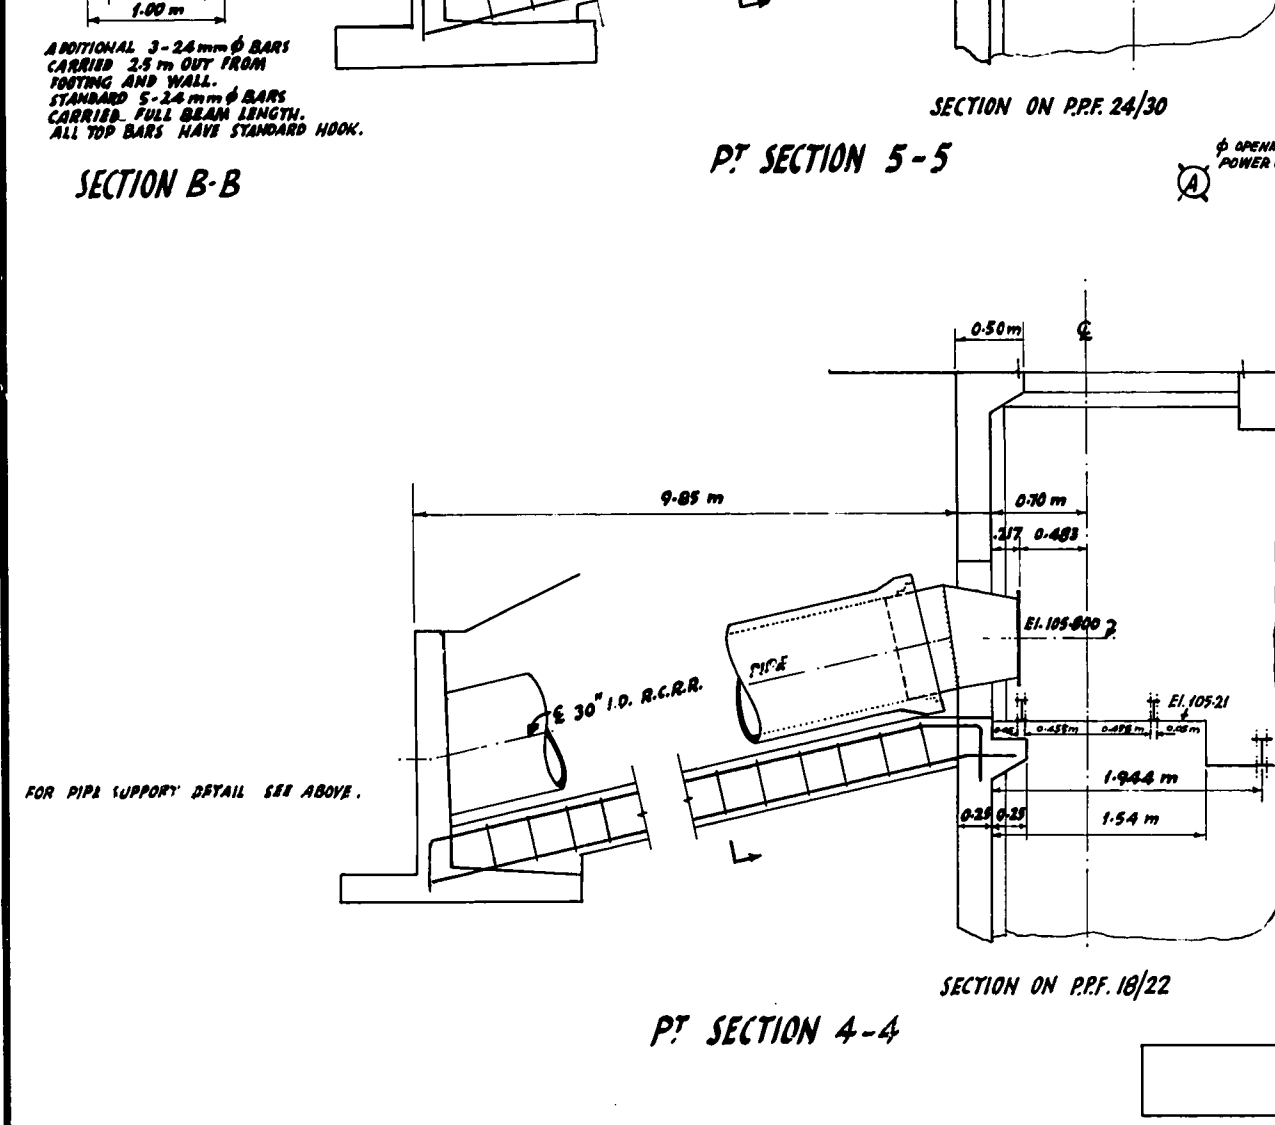
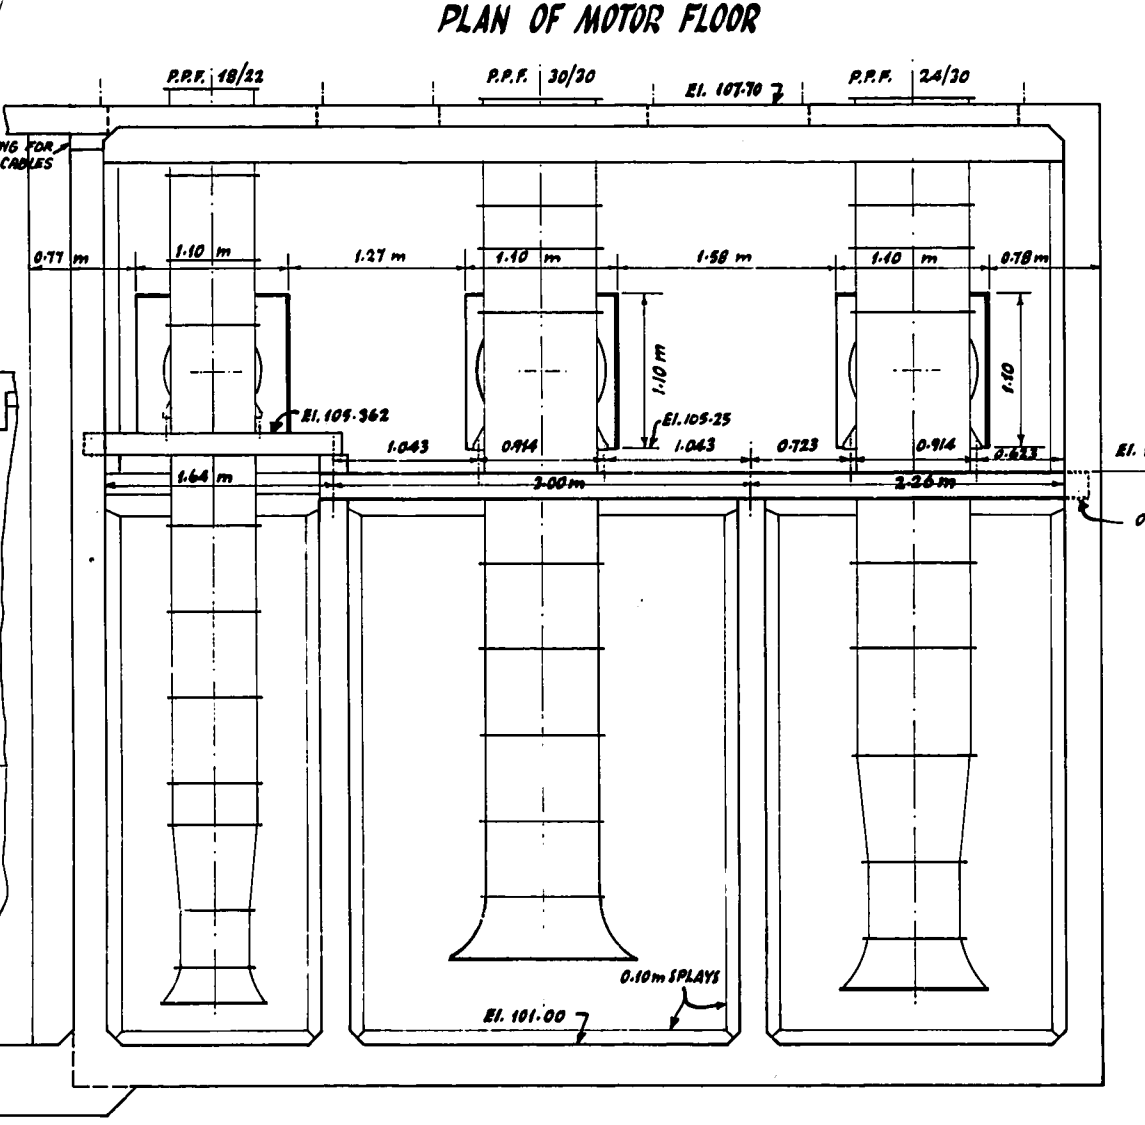
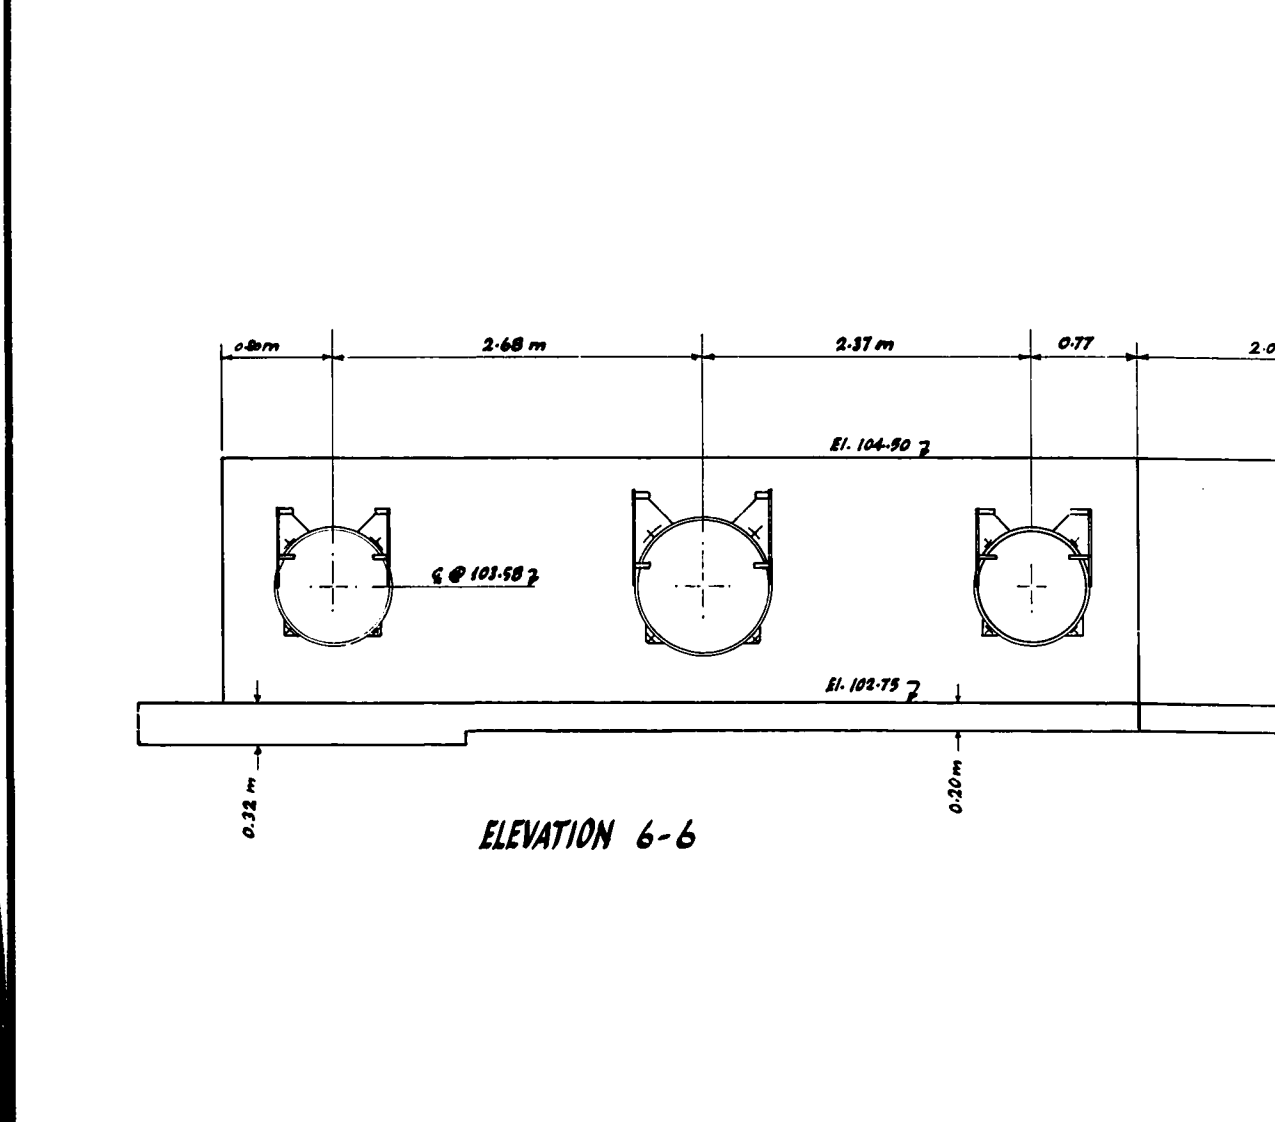
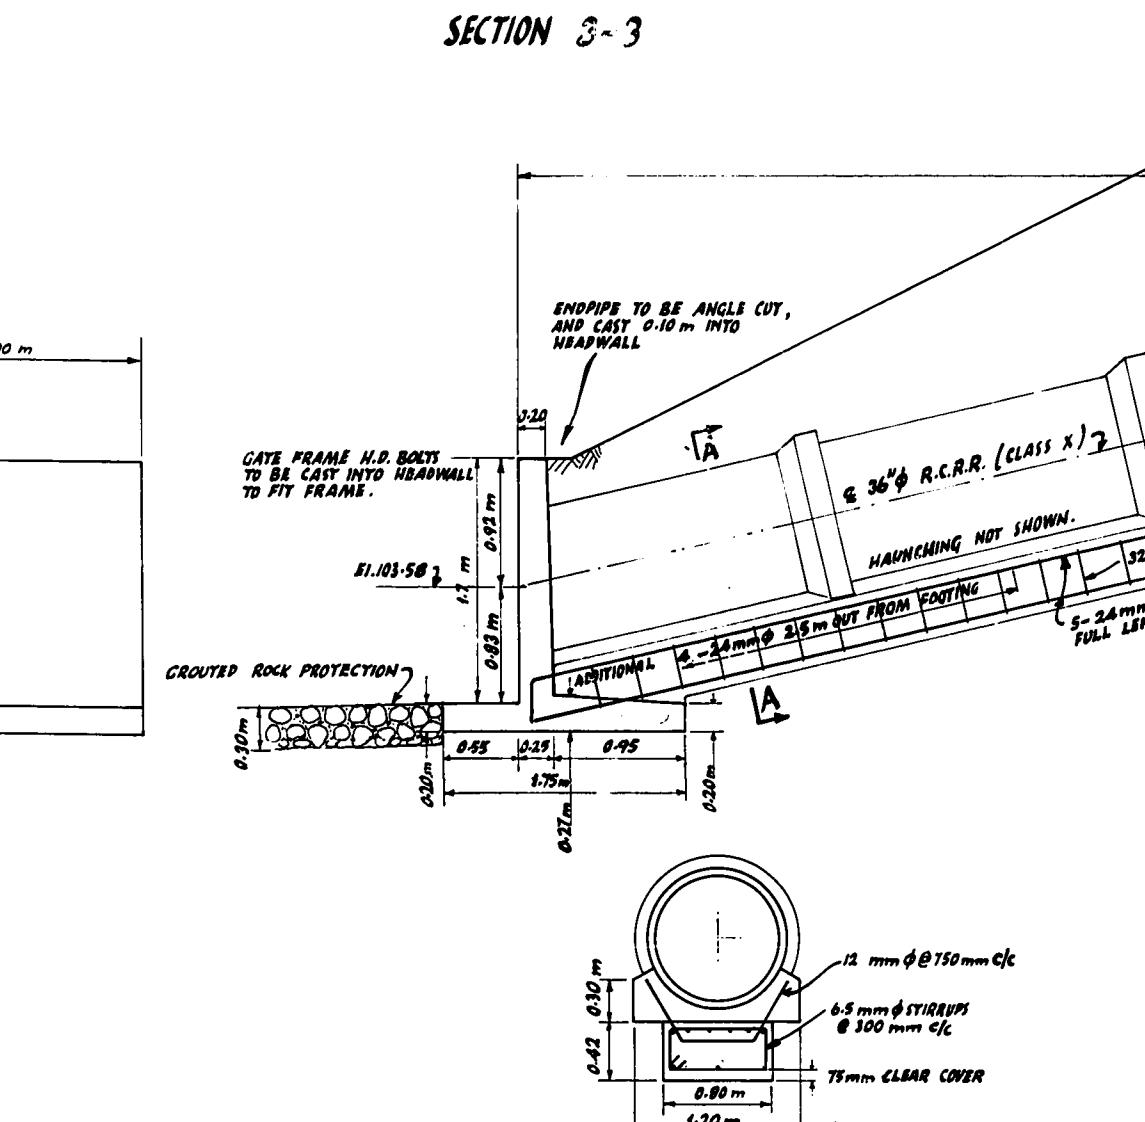
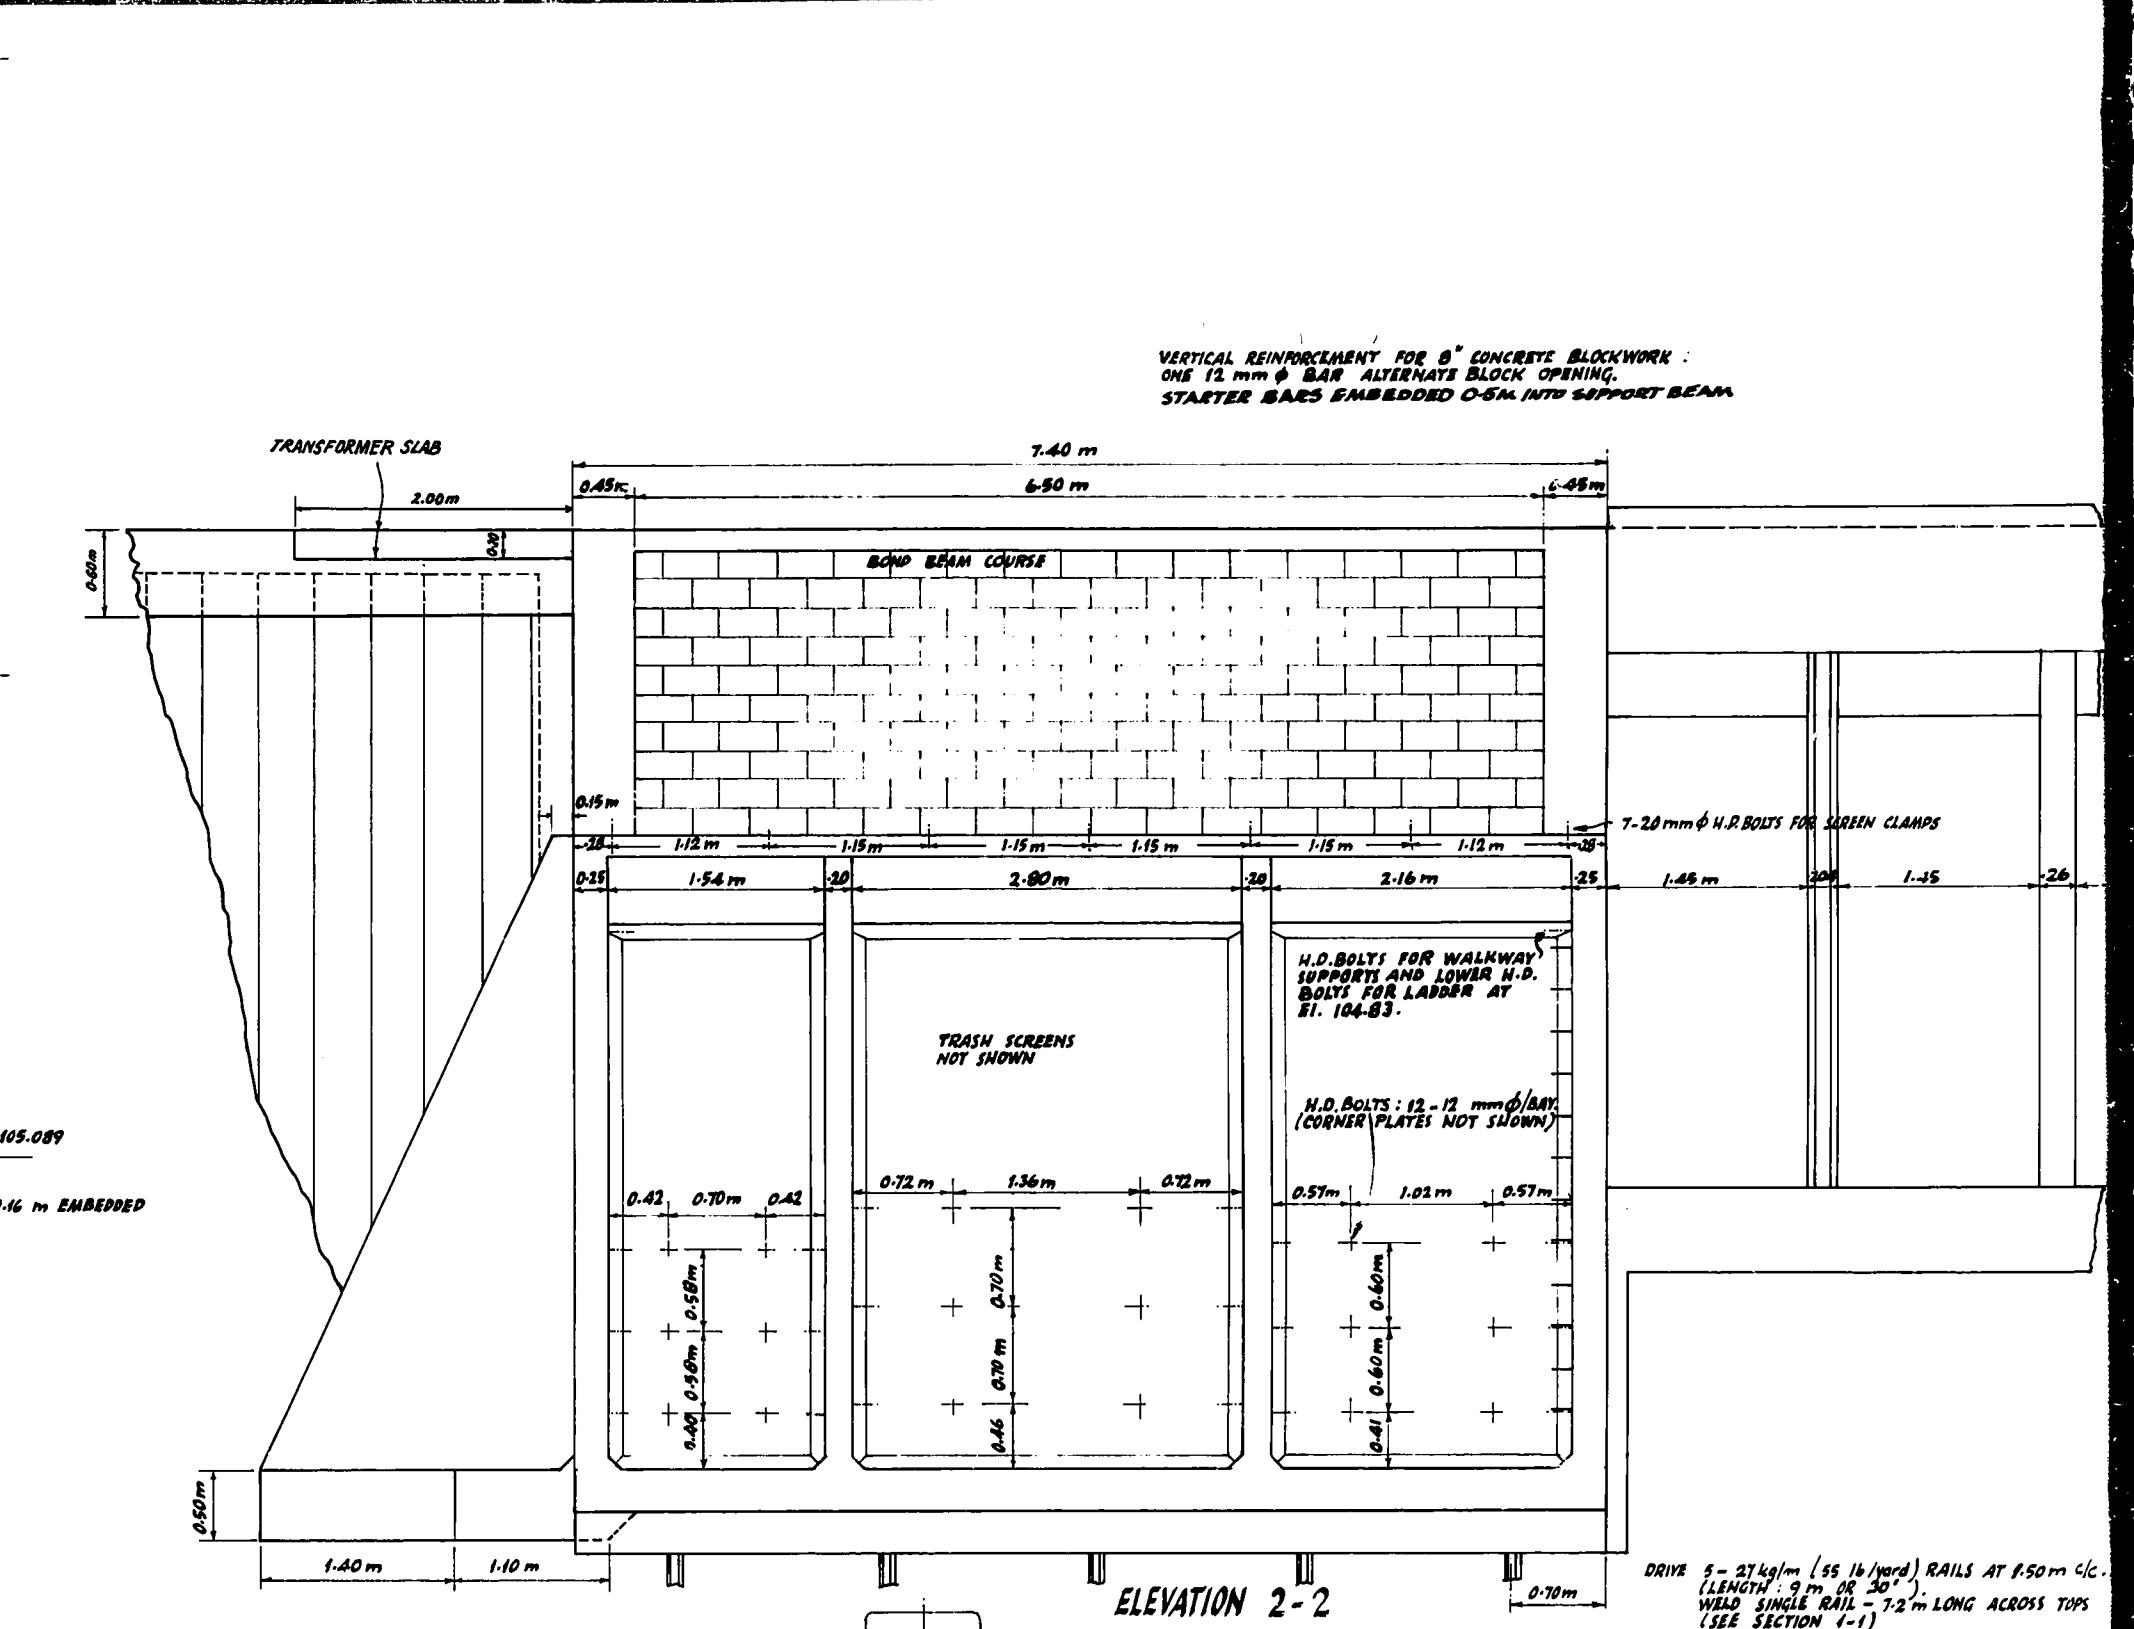
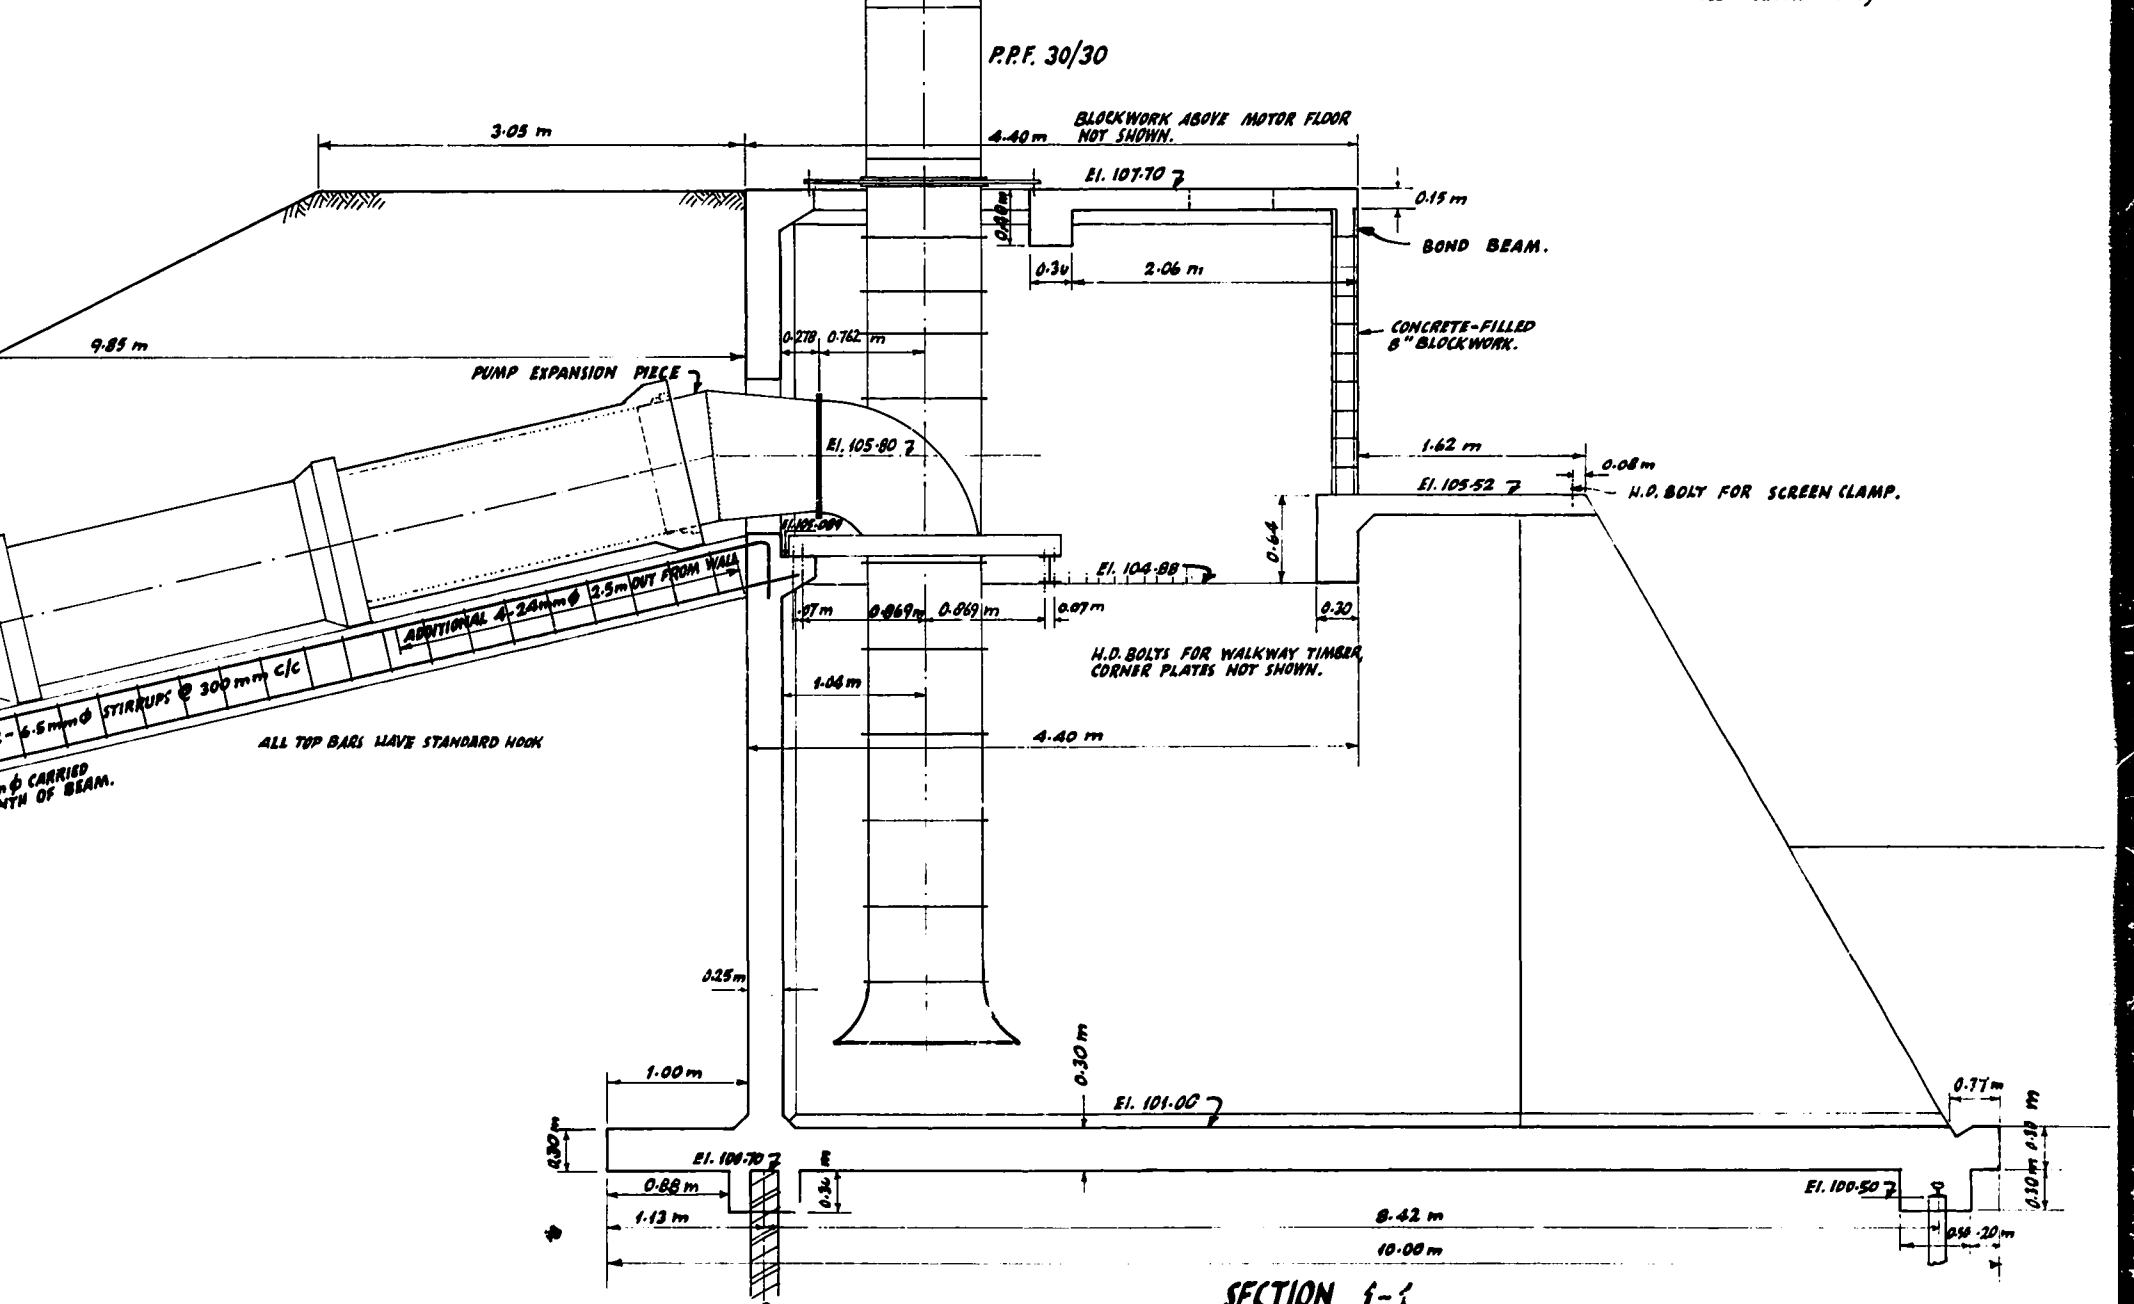
ENGINEERING REF. No.	AMENDMENTS	APPD.	DATE	NAME	DATE	APPROVED	OTAGO CATCHMENT BOARD	JOB No. 5/822/141	743090
	REFER A 8223 FOR OPENINGS TO CABLES		18-5-1976	SURVEYED					
				AERIAL PHOTO REF	JULY 1975				
				DRAWN	AUGUST 1975				
				TRACED					
				DESIGNED	JULY 1975				
				CHECKED	25-9-1975				
				RECOMMENDED	3-10				
				E. HILLENDORF		A.J. GILLIES		L 8022/4	
				I.M. SCARF		B.E., B.Sc., F.N.Z.I.E., M.I.C.E.		SCALE: 1/40	
				I.G.S. SHARPE I.M. SCARF		CHIEF ENGINEER

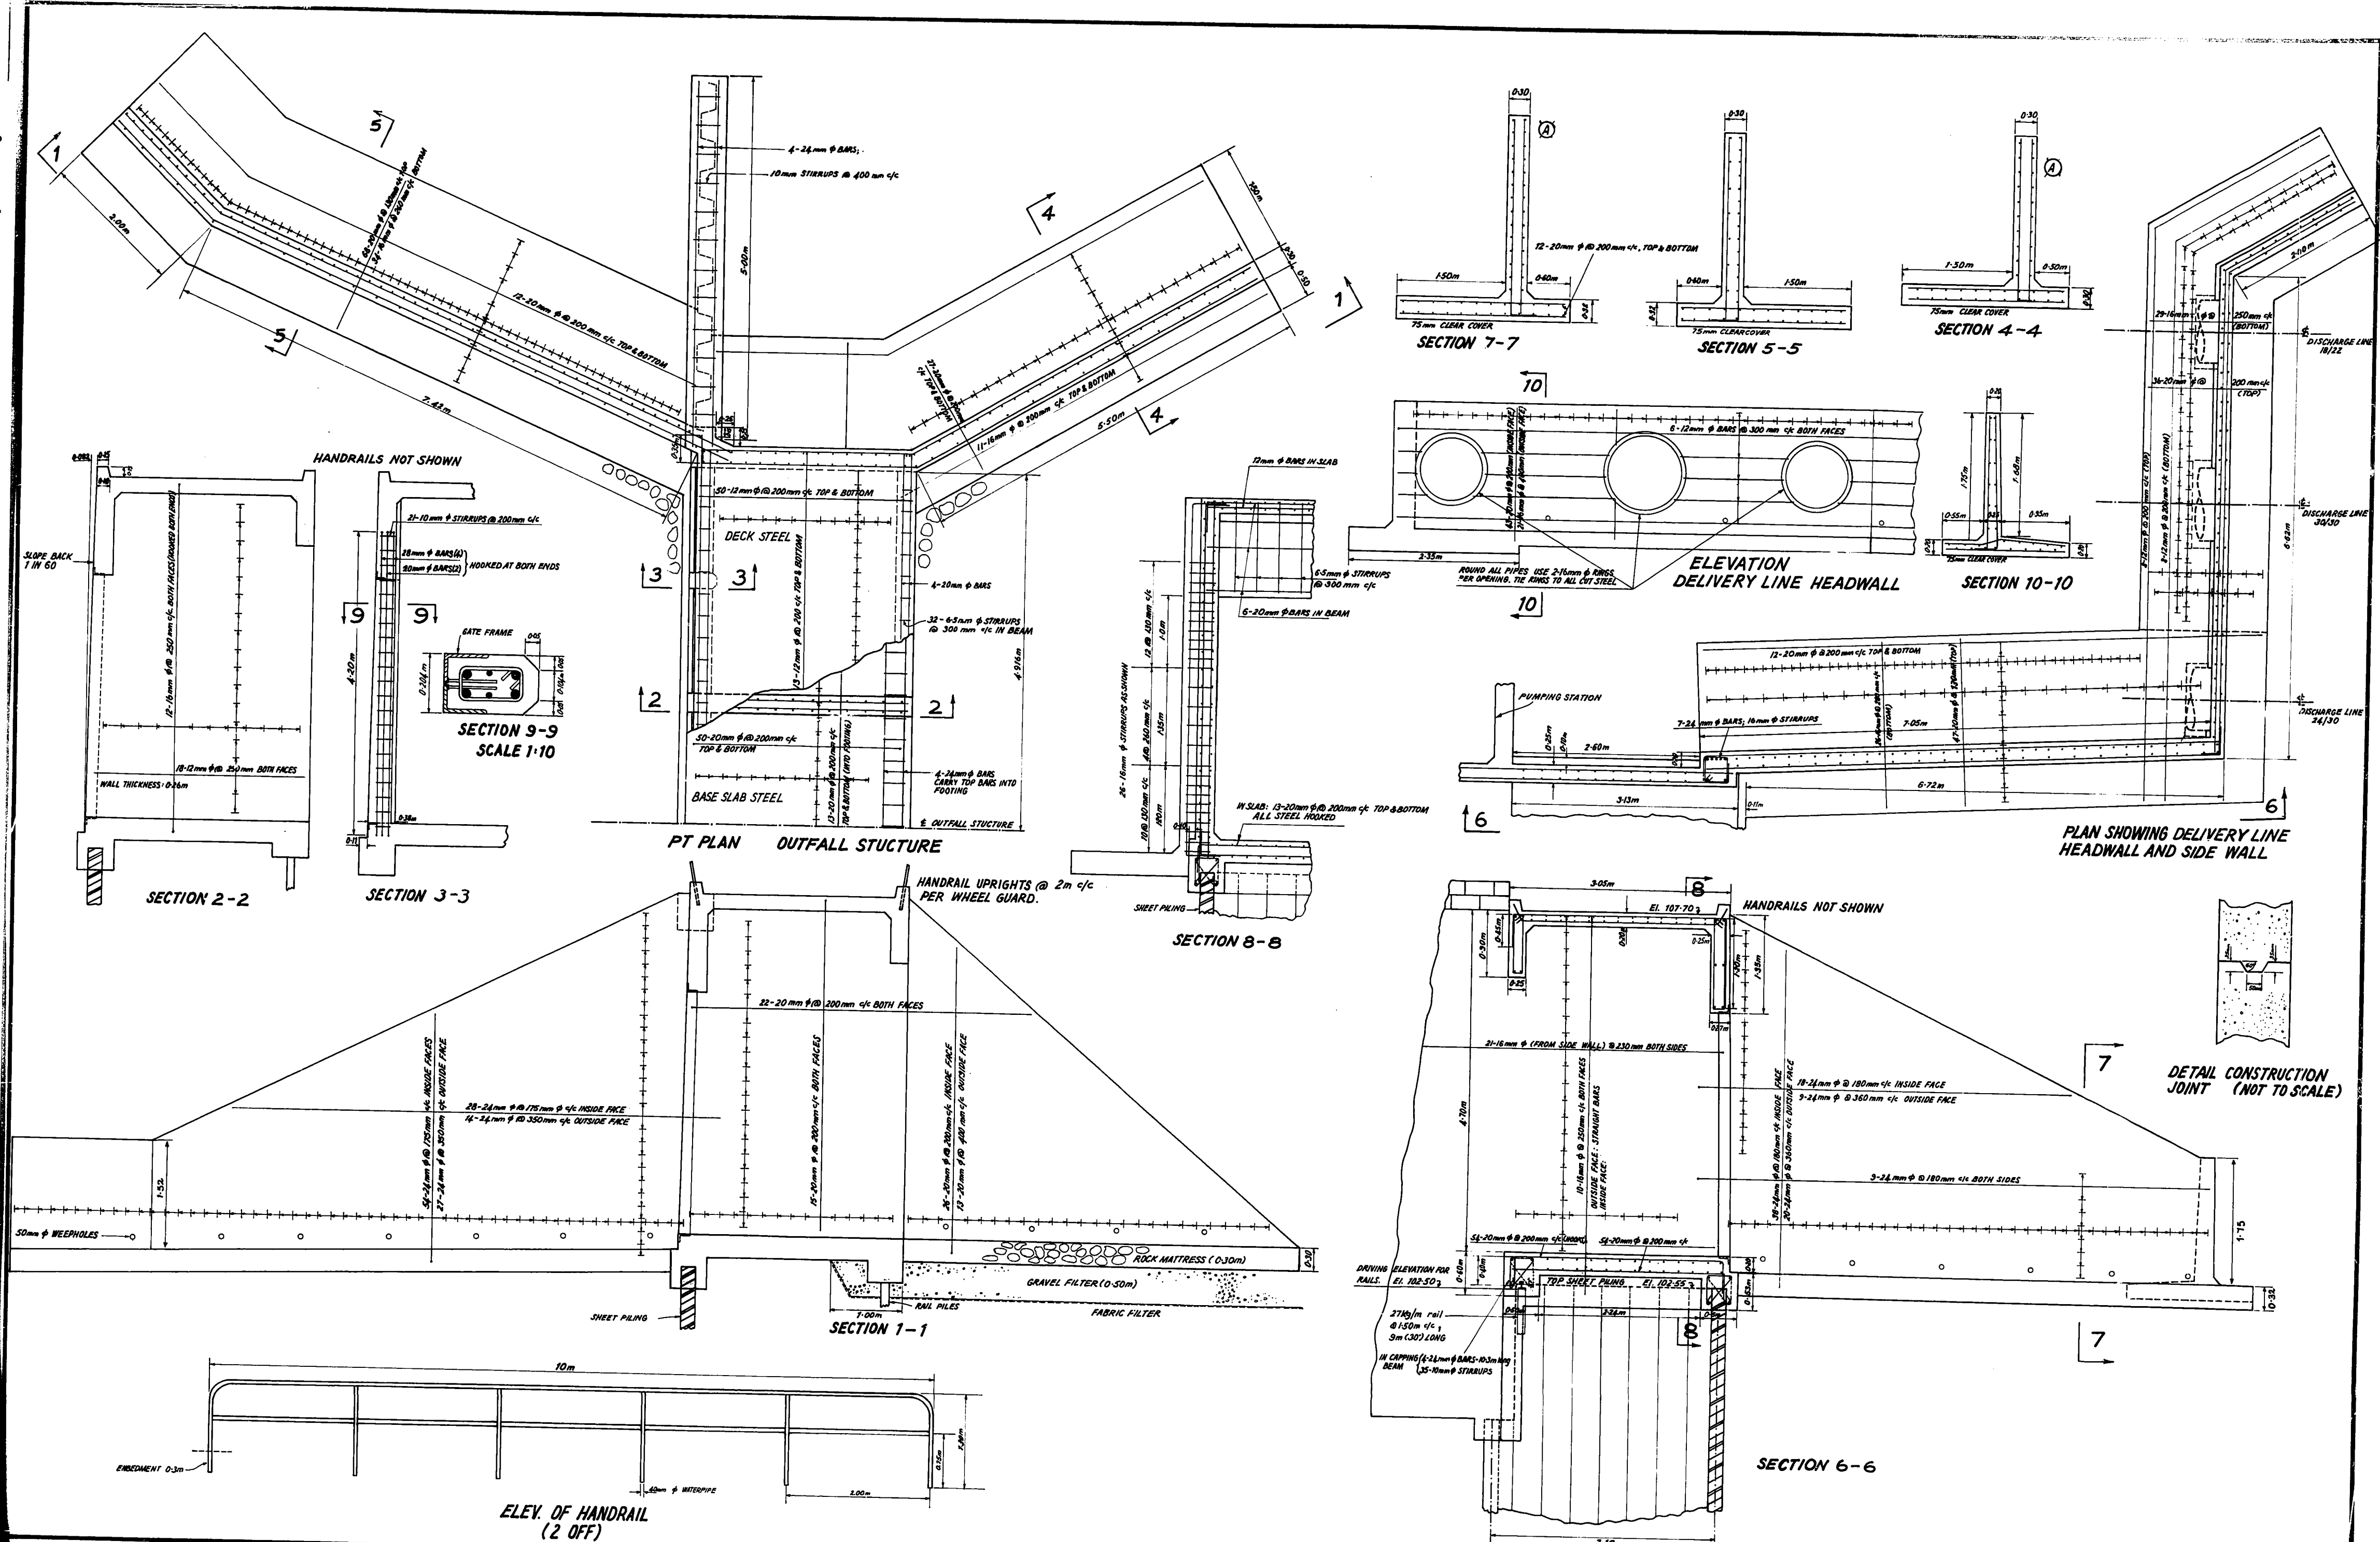
ENGINEERING REF. No.	AMENDMENTS ① WALL REINFORCING POSITION CORRECTED (SEE SECTIONS 4-4, 7-7)	APPD. <i>[Signature]</i> 18.9.1976	DATE	NAME	DATE	APPROVED	OTAGO CATCHMENT BOARD	JOB No. 3/182/14/1	C. No. 243090
SOIL AND WATER CONSERVATION FARM PLAN No.				SURVEYED AERIAL PHOTO REF DRAWN TRACED DESIGNED CHECKED RECOMMENDED		<i>[Signature]</i> A.J. GILLIES B.E., B.Sc., F.N.Z.I.E., M.I.C.E. CHIEF ENGINEER			
				E. HELLEDOORN L.J. MILLER I.M. SCARF I.G.S. SHARPE <i>[Signature]</i>	SEPT. '75 SEPT. '75 SEPT. '75 25/9/75 3.10

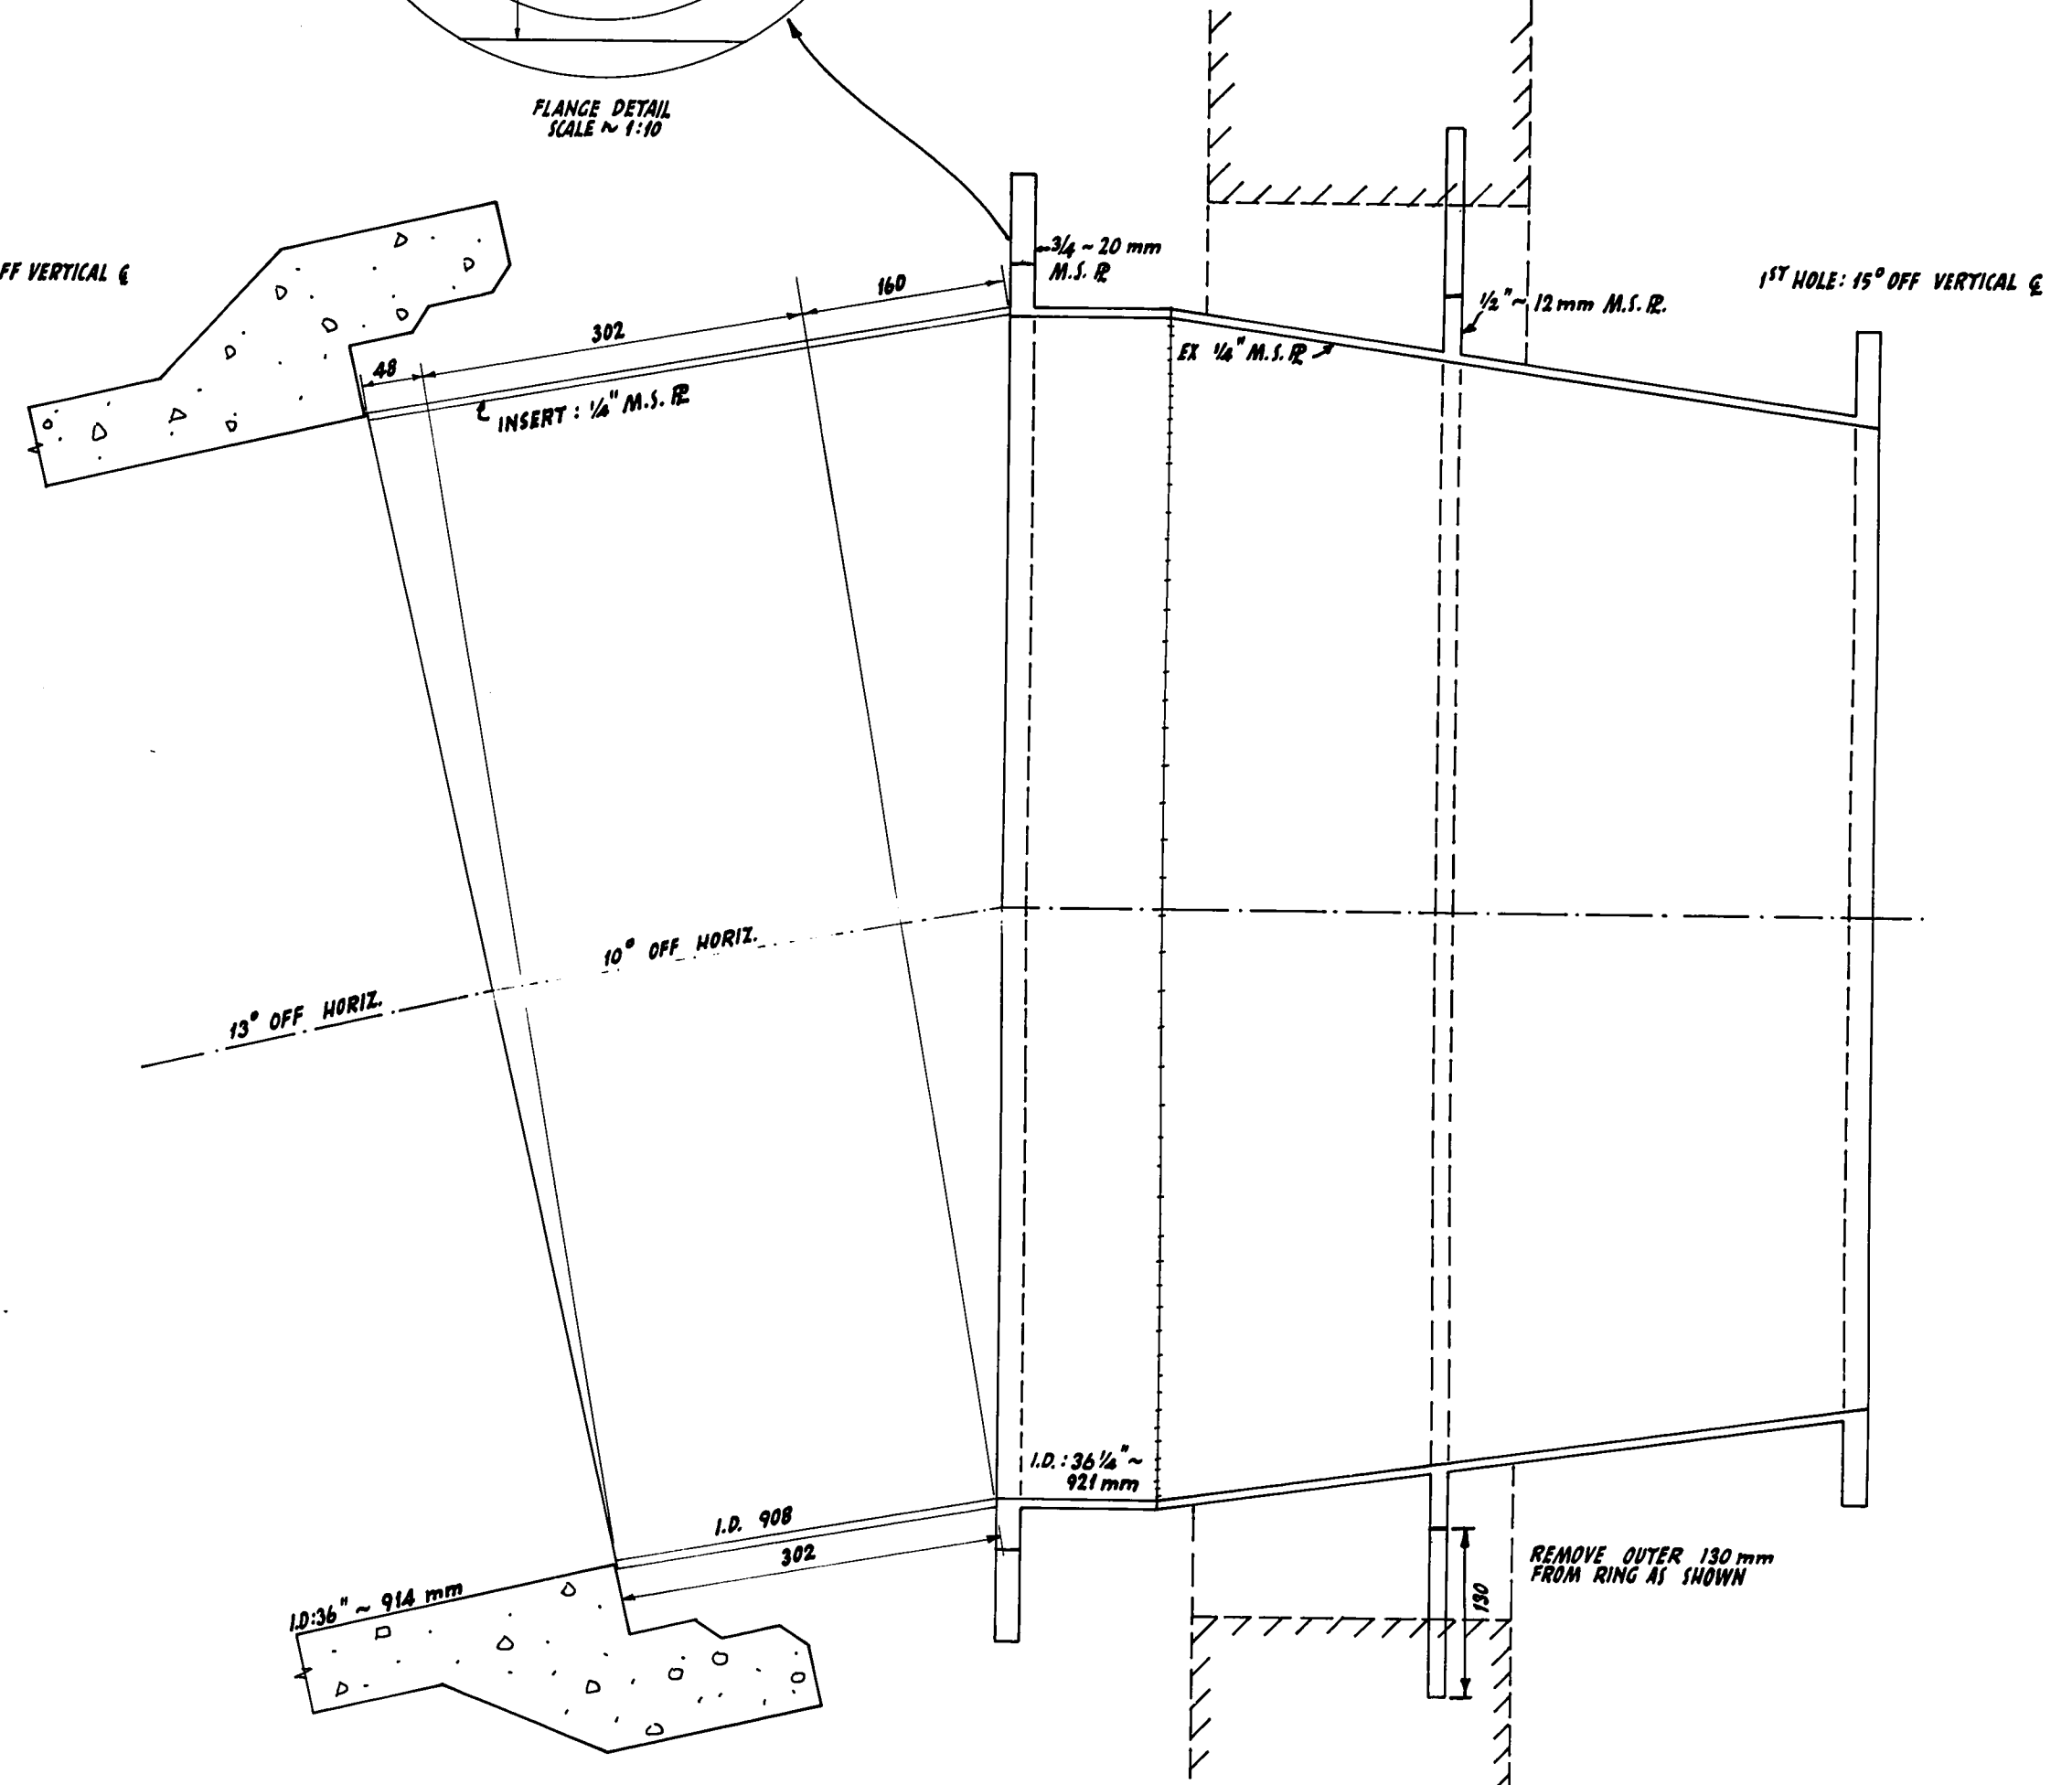
EXPANSION PIECE P.P.F. 30/30 (1 OFF)
