**Hazard and risk assessment of the Roxburgh
debris flows of 26th November 2017**

**GNS Science Consultancy Report 2018/65
May 2018**

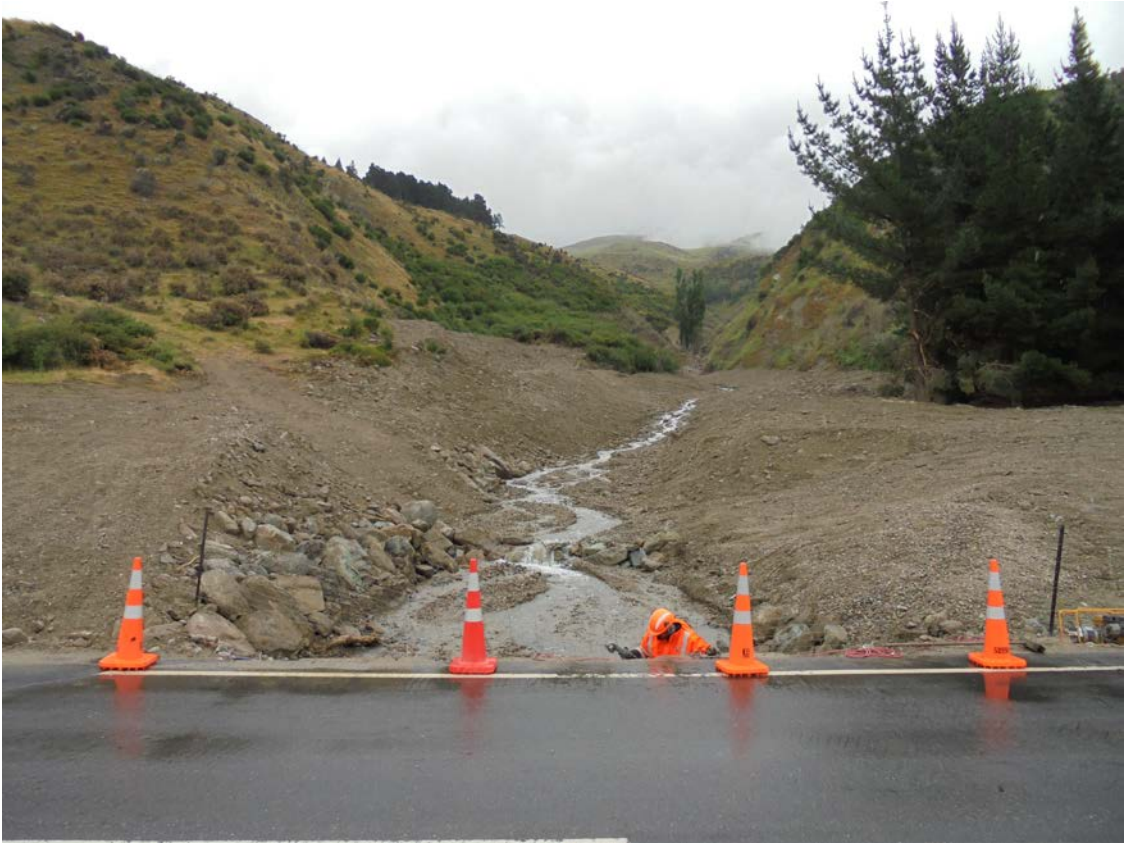
The debris flows travelled down the stream bed unimpeded until they encountered the raised embankment of SH8, constructed to allow the stream to pass through a culvert beneath SH8. The volume and size of debris overwhelmed the culvert, with some of the larger boulders too big to pass through the culvert. The debris accumulated behind the road embankment until a low point could be found over the roadway. The volume of debris was such that the road was buried to a depth of 1-2 m over 50-70 m, and consequently became impassable. The total volume of debris shifted by the debris flow is difficult to determine as a large amount ended up in the Clutha River.

Figure 3.3 Black Jacks Creek looking upstream from the culvert over SH8. The height of the un-vegetated channel banks provides some indication of the amount of aggradation caused by the debris flows close to the fan-head (Photo: S.Dellow 13/12/2017).

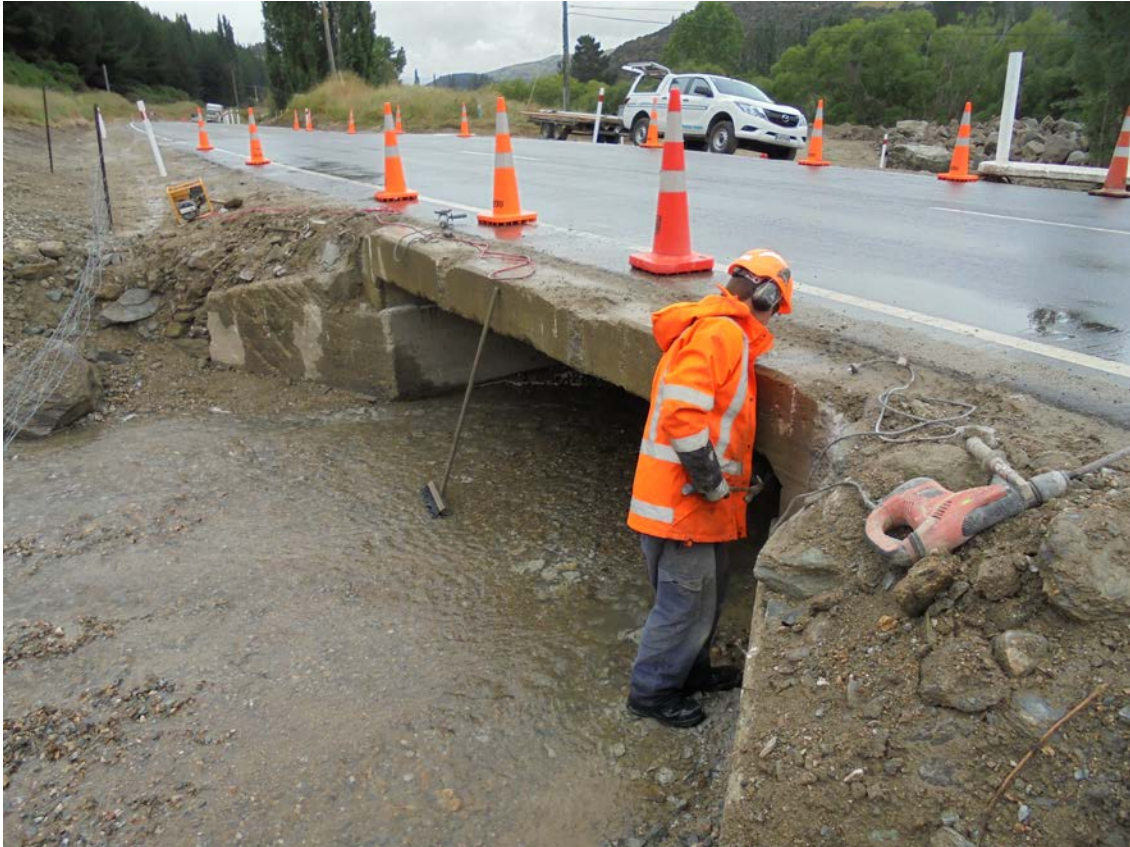
Figure 3.4 The culvert beneath SH8 at Black Jacks Creek. Note the height of the culvert in relation to the size of the largest boulders in the figure below (Photo: S.Dellow 13/12/2017).

In three streams (Black Jacks, Golf Course and Pump Station Creeks) the debris flows left the stream channel (they avulsed) when they reached culverts beneath SH8 which restricted their flow and were rapidly blocked by large boulders. In addition to the road was elevated above the debris flow fans which allowed debris to build up until a low point across SH8 could be found. These low points did not coincide with the position of the culverts and as a consequence debris from the debris flows was distributed over a large area.

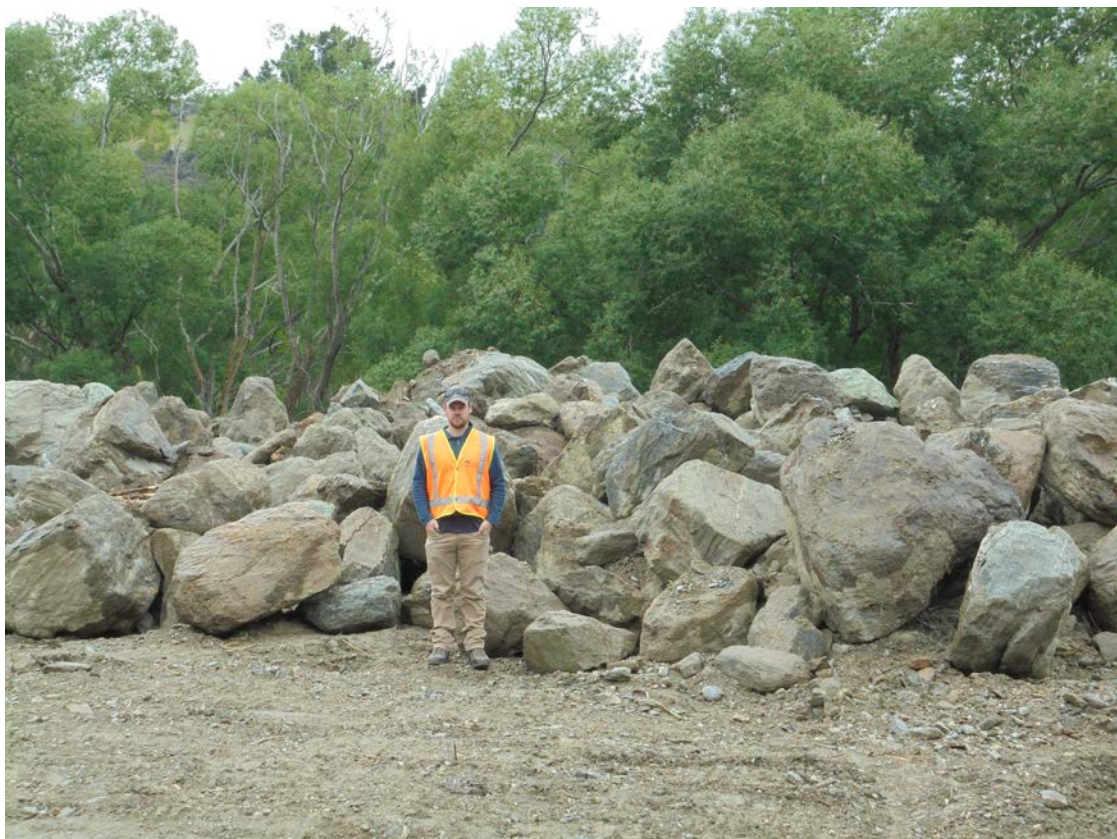
Figure 3.5 Large boulders entrained in the Black Jacks Creek debris flows. The largest sizes are nearly two metres in diameter and the total number of boulders is probably in the hundreds as many ended up in the Clutha River (Photo: S.Dellow 13/12/2017).

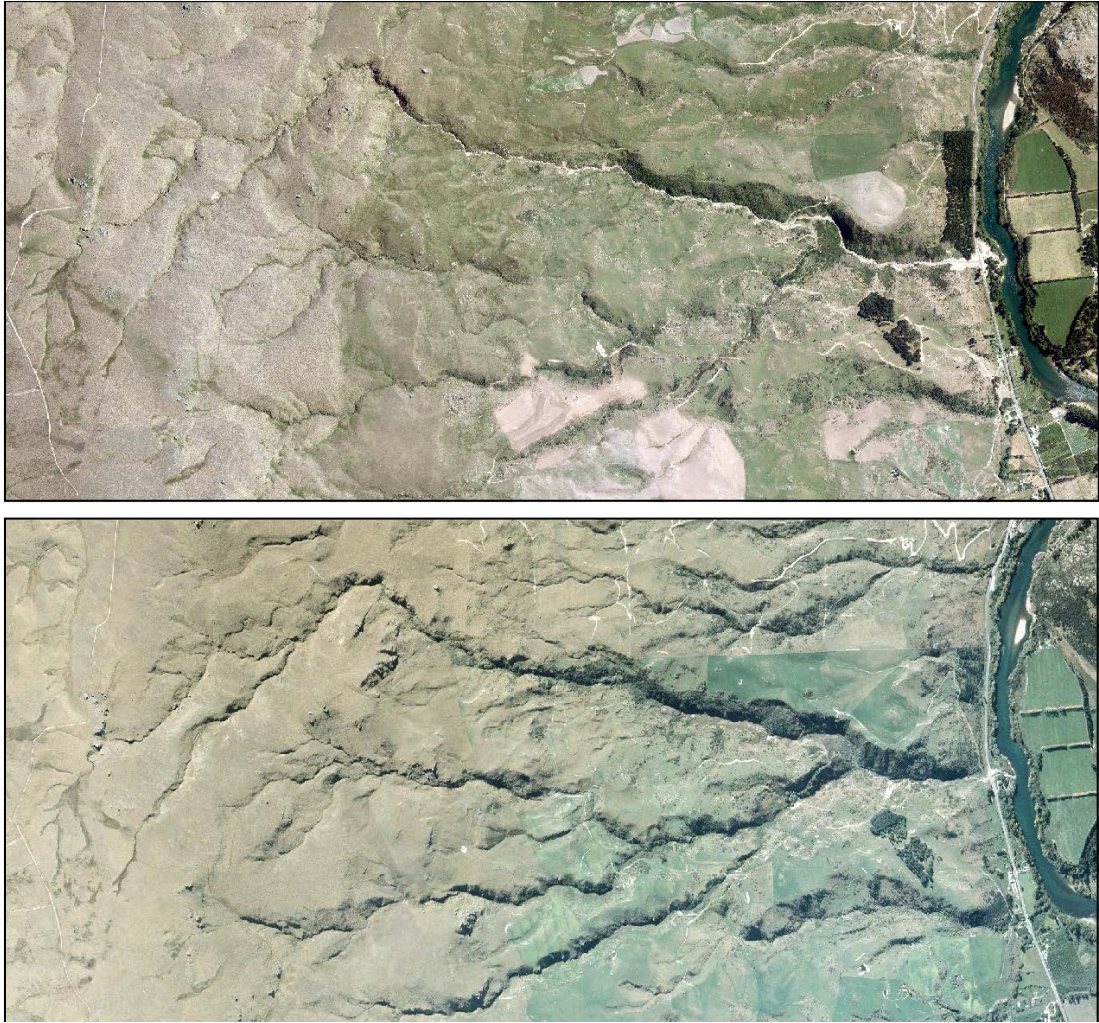
A comparison of pre-event and post-event aerial photography (Figure 3.6) has been used to assess the nature of the event (Figure 3.6). The photos show the loss of vegetation cover in the creek was limited to the stream channel for about two-thirds of its length. Many of the landslides observed were strongly coupled to the stream channel. In many instances, the lowest part of their source areas were coincident with the channel, indicating streambank erosion rather than ground saturation probably triggered their failure. No landslide source areas disconnected from the stream channel were observed in the post-event photos (Figure 3.7). This is thought to reflect the short-duration of the rainfall not allowing time for the soil structure to become saturated. At such intensities most of the rain that fell quickly flowed over the ground surface into the stream channel and the rapid accumulation of water in the channel led to scour of the stream bed, stripping the vegetation (Figure 3.8). This stripping of vegetation exposed sediment in the stream bed which then became entrained by the high water-flows in the debris flows.

Figure 3.6 Before (bottom; 30th March 2006) and after (top; 28th December 2017) photos vertical aerial photographs of Black Jacks Creek catchment. The features of note in the post-event image are the lack of landslides on slopes away from the main channel and the absence of scour in the southern branches of Black Jacks Creek. This indicates the rainfall was of higher intensity over the northern branch of the catchment.

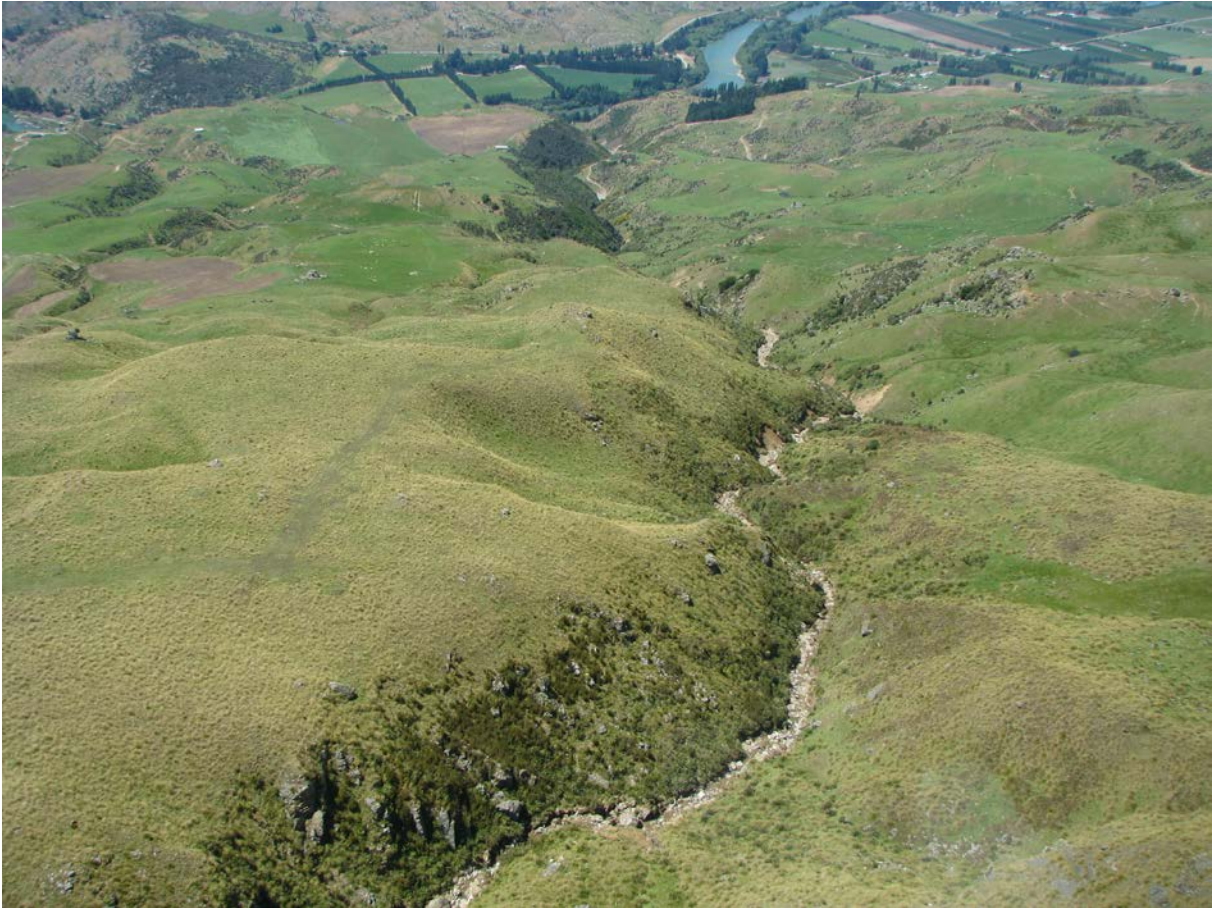
Figure 3.7 The upper reaches of Black Jacks Creek showing the lack of landslides in the country around the creek, and by contrast the scoured out creek bed with the vegetation gone and shallow landslides adjacent to the creek bed (Photo: Ben Mackey, ORC; 27/11/2017).

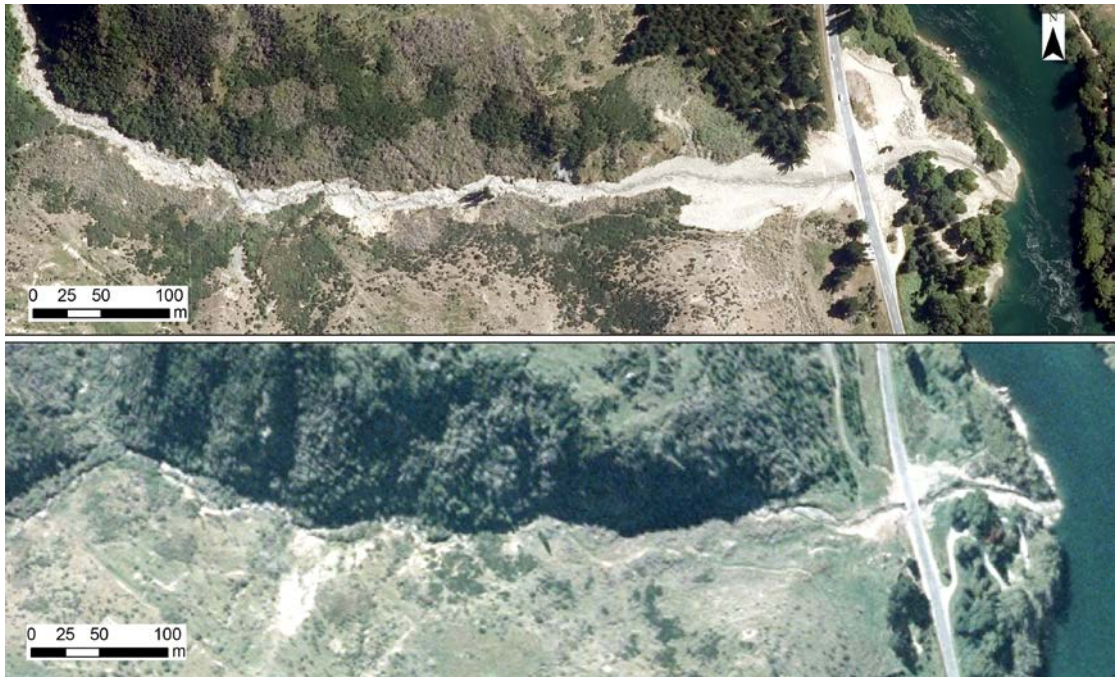
Figure 3.8 Before (bottom; 30th March 2006) and after (top; 28th December 2017) photos of the lower part of Black Jacks Creek including the debris flow fan across the Clutha River terrace.

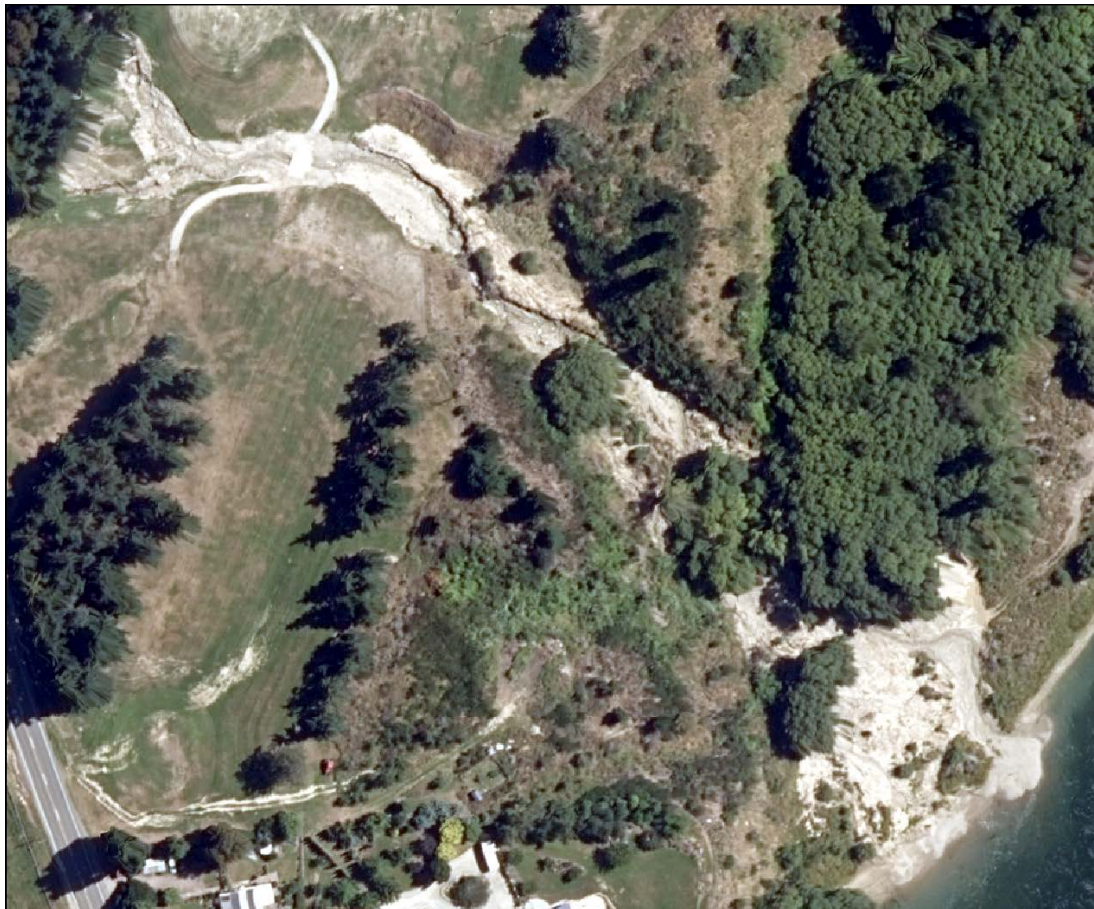
The Golf Course debris flow occurred in the smallest catchment where a limited volume of water was able to accumulate quickly. This is reflected in the size of boulders transported during the event with very few exceeding 0.5 m, and most less than 0.3 m in diameter. Again, the bare ground is mostly confined to the stream bed and lower sections of the adjacent slopes suggesting that stream bed a bank erosion was the main cause of landsliding within the catchment (Figure 3.9).

Figure 3.9 The creek bed between SH8 (left of the picture) and the Clutha River showing the results of scour and deposition on the Golf Course Creek fan (Photo: Aerial Surveys, 28th December 2017).

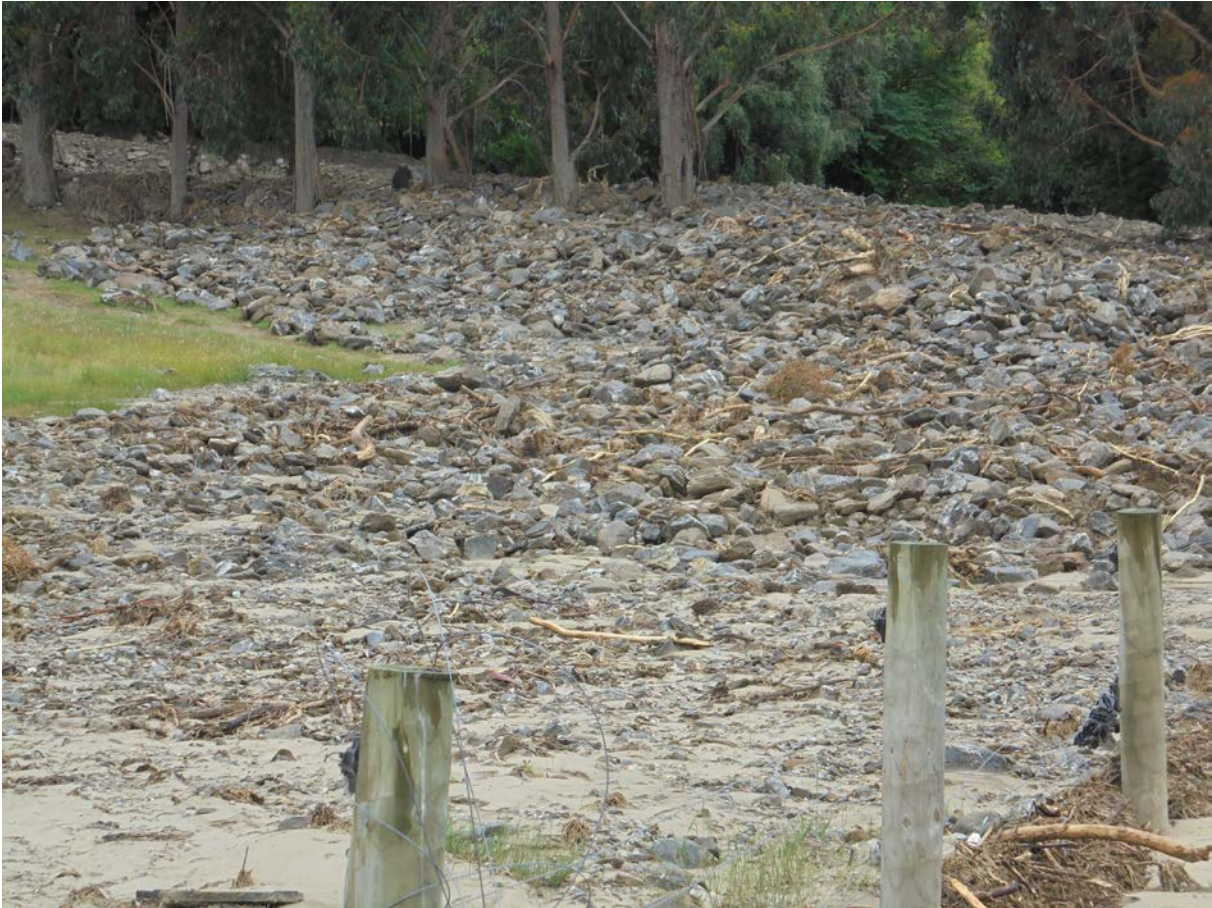
The debris travelled down the stream bed largely unimpeded until they encountered the culverts beneath SH8. The debris flows exceeded the capacity of these small culverts and quickly blocked, forced the debris to accumulate behind the slightly raised road embankment. As a consequence, the debris flowed across the road using several pathways and deposited sediment on a rugby field, golf course and along the margins of the original stream course (Figure 3.10).

Figure 3.10 Boulder field from the debris flows in Golf Course Creek on the uphill side of SH8 (Photo: S.Dellow 13/12/2017).

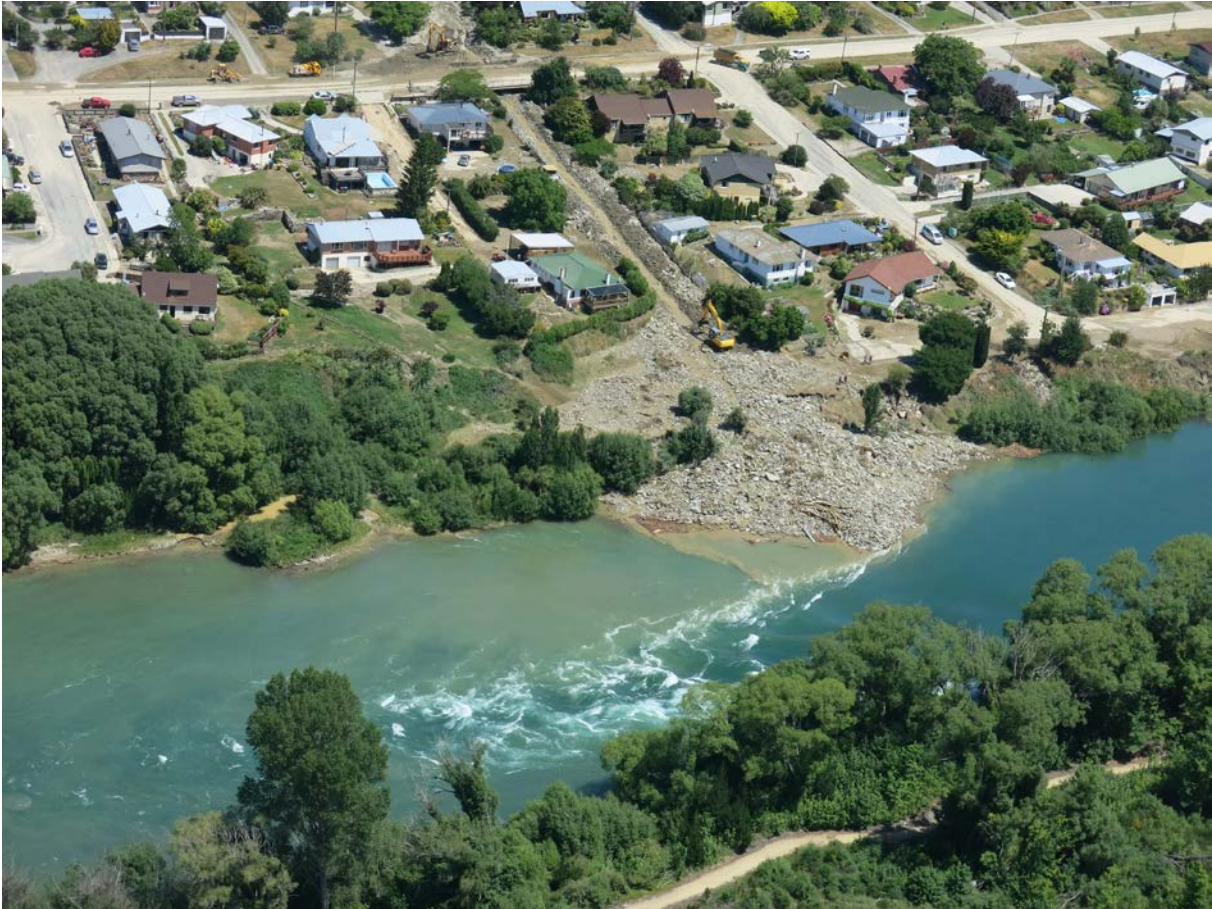
Figure 3.11 The Reservoir Creek debris fan the day after the debris flow event. There are two excavators in the photo, one at the SH8 bridge over Reservoir Creek and one on the lower fan clearing the concrete channel (Photo: Ben Mackey, ORC; 27/11/2017).

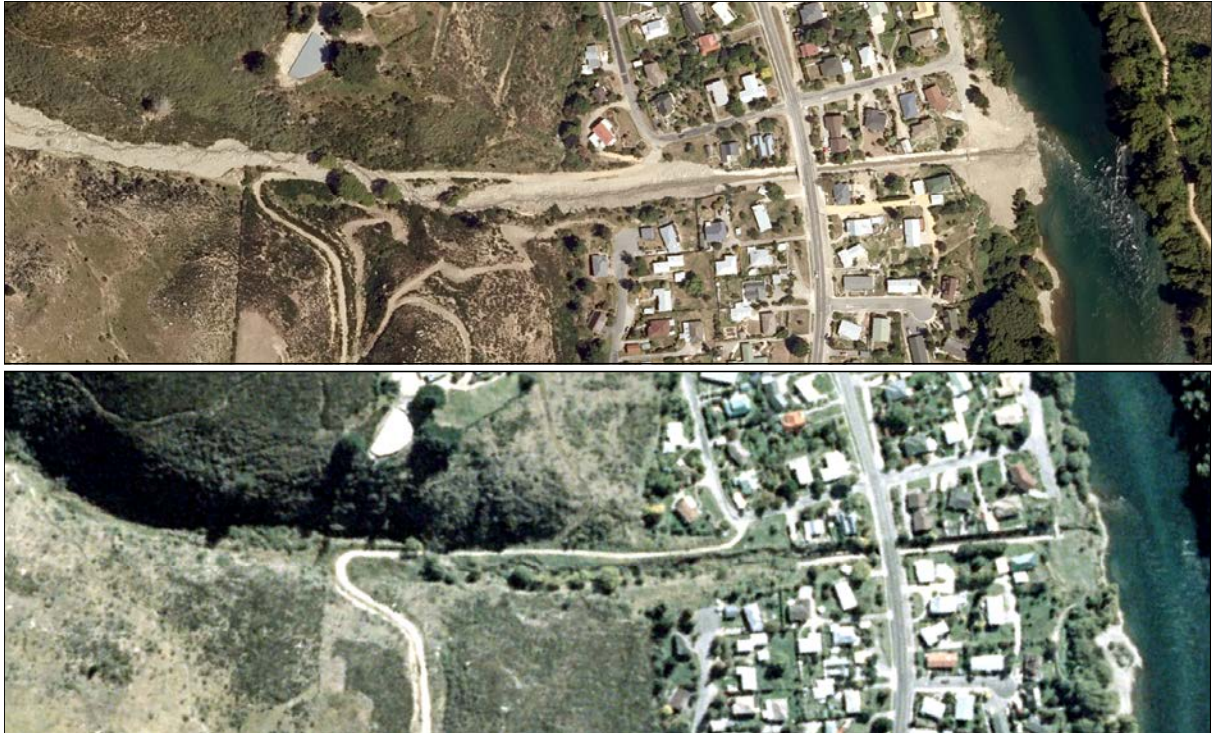
Aerial photography was flown on 28th December 2017 to help understand the nature of the event (Figure 3.12). In Reservoir Creek the loss of vegetation cover (when compared to a pre-event photograph) was limited to the stream channel for about two-thirds of its length. A number of landslides were observed strongly coupled to the stream channel because the lowest part of their source areas were in the channel indicating streambank erosion as the likely trigger for failure (rather than ground saturation). Landslide source areas distant from the stream channel were not present. This is thought to reflect the short-duration of the rainfall not allowing time for the soil structure to become saturated. Any rain that fell quickly flowed into the stream channel and the rapid accumulation of water in the channel led to scour of the stream bed, stripping the vegetation. This stripping of vegetation exposed sediment in the stream bed which then became entrained by the high-water flows as debris flows.

Figure 3.12 Before (bottom; 30th March 2006) and after (top; 28th December 2017) photos of the Reservoir Creek debris flows of 26th November 2017. The debris is largely confined to the stream channel which stands in contrast to the 2005 Matata debris flows shown in Figure 2.1.

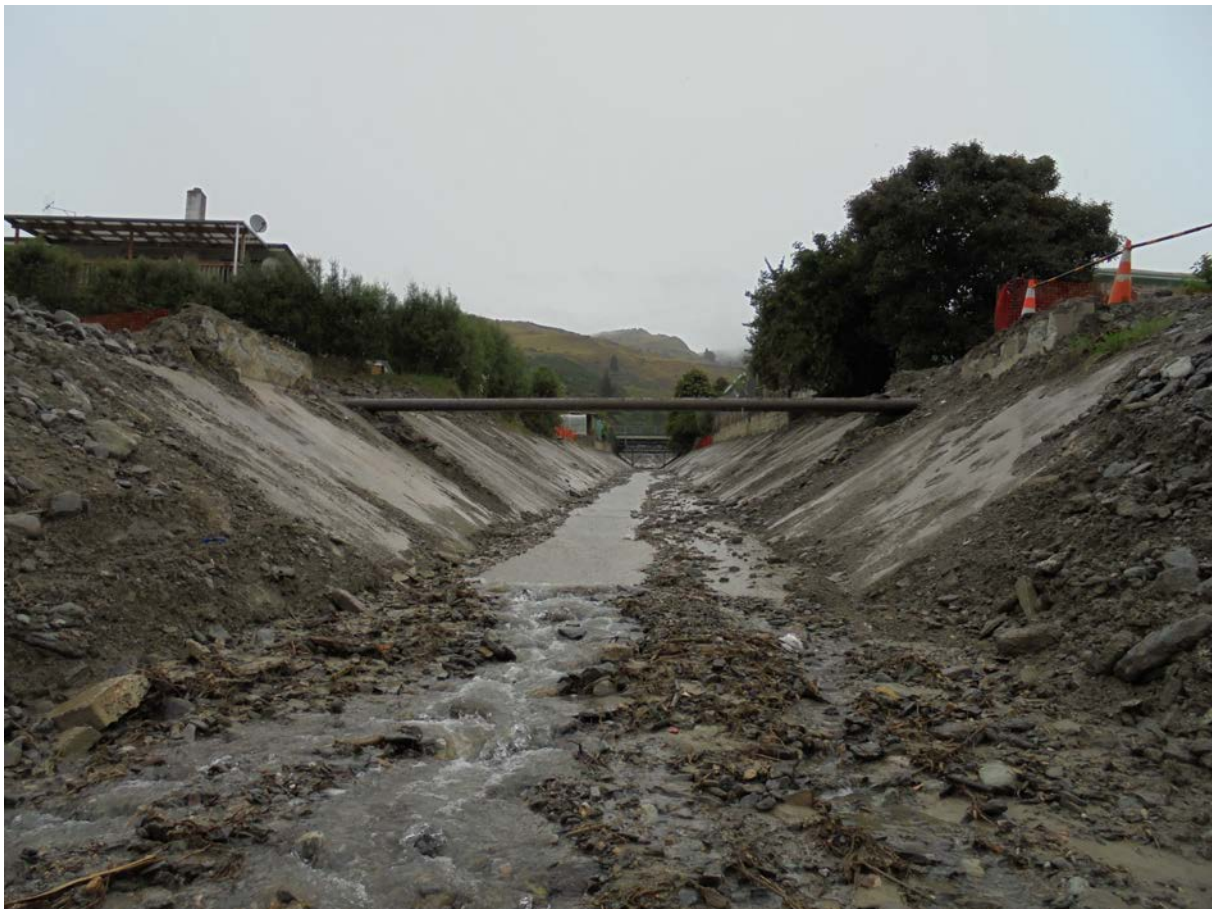
The concrete debris flow channel constructed after the 1978 debris flows performed well (Figure 3.13), but the debris flow events of 26th November 2017 may have been larger than the design event for the channel. However, the channel kept all the large debris (vegetation, boulders and gravel) within its course. This function of the debris flow channel probably reduced the clean-up costs and time by an order of magnitude based on anecdotal evidence from other events where a debris flow channel was not present (e.g. Matata, 2005; Port Ligar, 2011; Marehau-Motueka, 2018).

Figure 3.13 The cleared concrete debris flow channel two weeks after the debris flows of 26th November 2017 (Photo: S.Dellow 13/12/2017).

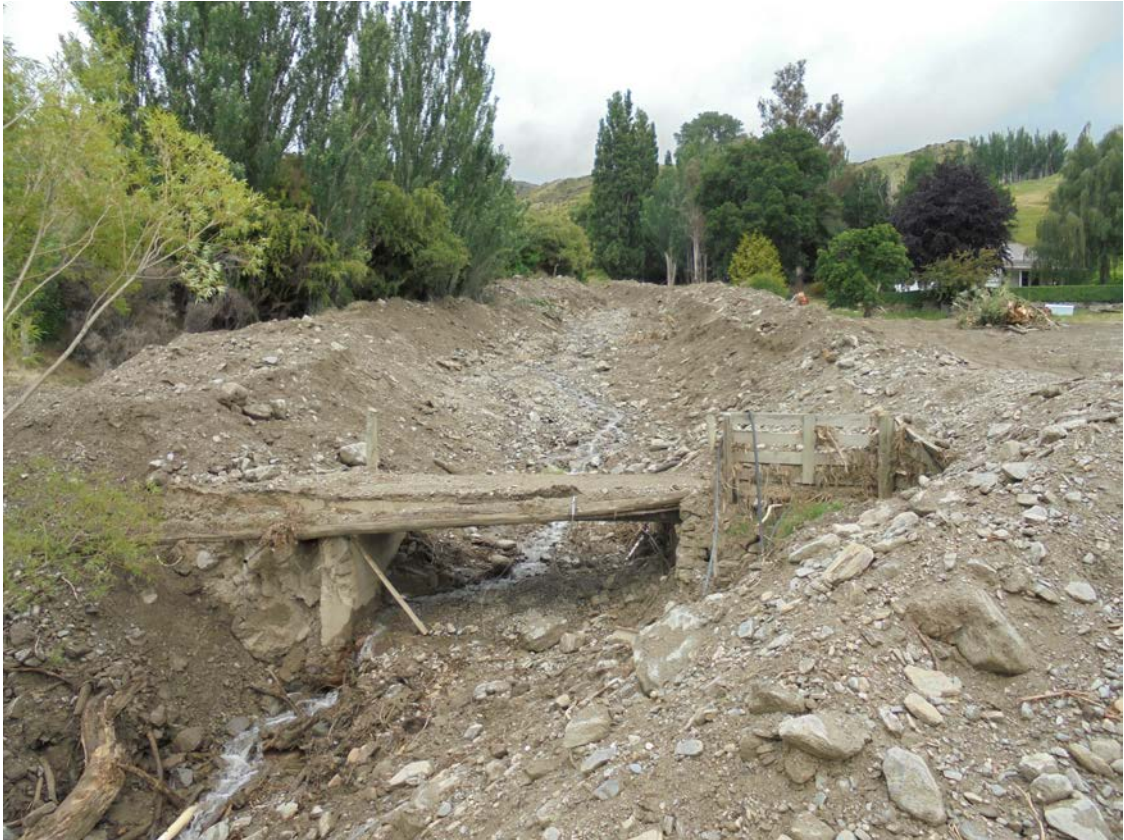
Figure 3.14 Pump Station Creek debris flow deposit at the farm bridge on the upper part of the debris flow fan (Photo: S.Dellow 13/12/2017).

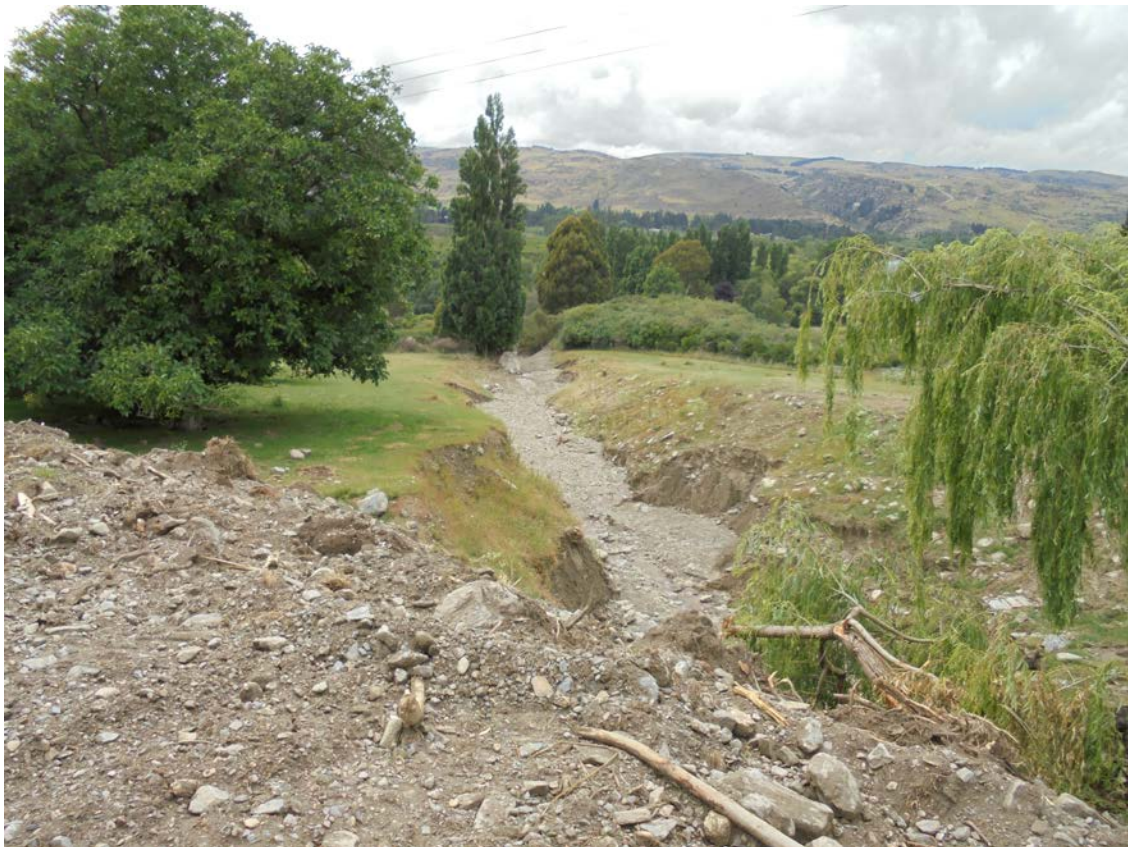
Figure 3.15 The upper site where stream avulsion occurred in Pump Station Creek. View downstream from near the farm implement shed in mid-upper part of Figure 3.16 (Photo: S.Dellow 13/12/2017).

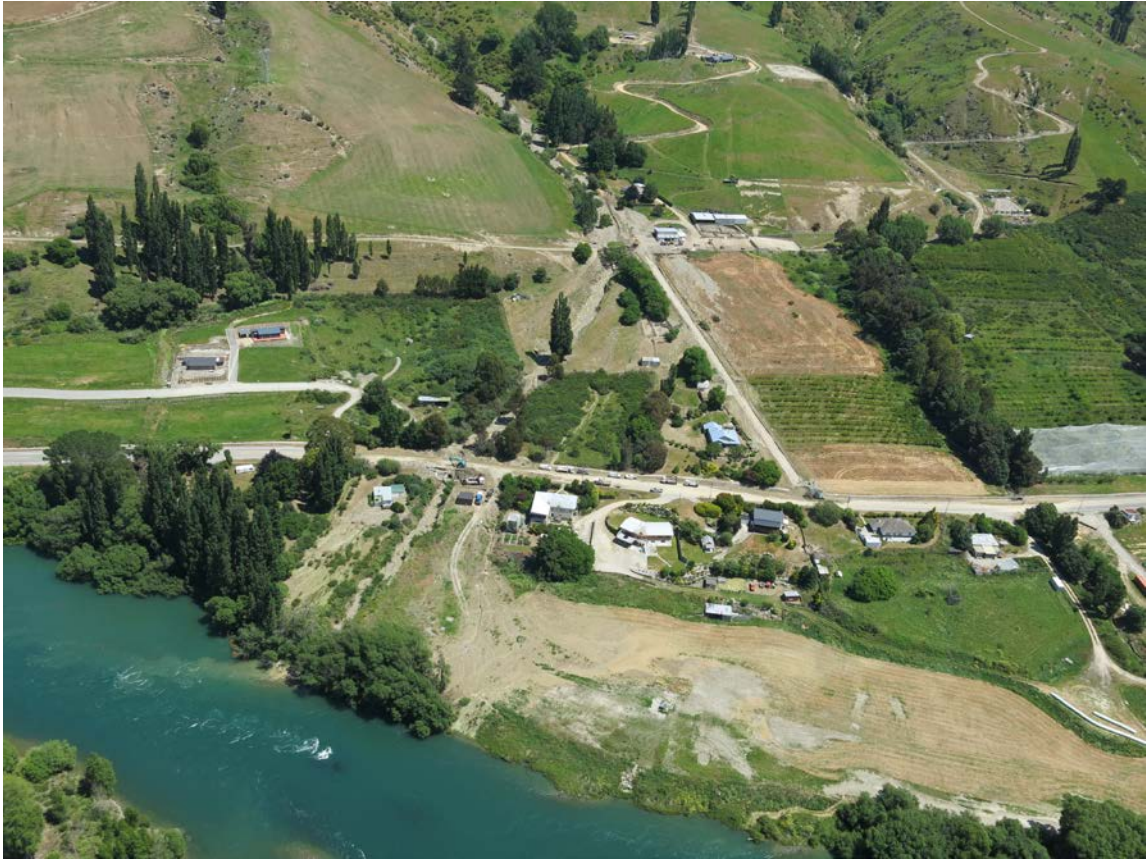
Figure 3.16 The Pump Station Creek debris flow fan showing the two avulsion sites, one near the fan-head and the other at SH8 (Photo: Ben Mackey, ORC; 27/11/2017).

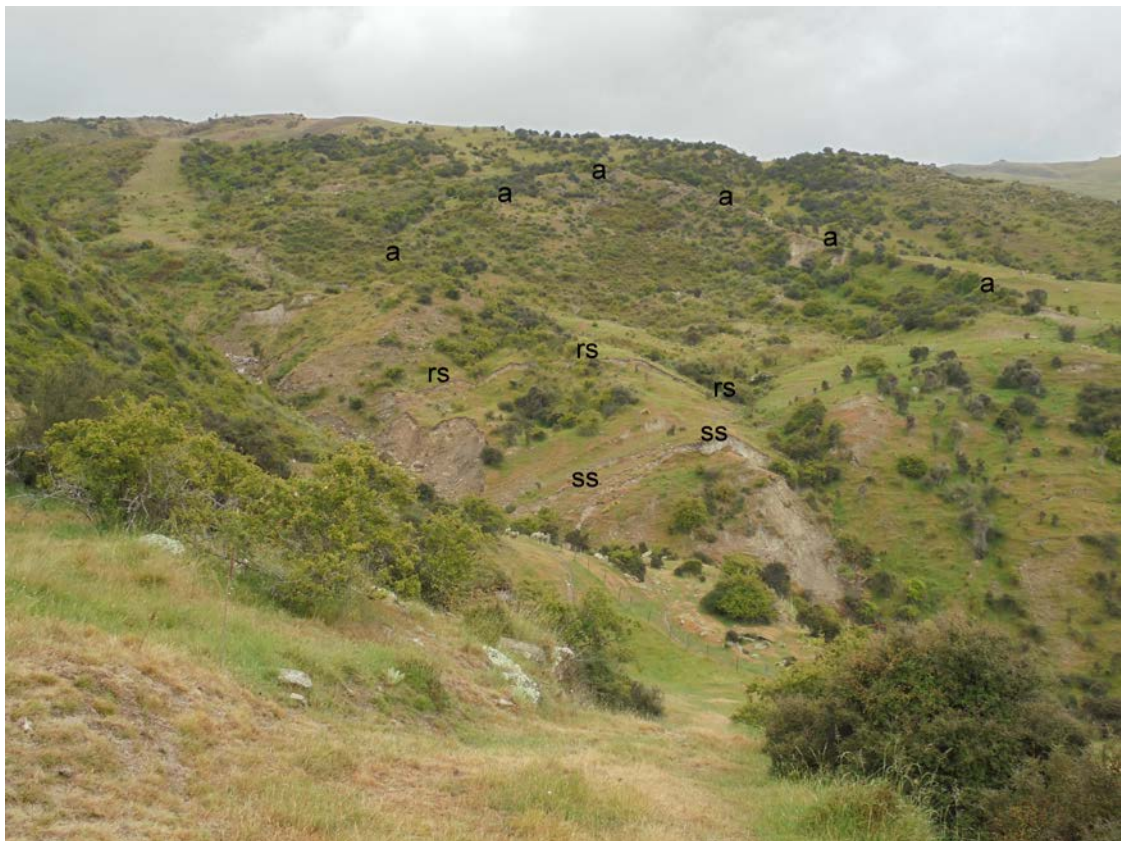
The other notable feature of the 26th November 2017 rainfall event in Pump Station Creek was the incipient movement of a large landslide a few hundred metres above the fan-head (Figure 3.17). The local land owner had noticed small scarps in the area prior to the 26th November but observed that they got larger after the rainfall of 26th November. This incipient landslide has the potential to block the stream channel and form a small landslide dam should it fail suddenly. It is recommended that it be observed and photographed at least once a month and more frequently if rainfall of more than 20 mm / 24 hours occurs.

Figure 3.17 An old landslide headscarp (aa) with recent incipient movement within the old landslide debris lobes in Pump Station Creek. A more recent headscarp (rs) has developed with recently active secondary scarps (ss) within the reactivated debris (Photo: S.Dellow 13/12/2017).

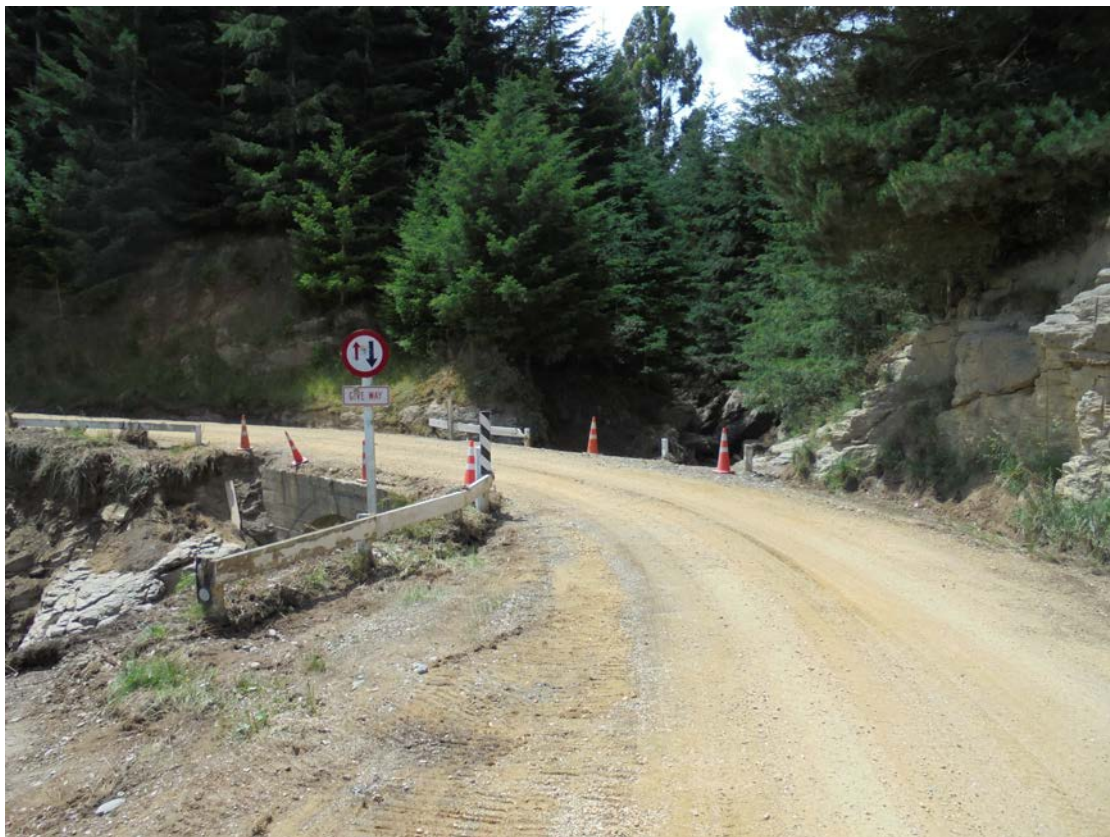
Figure 3.18 A small bridge across Tima Burn about halfway up the catchment. The stream bed is 2 to 3 m below the bridge deck. The damage to bridge railings provide evidence of flows down the creek large enough and fast enough to rip railings and posts off the top of the bridge structure (Photo: S.Dellow 13/12/2017).

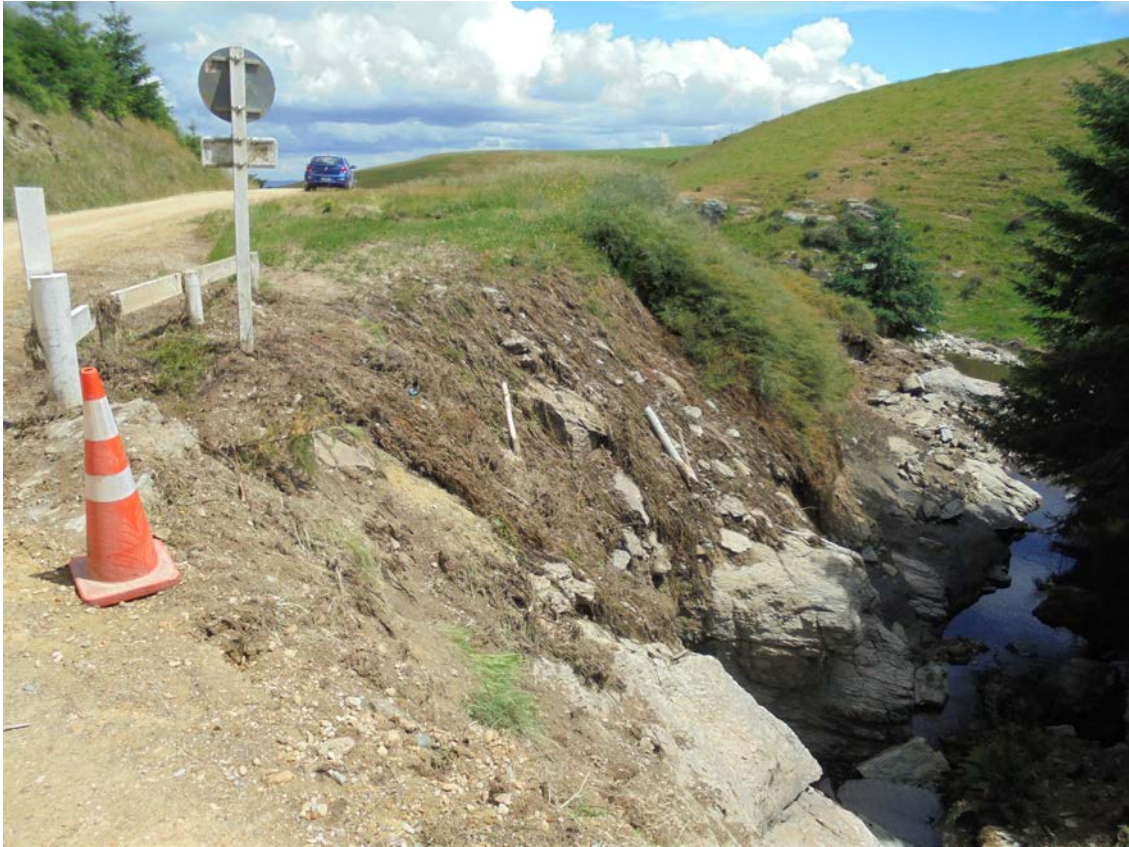
Figure 3.19 The small bridge over Tima Burn showing evidence for a large volume of water passing over the bridge, destroying posts and railings and stripping soil and pasture off the banks of the stream, exposing bare rock, rather than alluvium (Photo: S.Dellow 13/12/2017).

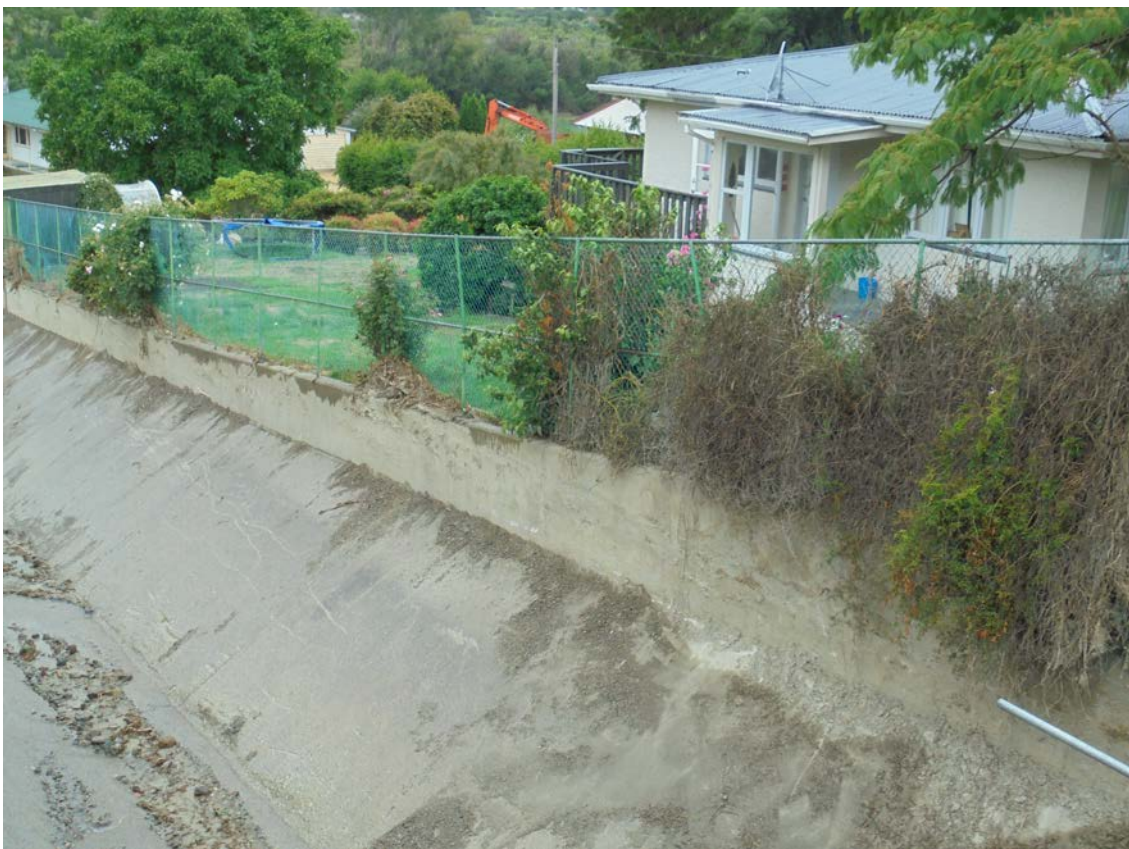
Figure 4.1 Undamaged fence on top of the concrete channel on the Reservoir Creek fan (Photo: S.Dellow 13/12/2017).

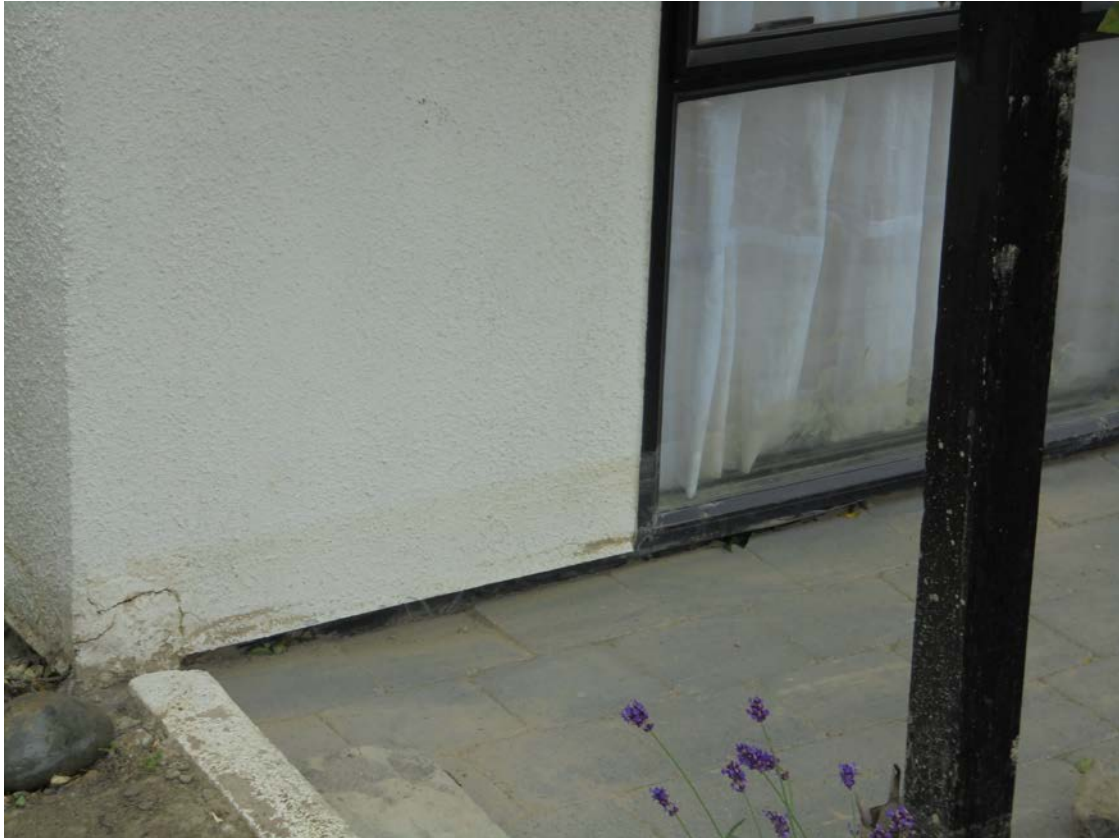
Figure 4.2 Evidence of silt and water damage on a building exterior. Depth of inundation appears to be about 100 mm (Photo: S.Dellow 13/12/2017).

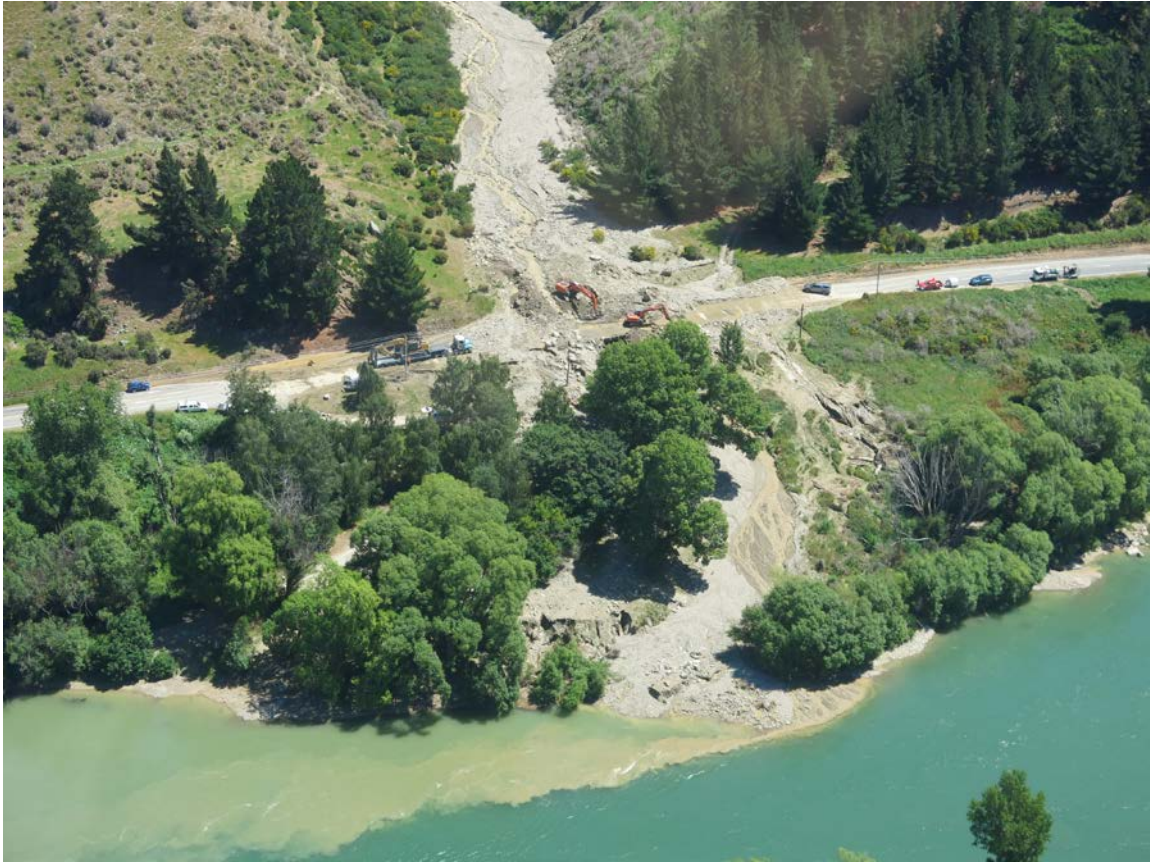
Figure 4.3 Debris blocking SH8 at Black Jacks Creek (Photo: Ben Mackey, ORC; 27/11/2017).
