**Hazard and risk assessment of the Roxburgh
debris flows of 26th November 2017**

**GNS Science Consultancy Report 2018/65
May 2018**

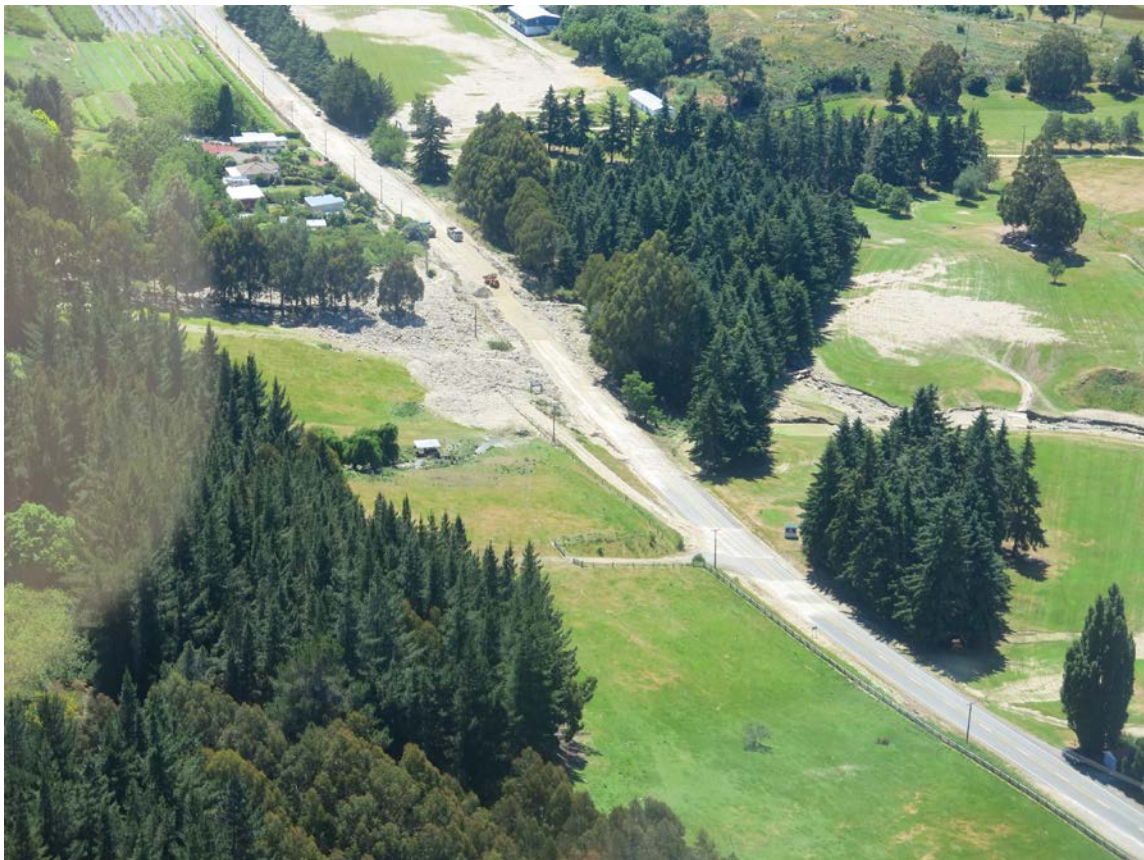
At Golf Course Creek and Pump Station Creek, the catchments were smaller, the debris flow volumes were smaller, the boulders were smaller (generally less than 0.3 m) and the thickness and width of the debris at the road consequently much smaller (0.5 m thick and 20-30 m wide) (Figure 4.4).

Figure 4.4 Debris blocking SH8 at Golf Course Creek has been cleared sufficiently to allow single lane traffic flow the day after the debris flows (Photo: Ben Mackey, ORC; 27/11/2017).
