Active landslides in the Dunedin area

October 2015

Report writer: Ben Mackey, Hazards Analyst (Geologic)
Reviewed by: Michael Goldsmith, Manager Natural Hazards

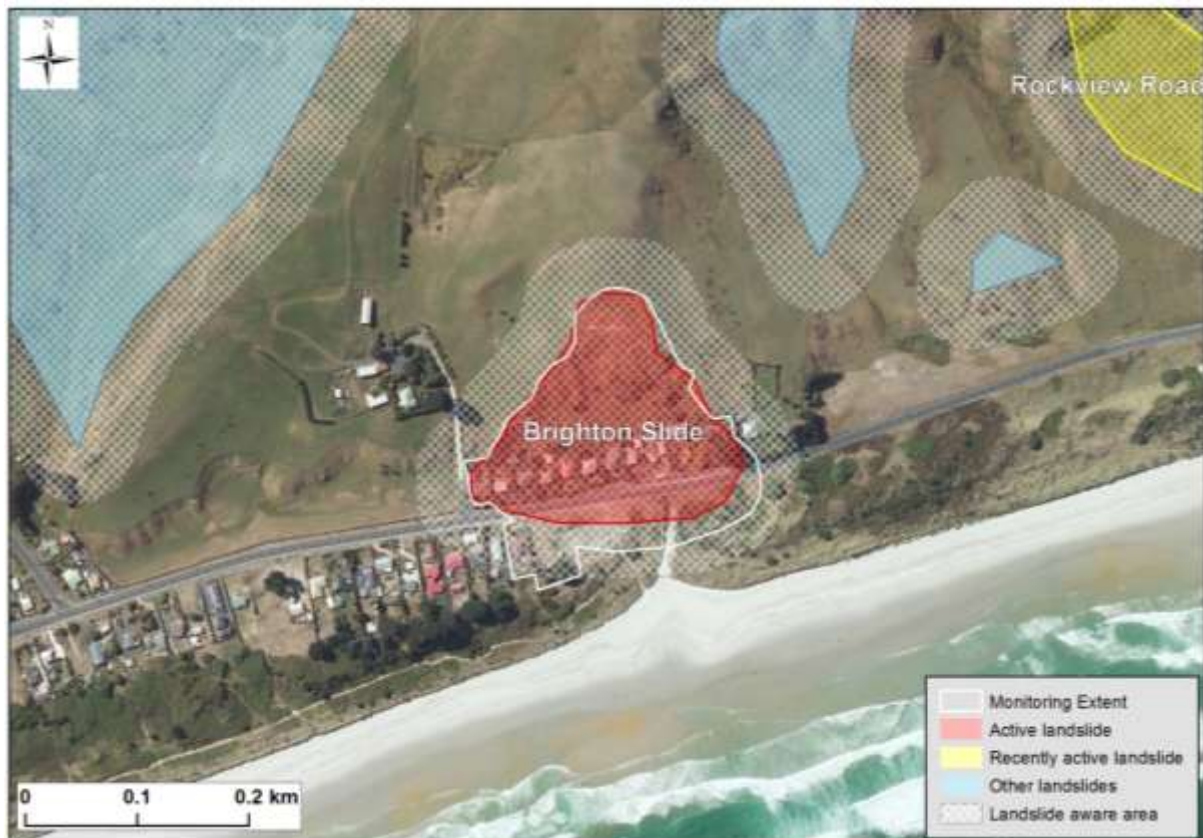
MWH monitors the site for the DCC (1998–present). The eastern flank of the landslide has experienced the greatest movement, with 1250 mm of cumulative movement over that period. During the most recent survey period (2013–2015), up to 116 mm of horizontal movement was recorded, again with the greatest movement on the eastern edge of the landslide. Only the northern or upslope part of the mapped landslide feature indicated in Figure 5 has been shown to be active.

Figure 4 Brighton Slide. Brighton Road runs across the map parallel to the beach.

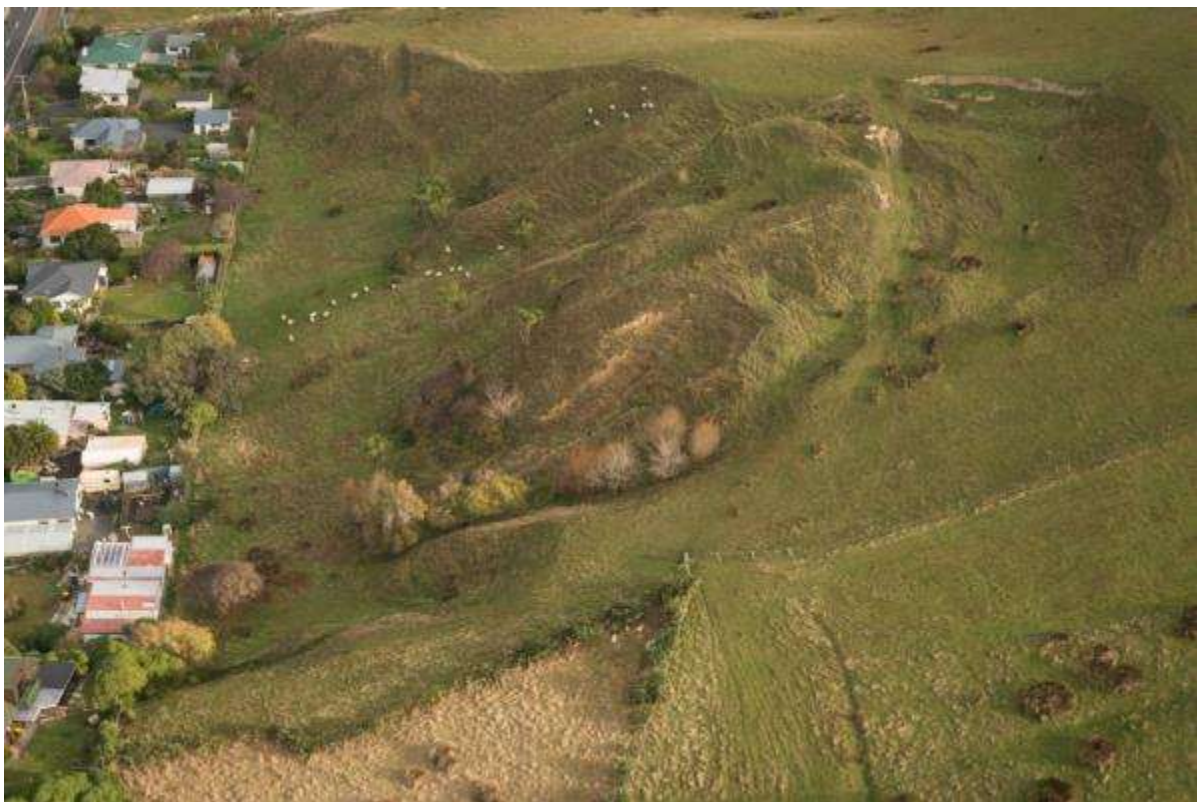
Figure 5 Brighton Slide from the air, looking towards the west, 16 June 2015. The landslide mass in the center of the image is the active part of the slide.

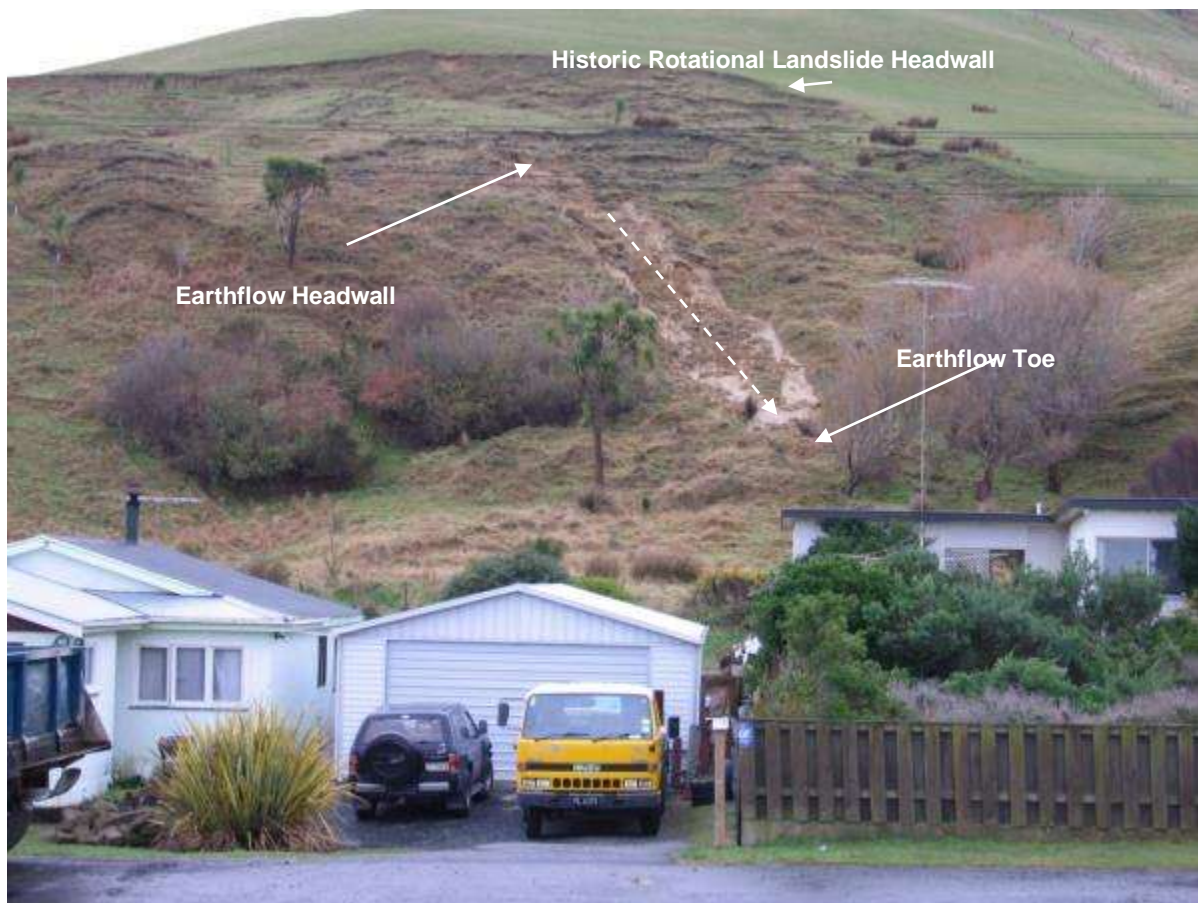
It is possible for smaller slips or mobile earthflows to slough off the face of the main landslide face, as occurred after heavy rains in 2008 (Figure 6) (Woods, 2008). Ongoing surveys indicate the landslide mass is still moving, and it has therefore been reclassified as ‘active’ in the database.

Figure 6 Evidence of recent movement on the Brighton Slide, 13 August 2008

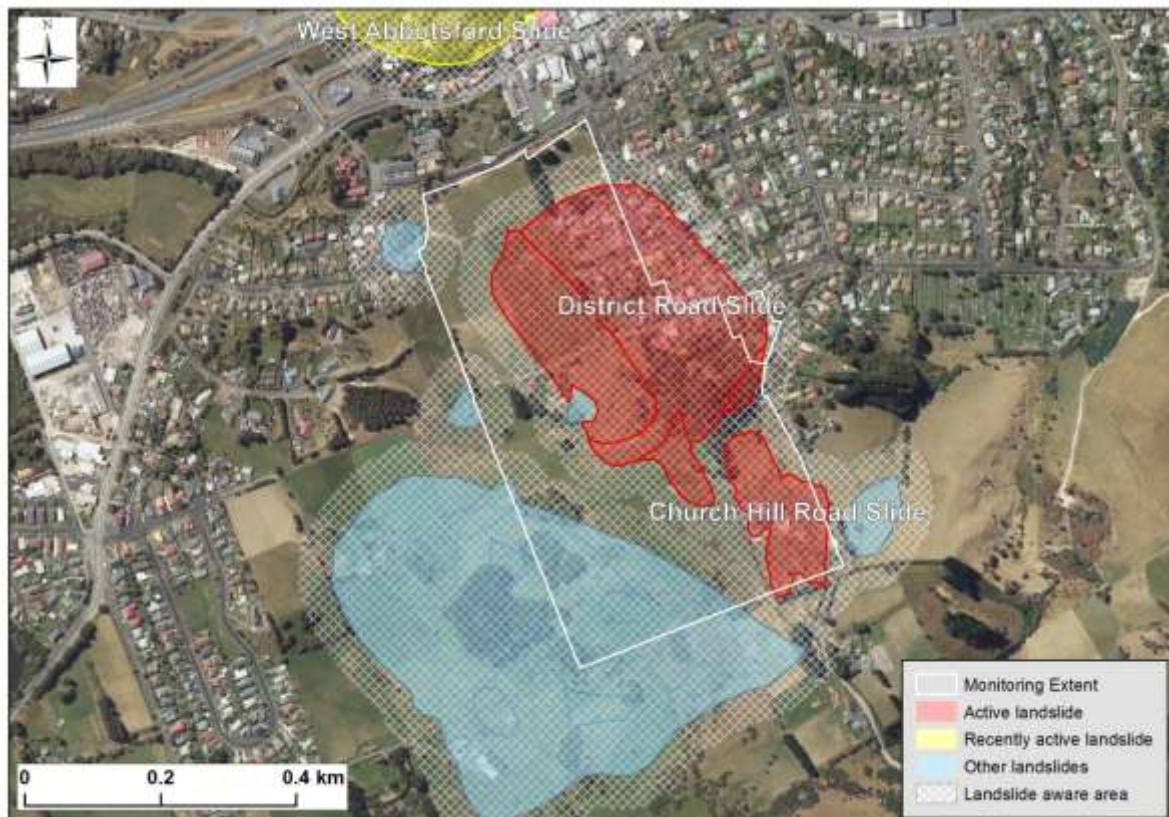
Several other landslides have been mapped in the vicinity of the Church Hill Road and District Road Slides (Figure 7). Although these landslides are not thought to be currently active, they show that hillslopes in this area are prone to instability.

Figure 7 The District Road Slide and Church Hill Road Slide, and other nearby landslides

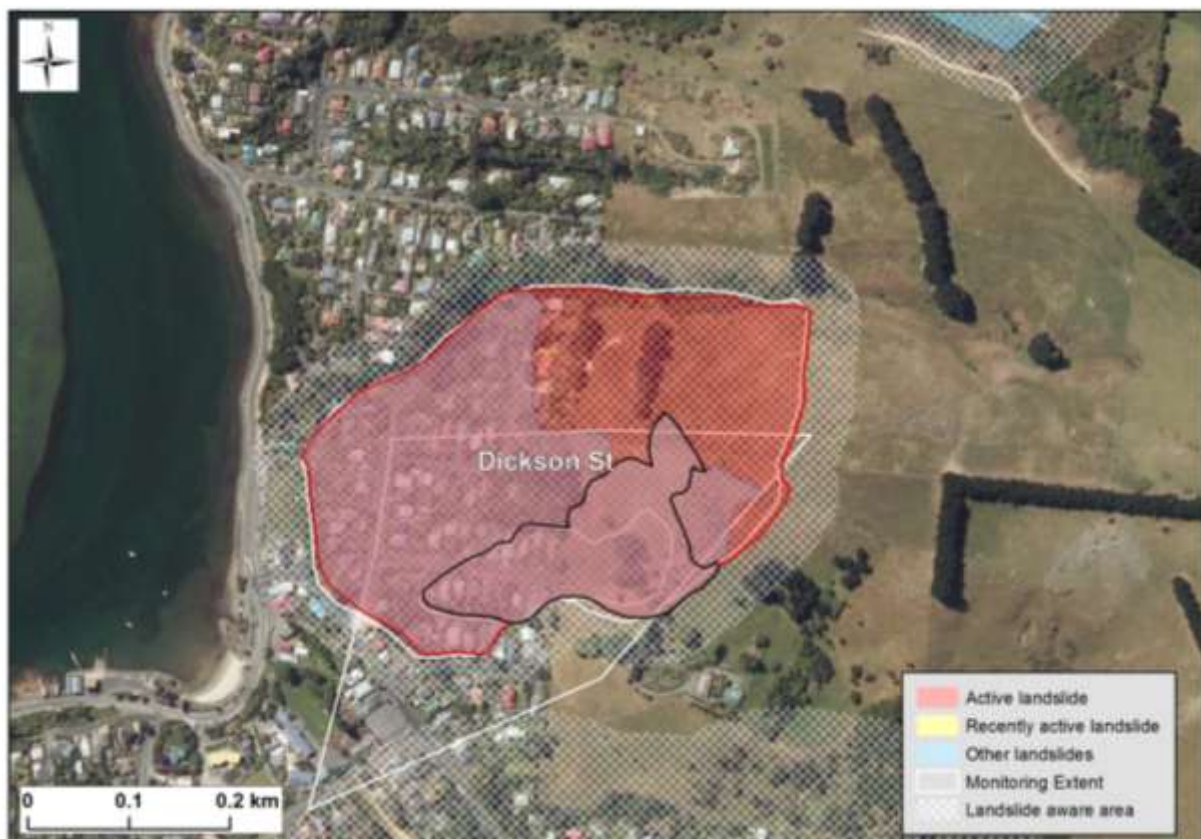
MWH has monitored the slope for the DCC since 1997. Maximum vertical and horizontal displacements over that period are 90 mm and 100 mm, respectively. Horizontal and vertical movement have increased beyond low background levels since about 2010, currently averaging 30–40 mm/yr. Some of the survey markers that have been displaced are outside the mapped landslide area, indicating that the area of movement is more extensive than that currently mapped.

Figure 9 The Dickson Street Slide. The internal area of the slide (black outline) was assessed by Barrell et al., 1994. The larger red outline is from Johnson, 1987.

Surveying indicates that the slide is currently active, and it has therefore been reclassified as active within the landslide database. The survey network could be expanded and densified to identify the extent of movement across the slope.

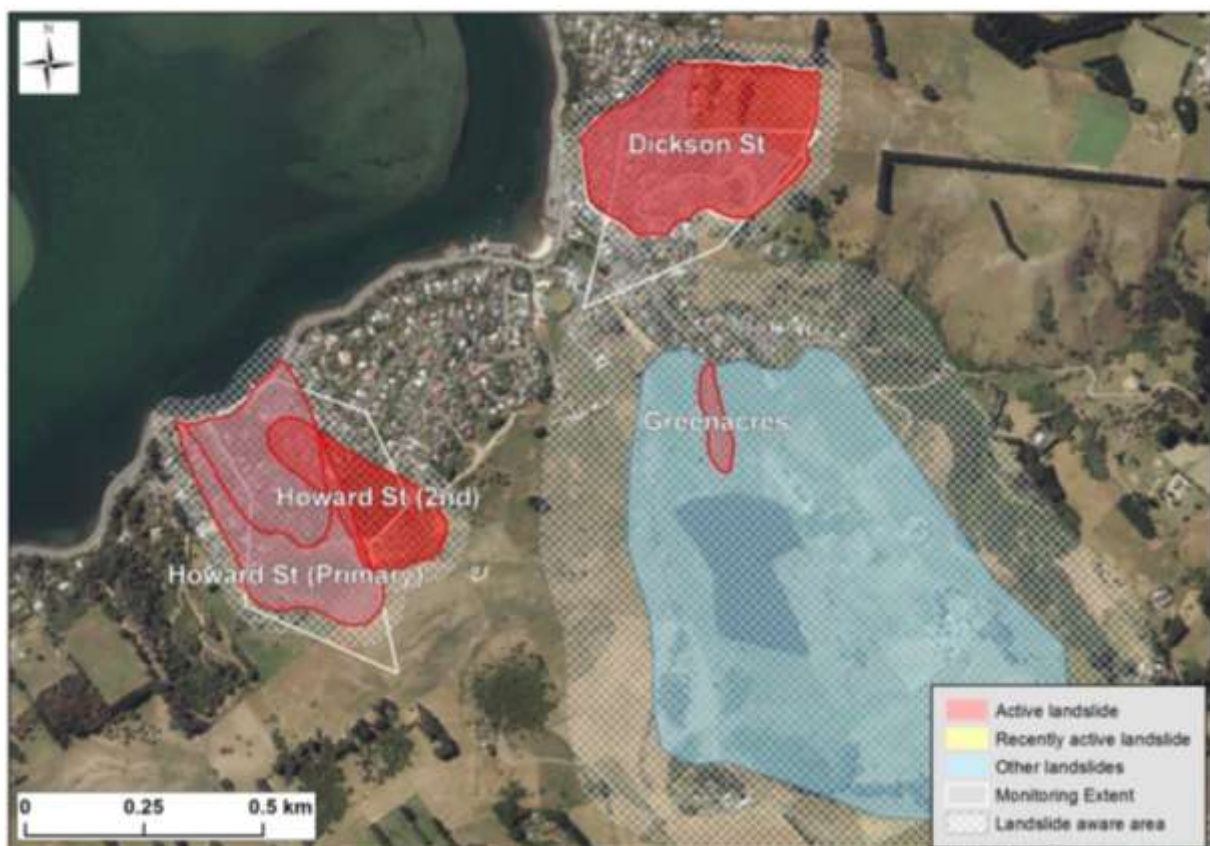
The slide overlies Dunedin Volcanic Group strata, although the active portion of the slide appears to comprise earthflow-style movement in a northerly direction, possibly to a depth of several metres. The reactivated earthflow may be overriding a section of the larger inactive landslide.

Figure 10 An active earthflow within the larger Greenacres Mass Movement Area (shaded blue). Signs of activity on the earthflow were observed in June 2015.

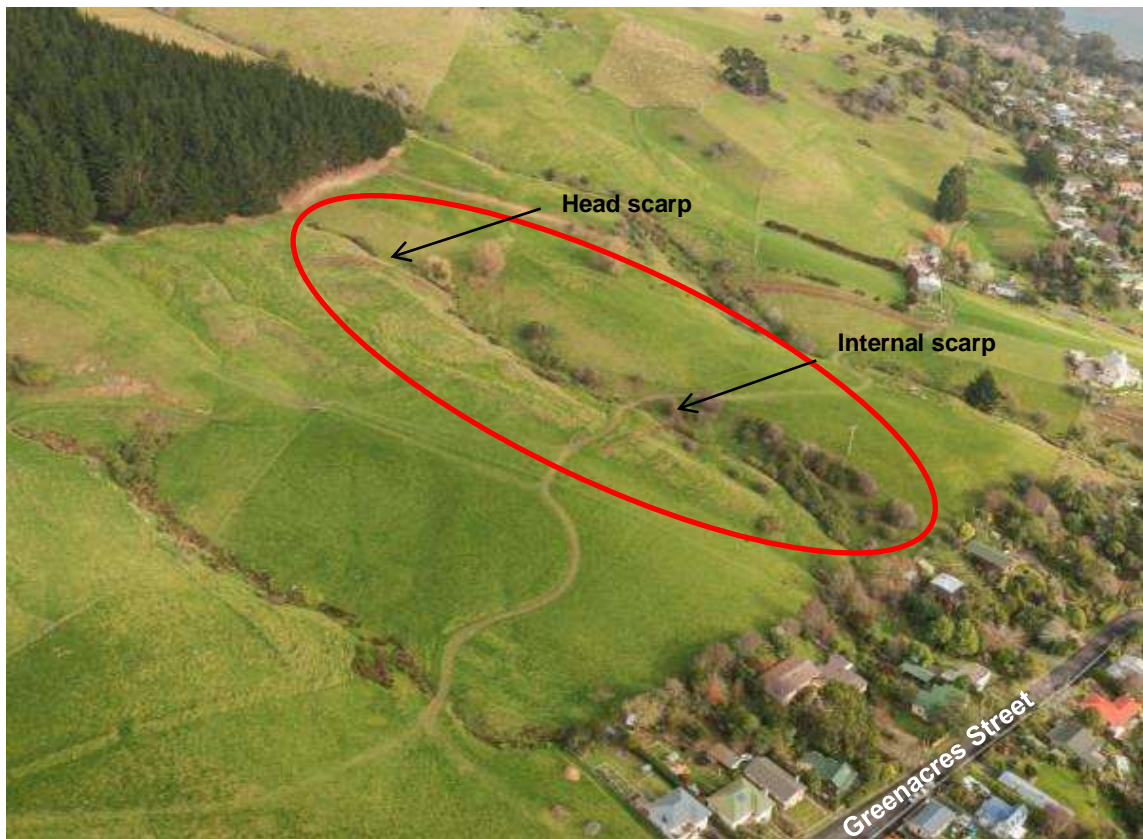
Figure 11 Aerial view of the slope above Greenacres St on 16 June 2015. The approximate extent of the most recent movement is circled in red. The view is to the southwest.

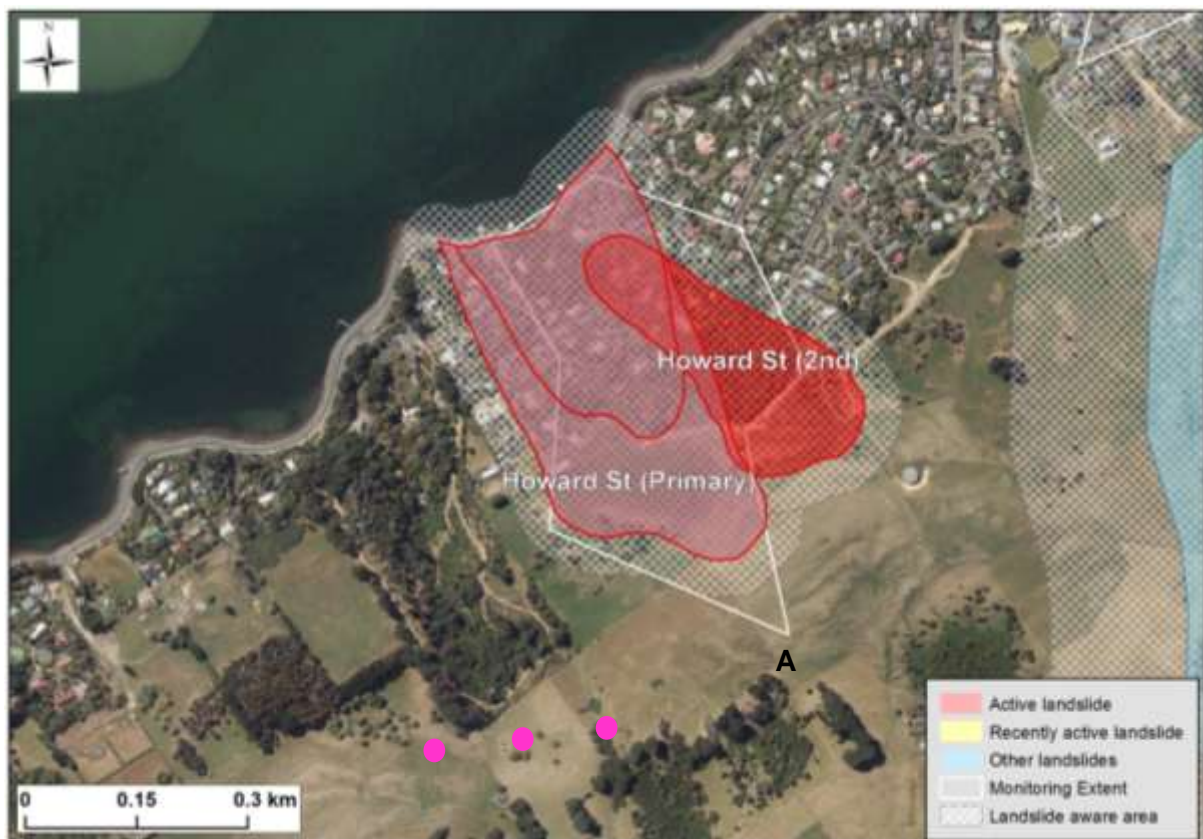
The DCC has monitored the Howard Street area almost annually since 1998. The monitoring extent is shown in Figure 12. Maximum cumulative horizontal displacement over that period is 180 mm (most of which occurred during 2013). The upper portion of the slide above Howard Street is the most active area of the slide based on the survey data. Following the period of increased activity in 2013, monitoring up until February 2015 indicated that movement across both the primary and secondary areas of the landslide has decreased to background levels of < 30 mm/yr.

Figure 12 Howard Street landslides. The approximate location of surficial landslides observed in June 2015 are shown (pink circles), and the uppermost survey point is labelled 'A'.

The uppermost survey point (marked as 'A' on Figure 12) has experienced the most vertical deformation of 130 mm between 1998 and 2015. The main body of the primary Howard St Slide was not designated as either active or recently active in the landslide database. However, surveying indicates that parts of the primary slide area are still active, and it has therefore been reclassified as such within the database.

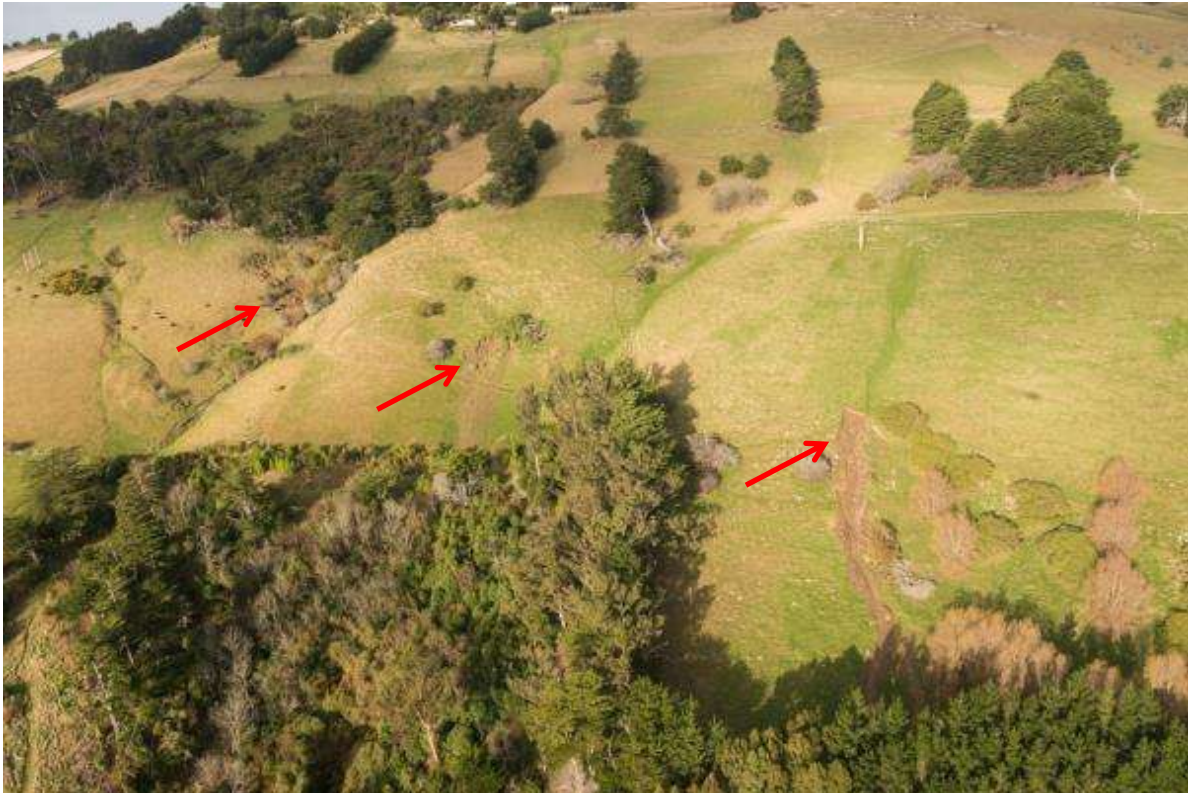
The aerial inspection did reveal a number of surficial landslides on the slopes above and adjacent to the Howard Street slides, and these are shown in Figure 12 and Figure 13.

Figure 13 Aerial view of the slopes above the Howard Street slides on 16 June 2015. The approximate locations of the surficial slides shown in this photograph (red arrows) are shown in Figure 12.

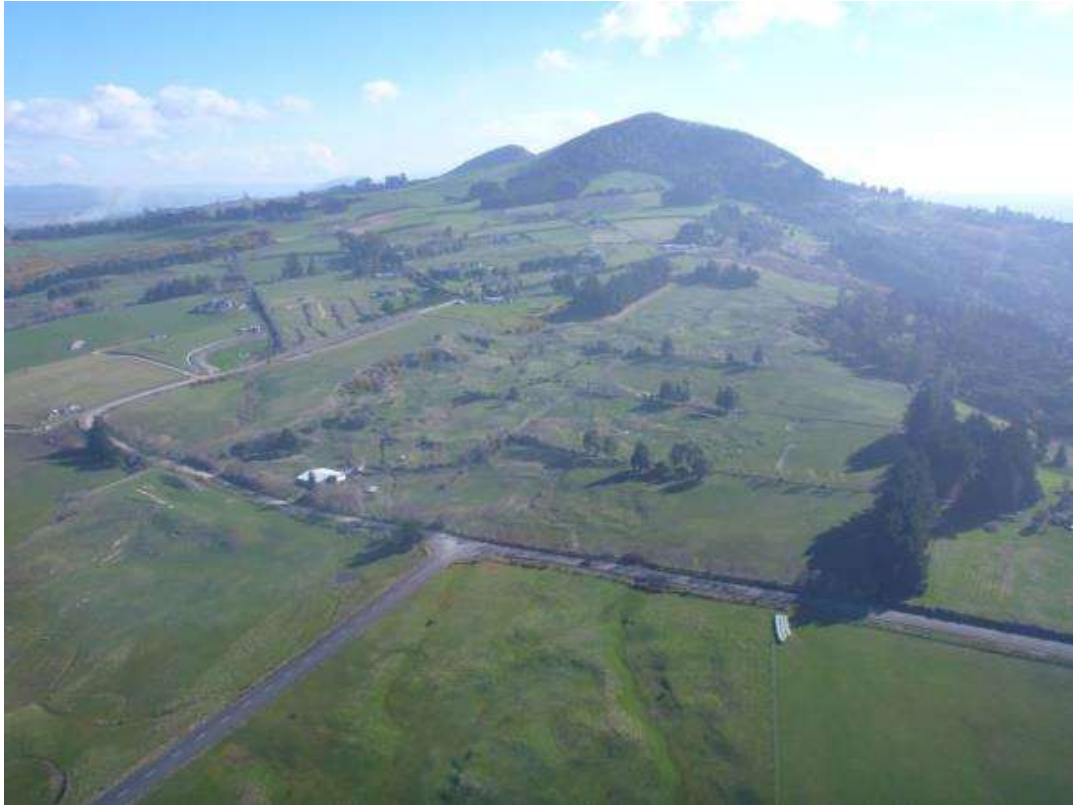
Figure 15 Aerial view of the upper part of the Jeffcoates Road earthflow, August 2014. Saddle Hill is the prominent peak on the skyline. Jeffcoates Road is on the lower left of the image.

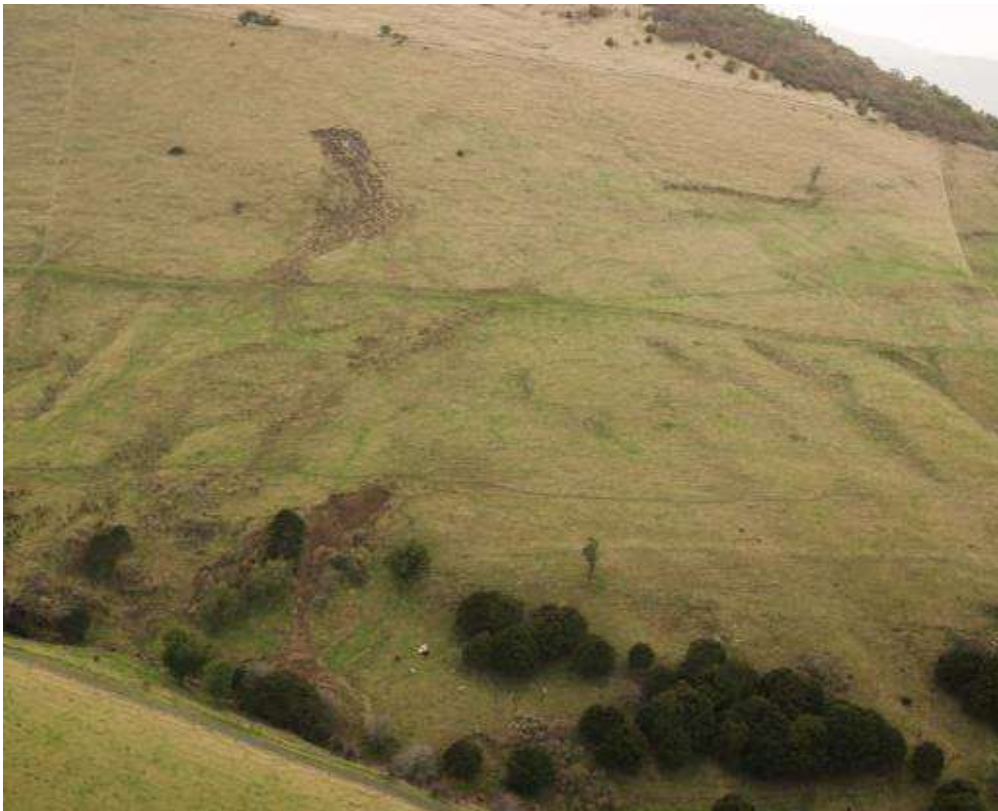
No evidence of large-scale surficial movement of these two landslides was observed during an aerial inspection in June 2015. However, some new surficial landslides were observed further upslope, as shown in Figure 16.

Figure 16 Surficial landslides on the southern flank of Saddle Hill, 16 June 2015

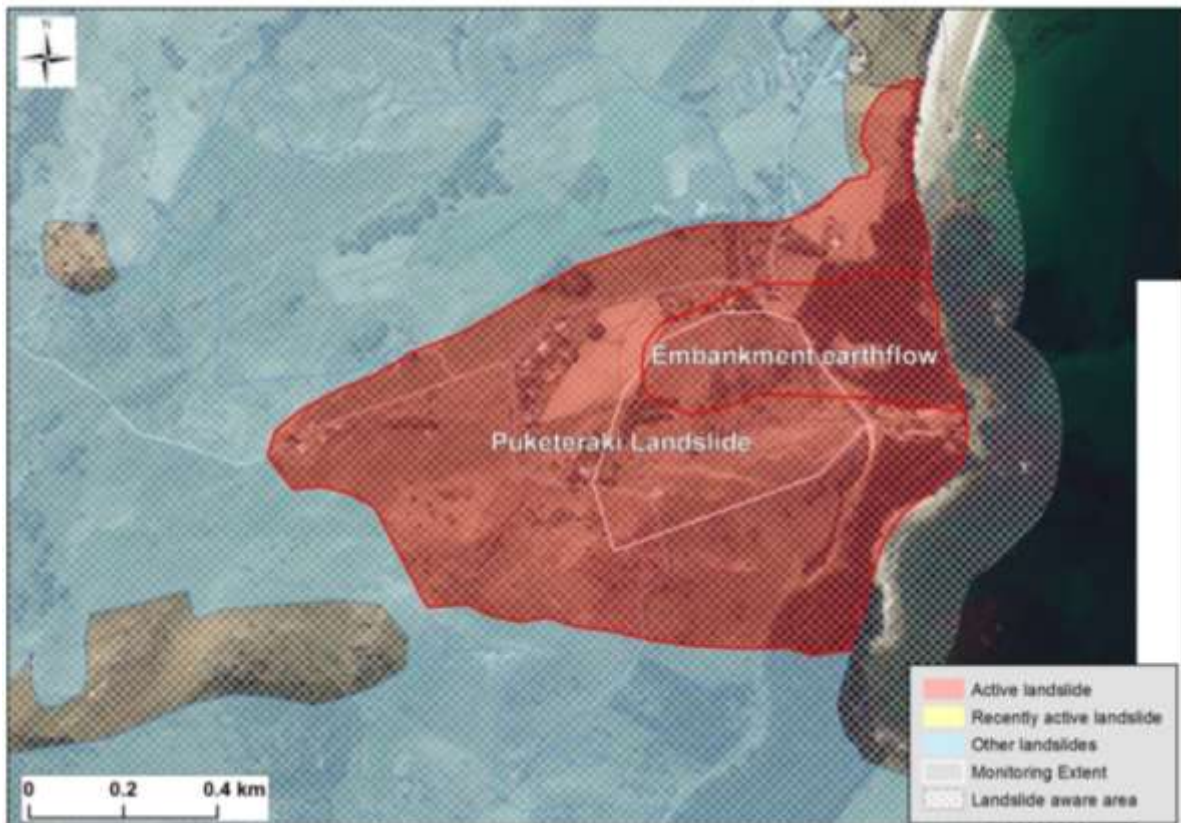
The DCC has surveyed the slide since 1992. Horizontal movement has recently averaged 230 mm/yr, with maximum horizontal displacement of 2,800 mm over the total survey period.

Figure 18 The Puketeraki landslide and Embankment earthflow. These active landslides are surrounded by landslides currently assessed as inactive.

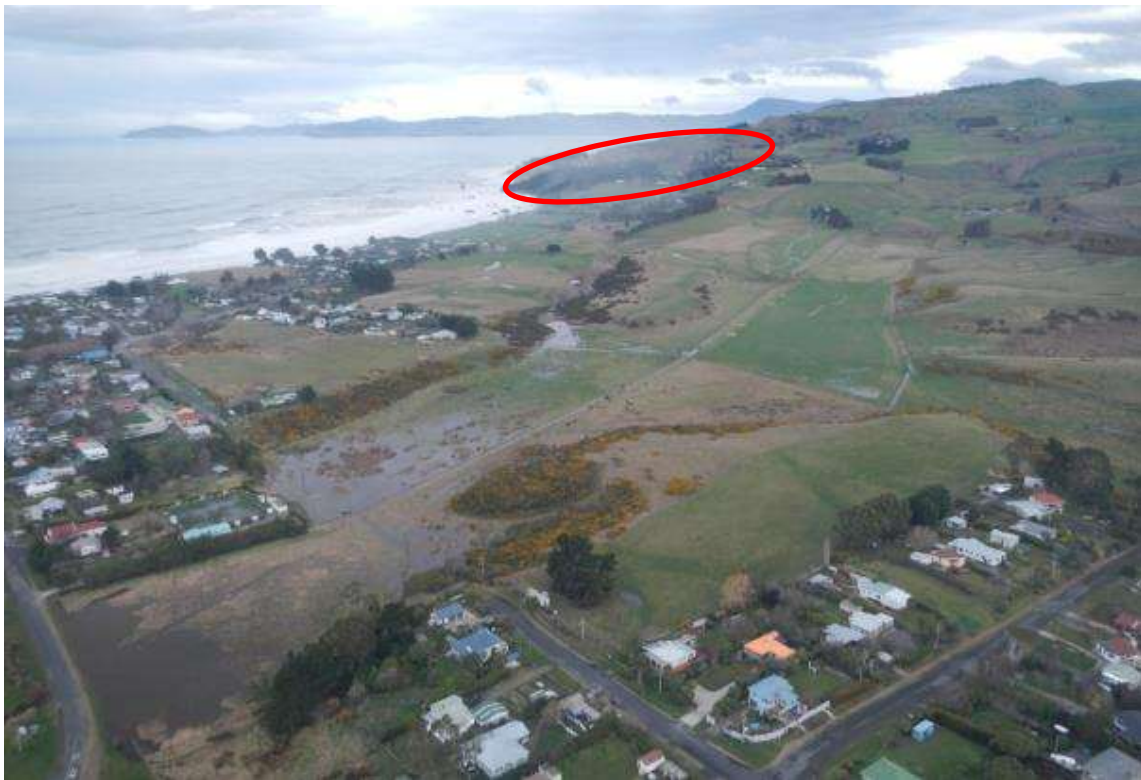
Figure 19 Aerial view towards the Puketeraki landslide from Karitane, following a period of heavy rainfall in August 2012. The red oval indicates the approximate location of the slide.

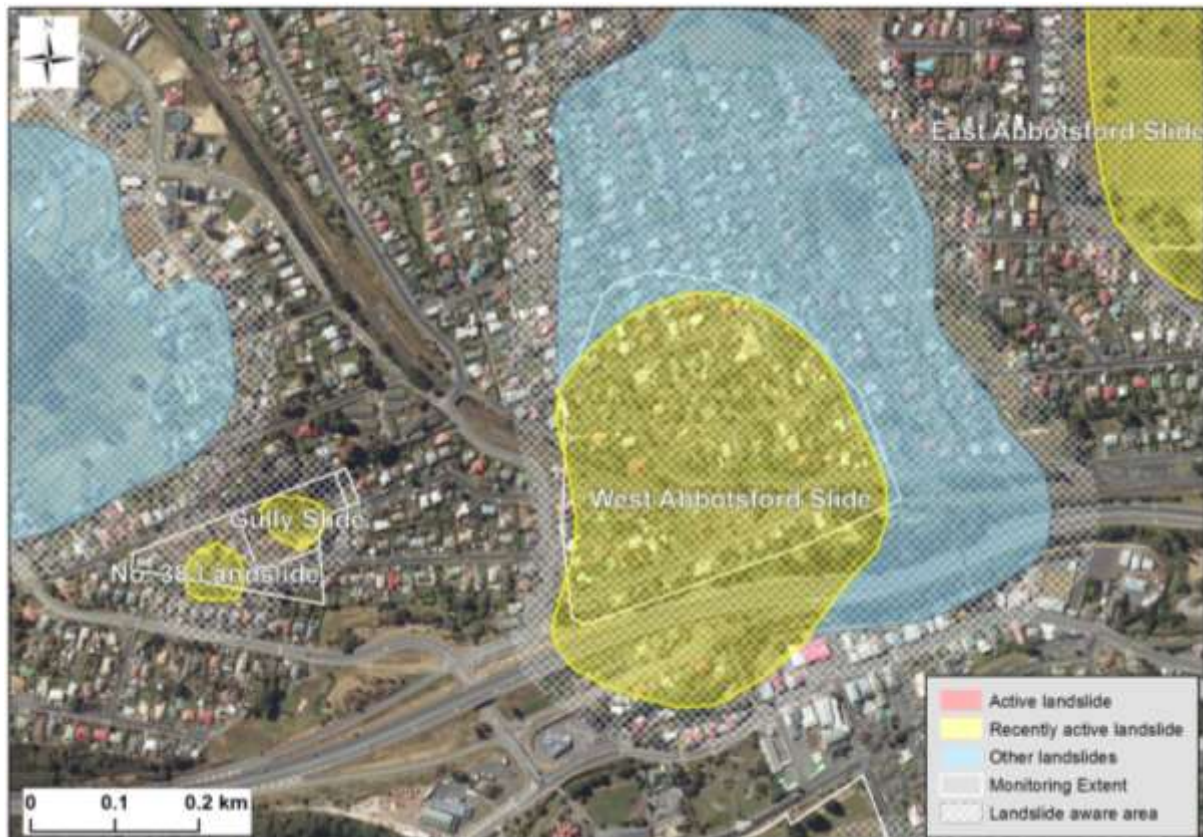
The West Abbotsford Slide is a large deep-seated failure that extends across a large area of residential Abbotsford (Barrell, 1999). The outline of the landslide is clearly visible in LiDAR-derived digital topography (Figure 24). The southwest lower toe area of the larger slide complex (sometimes referred to as the 'motorway slide') is identified as recently active, and is traversed by the main South Island main trunk line and the Southern Motorway.

Figure 23 The West Abbotsford Slide

This slide is reported to have been reactivated during removal of toe support during construction of the motorway, and the last documented movement was in 1968. Sand was placed to re-buttress the toe during road construction, which inadvertently partly contributed to the failure of the East Abbotsford Slide in 1979, as the sand was sourced from the base of the East Abbotsford Slide hillslope (Hancox, 2008).

MWH monitor the slide for the DCC, with most recent monitoring in January 2014, by way of a visual inspection of features (cracks, fissures). Field observations were compared with previous surveys. No new evidence of movement was documented during this 2014 inspection.

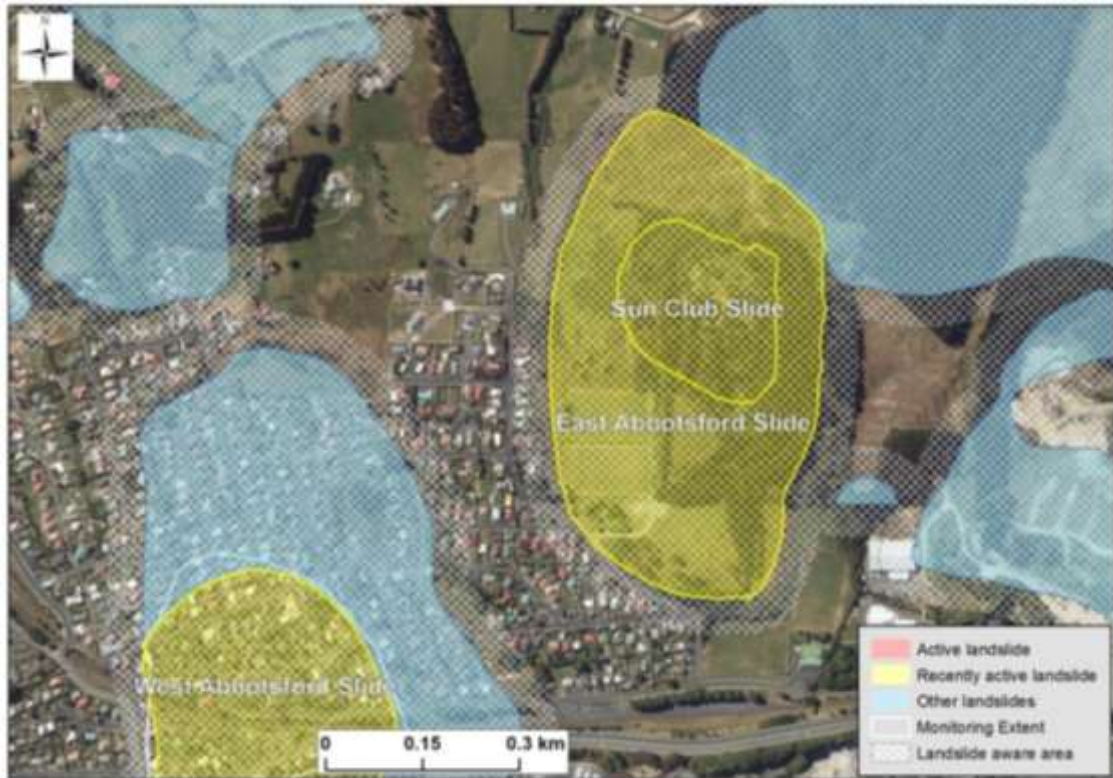
The East Abbotsford Slide failed catastrophically in 1979 (e.g. Hancox, 2008), and remains the most damaging landslide in an urban New Zealand area. The East Abbotsford Slide incorporated the pre-existing smaller Sun Club Slide, which was rafted down the slope within the East Abbotsford Slide block.

Figure 25 The East Abbotsford Slide and Sun Club Slide

It is unknown whether this site may be deemed suitable for development in the future. Once landslides have failed catastrophically, as at East Abbotsford, they can attain a stable geometry, with minimal risk of further movement. Future development of the site should be approached very cautiously, however, if at all. Full geotechnical consideration would need to

be given to the risks of ongoing movement, land settlement, drainage and whether development of the site could increase the risk of future instability.

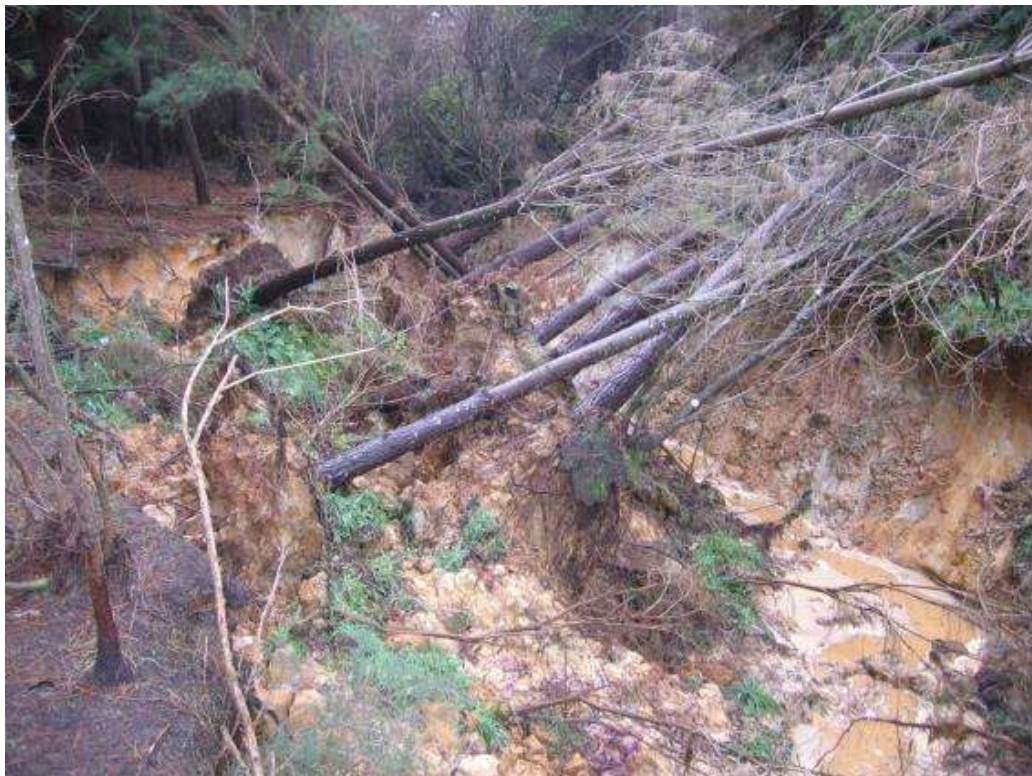
ORC investigated the creek next to the upper part of the landslide in June 2008 when a culvert intended to drain outflow from a pond on the upper part of the landslide became blocked, and piping occurred through the soil above the culvert. As Figure 26 shows, this resulted in a significant increase in pond level, damage to vegetation downstream and sedimentation of the channel (Woods, 2008b).

Figure 26 A view looking upstream showing the downstream limit of channel erosion in June 2008, caused in part by overflow of the pond. The pond is about 100 metres upstream from where this photograph was taken.

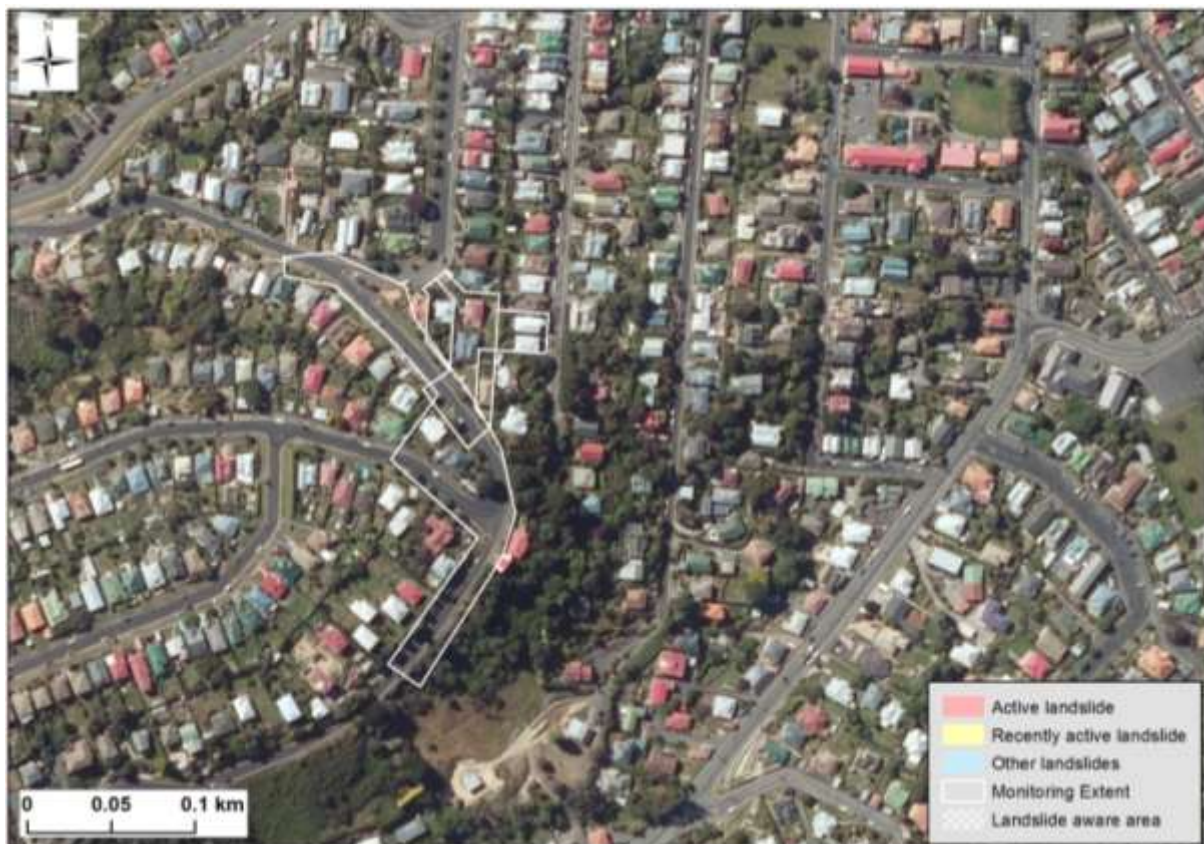
A mapped landslide extent for this movement area has not been determined, and the feature was not included in the landslide database. Movement of up to 1 metre or so occurred in 1997. At its head, it displaced part of the Sidey Street carriageway and affected as many as three properties downslope. A deep-piled retaining structure was constructed across the slide at the NE margin of the Sidey Street roadway, and the road was repaired. Little, if any, movement has been noticed subsequently (D. Barrell, pers. comm., July 2015).

MWH has monitored the area since 1997, and a new survey network was installed in 2010. The monitoring extent is shown in Figure 27. The most recent survey (April 2014) indicates there has been no detectable vertical movement at the site since the survey network was reinstated in 2010.

Figure 27 Sidey Street Slide area, showing the extent of the monitoring conducted by the DCC

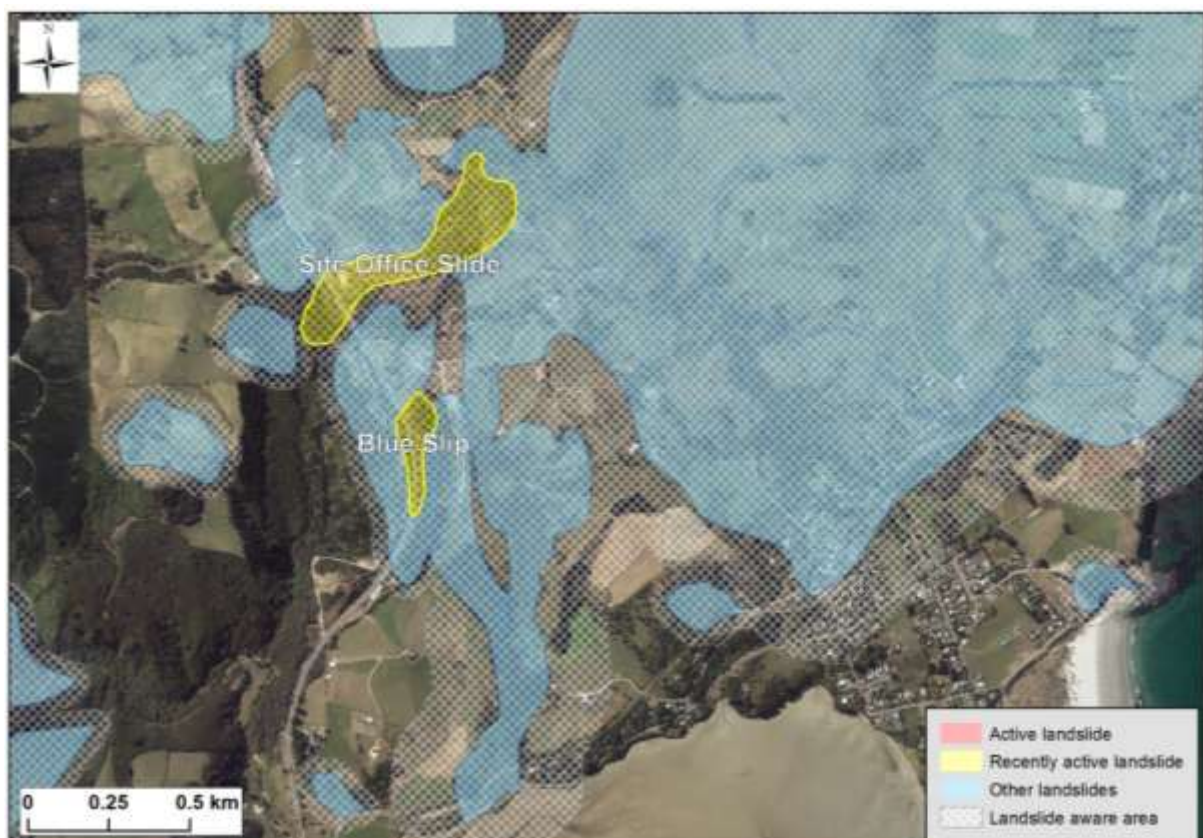
The Blue Slip cuts across State Highway (SH) 1 as it climbs north of Blueskin Bay (Figure 28). The underlying geology is the Onekakara Group strata (Abbotsford Formation). For many years, ongoing movement required frequent repairs to the road. Detailed investigations have been undertaken since the 1980s (e.g. McMillan and Reay, 1983) before extensive remedial work was done in the 1990s, which appears to have largely stemmed the movement (D. Barrell, pers. comm, July 2015).

Figure 28 Blue Slip and Site Office Slide. SH1 can be seen traversing both landslides.

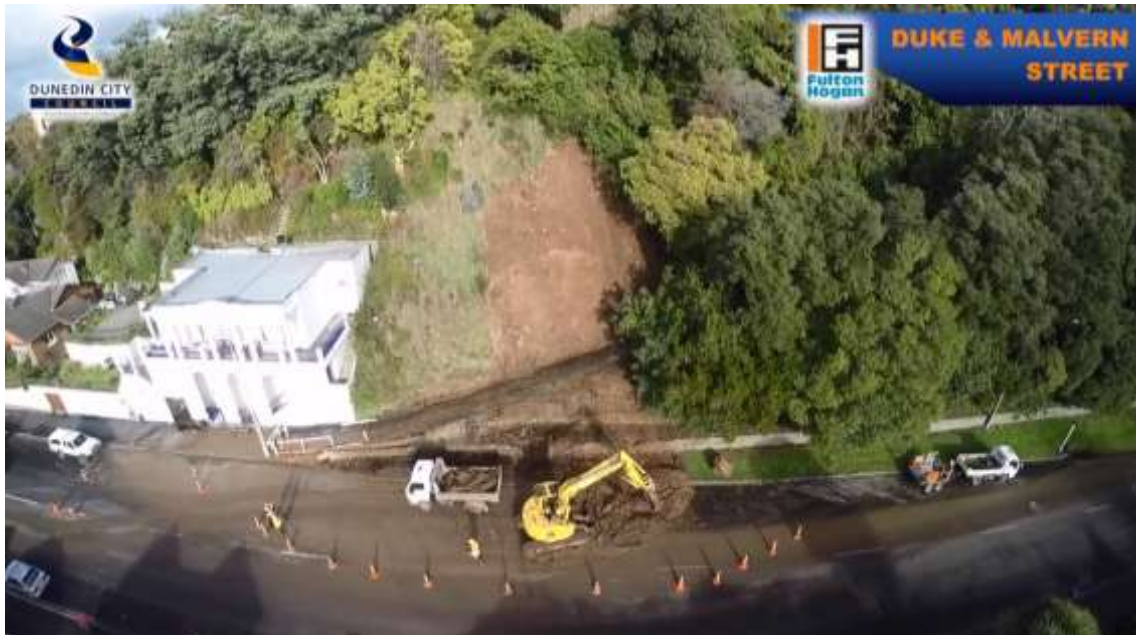
The landslide database indicates that the slide was last active in 1991 (Glassey, 1991). Following a heavy rainfall event on 3 June 2013, landslide activity was observed to the southeast of this mapped feature (Figure 32), suggesting that the wider area is still prone to shallow failure.

Figure 32 Aerial view showing a cleanup underway to remove landslide debris at the base of the Bullock Track and on Duke Street. Source: DCC/Fulton Hogan
