11 June 2020

Landpro Reference: S15298
Council Reference: RM20.079

Re: Further dam PIC information requested for Bendigo Pond

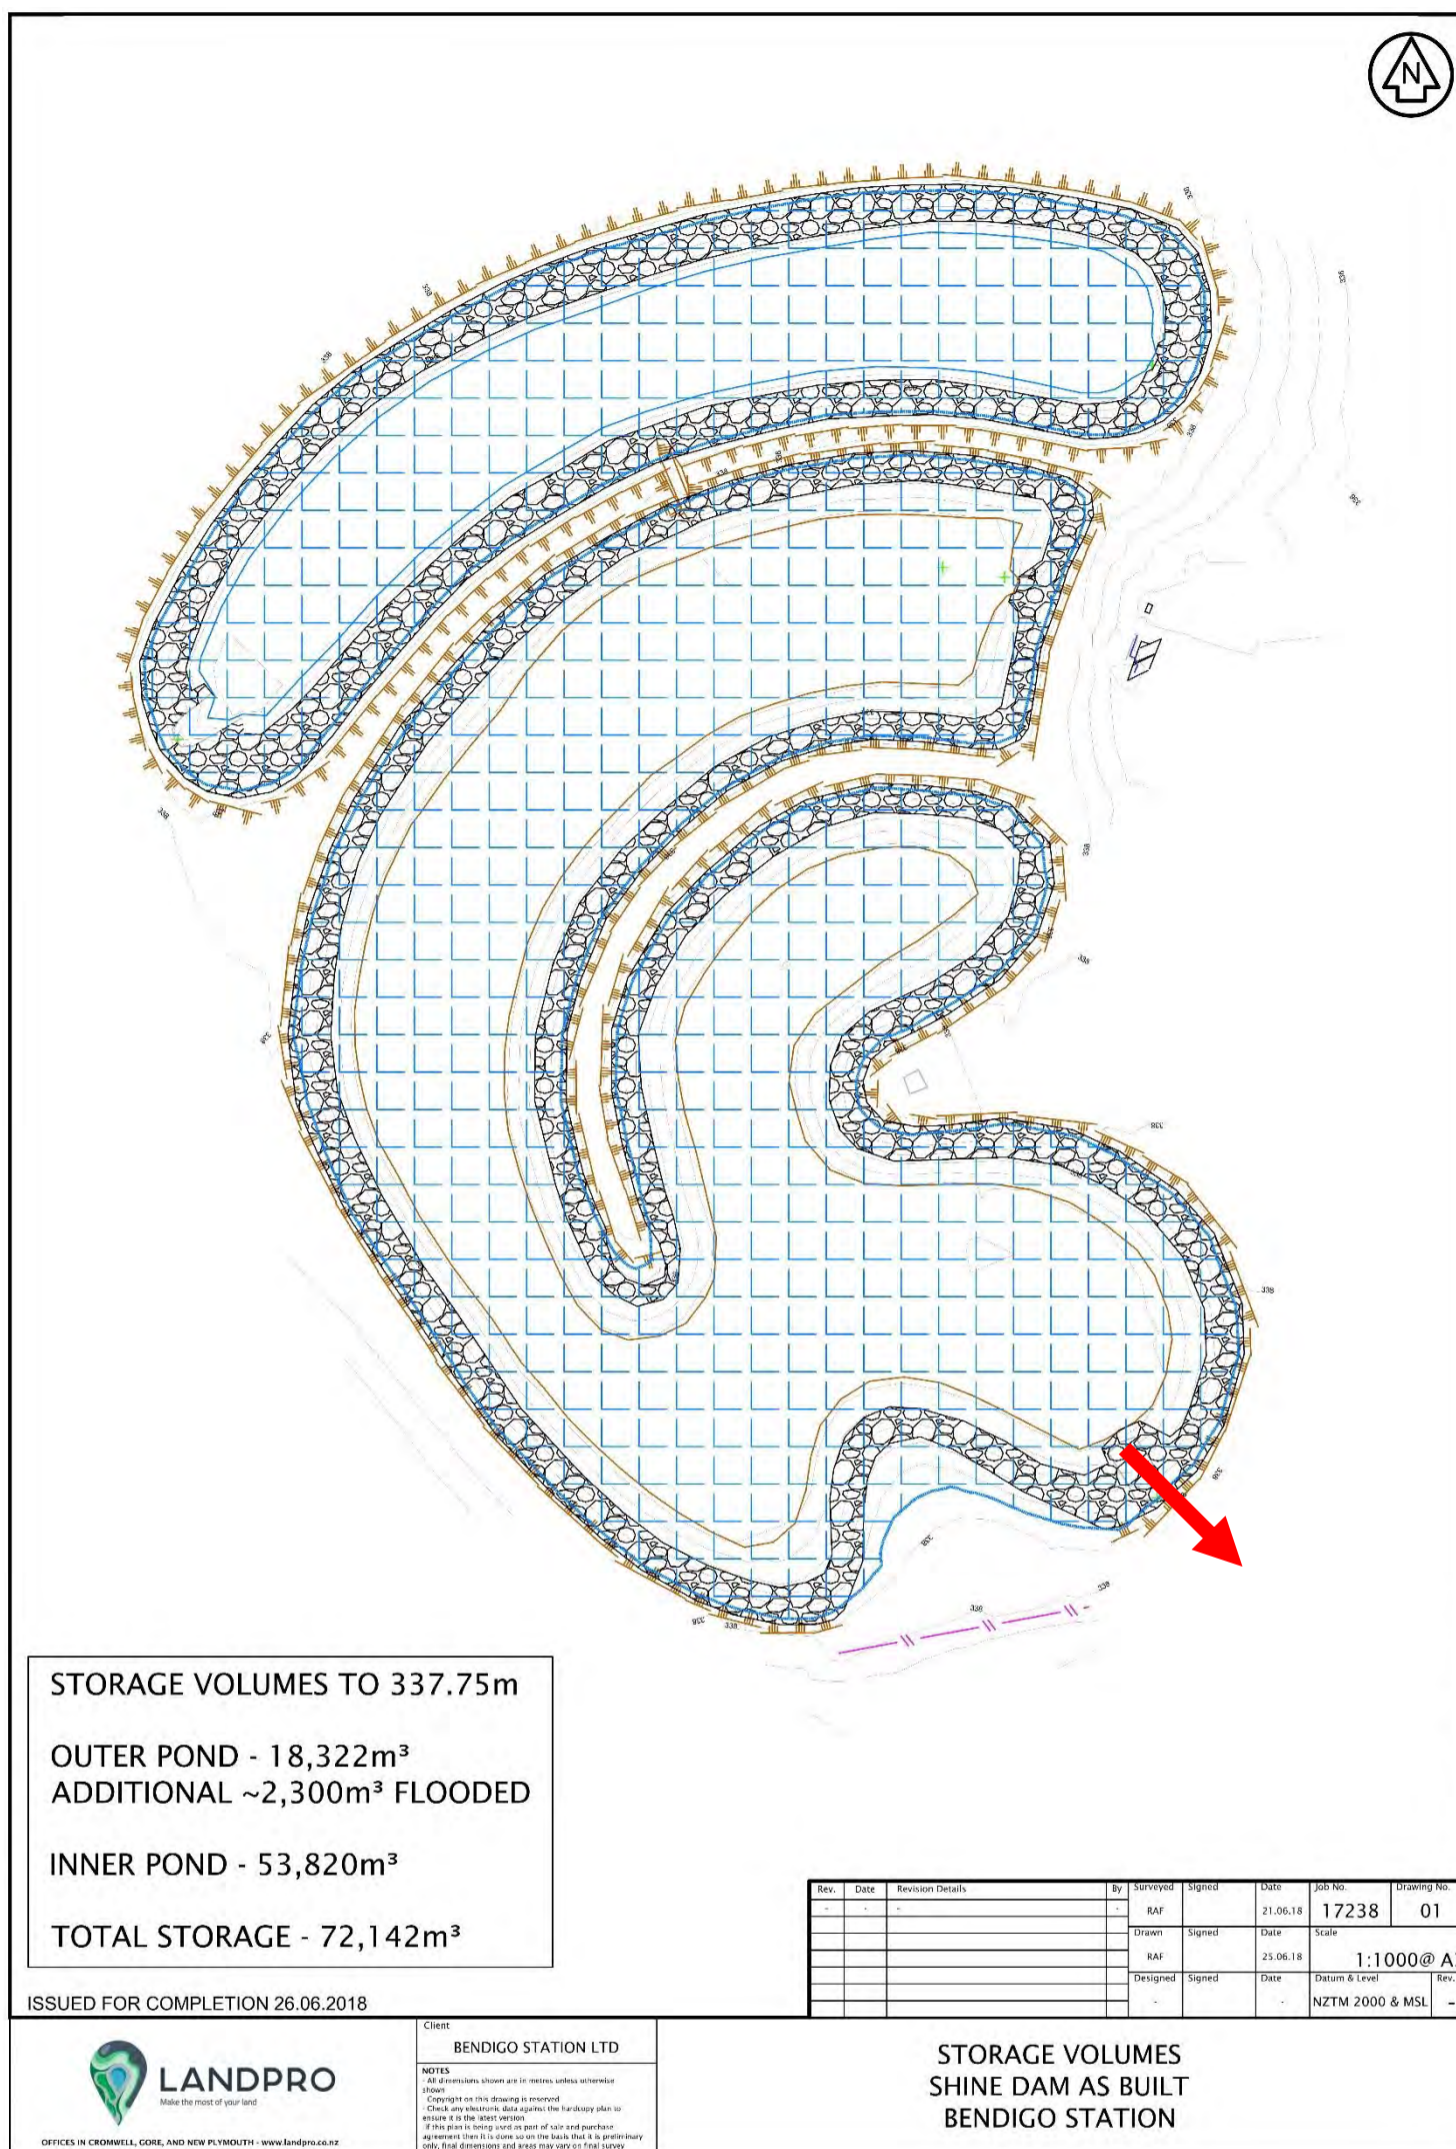
Figure 1, overleaf, shows the as built plan for Bendigo Pond, while Figure 2 shows the western shore of Bendigo Pond. As can be seen, stored water is largely below surrounding ground level, with the new pond generally conforming to the original layout of the former duck pond. Some minor in-filling has occurred around the outer embankments of the pond, however (see Figure 3).

Figure 1 & Figure 2: Bendigo Pond asbuilt and looking west across Bendigo Pond towards crest

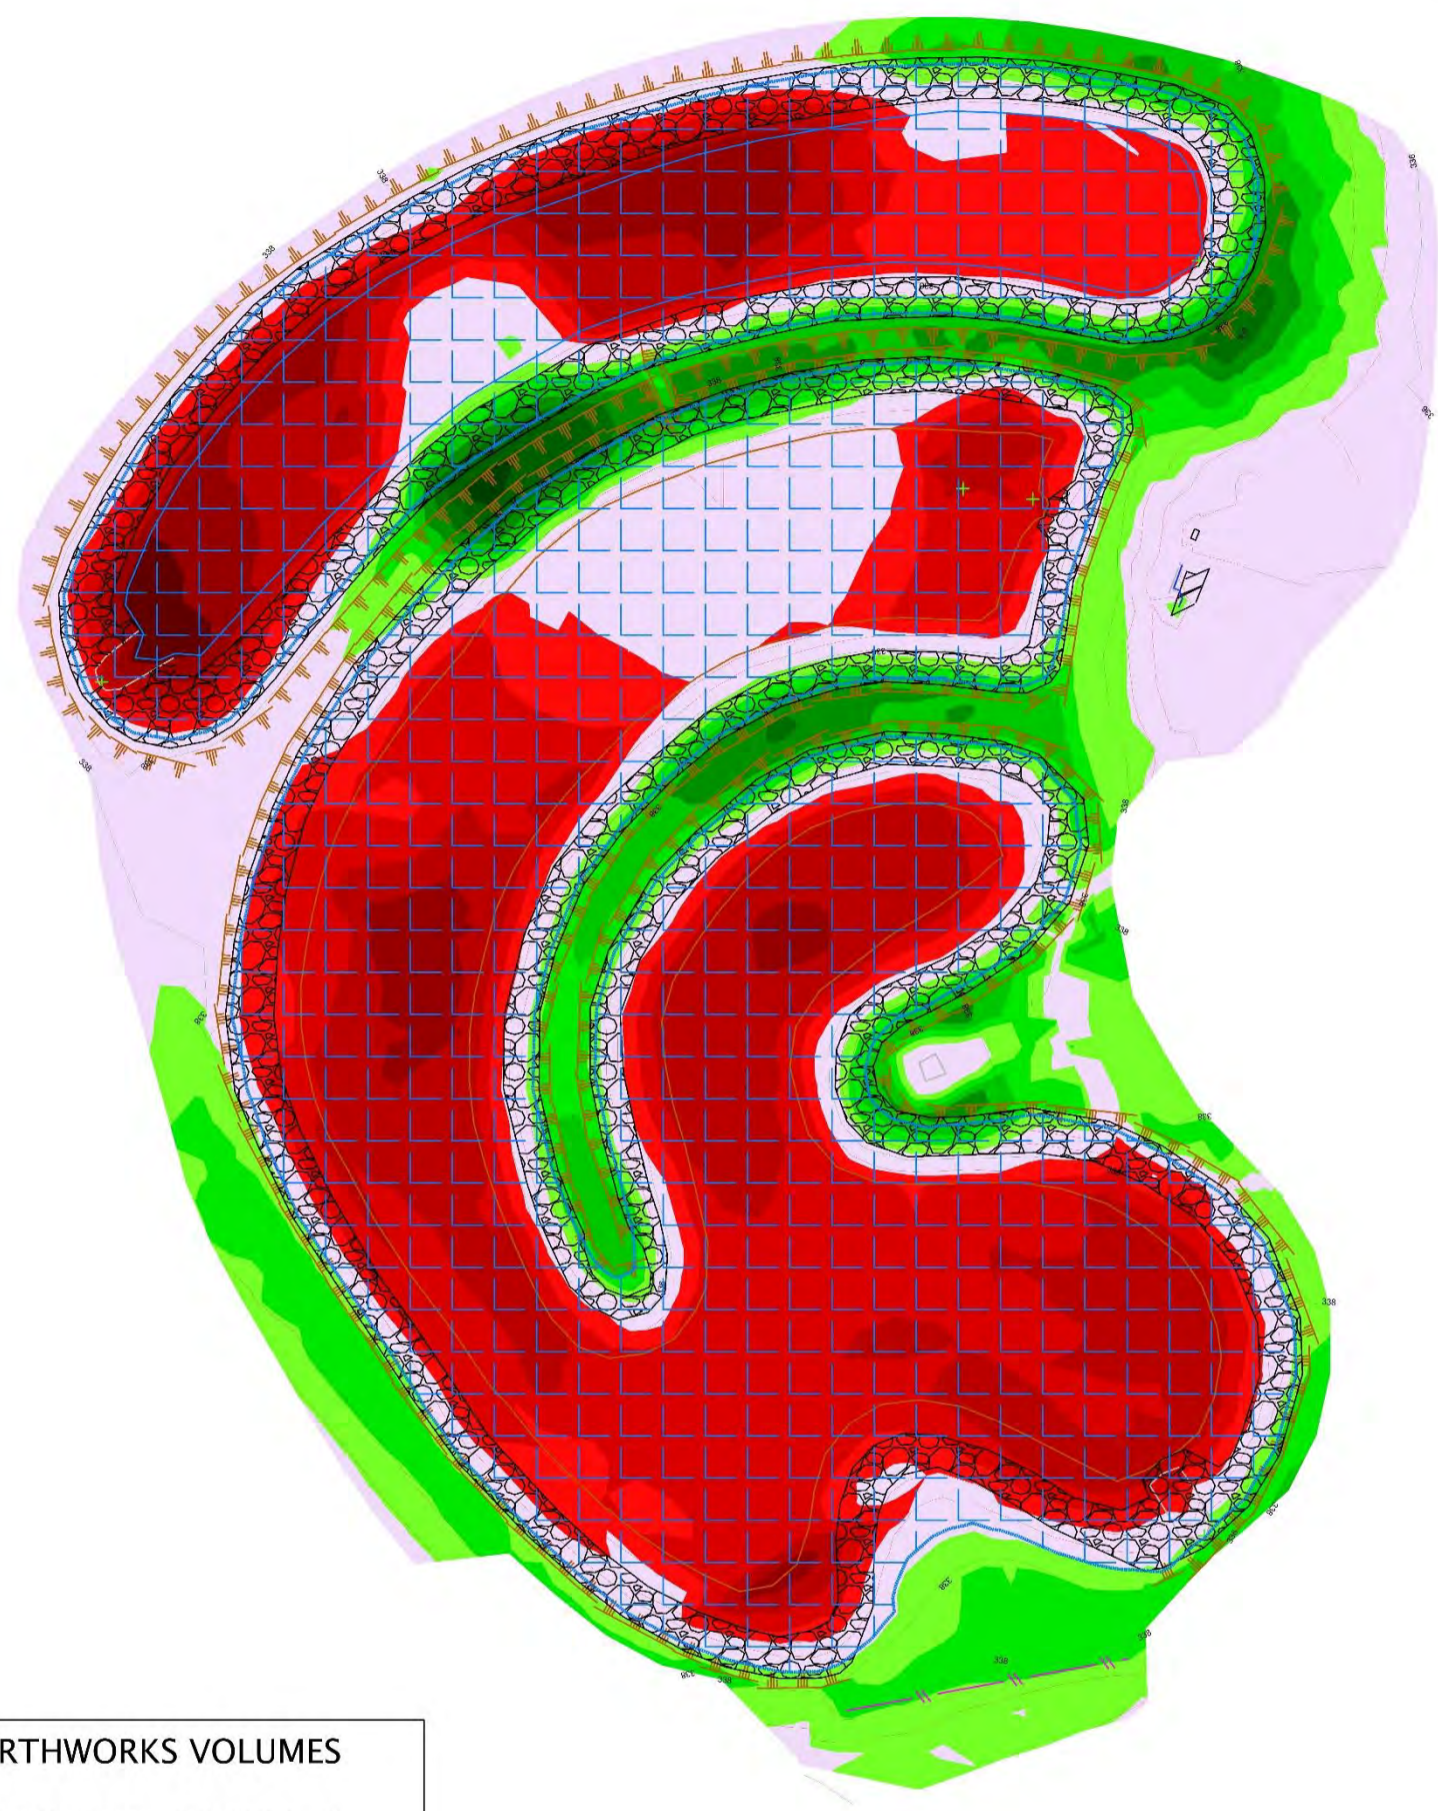
Figure 3: Bendigo Pond cut and fill earthworks plan

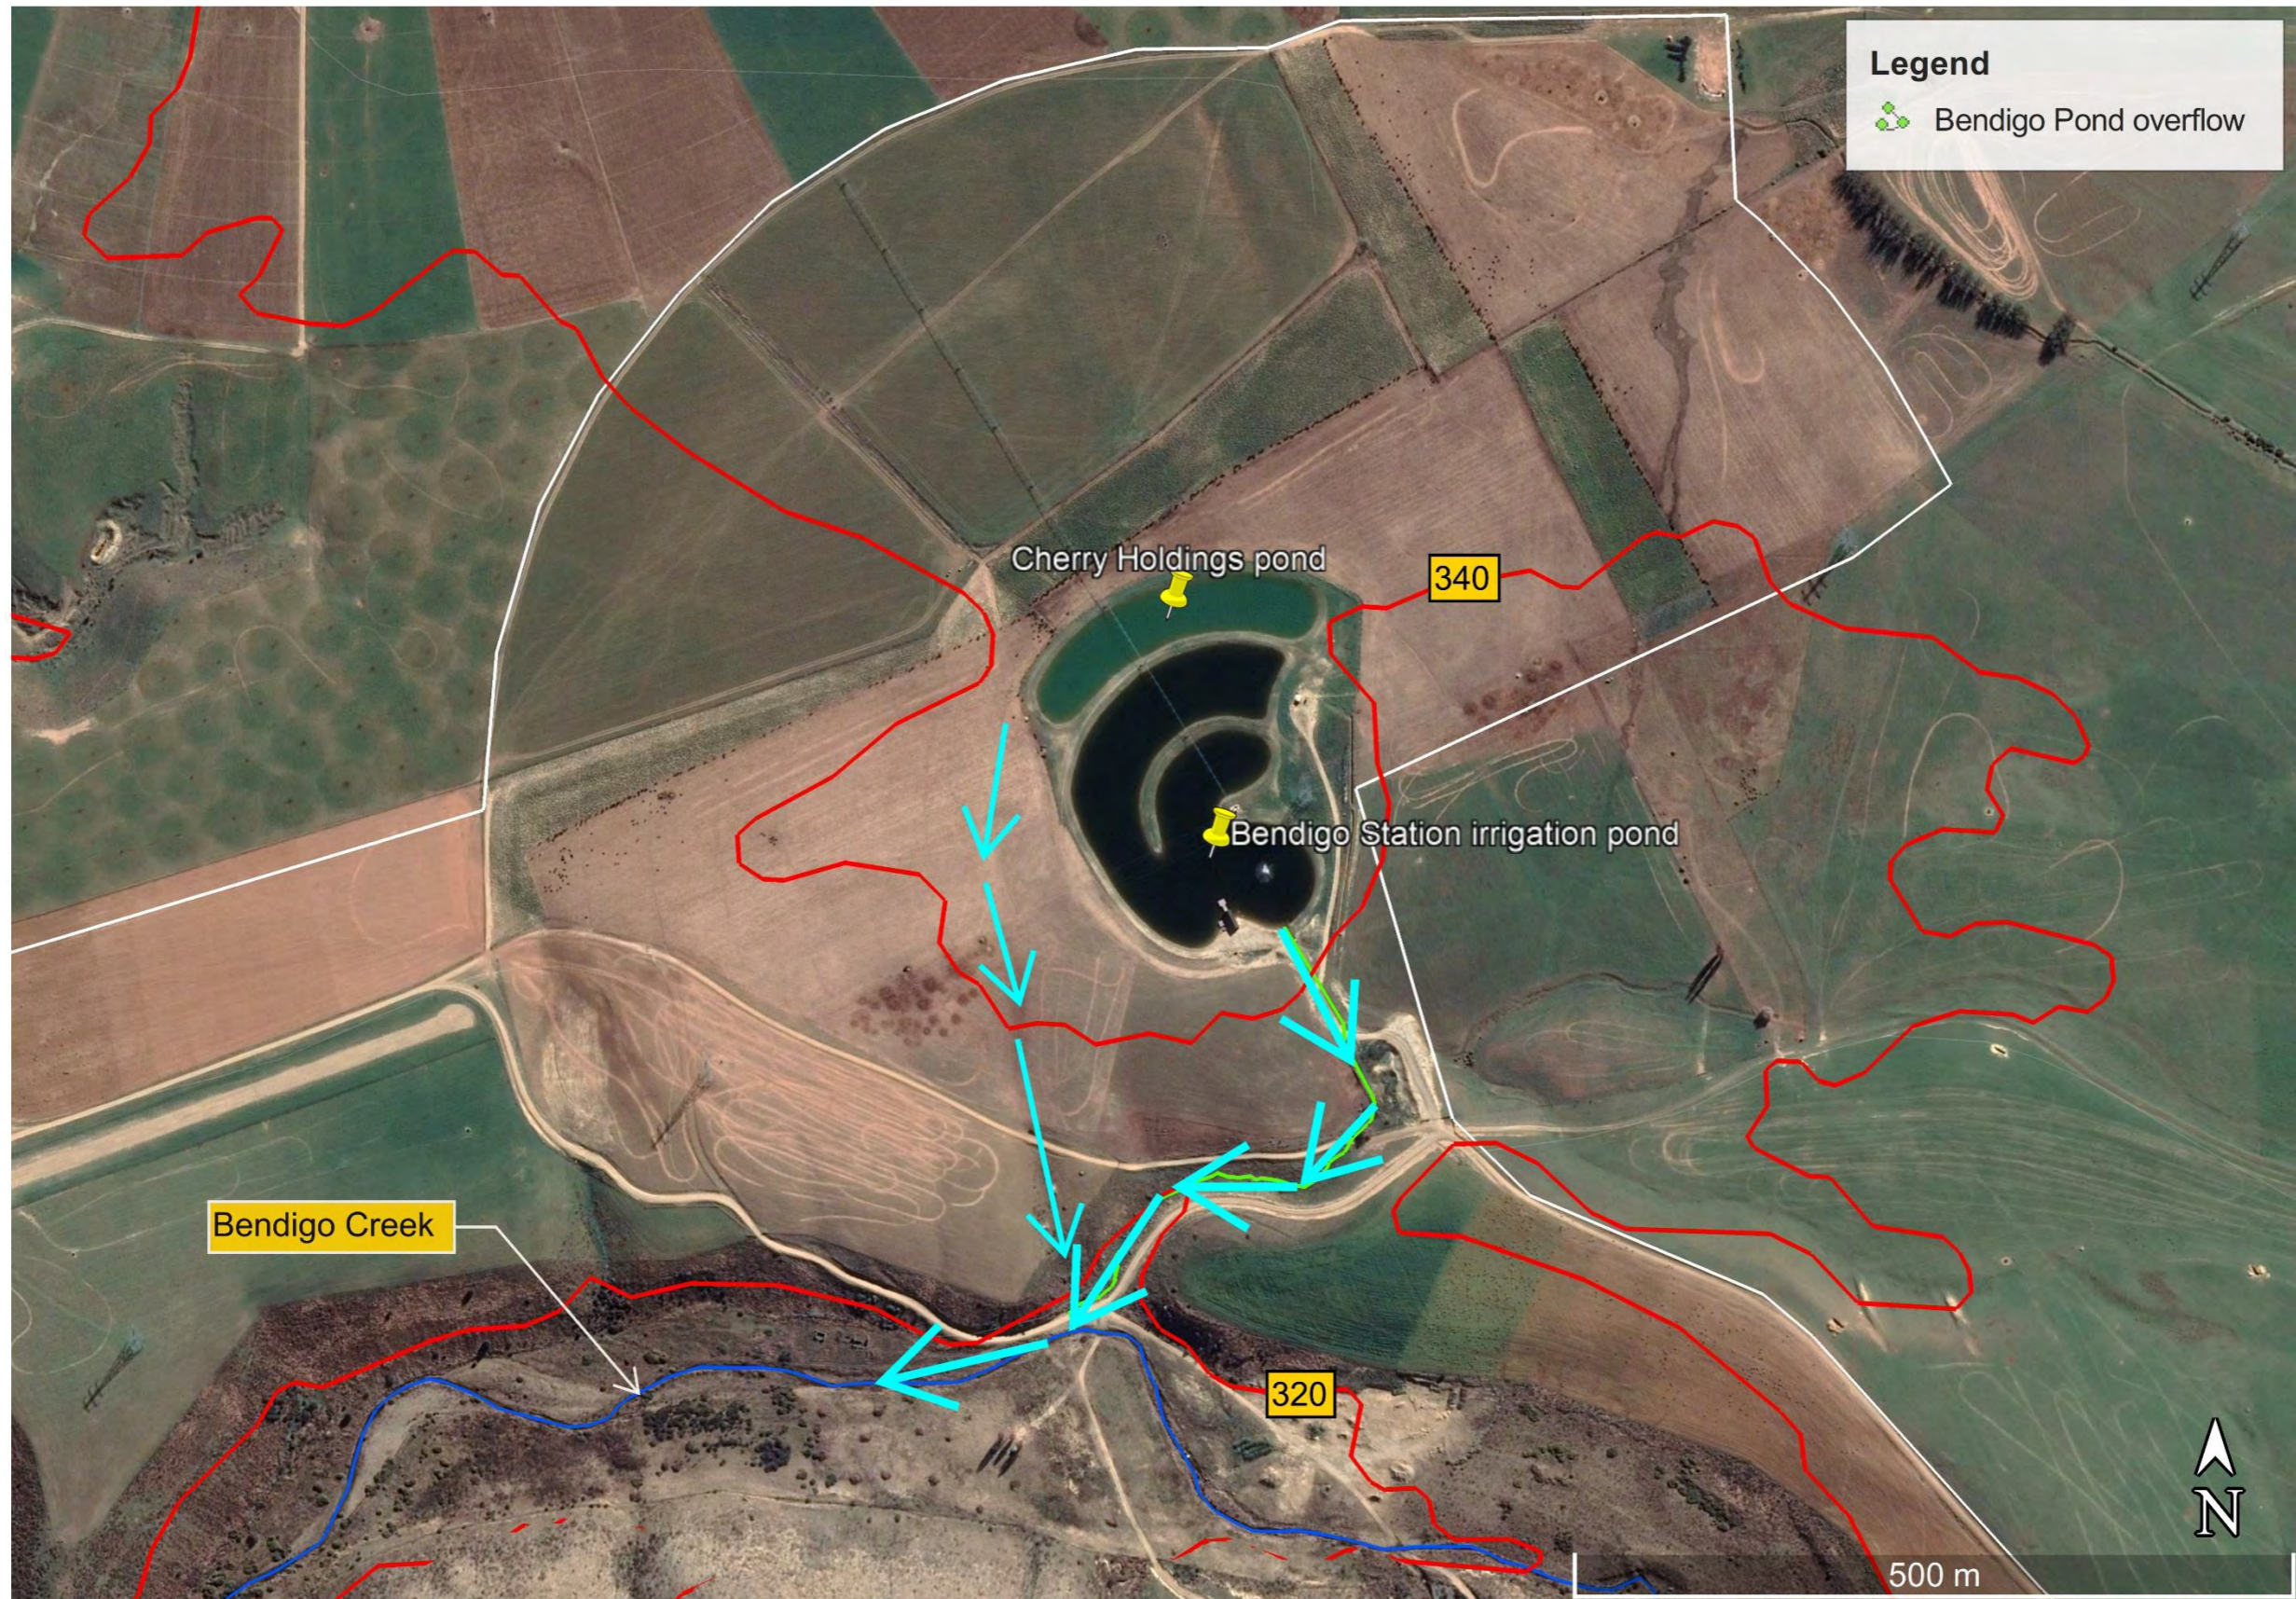
Based on this information, it is difficult to foresee a scenario whereby any catastrophic loss of water from the pond could occur – particularly given much of the stored water is below original ground level. Were uncontrolled loss of water to occur, the assumed direction of flow has been shown in Figure 4. In the event of a failure, stored water would flow primarily via the existing spillway and overflow channel to Bendigo Creek, which utilises an existing dry gully. In the event that the Cherry Holdings Pond was to fail, water would most likely flow south and discharge into Bendigo Creek in approximately the same location as Bendigo Pond water.

Figure 4: Bendigo Pond & Cherry Holdings Pond projected overland flow path in case of failure

Based on the assumed flow path, the holding capacity of the pond and information relating to the area, the damage level as per Table 2.2 of the NZSOLD Guidelines is considered to be Minimal. This conclusion has been drawn due to:
