## Site Visit Report

I attended a site visit for Bendigo Station Limited (RM20.079) on Tuesday the 15<sup>th</sup> of September between 10 am – 12 pm.

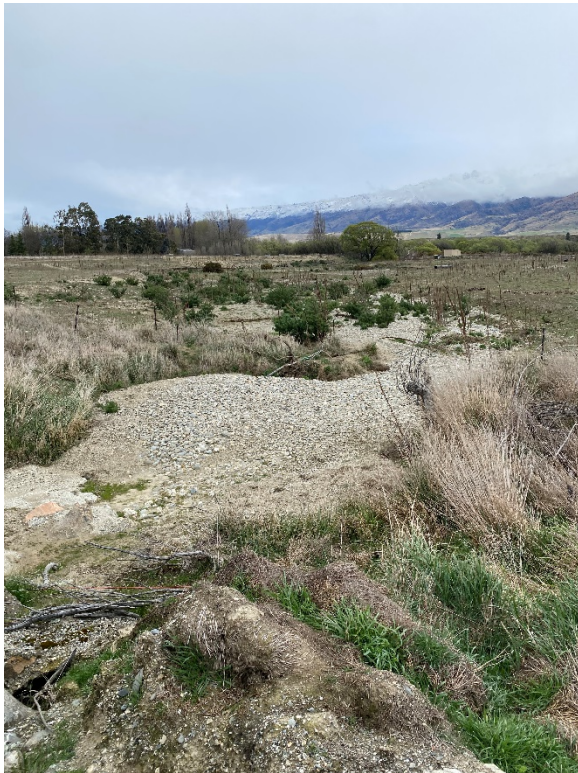
*Figure 1: Bendigo Creek towards the confluence with the Clutha River/Lake Dunstan.*

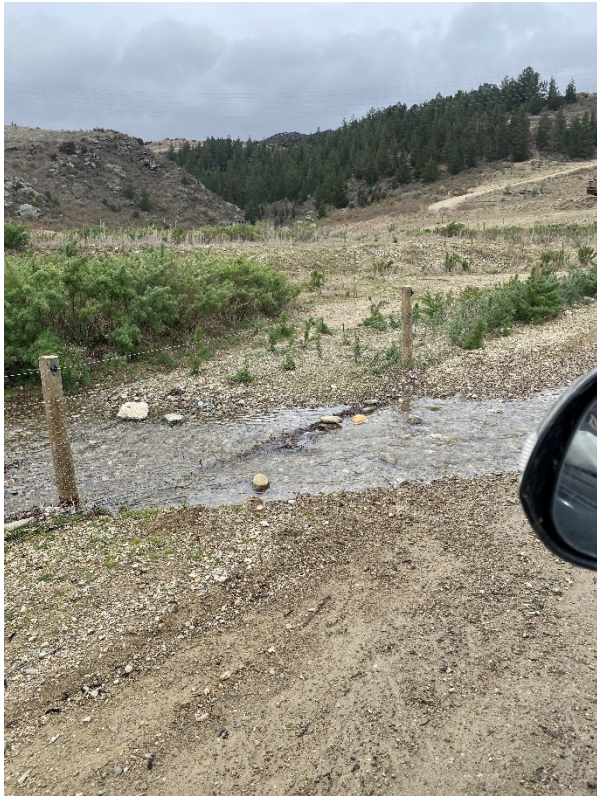
I was taken around the site by Will Nicolson (agent, Landpro) and Grant Porter (farm manager). From the office at the farm, we travelled to the intake. On the way, we inspected Bendigo Creek in various locations. Grant noted that they had received a substantial amount of water (for this time of year) recently, so flows would appear higher than usual. At the confluence with the Clutha, it was completely dry, and it was evident that there was very little flow through it due to Rye Grass in the bed upstream (**Figure 1**). Further upstream, it remained dry until a river crossing where there were small flows (20-30 L/s). Grant noted that it was unusual to see flows at this point and it would typically be dry. It was clear that this was the case given the fences that ran through the river (around the ford) were small mesh with no debris. If there were higher flows regularly, it would be expected that this would require regular clearance of debris - it would seem impractical to put the fence in if this was the case (**Figure 2**).

*Figure 2: Bendigo Creek at culvert crossing.*

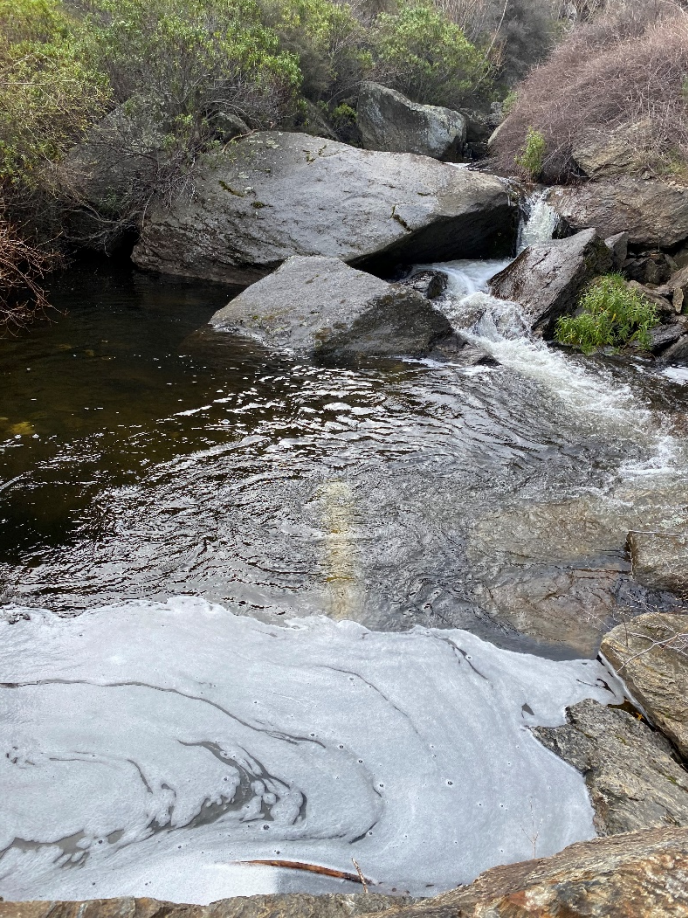
We then arrived at the intake (**Figure 3**). Flows at the intake were significantly higher with pools and riffles in a large boulder bed. Grant explained how the water was abstracted via the open pipe and conveyed via gravity fed piping to the junction box (**Figure 5**) (where the meter is located) followed by the dam (2 km). At the point of take, a valve controls flow (**Figure 4**) – it is noted that this is also managed at the meter. This was upgraded in 2018 by the original concrete and copper pipeline. He noted that the intake had the ability to abstract up to 180 L/s but currently it just takes the consented 55 L/s.

*Figure 3: Intake pipe.*

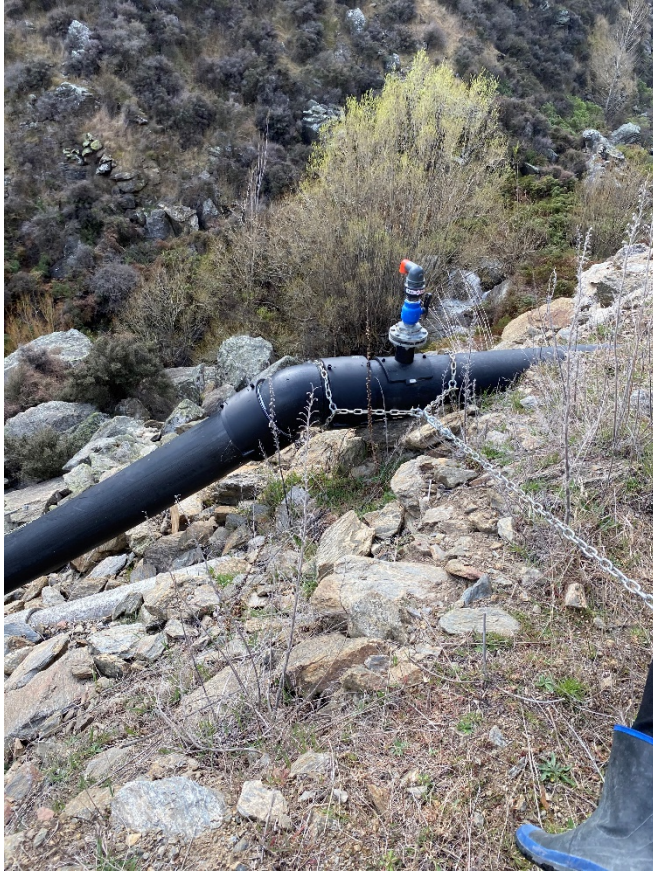
*Figure 4: Intake pipe with control valve.*

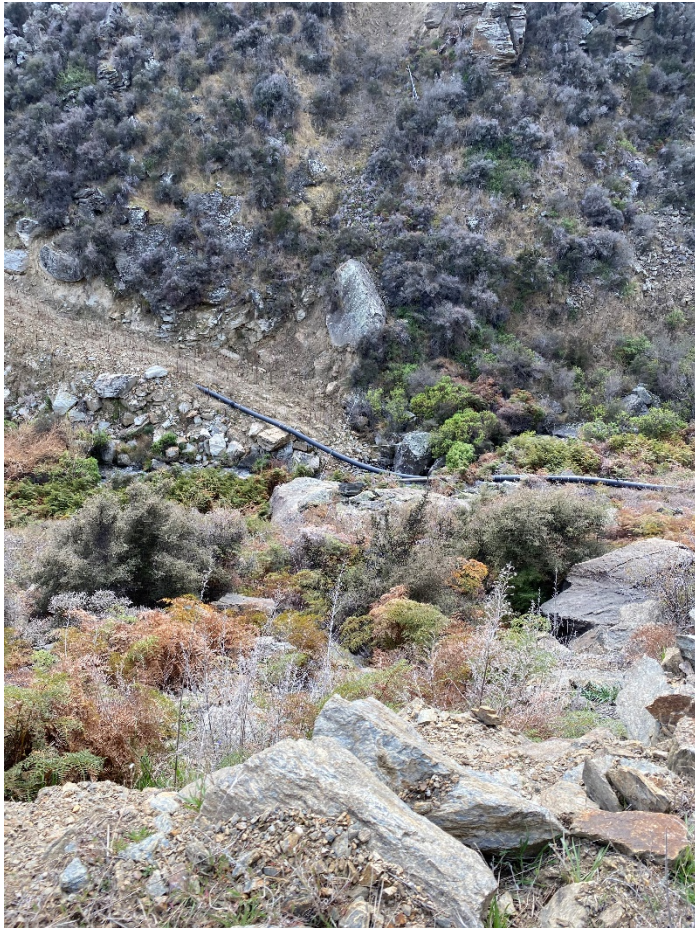
*Figure 5: Pipeline conveying water from the point of take across Bendigo Creek towards the ponds/junction box.*

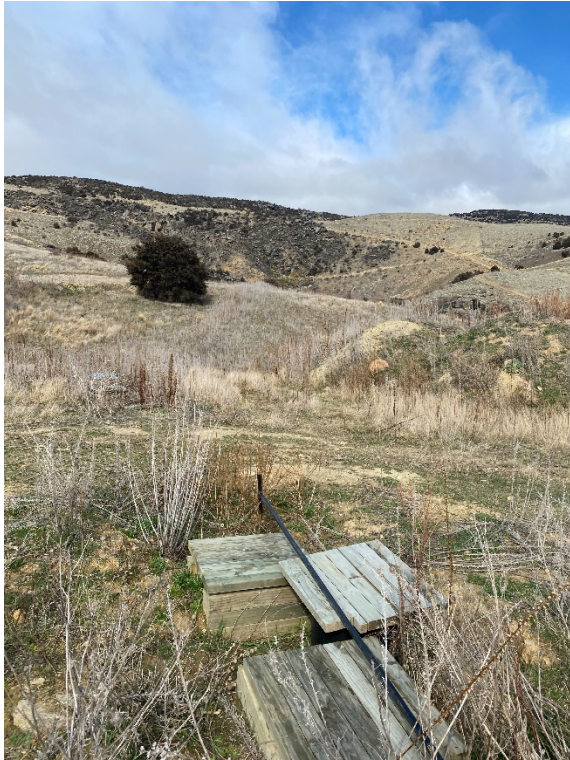
We then inspected the location of the water meter and the second valve for controlling flows (**Figure 6**). This is where water is conveyed via the junction to either the dam or for stockwater drinking (**Figure 7**). Grant estimated only a very small portion of water was taken for stockwater (5L/s).

*Figure 6: Second valve, junction and meter.*

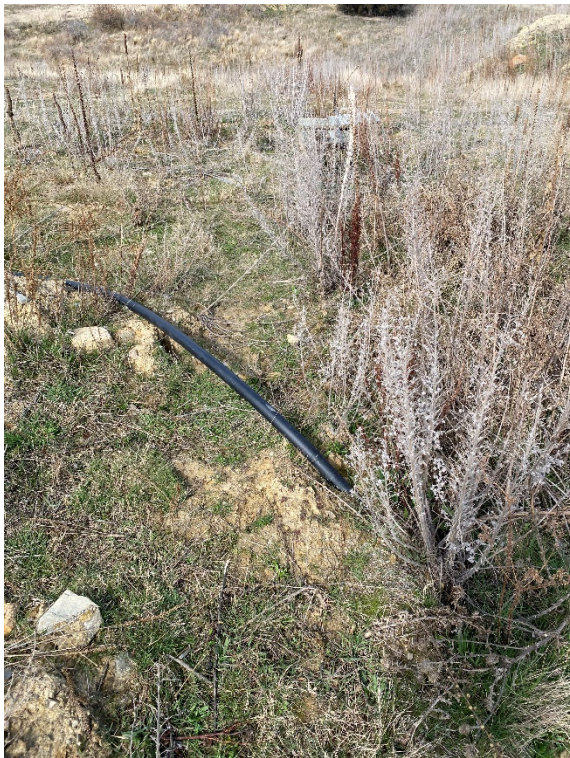
*Figure 7: Stockwater pipe.*

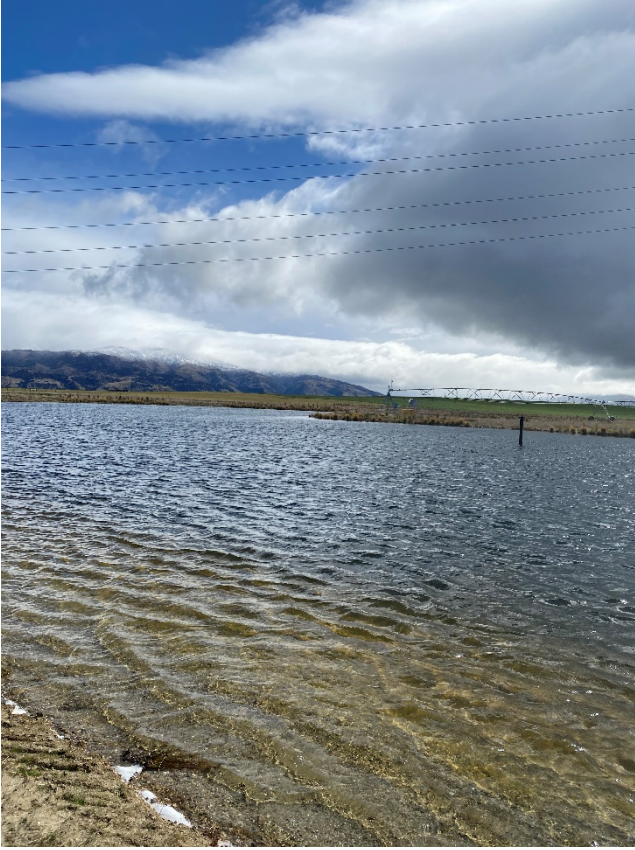
*Figure 9: Photo of lake from boatshed side.*

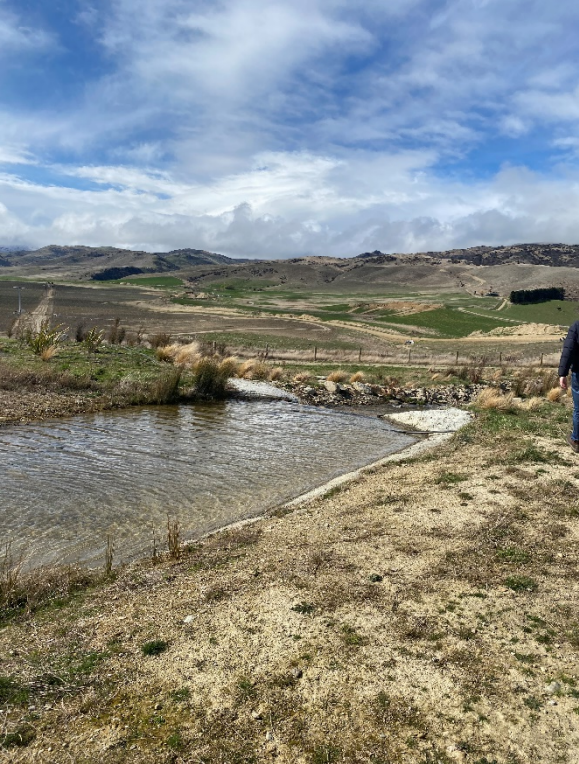
We then moved on to the dam, first inspecting the overflow (Figure 8Figure 10, followed by the dam itself. Grant demonstrated how water is fed into the pond through a valve near the spillway. It is noted that this makes three valves between the intake and the pond in order to restrict water. Grant discussed the ecological significance of the dam (see **Figure 11**).

*Figure 8: Spillway weir looking downstream*

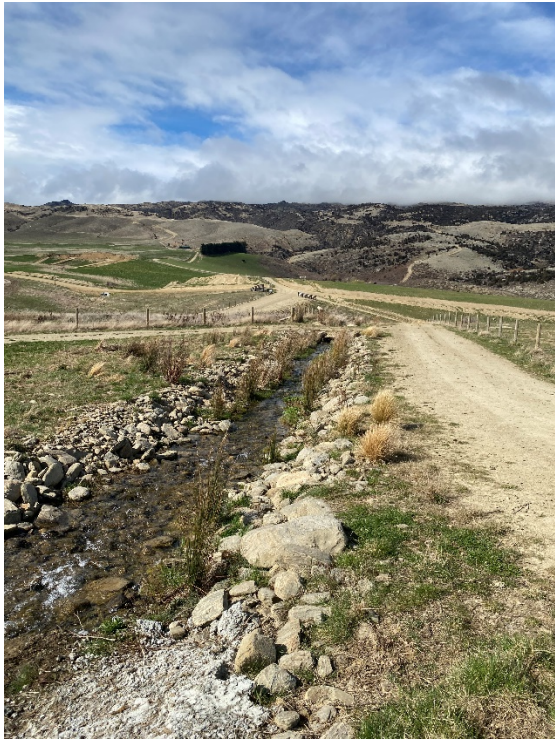
Figure 10: Spillway diversion channel flowing towards Bendigo Creek.

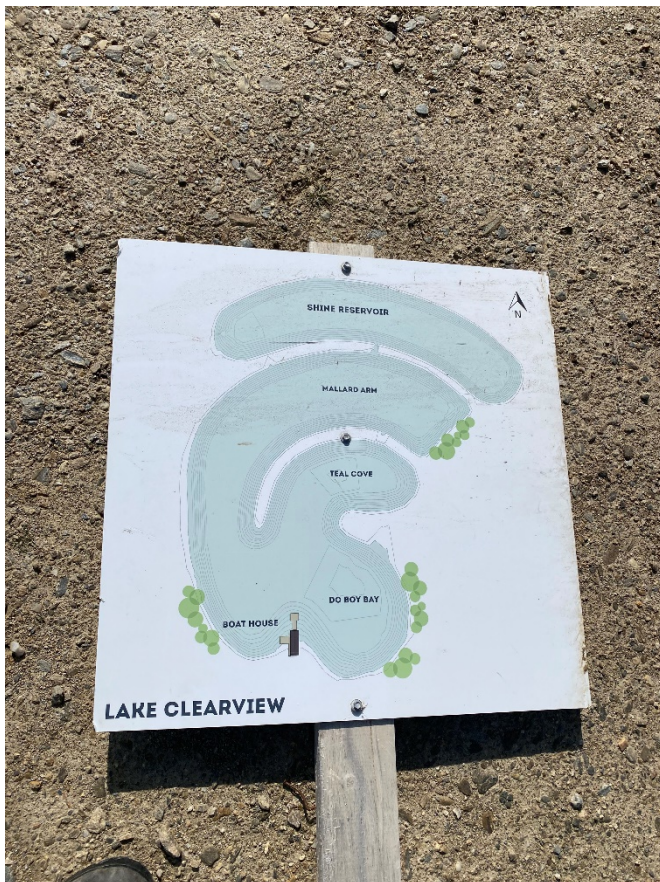
Figure 11: Sign showing features of pond (ecological)
