Channel morphology of the Waianakarua River, North Otago

Technical Summary

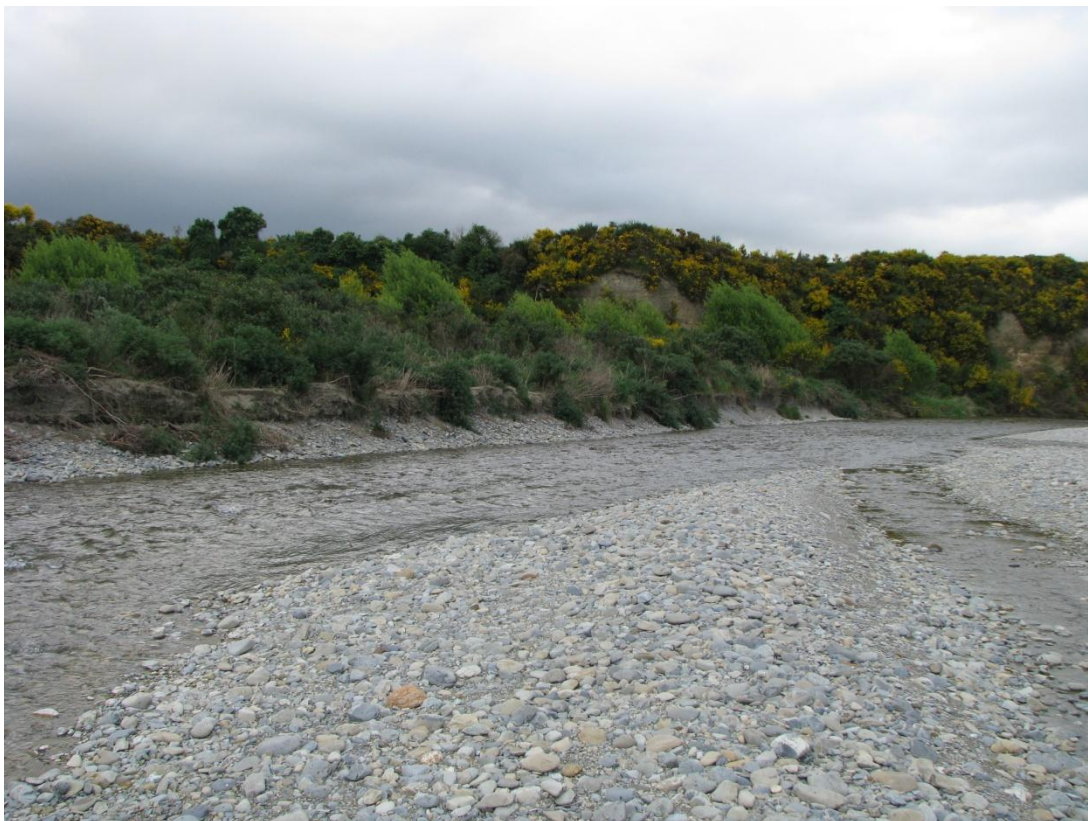
In the main stem of the Waianakarua River the channel switches between areas of braiding and single thread channels. The river is actively eroding the bank below Waianakarua Road, approximately 2km from the river mouth (Figure 6 and Figure 7). Between February 2008 and October 2013 survey data shows that the main stem of the Waianakarua has shown erosion of both the true left and true right banks (Figure 10). The upstream sites (WA3 - Figure 25, and WA4 - Figure 27) show aggradation of the bed and widening of the main channel (WA3) and the creation of multiple flow channels (WA4) during this period. The main channel became wider and shallower at the most downstream site (WA1, Figure 21) and narrower and deeper at WA2 (Figure 23) between 2008 and 2013. Cross-sections WA3 and WA4 are affected by gravel extraction activities.

Figure 5-Area of active bank erosion on the main stem of the Waianakarua River (between cross-section WA2 and WA3), photo taken looking downstream, October 2013

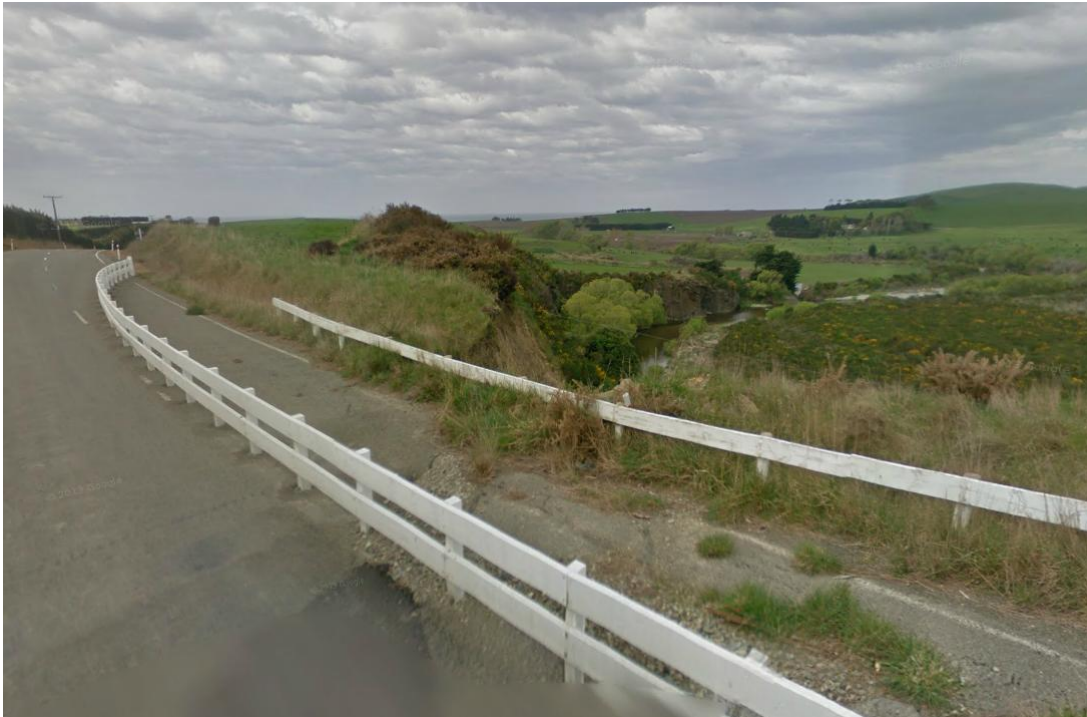
Figure 6-Section of bank erosion on the true left of the Waianakarua River below Waianakarua Road (Google Maps, Street view) (October 2012)

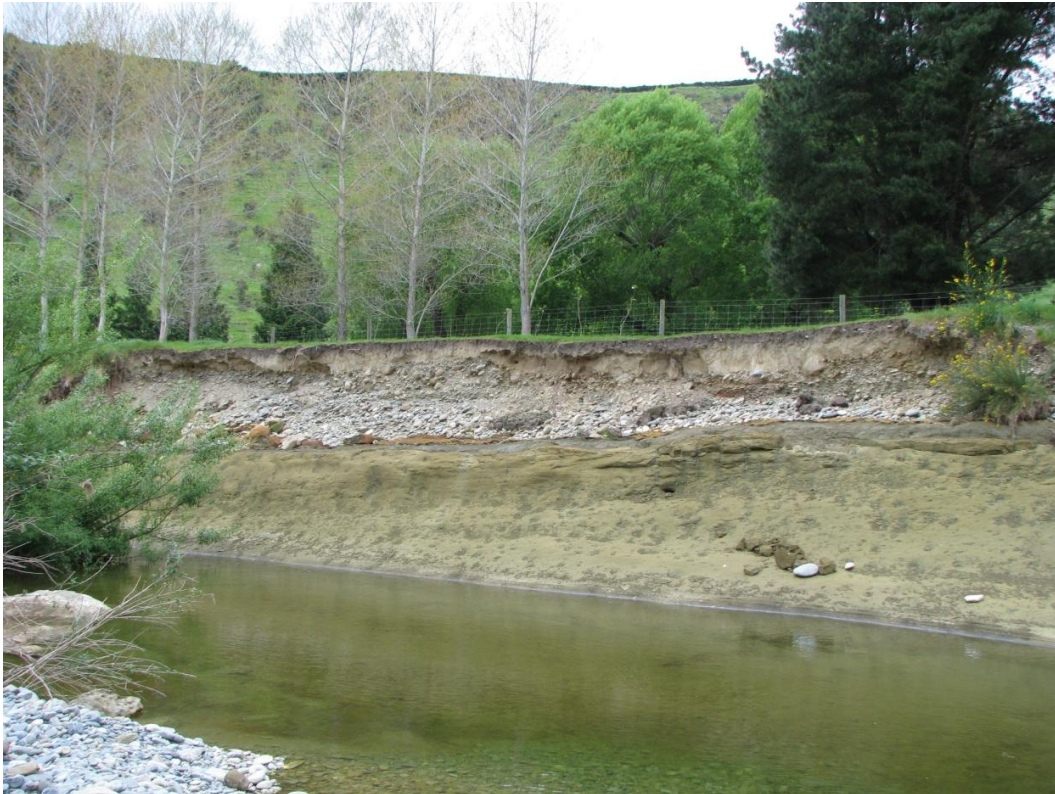
Between February 2008 and October 2013 there was erosion of both the left and right banks of the North Branch of the Waianakarua River (Figure 8, Figure 11). The surveyed reach of the North Branch includes areas of both aggradation and degradation, and an area where multiple

Figure 8-Area of active bank erosion on the North Branch of the Waianakarua River (upstream of SH1), photo taken looking upstream, October 2013

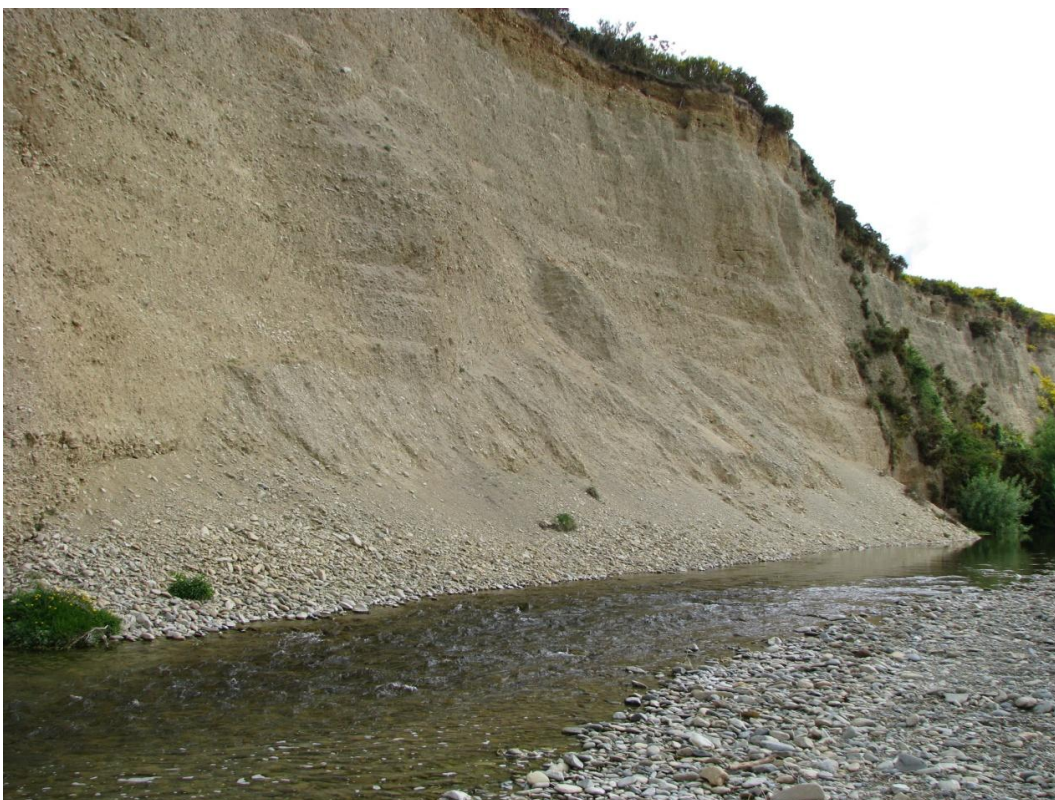
Erosion of both the left and right banks is an ongoing process in the South Branch of the Waianakarua River (Figure 9, Figure 12). Sediment movement (in the form of both erosion and deposition) in the surveyed reach and has led to the channel becoming wider in some locations (WA5S - Figure 37, and WA7S - Figure 41) but narrower and deeper in others (WA9S - Figure 45, and WA15S - Figure 57). Cross-sections between WA5S and WA9S are affected by gravel extraction activities.

Figure 9-Area of active bank erosion on the South Branch of the Waianakarua River (between cross-section WA7S and WA8S), photo taken looking upstream, October 2013

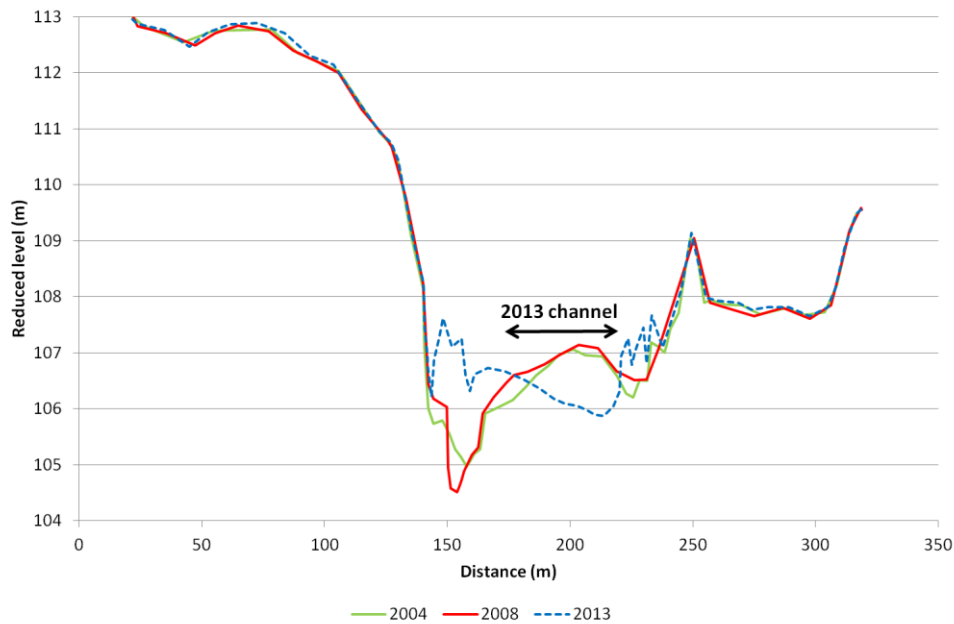
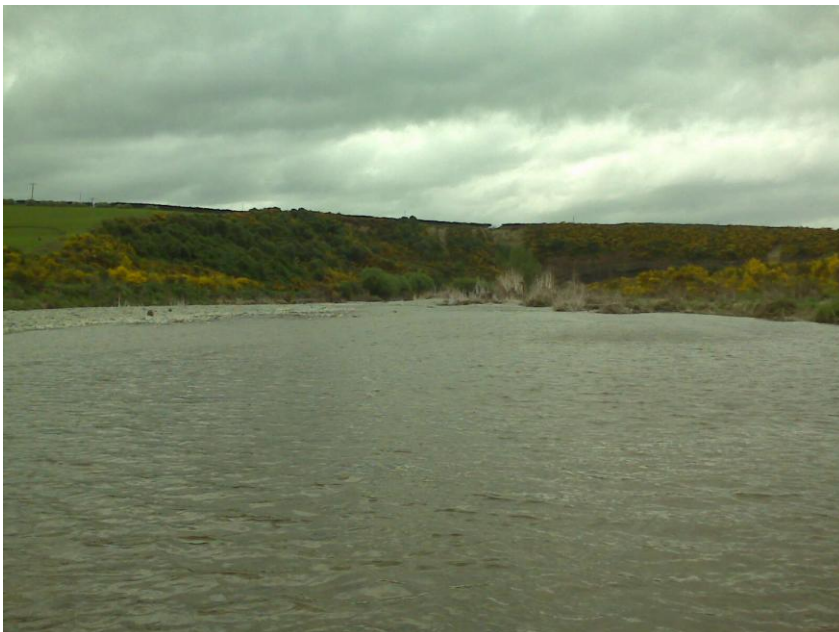
Waianakarua: WA1

Cross-section WA1 is located 2.65km upstream of the Waianakarua River mouth. The channel bed remained similar between June 2004 and February 2008 with a lowering of the main channel occurring. Between February 2008 and October 2013 the main channel has aggraded approximately 2.5m on the true left and degraded by 1m on the true right to create a wider, shallower channel. Minimal change has occurred in the wider floodplain. The thalweg level aggraded by 1.3m between 2008 and 2013 and has changed position (horizontally) from the left to the right bank.

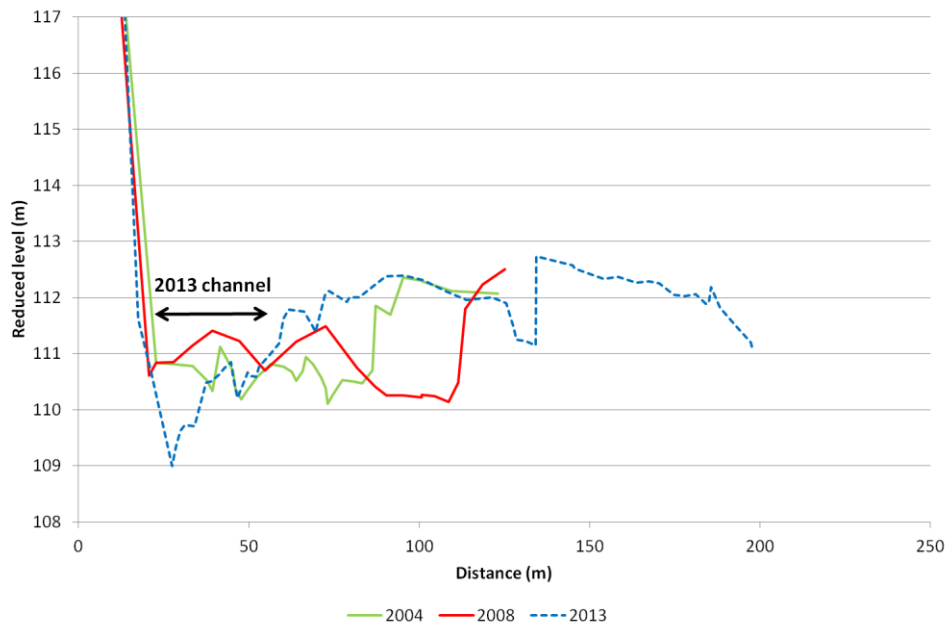
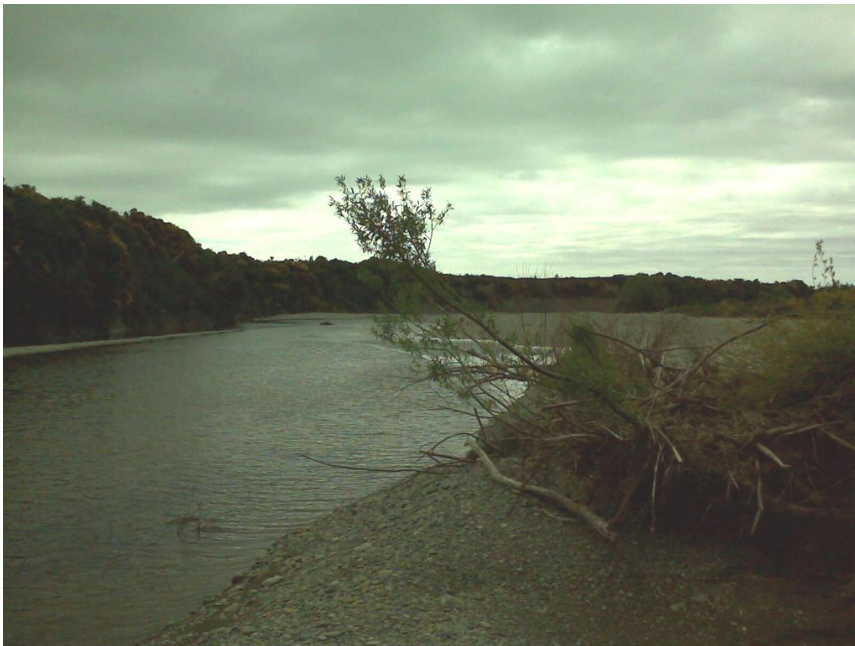
Waianakarua: WA2

Cross-section WA2 is located 4.35km upstream of the Waianakarua River mouth. The channel bed aggraded between June 2004 and February 2008 with erosion of the right bank occurring. Between February 2008 and October 2013 the main channel degraded approximately 2m on the true left and aggraded by 2m on the true right to create a narrower, deeper channel. Changes on the true right wider floodplain cannot be verified, as previous surveys in 2004 and 2008 did not extend as far to the true right as that completed in 2013. The thalweg degraded by 1.1m between 2008 and 2013 and has changed position (horizontally) from the right to the left bank.

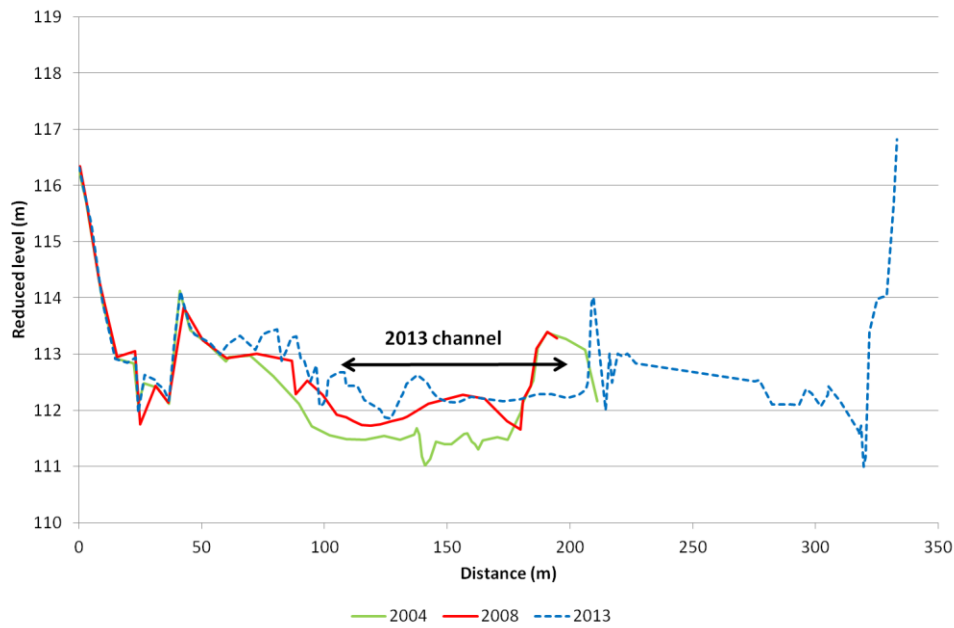
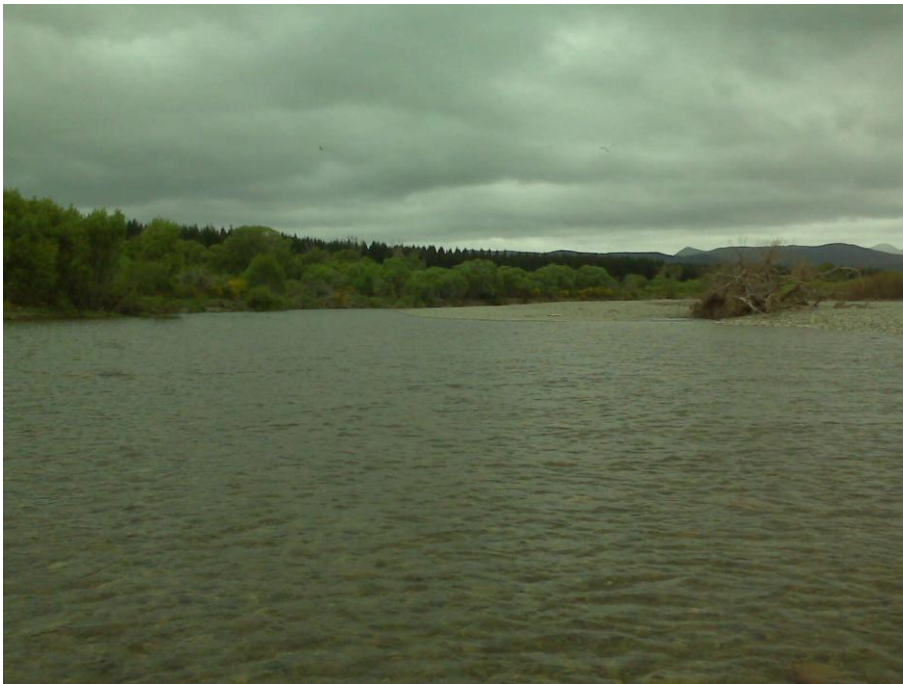
Waianakarua: WA3

Cross-section WA3 is located 4.6km upstream of the Waianakarua River mouth. The channel bed aggraded between June 2004 and February 2008. Between February 2008 and October 2013 the main channel aggraded up to 1m on the true left and eroded the true right bank by approximately 20m. Changes on the true right wider floodplain cannot be verified, as previous surveys in 2004 and 2008 did not extend as far to the true right as that completed in 2013. The thalweg aggraded by 0.6m between 2008 and 2013.

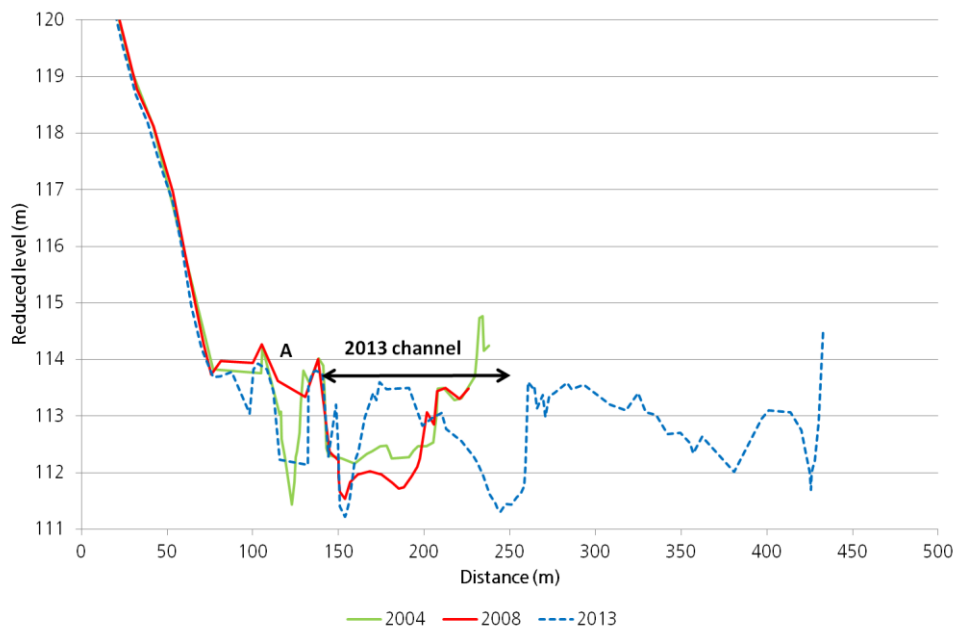
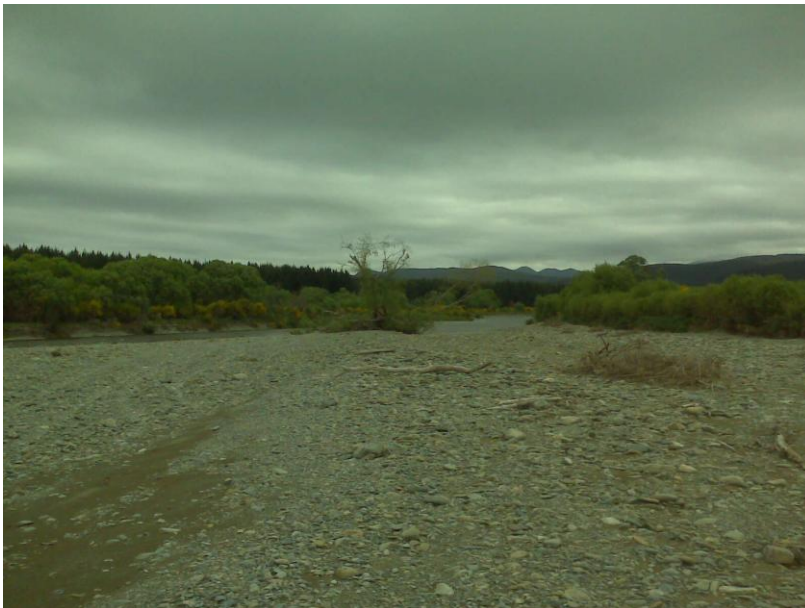
Waianakarua: WA4

Cross-section WA4 is located 4.7km upstream of the Waianakarua River mouth. The channel bed aggraded on the true left secondary channel (point labelled A) with degradation occurring in the main channel between June 2004 and February 2008. Between February 2008 and October 2013 the main channel aggraded approximately 2m, with degradation occurring in the secondary flow channel (point labelled A). The right bank eroded with another channel being created between 2008 and 2013 indicating the dynamic nature of the Waianakarua River at this location. Changes on the true right wider floodplain cannot be verified, as previous surveys in 2004 and 2008 did not extend as far to the true right as that completed in 2013. The thalweg degraded by 0.3m between 2008 and 2013.

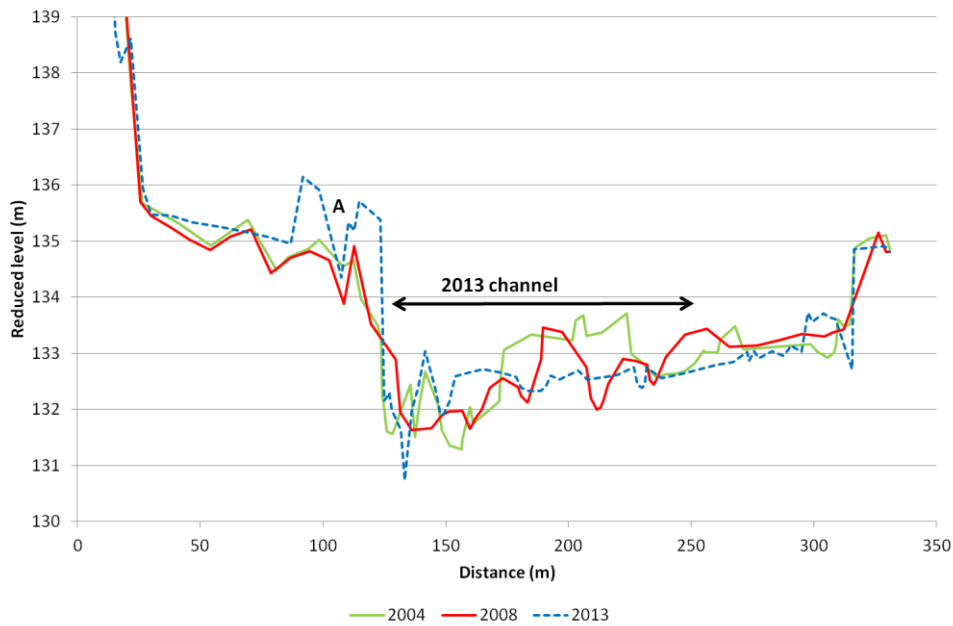
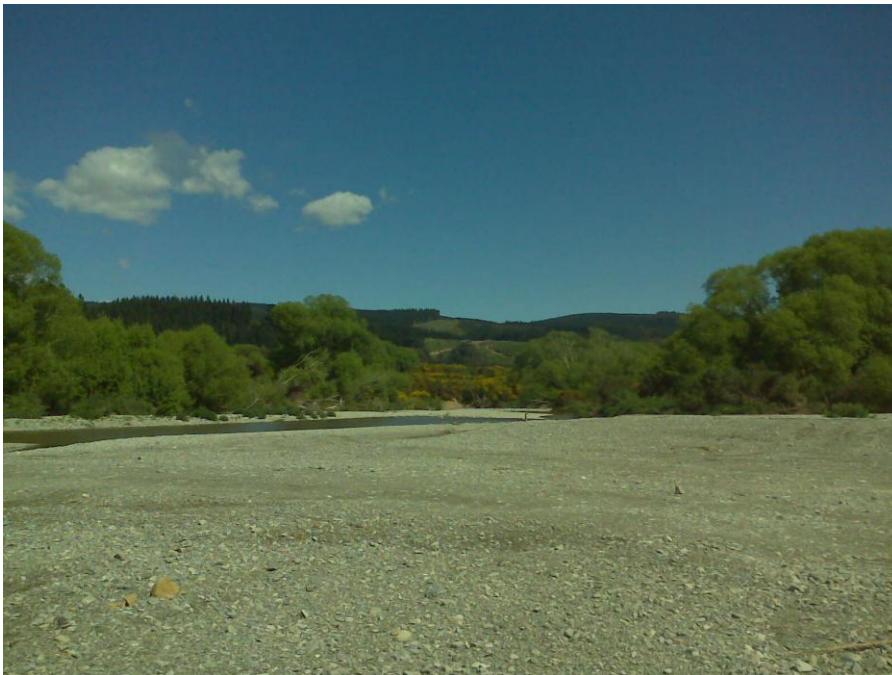
Waianakarua: WA5N

Cross-section WA5N is located 9.6km upstream of the Waianakarua River mouth on the North Branch at Sharps Bend. Sharps bend is an area of historic and recent gravel extraction activity and changes at this location reflect both natural and artificial change. The channel bed both aggraded and degraded between June 2004 and February 2008. Between February 2008 and October 2013 the main channel both aggraded and degraded creating a smoother and lower profile. The top of the left bank shows aggradation and the creation of two levees (at the point labelled A).The right bank aggraded and steepened between 2008 and 2013. The thalweg degraded by 0.9m between 2008 and 2013.

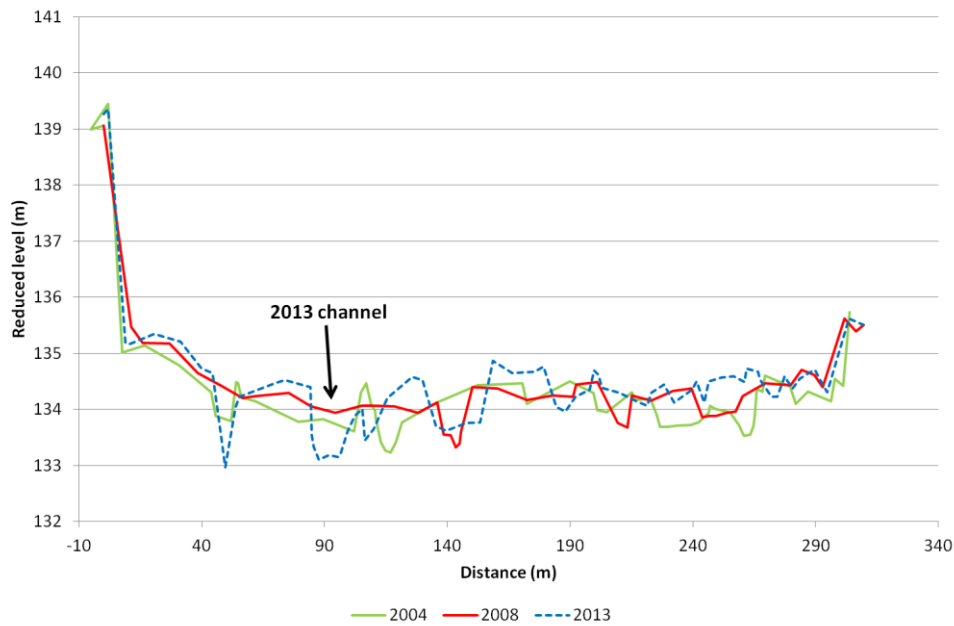
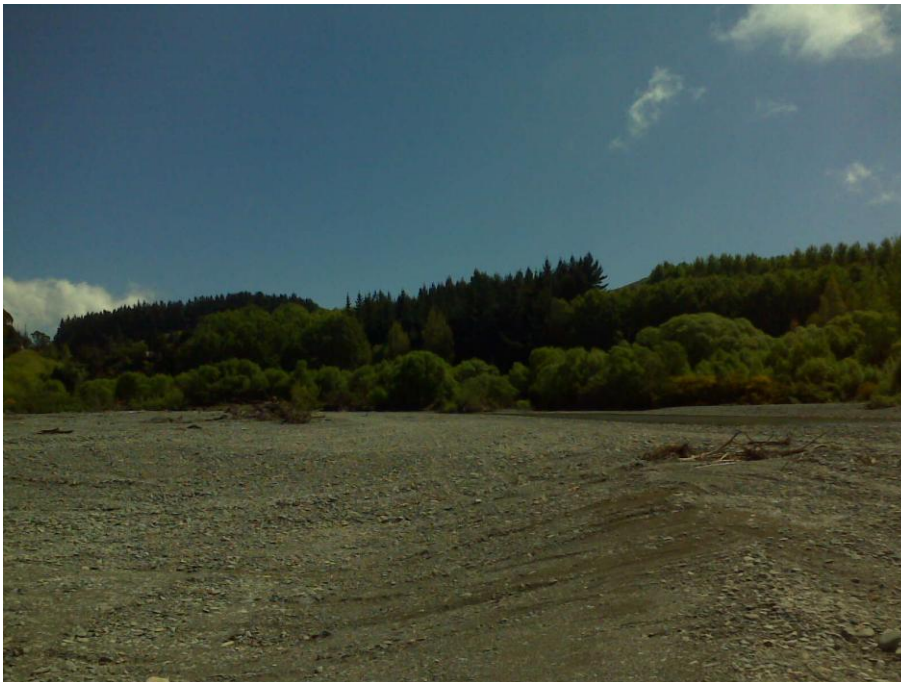
Waianakarua: WA6N

Cross-section WA6N is located 9.75km upstream of the Waianakarua River mouth on the North Branch at Sharps Bend. Sharps bend is an area of historic and recent gravel extraction activity and changes at this location reflect both natural and artificial change. The Waianakarua River at this location consists of several low flow channels with the bed both aggrading and degrading between June 2004 and February 2008. Three channels were created on the true left of the channel between February 2008 and October 2013 with aggradation occurring on the true left bank. The thalweg degraded by 0.35m between 2008 and 2013.

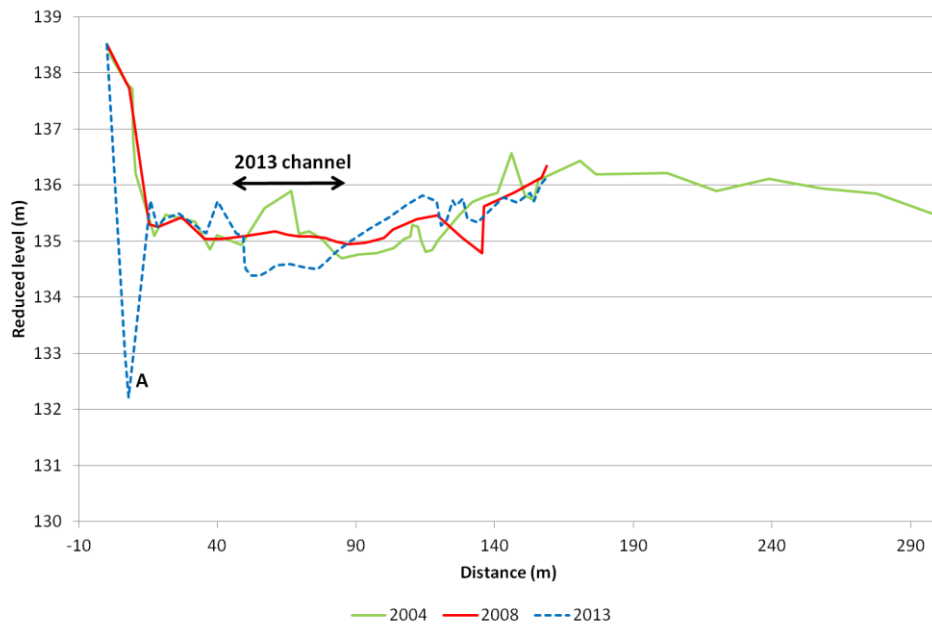
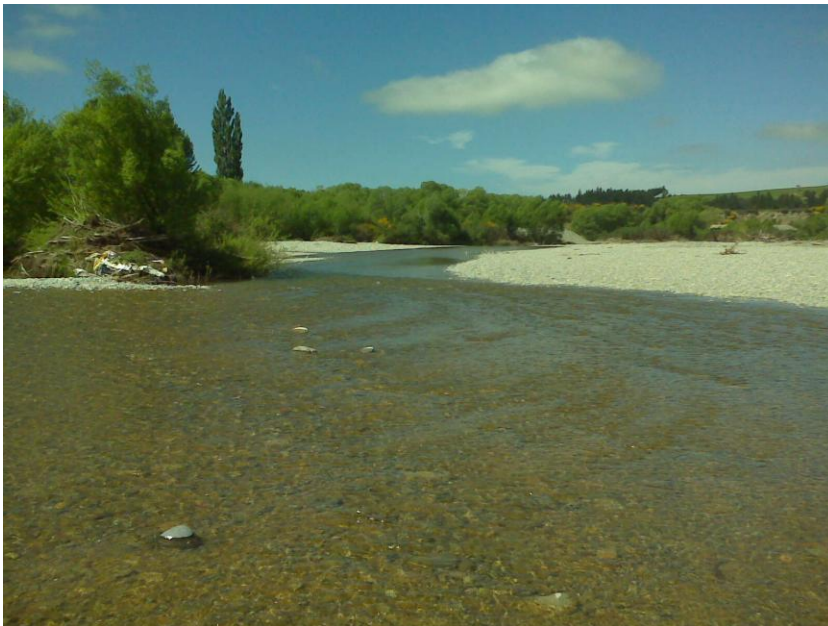
Waianakarua: WA7N

Cross-section WA7N is located 9.9km upstream of the Waianakarua River mouth on the North Branch at Sharps Bend. Sharps bend is an area of historic and recent gravel extraction activity and changes at this location reflect both natural and artificial change. Between June 2004 and February 2008 the bed both aggraded and degraded with the channel becoming smoother in 2008. Between February 2008 and October 2013 the left bank eroded approximately 9m and degraded 6m creating a deep secondary channel (point labelled A). The main channel degraded with aggradation occurring on the right bank between February 2008 and October 2013 creating a narrower deeper main channel. The thalweg degraded by 0.4m between 2008 and 2013.

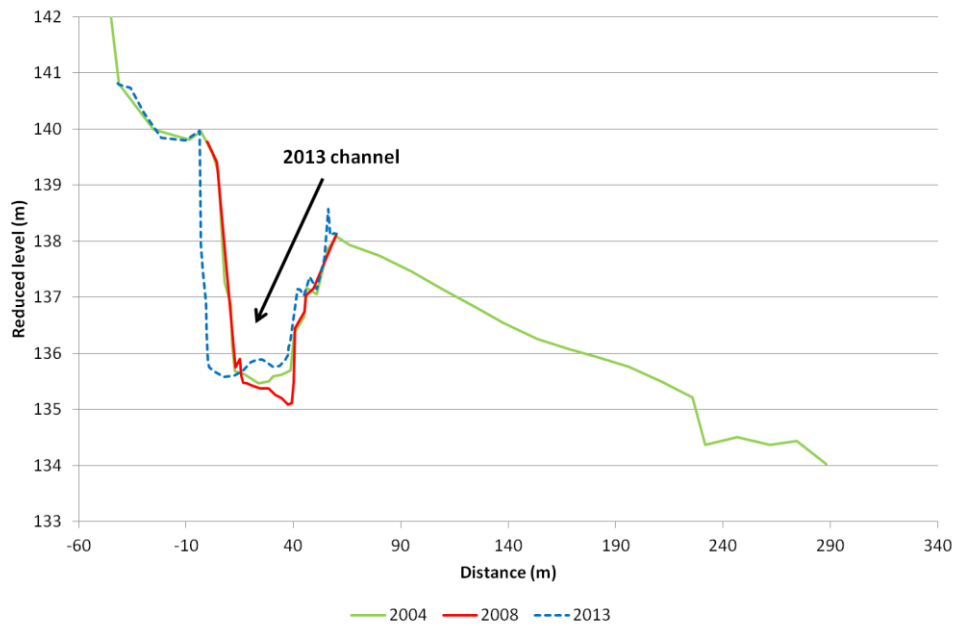
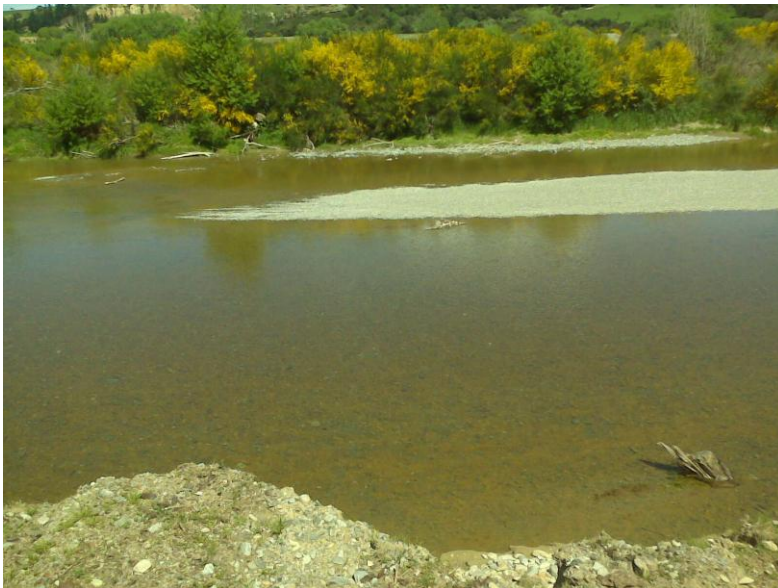
Waianakarua: WA8N

Cross-section WA8N is located 10.25km upstream of the Waianakarua River mouth on the North Branch at Sharps Bend. Sharps bend is an area of historic and recent gravel extraction activity and changes at this location reflect both natural and artificial change. Between June 2004 and February 2008 the main channel bed degraded by approximately 0.5m. Between February 2008 and October 2013 the left bank eroded by approximately 13m with the main channel aggrading by approximately 0.75m creating a wider shallower channel. Some aggradation occurred on the right bank between 2008 and 2013. Changes on the true right wider floodplain cannot be verified, as surveys in 2013 and 2008 did not extend as far to the true right as that completed in 2004. The thalweg aggraded by 0.49m between 2008 and 2013.

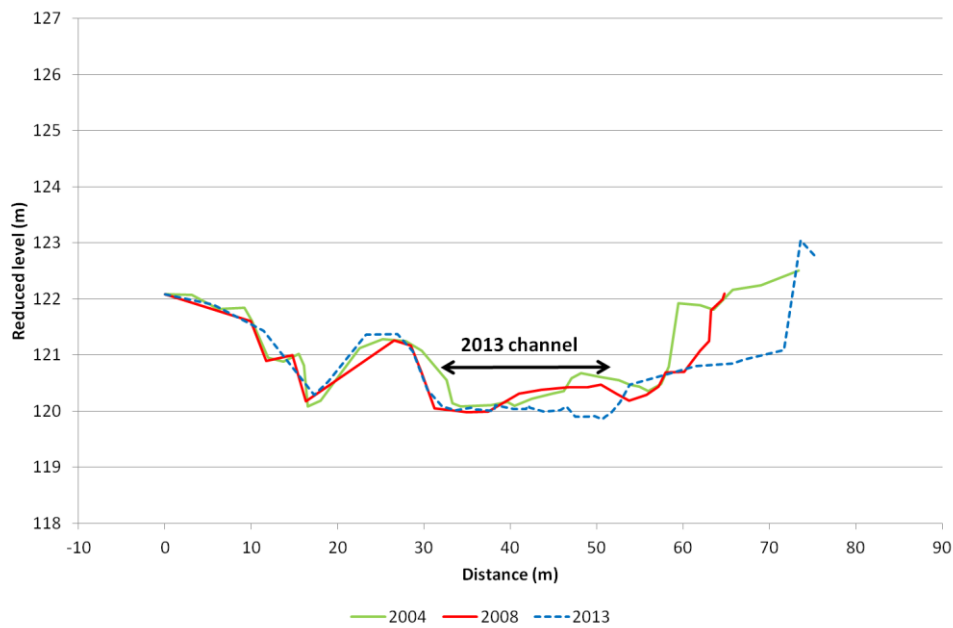
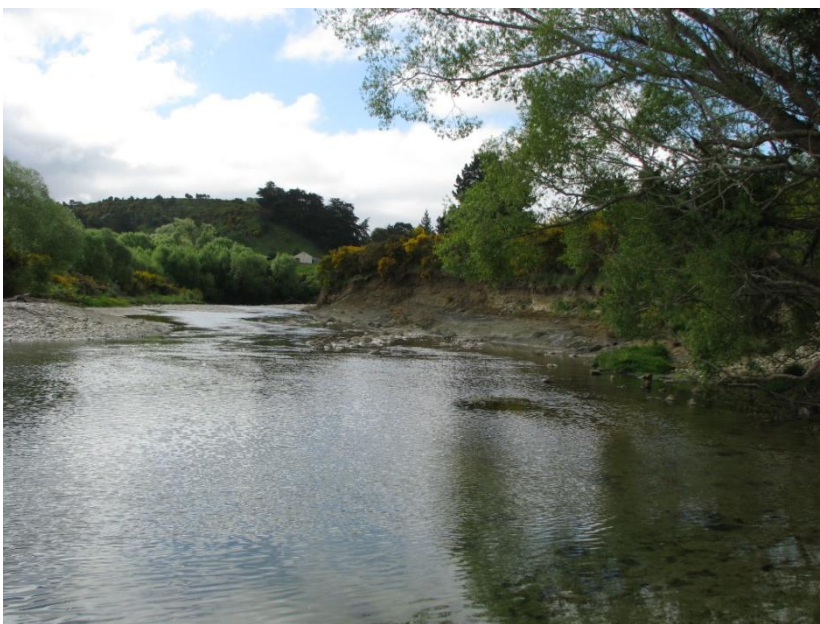
Waianakarua River: WA5S

Cross-section WA5S is located 6.85km upstream of the Waianakarua River mouth on the South Branch. Between June 2004 and February 2008 there was erosion of the left and right banks with the channel bed aggrading in some places and degrading in others. Continued erosion at this location would affect farmland on the right bank. Between February 2008 and October 2013 the wider left floodplain aggraded creating a smoother profile with degradation occurring in the main channel. The right bank eroded approximately 14m between 2004 and 2013. Changes on the true right wider floodplain between 2008 and 2013 cannot be verified, as the 2008 survey did not extend as far to the true right as that completed in 2004 and 2013. The thalweg degraded by 0.12m between 2008 and 2013.

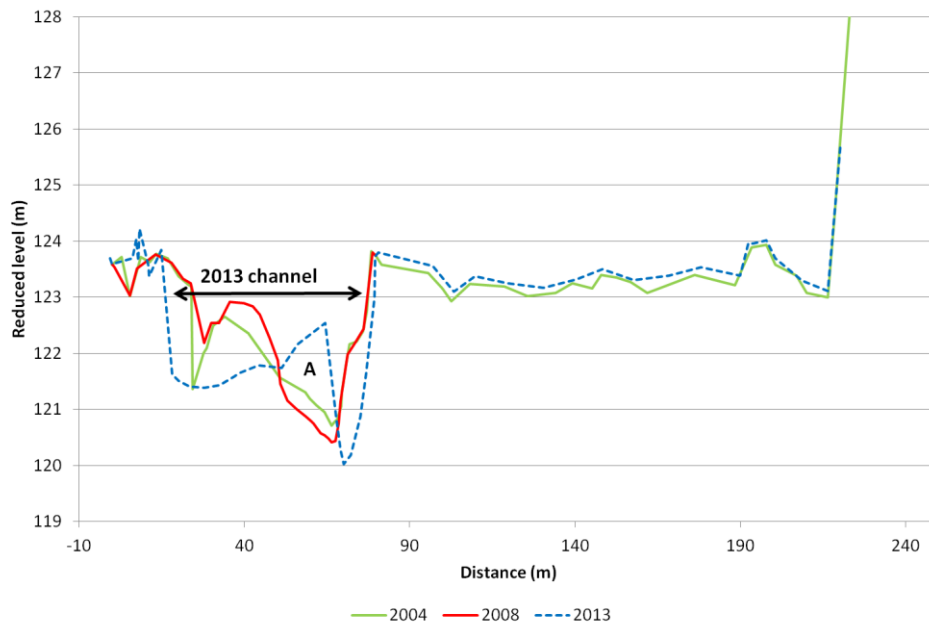
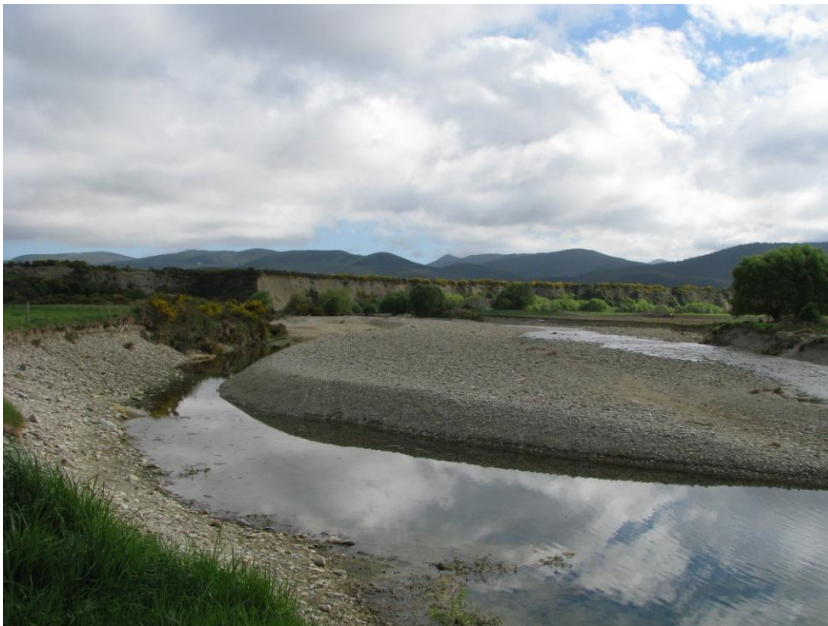
Waianakarua: WA6S

Cross-section WA6S is located 7km upstream of the Waianakarua River mouth on the South Branch. Between June 2004 and February 2008 there was aggradation of the left bank with the main channel bed degrading. Between February 2008 and October 2013 the left and right banks eroded with aggradation occurring in the 2004/2008 main channel. This has created two channels separated by a gravel bar (Figure 39) (point labelled A). The wider right bank floodplain has aggraded between 2004 and 2013. Changes on the true right wider floodplain between 2008 and 2013 cannot be verified, as the 2008 survey did not extend as far to the true right as that completed in 2004 and 2013. The thalweg degraded by 0.4m between 2008 and 2013.

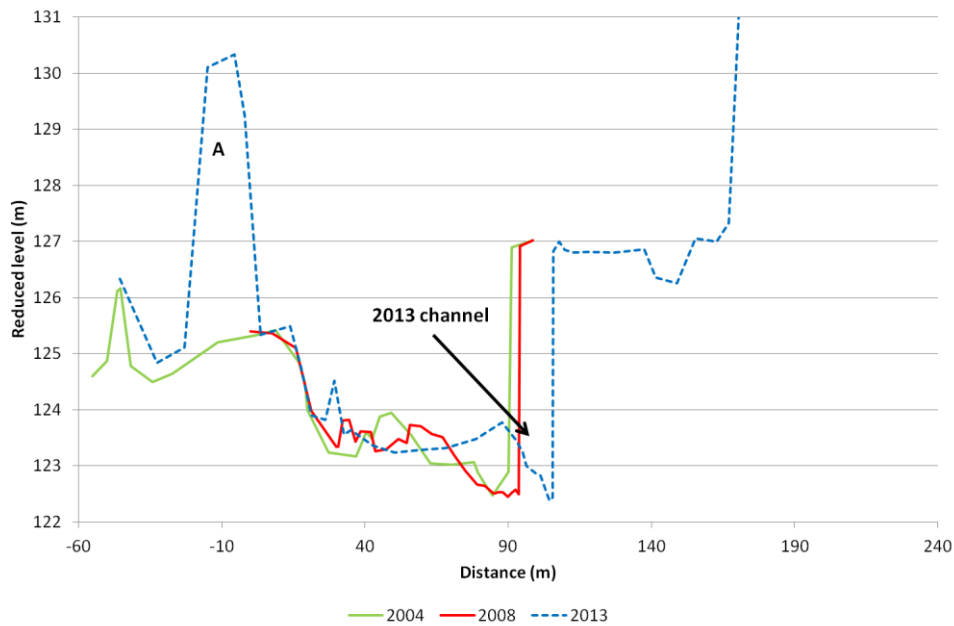
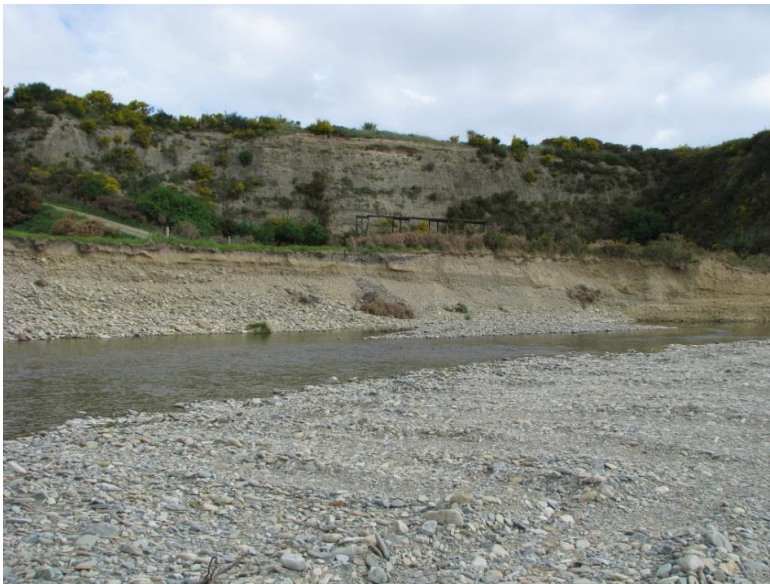
Waianakarua: WA7S

Cross-section WA7S is located 7.4km upstream of the Waianakarua River mouth on the South Branch. Between June 2004 and February 2008 the right bank eroded causing the main channel to shift towards the right bank. Between February 2008 and October 2013 the right bank eroded with both aggradation and degradation occurring across the main channel. If erosion of the right bank continues, farmland and a farm shed may become affected. Gravel is extracted from this location, the large bank feature (point labelled A) is a gravel stockpile and not a natural feature. Changes on the true right and true left wider floodplain between 2004-2013 cannot be verified, as the 2008 and 2004 surveys do not extend as far on the true right or left banks as that completed in 2013. The thalweg remained at a similar height between 2008 and 2013.

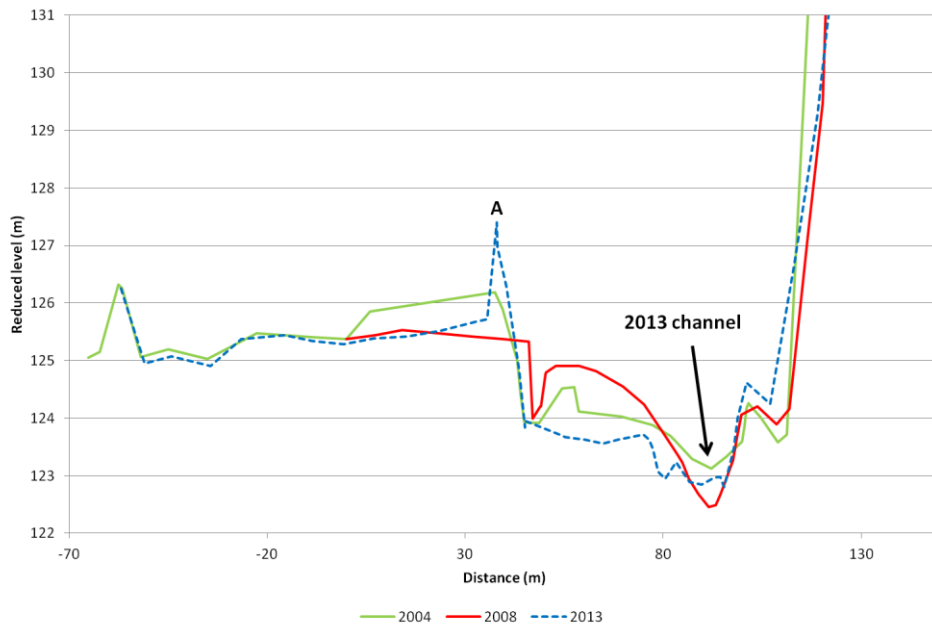
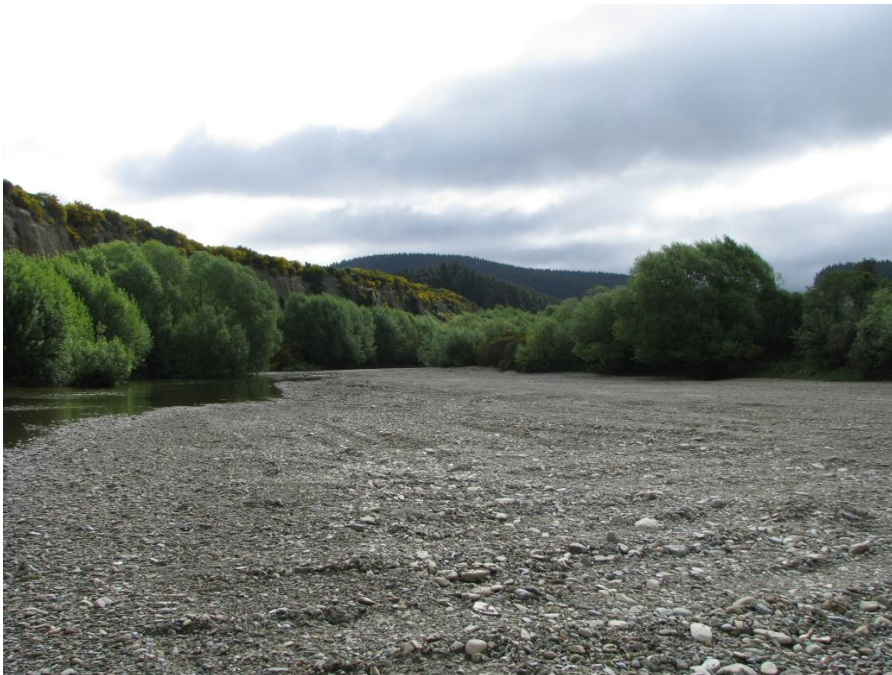
Waianakarua: WA8S

Cross-section WA8S is located 7.7km upstream of the Waianakarua River mouth on the South Branch. Between June 2004 and February 2008 the right bank eroded, the main channel degraded, and the left bank aggraded creating a narrower deeper channel. Between February 2008 and October 2013 the right bank and main channel aggraded. The left bank of the main channel degraded, creating a wider shallower channel. The top of the left bank has been shaped into a bank feature (point labelled A). Gravel is extracted from this location. The thalweg aggraded 0.35m between 2008 and 2013.

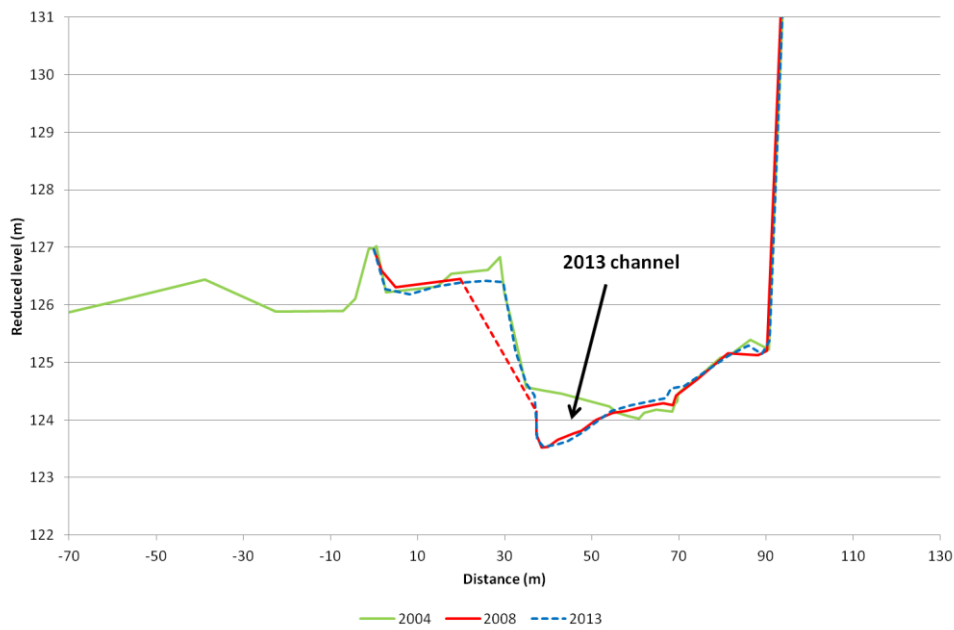
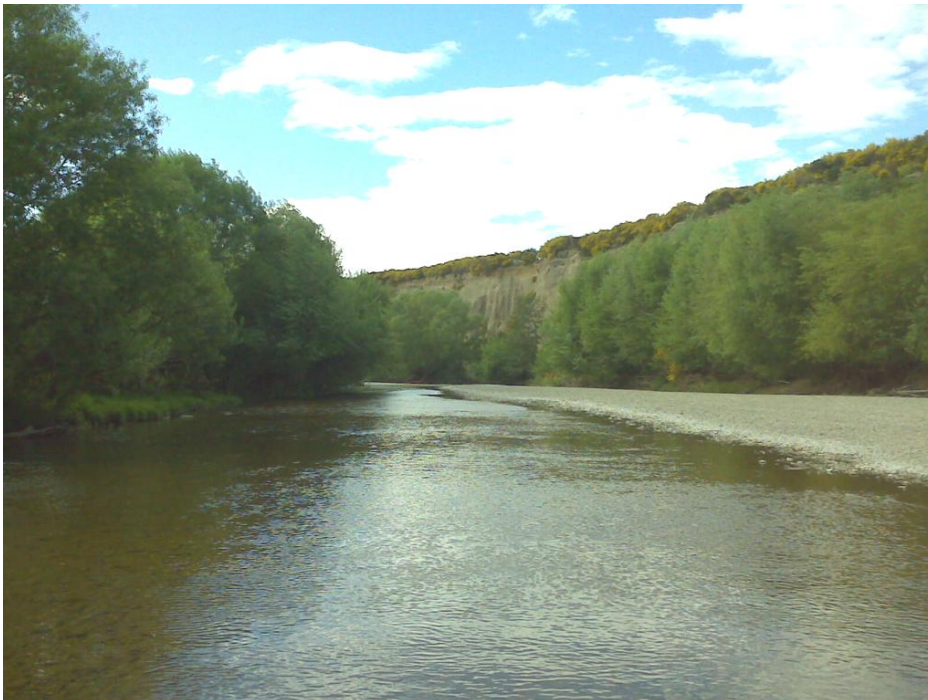
Waianakarua:WA9S

Cross-section WA9S is located 7.85km upstream of the Waianakarua River mouth on the South Branch. Between June 2004 and February 2008 the left bank eroded (although the 2008 data is unconfirmed for the left bank), the main channel degraded, and a small amount of aggradation occurred in the 2004 main channel. Between February 2008 and October 2013 the left bank aggraded to a similar position as 2004, the main channel remained in the same position as 2008. The thalweg level did not move vertically or horizontally between 2008 and 2013.

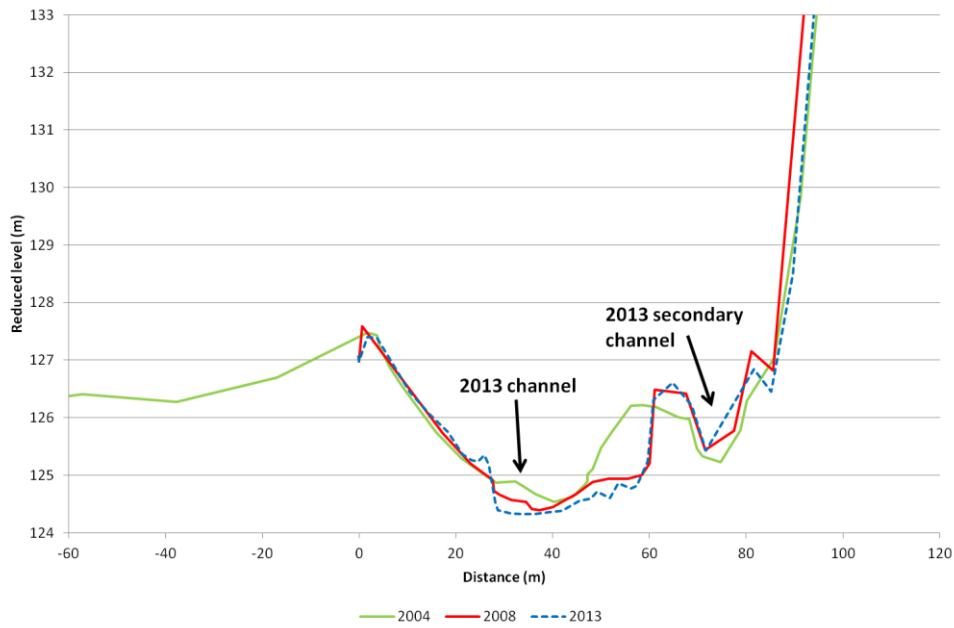
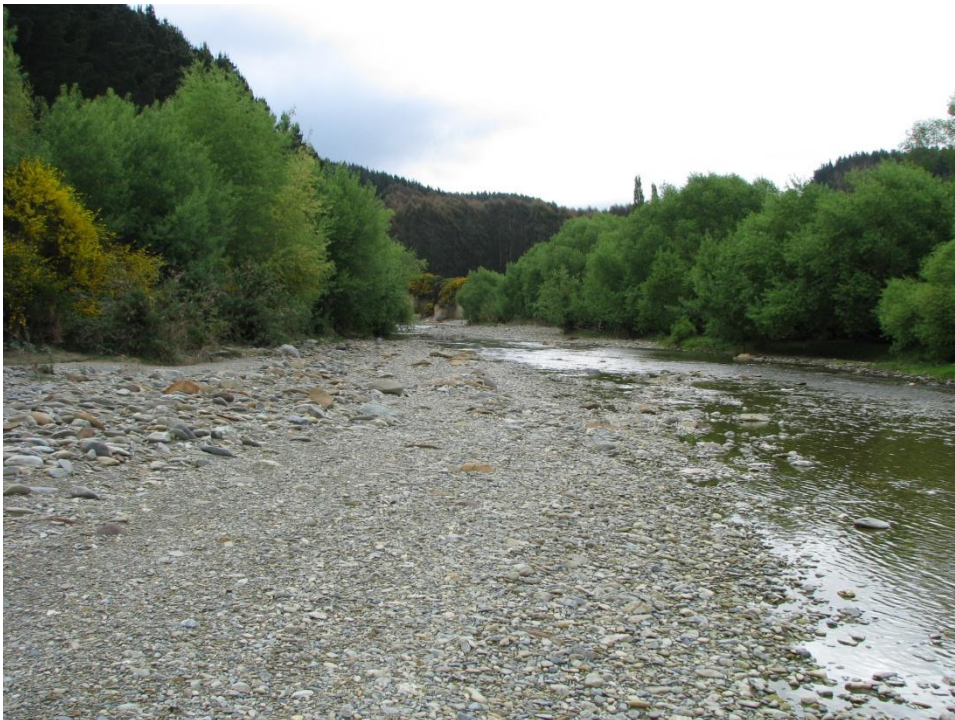
Waianakarua:WA10S

Cross-section WA10S is located 9.85km upstream of the Waianakarua River mouth on the South Branch. Between June 2004 and February 2008 the right bank of the main channel eroded approximately 10m with aggradation occurring on the right bank of the secondary channel. Between February 2008 and October 2013 the main channel degraded with both aggradation and degradation occurring on the right bank of the secondary channel. The thalweg degraded 0.07m between 2008 and 2013.
