Channel morphology of the Waianakarua River, North Otago

Technical Summary

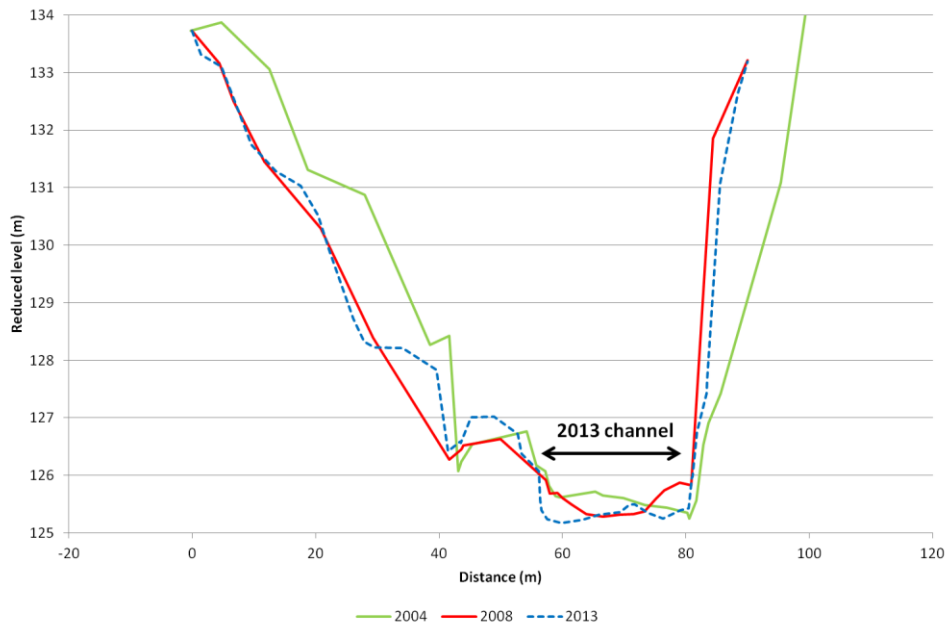
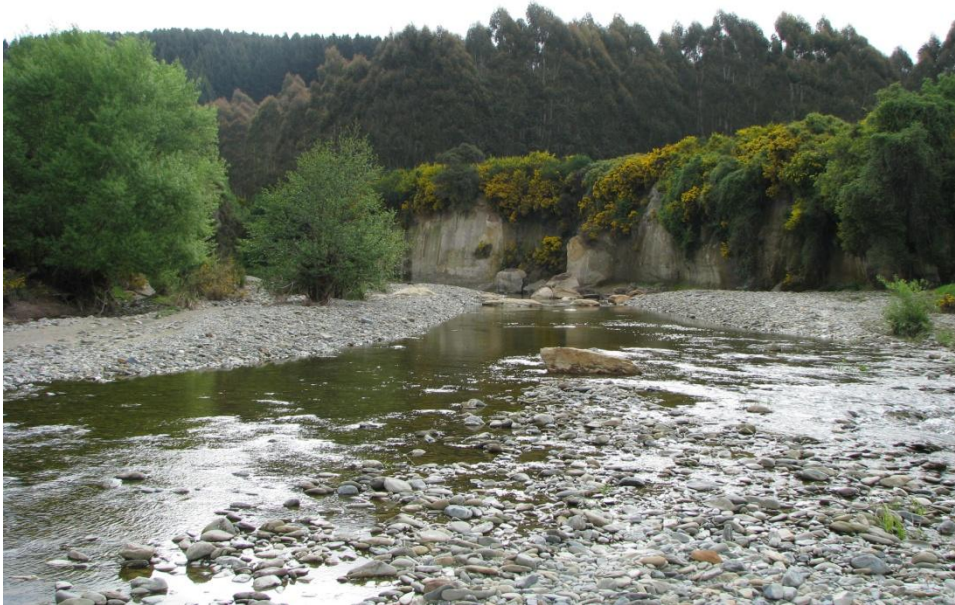
Waianakarua: WA11S

Cross-section WA11S is located 10.1km upstream of the Waianakarua River mouth on the South Branch. Between June 2004 and February 2008 the right bank of the main channel aggraded, the left bank degraded, and the main channel both aggraded and degraded. Between February 2008 and October 2013 the main channel degraded with aggradation occurring on the left bank and degradation occurring on the right bank. The thalweg degraded 0.11m between 2008 and 2013.

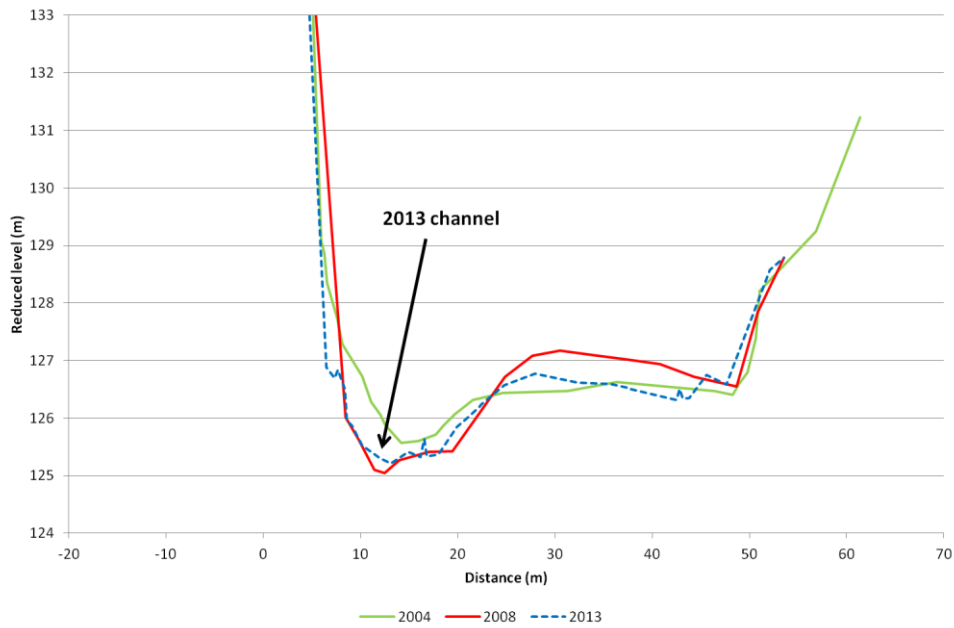
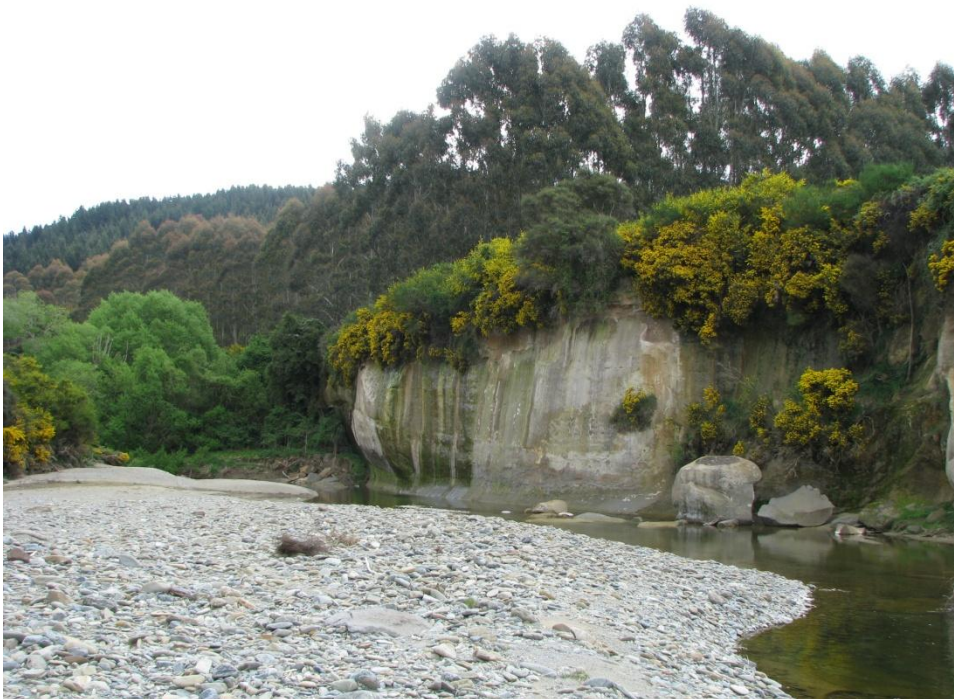
Waianakarua:WA12S

Cross-section WA12S is located 10.4km upstream of the Waianakarua River mouth on the South Branch. Between June 2004 and February 2008 the main channel degraded by approximately 0.75m, with the right bank floodplain aggrading by approximately 0.5m. Between February 2008 and October 2013 the main channel aggraded, the left bank eroded by approximately 2m, and the right bank floodplain degrading to a similar level as 2004. The thalweg degraded 0.16m between 2008 and 2013.

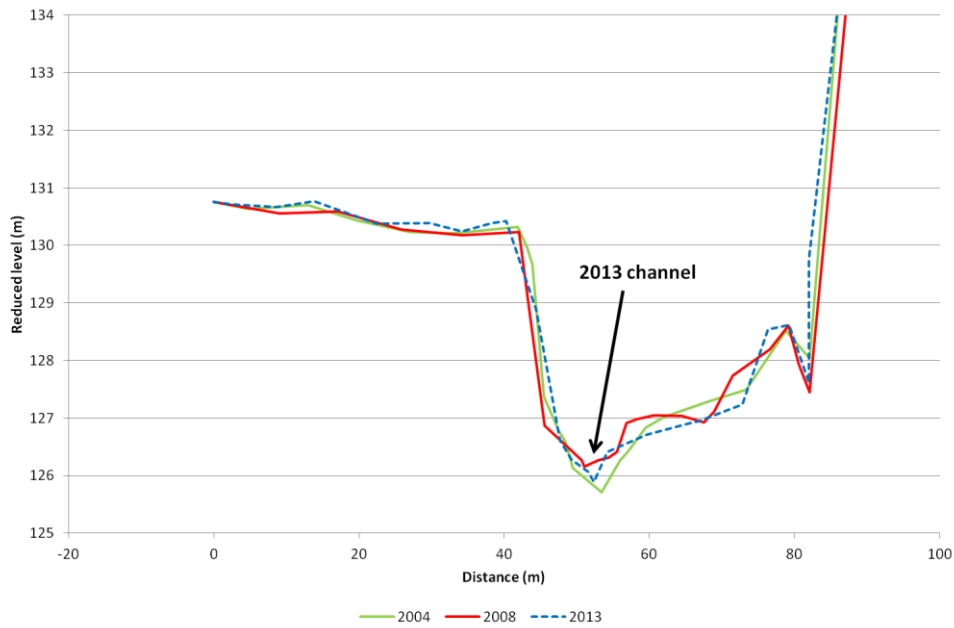
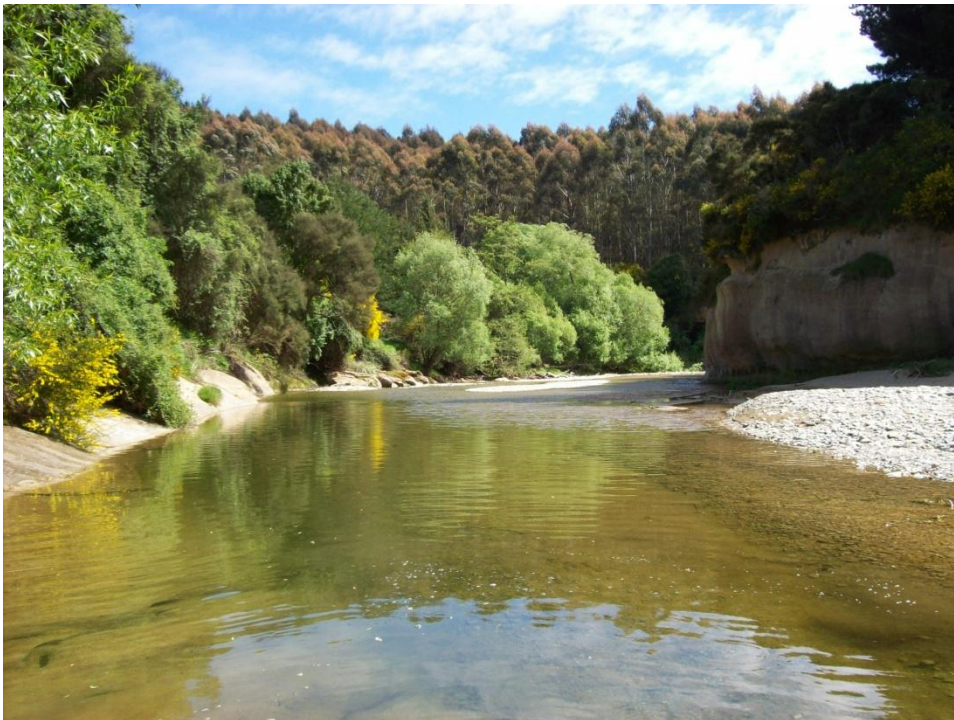
Waianakarua: WA13S

Cross-section WA13S is located 10.7km upstream of the Waianakarua River mouth on the South Branch. Between June 2004 and February 2008 the main channel aggraded by approximately 0.5m, the right bank floodplain both aggraded and degraded, and the left bank eroded by approximately 2m. Between February 2008 and October 2013 the main channel and the true right floodplain degraded and both the left and right banks aggraded by approximately 3m. The thalweg degraded 0.26m between 2008 and 2013.

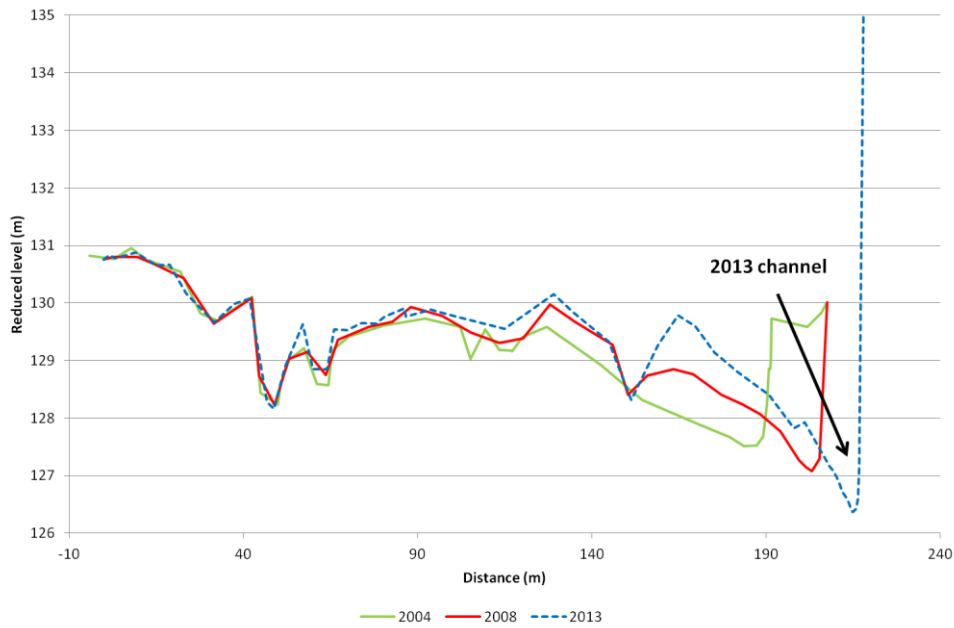
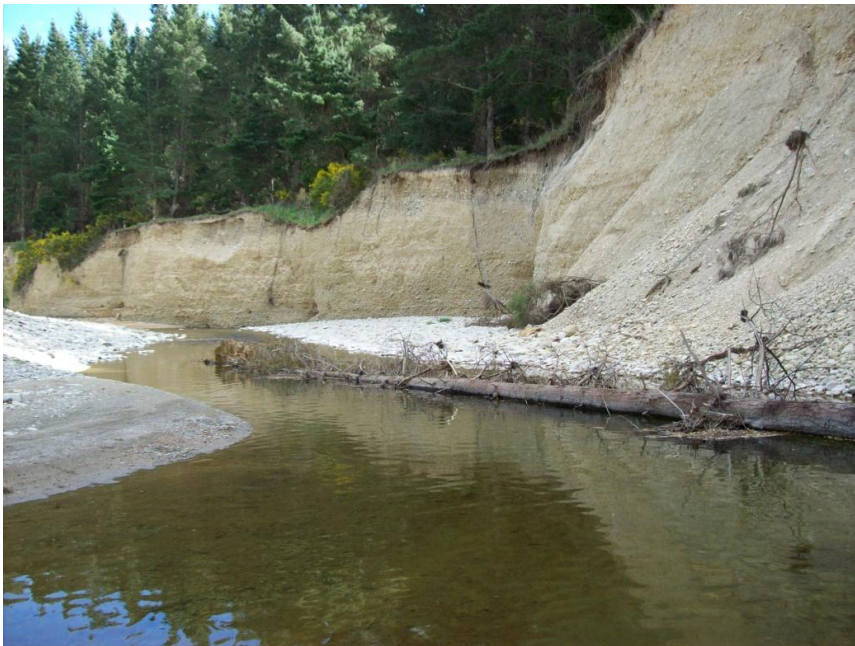
Waianakarua: WA14S

Cross-section WA14S is located 10.9km upstream of the Waianakarua River mouth on the South Branch. Between June 2004 and February 2008 the main channel degraded by approximately 0.5m, the left bank floodplain aggraded and the right bank eroded by approximately 18m. Between February 2008 and October 2013 the main channel degraded by approximately 0.5m, the left bank floodplain aggraded and the right bank eroded by approximately 13m. This shows that the river is currently continuing to move towards and erode the right bank, if this erosion continues more farmland will begin to be affected. The thalweg degraded 0.70m between 2008-2013.

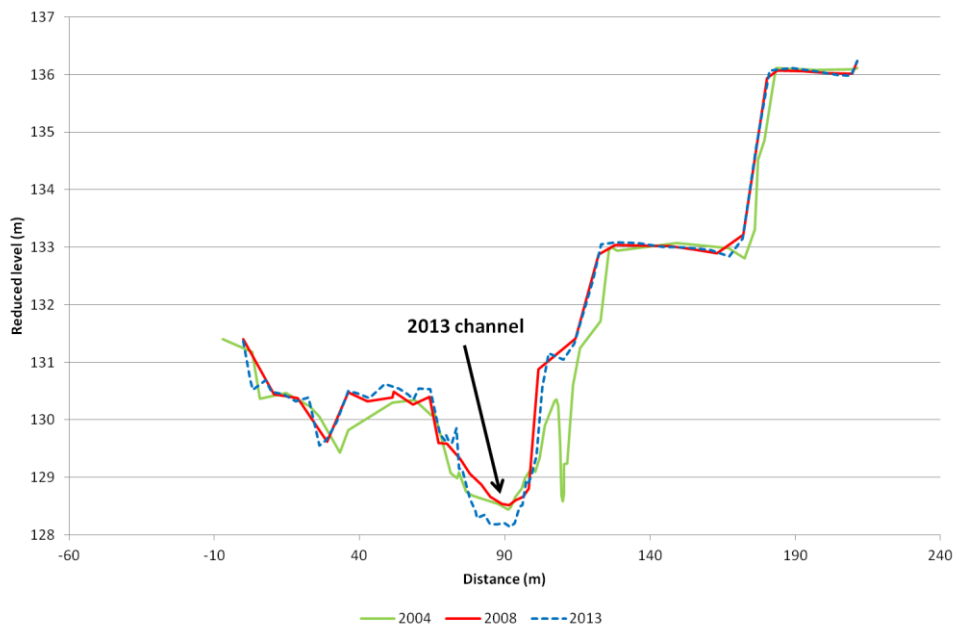
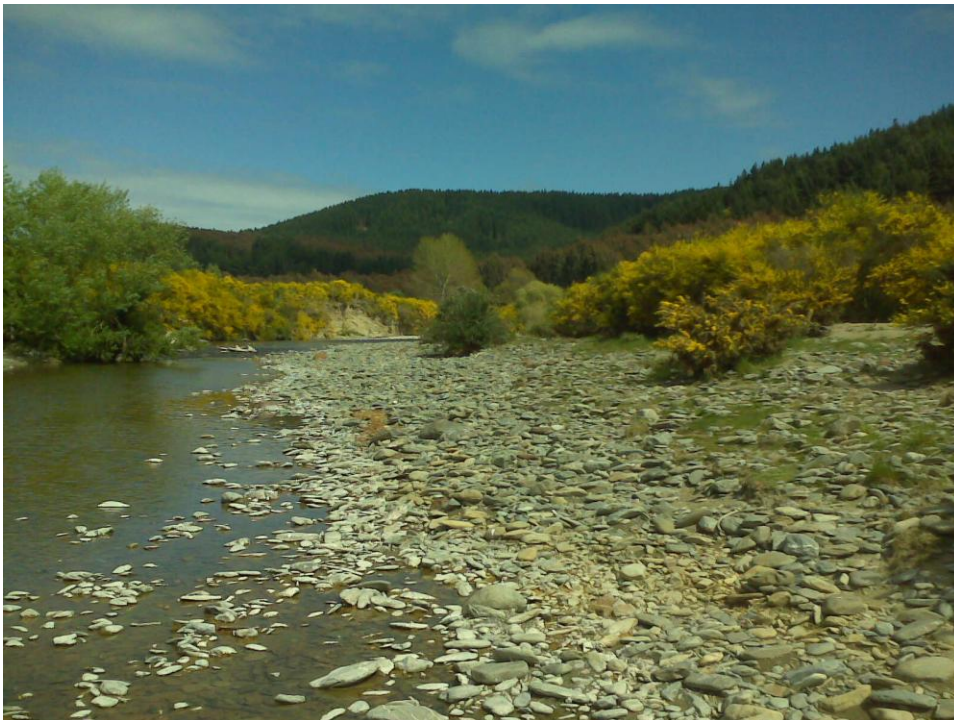
Waianakarua: WA15S

Cross-section WA15S is located 11.1km upstream of the Waianakarua River mouth on the South Branch. Between June 2004 and February 2008 both banks of the main channel aggraded, with aggradation occurring the on the right bank and the left bank floodplain. Between February 2008 and October 2013 the main channel degraded by approximately 0.4m, the left and right bank floodplains remained similar. The thalweg degraded 0.38m between 2008 and 2013.
