# **Otago Alluvial Fans: High Hazard Fan Investigation**

**June 2011**

Otago Regional Council

Prepared by Richard Woods, Natural Hazards Analyst, Otago Regional Council

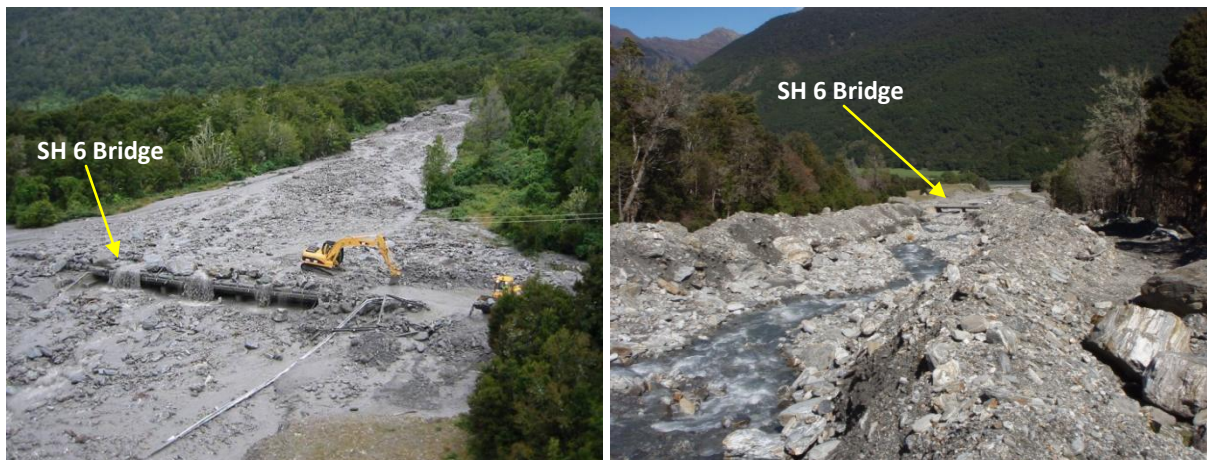
**Figure 1.2** Pipson Creek in March 2004 (left), looking upstream, and November 2008 (right), looking downstream. In the left image, the creek has aggraded, so that the channels are migrating laterally outside of the channels low-flow banks; the hydrographic apex is located upstream and out of sight. In the right image, excavation and channel contouring has confined the channel to a single-thread channel, far beyond the state highway; the hydrographic apex is located near the confluence with Makarora River in this image.

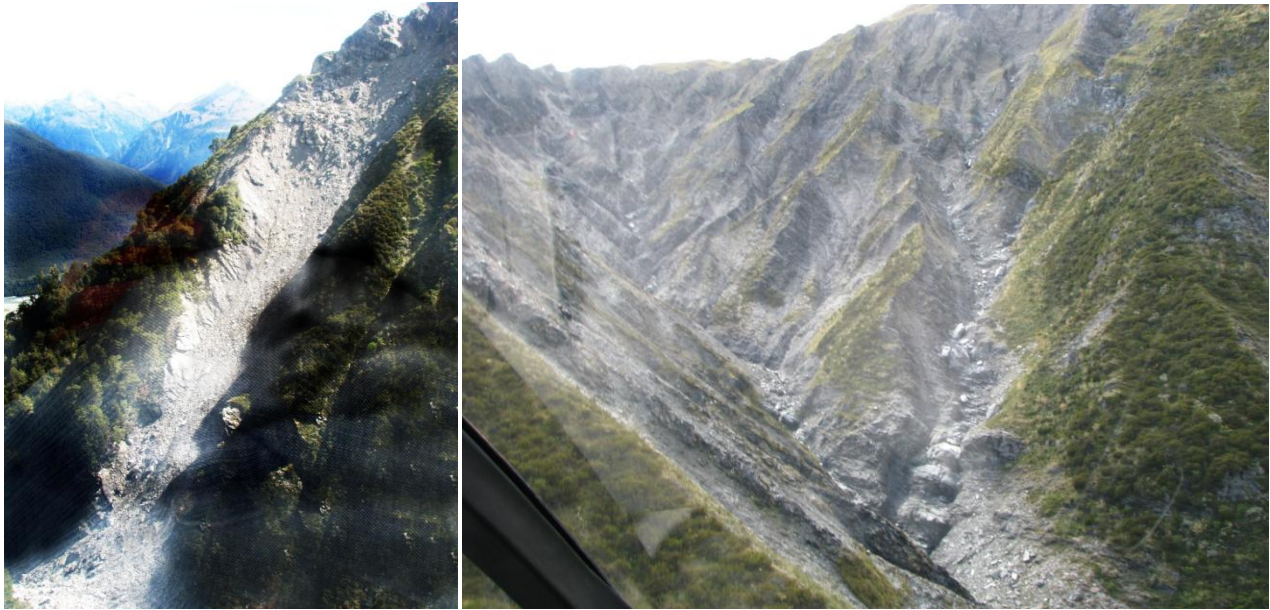
Figure 2.3 also shows *Photo C2* (Figure 2.2) of the upper catchment slopes on 7 March 2011. Steep fresh, gullying of bedrock in the head of the catchment shows that large clasts of material are being actively supplied to the Pipson Creek channel throughout the upper catchment.

**Figure 2.3** Photo C1 (left) and Photo C2 (right), showing recent mass movement in the upper catchment of Pipson Creek on 7 March 2011

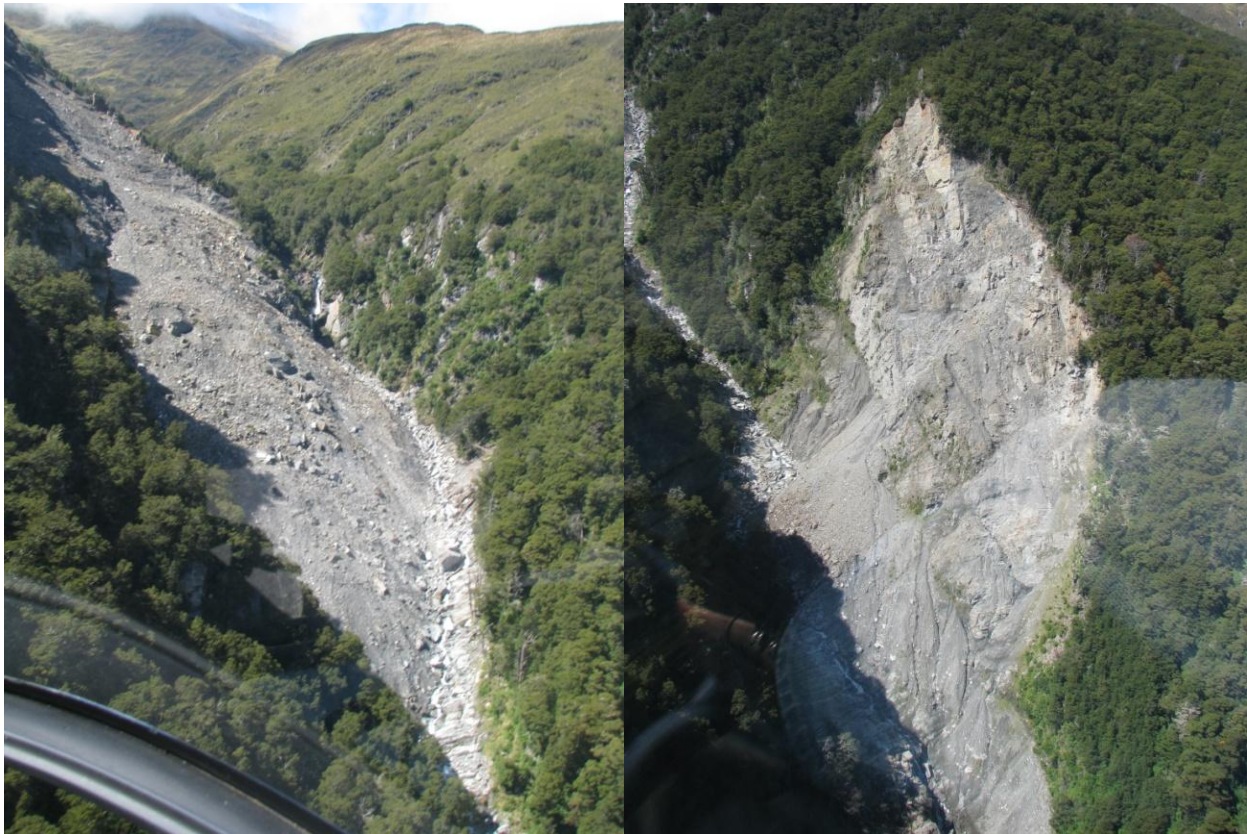
Field observations indicate that the majority of the Pipson Creek catchment is dominated by mass-movement processes. An increased level of instability has been observed in the catchment over the last 50 years, a phenomenon that continues today.

**Figure 2.4** Pipson Creek lower-catchment primary-source areas. The main source area, as identified by Opus (2004), is viewed on the left, while the secondary source area is shown on the right

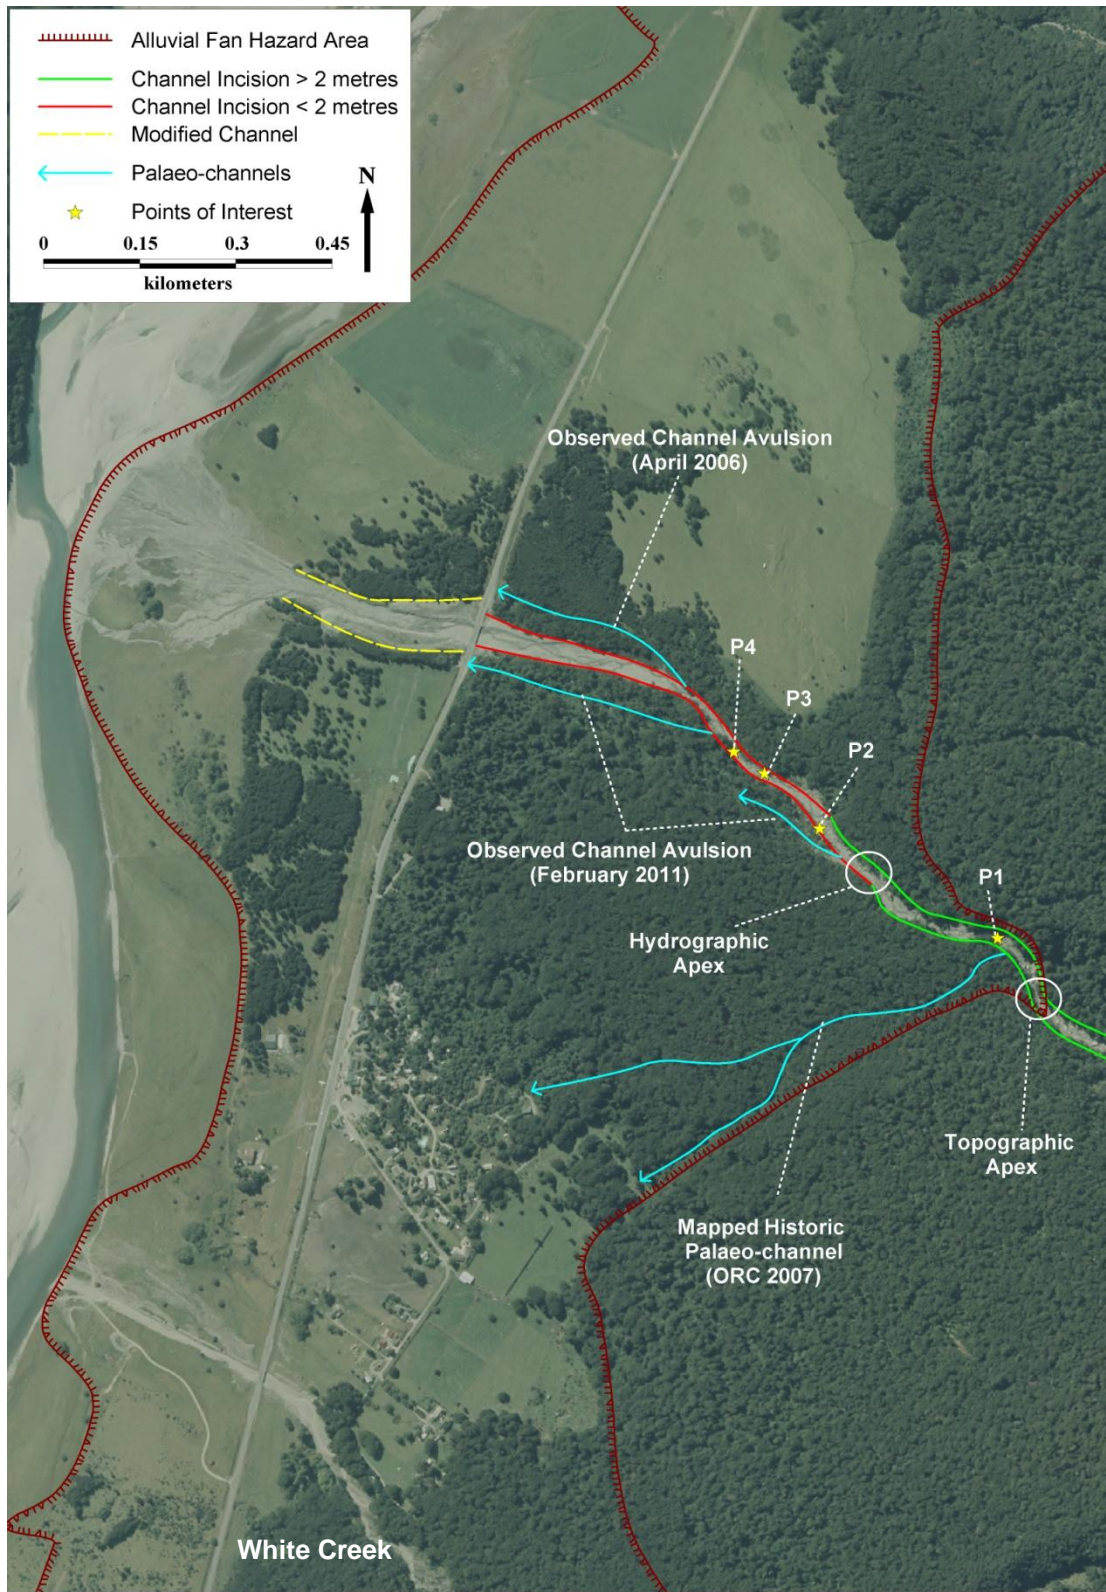
In the lower reaches of the fan, there is little elevation difference (freeboard) between the natural channel level and the level of the surrounding alluvial-fan surface. As shown in Figure 2.5, the channel has been considerably modified by in-channel excavation and works downstream of the SH 6 bridge.

**Figure 2.5** Pipson Creek alluvial fan, noting some key alluvial fan features; aerial photo dated March 2006

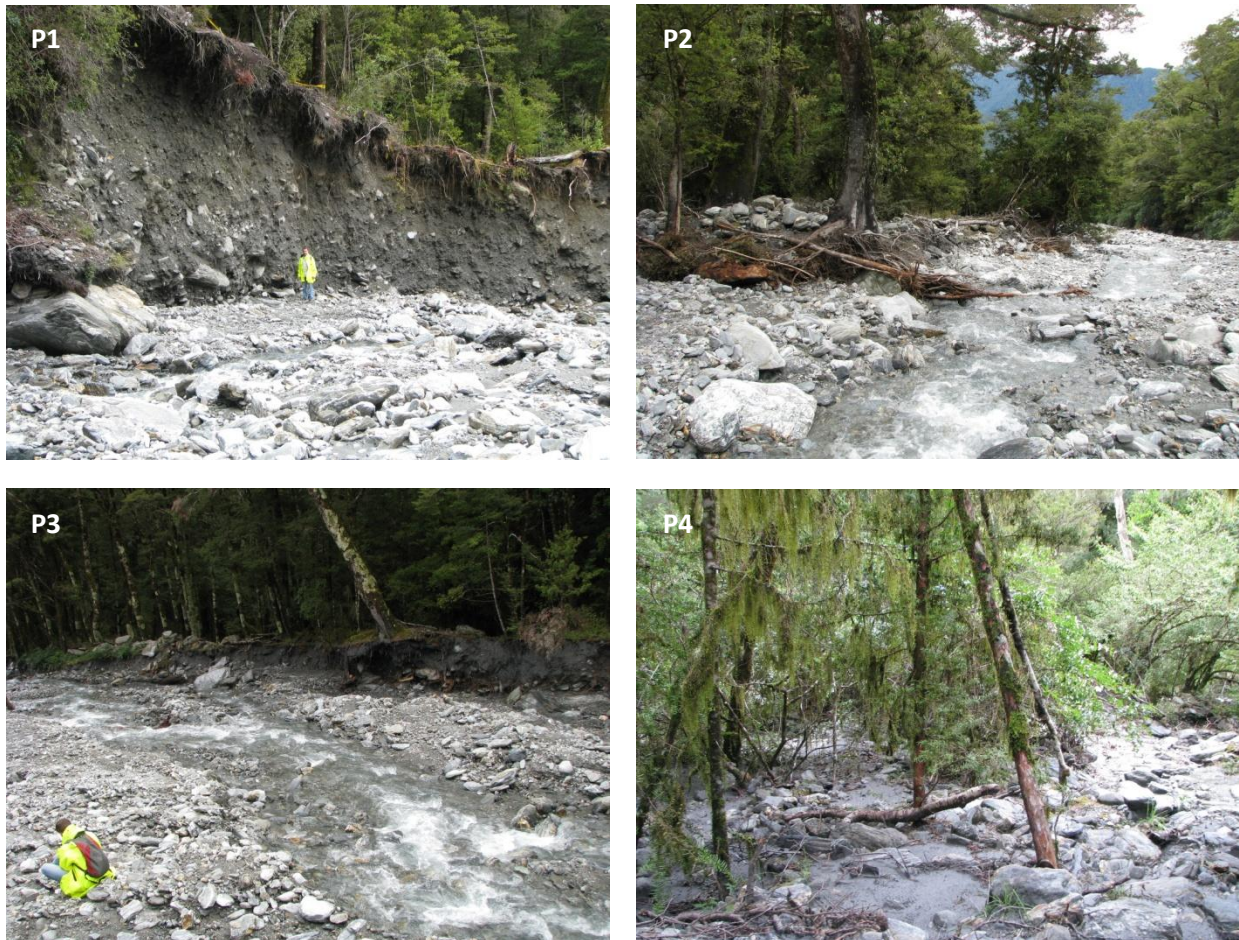
**Figure 2.6** Photographs relating to the points of interest identified in Figure 2.5. P1 shows greater than 10m of channel incision into the alluvial-fan surface near the fan-topographic apex. P2 shows super-elevation of the true right of the Pipson creek bed, causing avulsion onto the true-left alluvial-fan surface. P3 shows the concave aspect of a slight channel meander, inducing erosion of the true-right bank. P4 shows deposition on the alluvial-fan surface as a result of Pipson Creek avulsing from its channel.

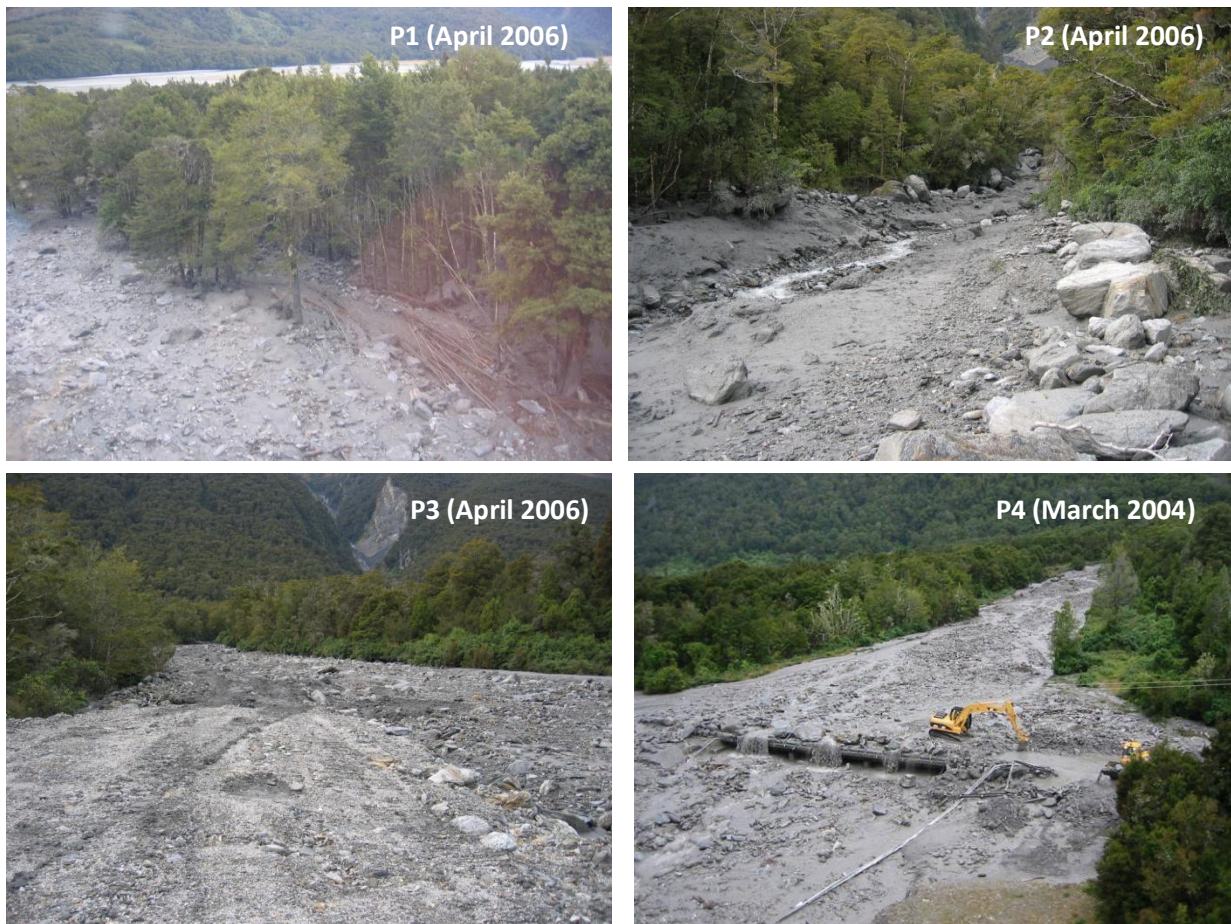
**Figure 2.7** Pipson Creek, following large debris flows in 2004 and 2006. Photo P1 shows significant bank overflow on the true-right channel upstream of the SH6 bridge. Photo P2 shows large levee embankments formed on the outside of the channel, which are indicative of high-velocity-debris flows on the upper fan. Photo P3 shows bank-full conditions upstream of the SH6 bridge, after debris flow in 2006. Photo P4 shows bank-full conditions, upstream of the SH6 bridge, after debris flow in 2004.

Debris-flow events in Pipson Creek will recur, as has been observed in recent times. Channel aggradation, erosion, bank overflow and avulsion will occur in varying magnitudes, depending on the nature and characteristics of the storm event and condition of the catchment. It is likely that bank overflow and aggradation will occur in those locations where channel incision is less than 2m and further upstream in very large events. While the fan is heavily forested, woody debris and trees often exacerbate the possible effects of debris flow and cannot be relied upon as suitable mitigation.

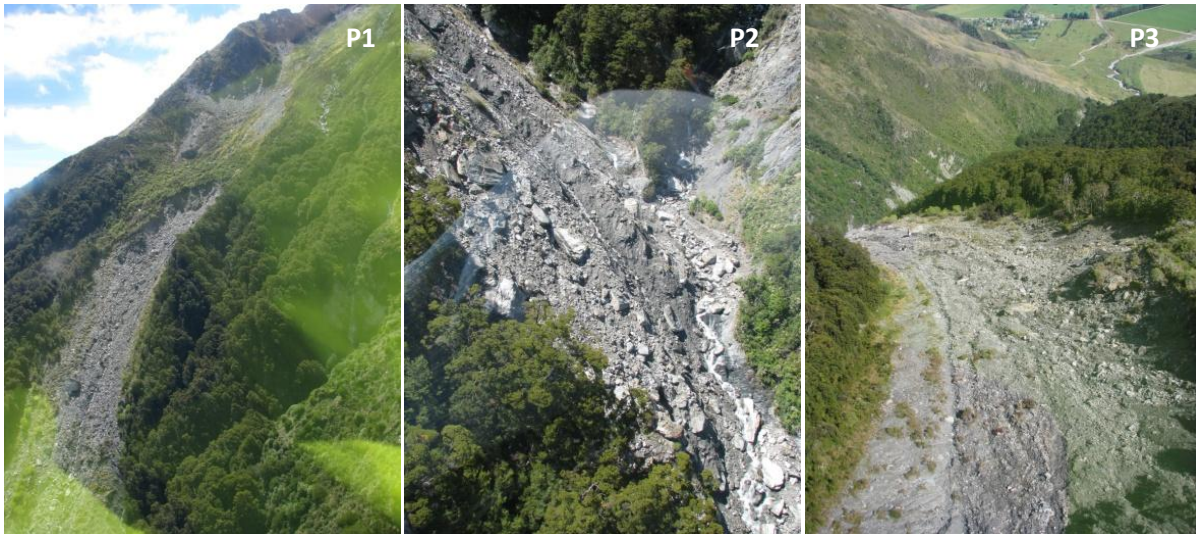
Field investigations, undertaken by ORC on 7 March 2011, indicate that a primary-sediment-source area in Flaxmill Creek (Figure 3.2) is actively providing sediment to the channel (Figure 3.3). The absence of vegetation on this slip area, particularly when compared to 2006 aerial photography (Appendix 1), indicates that it has been active during the period 2006 to 2011. Intense rainfall events, greater than 20mm/hour, in February 2011 and December 2010, have likely contributed to the reactivation of this slip, as well as progressive incision of the toe by Flaxmill Creek.

**Figure 3.3** The primary-sediment-source area in the Flaxmill Creek catchment on 7 March 2011, as annotated in Figure 3.2. Photo P1 shows the fresh face of this slip area, leading up to the head of slide where instability has been initiated. P2 shows the toe of the primary-source area and shows incision by Flaxmill Creek. The fresh slip face is observed in Photo 3, indicating the recent removal of material.

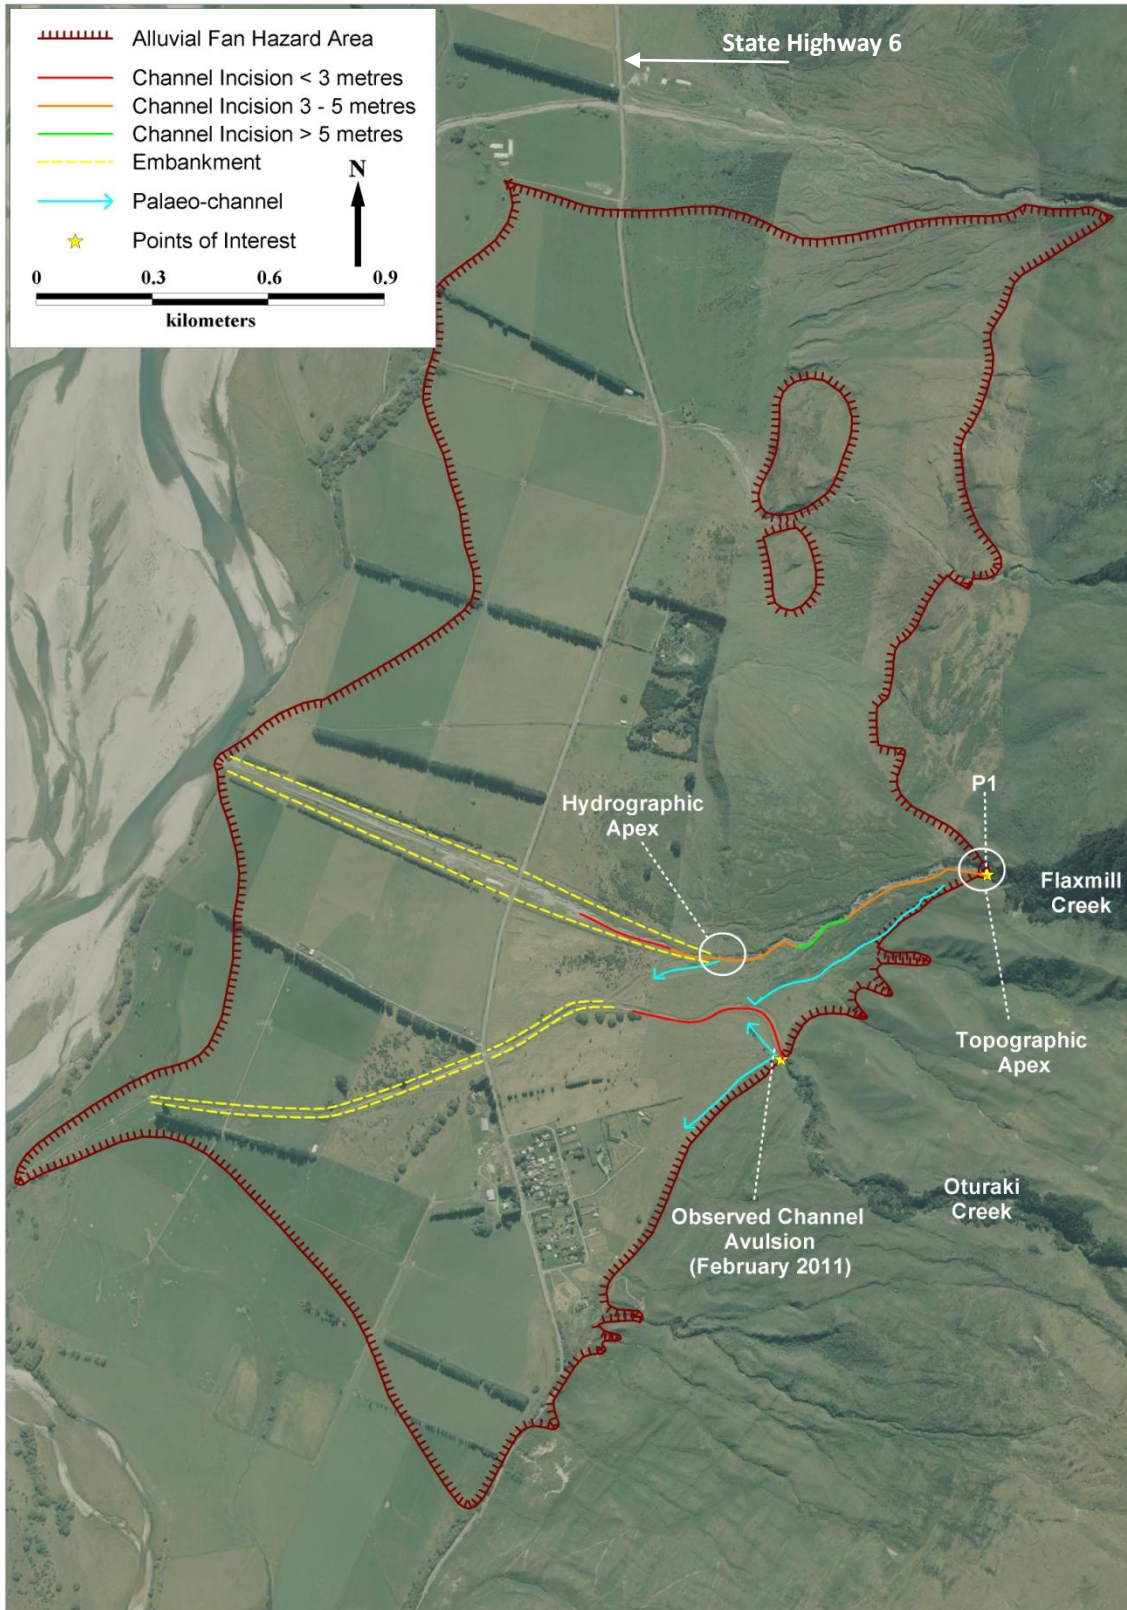
Figure 3.4 shows Flaxmill and Oturaki creeks' alluvial fans and key features. Channel incision varies along the length of the Flaxmill Creek alluvial fan. Near the topographic apex of the fan, where the creek leaves the confines of the valley, the channel is incised by between 3-5m (Figure 3.5). In this reach of the fan, the channel is subject to rapid aggradation during storm events, as observed in Figure 3.5. Such aggradation has historically induced avulsion of the channel, spilling debris flows across the true-left alluvial-fan surface, with large lobate-debris deposits observed in this location. In addition, large palaeochannels exist (Figure 3.5), where flow has historically been transferred down the southern part of the fan surface. The true-right fan surface is elevated above the true left in this location, as mapped in Barrel *et al.* (2009).

**Figure 3.4** Flaxmill and Oturaki creek alluvial fans, noting some key alluvial fan features; aerial photo dated March 2006

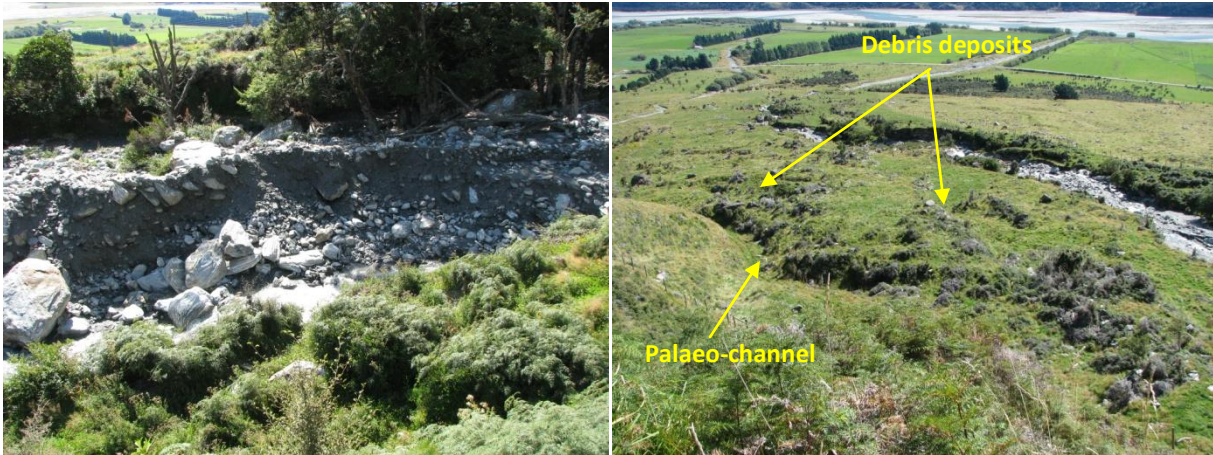
**Figure 3.5** Flaxmill Creek alluvial fan just downstream of P1, as shown on Figure 3.4. At this location, metres of recent channel aggradation (left) have been incised by the active channel. Large debris deposits and palaeo-channels (right) are located on the true-left surface of the alluvial fan.

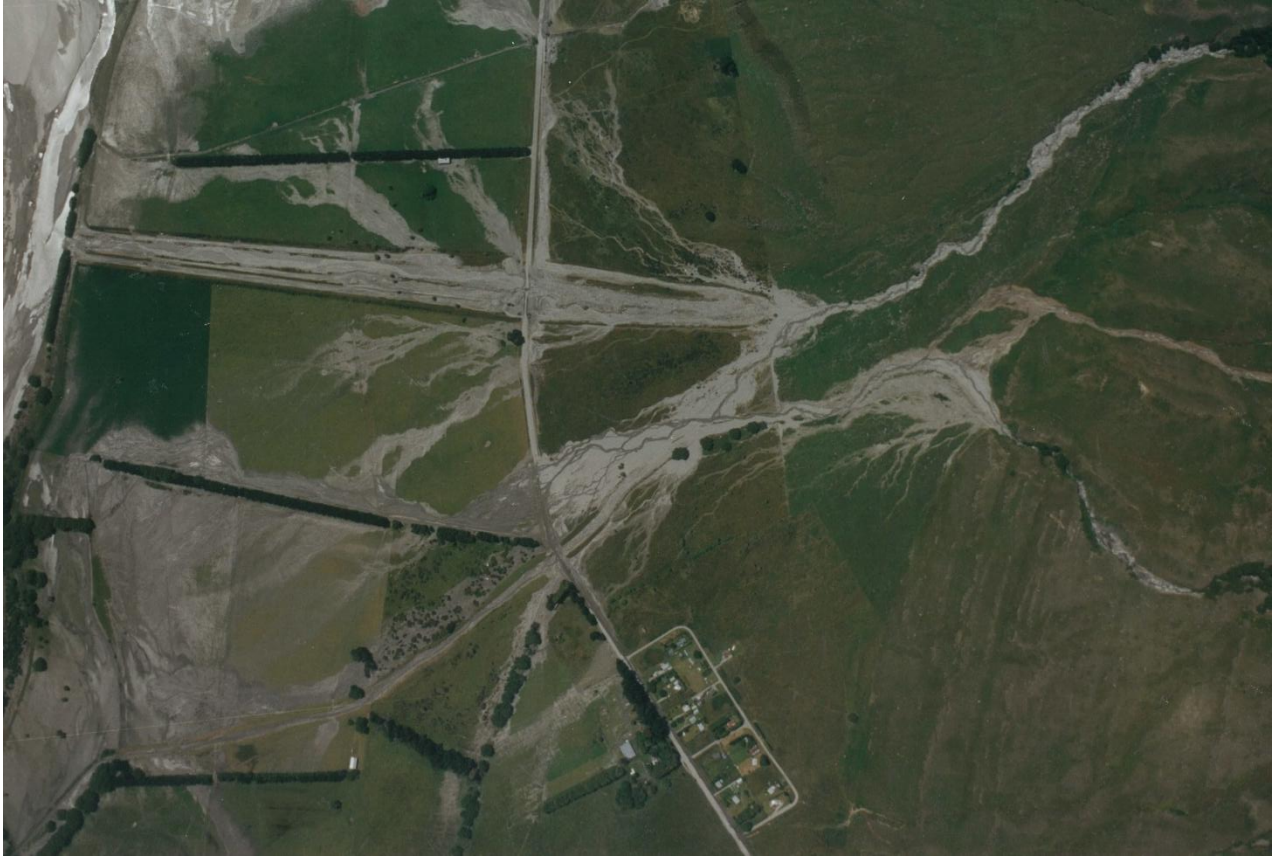
**Figure 3.6** Flaxmill and Oturaki creeks, following the storm event of January 1994

Debris and flood flows have been well observed on the Flaxmill Creek alluvial fan in recent decades. Figure 3.6 shows considerable in-channel aggradation and channel avulsion, from debris and debris-flood flows in January 1994.

The lateral migration of channels was well observed in January 1994, with large areas of the fan surface being subjected to flows and subsequent sedimentation (Figure 3.6). In the lower reaches, the fan is more susceptible to floodwater inundation processes and is likely to reoccupy palaeo-channels on the southern margins of the fan in the future.

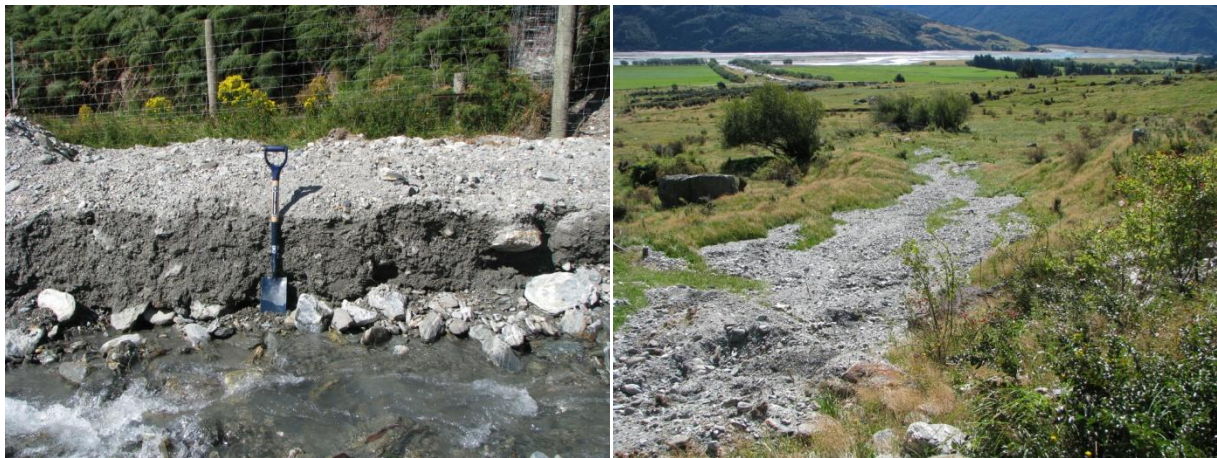
**Figure 3.7** Channel aggradation at the head of the Oturaki Creek alluvial fan (left) and channel avulsion and sediment deposition down the true left of the fan, March 2011 (right)

The Oturaki Creek alluvial fan is superposed onto the greater Flaxmill Creek alluvial fan. The alluvial-fan hazards associated with this creek are largely aggradational, where recurring debris and debris-flood flows deposit sediment across the fan surface. Due to very little channel incision, the creek has the potential to migrate and avulse across the fan surface, as observed in Figure 3.7.

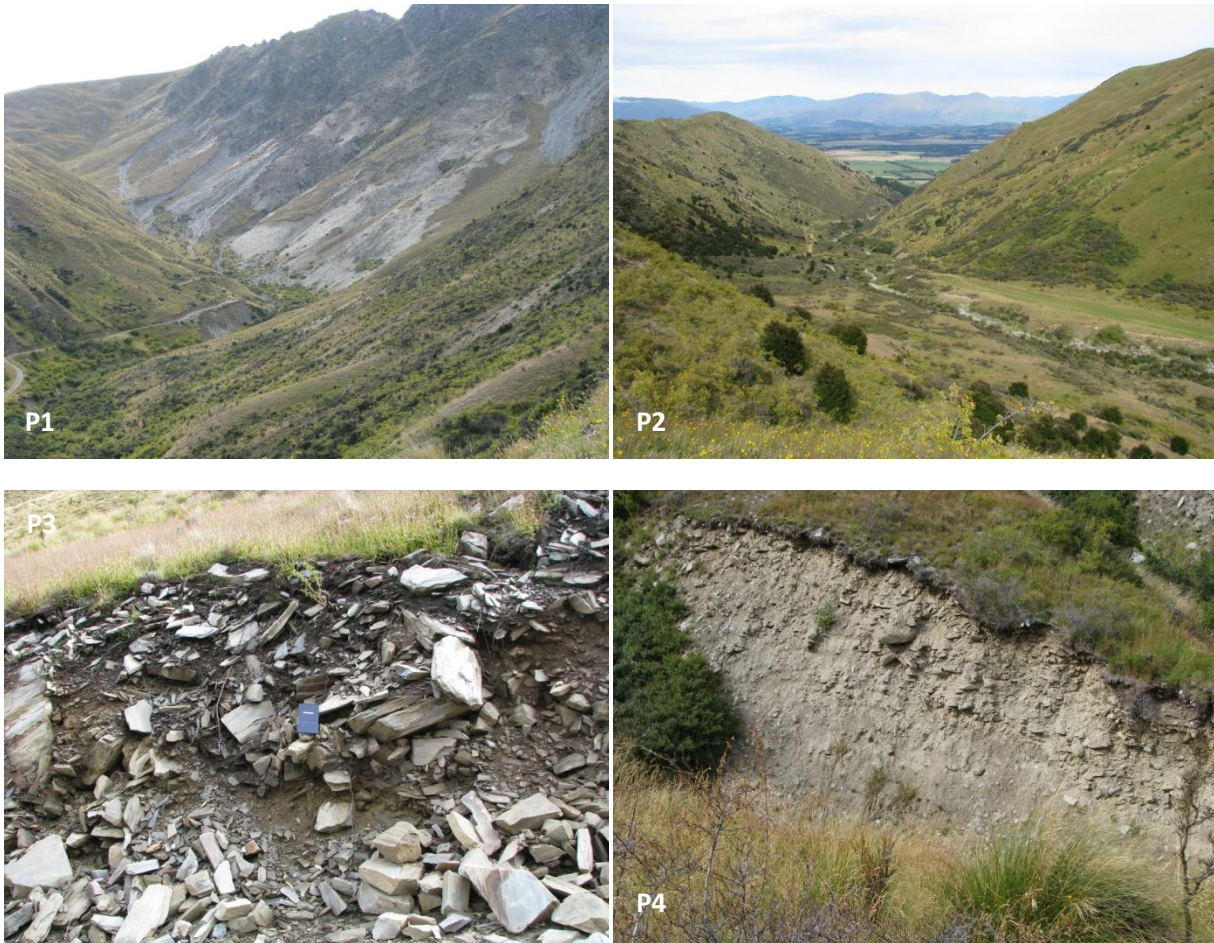
**Figure 4.3** Photographs relating to the points of interest identified in Figure 4.2. P1 shows persistent mass movement on northern-facing slopes at the head of the Johns Creek catchment. P2 shows the wide valley setting of the Johns Creek catchment and incised channel into mid-catchment fan deposits. P3 shows chaotic landslide debris on the catchment's true right, where these deposits are being actively eroded by the creek. P4 shows a close-up of incision in the channel mid-catchment.

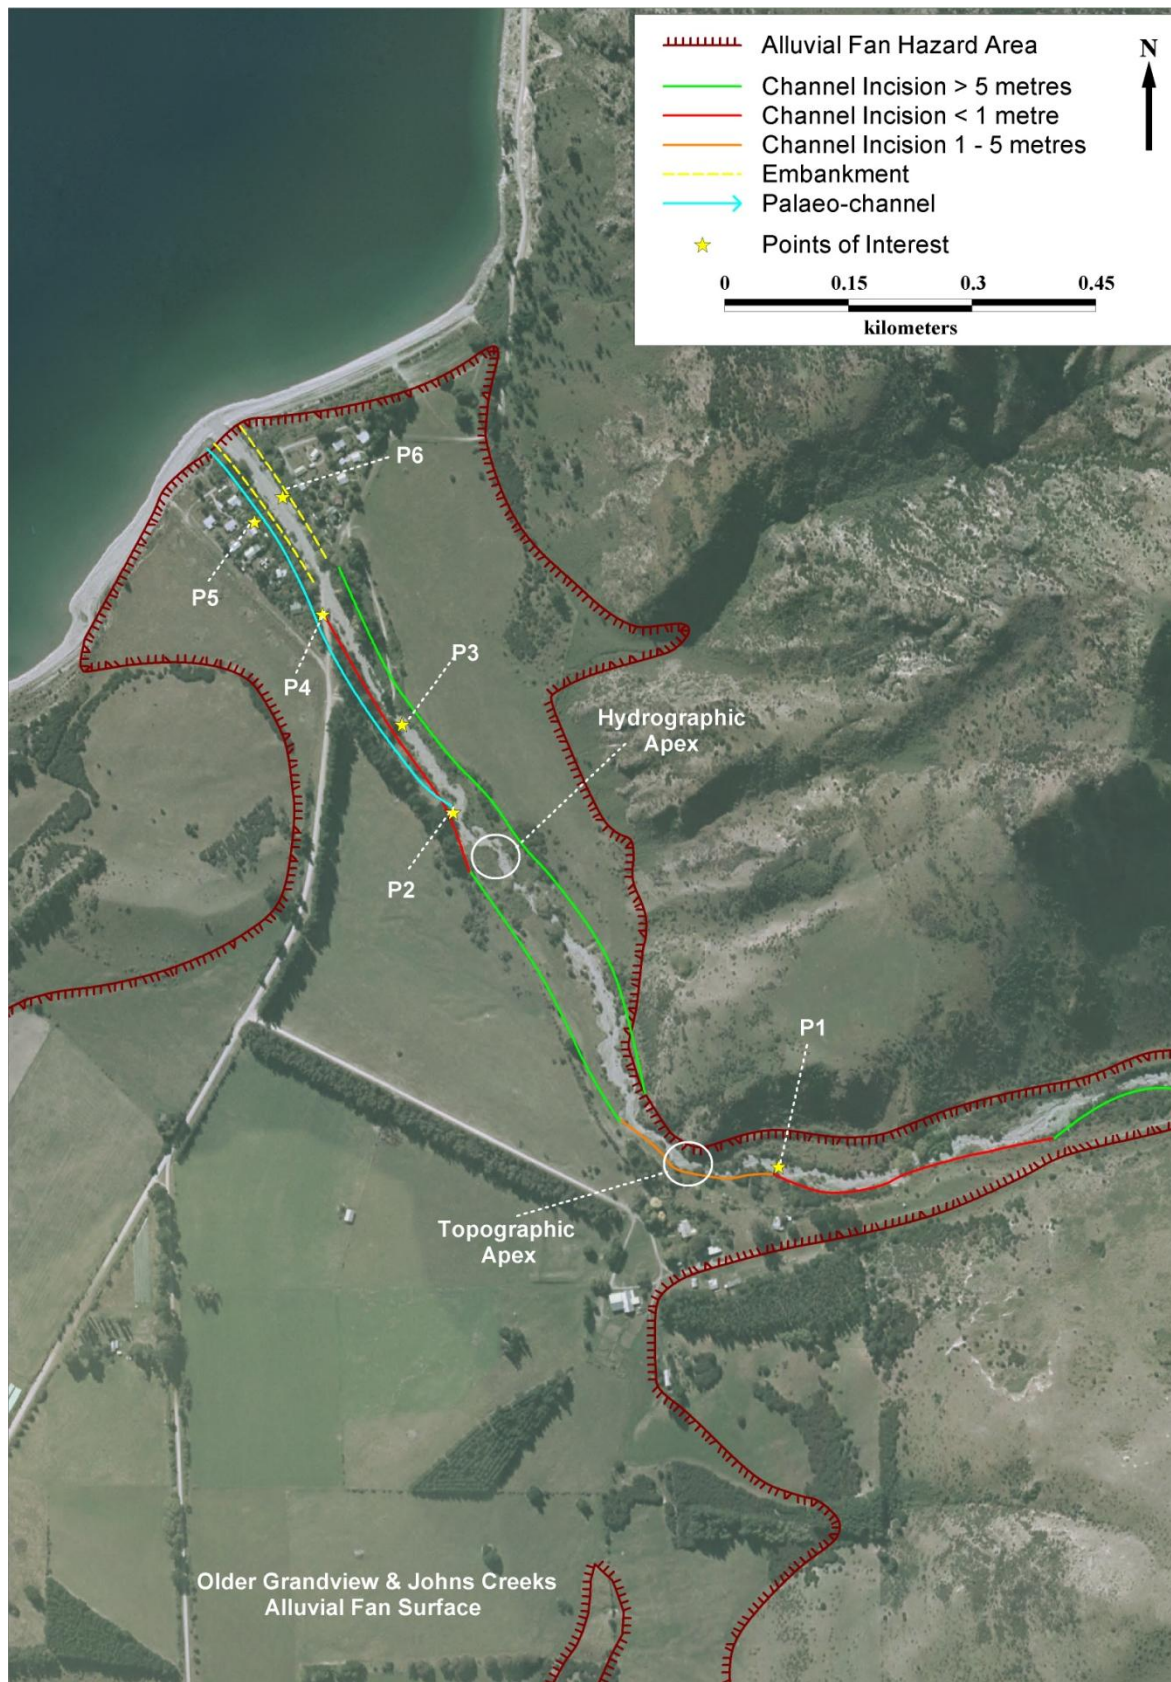
Figure 4.4 shows the Johns Creek alluvial fan and key features. Channel incision varies along the length of the alluvial fan. The true-right bank is incised into the higher fan surface by greater than 5m downstream of the topographic apex. Just upstream of the topographic apex, in P1, overbank deposition was observed in a number of locations, where debris flows have reached elevations above the existing bank height (Figure 4.5-P1). This phenomenon becomes less prevalent as the creek turns northwards and becomes more incised into the wider fan surface. Downstream of this location, the true-left bank of the fan becomes less incised, with less than one metre incision between the current channel level and

adjacent topography, as observed in P2. The channel in this reach is wide and heavily laden with fresh sediment and debris, indicating that it is often active. In this reach, a palaeo-channel is situated on the left bank, where flow can be transferred a considerable distance behind earth embankments to lower parts of the fan.

**Figure 4.4** Johns Creek alluvial fan, noting some key alluvial fan features; aerial photo dated April 2005

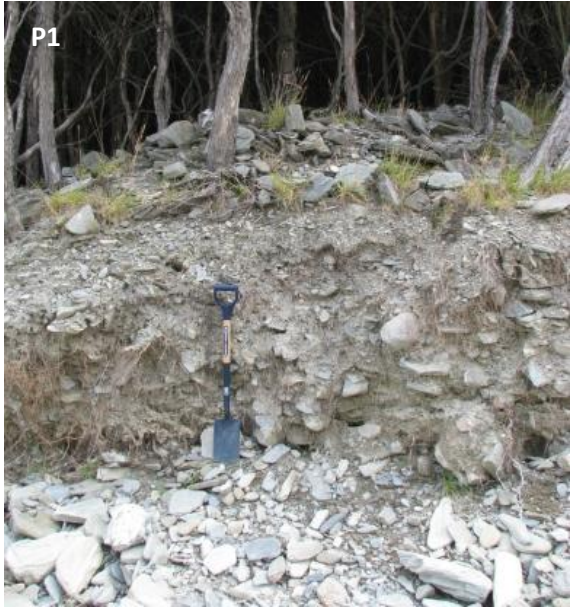
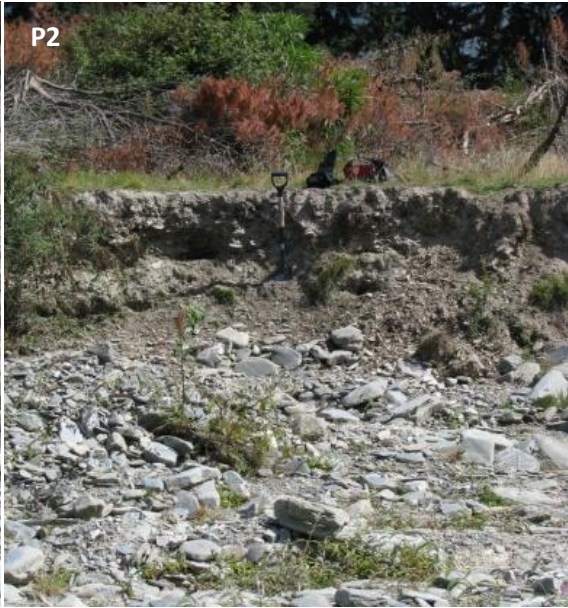
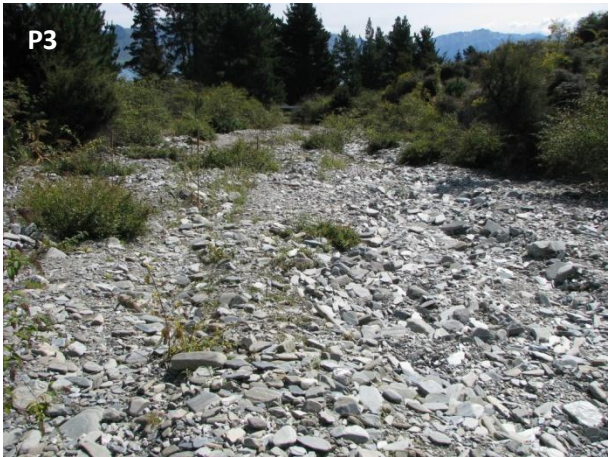
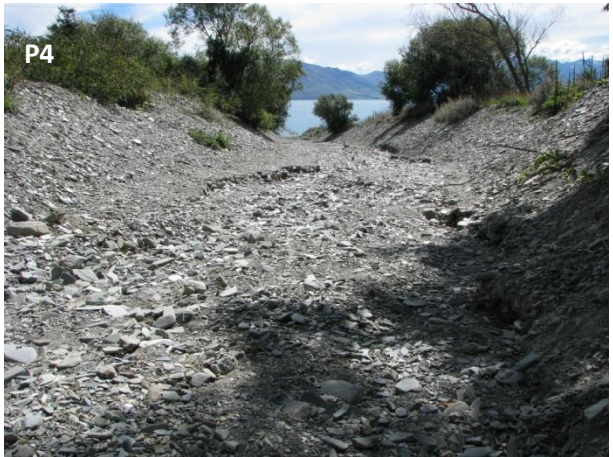
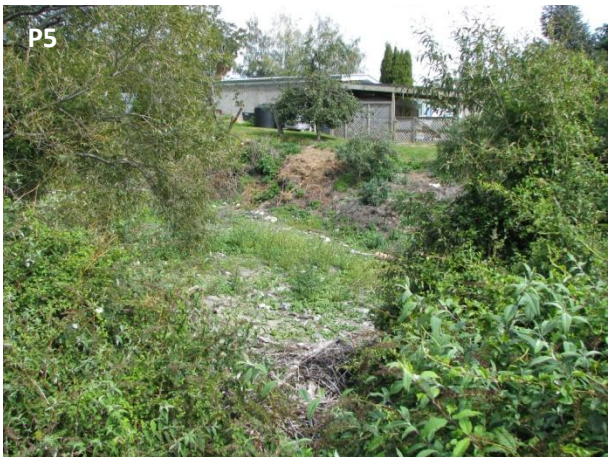
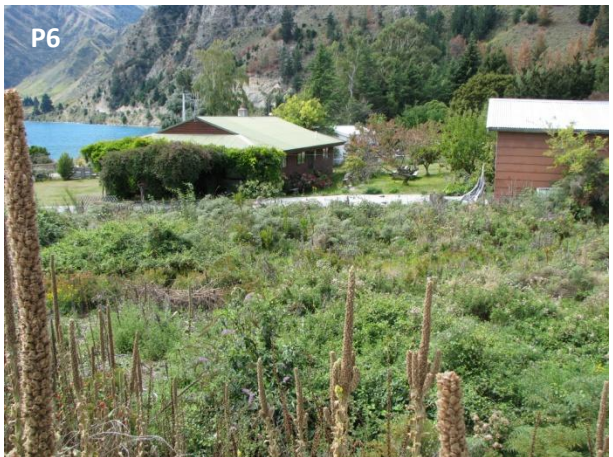
**Figure 4.5** Photographs relating to the points of interest identified in Figure 4.4

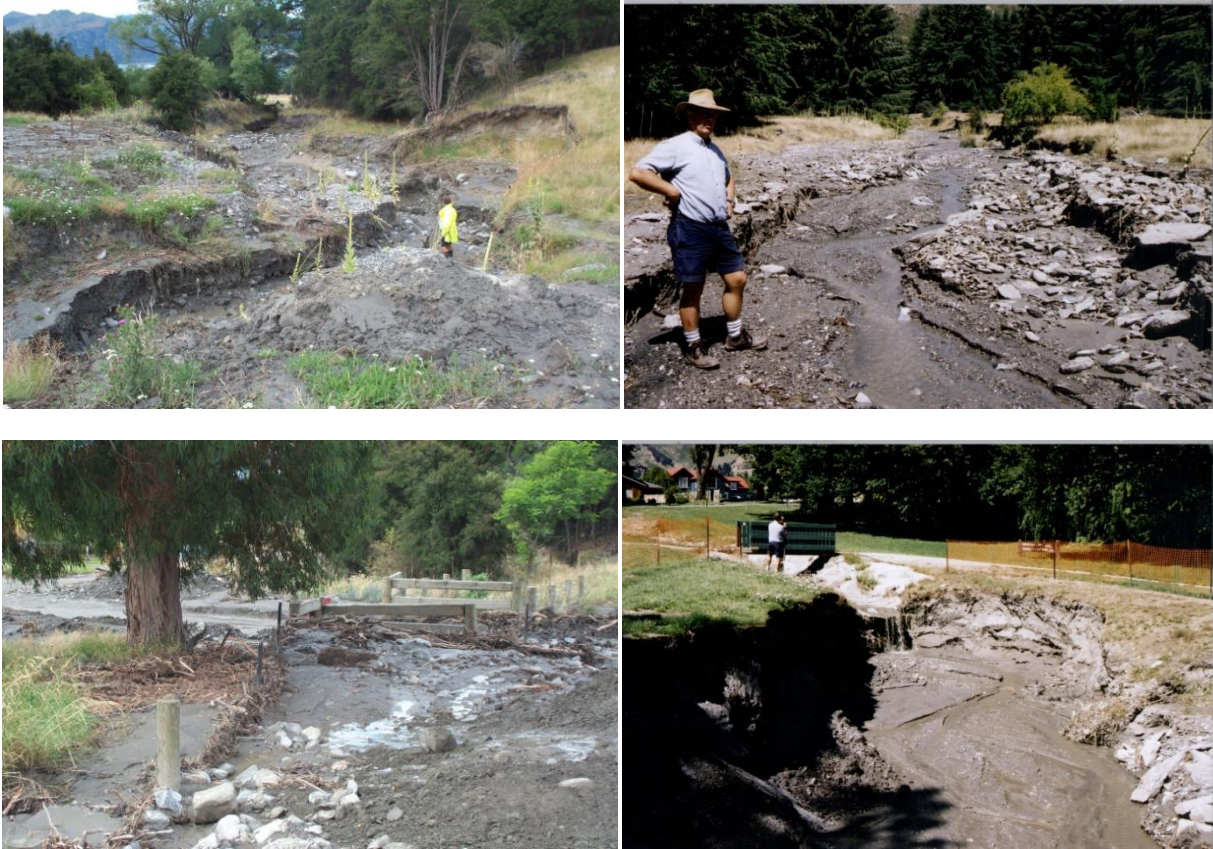
**Figure 5.6** The effects of debris and flood floods derived from Stoney Creek in January 2004. Top left: Channel and bank erosion and overbank-debris deposition near the head of the alluvial fan. Top right: Channel aggradation and debris deposition in the Stoney Creek channel. Bottom left: Channel aggradation near Studholme Road resulting in channel avulsion and a build-up of sediment against adjacent fencing. Bottom right: Channel and bank erosion near the Stoney creek outlet at Lake Wanaka

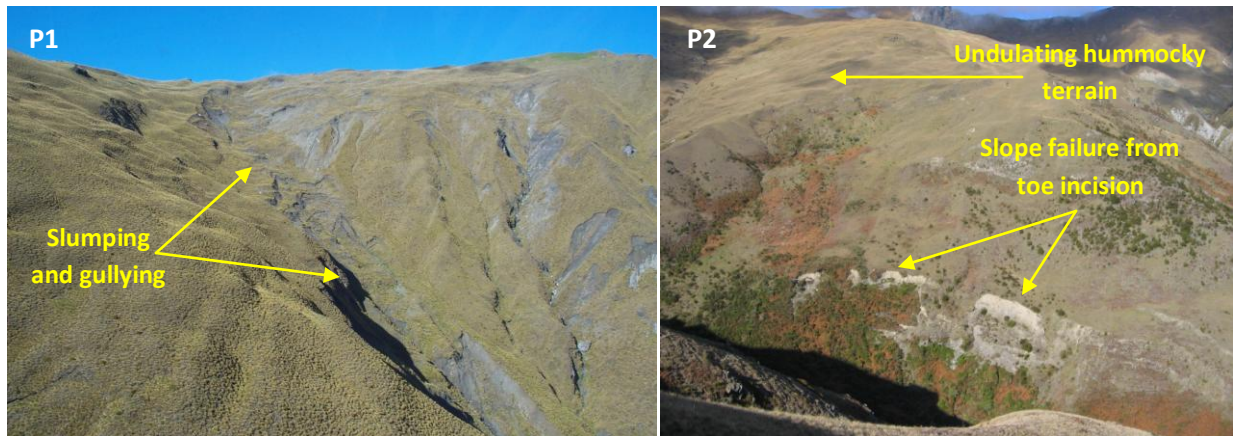
**Figure 6.3** Mass-movement processes in the form of slumping and gullyng in the upper Waterfall Creek catchment (left); photograph taken 09 February 2004. Slope failure, induced by toe incision by Waterfall Creek, can be seen on the right.

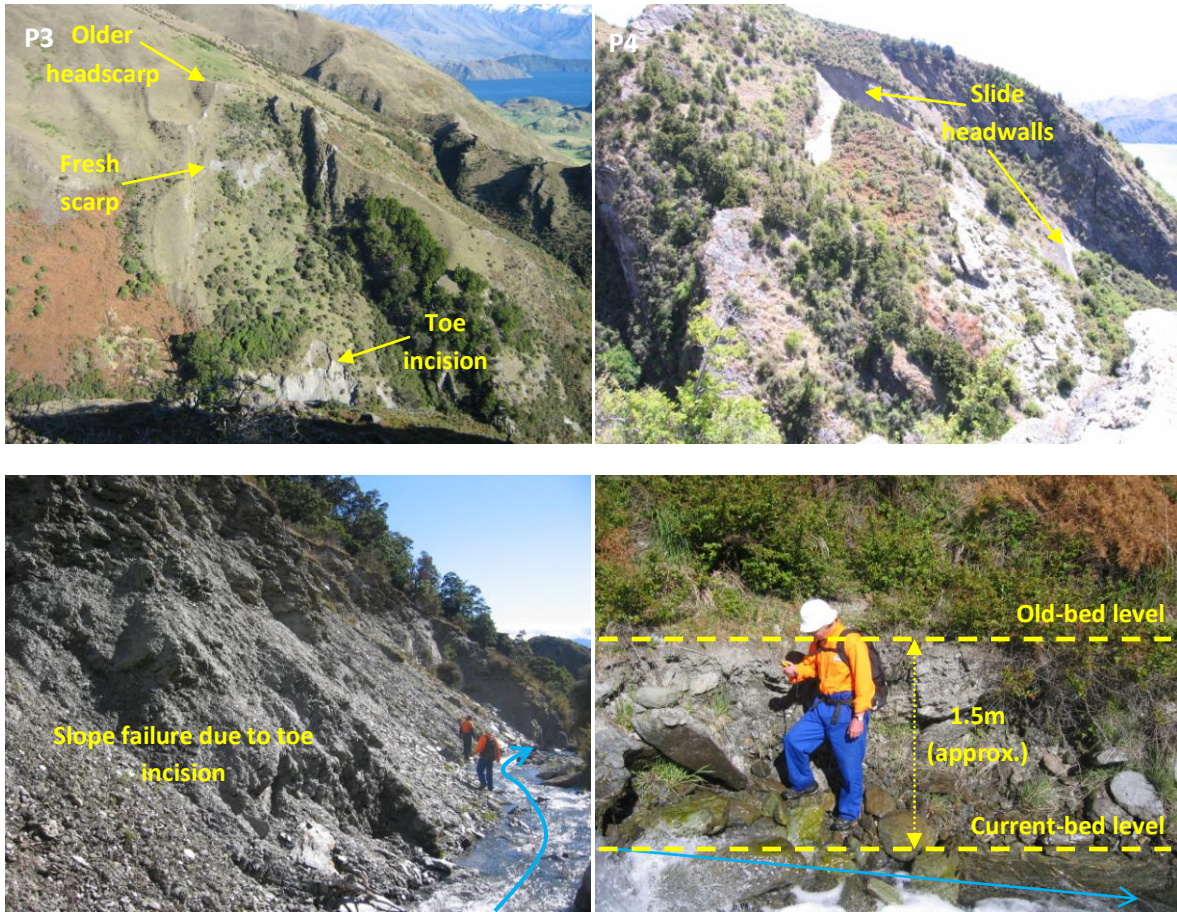
**Figure 6.4** Top left: Large schistose slide induced by toe incision, as shown in Figure 6.2. Top right: Two large slides are evident near the Waterfall Creek alluvial-fan topographic apex. Bottom left: Toe incision of the slide, shown in P3, is contributing large volumes of sediment to the active Waterfall Creek channel. Bottom right: Old-bed levels are observed mid-catchment, indicating that debris-flow events have occurred in the catchment in the past.

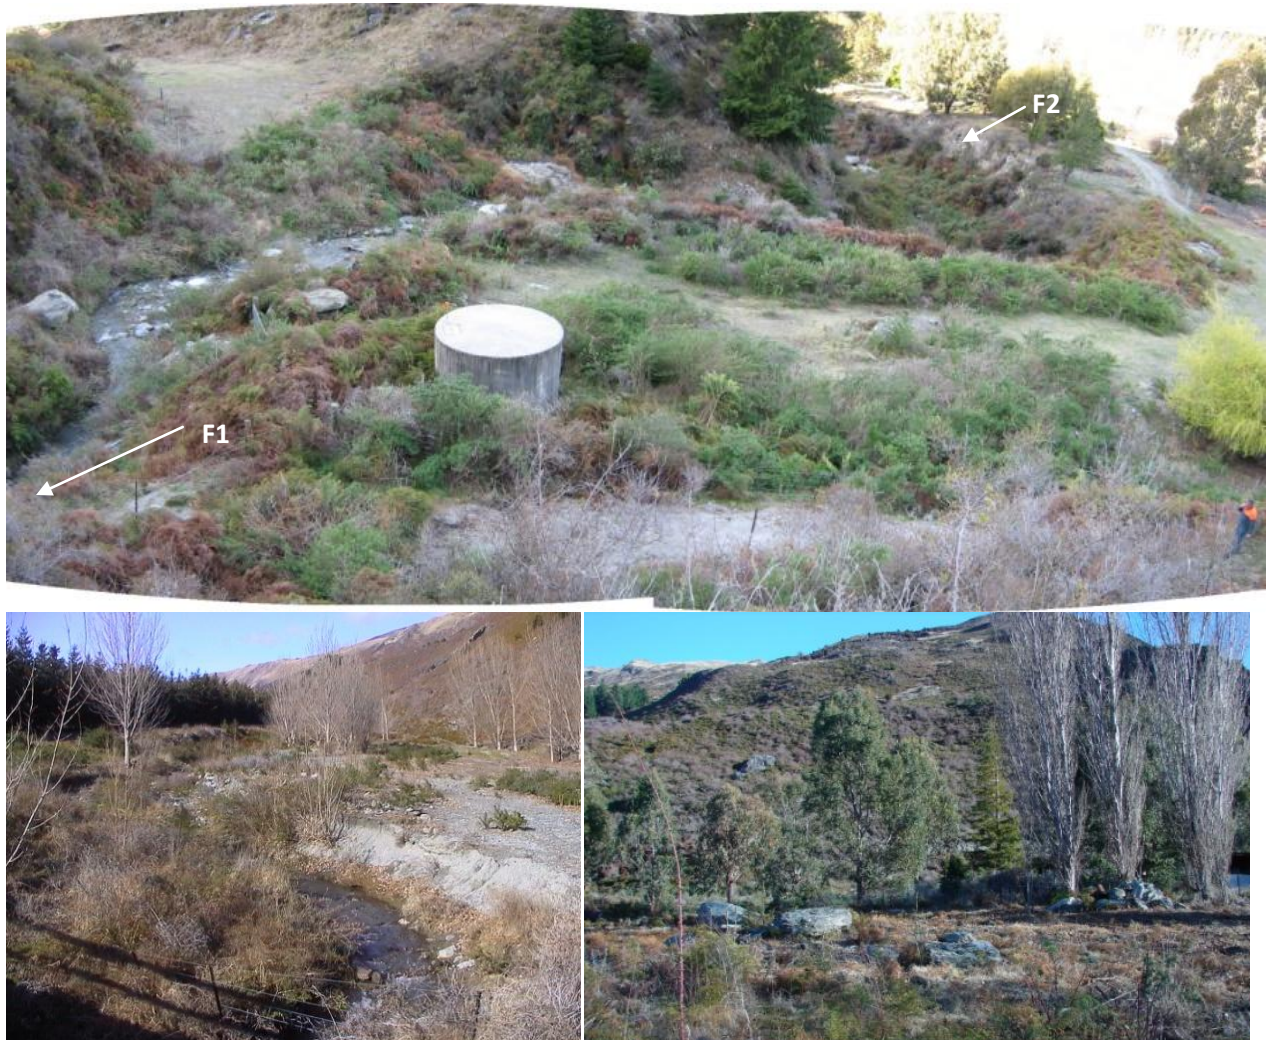
**Figure 6.6** Photographs that relate to the points of interest in Figure 6.5. Top: Head of Waterfall Creek fan, showing less than 1m incision (F1) and becoming much more incised further downstream (F2). Bottom left: Waterfall Creek, looking upstream from Wanaka-Mount Aspiring Road (F3). Bottom right: Debris lobe on the Waterfall Creek fan, showing large boulders on the fan surface (F4)
