# **Otago Alluvial Fans: High Hazard Fan Investigation**

**June 2011**

Otago Regional Council

Prepared by Richard Woods, Natural Hazards Analyst, Otago Regional Council

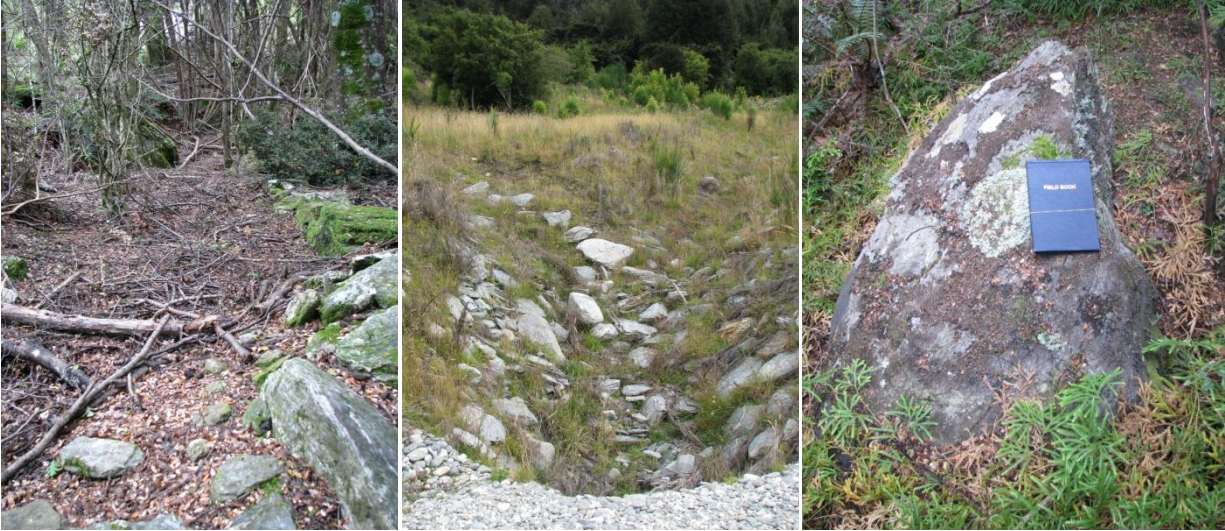
**Figure 7.4** Left: Ephemeral channel located within the upper forested area of an alluvial fan at Bob's Cove; lateral-debris deposits are evident from historic-debris flow. Centre: Formed subdivision has changed the flow-path characteristics of the alluvial fans at Bob's Cove (Figure 7.3-F1). Right: Large clasts are evident on the upslope parts of alluvial fans at Bob's Cove (Figure 7.3-F2).

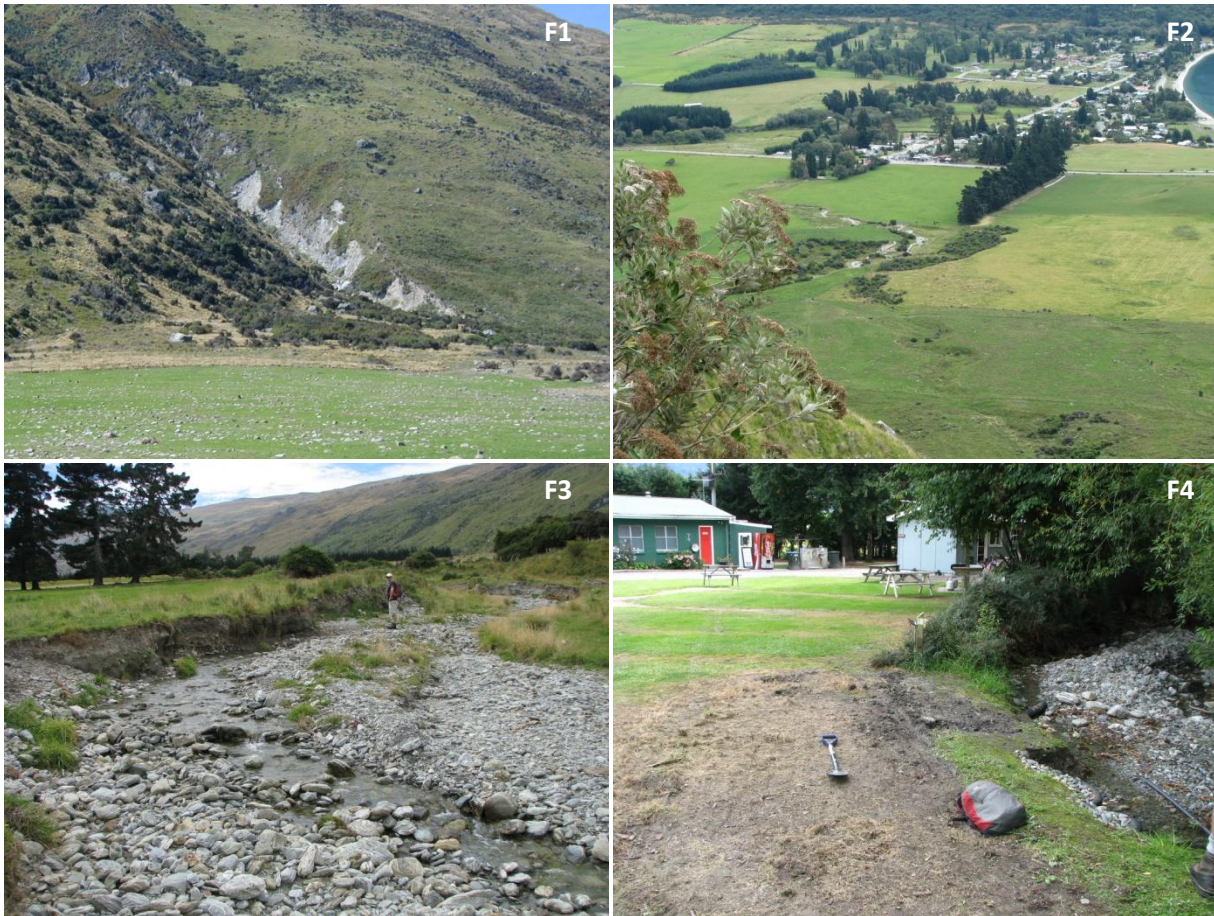
**Figure 9.5** Photographs that relate to points of interest depicted on Figure 9.4. Top left: The upper Kingston Creek alluvial fan showing a large clast boulder field at the fan head and recently overturned debris deposits in the foreground. Top right: Large palaeo-channels traverse the Kingston creek alluvial-fan surface. Bottom left: The Kingston Creek channel above SH 6 is incised less than one metre for much of its length. Bottom right: Downstream of the state highway, the creek has almost no incision through the Kingston camping ground.

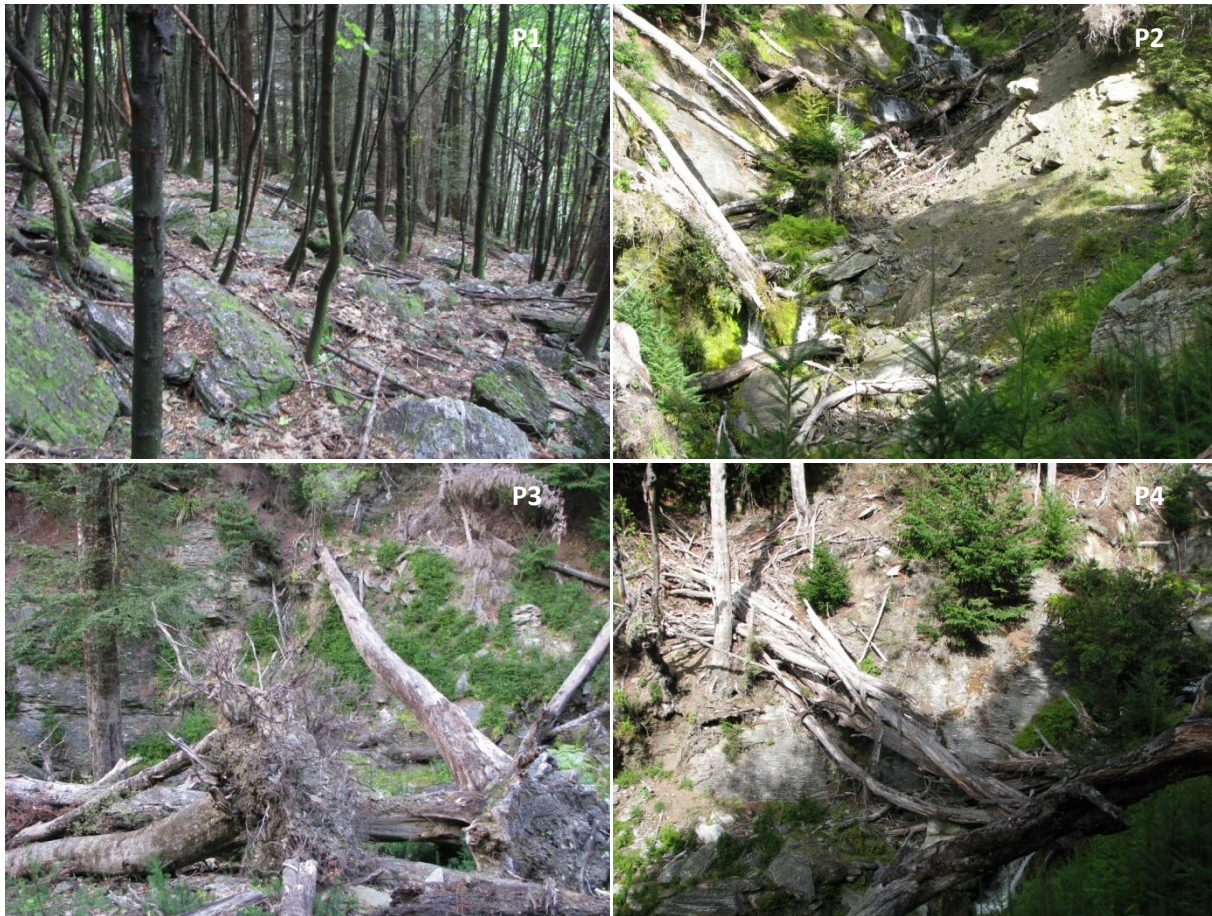
**Figure 10.3** Photographs that relate to points of interest depicted in Figure 10.2. Top left: Large rock-fall boulders strewn across the Brewery Creek’s left bank; this location has been succeeded by younger trees. Top right: Brewery Creek, looking upstream, colluvial landslide deposits are being eroded on the true left (image right), and the creek is bound by bedrock on the true right (image left). Bottom left: Large toppled trees lie on slopes next to the incised Brewery Creek channel. Bottom right: Log-jam dam formed in the Brewery Creek channel

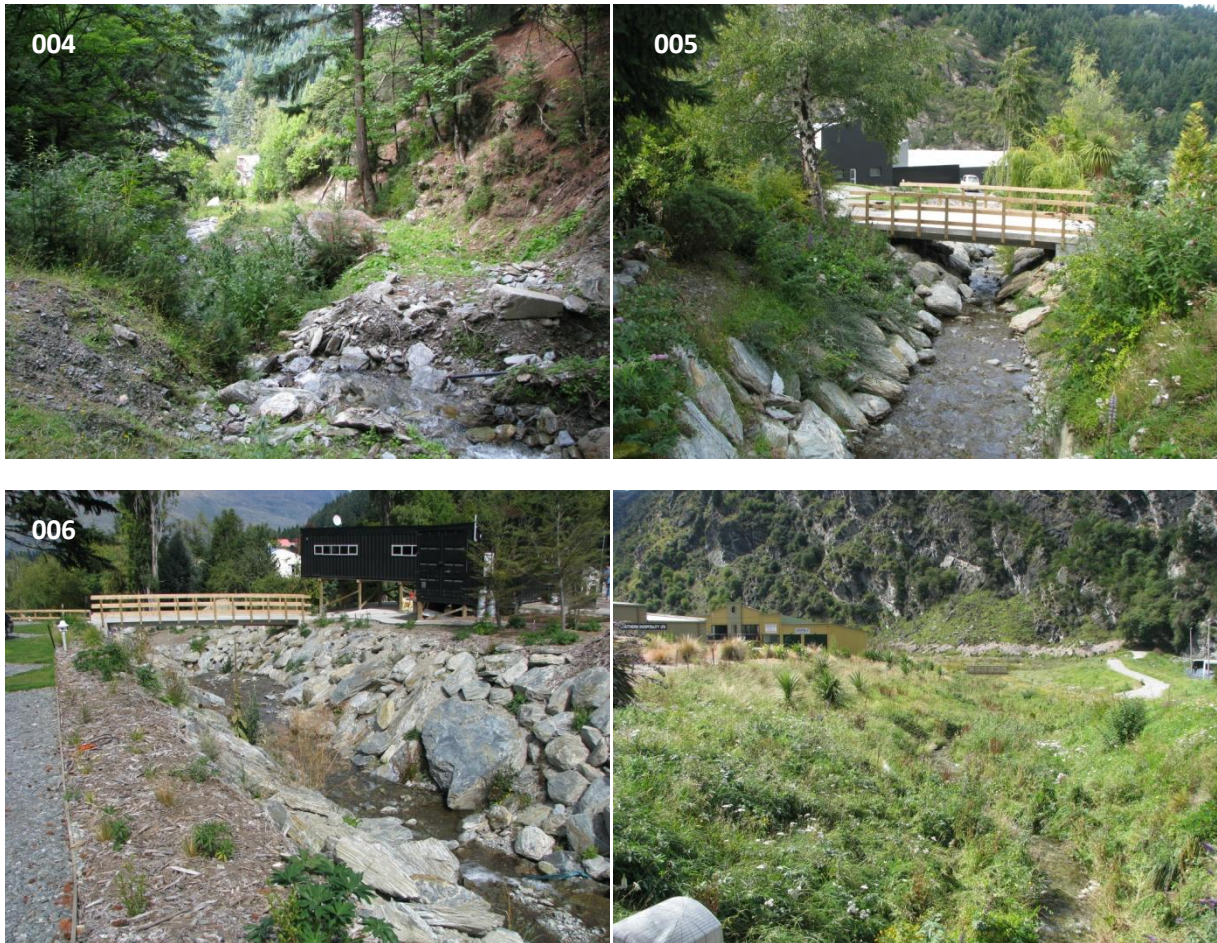
**Figure 10.5** Top left: The U-shaped valley near the topographic apex of Brewery Creek. Top right: Modified Brewery Creek channel downstream of the topographic apex. Bottom left: Brewery Creek’s modified channel in the mid-fan area, with visitor accommodation complex in the background. Bottom right: Brewery Creek’s unconfined channel below Gorge Road

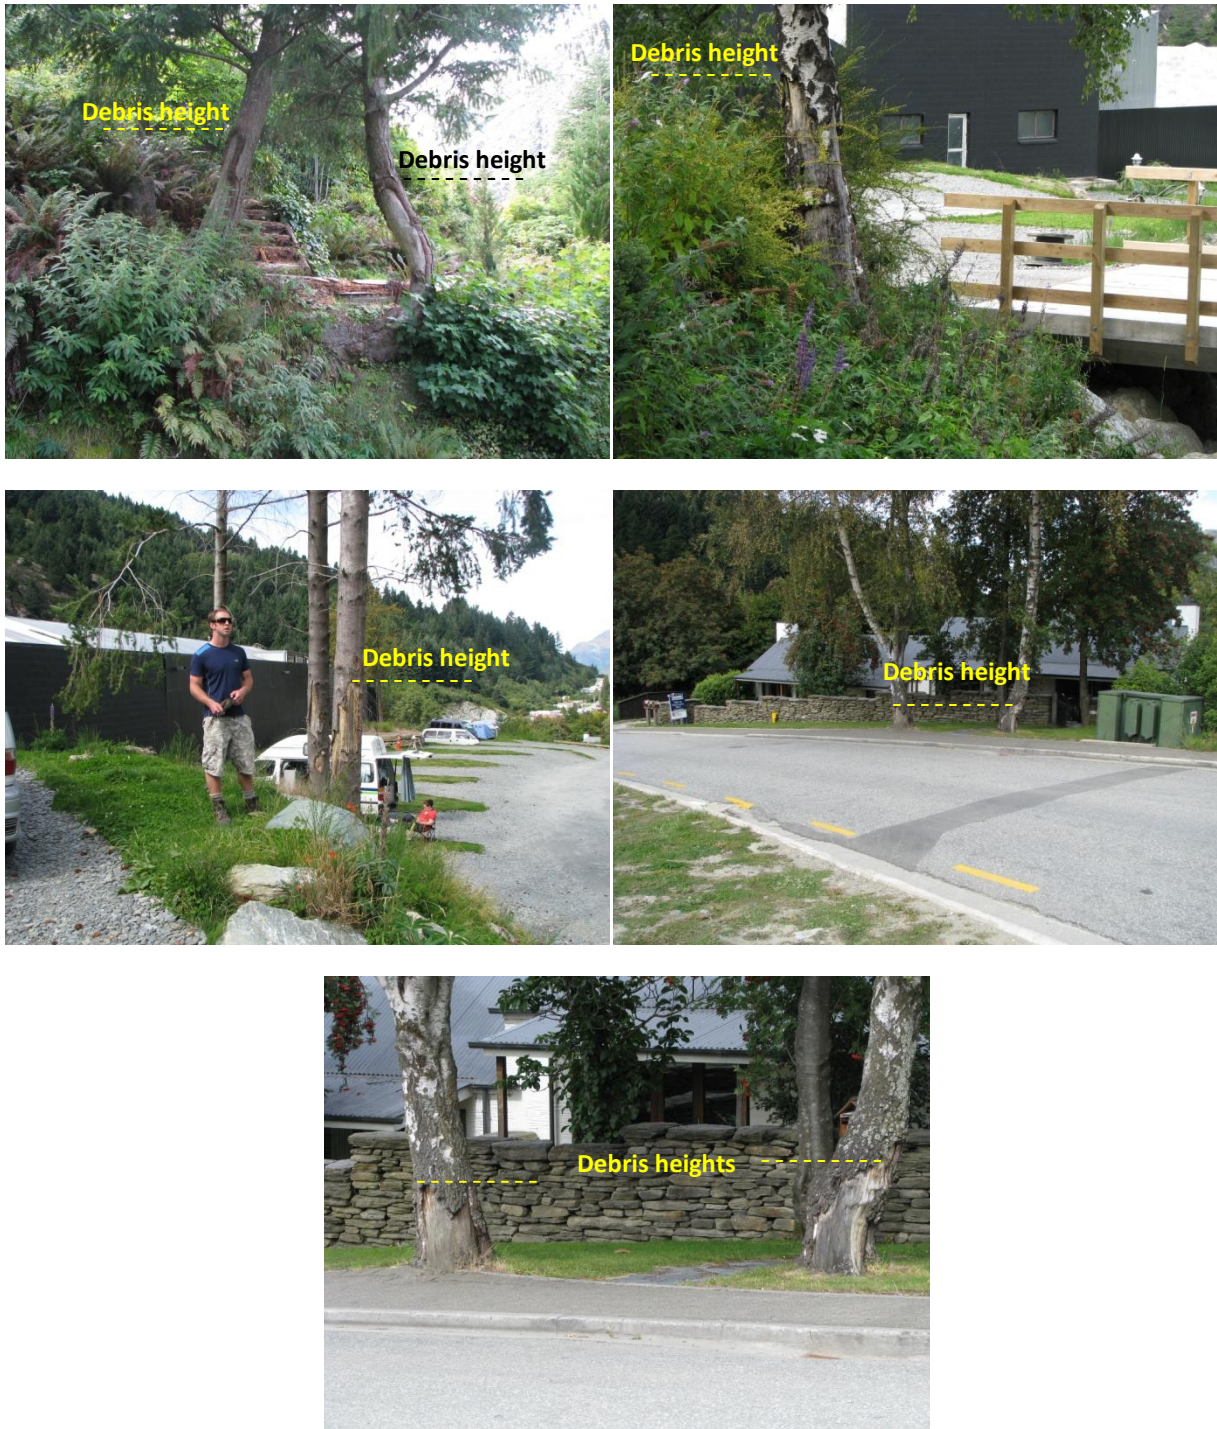
**Figure 10.7** Debris-impact scars on mature trees on the Brewery Creek alluvial fan. Top left: Debris scars on left-bank trees just upstream of point 005 (Figure 10.4). Top right: Debris scar on true-left tree at point 005. Mid-left: Debris scars on trees at point 006 with figure for scale. Mid-right: Looking across Bowen Street towards trees at point 008. Lower image: Trees on far side of Bowen Street at 008

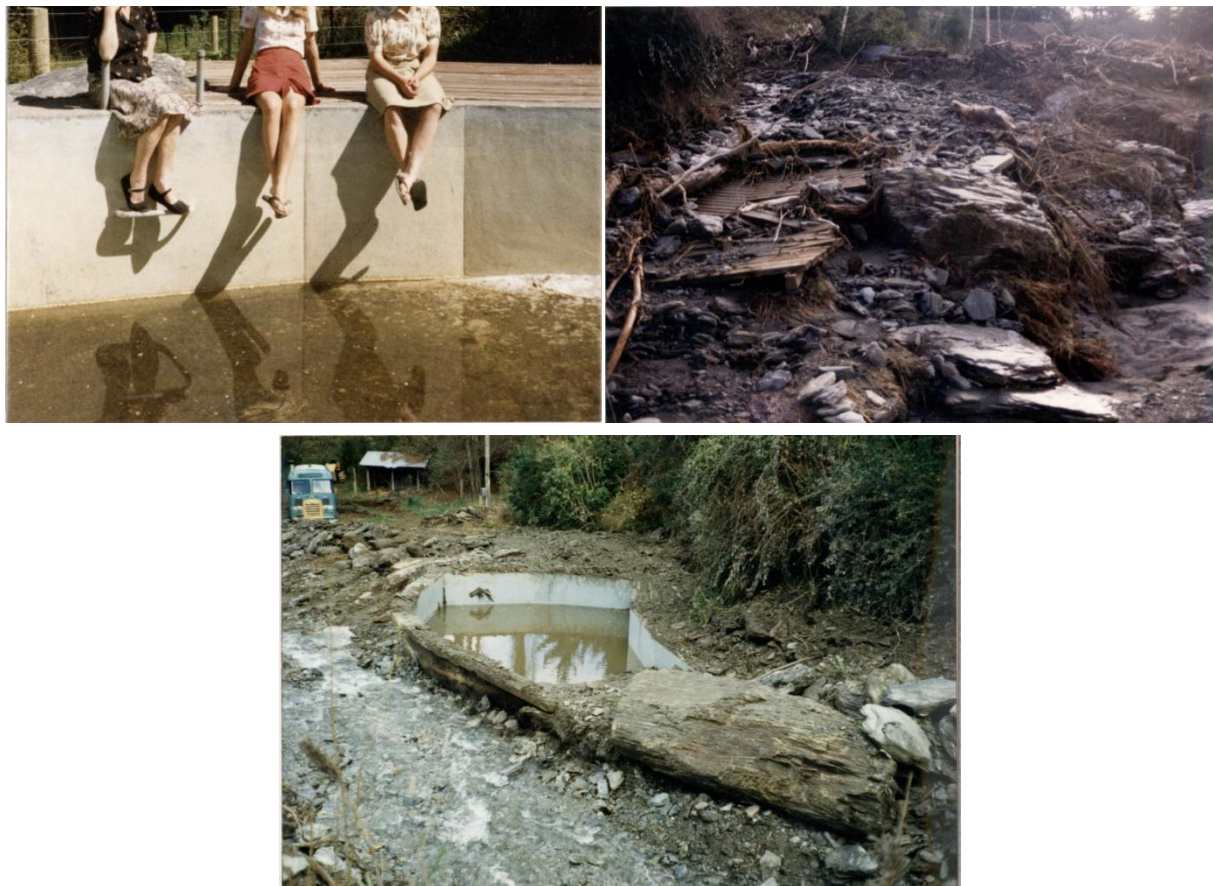
**Figure 10.8** Photographs of a swimming pool on the Brewery Creek alluvial fan. Top left: Pool before May 1986, showing depth with respect to figures. Top Right: Pool filled with debris, following the storm event of May 1986. Bottom: Excavated pool after the May 1986 flood event; Brewery Creek flows to the immediate left of the pool.
