APPENDIX A

Photographs

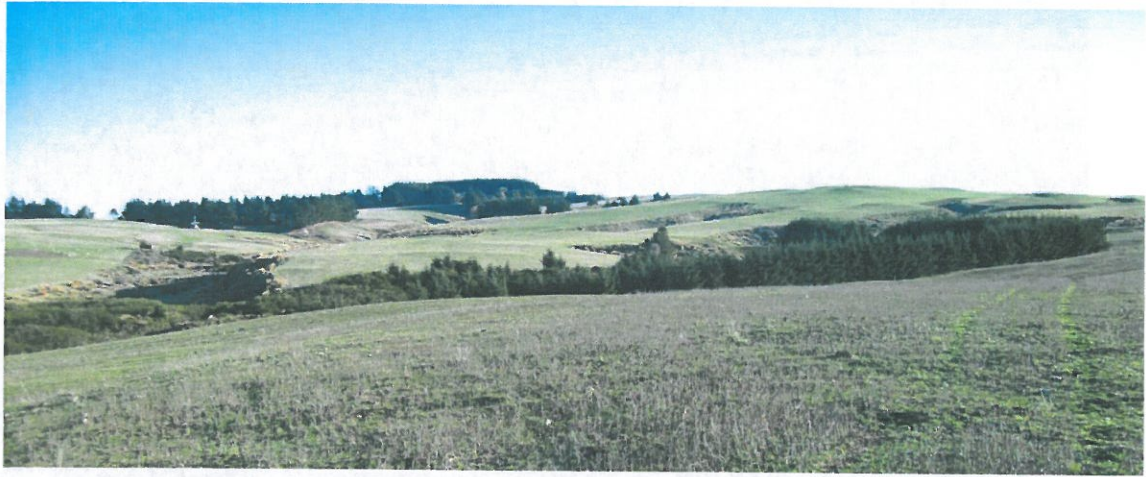
Photograph 3

View from near the main embankment looking west.

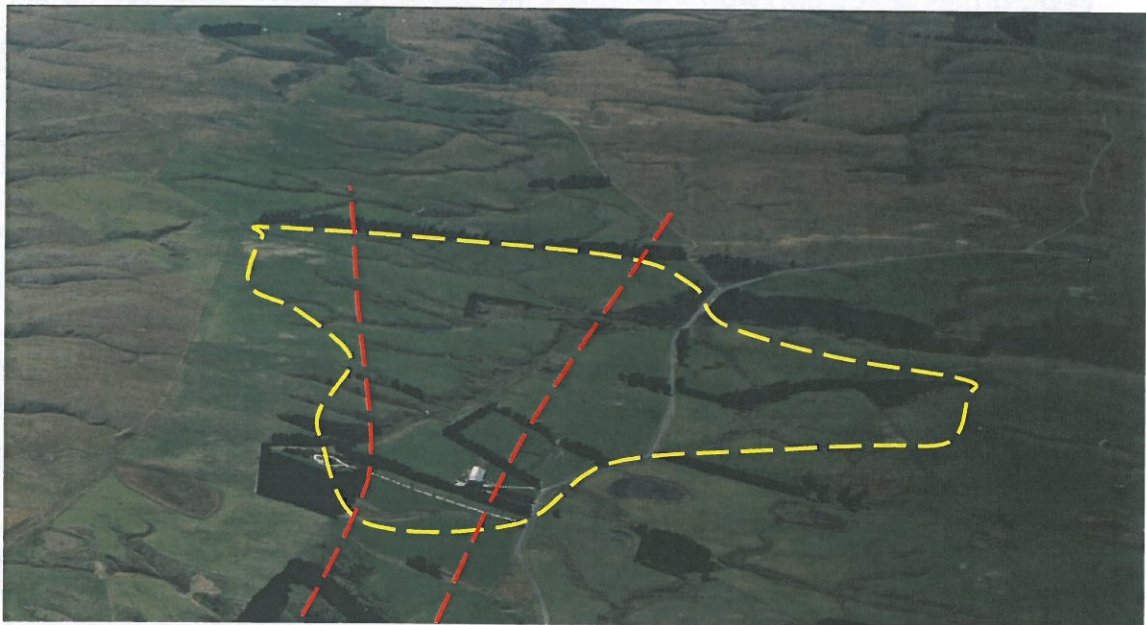
Photograph 4

Oblique aerial view of the proposed TSF site looking east. Approximate TSF footprint is indicated in yellow, Margins of the Macraes Fault are shown in red.

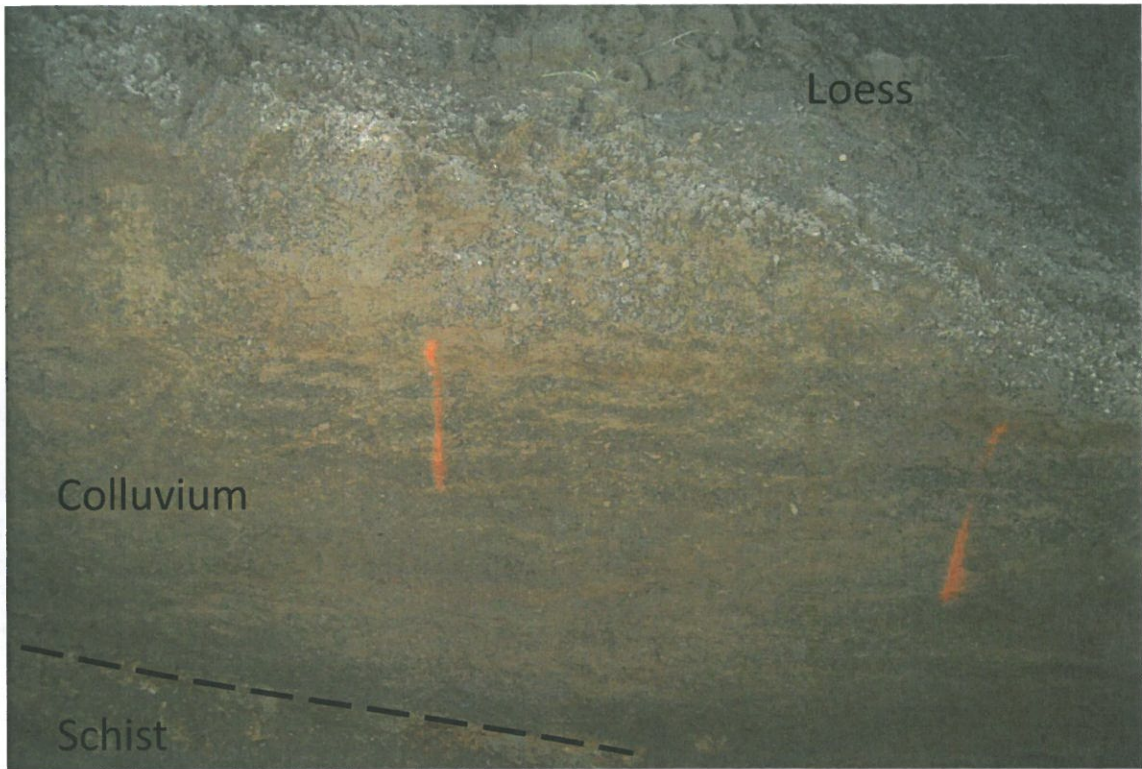
Photograph 5

Interbedded gravelly sands and silts within colluvium in Trench 100 (+18m). Orange spray marks are 1m apart. HW schist is exposed in the base of the trench and the colluvium/loess contact corresponds with the bench.

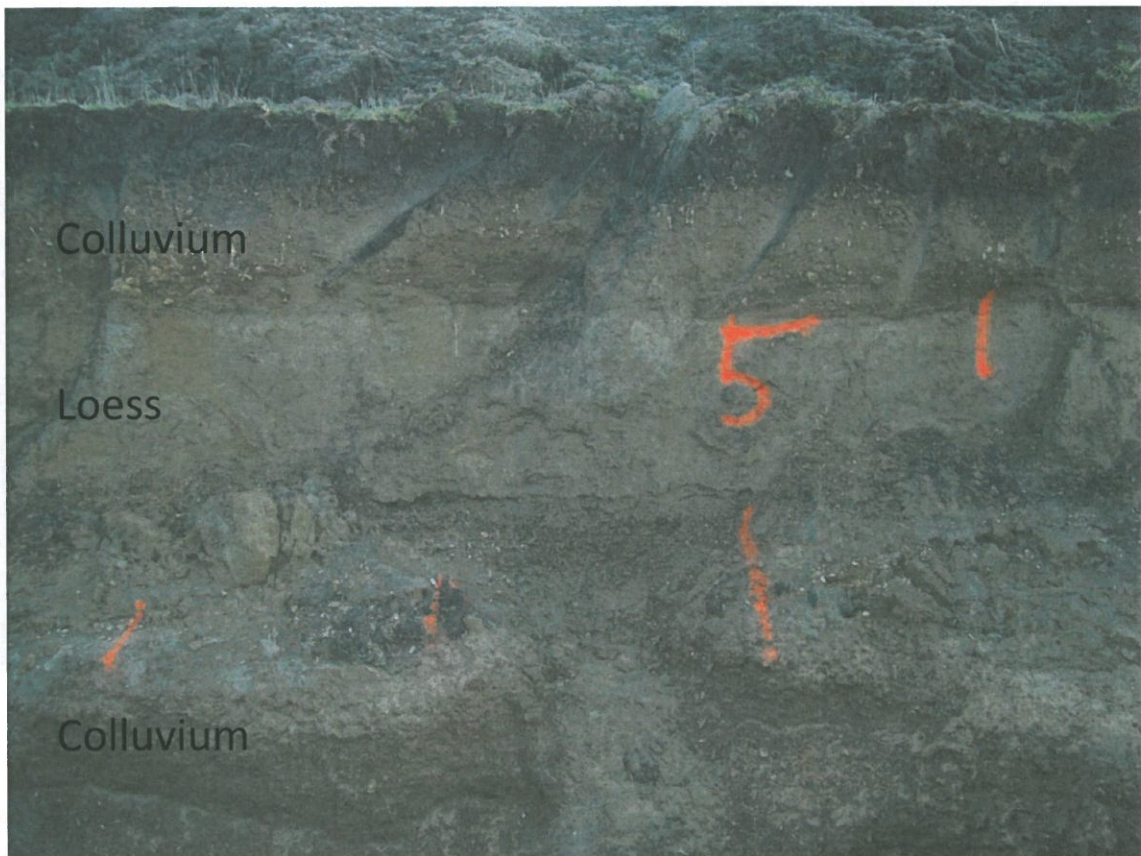
Photograph 6

Colluvium overlain by 0.8 m thick loess layer, overlain by loess colluvium with 0.25 m thick soil profile. Trench 200 (+5 m).

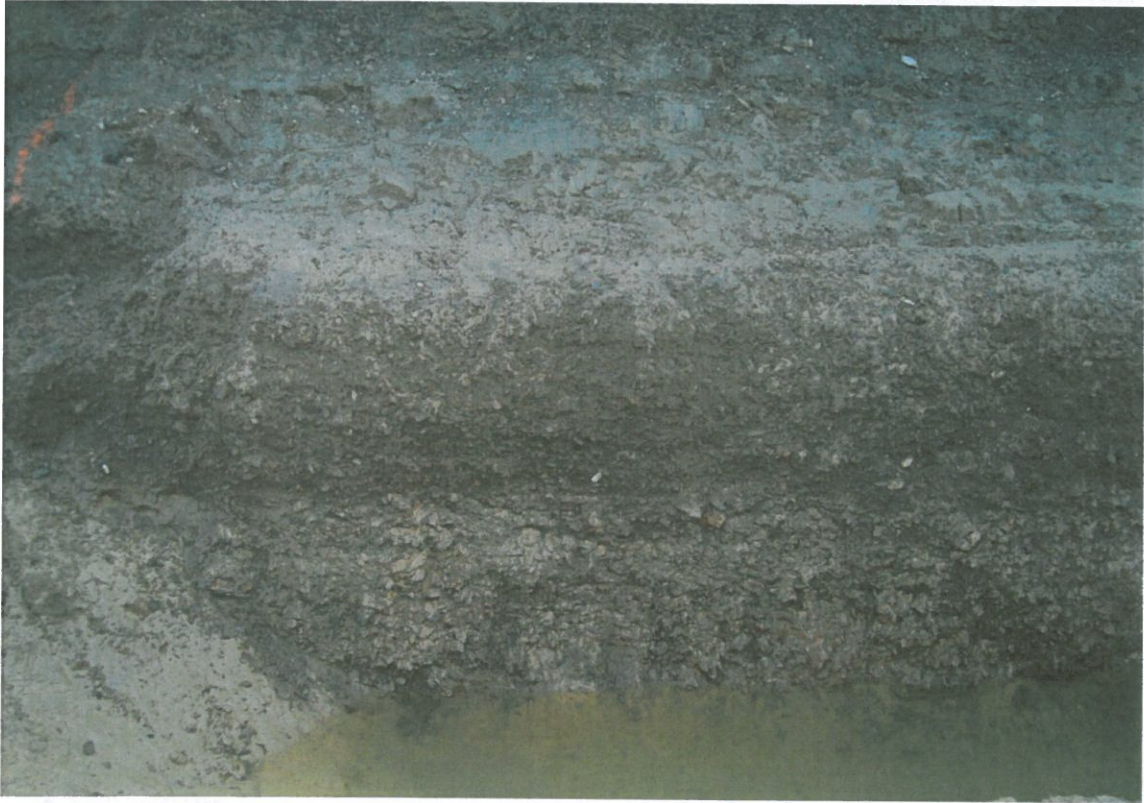
Photograph 7

Horizontally bedded gravels within colluvium in Trench 200 (+5 m). This strata is the lower colluvium exposed in Photograph 6.

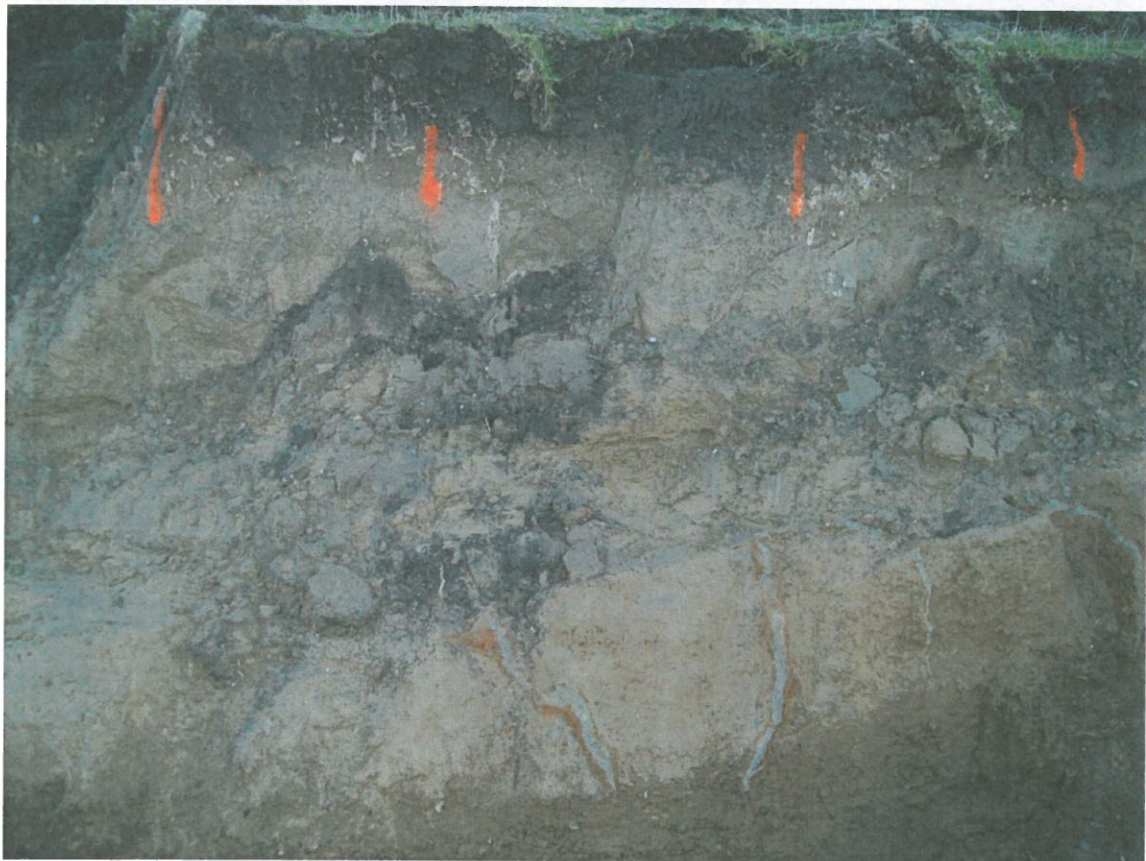
Photograph 8

Loess containing characteristic light grey veins exposed in Trench 200 (+12 m).

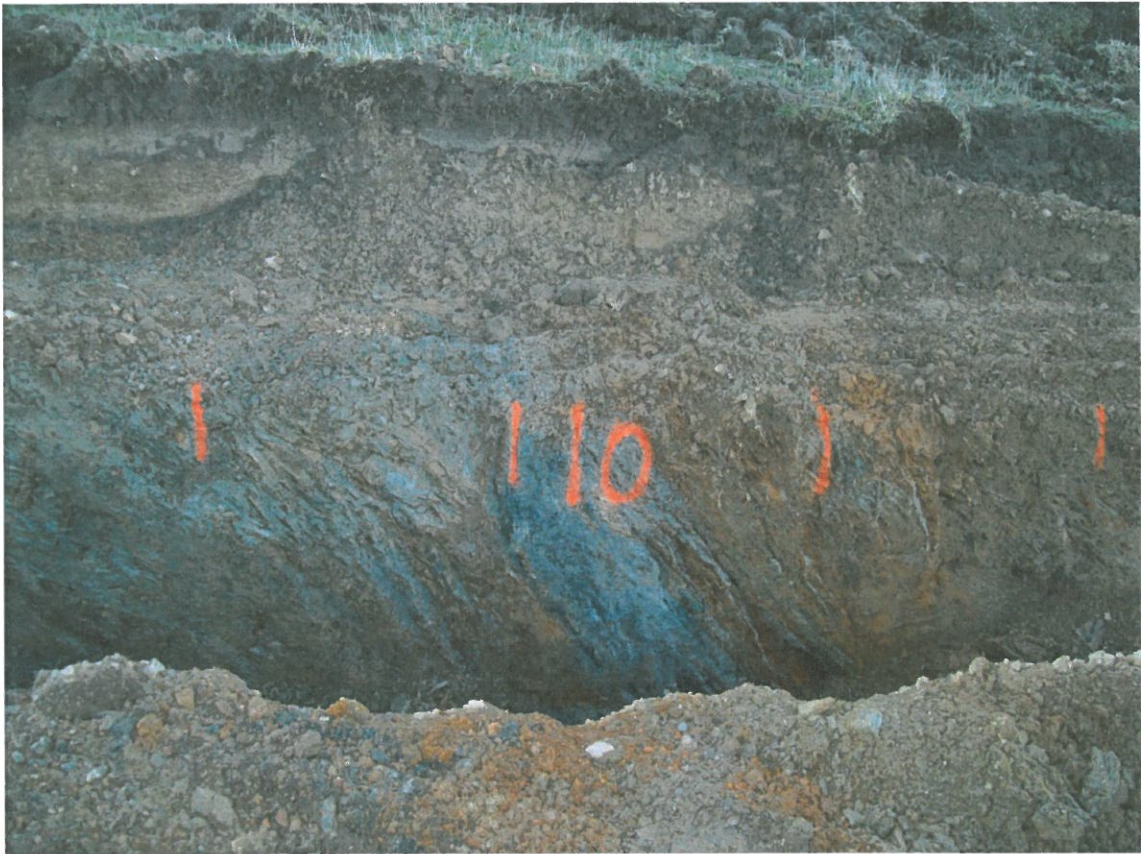
Photograph 9

Steeply dipping fault in schist (Trench 300 (+10 m)). The fault cuts across foliation, strikes parallel to the Macraes Fault but dips to the south.

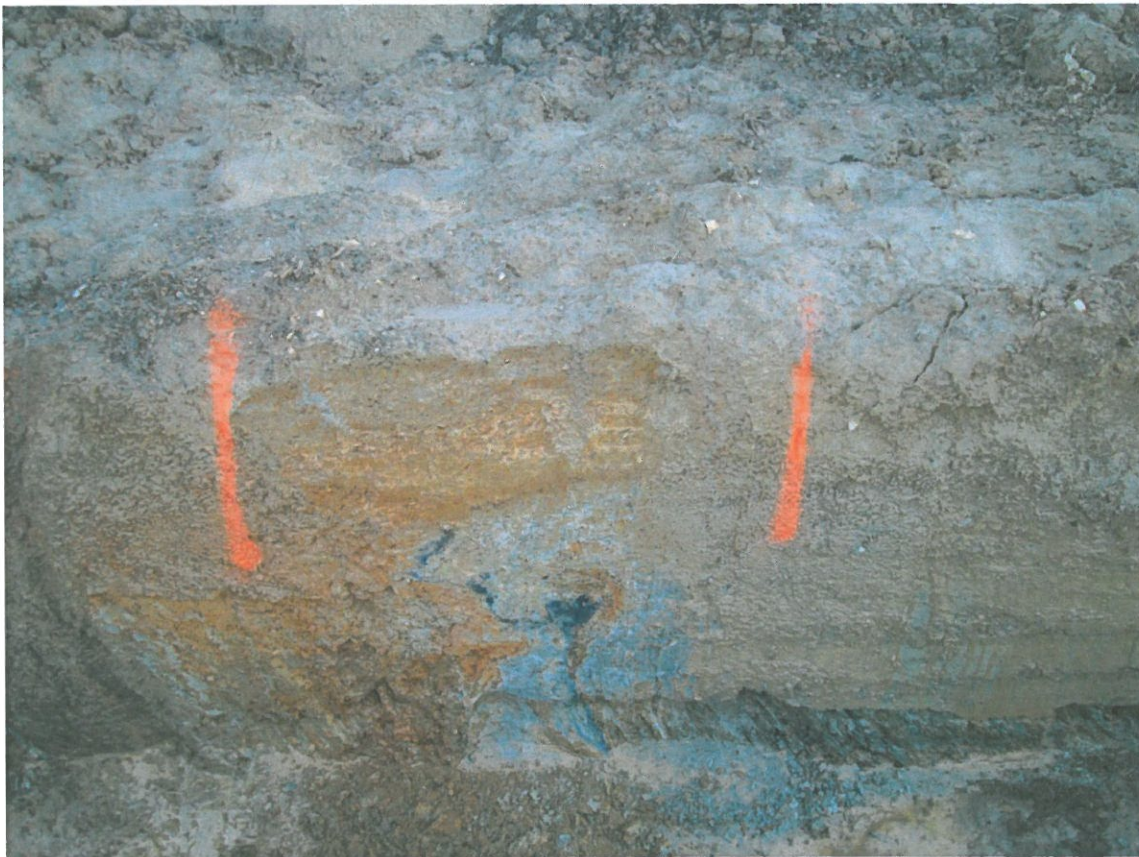
Photograph 10

Fault exposed in Trench 400 (+67 m). Fault dips steeply to the southeast, parallel to foliation.

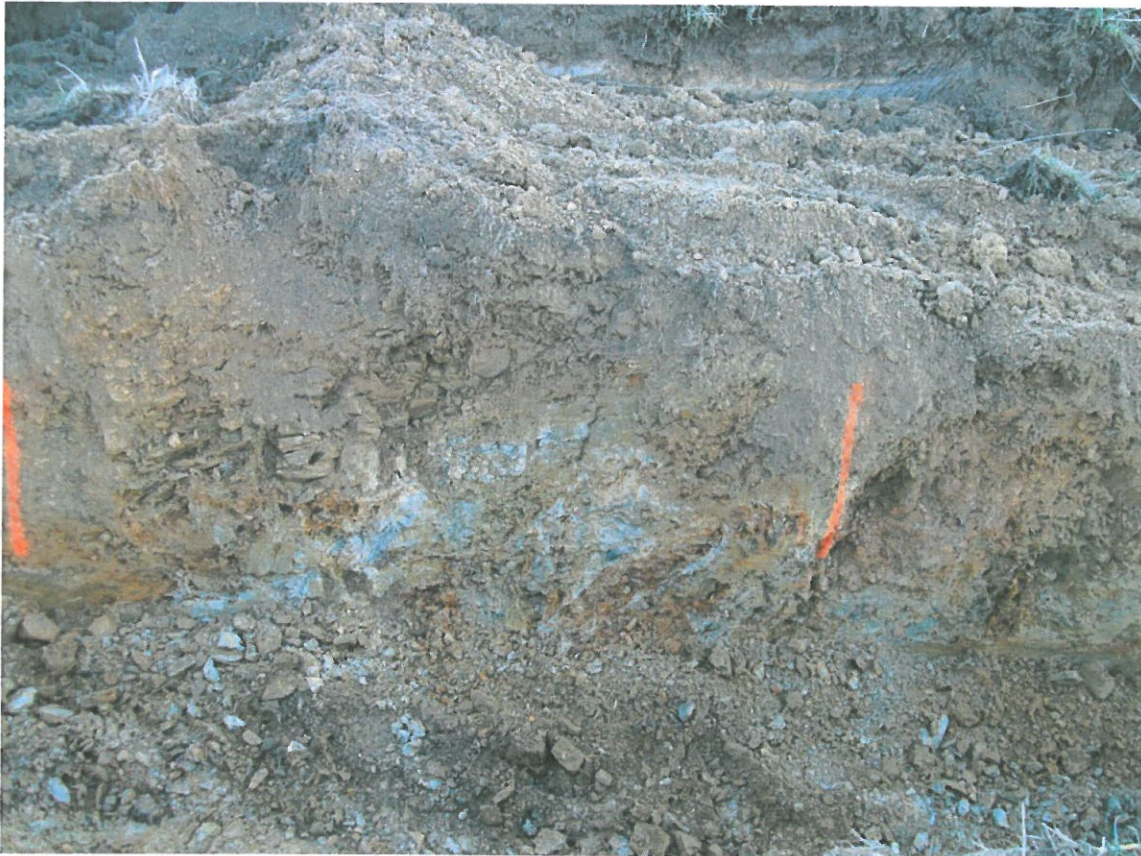
Photograph 11

North dipping ($\sim 45^\circ$) fault in schist (Trench 100 (-22 m)). The fault has the same orientation as the Macraes Fault and is inferred to be the main fault plane. No offset is apparent across the soil/rock contact.

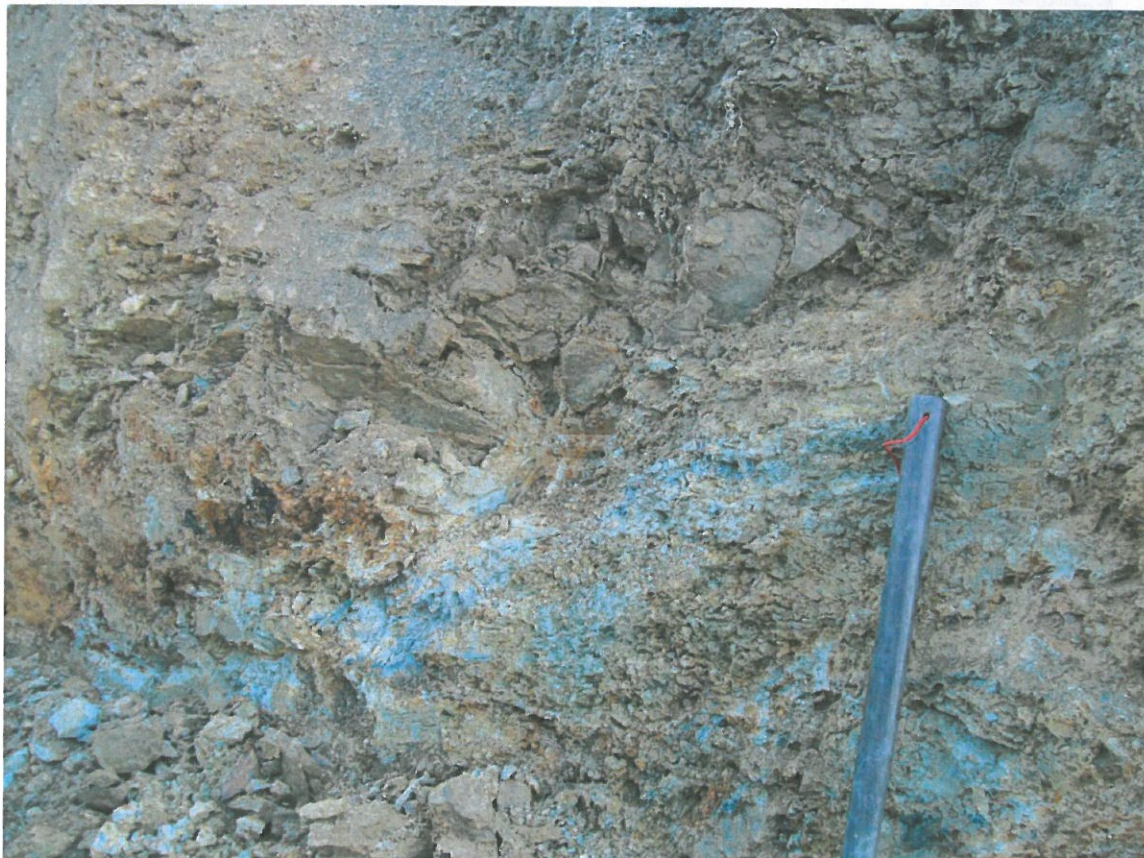
Photograph 12

Close-up of the above fault (Trench 100 -22m).

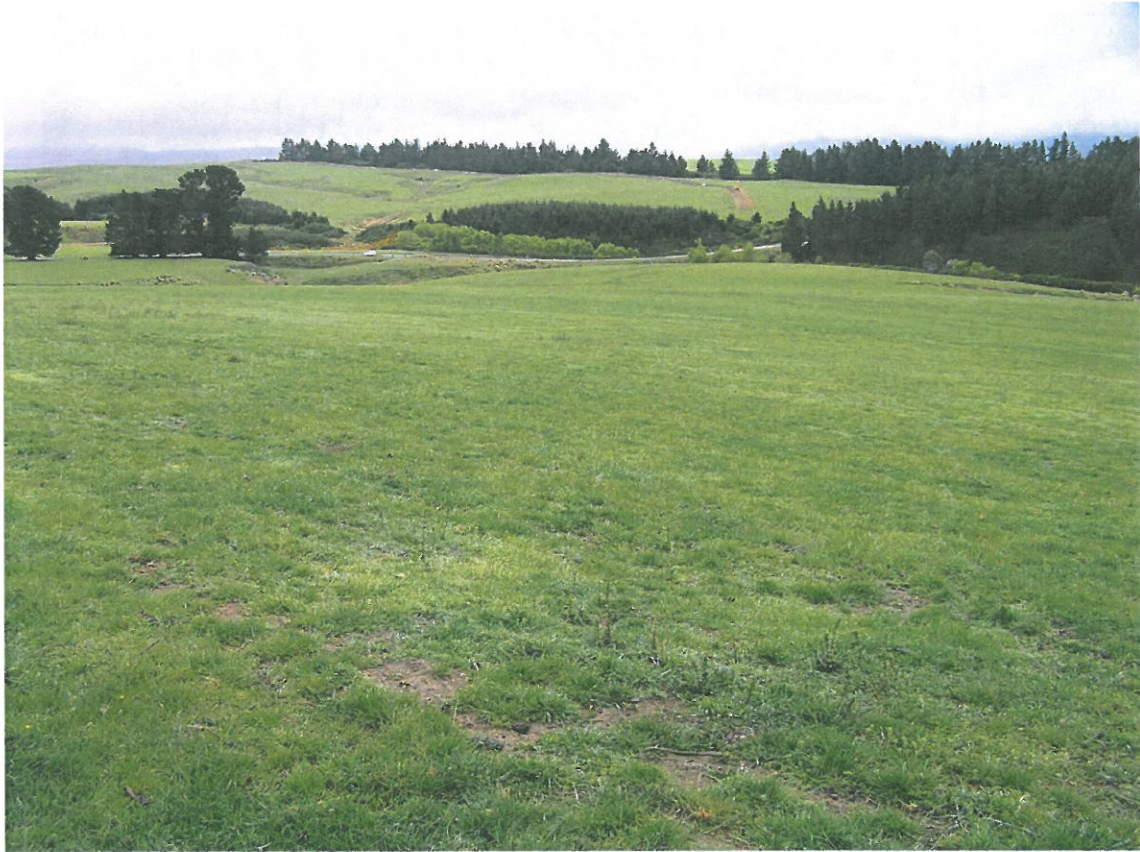
Photograph 13

Layout of Trench 700 along the proposed main embankment footprint, across the Macraes Fault

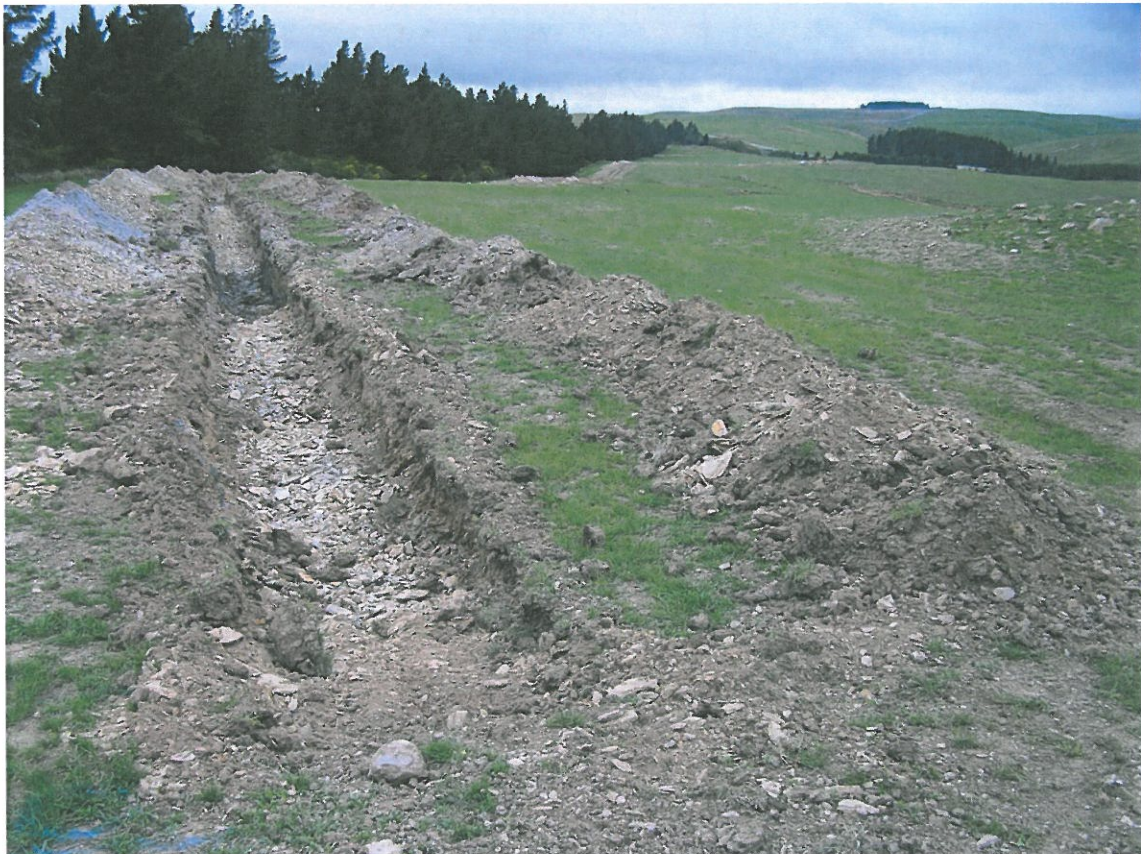
Photograph 14

View along Trench 700 from the north

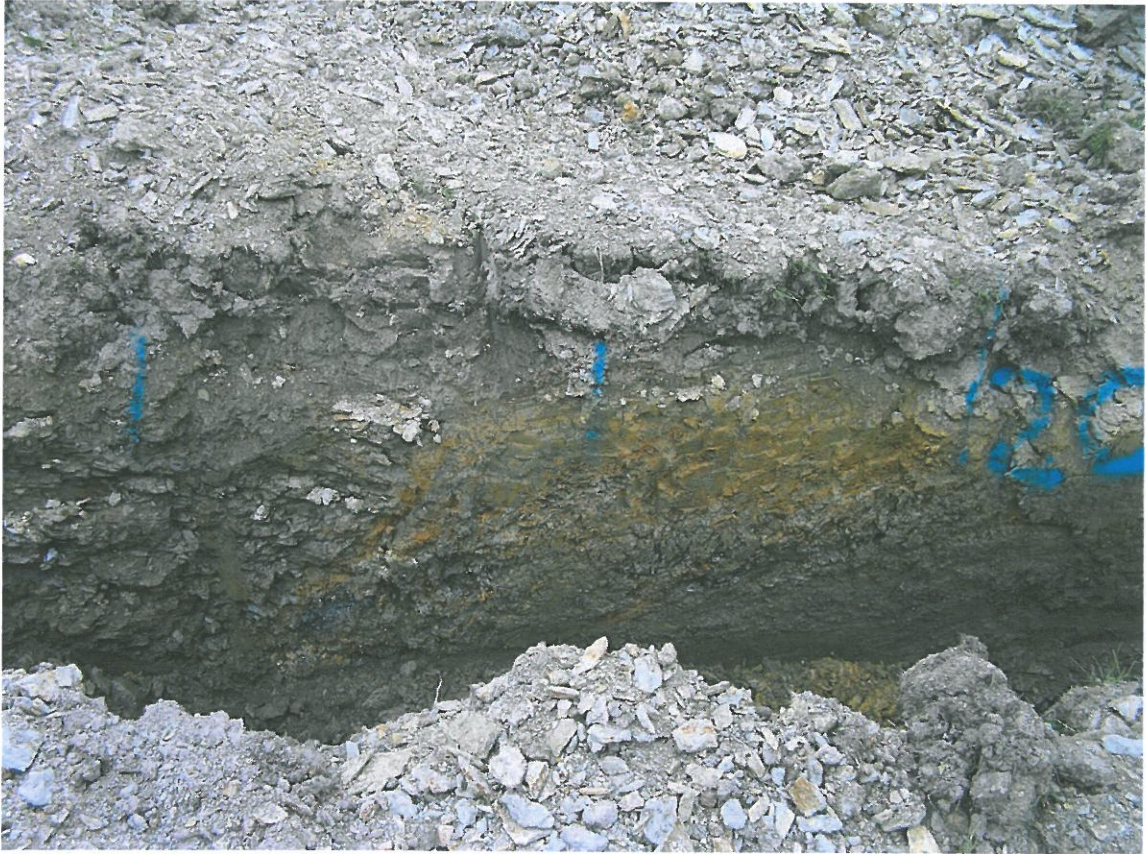
Photograph 15

North dipping fault exposed in Trench 700 at 120m. No deformation of thin loess soil.

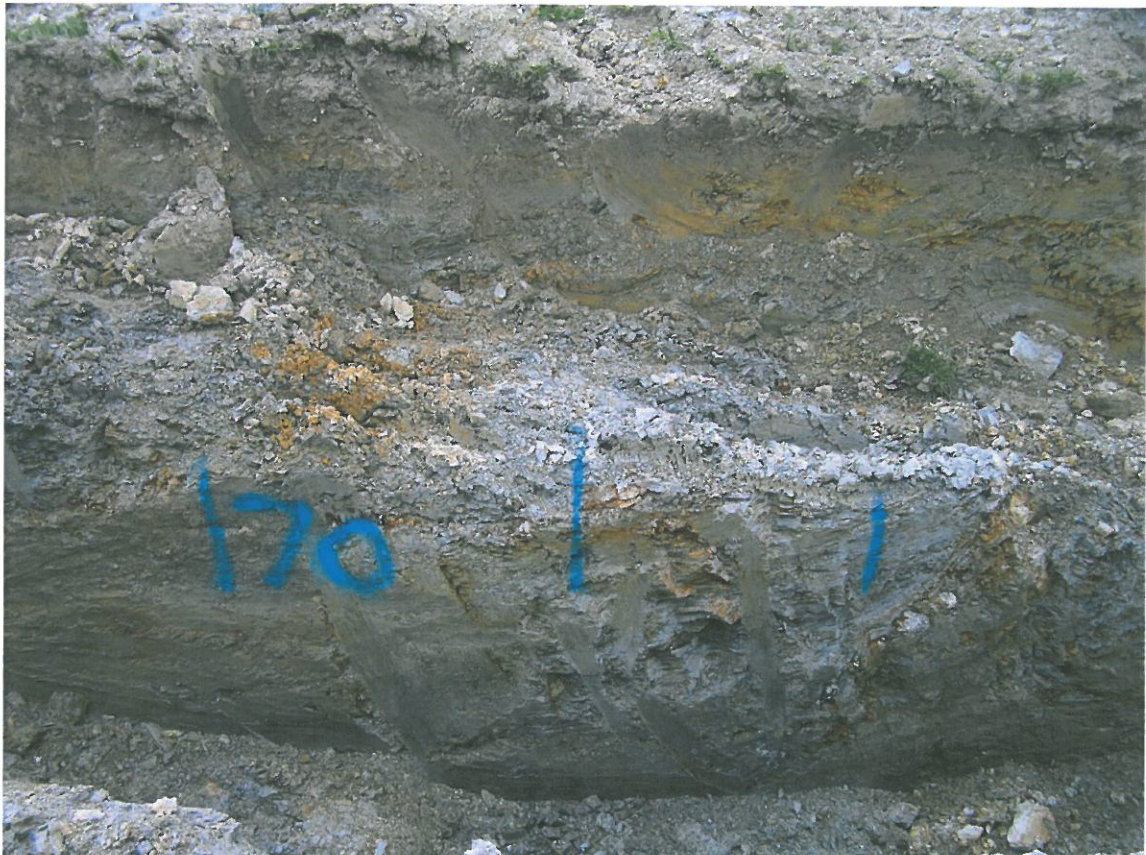
Photograph 16

North dipping fault exposed in Trench 700 at 170 m. Continuous topsoil and unfaulted loess layer can be seen across the exposure.

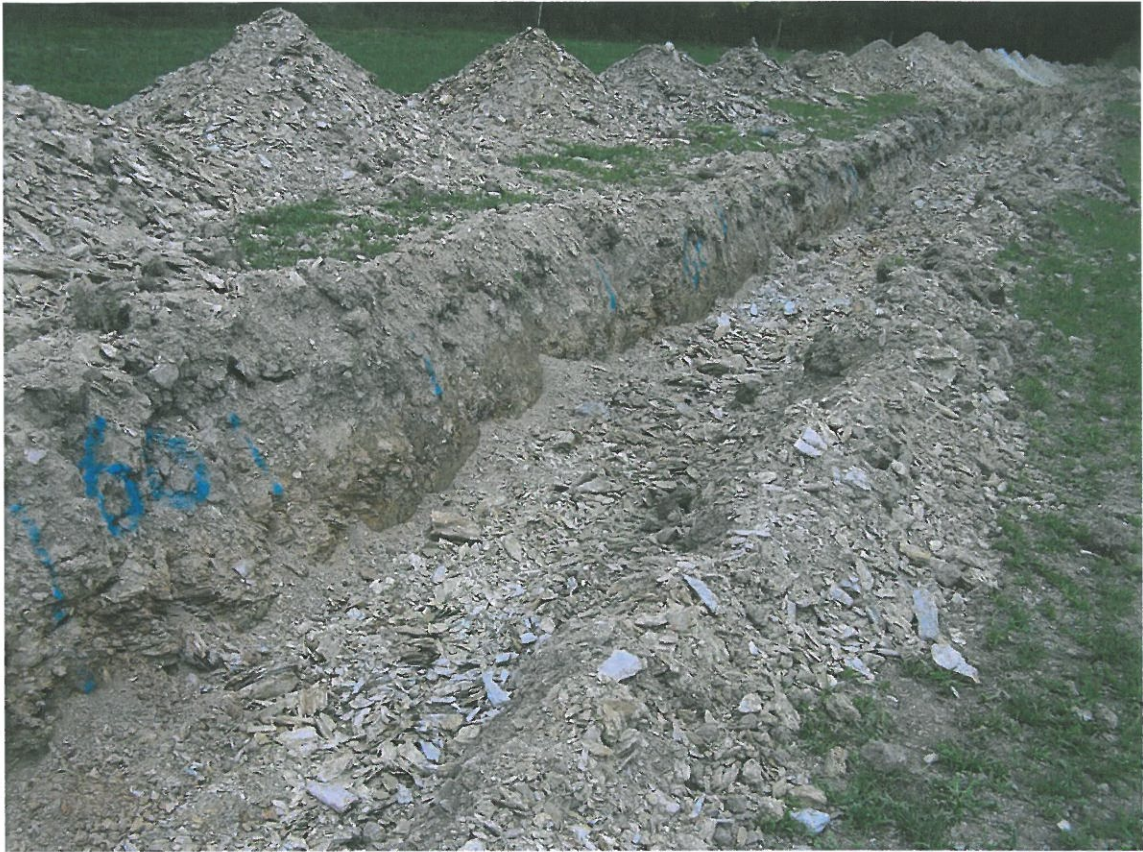
Photograph 17

View of Trench 700 from 260 m showing generally weak or moderately strong, unfaulted schist with thin covering soil for the next 50 m of trench.

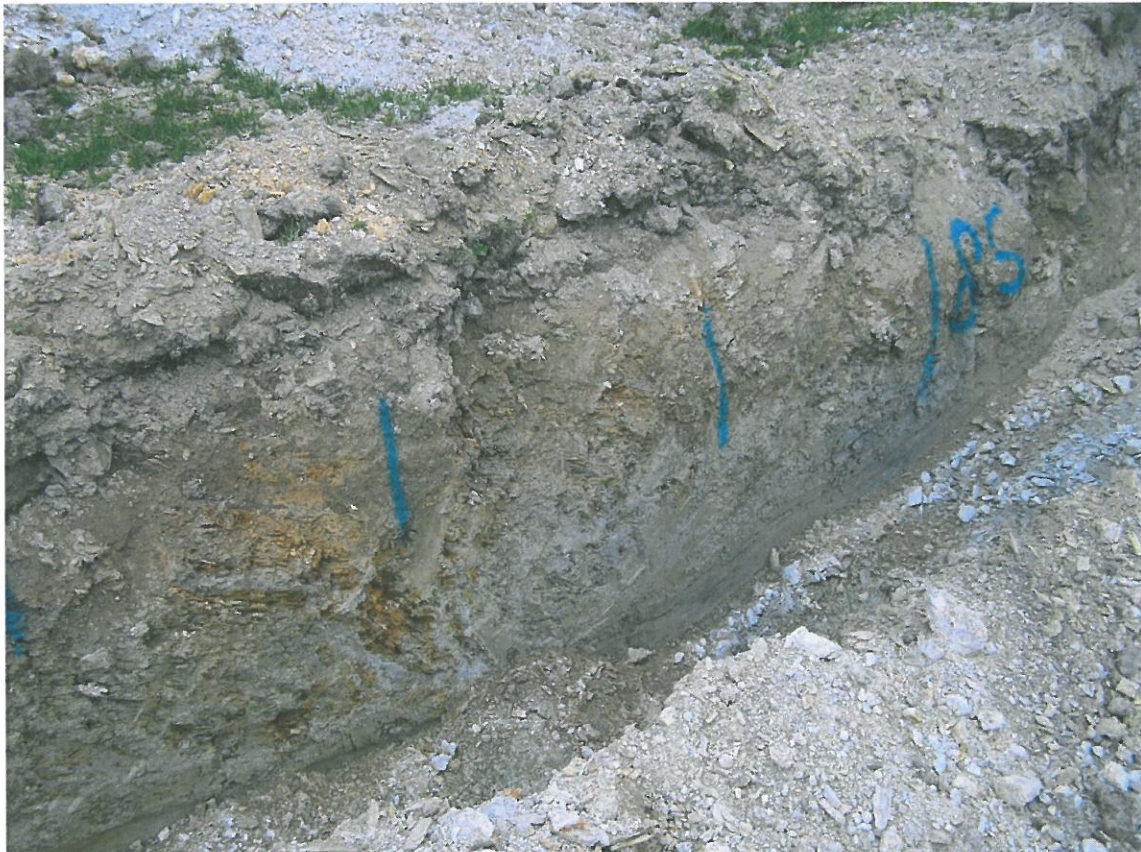
Photograph 18

South-east dipping fault, oriented parallel to local foliation attitude in Trench 700 at 385 m.

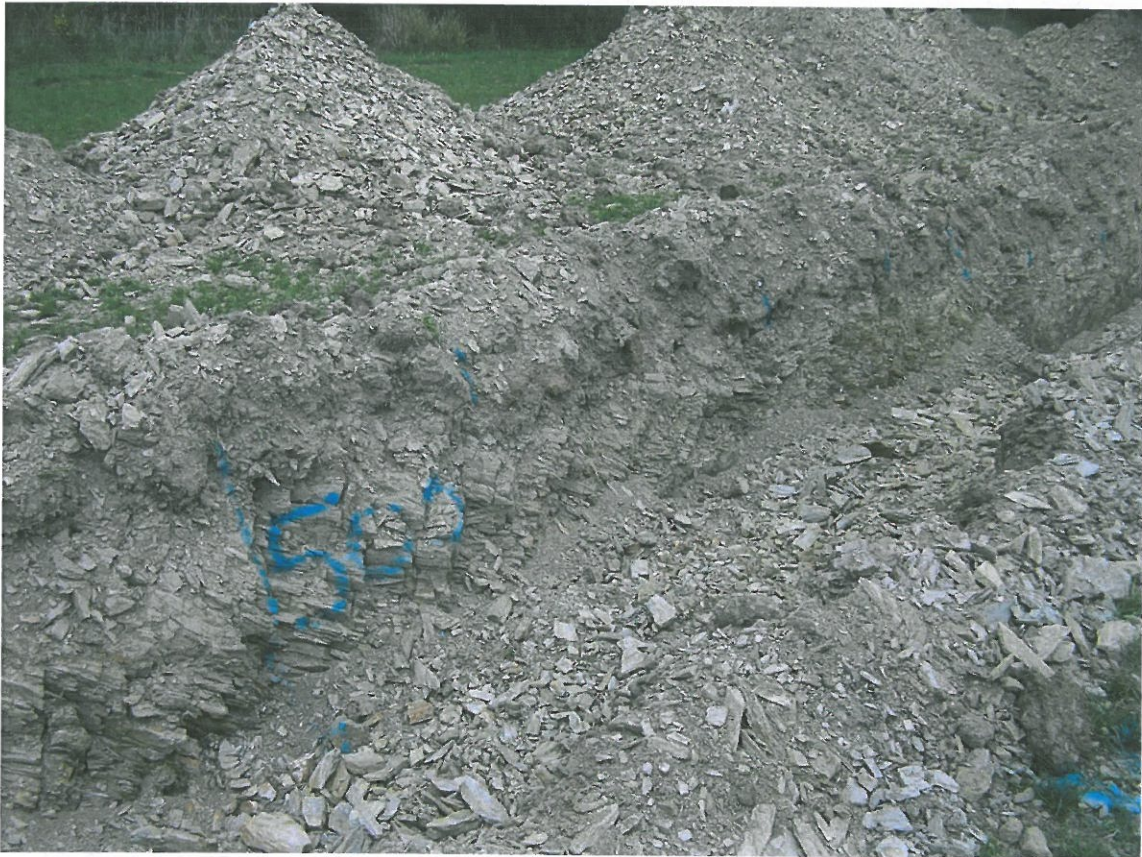
Photograph 19

View of Trench 700 from 500 m showing generally weak or moderately strong, unfaulted schist with thin covering soil in this area.

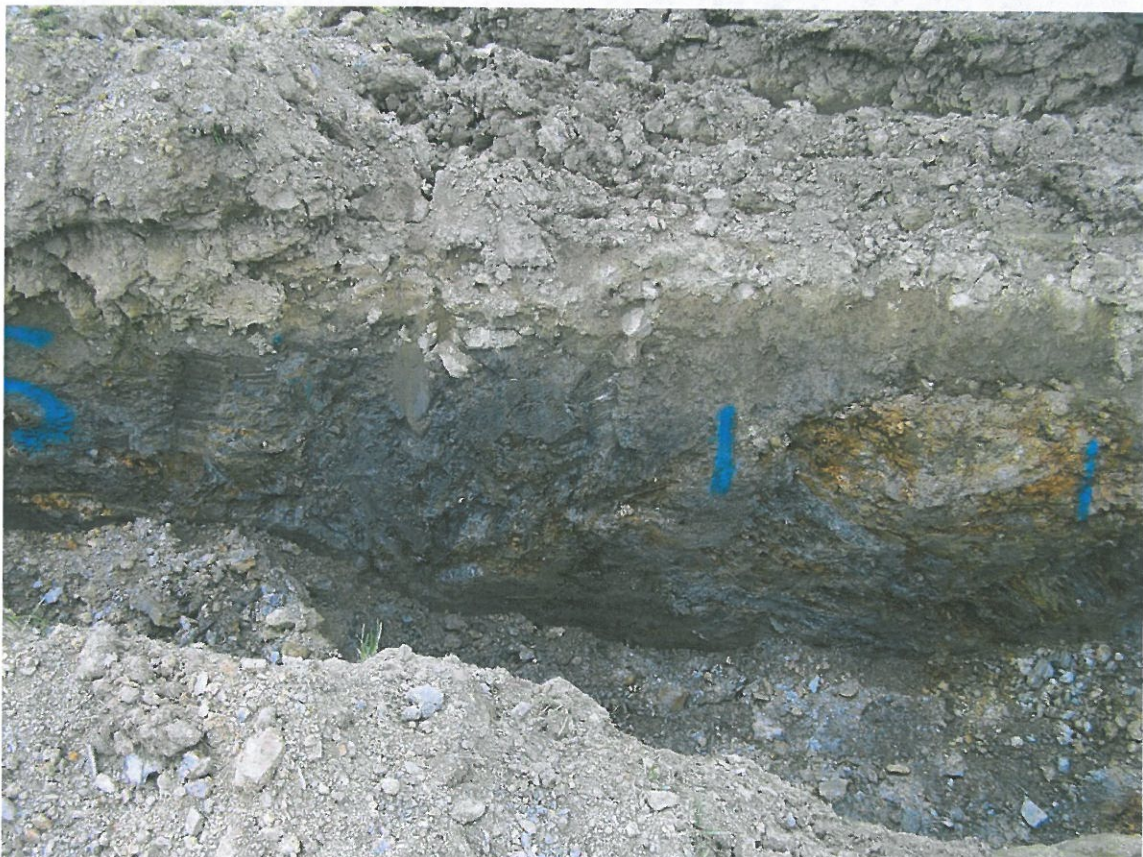
Photograph 20

One of several south-east dipping faults, oriented parallel to local foliation attitude in Trench 700 at about 635 m.

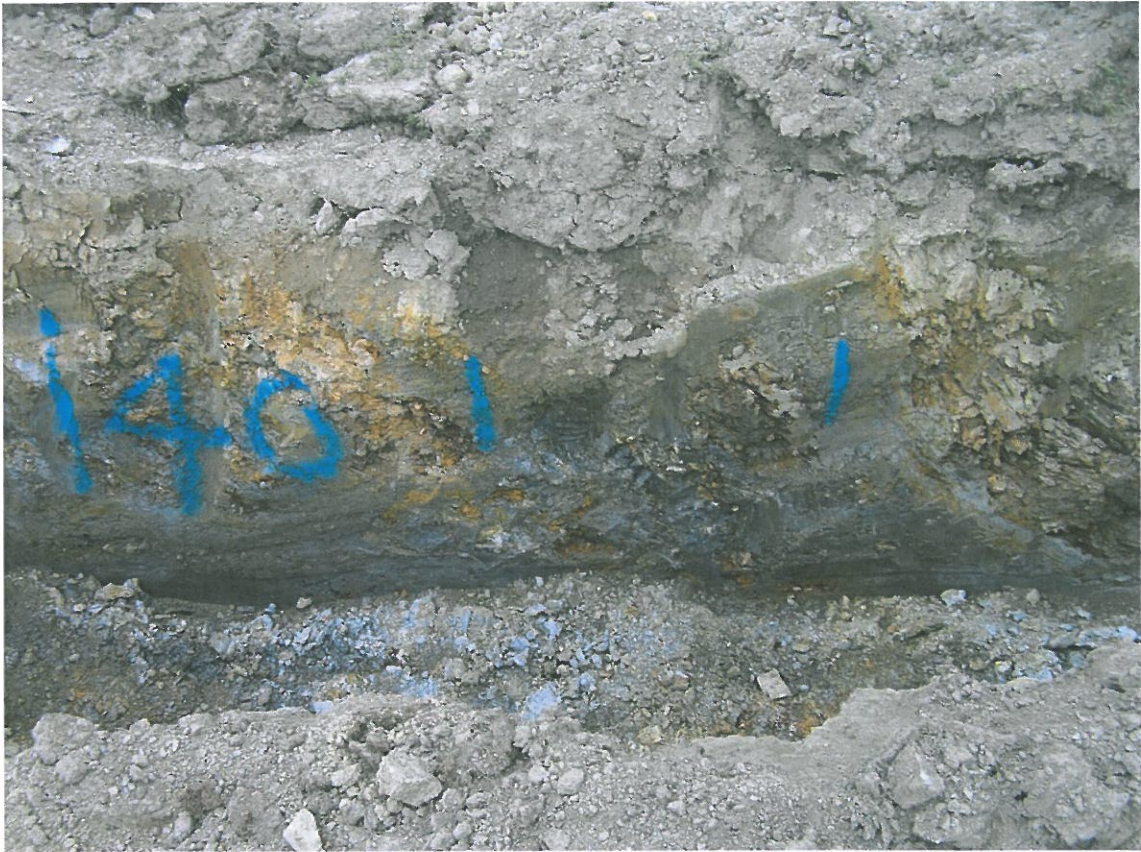
Photograph 21

South dipping fault parallel to local foliation oriented at 640 m in Trench 700.

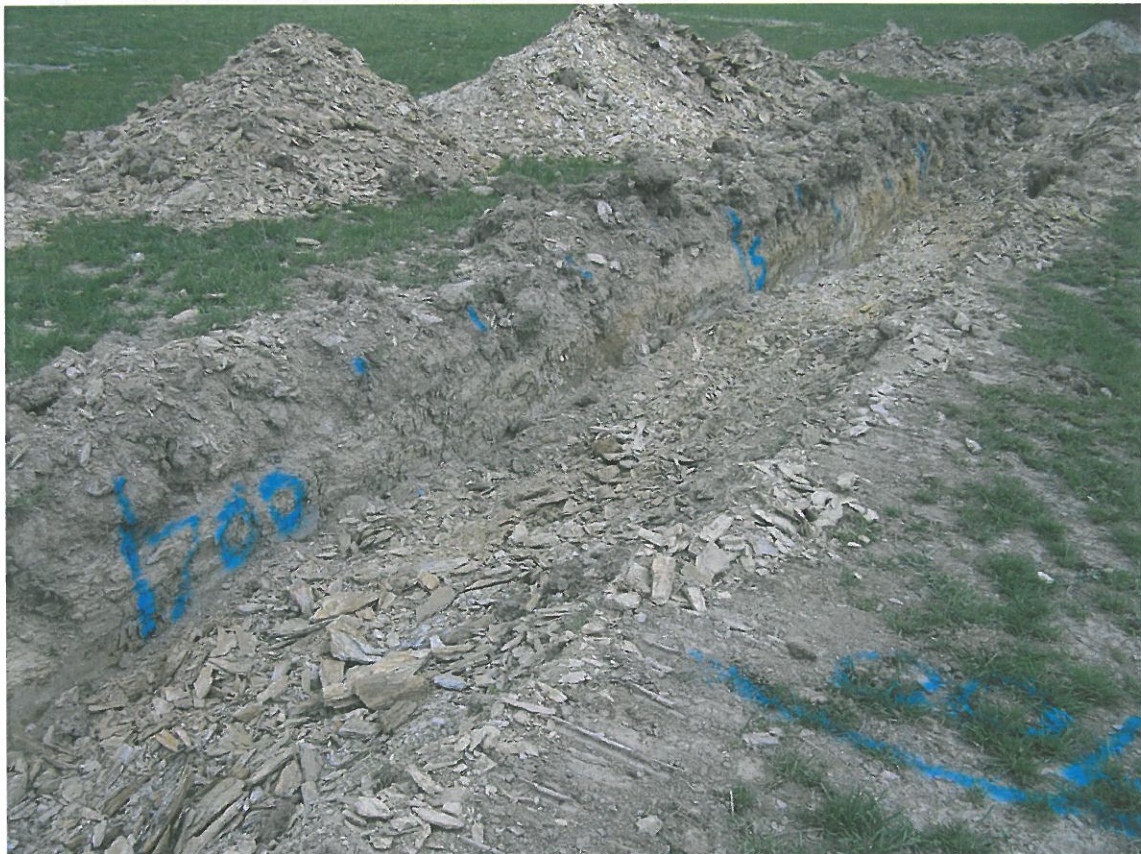
Photograph 22

Weak or moderately strong schist with thin soil cover exposed at 700 m in Trench 700
