**Channel morphology of the
Waianakarua River, North
Otago**

Report writer: Jacob Williams, Natural Hazards Analyst
Reviewed by: Michael Goldsmith, Manager Natural Hazards

Published December 2014

Technical Summary

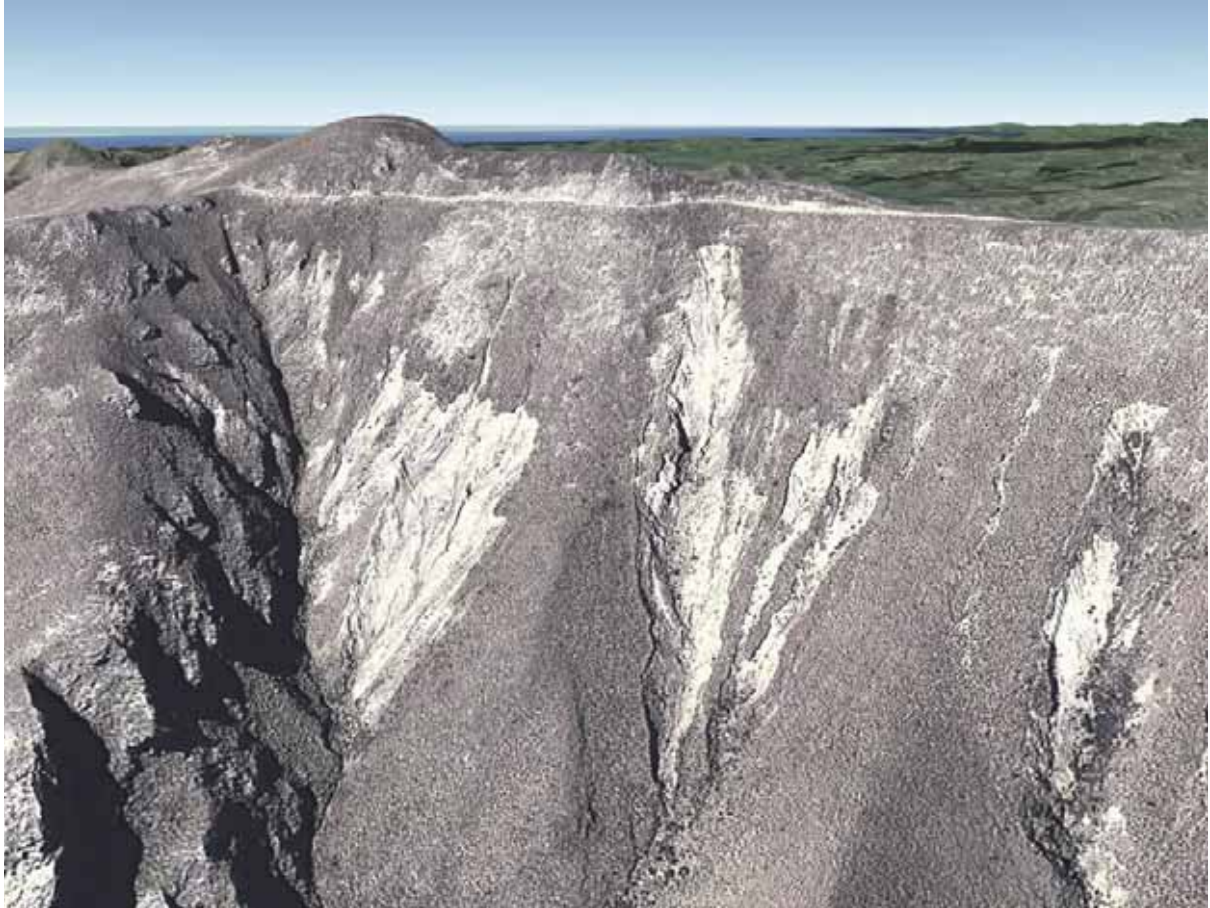
Figure 2. Evidence of land instability in the upper reaches of the North Branch of the Waianakarua River image date June 2012 (Google Earth). This location is shown on Figure 1 (red circle).

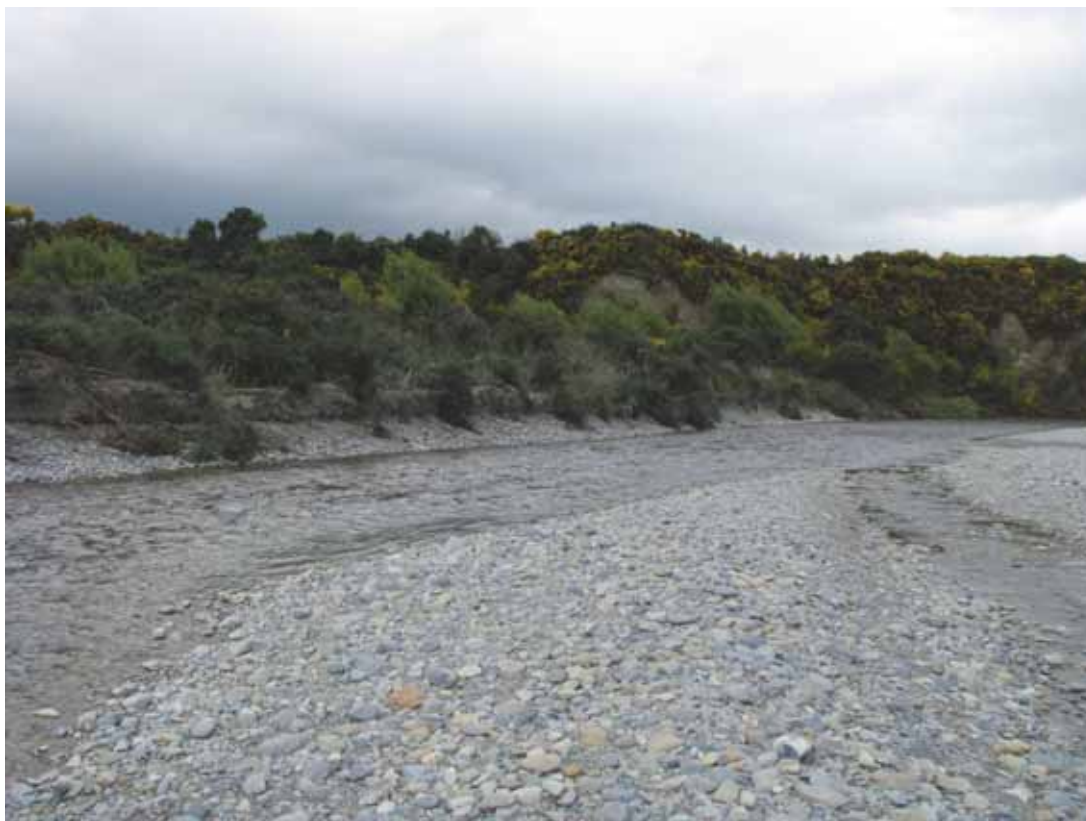
Figure 5. Area of active bank erosion on the main stem of the Waianakarua River (between cross-section WA2 and WA3), looking downstream, October 2013

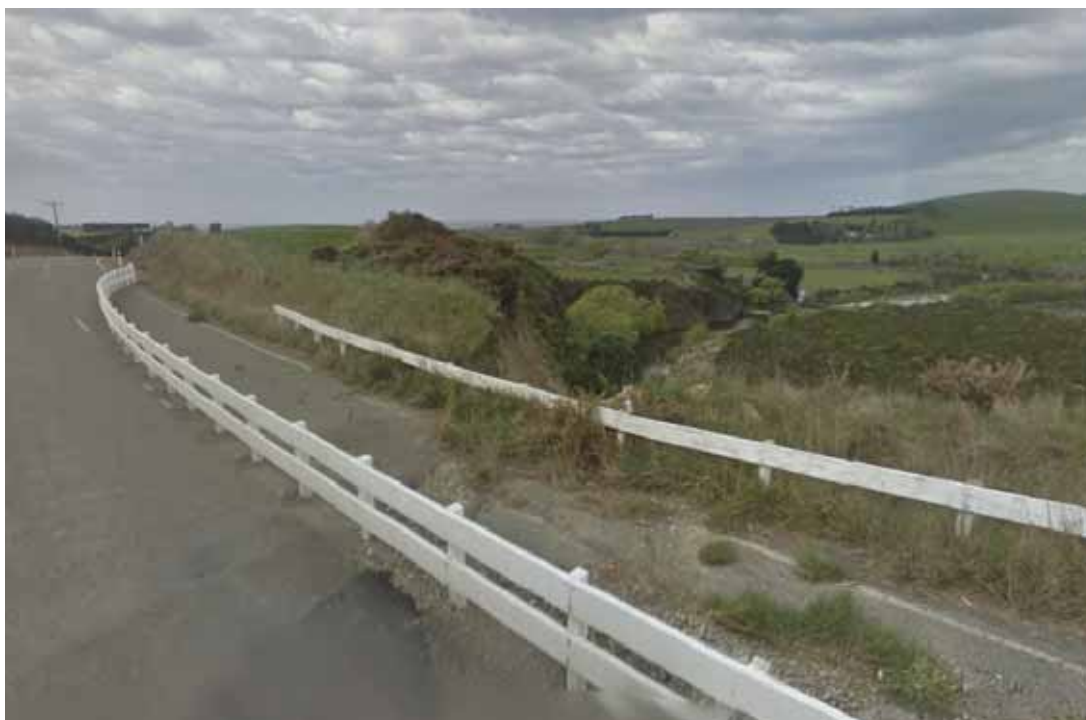
In the main stem of the Waianakarua River the channel switches between areas of braiding and single thread channels. The river is actively eroding the bank below Waianakarua Road, approximately 2km from the river mouth (Figure 6 and Figure 7). Between February 2008 and

Figure 6. Section of bank erosion on the true left of the Waianakarua River below Waianakarua Road, October 2012 (Google Maps, Street View)

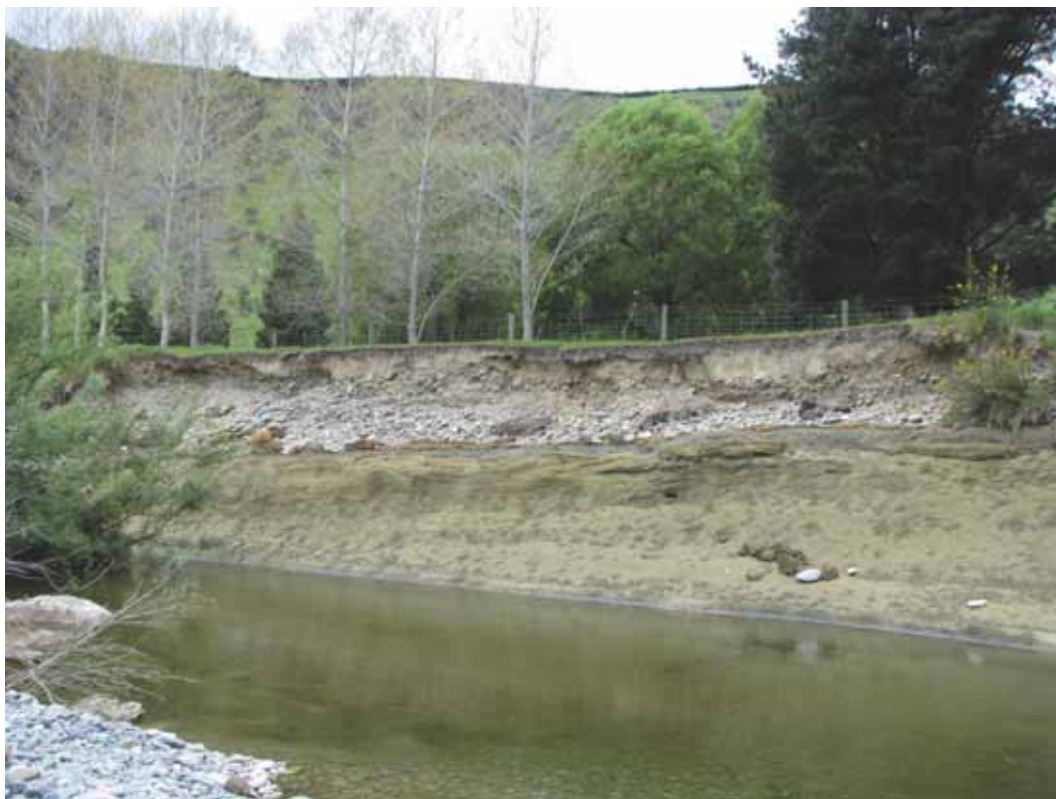
Between February 2008 and October 2013 there was erosion of both the left and right banks of the North Branch of the Waianakarua River (Figure 8, Figure 11). The surveyed reach of the North Branch includes areas of both aggradation and degradation, and an area where multiple channels have developed during the most recent survey period (WA6N, Figure 31). The morphology of the surveyed reach of the North Branch is affected by gravel extraction activities at Sharps Bend (Figure 1).

Figure 8. Area of active bank erosion on the North Branch of the Waianakarua River (upstream of SH1), looking upstream, October 2013

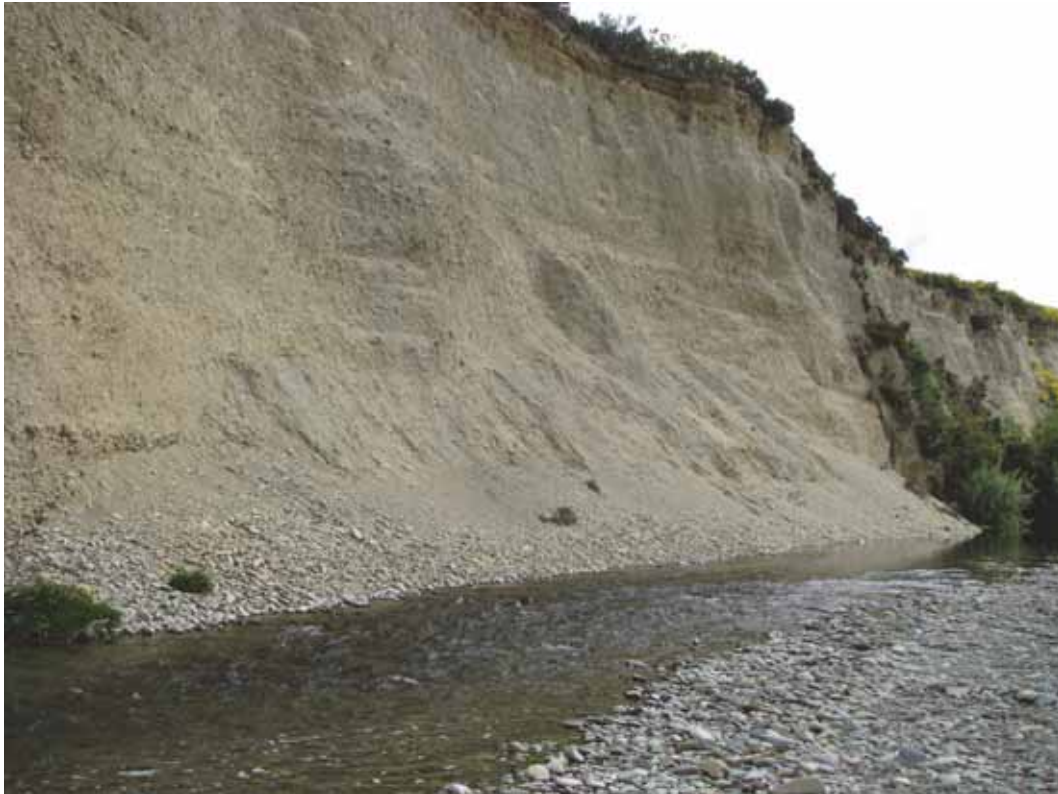
Erosion of both the left and right banks is an ongoing process in the South Branch of the Waianakarua River (Figure 9, Figure 12). Sediment movement (in the form of both erosion and deposition) in the surveyed reach has led to the channel becoming wider in some locations (WA5S - Figure 37, and WA7S - Figure 41) but narrower and deeper in others (WA9S - Figure 45, and WA15S - Figure 57). Cross-sections between WA5S and WA9S are affected by gravel extraction activities.

Figure 9. Area of active bank erosion on the South Branch of the Waianakarua River (between cross-section WA7S and WA8S), looking upstream, October 2013

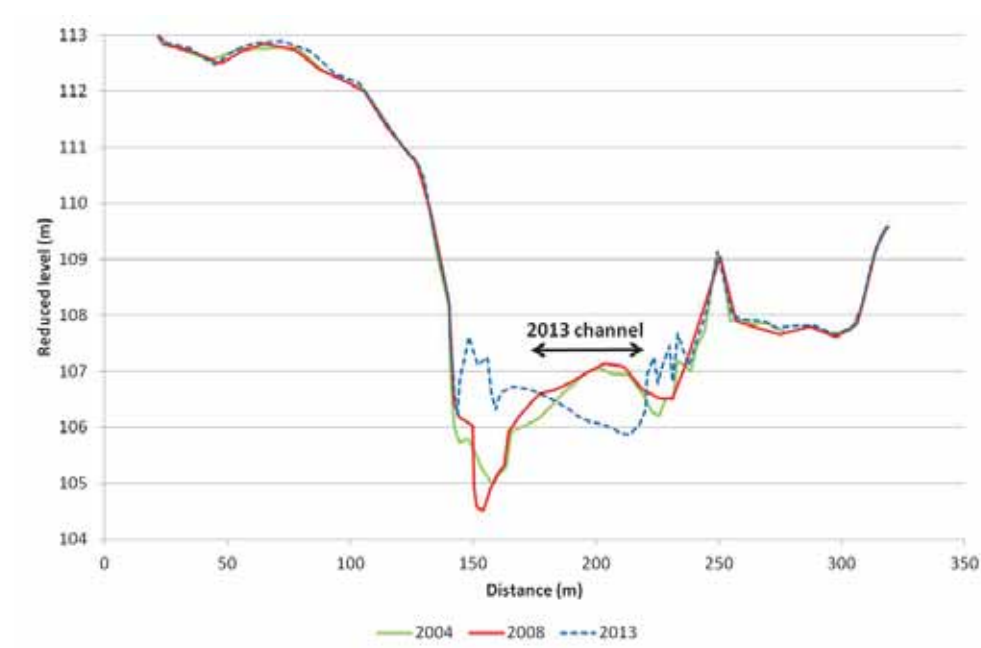
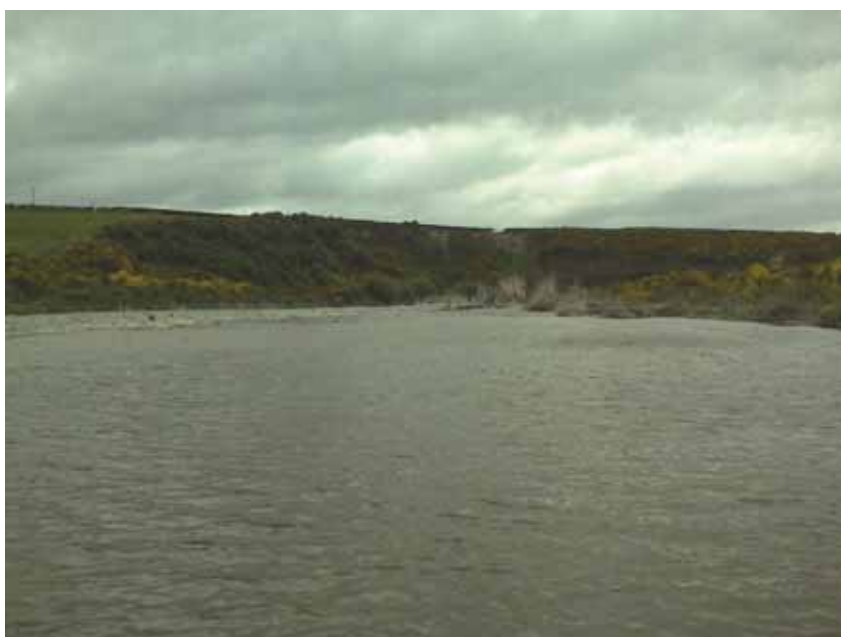
Waianakarua: WA1

Cross-section WA1 is located 2.65km upstream of the Waianakarua River Mouth. The channel bed remained similar between June 2004 and February 2008 with a lowering of the main channel occurring. Between February 2008 and October 2013 the main channel has aggraded approximately 2.5m on the true left and degraded by 1m on the true right to create a wider, shallower channel. Minimal change has occurred in the wider floodplain. The thalweg level aggraded by 1.3m between 2008 and 2013 and has changed position (horizontally) from the left to the right bank.

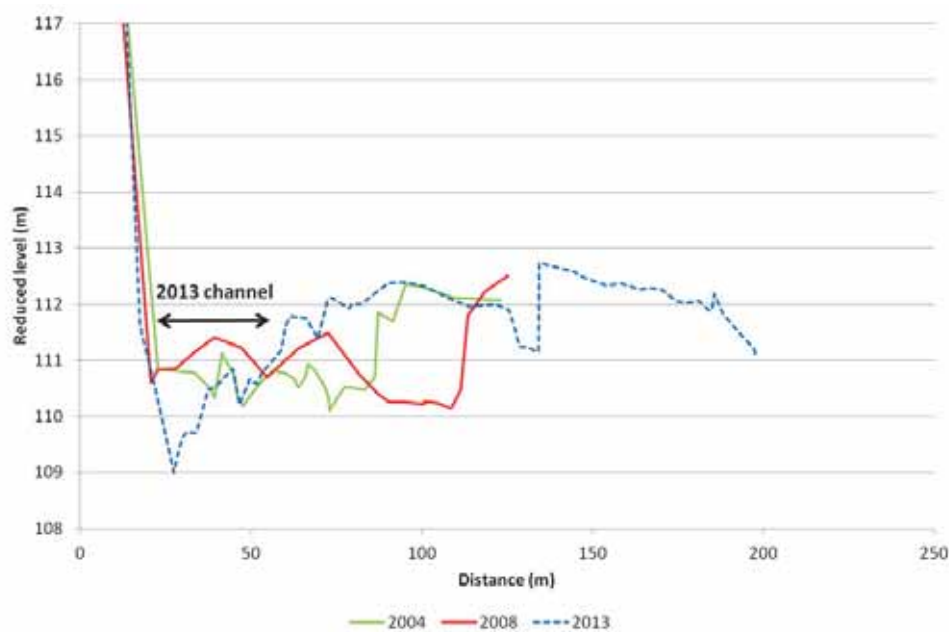
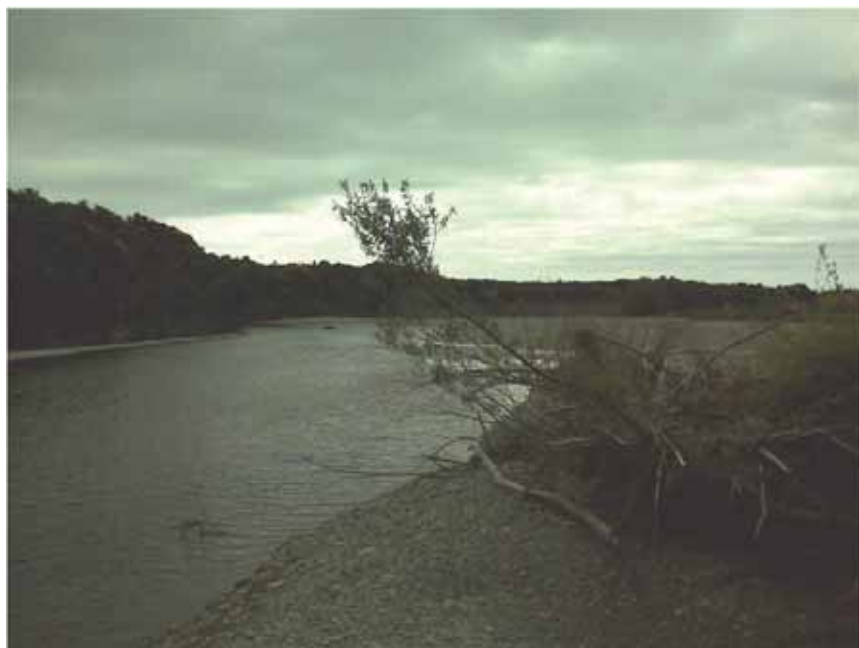
Waianakarua: WA2

Cross-section WA2 is located 4.35km upstream of the Waianakarua River Mouth. The channel bed aggraded between June 2004 and February 2008 with erosion of the right bank occurring. Between February 2008 and October 2013 the main channel degraded approximately 2m on the true left and aggraded by 2m on the true right to create a narrower, deeper channel. Changes on the true right wider floodplain cannot be verified, as previous surveys in 2004 and 2008 did not extend as far to the true right as that completed in 2013. The thalweg degraded by 1.1m between 2008 and 2013 and has changed position (horizontally) from the right to the left bank.

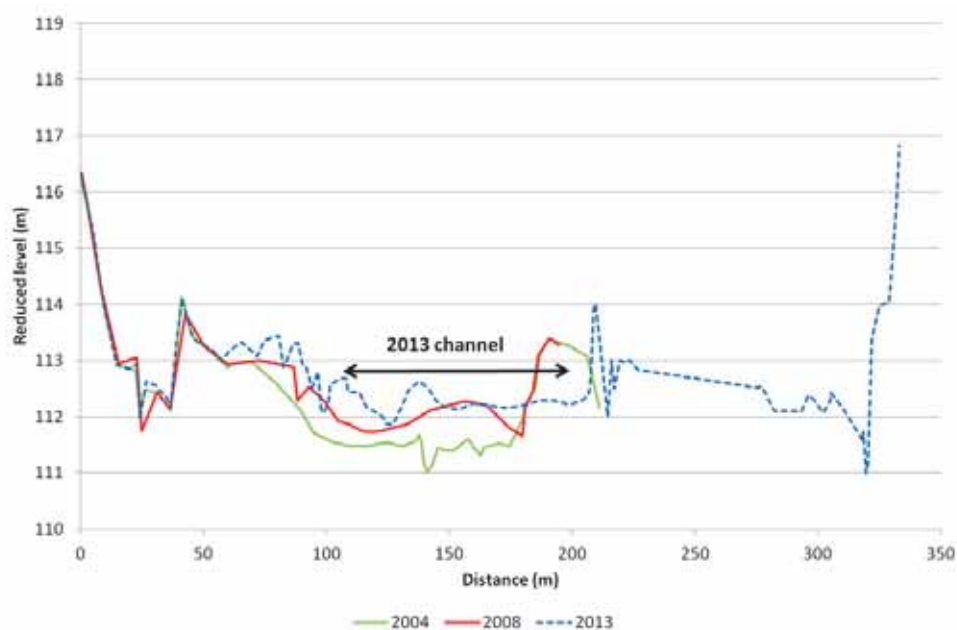
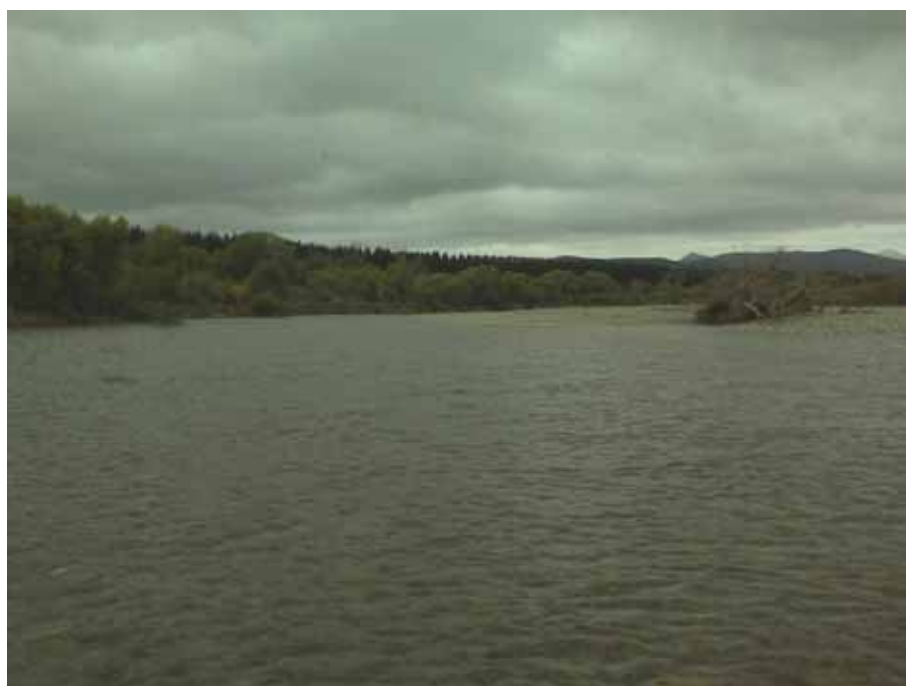
Waianakarua: WA3

Cross-section WA3 is located 4.6km upstream of the Waianakarua River Mouth. The channel bed aggraded between June 2004 and February 2008. Between February 2008 and October 2013 the main channel aggraded up to 1m on the true left and eroded the true right bank by approximately 20m. Changes on the true right wider floodplain cannot be verified, as previous surveys in 2004 and 2008 did not extend as far to the true right as that completed in 2013. The thalweg aggraded by 0.6m between 2008 and 2013.

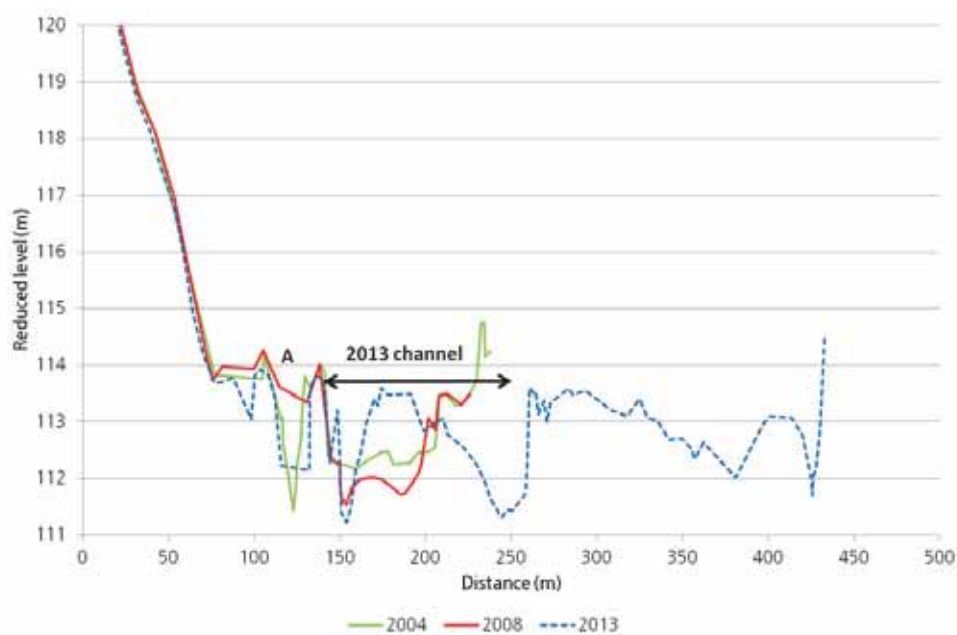
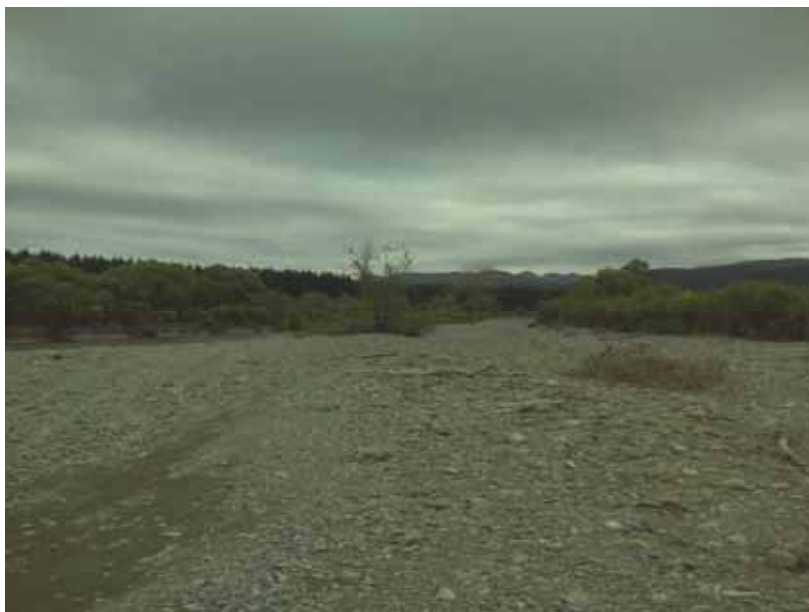
Waianakarua: WA4

Cross-section WA4 is located 4.7km upstream of the Waianakarua River Mouth. The channel bed aggraded on the true left secondary channel (point labelled A) with degradation occurring in the main channel between June 2004 and February 2008. Between February 2008 and October 2013 the main channel aggraded approximately 2m, with degradation occurring in the secondary flow channel (point labelled A). The right bank eroded with another channel being created between 2008 and 2013, indicating the dynamic nature of the Waianakarua River at this location. Changes on the true right wider floodplain cannot be verified, as previous surveys in 2004 and 2008 did not extend as far to the true right as that completed in 2013. The thalweg degraded by 0.3m between 2008 and 2013.

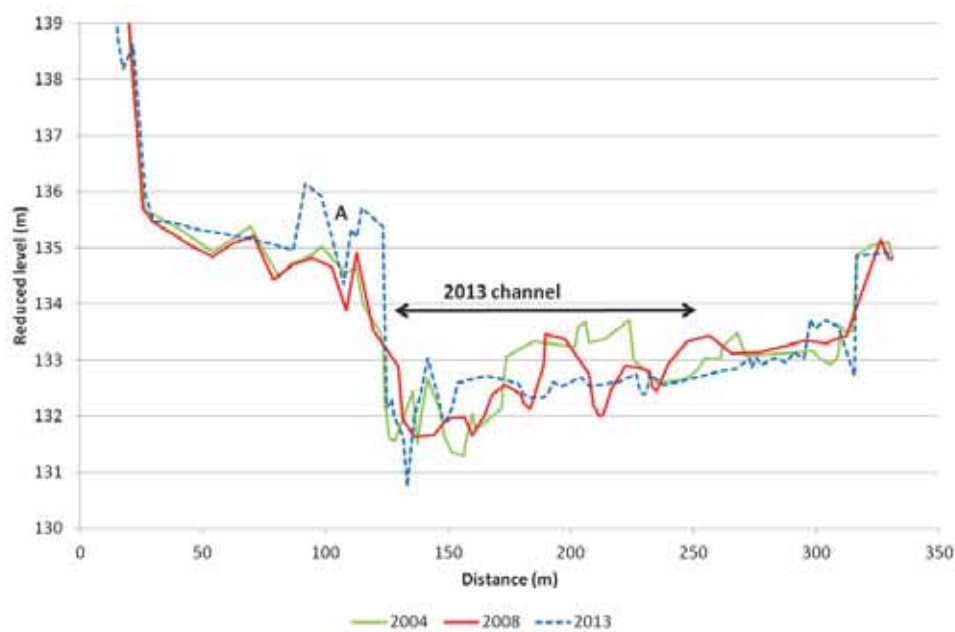
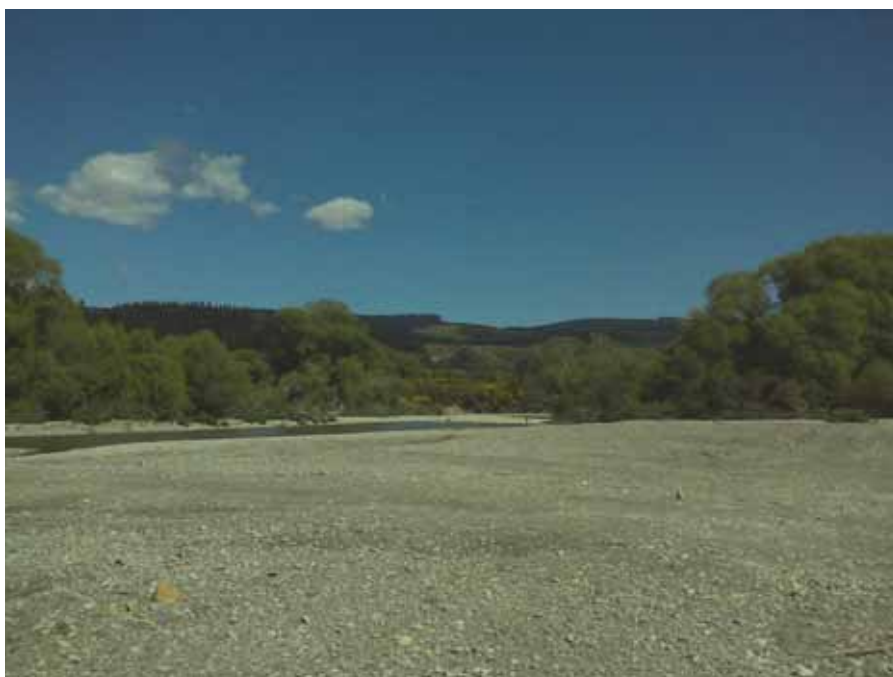
Waianakarua: WA5N

Cross-section WA5N is located 9.6km upstream of the Waianakarua River Mouth on the North Branch at Sharps Bend, an area of historic and recent gravel extraction, where natural and artificial changes are reflected. The channel bed both aggraded and degraded between June 2004 and February 2008. Between February 2008 and October 2013 the main channel both aggraded and degraded, creating a smoother and lower profile. The top of the left bank shows aggradation and the creation of two levees (at the point labelled A). The right bank aggraded and steepened between 2008 and 2013. The thalweg degraded by 0.9m between 2008 and 2013.

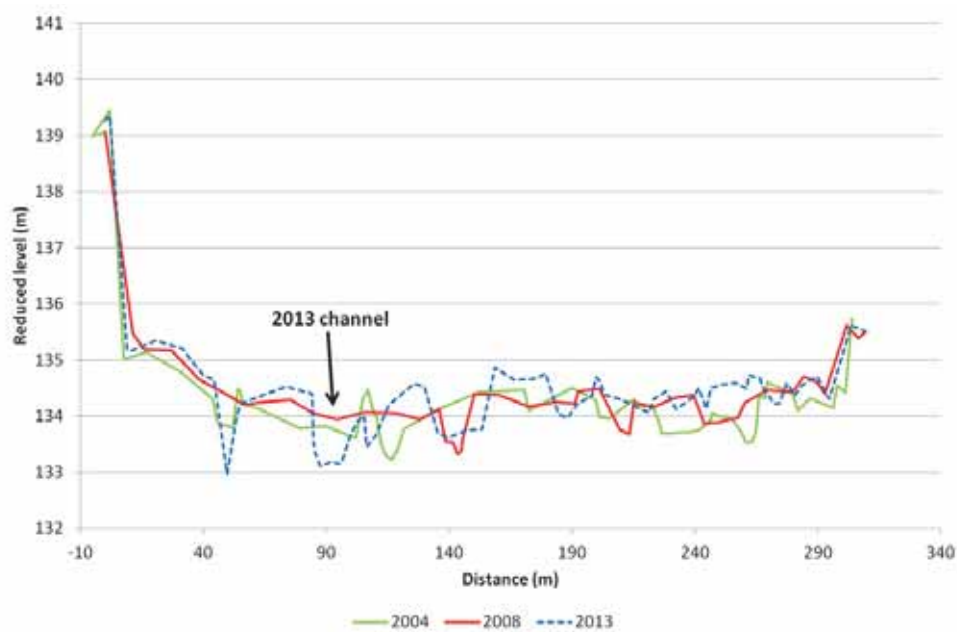
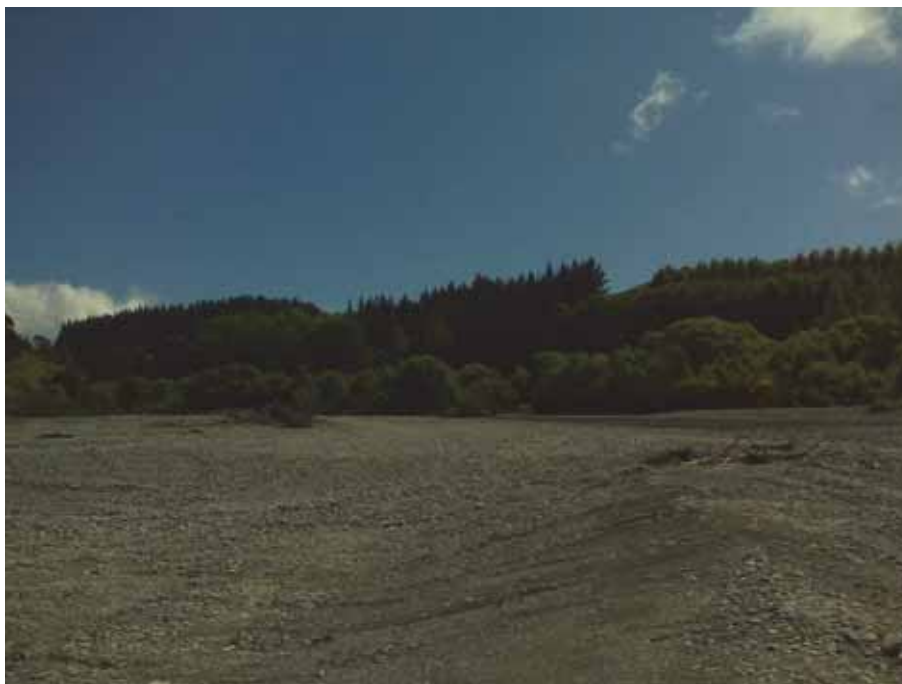
Waianakarua: WA6N

Cross-section WA6N is located 9.75km upstream of the Waianakarua River Mouth on the North Branch at Sharps Bend, an area of historic and recent gravel extraction, where natural and artificial changes are reflected. Here the river consists of several low flow channels with the bed both aggrading and degrading between June 2004 and February 2008. Three channels were created on the true left of the channel between February 2008 and October 2013 with aggradation occurring on the true left bank. The thalweg degraded by 0.35m between 2008 and 2013.

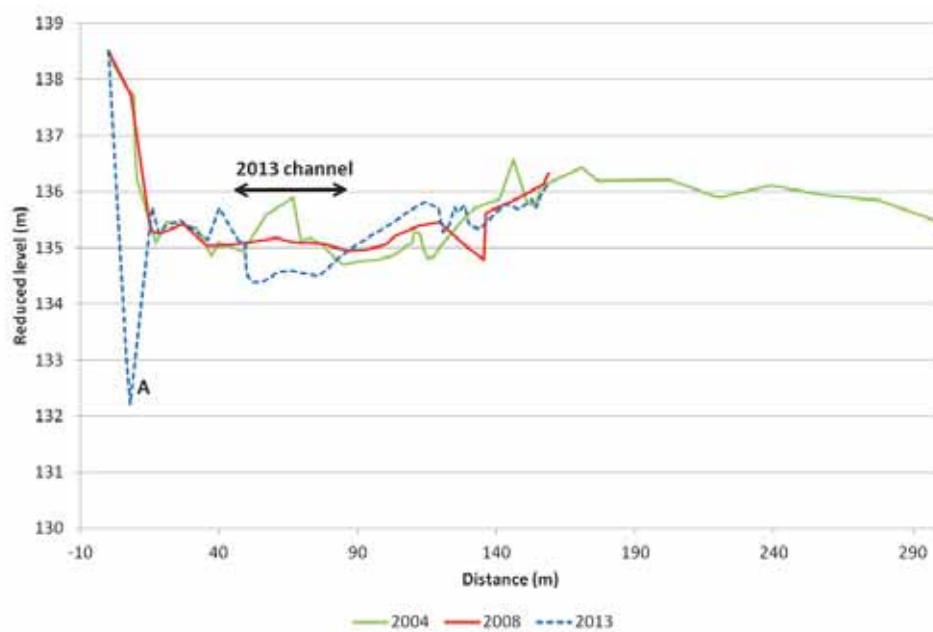
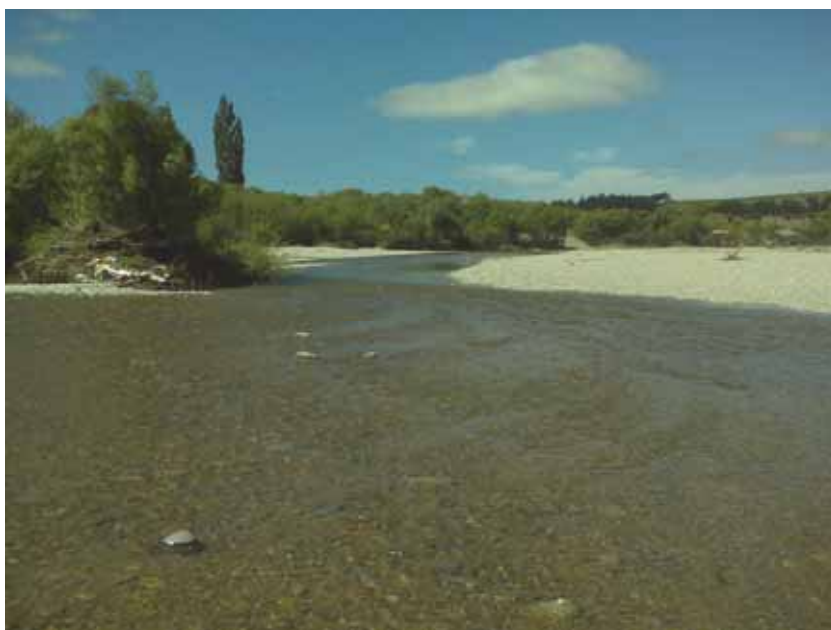
Waianakarua: WA7N

Cross-section WA7N is located 9.9km upstream of the Waianakarua River Mouth on the North Branch at Sharps Bend, an area of historic and recent gravel extraction, where natural and artificial changes are reflected. Between June 2004 and February 2008 the bed both aggraded and degraded with the channel becoming smoother in 2008. Between February 2008 and October 2013 the left bank eroded approximately 9m and degraded 6m, creating a deep secondary channel (point labelled A). The main channel degraded with aggradation occurring on the right bank between February 2008 and October 2013, creating a narrower deeper main channel. The thalweg degraded by 0.4m between 2008 and 2013.

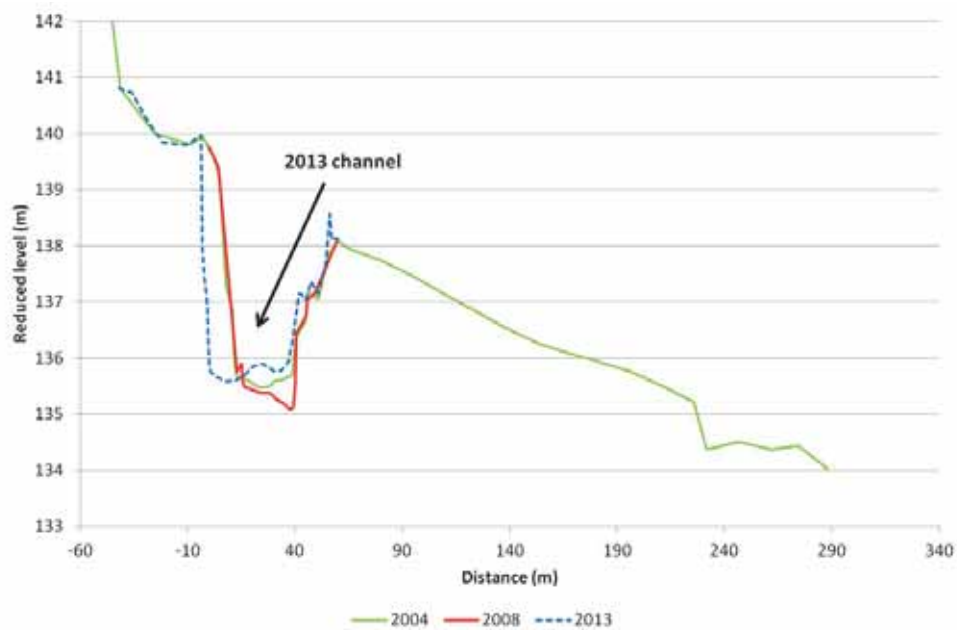
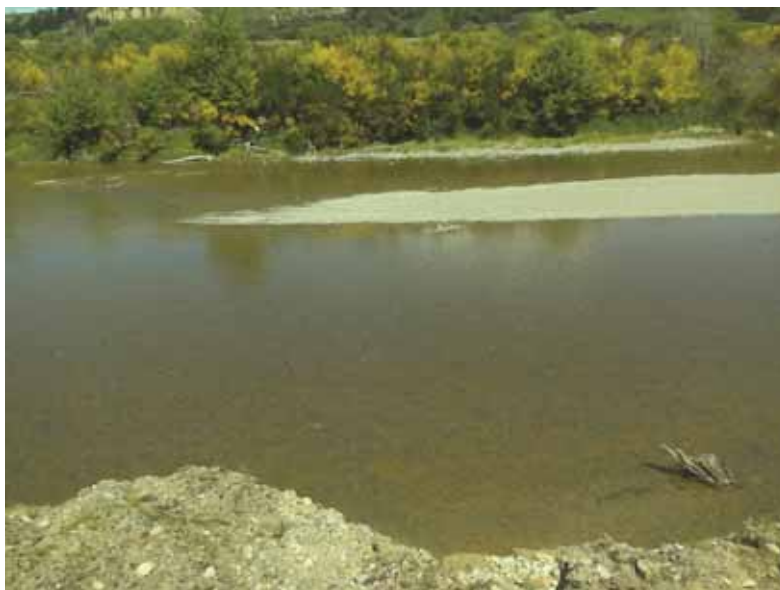
Waianakarua: WA8N

Cross-section WA8N is located 10.25km upstream of the Waianakarua River Mouth on the North Branch at Sharps Bend, an area of historic and recent gravel extraction, where natural and artificial changes are reflected. Between June 2004 and February 2008 the main channel bed degraded by approximately 0.5m. Between February 2008 and October 2013 the left bank eroded by approximately 13m with the main channel aggrading by approximately 0.75m, creating a wider, shallower channel. Some aggradation occurred on the right bank between 2008 and 2013. Changes on the true right wider floodplain cannot be verified, as surveys in 2013 and 2008 did not extend as far to the true right as that completed in 2004. The thalweg aggraded by 0.49m between 2008 and 2013.

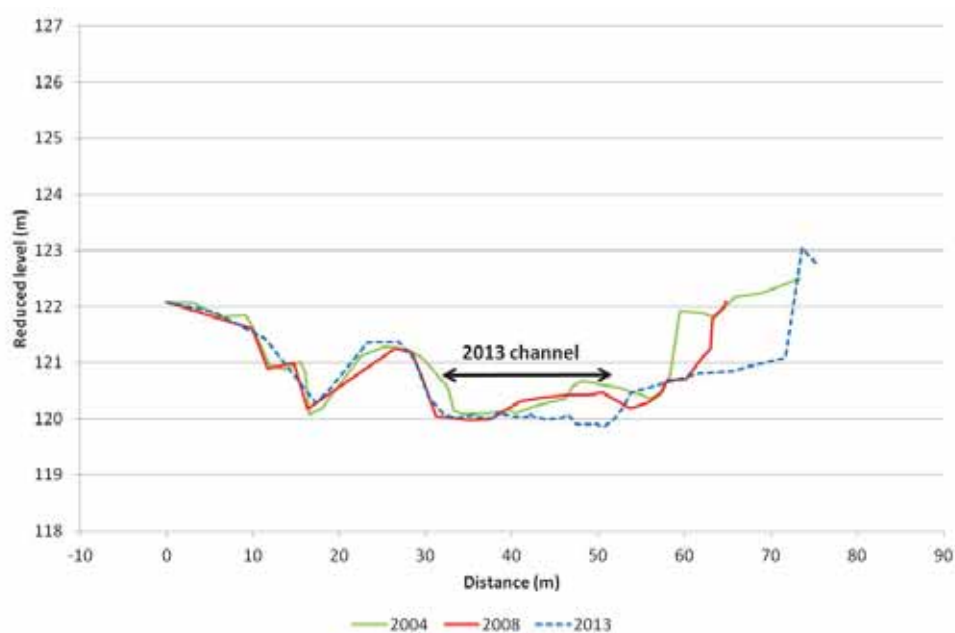
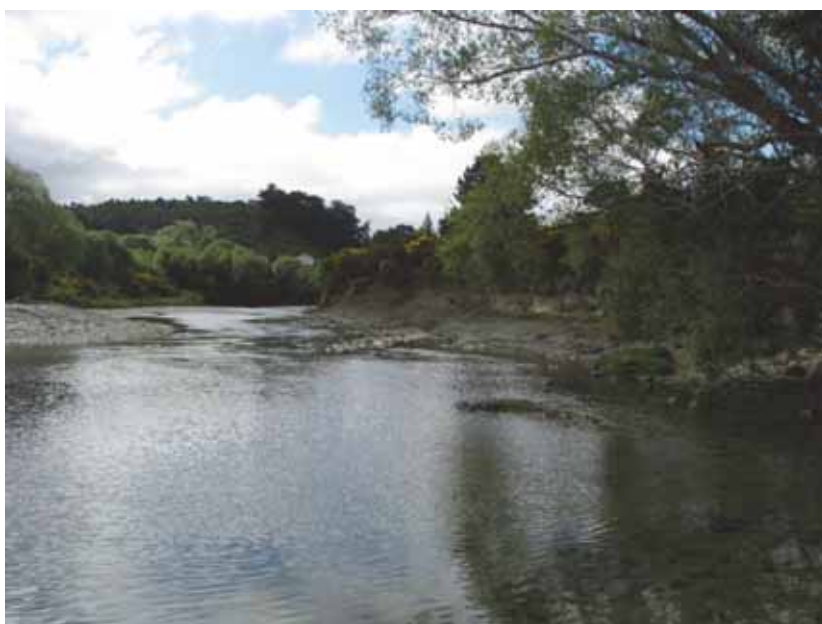
Waianakarua River: WA5S

Cross-section WA5S is located 6.85km upstream of the Waianakarua River Mouth on the South Branch. Between June 2004 and February 2008 there was erosion of the left and right banks with the channel bed aggrading in some places and degrading in others. Continued erosion at this location would affect farmland on the right bank. Between February 2008 and October 2013 the wider left floodplain aggraded, creating a smoother profile with degradation occurring in the main channel. The right bank eroded approximately 14m between 2004 and 2013. Changes on the true right wider floodplain between 2008 and 2013 cannot be verified, as the 2008 survey did not extend as far to the true right as that completed in 2004 and 2013. The thalweg degraded by 0.12m between 2008 and 2013.

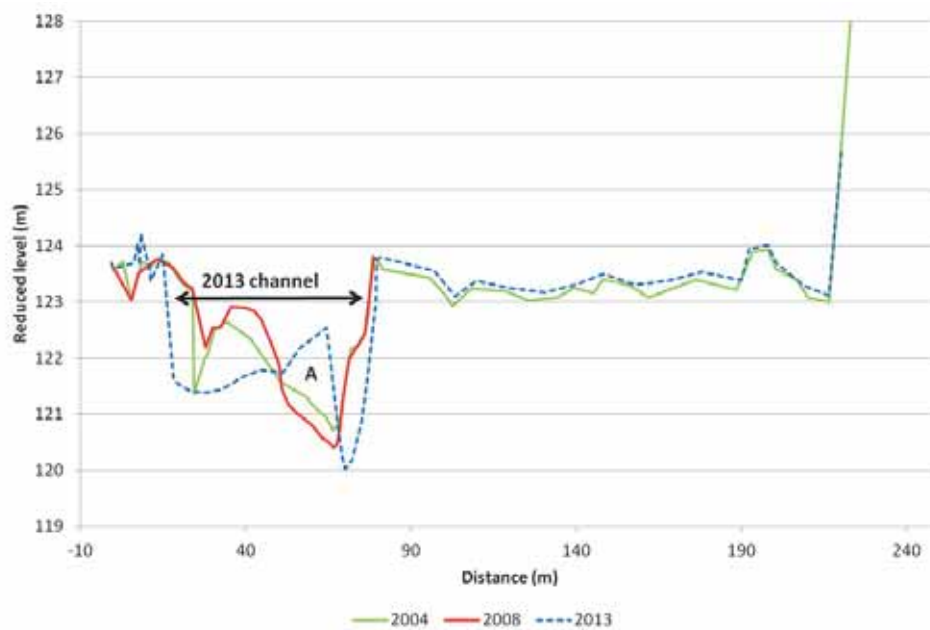
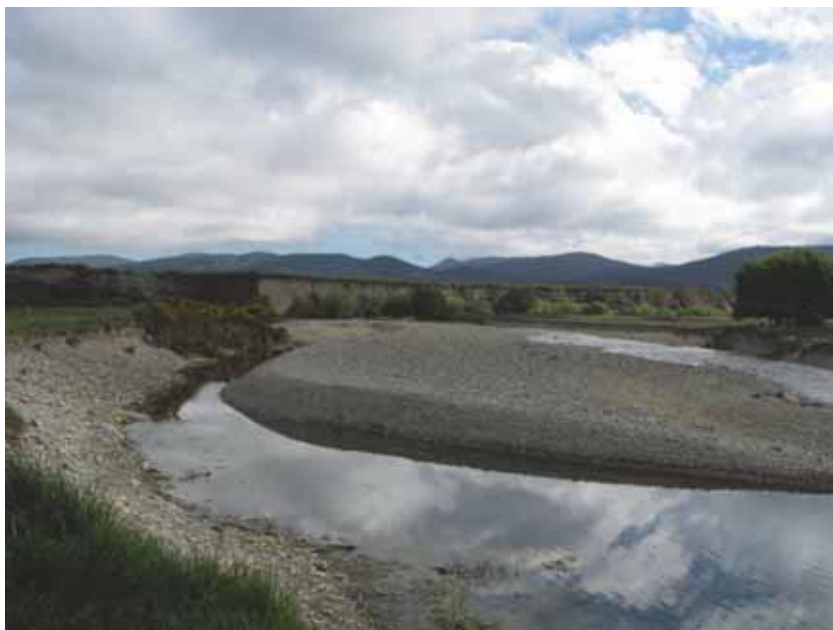
Waianakarua: WA6S

Cross-section WA6S is located 7km upstream of the Waianakarua River Mouth on the South Branch. Between June 2004 and February 2008 there was aggradation of the left bank with the main channel bed degrading. Between February 2008 and October 2013 the left and right banks eroded with aggradation occurring in the 2004/2008 main channel. This has created two channels separated by a gravel bar (Figure 39) (point labelled A). The wider right bank floodplain aggraded between 2004 and 2013. Changes on the true right wider floodplain between 2008 and 2013 cannot be verified, as the 2008 survey did not extend as far to the true right as that completed in 2004 and 2013. The thalweg degraded by 0.4m between 2008 and 2013.

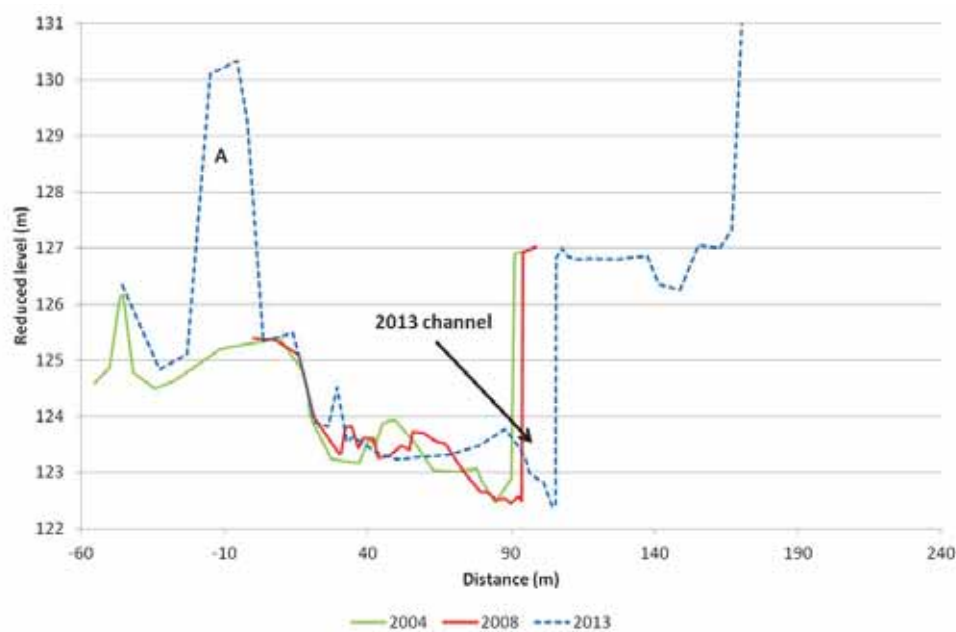
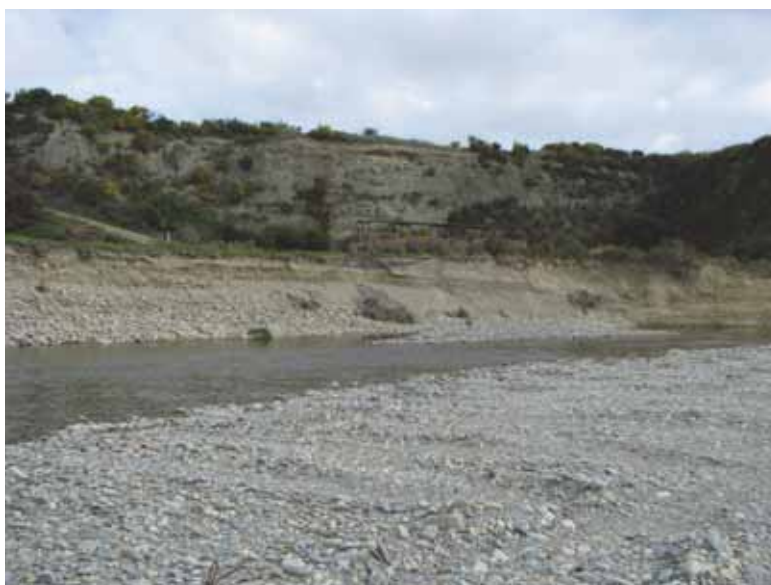
Waianakarua: WA7S

Cross-section WA7S is located 7.4km upstream of the Waianakarua River Mouth on the South Branch. Between June 2004 and February 2008 the right bank eroded, causing the main channel to shift towards the right bank. Between February 2008 and October 2013 the right bank eroded with both aggradation and degradation occurring across the main channel. If erosion of the right bank continues, farmland and a farm shed may become affected. Gravel is extracted from this location, the large bank feature (point labelled A) is a gravel stockpile and not a natural feature. Changes on the true right and true left wider floodplain between 2004 and 2013 cannot be verified, as the 2008 and 2004 surveys do not extend as far on the true right or left banks as that completed in 2013. The thalweg remained at a similar height between 2008 and 2013.

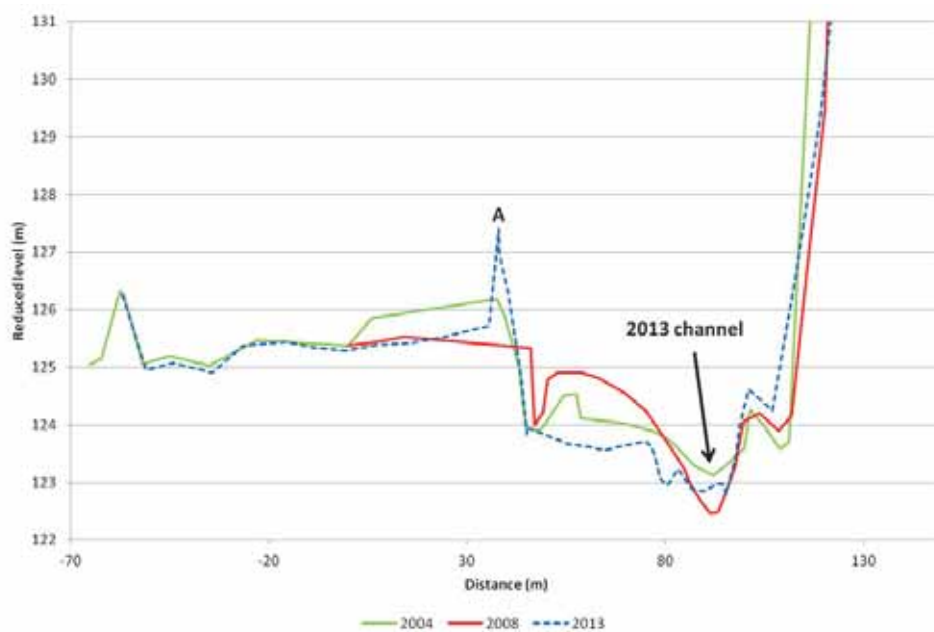
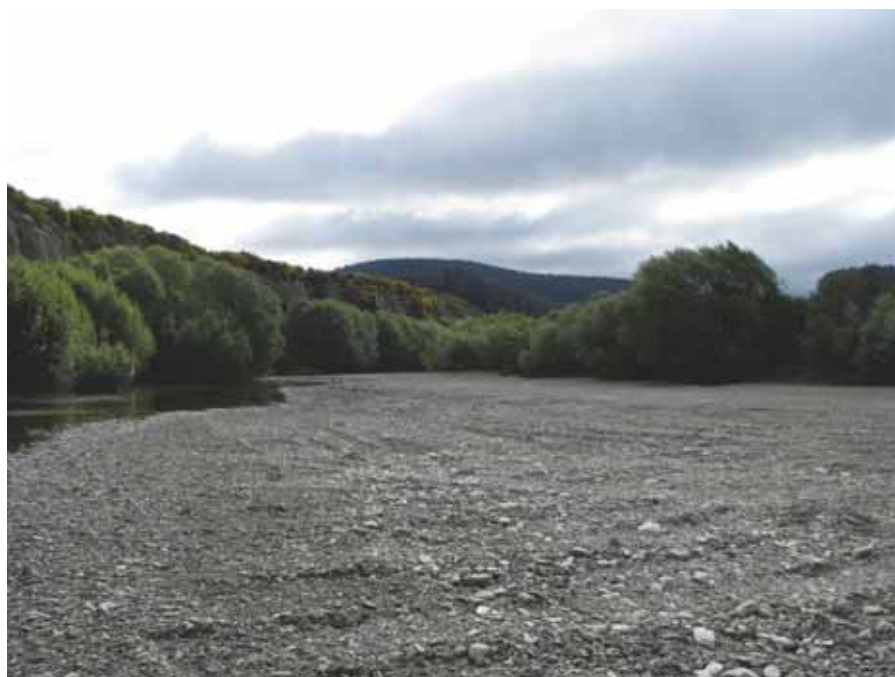
Waianakarua: WA8S

Cross-section WA8S is located 7.7km upstream of the Waianakarua River Mouth on the South Branch. Between June 2004 and February 2008 the right bank eroded, the main channel degraded, and the left bank aggraded, creating a narrower, deeper channel. Between February 2008 and October 2013 the right bank and main channel aggraded. The left bank of the main channel degraded, creating a wider, shallower channel. The top of the left bank has been shaped into a bank feature (point labelled A). Gravel is extracted from this location. The thalweg aggraded 0.35m between 2008 and 2013.

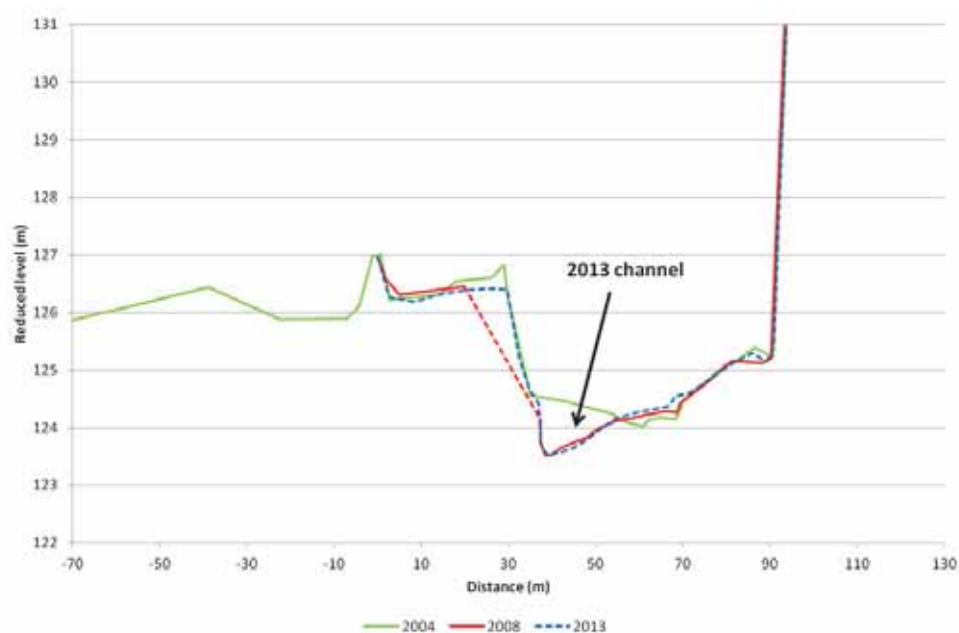
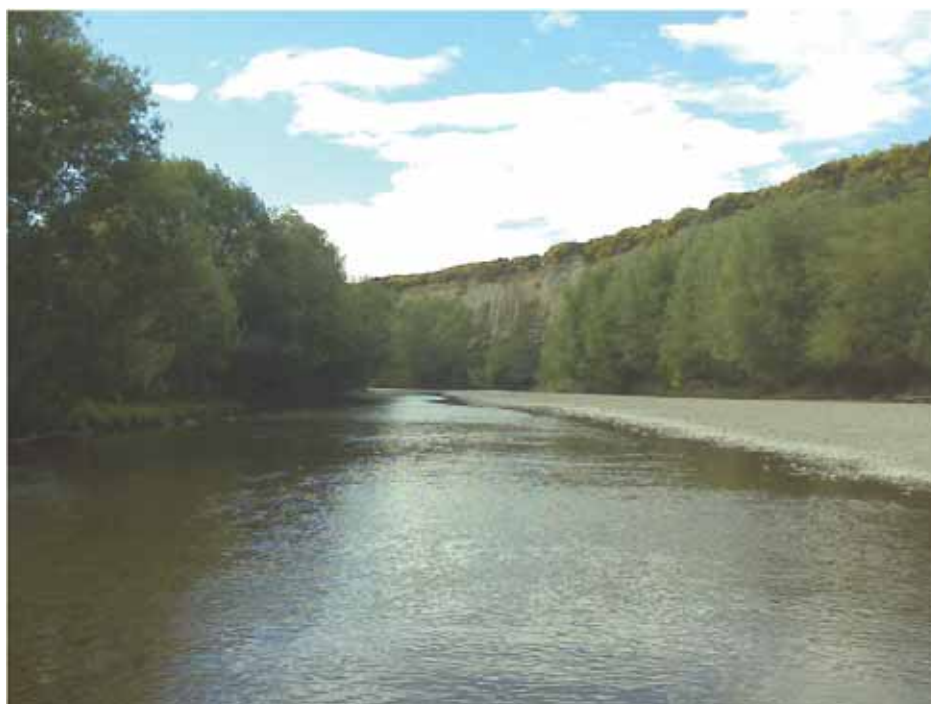
Waianakarua:WA9S

Cross-section WA9S is located 7.85km upstream of the Waianakarua River Mouth on the South Branch. Between June 2004 and February 2008 the left bank eroded (although the 2008 data are unconfirmed for the left bank), the main channel degraded, and a small amount of aggradation occurred in the 2004 main channel. Between February 2008 and October 2013 the left bank aggraded to a similar position as 2004, the main channel remained in the same position as 2008. The thalweg level did not move vertically or horizontally between 2008 and 2013.
