**Channel morphology of the
Waianakarua River, North
Otago**

Report writer: Jacob Williams, Natural Hazards Analyst
Reviewed by: Michael Goldsmith, Manager Natural Hazards

Published December 2014

Technical Summary

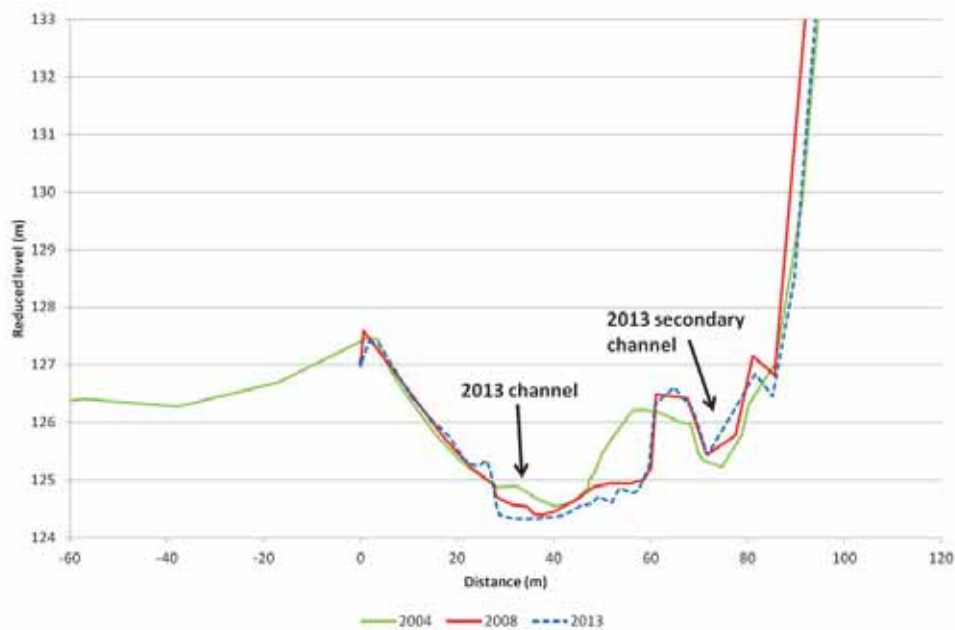
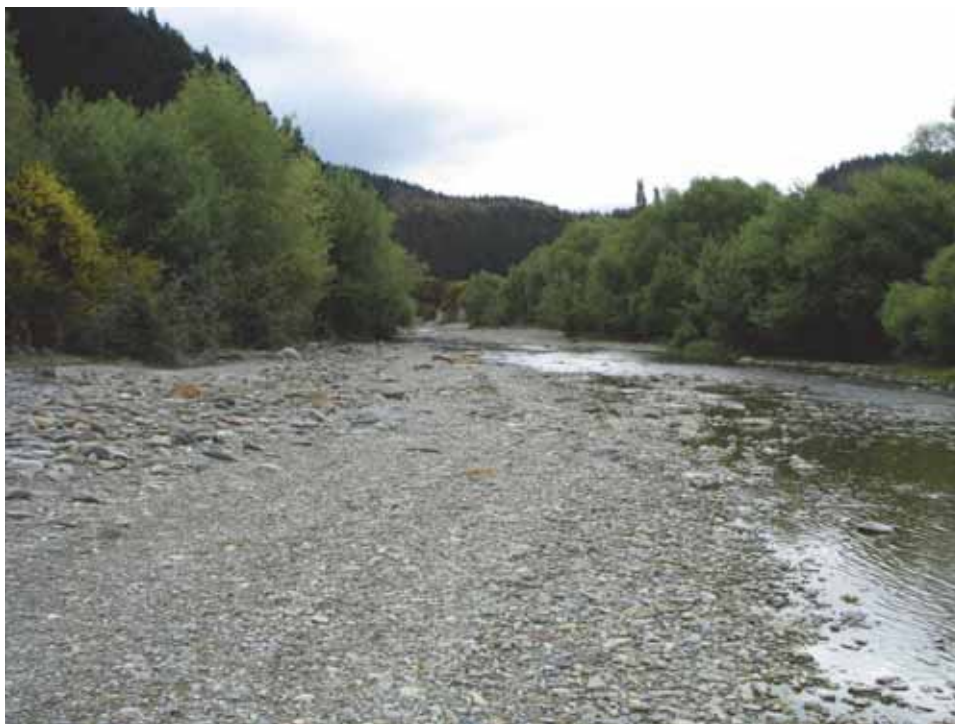
Waianakarua:WA10S

Cross-section WA10S is located 9.85km upstream of the Waianakarua River Mouth on the South Branch. Between June 2004 and February 2008 the right bank of the main channel eroded approximately 10m with aggradation occurring on the right bank of the secondary channel. Between February 2008 and October 2013 the main channel degraded with both aggradation and degradation occurring on the right bank of the secondary channel. The thalweg degraded 0.07m between 2008 and 2013.

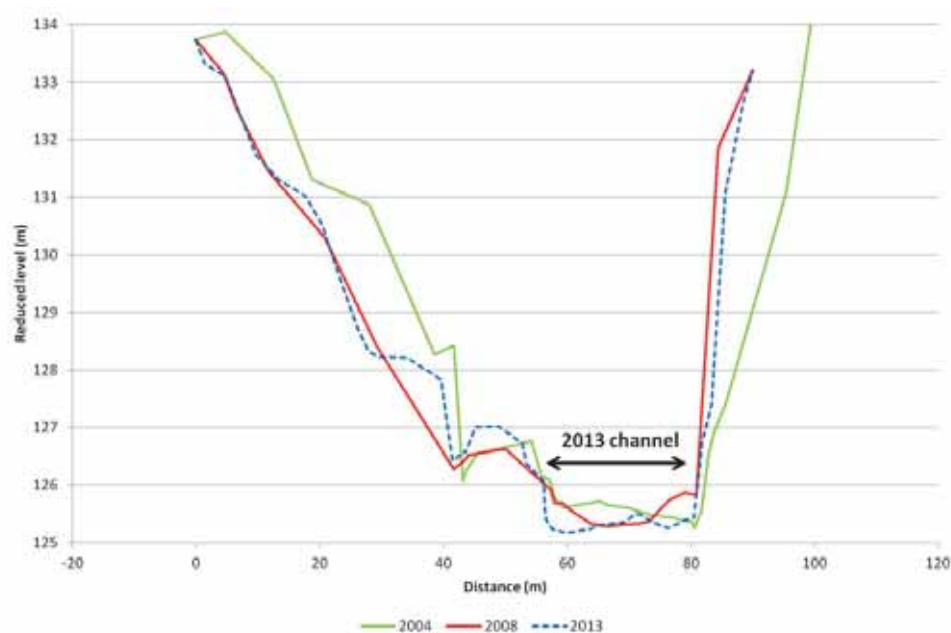
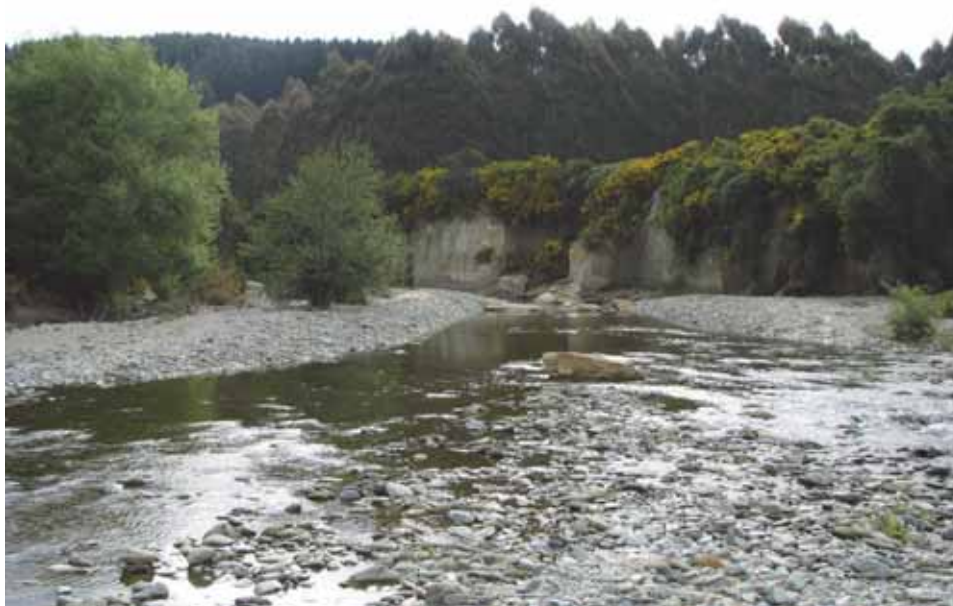
Waianakarua: WA11S

Cross-section WA11S is located 10.1km upstream of the Waianakarua River Mouth on the South Branch. Between June 2004 and February 2008 the right bank of the main channel aggraded, the left bank degraded, and the main channel both aggraded and degraded. Between February 2008 and October 2013 the main channel degraded with aggradation occurring on the left bank and degradation occurring on the right bank. The thalweg degraded 0.11m between 2008 and 2013.

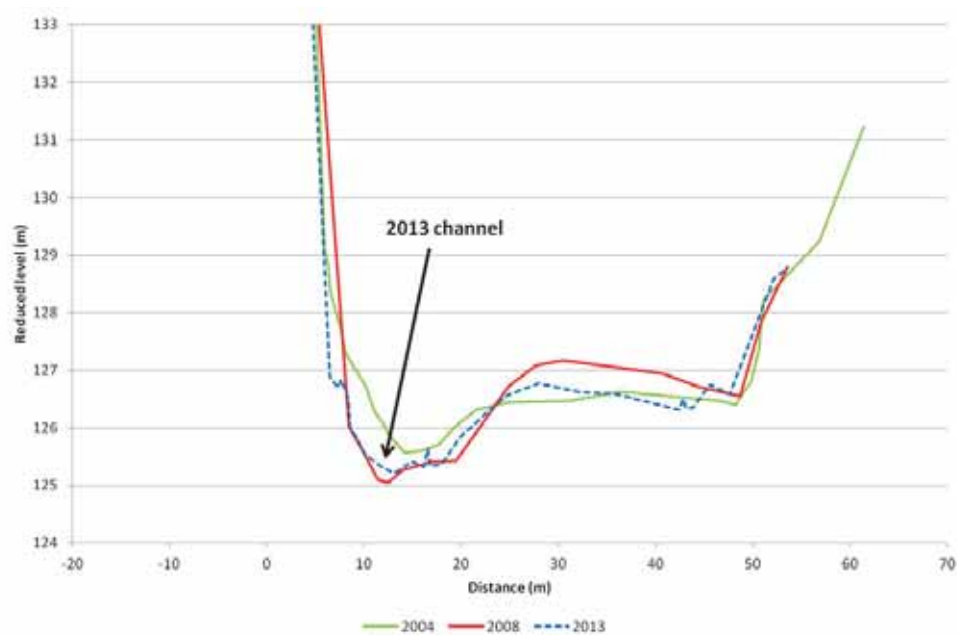
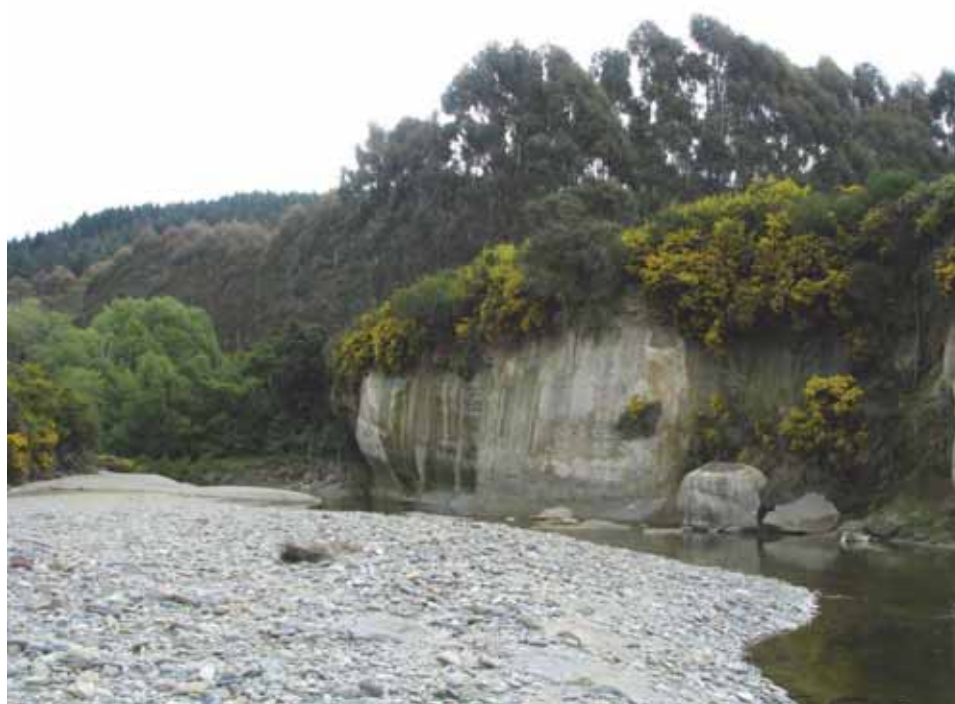
Waianakarua:WA12S

Cross-section WA12S is located 10.4km upstream of the Waianakarua River Mouth on the South Branch. Between June 2004 and February 2008 the main channel degraded by approximately 0.75m, with the right bank floodplain aggrading by approximately 0.5m. Between February 2008 and October 2013 the main channel aggraded, the left bank eroded by approximately 2m, with the right bank floodplain degrading to a similar level as 2004. The thalweg degraded 0.16m between 2008 and 2013.

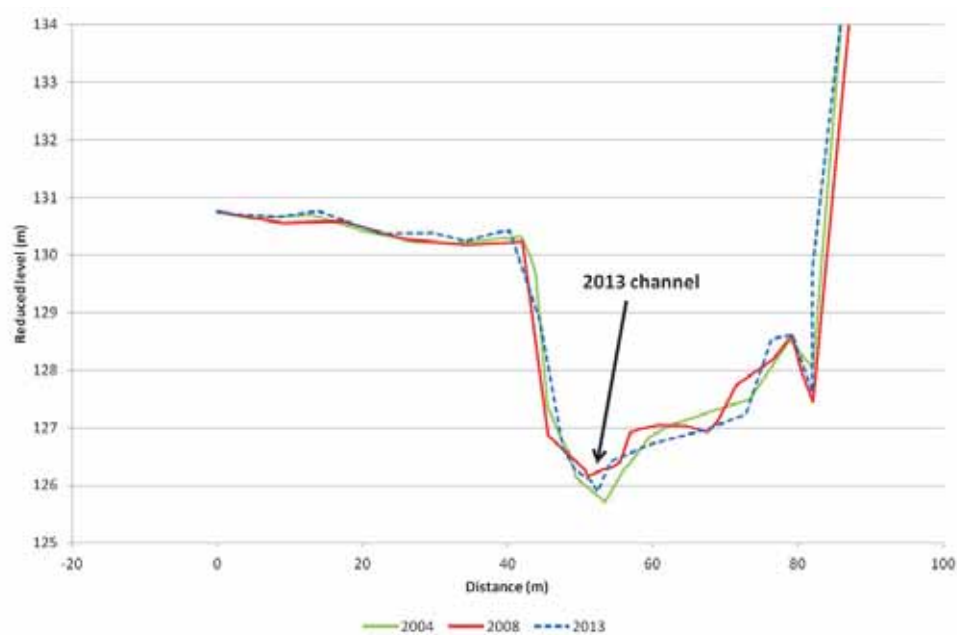
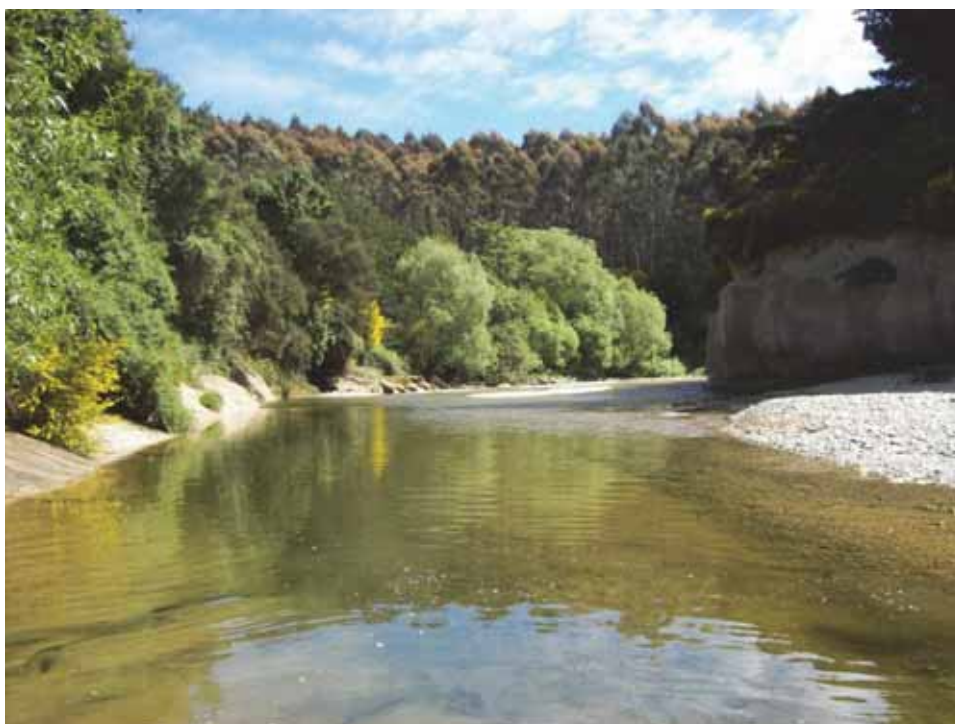
Waianakarua: WA13S

Cross-section WA13S is located 10.7km upstream of the Waianakarua River Mouth on the South Branch. Between June 2004 and February 2008 the main channel aggraded by approximately 0.5m, the right bank floodplain both aggraded and degraded, and the left bank eroded by approximately 2m. Between February 2008 and October 2013 the main channel and the true right floodplain degraded and both the left and right banks aggraded by approximately 3m. The thalweg degraded 0.26m between 2008 and 2013.

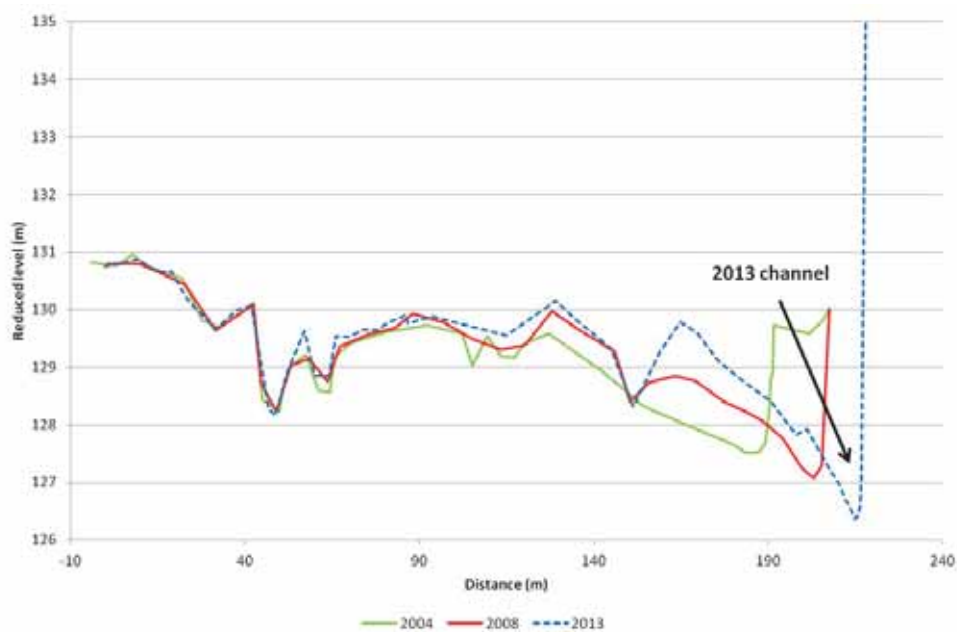
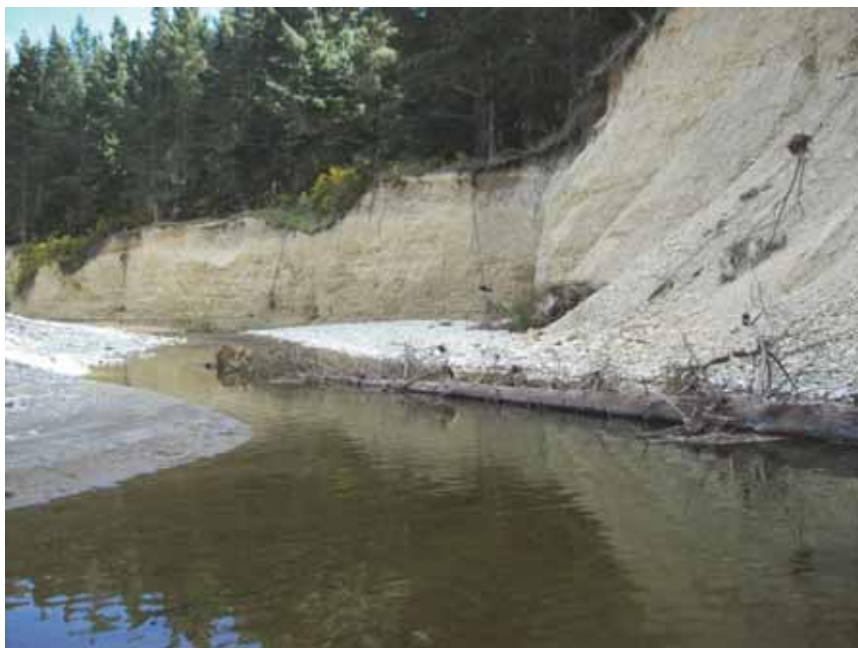
Waianakarua: WA14S

Cross-section WA14S is located 10.9km upstream of the Waianakarua River Mouth on the South Branch. Between June 2004 and February 2008 the main channel degraded by approximately 0.5m, the left bank floodplain aggraded and the right bank eroded by approximately 18m. Between February 2008 and October 2013 the main channel degraded by approximately 0.5m, the left bank floodplain aggraded and the right bank eroded by approximately 13m. This shows that the river is currently continuing to move towards and erode the right bank, which, if this process continues, it will begin to affect more farmland. The thalweg degraded 0.70m between 2008-2013.

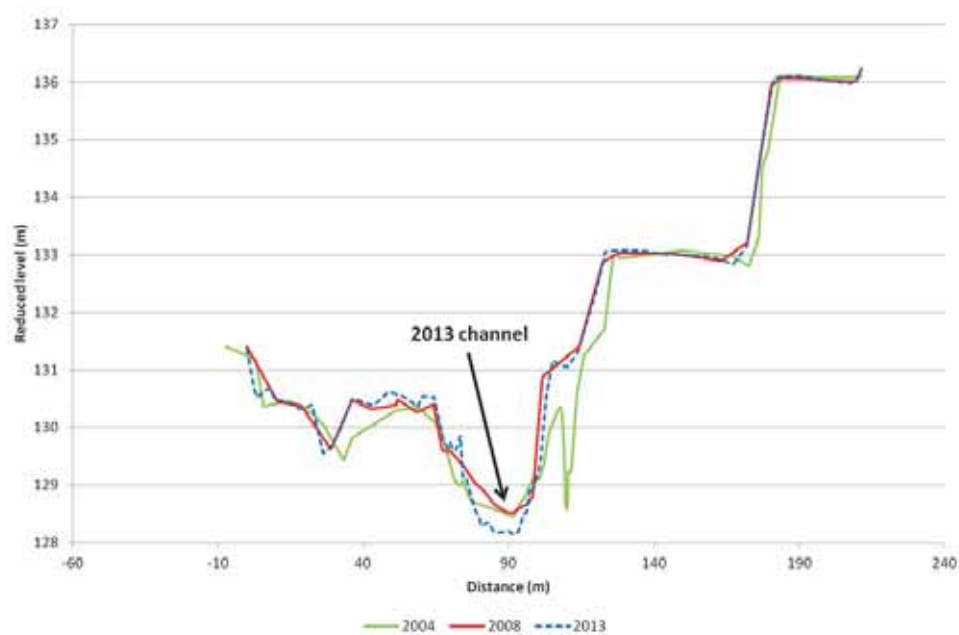
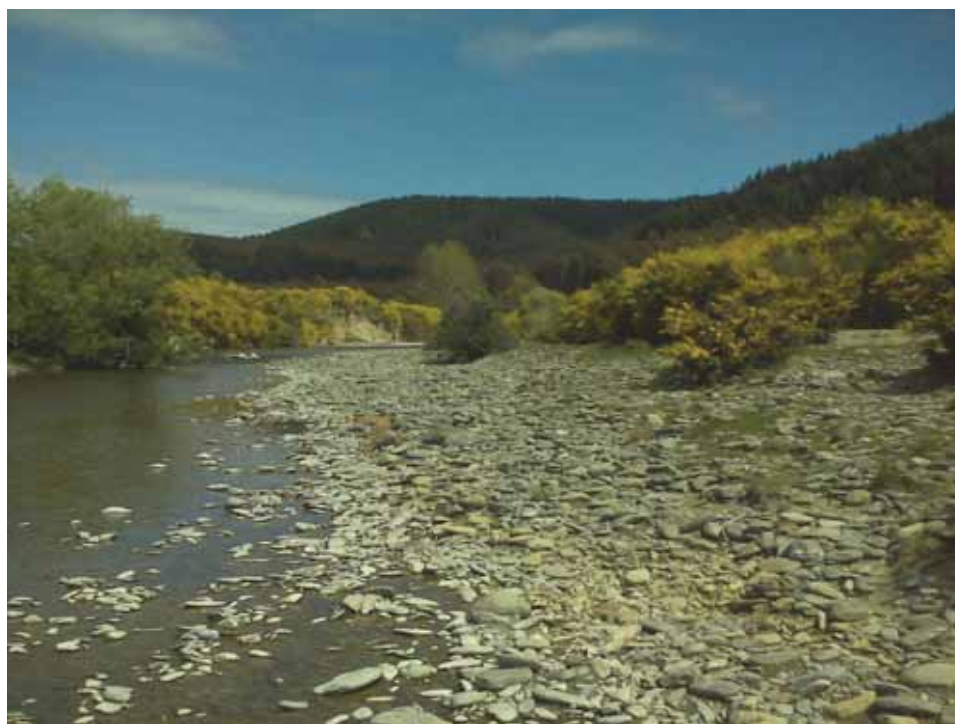
Waianakarua: WA15S

Cross-section WA15S is located 11.1km upstream of the Waianakarua River Mouth on the South Branch. Between June 2004 and February 2008 both banks of the main channel aggraded, with aggradation occurring on the right bank and the left bank floodplain. Between February 2008 and October 2013 the main channel degraded by approximately 0.4m, while the left and right bank floodplains remained stable. The thalweg degraded 0.38m between 2008 and 2013.
