10.1. General Manager Operations Report to Technical Committee

Prepared for: Technical Committee
Report No. EHS1856
Activity: Flood Protection & Control Works
Author: Jean-Luc Payan, Manager Natural Hazards
Julie Everett-Hincks, Manager Science
Endorsed by: Gavin Palmer, General Manager Operations
Date: 12 June 2019

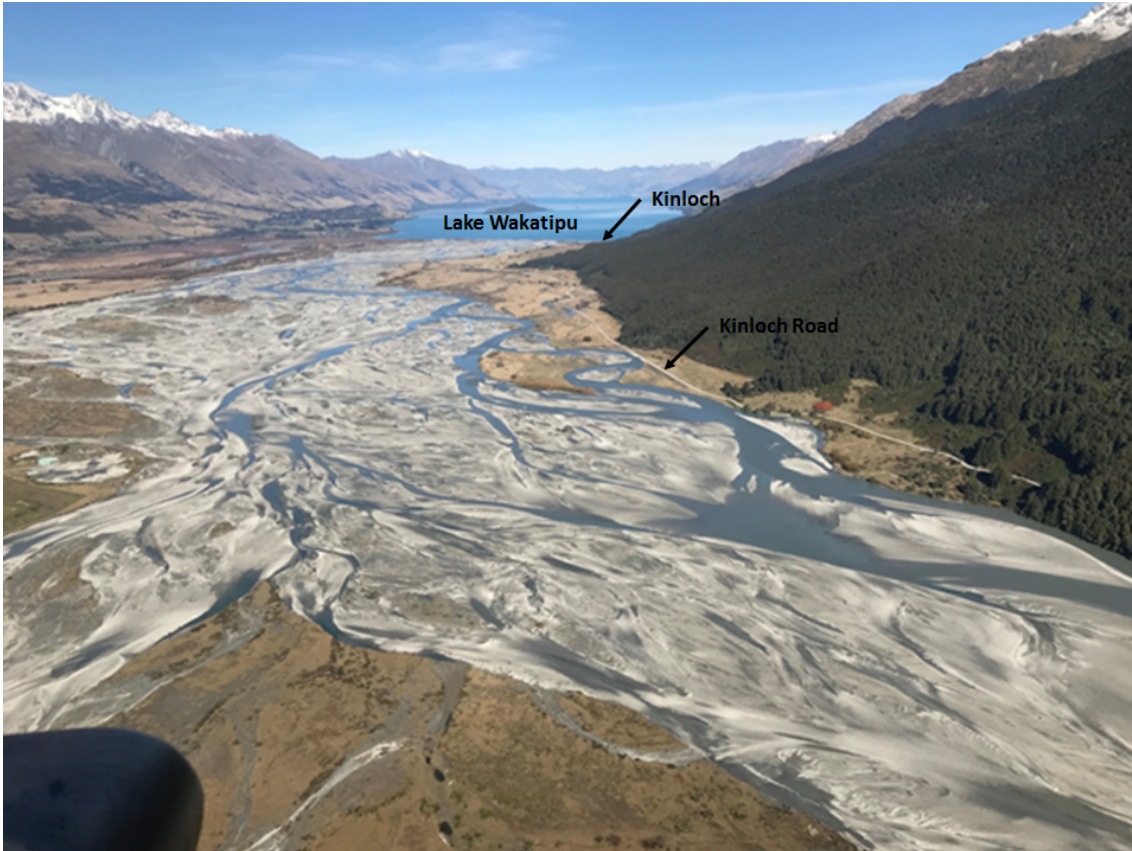
- [8] Kinloch Road, the only terrestrial access to Kinloch, has low lying sections located on the right bank in the Dart River floodplain (Figure 4). The road is affected by bank erosion and flooding and can become impassable during high river flows. This road is used by residents and to access popular tourist attractions, facilities and accommodation.

Figure 4: Dart River looking downstream towards Lake Wakatipu – Kinloch Road located on the right of the photograph (photograph taken by Geoffrey Thomson on 1 May 2019).

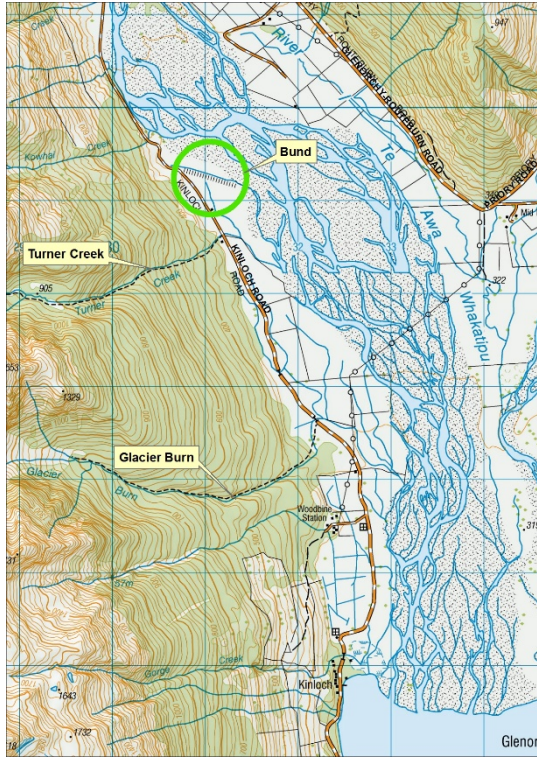
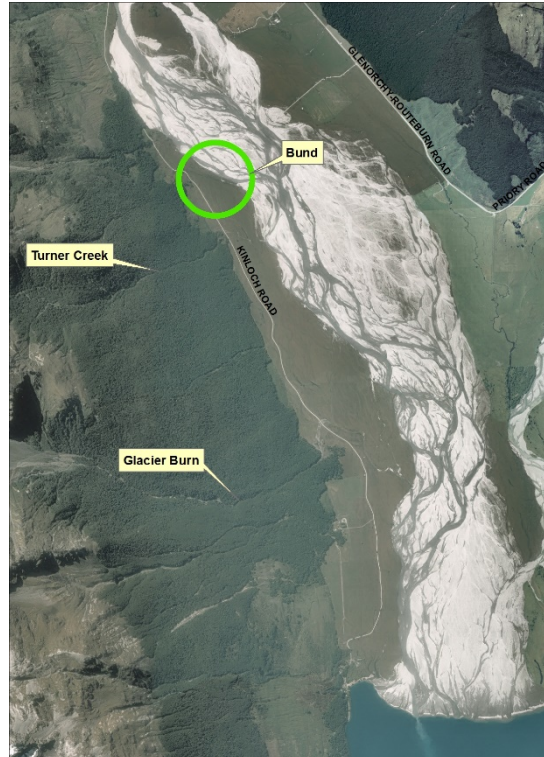
- [9] Queenstown Lakes District Council (QLDC) maintains the road and regularly repair flood and erosion damage.
- [10] In 2018, a flood channel broke through a remnant gravel bund between Kowhai and Turner Creeks and ORC agreed with residents and QLDC to reinstate this bund. The work was intended to provide limited protection to the section of Kinloch Road located downstream during small floods (Figure 5).

Figure 5: Bund location

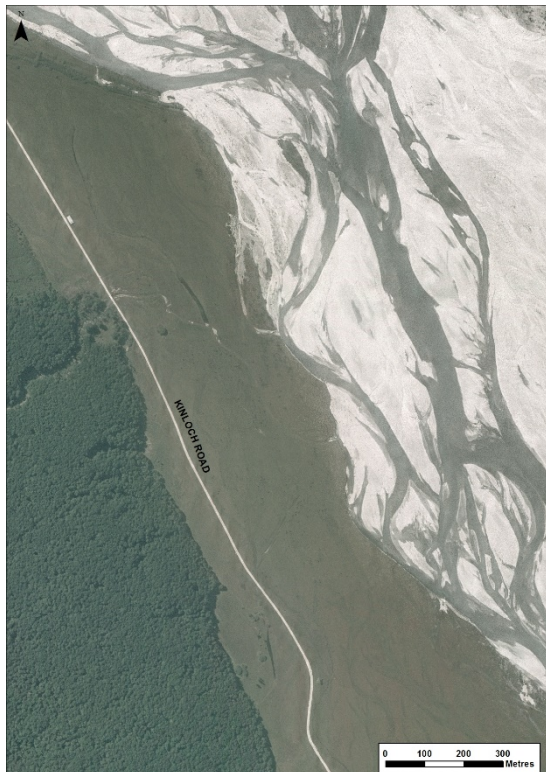
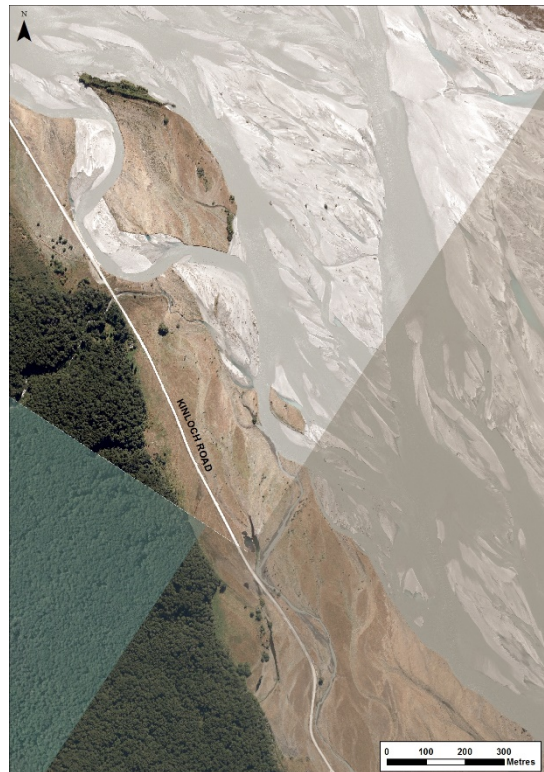
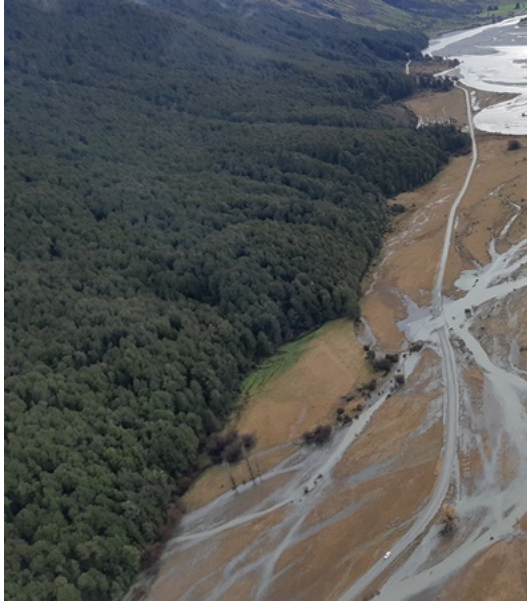
[11] The bund was reinstated twice by ORC before it was entirely washed away in the record (since 1996) Dart River flows in March 2019. One active channel is now flowing in proximity to this section of road and the threshold at which Kinloch Road between Turner Creek and Glacier Burn becomes inundated has lowered (Figure 6).

**Figure 6: Top: Channel position – 2007 (left) and 2019 post March 2019 high flows (right)
Bottom: Kinloch Road flooding between Turner Creek and Glacier Burn – 31 May 2019**

- [13] QLDC with assistance from ORC is currently considering short-term immediate options to improve flood and erosion protection to vulnerable sections of Kinloch Road with the intention to carry out the repair work in June 2019, pending on likely consenting requirements.

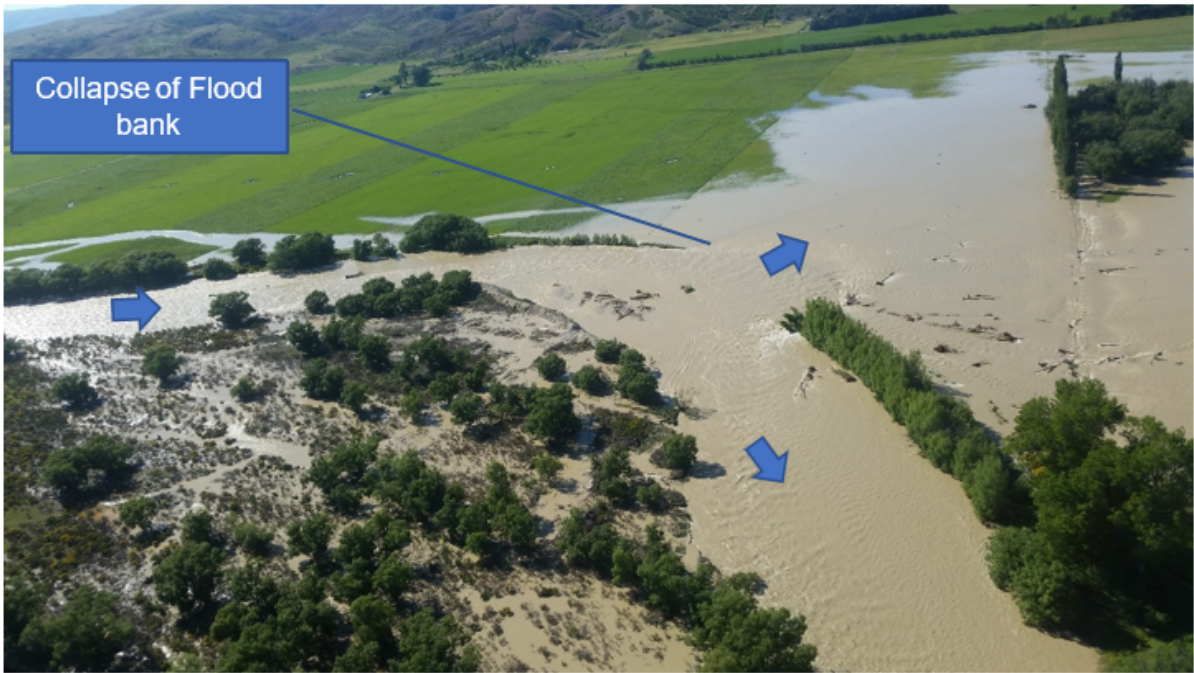
- [19] Following the November 2018 high flow event in the Manuherikia River, this section was severely eroded resulting in bank damage. A low-level bund located at the same location also collapsed, resulting in significant overland flow (Figure 8). The purpose of the bund was to provide limited flood protection during small floods.

- [20] Bank damage in this location occurred in the past and is the result of natural erosion processes, usually more pronounced on the outside river bends (concave side). Bank protection work in this section of the river existed prior to the November 2018 high flow event but were undermined by the high flows observed in November 2018.

Figure 8: Manuherikia River – Left bank overflow – November 2018

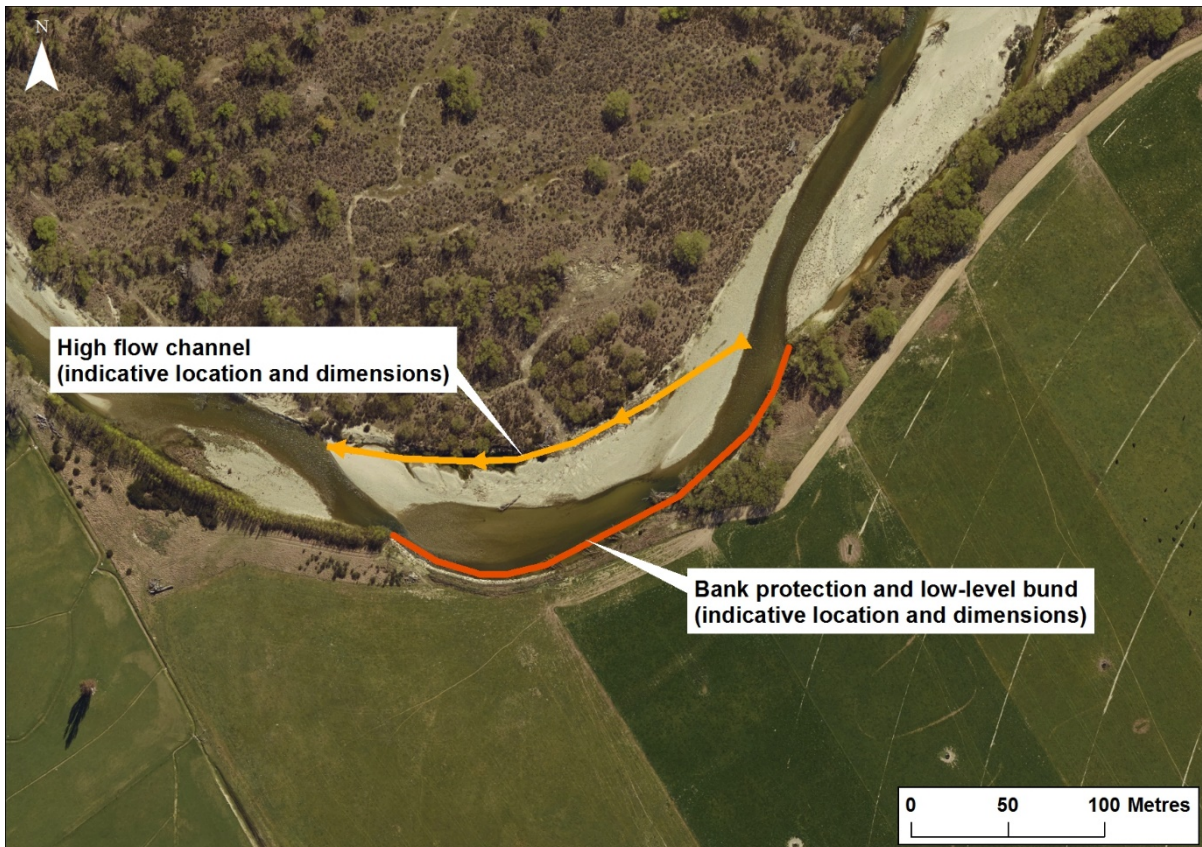
Figure 9: Indicative location and scale of the bank protection work completed in April 2019 on the Manuherikia River approximately 1.5 km upstream of the Omakau Bridge. The river flows from right to left.

- [21] The purpose of the work completed in April 2019 is to protect the damaged section of left bank and to reinstate the bund to the pre-November 2018 state. A channel was also formed close on the right bank to guide the river away from the left bank during high flows (Figure 9). Willow trees will be planted at the end of winter 2019 to reinforce the stability of the left bank.

- [22] These engineering works are unlikely to be successful in the longer term. Consideration will be given to incorporating a more comprehensive and strategic investigation of management options as a project in the Draft 2021-2031 Long Term Plan. Those options could include removing vegetation from the active river bed to restore channel capacity and give the river room to move.
