Mapping of sediment types Te Hakapupu – Pleasant River Catchment

GeoSolve Ref: 230663

November 2023

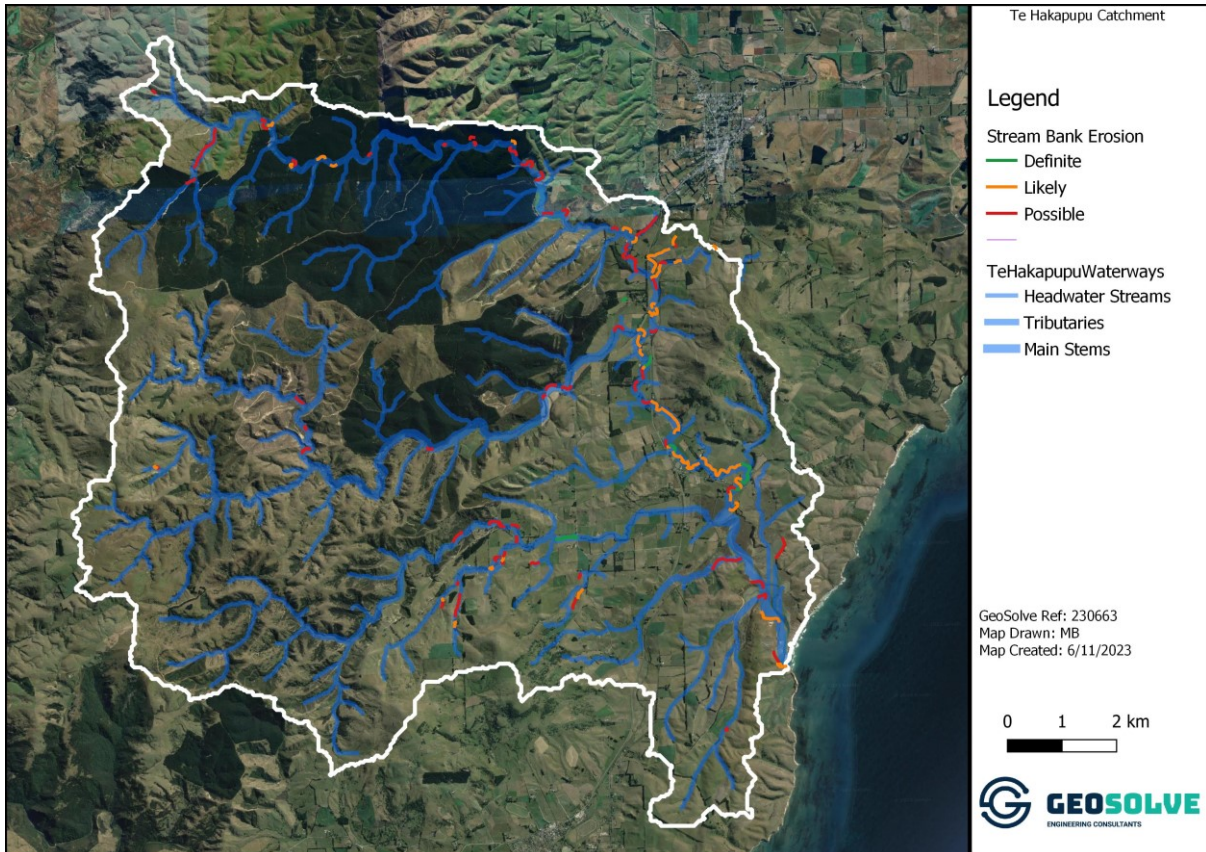
Figure 1: Mapped Stream Bank Erosion

The mapped Stream Bank Erosion features are shown in Figure 1 below with the features mapped in terms of Certainty.

The map also shows the waterways categorised to relative flow as provided. From this it can be concluded that the visible erosion within the catchment is predominantly within the main stems of the catchments where higher flows are likely present.

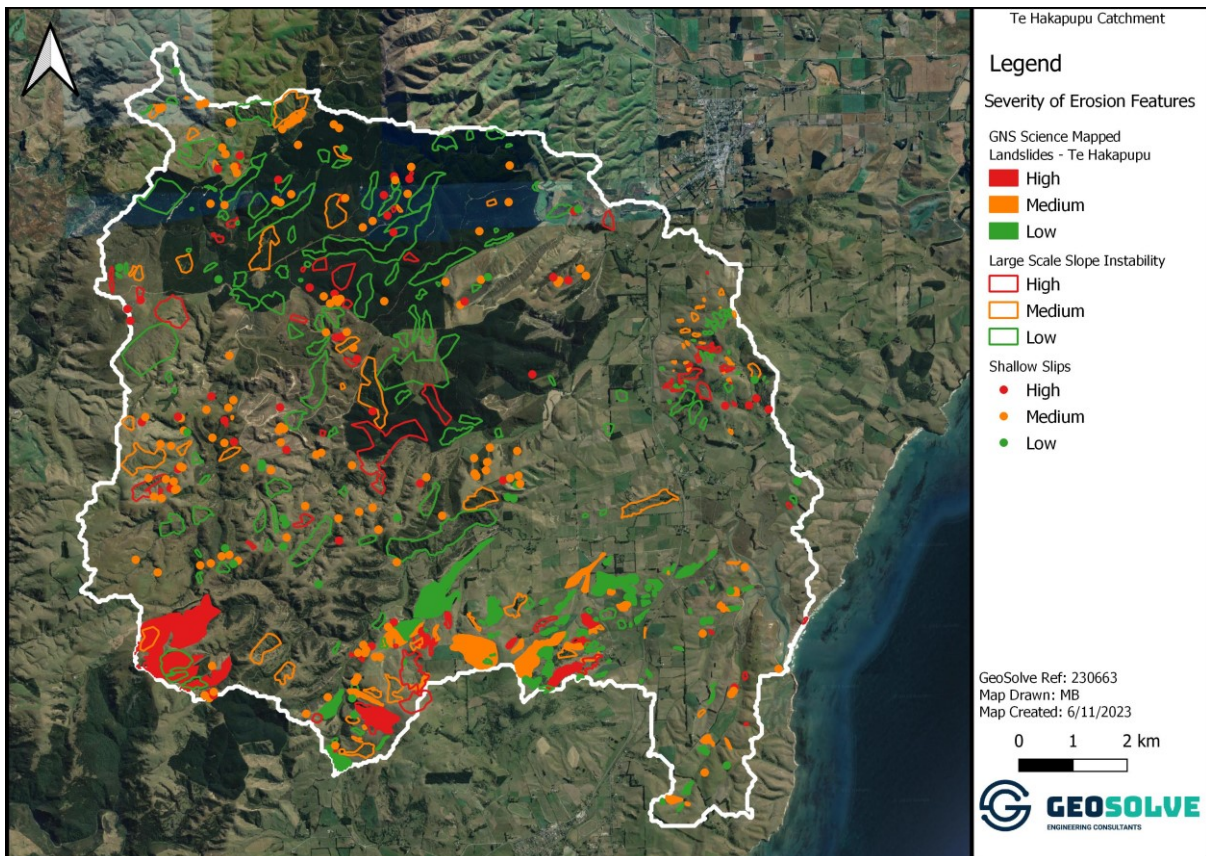
Figure 2 – Mapped slope instability identified in the figure with Severity.

The mapped instability is shown in Figure 2 below with each feature categorised into Severity. As indicated within Table 1, the severity is a direct correlation to the activity of the feature and whether any recent movement has been sited within the aerial imagery available back to 2005-2006.

We note that a low severity indicates that no recent movement has been identified within the available dataset. There is potential for future movement that would result in ‘high’ severity classification. Larger landslides commonly ‘creep’ during heavy rainfall events or prolonged wet periods and evidence of these creep movements may not have been identifiable from the lidar and aerials available.

Following the mapping exercise it can be concluded that the catchment is vulnerable to slope instability. This is largely due to the geology of the area and the presence of weak

tertiary aged rock types that can be prone to instability where present on steep slopes or where groundwater regimes allow pore water pressures to become elevated.

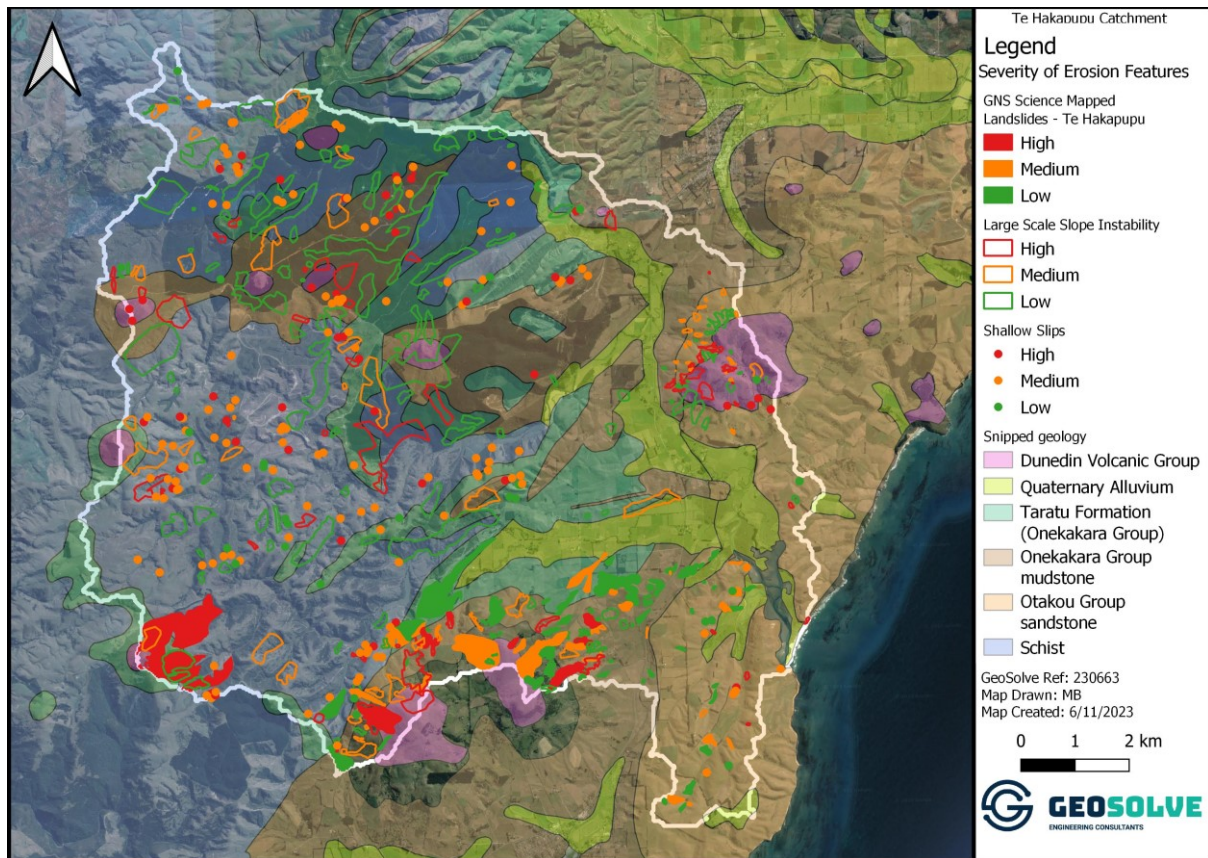
Figure 3: Mapped slope instability overlaying GNS Science 1:250k mapping.

Areas that are most susceptible to slope instability and mass movement are where volcanic rock types have cross cut Late Cretaceous to Paleocene Mudstones of the Onekakara Group. In particular large mass movements are mapped adjacent to the geological contact between the two units. This can be seen in Figure 3 below which overlays the mapped slope instability feature over GNS Science’s 1:250k geological map. A high density of Large Scale Slope Instability is mapped near the boundary of the purple (Dunedin Volcanic Group) and brown units (Onekakara Group mudstone). These areas have also been identified as mass movement zones within GNS Science’s geological mapping.

Slope instability is also common near the geological contact between the Late Cretaceous Taratu Formation (green unit below) and the underlying Otago Schist (grey unit below). Taratu Formation rock/soils types can become unstable on steep slopes whereas the schist is relatively stable at steeper angles. This commonly results in landslides where the Taratu Formation can become unstable on gully margins where slopes steepen.

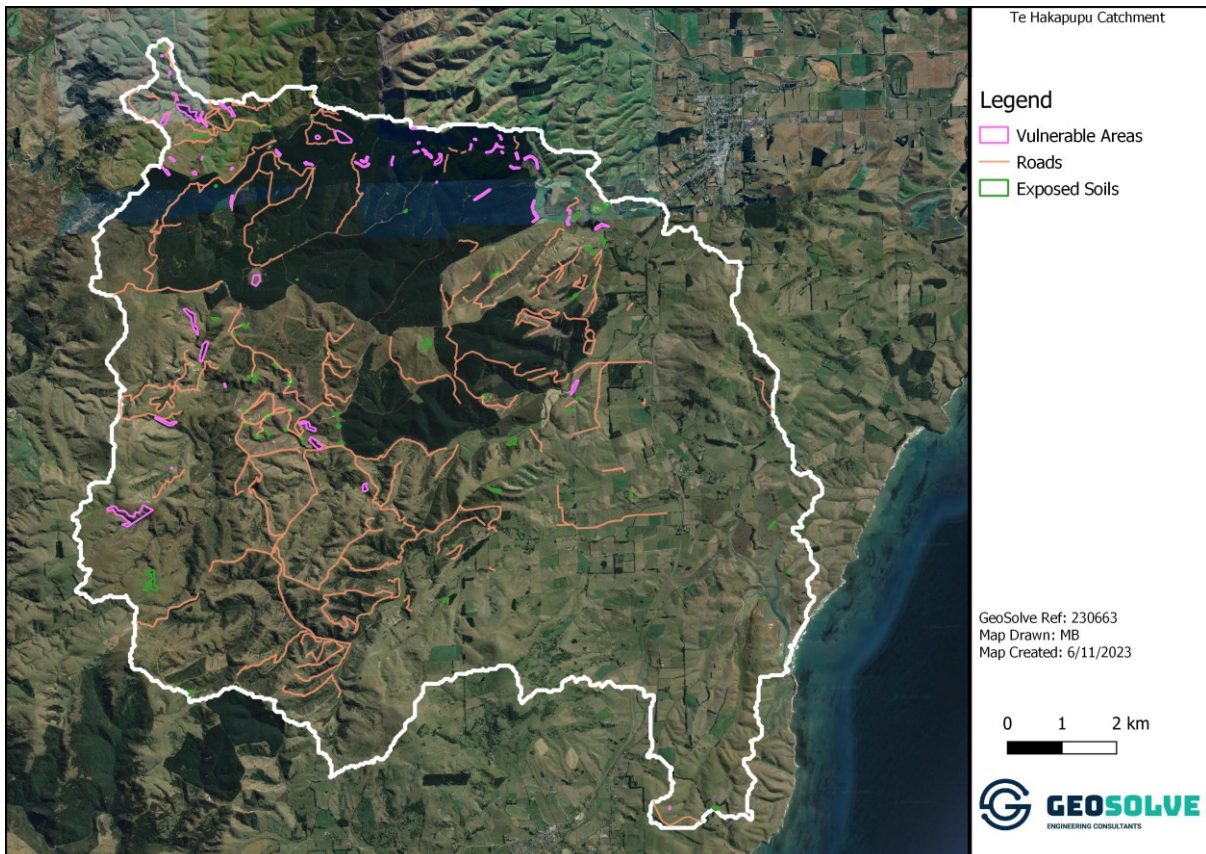
Figure 4: Mapped Track/private roads, exposed soils and vulnerable areas.

Exposed soils and roads/tracks that have the potential to be a sediment source were mapped. These features were identified using available aerial maps. Public roads were excluded as these spatial data is already available from LINZ for these locations. These features were typically associated with the land current land use i.e. informal access to farmland or forestry ares, logging sites, stock yards etc.

A number of the tracks mapped are likely to be temporary access for forestry harvest and often have involved steep cut and fill earthworks. These areas will be vulnerable to erosion.

The mapped areas of exposed soils and road/tracks are shown in Figure 4 below.

Vulnerable areas mapped are areas that may be at higher risk of erosion but may not have active erosion visible. These were typically steep slopes or rock faces. Further assessment of these areas could be considered to determine whether these features are a sediment source. These features will typically have low remediation potential due to the large or steep nature of the areas.

Mapped vulnerable areas are shown as purple polygons in Figure 4 above.
