Appendix 5: Geotechnical Interpretive Report

Dunedin City Council

Waste Futures - Smooth Hill Landfill Consenting Geotechnical Interpretive Report

August 2020 ([updated May 2021](#))

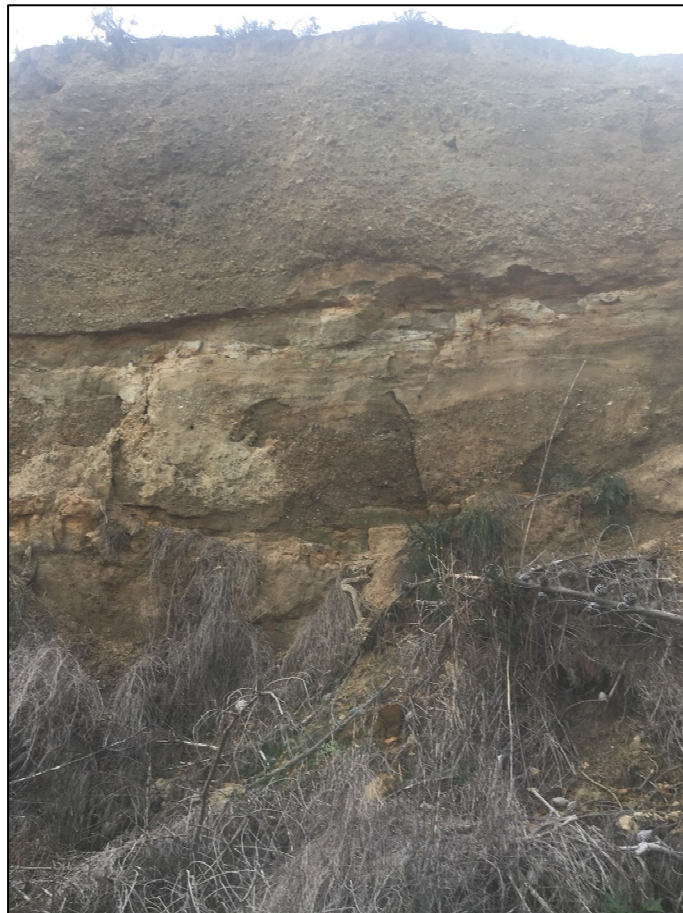
Figure 5 Rock Taratu Formation outcrop near the northwest extent of the site

A single rock outcrop was mapped adjacent to the northwest boundary of the site. A photograph of the outcrop is presented in Figure 5 below. Bedding is most evident in the interface between the sandstone and conglomerate beds and appears to display cross-bedding in the sandstone beds. The bedding observed in the outcrop is consistent with that indicated in the published geological map for the Henley Breccia.

As discussed in Section 1.4 of this report, this outcrop has now been mapped as Henley Breccia rather than Taratu Formation. Similar material was logged in boreholes (BH09, BH209 & BH10). Although not indicated by published geology as outcropping on the site, the Taratu Formation was mapped on-site in a single outcrop (adjacent to the northwest boundary of the site). A photograph of the outcrop is presented in Figure 5 below. Bedding is most evident in the interface between the sandstone and conglomerate beds, and appears to display cross-bedding in the sandstone beds. The bedding observed in the outcrop is consistent with that indicated in the published geological map

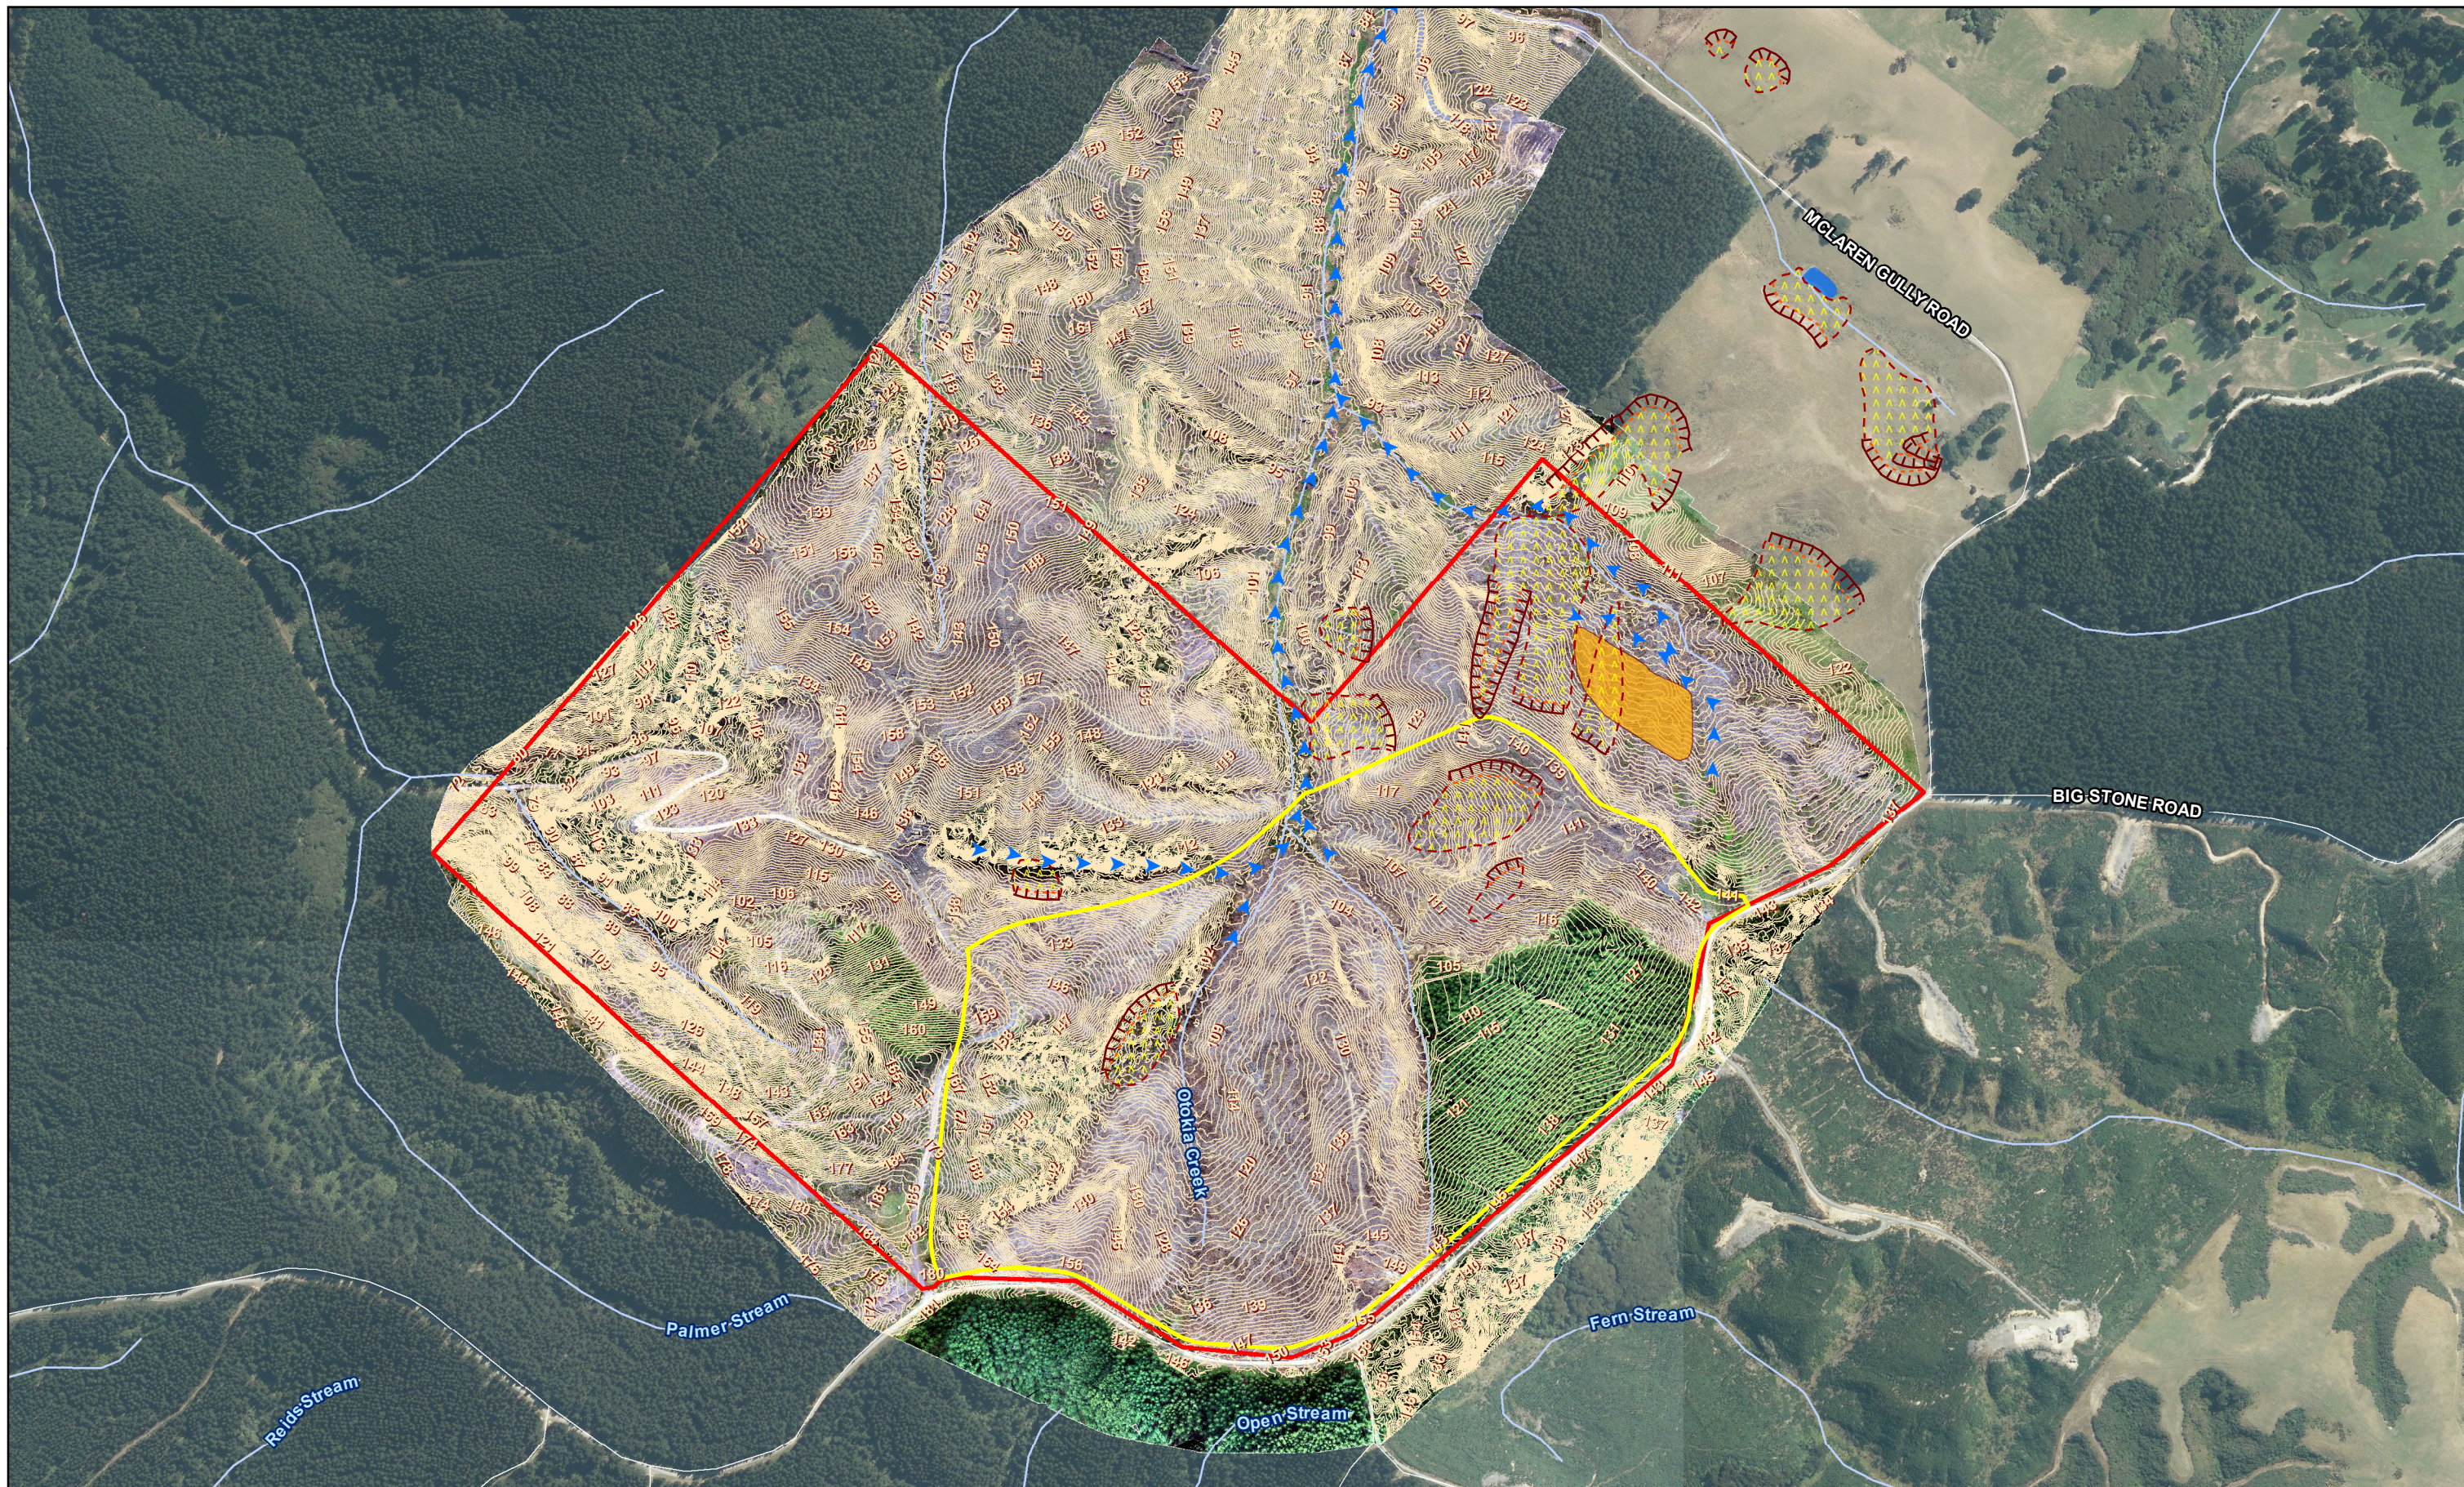
Slope instability plan

- Site boundary
- Landfill operational extent
- Slope failure headscarp base
- Slope failure debris runout extent
- Slope failure headscarp crest
- Hummocky ground
- Possible stockpile area
- Drainage
- Pond
- Waterways
- Contours (1m)
