Appendix 6: Geotechnical Factual Report

Dunedin City Council

Waste Futures Phase 2, Workstream 3 Smooth Hill Landfill
Smooth Hill Consenting - Geotechnical Factual Report

August 2020 [\(updated May 2021\)](#)

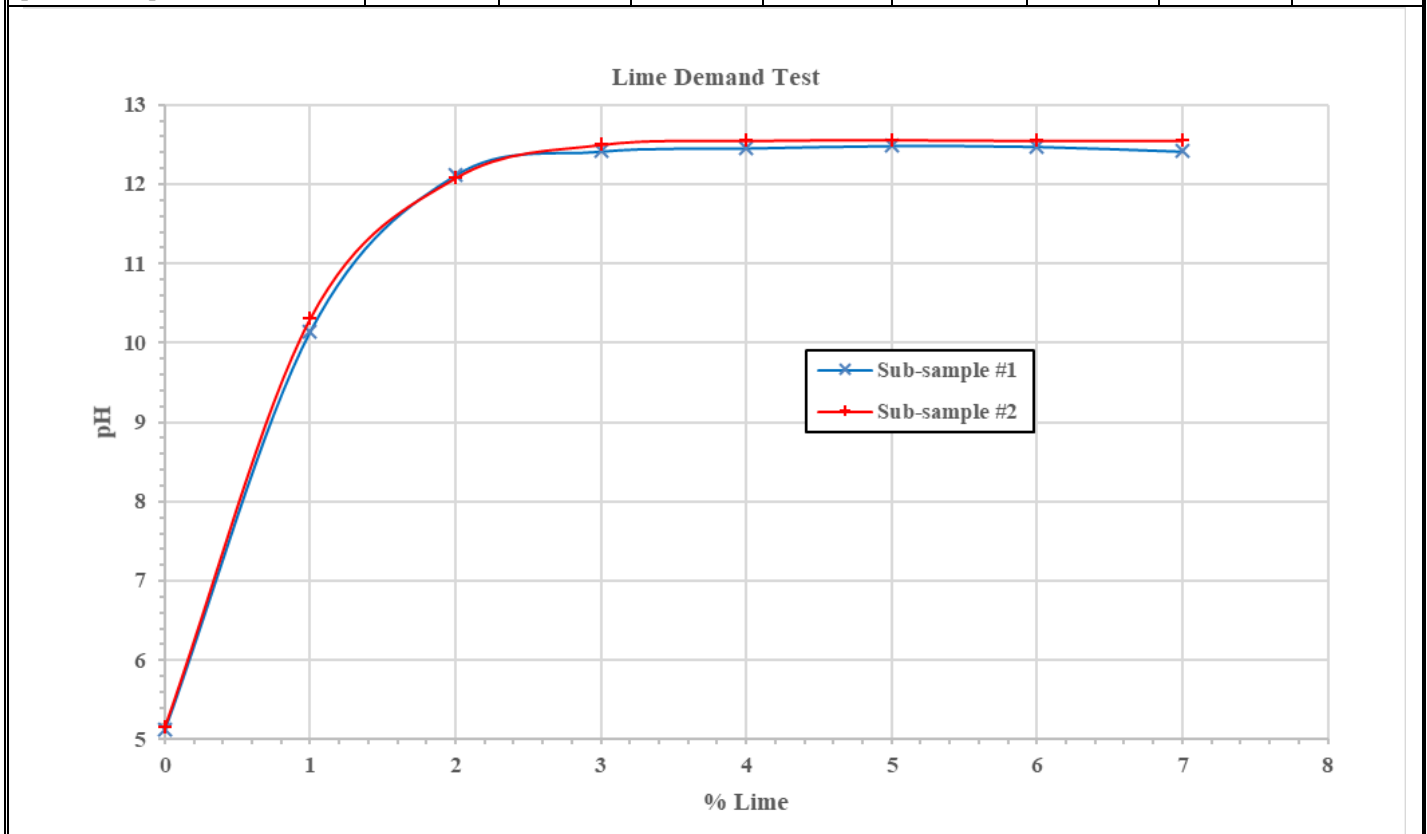
LIME DEMAND TEST – NSW Transport; Roads & Maritime Services Test Method T144 (Not IANZ Accredited)								
Sample Description:	Loess - Natural Soil Sub-sample #1				Loess - Natural Soil Sub-sample #2			
% Passing 2.36mm Test Sieve:	99.5%				99.5%			
Lime Type:	Taylors Hydrated Lime				Taylors Hydrated Lime			
pH of Lime Solution	12.60				12.63			
% Added Lime: (by dry mass)	0%	1%	2%	3%	4%	5%	6%	7%
pH Sub-sample #1:	5.12	10.15	12.12	12.42	12.46	12.49	12.48	12.42
pH Sub-sample #2:	5.16	10.31	12.08	12.50	12.55	12.56	12.55	12.55
