Appendix 8: Groundwater Report

Dunedin City Council

Waste Futures Phase 2 - Work Stream 3. Smooth Hill Landfill Assessment of Effects to Groundwater

August 2020 ([Updated May 2021](#))

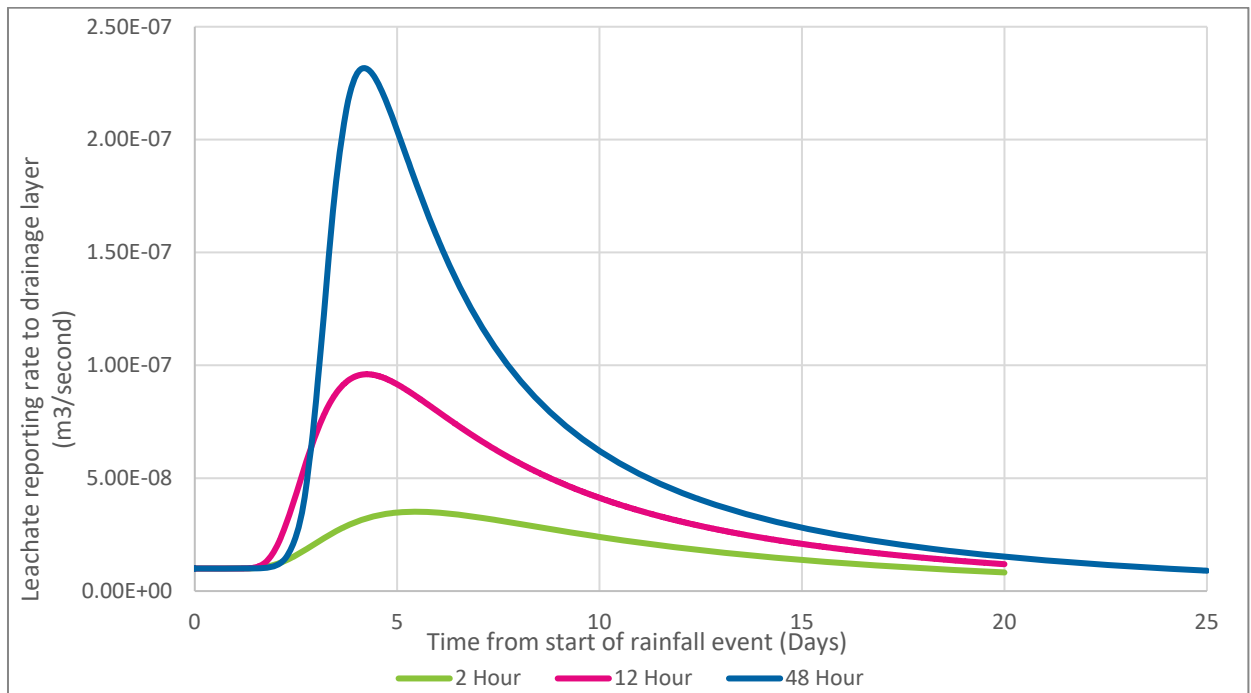
Figure 3: Leachate reporting rate to drainage layer following 10 Year ARI rainfall event

The results of the SEEP/W leachate modelling is presented in Figure 3, with Table 5 presenting the percentage of total rainfall reporting to the drainage layer for each of the ARI events. The results indicate that peak leachate reporting rates through 14 m of landfill waste occur approximately 4 to 5 days after the start of each rainfall event for the three ARI events modelled. It is anticipated that rainfall events with varying intensity would also respond within this approximate timeframe for the same thickness of waste. Reporting times would be expected to be faster for a smaller waste layer, and greater for a larger waste layer, due to the respective reduced and increased flow path lengths.

The results also demonstrate that increasing the length of the rainfall event corresponds with increasing reporting rates during peak flow. Infiltration resulting from the two and twelve hour events appears to travel through the waste within approximately 20 days, while infiltration from the 48 hour event took approximately 25 days. Rainfall events that last longer than 48 hours are therefore anticipated to take longer than 25 days to report to the landfill drainage system for a similar waste thickness as that modelled.
