In the matter a resource consent application by Queenstown Lakes District Council to discharge treated wastewater to land for the purpose of disposing of wastewater from Kingston Township

Statement of evidence of Dr Ruth Johanna Goldsmith

23 December 2021

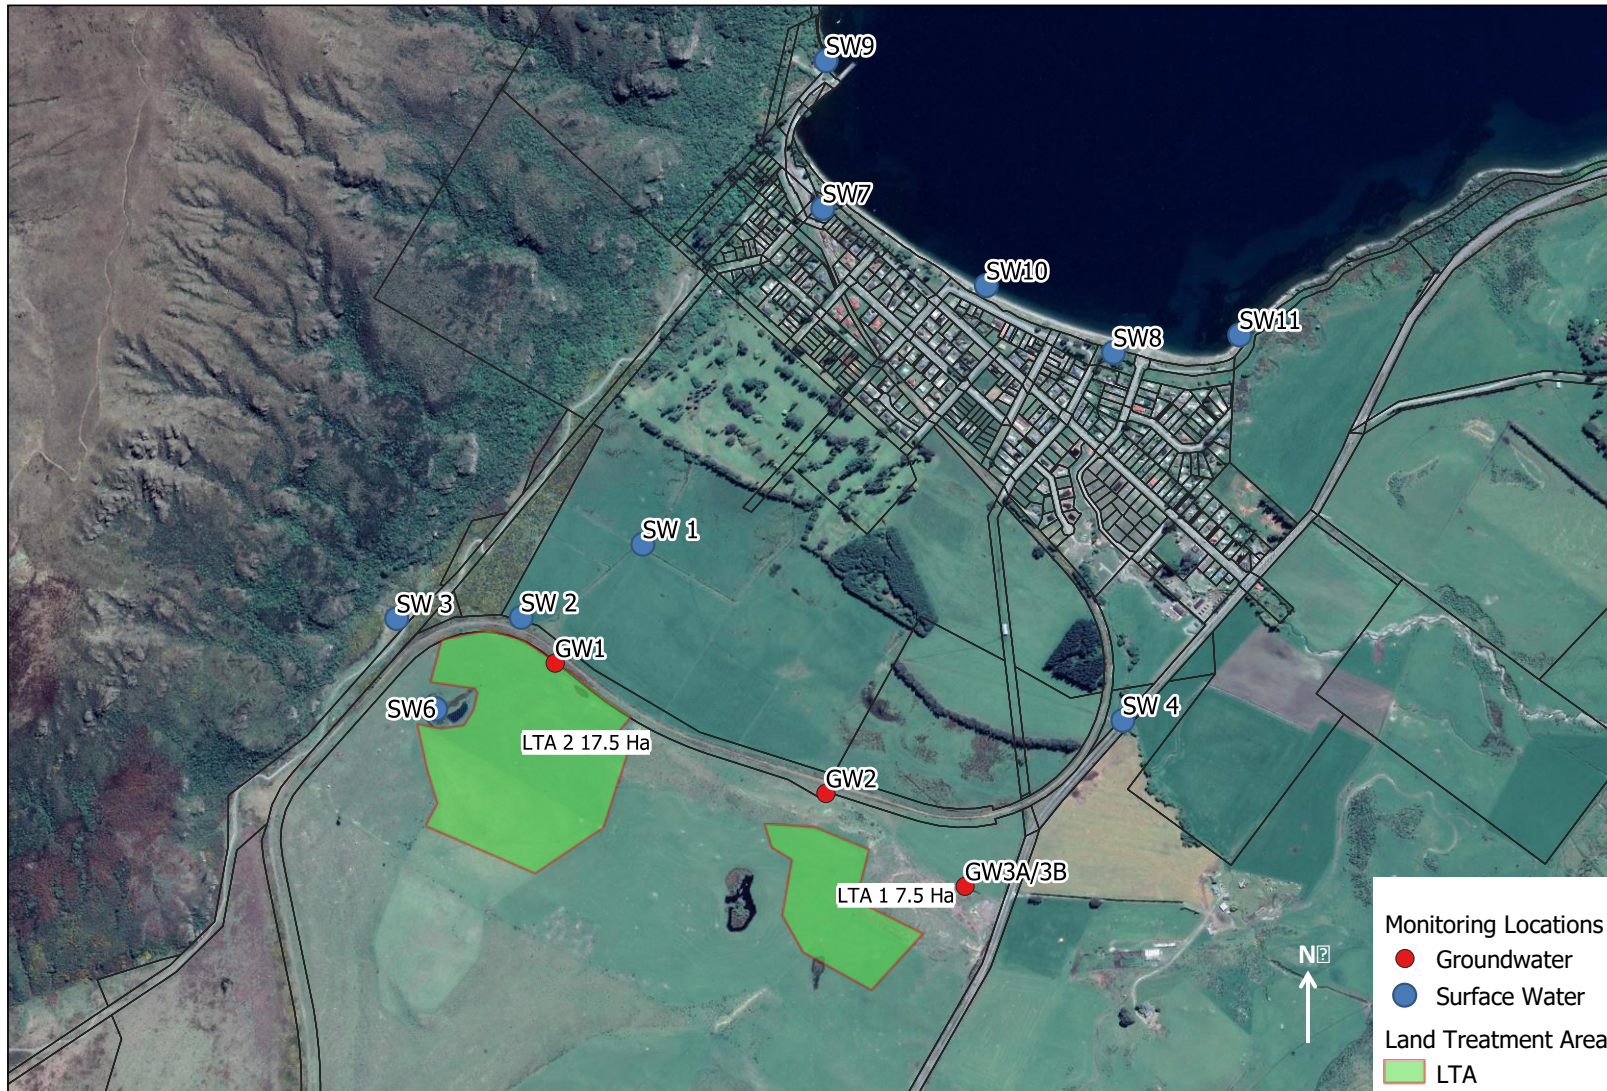
- 4.1 A map of the Site showing the location of surface water bodies and sampling sites is provided in Figure 1. I discuss the existing environment of each in paragraphs 4.2 to 4.8 below.

Figure 1. QLDC's proposed WWTP LTA (green highlighted areas) at Kingston Station (Site) and surface water quality sampling sites (blue circles).

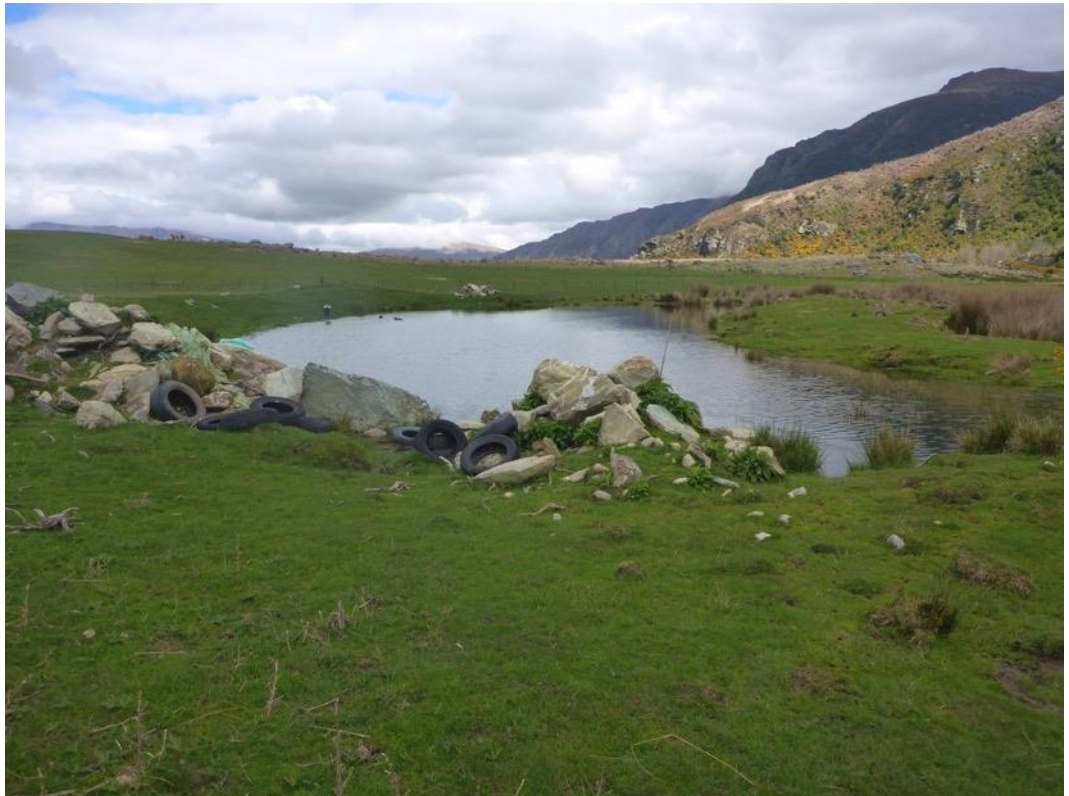
- 4.2 The closest surface water body to the LTA is a small (0.09 ha) constructed pond (Figure 2), which is surrounded on three sides by the proposed LTA. The pond has no direct connection to any other surface water bodies. Water quality within the pond was the poorest of all the surface water bodies sampled (Table 1). This was expected given that it is a small, artificial pond draining agricultural land. The benthic macroinvertebrate community indicated 'poor' conditions, and netting and trapping overnight found no fish.

Figure 2. Pond, SW6, October 2020.

- 5.2 The closest surface water body to the LTA, and therefore the one at highest risk of receiving contaminant inputs, is the small, isolated pond. The pond had the overall poorest water quality of all sites sampled in October 2020. No fish were found and the existing macroinvertebrate community was indicative of 'poor' conditions. As such, it is expected that the community would be tolerant of any potential contaminant input should leaching occur. The establishment and maintenance of a buffer zone between the pond and the LTA has been proposed to reduce the risk of any leaching⁷.

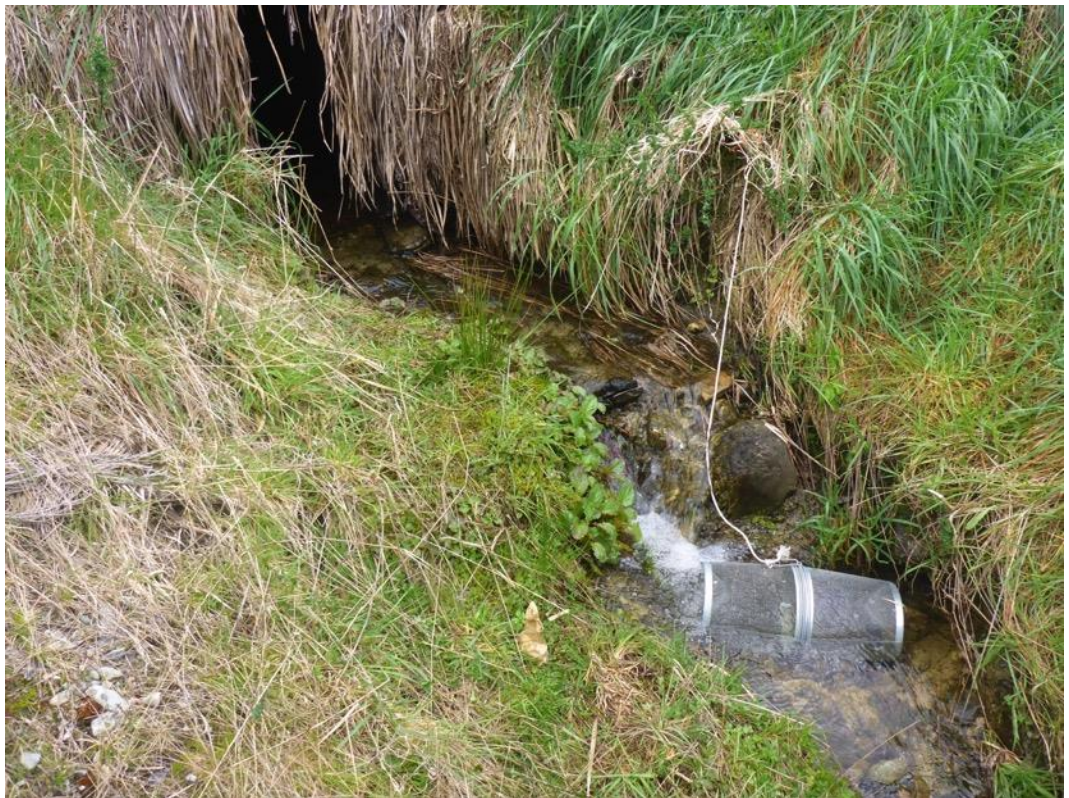
- 4.4 The unnamed tributary has a total length of approximately 2 km, and the channel alternates between being narrow and incised with a gravel and cobble dominated substrate (e.g. Figure 3), and being undefined and heavily vegetated with a soft fine sediment substrate (e.g. Figure 4). At the time of sampling there

Figure 3. Unnamed tributary, SW3, October 2020.

- 6.6 In Kingston Creek I recommend that a water level staff be installed at the culvert located near SW4. In the unnamed tributary I recommend that a staff be installed at the culvert near SW3 and at the culvert near SW7. These culvert structures will provide stable locations for water level staffs. At SW6 a water

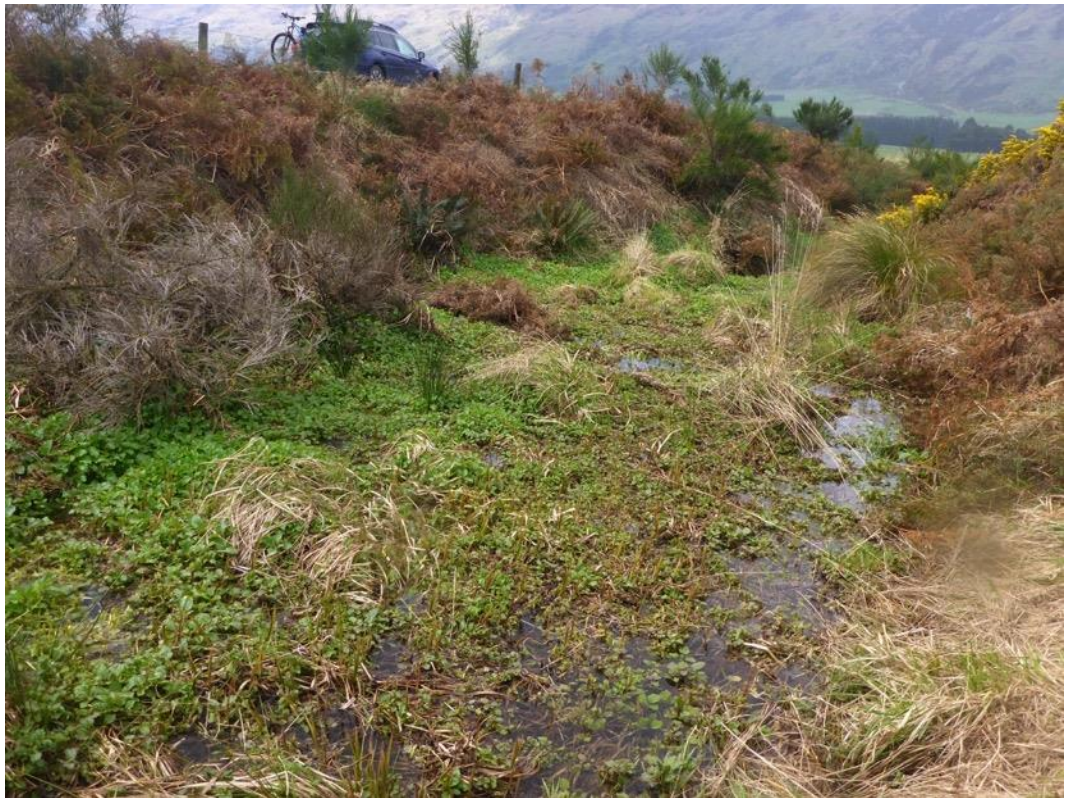
was an approximately 10 m long section with no visible surface flow immediately downstream of site SW2. It appeared though that during higher flows this section of channel would have surface flow.

Figure 4. Unnamed tributary, SW2, October 2020.

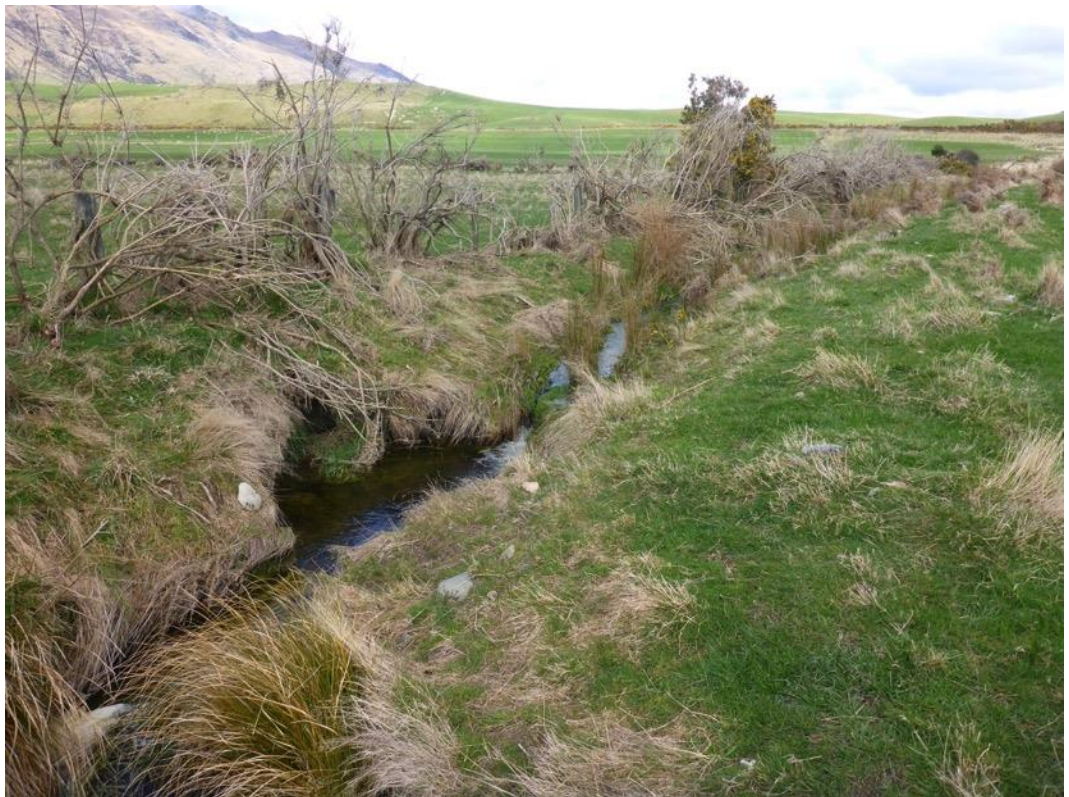
- 4.3 A small, unnamed tributary of Lake Wakatipu is located to the north/north-east of the LTA. The unnamed tributary has no surface flow connection with the LTA but skirts the northern side of the area and may potentially receive groundwater inflows. I sampled four sites within this tributary; including a site located upstream of any potential influence of the LTA (SW3, Figure 3), two sites located downstream of the LTA within agricultural land (SW2 and SW1, Figures 4 and 5), and the fourth site (SW7, Figure 5) approximately 1 km downstream of the LTA within the Kingston Township.

Figure 5. Unnamed tributary, SW1, October 2020.

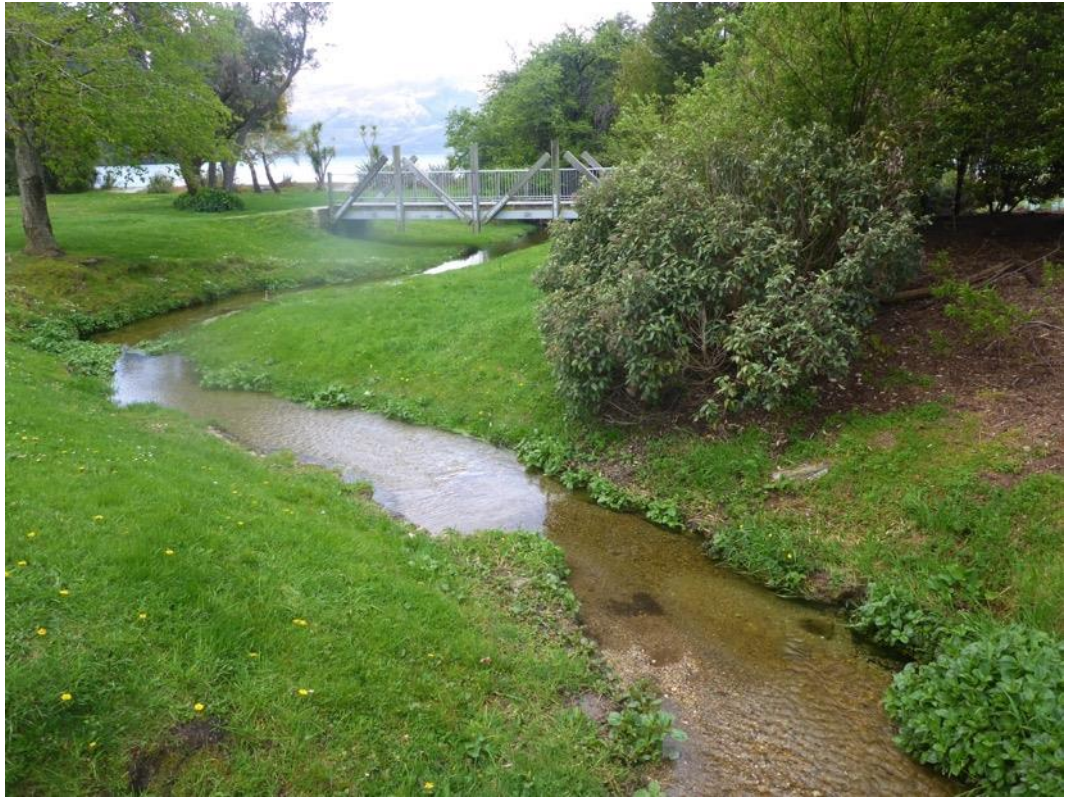
- 4.5 Of the four sites, the most downstream site (SW7) had the highest nutrient concentrations (Table 1), which is typical, as contaminant inputs tend to increase downstream as development increases (i.e., from native bush to agricultural and residential development). Faecal bacteria concentrations were, however, lowest at the downstream site (SW7) and highest at the most upstream site (SW3). Aside from nutrients and faecal bacteria, other water quality parameters (i.e., dissolved oxygen, pH, conductivity, turbidity, $TBOD_5^1$) were similar among all four unnamed tributary sites (Table 1). Benthic macroinvertebrate communities indicated 'poor' to 'good' conditions, with taxa that are tolerant of a range of conditions abundant (e.g., true flies, snails, worms). Fish were only caught at the downstream site near the lake: brown trout (introduced), kōaro (native, at risk-declining²) and common bully (native, not threatened). In addition to no fish being caught at the upper three unnamed tributary sites, the substrate present is not suitable for kōaro or brown trout spawning (as it is dominated by aquatic plants and soft fine sediments).

Figure 6. Unnamed tributary, SW7, October 2020.

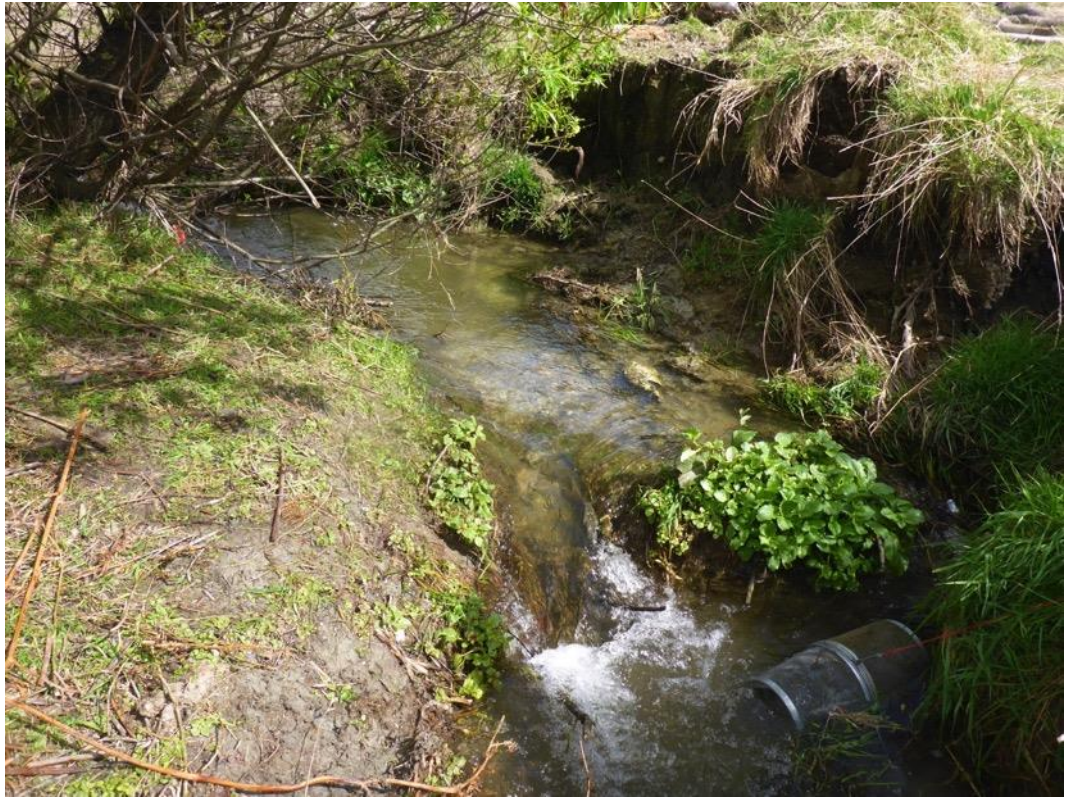
- 4.6 Kingston Creek is located approximately 500 m north/north-east of the LTA and has no surface flow connection to it. I sampled two sites in Kingston Creek: in a tributary within agricultural land immediately upstream of the State Highway 6 (SH6) road culvert (SW4, Figure 7), and in the mainstem downstream within the Kingston Township (SW8, Figure 8). Nutrient concentrations were higher, and faecal bacteria concentrations lower, at the Kingston Creek downstream site (SW8) than the upstream site (SW4) (Table 1). Benthic macroinvertebrate communities were similar to those in the unnamed tributary and indicated 'poor' to 'good' conditions. Brown trout and kōaro were found in Kingston Creek.

Figure 7. Kingston Creek tributary, SW4, October 2020.

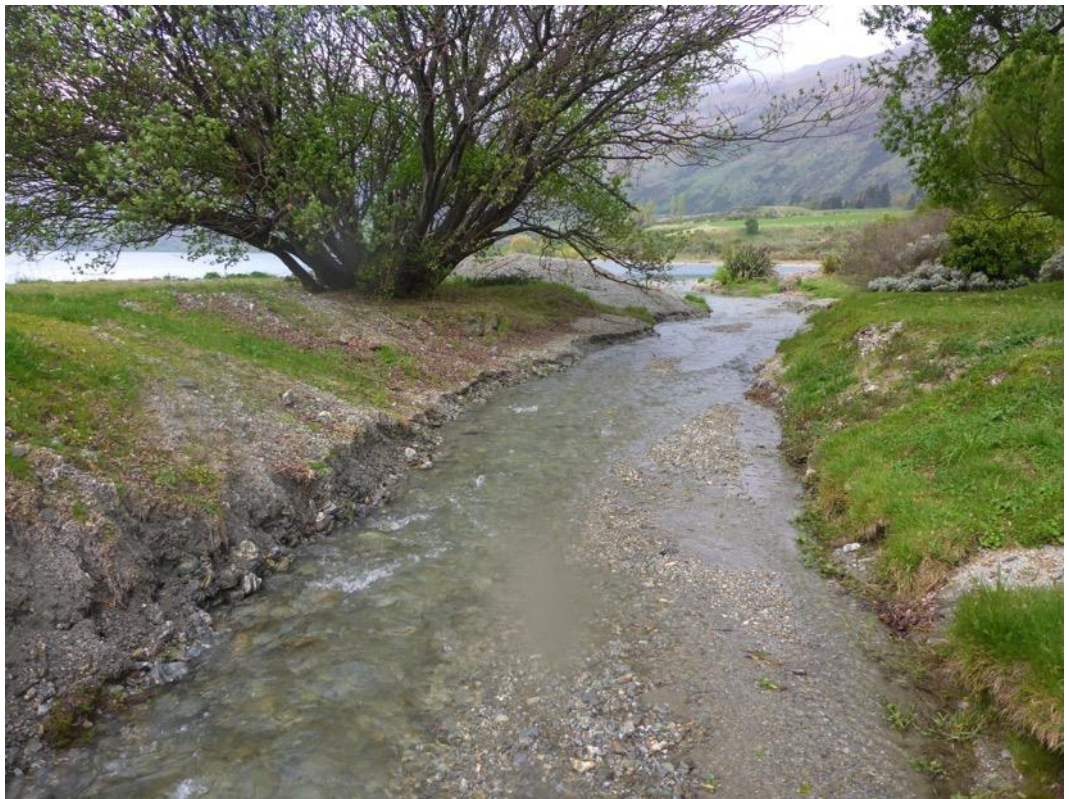
Figure 8. Kingston Creek, SW8, October 2020.

- 6.5 Establishing and maintaining an accurate water level staff would be difficult at several of the sites due to the mobile nature of the bed and the effects of high water velocities/waves (e.g. SW8, Figure 8). The water level in Lake Wakatipu is monitored by the ORC/NIWA at Willow Place near Queenstown¹² and this level can be referenced during each survey. Variations in water level in the unnamed tributary and Kingston Creek can be determined by establishing a water level staff at representative sites within each waterbody.

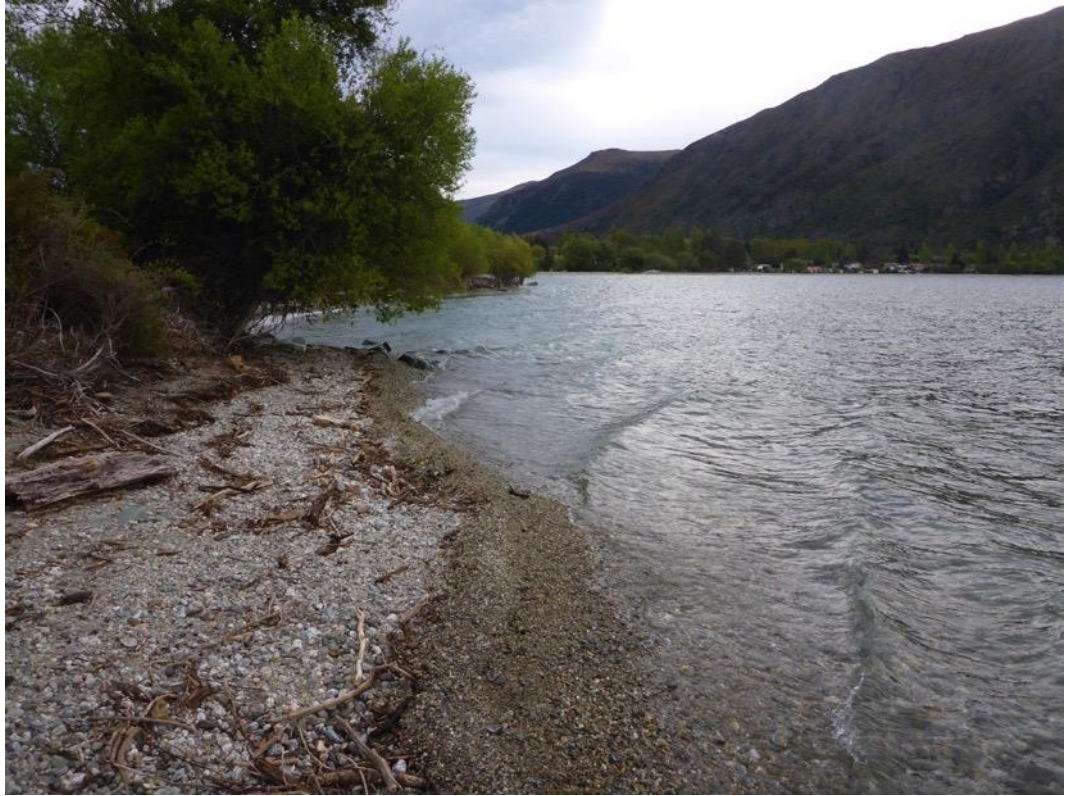
- 4.8 I sampled three sites on the shore of Lake Wakatipu: SW9 (Figure 9), SW10 and SW11 (Figure 10). The lake had the overall lowest faecal bacteria concentrations of all surface water bodies sampled (Table 1). Nutrient concentrations varied between the lake sites, with phosphorus highest at SW9 to the east of Kingston Township, and nitrogen highest at SW10 directly adjacent to Kingston Township. Other water quality parameters (i.e., dissolved oxygen, pH, conductivity, turbidity, TBOD₅) were similar among the three lake sites (Table 1). Benthic macroinvertebrate communities in the lake include freshwater mussels (native, 'at risk – declining'⁴), and the New Zealand Freshwater Fish Database (NZFFD) and my sampling recorded brown trout, kōaro, common bully and a large longfin eel (native, 'at risk - declining').

Figure 10. Lake Wakatipu, SW11, October 2020.
