Implementation Committee Agenda - 9 June 2022

| 8.3 | FLOOD RECOVERY 2020 PROGRESS UPDATE | 44 |
| | This report updates on recovery from damage resulting from February 2020 flooding. | |

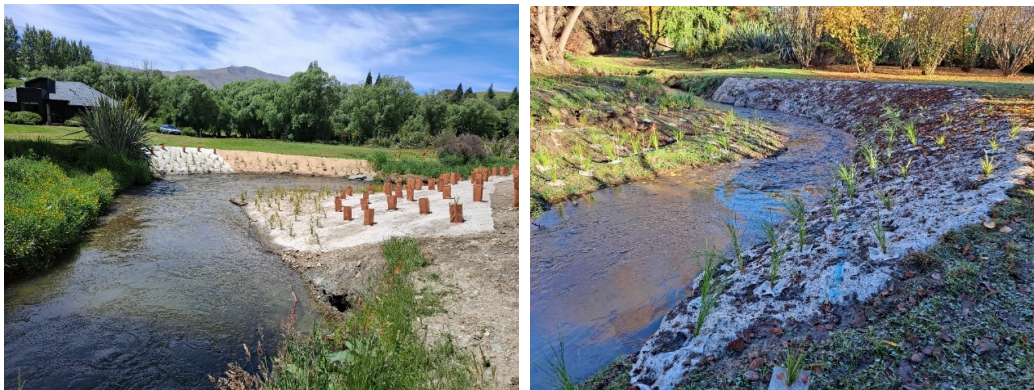
Figure 5: Photographs of work carried out in Mill Creek. Work was completed at different sites along Mill Creek in November 2021 (left) and April 2022 (right).

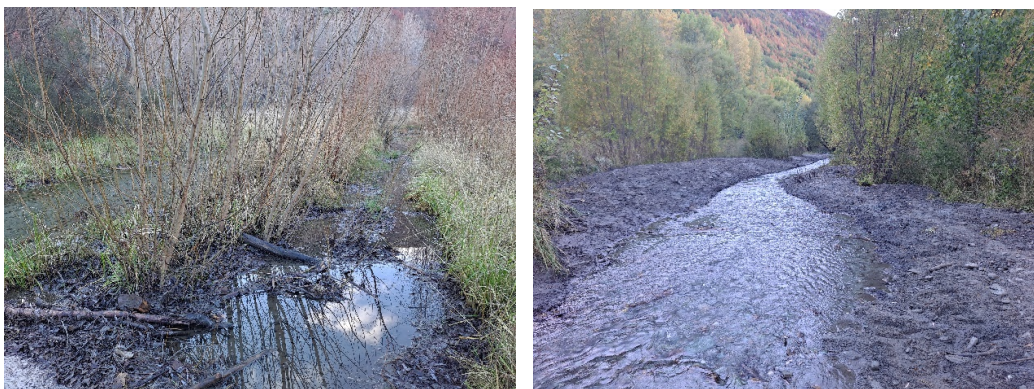
Figure 6: Before and after photos of work completed in Bush Creek near Arrowtown (30 March – 4 April 2022).

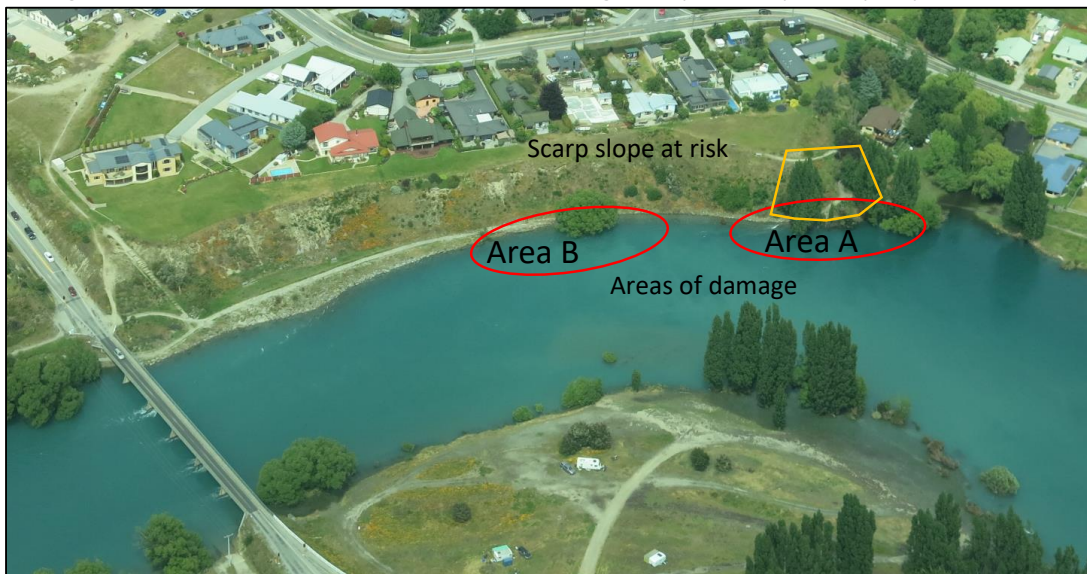
Albert Town Flood Damage Repair – Summary. Before and after Repair Photos

- [16] Flood damage included erosion and slumping of the rock buttress on the right bank of the Clutha River as it flows out of Lake Wanaka. Parts of the access track supported by the rock buttress had washed away and the slope above it had become unstable. Resilience of the buttress is important as helps protect the buffer between the edge of the river and the houses on the terrace.

- [17] The repair involved stabilising the buttress slope by removing material from the steep scarp and bringing in rock to repair and stabilise the buttress. The access track was then reinstated.

The figures that follow show the location of the damage and pre- and post-repair photos

- [18] Approximately 1,400 cubic metres of material were removed from the unstable scarp slope and 3,000 cubic metres of rock used to repair the rock buttress at a total cost, (including investigation, monitoring and consents) of around \$906,000. It is noted that the nature of this site makes this work vulnerable to future floods despite being carefully engineered. This is a cost risk for ORC.

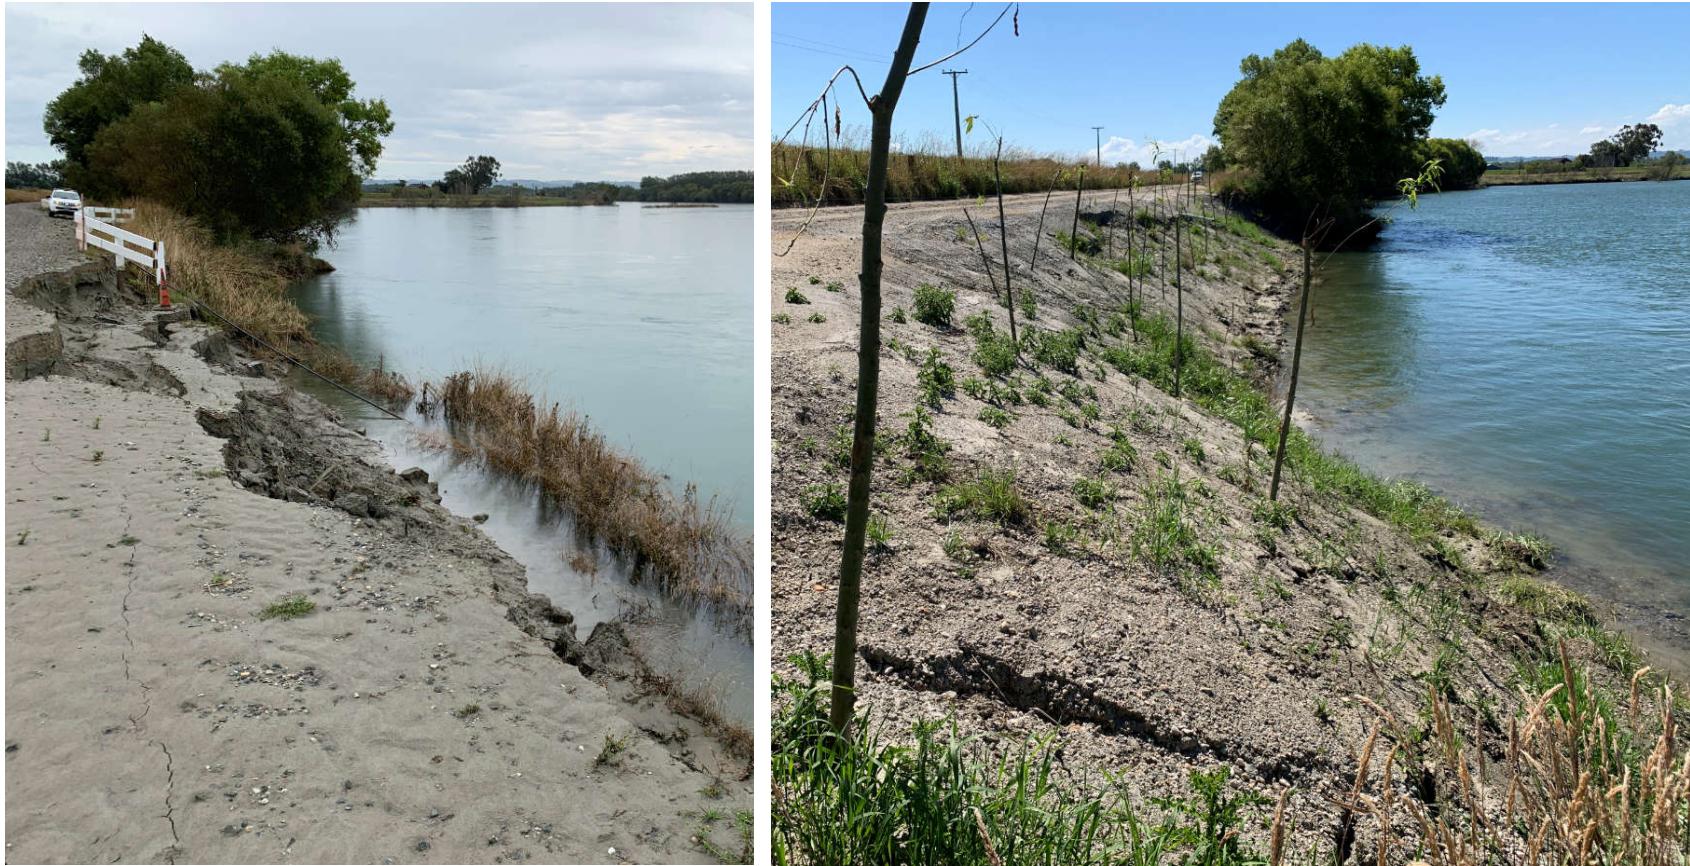
Figure 2. Riverbank Road at Renton Road (LC17) floodbank before and after reshaping and vegetation stabilisation.

- [22] A budget of \$1.0 million was included for floodbank stabilisation at the four sites, however when these repairs were completed under budget for approximately \$850,000 a fifth flood damage site (see Appendix 4a) on Riverbank Road was added to the project.

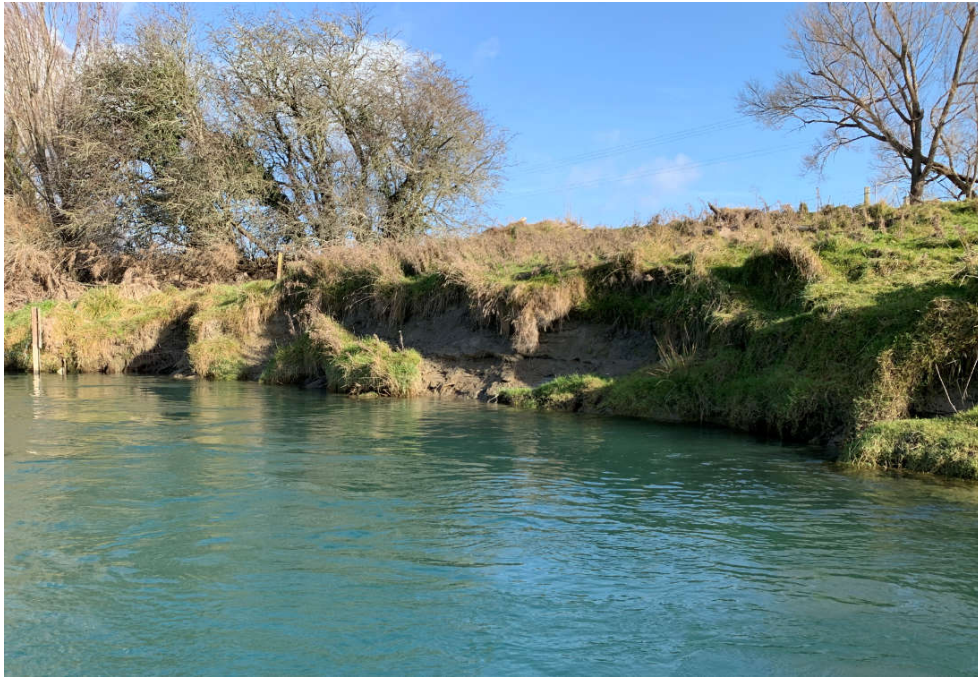
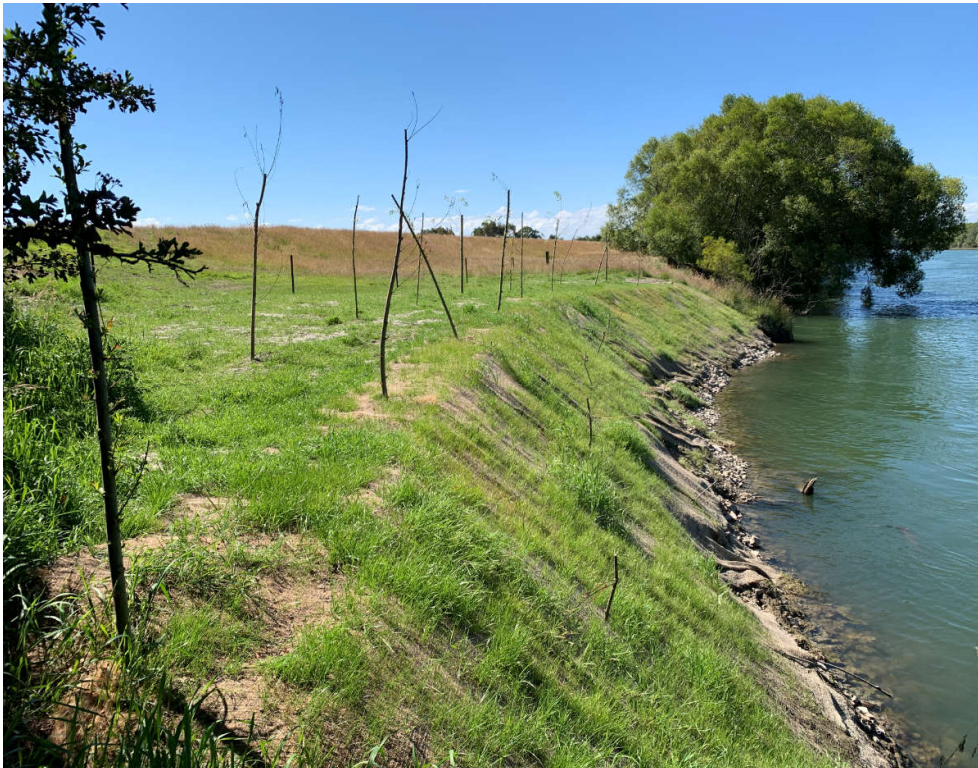
Figure 3. Riverbank Road (262 or LC18) floodbank before(above) and after (below) reshaping and vegetation stabilisation.

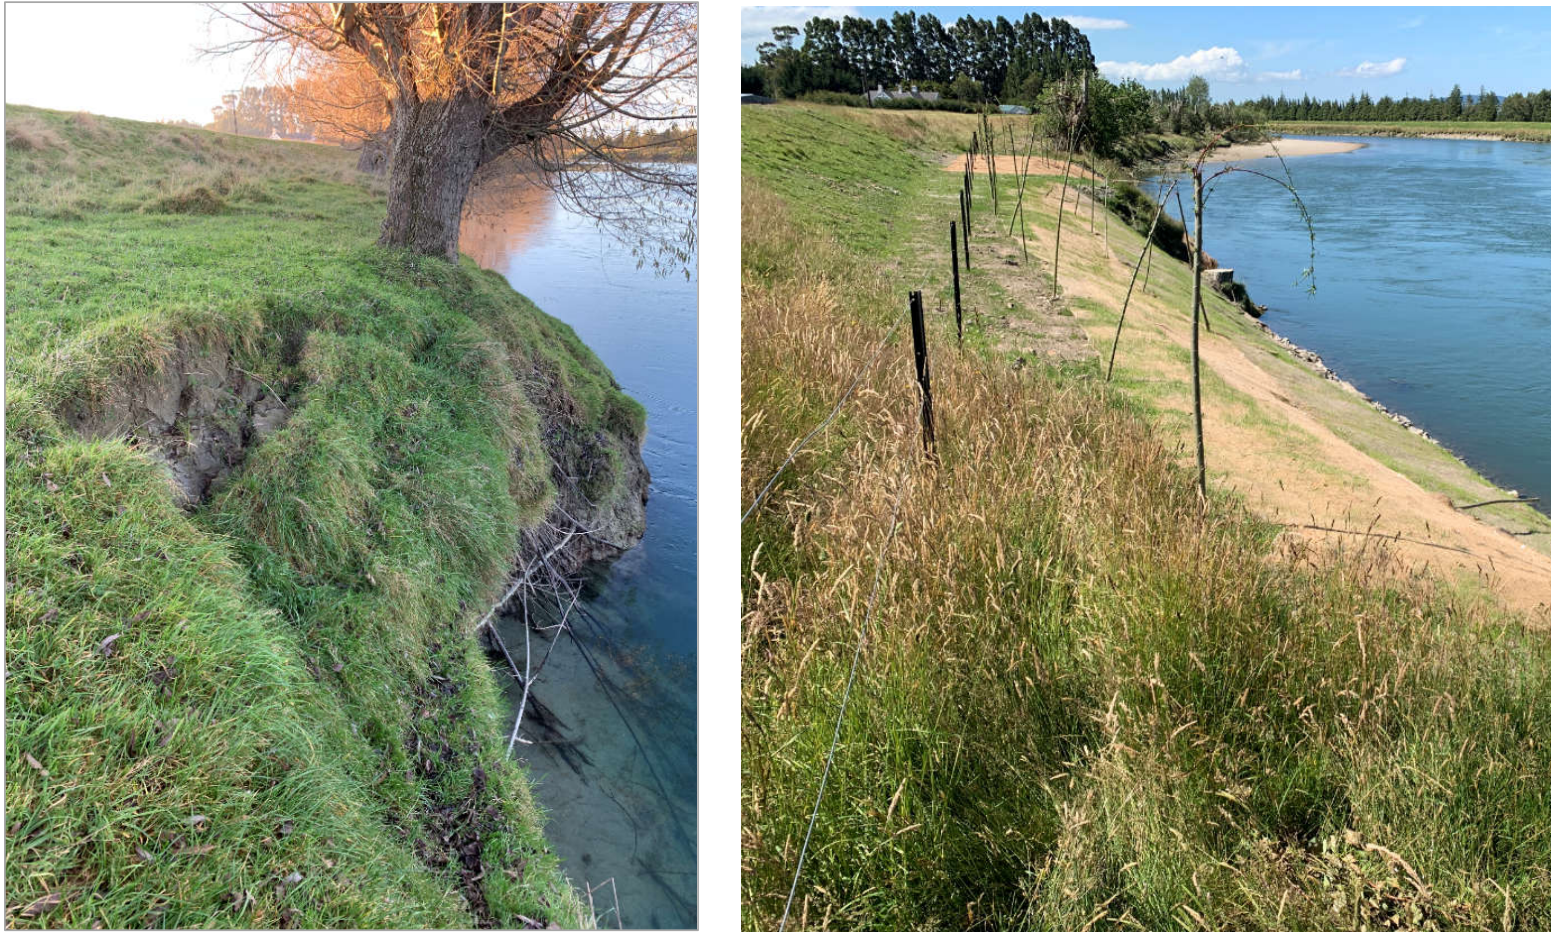
Figure 4. Riverbank Road floodbank at Lawsons (LC20), before(left) and after (right) reshaping and vegetation stabilisation.

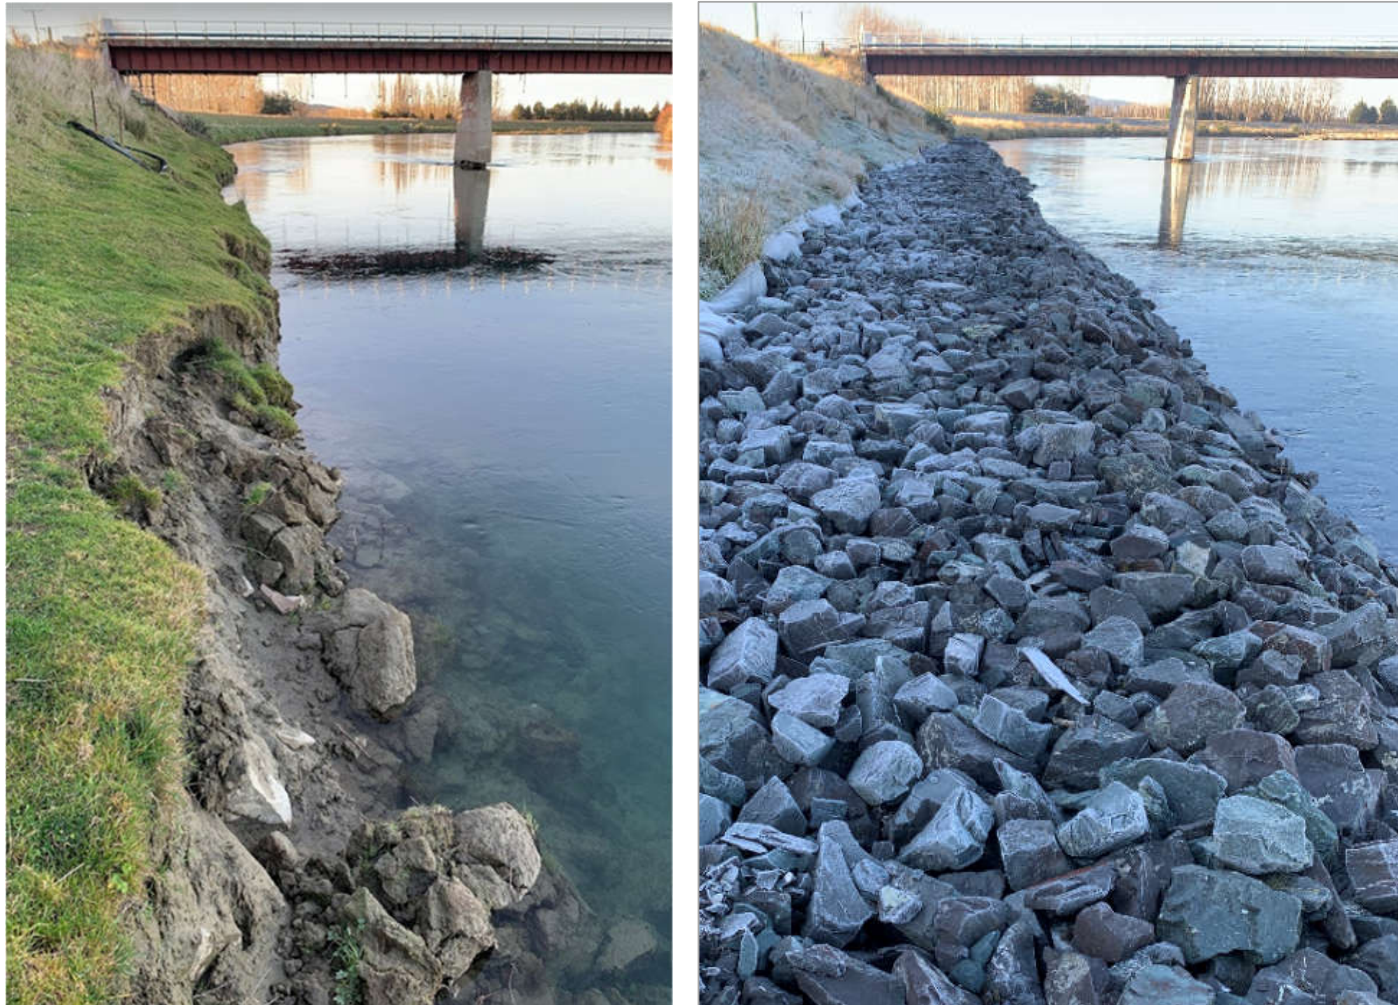
Figure 5. Riverbank Road floodbank at bridge near Stirling (LC21), before(left) and after (right) reshaping and vegetation stabilisation.

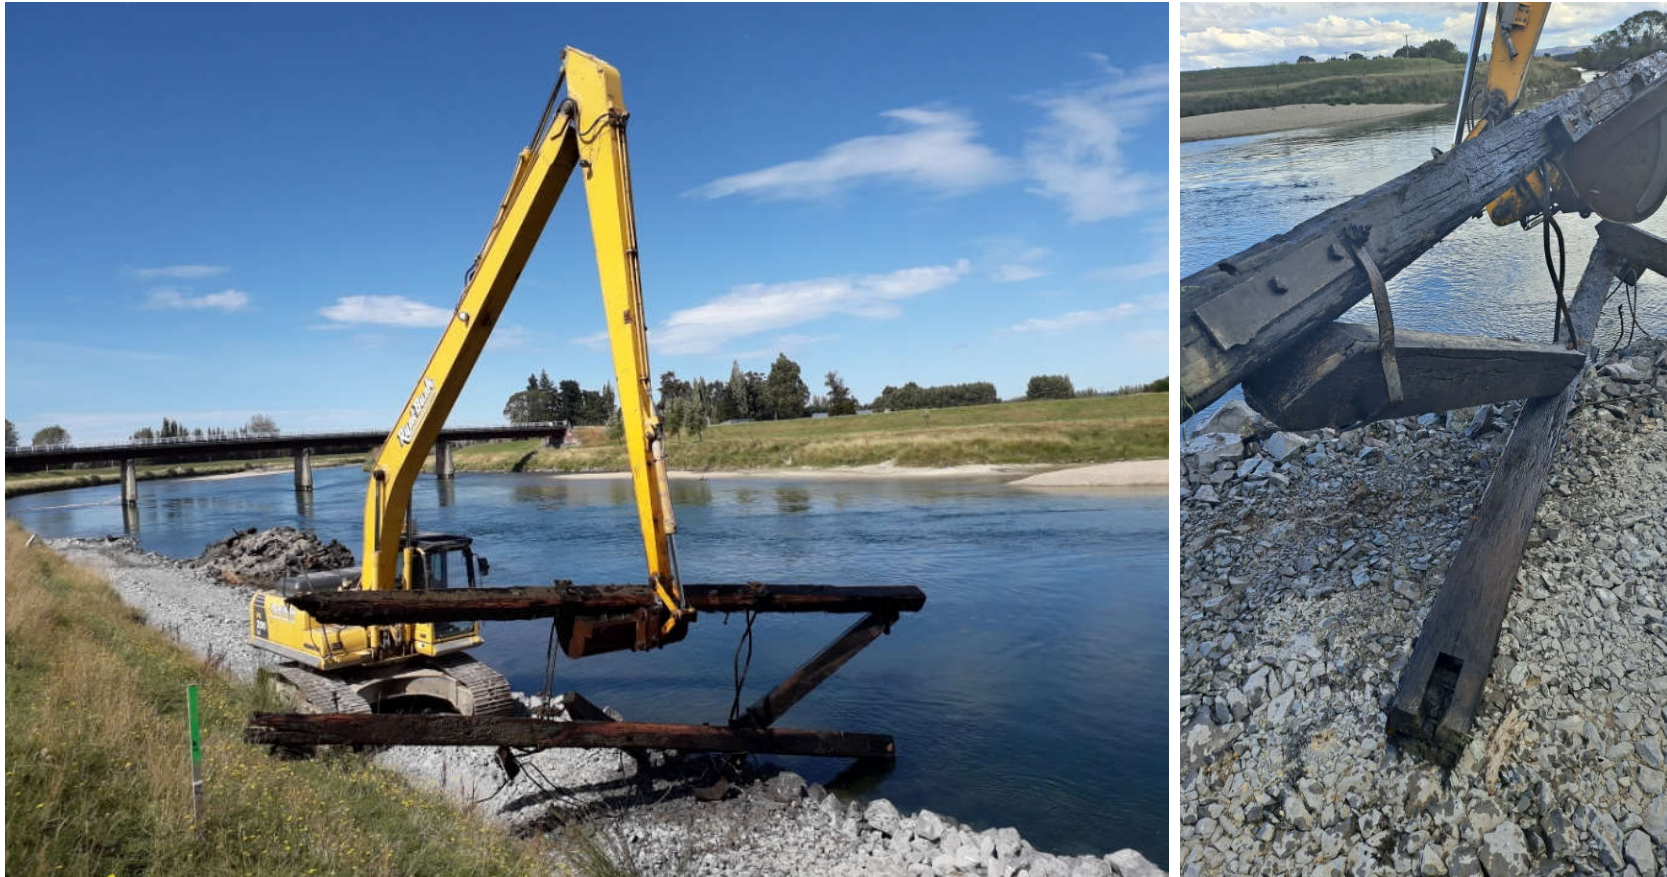
Figure 6. Discovery of historic (Pre-1900) bridge beams at Riverbank Road floodbank works at bridge near Stirling (LC21).

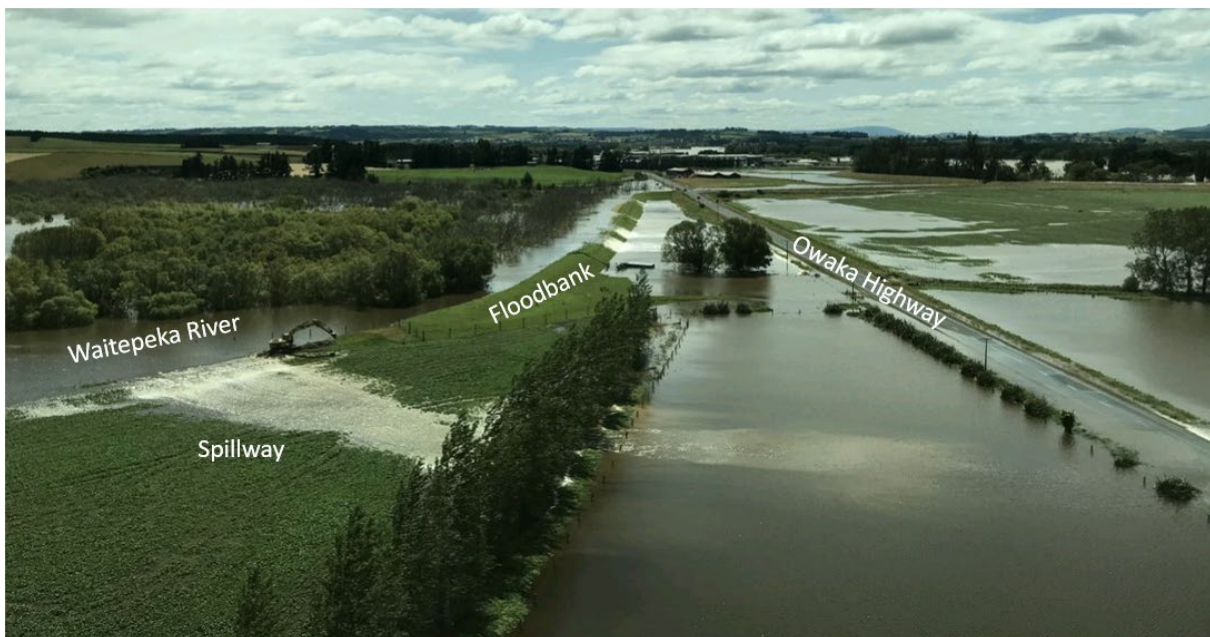
Figure 2. Waitepeka Floodbank during flooding. 5 February 2020.

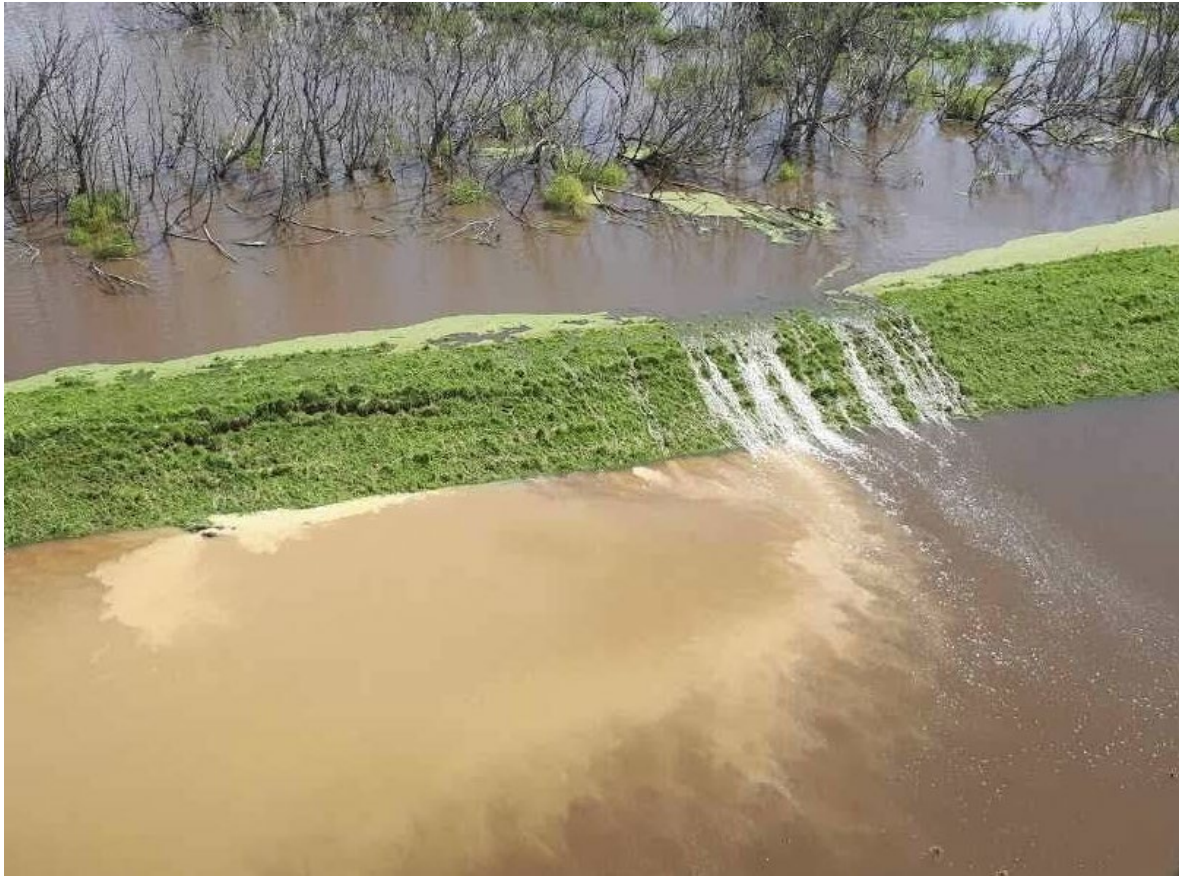
Figure 3. Waitepeka Floodbank showing slumping, overtopping and piping. 5 February 2020.

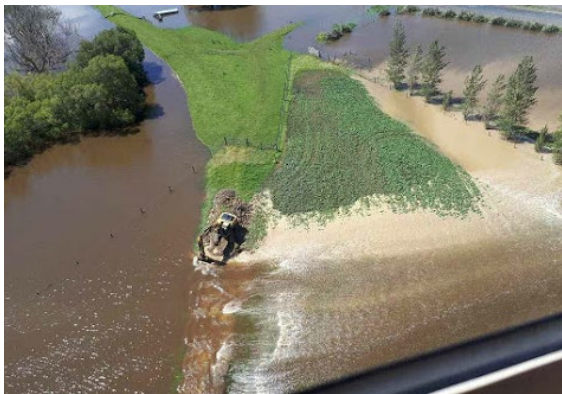
Figure 4. Excavating spillway during flood (5 February 2020).

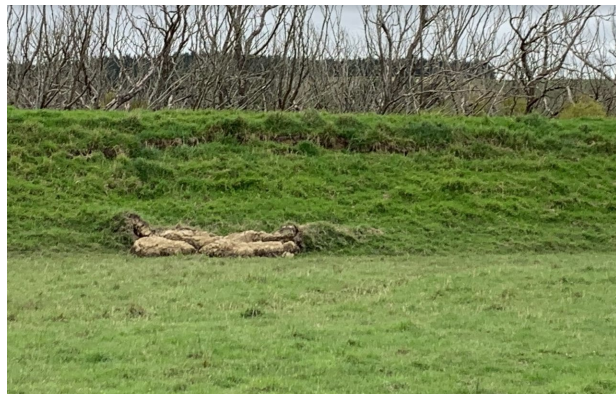
Figure 5. Slumping on floodbank (14 February 2020).

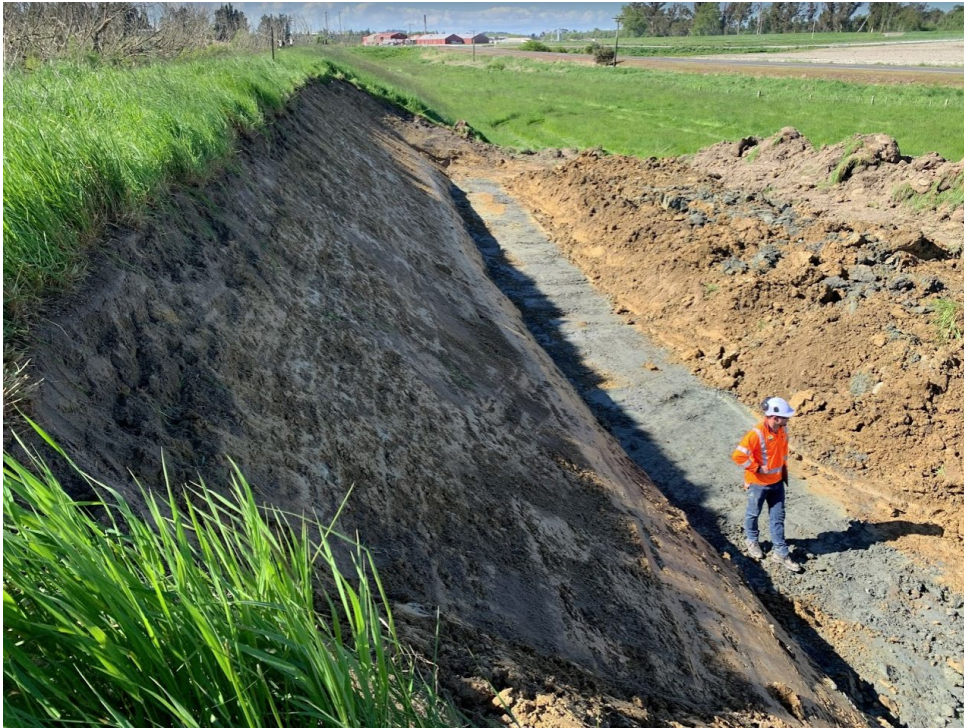
Figure 6. Repair of slumped section of embankment

Earthwork included a total volume of 23,200 cubic metres. The final cost for the floodbank repair, including design and engineering supervision was \$360,780.

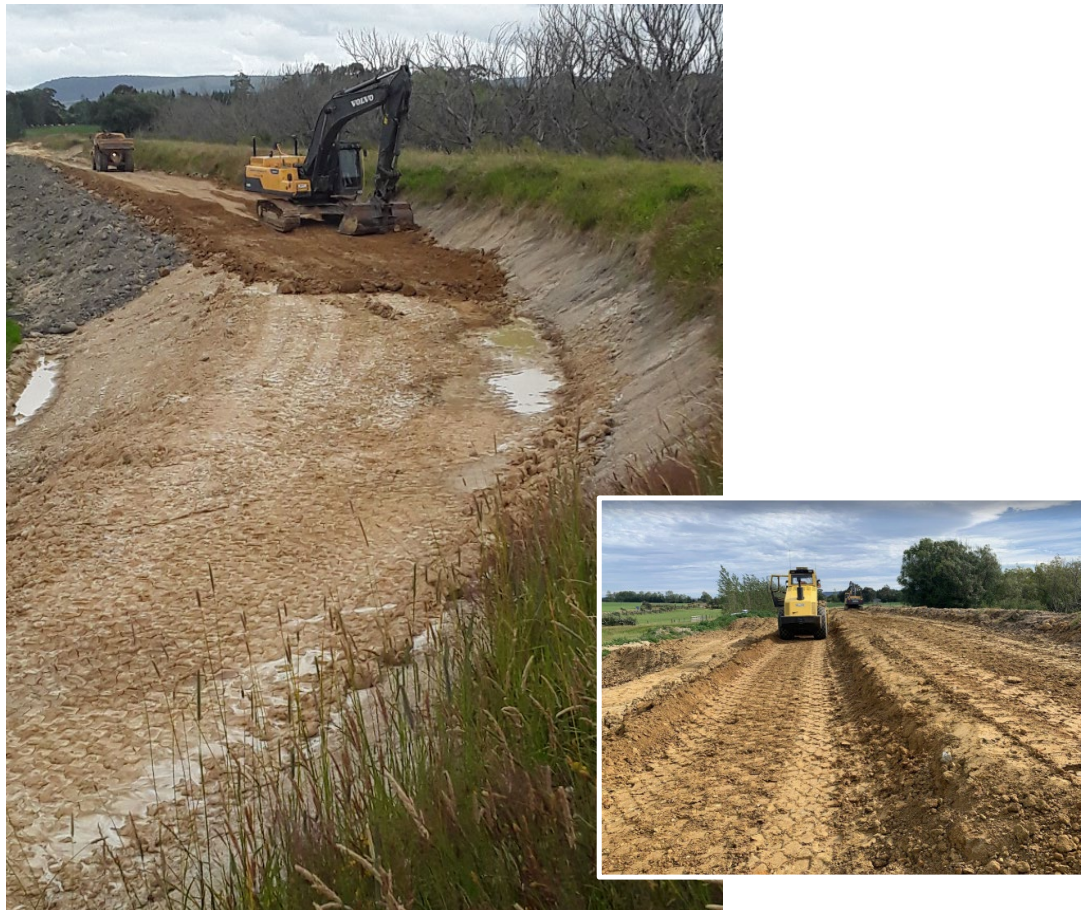
Figure 7. Repair of embankment toe

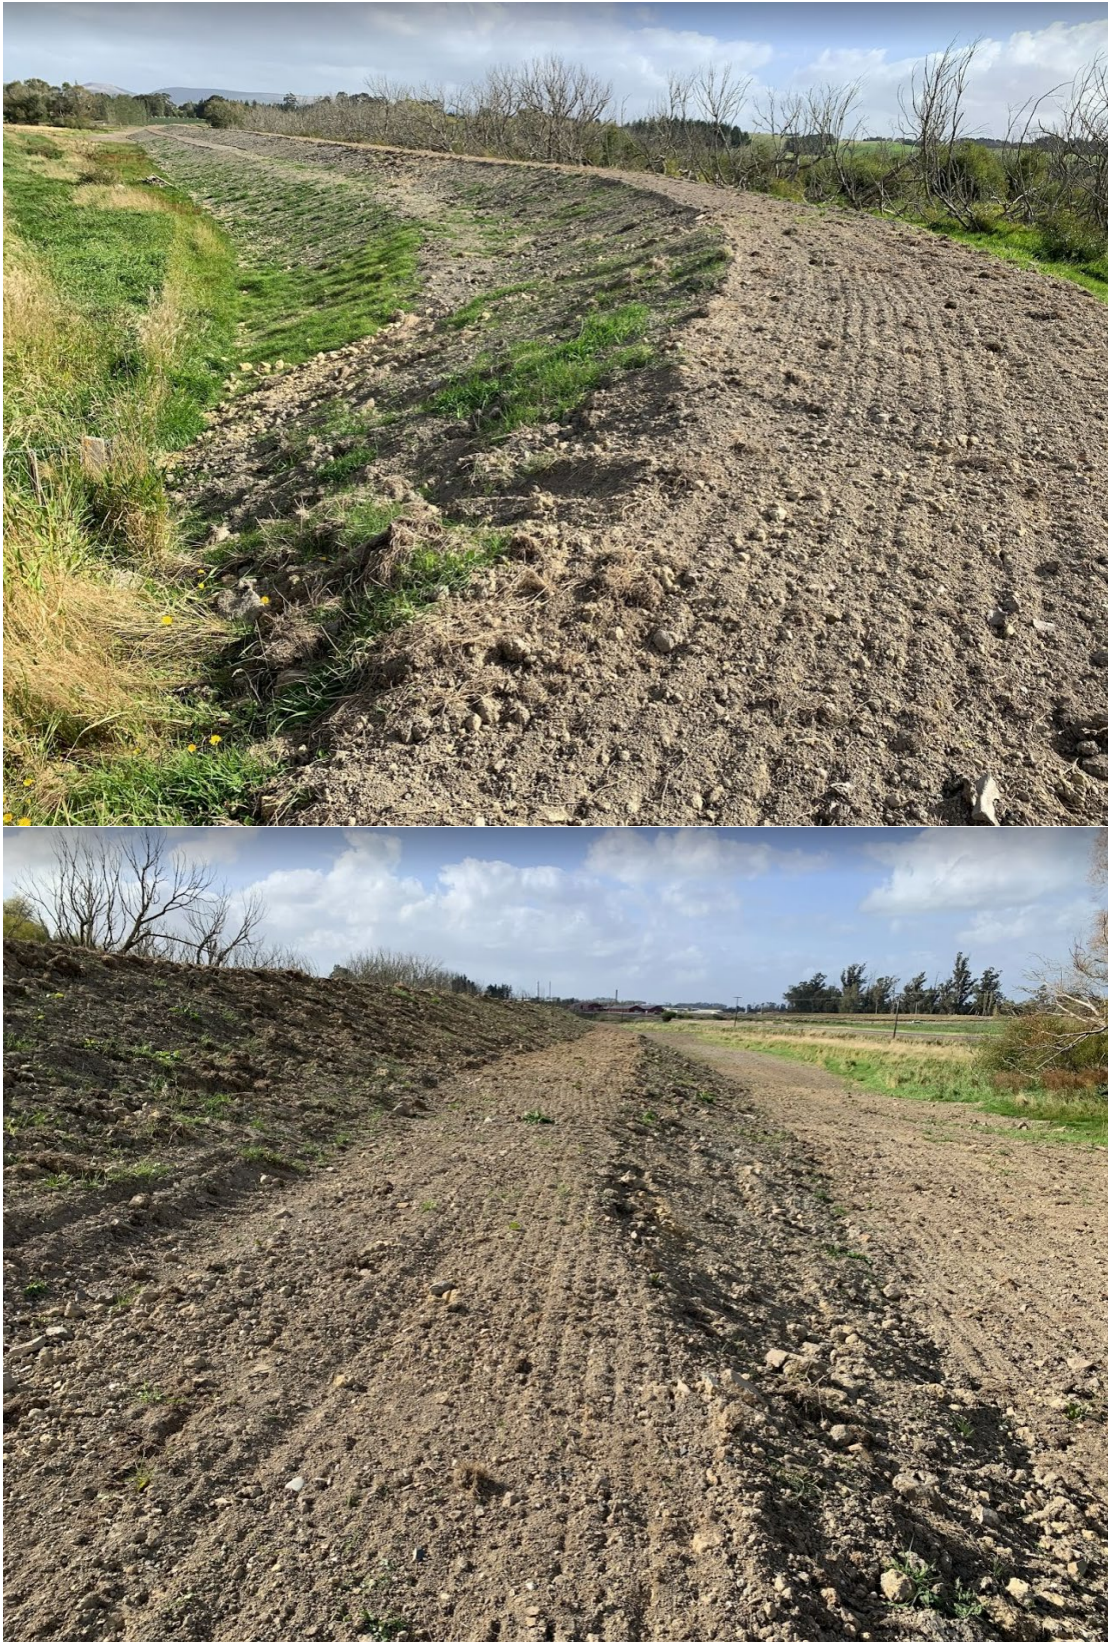
Figure 8. Completed Embankment.
