# Data and Information Committee Agenda

### 5.1. Head of Lake Wakatipu flooding and liquefaction hazard investigations

# Glenorchy Liquefaction Vulnerability Assessment

**Rees / Dart Rivers: Flood Hazard Modelling**

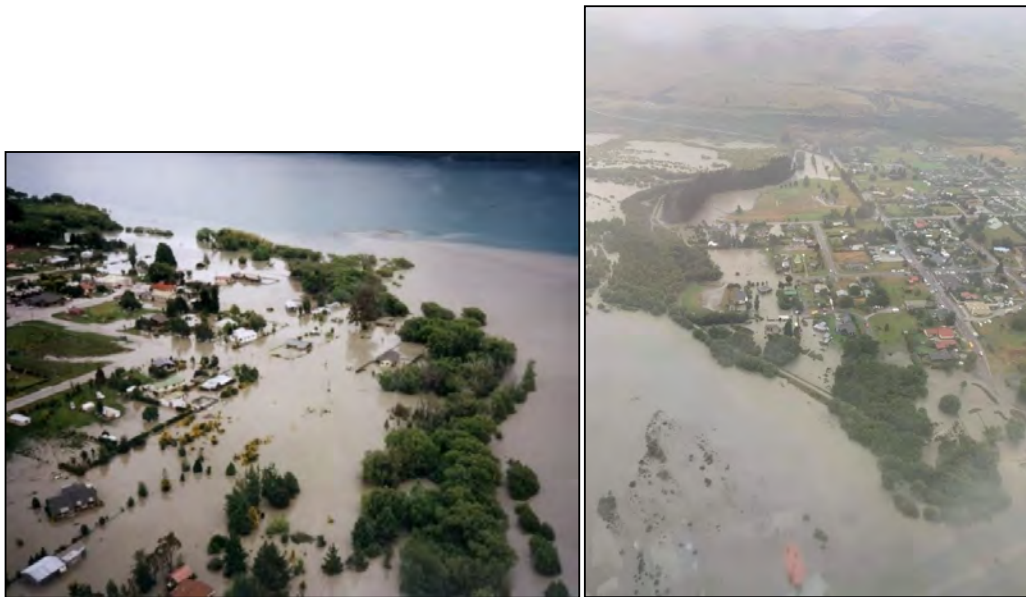
Figure 2: Flooding in Glenorchy township in November 1999 (a, left) and February 2020 (b, right). (photo of 2020 event provided by Luke Hunter).

- [22] The flooding hazard at Glenorchy township is known from observations of several flooding events in recent decades. Flooding most recently impacted on the residential area of the township in February 2020 (Figure 2b). Previous recent floods include that November 1999 (Figure 2a).

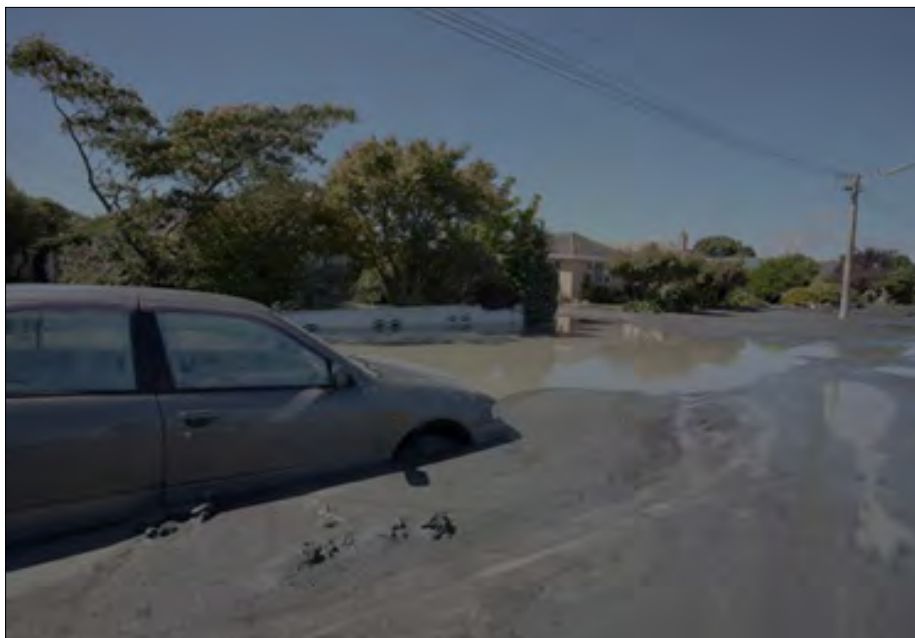
**Figure 7: Example of liquefaction following the 2011 Christchurch earthquake, showing the type of liquefaction land damage expected where the LSN is 25 or greater.**

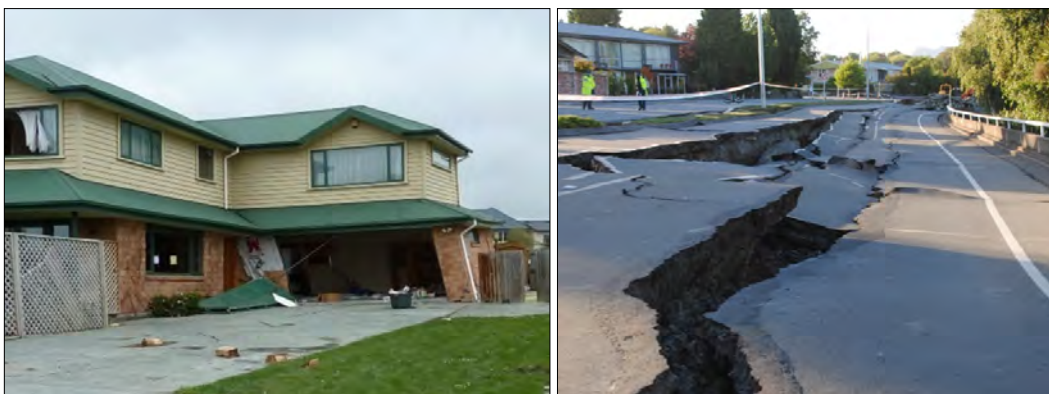
**Figure 9: Example of lateral spreading damages following the 2010 Darfield and 2011 Christchurch earthquake, showing the type of damage to buildings or roads expected where lateral spreading is in the range of 1-3 metres.**

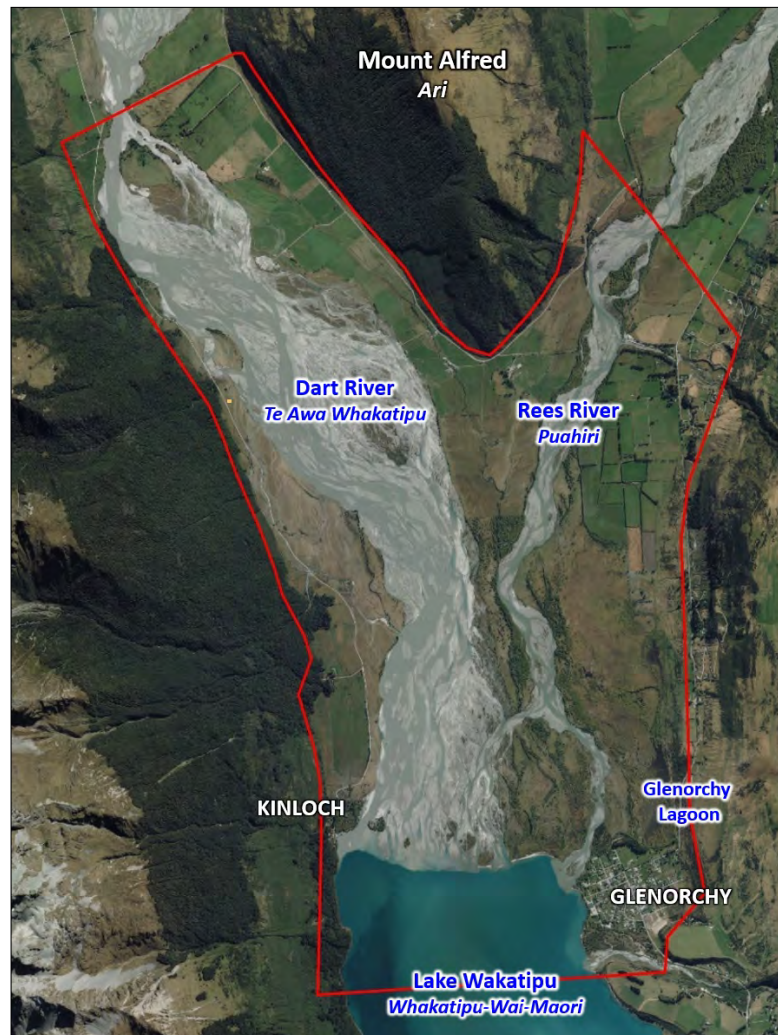
**Figure 12: Overview of the lower Dart and Rees Rivers systems, showing the extent of hydraulic modelling and flood hazard assessment (red outline).**

- [61] Hydraulic modelling and flood hazard assessment was undertaken for the Dart-Rees floodplain and delta for the extent shown in Figure 12.
- [62] Numerical hydraulic modelling for flood event scenarios was completed using MIKE21, an industry-standard 2D hydraulic modelling software.
- [63] Model topography is based on a 2019 LiDAR dataset, with channel bathymetry interpolated based on surveyed cross-section data.

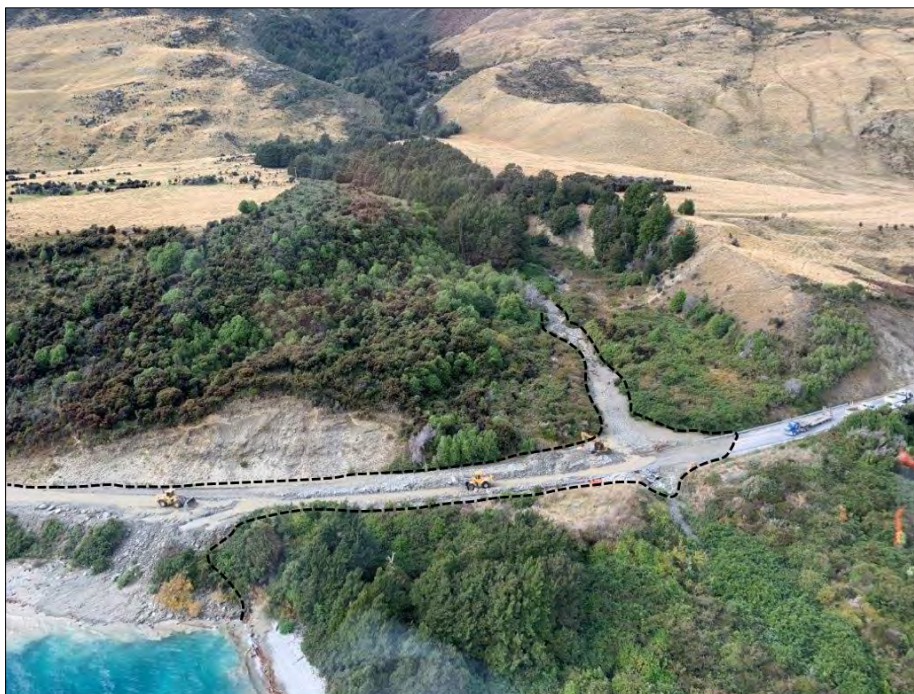
**Figure 20: Aerial view of debris flow impacts at the Queenstown-Glenorchy road, annotated to show the approximate extent of debris deposition (photo provided by Maddi Phillips, WSP Ltd).**

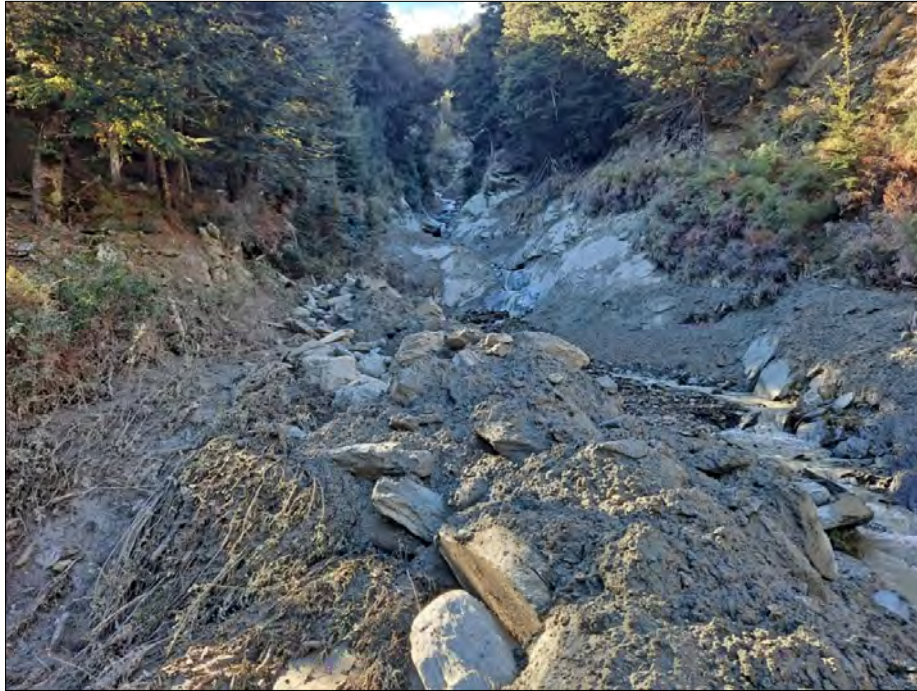
**Figure 21: A lower section of Shepherd's Hut Creek following the 21 April 2022 event, showing freshly deposited debris including large boulders (photo by Scott Liddell, ORC).**

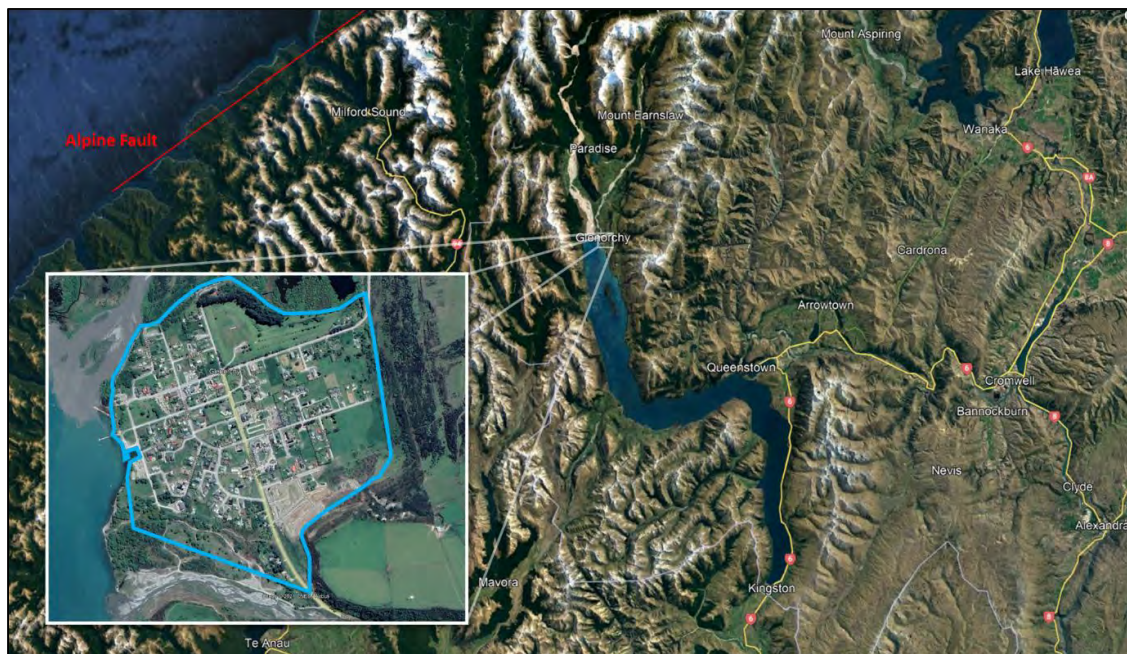
Figure 2.1: Glenorchy township location. The approximate location of the Alpine Fault is shown in red. The study area for this project is shown outlined in blue on the inset map.

The spatial extent of the study includes the township area bounded by the Glenorchy lagoon, the Lake Wakatipu foreshore, the Buckler Burn, and the base of Bible Terrace (shown in Figure 2.1, below).

Glenorchy township is located at the head of Lake Wakatipu, approximately 30 km northwest of Queenstown and 40 km southeast of Milford Sound. The site location is shown in Figure 2.1 below.

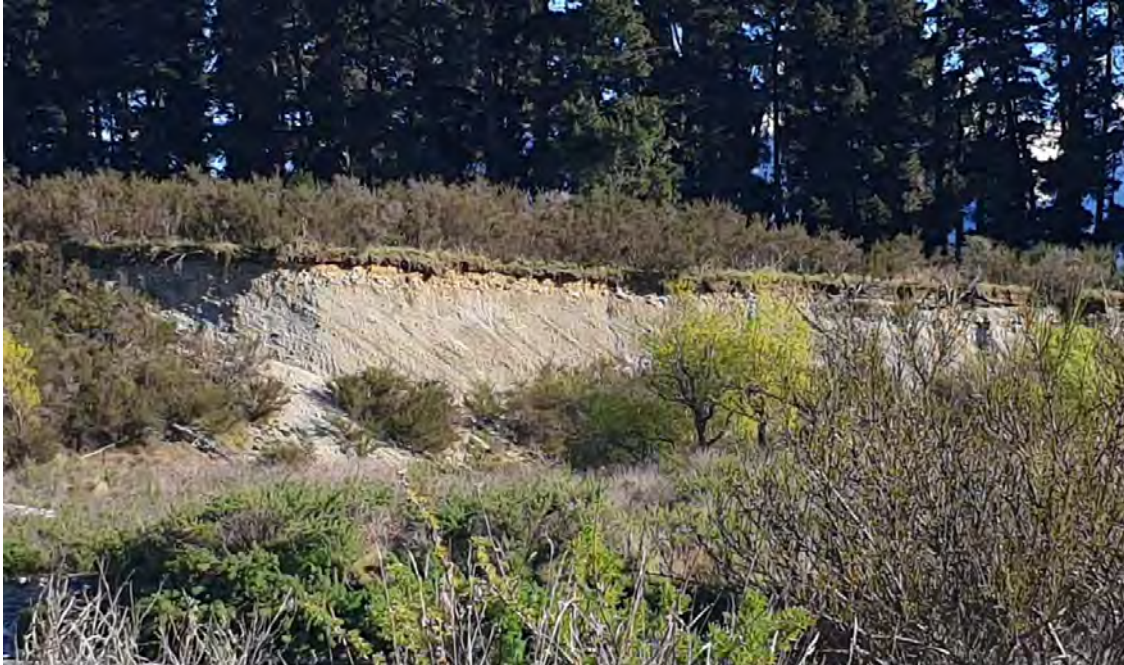
*Figure 6.2: A photo of proximal delta topsets and Gilbert Type delta foreset beds in distal deposits in the river cut exposures along the true left bank of the modern-day Buckler Burn.*

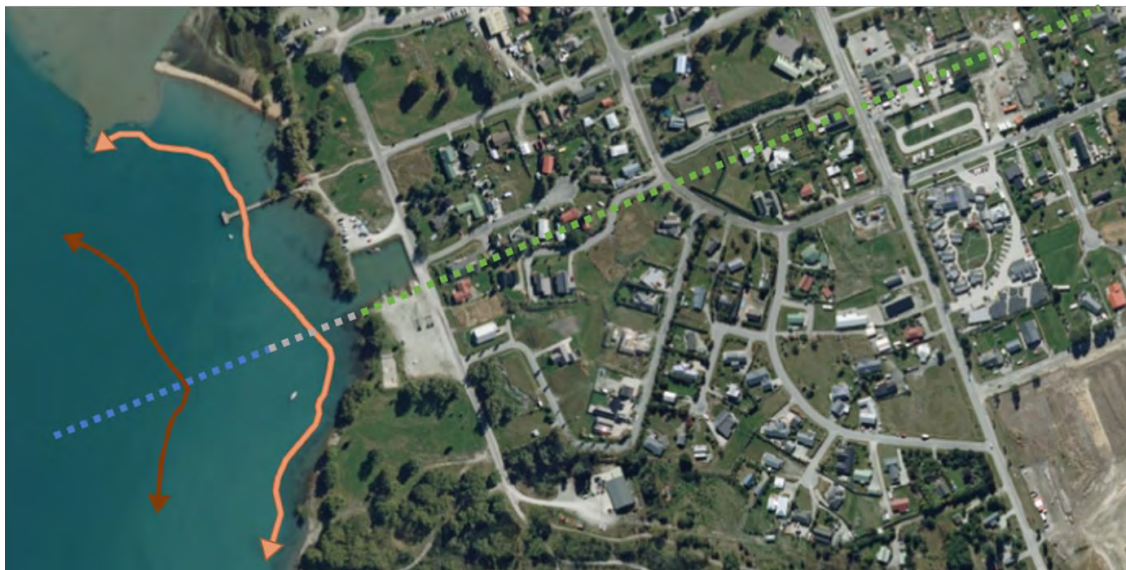
Figure 7.2: The mapped free face crest location and base locations along the edge of Lake Wakatipu around Glenorchy, together with the line along which the surface in Figure 7.1 is taken. The crest and base intersect at points D and E from that figure, respectively.

For the purposes of a lateral spreading assessment, the drop-off starting at Point D is known as a *free face*. The edge of the free face (a.k.a. the crest) has been mapped along the lake edge (using the full Bathymetry and LiDAR data rather than a single cross section); shown in Figure 7.2. Likewise, the base of the free face (e.g., Point E in the cross section) has been mapped using a similar methodology.

The Gillins & Bartlett (2014) method was used to develop lateral spread contours across the entire western side of Glenorchy in 2D at points in a 1m x 1m grid. The distance to the nearest point on the free face (mapped in Figure 7.2) was determined for each grid point, and the effective free face height was determined based on the maximum depth of predicted liquefaction (according to the assessment in Section 11), along with the cumulative thickness of liquefiable material. Lateral spread calculations were then performed at each grid point using these inputs, along with the seismicity information from Table 5.1.

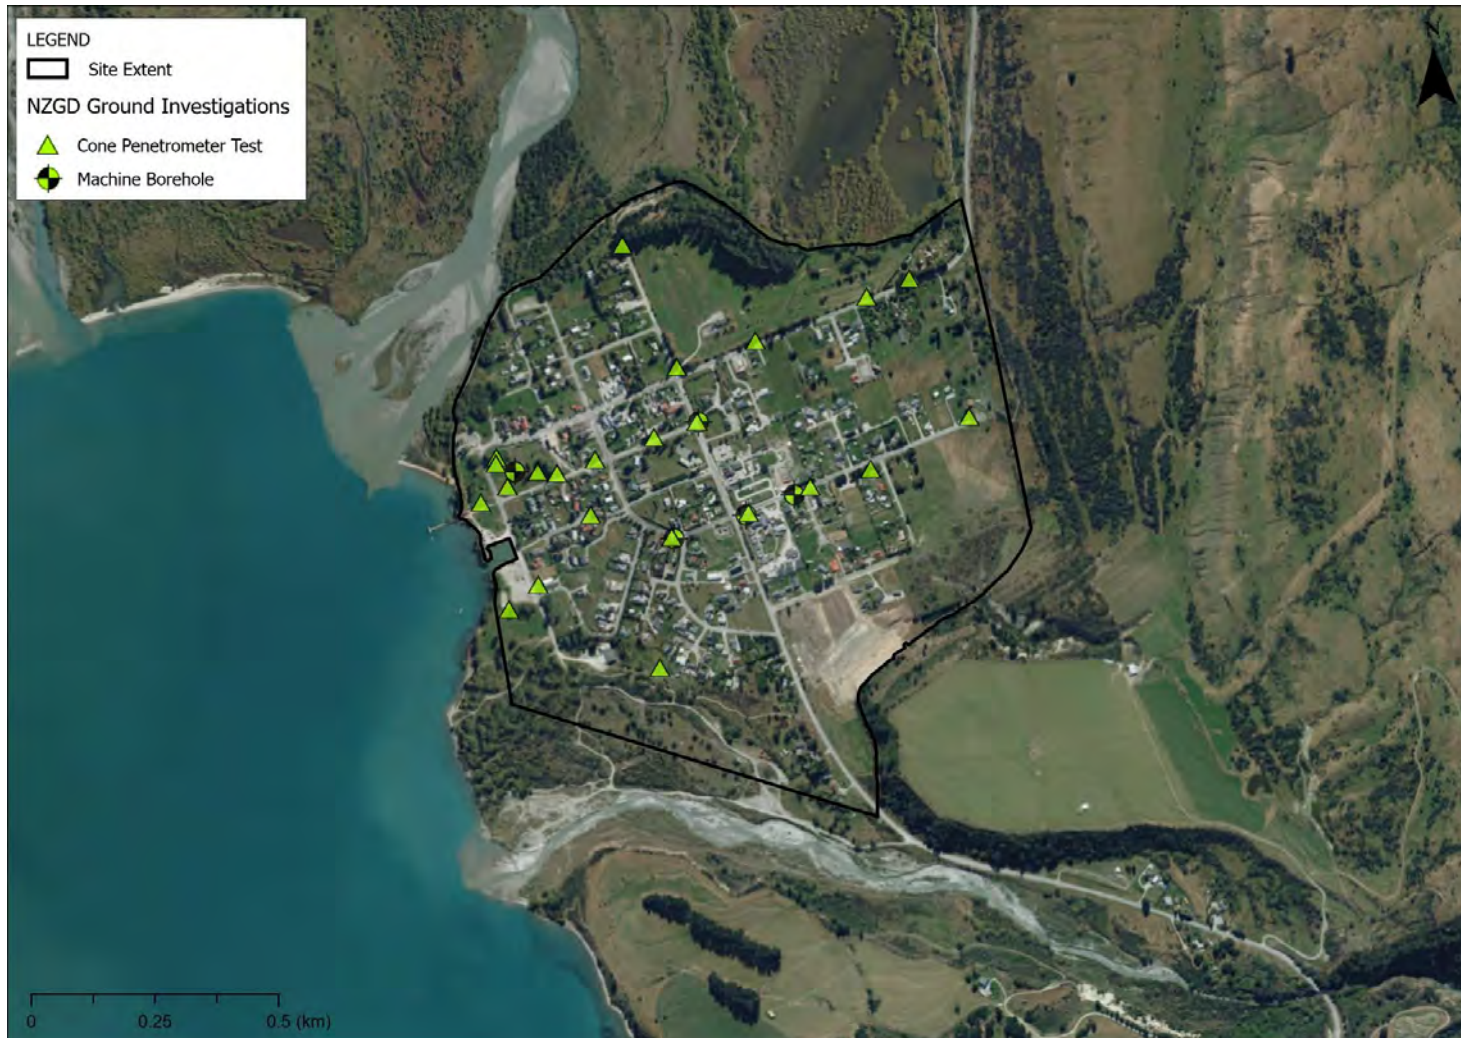
Figure 8.1: Geotechnical Investigation locations: data and logs available on the NZGD.

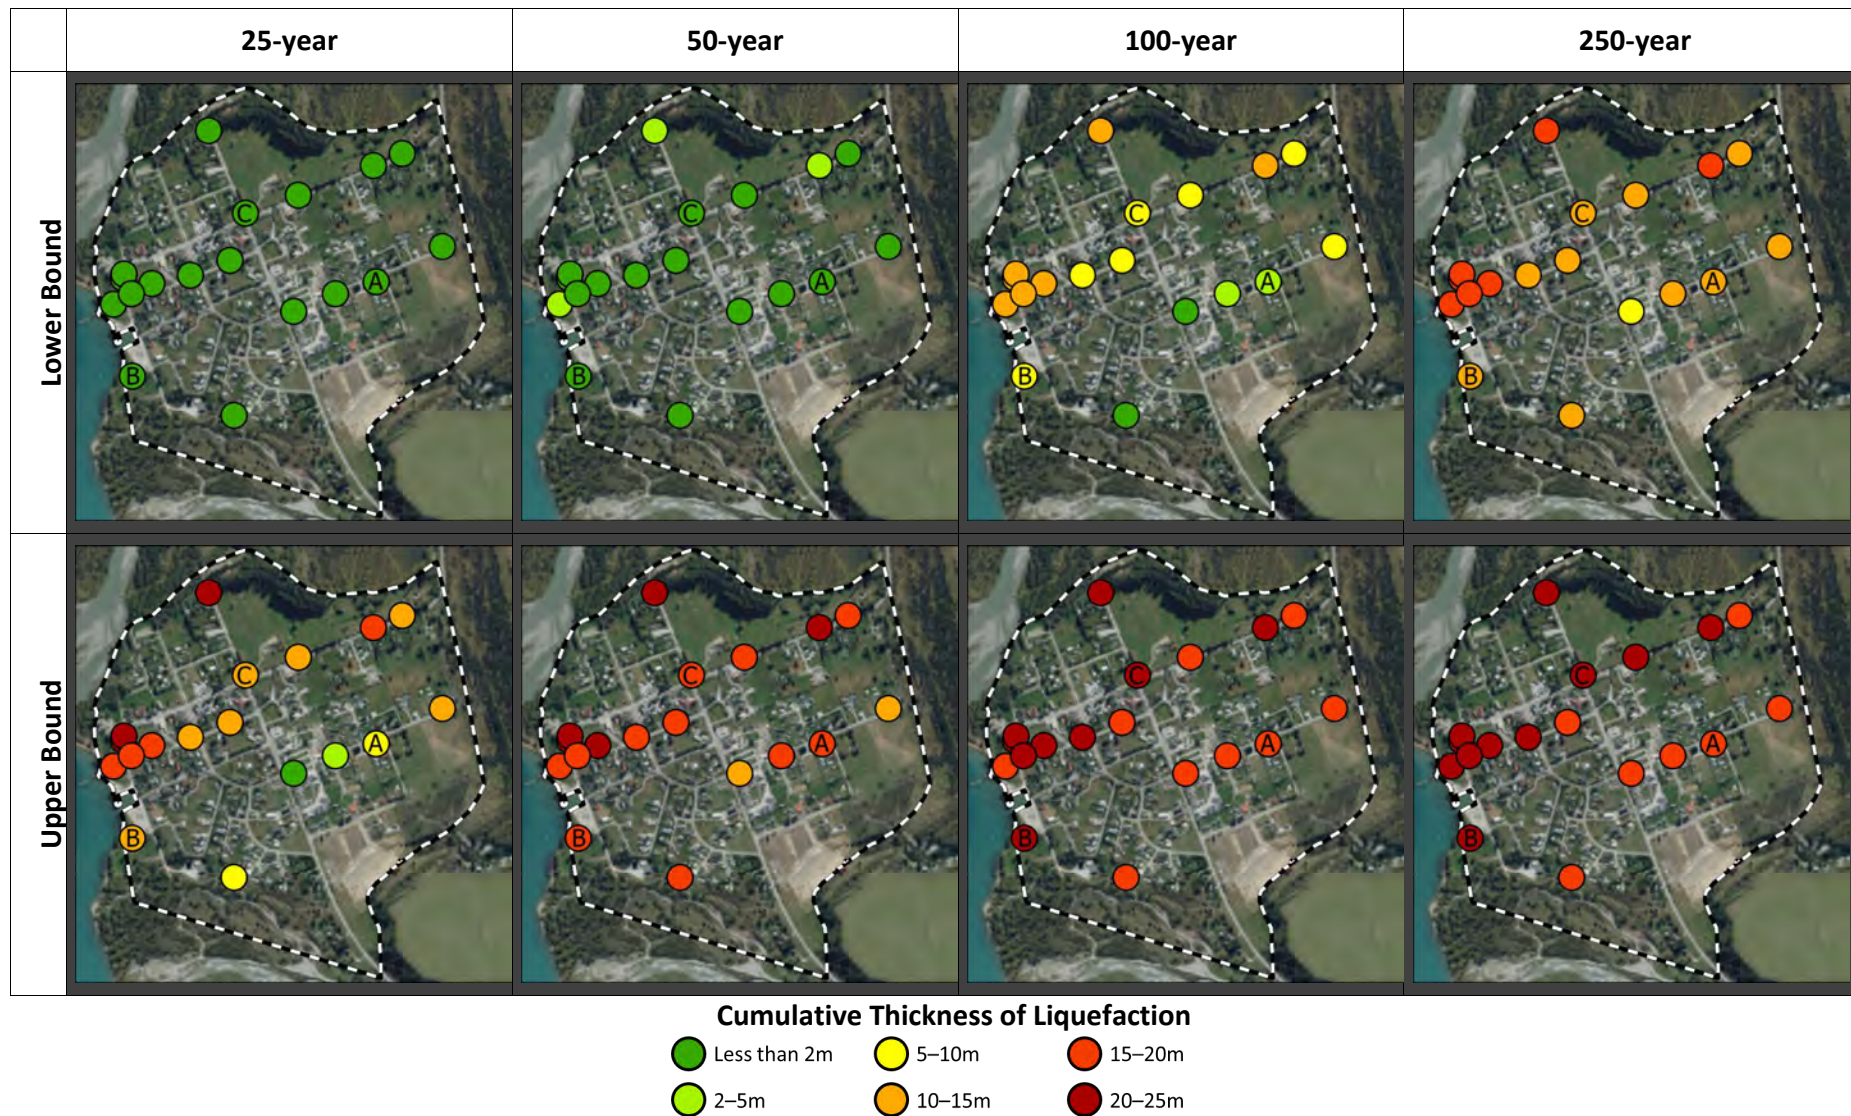
Table 11.2: The cumulative thickness of liquefaction at each CPT for the Alpine Fault Rupture Scenario for the 16<sup>th</sup>, 50<sup>th</sup> and 84<sup>th</sup> percentile shaking estimates. NZGD CPTs 168502, 167503, and 16896 are labelled as A, B, and C respectively.

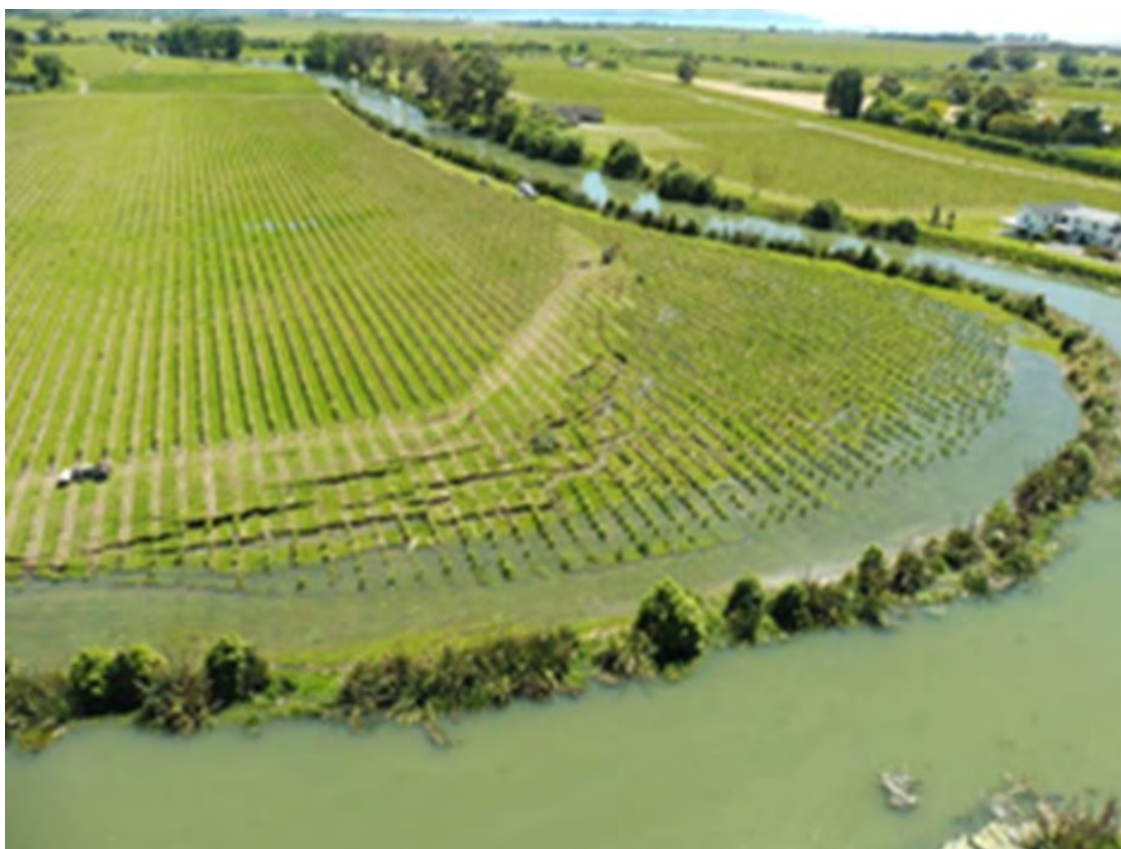
*Figure B3 – Photo showing the lateral spreading that occurred in Blenheim at a vineyard along the Wairau River following the 2016 Kaikoura earthquake. The lateral spreading horizontal movement was approximately 3m and the vertical drop was approximately 1m (approx. 33% of the horizontal movement).*

- [58] The T+T report shows an example from the 2016 Kaikoura earthquake where lateral spreading damage caused approximately 1 metre of vertical drop to land adjacent to a river channel, causing flooding and increased flood exposure. This example is Figure B3 of Appendix B.

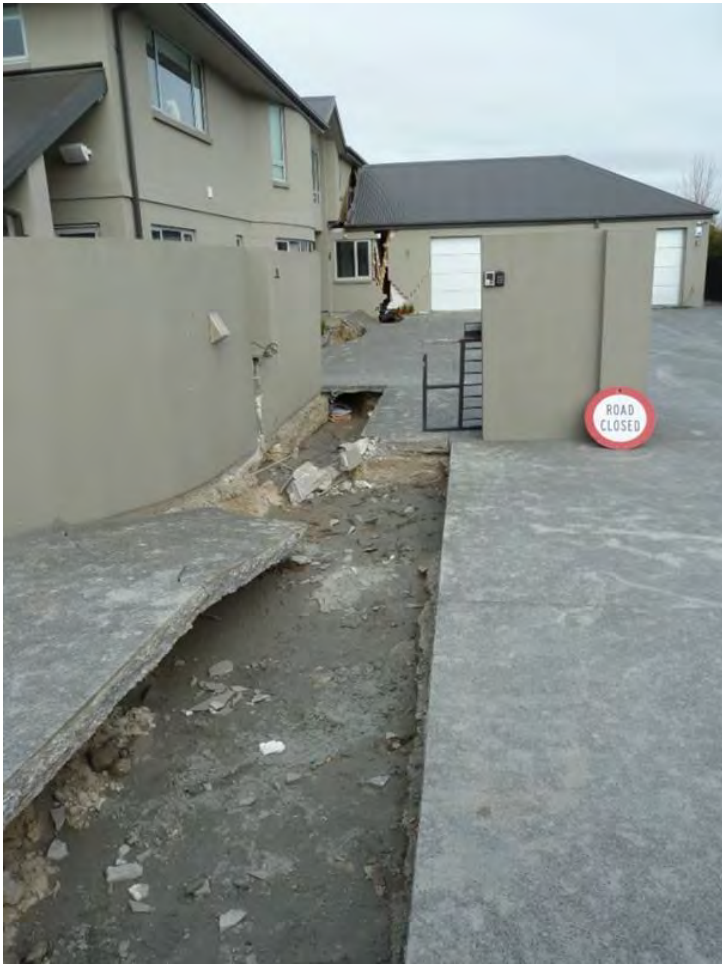
*Figure B4 - Photo showing lateral spreading effects at Courtenay Drive, Kaiapoi following the 2010 Darfield earthquake. The ground crack filled up with liquefied sand and resulted in a significant evacuation hazard following the event. The lateral spreading at this site was approximately 2m.*

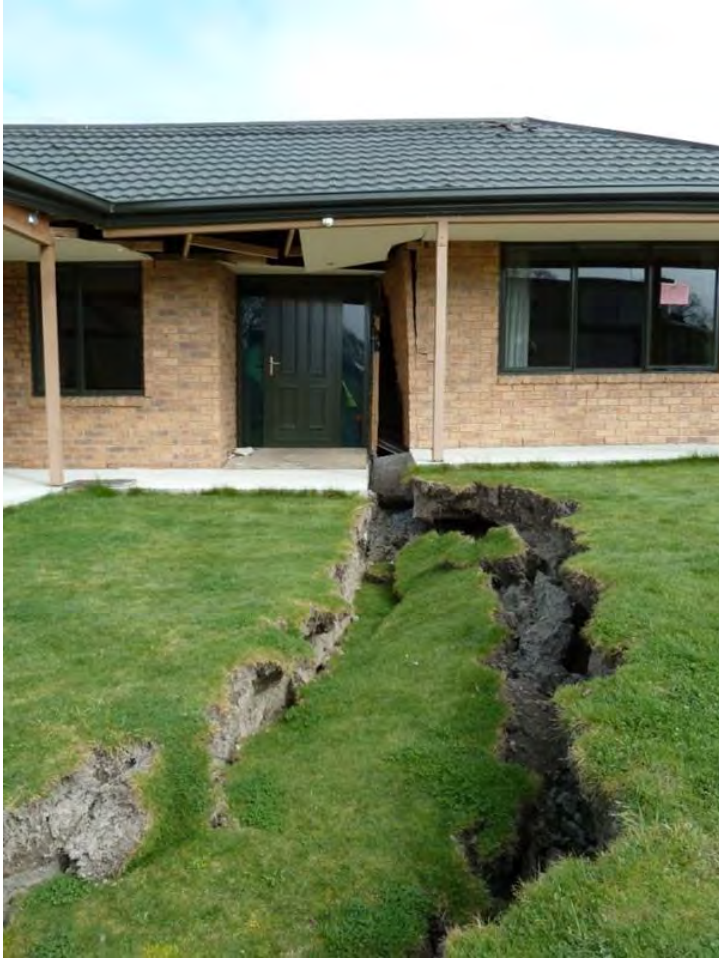
*Figure B5 - Photo showing lateral spreading effects at Courtenay Drive, Kaiapoi following the 2010 Darfield earthquake. The lateral spreading caused approximately 1m of horizontal stretch and also a 300mm vertical offset. The total lateral spreading at this site was approximately 2m.*

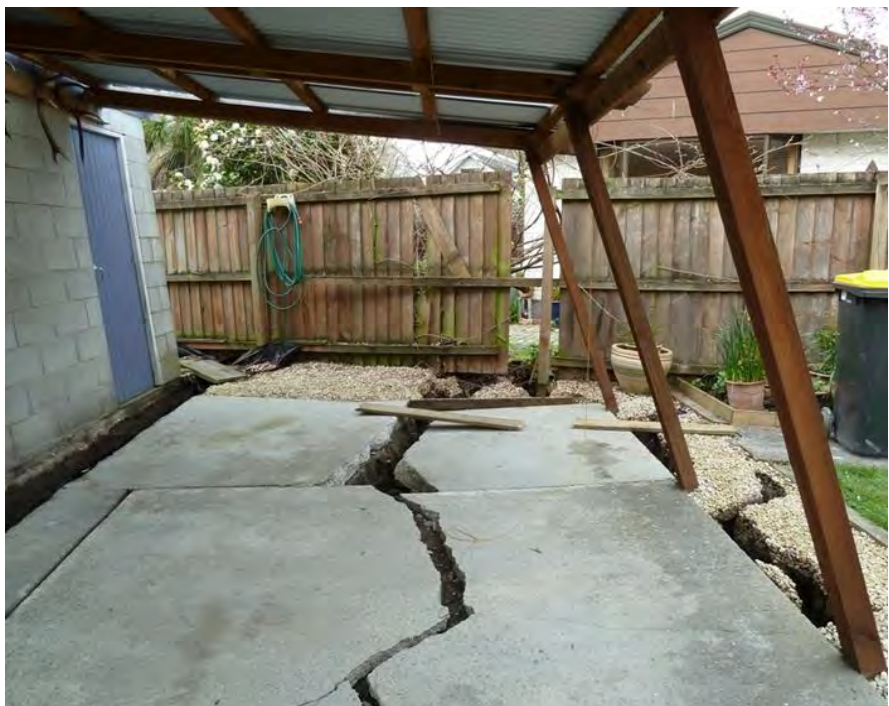
Figure B6 - Photo showing lateral spreading effects at Courtenay Drive, Kaiapoi following the 2010 Darfield earthquake. The total lateral spreading at this site was approximately 2m.

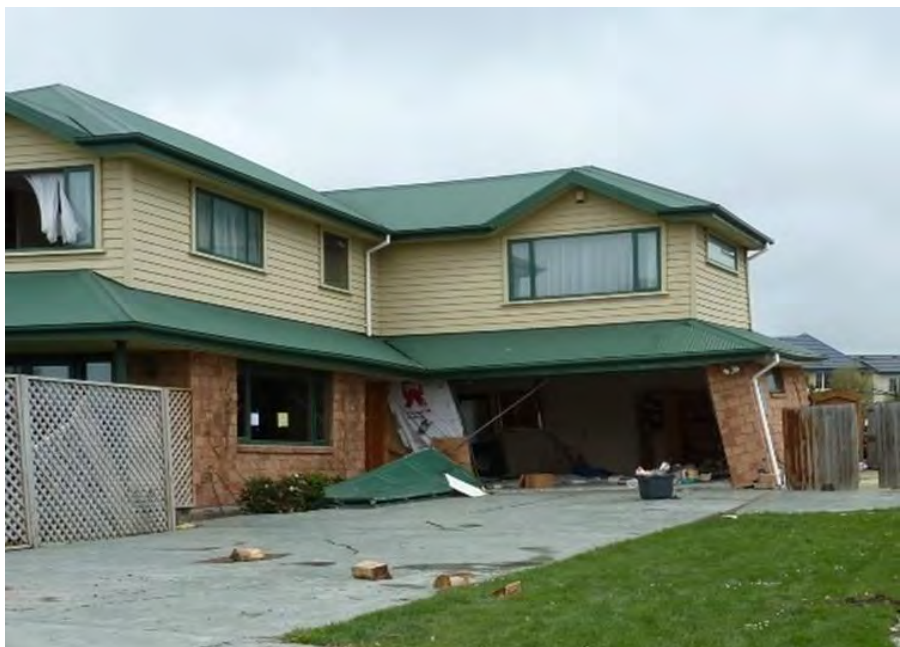
Figure B7 - Photo showing lateral spreading effects at Courtenay Drive, Kaiapoi following the 2010 Darfield earthquake. The total lateral spreading at this site was approximately 2m. If the lateral spreading at the site had been higher, this building would likely have collapsed.

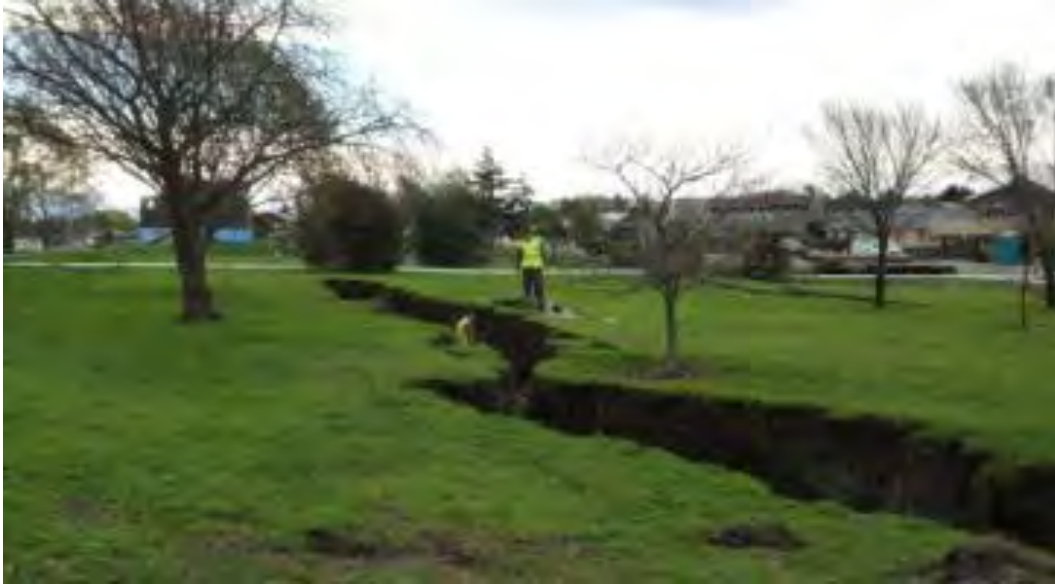
*Figure B8 - Photo showing lateral spreading at Charles Steet, Kaiapoi following the 2010 Darfield earthquake. The total lateral spreading at this site was approximately 1.5m. Vertical offsets in the order of 300mm can also be seen in the photo (approx. 20% of the horizontal movement).*

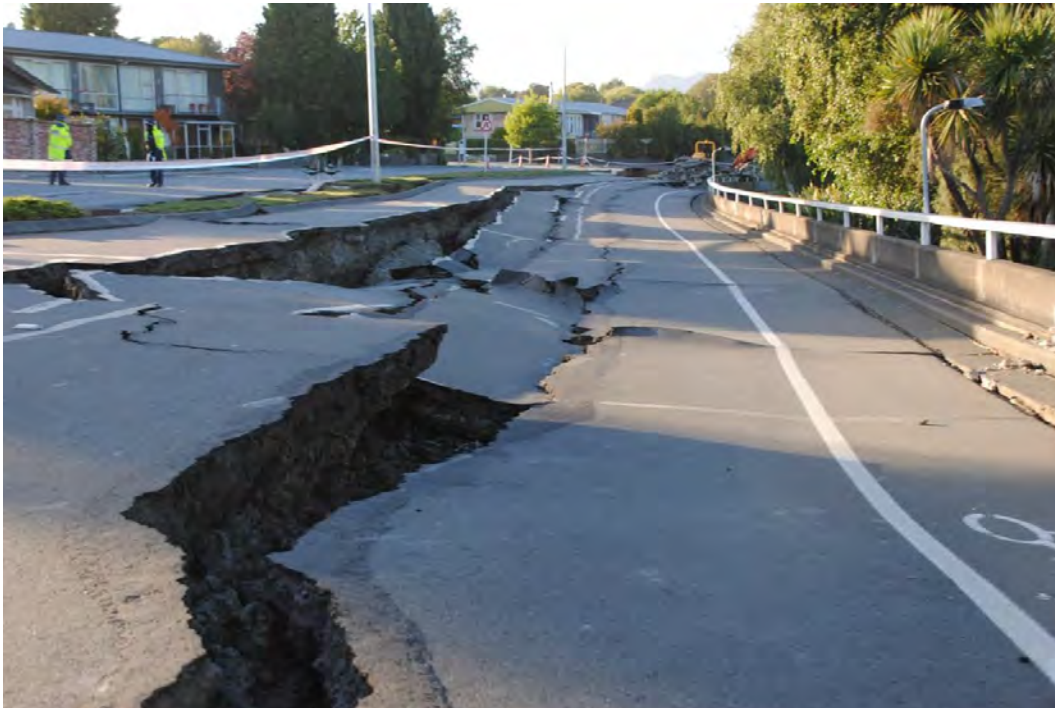
*Figure B9 - Photo showing lateral spreading at Fitzgerald Ave, Christchurch following the 2011 Christchurch earthquake. The total lateral spreading at this site was approximately 2m. Vertical offsets in the order of 500mm (approx. 50% of the horizontal movement).*

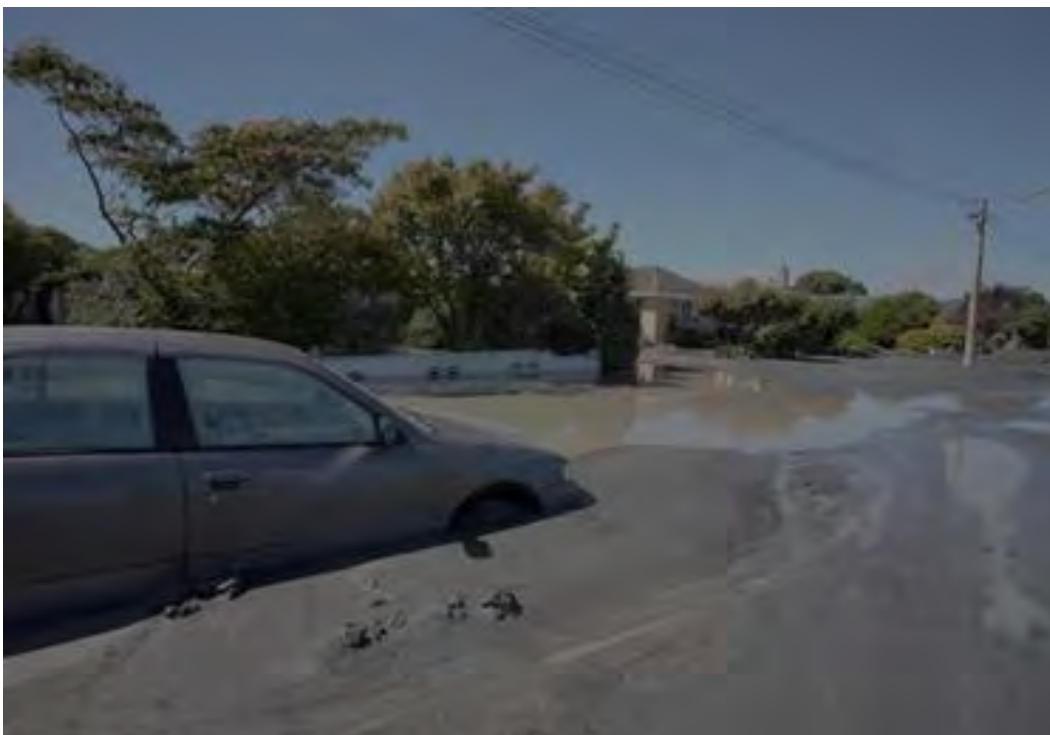
*Figure B10 - Photo showing liquefaction in Christchurch following the 2011 Christchurch earthquake. Approximately 400 to 500mm of liquefaction ejecta inundated the roads.*

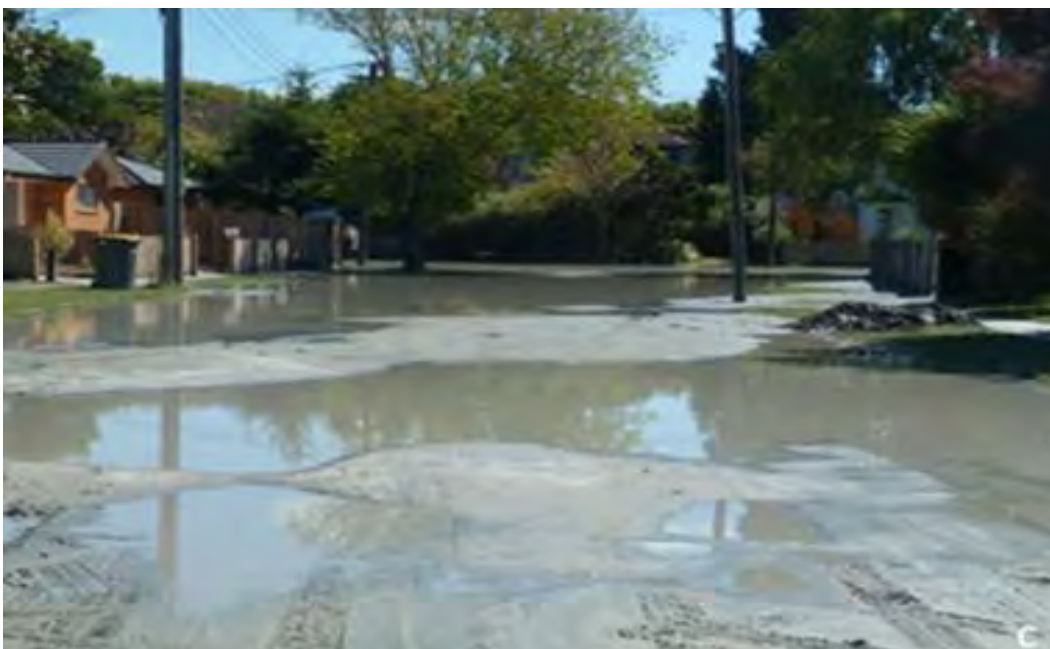
*Figure B11 - Photo showing liquefaction in Christchurch following the 2011 Christchurch earthquake. Approximately 200mm to 300mm of liquefaction ejecta inundated the roads.*

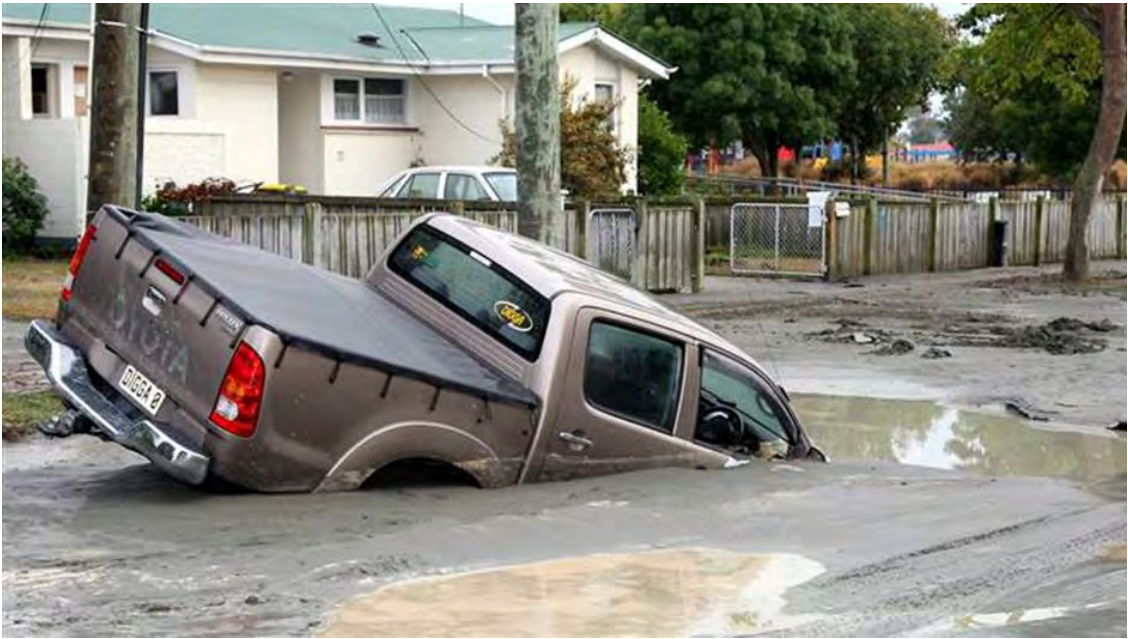
*Figure B12 - Photo showing liquefaction in Christchurch following the 2011 Christchurch earthquake. There were significant roadway stability issues causing significant evacuation hazards.*

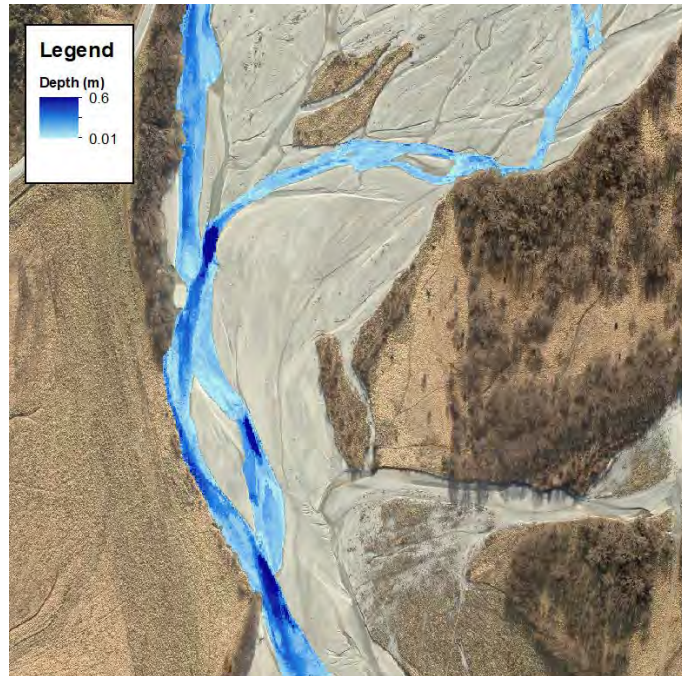
Figure 5-2 – Visualisation of DEM of Depth

In order to convert the DEM of depth into a DEM of bed elevation, a model of the water surface was generated by estimating the water level down the length of the channel from the LiDAR data. Once a satisfactory water surface was developed, the DEM of depth was subtracted from the water surface and therefore converting the data to bed elevation. Because the primary focus for this model build has been the Rees River, for now, no effort has been made to represent the bathymetry of the Dart River, however sensitivity tests on the Rees River have shown that the bathymetry makes little difference to the flood levels (~2cm). This is simply due to the significant size of the flow for the design events in relation to the channel capacity, i.e., most of the flood flows are conveyed outside the (braided) channels. More effort could be put into refining the DEM for the Dart River in the future if desired.

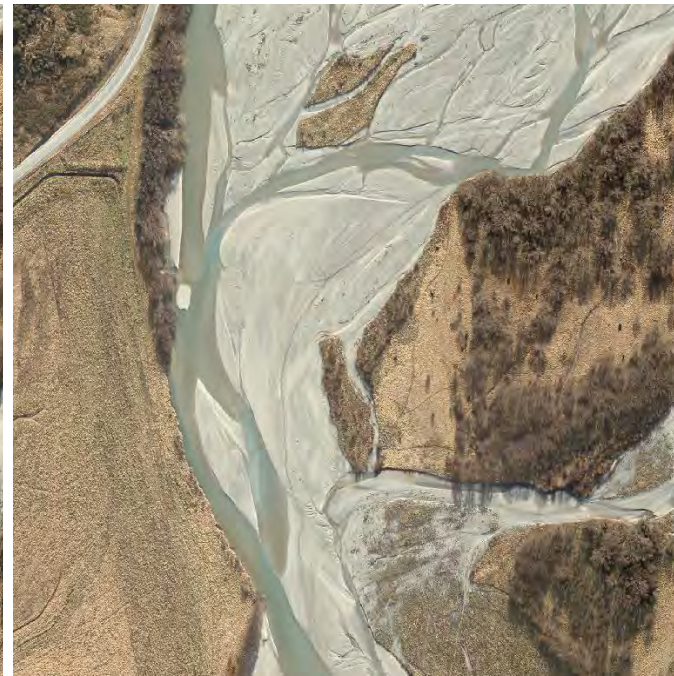
Figure 5-3 – Aerial Image used for generating DEM of Depth

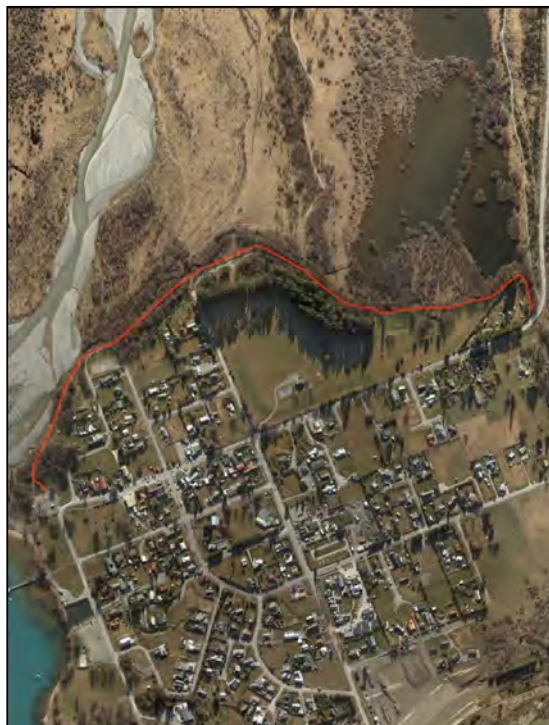
**Figure 5-7 – Location of Glenorchy stopbank**

In order to ensure that the crest level of the Glenorchy stopbank (Figure 5-7) is represented in the model, the stopbank crest has been removed from the 2D terrain and has been represented using a 1D DIKE feature based on actual ground survey. This ensures the precise crest level is represented in the model, and also allows for stopbank heights to be modified dynamically allowing for the simulation of a range of breach mechanisms.

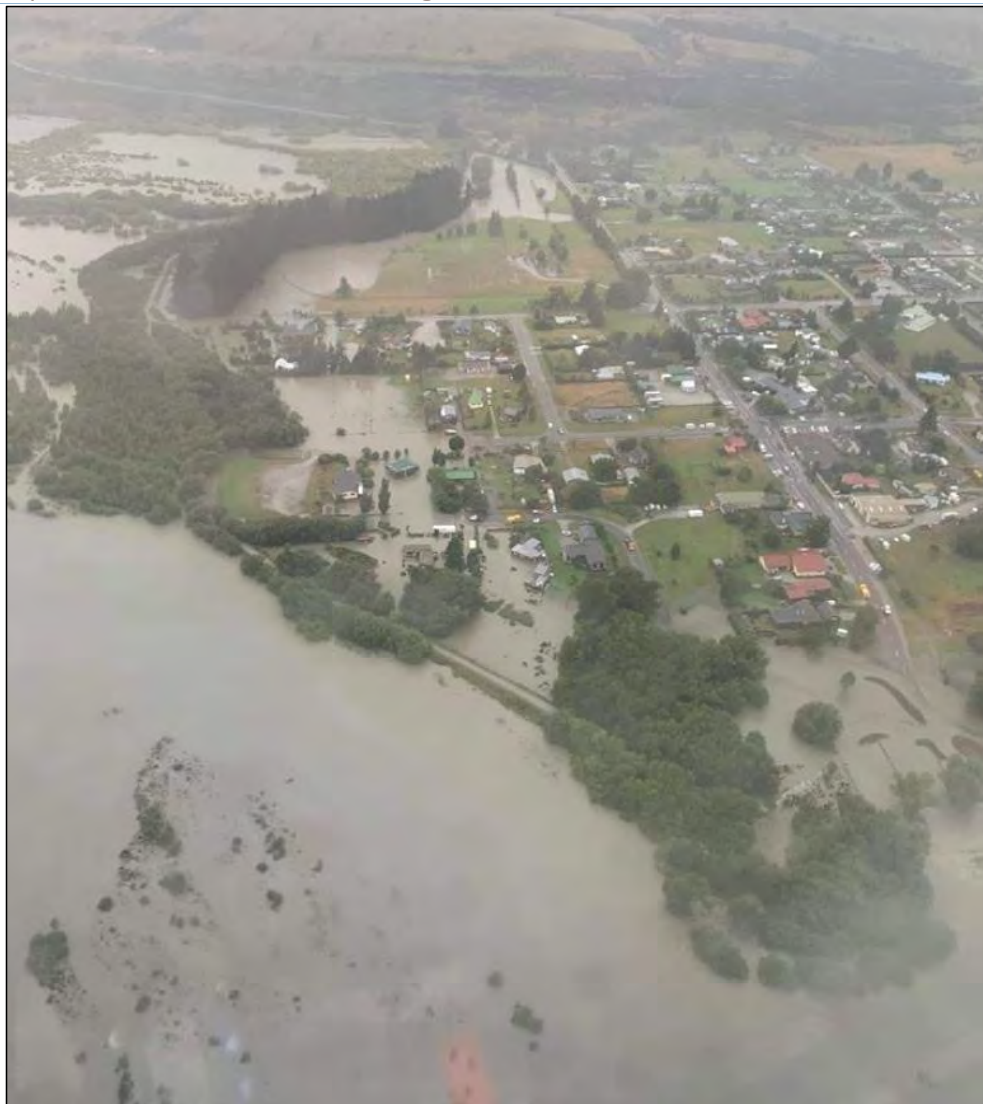
**Figure 6-1 - Aerial image taken about 6.30pm 4<sup>th</sup> February, taken prior to the maximum floodwater extent (photo from Luke Hunter, Donerite Contracting)**

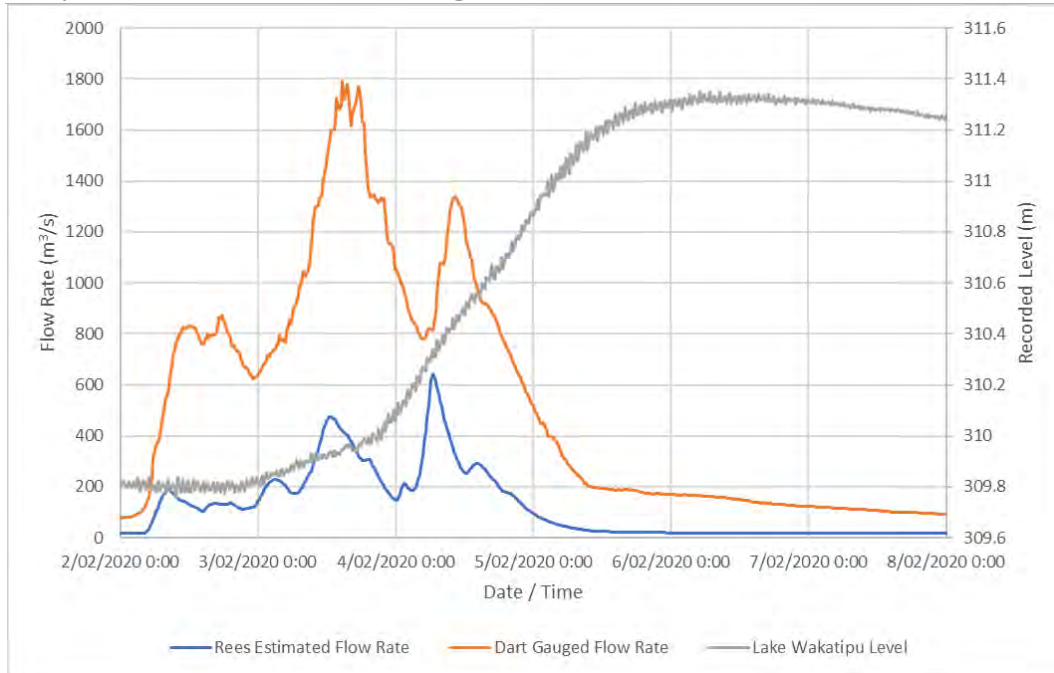
**Figure 6-3 – Modelled hydrographs and lake levels for the 3/4 February 2020 validation event**

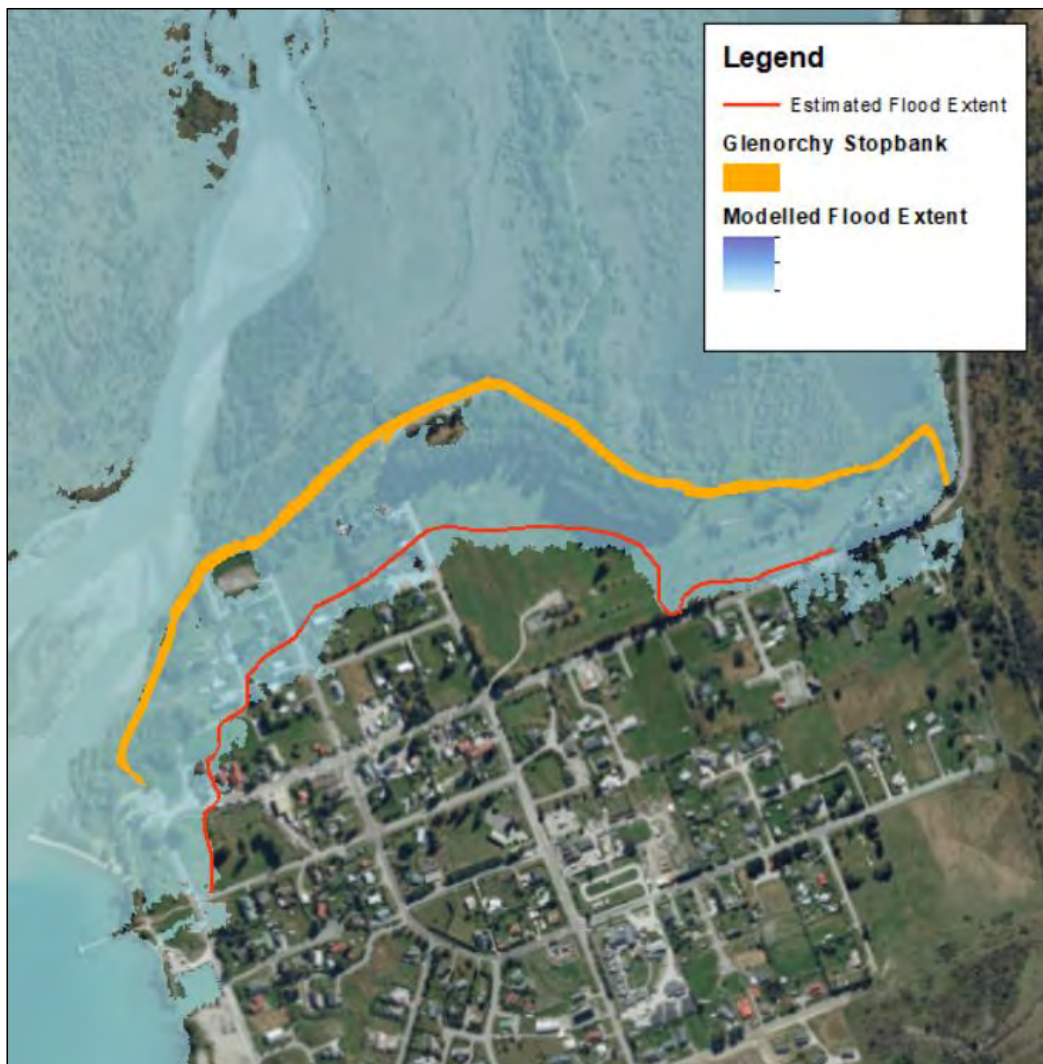
**Figure 6-4 – Comparison of modelled flood extent with estimated actual extent**
