# Data and Information Committee Agenda

### 5.1. Head of Lake Wakatipu flooding and liquefaction hazard investigations

# Glenorchy Liquefaction Vulnerability Assessment

**Rees / Dart Rivers: Flood Hazard Modelling**

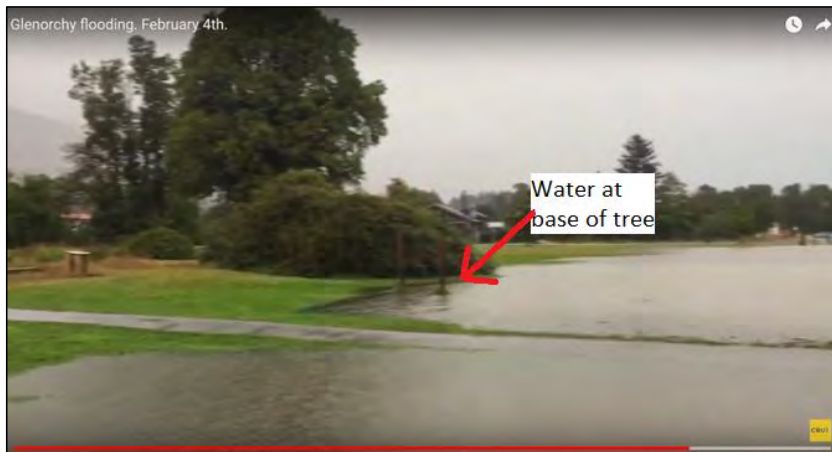
Figure 6-5 – Screenshot from video of flood extent

Close comparison of landmarks in online photography and video has also been used to confirm the extent of flooding. The following figures show the location of the floodwaters in relation to vegetation on waterfront properties in online video (<https://crux.org.nz/community/glenorchy-homes-evacuated-qtown-lake-level-critical>) compared to the modelled flood extent. It is understood that this video was taken close to the time of the peak.

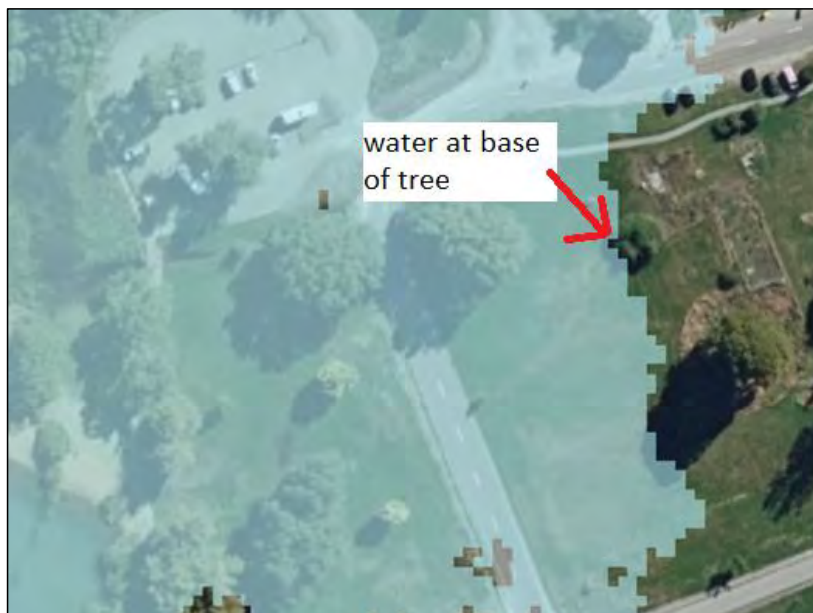
Figure 6-6 – Modelled flood extent in same location

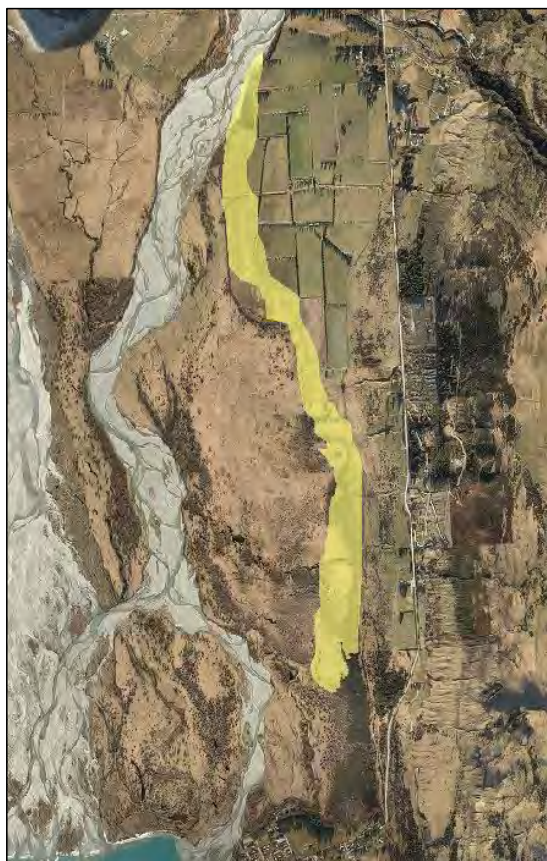
**Figure 7-1 – Modelled avulsion path**

path in the February 2020 event as evidenced by satellite imagery (see section 6.1) and discussion with local landowners. This avulsion channel has been simulated by further lowering the terrain by using a relationship between depth and velocity and assigning a maximum depth of 1m to the avulsion channel. This depth was decided upon based on the depth of the existing natural braids in the main river. This avulsion scenario has been designed in collaboration with Professor James Brasington and is considered to be a probable / credible location for a future avulsion. The modelled avulsion path is shown in yellow in Figure 7-1. To ensure sufficient flow goes down the avulsion path, a small weir was modelled across the river channel immediately downstream of the avulsion location. Whilst this is not a realistic physical process, this method was necessary to mimic the results of the likely physical behaviour of a gravel bed river system due to the significant mobilisation of the bed during a large flood event.

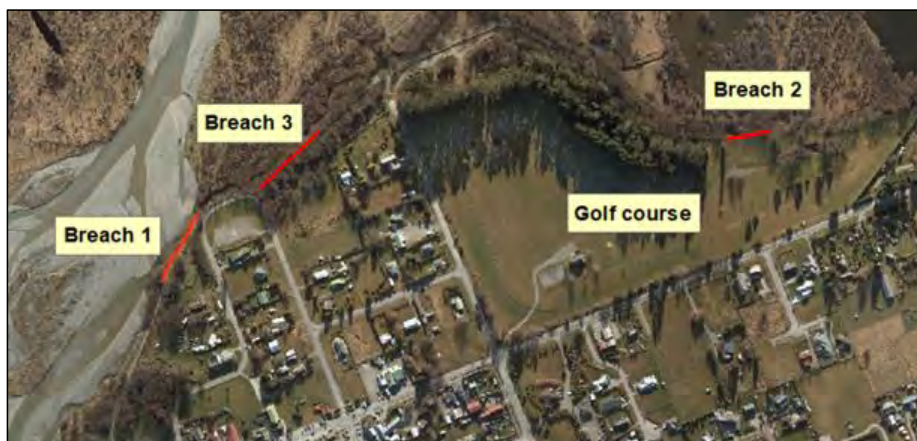
**Figure 7-2 – Modelled breach locations**

Two stopbank breach scenarios have been simulated in the model based on the parameters provided in the Tonkin and Taylor memo<sup>3</sup> and an additional third breach scenario has been identified and tested for sensitivity. The breach scenarios have been run using both the mid-range and worst-case breach parameters provided in the report. The location of the breach scenarios is shown below. Breaches 1 and 3 had a maximum breach width of 90m and were timed to breach prior to overtopping. Breach two had a maximum width of 50m and was timed to breach after several hours of overtopping. Full details on the dam break mechanism can be found in the Tonkin and Taylor report attached in Appendix D.

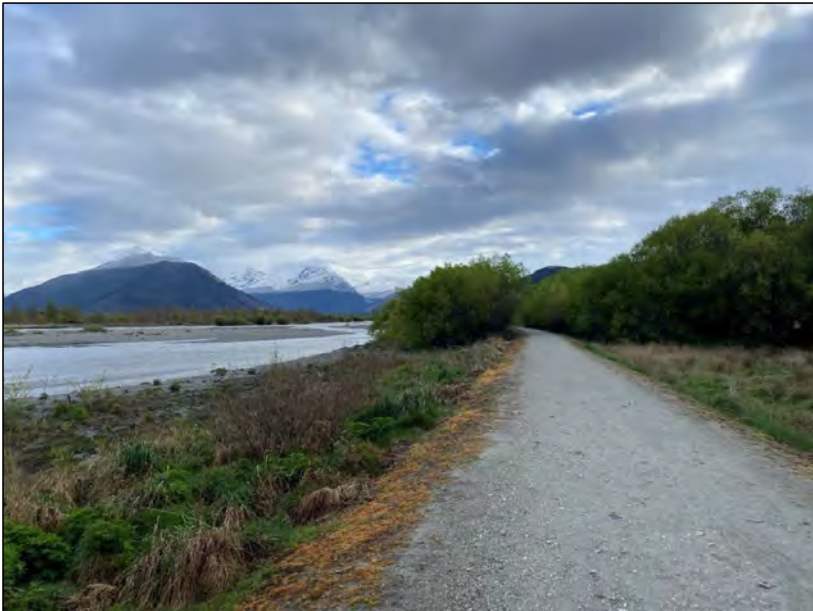
View of Glenorchy Stopbank with Rees River on left

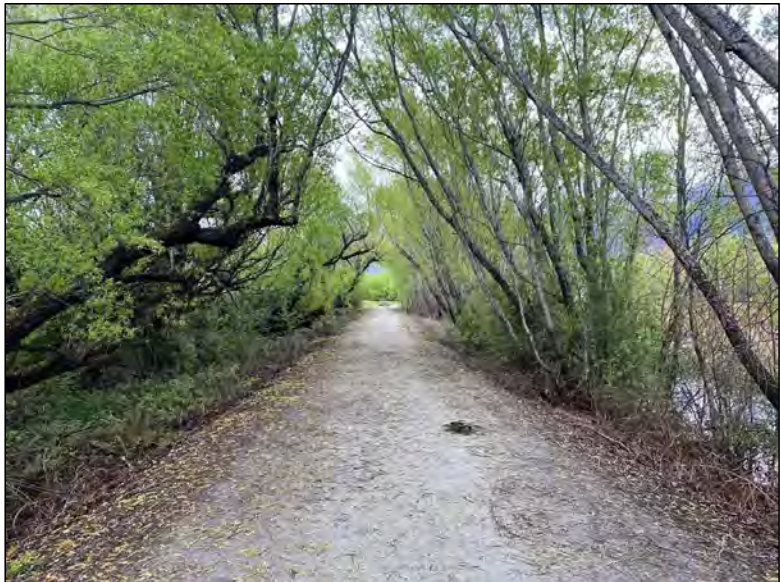
View of Glenorchy Stopbank with Lagoon Creek visible on the right through the willows

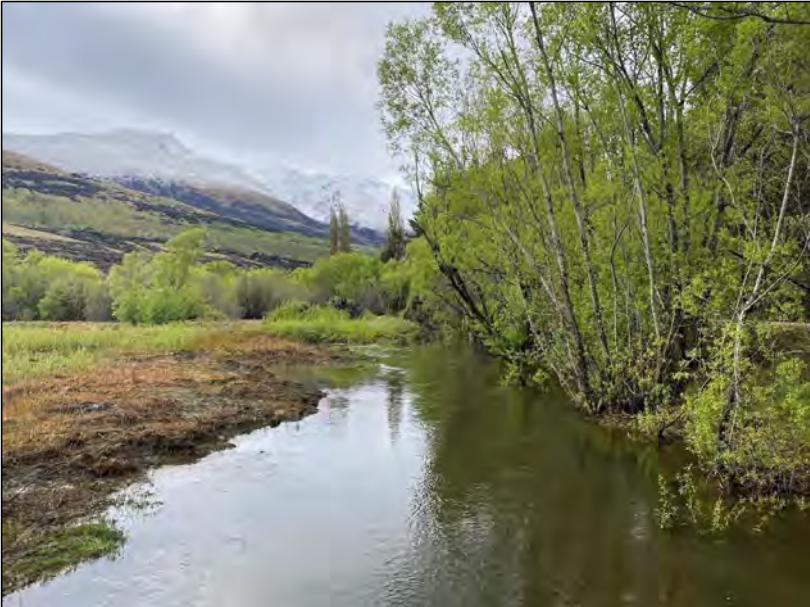
View of Lagoon Creek – Glenorchy stopbank is on the right behind the willows

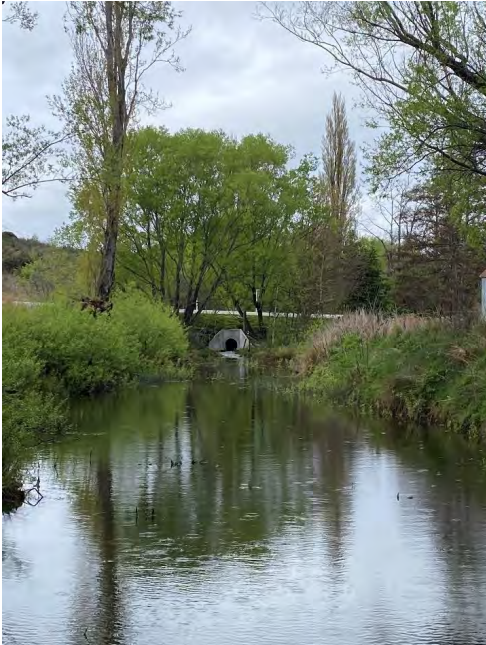
View of culvert under Glenorchy-Paradise Road

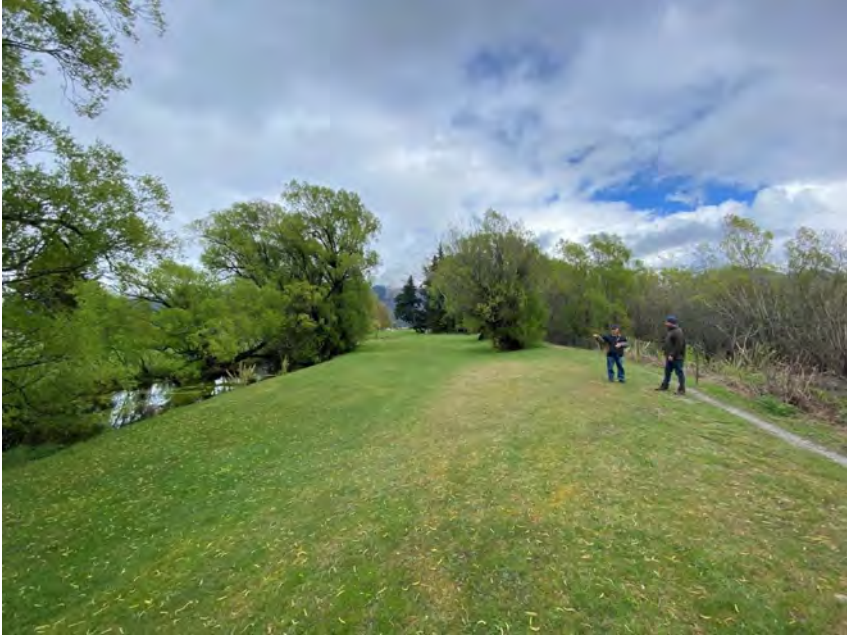
Photo of Glenorchy Stopbank adjacent to the Golf Course (overflow location)

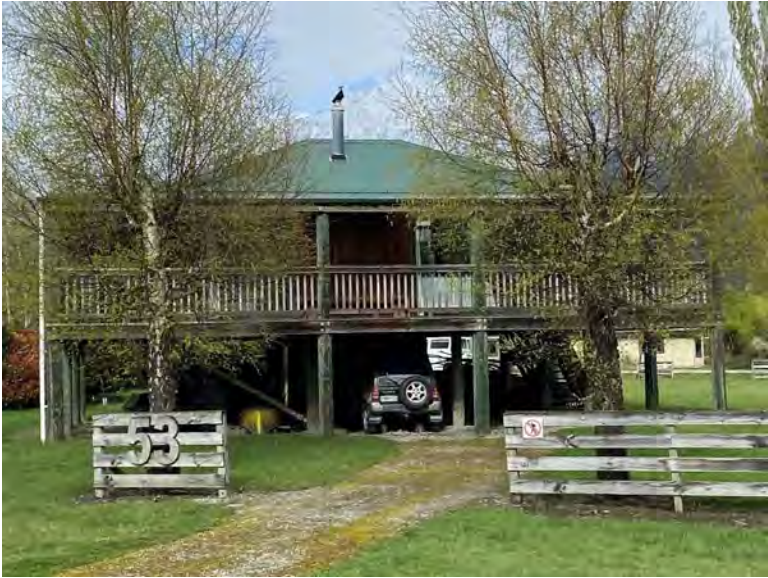
Example of house built on overflow path on stilts (section was significantly flooded in Feb 2021)

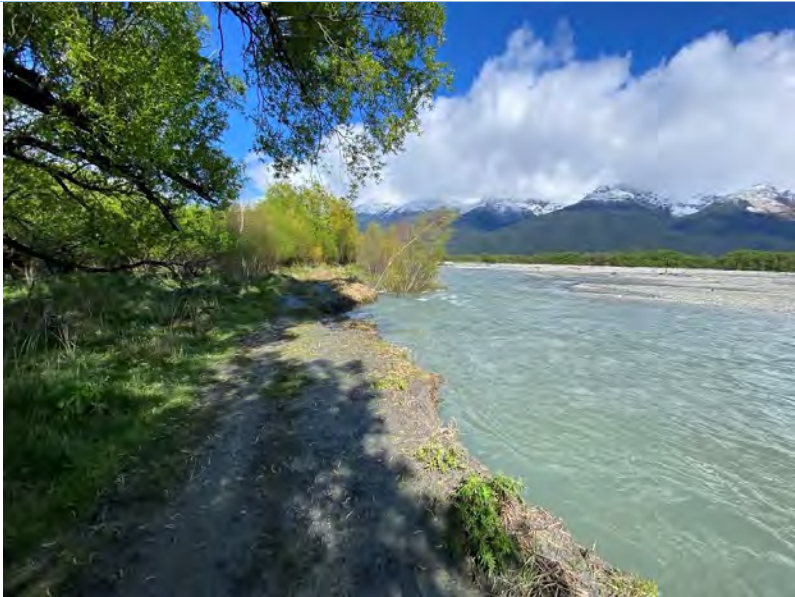
Photo of erosion on left bank of the Rees River (Rees Valley Station)

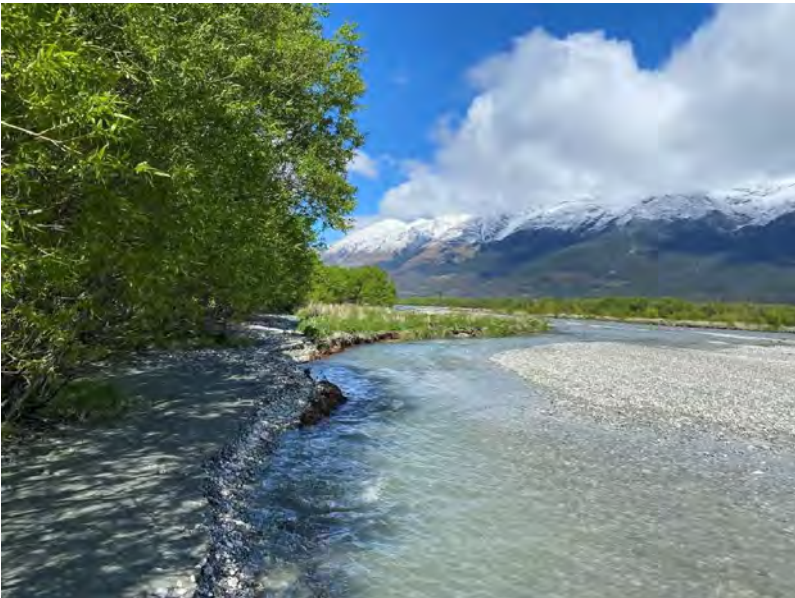
Photo of erosion on left bank of the Rees River (Rees Valley Station) – this photo also highlights the lack of available freeboard for the Rees River before it overflows onto the left bank

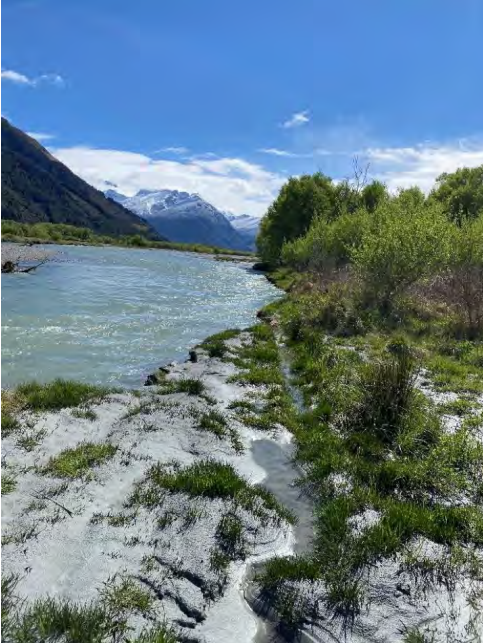
Photo of silt buildup due from Rees Rover overflows

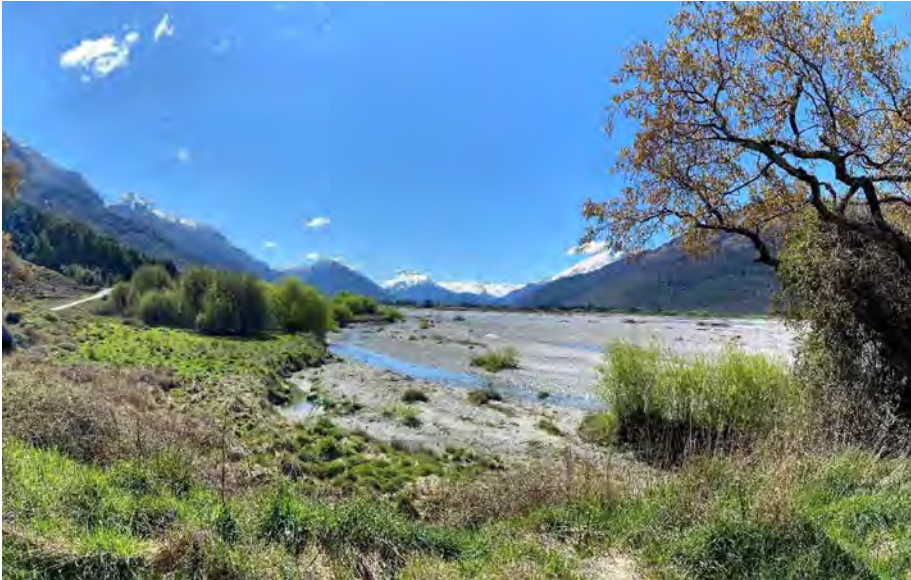
Photo looking upstream of the Dart River from Kinloch Rd (photo highlights erosion as well as vicinity to road)

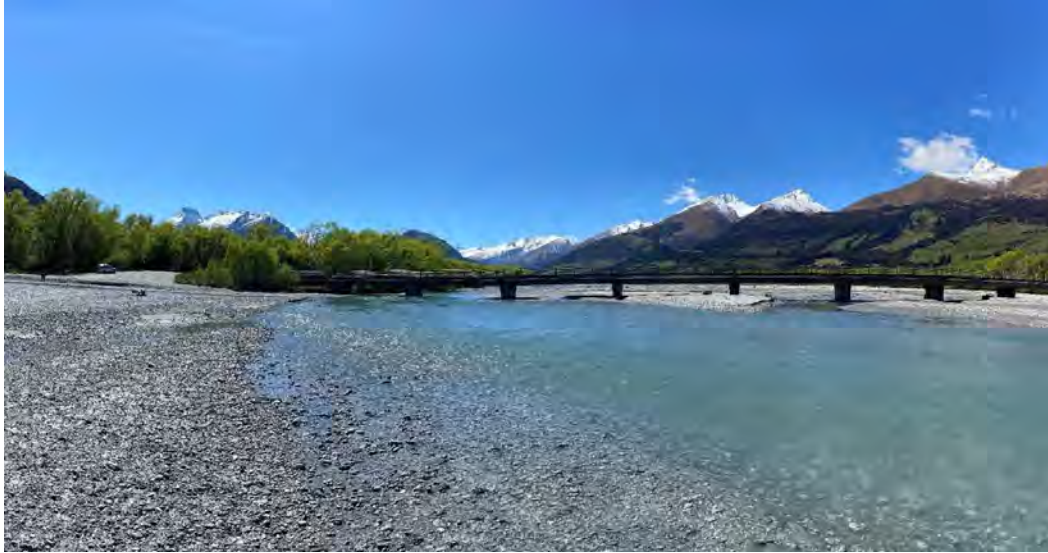
Photo of Rees River bridge, highlighting very limited capacity / freeboard available

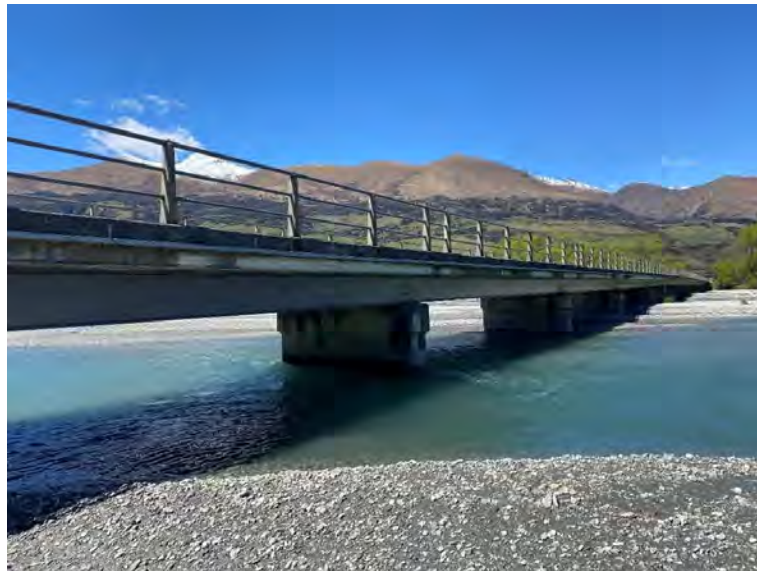
Close up photo of Rees River bridge further highlighting the limited capacity

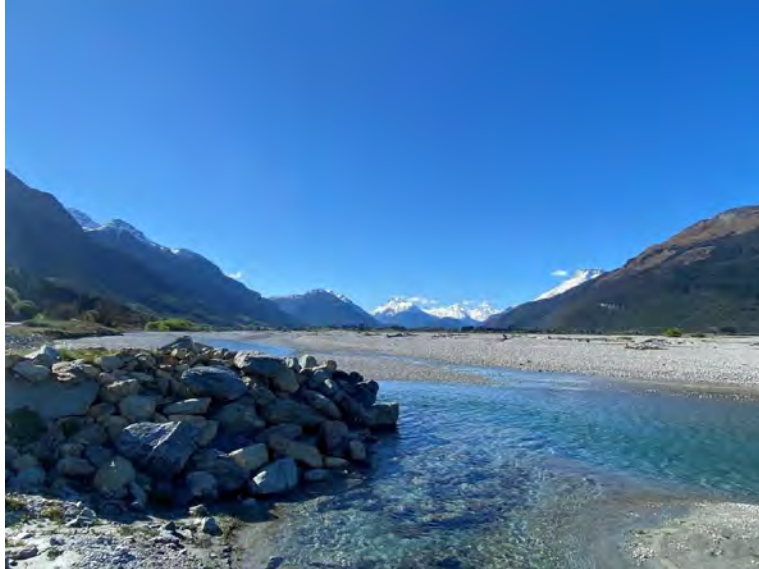
Example of a typical rock groyne constructed on the true right bank of the Dart River with significant scour on the downstream side of the groyne.

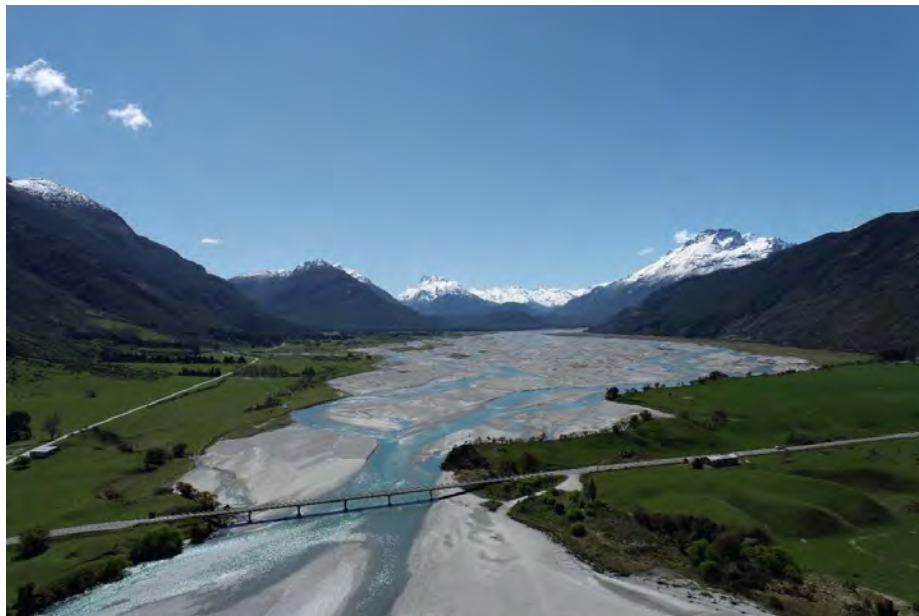
Drone photo of the Dart River bridge (upstream extent of the model)

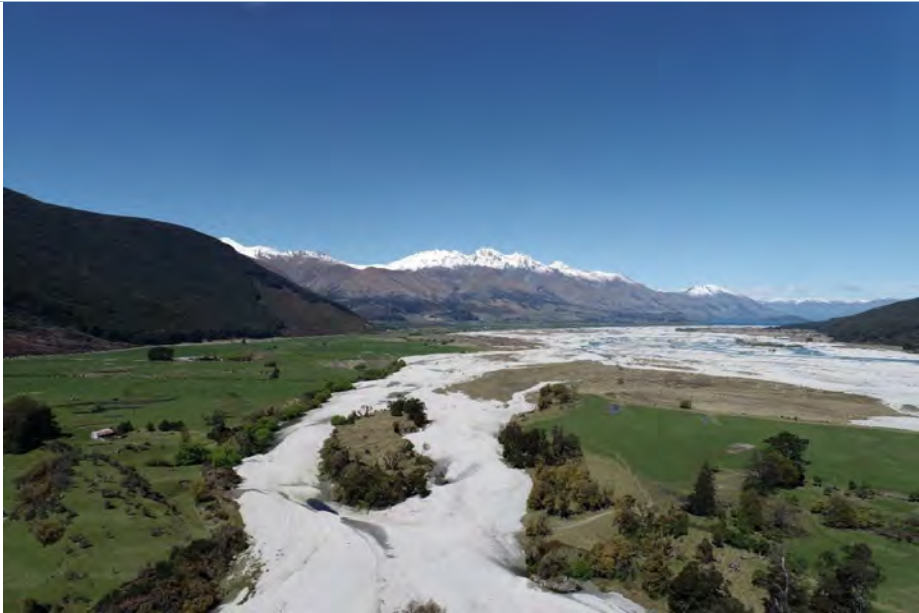
Drone image looking downstream from the Dart River bridge showing the potential overflow paths on the true left bank with the Glenorchy-Routebourn Rd visible at the base of the hill.

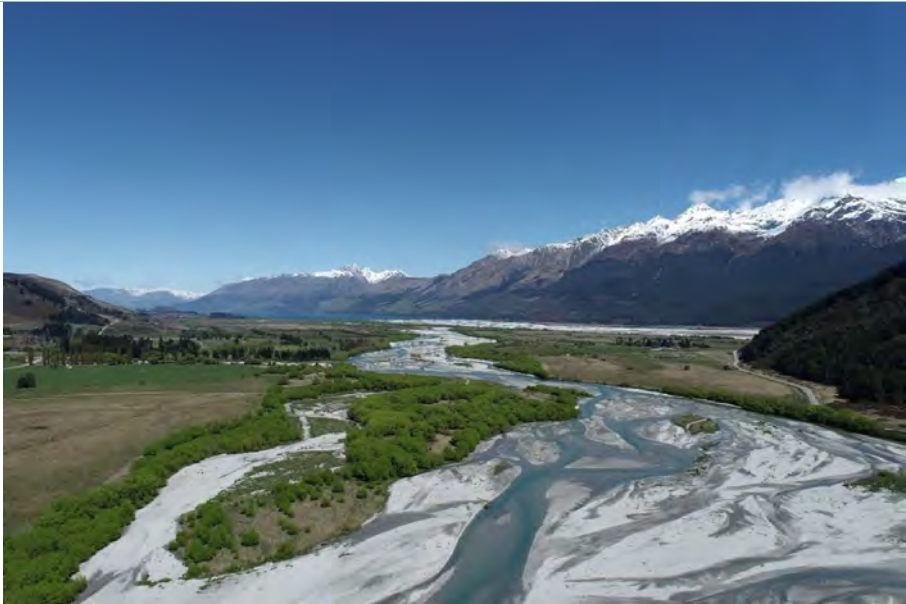
Drone image looking downstream from the Rees River bridge showing the potential overflow paths on the true left bank

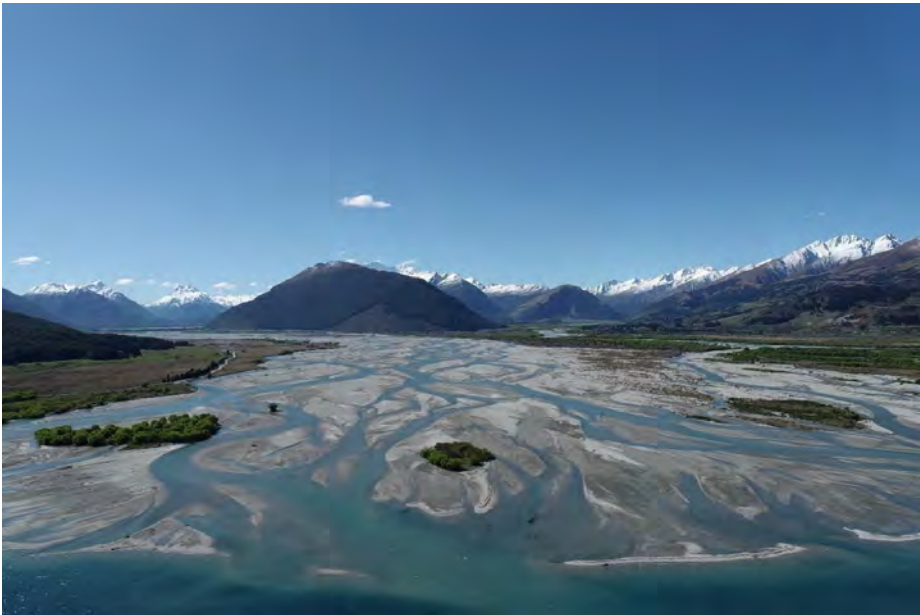
Drone image of the significant delta at the mouth of the Dart River with the confluence of the upper branch of the Rees River visible at the right of the image

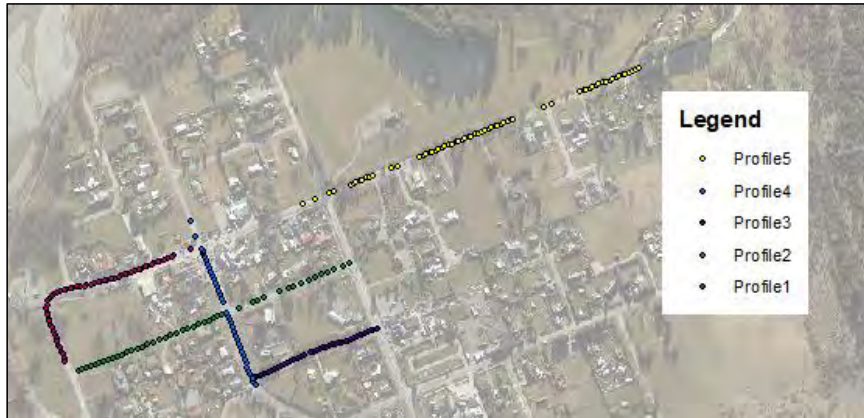
Figure 2 – Profile Locations

Five long section profiles have been plotted in order to visualise the difference between the LiDAR DEM and the survey data as per the location shown in Figure 2.

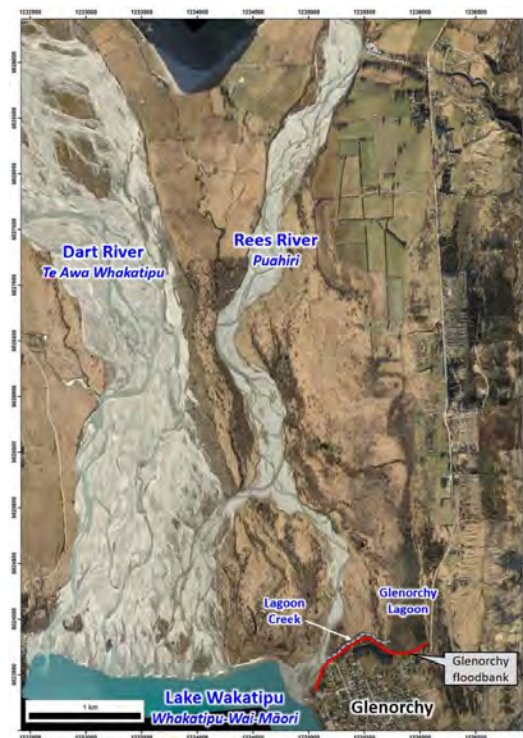
Figure 1 Site location plan (provided by ORC).

This memo overviews a qualitative rainy day/flood event failure mode assessment of the Rees-Glenorchy Floodbank. The Rees-Glenorchy Floodbank extends approximately 1,400 m from the Glenorchy-Paradise Road to the Glenorchy Scenic Walkway carpark adjacent to the Rees River mouth at Lake Wakatipu. Figure 1 provided by Otago Regional Council (ORC) illustrates the location and alignment of the Rees-Glenorchy Floodbank as well as the general arrangement of the site area including Glenorchy (bottom right), the Rees River, Glenorchy Lagoon (north of Glenorchy village and east of Lagoon Creek) and Lagoon Creek.

- Changes in Rees River morphology such as:
  - Long term aggradation of the Rees Riverbed.
  - Changes to Rees River braids such as alignment and channel size in the vicinity of the Rees-Glenorchy Floodbank.
- Changes to the channel capacity of Lagoon Creek. It was noted that at the time of the site appraisal that willows had been cleared to improve channel capacity.
- The amount of flow from the Rees River entering the Dart River upstream of the Glenorchy Lagoon area and thereby avoiding the Rees-Glenorchy Floodbank area (refer Figure 1).

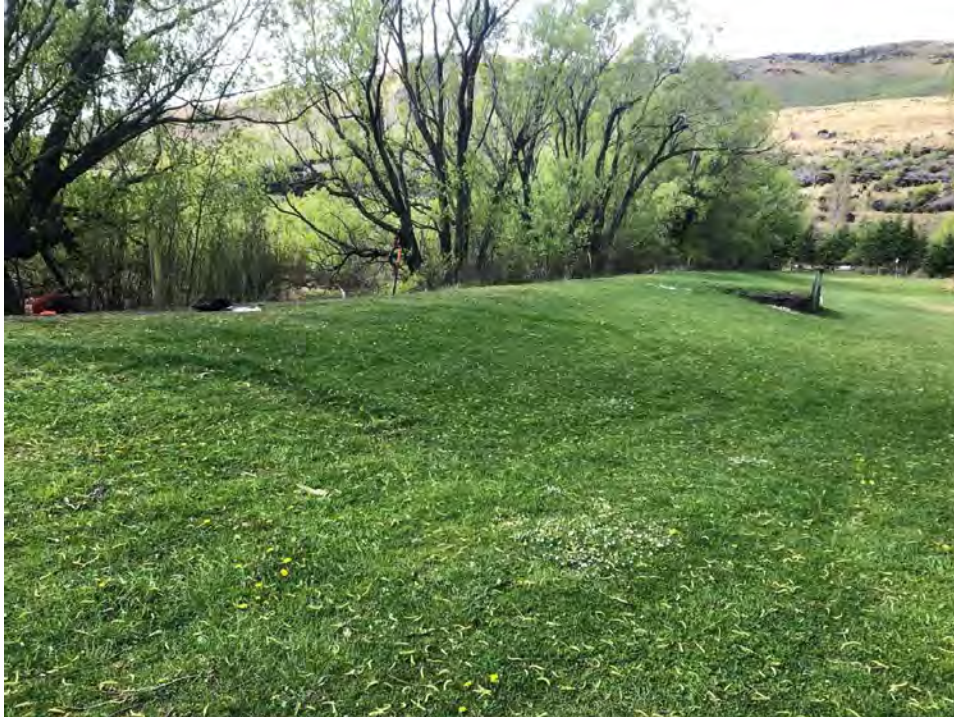
*Figure 2 Golf course adjacent to the Rees-Glenorchy Floodbank where sheet flow overtopping has been reported.*

Based on discussions with ORC<sup>2</sup> we understand during recent floods of significance (e.g. February 2020), that flood levels can rise in the Glenorchy Lagoon area to exceed the adjacent Rees-Glenorchy Floodbank crest level. When this has occurred, ORC have indicated that the Rees-Glenorchy Floodbank first overtops in the vicinity of where the golf course directly adjoins the Rees-Glenorchy Floodbank. We understand that during the February 2020 event the Rees-Glenorchy Floodbank first overtopped at isolated locations and as the upstream water level increased, shallow sheet flow subsequently occurred over most of the Rees-Glenorchy Floodbank adjacent to the golf course. The length of the golf course adjacent to the land side of the Rees-Glenorchy Floodbank is of approximately 230 m. Figure 2 following illustrates the location.

The Rees-Glenorchy Floodbank crest width at the area of interest in the vicinity of the golf course was typically over 2 m wide before transitioning to a flat land side slope. Land side slope angles were estimated to be in the order of 5° and 10° (noting the 5° estimate corresponds to a potential flow path oblique to the slope). The Rees-Glenorchy Floodbank is likely to behave as a broad crested weir during shallow overtopping flows. The crest and land side slopes were well grassed, indicating that the Rees-Glenorchy Floodbank can withstand shallow low velocity overtopping flows for an appreciable period if flow is not able to concentrate at irregularities (albeit the grass observed in the golf course environment was shorter than would provide optimum erosion protection). Based on ORC advice, we understand that no significant damage was reported during the recent floods when shallow overtopping depths were sustained for at least 10 hours and no significant debris accumulation was reported<sup>3</sup>. However, more adverse flood conditions may result in greater overtopping beyond what the existing flood bank can withstand.

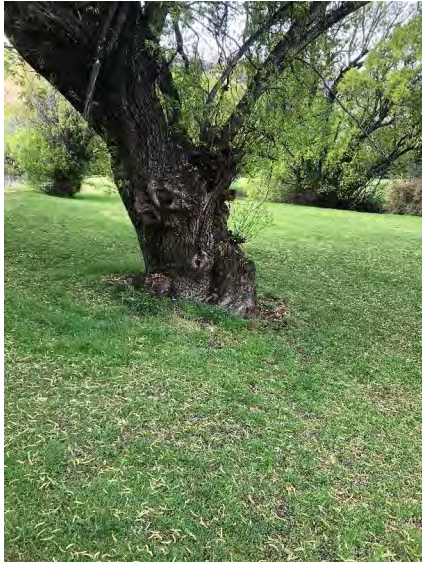
Typically, on embankments that have been overtopped by floods in excess of erosion thresholds, severe erosion has often been observed to begin where sheet flow on the slope meets and/or is concentrated/disrupted by an obstacle/irregularity. For example trees and/or other irregularities in the vicinity of the Rees-Glenorchy Floodbank land side as shown at Figures 2 and 3.

*Figure 3 Large willow trees at Rees-Glenorchy Floodbank downstream face.*

- Tree roots may cause piping. A number of large willow trees were observed adjacent to the embankment. In several instances it appeared that the fill had been placed around large trees (e.g. Figure 3). One way tree roots can lead to piping is the formation of preferential seepage paths as roots decay following tree removal.

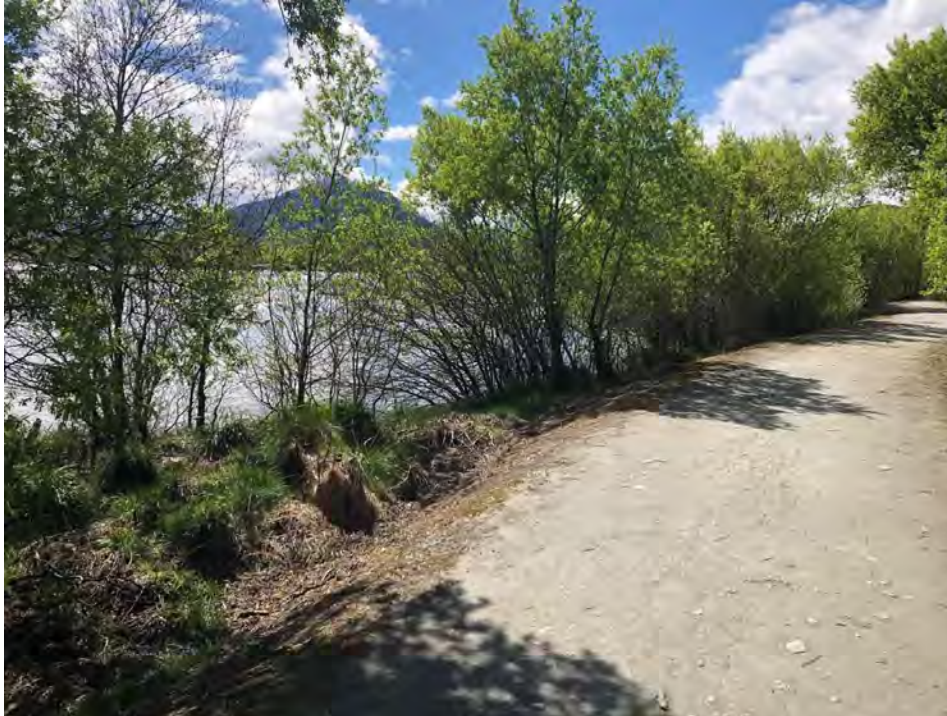
*Figure 4 Rees-Glenorchy Floodbank adjacent to the Rees River confluence with Lagoon Stream. The Rees River is directed towards the Rees-Glenorchy Floodbank, increasing the likelihood of scour damage.*

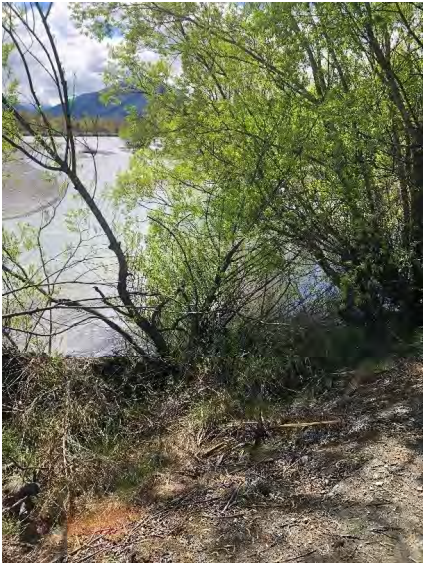
Based on walkover visual assessment it is our opinion that the more likely location for scour damage is in the vicinity of the Rees River confluence with Lagoon Stream. There is a bend in the Rees River at this location, with the Rees River flow directed towards the Rees-Glenorchy Floodbank at an oblique angle as illustrated at Figures 4 and 5.

*Figure 5 Rees River directed towards the Rees-Glenorchy Floodbank.*

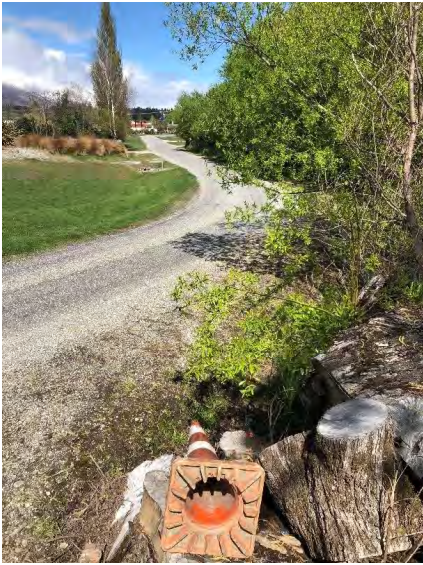
*Figure 6 Butement Street on the land side of the Rees-Glenorchy Floodbank at the location assessed as vulnerable to damage instigated by scour.*

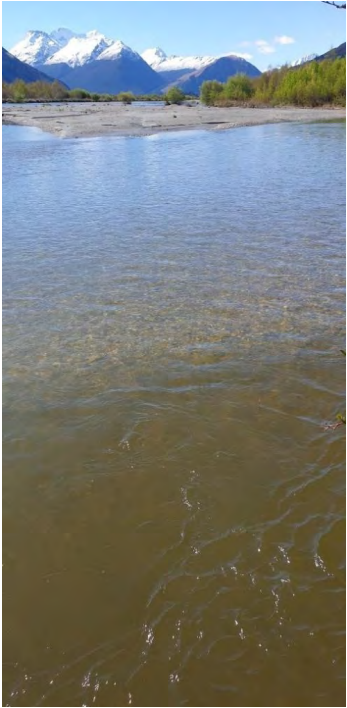
*Figure 7 Deeper Lagoon Creek water and bank prone to scour near confluence with Rees River.*

A deepened section of Lagoon Creek in close proximity to the Rees River was also observed (Figure 7). The area of interest included an over steepened bank that was close to the riverside toe of the embankment and presents a location of enhanced scour risk to the Rees-Glenorchy Flood bank.

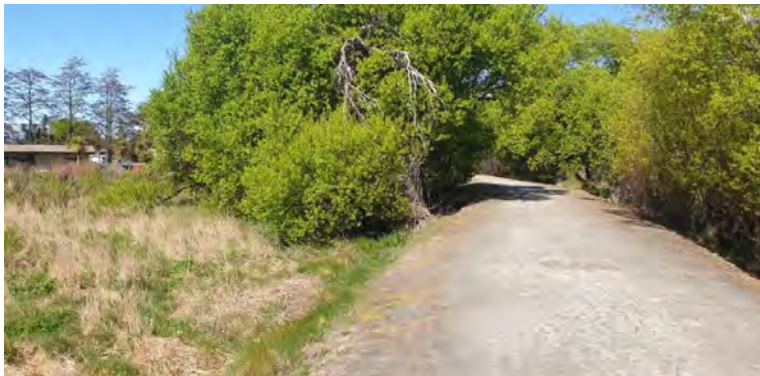
Figure 9 Embankment at location inferred by WSP to be an area of interest for possible piping.

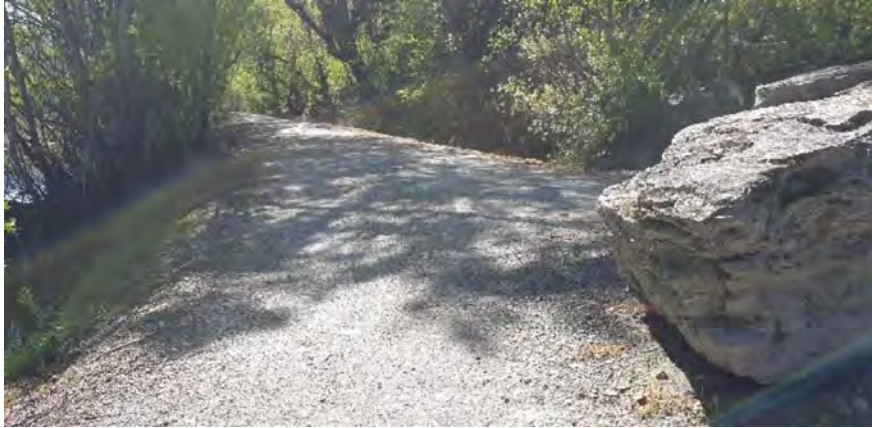
- From seepage and poor detailing at conduits/culverts under the embankment. Multiple culverts under the embankment were observed. Possible evidence associated with adverse seepage at one culvert was observed (Figure 10). It is appropriate that culvert crossings under the Rees-Glenorchy Floodbank are inspected on an ongoing basis as part of routine operation and maintenance procedures with appropriate action taken if adverse behaviour is confirmed.

*Figure 10 Embankment at location where culvert crosses under embankment. Potential area of interest for piping.*
