Dart / Rees Rivers

Flood Hazard Modelling

Client: Otago Regional Council

Land River Sea Consulting Limited

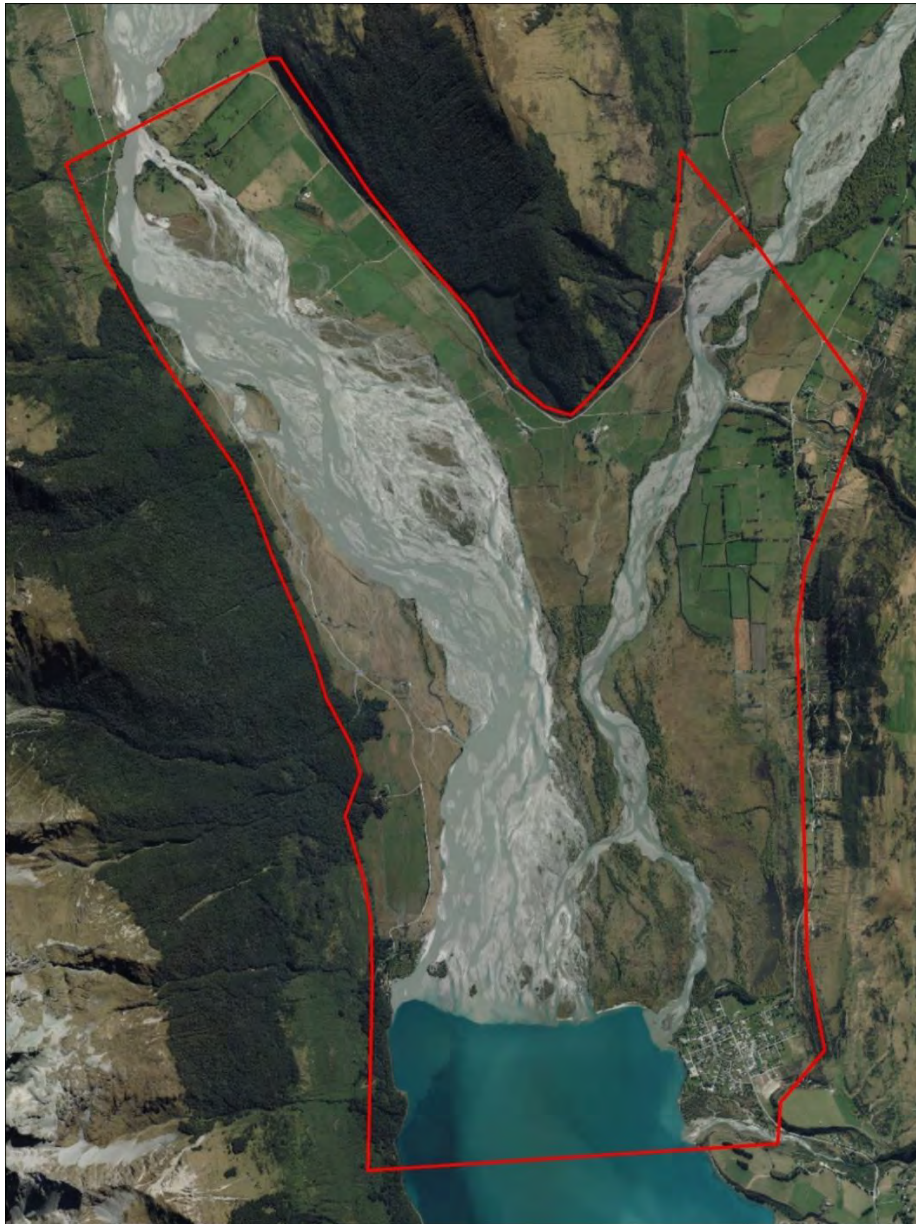
Figure 1-1 – Area of Interest

The area of interest for this project is presented in Figure 1-1 below.

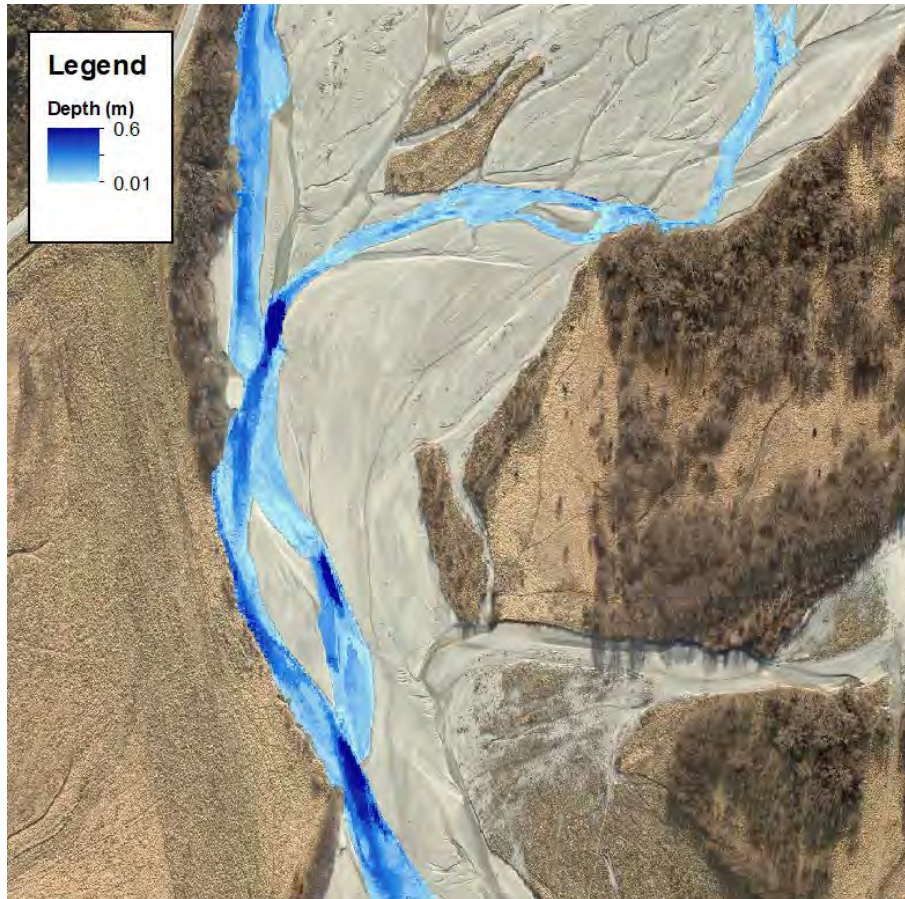
It is apparent from the coloured visualisation that the DEM of depth shows a realistic and nature depth profile when compared with the aerial imagery.

Figure 5-2 - Visualisation of DEM of Depth

Whilst there is limited data available to enable the creation of a detailed bathymetry DEM, we consider that this technique will produce more terrain model than any other method available to us. A visualisation of the DEM of depth is presented on the following page (Figure 5-2, Figure 5-3).

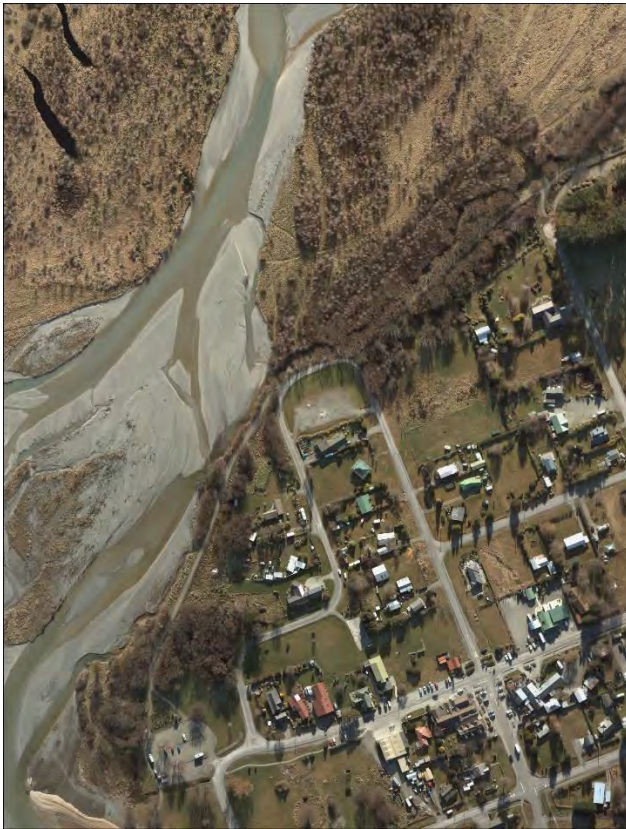
Figure 5-5 – Aerial imagery

Road centrelines were manually drawn due to discrepancies between the online datasets and the aerial imagery, and a buffer polygon was created around the road centreline since the available GIS datasets did not have sufficient accuracy. An example of the Manning's delineation is shown (Figure 5-5, Figure 5-6).

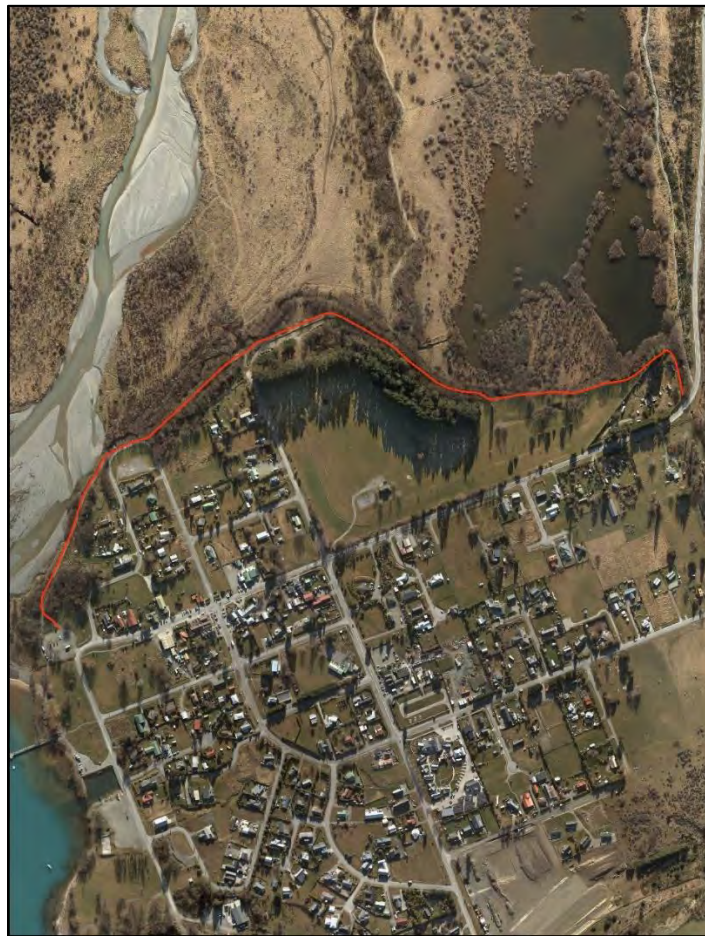
Figure 5-7 - Location of Glenorchy stopbank

In order to ensure that the crest level of the Glenorchy stopbank (Figure 5-7) is represented in the model, the stopbank crest has been removed from the 2D terrain and has been represented using a 1D DIKE feature based on actual ground survey. This ensures the precise crest level is represented in the model, and also allows for stopbank heights to be modified dynamically allowing for the simulation of a range of breach mechanisms.

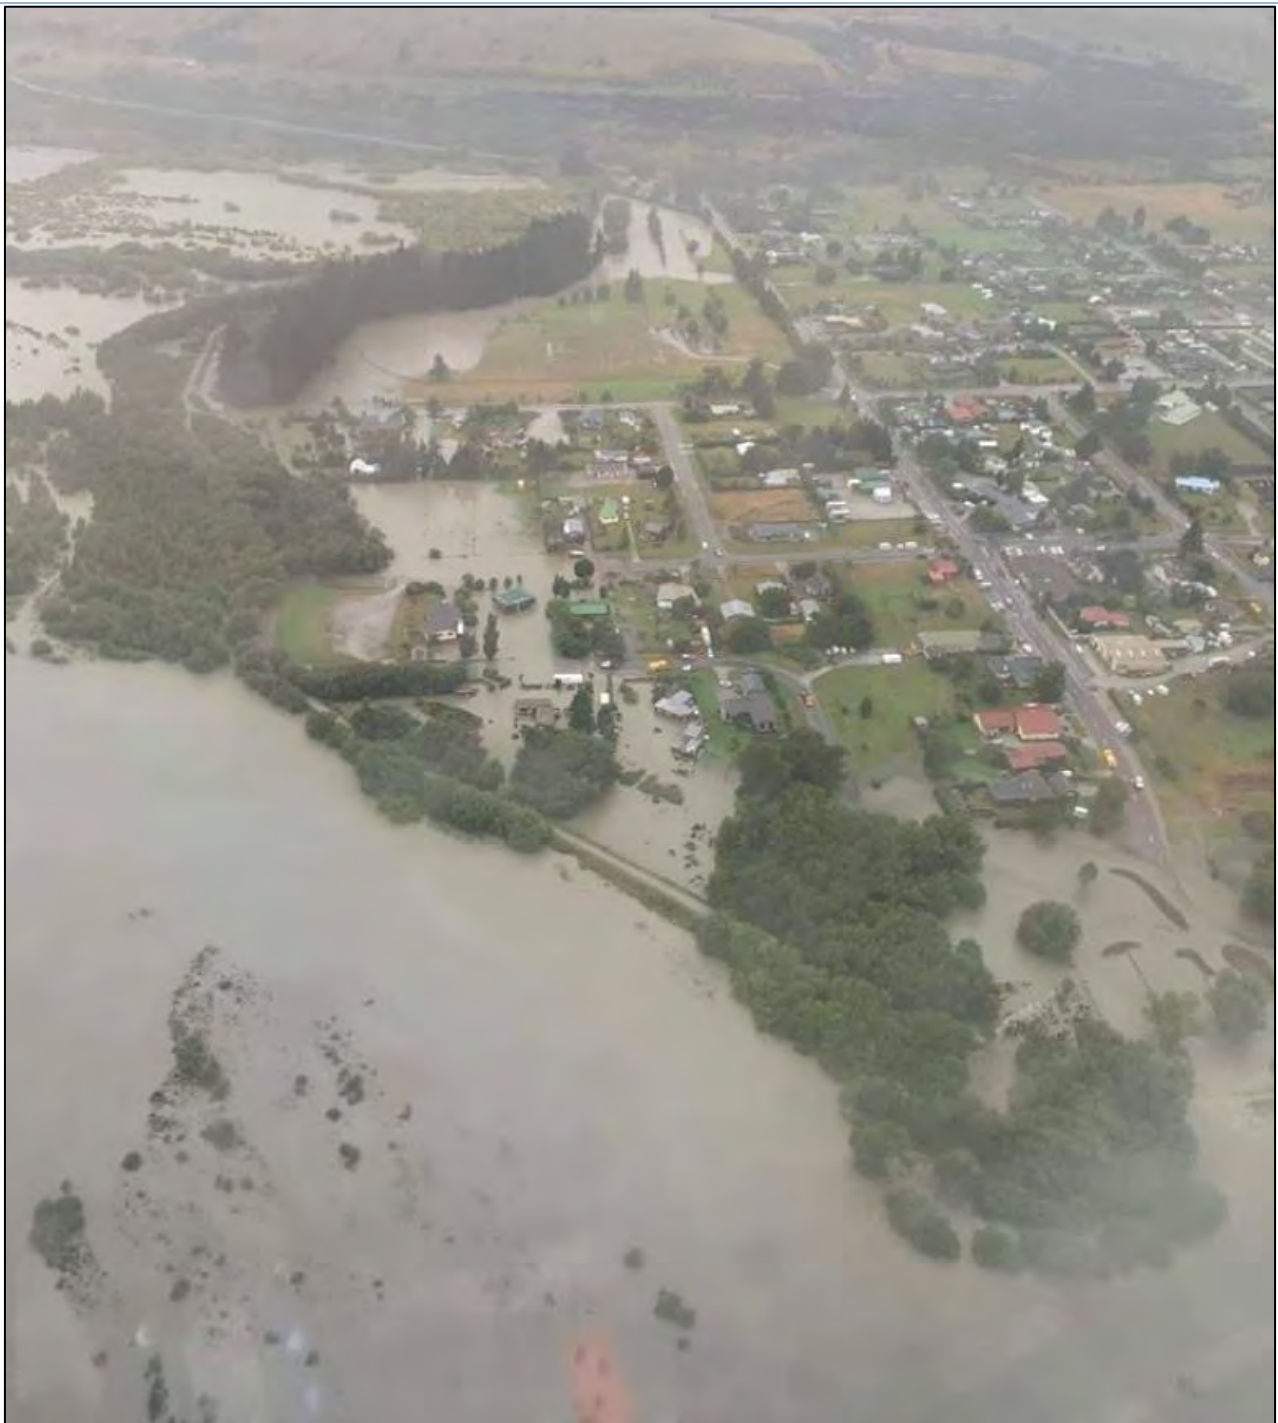
Floodwaters filled much of the Glenorchy recreation ground and golf course, before flowing along the northern/northwestern margin of the township to enter Lake Wakatipu near the lower end of Mull Street, with flooding of residential areas at the northern ends of Oban and Argyle Streets, and along much of Butement Street. Flooding caused inundation and damages at several houses, and precautionary evacuations of a number of others.”

Figure 6-1 - Aerial image taken about 6.30pm 4th February, taken prior to the maximum floodwater extent (photo from Luke Hunter, Donerite Contracting)

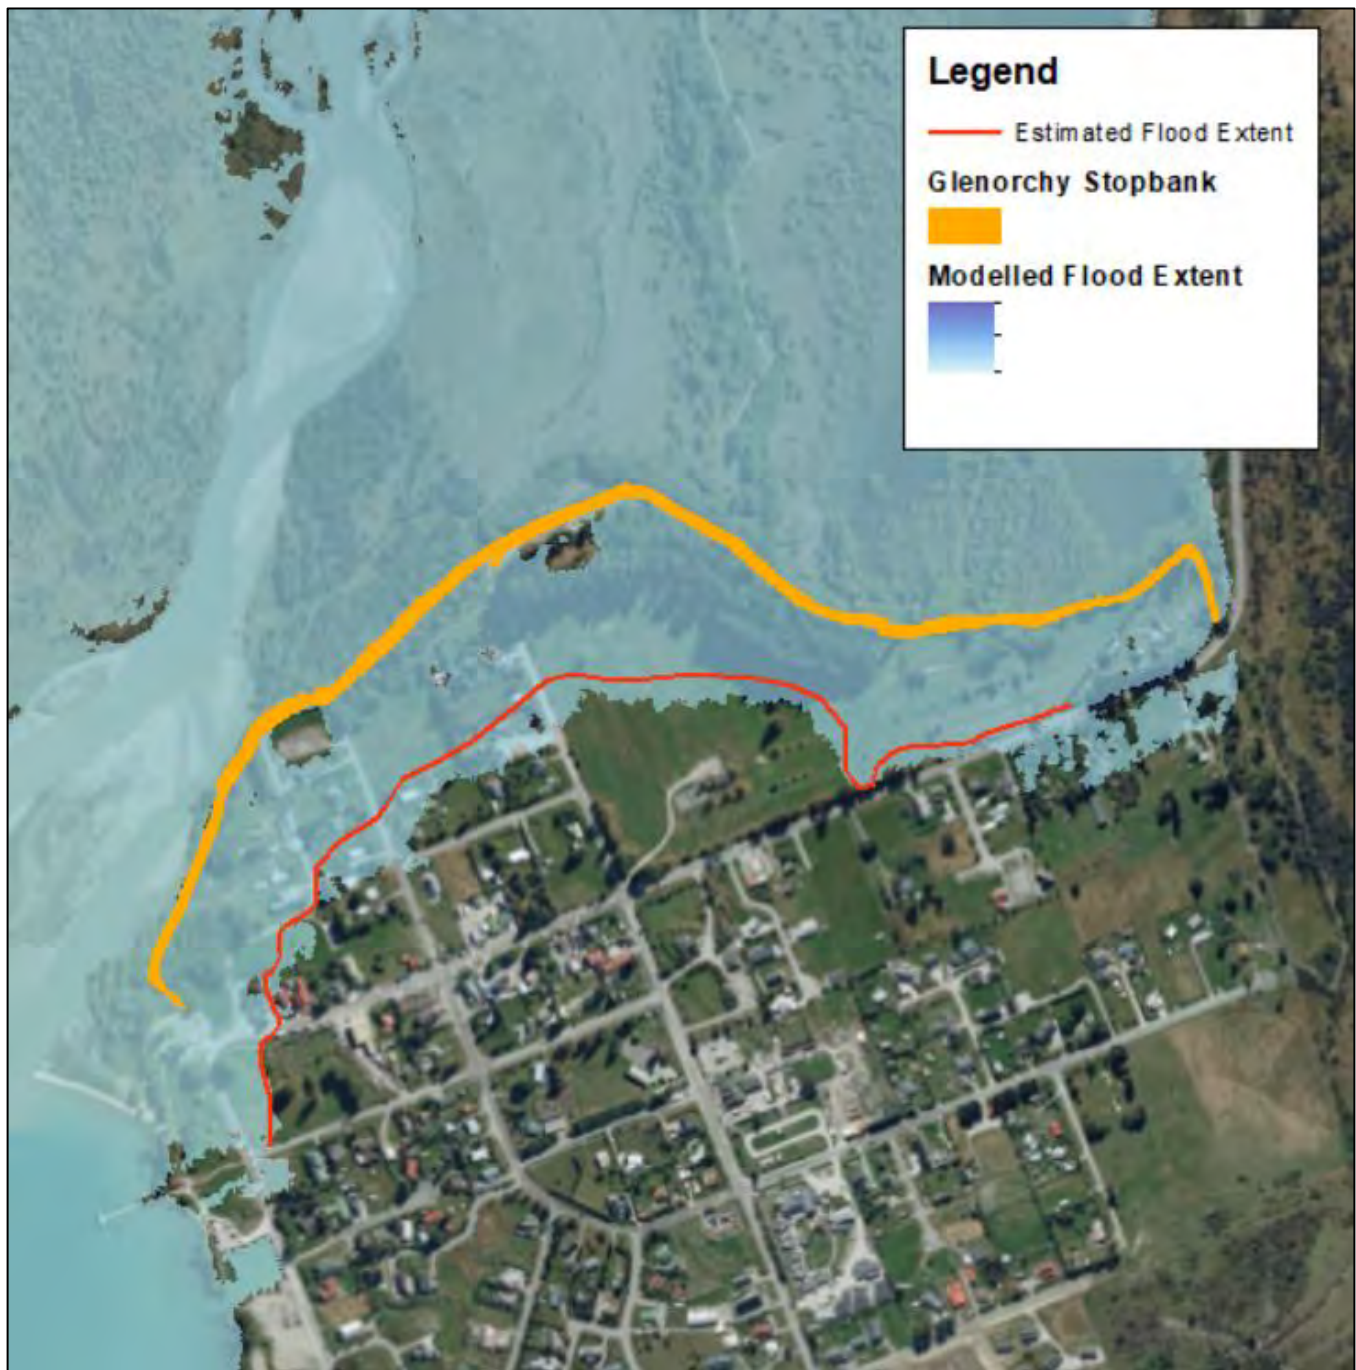
Figure 6-4 – Comparison of modelled flood extent with estimated actual extent

The model has been found to validate reasonably well to the February 2020 flood event with the Glenorchy township area. Flood levels are estimated to be within 0.1m of the modelled results (when compared to surveyed debris at the stopbank) and the estimating the terrain level at the edge of the flood extent. Tim van Woerden from ORC sought feedback on the model validation results from local community members. The general feedback was that the flood extent is close to what occurred during the flood event, however the model is likely slightly overestimating the flood extent in the vicinity of the golf course (the extent is generally within 30m of the observed flood extent). This may be due to a number of reasons including a) uncertainty in the input hydrology b) lack of fine detail in the model terrain such as fences etc which can

divert water to some degree. A comparison of the model results with the estimated flood extent from the February 2020 event is shown in Figure 6-4.

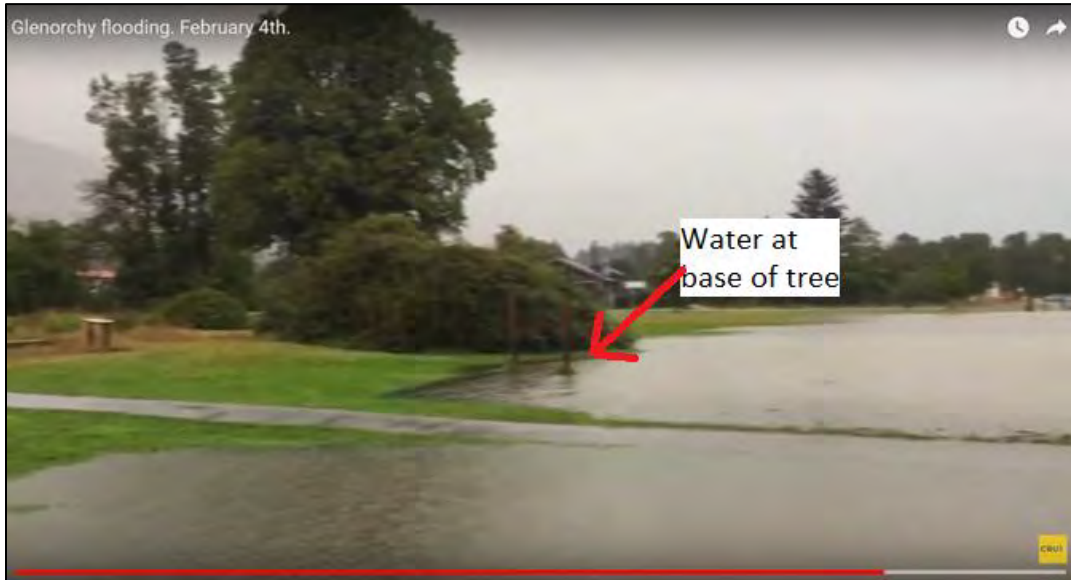
Figure 6-5 – Screenshot from video of flood extent

Close comparison of landmarks in online photography and video has also been used to confirm the extent of flooding. The following figures show the location of the floodwaters in relation to vegetation on waterfront properties in online video (<https://crux.org.nz/community/glenorchy-homes-evacuated-qtown-lake-level-critical>) compared to the modelled flood extent. It is understood that this video was taken close to the time of the peak.

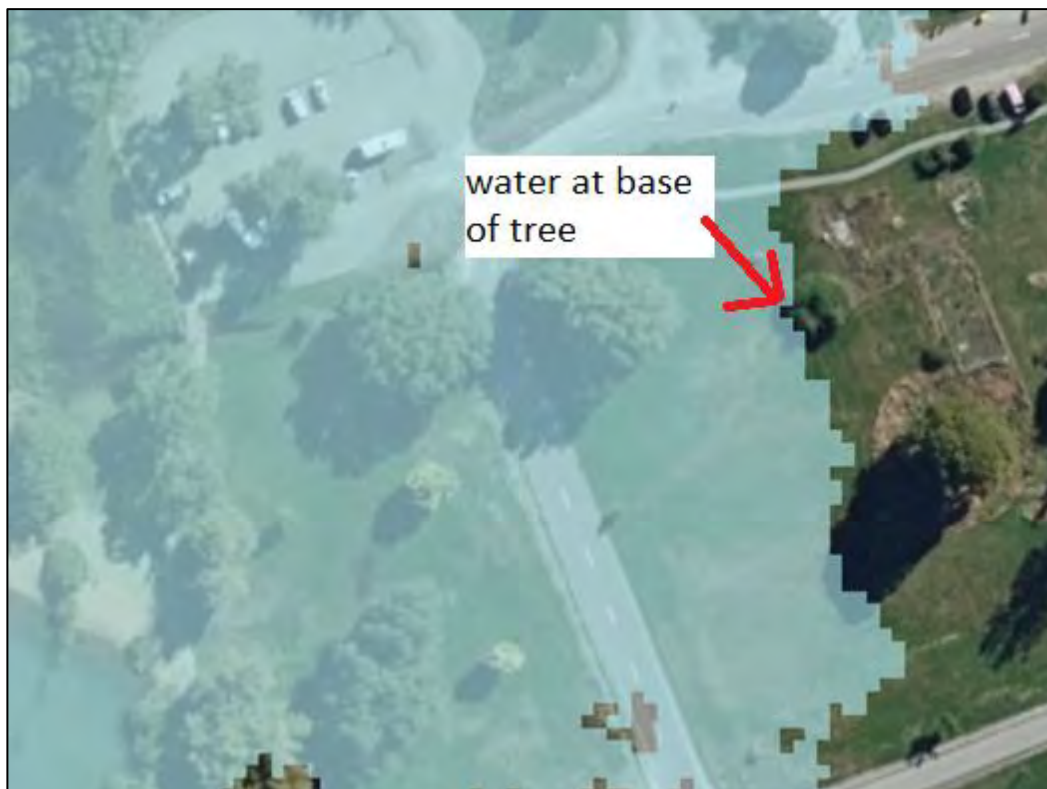
Figure 6-6 – Modelled flood extent in same location

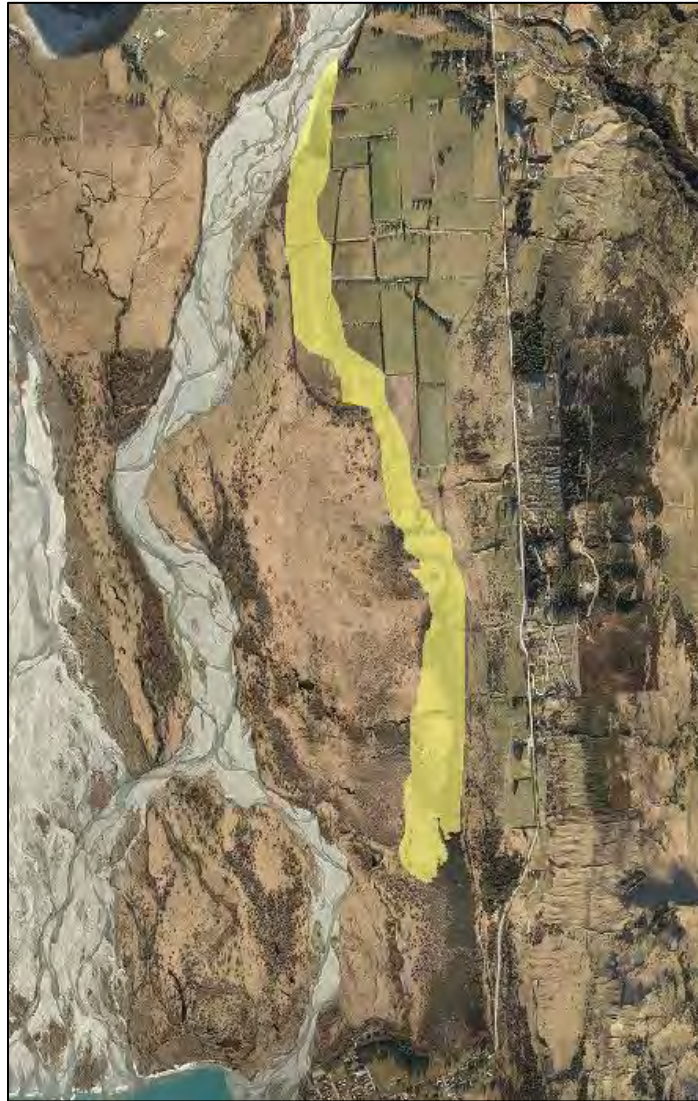
Figure 7-1 – Modelled avulsion path

path in the February 2020 event as evidenced by satellite imagery (see section 6.1) and discussion with local landowners. This avulsion channel has been simulated by further lowering the terrain by using a relationship between depth and velocity and assigning a maximum depth of 1m to the avulsion channel. This depth was decided upon based on the depth of the existing natural braids in the main river. This avulsion scenario has been designed in collaboration with Professor James Brasington and is considered to be a probable / credible location for a future avulsion. The modelled avulsion path is shown in yellow in Figure 7-1. To ensure sufficient flow goes down the avulsion path, a small weir was modelled across the river channel immediately downstream of the avulsion location. Whilst this is not a realistic physical process, this method was necessary to mimic the results of the likely physical behaviour of a gravel bed river system due to the significant mobilisation of the bed during a large flood event.

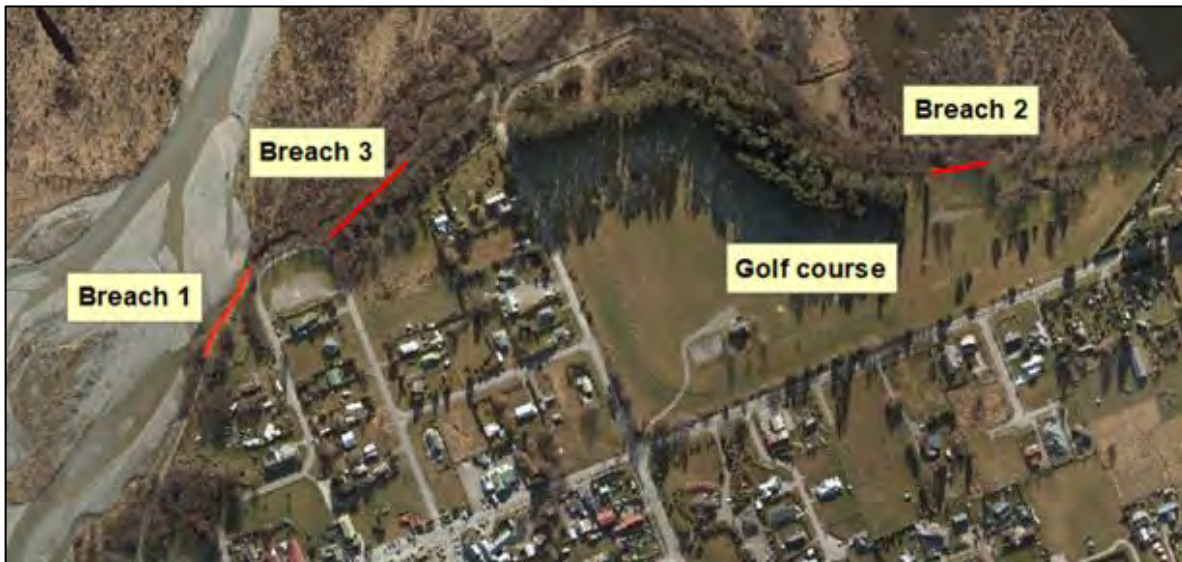
Figure 7-2 – Modelled breach locations

Two stopbank breach scenarios have been simulated in the model based on the parameters provided in the Tonkin and Taylor memo³ and an additional third breach scenario has been identified and tested for sensitivity. The breach scenarios have been run using both the mid-range and worst-case breach parameters provided in the report. The location of the breach scenarios is shown below. Breaches 1 and 3 had a maximum breach width of 90m and were timed to breach prior to overtopping. Breach two had a maximum width of 50m and was timed to breach after several hours of overtopping. Full details on the dam break mechanism can be found in the Tonkin and Taylor report attached in Appendix D.

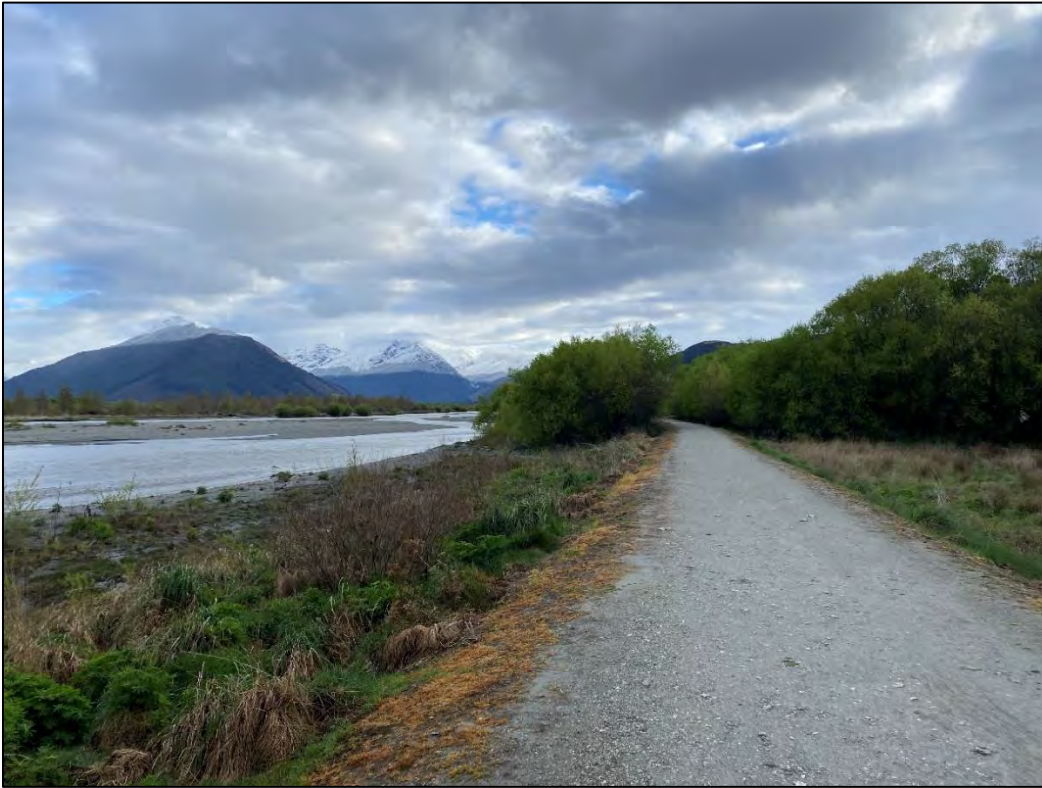
View of Glenorchy Stopbank with Rees River on left

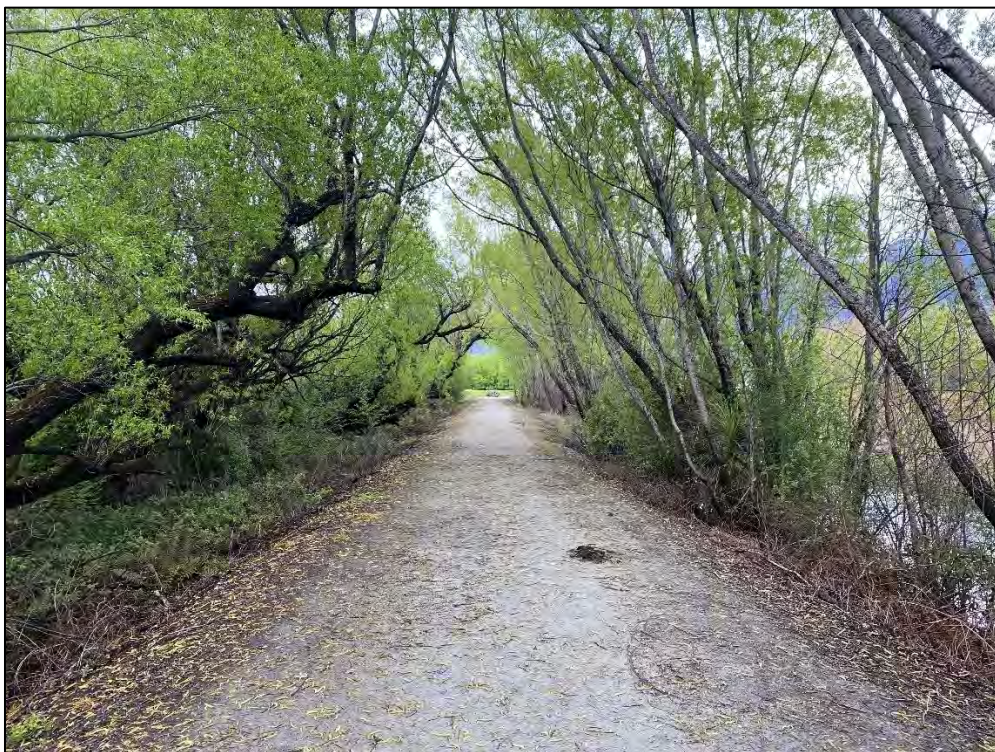
View of Glenorchy Stopbank with Lagoon Creek visible on the right through the willows

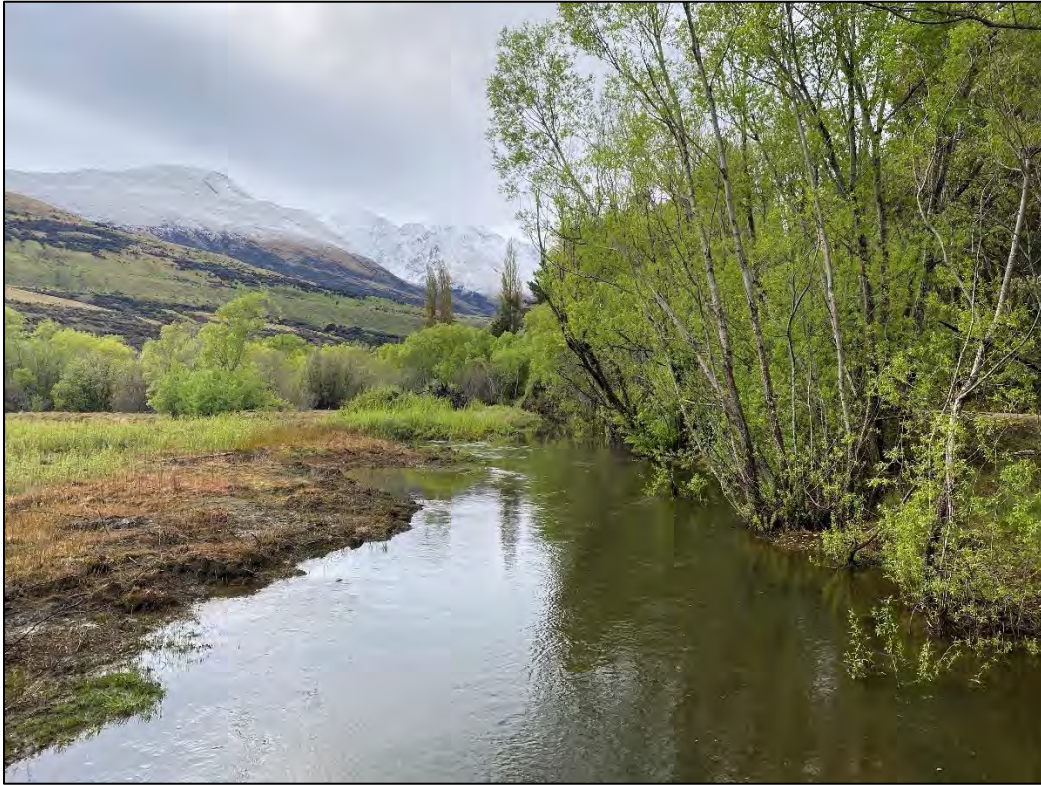
View of Lagoon Creek – Glenorchy stopbank is on the right behind the willows

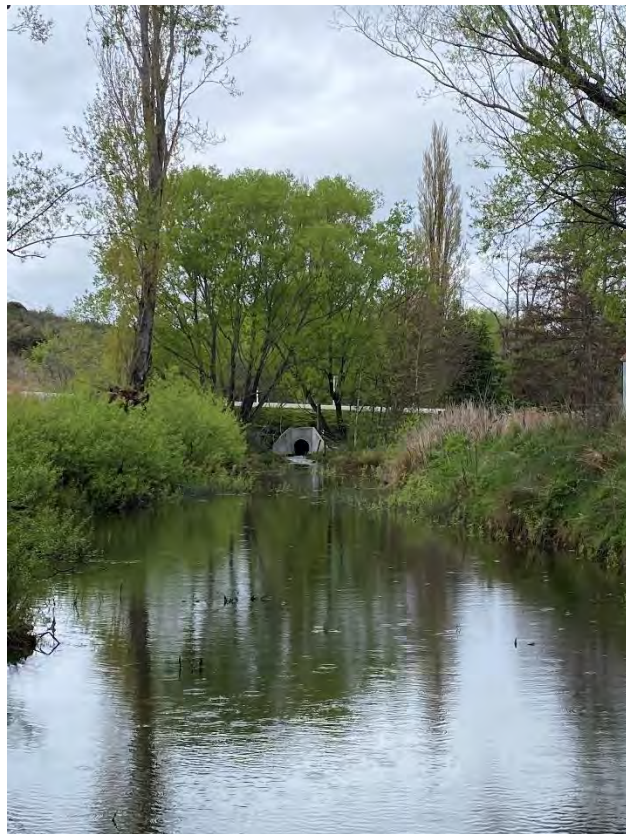
View of culvert under Glenorchy-Paradise Road

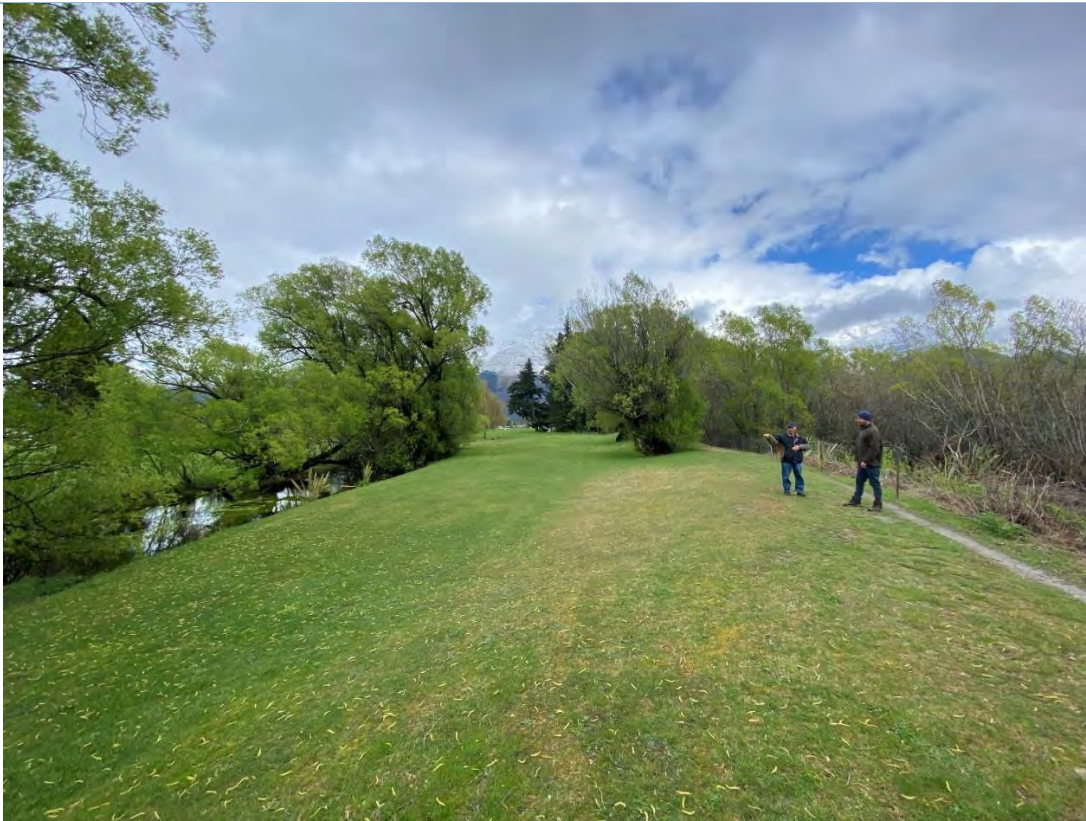
Photo of Glenorchy Stopbank adjacent to the Golf Course (overflow location)

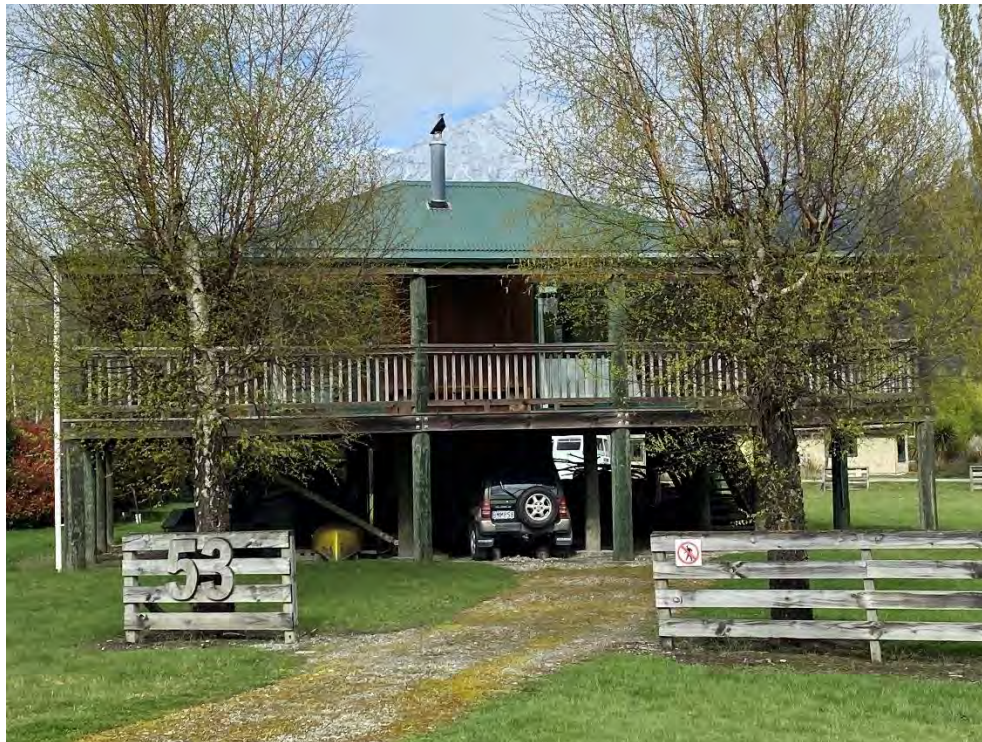
Example of house built on overflow path on stilts (section was significantly flooded in Feb 2021)

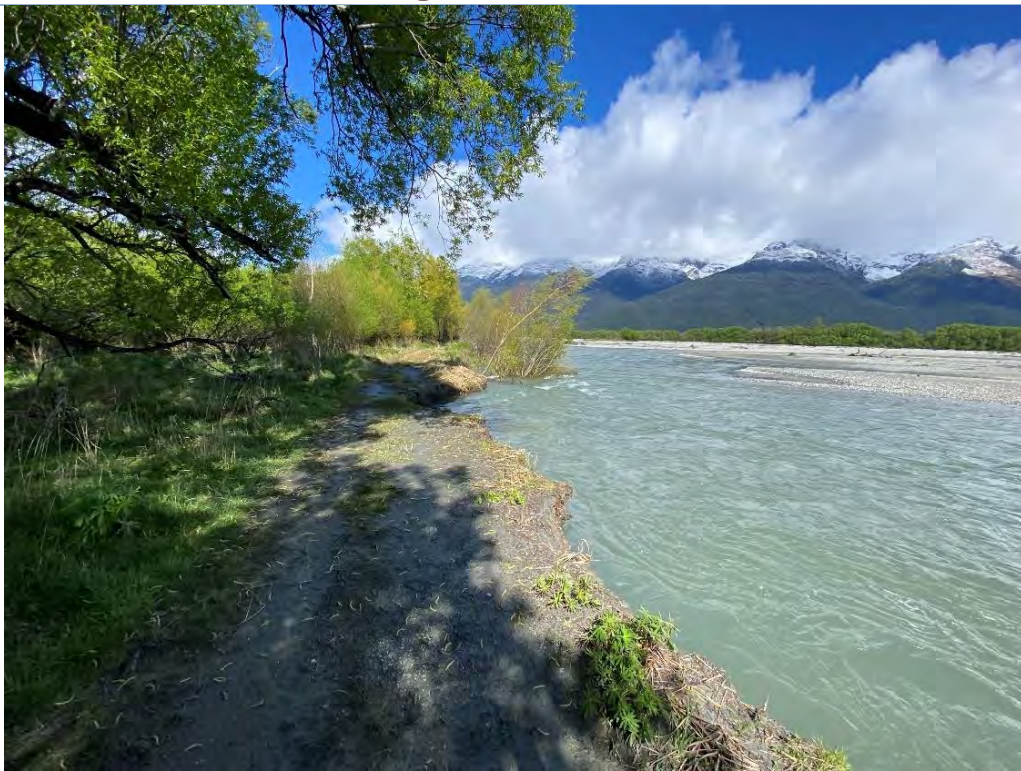
Photo of erosion on left bank of the Rees River (Rees Valley Station)

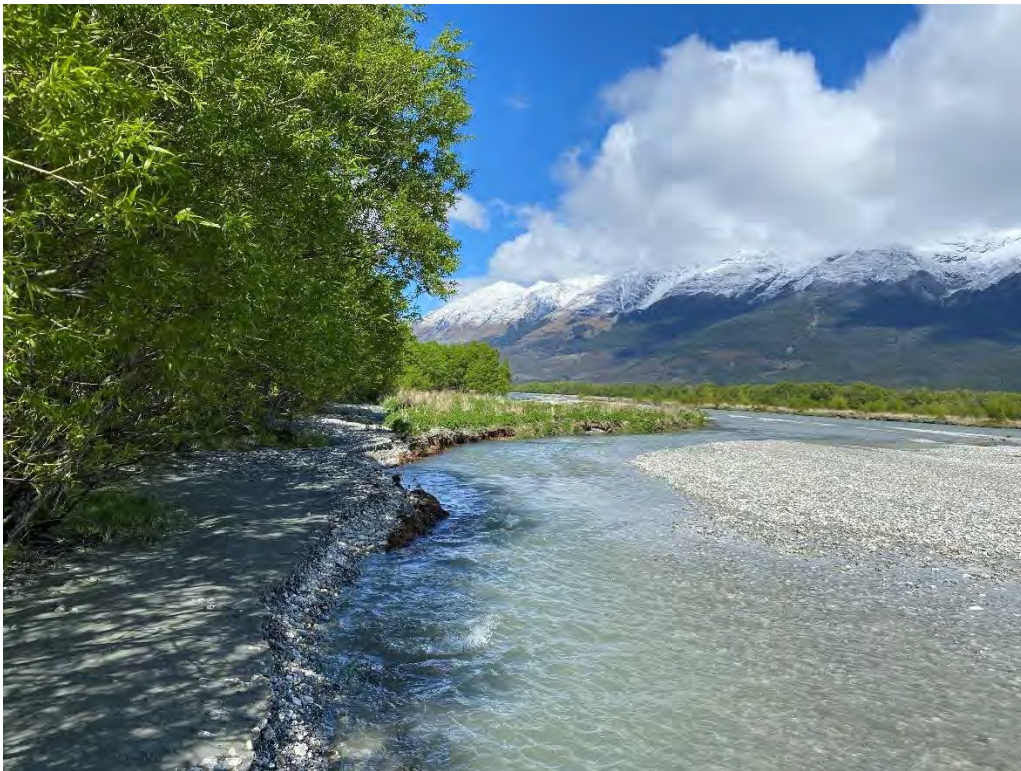
Photo of erosion on left bank of the Rees River (Rees Valley Station) – this photo also highlights the lack of available freeboard for the Rees River before it overflows onto the left bank

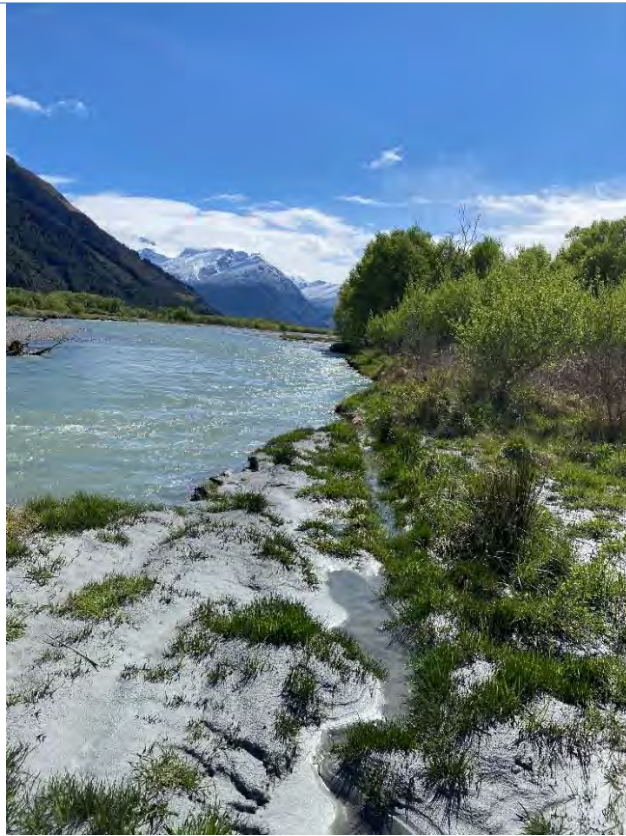
Photo of silt buildup due from Rees Rover overflows

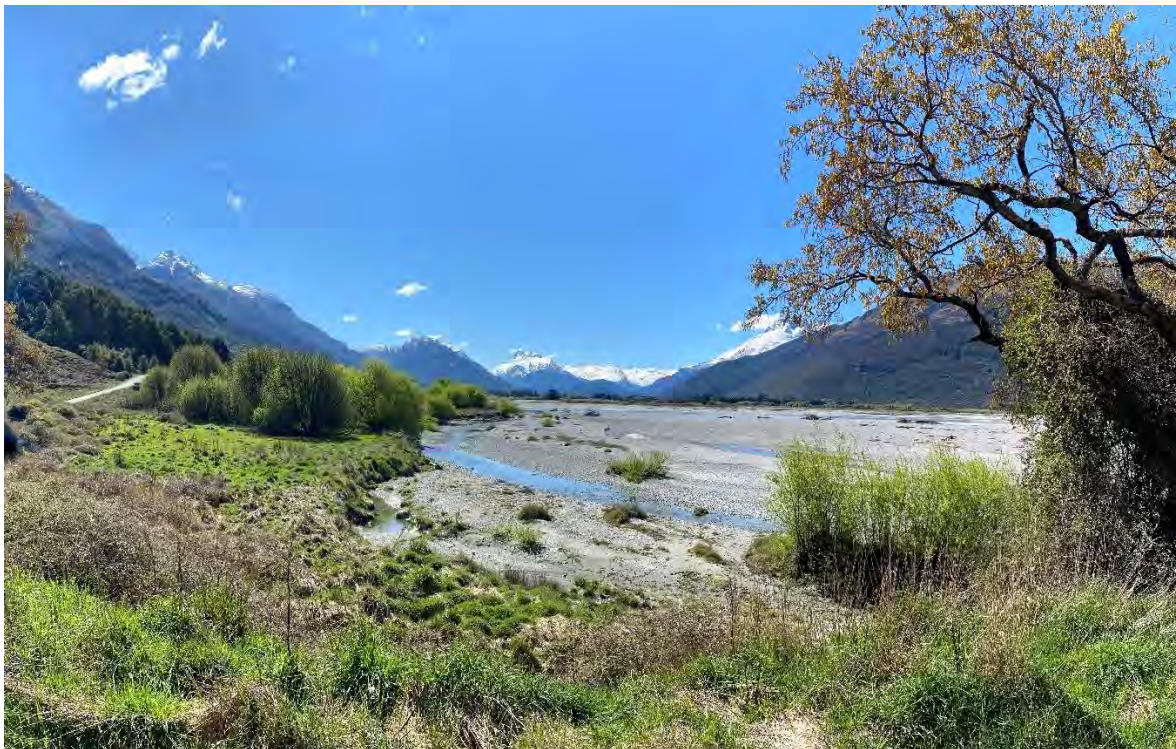
Photo looking upstream of the Dart River from Kinloch Rd (photo highlights erosion as well as vicinity to road)

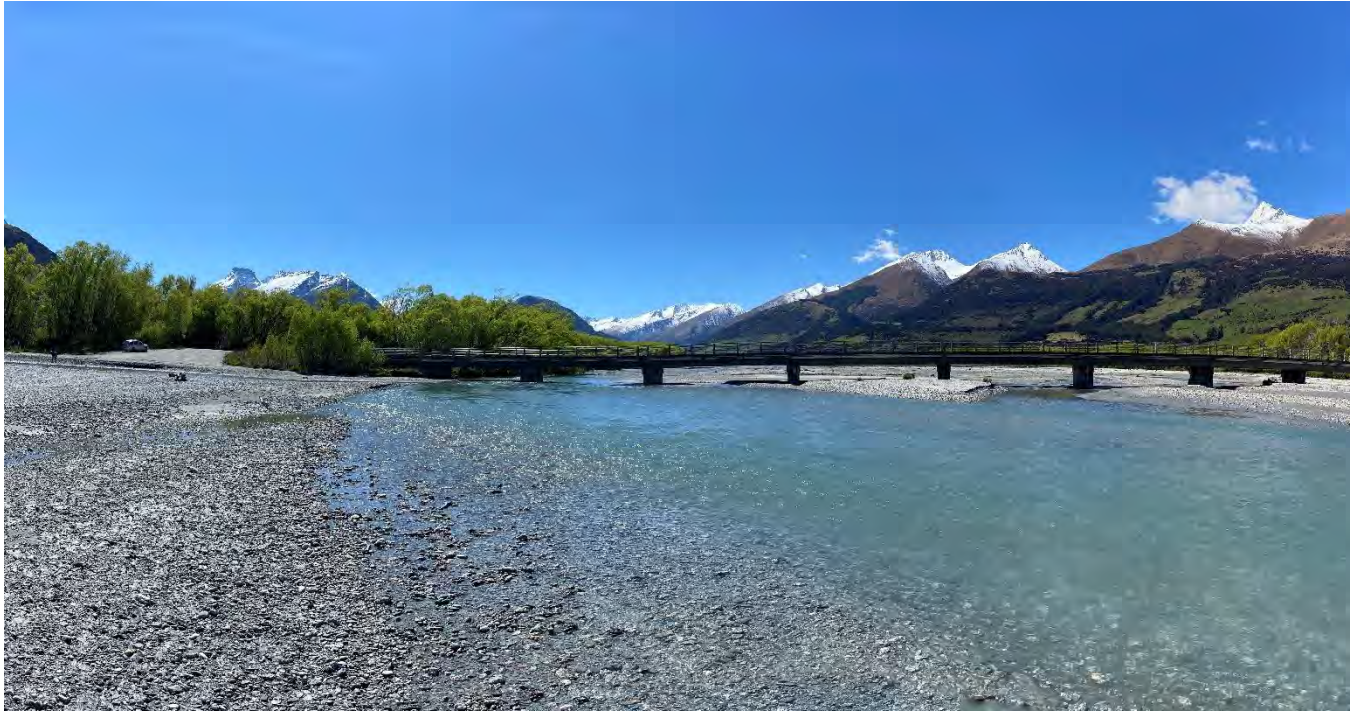
Photo of Rees River bridge, highlighting very limited capacity / freeboard available

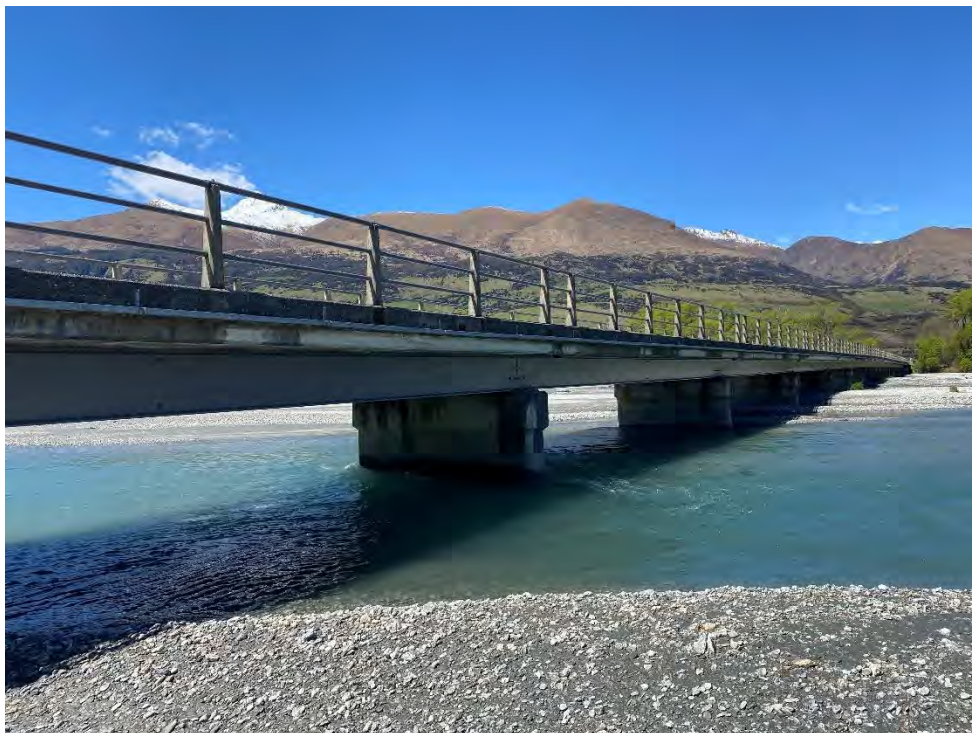
Close up photo of Rees River bridge further highlighting the limited capacity

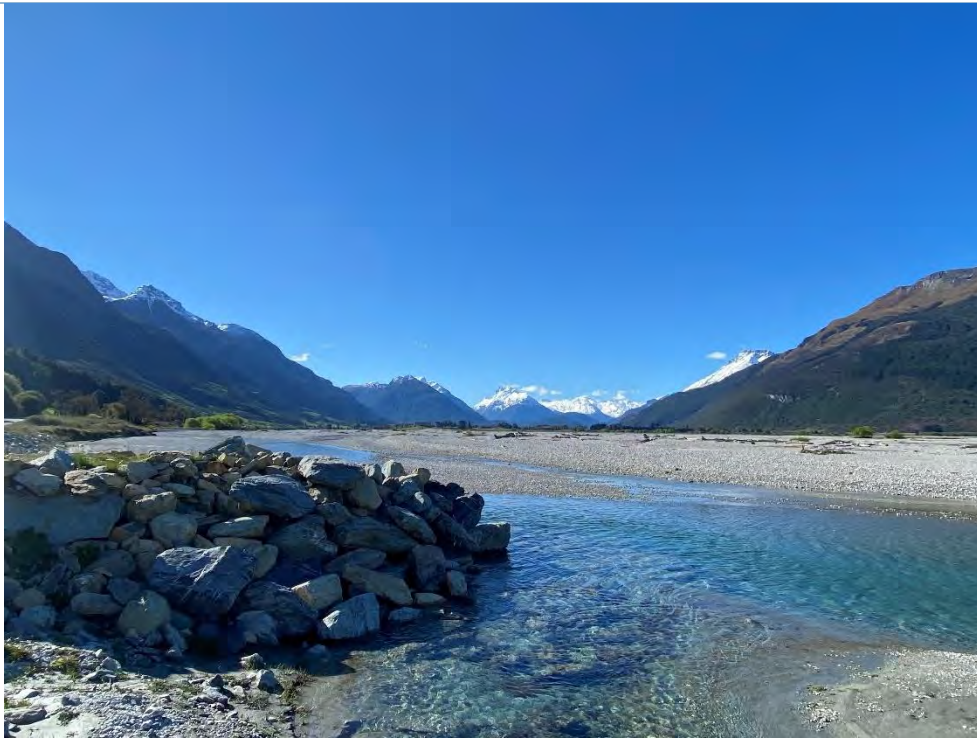
Example of a typical rock groyne constructed on the true right bank of the Dart River with significant scour on the downstream side of the groyne.

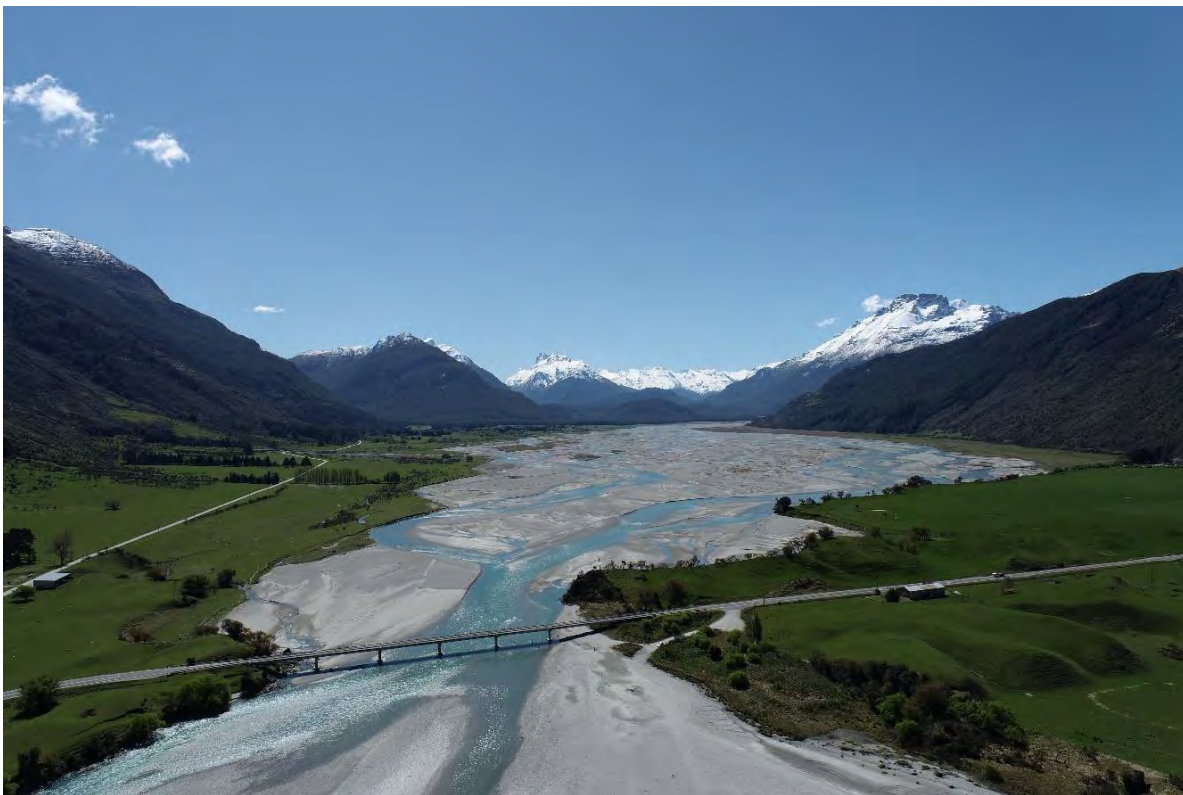
Drone photo of the Dart River bridge (upstream extent of the model)
