Dart / Rees Rivers

Flood Hazard Modelling

Client: Otago Regional Council

Land River Sea Consulting Limited

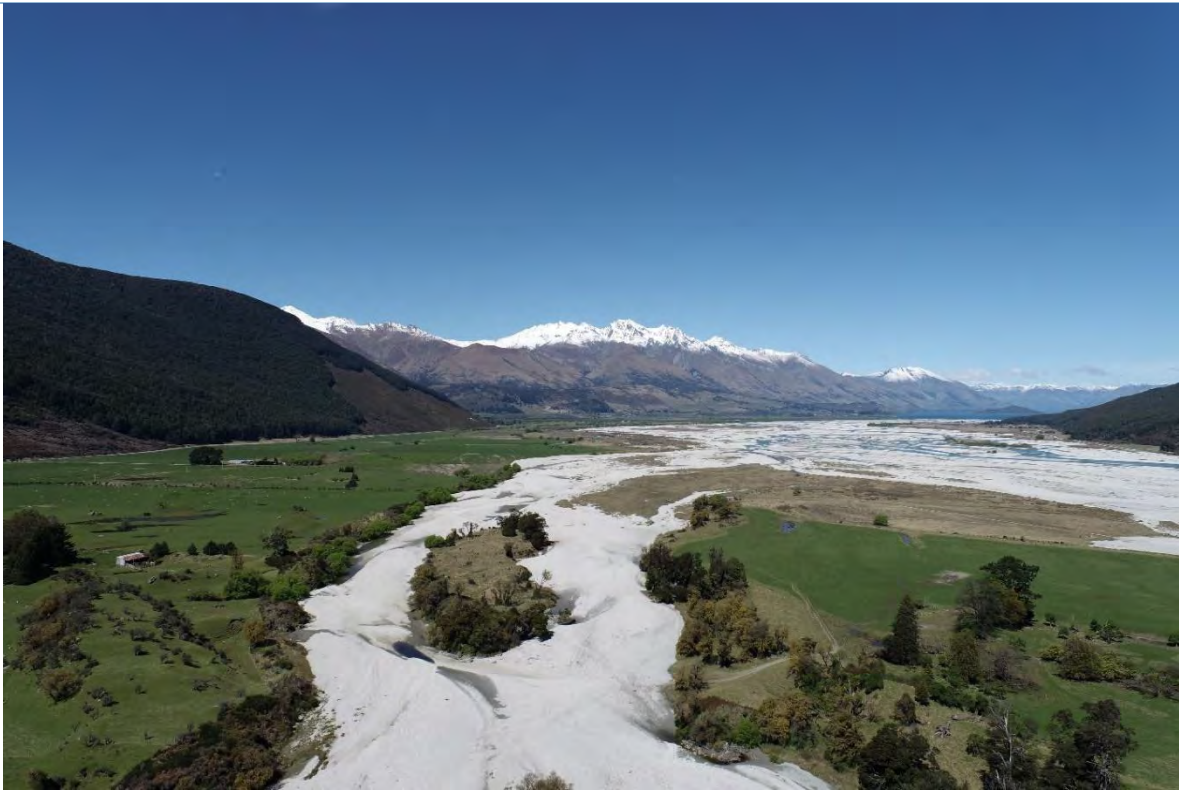
Drone image looking downstream from the Dart River bridge showing the potential overflow paths on the true left bank with the Glenorchy-Routebourn Rd visible at the base of the hill.

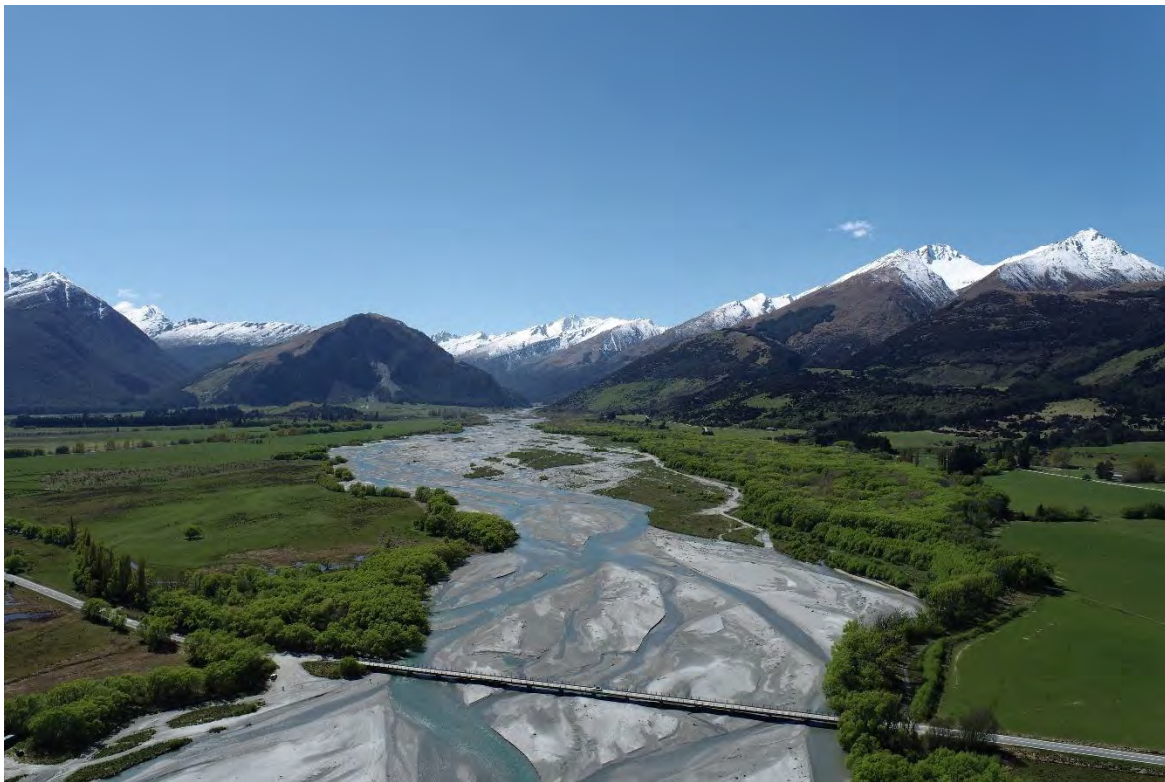
Drone photo of the Rees River bridge (upstream extent of the model)

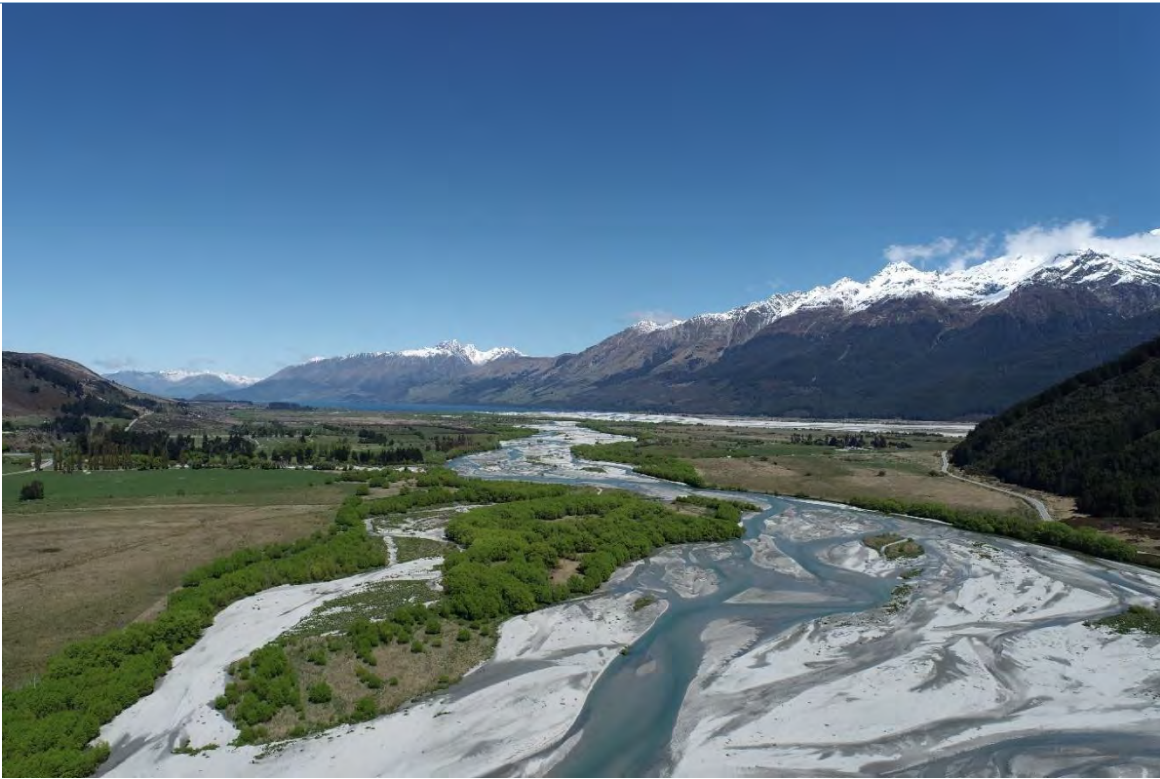
Drone image looking downstream from the Rees River bridge showing the potential overflow paths on the true left bank

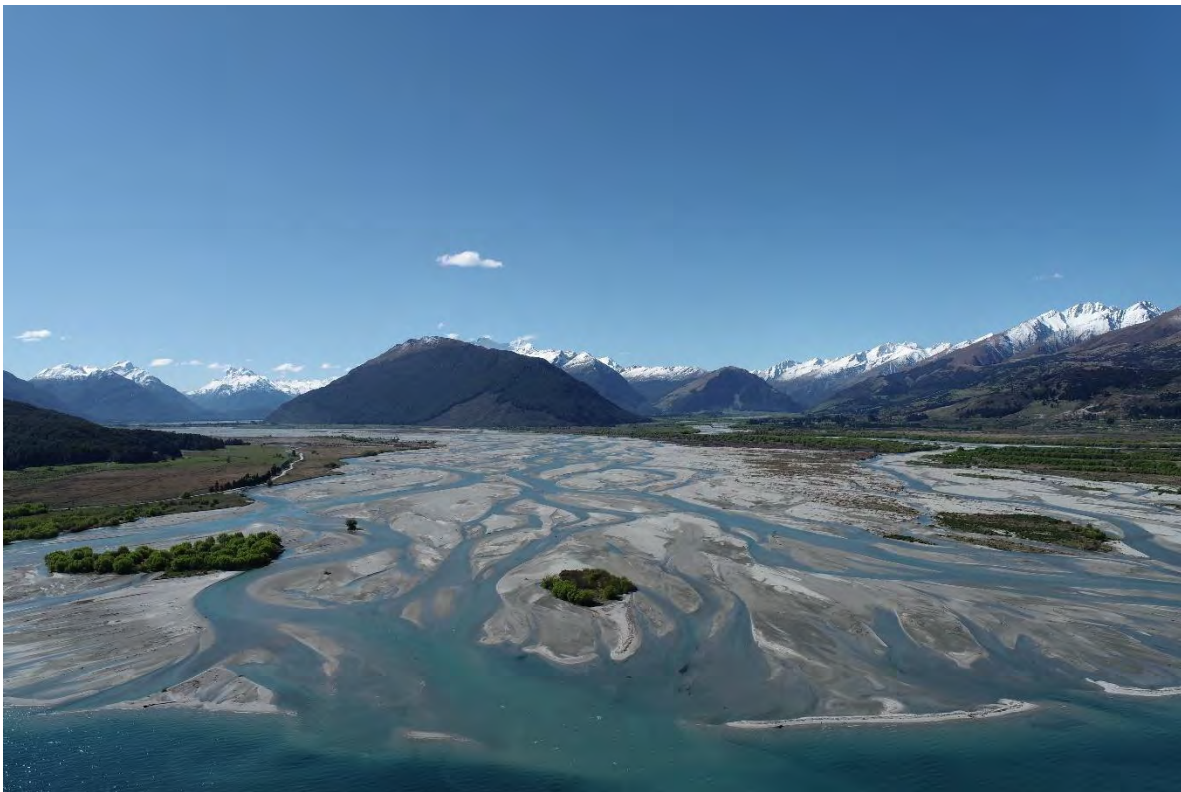
Drone image of the significant delta at the mouth of the Dart River with the confluence of the upper branch of the Rees River visible at the right of the image

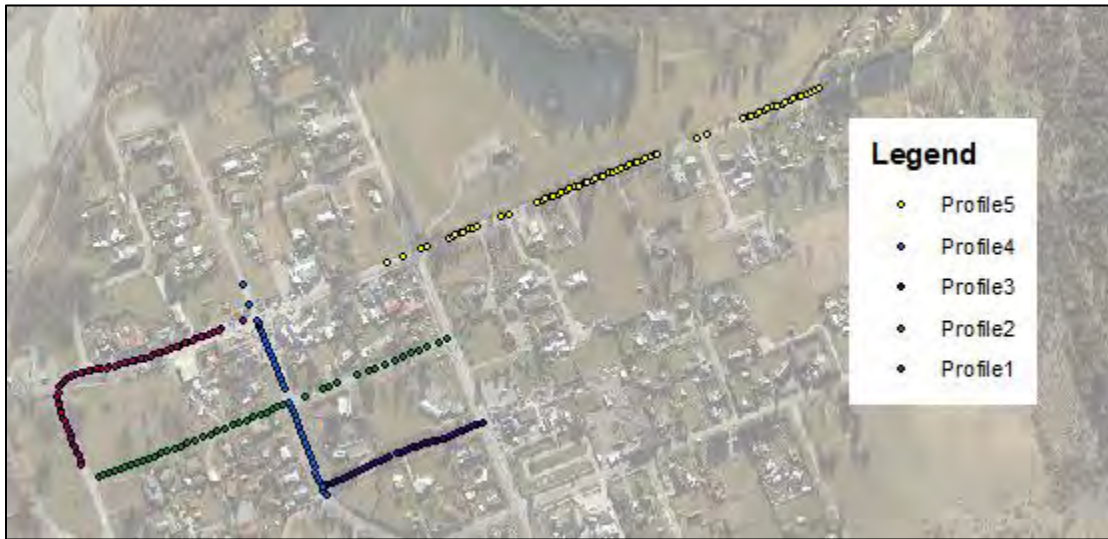
Figure 2 – Profile Locations

Five long section profiles have been plotted in order to visualise the difference between the LiDAR DEM and the survey data as per the location shown in Figure 2.

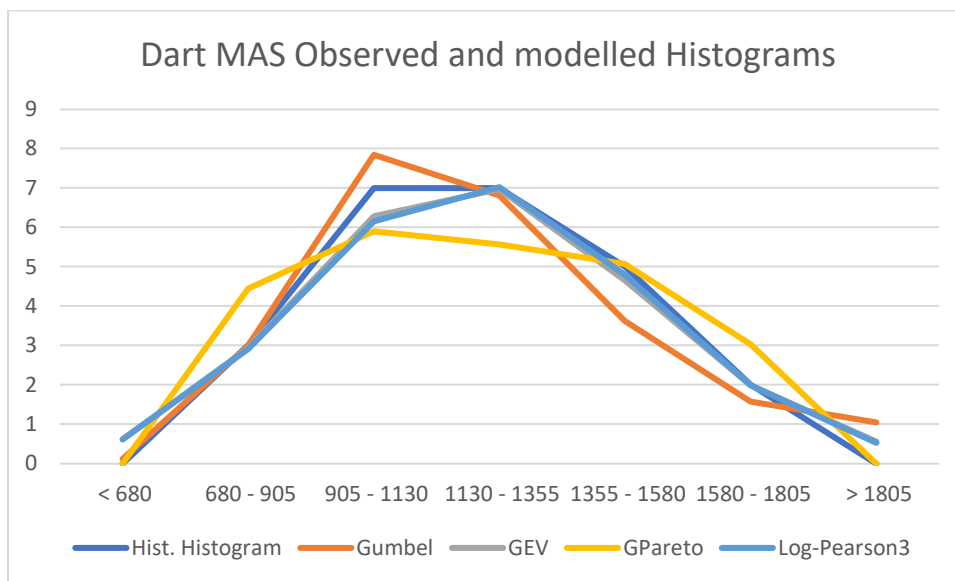
Figures 2 and 3 clearly show that frequency analysis for the Dart at the Hillocks based on partial duration series performs much better in simulating the observed histogram of the peak flows. Other performed goodness of fit tests “Cumulative frequency of observed vs modelled, Kolmogorov Smirnov, Chi squared, and Filliben correlation” also favour the PDS approach for frequency analysis.

Figure 2 Dart MAS Observed and modelled Histograms

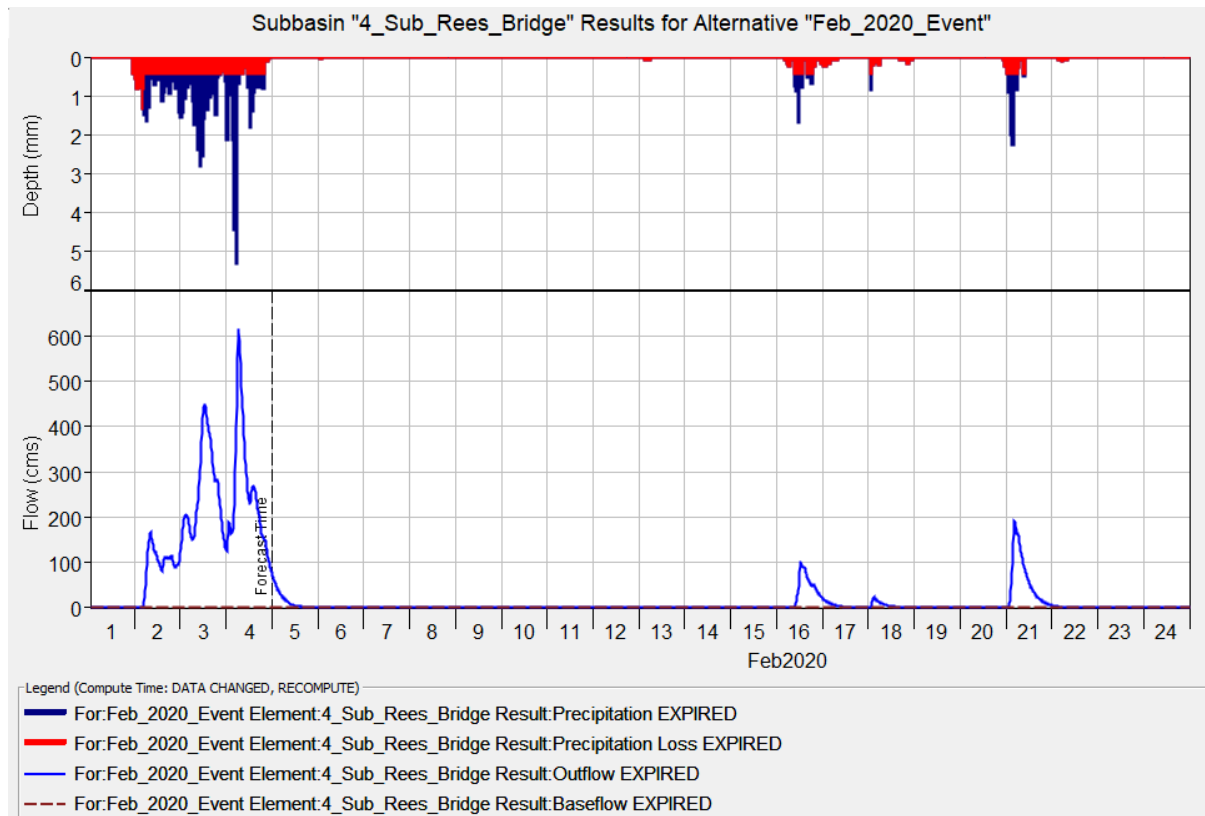
Based on the observed rainfalls at the Hillocks, Paradise and Cascade Hut for the event February 2020 which flooded parts of Glenorchy township, the developed HEC-HMS, has been used to simulate the flows for the Rees River during this event. The “modelled” flow hydrograph for the February 2020 even, as shown in figure 15, has been used to calibrate the hydraulic model which simulates the extent of Glenorchy flooding from the Rees River during high flows.

Figure 15 Rees at Bridge flow hydrograph for the Event February 2020

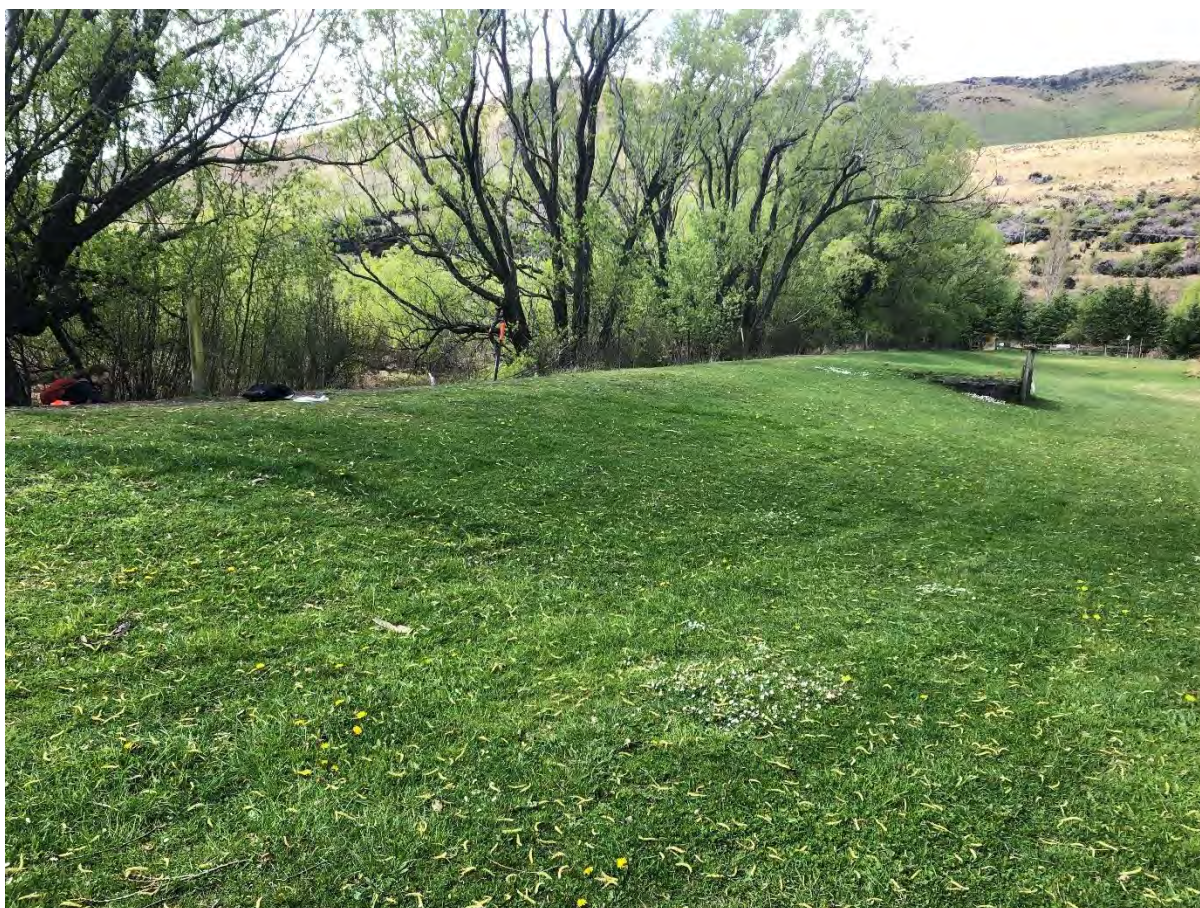
Figure 2 Golf course adjacent to the Rees-Glenorchy Floodbank where sheet flow overtopping has been reported.

The Rees-Glenorchy Floodbank crest width at the area of interest in the vicinity of the golf course was typically over 2 m wide before transitioning to a flat land side slope. Land side slope angles were estimated to be in the order of 5° and 10° (noting the 5° estimate corresponds to a potential flow path oblique to the slope). The Rees-Glenorchy Floodbank is likely to behave as a broad crested weir during shallow overtopping flows. The crest and land side slopes were well grassed, indicating that the Rees-Glenorchy Floodbank can withstand shallow low velocity overtopping flows for an appreciable period if flow is not able to concentrate at irregularities (albeit the grass observed in the golf course environment was shorter than would provide optimum erosion protection). Based on ORC advice, we understand that no significant damage was reported during the recent floods when shallow overtopping depths were sustained for at least 10 hours and no significant debris accumulation was reported³. However, more adverse flood conditions may result in greater overtopping beyond what the existing flood bank can withstand.

Based on discussions with ORC² we understand during recent floods of significance (e.g. February 2020), that flood levels can rise in the Glenorchy Lagoon area to exceed the adjacent Rees-Glenorchy Floodbank crest level. When this has occurred, ORC have indicated that the Rees-Glenorchy Floodbank first overtops in the vicinity of where the golf course directly adjoins the Rees-Glenorchy Floodbank. We understand that during the February 2020 event the Rees-Glenorchy Floodbank first overtopped at isolated locations and as the upstream water level increased, shallow sheet flow subsequently occurred over most of the Rees-Glenorchy Floodbank adjacent to the golf course. The length of the golf course adjacent to the land side of the Rees-Glenorchy Floodbank is of approximately 230 m. Figure 2 following illustrates the location.

Typically, on embankments that have been overtopped by floods in excess of erosion thresholds, severe erosion has often been observed to begin where sheet flow on the slope meets and/or is concentrated/disrupted by an obstacle/irregularity. For example trees and/or other irregularities in the vicinity of the Rees-Glenorchy Floodbank land side as shown at Figures 2 and 3.

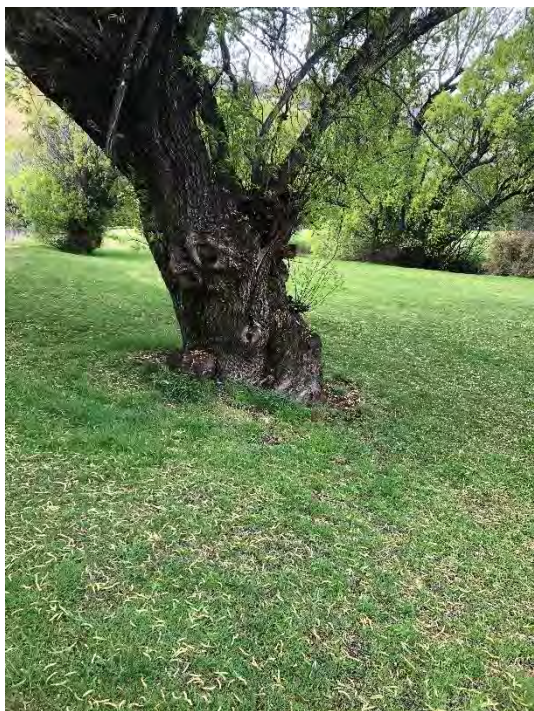
Figure 3 Large willow trees at Rees-Glenorchy Floodbank downstream face.

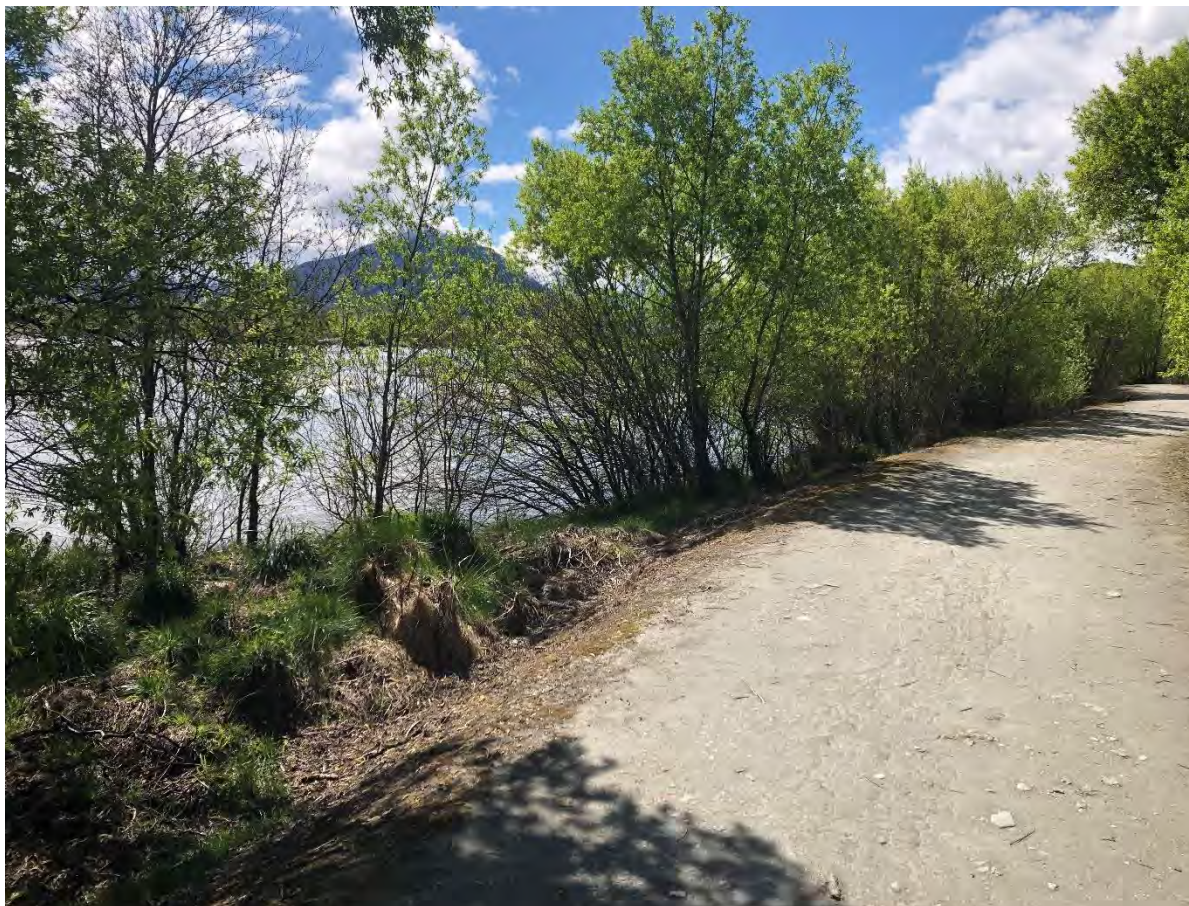
Based on walkover visual assessment it is our opinion that the more likely location for scour damage is in the vicinity of the Rees River confluence with Lagoon Stream. There is a bend in the Rees River at this location, with the Rees River flow directed towards the Rees-Glenorchy Floodbank at an oblique angle as illustrated at Figures 4 and 5.

Figure 4 Rees-Glenorchy Floodbank adjacent to the Rees River confluence with Lagoon Stream. The Rees River is directed towards the Rees-Glenorchy Floodbank, increasing the likelihood of scour damage.

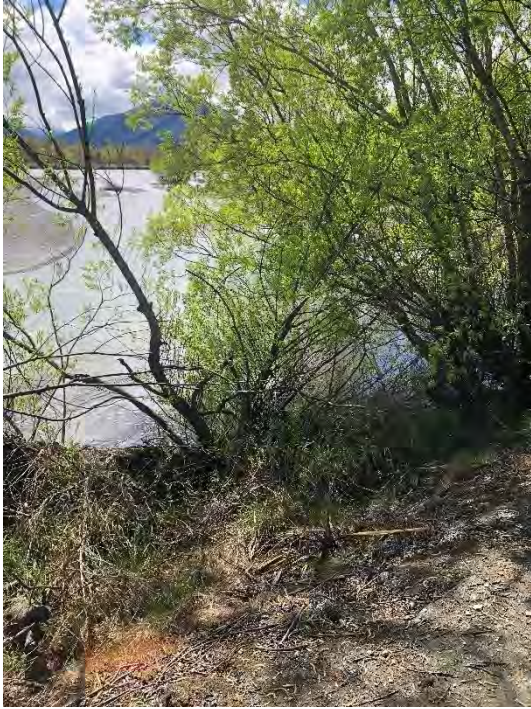
Figure 5 Rees River directed towards the Rees-Glenorchy Floodbank.

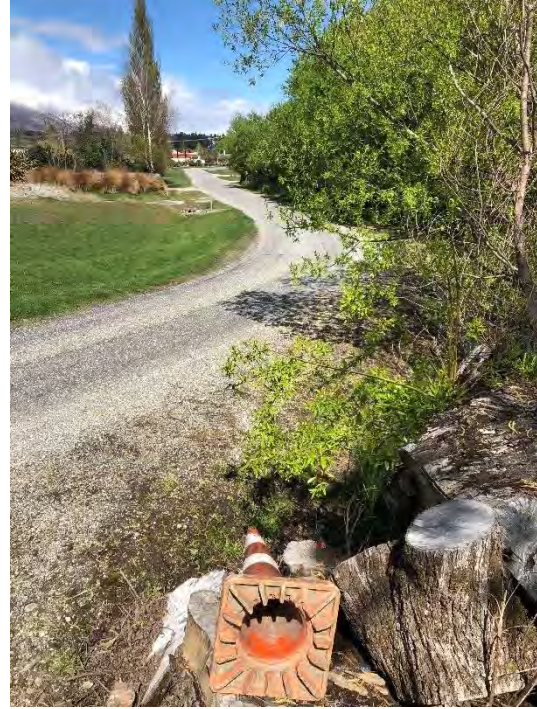
Figure 6 Butement Street on the land side of the Rees-Glenorchy Floodbank at the location assessed as vulnerable to damage instigated by scour.

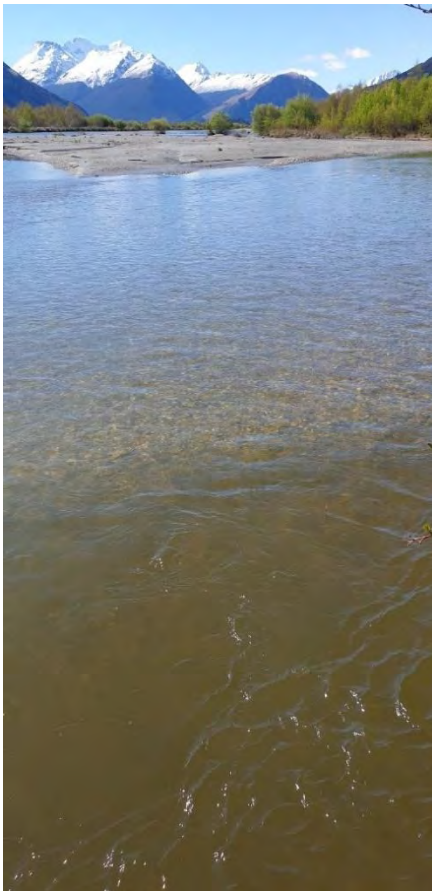
- ix. Deepened parts of the creek channel were observed near Lake Road and where Lagoon Stream currently meets a braid of the Rees. These scour deepened parts of the channel were located up against the toe of the floodbank.

Figure 7 Deeper Lagoon Creek water and bank prone to scour near confluence with Rees River.

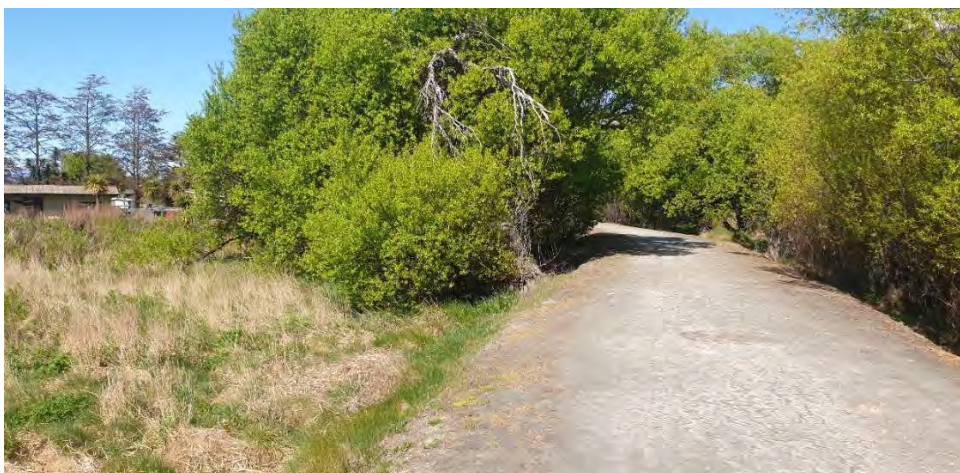
- Tree roots may cause piping. A number of large willow trees were observed adjacent to the embankment. In several instances it appeared that the fill had been placed around large trees (e.g. Figure 3). One way tree roots can lead to piping is the formation of preferential seepage paths as roots decay following tree removal.

Figure 9 Embankment at location inferred by WSP to be an area of interest for possible piping.

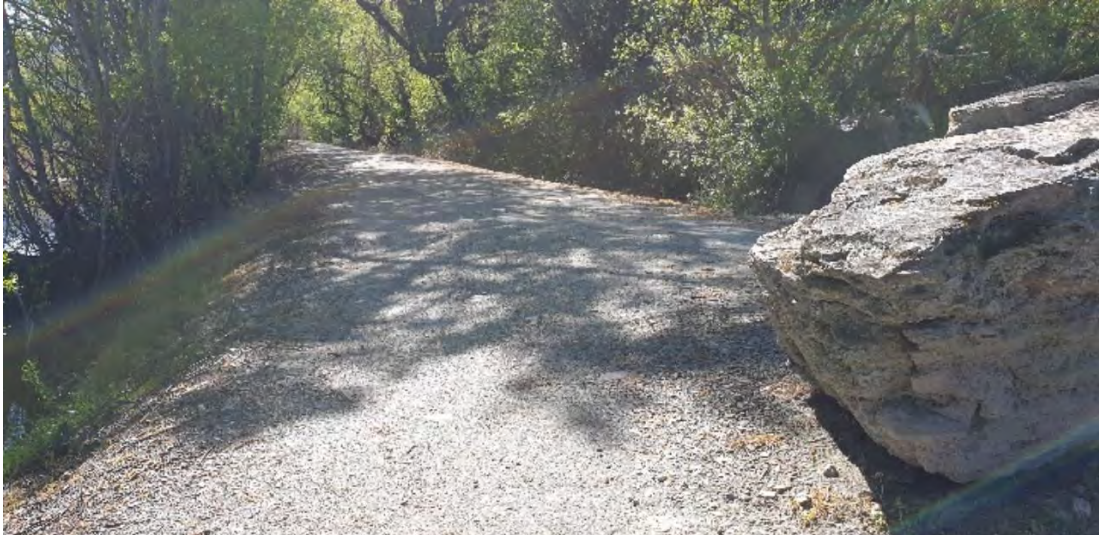
Figure 10 Embankment at location where culvert crosses under embankment. Potential area of interest for piping.

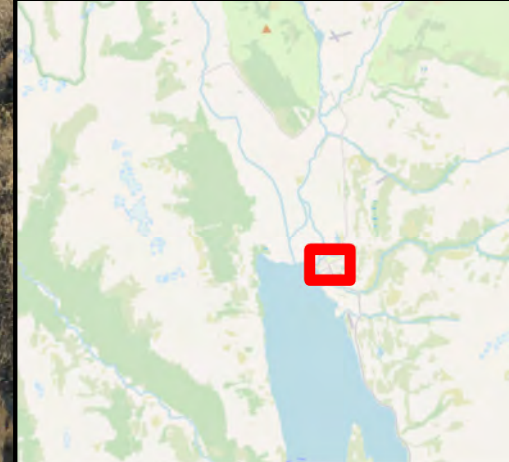
H1 - Generally safe for vehicles, people and buildings
 H2 - Unsafe for small vehicles
 H3 - Unsafe for vehicles, children and the elderly
 H4 - Unsafe for vehicles and people
 H5 - Unsafe for vehicles and people
 All buildings vulnerable to structural damage
 Some less robust buildings subject to failure
 H6 - Unsafe for vehicles and people
 All building types considered vulnerable to failure

MAP TITLE
HAZARD MAP
Scenario 1 – 100 year ARI flow (historic climate)
10 year ARI lake level

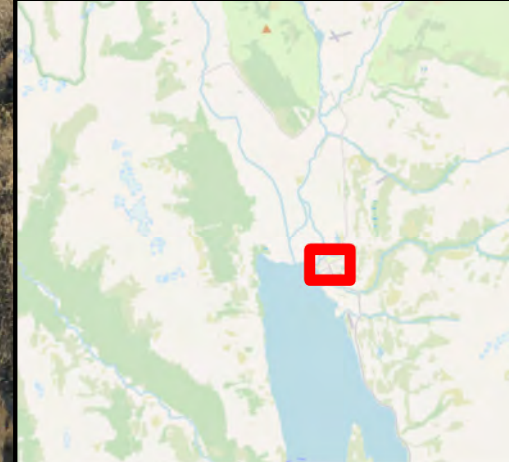
H1 - Generally safe for vehicles, people and buildings
 H2 - Unsafe for small vehicles
 H3 - Unsafe for vehicles, children and the elderly
 H4 - Unsafe for vehicles and people
 H5 - Unsafe for vehicles and people
 All buildings vulnerable to structural damage
 Some less robust buildings subject to failure
 H6 - Unsafe for vehicles and people
 All building types considered vulnerable to failure

MAP TITLE
HAZARD MAP
Scenario 2 - 100 year ARI flow (historic climate)
100 year ARI lake level

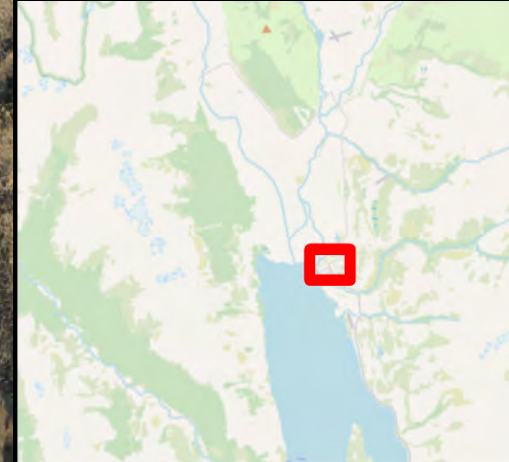
H1 - Generally safe for vehicles, people and buildings
 H2 - Unsafe for small vehicles
 H3 - Unsafe for vehicles, children and the elderly
 H4 - Unsafe for vehicles and people
 H5 - Unsafe for vehicles and people
 All buildings vulnerable to structural damage
 Some less robust buildings subject to failure
 H6 - Unsafe for vehicles and people
 All building types considered vulnerable to failure

MAP TITLE
HAZARD MAP
Scenario 3 – 100 year ARI flow (Future Climate, RCP8.5)
10 year ARI lake level

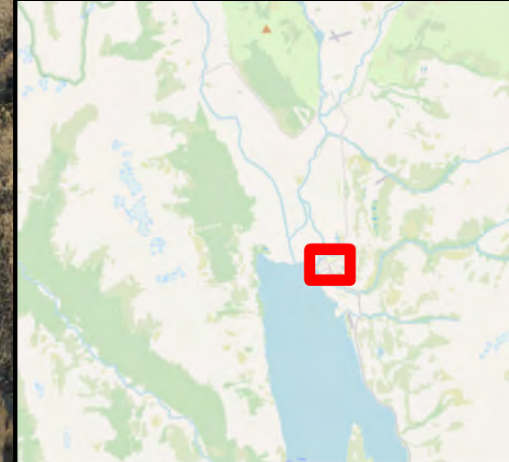
H1 - Generally safe for vehicles, people and buildings
 H2 - Unsafe for small vehicles
 H3 - Unsafe for vehicles, children and the elderly
 H4 - Unsafe for vehicles and people
 H5 - Unsafe for vehicles and people
 All buildings vulnerable to structural damage
 Some less robust buildings subject to failure
 H6 - Unsafe for vehicles and people
 All building types considered vulnerable to failure

MAP TITLE
HAZARD MAP
Scenario 4 – 100 year ARI flow (historic climate)
10 year ARI lake level – Avulsion towards lagoons

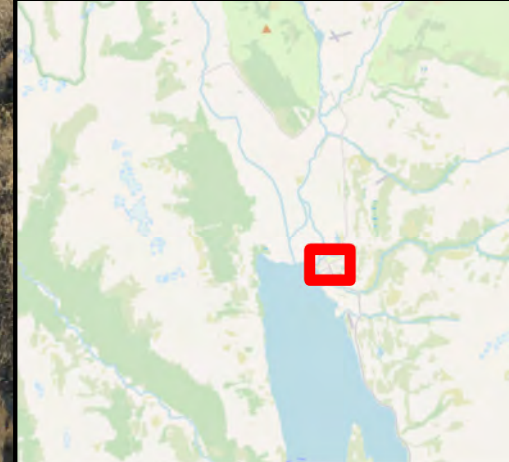
H1 - Generally safe for vehicles, people and buildings
 H2 - Unsafe for small vehicles
 H3 - Unsafe for vehicles, children and the elderly
 H4 - Unsafe for vehicles and people
 H5 - Unsafe for vehicles and people
 All buildings vulnerable to structural damage
 Some less robust buildings subject to failure
 H6 - Unsafe for vehicles and people
 All building types considered vulnerable to failure

MAP TITLE
HAZARD MAP
Scenario 5 – 100 year ARI flow (Future Climate, RCP8.5)
10 year ARI lake level – Avulsion towards lagoons

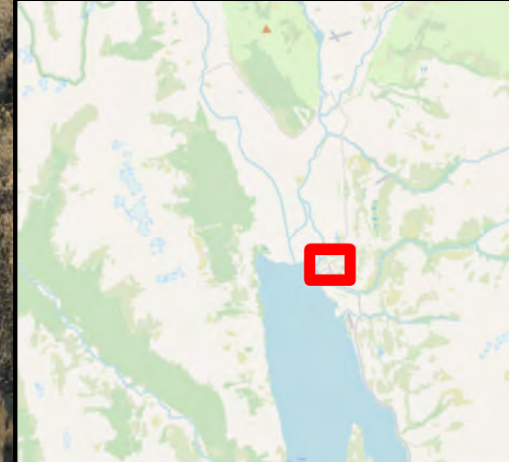
H1 - Generally safe for vehicles, people and buildings
 H2 - Unsafe for small vehicles
 H3 - Unsafe for vehicles, children and the elderly
 H4 - Unsafe for vehicles and people
 H5 - Unsafe for vehicles and people
 All buildings vulnerable to structural damage
 Some less robust buildings subject to failure
 H6 - Unsafe for vehicles and people
 All building types considered vulnerable to failure

MAP TITLE
HAZARD MAP
Scenario 6 - 100 year ARI flow (Future Climate, RCP8.5)
10 year ARI lake level - Breach 1 (90m Wide)
Avulsion towards lagoons

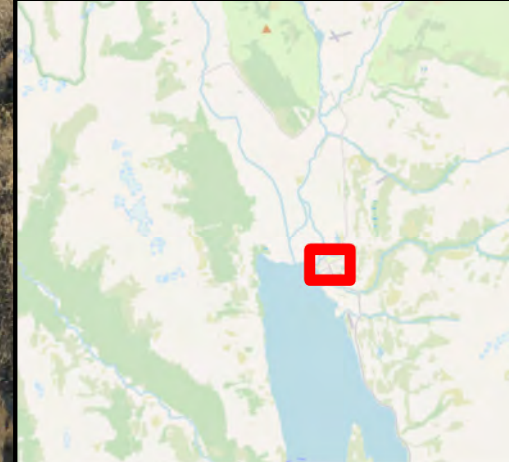
H1 - Generally safe for vehicles, people and buildings
 H2 - Unsafe for small vehicles
 H3 - Unsafe for vehicles, children and the elderly
 H4 - Unsafe for vehicles and people
 H5 - Unsafe for vehicles and people
 All buildings vulnerable to structural damage
 Some less robust buildings subject to failure
 H6 - Unsafe for vehicles and people
 All building types considered vulnerable to failure

MAP TITLE
HAZARD MAP
Scenario 7 - 100 year ARI flow ((Future Climate, RCP8.5)
10 year ARI lake level - Breach 2 (90m Wide)
Avulsion towards lagoons
