Dart-Rees Floodplain Adaptation - Report on 23-24 February 2022 Workshop

Prepared for Otago Regional Council

Damwatch Engineering Ltd
PO Box 1549
Wellington 6140
New Zealand

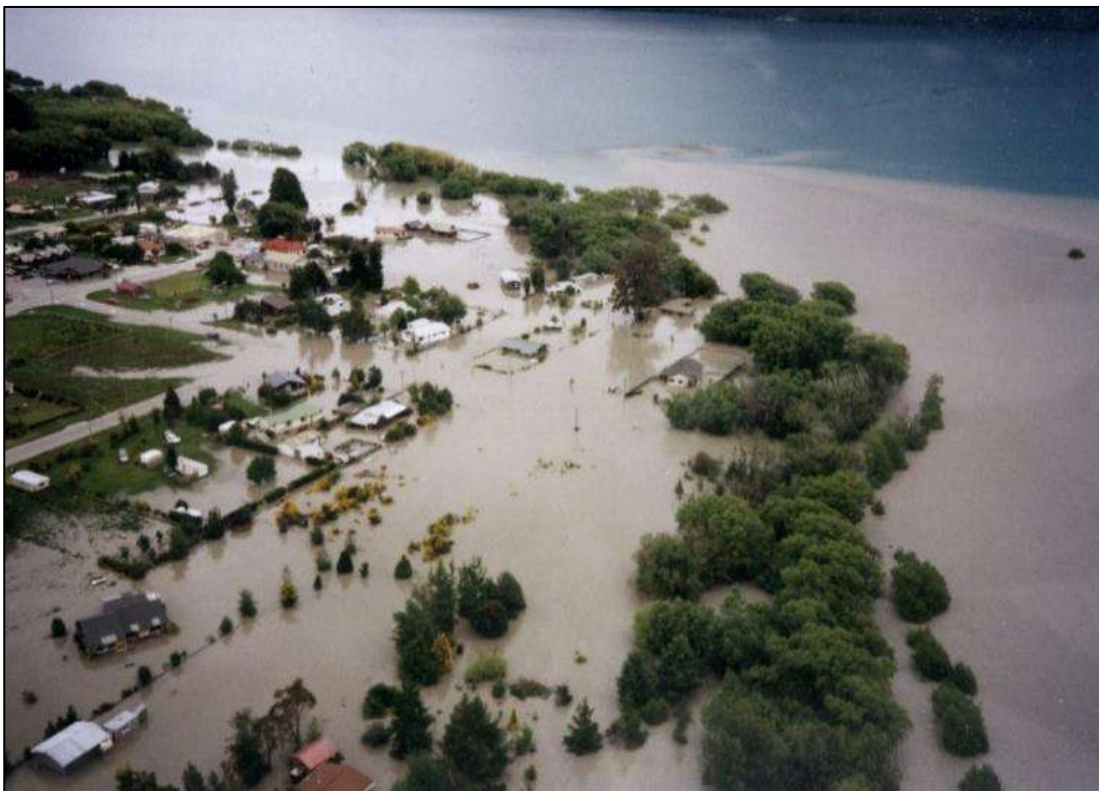
Figure 2.3: Flooding in Glenorchy in November 1999 (a combination of lake and fluvial sourced flooding)

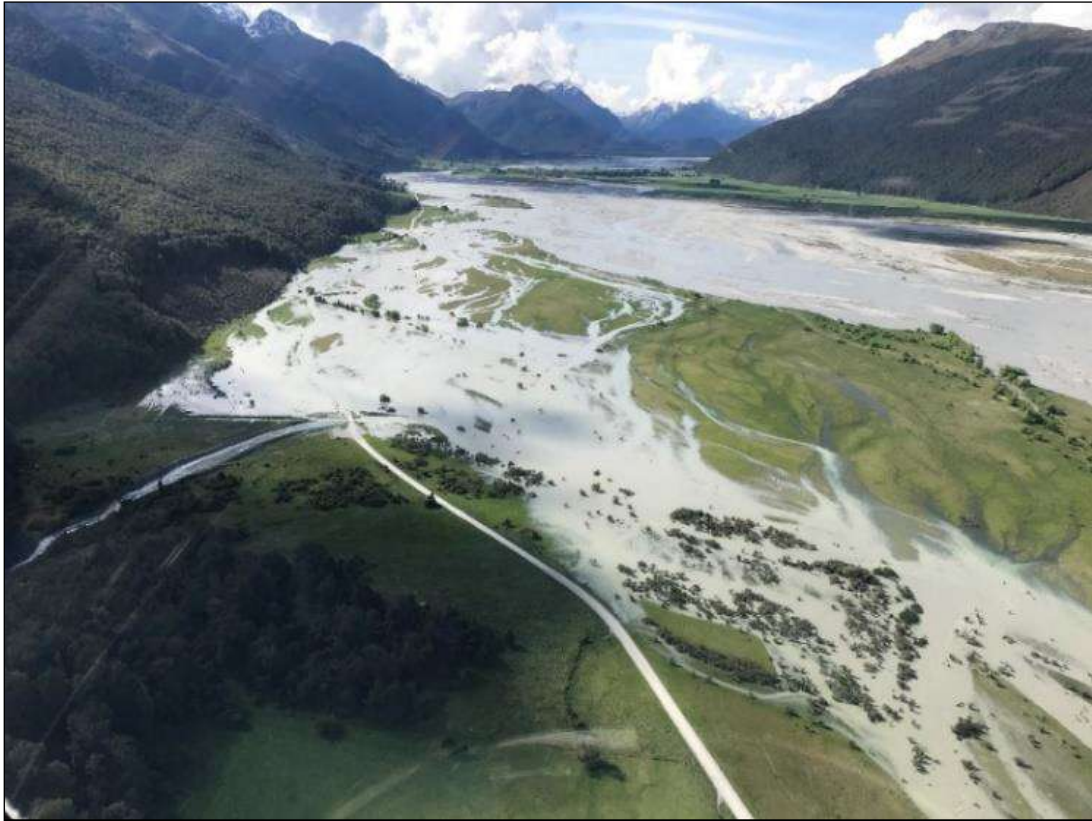
Figure 2.4: Flooding of Kinloch Road (in the foreground) in a minor flood event in 2019 - Dart River floodplain looking upstream

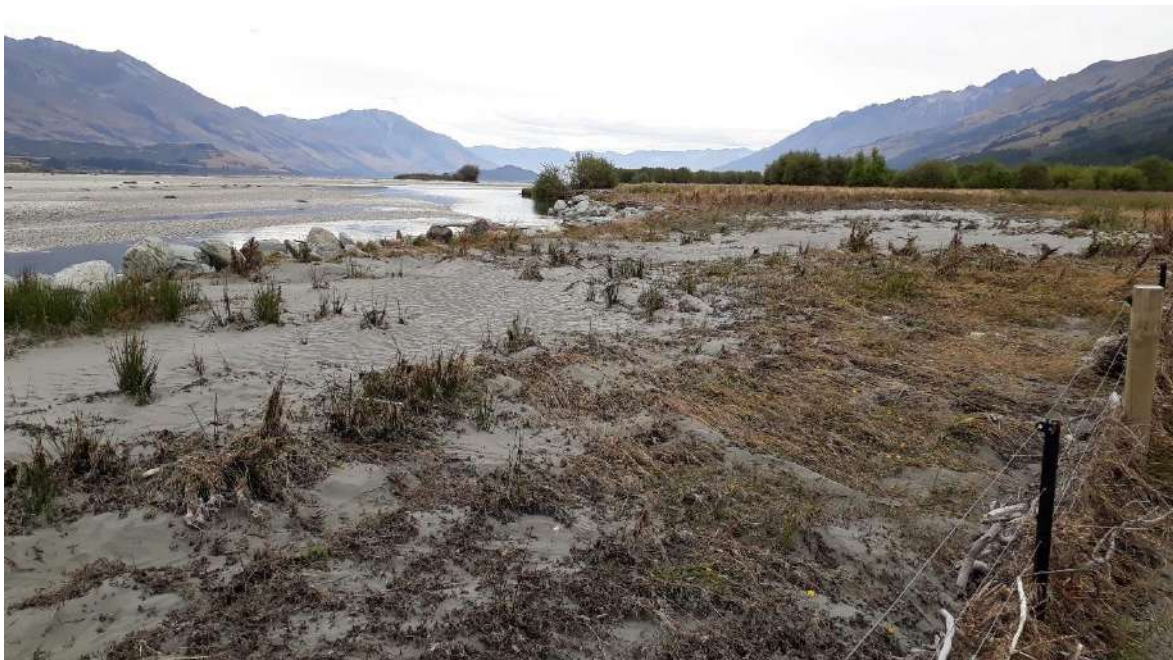
Figure 2.5: Erosion protection works adjacent to Kinloch Road with evidence of recent breakout flows across road in February 2022 (note level of riverbed adjacent to right bank floodplain)

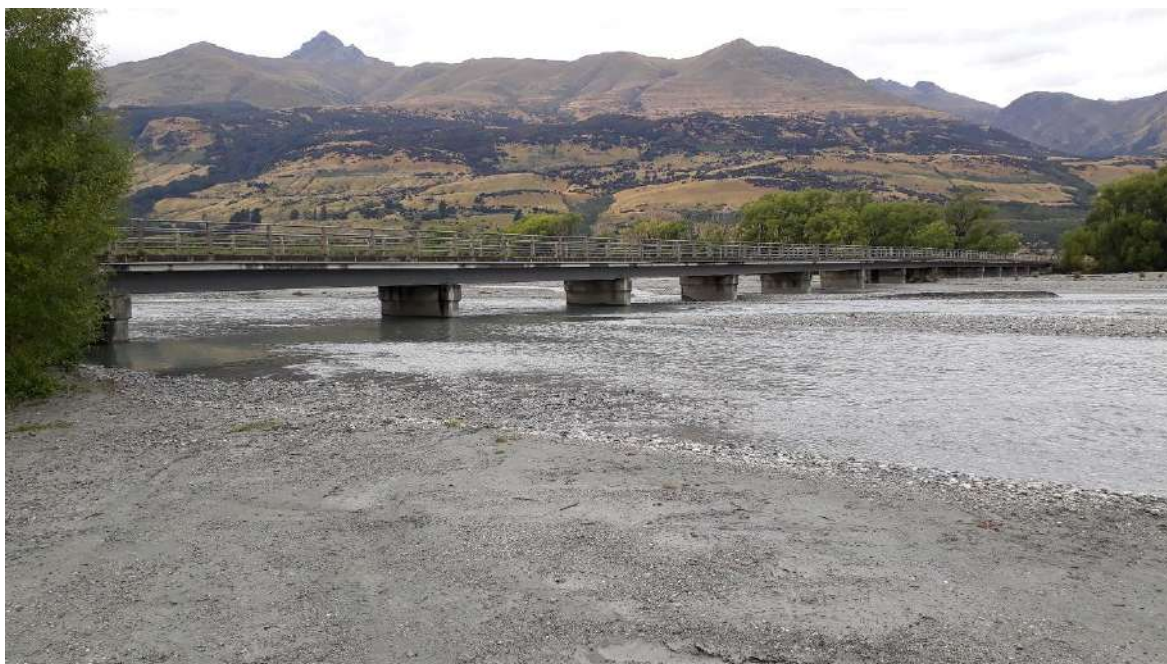
Figure 2.6: Riverbed aggradation under Rees Bridge in February 2022 (viewed looking upstream)

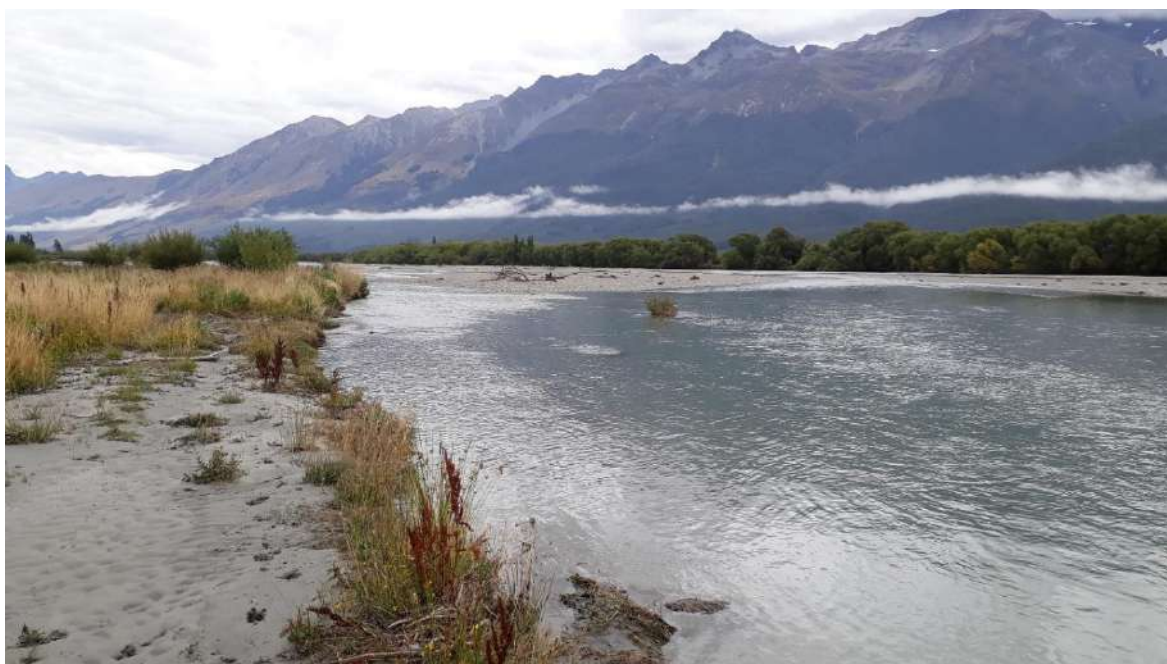
Figure 2.9: View looking downstream along the left bank of the Lower Rees River showing evidence of loss of freeboard and sediment deposition from recent flood breakout flows (photo taken on 9 February 2022 near start of bed level change map in Figure 2.8 – river flow $\approx 13 \text{ m}^3/\text{s}$ at time of photograph)

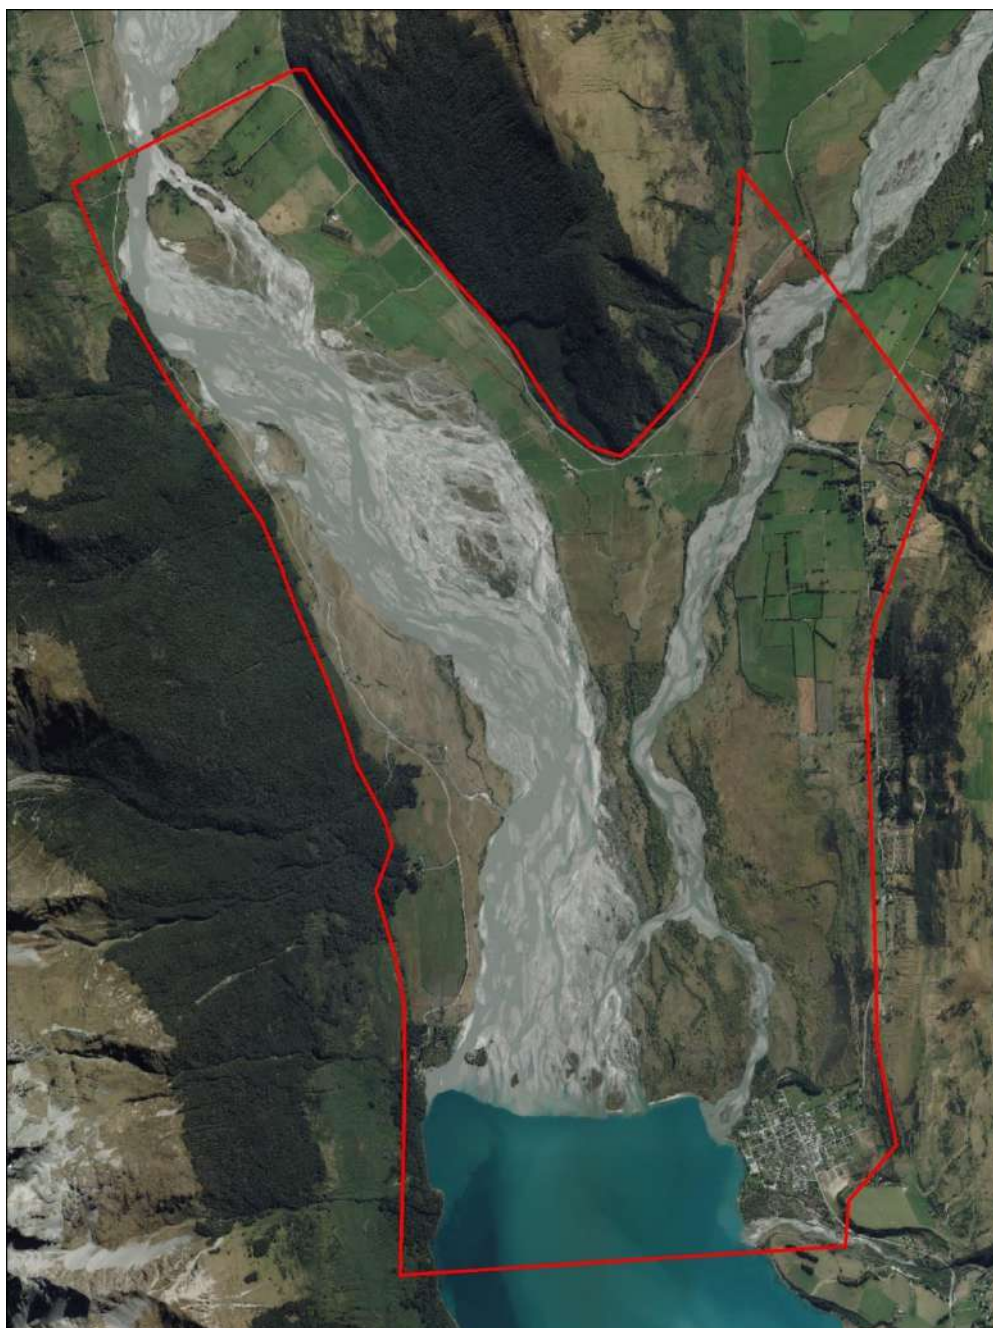
Figure 2.10: Extent of 2D computational hydraulic model of Dart-Rees River System used for flood hazard assessment

ORC recently commissioned Land River Sea Consulting to undertake a flood hazard assessment for the Dart-Rees River System using a two-dimensional (2D) computational hydraulic modelling approach. The 2D model developed for the assessment was based on a 2019 LiDAR topographic survey of the river system and covered the area shown in Figure 2.10 (reproduced from the Land River Sea Consulting report¹⁷). The model extended from the Rees River and Dart River Bridges down to Lake Wakatipu.

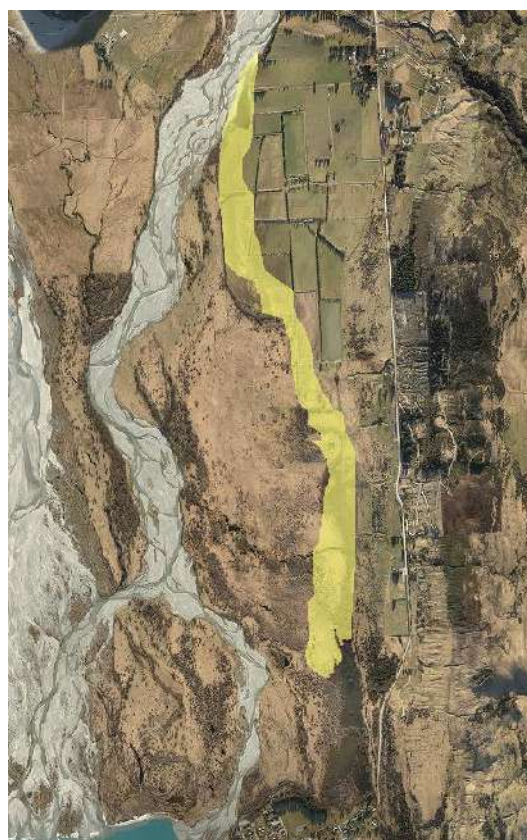
Figure 2.12: Possible channel avulsion path along left bank of Lower Rees River towards Glenorchy Lagoon

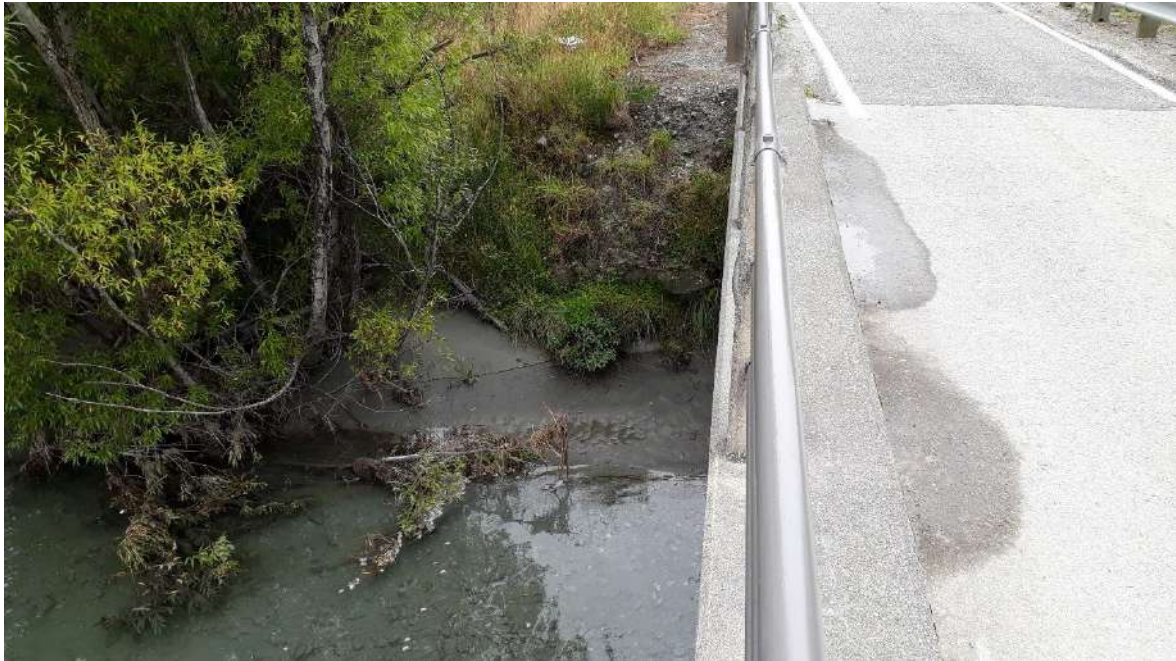
Figure 6.1: View of left abutment of Rees Bridge on upstream side from bridge

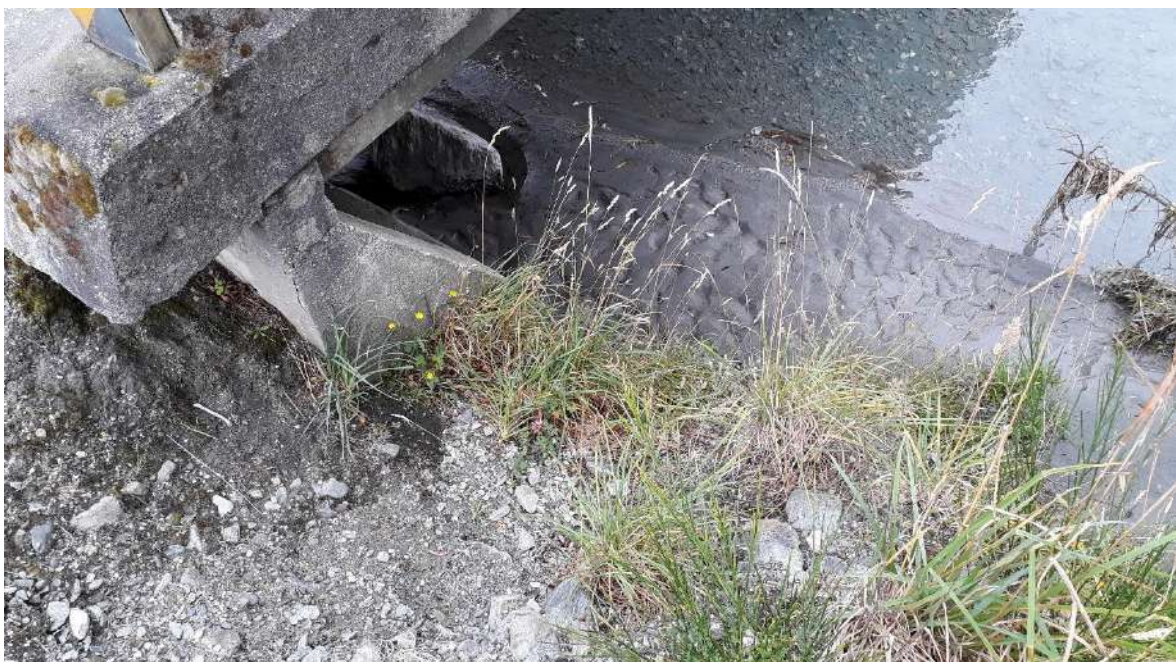
Figure 6.2: View under left abutment of Rees Bridge from upstream side of road embankment showing small amount of slumping of approach embankment fill material

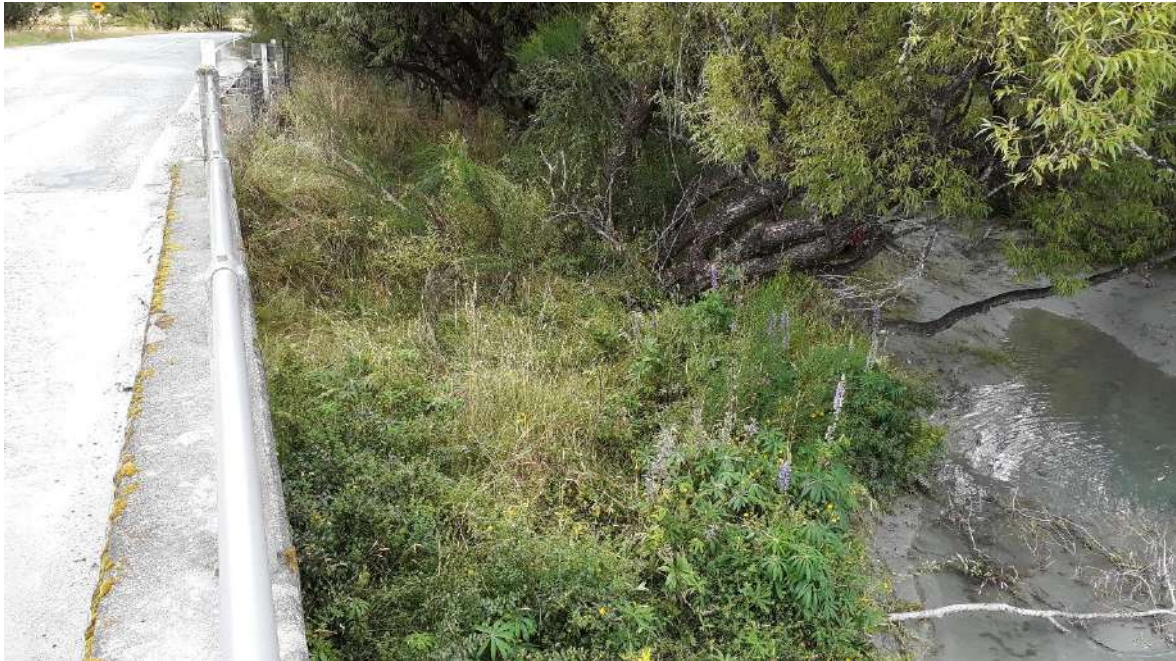
Figure 6.3: View of right abutment of Rees Bridge on upstream side from bridge

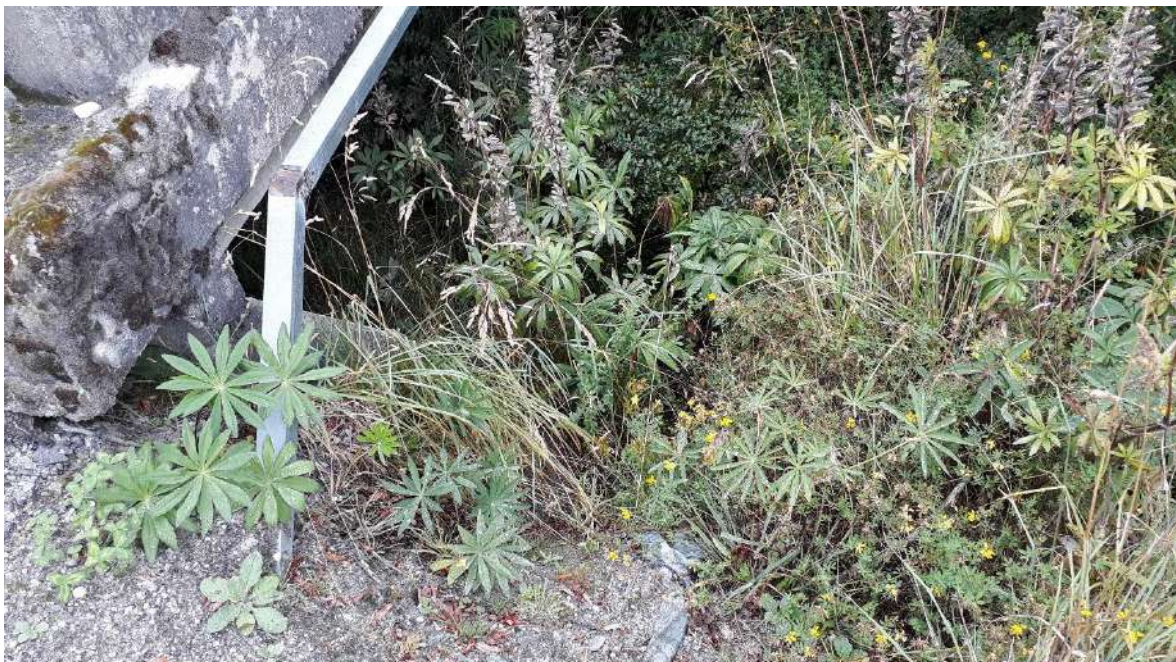
Figure 6.4: View under right abutment of Rees Bridge from downstream side of road embankment

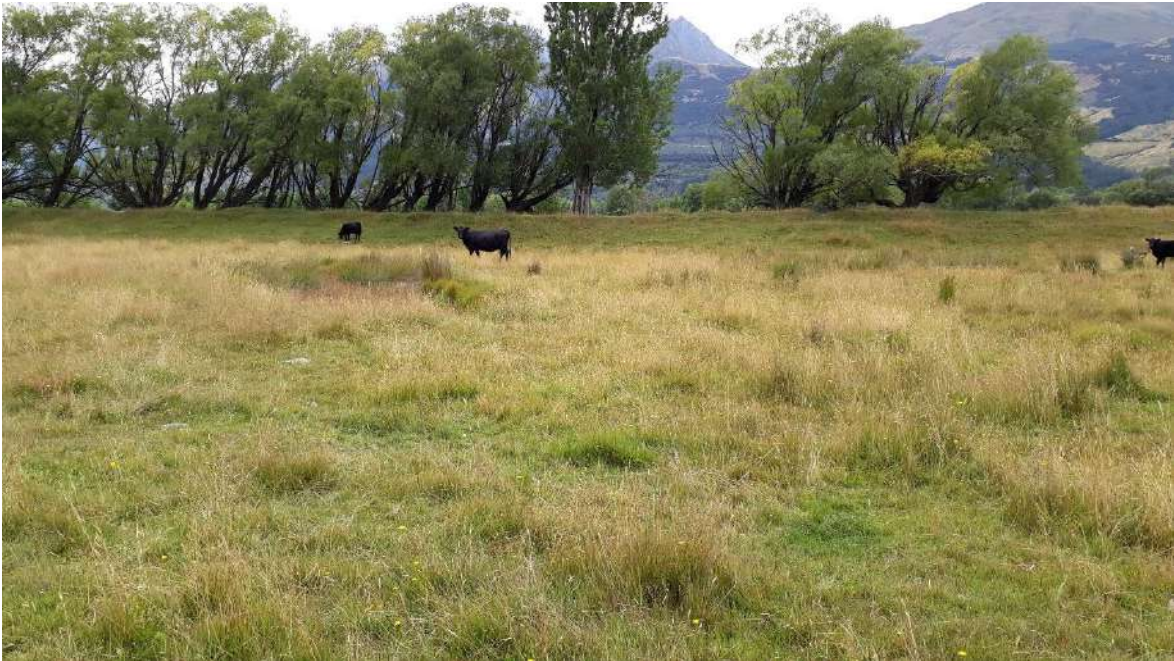
Figure 6.6: Secondary stopbank on right bank upstream of Rees Bridge which runs parallel with Paradise Road

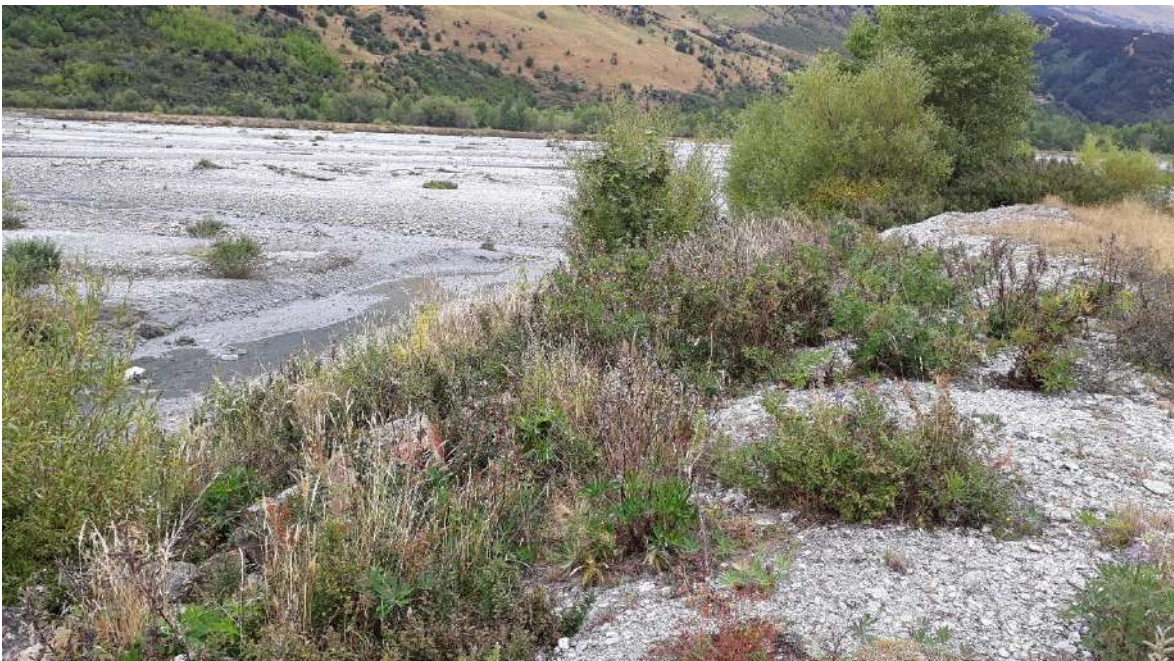
Figure 6.7: Rock groyne structure on right bank of Rees River upstream of existing bridge (the head of the structure beyond the willow saplings in the right of the photo was damaged in a recent flood event)

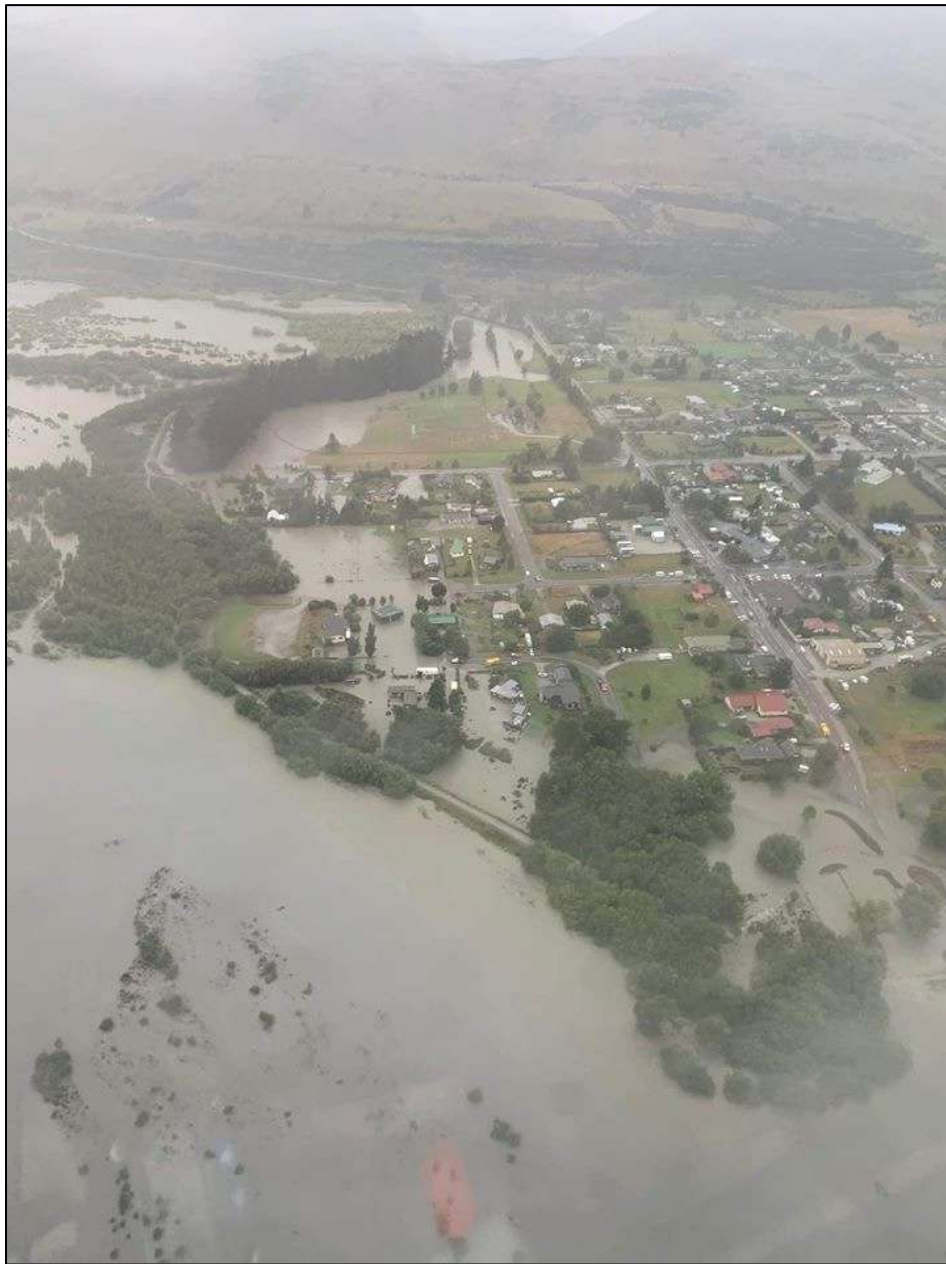
Figure 2: Flooding of the township in February 2020. In this event, floodwaters from the Rees River filled the Glenorchy Lagoon to the crest level of the adjacent Glenorchy floodbank and then overtopped to flow through the northwest margins of the township.

The key factors in this flood event are interpreted as; 1. the sustained, high flows in the Rees River, with overland flows eastwards into the wetland area, and 2. the backwater effects of elevated lake levels on flows in the lower Rees River, and on the drainage of the Glenorchy Lagoon. (Photo credit: Luke Hunter)

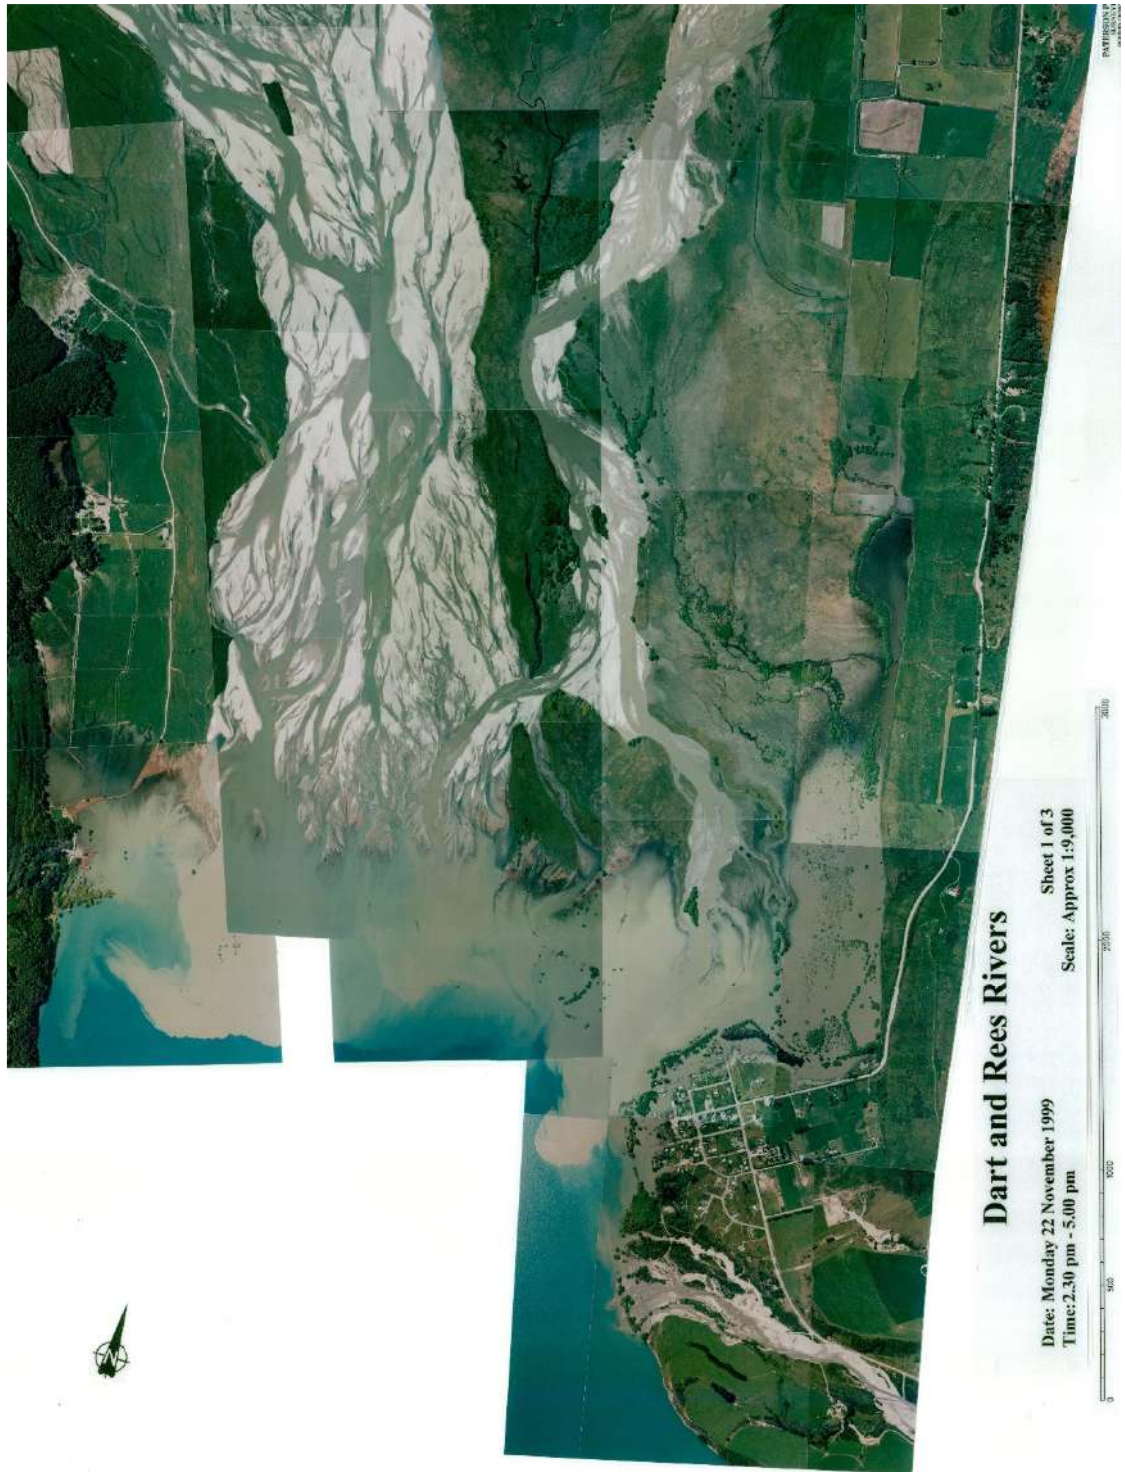
Figure 7: Vertical aerial photograph of the lower Dart-Rees floodplain and delta, and Glenorchy township during the November 1999 flood event.

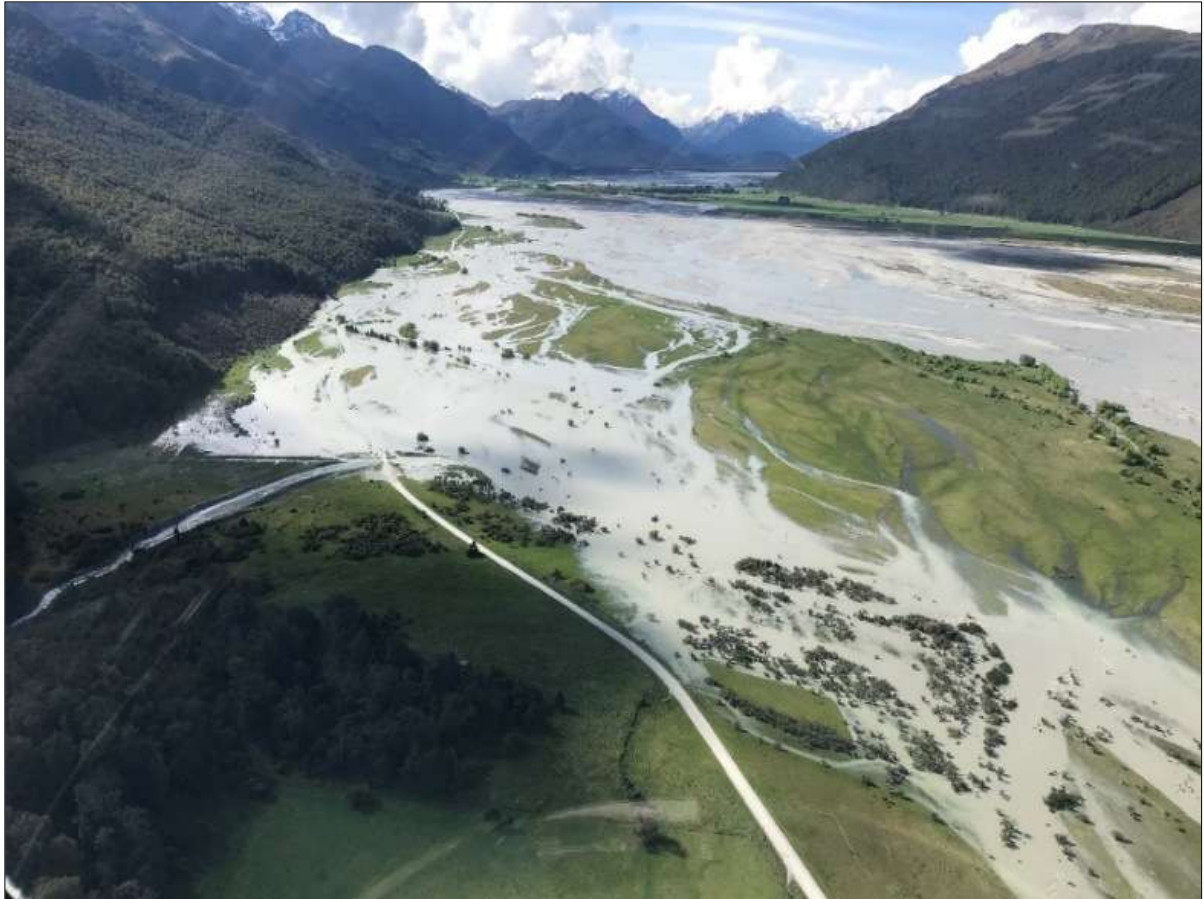
Figure 9: Flooding of the lower Dart floodplain in a moderate 2019 flood event. This shows the Kinloch Road closed due to flooding of sections between Glacier Burn and Turner Creek.

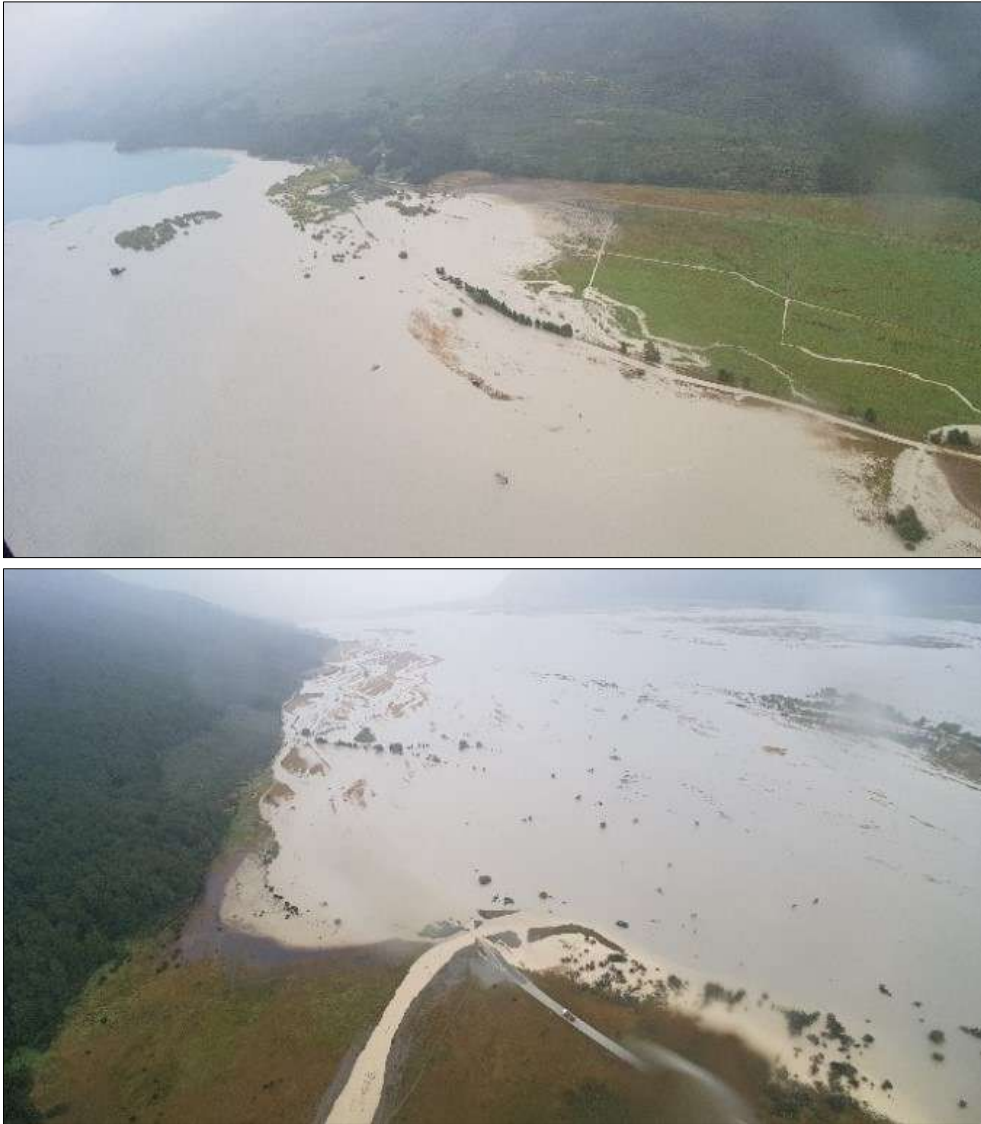
Figure 10: Flooding of the lower Dart floodplain in the March 2019 flood event where the Dart River peaked at ~ 1800 cumecs. Upper photo shows the road near the delta closed due to the combination of river flooding and high lake levels. Lower photo is looking up-valley and shows flooding between Glacier Burn and Turner Creek.

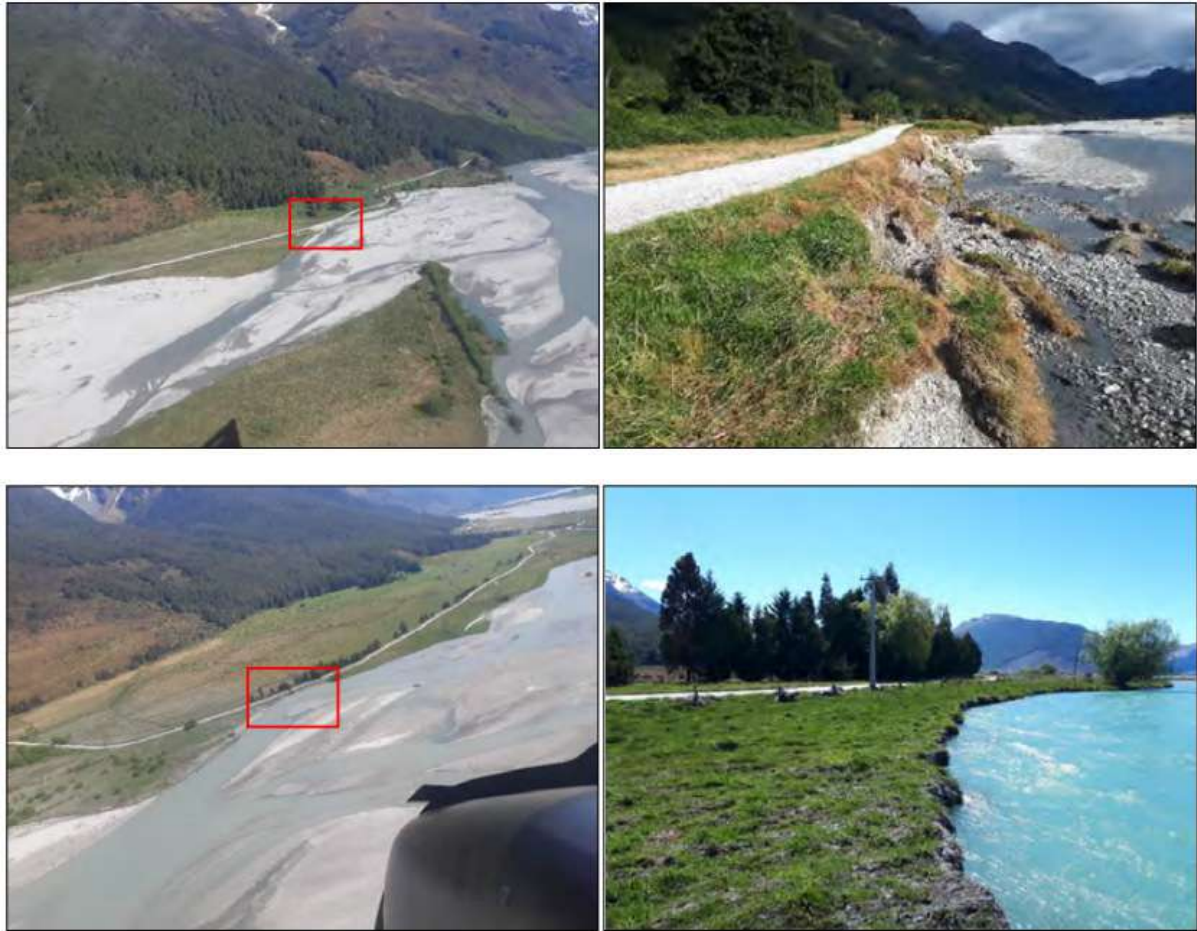
Figure 12: Aerial views (October 2020) of the Dart floodplain between Turner Creek and Kowhai Creek confluences (upper left) and between Glacier Burn and the Dart delta (lower left). Right-hand images show detail of erosion at these locations, taken February 2020 (upper right) and November 2020 (lower right).
