Project No. 20446132-004-L-Rev0

RESPONSE TO REQUEST FOR FURTHER INFORMATION – RM22.099 – MOBIL OIL NEW ZEALAND LIMITED

20449679-003-R-Rev0

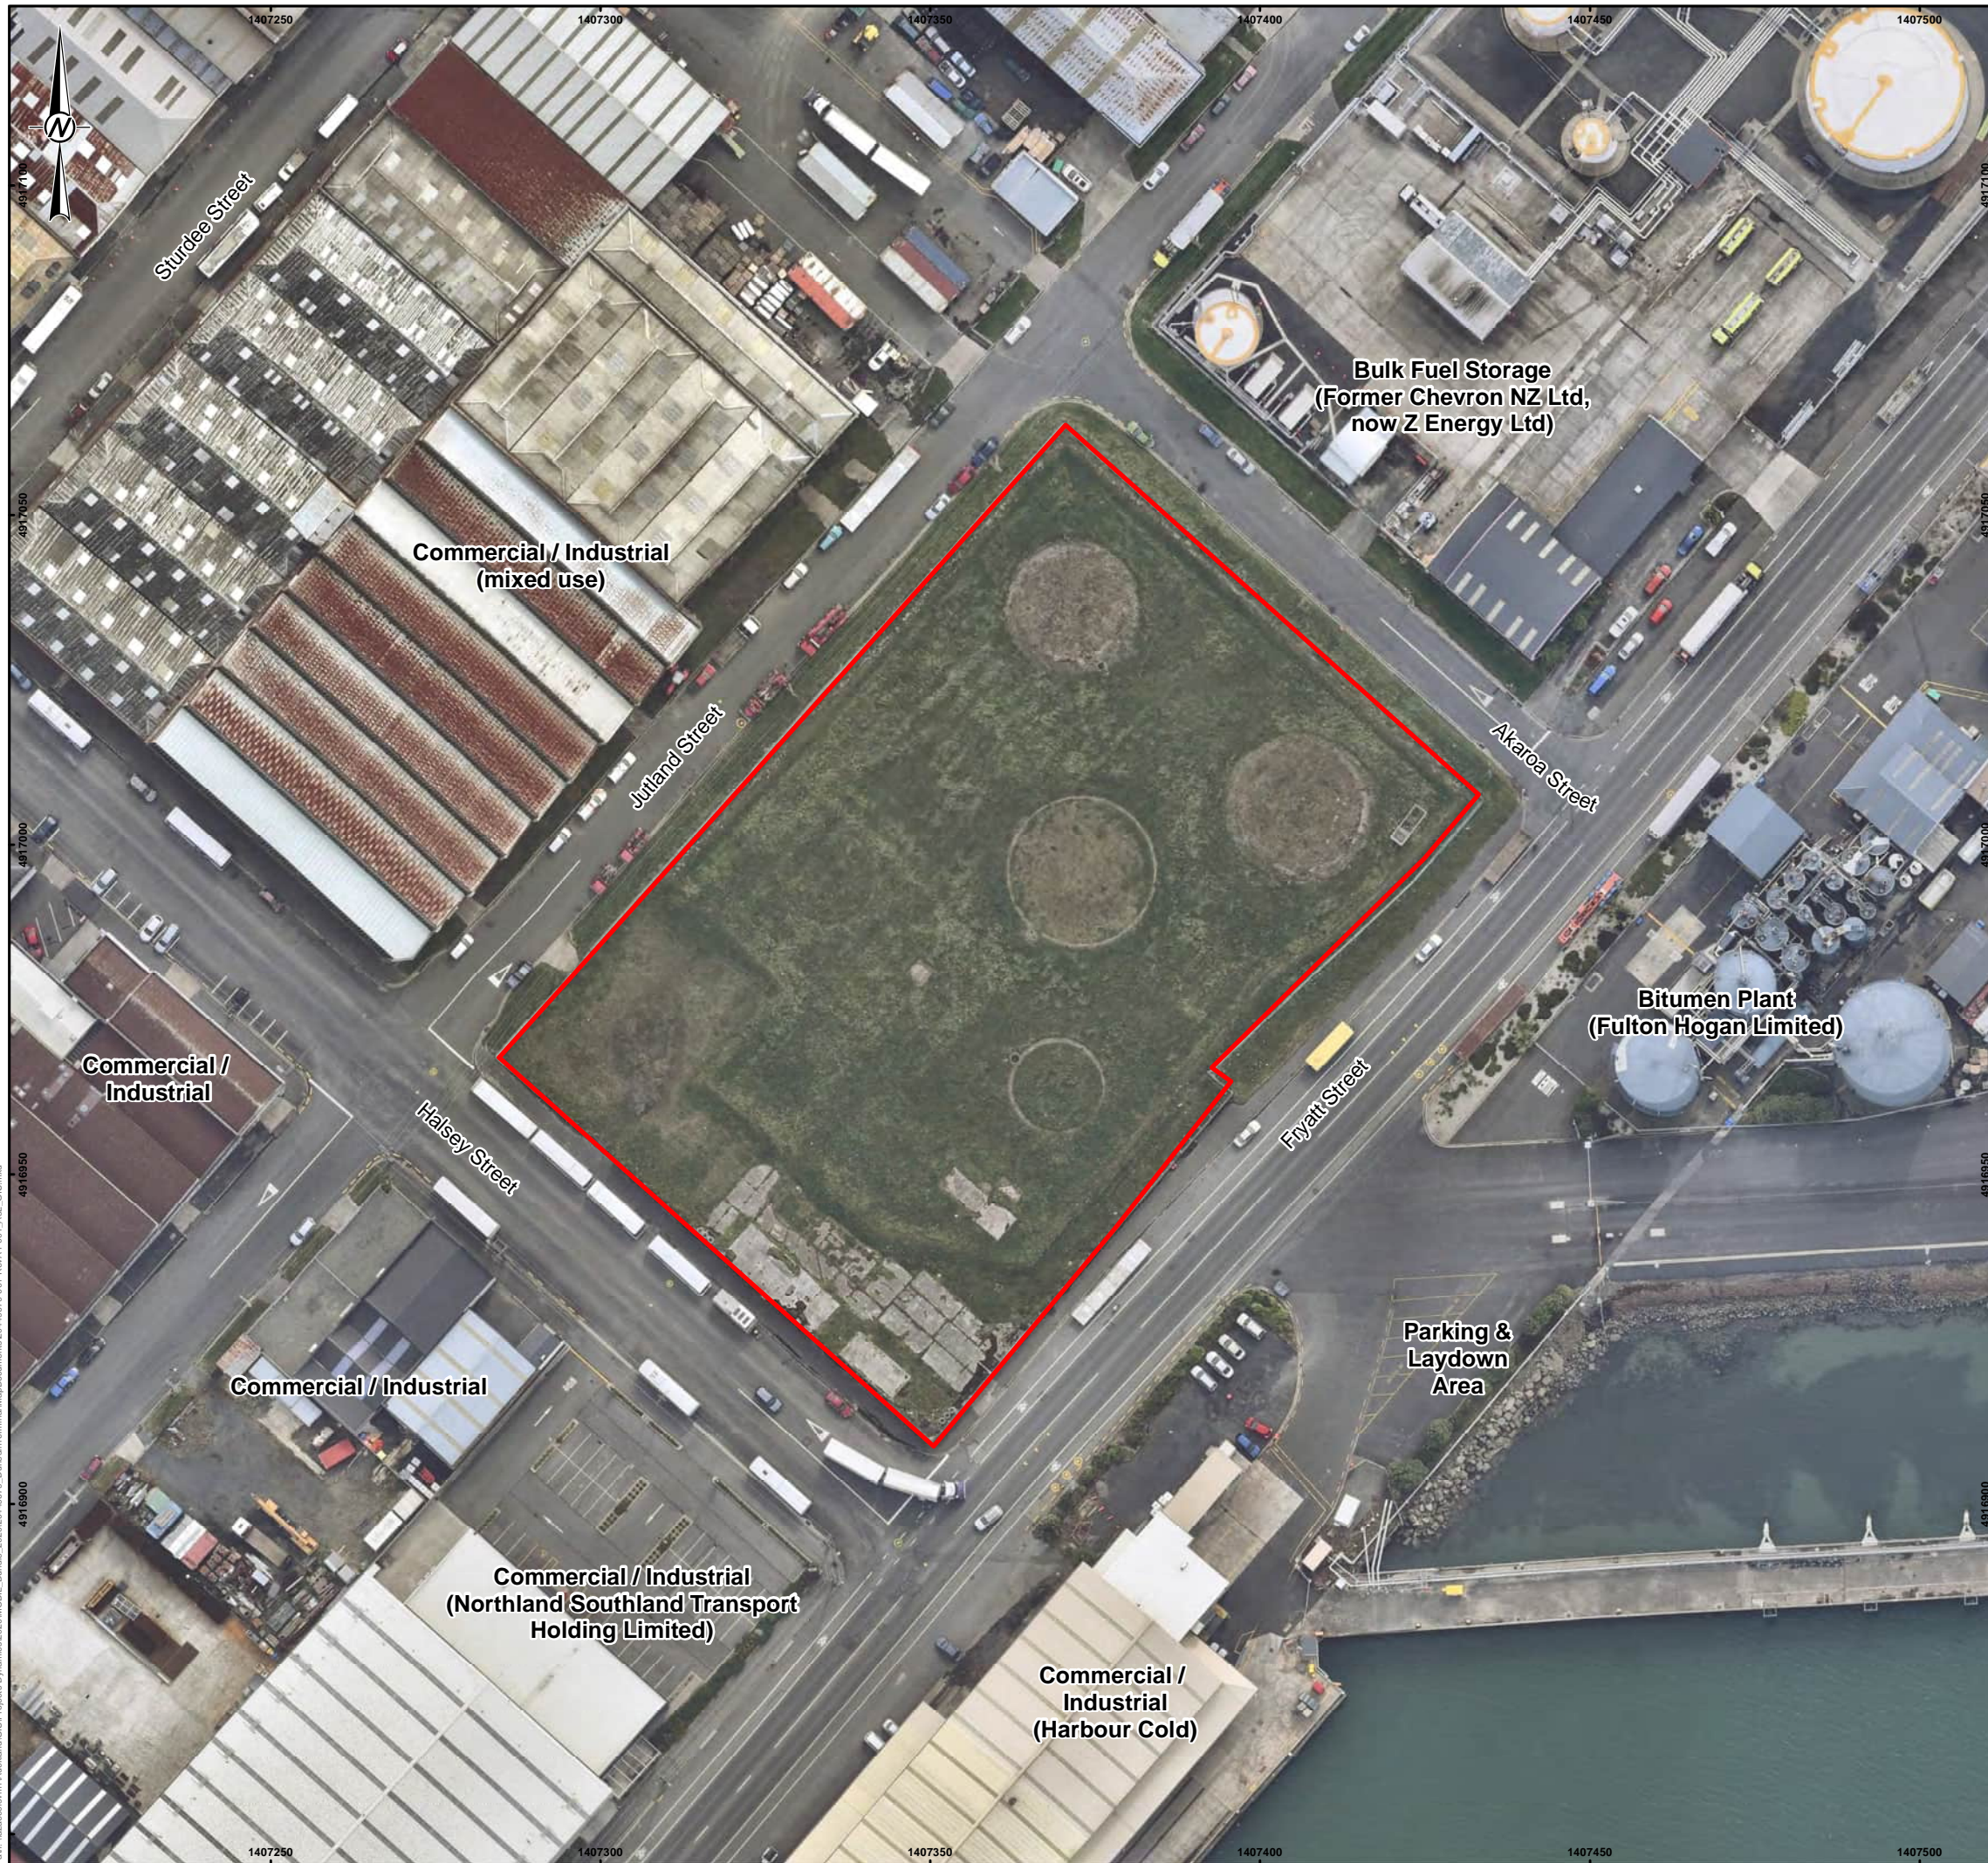
PROJECT NO. 20449679 REPORT 003 REV. 0 FIGURE 01

Currently, the site comprises a predominantly grassed vacant block of land, with concrete building foundations present in the southern corner of the site. Elements associated with former Mobil operations remaining on site include (Figure 2):

- Four fire hydrants and water lines associated with the former fire suppression system.
- Two separators formerly referred to as Separator 1 and Separator 3. Separator 1, a four-chamber separator, is in the eastern corner of the site and was connected to the stormwater system that collected water from the tank compound. Separator 3, a three-chamber separator, is located mid-way along the Halsey Street (south-west) boundary. The source of water received by Separator 3 is not known. Separator 2, formerly located in the southern corner of the site, was not observed during site works and is assumed to have been removed.

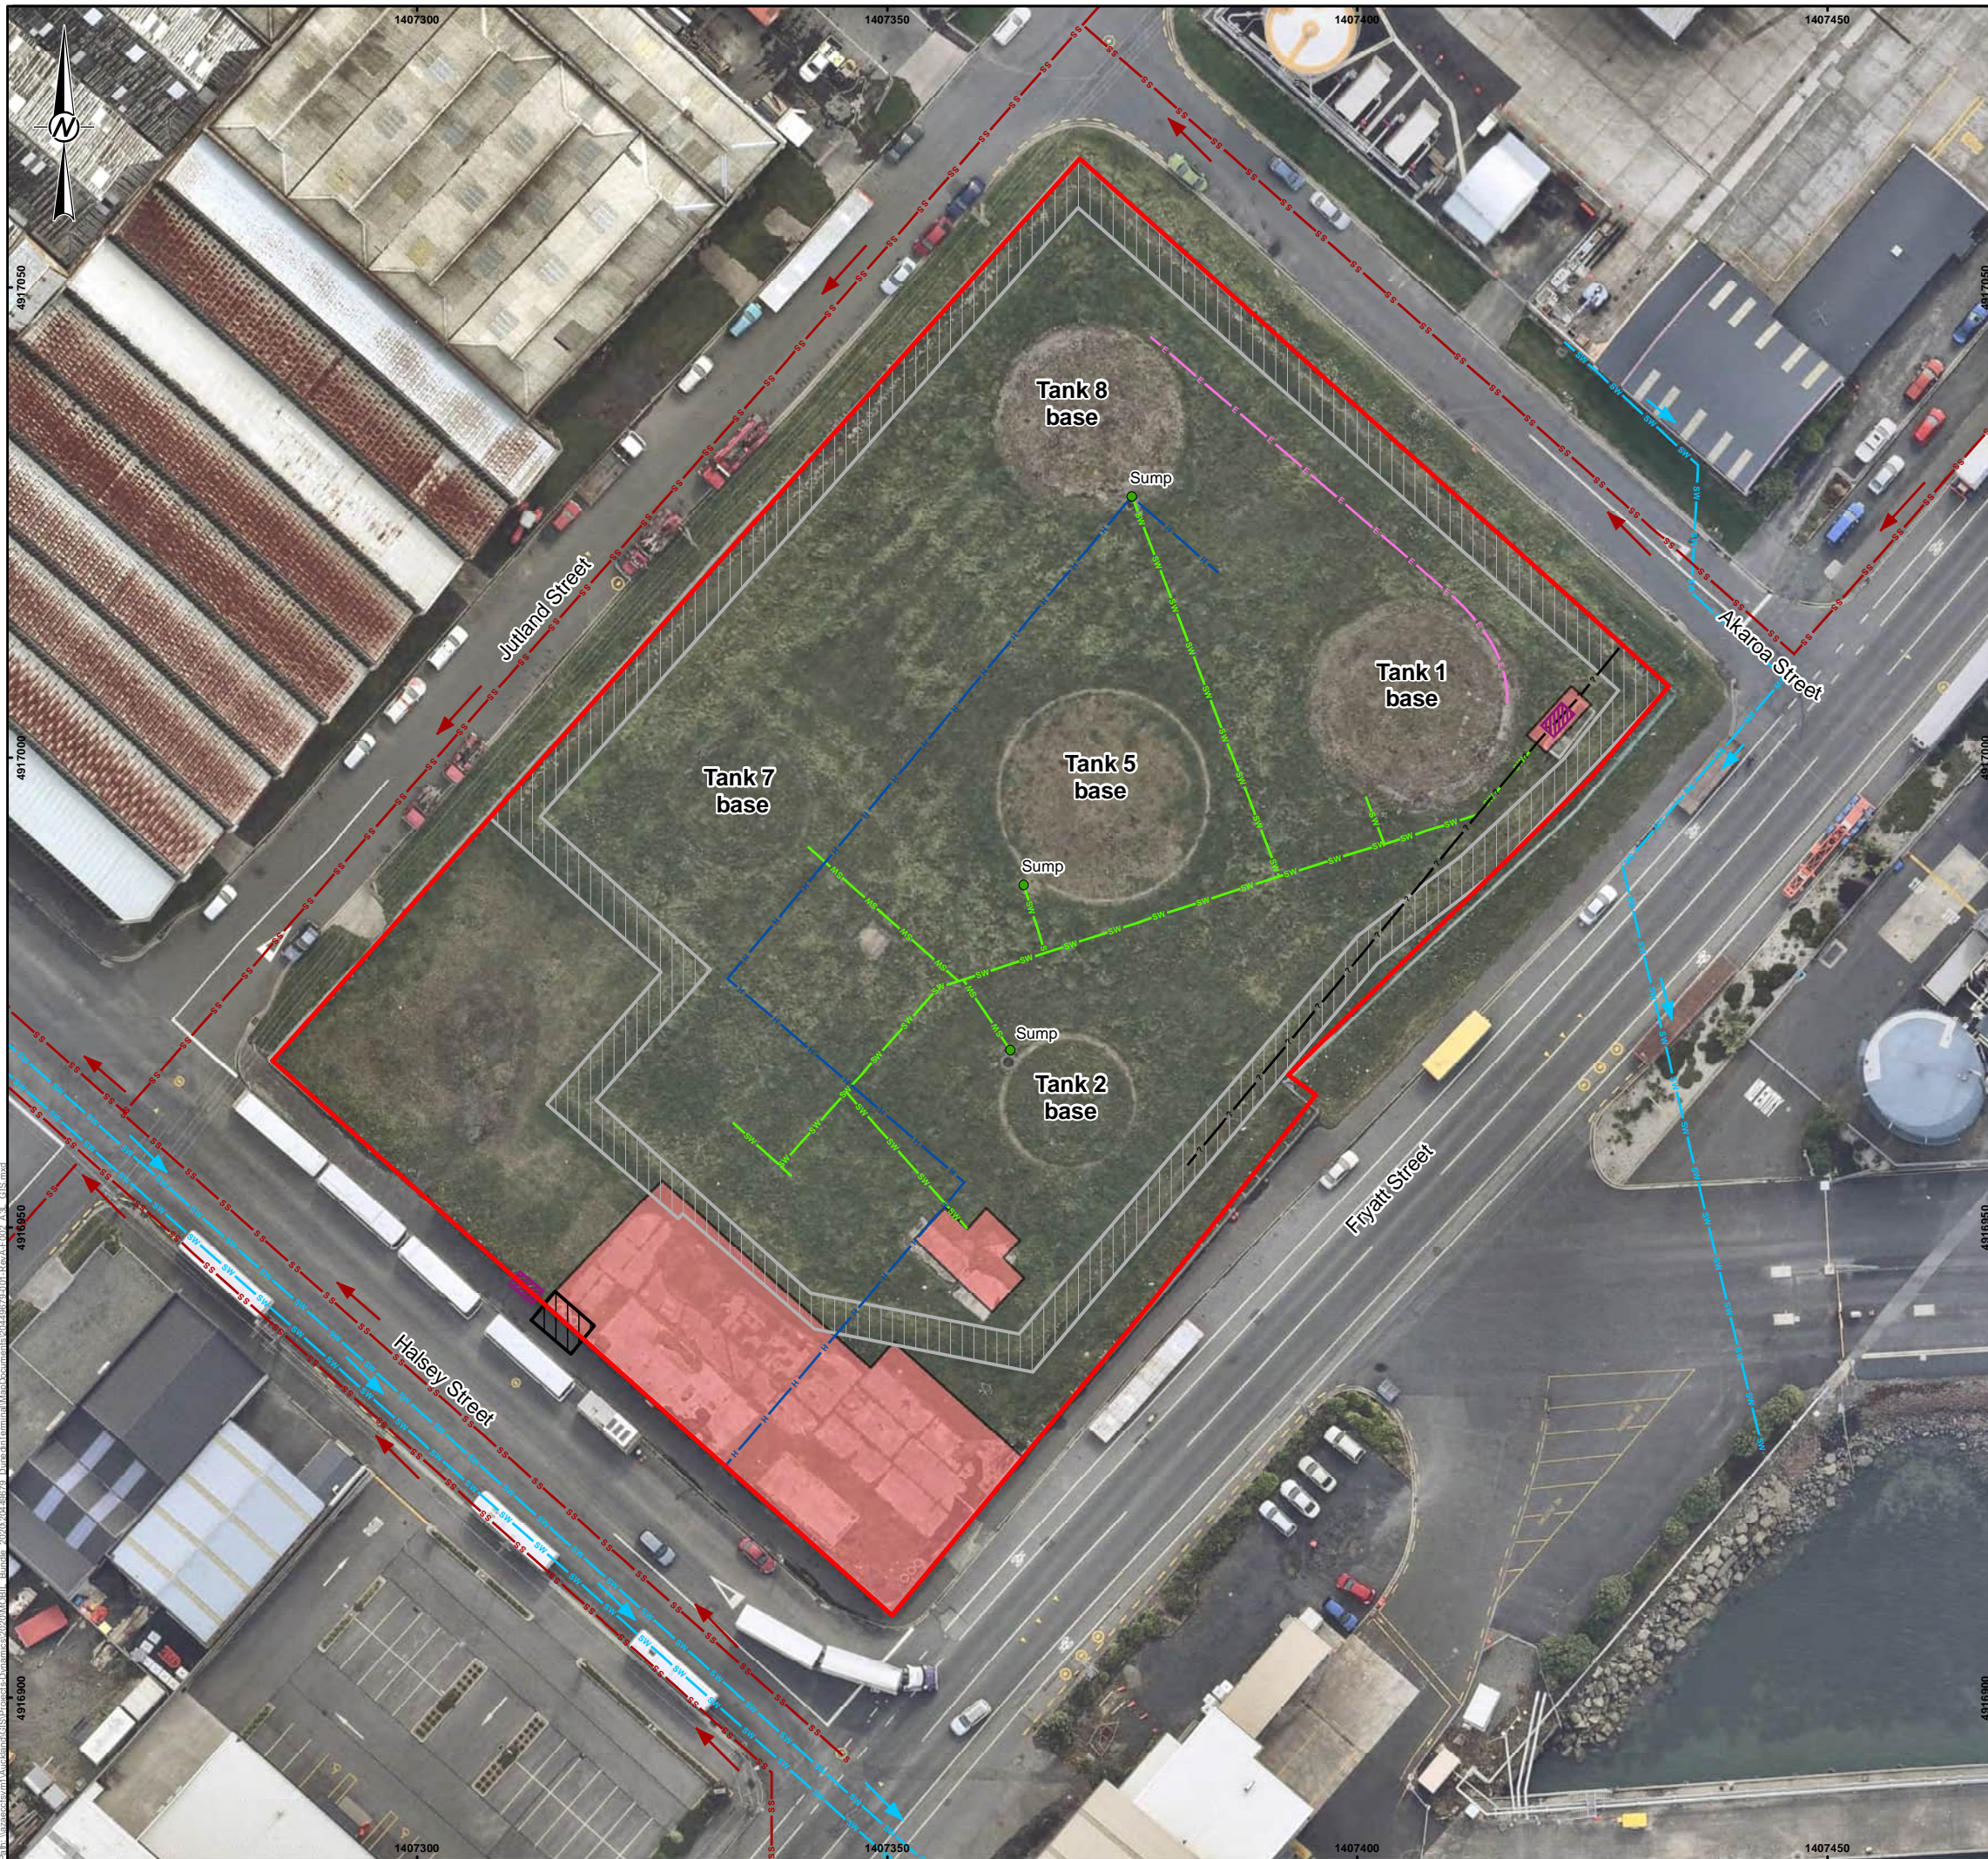
- Site boundary
- SS—S Sanitary sewer
- SW—S Stormwater
- Interceptor
- E—E Electrical (de-energised)
- H—H Hydrant line (de-energised)
- ?—? Unknown
- SW—S Stormwater on site
- Sump (1m diameter)
- Historic fuel lines
- Existing bund
- Concrete pad / surface structure

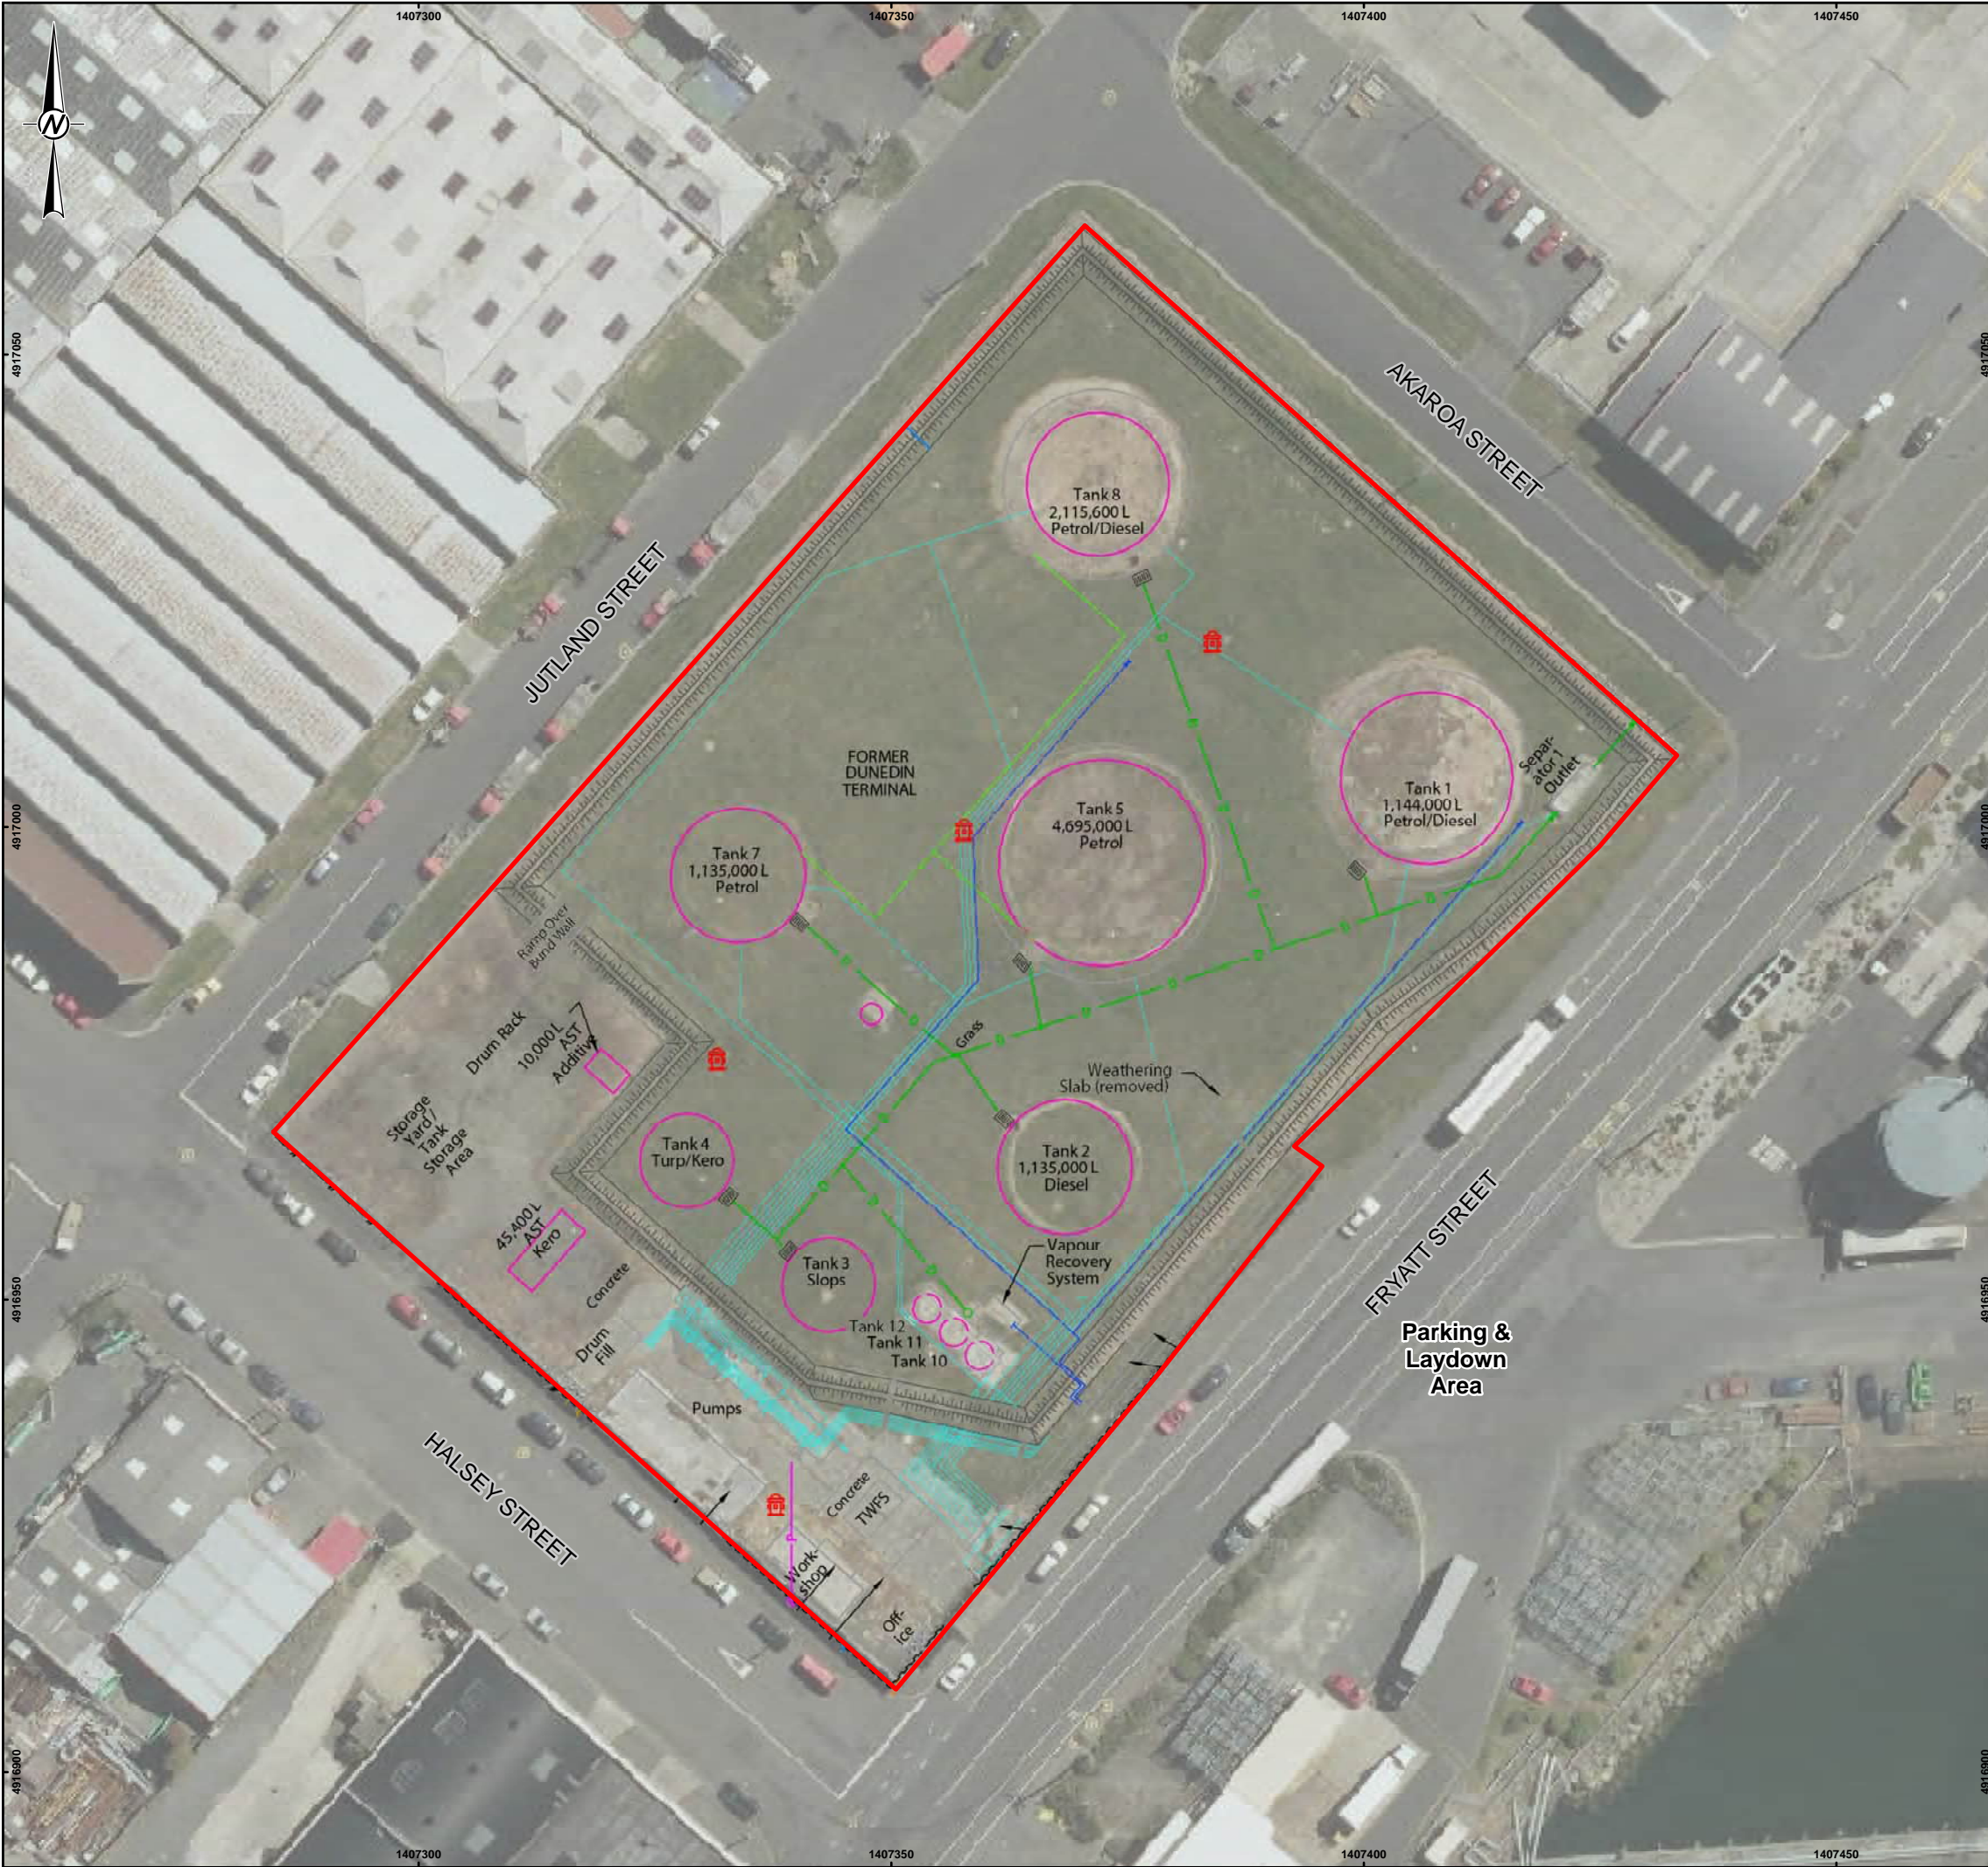
Based on a review of the site history the key sources of hydrocarbon and/or solvent contamination comprise:

- Bulk storage tank compound – bulk tanks and oil-water separator.
- Rail siding along Fryatt Street boundary.
- Drum filling plant approximately half way along the Halsey Street boundary.
- Drum storage in the western corner of the site.
- Tanker wagon fill station in the southern corner of the site.

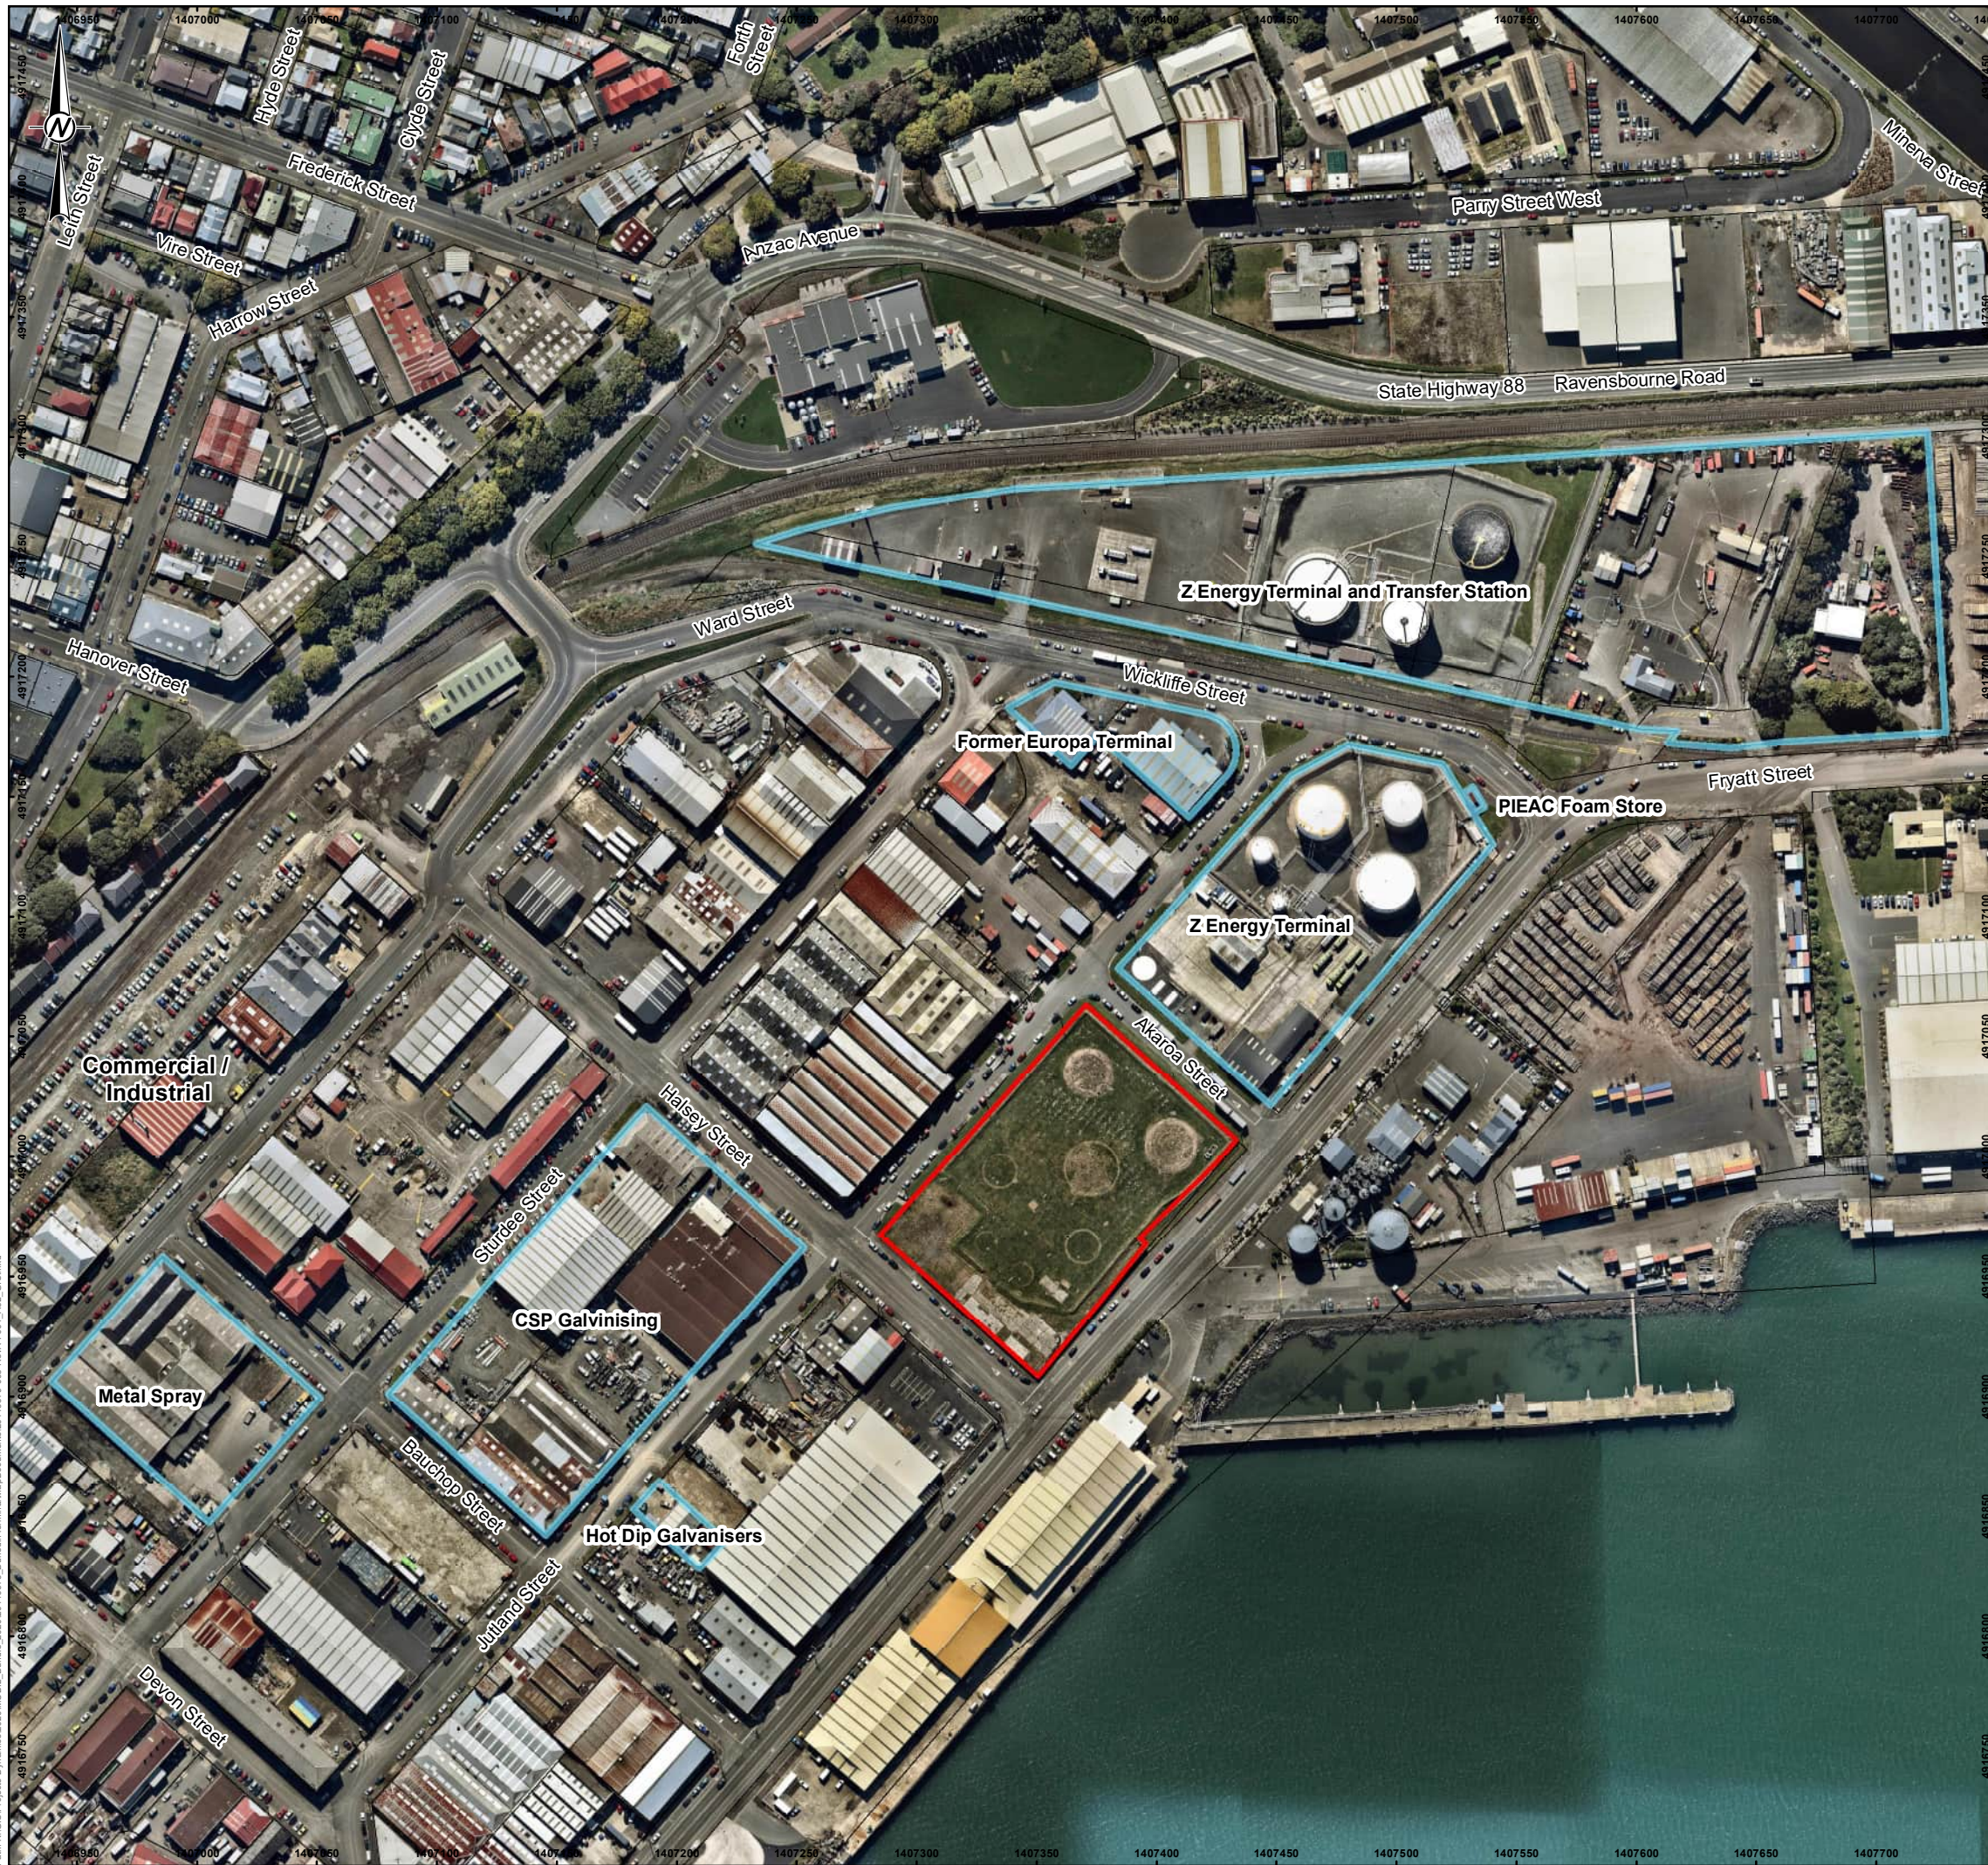
Based on the available information reviewed, the following is noted with respect to potential sources of potential PFAS contamination at the site:

It is noted that with the exception of the Z Energy sites to the north-east of the former Mobil Terminal, the majority of these are listed as not investigated. As such, there is limited information as to potential presence and magnitude of PFAS contamination on and migrating from these properties.

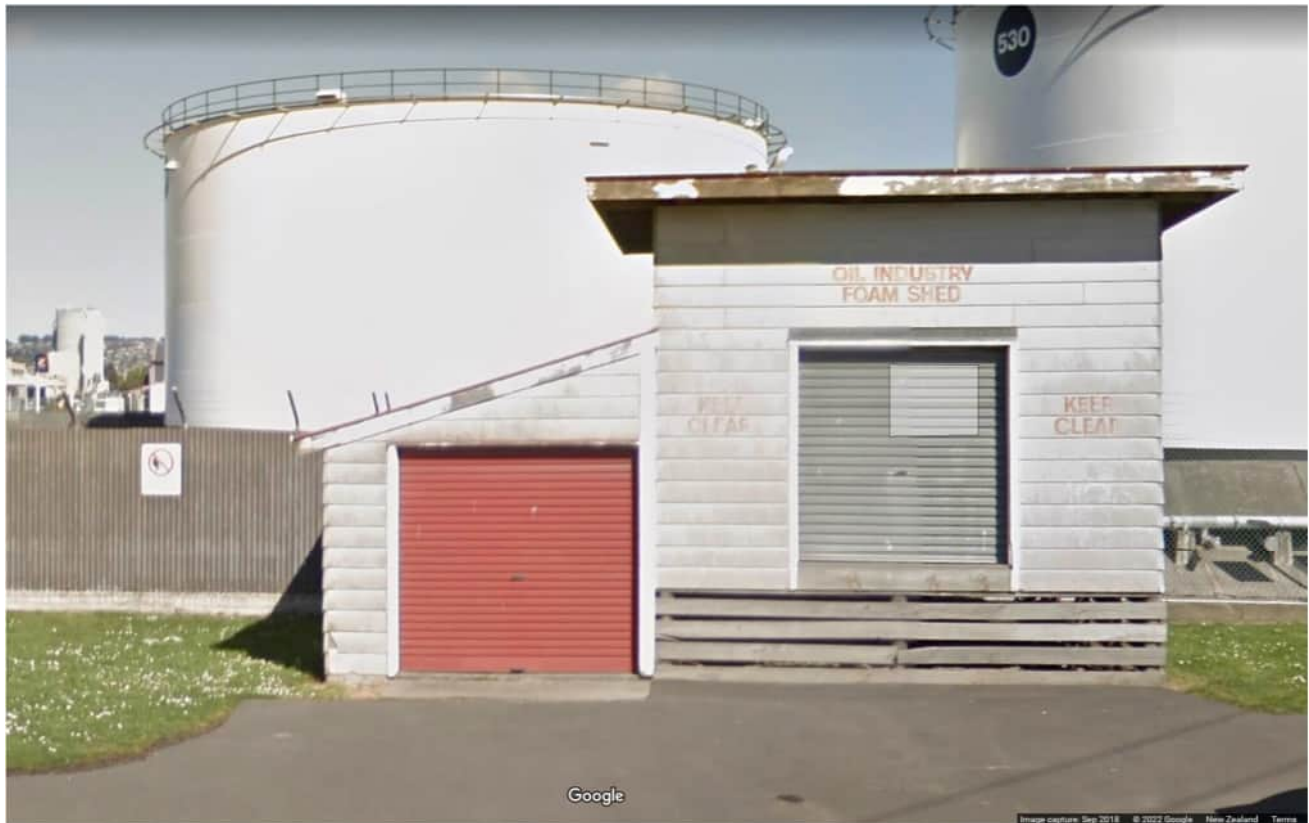
Figure 6: Oil industry (PIEAC) foam shed located adjacent to northern boundary of Z Energy terminal (source: Google Maps - 2018 image).

The DCC HAIL file identifies the Z Energy terminal as being the location of the PIEAC foam store. The foam store was located to the north of the fenced boundary of the Z Energy terminal in the grass verge adjacent to the intersection of Fryatt Street and Wickliffe Street (Figure 6). The DCC HAIL file does not include information regarding the use of foam on the Z Energy terminal or whether there has been an assessment of PFAS impacts to soil and groundwater.
