Safety and Resilience Committee 9 November 2023

| 9.1 | Head of Lake Whakatipu Natural Hazards Adaption | 7 |
| 9.1.2 | Land River Sea Consulting 2023 Buckler Burning flood hazard modeling | 31 |

Buckler Burn Flood Hazard Modelling

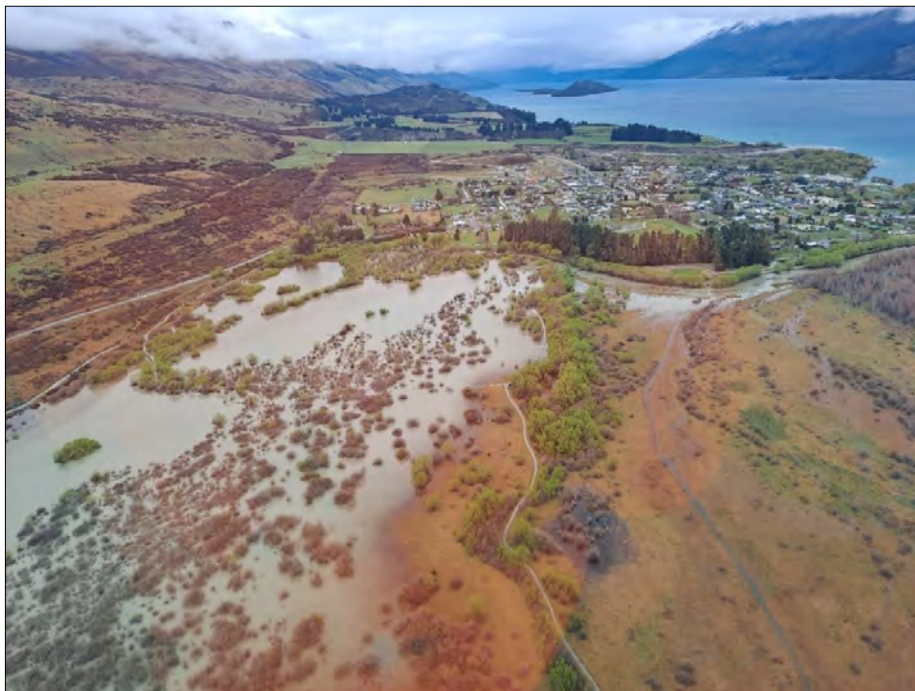
Figure 9: View of Glenorchy Lagoon and Glenorchy township, taken 22 September 2023.

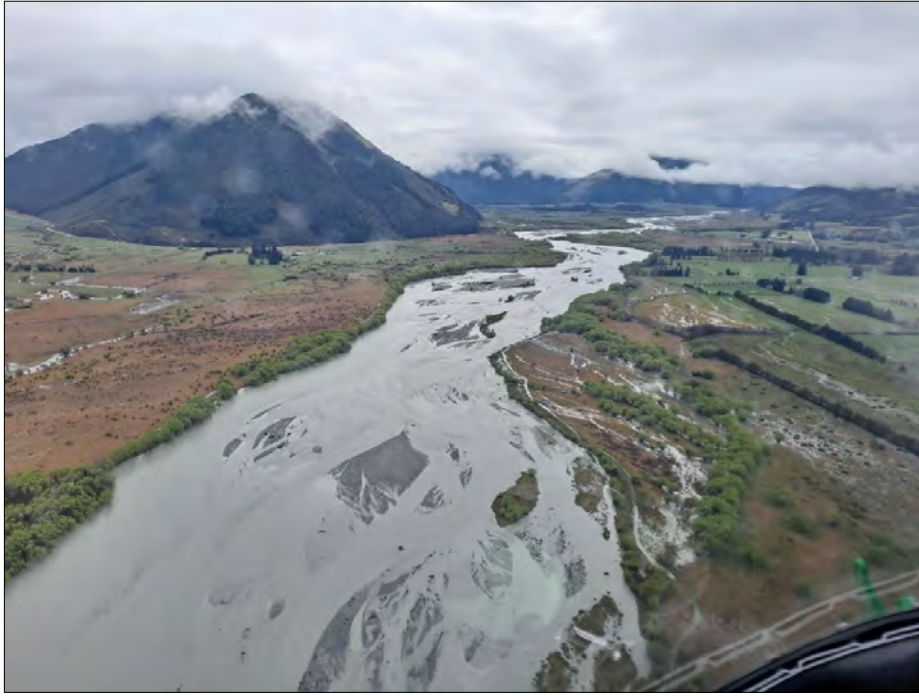
Figure 10: View upriver on the lower Rees floodplain towards Mount Alfred and the Rees bridge, taken 22 September 2023.

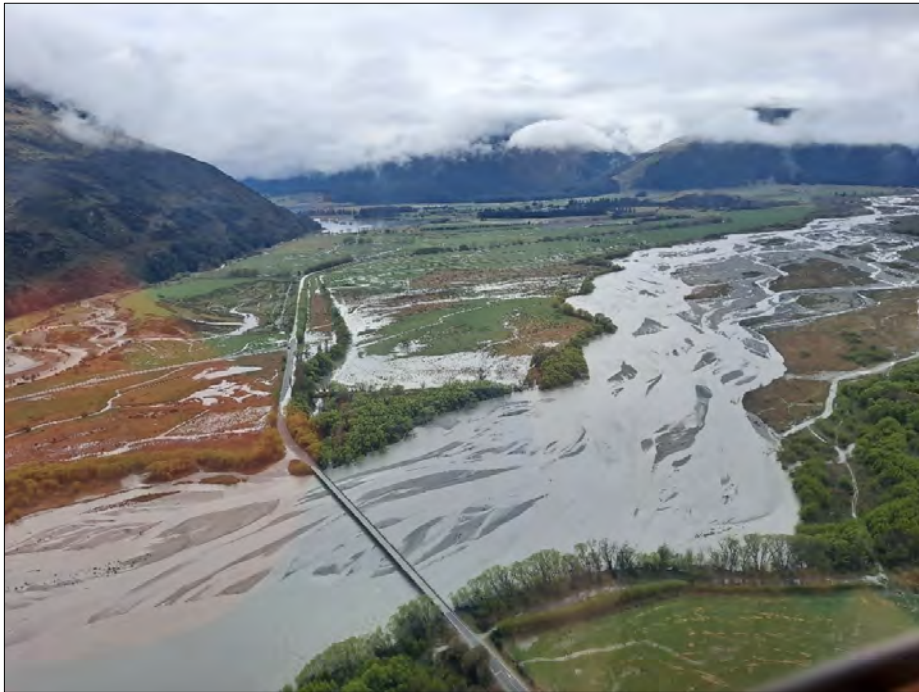
Figure 11: View upriver on the upper Rees floodplain, taken 22 September 2023.

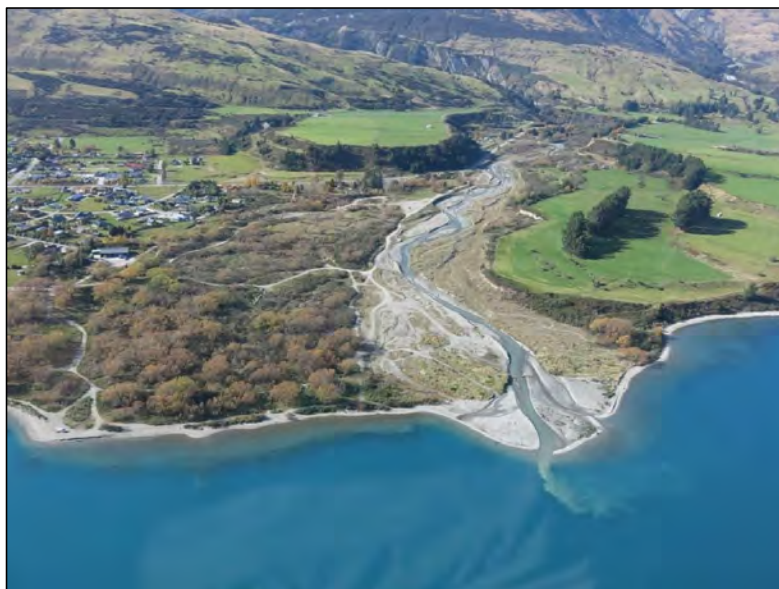
Figure 1: Overview of the Buckler Burn stream and alluvial fan, with Glenorchy township located the northern side of stream's active channel. The full township area is developed on Buckler Burn alluvial fan deposits, and the higher terraces to each side of the stream are remnants of older alluvial fan-delta surfaces formed when the lake was at higher levels. Photograph dated May 2018.

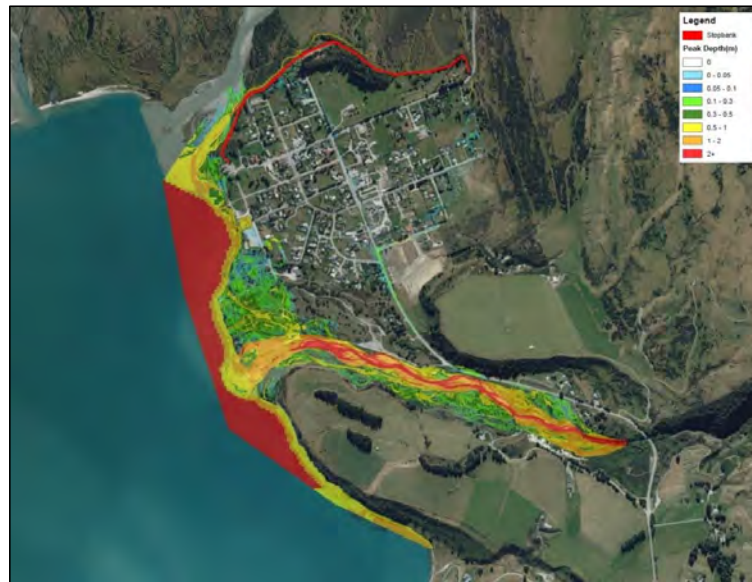
Figure 2: Model results for a Buckler Burn flooding scenario with a 300 cumec peak flow (<1% AEP). In this scenario minor floodwaters flow into the township area, mainly flowing northwards along Oban Street and around the eastern margin of the township. Colouring shows peak floodwater depths according to the included legend.

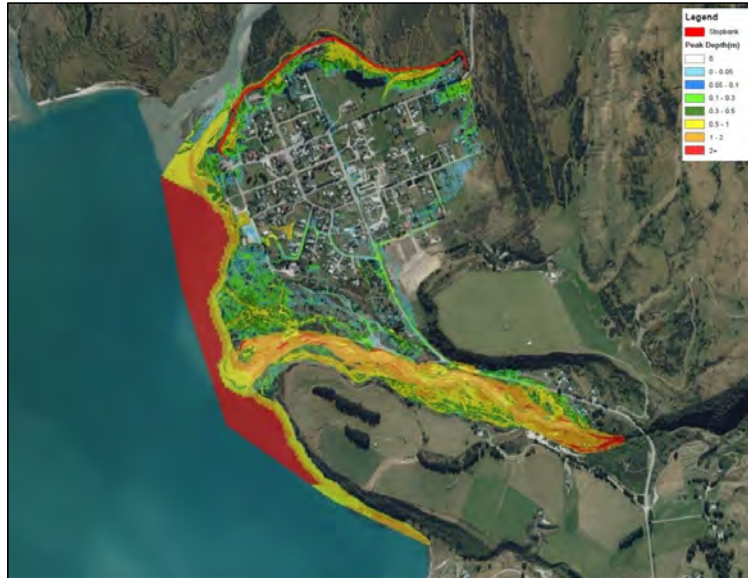
Figure 3: Model results for a Buckler Burn flooding scenario with a 300 cumec peak flow (<1% AEP) and a 3 metre thickness of channel aggradation on the mid-upper reaches of the alluvial fan. In this scenario floodwaters flow into the township area mainly flowing northwards along Oban Street, and along Invincible Drive and Shiel Street. Colouring shows peak floodwater depths according to the included legend. The flood hazard categorisation for this scenario is shown as Figure 4.

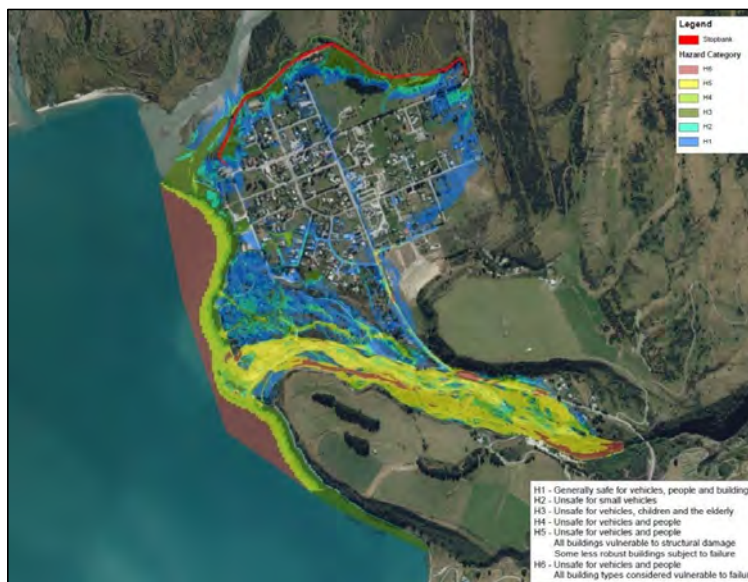
Figure 4: Flood hazard categorisation for a Buckler Burn flooding scenario with a 300 cumec peak flow (<1% AEP) and 3 metres channel aggradation on the mid-upper reaches of the alluvial fan. Colouring shows hazard categorisation according to the included legends.

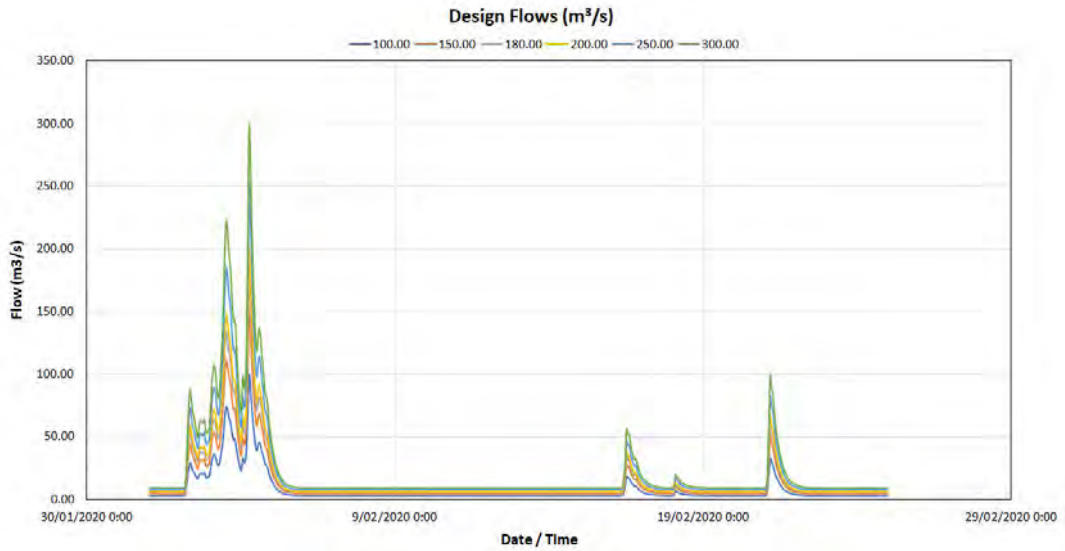
Figure 3-6 - LRS design flow hydrographs for the Buckler Burn.

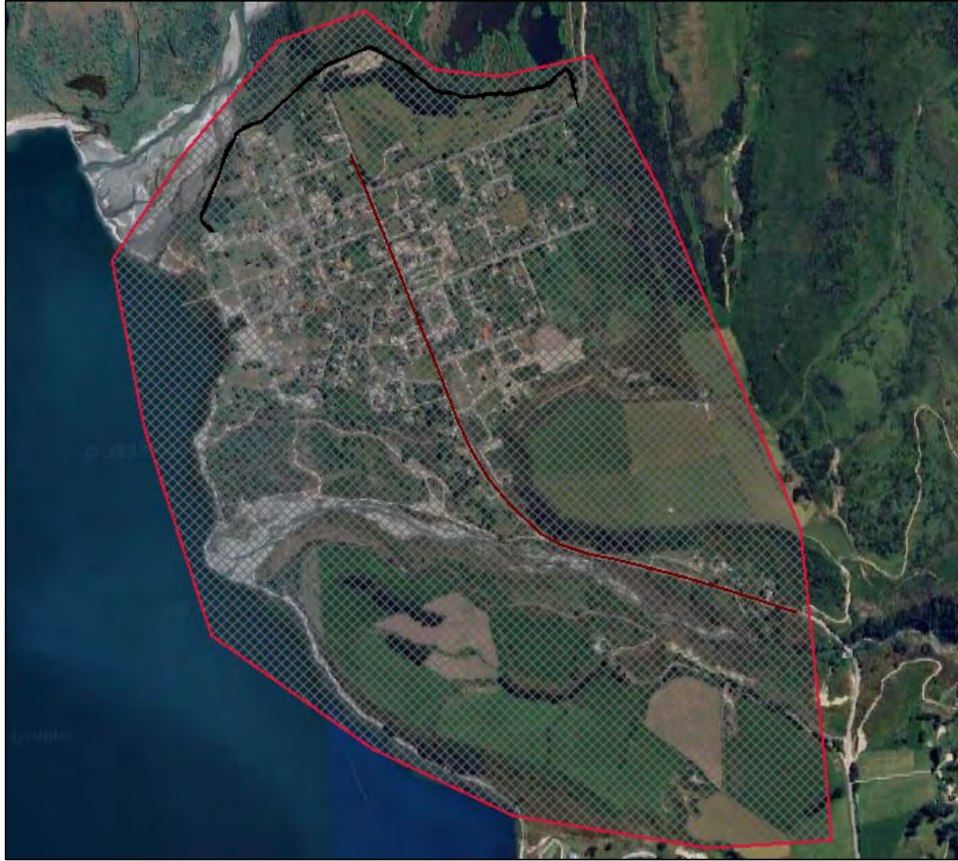
Figure 4-1 - Visualisation of the mesh with the inclusion of the Glenorchy stopbank (black line) and the Glenorchy-Queenstown Rd and Oban St break line (dark red).

A visualisation of the mesh for the Buckler Burn / Glenorchy portion of the model is presented in Figure 4-1.

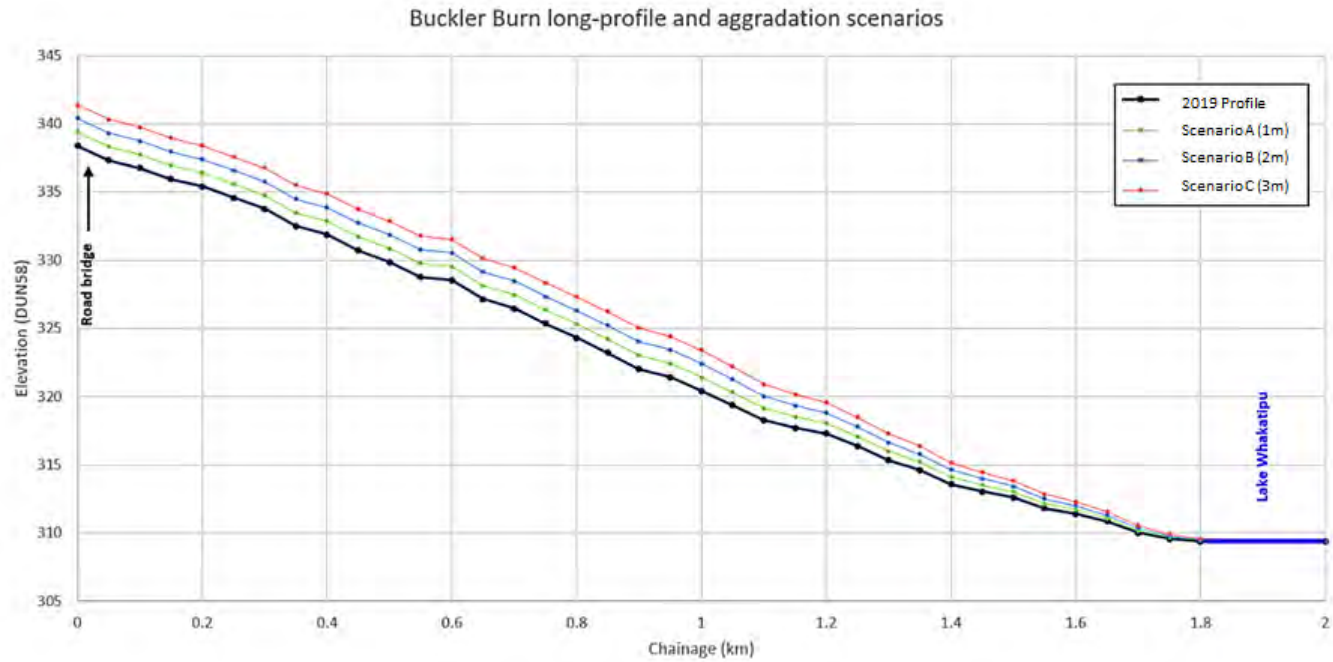
Figure 4-7 – Buckler Burn long profile and aggradation scenarios developed for use in the flood hazard modelling.

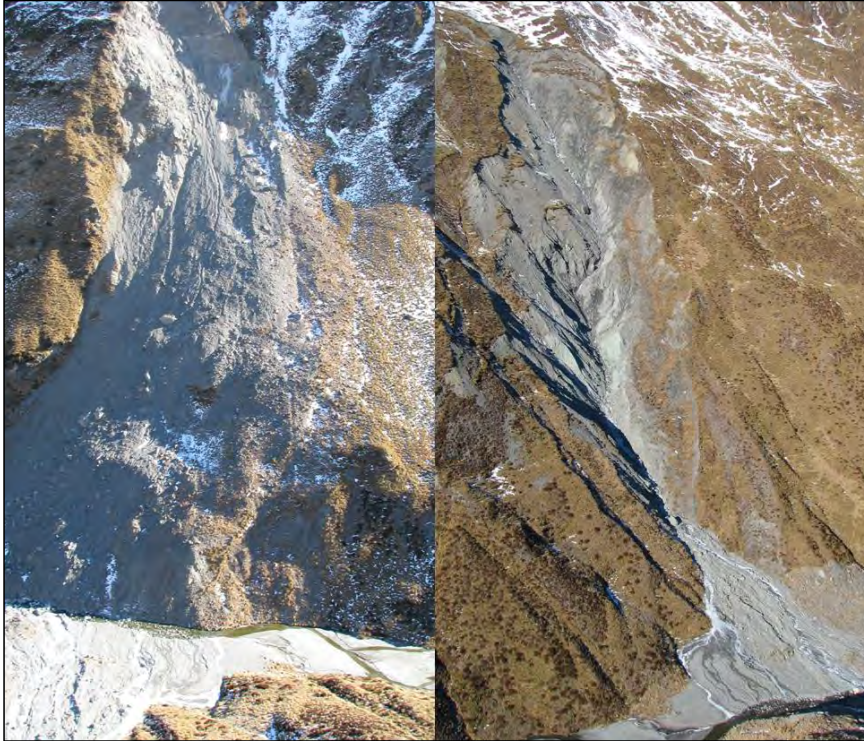
Figure 5-2 – ORC photos showing a large landslide in the upper Buckler Burn catchment on the TR of the channel (left image) and the TL of the channel (right image).

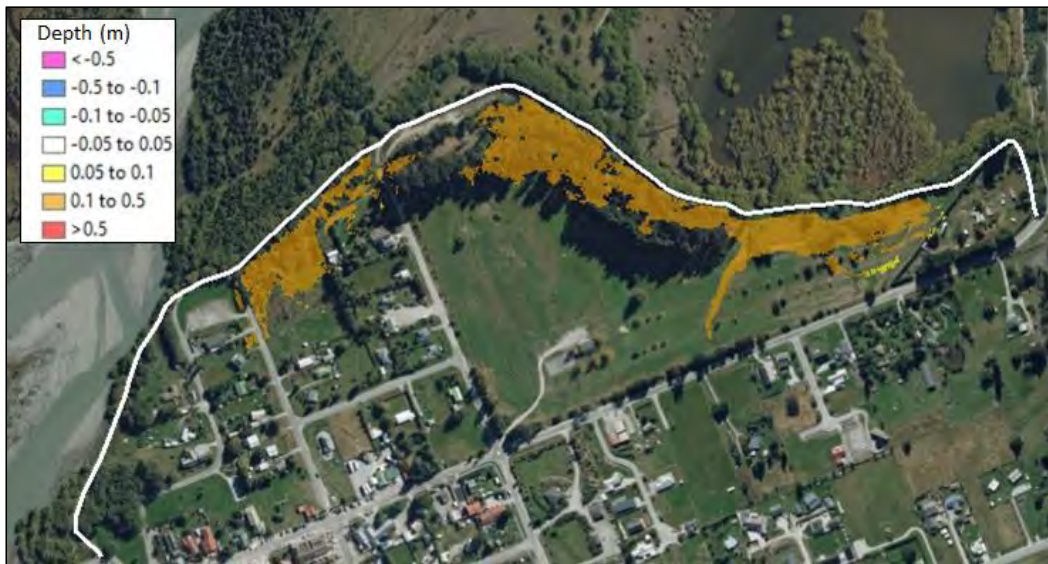
Figure 6-10 – Depth difference map between the 100m³/s aggradation (2m) and 300m³/s design (2019) runs. Despite the smaller flow, the aggradation scenario produces greater inundation.

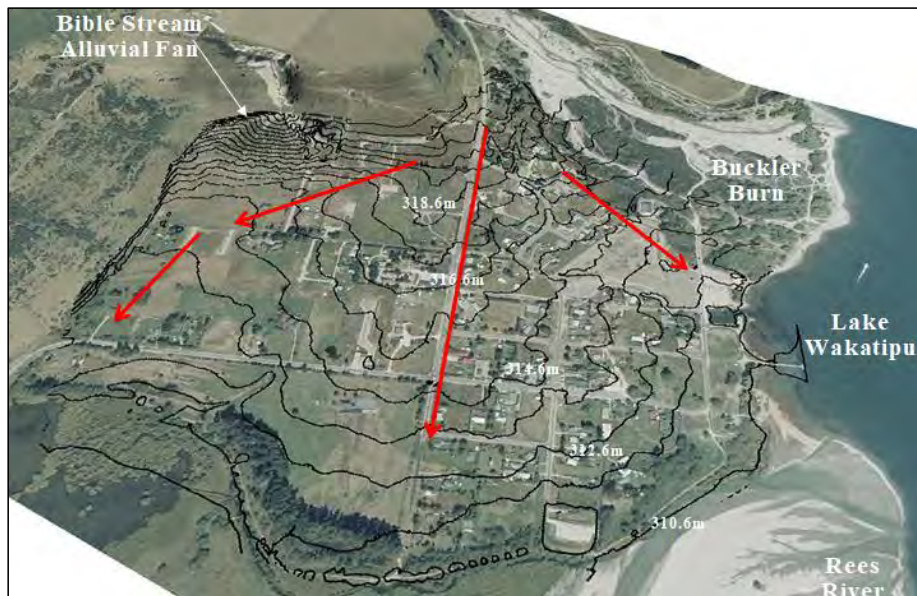
Figure 7-1 - ORC generated image. Land River Sea Buckler Burn model flow paths drawn on in red.

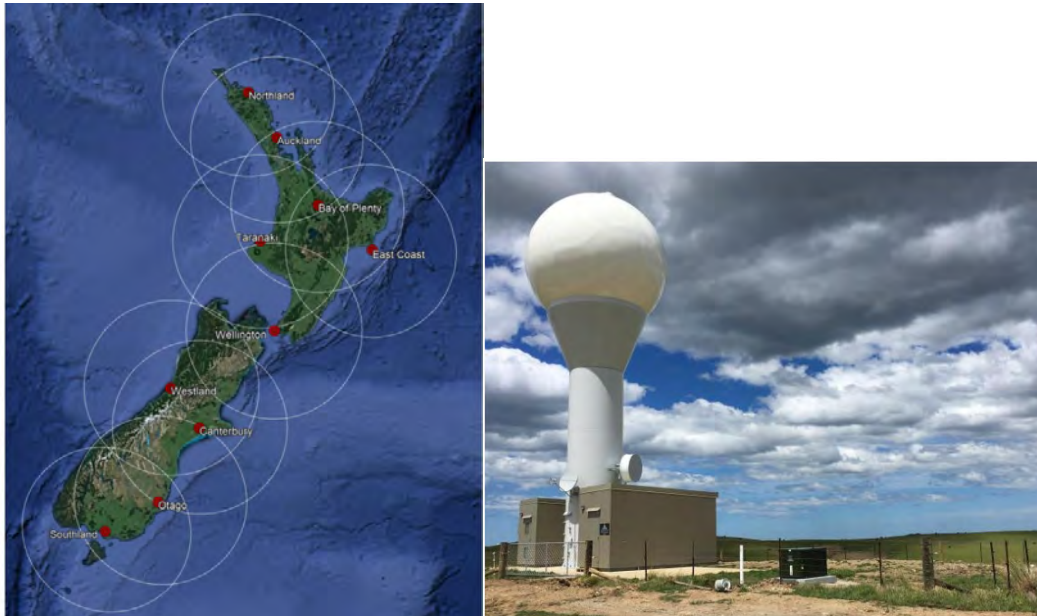
Figure 1 – MetService National Radar Coverage (left)¹ and the Otago Radar (right).²

- [9] MetService completed the installation of the Otago weather radar in December 2020. The radar site, located near Hindon (25 kilometres northwest of Dunedin, Figure 1) and 750 metres above sea level, provides excellent coverage of Dunedin City, the lower Taieri and the lower Clutha River catchments, and coastal Otago from the Catlins to the Waitaki.

- [10] The \$3 million radar is the tenth in the national network of weather radar owned and operated by MetService (Figure 1). The radar data can be used to estimate the location and severity of precipitation within the area of coverage of the radar equipment (i.e., where and how much rain is currently falling and has recently fallen). It can also be used to estimate where the rain is likely to go next and how quickly. The Otago radar uses the latest dual polarisation technology which can identify different types of precipitation, be it rain, hail or snow.

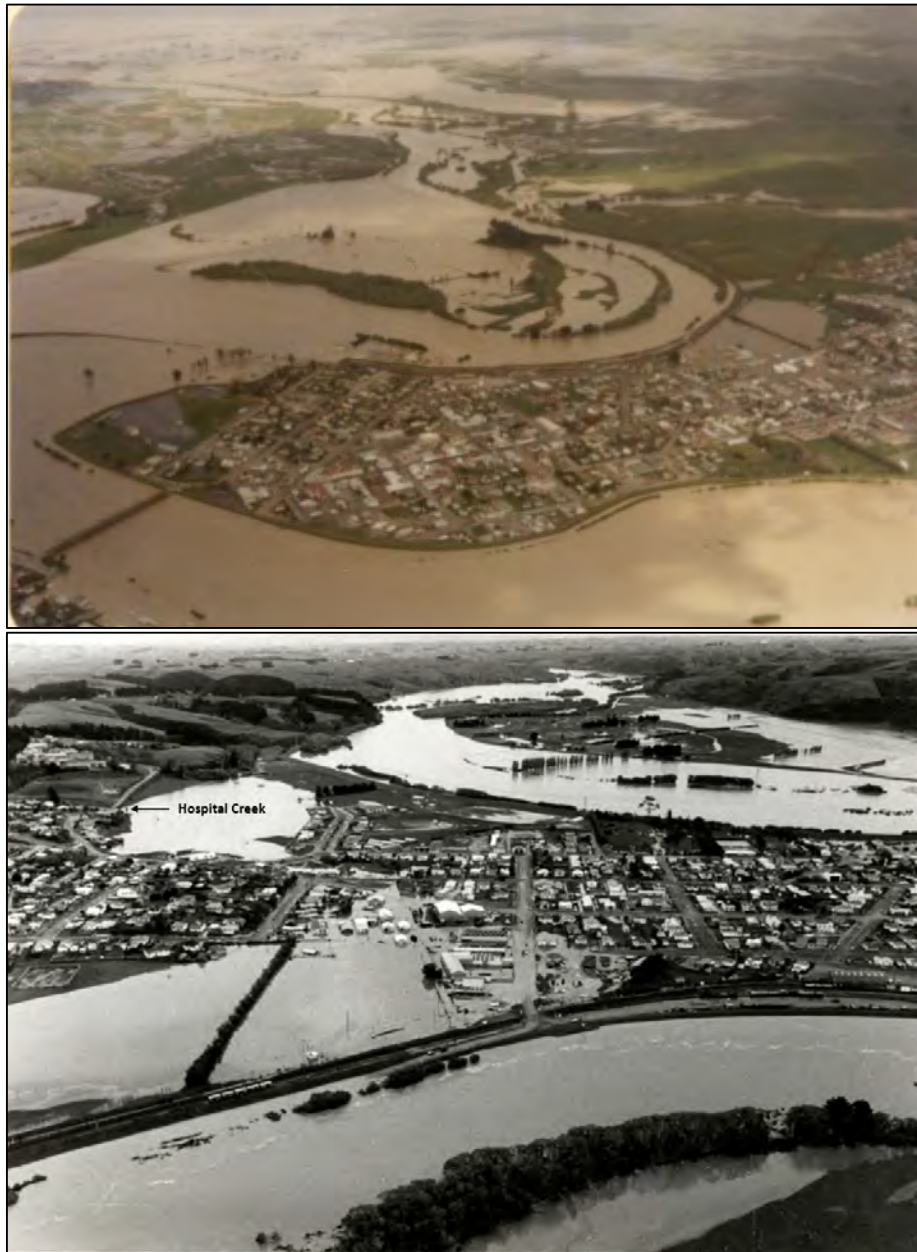
Figure 4: Flooding in Balclutha during the October 1978 flood event (estimated peak flow of 4,580 m³/s at Balclutha). Upper photo is looking southwards towards the coast, lower photo is looking north (upriver). Note ponding behind the flood bank in the southern part of the township, and ponding to the northeast from Hospital Creek and/or rainfall accumulation.

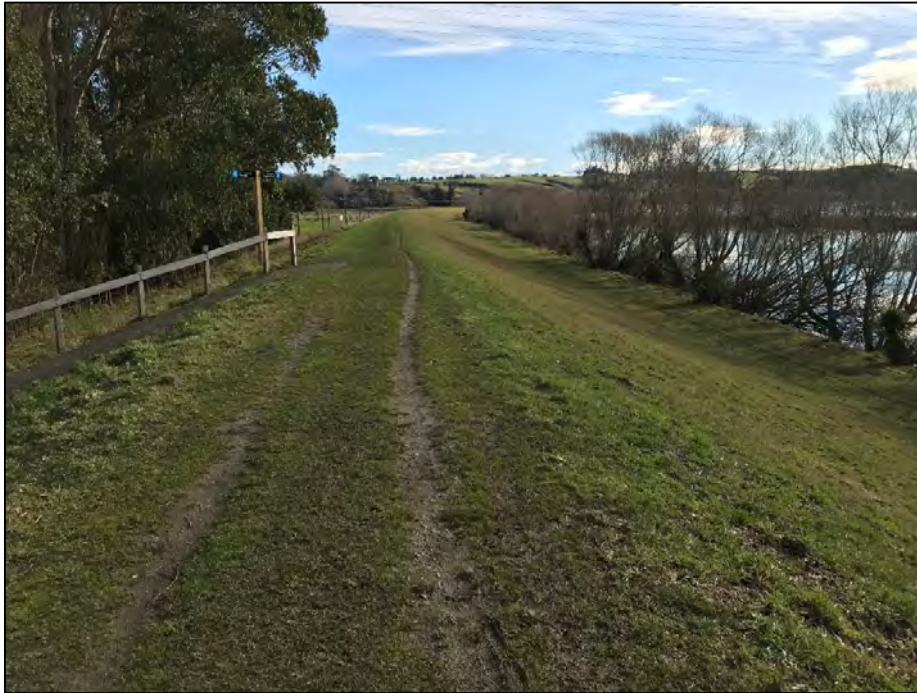
Figure 5: Example of ORC flood banks in the Balclutha township area, showing the scale of these flood protection structures. This location is upstream of the SH1 bridge.

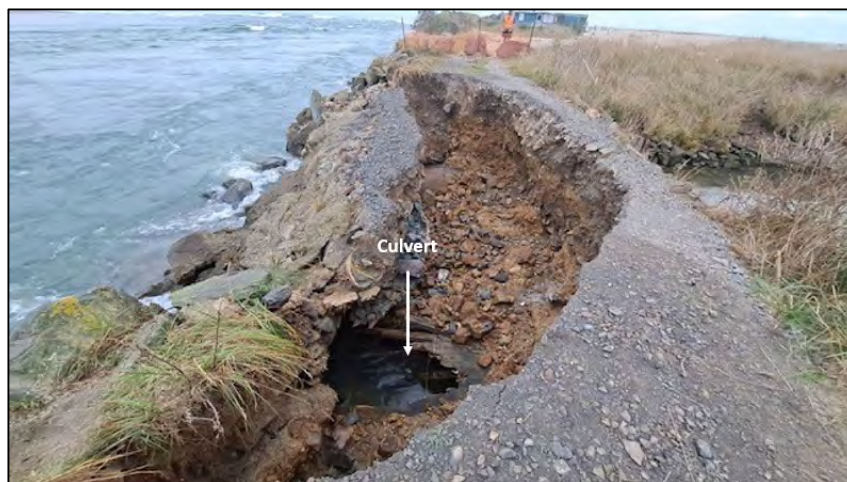
- [35] In 2022³ and 2023⁴ there were notable erosion damages to the ORC training line structure and outfall culverts at the Clutha River’s Koau mouth (Figures 8, 9). ORC’s next investigations being completed to assess the impacts of this erosion event, and to inform future decision-making, are summarised in the Next Steps section and Appendix 1.

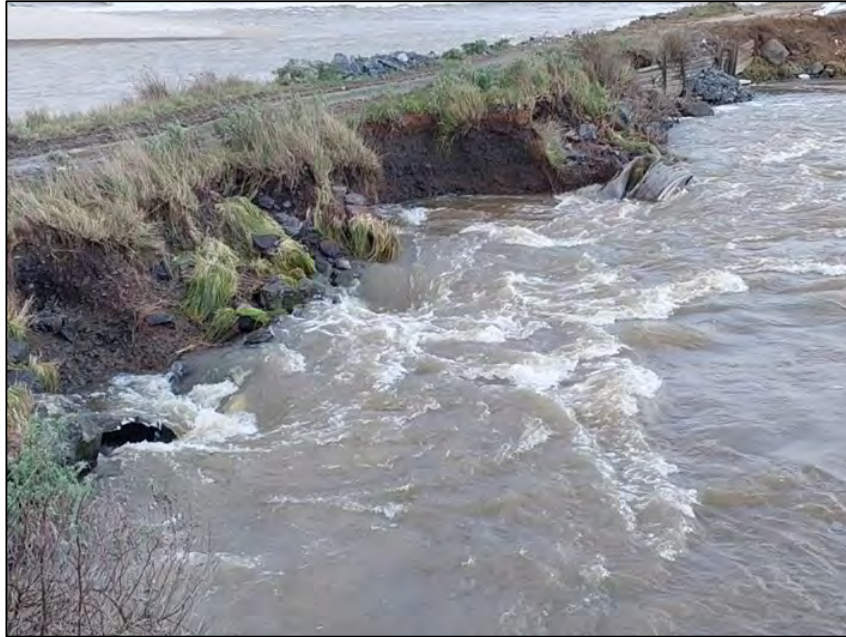
Figure 9: Erosion damages to the southern (Puerua River) side of the Koau mouth training line structure (June 2023).

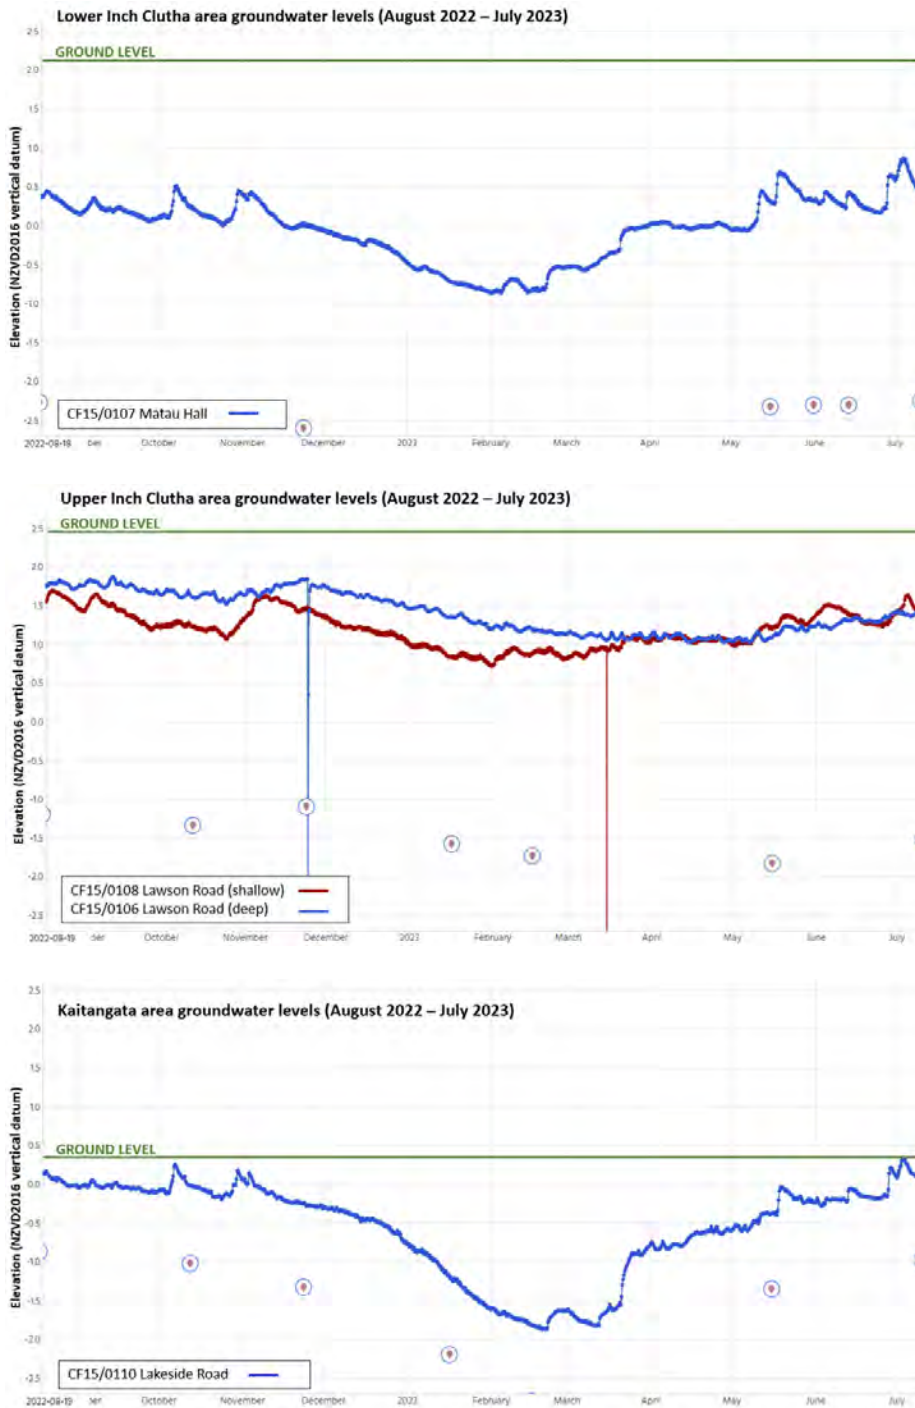
Figure 14: Groundwater level data from the lower Clutha Delta at Paretai, Inch Clutha and Kaitangata (August 2022 to July 2023), all levels are relative to NZVD2016 vertical datum. Bore locations are shown in Figure 12. These bores are all located within pumped drainage areas, so groundwater levels are lower than they would be if drainage was through gravitational processes only. Sharp downward dips in some plots are due to the taking of water samples in wells with a low yield.

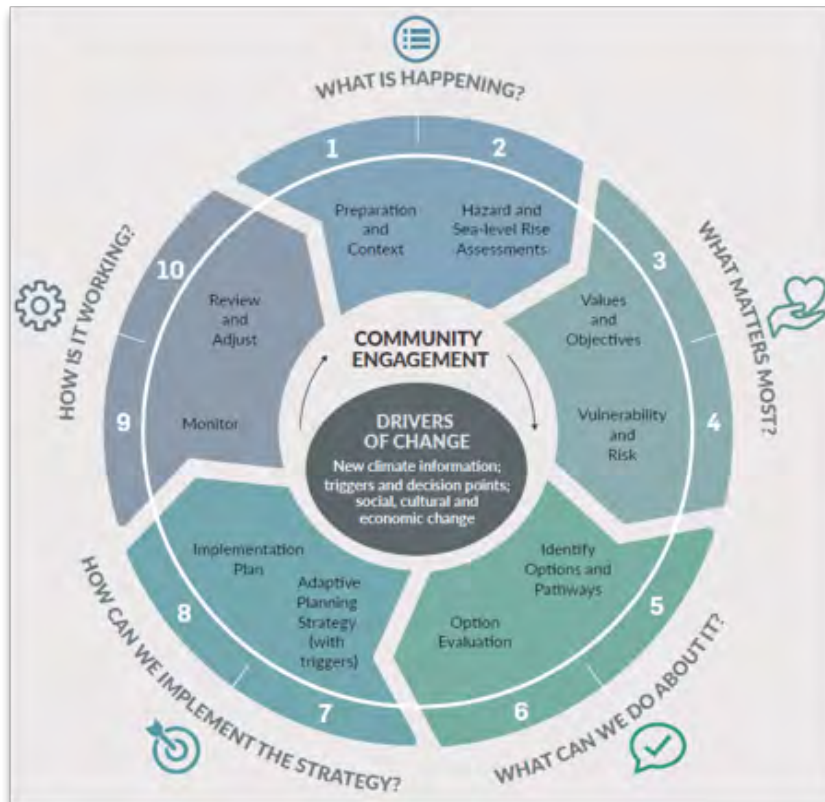
Figure 15: The 10-step decision cycle framework of the Dynamic Adaptive Pathways Planning (DAPP) approach (MfE 2017).
