Buckler Burn Flood Hazard Modelling

7 August 2023

Client: Otago Regional Council

Land River Sea Consulting Limited

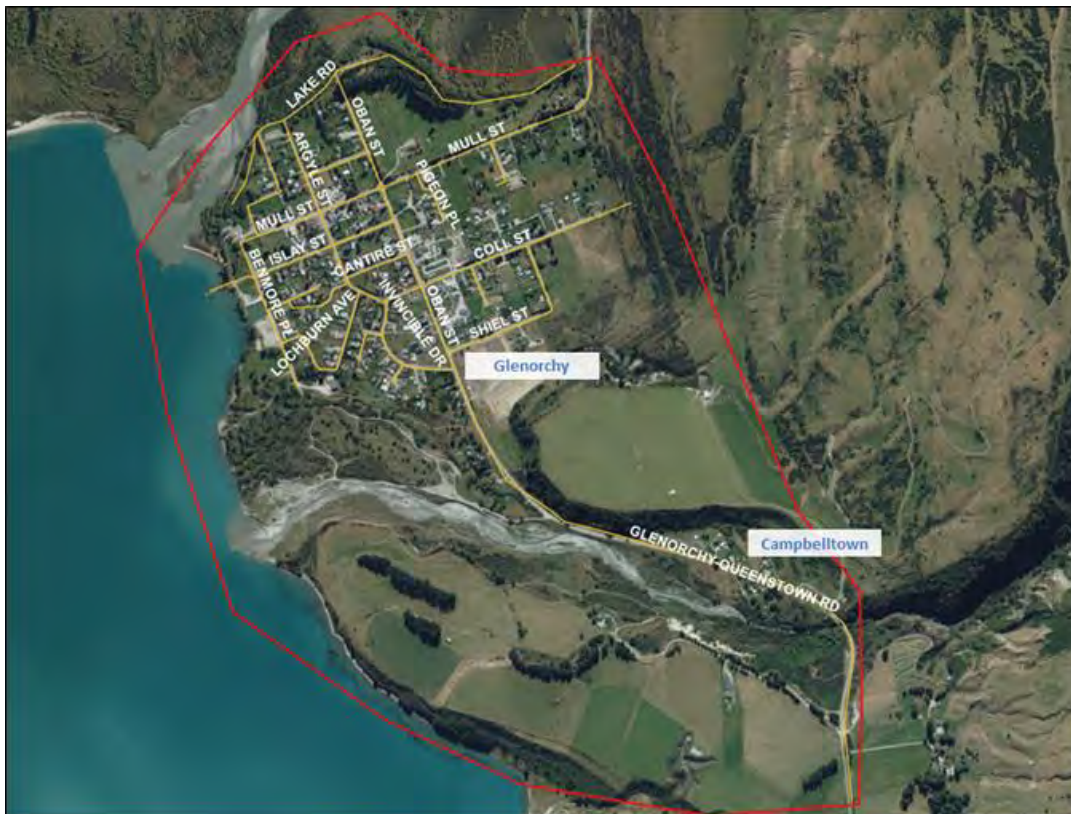
Figure 1-1: Area of interest showing the Buckler Burn, Glenorchy and Campbelltown.

The area of interest for this project is presented in Figure 1-1 below.

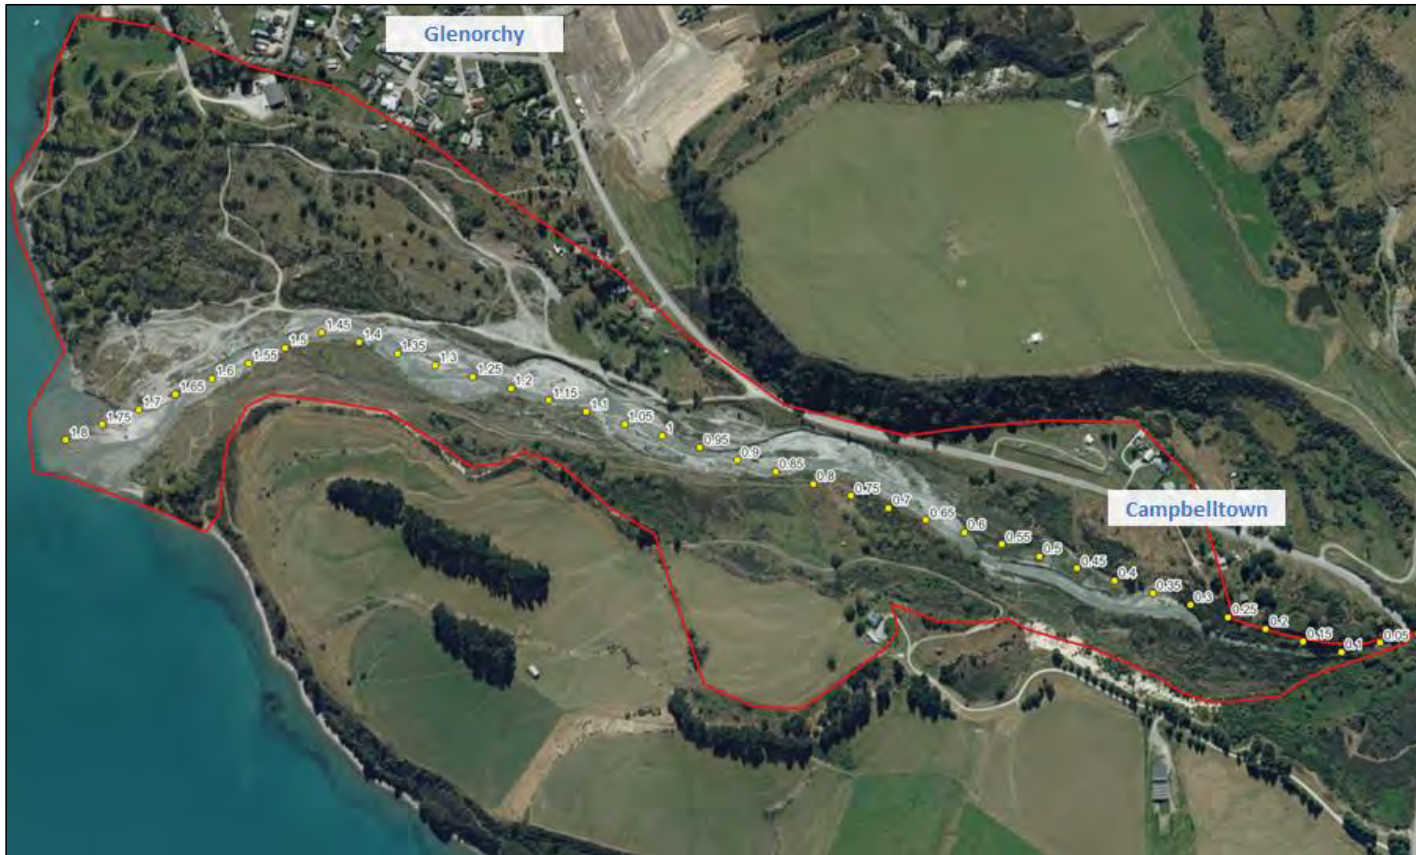
Figure 3-2 – The Buckler Burn fan edge outlined in red, overlain by chainage measured in kilometres downstream from the road bridge.

In order to be consistent with any observations or references made to the alluvial fan in the section and the report as a whole, we have used the chainage created by ORC, measured in kilometres from the Glenorchy-Queenstown Rd bridge down the Buckler Burn alluvial fan to Lake Wakatipu (Figure 3-2).

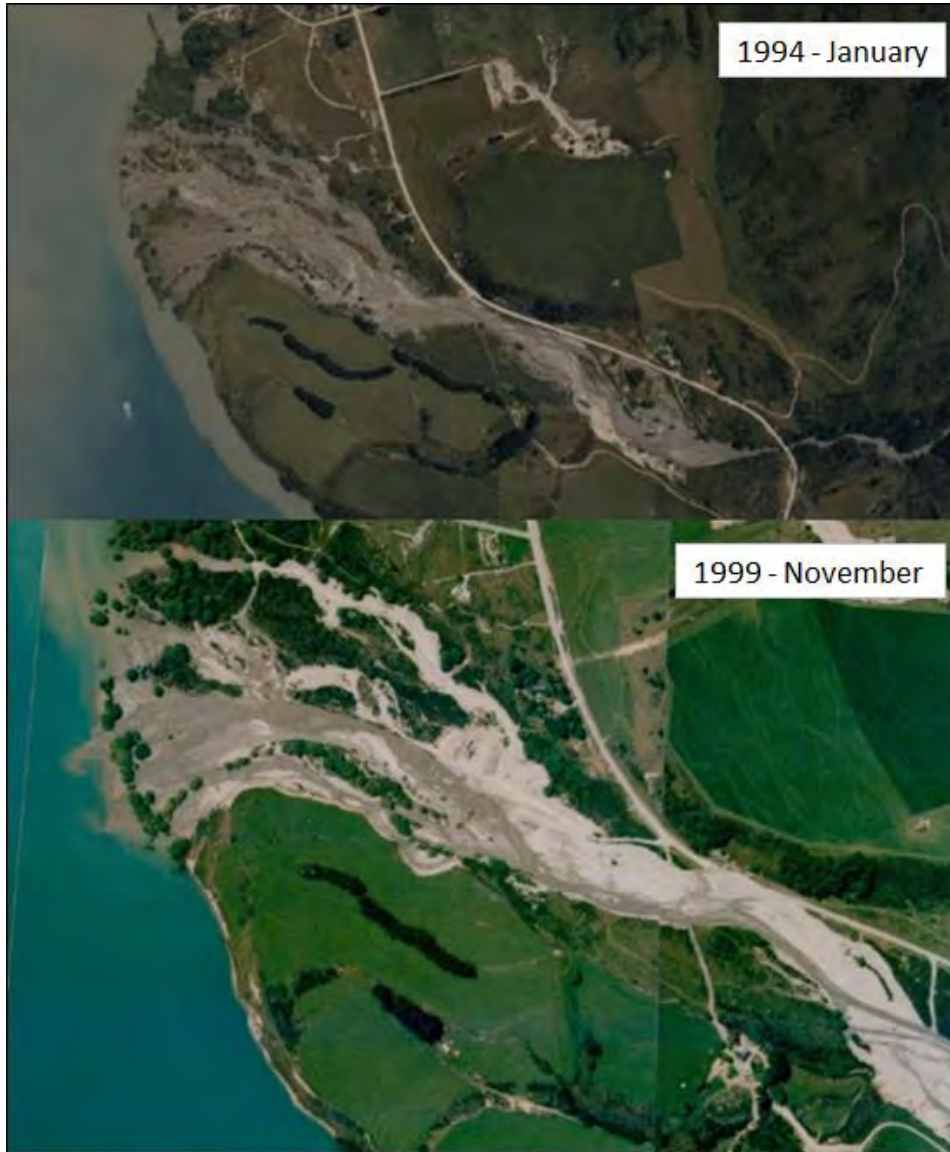
Figure 3-4 – January 1994 and November 1999 aerial imagery.

The aerial imagery from 1937, 1994, and 1999 (Figure 3-3 and Figure 3-4) suggest a much more active phase of the fan's lifecycle, with wider active channel belts and larger areas of exposed gravel compared to imagery post 2000 through to 2019, and in the 1960s. In these periods it is likely that sediment laden flood events occurred frequently enough to aggrade the fan and force channel changes through processes such as infilling, bifurcation, lateral migration, and avulsion.

Furthermore, in the aerial imagery from the January 1994 flood event, vegetation is still present between the Buckler Burn fan surface and the Queenstown-Glenorchy Rd (0.7 to 0.8km chainage). This vegetation and the road was then inundated with debris and water during the November 1999 flood (Figure 3-4).

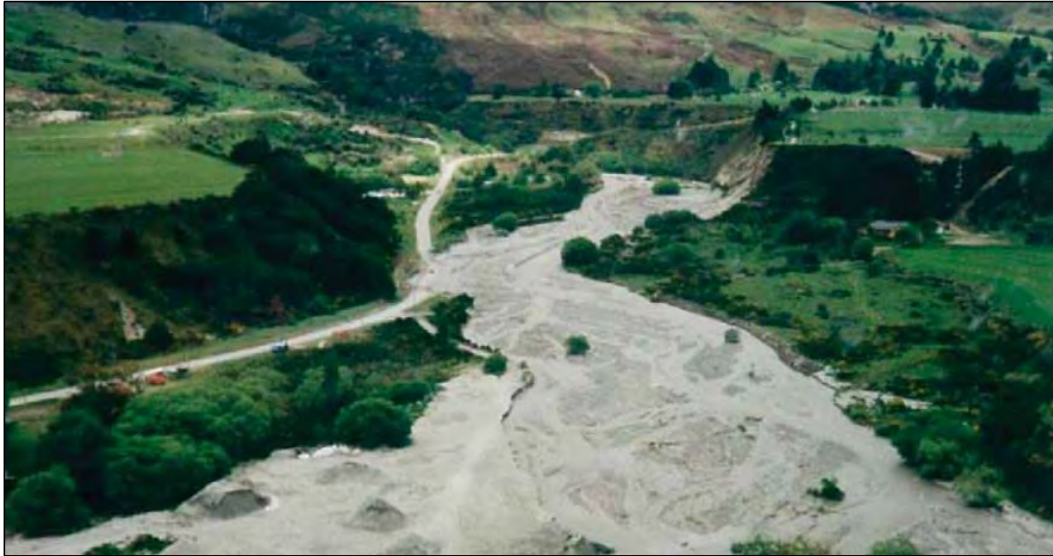
Figure 3-5 – The Buckler Burn following the November 1999 flood event, showing debris deposition over the Queenstown-Glenorchy Road on the true right bank.

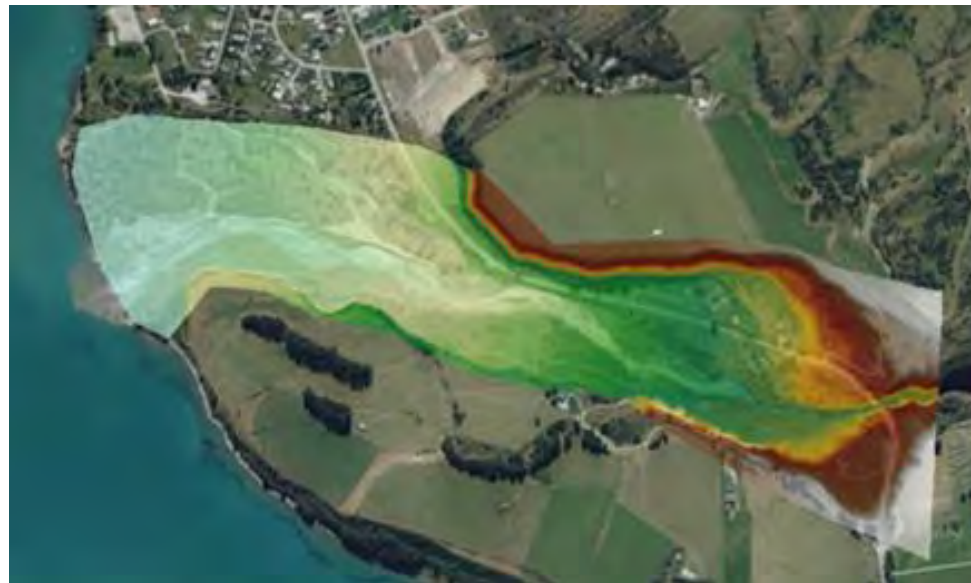
Figure 4-3 - 2022 LiDAR for the Buckler Burn alluvial fan

However, additional runs have looked at the impact of recent changes in the Buckler Burn alluvial fan utilising 2022 LiDAR flown by the University of Canterbury (Figure 4-3). The main changes between 2019 and 2022 were:

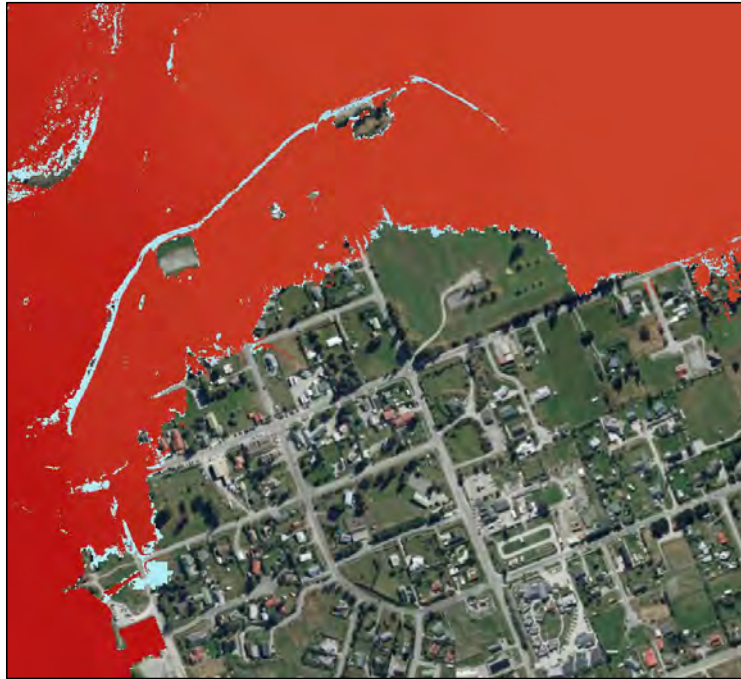
Figure 4-6 – Comparison of HEC-RAS results (red) with MIKE21FM results (blue) at Glenorchy

Model results have shown that the model gives a very similar flood extent to the calibrated MIKE21 model (Figure 4-6).

Comparison of peak water levels at key locations show a slight improvement in model calibration:

However, the HEC-RAS does not show overtopping of the Glenorchy stopbank, likely as a result of interpolating from larger triangles to squares during the conversion from a triangular mesh within MIKE to a rectangular grid for viewing within ArcGIS. Despite this, due to the general similarity in results between the two models, we are comfortable to continue using the HEC-RAS model for simulations within the Buckler Burn catchment.

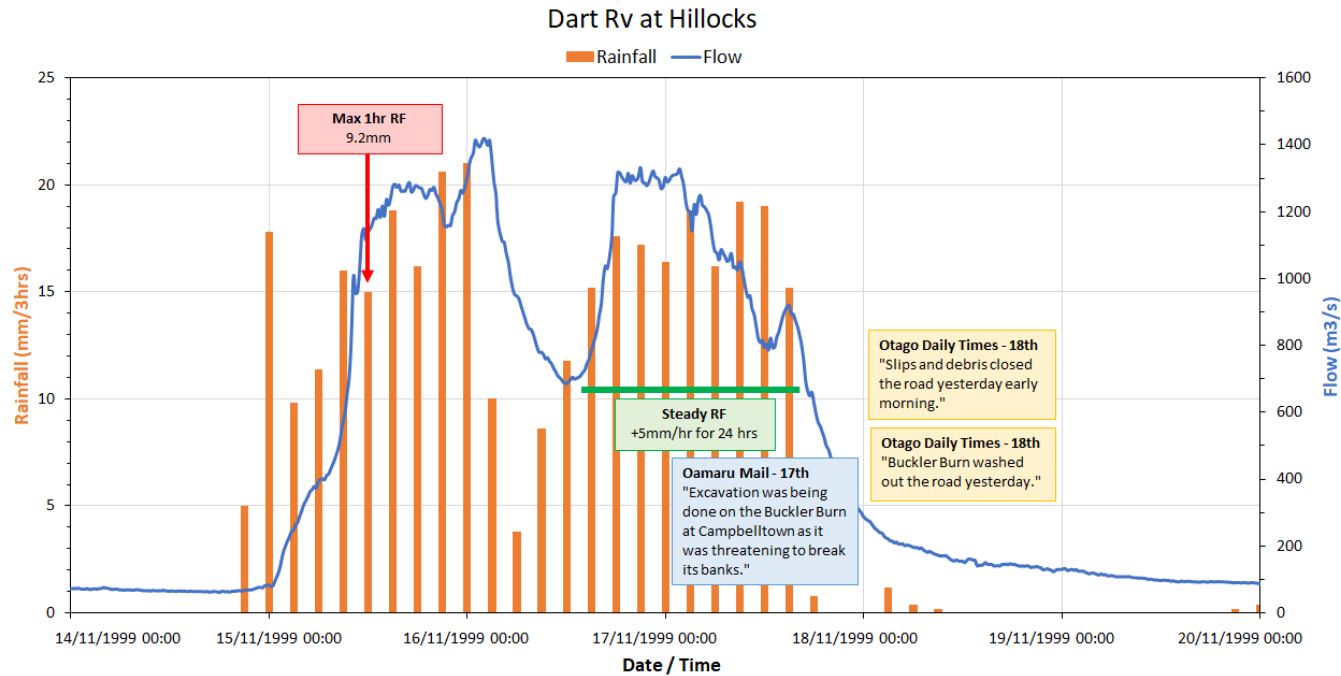
Figure 5-1 - Rainfall and flow data and stats from the nearby Dart Rv at Hillocks monitoring site and newspaper articles from the November 1999 event.

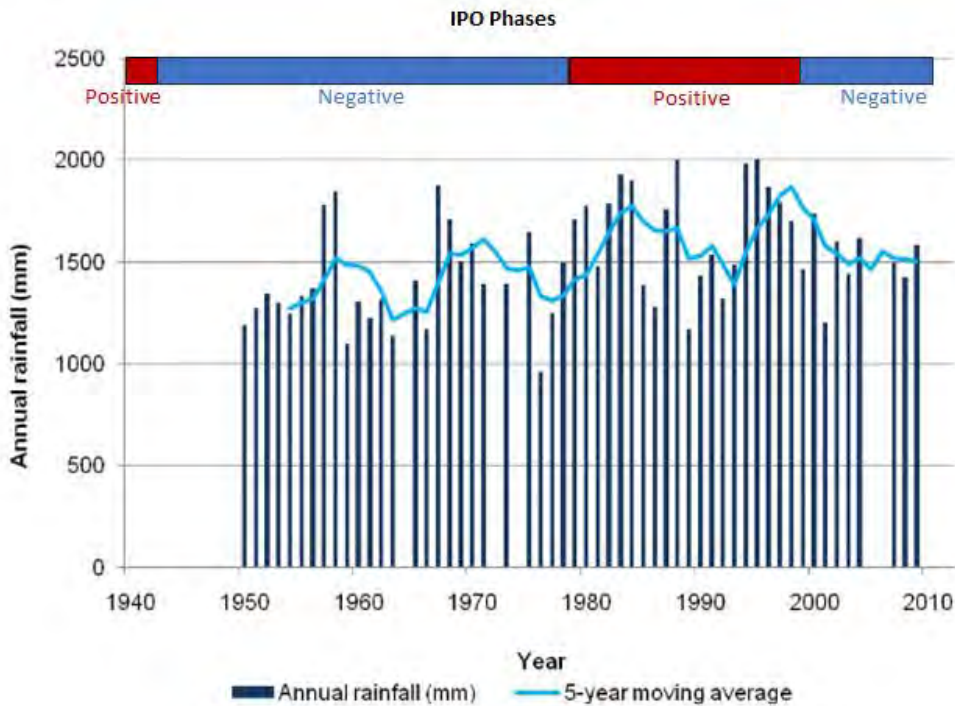
Figure 5-3 – Annual rainfall totals for the Rees at Earnslaw gauge, 1950 to 2009 with the positive and negative IPO phases above. The rainfall data is missing: 1964, 1972, 1974, 2005, and 2006.

The November 1999 event occurred at the end of a ~20 year positive IPO phase, when the average annual rainfall at the Earnslaw gauge was at its highest.

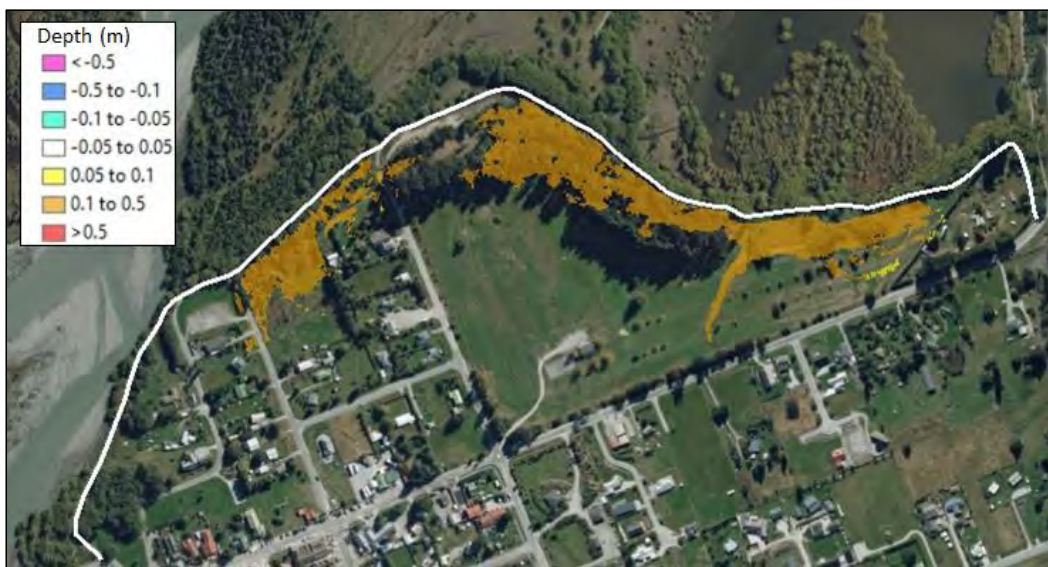
Figure 6-10 – Depth difference map between the 100m³/s aggradation (2m) and 300m³/s design (2019) runs. Despite the smaller flow, the aggradation scenario produces greater inundation.

In this scenario most of the flow entering the town comes from the where the burn spills over onto the Glenorchy-Queenstown Rd between chainages 0.25 and 0.5km, and results in the water pooling behind the Glenorchy stopbank and eastern end of Mull St reaching depths as high as 2m.
