Salt Ecology Short Report 009. Prepared by Barrie Forrest for Otago Regional Council, March 2022

Since Dec-2016, Otago Regional Council has undertaken annual State of the Environment monitoring in Catlins River Estuary to assess trends in the deposition rate, mud content, and oxygenation of intertidal sediments. Sediment monitoring is undertaken at two sites (Fig. 1), with the latest survey carried out on 1 December 2021.

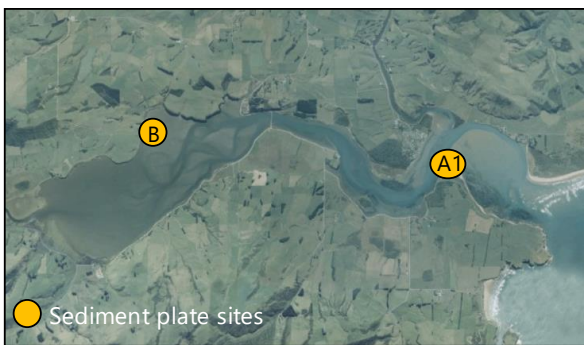
Fig. 1. Location of Catlins River Estuary monitoring sites. Site A1 has been replaced Site A, which was in the same general location but washed away prior to the Feb-2019 survey.

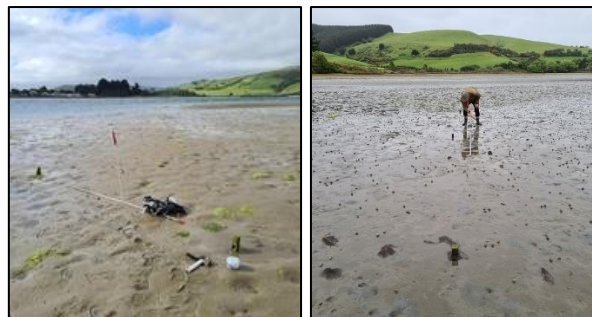
The cumulative change in sediment depth over plates at each site is shown in Fig. 2. There has been steady sediment accrual at both sites, with annual mean value exceeding the 2mm/yr guideline value (rated ‘poor’, Table 1). High variability between plates at Site A1 reflects the dynamic hydrological environment near the estuary entrance (see photo on next page).

Mobile and undulating sand-dominated sediment at Site A1 (left) compared with mud-dominated upper estuary sediment at Site B (right) in Dec-2021.
