Salt Ecology Short Report 025. Prepared by Barrie Forrest for Otago Regional Council, March 2023

OVERVIEW

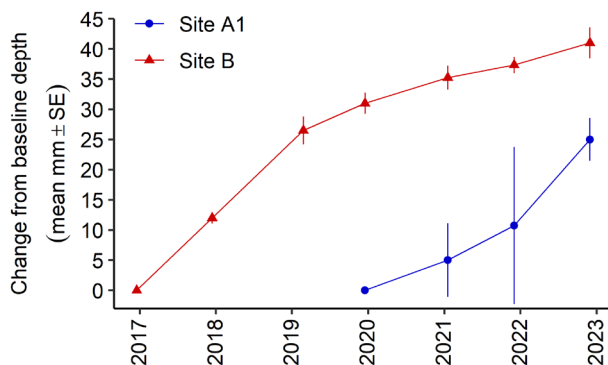
Fig. 2. Temporal change in mean sediment depth over buried plates (\pm SE) relative to the baselines for Site A1 (Dec-2019) and B (Dec-2016).

The cumulative change in sediment depth over plates at each site is shown in Fig. 2. There has been steady sediment accrual at both sites, with annual mean values significantly exceeding the 2mm/yr guideline (rated ‘poor’). High variability among plates at Site A1 (Fig. 2) reflects the dynamic hydrological environment near the estuary entrance, where sediment accrual reflects the movement of sand rather than fine sediment deposition from catchment sources. In contrast sedimentation in the upper estuary (Site B) likely reflects catchment sources.

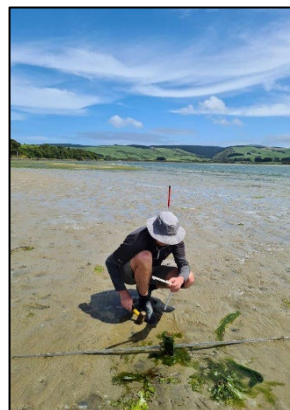
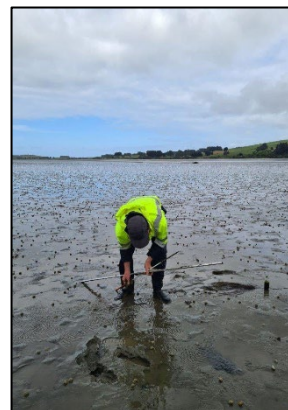
Sediments were sandy at lower estuary Site A1. By contrast, the mud content at upper estuary Site B exceeded the biologically relevant threshold of 25% and was rated 'poor' (Table 2). Combined with the elevated sedimentation rate, these results suggest there is significant ongoing deposition of muddy sediment in the upper estuary, which likely reflect catchment sources, including inputs from the dominant pastoral farming catchment land use (Stevens & Robertson 2017).

Mobile, sand-dominated sediment at Site A1 (left), and mud-dominated upper estuary sediment at Site B (right) in November 2022
