Salt Ecology Short Report 026. Prepared by Barrie Forrest for Otago Regional Council, March 2023

**OVERVIEW**

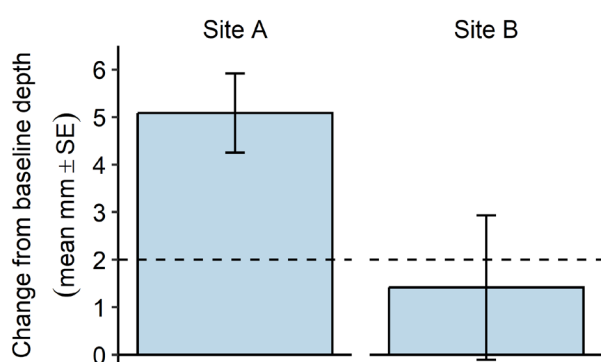
Fig. 2. Change in mean sediment depth over buried plates ( $\pm$ SE) in Dec-2022 relative to the Dec-2021 baseline. The dashed line represents the national guideline value of 2mm/yr.

In the first year of measurement, sediment accrual was rated ‘fair’ at Site B (1.4mm/y), and exceeded the 2mm/yr national guideline value at Site A (5.1mm/yr, a condition rating of ‘poor’). Given that the catchment is largely unmodified and there were no significant rainfall events in the local area in 2022 (ORC & ES Environmental data portals), the sediment deposition observed at Site A is unlikely driven by catchment

sources. It is possible that fine sediments have been released from eroding salt marsh habitat and/or fine sediments have been re-mobilised and deposited from other parts of the estuary. These results represent the first year of data collection and a time series of at least 5 years is required before a meaningful trend can be established.

Continue annual monitoring of sedimentation rate, sediment grain size and aRPD depth, and include results in a summary report. Comprehensive reporting should be undertaken in 2023/24 as part of the completion of the 'fine scale' ecological and sediment monitoring three-year baseline.

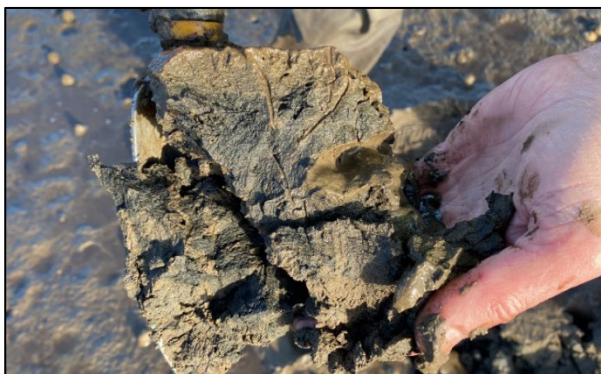
Sediments at Site A are rated 'fair' in terms of their mud content and are approaching the threshold of concern (Table 1), while sediments at Site B comprise ~50% mud and are rated 'poor'. This situation likely reflects that Site B is located in a depositional area within the mid-upper estuary, while Site A represents the more well-flushed mid-estuary flats.

Sediment oxygenation was generally quite high, although the average aRPD depth was generally shallower (rated 'fair') at Site B than Site A. This result reflects the relatively muddy surface sediment at Site B, which reduces oxygen penetration into the sediment matrix. However, the sediment did not show any of the typical symptoms of strong enrichment (e.g. black colour, strong sulfide odour, extensive cover of opportunistic macroalgae) and burrowing fauna were visible in the sediment samples.

Sediment oxygenation (aRPD transition from brown to dark grey sediment) at Site B in November 2022.

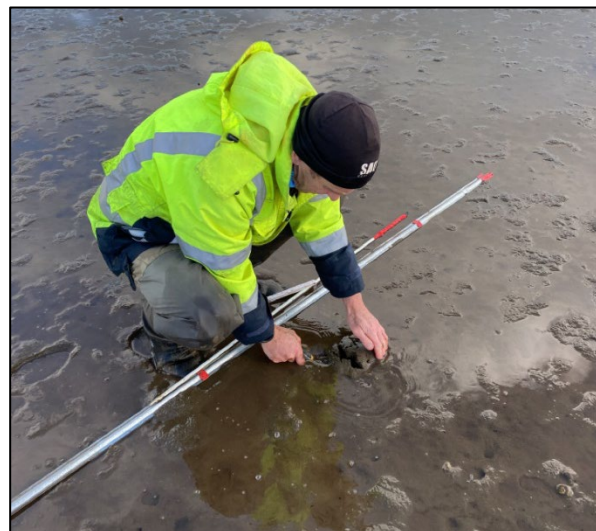
Firm muddy sand sediments at Site A, November 2022
