Habitat Mapping of the Kaikorai Stream Estuary

Otago Regional Council State of the Environment Report

Ryder Consulting

April 2008

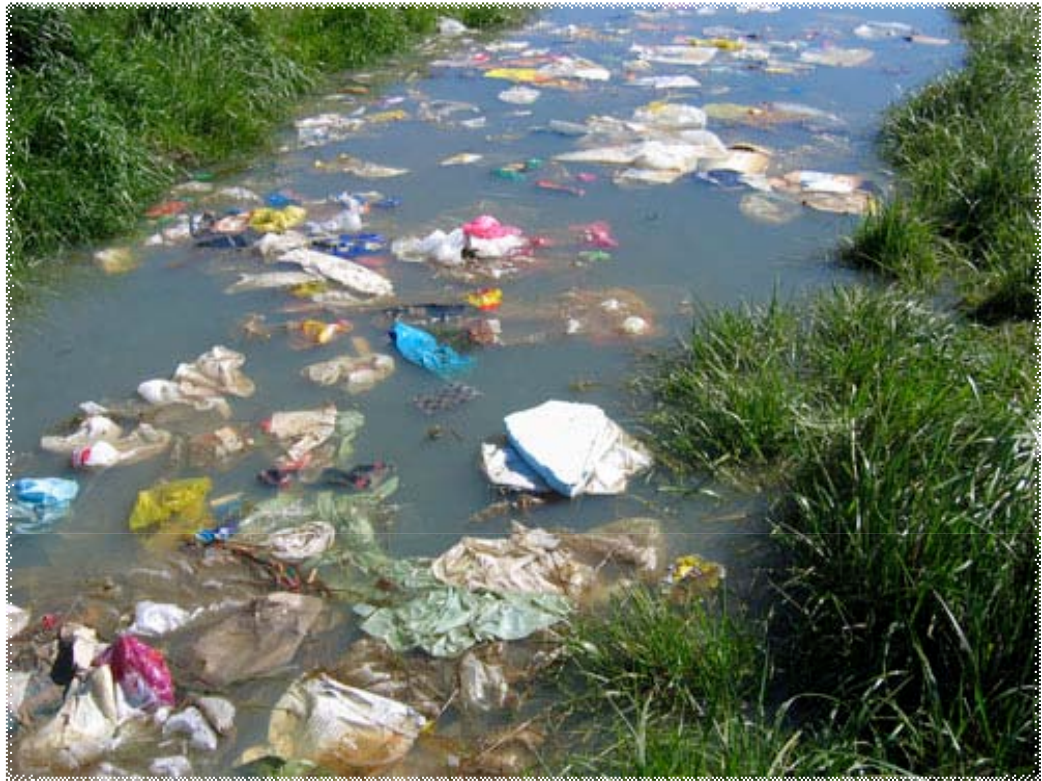
Figure 2. *An example of presumably wind blown debris, Kaikorai Estuary.*

For the Kaikorai Estuary three red cells shows there is a need for some further investigation and/or action with respect to the estuary. Certainly the amount of wind blown and otherwise dumped items around the estuary was a cause of some concern (Figure 2). It is appreciated that mitigation measures and monitoring programmes are in place for leachate from the two landfills on either side of the estuary and it may be that leachate is not an issue.

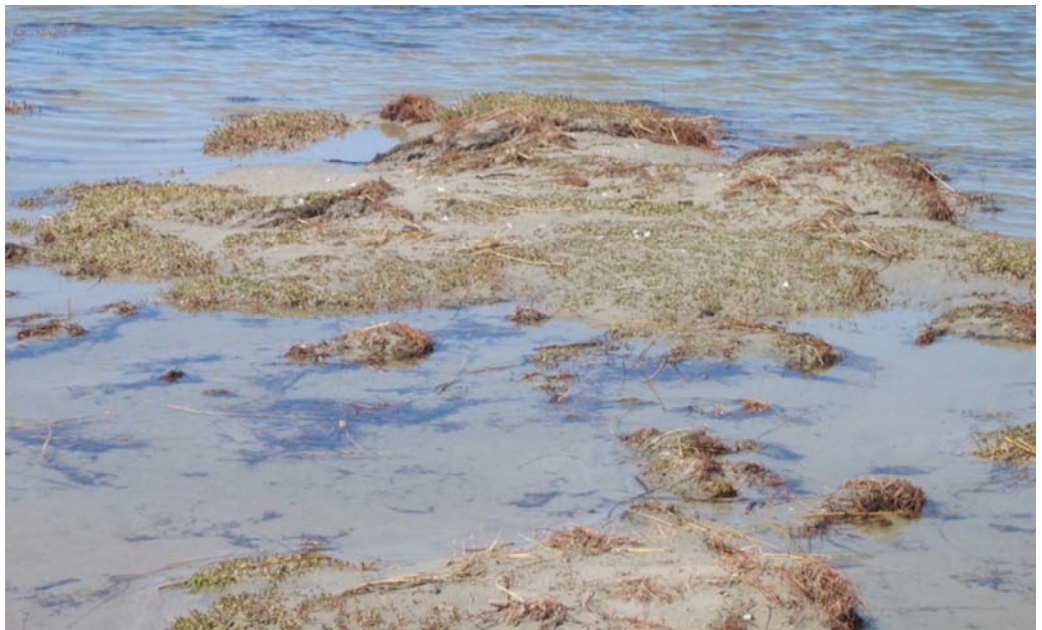
Figure 3. *Heavily eroded herbfields near the mouth of the Kaikorai Stream Estuary.*

Erosion does not appear to be a pressing issue at the Kaikorai Estuary. However, recent high southerly swells had eroded and/or disturbed a considerable area of the herbfields immediately beyond the dune line adjacent to the estuary mouth (Figure 3).

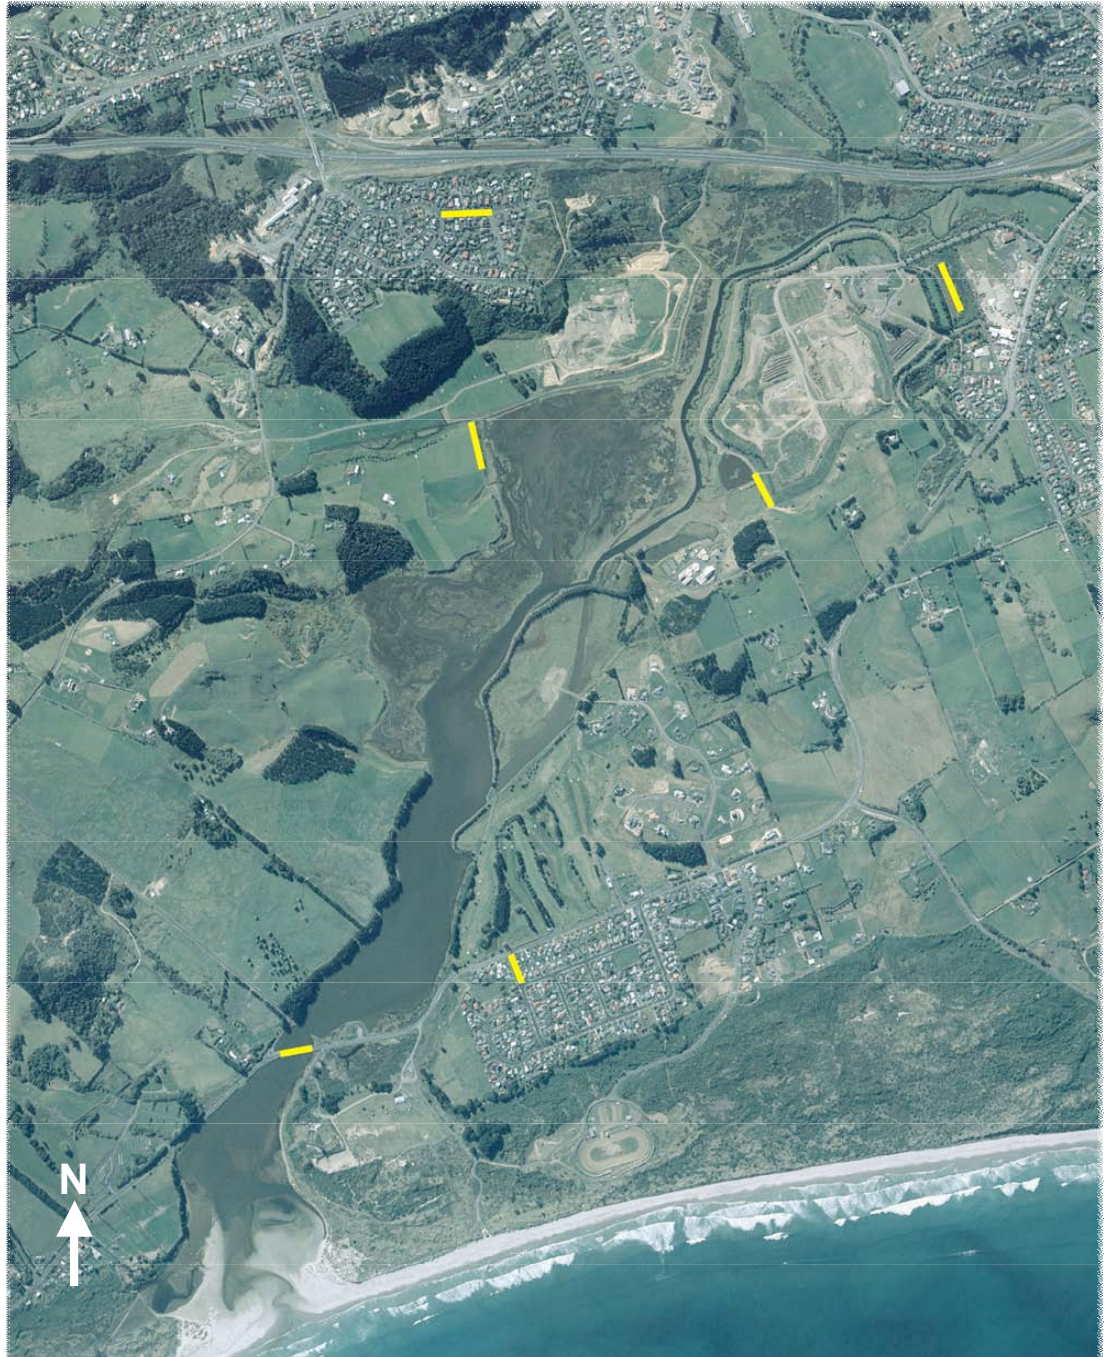
Figure 4. Kaikorai estuary with ground truthing sites marked as yellow bars.

The Kaikorai Estuary was visited for the purpose of broad scale mapping on 29 October 2007. Six prominent landmarks were located using aerial photographs (Figure 4) and GPS readings taken at points either end of each landmark. The distance between points on each landmark was measured using a 100m tape, then compared with maps generated using aerial photographs and tfw files supplied by the ORC. Aerial photographs were ortho-rectified using MAPublisher® 6.2. All distances measured on photographs corresponded with ground truth measurements to within 2m.

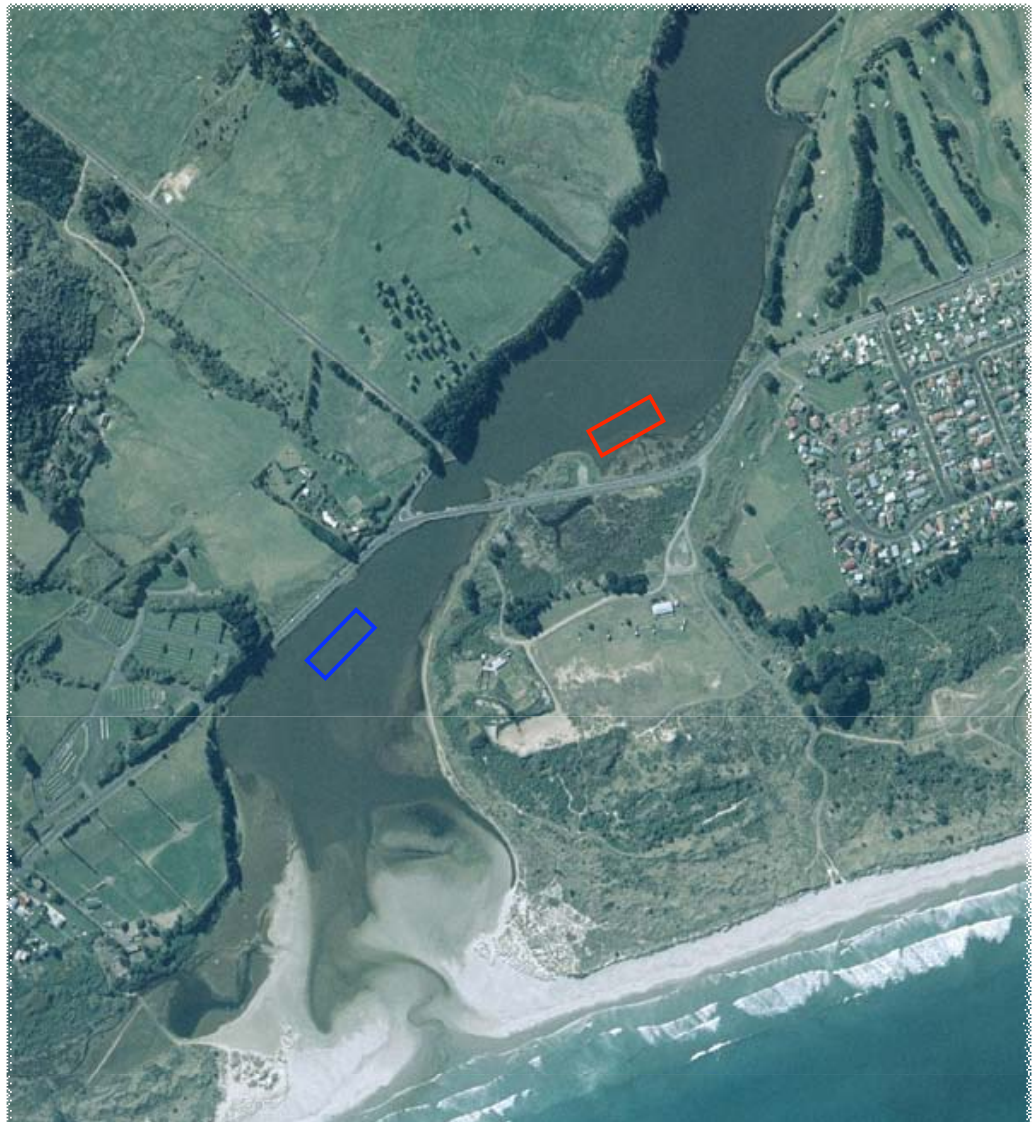
Figure 6. Location of fine scale sites at the Kaikorai Estuary in relation to Taieri Road bridge and Waldronville. Downstream site in blue, upstream site in red.

The Kaikorai Stream Estuary was visited on 30 October 2008. Two sites (Figure 6), selected during the broad scale mapping, were sampled according to the methodology described above. Both sites were located on low tidal sand/mud flats, representative of much of the greater estuarine area.

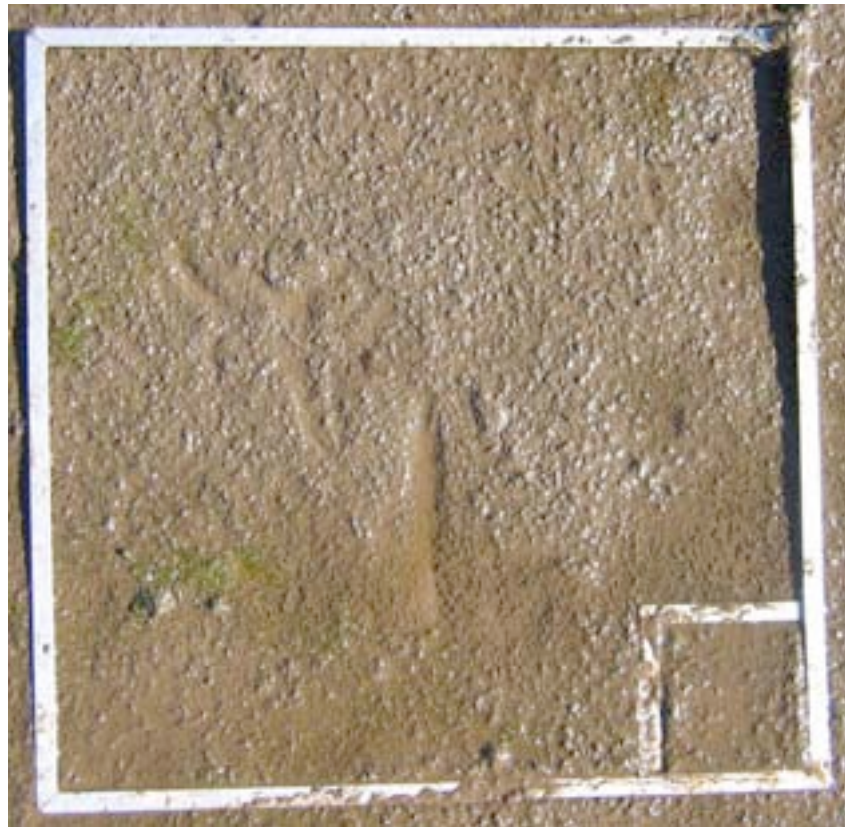
Figure 7. Kaikorai Estuary. Diatomaceous film with wisps of green algae, Site 2.

Site 2 (upstream) also displayed a real paucity of epifauna with no animals seen within any of the quadrats. The surface of the substrate was, however, characterised by an almost uniform diatomaceous film with occasional wisps of filamentous green algae (Figure 7).
