# Synoptic Intertidal and Subtidal Monitoring of Kakanui Estuary

Prepared for Otago Regional Council June 2021

Salt Ecology Report 067

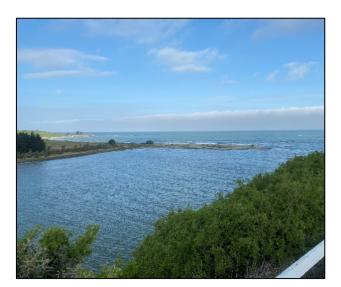
Kakanui Estuary entrance at high tide (top) and upper estuary (bottom)

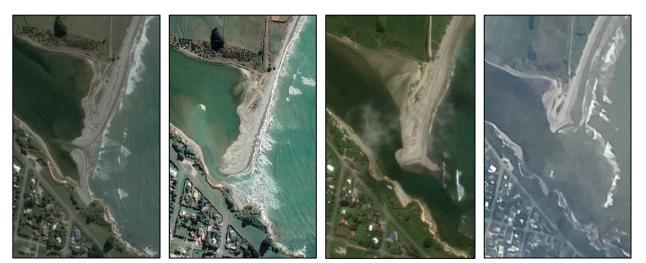
The extent of seawater intrusion into the estuary is determined by the position and width of the estuary mouth (see photos). Low flows in summer, exacerbated by water abstraction, mean mouth constriction is more likely to occur during this period. However, when the entrance is open seawater intrusion can extend approximately 2.5km inland from the coast. Under these conditions the estuary is commonly stratified in the upper reaches where fresh surface water is overlying denser (heavier) seawater. This denser seawater can become trapped in deep (2-4m) pools in the estuary with the potential for phytoplankton blooms to establish and oxygen to deplete after extended periods of poor flushing.

Satellite imagery of the entrance closed (left), partial opening (middle left) and narrow opening (middle right). At the time of sampling the entrance was open (right). Imagery source for three left images Google Earth and right image L. Stevens.

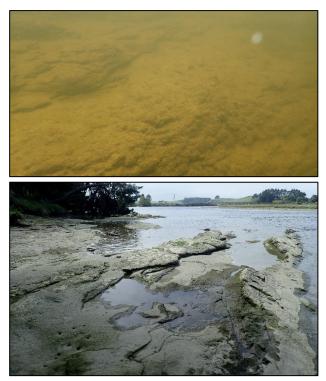
Bedrock in lower Kakanui Estuary

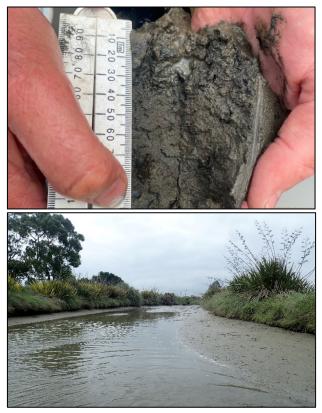
Sandy mud site T4, with no distinct aRPD and large burrows visible

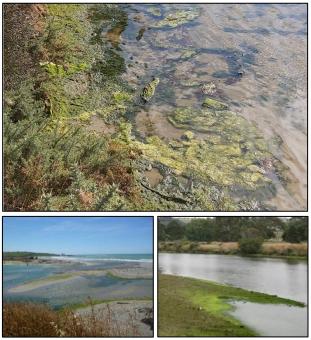
Previously, the most significant issues identified in the Kakanui Estuary has been the proliferation of algae and macroalgae during summer months (see photos below), and a build-up of fine muddy sediment. By contrast, in January 2021 the amount of macroalgae in the estuary was negligible, and sediments were primarily clean hard substrates. These changes almost certainly reflect the post-flood timing of sampling, rather than the outcome of any improvements in the catchment. Flood debris was still evident at the time of the survey.

Proliferation of algae in Kakanui Estuary March 2020 (top; source Sam Thomas), January 2015 (bottom left; Plew & Barr 2015) and February 2012 (bottom right; Ozanne & Wilson 2013)

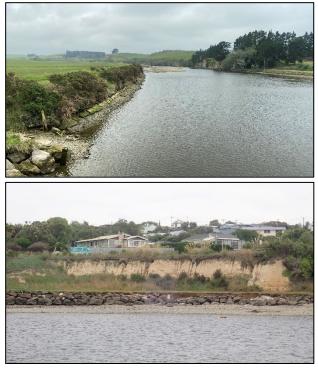
Kakanui Estuary margin, artificial rock walls in the lower and mid estuary (top) and natural steep banks (bottom)

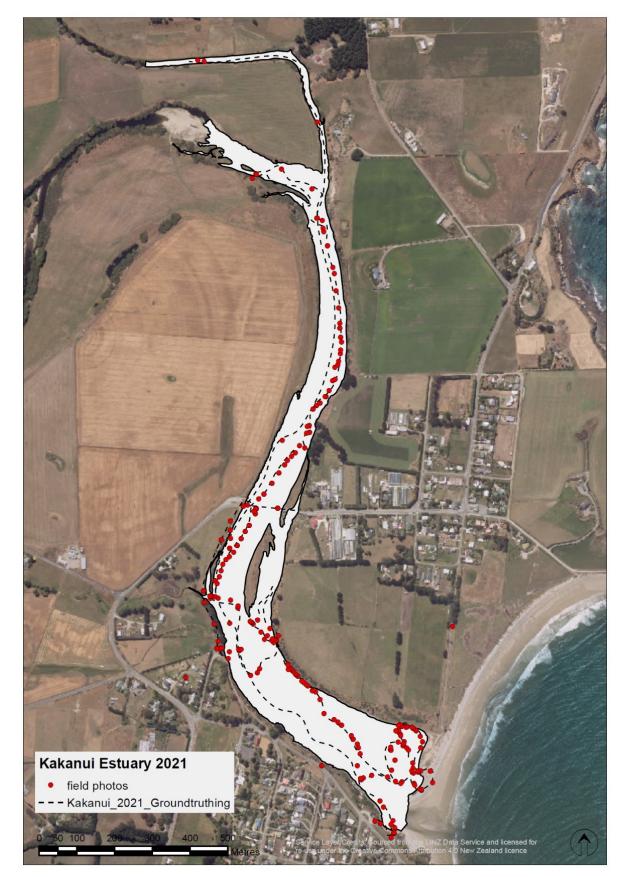
Appendix 3. Ground truthing Kakanui Estuary January 2021

Ground-truthing extent and location of field photos in January 2021
