## MEMORANDUM

**To:** Hearing Panel PC5A  
**From:** Peter Stevenson, Tom de Pelsemaeker  
**Date:** 16/05/2016  
**Re:** PC5A Request for further information - Hydrological information

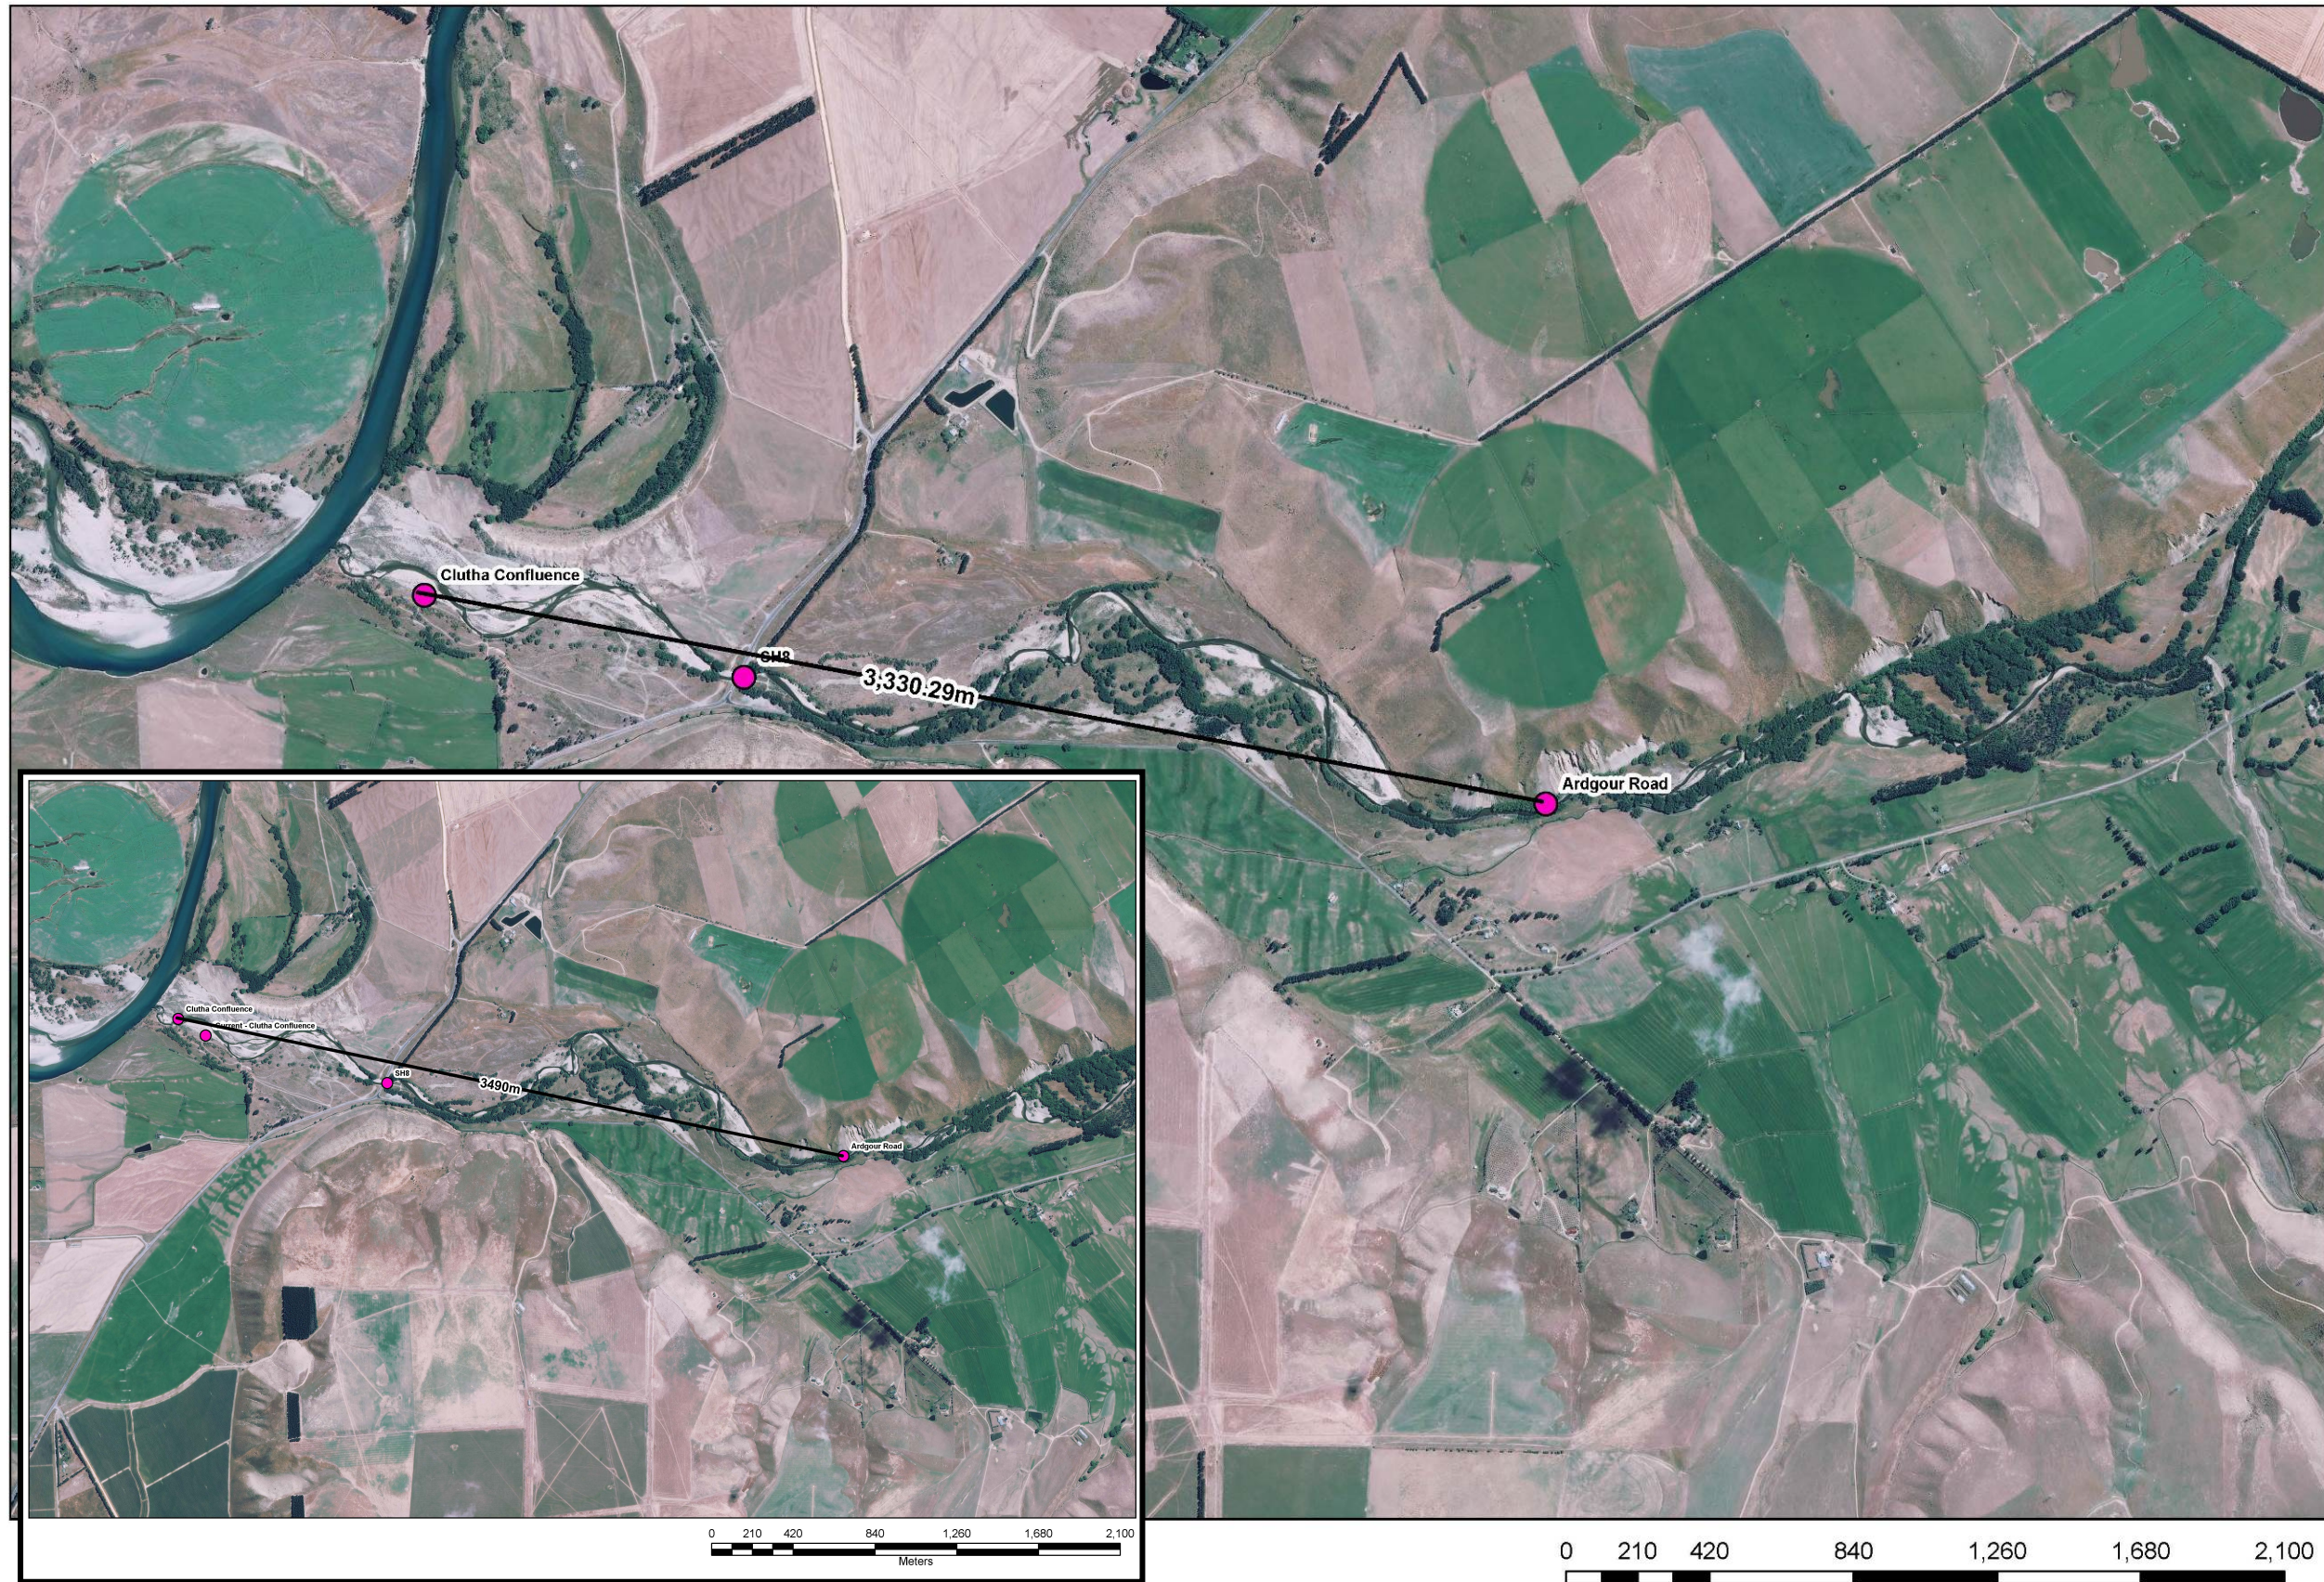
**1.b *aerial photograph & topo map showing the location of the Clutha Confluence flow monitor (Insert show location of 2007 until May 2008 the monitoring station).***

From November 2007 until May 2008 the monitoring station was at 1311035E 5024158N. The site was reopened October 2014 at 1311175E 5024075N

The Lindis at Clutha Confluence flow monitoring station was reinstated in September 2014 at a site approximately 200 metres upstream from the location used in 2007.

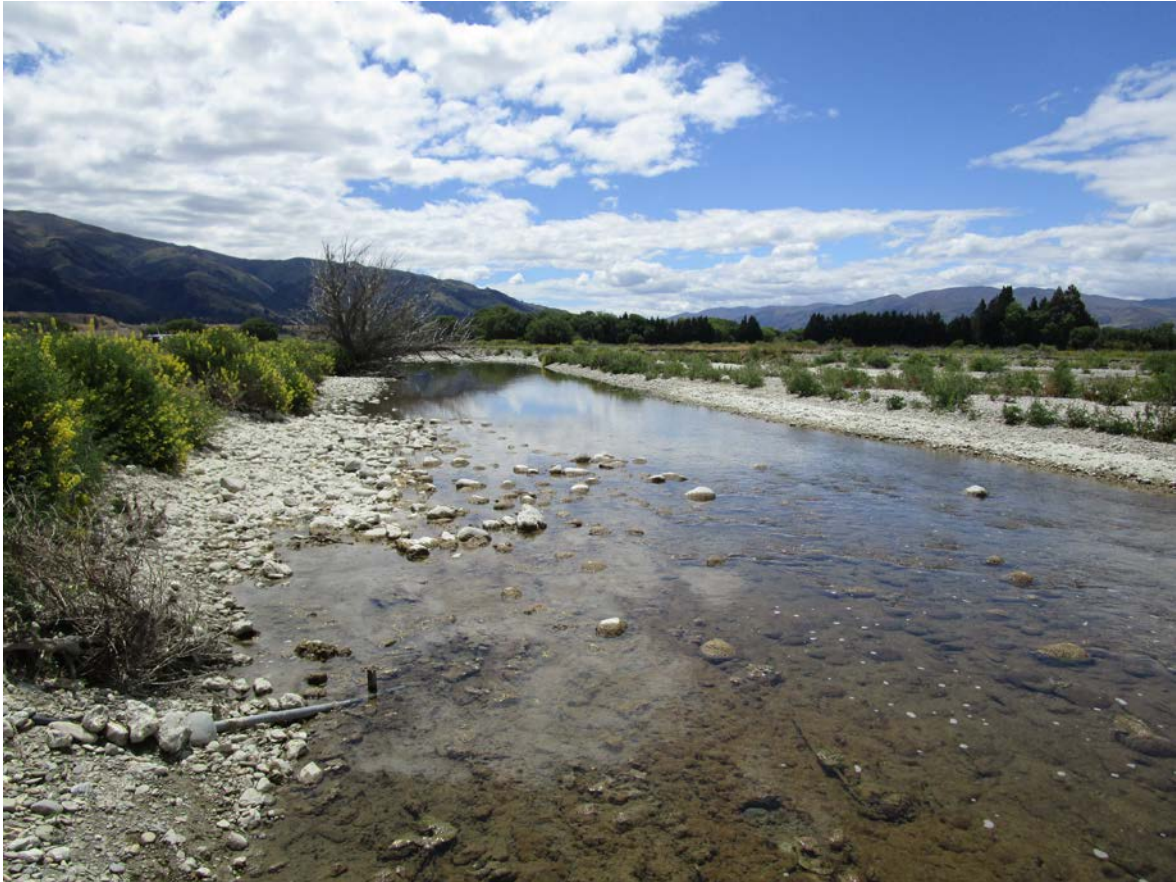
**1.c** *Photograph of the Clutha Confluence flow monitoring site*

The station was re-established upstream from the original location as it gave better protection for the monitoring instrumentation and more sensitive and stable control for readings at low flow.

The flow is concentrated into one channel during low flow at the monitoring location. There is a reasonable depth of water for the water level sensor to have a calm point of measurement.

The flow site lies on the True left of the river in a channel that is approximately 10 to 15m wide. The entire cross section of the river at this site is approximately 50m wide.

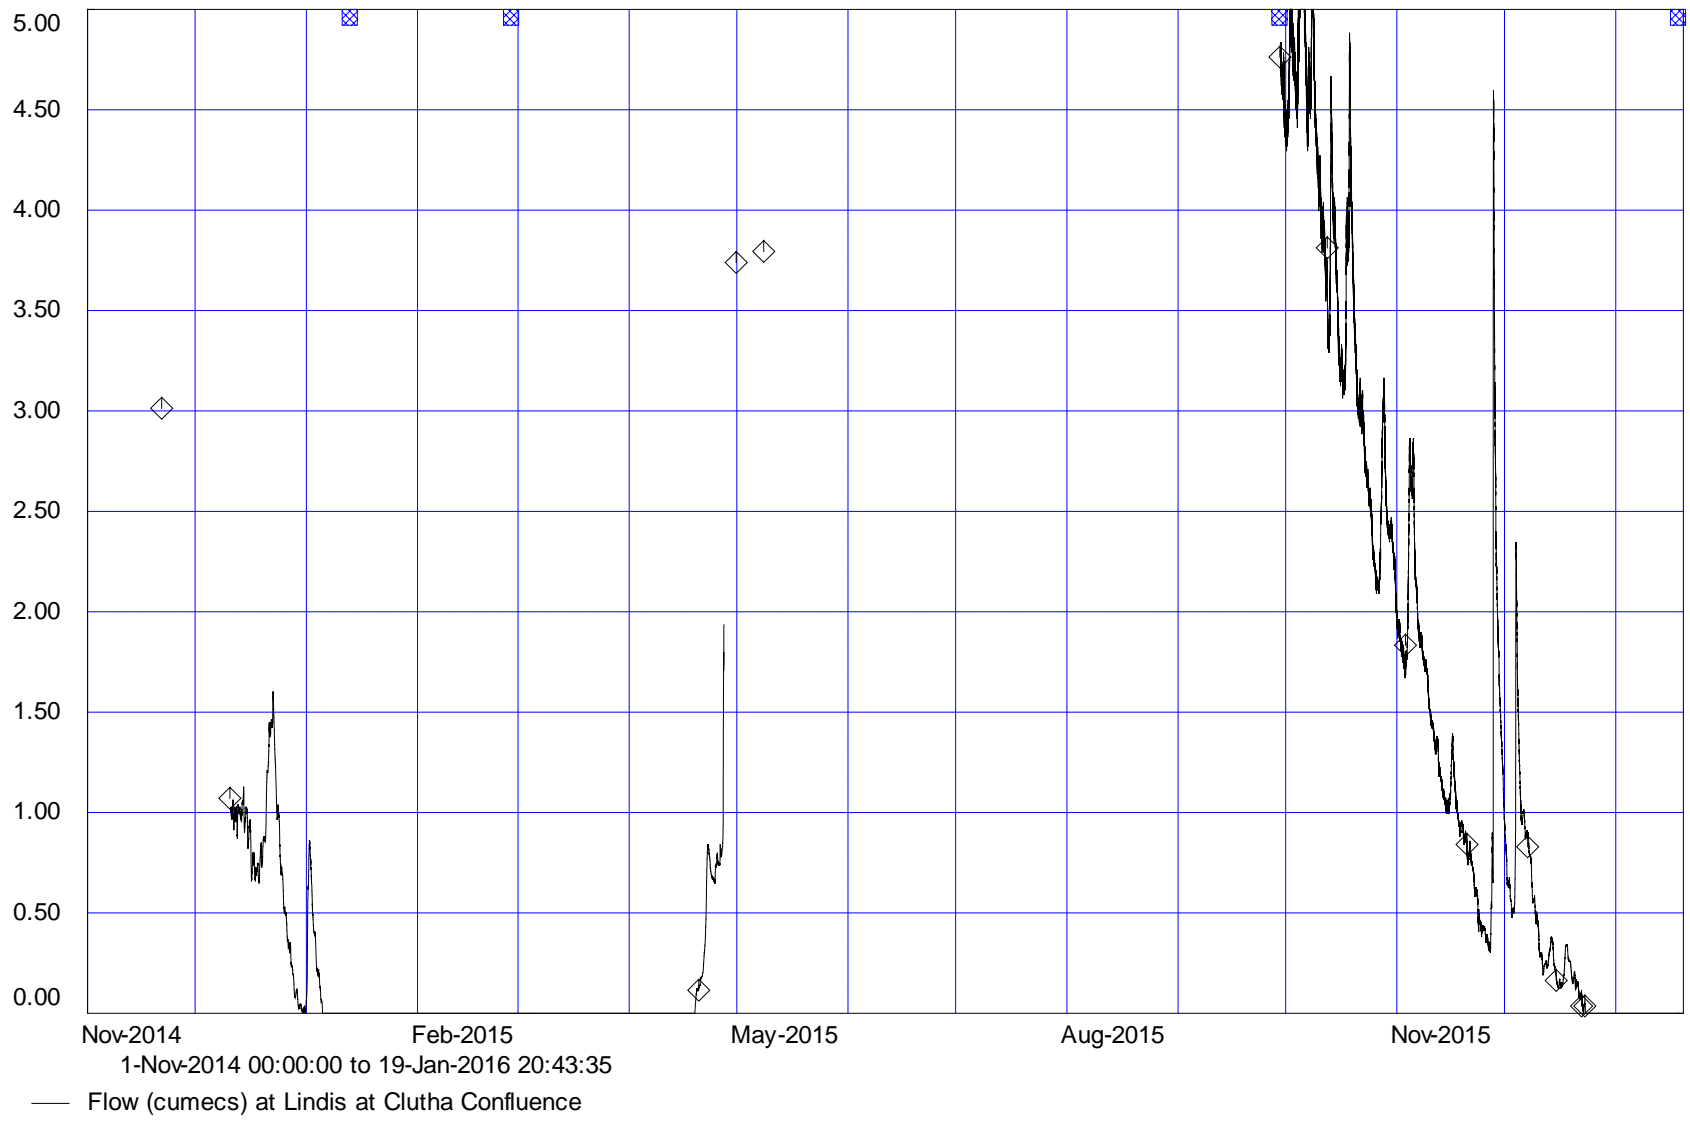
List of flow gaugings with measured flow (cumecs)

Flow (m3/sec) at Lindis at Clutha Confluence

From 7-Nov-2007 16:30:00 to 22-Apr-2016 13:27:00

Comments have been added to the metadata records when a problem that may compromise data quality has been identified. The flow derived from applying the flow rating to the stage data to produce the continuous time-series record has been compared with the gauged flow to ensure the time-series data agrees with the gauged flow at the time. Flow gaugings have a calculated uncertainty of 8% or better based on ISO 748:2007. The majority of gaugings are within the +/-8% of the rated flow data for all stations on the main stem of the Lindis River.

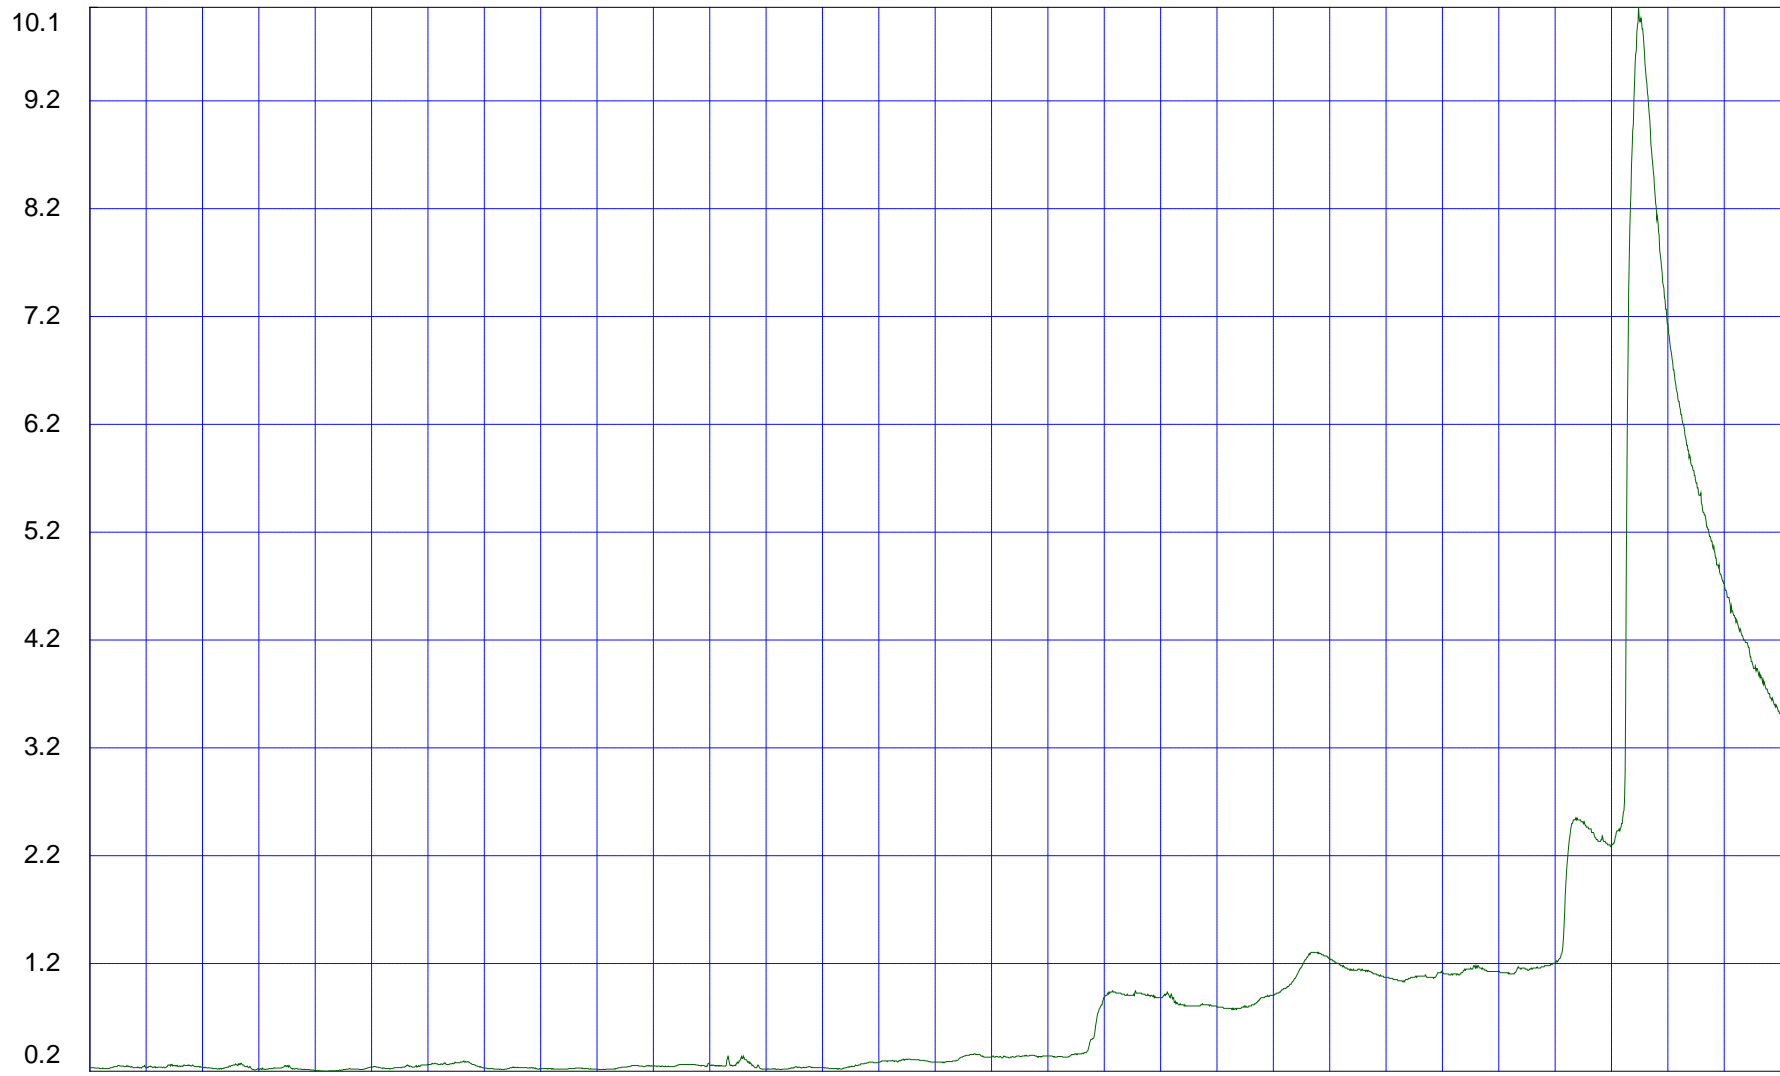
**2.a Certified hydro-graph data from the flow recorder at Ardgour Road for the period 1 April 2015 to 30 April 2015.**

Hydrograph is shown below (Updated flow data for the Ardgour Rd Flow Monitoring Site can be downloaded from the ORC webpage)

1-Apr-2015 00:00:00 to 1-May-2015 00:00:00

— Flow (cumecs) at Lindis at Ardgour Road
