**The hazard significance of landslides in and around
Dunedin City**

**GNS Science Consultancy Report 2013/339
January 2014**

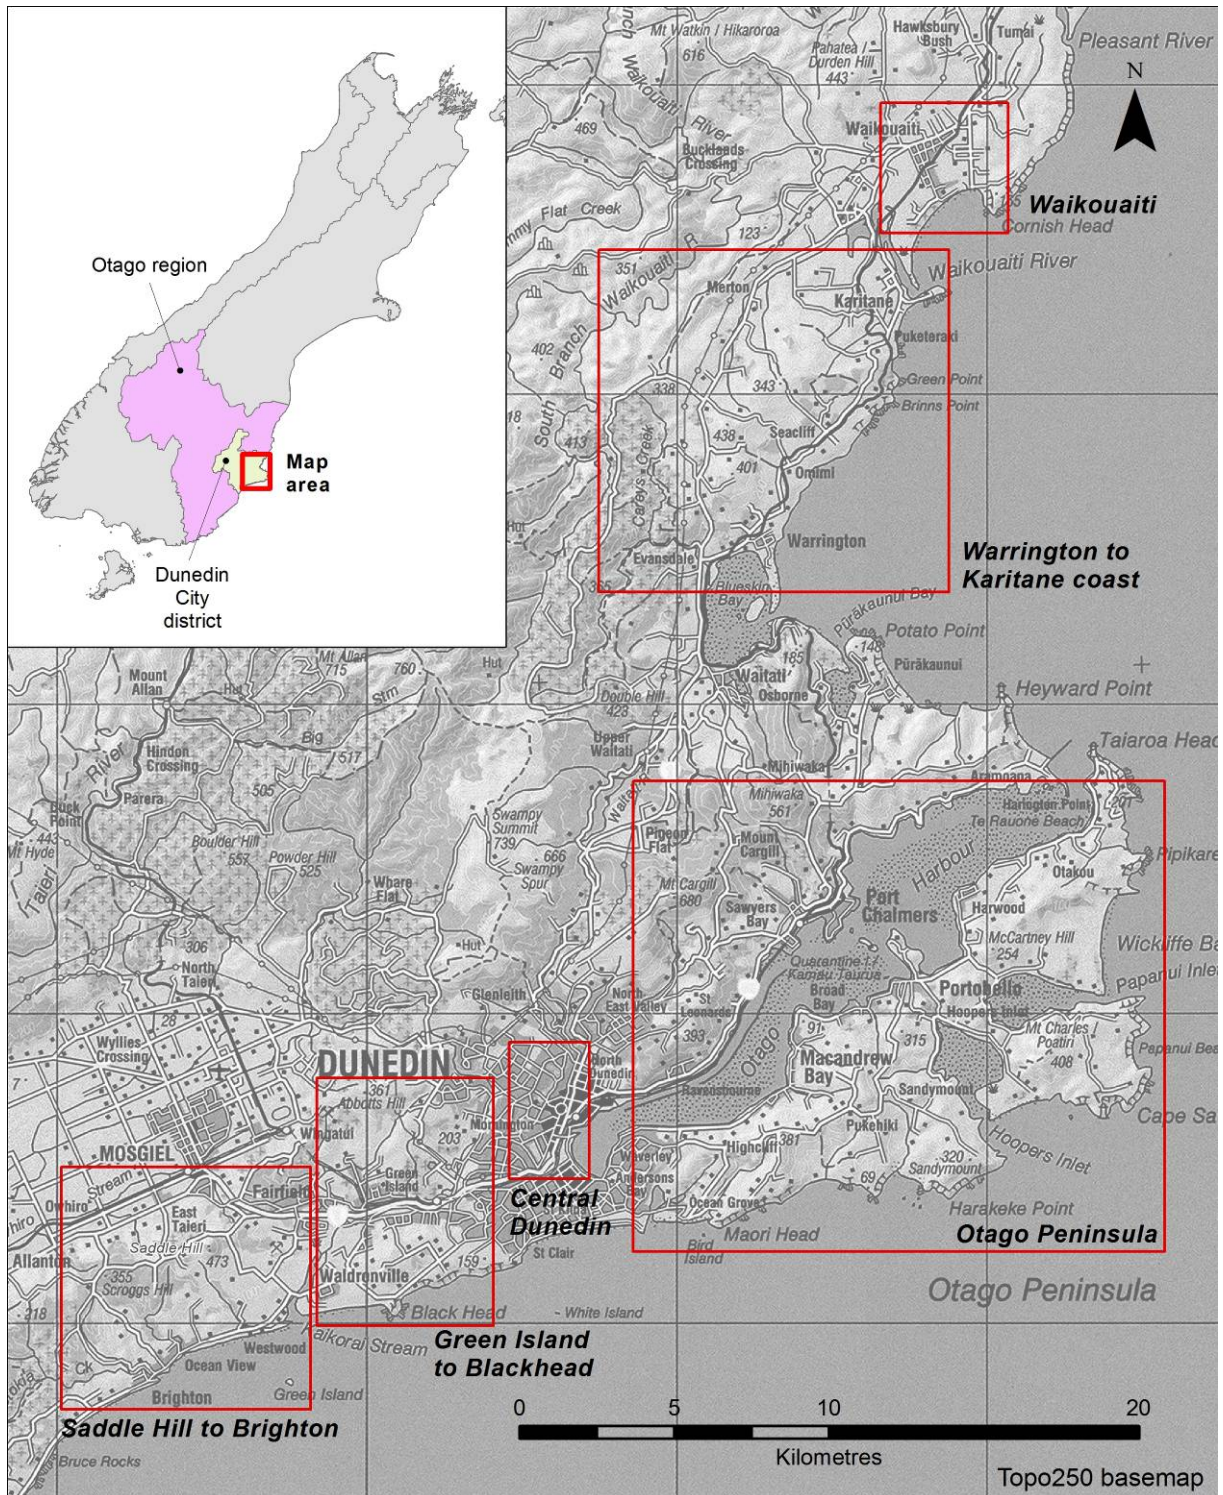
Figure 1 Location of the six landslide hazard assessment areas that are addressed in this report.

A limitation of the updated landslide dataset is that it contains little, if any, information on the significance of the hazard posed by each identified landslide. ORC subsequently contracted GNS Science to provide more information on this aspect of the mapped landslides within six areas within the Dunedin City district, and that is the subject of this report (Figure 1).

The nature and distribution of landslides is described for six selected areas (Figure 1), with emphasis on aspects that highlight the significance of landslide hazards, as illustrated on maps accompanying each sub-section. The selected areas include existing urban sectors of Dunedin, places where further development may occur, and areas known to have a propensity for landsliding. Table 6 presents a statistical evaluation of the extent to which each area has been affected by landsliding (noting that only the on-land area, not estuaries or the sea, is considered). The landslide areas (polygons) are evaluated separately from the landslides that are denoted only as points in the database. The statistics are discussed below in relation to each assessment area.

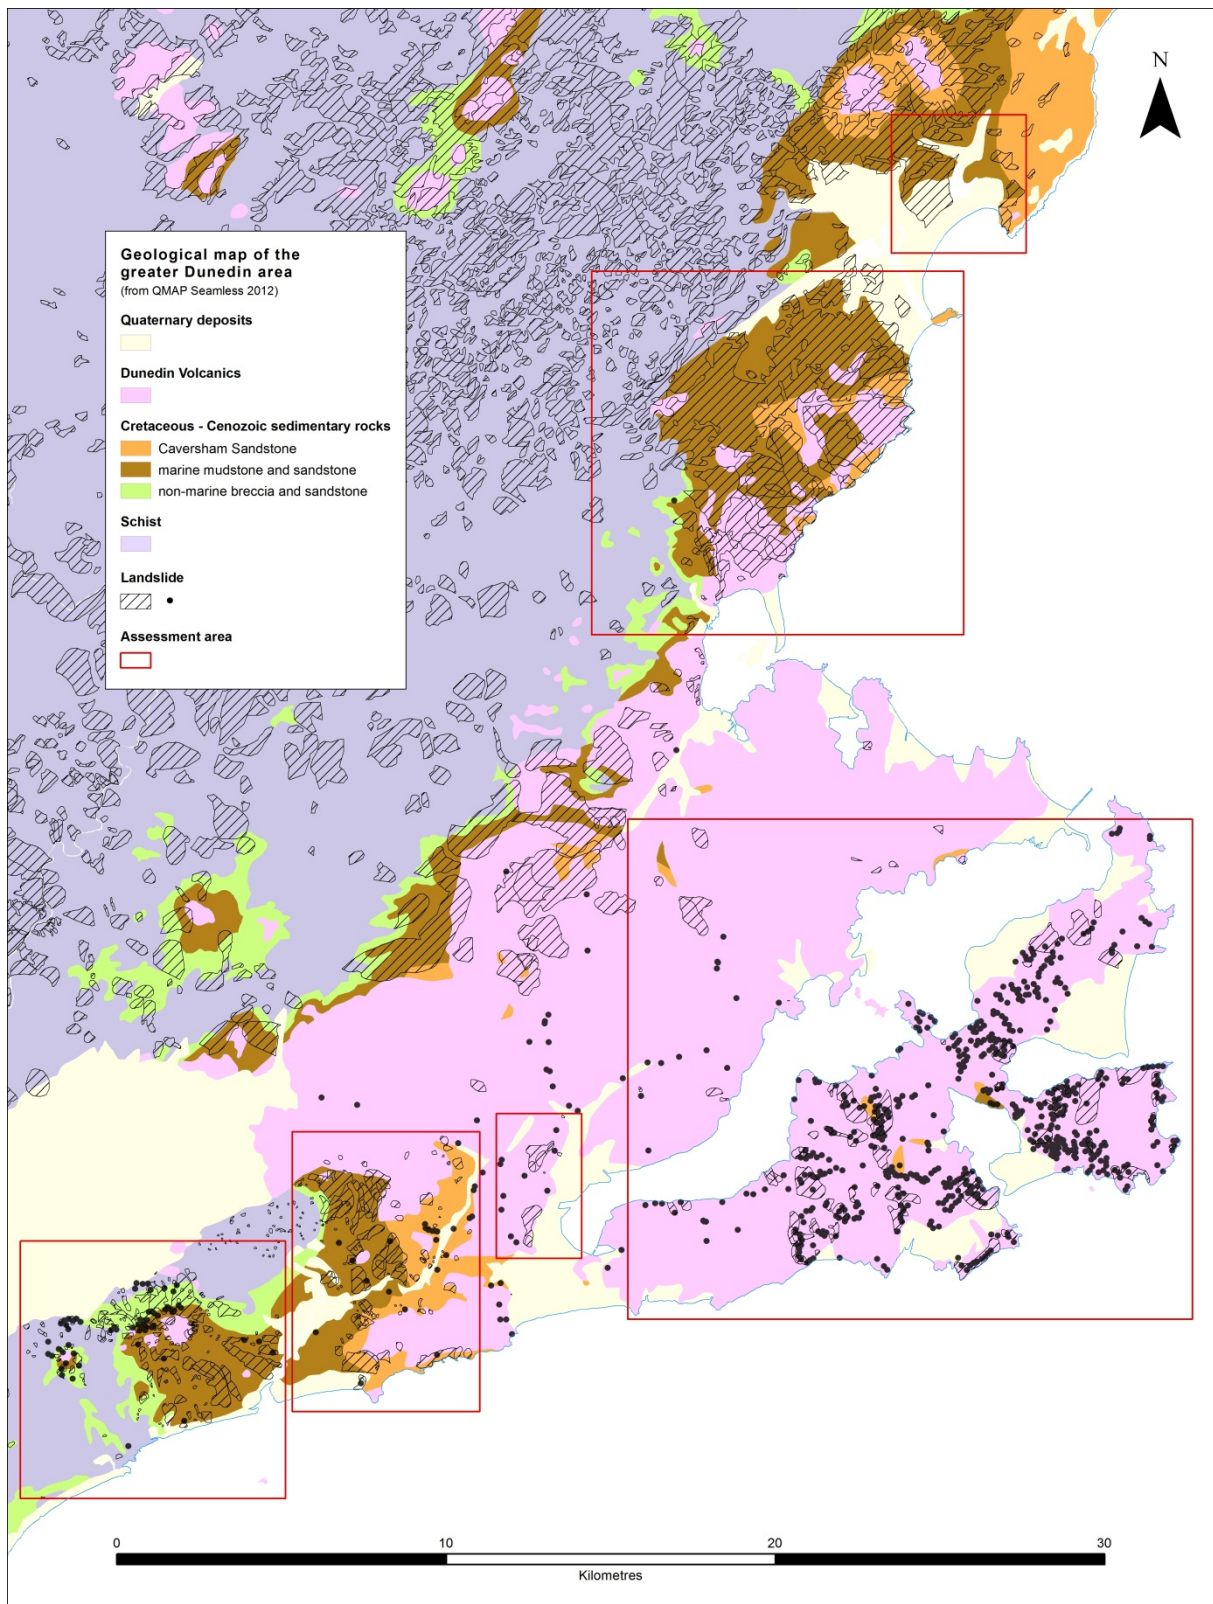
Figure 2 Simplified geology of the Dunedin area and landslides from the ORC landslide database. The landslides are represented by both black cross-hatched areas (polygons) and black dots (points).

Generally speaking, most medium to large landslides, such as are shown in Figure 2 as areas (polygons), are deep-seated and probably are bedrock landslides. In contrast, most small landslides, such as are represented in Figure 2 by points, are probably surficial landslides. However, small landslides can occur within surficial materials that have formed on larger bedrock landslides.

No analyses of these types have been undertaken as part of the present report, other than the simple comparison of bedrock geology to landslide distribution (Figure 2) and consideration of the percentage of land area affected by landslides in each of the assessment areas.

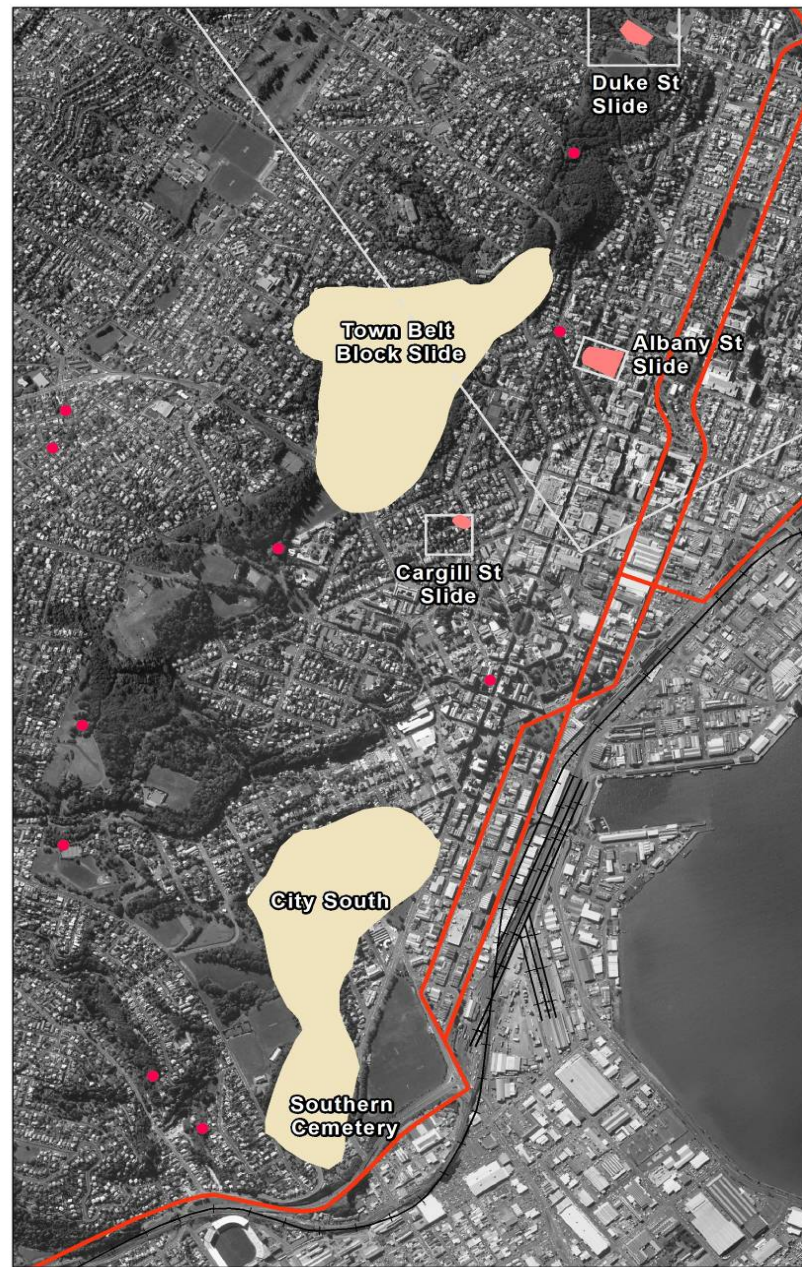
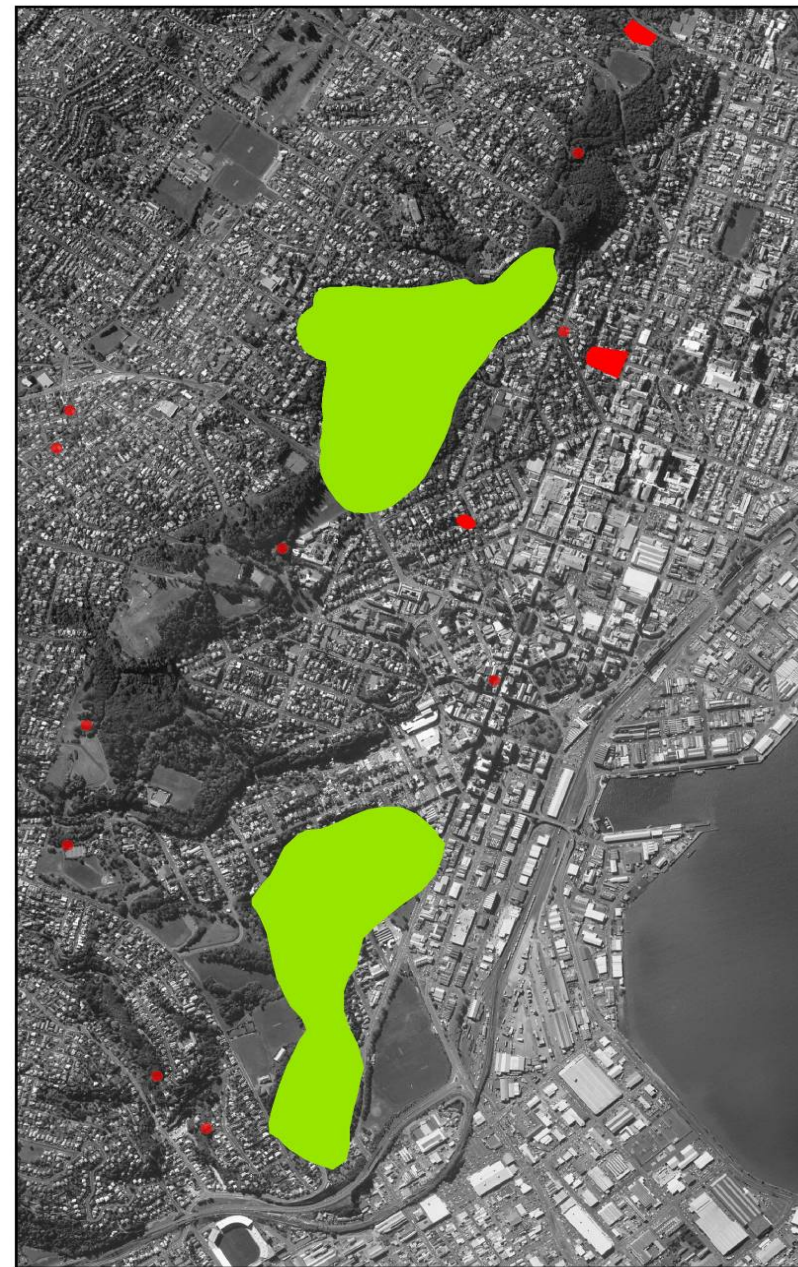
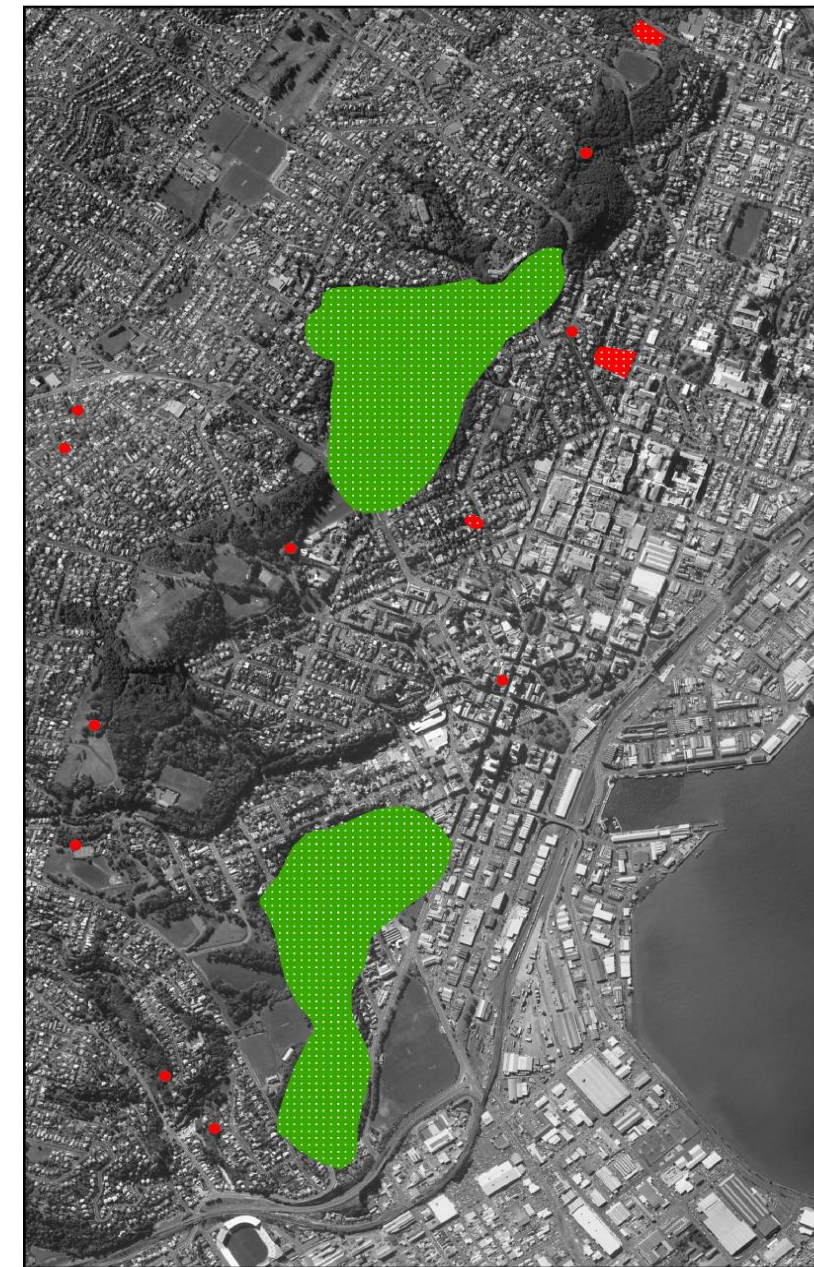
Figure 3 Central Dunedin Landslide Certainty, Activity, and Sensitivity.

Most of the landslide point data relate to minor surficial landslides that occurred during the March 1994 rainstorm (Stewart 1996).

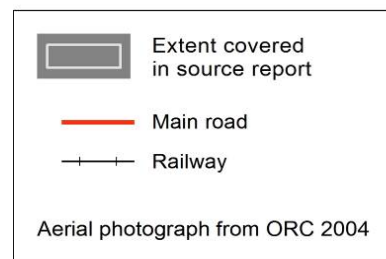
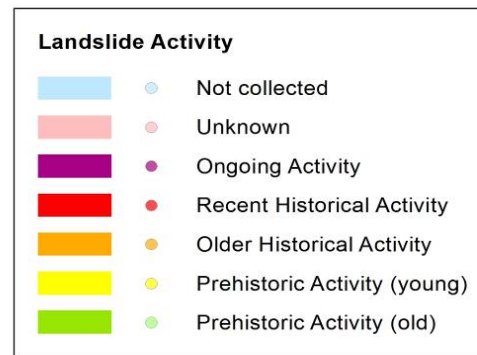
The landslides within central Dunedin are shown on Figure 3. About 7% of this area comprises mapped landslides, but most of these have a *certainty* attribute of possible. Definite and likely landslides comprise only 0.2% of the assessment area, while the mean density of landslide points is 1.0 per square kilometre (Table 6). Overall, existing identified landslides in the central Dunedin are relatively sparse.

Examination of aerial photographs and topographic maps has identified three areas that have features that are similar to those associated with large block landslides (City South, Southern Cemetery and Town Belt block slides – see Figure 3). They are attributed as possible slides and have no record of historical movement. Intensive urban development has taken place across much of these suspected landslide areas, and they also include parts of the Town Belt reserve. The urbanisation in conjunction with the vegetation of the Town Belt has masked many of the diagnostic features of these suspected landslides and their full extents are uncertain. Alternative interpretations of the features are possible, and the landslide-like features could be formed by differential erosion of various volcanic lavas flows, for example. If they are in fact landslides, then they are interpreted as having formed in pre-Holocene times and are assessed as having low sensitivity to natural or anthropogenic changes in stability factors.

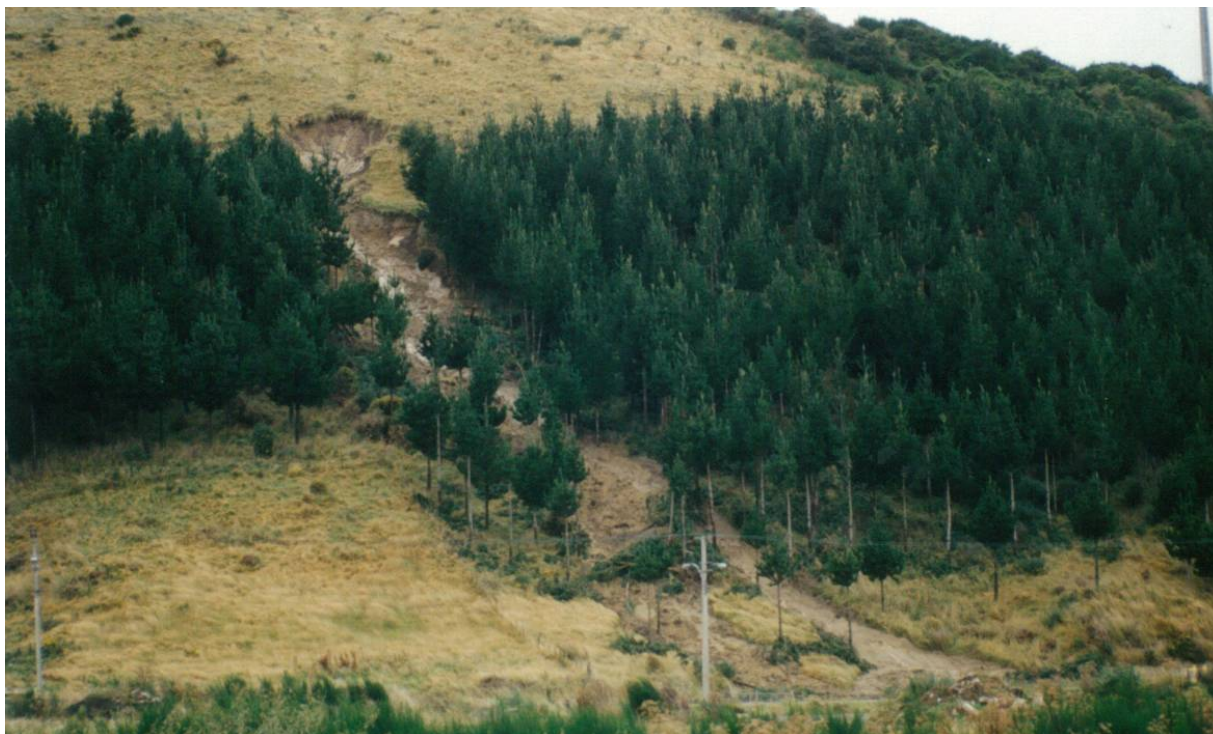
Figure 4 A surficial landslide occurred midway up the eastern side of Kaikorai valley during the March 1994 rainstorm. Near the upper limit of the plantation, the steep crests at the top of the scars are the landslide head scarps. The waterlogged landslide debris mobilised into a porridge-like slurry and ran down the slope as a debris flow, which had sufficient power to uproot or break off several pine trees. The debris flow extended onto to Kaikorai Valley Road (obscured in the middle ground) where it completely blocked the southbound lane. Photo: GNS Science, D.L. Stewart, March 1994.

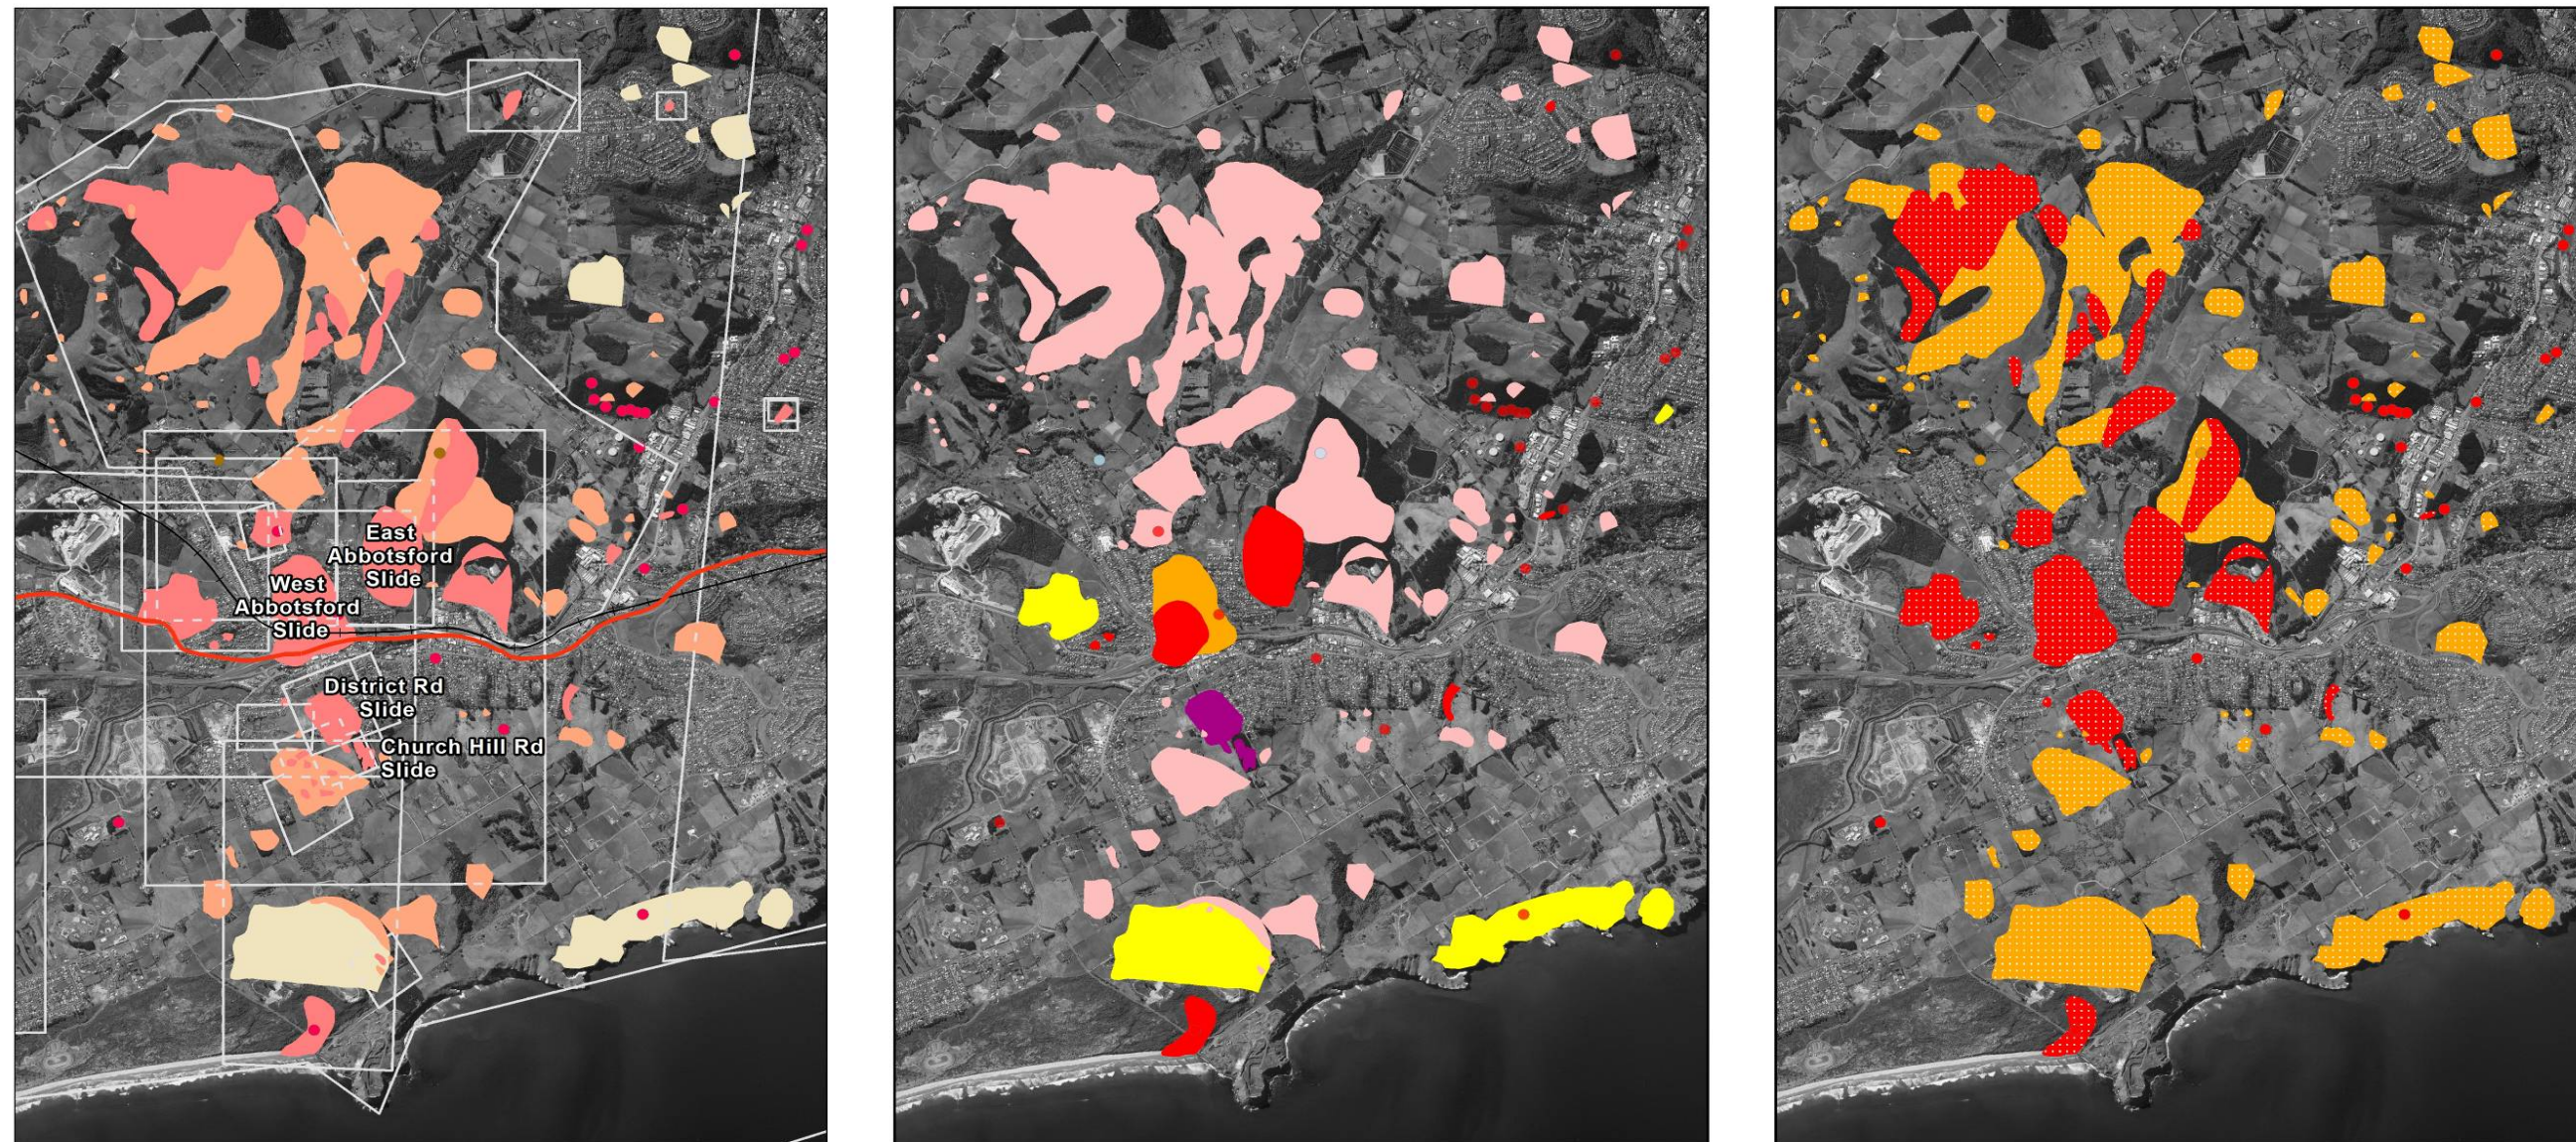
Green Island to Blackhead

Figure 5 Green Island to Black Head: Landslide Certainty, Activity, and Sensitivity.

A surficial landslide occurred at Waldron Crescent, in Green Island, in 1993 when a 1.5 m high cut was excavated across a moderate slope of about 15° (Barrell & Glassey 1993). Minor instability continues to affect houses and infrastructure at the Church Hill Road and District Road slides in Green Island despite minor remediation (Lee Paterson, MWH, pers. comm.). These movements all indicate that the slopes are highly sensitive to small changes in stability factors, such as groundwater fluctuations due to rainfall variation and slope modification. The sensitivity is primarily due to the nature of the underlying geology which is dominated by Cretaceous-Cenozoic sedimentary rocks that appear to be particularly susceptible to landsliding (Table 5).

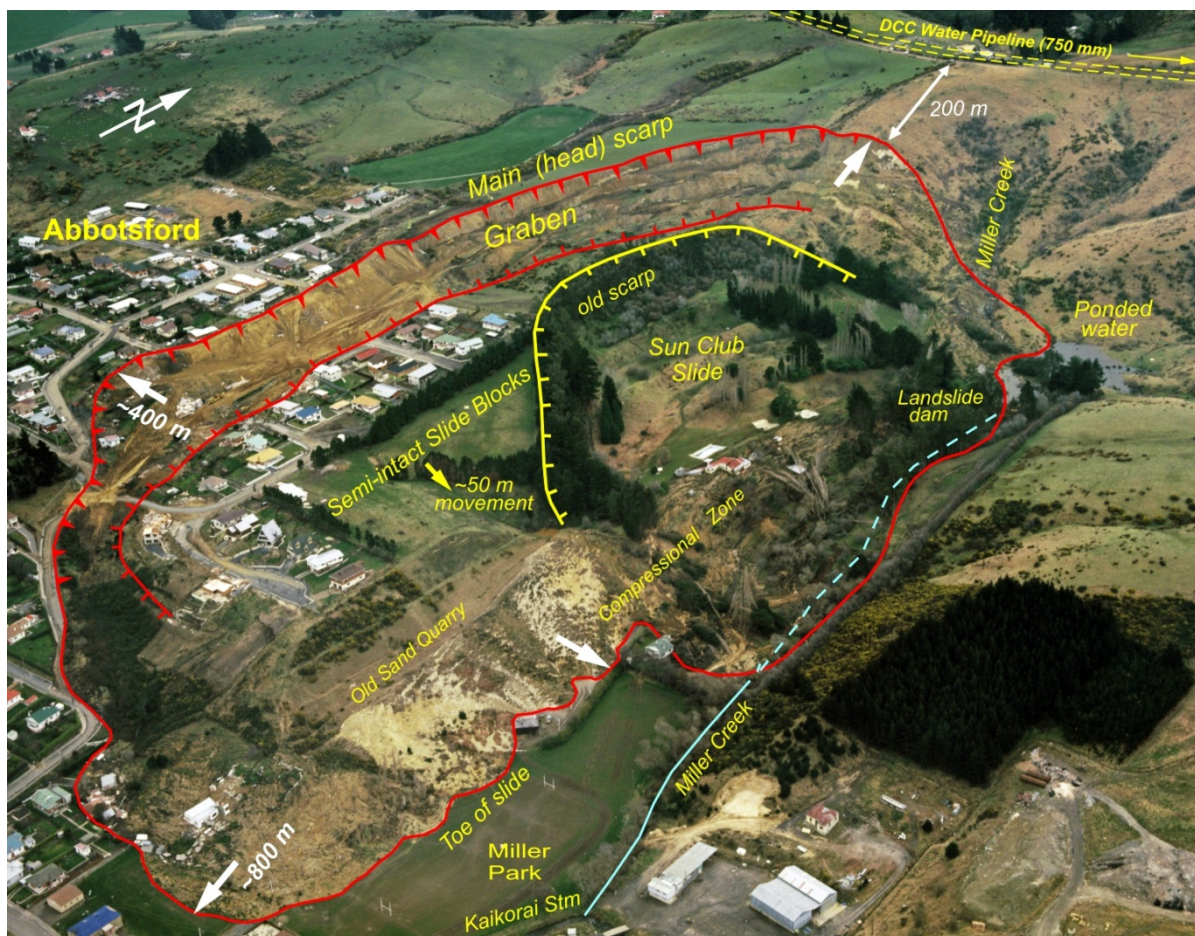
Figure 6 An annotated photograph looking northwest across the 1979 East Abbotsford Landslide on 9 August 1979, the day following the main movement. This was a 'first time' bedrock landslide, of the 'block slide' variety. The slide block is about 400 m long, from the head of the graben to the toe of the slide, and about 800 m wide. The Sun Club Slide was an existing prehistoric landslide on the flank of the Miller Creek valley. The Sun Club Slide area was 'piggy-backed' downhill during the 1979 block slide. Illustration from Hancox (2009).

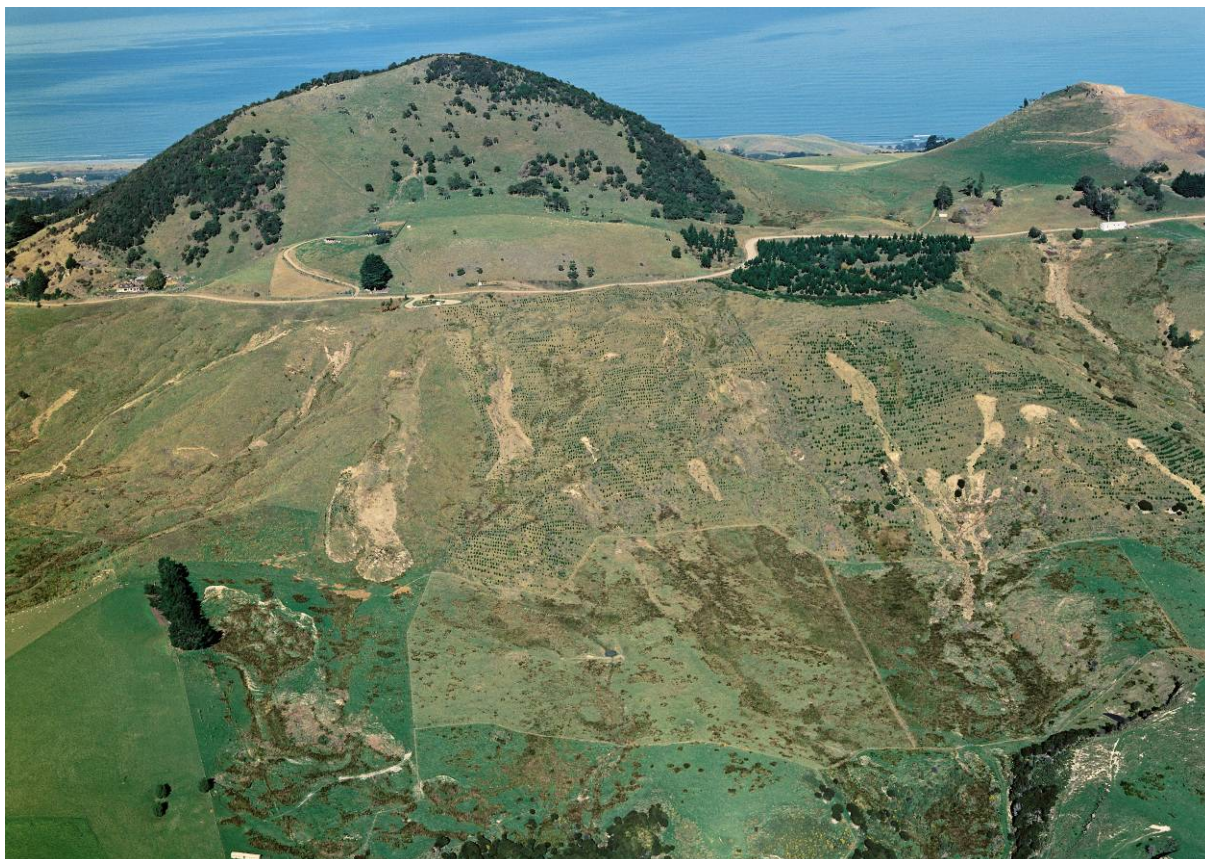
Figure 7 An aerial view south towards Saddle Hill Road, running left-right, above which rise the promontories of Saddle Hill (left) and Jaffray Hill (far right). From Saddle Hill Road to below the bottom of the photo is a moderate slope descending towards the Taieri Plain (out of sight below the photographer). Much of the slope below Saddle Hill Road is interpreted as a large, deep-seated, bedrock landslide. Superimposed on that landslide are numerous surficial landslides, the freshest of which moved during the March 1994 rainstorm, but many older, more subdued, scars relate to previous recent historical activity. This area is clearly very susceptible to landsliding. The young trees evident in this photo are now mature, and today obscure much of the detail of past landsliding on this slope. Photo: GNS Science CN 32285b, D.L. Homer, 1 May 1994,

gullies. Many surficial landslide movements occurred as a result of the April 1994 rainstorm (Stewart 1996) (Figure 7; most of the landslide points in Figure 8).

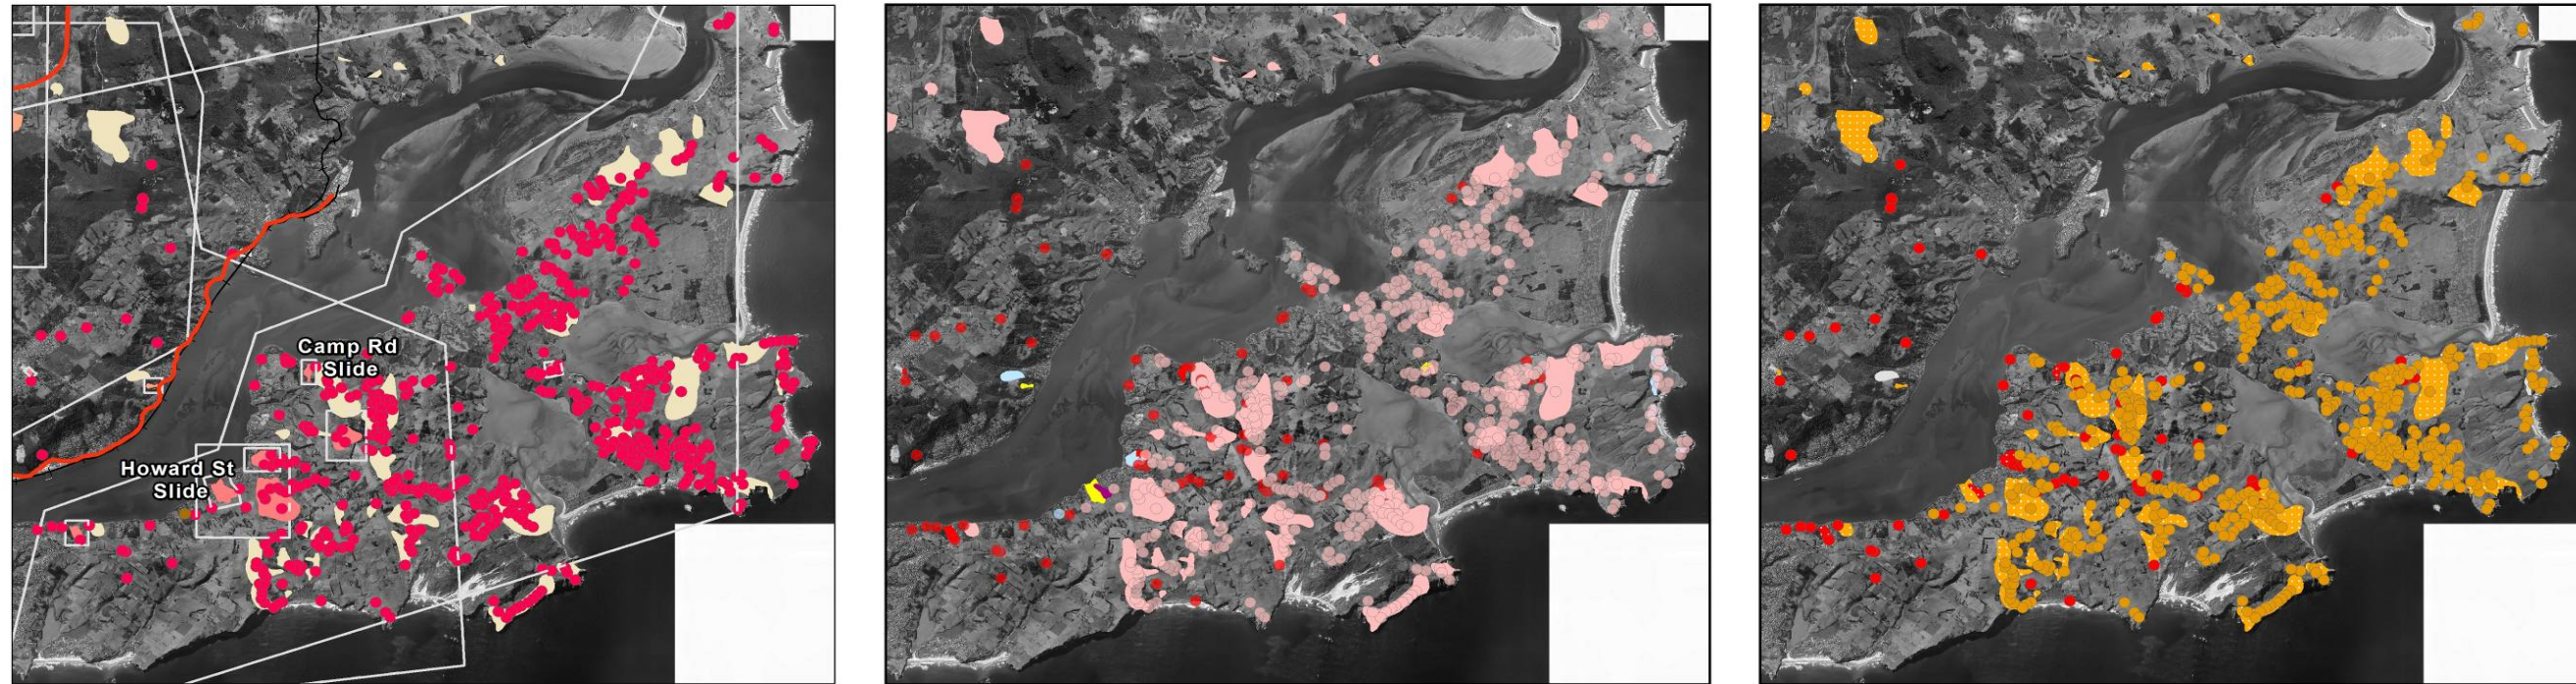
Otago Peninsula

Figure 9 Otago Peninsula: Landslide Certainty, Activity, and Sensitivity.

The majority of landslides on the peninsula are shallow surficial earth flows, debris flows and earth slides that have occurred in loess, colluvium and weathered volcanic material that mantle the volcanic bedrock (Leslie, 1974; Stewart, 1996). Most are initiated on slopes of between 12 and 28 degrees (Leslie 1974). Major rainstorms (see textbox, following Figure 9) tend to generate many surficial landslides, some of which are first-time failures while others are reactivated existing landslides. In some cases, surficial landslide material is remobilised as debris flows that, if confined within a stream valley or even minor gully, may travel rapidly for long distances (up to 2 km), and in some cases have caused significant damage to buildings, roads or water/power supplies (e.g. Stewart 1996, Photo 1; reproduced in Figure 10 of this report). Most of the surficial landslides are classified as definite. Those mapped by Stewart (1996) are categorised as having recent historical activity and those mapped earlier by Leslie, 1974 as unknown activity. All are considered to have moderate to high sensitivity to changes to stability factors.

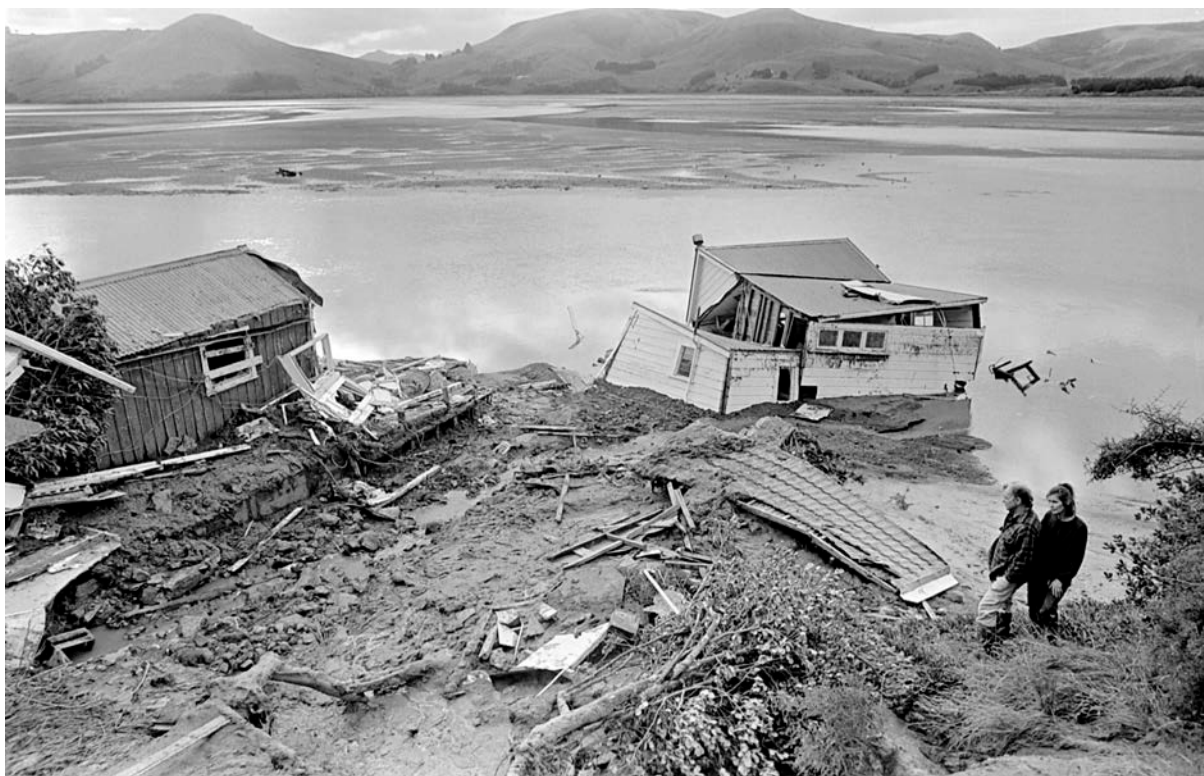
Figure 10 During the March 1994 rainstorm, a small landslide occurred in the head of a minor gully about halfway up Mt Charles, near Papanui Inlet, Otago Peninsula. The landslide material was mobilised into a debris flow that proceeded rapidly down the gully, crossed Cape Saunders Road and broke through the front gate of a holiday house built in the gully. Debris piled up against the house, which was broken off its foundations by the weight of debris and carried downhill several tens of metres before ending up in the Inlet, as seen in this view, looking north-northeast. The boatshed to the left largely escaped damage. The minor gully down which the debris flow came normally carried a small creek that ran past the house. This photo illustrates the potential hazard of landslide movement inundating a property, even though the landslide was initiated a long way from the property. Photograph courtesy of Otago Daily Times Newspaper, Jane Dawber, March 1994.

An aspect of the hazard significance of landslides is whether landslide movement occurs slowly or rapidly. The ORC landslide database classifies the main type of landslide movement that has occurred, but not the rate at which landslide movement occurred. The reason for its exclusion is that for most of the mapped landslides, the actual movements were not observed, and indeed many of the mapped landslides pre-date human settlement (i.e. are prehistoric). Nonetheless, some generalisations can be made. Most of the mapped landslides can reasonably be assumed to have moved at rates ranging between slow (about 1 m per year), moderate (about 1 m per day) and rapid (about 1 m per minute), based on the classification of Cruden & Varnes (1996). Only in proximity to very steep slopes or cliffs is there a possibility of very rapid rock or soil falls, although noting that in small valleys and gullies, small landslides have been known to temporarily block or impede drainage. Build-up of water behind the blockage can result in remobilisation of the landslide material into a very rapid debris flow that sweeps down the valley (see Figure 10).

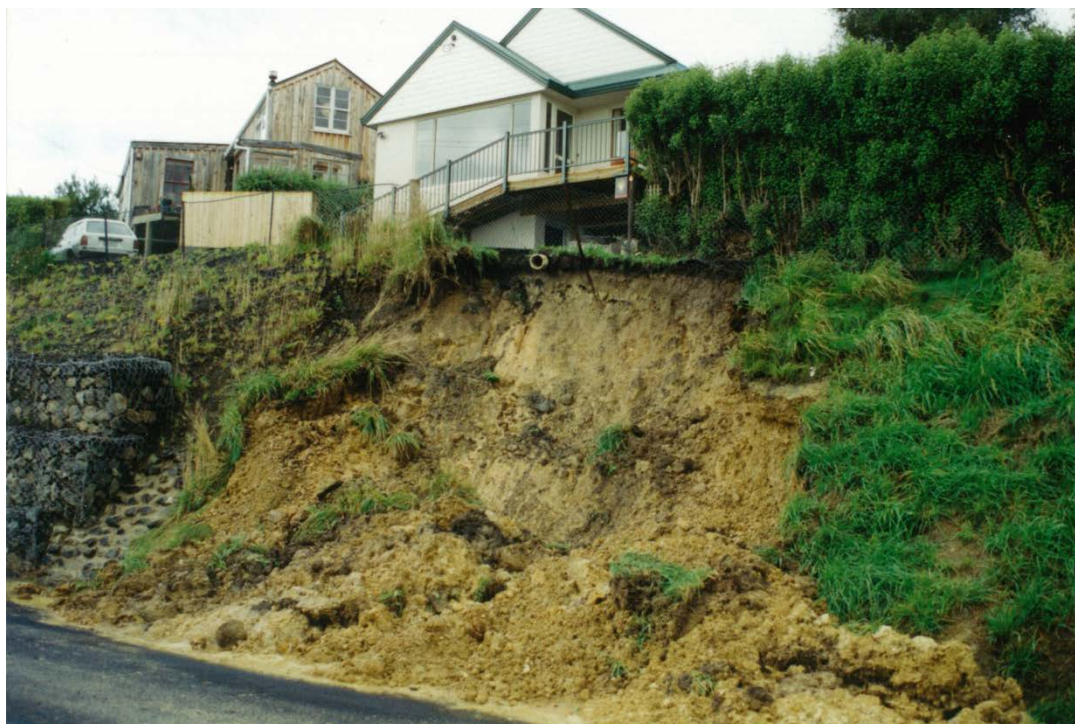
Figure 11 A small surficial landslide from this road cut in Margate Ave, Broad Bay, resulted from the March 1994 rainstorm. Flow from the drain at the head of the slide may have contributed to the failure. However, the gabion wall to the left indicates that this slope has previously experienced instability, which the gabions were doubtless installed to remediate. This photo illustrates the potential hazard of landslide movement undermining a property. Photo: GNS Science, I.M. Turnbull, 20 March 1994.

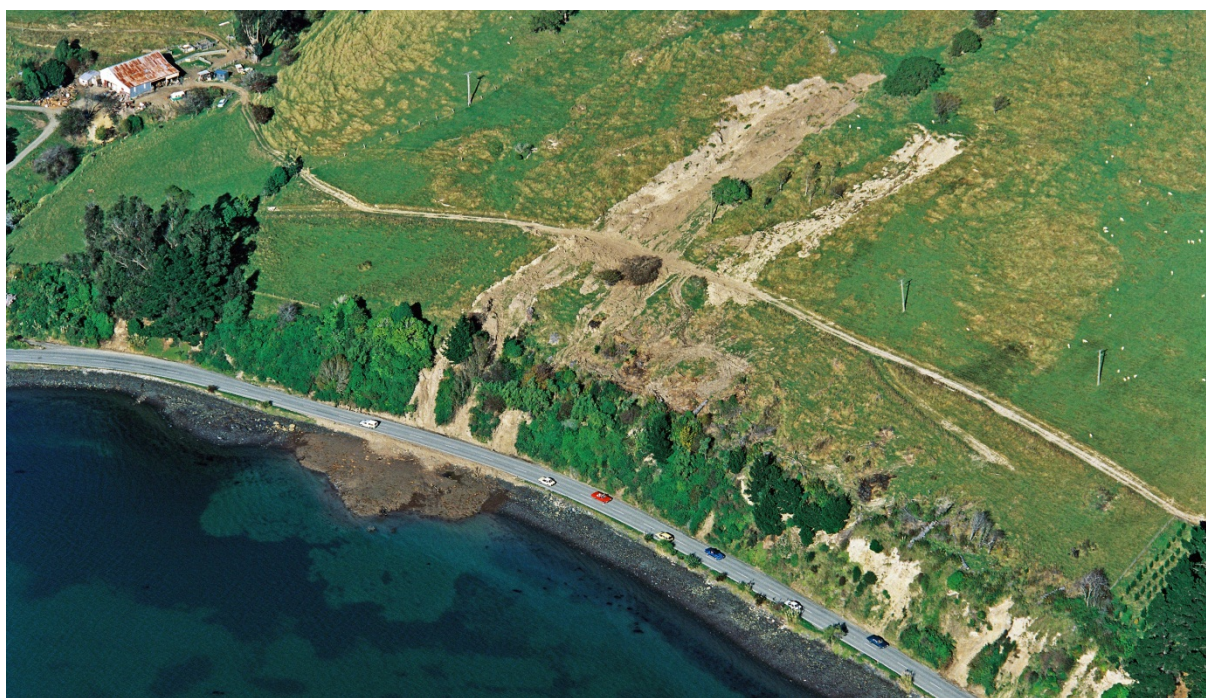
Figure 12 Surficial landslides occurred above Portobello Road, between Challis and Glenfalloch, during the March 1994 rainstorm, and generated debris flows that ran downslope, crossed the road and accumulated in Otago Harbour. The photo was taken after the debris had been cleared off the road, although the debris remains evident on the foreshore (brown) and seabed (pale). Being one of only two access roads to Otago Peninsula, this photo illustrates the potential vulnerability of this key transport route for peninsula residents. Photo: GNS Science, D.L. Homer, CN32057b, 1 May 1994.

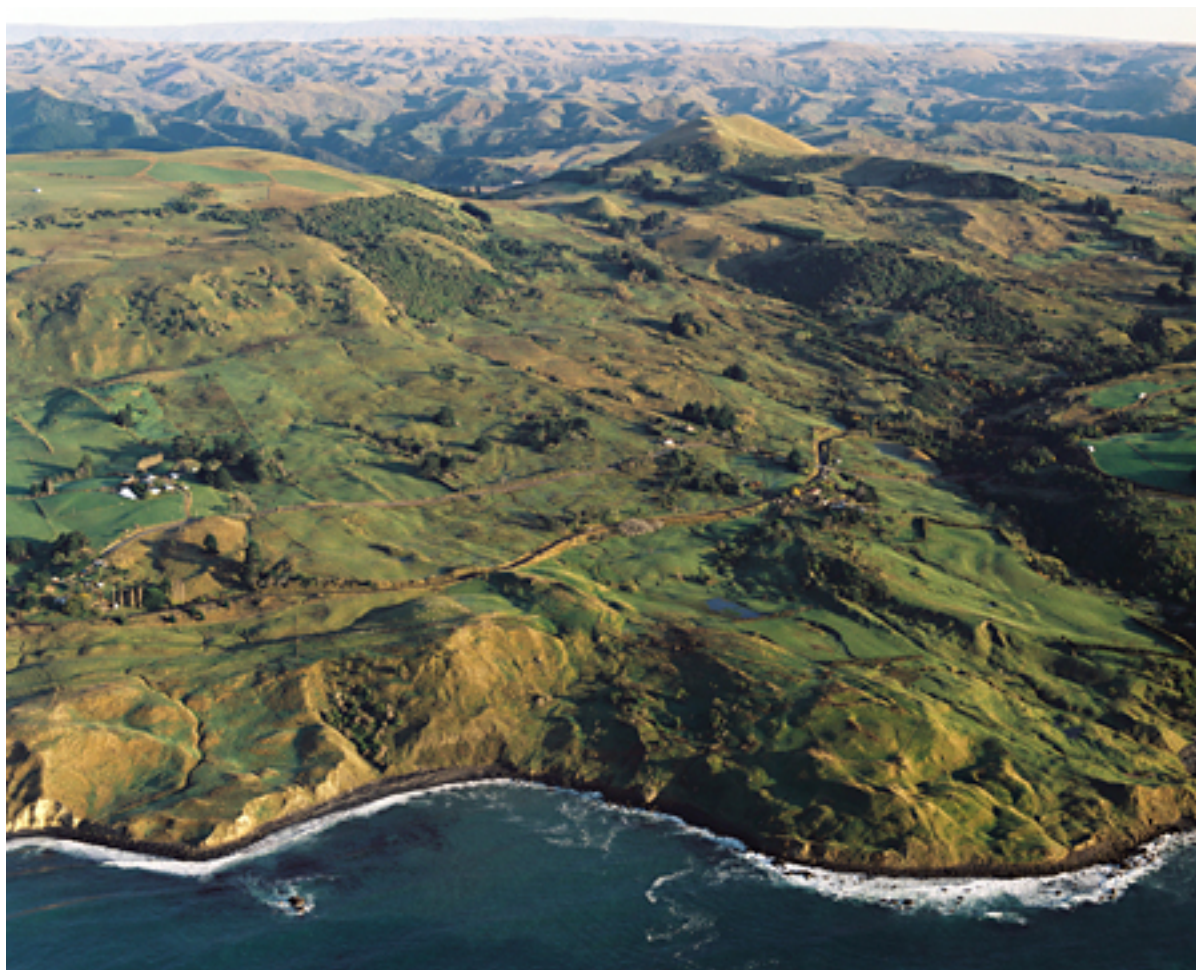
Figure 13 Typical earthflow ‘hummocky’ terrain Warrington to Karitane. Most of the land between the coast and the flat topped ridge is landslide. The Scenic Coast Road and the South Island Main Trunk railway cross the centre of photo (GNS Science, CN26986-03, Photographer, L. Homer).
