**The hazard significance of landslides in and around
Dunedin City**

**GNS Science Consultancy Report 2013/339
January 2014**

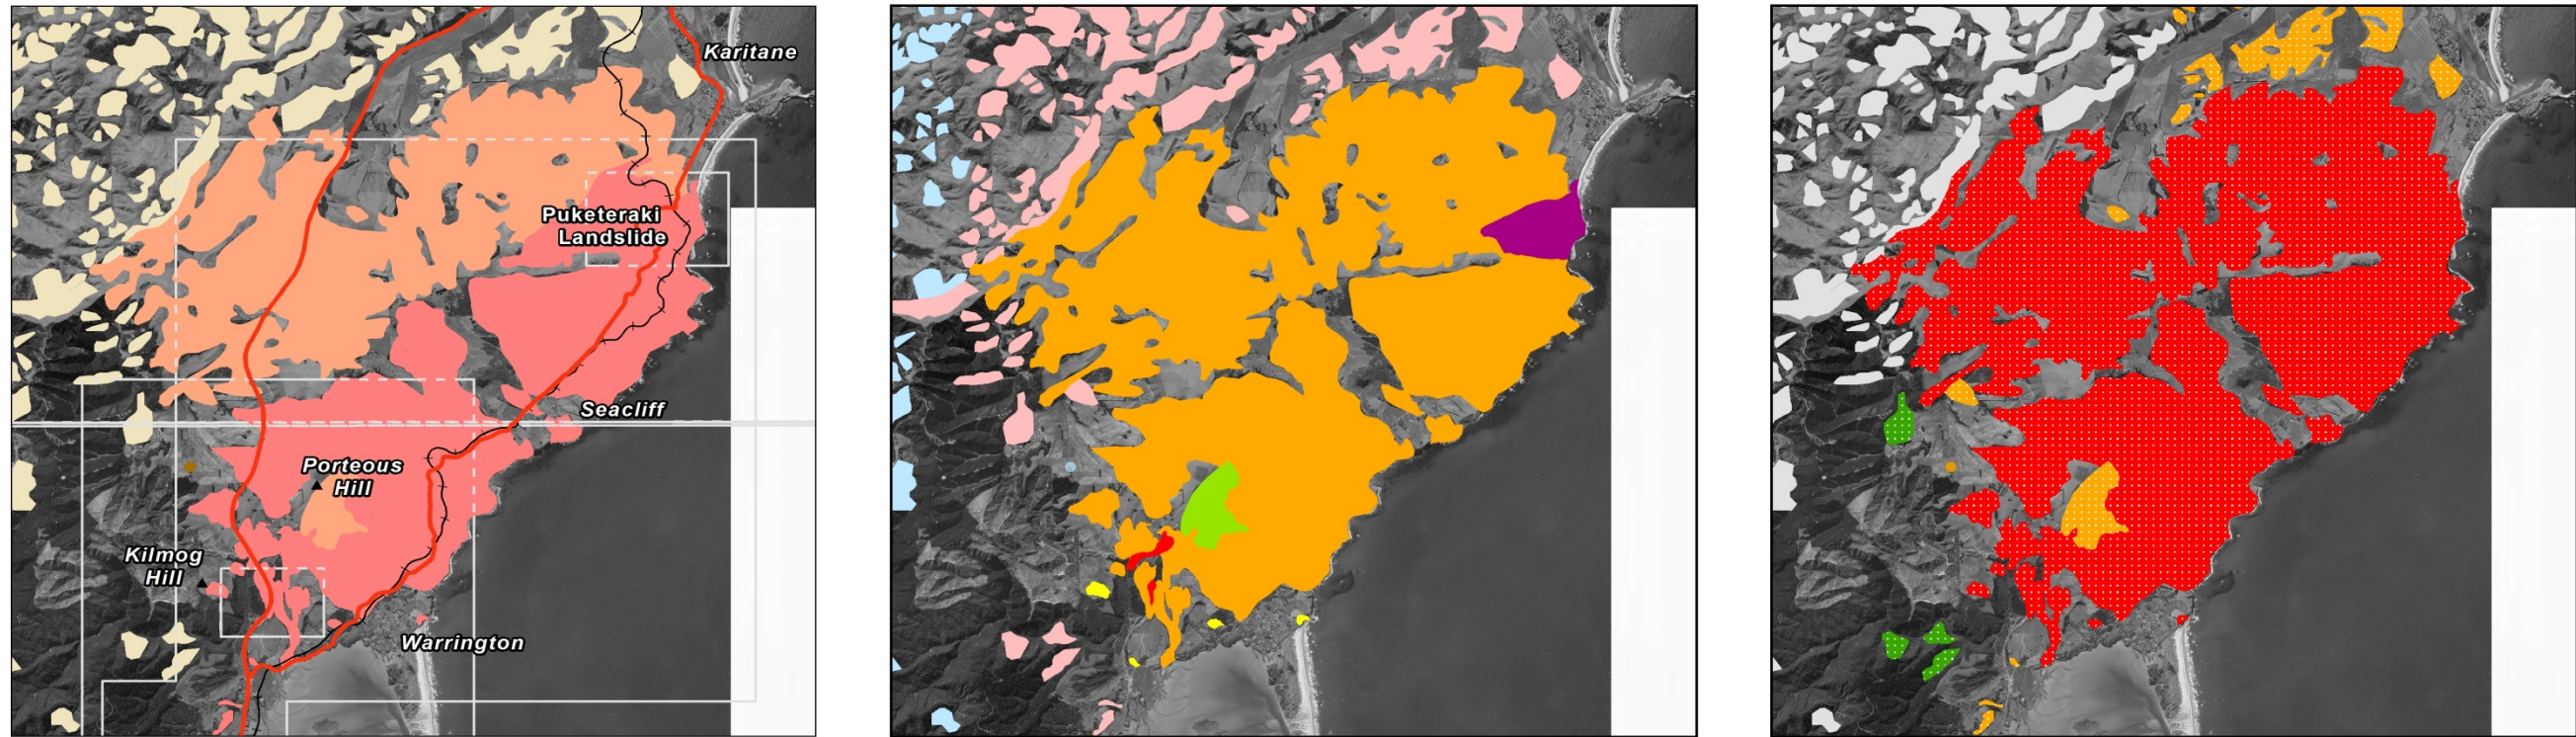
Warrington to Karitane coast

Figure 134 Warrington to Karitane: Landslide Certainty, Activity, and Sensitivity.

The landslide at Cornish Head is classified as a definite landslide. Most of those landslides mapped on the slopes in farmland northwest of State Highway 1 north of Waikouaiti township are considered likely to be landslides, while others are classed as possible. There are a few definite small landslides within that area, but these are not differentiated in the database. These landslides are most likely bedrock landslides, developed in the Cretaceous-Cenozoic sedimentary rocks that underlie this area.

Young prehistoric activity is inferred for the slide at Cornish Head and a slide northwest of Waikouaiti. The slide at Cornish Head is considered highly sensitive to stability factors, due to sea erosion of the foot of the slope, while the rest of the landslides mapped in this assessment area are assigned a moderate to high sensitivity.
