Flood and erosion hazard in the Clutha River/Mata-Au between Queensberry and Lake Dunstan

August 2014

Overview

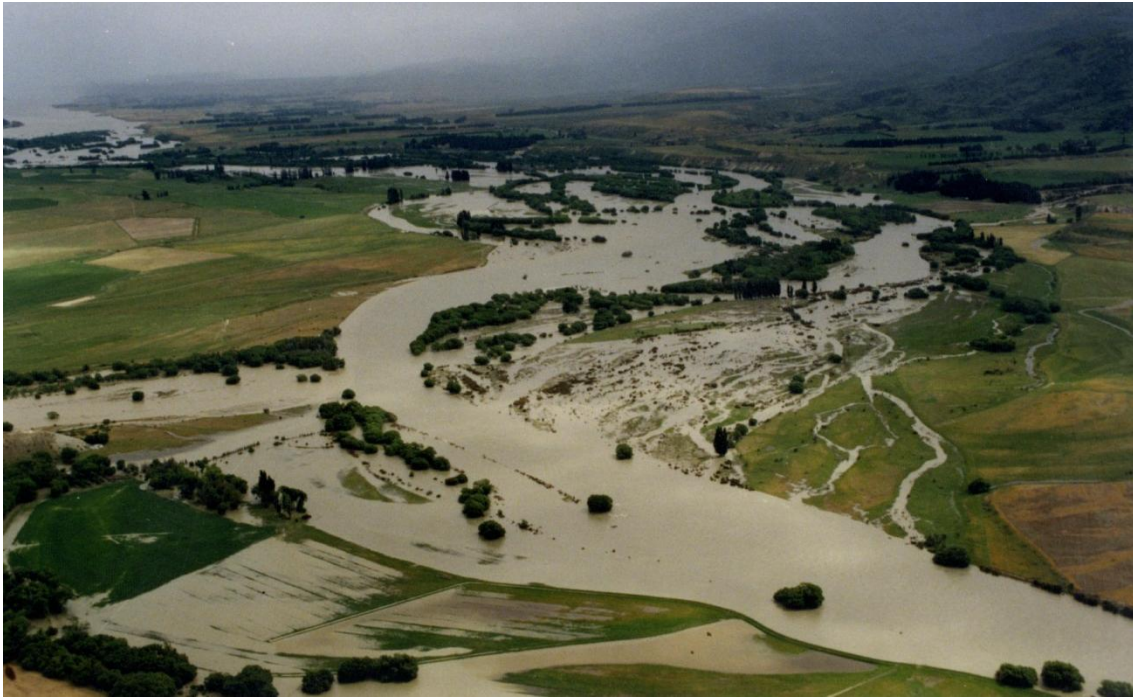
Figure 1 **The Clutha River/Mata-Au looking downstream to Lake Dunstan, November 1999, the exact time and date of the photograph is unknown (Appendix 2).**

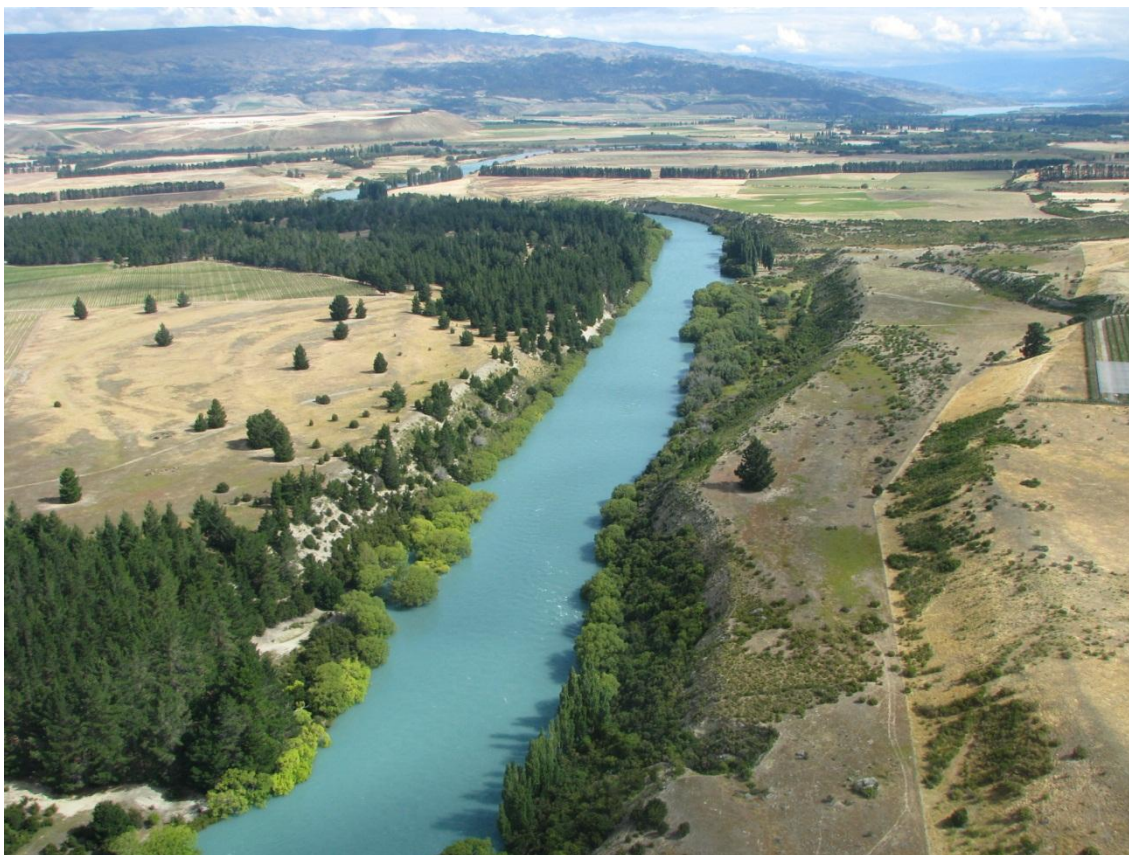
Figure 5. View of the Clutha River/Mata-Au looking downstream, adjacent to Queensberry, during a period of high flow (approximately $700\text{m}^3/\text{sec}$) on 15 January 2013. Lake Dunstan can be seen at the top right of the image.

Queensberry⁵ is located on the true right bank of the river, 15km downstream of Luggate and 13.5km upstream of Lake Dunstan. The river is incised and restricted between steep banks at this point (Figure 5).

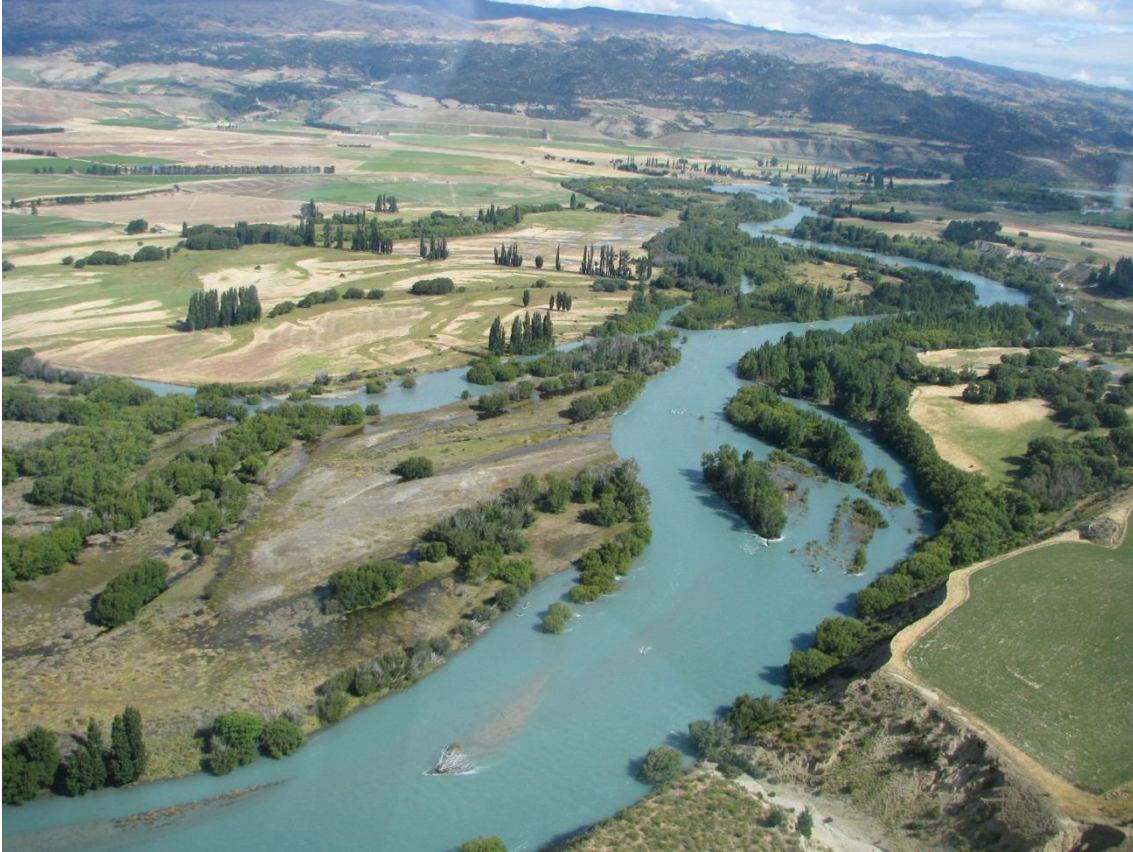
Figure 6. View of the Clutha River/Mata-Au looking downstream, adjacent to Locharburn, during a period of high flows (approximately $700\text{m}^3/\text{sec}$) on 15 January 2013.

Downstream of Queensberry the river changes from a single thread incised river to a more braided form, with a broad floodplain bounded by alluvial terraces which flank the valley floor (Figure 6). The wider floodplain is not significantly elevated above the braided 'low-flow' channel. As a result, the river can migrate within the bounds of the terraces, causing sedimentation and erosion, particularly at higher flows. Opus (2011) described this reach as showing inherent instability due to its hydraulic steepness.

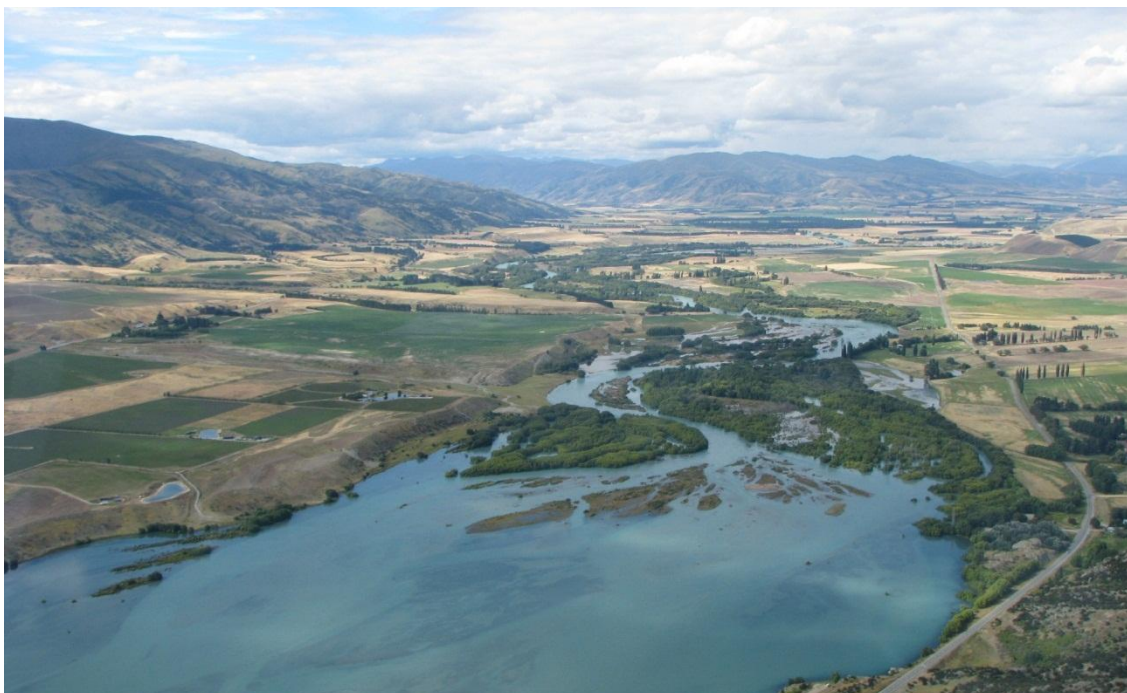
Figure 7. Clutha River/Mata-Au discharging into the northern end of Lake Dunstan on 15 January 2013. The Bendigo Wildlife Reserve is located on the true left of the river mouth.

The river discharges to Lake Dunstan at Cripple town, where it forms a delta, part of which makes up the Bendigo Wildlife Reserve (Figure 7). Lake Dunstan was created when the Clyde dam was constructed near the township of Clyde, and was filled from April 1992 till September 1993. The average rate of sediment deposition into Lake Dunstan from the Clutha River/Mata-Au has been estimated at $168,000\text{m}^3/\text{yr}$ (Cowan, 1992). This sediment supply has produced a slowly prograding delta, although the rate of delta growth is considerably lower than that experienced at the mouth of the Kawarau River, which has a sediment load of approximately $1,320,000\text{m}^3/\text{yr}$ (Cowan, 1992).

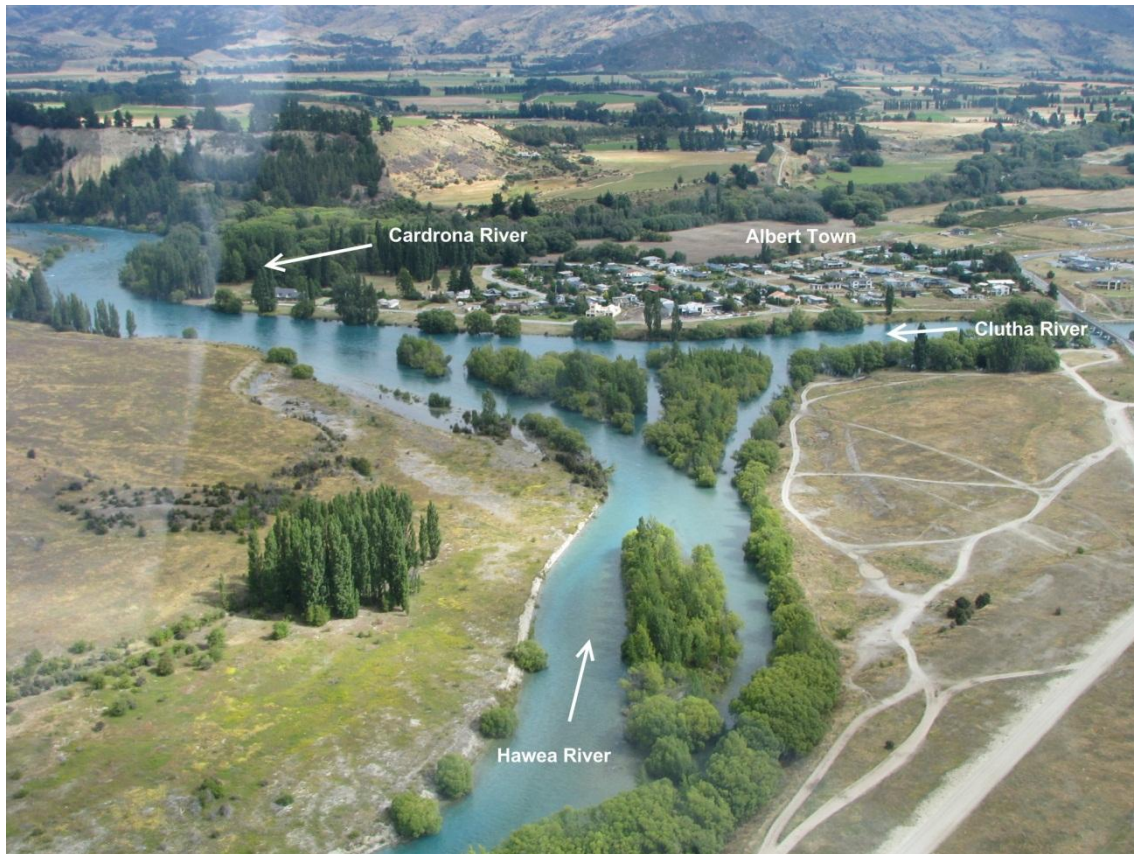
Figure 8. The confluence of the Hawea, Clutha and Cardrona rivers during a period of high flows on 15 January 2013. The Clutha River/Mata-Au at the Cardrona Confluence site was flowing at 700m³/s at this time.

Flood hazard in the study area is associated with the Clutha River/Mata-Au and its tributaries. Figure 8 shows the confluence of the Clutha and Hawea Rivers at Albert Town, 25km north of the study site, with the smaller Cardrona River also merging just downstream.

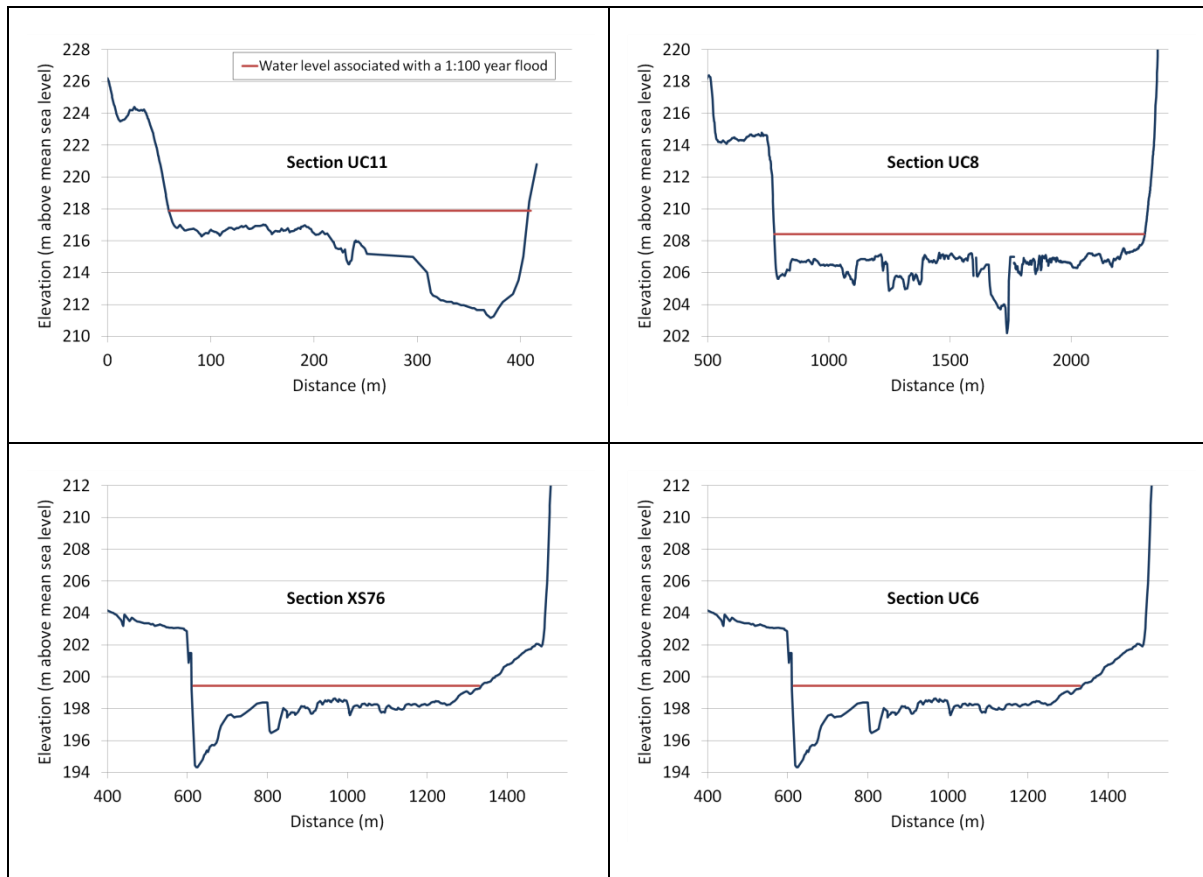
Figure 14. Representative cross sections (looking downstream) and the water level at each location for a 1:100 year flood event (as modelled by Opus, 2014).

The margins of the Clutha River/Mata-Au floodplain vary considerably in their form through the study area. The upper section (adjacent to Queensberry) is steep, confined and incised into alluvial terraces. Flood hazards within this reach are confined to the main channel. Below the confluence of the Albert Burn, the floodplain begins to widen, and at section UC11, extends for approximately 350m. The modelling shows that during a 1:100 year flood event, the depth of water in the main channel at UC11 would exceed 7m, and the depth of inundation on the adjacent floodplain would be between 2 and 4m (Figure 14).

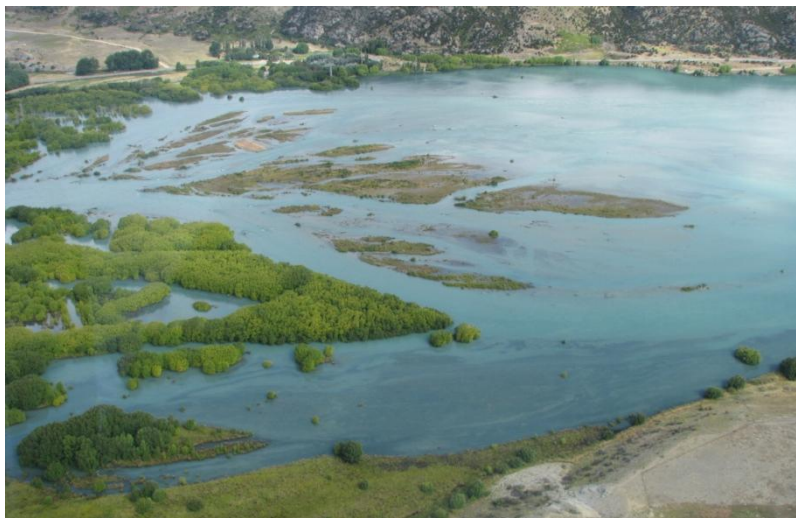
Figure 16. Sedimentation at the transition from the Clutha River/Mata-Au to Lake Dunstan (January 2013)

Sediment deposition and the gradual formation of a river delta at the lower end of the study area have occurred since April 1992, when Lake Dunstan was formed, following completion of the Clyde Dam. Future sediment accumulation in the channel and berm areas and the additional growth of this delta is expected to influence the water level profile during large flood events (Opus, 2014). The modelling undertaken by Opus includes an estimate of how the water level associated with a 1:100 year flood event would change by the year 2030, if sedimentation continues at the same rate observed since 1992.

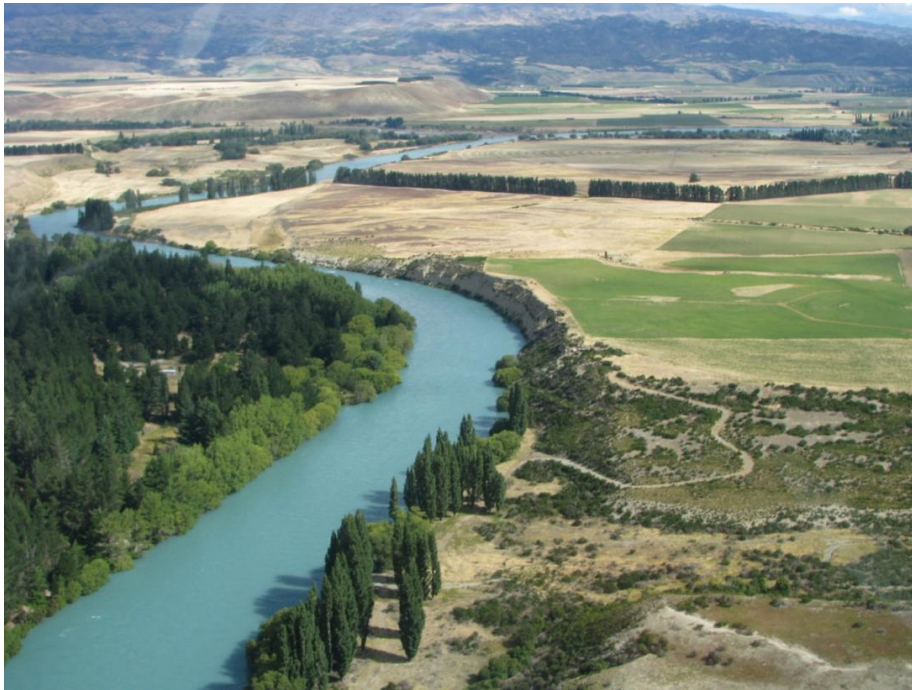
Figure 19. View of the Clutha River/Mata-Au, looking downstream and showing erosion of the true right bank, downstream of Queensberry (point 1 on Figure 18). Photo taken during a period of high flow on 15 January 2013 (approximately $700\text{m}^3/\text{sec}$).

1. **On the true right bank, downstream of Queensberry and the Albert Burn confluence.** Continued erosion at this location would affect farmland on the true right bank (Figure 19).

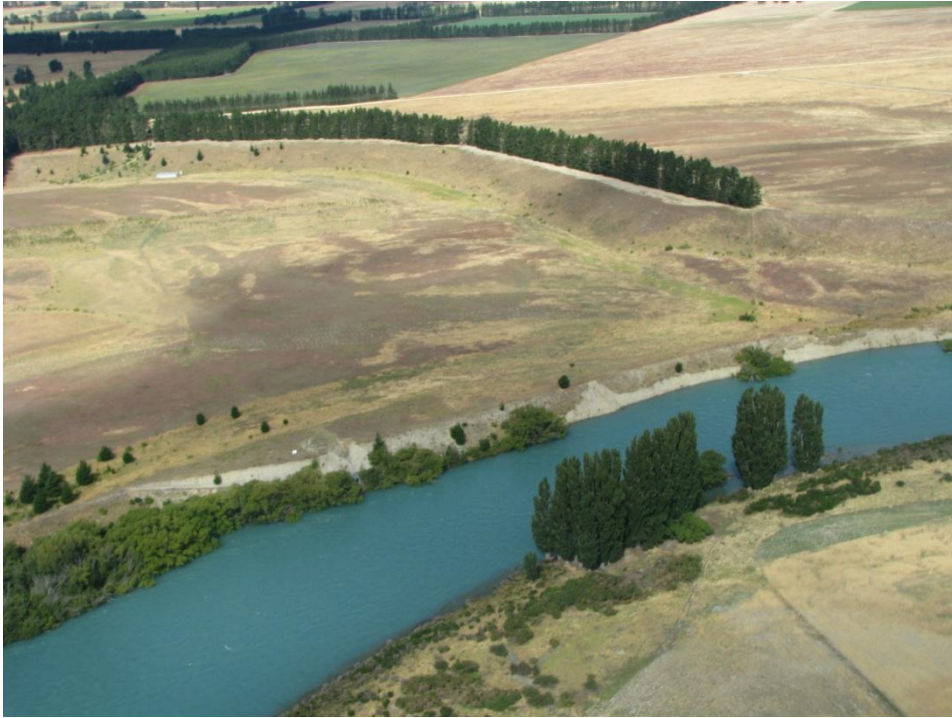
Figure 20. View of the Clutha River/Mata-Au, looking downstream and showing erosion of the true left bank, downstream of Queensberry (point 2 on Figure 15). Photo taken 15 January 2013.

2. **On the true left bank, downstream of ‘The Pines’.** Continued erosion at this location would affect farmland on the true left bank (Figure 20).

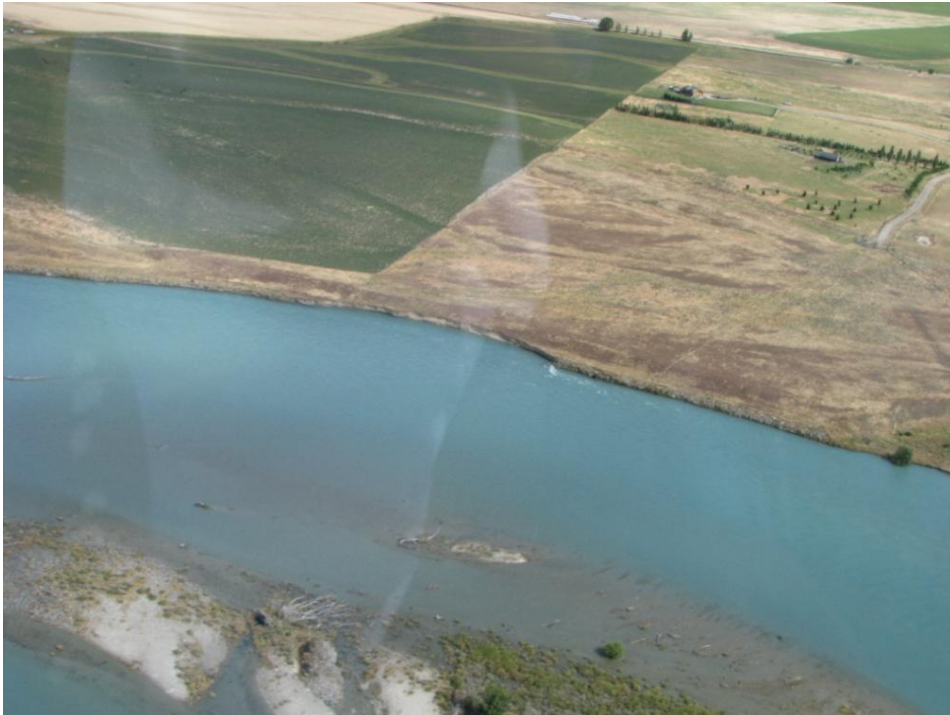
Figure 21. View of the Clutha River/Mata-Au, looking downstream and showing erosion of the true left bank, downstream of the Lindis confluence (point 3 on Figure 15). Photo taken 15 January 2013.

3. **On the true left bank, downstream of the Lindis River confluence.** Between 1995 and 2013 the rate of erosion at this location was 5.6m/year. If this rate of erosion were to continue, the houses nearest to the eroding bank (about 400m away) would be affected in about 70 years (Figure 21).

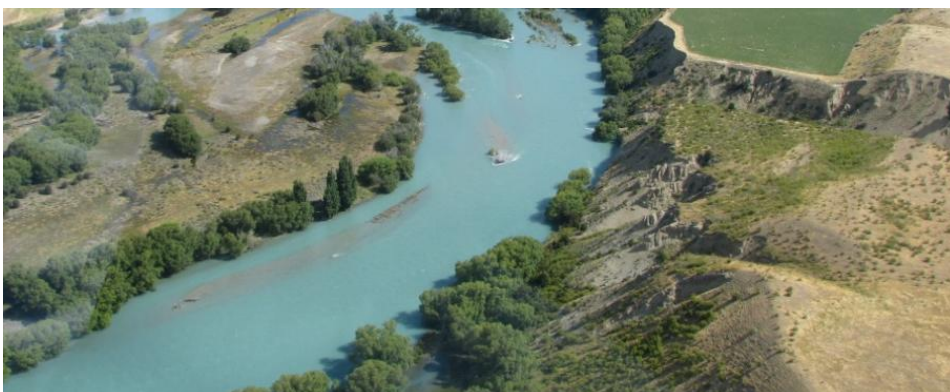
Figure 22. View of the Clutha River/Mata-Au, looking downstream and showing erosion of the true right bank (point 4 on Figure 15). Photo taken 15 January 2013.

4. **On the true right bank, at the confluence of a small, un-named tributary, approximately 1.3km upstream of Locharburn.** If erosion continues at this location, scrub and farmland on the true right bank will be affected. SH6 is located 450m away from this location (Figure 22).

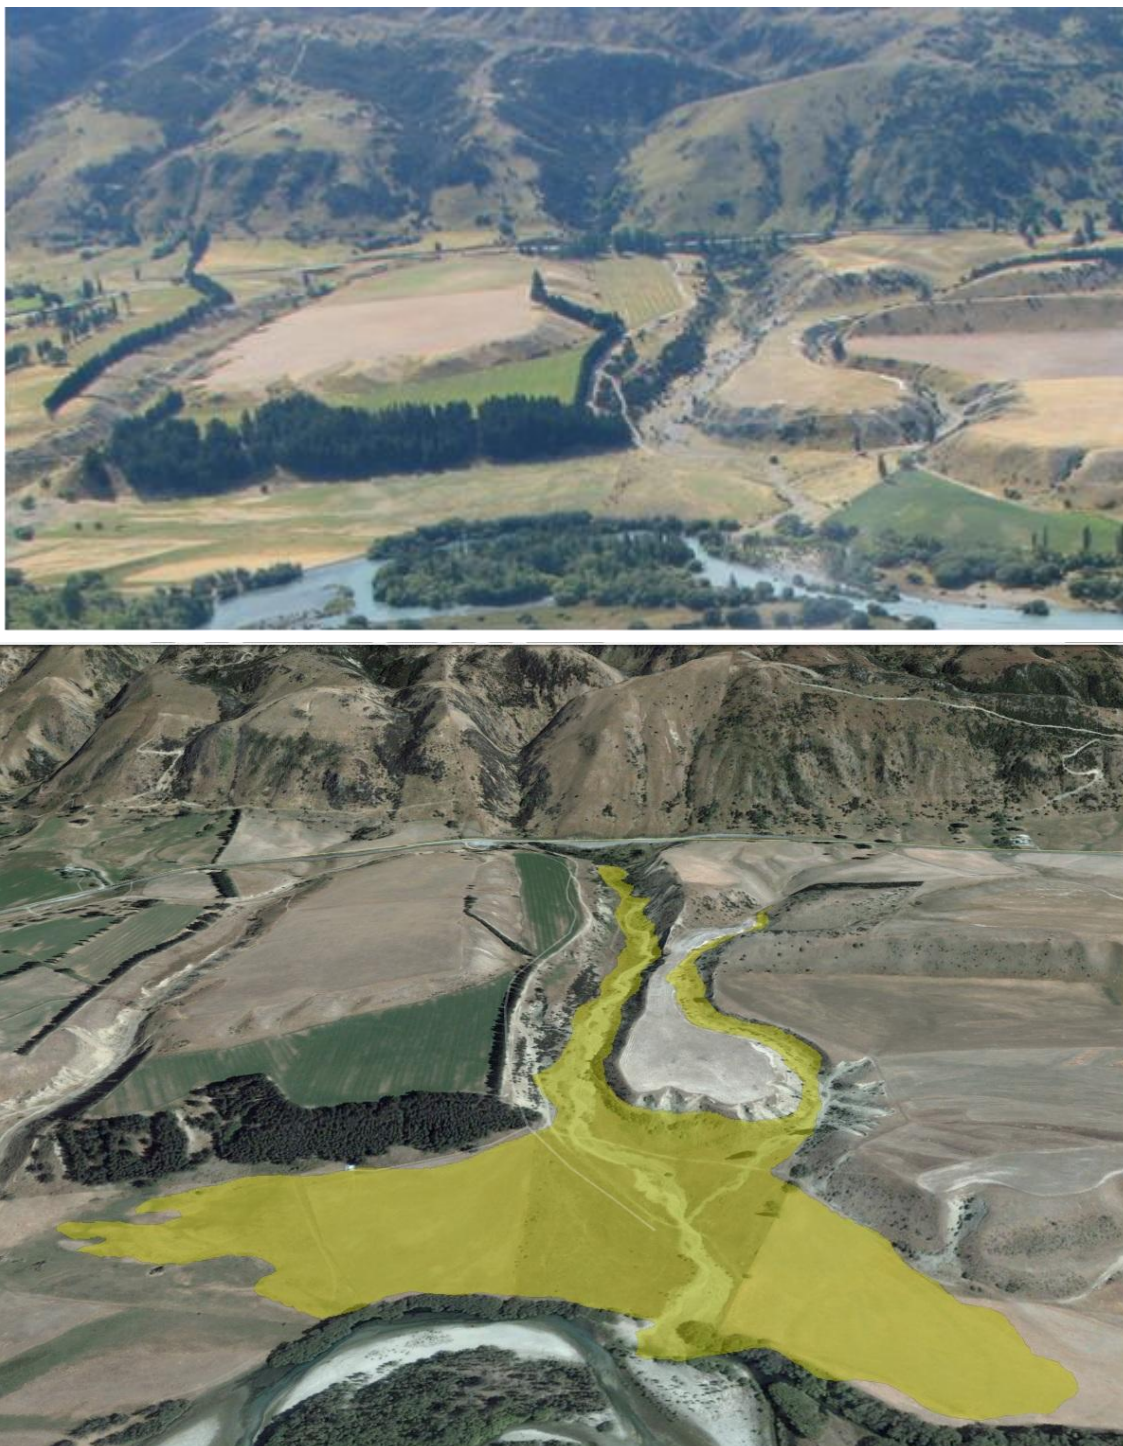
Figure 26. Looking west across the lower reaches of an active floodwater-dominant alluvial fan that drains from Kidd Creek in the Pisa Range. The upper image was taken on 15 January 2013, during a period of high flow in the Clutha River/Mata-Au (approximately 700m³/sec). The lower image was generated using Google Earth, and shows the approximate extent of the active floodwater-dominant alluvial fan, as mapped by Opus (2009).

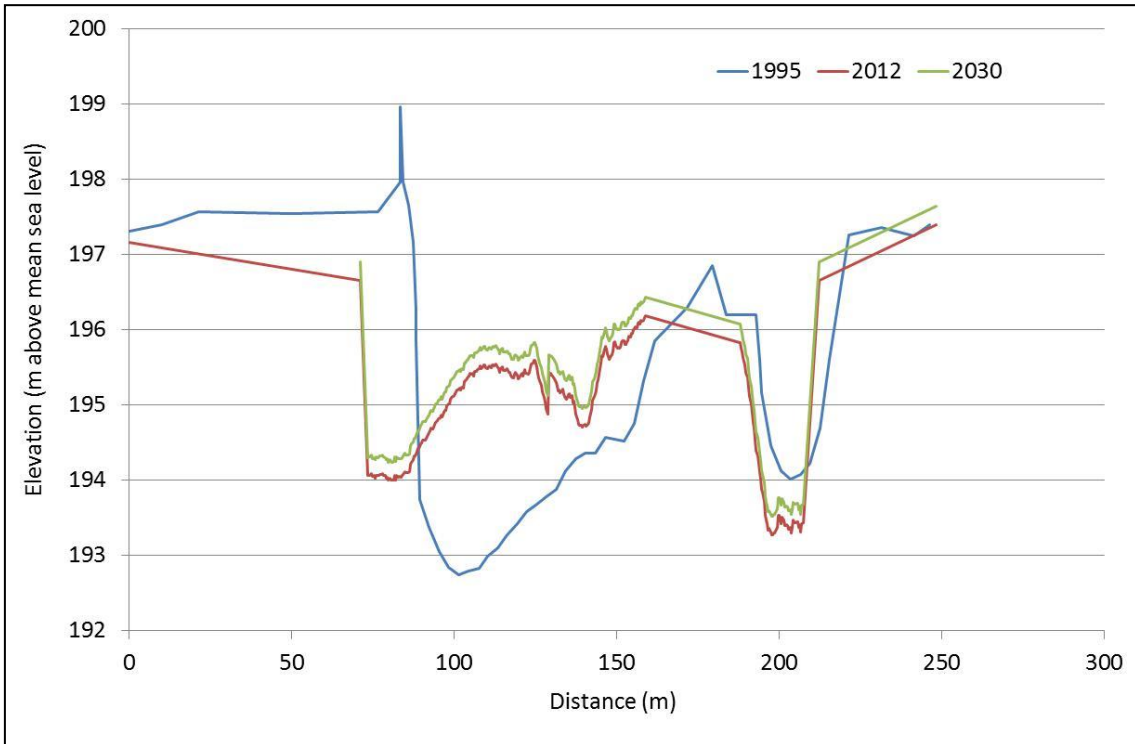
Figure C2. Observed and predicted profiles for cross-section 3
