The effects of the 24 hour voluntary  
irrigation shutdown on flows in the  
Taieri River: 15th–16th January 2015

July 2015

Report writer: Matt Dale, Resource Scientist  
Reviewed by: Dean Olsen, Manager - Resource Science

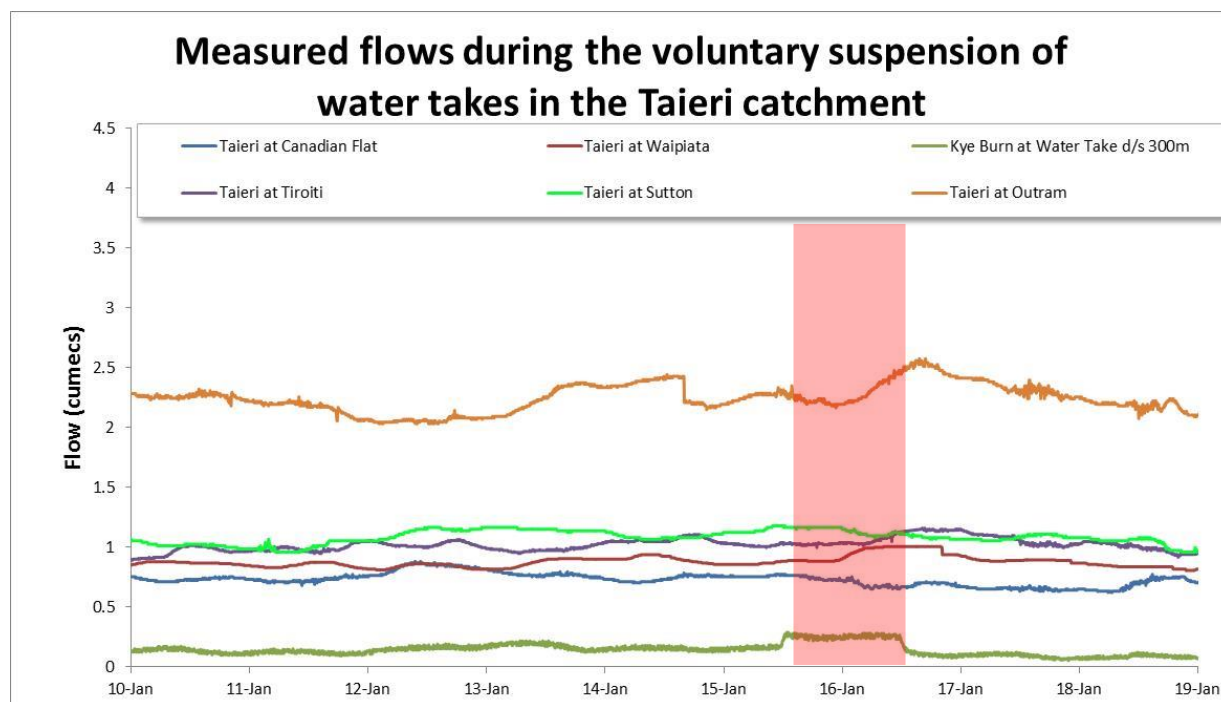
The effects of the shutdown were not observed at Canadian Flat (no upstream takes), and Sutton due to a combination of travel time and the resumption of water abstraction after the shutdown period (Figure 3). Maniototo Irrigation Company (MIC) maintained a flow of around 1,000 l/s at the Paerau Weir for the duration of the shutdown period. The increase in flows observed at the Outram flow recorder were due to a slight increase in tributary inflows in the lower catchment caused by some overnight drizzle on the 15th, rather than the cessation of water takes. The red shaded area indicates the period of the voluntary shutdown.

**Figure 3** Measured flows during the January 15-16 shutdown

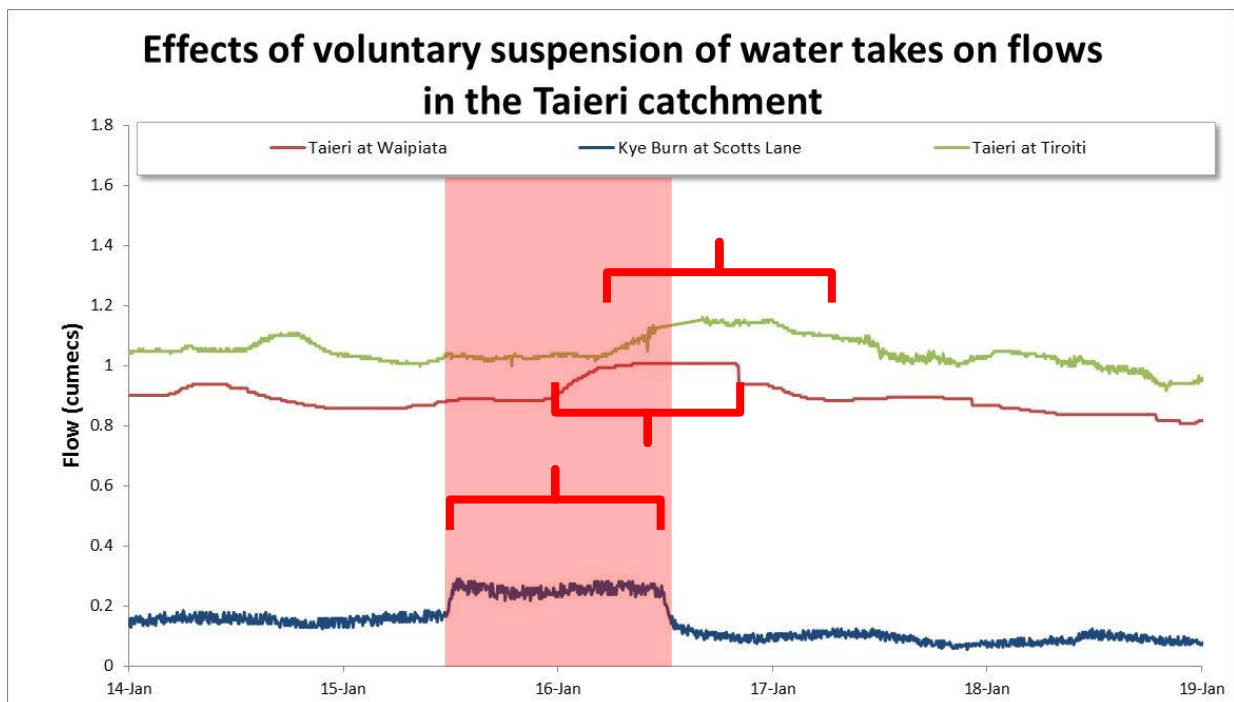
A more detailed view of the effect of the shutdown is shown in Figure 4, with the red shaded area indicating the period of the voluntary shutdown. The flow “pulse” as water abstraction ceased is shown by the red brackets.

**Figure 4** Effects of the 15<sup>th</sup>/16<sup>th</sup> January shutdown on flows at Waipiata, Scotts Lane, and Tiroiti

The cessation of water abstraction from the Taieri upstream of the Waipiata flow recorder caused flows to increase by 130 l/s and met the Waipiata minimum flow of 1000 l/s.

Kye Burn flows increased by 100 l/s to approximately 260 l/s for the 24 hour shutdown period. However due to the inadvertent abstraction of approximately 40 l/s in the lower reaches of the Kye Burn (due to the setup of the race intake) and further losses to groundwater, the surface water contribution of the Kye Burn to the main stem of the Taieri was measured at 41 l/s at the confluence.

Monitoring undertaken in the period before the shutdown indicated that there was a gain in flow of approximately 140 l/s between Waipiata and Tiroiti, and this increased to 200 l/s during the shutdown due mainly to inputs from the Kye Burn.

The shutdown of takes above Tiroiti and in the Kye Burn meant the Tiroiti minimum flow (1,100 l/s) was met, with a maximum 1,161 l/s recorded. The flow pulse at Tiroiti was more prolonged than that of the upstream sites due to differences in travel time between the Kye Burn and Waipiata. There was also a 50 l/s abstraction occurring from the Taieri River between Waipiata and Tiroiti.

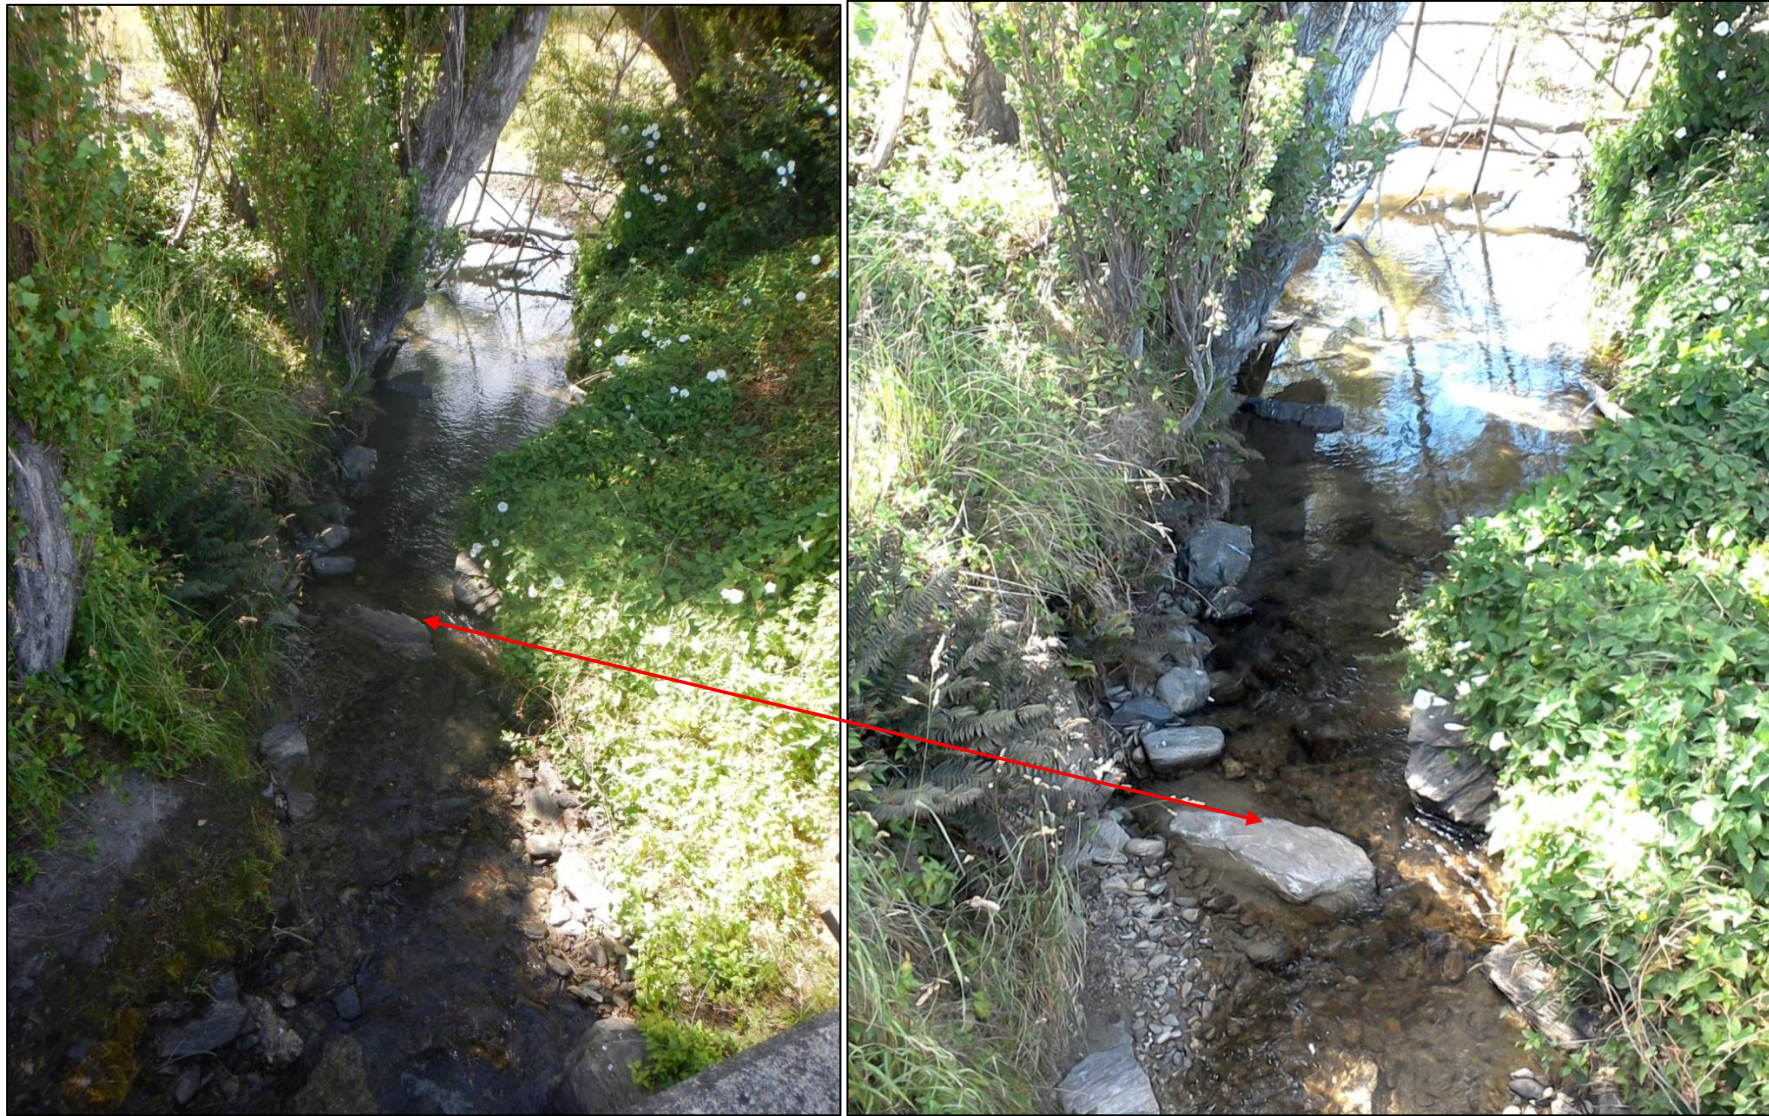
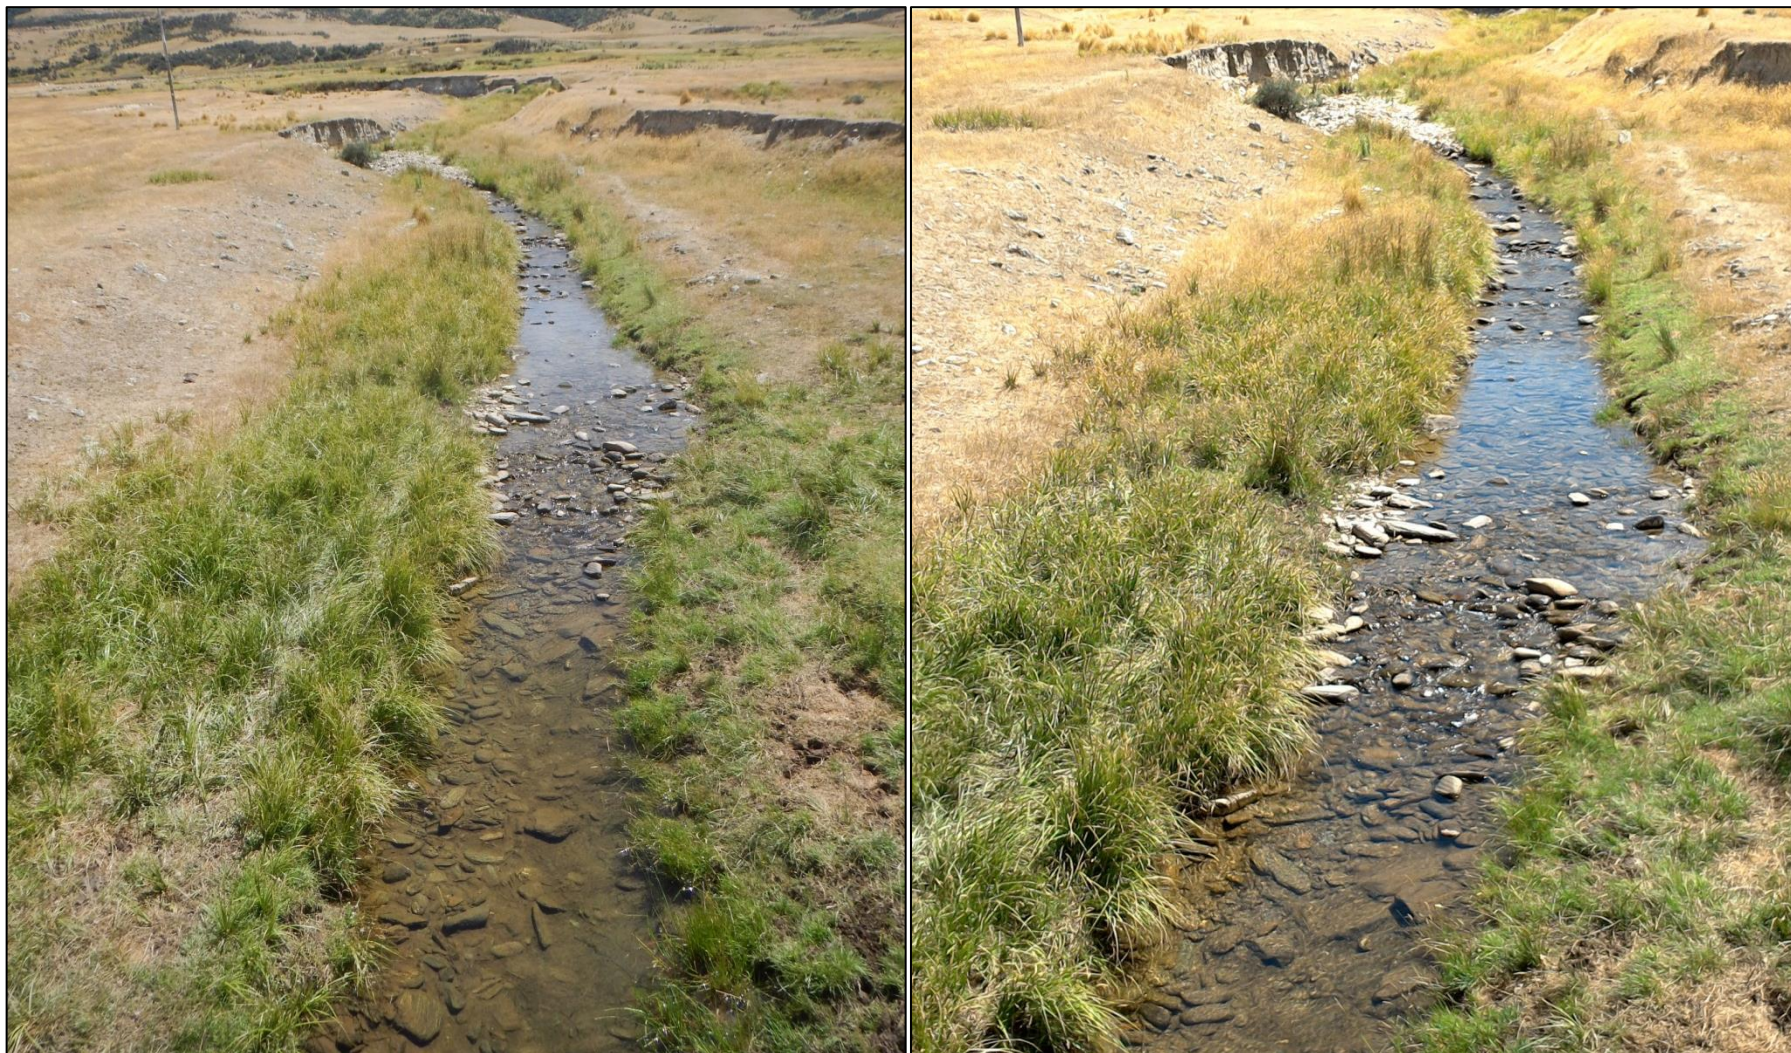
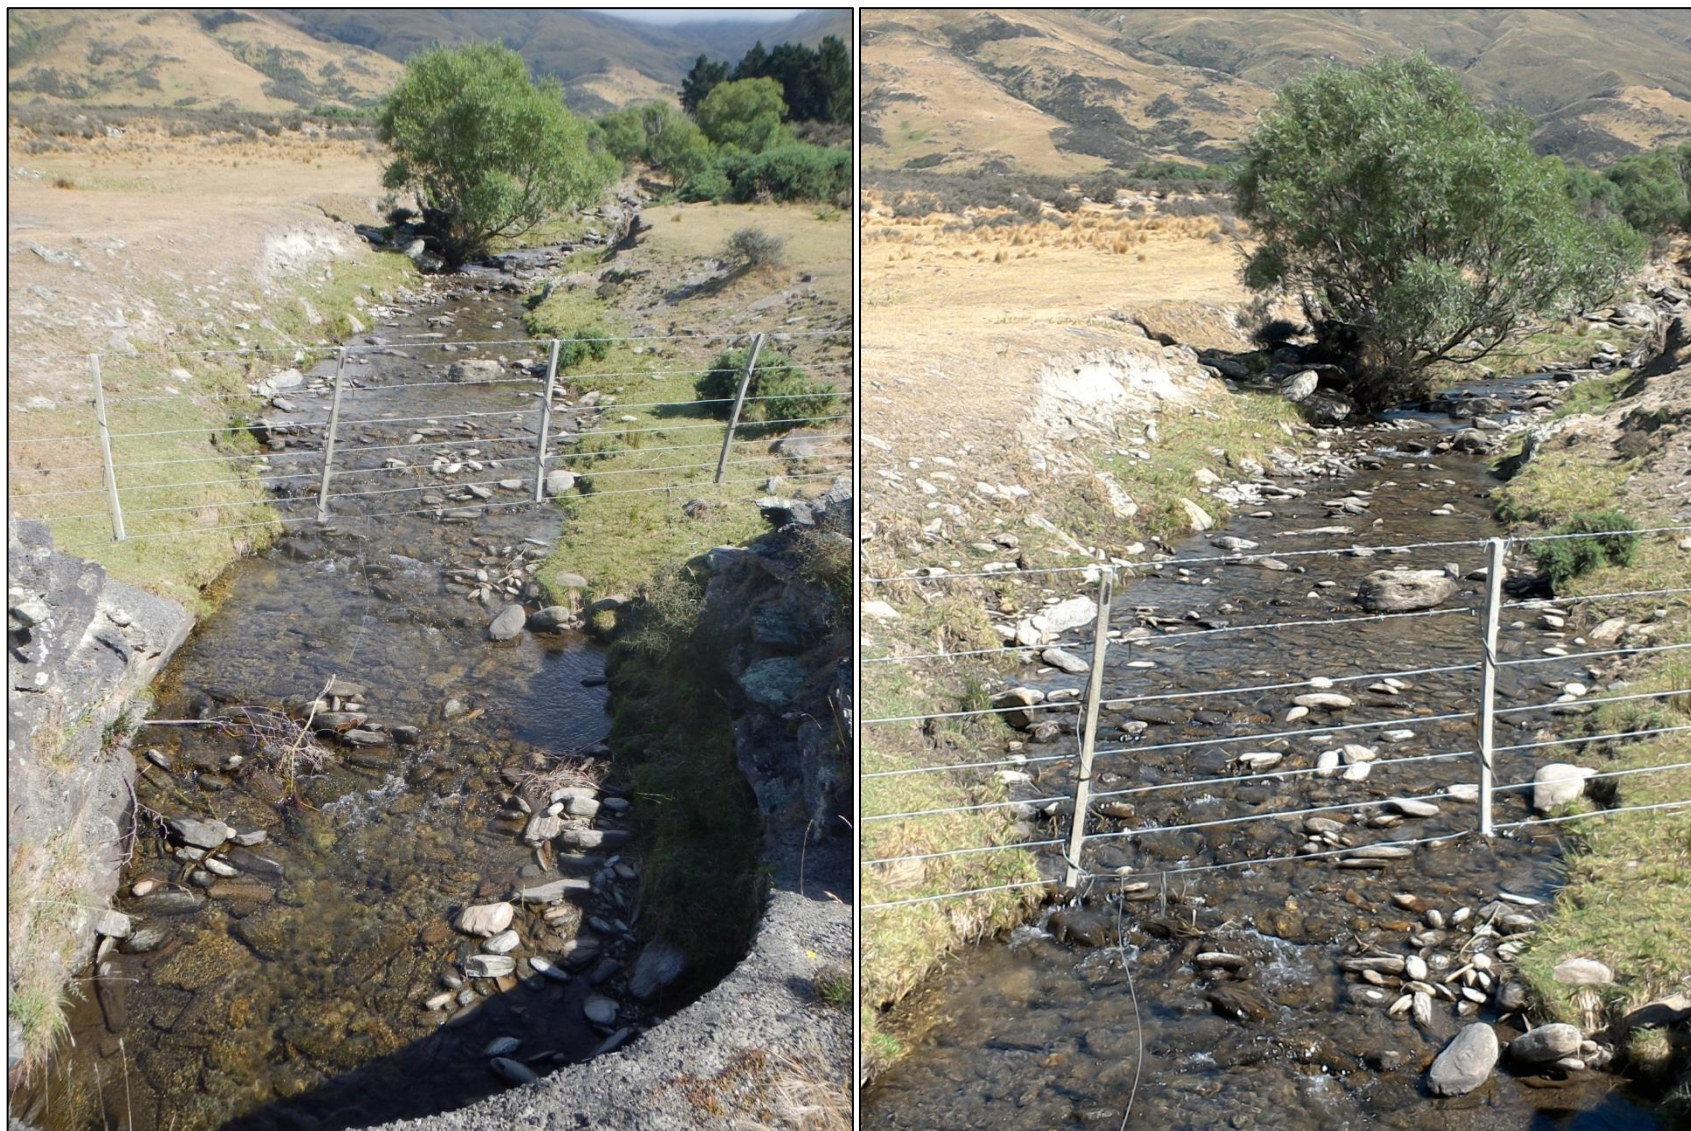
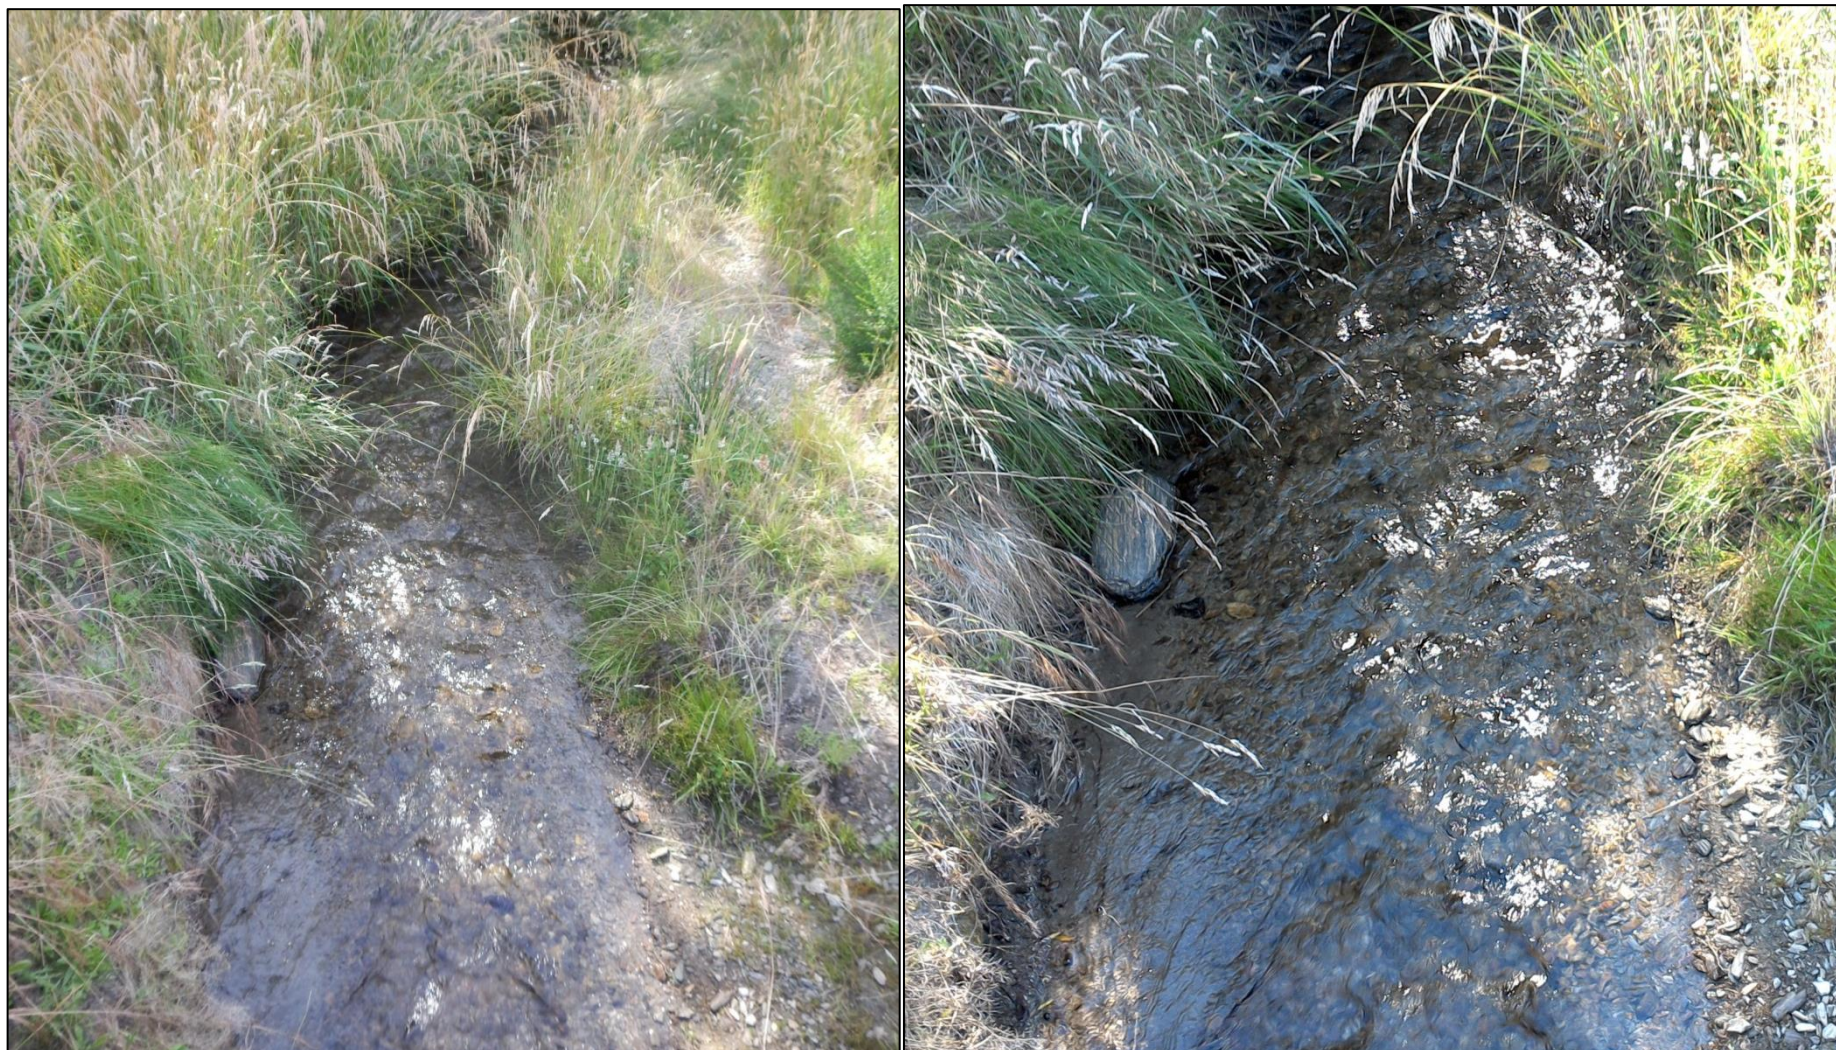
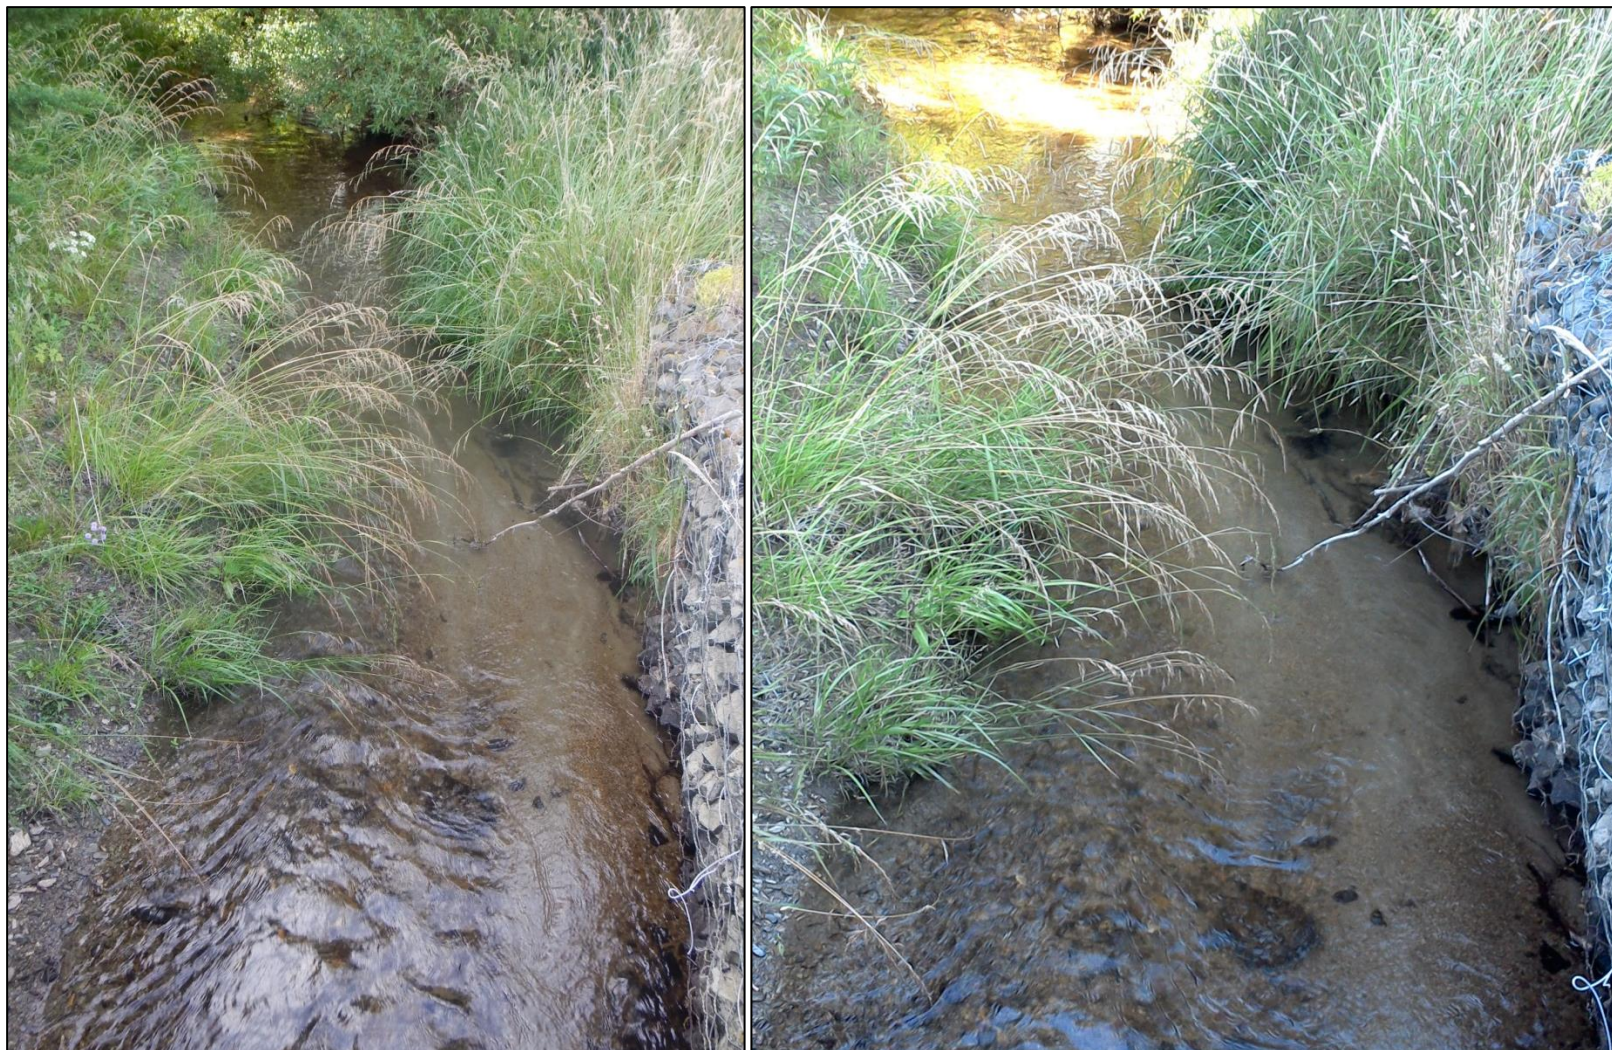
The comparison of the January 14<sup>th</sup> and 16<sup>th</sup> photos does not show a visual change in flows at any of the sites.

Figure 6 Dewar Stream at SH87 on January 14<sup>th</sup> (left) and 16<sup>th</sup> January (right)

Figure 7 Heeney Creek at SH87 on January 14<sup>th</sup> (left) and 16<sup>th</sup> January (right)

Figure 8 Six Mile Creek at SH87 on January 14<sup>th</sup> (left) and 16<sup>th</sup> January (right)

**Figure 9** March Creek at SH87 on January 14<sup>th</sup> (left) and 16<sup>th</sup> January (right)

Figure 10 Rock Creek SH87 on January 14<sup>th</sup> (left) and 16<sup>th</sup> January (right)

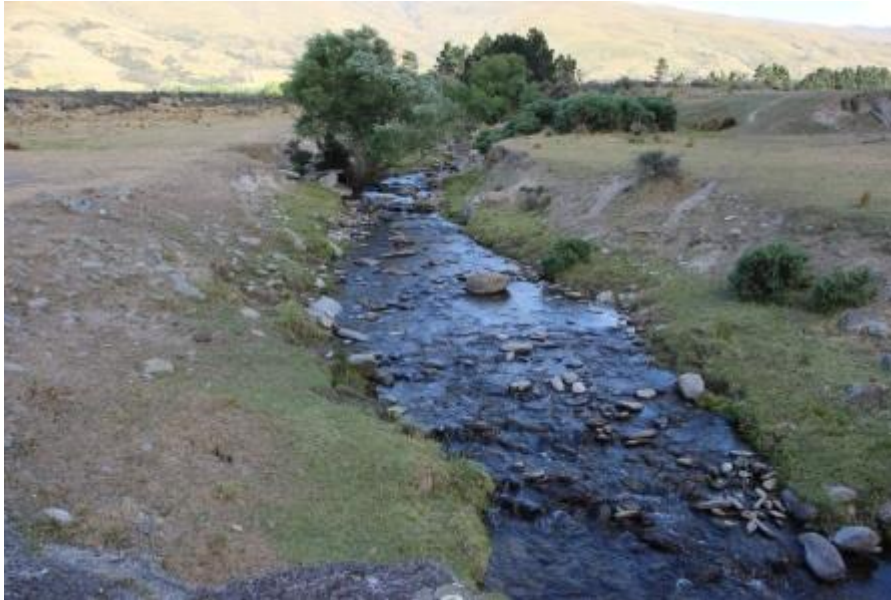
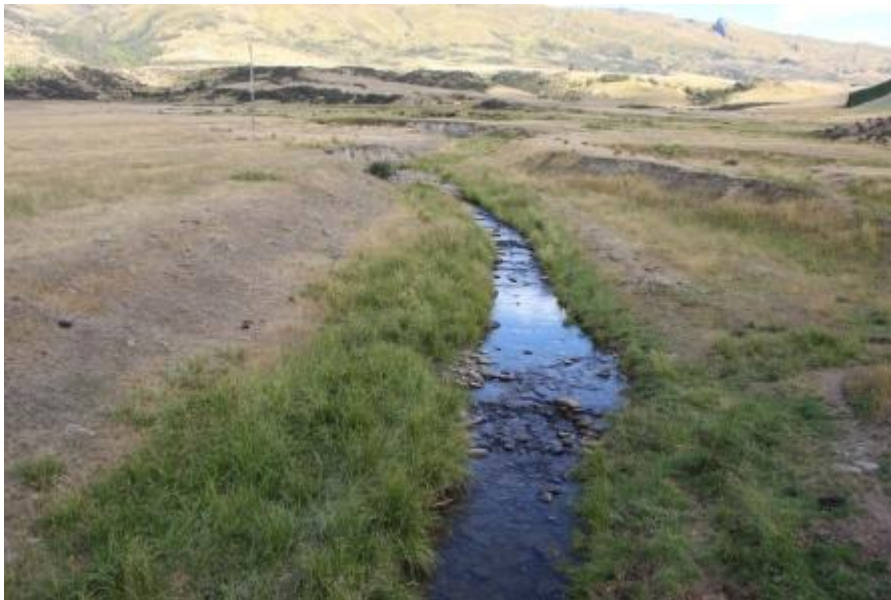
Flows in Six Mile (Figure 11) and Heeney (Figure 12) Creeks appeared to be slightly increased from base flows, and algal cover and macroinvertebrates indicated that both Creeks had been flowing before the shutdown period.

Figure 11 Six Mile Creek at SH87 – 16<sup>th</sup> January

Figure 12 Heeney Creek at SH87 – 16<sup>th</sup> January

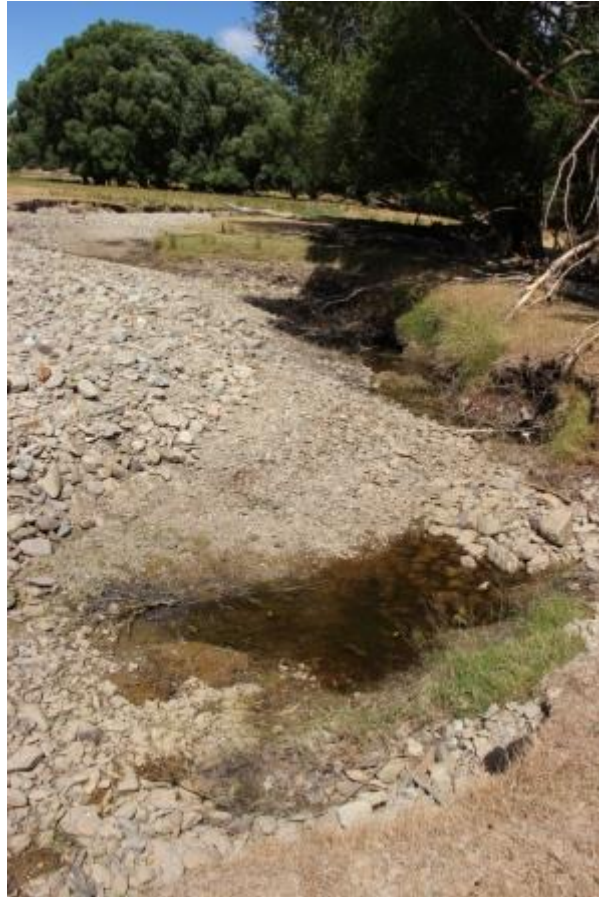
**Figure 13**

Flows were disconnected both upstream and downstream of the Cemetery Rd Bridge, with no indication of any recent re-wetting. There were two isolated refuge pools approximately 50m downstream of the Cemetery Rd Bridge (Figure 13); one of which contained

**Swin Burn refuge pools downstream of Cemetery Rd - 16<sup>th</sup> January**

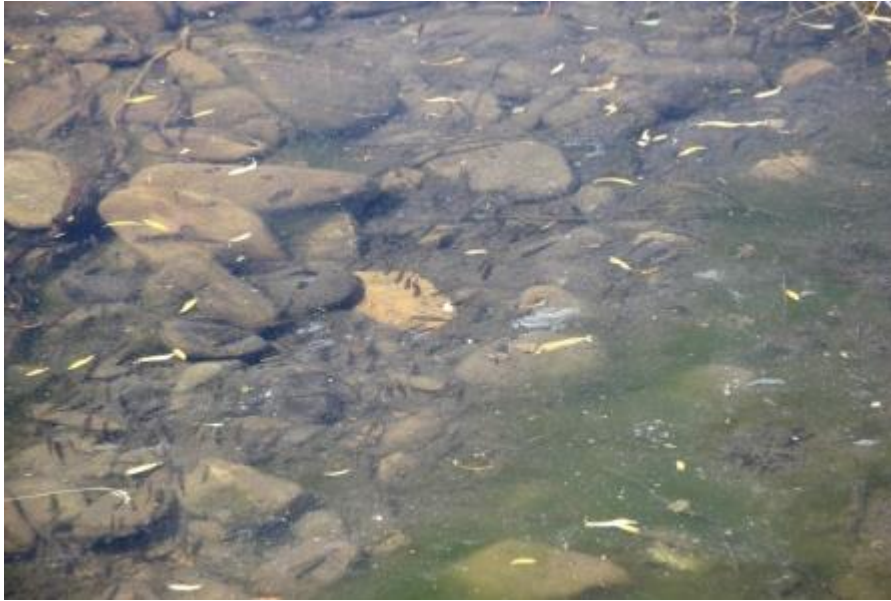
approximately 50 brown trout fry showing signs of thermal stress (Figure 14), and another that contained one adult Central Otago Roundhead galaxias and approximately 12 galaxias fry. There was evidence that these pools had only recently disconnected from the larger pool at the bridge, including discolouration of substrate, damp areas under cobbles and live macroinvertebrates (Figure 15).

**Figure 14** Brown trout fry in downstream refuge pool - 16<sup>th</sup> January

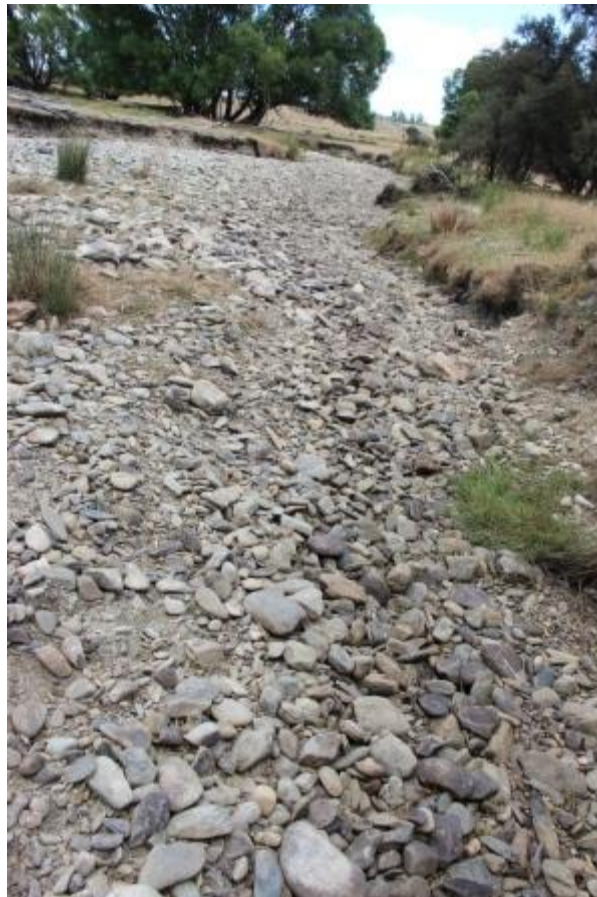
**Figure 15** Signs of recent dewatering (darker cobbles in middle of channel) downstream of Cemetery Rd - 16<sup>th</sup> January

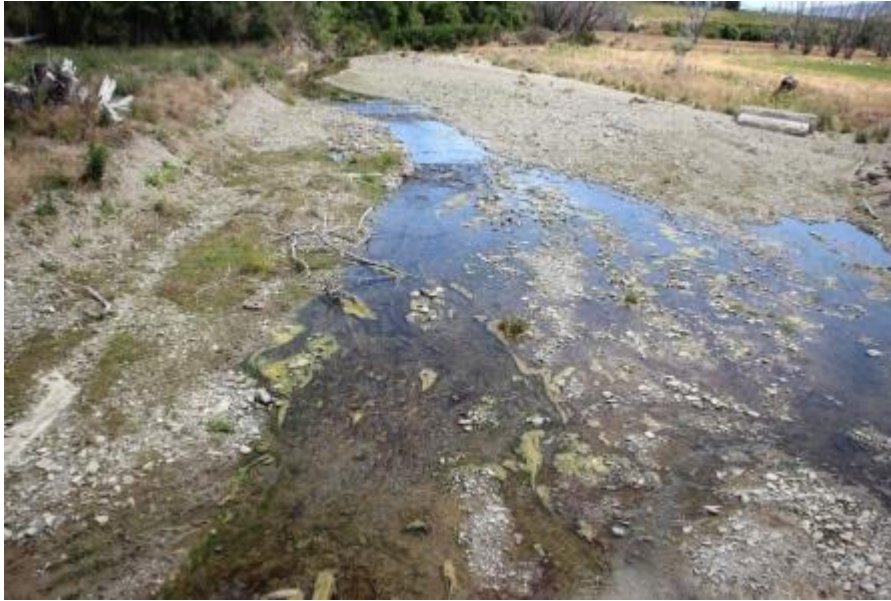
Further upstream at SH85 (upstream of water takes); there was continuous flow both upstream and downstream of the bridge. Heavy periphyton growth could be seen from the bridge (Figure 16) as well as 30+ brown trout fry.

**Figure 16** Swin Burn at SH85 (no irrigation takes operating upstream of this point) - 16<sup>th</sup> January

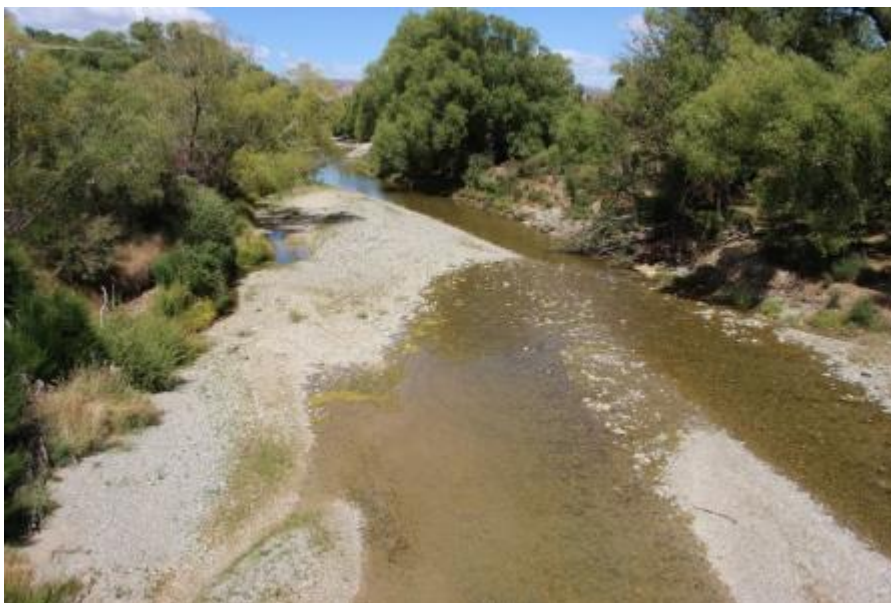
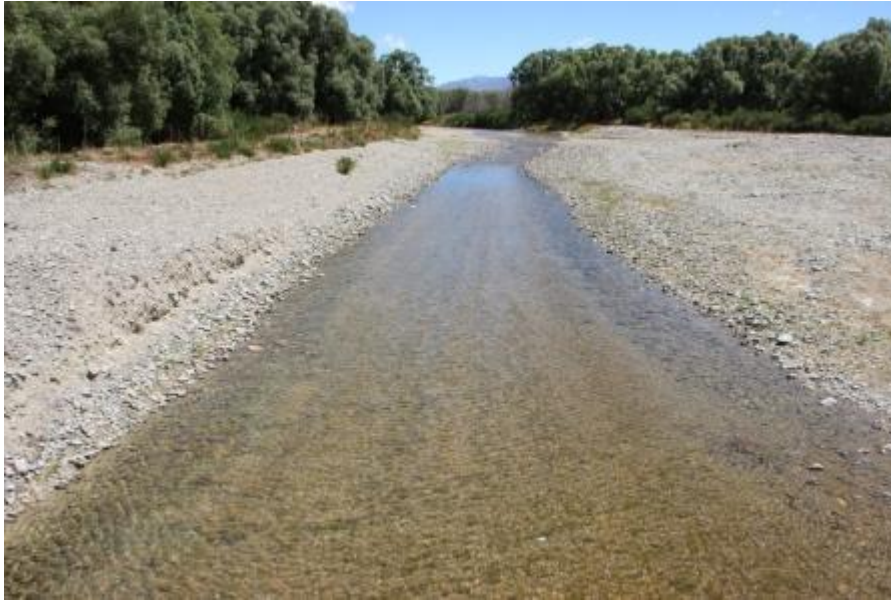
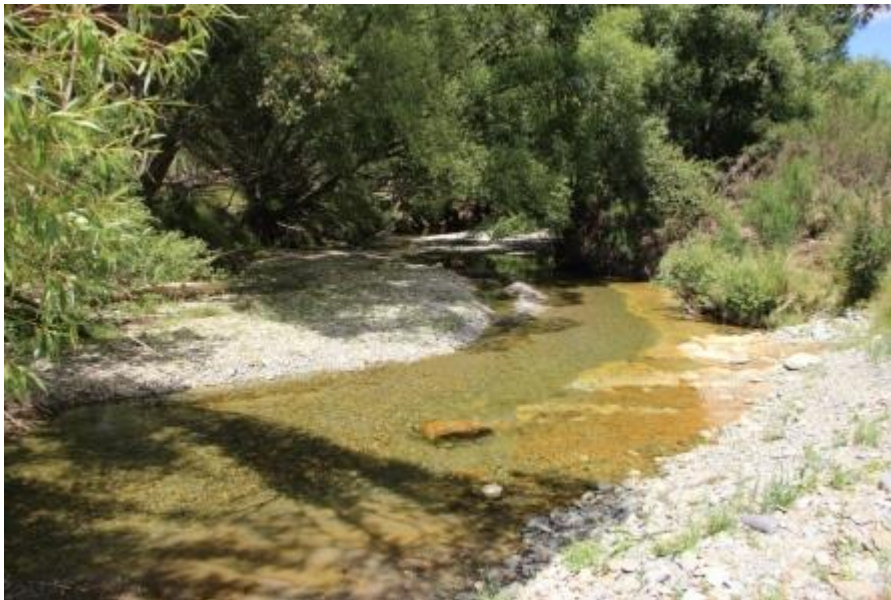
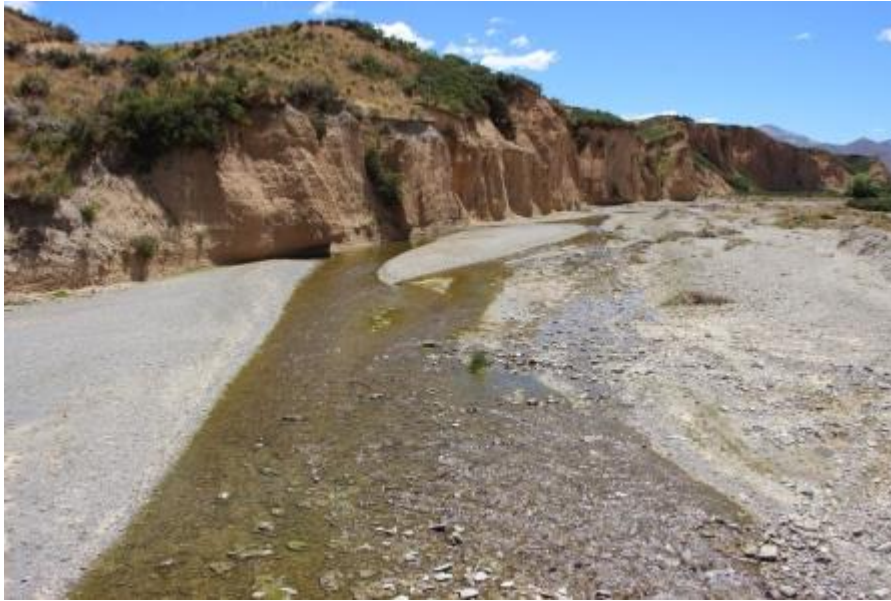
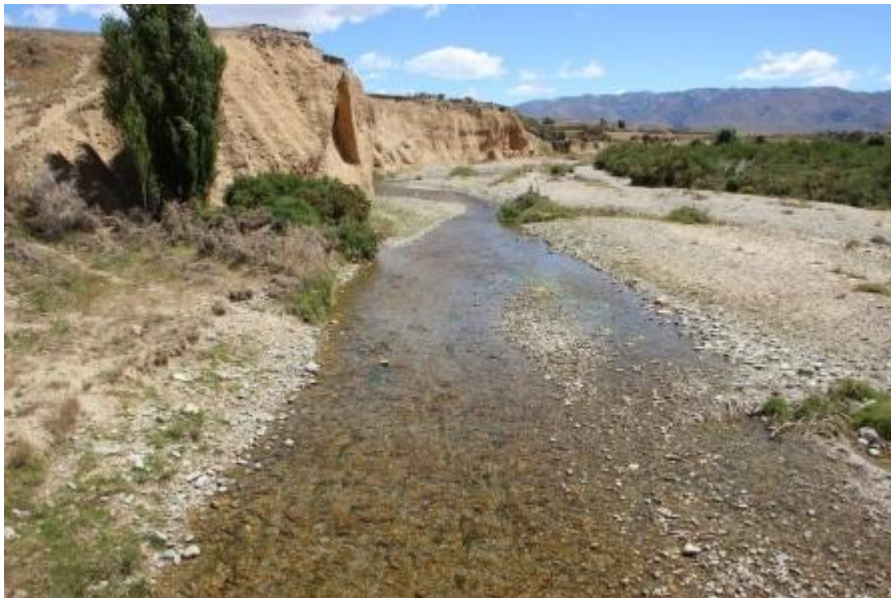
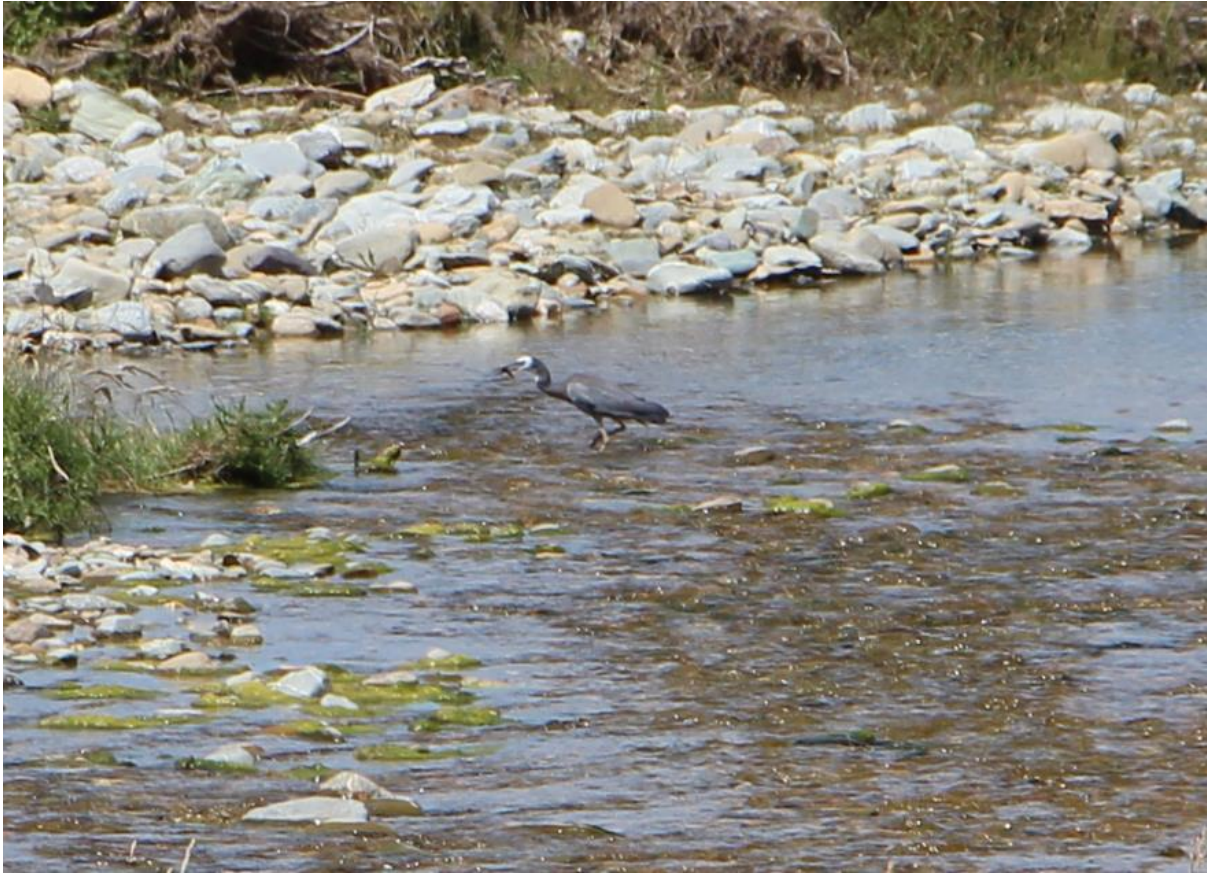
Continuous flows were observed at all sites in the Kye Burn; SH85 (Figure 17), Scotts Lane (Figure 18), Campbells Crossing (Figure 19), Kye Burn Diggings Rd (Figure 20), and Little Kye Burn (Figure 21). Heron were observed feeding on juvenile trout in the Little Kye Burn downstream of Kye Burn Diggings Rd (Figure 22).

**Figure 17** Kye Burn at SH85 - 16<sup>th</sup> January

**Figure 18** Kye Burn at Scotts Lane - 16<sup>th</sup> January

**Figure 19** Kye Burn at Campbells Crossing - 16<sup>th</sup> January

**Figure 20** Kye Burn at Kyeburn Diggings Rd - 16<sup>th</sup> January

**Figure 21** Little Kye Burn at Kye Burn Diggings Rd - 16<sup>th</sup> January

**Figure 22** Heron feeding on brown trout fry in Little Kye Burn downstream of Kyeburn Diggings Rd - 16<sup>th</sup> January

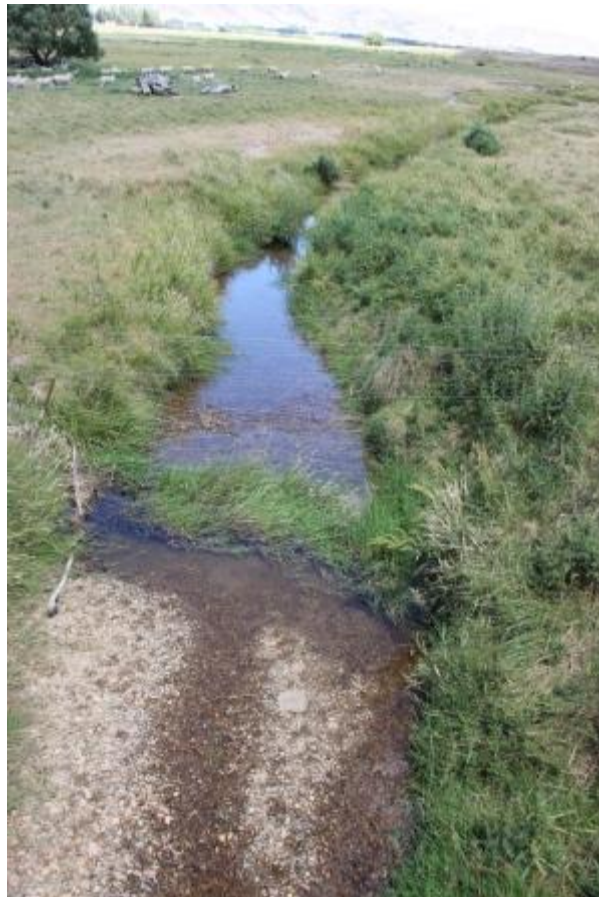
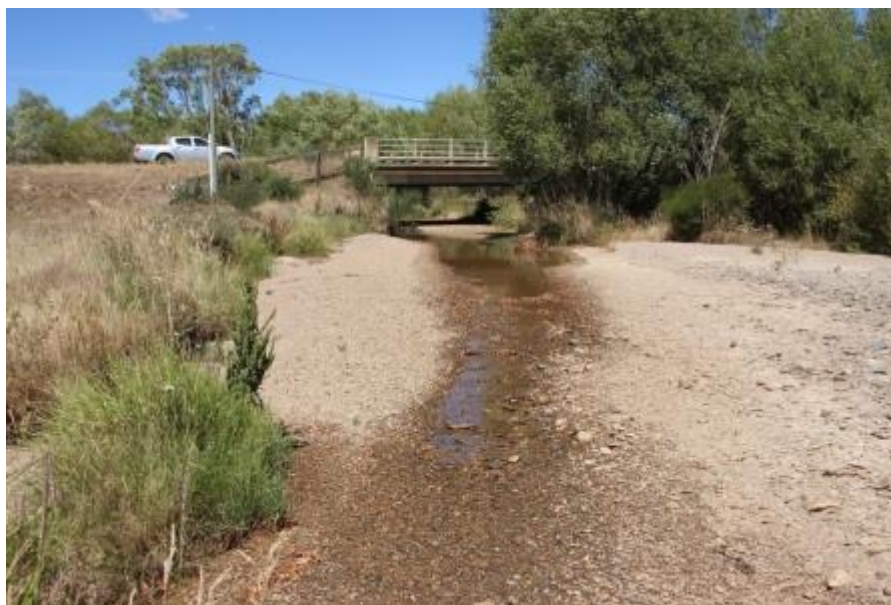
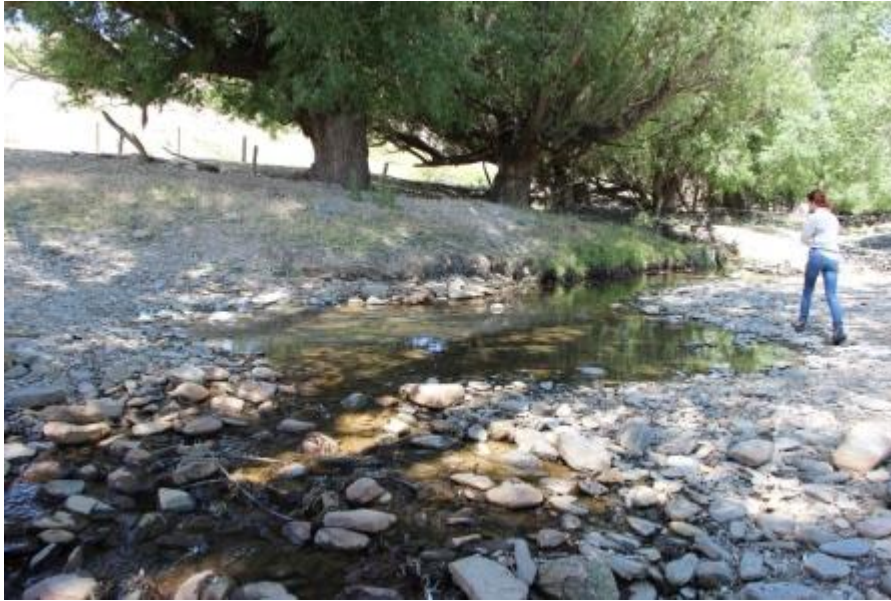
Flows in the Pig Burn at O'Neil Rd were low and stable, with no signs of recent drying or re-wetting (Figure 23). Further upstream at Patearoa-Waipia Rd, surface flows ceased approximately 30m downstream of the bridge due to losses to gravel (Figure 24). The most upstream site at Hamilton Rd showed higher flows than those further downstream, with several schools of brown trout fry present.

**Figure 23** Pig Burn at O'Neil Rd - 16<sup>th</sup> January

**Figure 24** Beginning of dewatered reach in the Pig Burn 40 m downstream of the Patearoa-Waipiatā Rd Bridge - 16<sup>th</sup> January

**Figure 25** Pig Burn at Hamilton Rd - 16<sup>th</sup> January

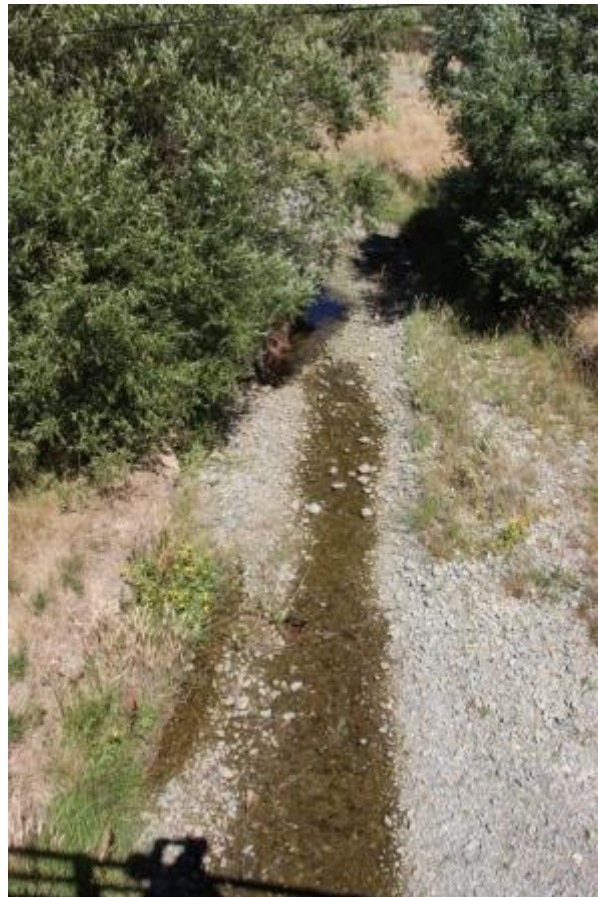
Surface flow in the Ewe Burn ceased approximately 20m downstream of the Allison Rd Bridge (Figure 26).

**Figure 26** Ewe Burn at Allison Lane - 16<sup>th</sup> January
