The effects of the 24 hour voluntary  
irrigation shutdown on flows in the  
Taieri River: 15th–16th January 2015

July 2015

Report writer: Matt Dale, Resource Scientist  
Reviewed by: Dean Olsen, Manager - Resource Science

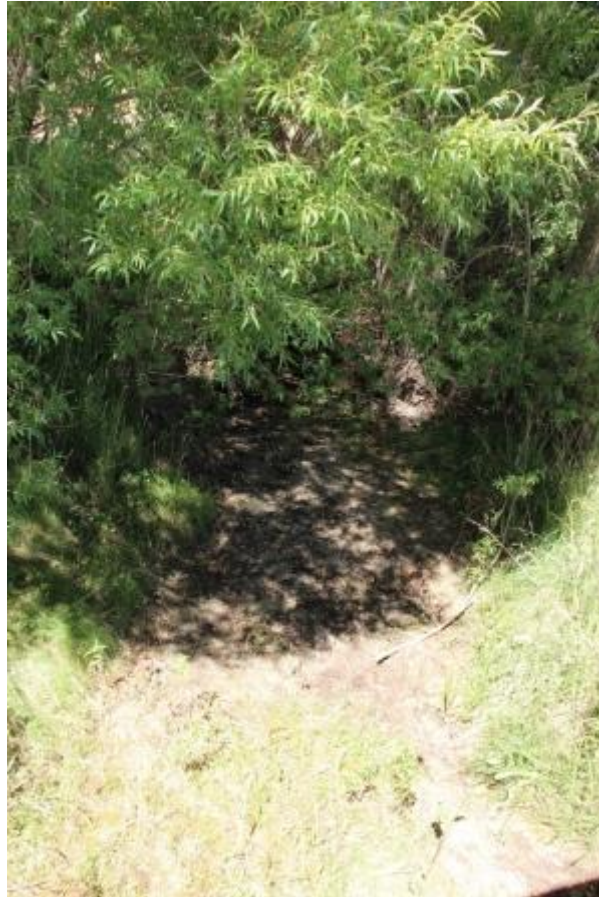
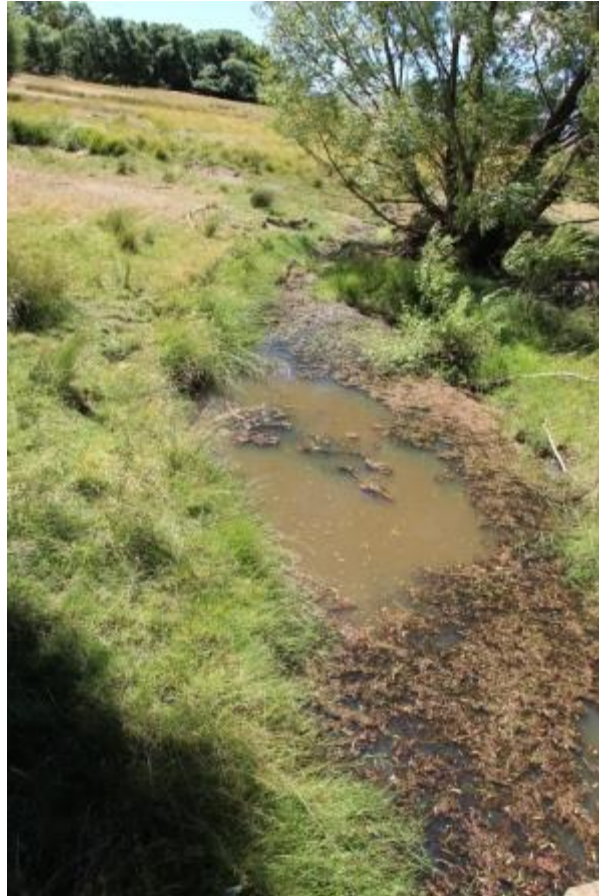
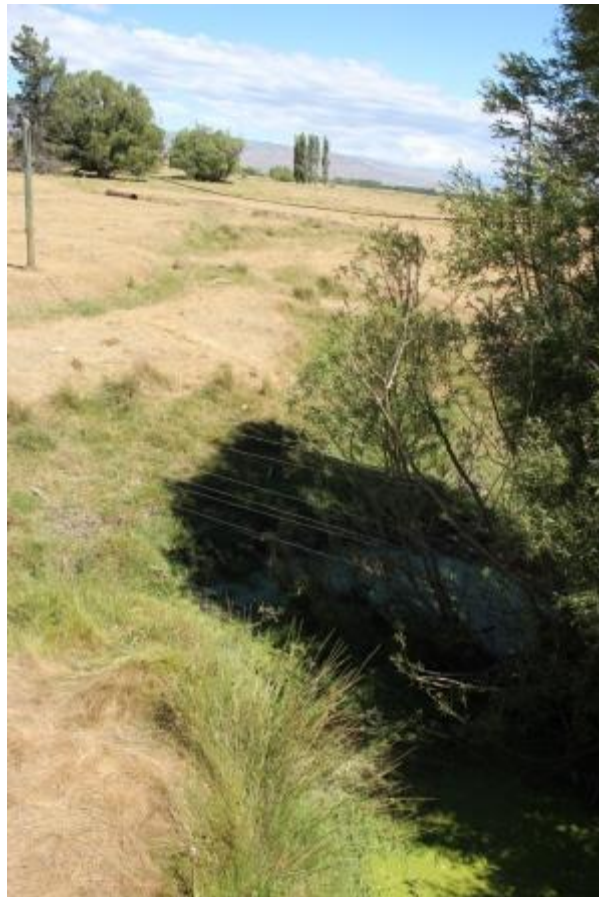
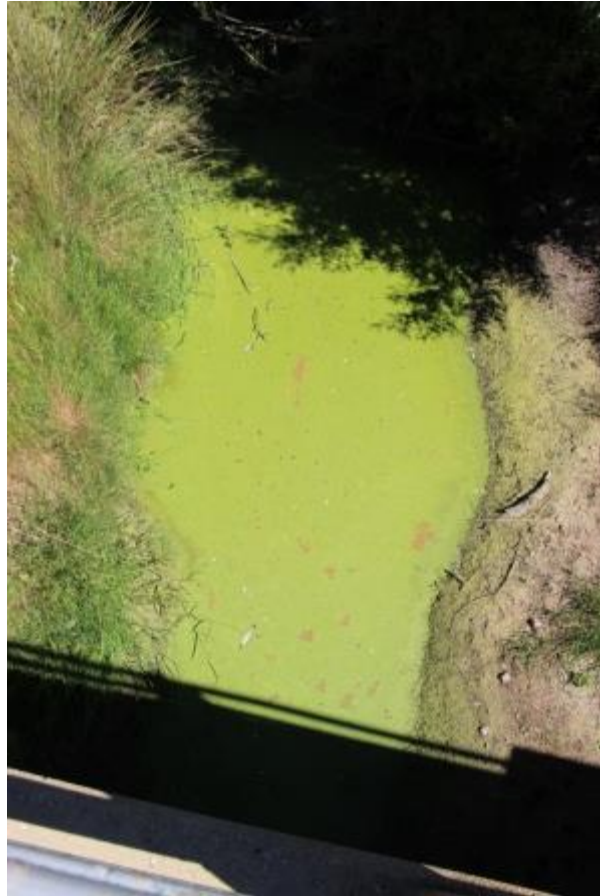
The Wether Burn at Devenney Rd was mostly dry (Figure 27), with several disconnected pools showing signs of very poor water quality (Figure 28). Flows were similar further downstream at Sharkeys Rd, with disconnected pools at the bridge and a dry channel both upstream and downstream.

**Figure 27**      **Wether Burn downstream of Devenney Rd - 16<sup>th</sup> January**

**Figure 28**      **Disconnected pools in the Wether Burn at Devenney Rd - 16<sup>th</sup> January**

**Figure 29**      **Wether Burn at Sharkeys Rd - 16<sup>th</sup> January**

**Figure 30** Isolated pool at the Sharkeys Rd Bridge - 16<sup>th</sup> January

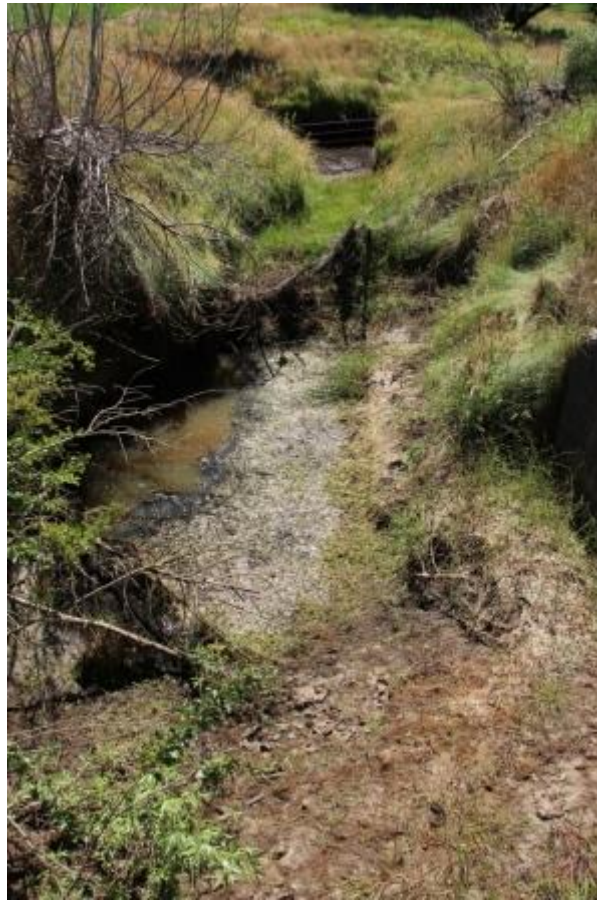
The Gimmer Burn was mostly dry in the reach around Puketoi-Highfield Rd, with only small isolated pools remaining (Figure 31).

**Figure 31** Isolated pools upstream of the Puketoi-Highfield Rd bridge - 16<sup>th</sup> January

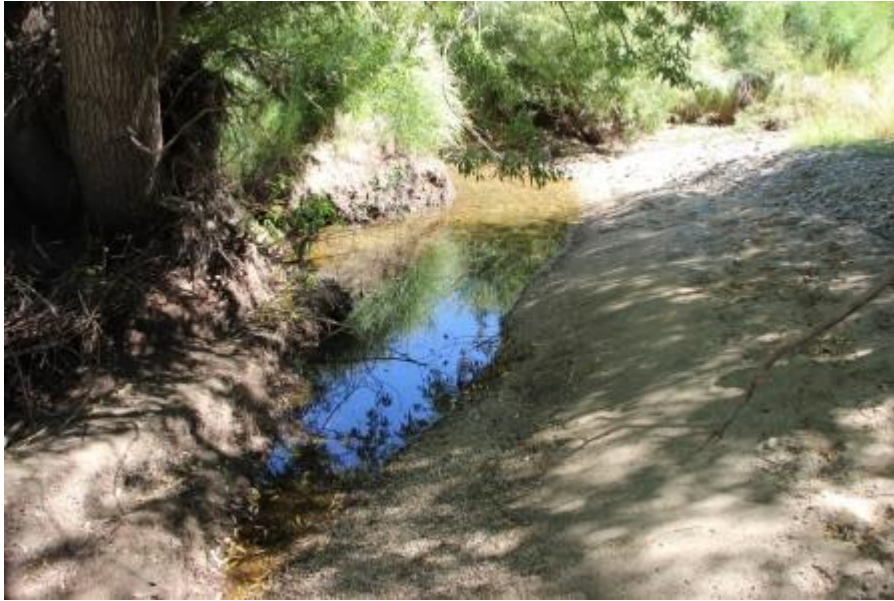
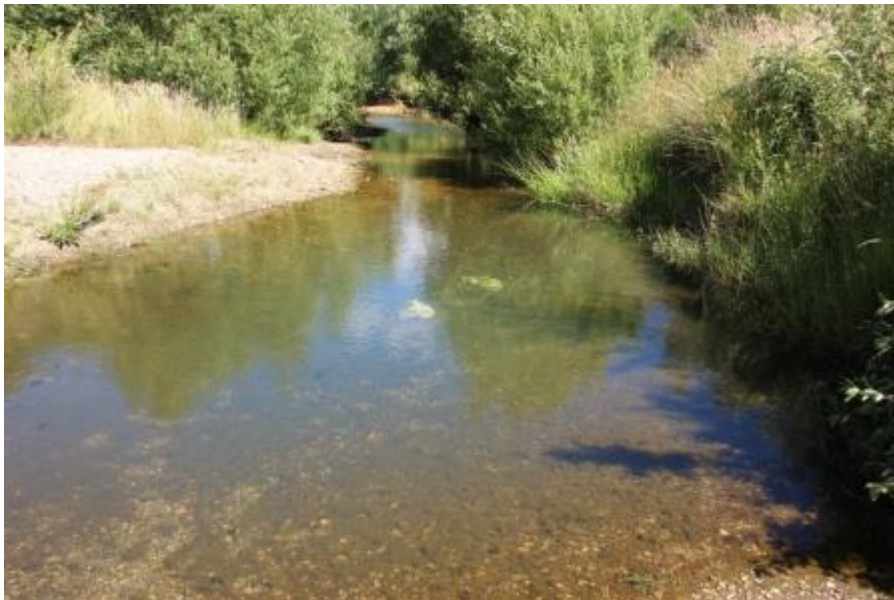
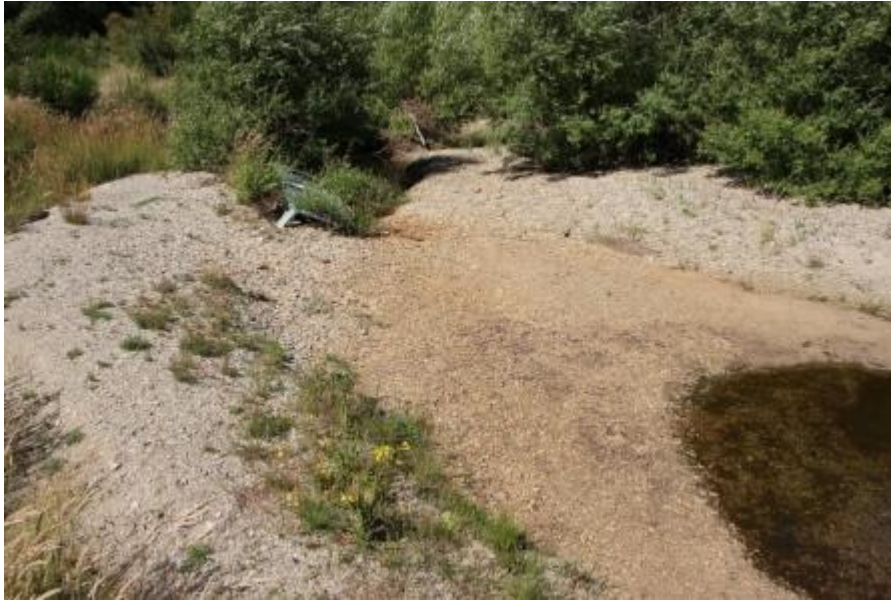
The Sow Burn was dry under bridge at Duffy Lane, with disconnected pools downstream (Figure 32). The number of pools increased downstream, with surface flow resuming approximately 300 m downstream at E136775, N4985601 (Figure 33). Many (several hundred) trout fry were trapped in refuge pools and were showing signs of thermal stress. The refuge pool immediately upstream of the resumption of surface flow (Figure 34) showed signs of recent dewatering. Professionalism

**Figure 32** Refuge Pool downstream of Duffy Lane - 16<sup>th</sup> January

**Figure 33** Resumption of surface flow downstream of Duffy Lane - 16<sup>th</sup> January

**Figure 34** Recently disconnected refuge pool downstream of Duffy Lane - 16<sup>th</sup> January

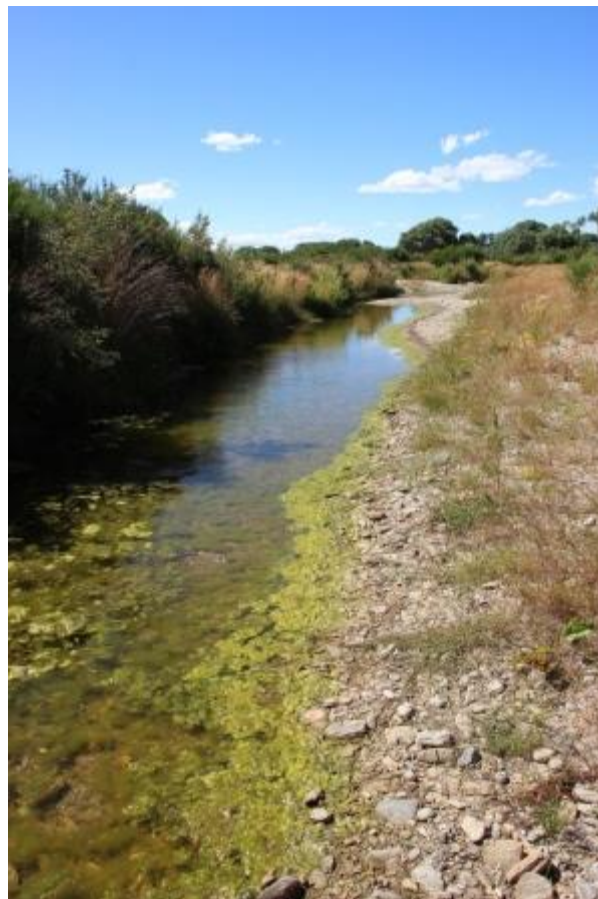
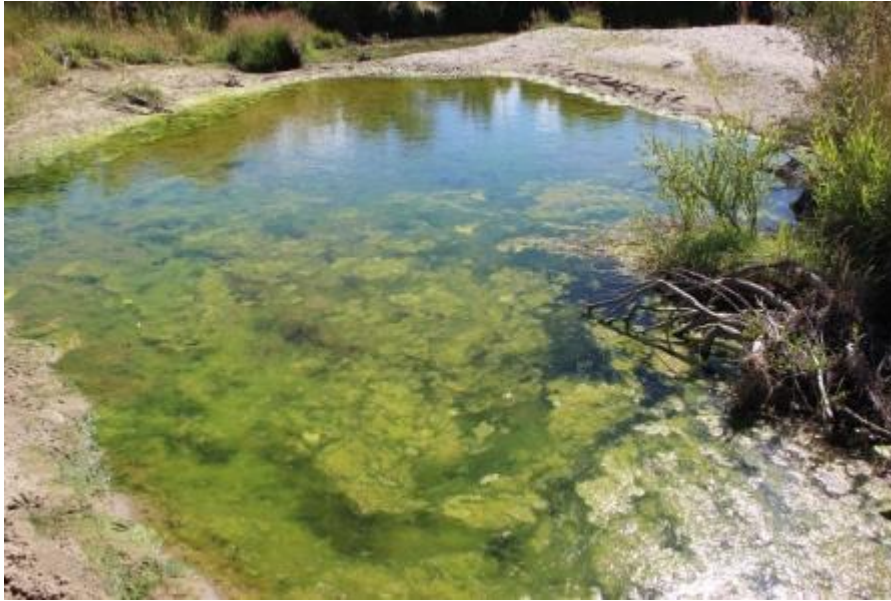
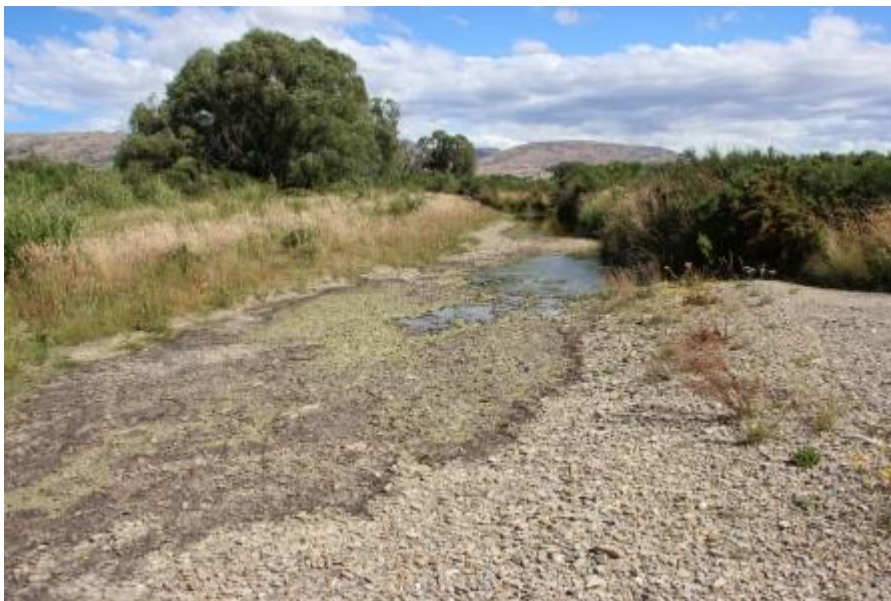
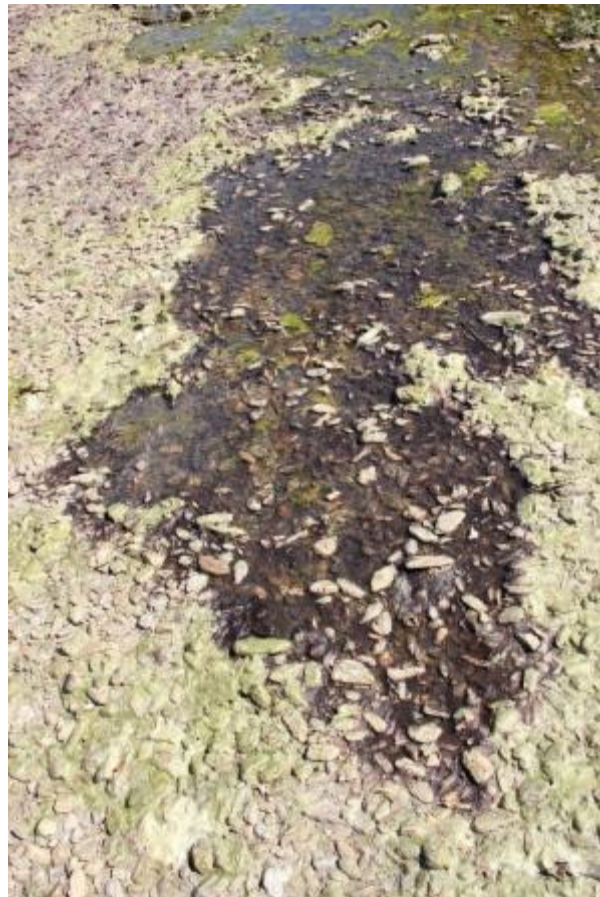
Surface flow resumed 150 m upstream of Duffy Lane (Figure 35), with several isolated pools with dense cover of green filamentous algae (Figure 36). Between these pools there were obvious signs of that this reach had only recently dewatered, and that approximately 10 m of steam bed had re-wetted due to the shutdown (Figure 37 & Figure 38).

**Figure 35** Surface flow upstream of Duffy Lane showing heavy growth of green filamentous algae - 16<sup>th</sup> January

**Figure 36** Recently disconnected refuge pool upstream of Duffy lane showing heavy growth of green filamentous algae - 16<sup>th</sup> January

**Figure 37** Recently dewatered section immediately below upstream surface flow - 16<sup>th</sup> January

**Figure 38** Evidence of recent re-watering as a result of shutdown - 16<sup>th</sup> January

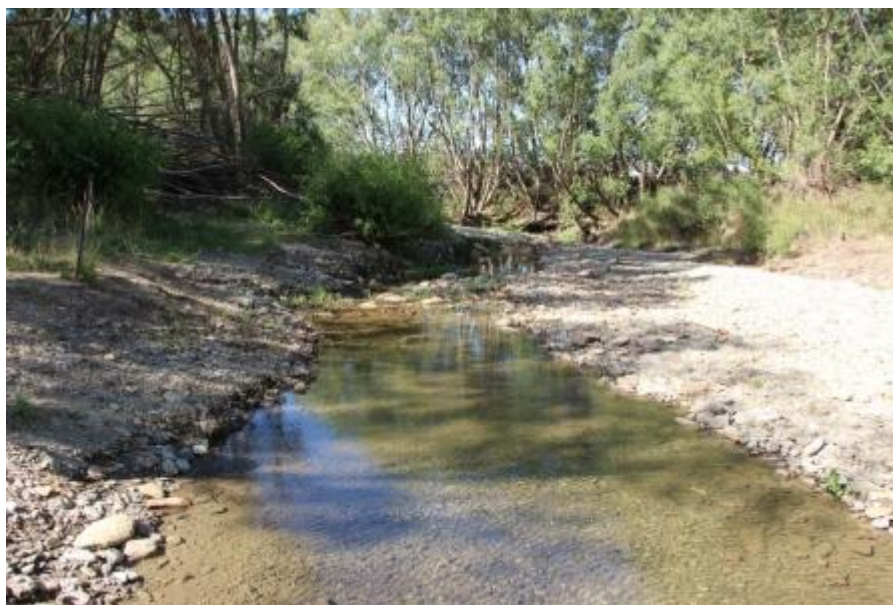
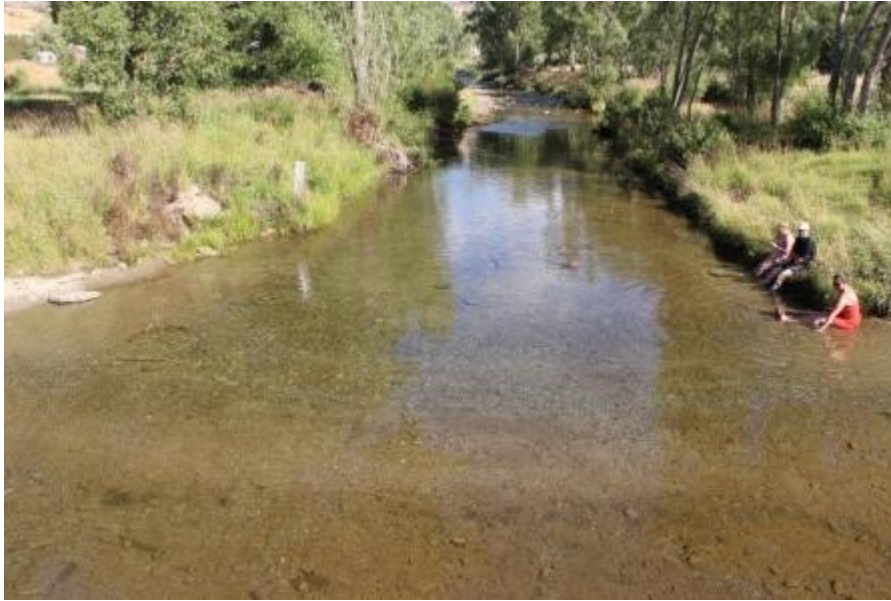
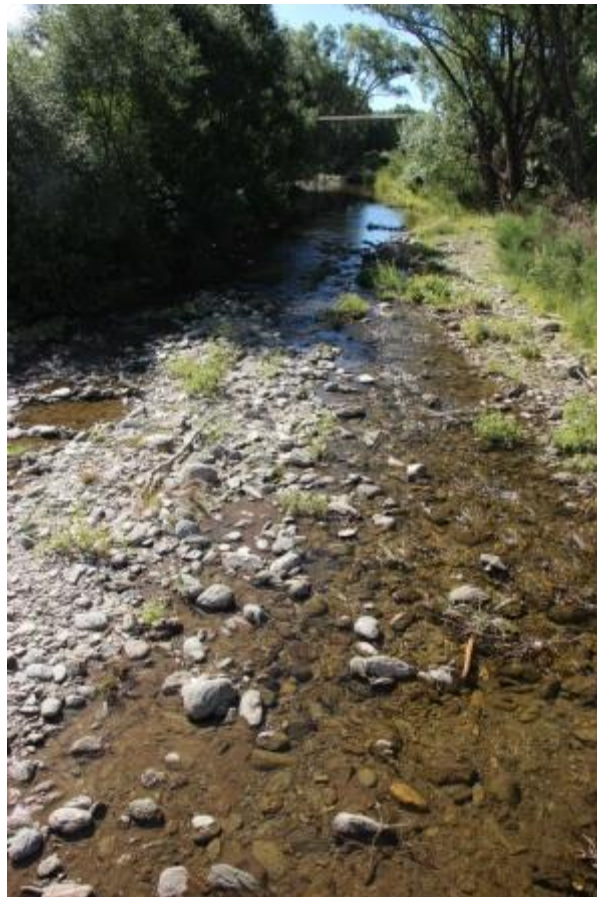
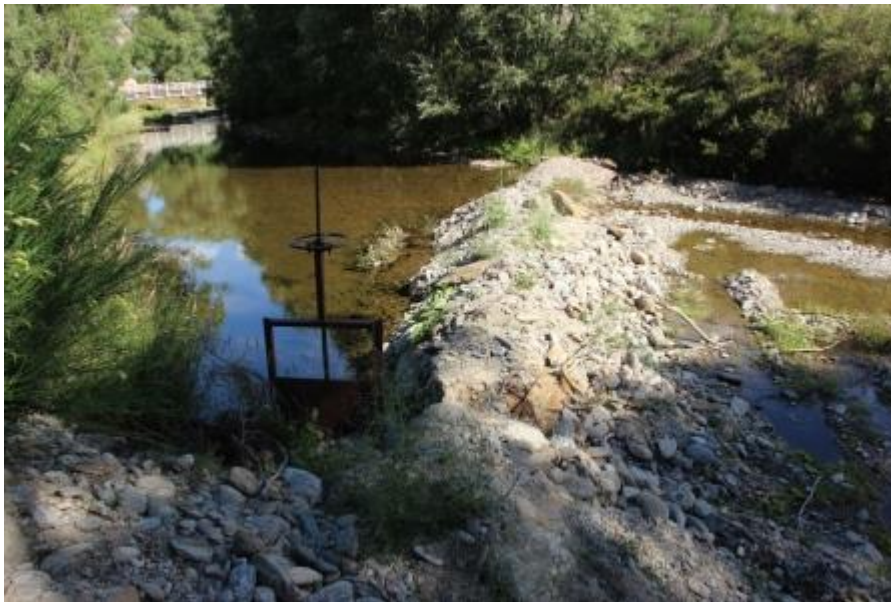
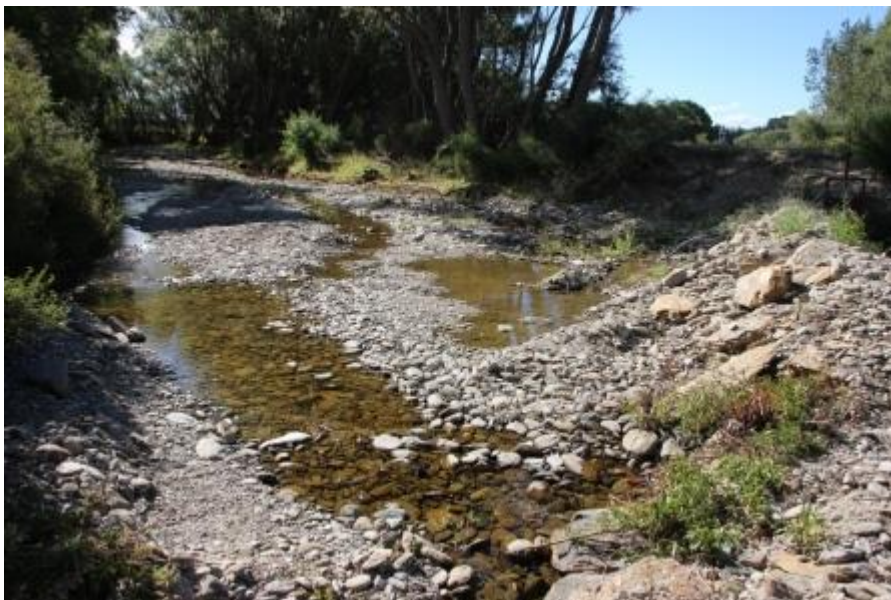
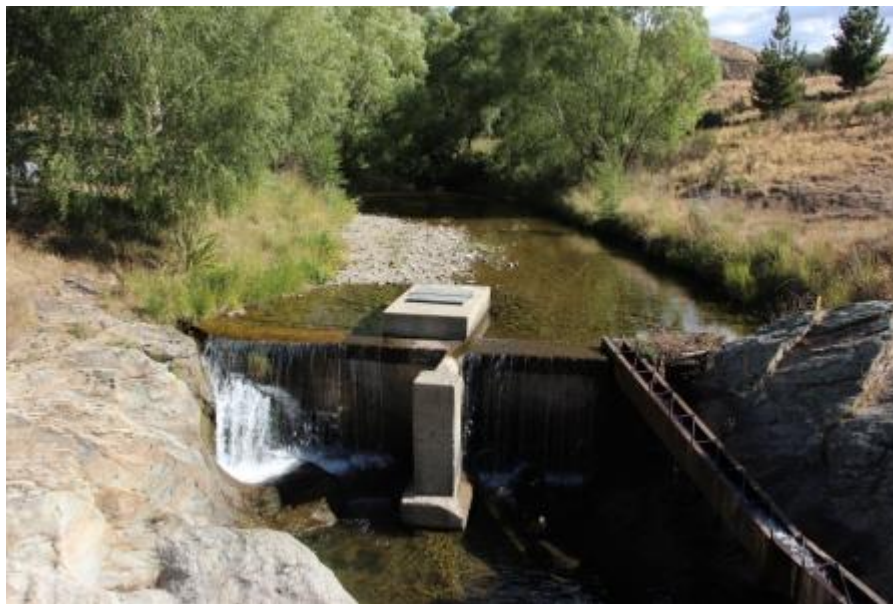
Continuous flow was observed further upstream at Halls Ford (Figure 39), with the estimated total flow less than 20 l/s. Flows were higher (over 100 l/s) at the Styx-Patearoa Rd Bridge (Figure 40 & Figure 41), however a large bund approximately 100 m below the bridge significantly reduced downstream flows (Figure 42). Flows at the Aitkin Rd Bridge were similar to those at Styx-Patearoa Rd (Figure 44).

**Figure 39** Sow Burn at Halls Ford - 16<sup>th</sup> January

**Figure 40** Sow Burn upstream of the Styx-Patearoa Rd bridge - 16<sup>th</sup> January

**Figure 41** Sow Burn downstream at Styx-Patearoa Rd - 16<sup>th</sup> January

**Figure 42** Gravel bund downstream of Styx-Patearoa Rd - 16<sup>th</sup> January

**Figure 43** Reduced flow downstream of gravel bund - 16<sup>th</sup> January

**Figure 44**      **Sow Burn upstream of Aitkin Rd - 16<sup>th</sup> January**

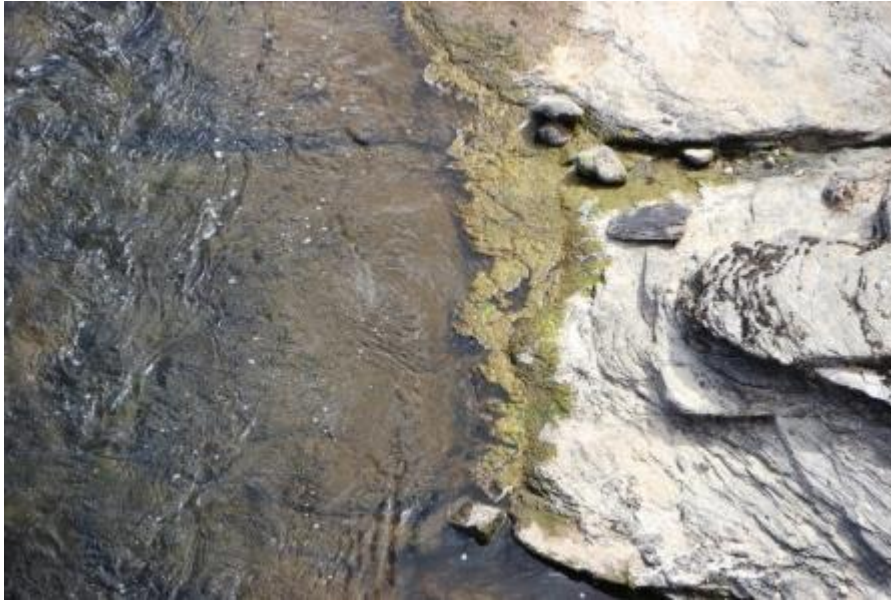
**Figure 53** Build-up of algae on the banks of the Taieri River at Hyde-Macraes Rd - 16<sup>th</sup> January

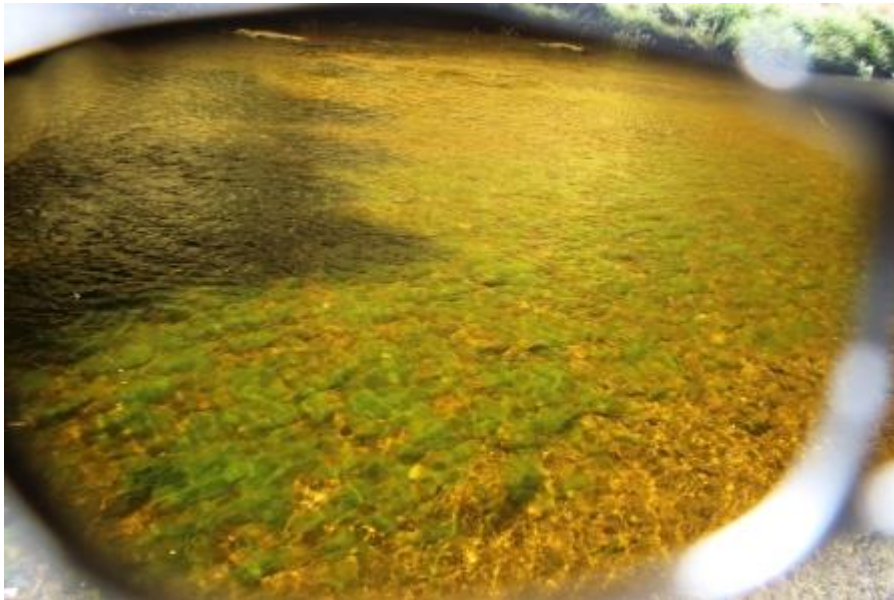
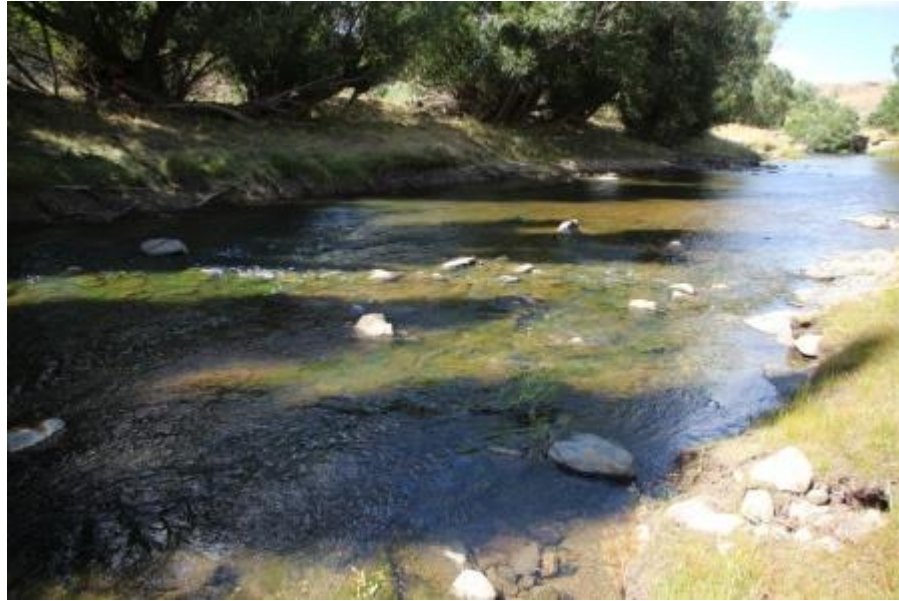
Significant filamentous green algae was observed both upstream and downstream of the bridge.

**Figure 56** Thick green filamentous algal growth at Taieri River at Tiroiti - 16<sup>th</sup> January

**Figure 57**      **Extent of green filamentous algal growth at Taieri River at Tiroiti - 16<sup>th</sup> January**

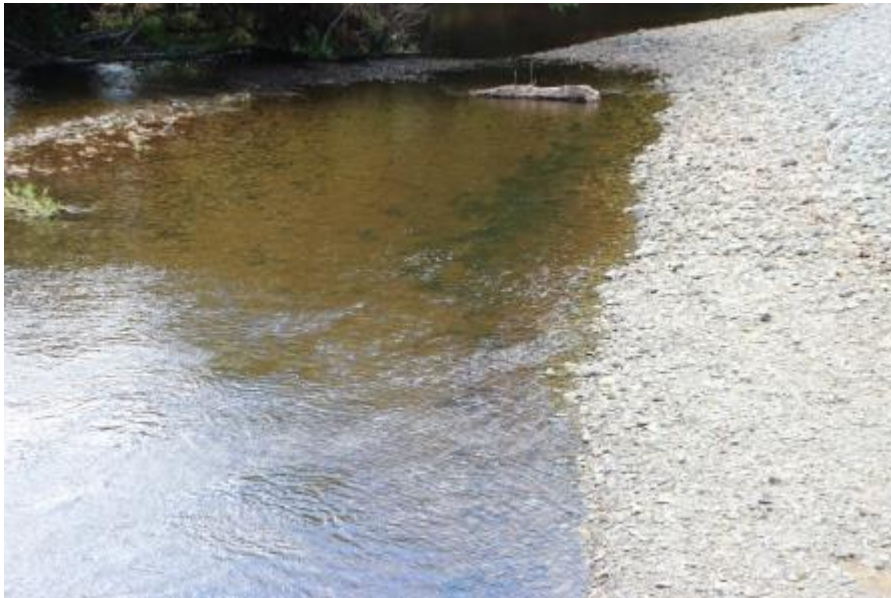
Heavy cover of green filamentous algae was evident on the channel margins, but less than observed at Tiroiti.

**Figure 60** Filamentous green algal growth in the Taieri River at Kokonga - 16<sup>th</sup> January

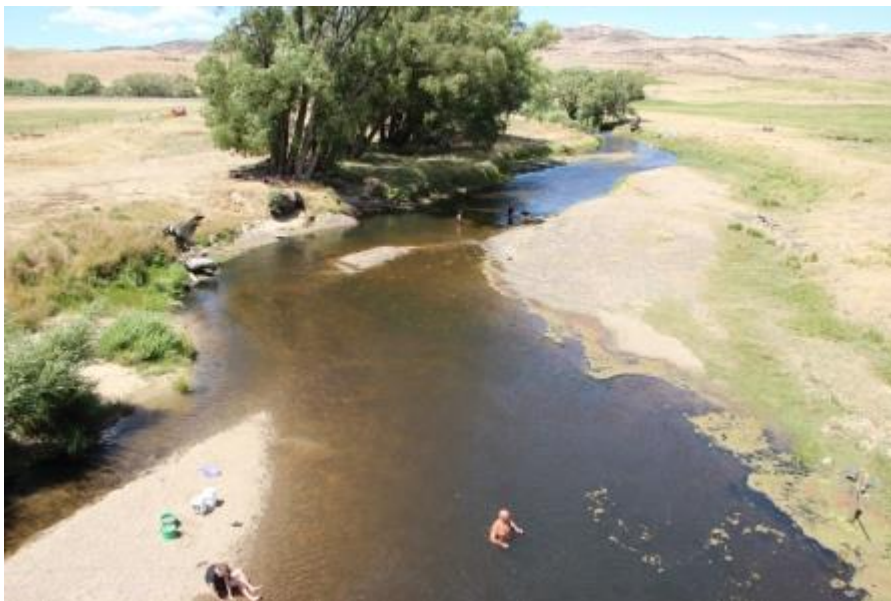
The swimmers seen in Figure 62 mentioned that the flows on the 16<sup>th</sup> January were noticeably higher than those on the previous day.

**Figure 62**      **Taieri River at Waipiata, looking downstream - 16<sup>th</sup> January**
