APPENDIX D

Test Pit and Trench Logs and Photographs

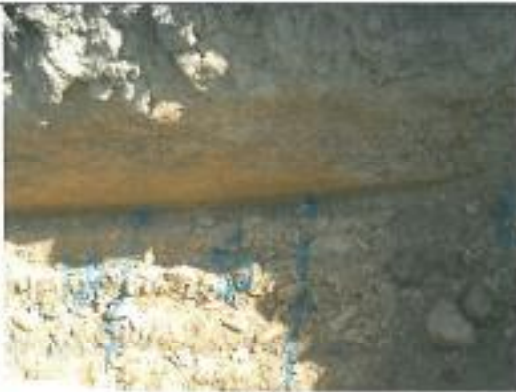
<p>CTP01, 19 Apr 2010 Trench oriented to 210 degrees S. Length 6m x depth 1.4m Soil depth approx 500mm Competent schist moderately weathered</p>	 
<p>CTP02, 19 Apr 2010 Trench oriented to 030 degrees N. Length 6m x depth 1.5m Soil depth approx 700mm Weak schist highly weathered</p>

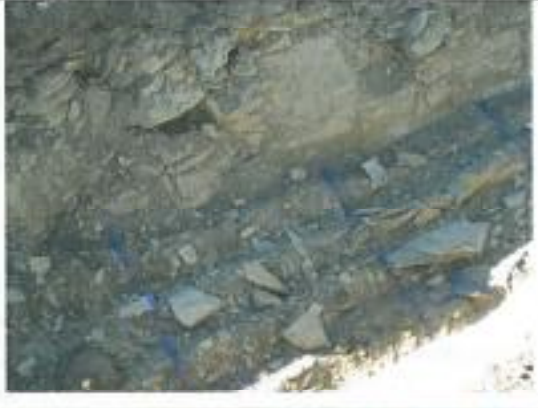
<p>CTP07, 16 Apr 2010</p> <p>Trench oriented to 020 degrees N.</p> <p>Length 7m x depth 1m</p> <p>Soil depth approx 200-300mm</p> <p>V. competent schist moderately weathered</p>

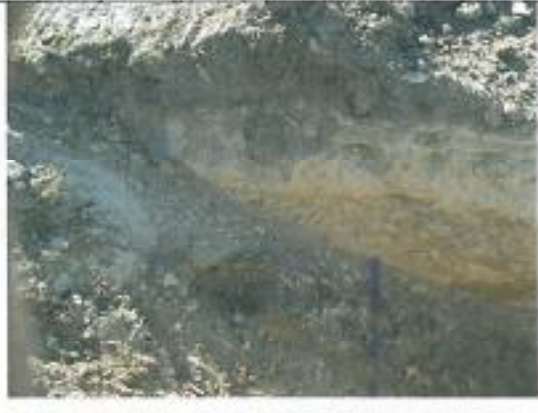
<p>CTP08, 16 Apr 2010</p> <p>Trench oriented to 010 degrees N.</p> <p>Length 6m x depth 1.2m</p> <p>Soil depth approx 300-400mm</p> <p>Weak schist highly-moderately weathered</p>

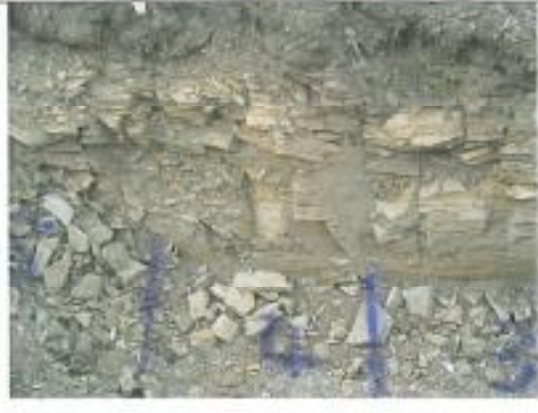
<p>CTP09, 16 Apr 2010</p> <p>Trench oriented to 350 degrees N.</p> <p>Length 6m x depth 1.5m</p> <p>Soil depth approx 300-400mm</p> <p>Competent schist moderately weathered</p>

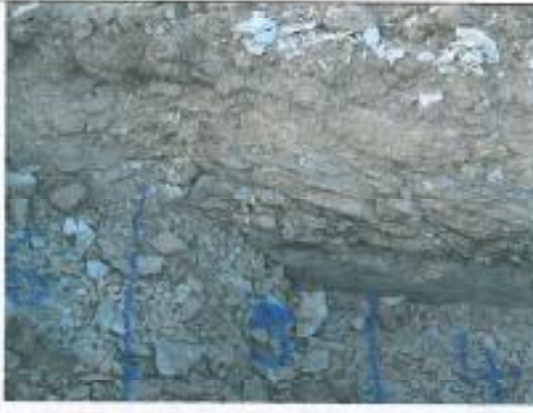
<p>CTP10, 15 Apr 2010</p> <p>Trench oriented to 346 degrees N.</p> <p>Length 6m x depth 1.2m</p> <p>Soil depth approx 200-300mm</p> <p>Competent schist moderately weathered</p>

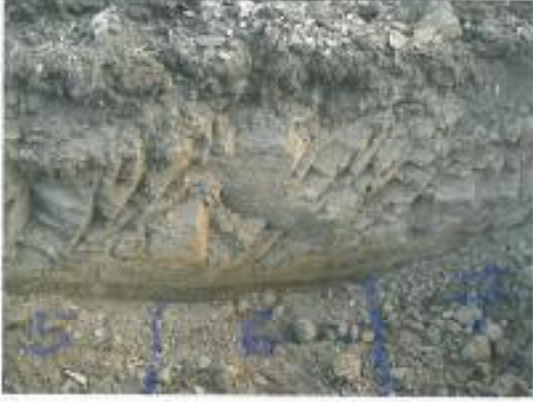
<p>CTP11, 15 Apr 2010 - Trench 30m west of original survey at request of farmer</p> <p>Trench oriented to 350 degrees N.</p> <p>Length 8m x depth 1.2m</p> <p>Soil depth approx 200-300mm</p> <p>Competent schist moderately weathered</p>

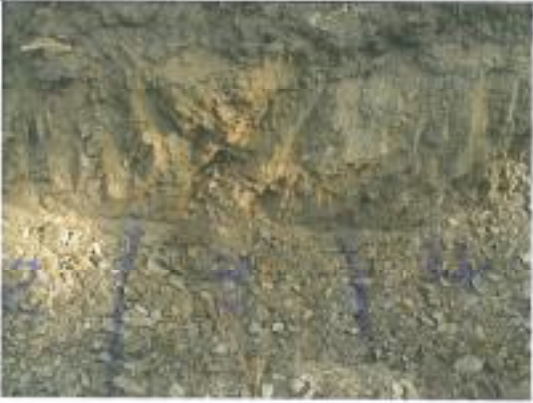
<p>CTP12, 15 Apr 2010 – Trench 45m west of original survey at request of farmer</p> <p>Trench oriented to 350 degrees N.</p> <p>Length 7m x depth 1.2m</p> <p>Soil depth approx 300-400mm</p> <p>Weak schist highly-moderately weathered, at 3.20m and 3.70m small foliation shears 50mm and 30mm thick respectively and at 4.10 small shear and crush zone 200mm thick</p>

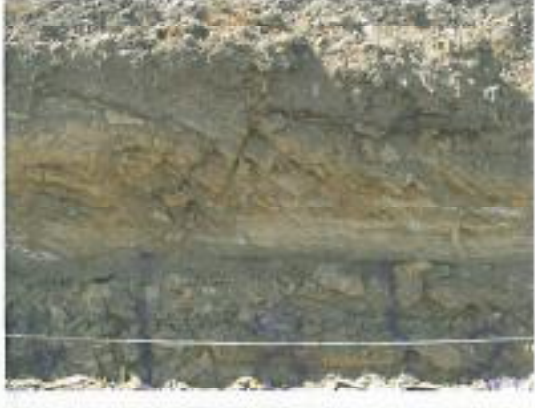
<p>CTP13, 15 Apr 2010 - Trench 70m west of original survey at request of farmer Trench oriented to 350 degrees N.</p> <p>Length 7m x depth 1.4m</p> <p>Soil depth approx 200-300mm</p> <p>Competent schist moderately weathered</p>

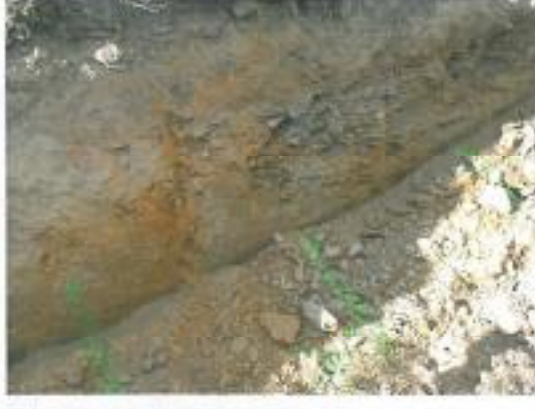
<p>CTP14, 14 Apr 2010 - Trench 70m west of original survey at request of farmer Trench oriented to 350 degrees N.</p> <p>Length 6m x depth 1.4m</p> <p>Soil depth approx 200-400mm</p> <p>Weak schist highly-moderately weathered 4-6m more deeply weathered v. weak</p>

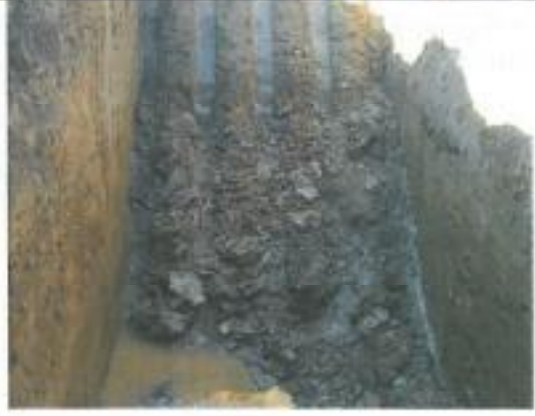
<p>CTP15, 02 June 2010</p> <p>Soil depth approx 100mm</p> <p>Dark grey brown silt to 0.2m</p> <p>Yellow brown loess to 1m</p> <p>Grey and brown moderately weathered moderately strong schist, weak schist from 1.0-1.3m. Water seeps at rock surface.</p>

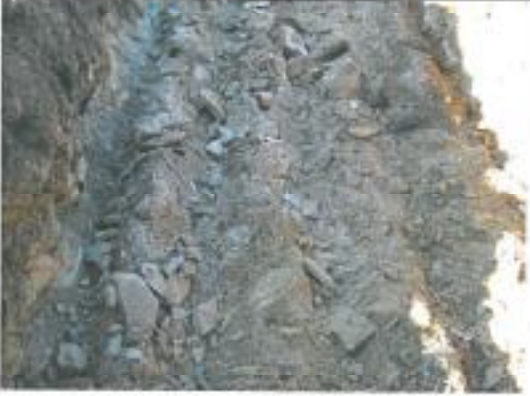
<p>CTP16, 21 June 2010</p> <p>Soil depth approx 200mm</p> <p>Gravelly yellow brown silt containing schist fragments to 0.4m</p> <p>Laminated grey and brown schist, slightly weathered, moderately strong to 0.6m</p>

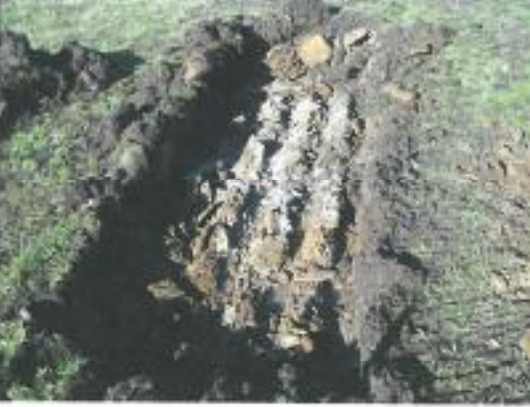
<p>CTP17, 02 June 2010</p> <p>Soil depth approx 200mm</p> <p>Light yellow grey silt loess to 1m</p> <p>Highly weathered, weak brown schist to 1.5m</p>	<p>NO PHOTOGRAPH</p>
<p>CTP18, 02 June 2010</p> <p>Soil depth approx 200mm</p> <p>Moderately strong slightly weathered grey and brown schist to 0.3m</p> <p>Small quantity of seepage from rock contact</p>

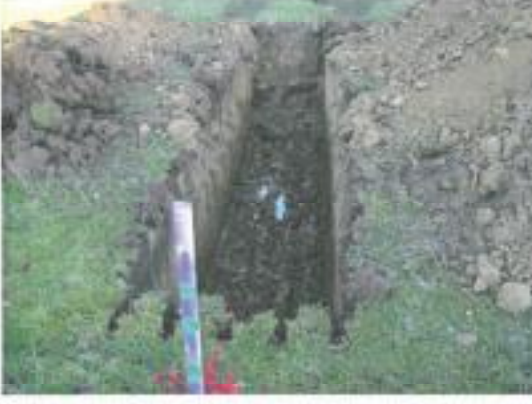
<p>CTP20, 01 June 2010</p> <p>Soil depth approx 200mm</p> <p>Yellow brown loess to 1m</p> <p>Weak, foliated, moderately weathered brown schist to 1.3m</p>

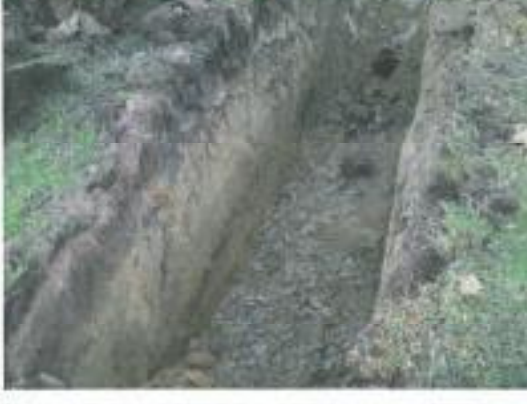
<p>CTP21, 01 June 2010</p> <p>Soil depth approx 200mm</p> <p>Yellow brown loess to 0.8m</p> <p>Highly weathered weak schist to 1.4m</p>

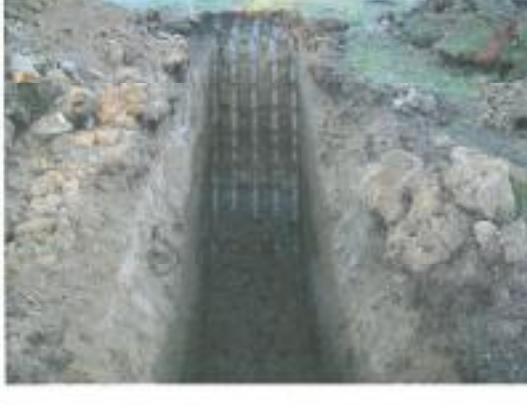
<p>CTP22, 01 June 2010</p> <p>Soil depth approx 200mm</p> <p>Yellow brown loess & loess colluviums to 1.8m</p> <p>Gravelly clay & light grey loess colluviums containing schist fragments to 2.1m</p> <p>Thinly laminated, weak, highly weathered schist to 2.7m</p>

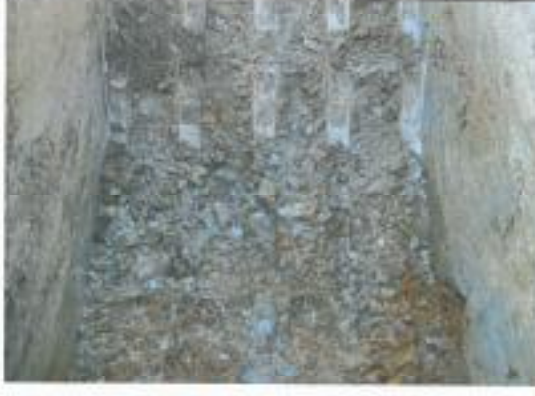
<p>CTP23, 02 June 2010</p> <p>Soil depth approx 200mm</p> <p>Yellow brown loess to 0.8m</p> <p>Light grey schist and highly weathered, weak schist to 1.4m</p>

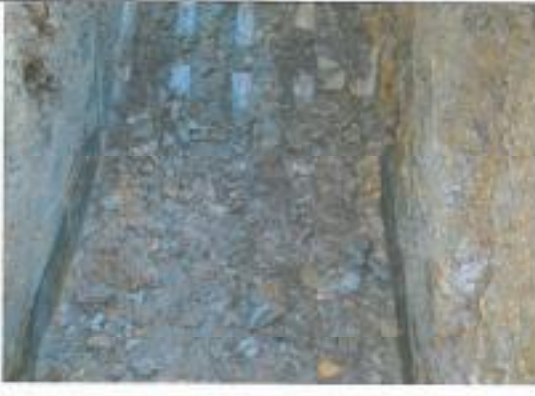
<p>CTP24, 02 June 2010</p> <p>Soil depth approx 200mm</p> <p>Gravelly yellow brown silt -loess colluvium to 0.6m</p> <p>Light grey and yellow brown weak, highly weathered schist to 1.5m</p>

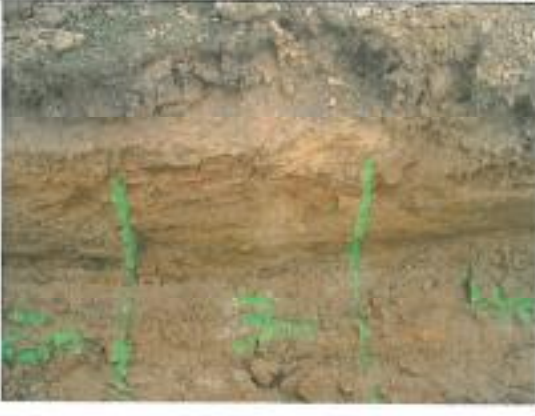
<p>TP01, 13 Apr 10</p> <p>Trench oriented to 0 degrees N.</p> <p>6m x depth 1.2m</p> <p>Soil depth approx 400</p> <p>Competent schist, moderately weathered</p>

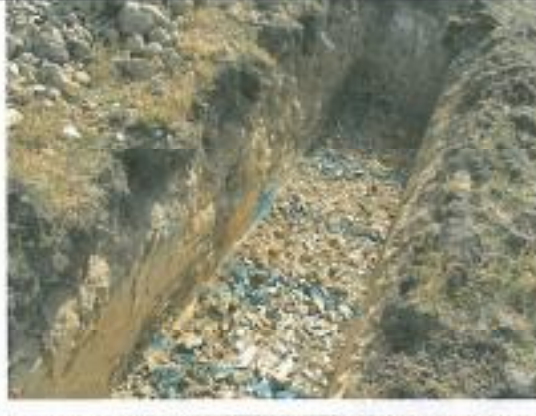
<p>TP02, 13 Apr 2010</p> <p>Trench oriented to 0 degrees N.</p> <p>length 6m x depth 1.2m</p> <p>Soil depth approx 300-400mm</p> <p>Competent schist moderately weathered</p>	 
<p>TP03, 13 Apr 2010</p> <p>Trench oriented to 0 degrees N.</p> <p>Length 6.5m x depth 1.5m</p> <p>Soil depth approx 1m (completely weathered)</p> <p>Competent schist moderately weathered below 1.3m</p>

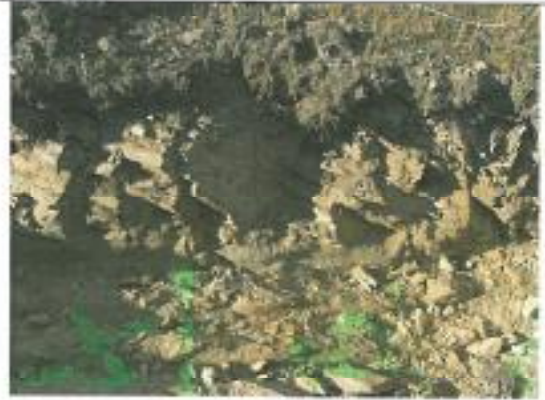
TP05, 14 Apr 2010

Trench oriented to 0 degrees N.

Length 6m x depth 1.2m

Soil depth approx 300-400mm

Competent schist moderately weathered

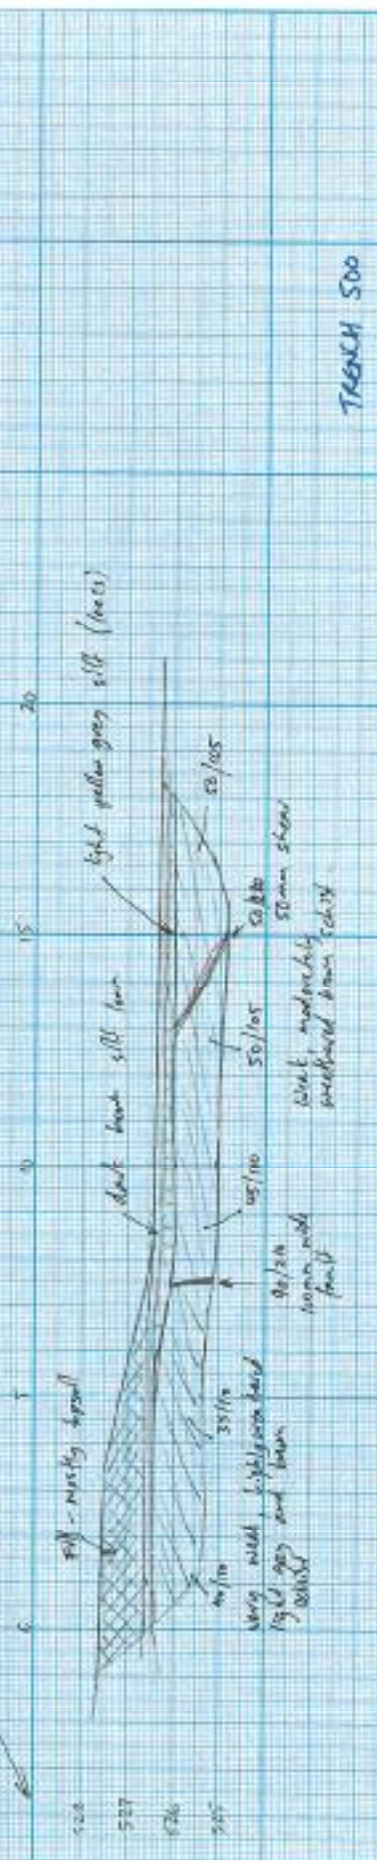
TRENCH 500

very weak highly weathered granulated siltstone with silty siltstone

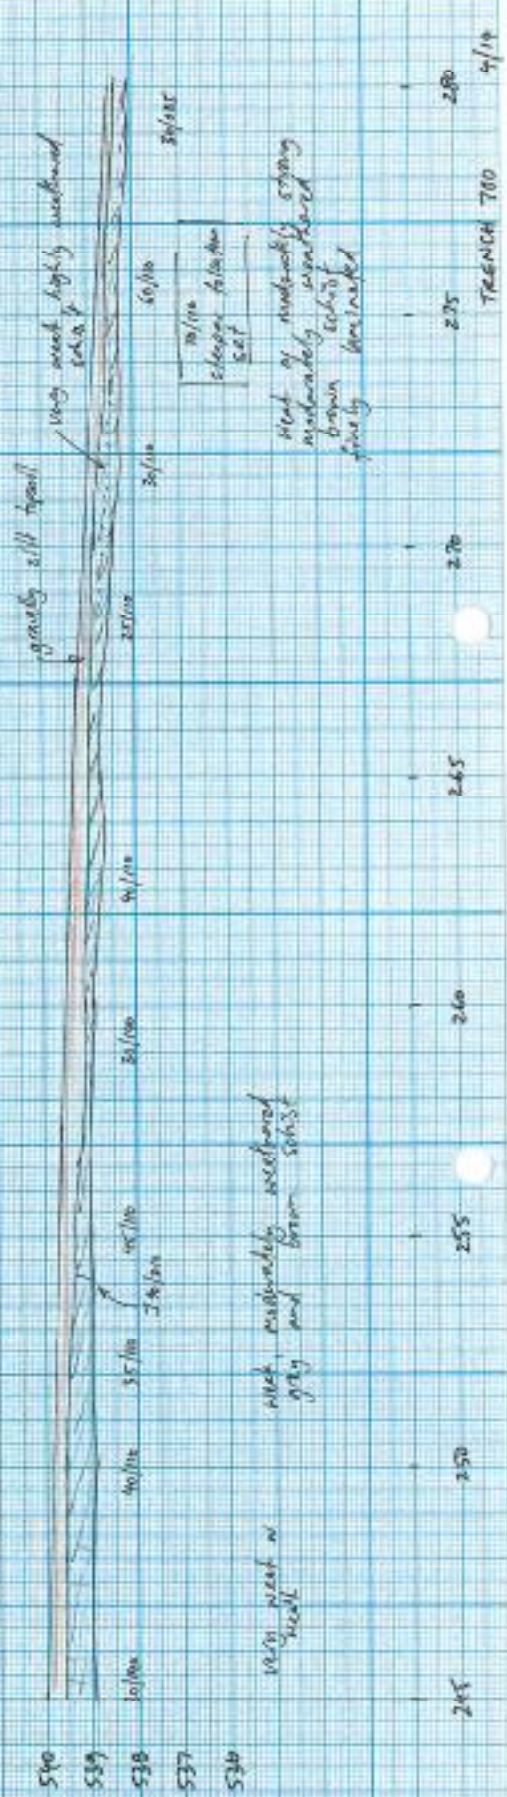
very weak and wet highly weathered light grey and dark schist
No. short fabric identified

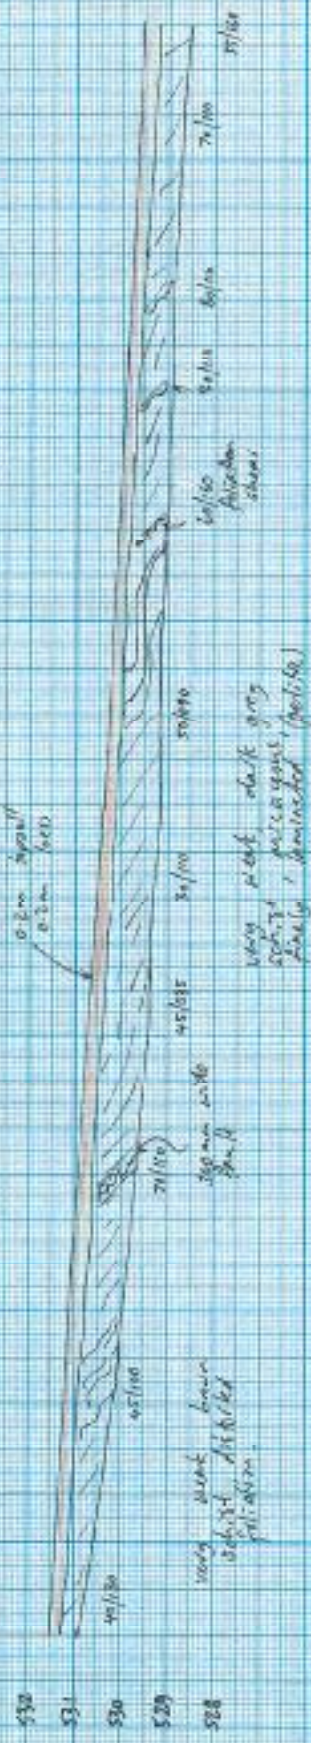
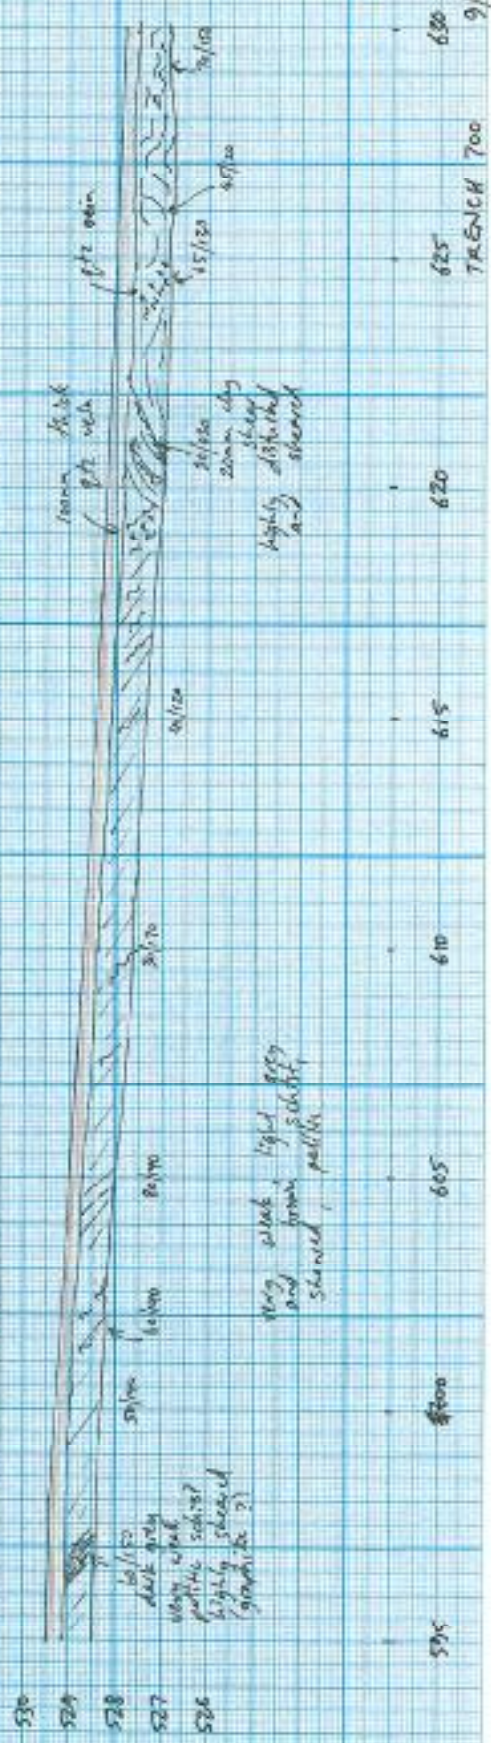
TRENCH 007 5/14

0.2m thick brown silt loam

weak to moderately strong moderately weathered sand coarsely laminated

very weak grey sand highly weathered

weak to moderate weathered siltstone

weak to moderately strong moderately highly weathered coarsely laminated

very pink highly weathered grey and brown siltstone

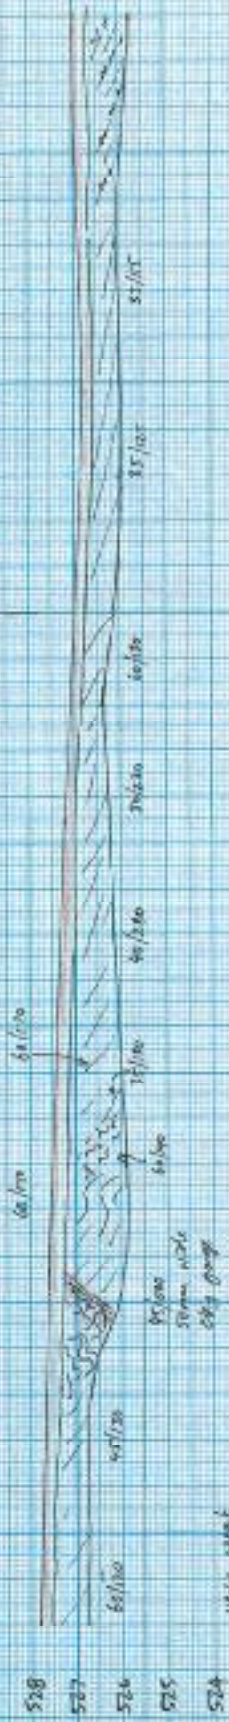
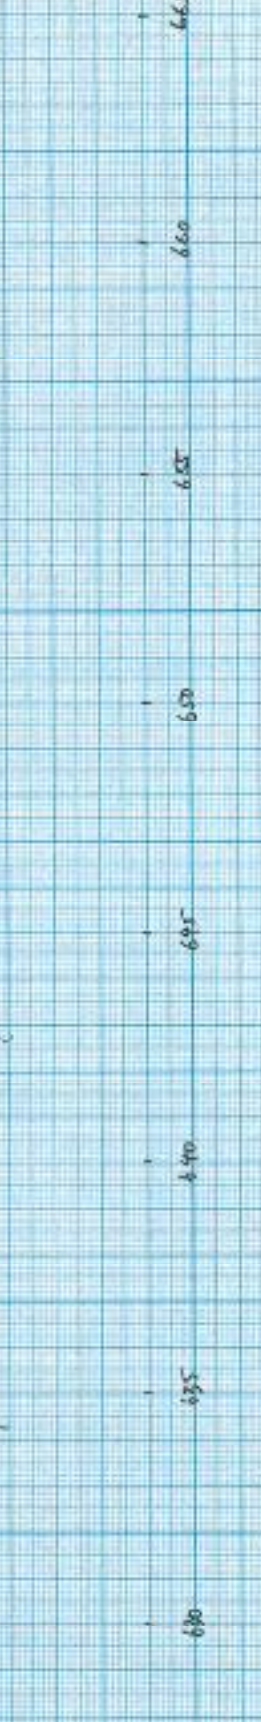
very pink
finely laminated
schist

slightly pinkish and grey
bluish

very red, moderately weathered
brown schist, fairly laminated
and obviously sheared

very weak, light
grey and brown
sheared schist

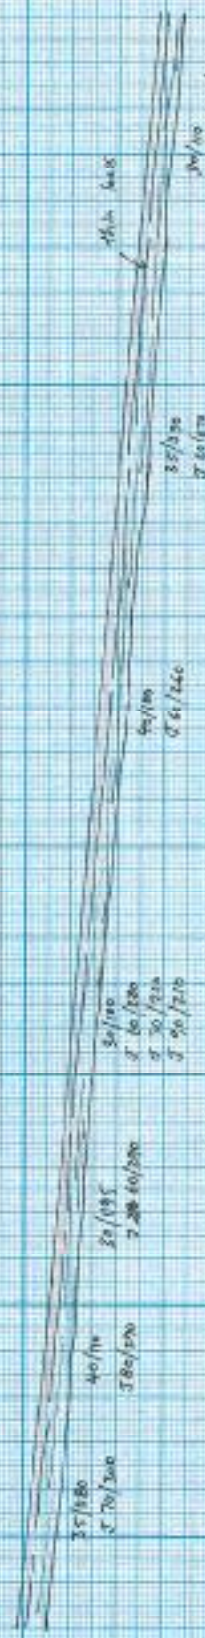
TRENCH 700

weak to moderately strong
moderately weathered
chert
followed closely

weak to moderately strong
moderately weathered chert
also encountered in hill pit
in this area
