## MACRAES PHASE III PROJECT

# Tipperary Creek Hydrological Monitoring

REPORT

Report Number. 0978110-562 R003 vC

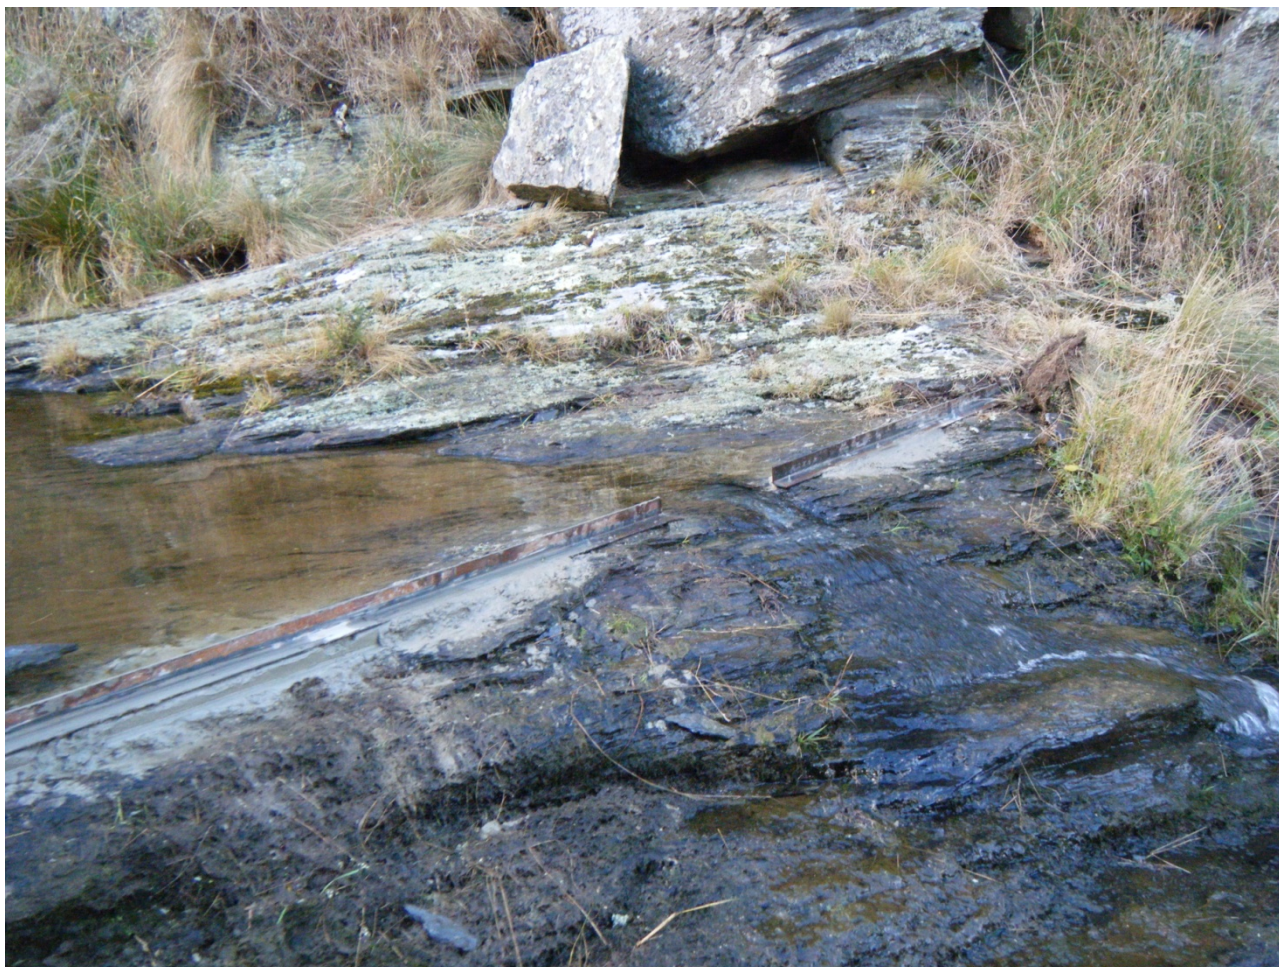
Figure 2: Tipperary Creek at rock weir.

On 18 May 2010 water level monitoring equipment was installed on the Tipperary Creek upstream of an existing natural rocky outcrop (Figure 2). The site, subsequently named "Tipperary Creek at rock weir" has a catchment area of approximately 3.9 km<sup>2</sup> and sits at an elevation of approximately 427 m. The maximum elevation of the catchment is approximately 575 m.

The location of the monitoring site was selected because water was confined to a hard rock bed section. A length of angle iron was bolted and mortared in place to provide a weir like control. This was undertaken to ensure particularly low flows could be accurately monitored.

A water level measuring device (transducer) was bolted to the bed of the stream in the pool created above the angle iron weir. An external staff gauge (ESG) was not installed due to the difficulties in securing it at the site. Instead, a measurement from a dynabolt in the upstream pool is undertaken to provide check data for the recorded water level. This bolt is assumed to have an arbitrary relative level (RL) of 1,000 mm. The survey and site establishment documentation is attached in Appendix B.

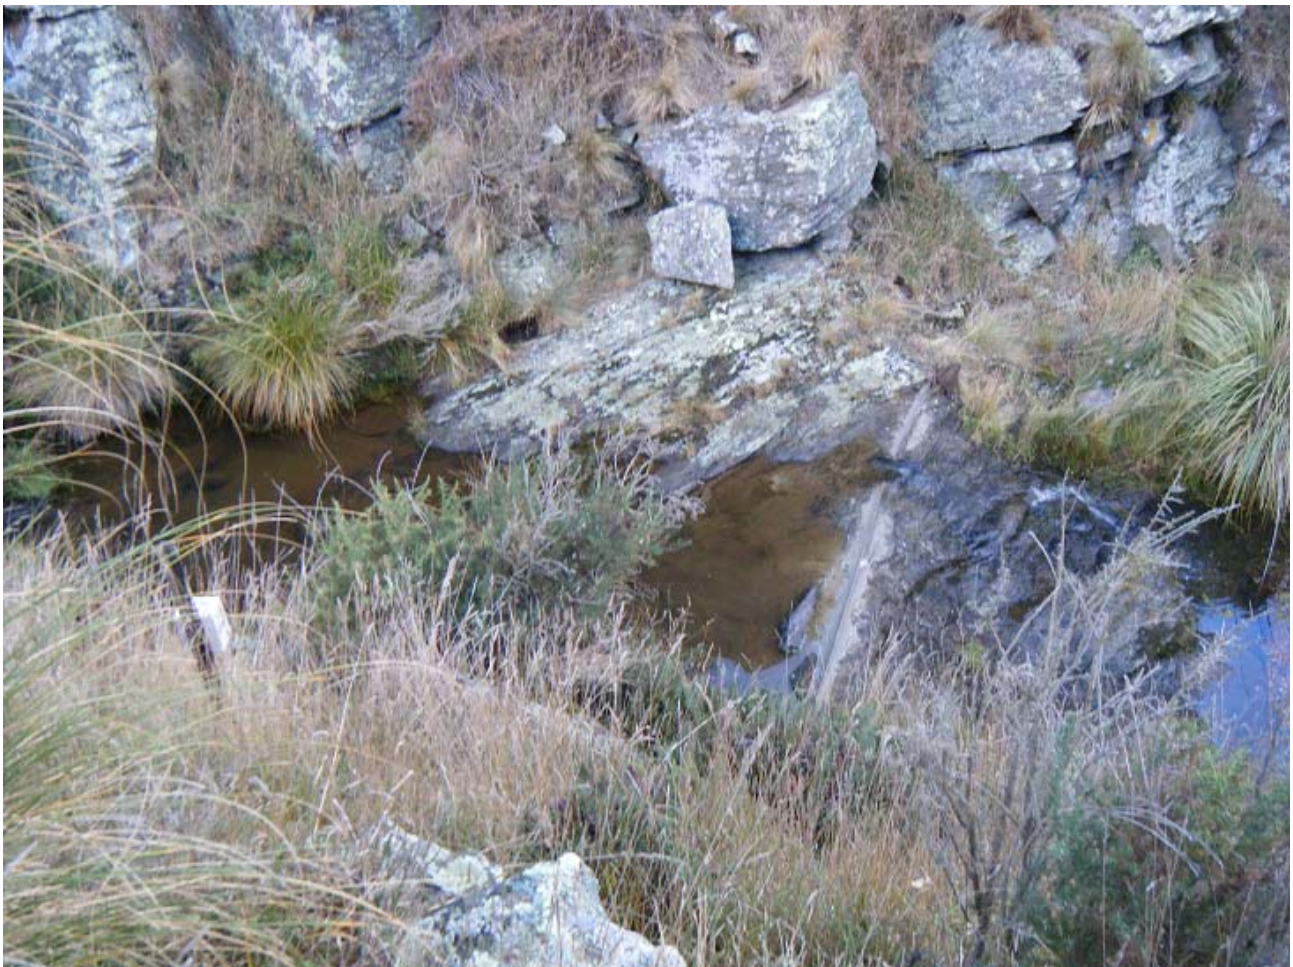
*Figure 3: Tipperary Creek site on 18-05-2010, flow estimated at approximately 2 L/s.*

The gauging on 25 May 2010 occurred during a flood event. The full section could not be gauged safely and only around 75% of the section was measured. The water level was pegged for later survey of the missing portion of the cross section. Where the water was too swift to enter, a velocity estimate was made based on previous verticals and professional judgement. The cross section was surveyed on the following visit. For this reason, the gauging on 25 May should be treated with caution as it has a larger degree of error than the other gaugings. The estimated margin of error associated with the 25 May 2010 gauging is 20% – 30% or  $\pm 0.8 \text{ m}^3/\text{s} - 1.2 \text{ m}^3/\text{s}$ , due to the estimated velocities in part of the section and the uncertainty in undertaking high flow gaugings. Figure 3 and Figure 4 show the site during low and high flow.

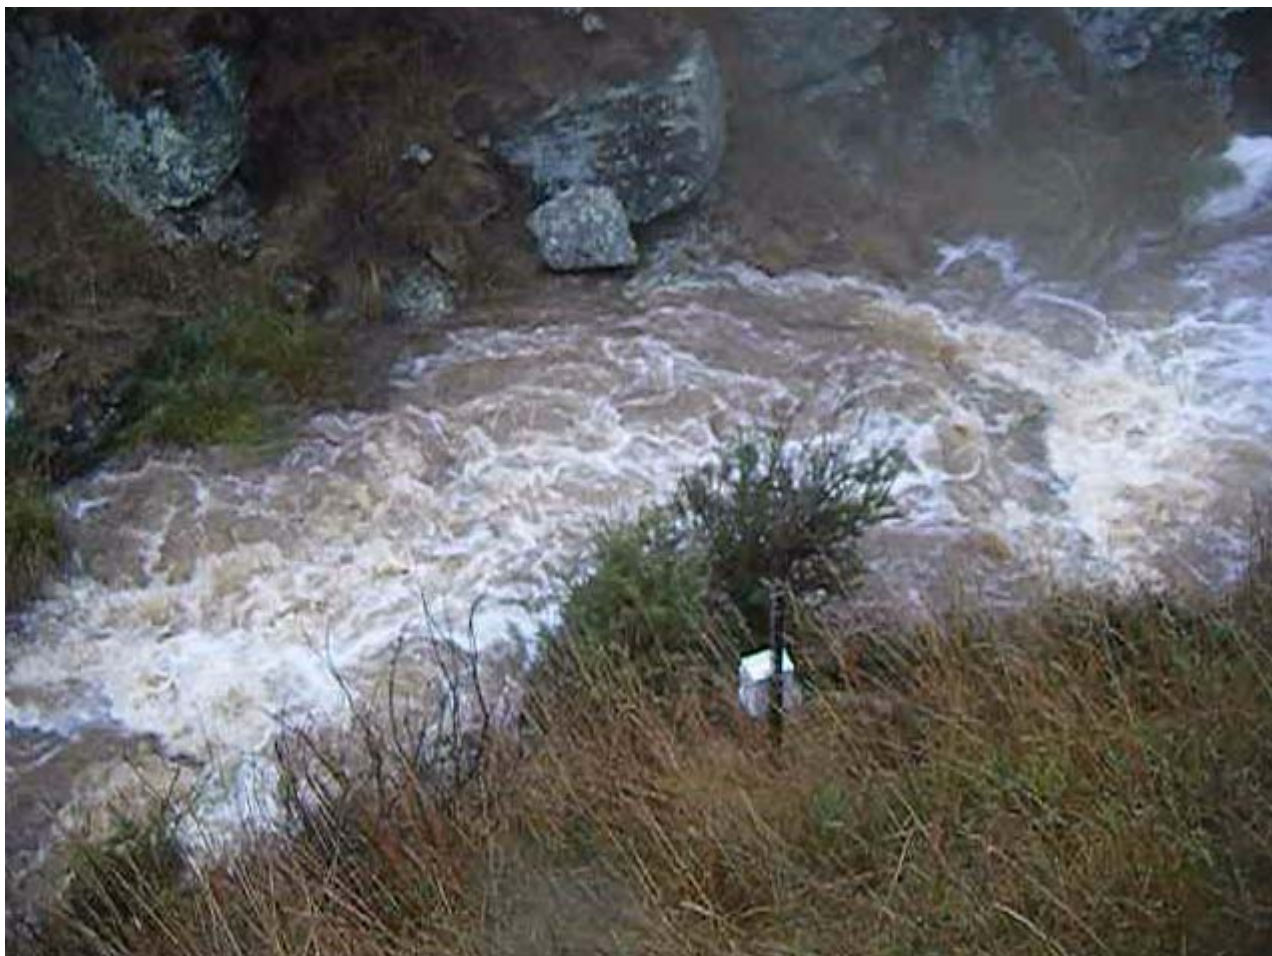
Figure 4: Tipperary Creek site on 25-05-2010, flow estimated at approximately 4,000 L/s

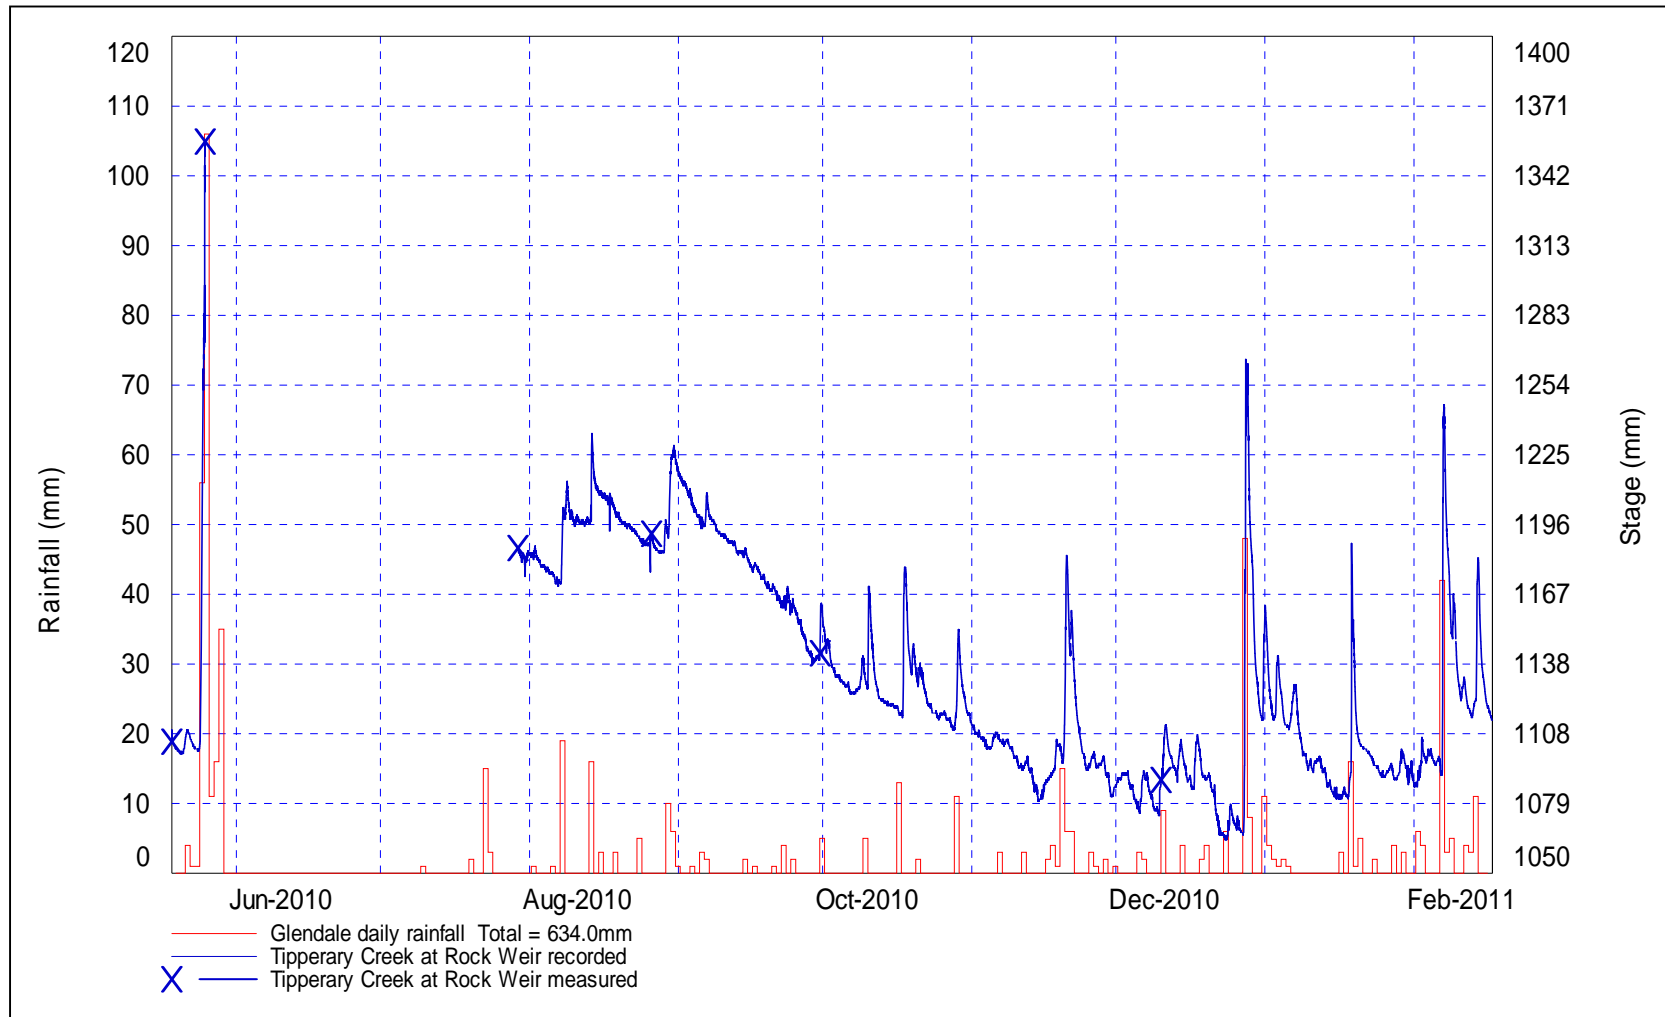
Figure 5: Tipperary Creek daily average water level data for the period 18 May 2010 to 17 February 2011 presented with rainfall data for the Glendale rainfall station.

Water levels in Tipperary Creek at the rock weir monitoring site have been recorded continuously by Golder since 18 May 2010. The water level record up to 17 February 2011 contains one gap associated with a large flood on 29 May 2010. During this flood the water level monitoring instrument was damaged and consequently stopped logging. The water level monitoring instrument was replaced during the next inspection on 29 July 2010 and logging recommenced. The recorded water level data are presented in Figure 5 as daily average water level. The data up to 30 September 2010 have been referenced to the external staff gauge (ESG). Due to the 22 February 2011 Christchurch earthquake it has not been possible to retrieve the field sheets from the site visits on 10 December 2010 and 17 February 2011. The water level data since 30 September 2010 has therefore not been referenced to the ESG and should be treated with caution. The water level immediately prior to the logger being damaged on 29 May 2010 should also be treated with some caution as there is some uncertainty over exactly when the logger was damaged.

Weed growth appeared to affect the water level data during a prolonged period of low flow between 26 August 2010 and 30 September 2010. Consequently, a data correction was undertaken to remove the effect of weed growth. A simple ramp correction was undertaken on the stage data after weed was removed on 30 September and the water level receded to its natural level. This ramp correction assumes weed growth rate was constant over this period.

Rainfall data from the Glendale rainfall monitoring station (I50341) until 17 February 2011 is also presented in Figure 5. The rainfall monitoring station is approximately 2.3 km northwest of the Tipperary Creek at rock weir flow monitoring site, at an elevation of 550 m. There is a strong correlation between water level in Tipperary Creek and local rainfall.

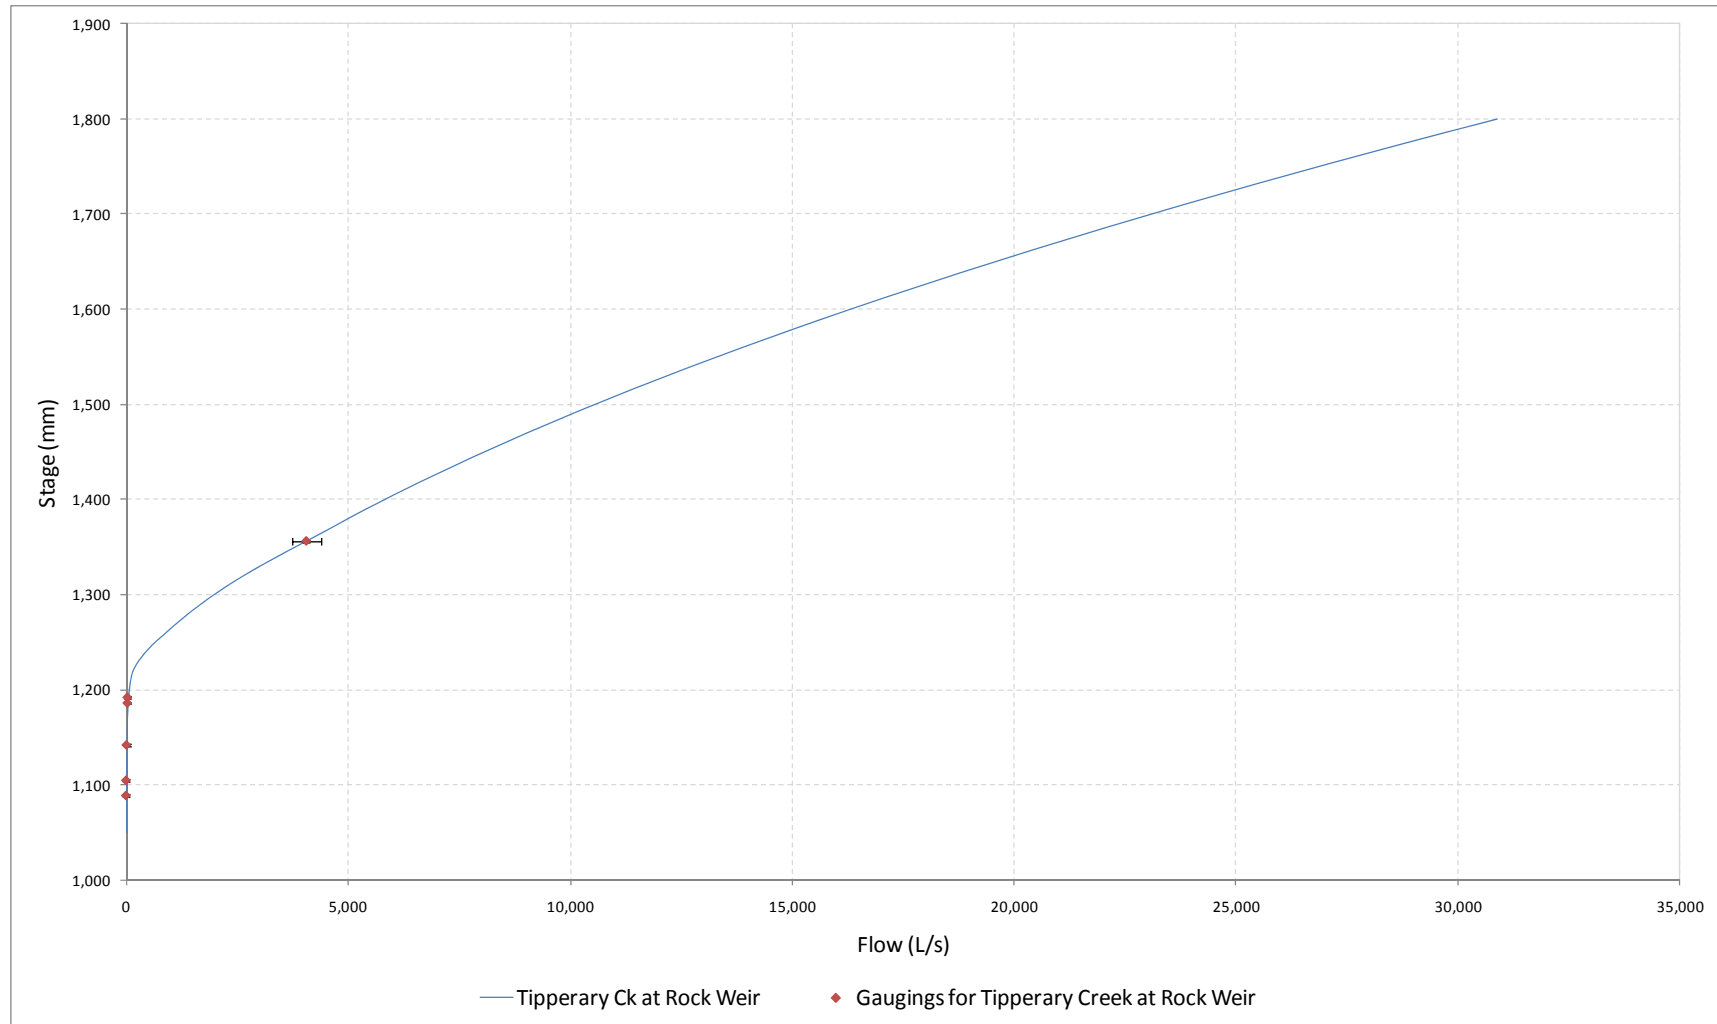
Figure 6: Tipperary Creek rating relationship (rating curve).

Of the seven instantaneous flow gaugings undertaken since installation of the water level monitoring equipment on 18 May 2010 (Table 1), six were used to derive a preliminary relationship between stage height and discharge (i.e. the rating curve). The gauging undertaken on 17 February 2011 was not included in generation of the rating curve as the 22 February 2011 Christchurch earthquake prevented retrieval of the necessary field sheets. The stage for zero flow, the level at which flow over the rock weir ceases, was estimated from survey data. Figure 6 presents the rating curve and Figure 7 illustrates the early portion of the curve.

No rating changes were observed over the monitoring period. The six gauged flows used to generate the rating curve ranged from 1 L/s to 4,051 L/s (Table 1 in Section 3.0). The gauging undertaken on 25 May 2010 (4,051 L/s) is considered high in the context of the data collected to date. All gauging points fit well (within 8%) on the preliminary rating curve that has been developed (Table 2) with the exception of the gauging on 26 August 2010. This gauging plotted around 14% off the rating and is possibly due to water level or gauging error.

The current rating relationship is considered reasonably strong for flows up to approximately 100 L/s. Additional gauging of flows greater than approximately 50 L/s is required to further develop and verify the preliminary rating curve.

The high end of the rating curve (flows > 4,051 L/s) has been calculated using extrapolated stage area and stage velocity curves, measured cross sectional area and an estimate of catchment flood flows. This high flow estimate of the rating should be treated with caution as no gauging data is available to qualify the estimate and it is likely that a reasonable degree of error will be associated with flows above 4,000 L/s. Flood gaugings should be targeted in the future.

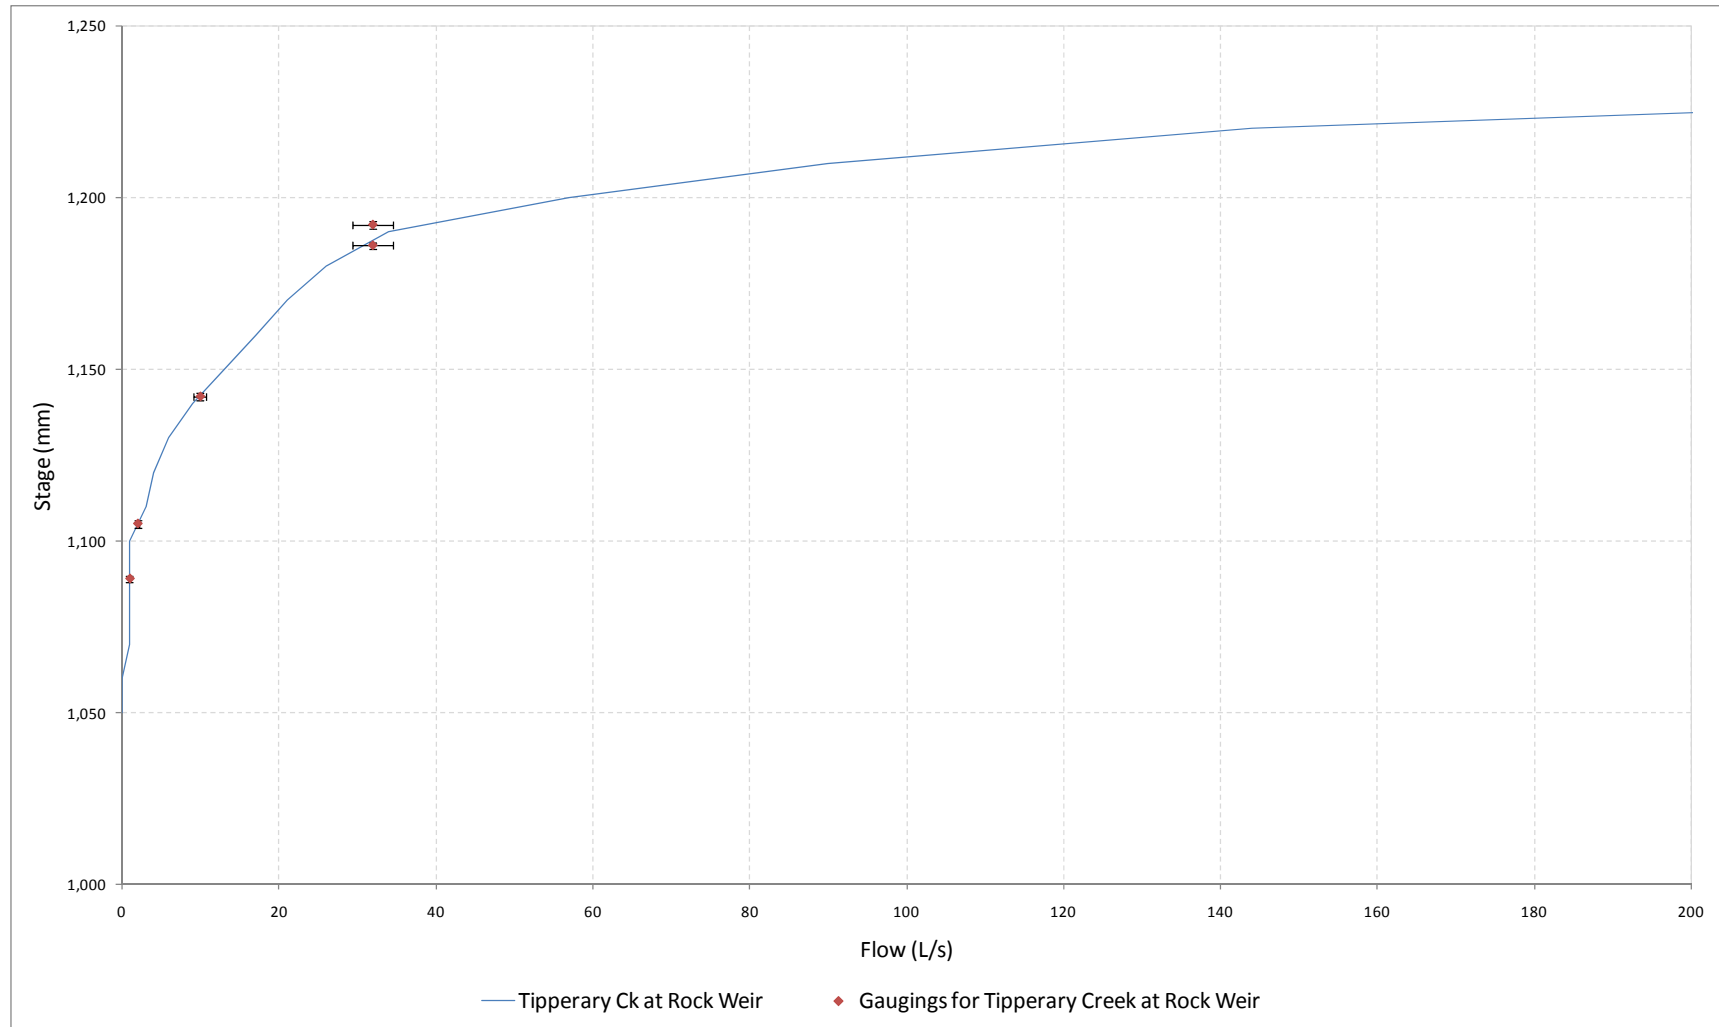
Figure 7: Tipperary Creek at rock weir rating relationship (rating curve) expanded.

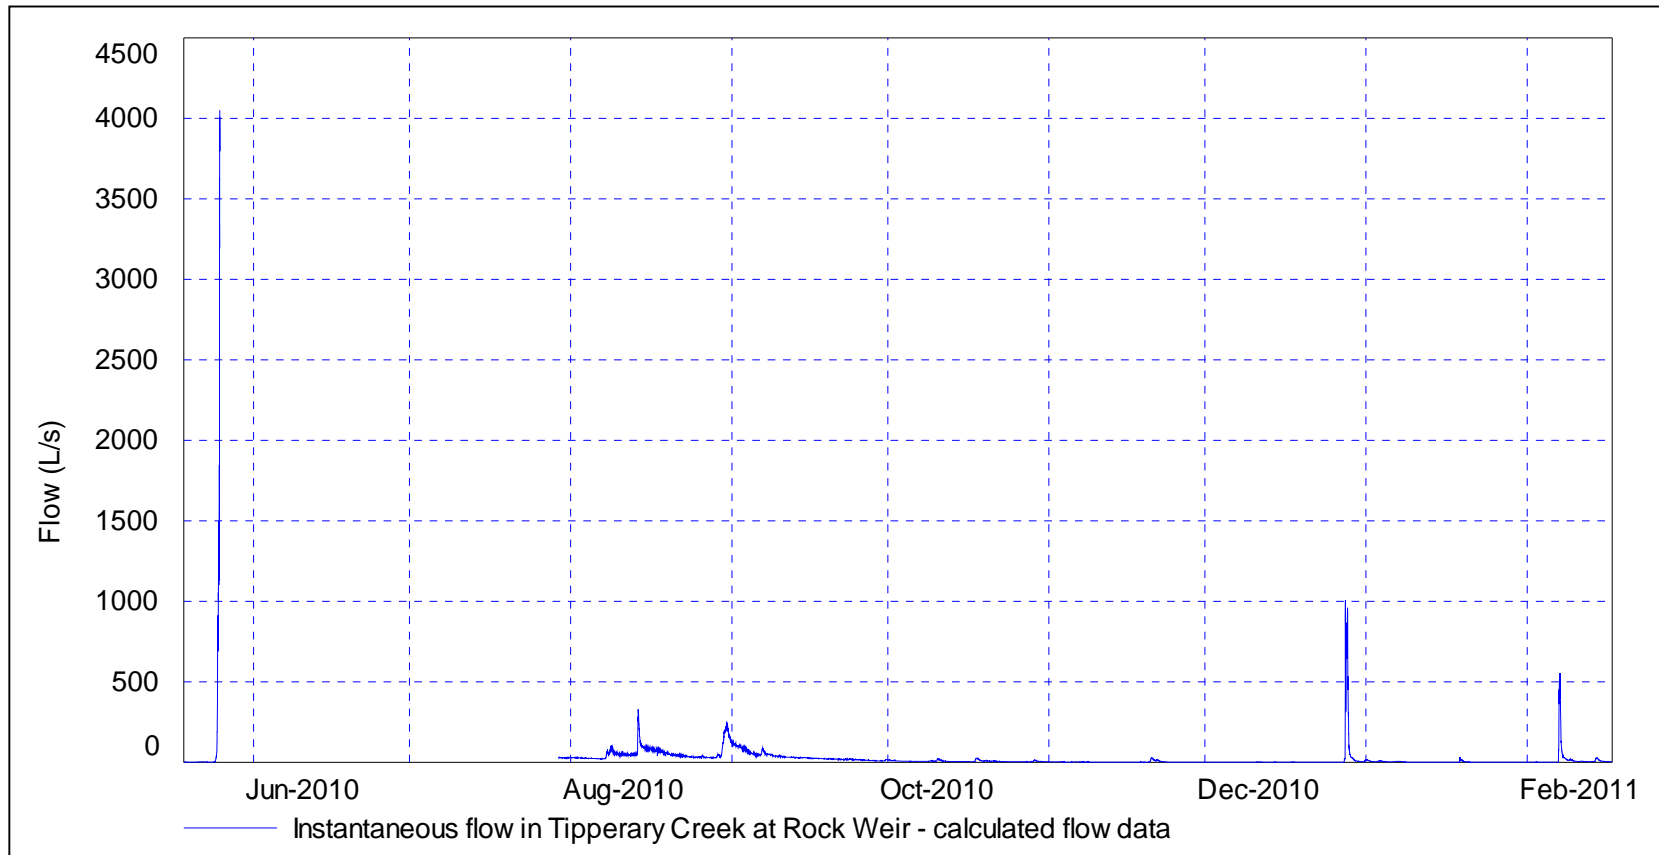
Figure 8: Tipperary Creek at rock weir calculated 15 minute flow data for the period 18 May 2010 to 17 February 2011

Water level data for the period 18 May 2010 to 17 February 2011 together with the rating relationship (Table 3) were used to calculate a 15-minute interval flow record for the Tipperary Creek at rock weir monitoring site (Figure 8 and Figure 9). The short record indicates that the Tipperary Creek experiences long periods of relatively low flow but can experience very large flood events. Between 18 May 2010 and 17 February 2011 the mean flow in the stream was 23 L/s while the median flow was 5 L/s. The minimum flow recorded was less than 1 L/s which occurred on 23 December 2010. A large flood event in the record peaked at approximately 4 m<sup>3</sup>/s on 25 May 2010.

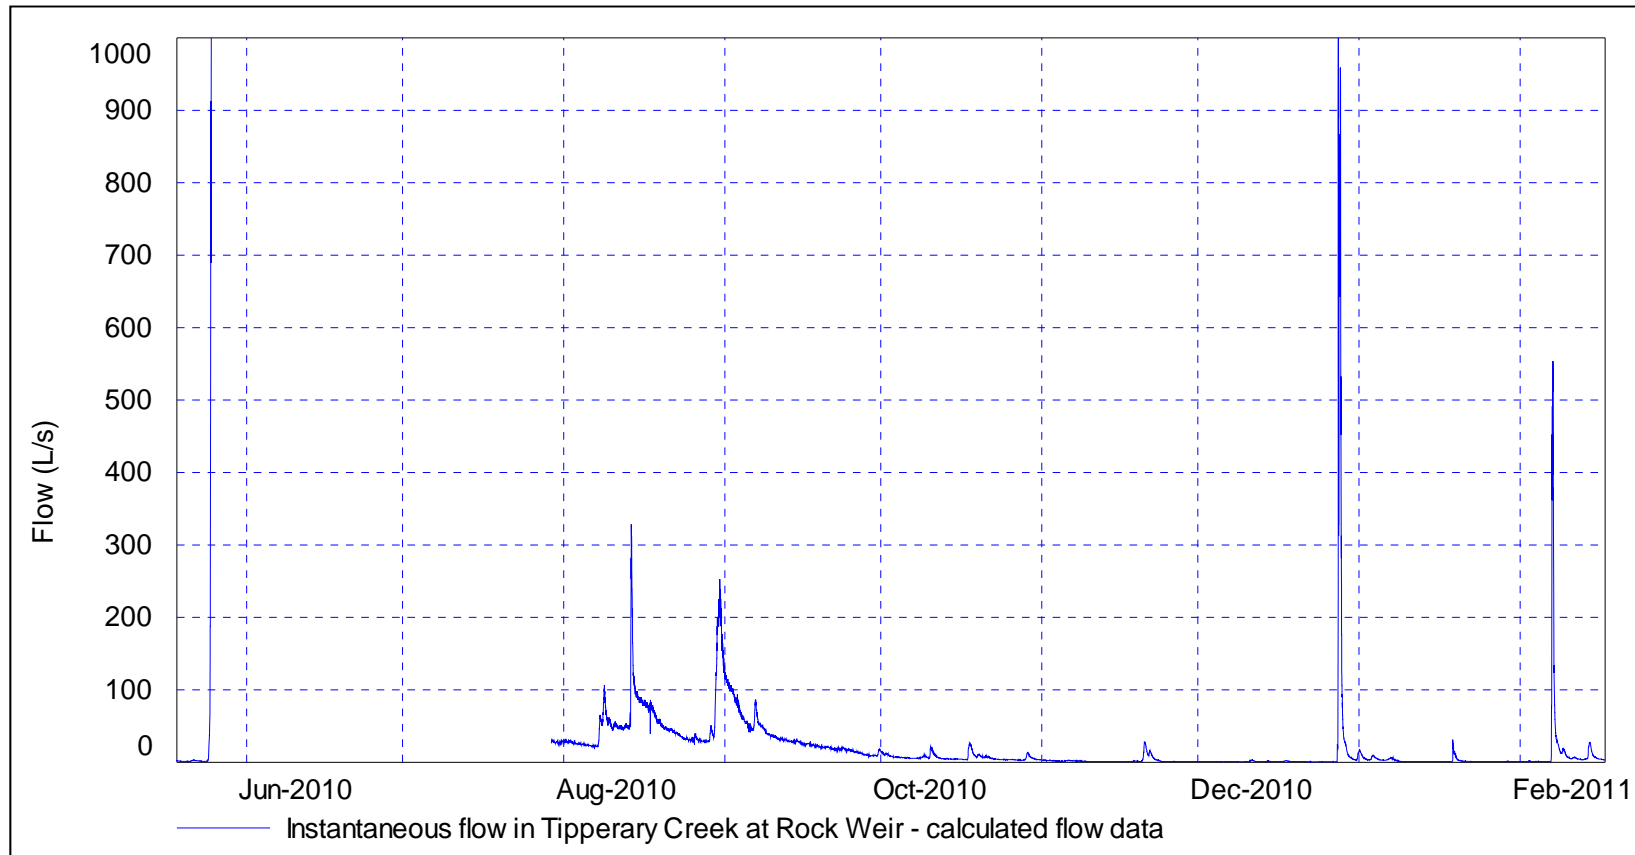
Figure 9: Tipperary Creek at rock weir calculated flow data for the period 18 May 2010 to 17 February 2011 (expanded 0 to 1,000 L/s).

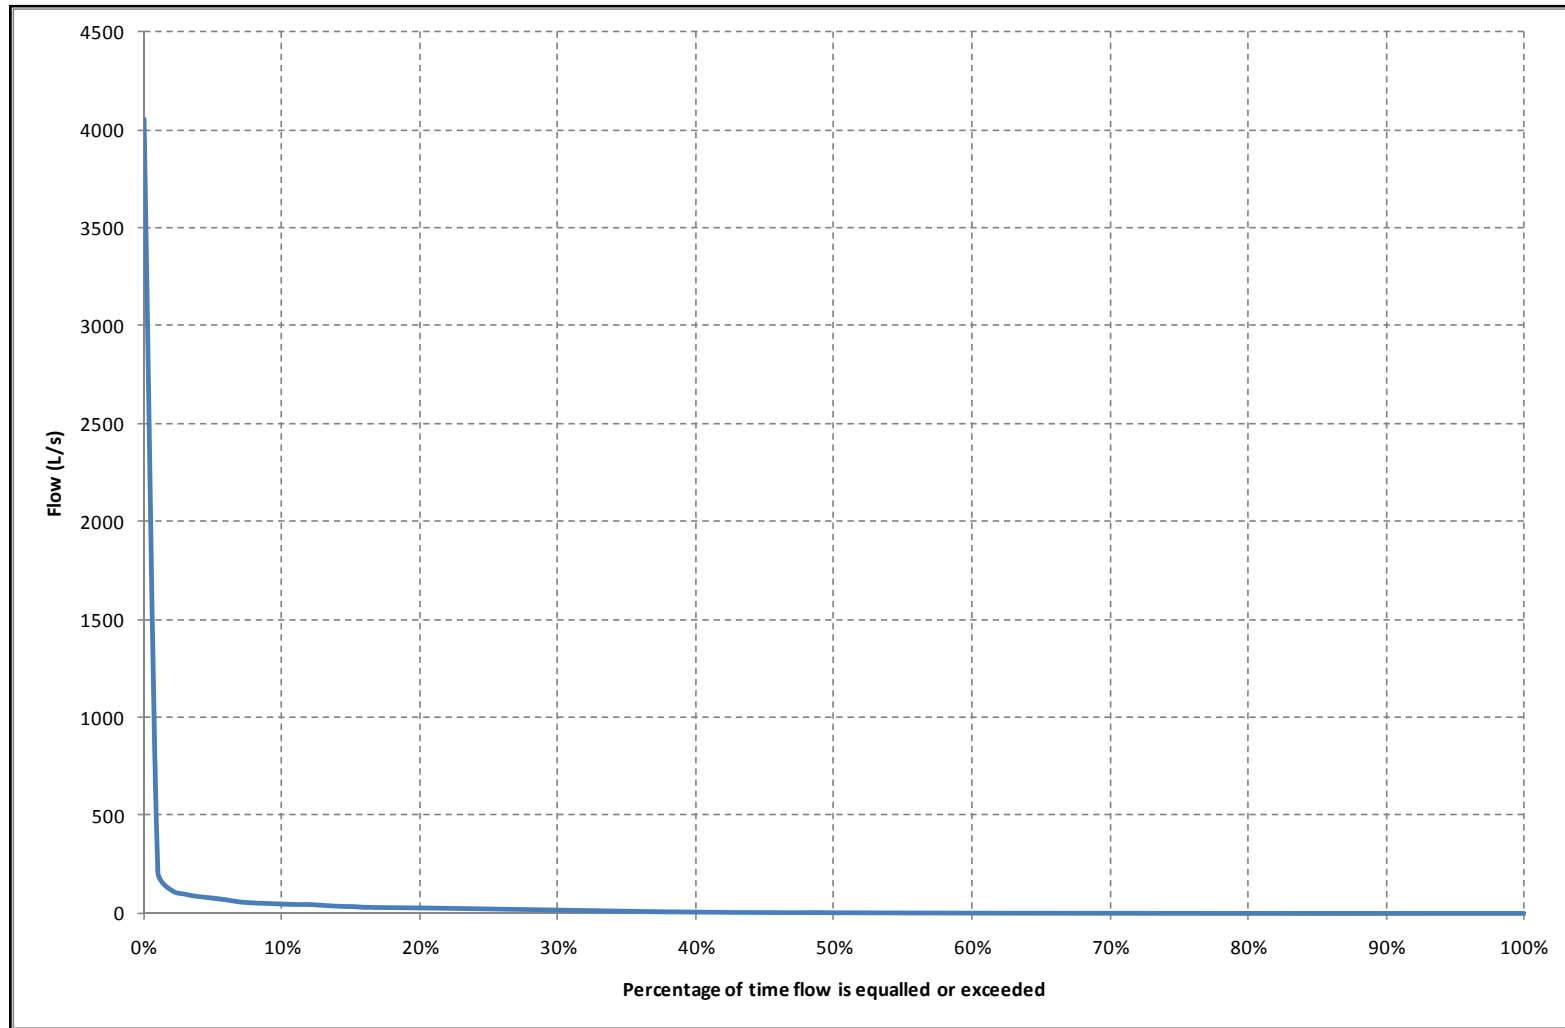
Figure 10: Flow distribution curve for the instantaneous flow record for Tipperary Creek at rock weir for the period 18 May 2010 to 17 February 2011.

The flow distribution curve for the record is shown in Figure 10 and expanded in Figure 11. These figures illustrate the exceedance percentiles for any given flow. Exceedance percentiles identify the period of time (identified as a percentage) that a particular flow is equalled or exceeded. For example (the flow at the Tipperary site equals or exceeds 18.0 L/s for 30% of the time over the monitoring period. Appendix C contains all the daily flow information derived from the water level information recorded at Tipperary Creek over the 18 May 2010 to 17 February 2011 monitoring period.

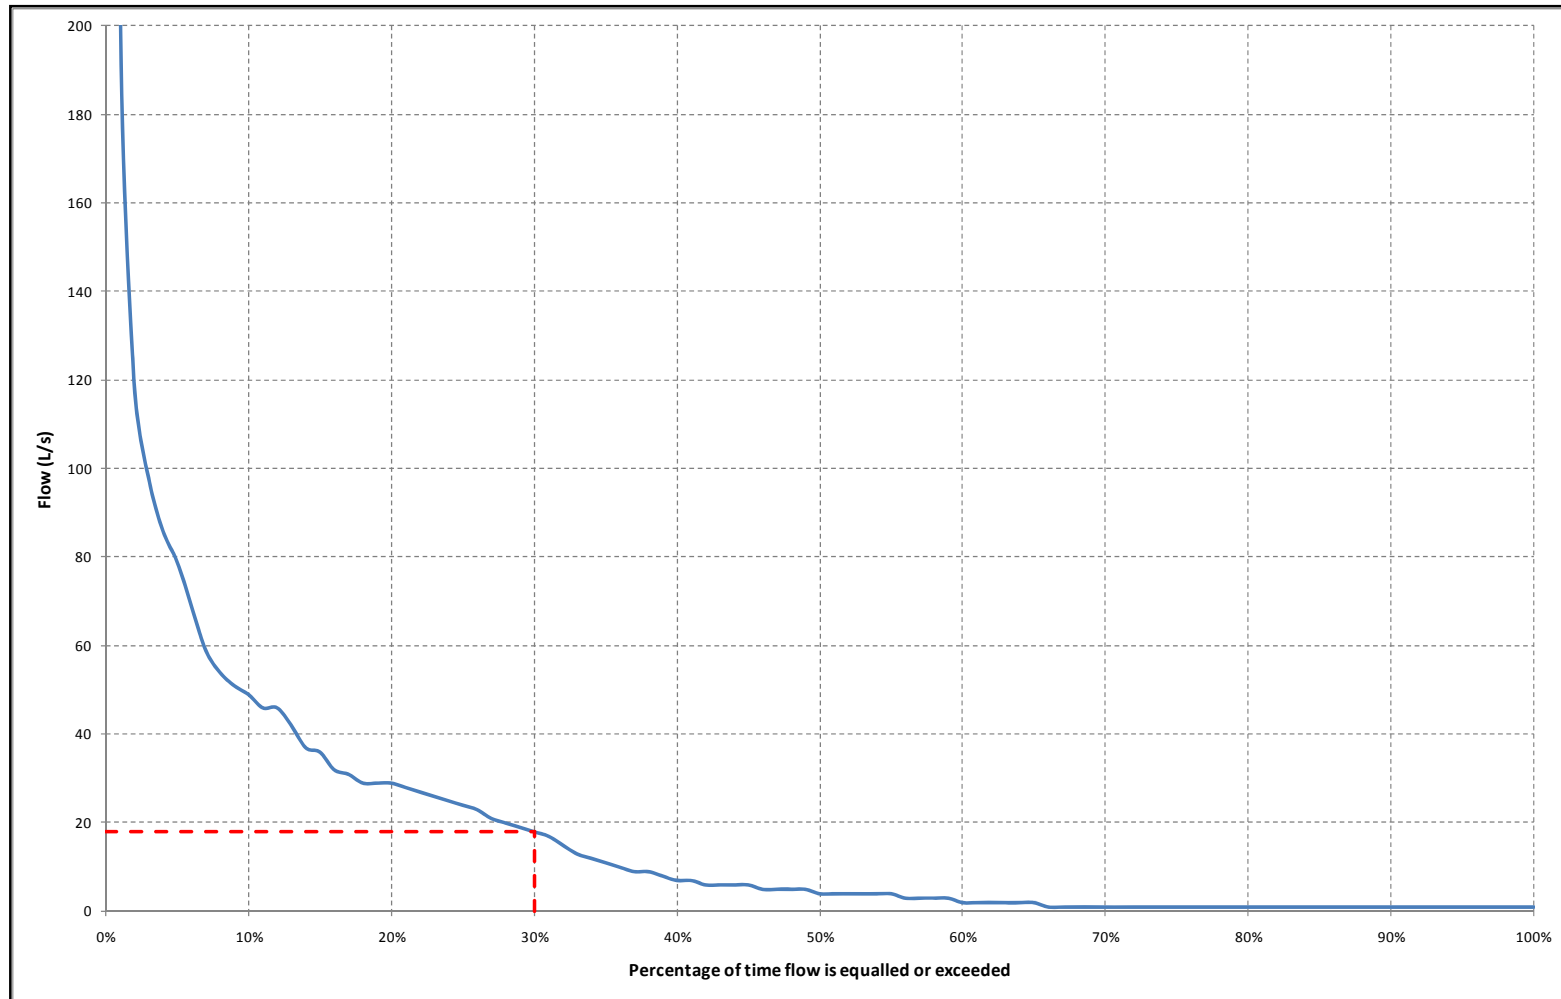
Figure 11: Flow distribution curve for the instantaneous flow record for Tipperary Creek at rock weir for the period 18 May 2010 to 17 February 2011.

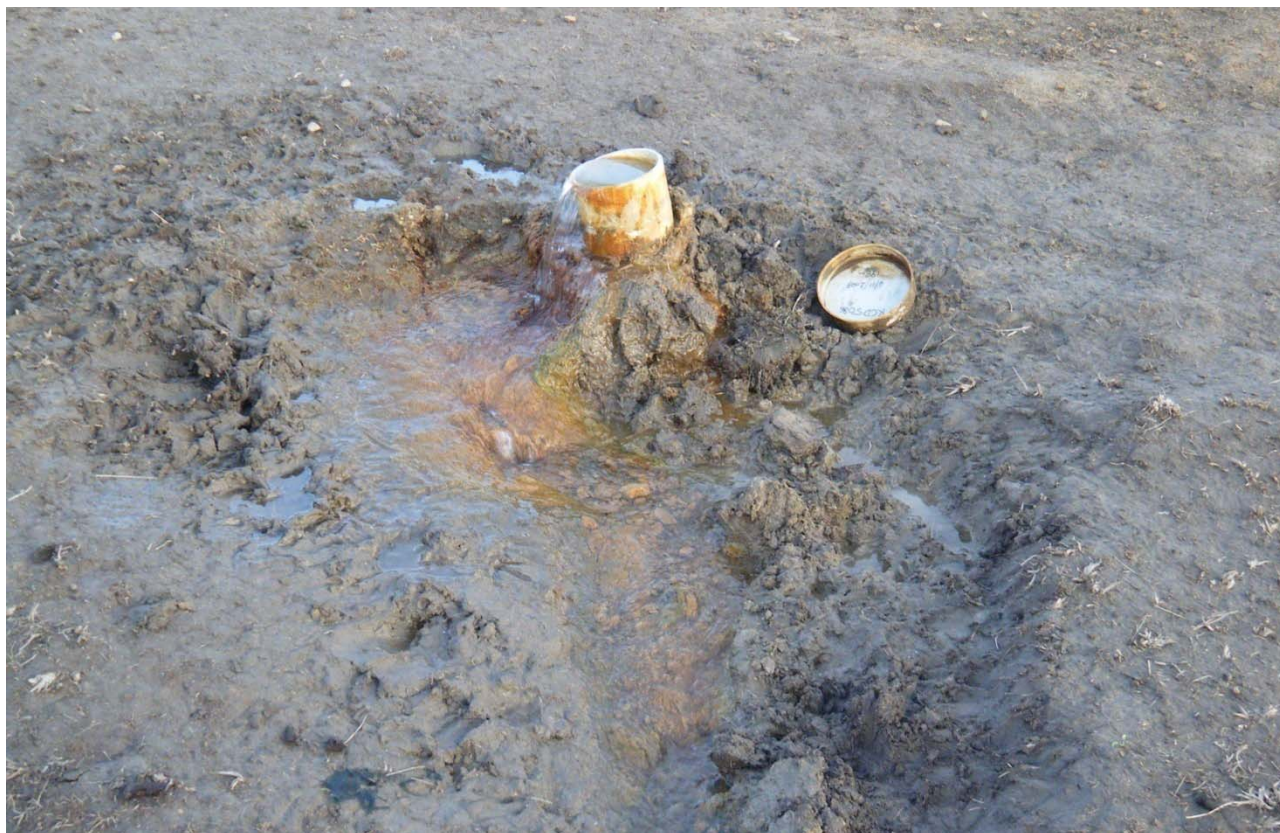
Figure 12: Artesian borehole with flowing groundwater.

Upstream of the hydrological monitoring site on Tipperary Creek, a source of groundwater enters the creek. The groundwater is sourced from an exploration borehole which became artesian after it was drilled (Figure 12). Groundwater now flows out of this uncapped borehole and into the Tipperary Creek catchment approximately 3.1 km upstream of the monitoring site. This additional flow artificially alters the flow regime, and the flow in Tipperary Creek must therefore be naturalised.

The flow of groundwater out of the borehole has been measured on seven occasions from 6 June 2010 to 17 February 2011 using a volumetric method. The time taken to fill a container of known volume is recorded, and a discharge rate calculated. The results of the seven volumetric measurements are summarised in Table 5.

The average flow of around 1 L/s from the artesian borehole signifies the artificial flow added to Tipperary Creek. Subtracting this artificial flow from Tipperary Creek flows provides the naturalised flow. Naturalised flow statistics for the period 18 May 2010 to 17 February 2011 are presented in Table 6 and Table 7. The naturalised record indicates the stream was likely to have ceased flowing at the monitoring site during the dry summer period. Mean naturalised flow for the monitoring period was 22 L/s while the median naturalised flow was 3 L/s. The maximum flow is unaffected by the small addition and as such is still around 4 m<sup>3</sup>/s. Appendix C includes all naturalised daily flow information calculated for Tipperary Creek over the 18 May 2010 to 17 February 2011 monitoring period.
